Experimental and Numerical Studies on Repaired Wooden Beam of Traditional Buildings in Huizhou Region, China

Abstract: In this study, three different repair methods are proposed for the common broken parts of traditional wooden beams. Four wooden beams without initial damage and six repaired beams in a planar wooden frame are tested and numerical simulated. The test phenomena, bearing capacity, and stiffness of all the wooden beams are analyzed. Compared with the wooden beams without initial damage, the bearing capacity of the beams with upper inlay repair, upper core repair, partial tenon repair, and lower core repair increases by 38.93%, 13.06%, 5.08%, and 3.94%, respectively. Furthermore, the experimental and numerical results indicate that the upper and lower parts of the wooden beam with initial damage can be more effectively repaired by the inlay and core methods, respectively. When the tenon is partially damaged, the mechanical properties of the wooden beam are improved after repair. The simulation of lower inlay repair shows that the bearing capacity of the wooden beam is inversely proportional to the repair height and the distance between the repair position and the span.

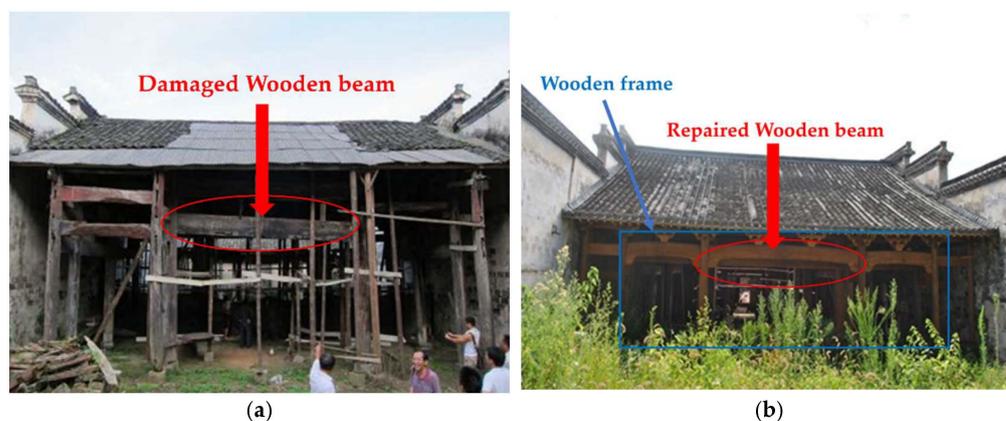
Figure 1. Repair of traditional wooden beams at Dunmu hall in Huizhou: (a) before repair; (b) after repair.

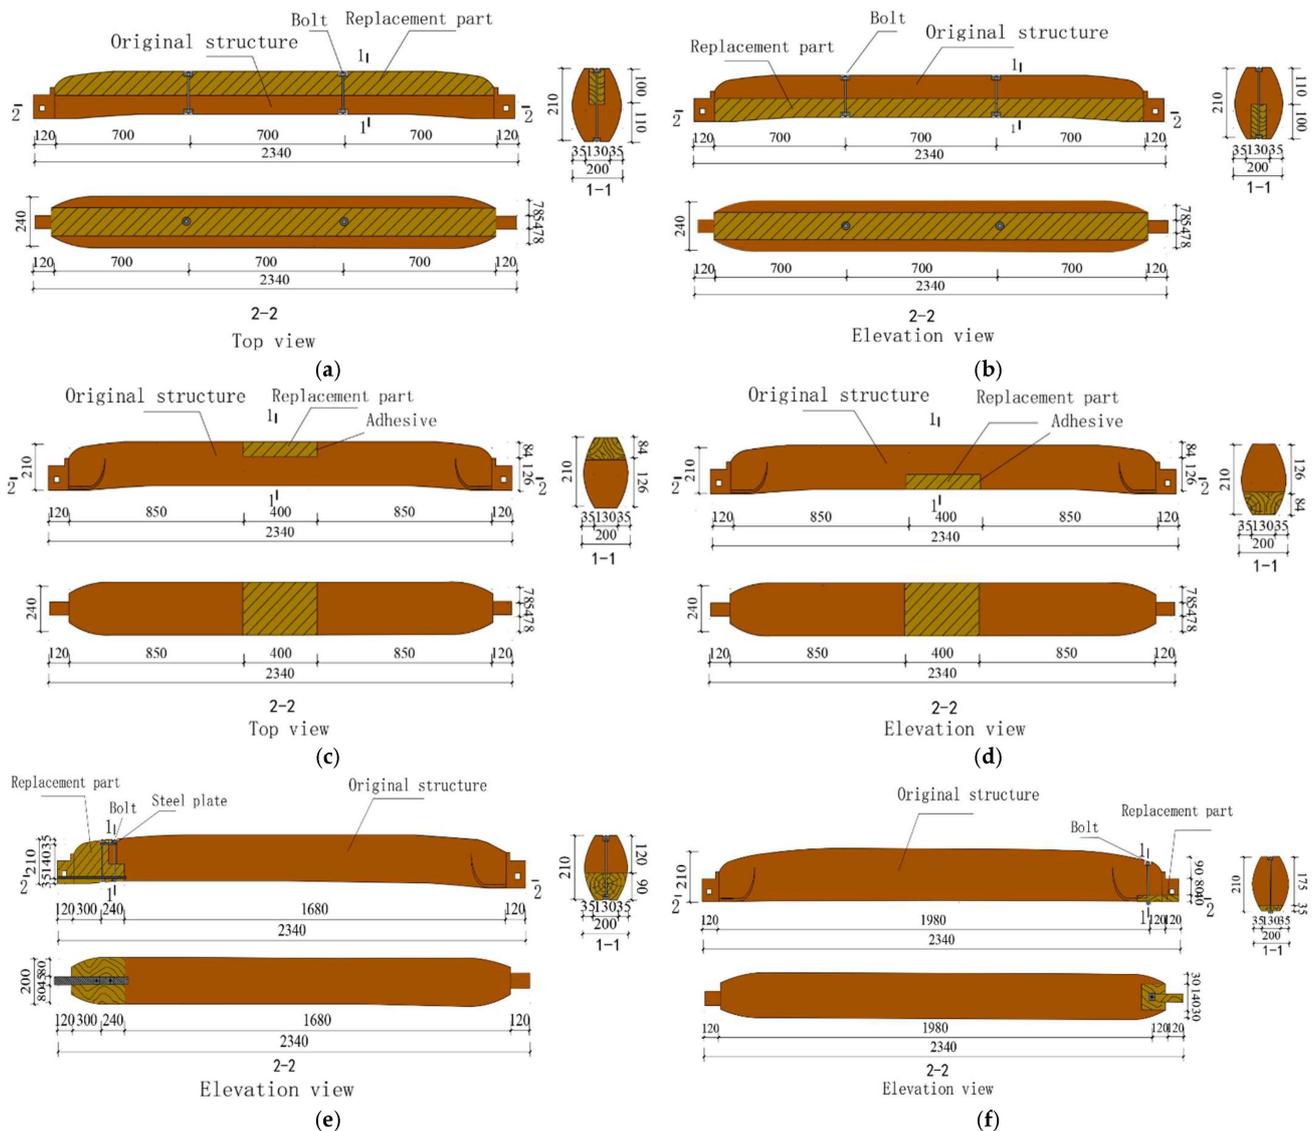
Figure 3. Restoration of specimens: (a) specimen B2Z; (b) specimen B2Y; (c) specimen B3Z; (d) specimen B3Y; (e) specimen B4Z; (f) specimen B4Y (unit: mm).

Based on a site survey of the damaged parts of wooden beams in the traditional building Dunmu Hall, three repair methods have been designed to stably connect the original structure and replacement part. These repair methods are shown in Figure 3. In the core repair method, bolts are used to connect the original structure with the replacement part. In the inlay repair method, the original structure and replacement part are bonded with an adhesive layer. In the tenon repair method, the wooden beam is connected to the completely repaired tenon with steel plates and bolts and the 1/3 repaired tenon with bolts.

These methods are designed based on the principle of “maintaining original appearance after restoration”. A Q235 steel plate with a yield strength of 235 MPa and thickness of 10 mm is used. The length of the M8 bolt is 190 mm. All the plates and bolts are placed inside the structure to retain the original appearance of the old building. The wooden beams are divided into five groups: 1–5. Among them, two groups (group 1 and 2) are without initial damage and the other three (group 3–5) are repaired by different methods. The letters Y and Z refer to the right and left side of the timber frame respectively.

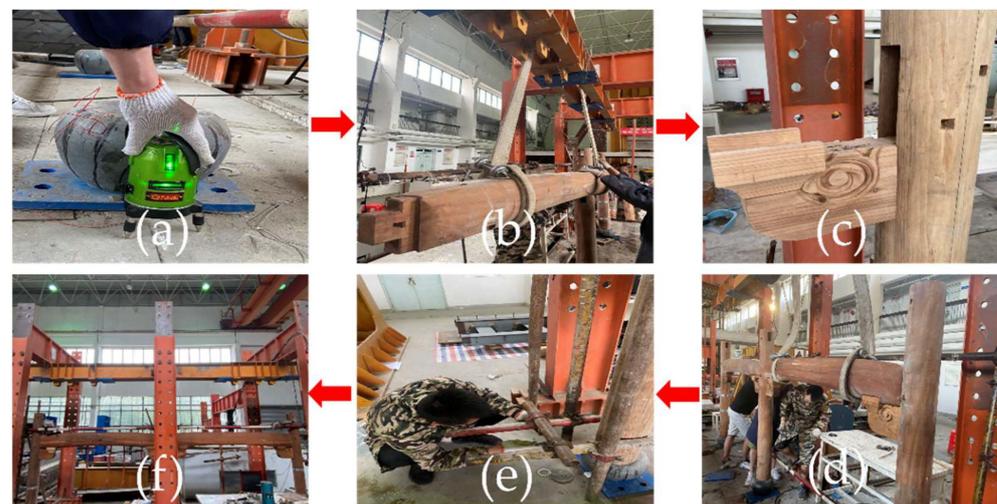
Figure 4. Assembling process: (a) determination of plan axes; (b) lifted wooden beams; (c) connection of sparrow brace with the wooden columns; (d) assembly of wooden beams and columns; (e) installation of lateral supports; (f) installation of loading devices.

With reference to the traditional building Dunmu Hall in Xu Village, Huizhou region, five 1:2.75-scale wooden frames have been designed for the vertical loading test. The details were presented in Table 1. Figures 4 and 5 show the assembly process and overview of wooden beams after repair, respectively. The planar wooden frame has been assembled from wooden beams, wooden columns, and sparrow brace. The sparrow brace in Figure 4c is a load-bearing and decorative component. A rectangular block named “Guanjian” is used to connect the beam to the column. The dimensions of the wooden beams are 2340 mm × 210 mm × 200 mm, and their surface is chamfered with a radius of 6 mm

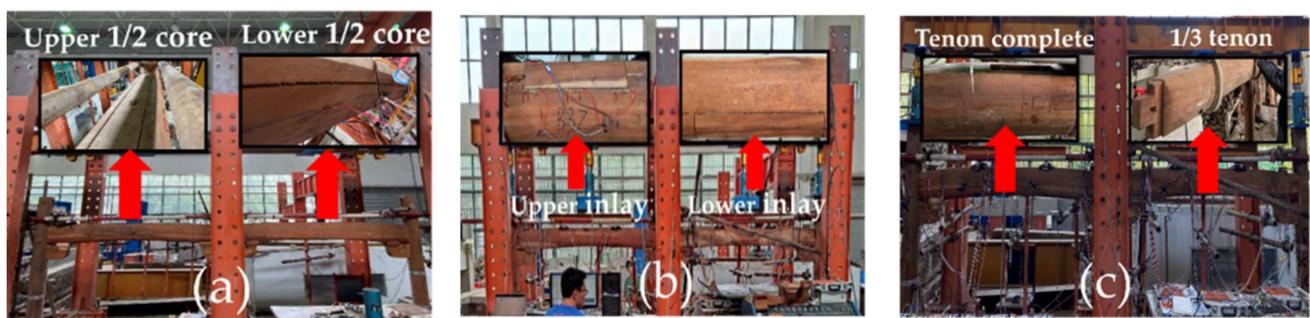
Figure 5. Overview of the wooden beams: (a) core repair; (b) inlay repair; (c) tenon repair.

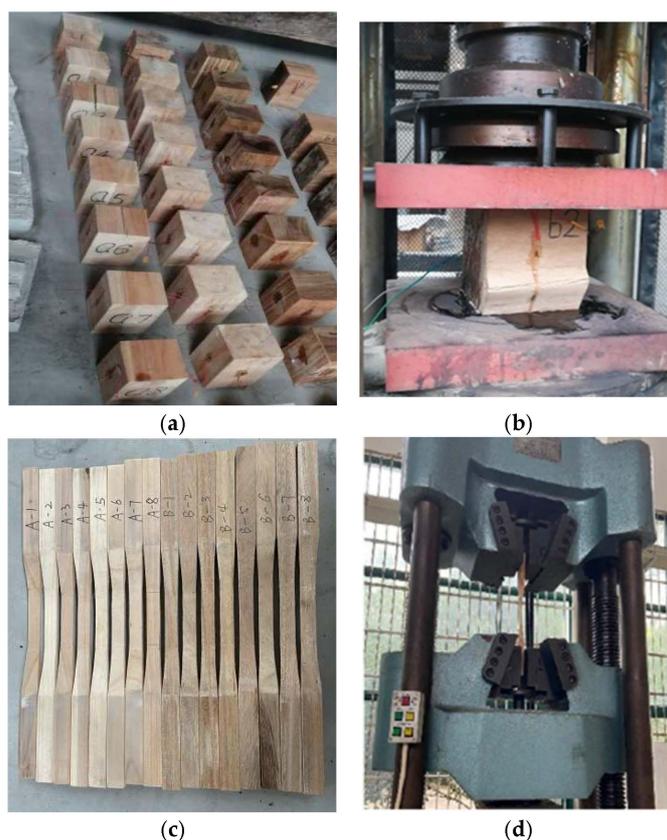
Figure 6. Material property test: (a) test blocks for compression test; (b) servo-electric universal testing machine; (c) test blocks for tensile test; (d) electro-hydraulic type pressure tester.

The wooden beams were made of Malaysian Merbau and Chinese fir. Figure 6 shows the test blocks prepared to examine the mechanical properties of wood based on the relevant standards [38–40]. The mechanical properties of wood are listed in Table 2.

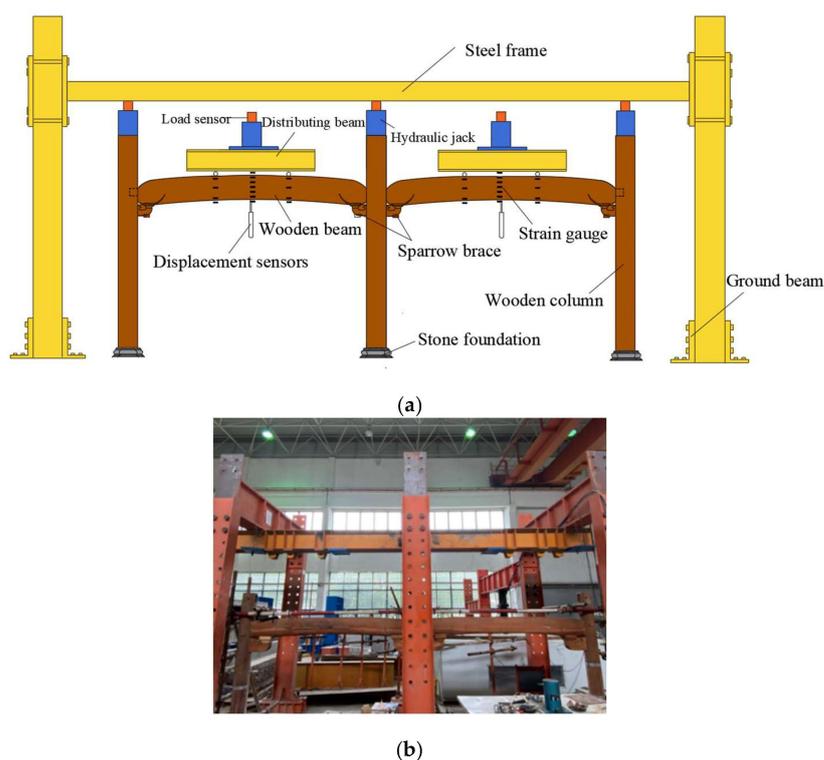
Figure 7. Schematic of test working conditions: (a) experimental setup; (b) field image.

The experiments were performed in the structural test hall at the Anhui University of Architecture. A 50 t hydraulic jack was used to apply vertical load to the distribution beam and transfer it to the wooden beam. To prevent out-of-plane displacement of the wooden frame, lateral support restraint was set. Considering the effect of actual constant load of roof on the mechanical properties of the wooden frame, the wooden column was loaded to 20 kN in the first stage of loading, which was kept constant during the test. For failure loading, a preliminary value of 20 kN was maintained for 5 min to eliminate the installation error of the specimen. When the test was officially started, the vertical load was applied at a rate of 2 kN/min until beam failure. When the load value dropped to 80% of the ultimate load, it was considered that the specimen is destroyed. The loading test setup is shown in Figure 7.

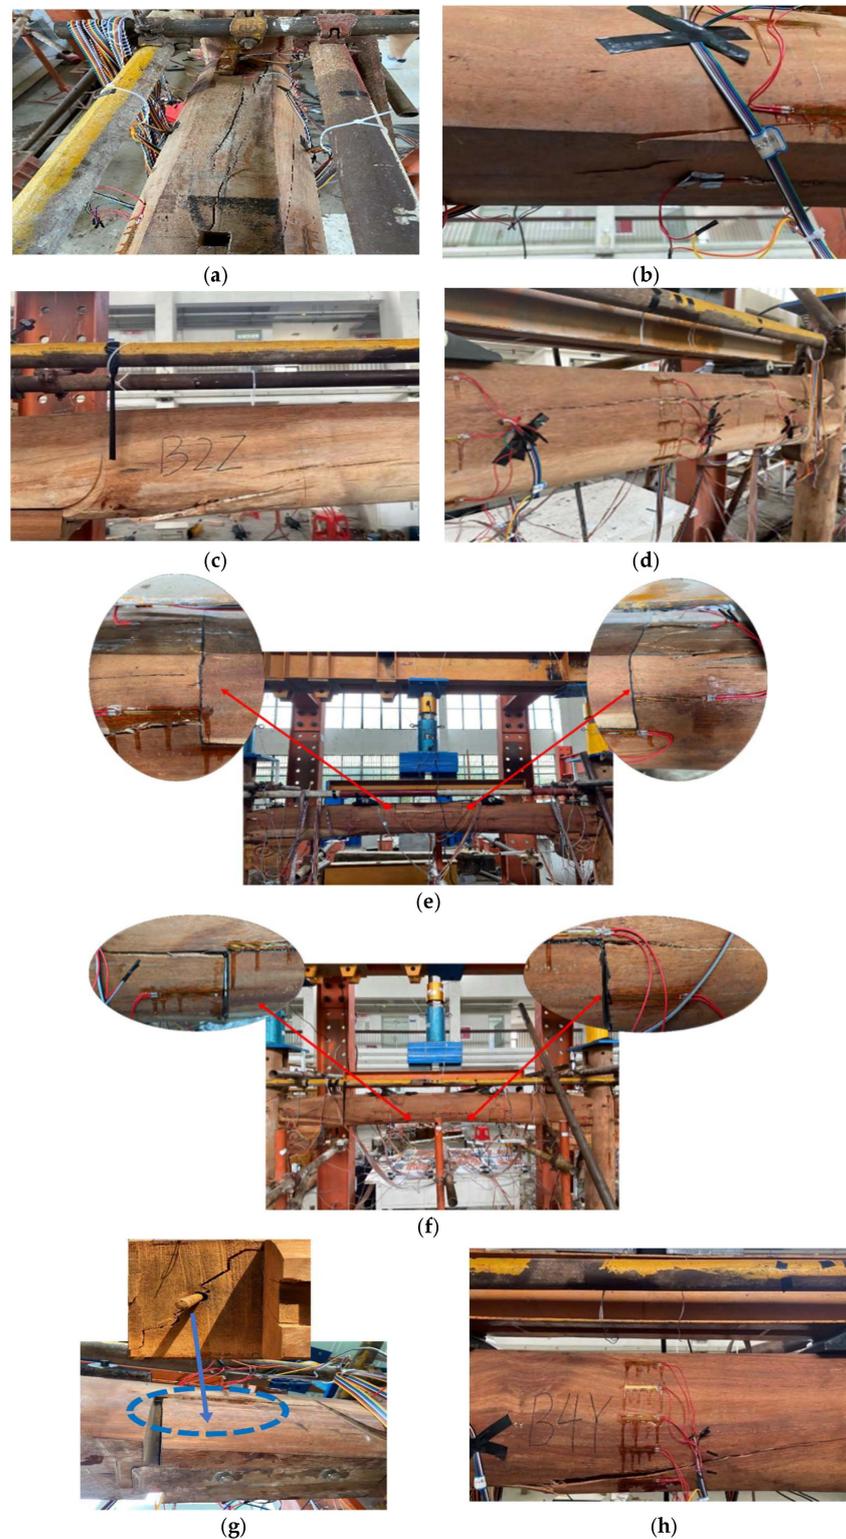
Figure 8. Damage patterns of the specimens. (a) B1Z; (b) B1Y; (c) B2Z; (d) B2Y; (e) B3Z; (f) B3Y; (g) B4Z; (h) B4Y.

The failure modes of the B0 and B1 groups are shown in Figure 8a,b. The wooden beam moves downward with the increase in load during the initial loading process. When the load reaches 47% of the final load, transverse cracks appear in the compression zone along the down-grain direction of the beam. When the load reached 80% of the final load, the pulling and cracking sound of wooden fibers started to become intense. Eventually, the tensile zone at the bottom one-third and two-third of the length cracked with a loud sound.

Figure 8c,d present the failure modes of the B2 group. When the load of the specimen B2Z reaches nearly 45% of the ultimate load, a preliminary crack is developed in the upper-pressure zone of the specimen. As the load increases, folded wood fibers appear at the pressure area. When the load reaches nearly 80% of the maximum bearing capacity, transverse cracks appear at the tensile zone along the left one-third of the specimen. At the same time, a horizontal crack at one-third height of the span gradually expands to the ends. Further, the specimen cracks at the span center. Eventually, the crack extends toward the bottom of the tensile zone of the specimen and the tensile zone suddenly breaks. The reinforced part of the B2Y specimen is completely peeled off from the structure.

Figure 8e,f demonstrate the failure mode of the B3 group. Under loading, the two specimens of this group exhibit significantly different damage patterns. For specimen B3Z, extrusion wrinkling gradually appears in the repaired part of the pressure zone when the load reaches approximately 63% of the maximum bearing capacity. As the load increases, it extends along the edge of the repaired part toward the loading points on both the sides. For the B3Y specimen, the initial failure occurs at the repaired part of the vertical contact with the structure. This phenomenon is primarily attributed to the considerable transverse stress at this location and the initial formation of transverse cracks. Finally, the wooden fibers gradually pull apart laterally along the top of the repaired section.

Figure 8g,h show the failure mode of the B4 group. For specimen B4Z, as the load increases, the repaired part of the pressure area is horizontally extruded from the structure, and a large gap is formed between the reinforced contact area and the structure. When the

load reaches nearly 58% of the maximum bearing capacity, a clattering sound continuously comes from the end of specimen B4Y. Eventually, the reinforced part splits along the bending direction of the bolts, and the bottom of the tensioned area is detached from the original structure.

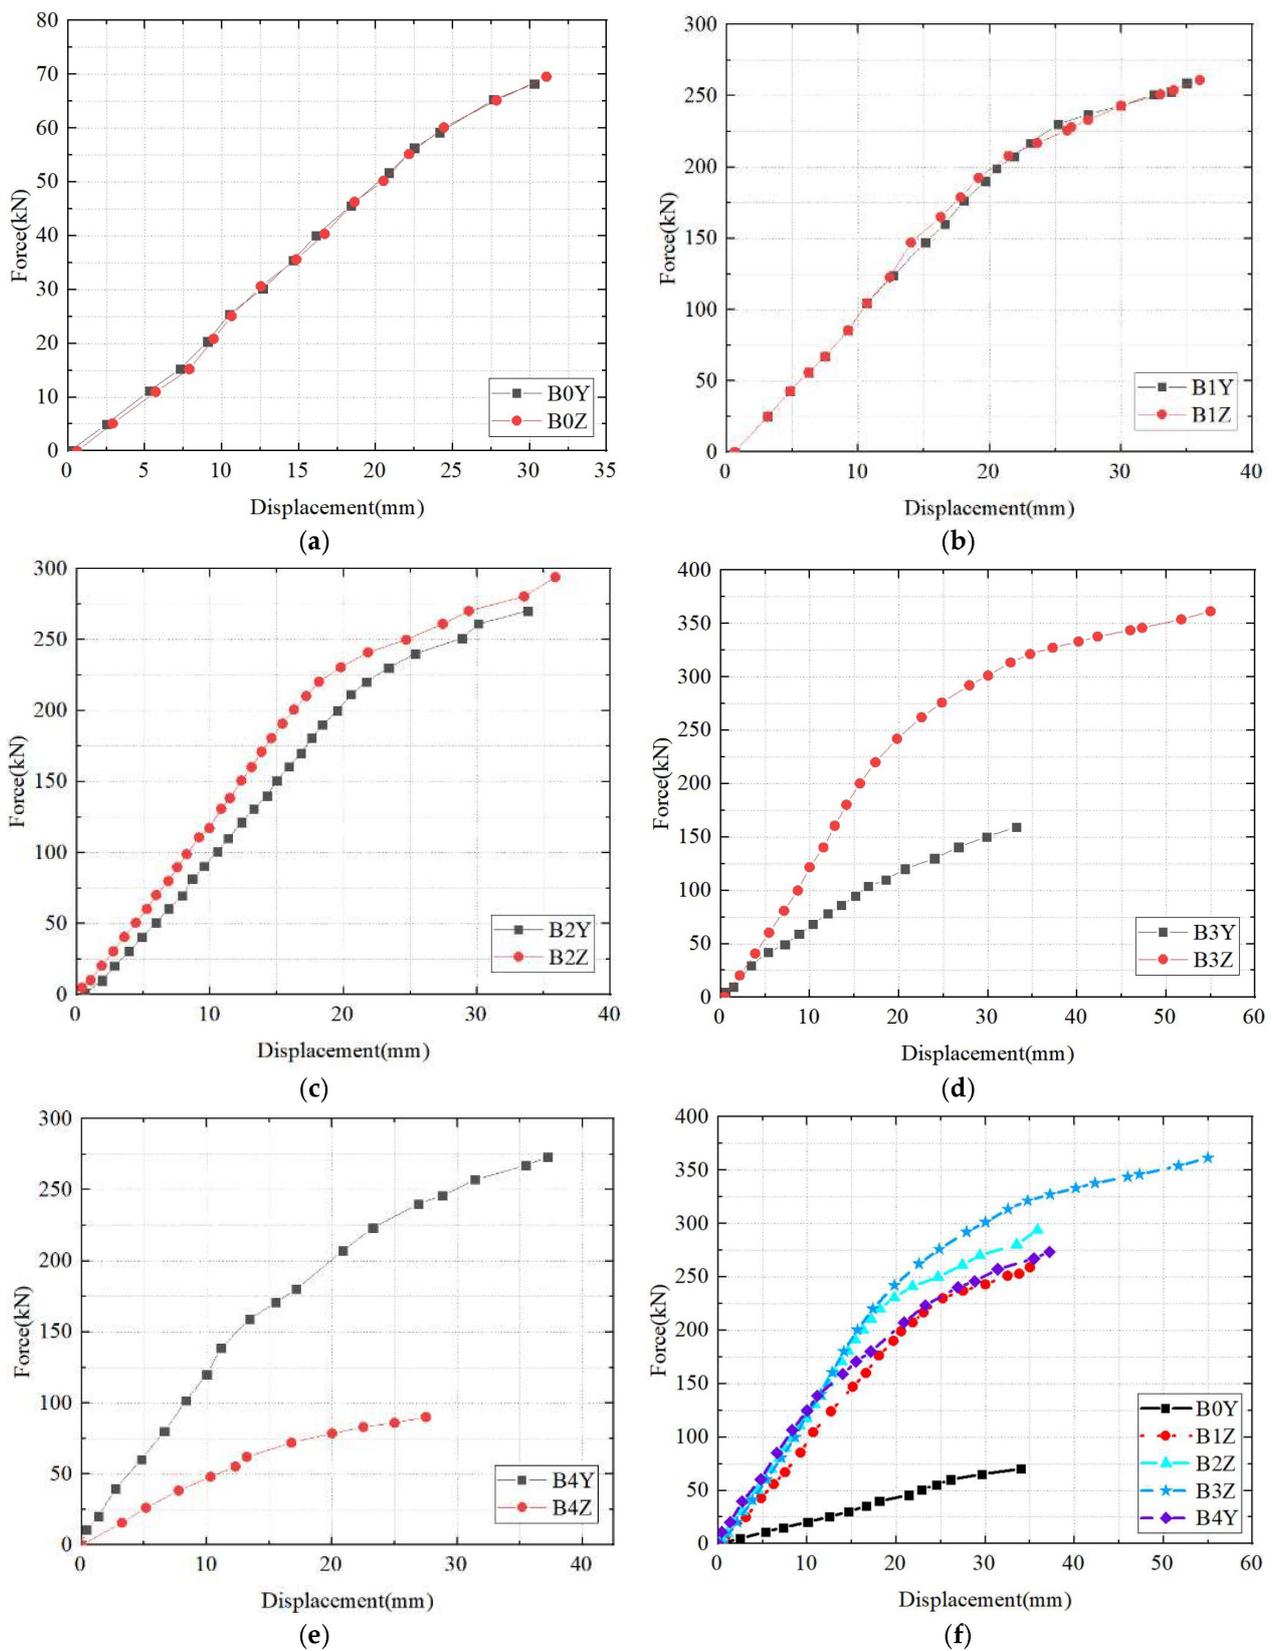
Figure 9. Force-displacement curves of the specimens: (a) group 1; (b) group 2; (c) group 3; (d) group 4; (e) group 5; (f) typical specimens of each group.

Figure 9 shows a comparison between the force-displacement curves of the five specimen groups. The ultimate load and ultimate displacement of each group of specimens are not equal, but the load and displacement linearly increase at the beginning of loading. In the wooden beam without initial damage, the ultimate load capacity of group 2 is nearly 3.71 times higher than that of group 1. Due to the large wood dispersion, the wooden fibers of the unrepaired beam are easily pulled off, resulting in smaller plastic deformation of specimens B1Y and B1Z. However, the variation trends of stiffness and ultimate bearing capacity of both the specimens are approximately similar. In the group 3, the specimen B2Y is less stiff than the specimen B2Z, which is due to the gap formed between the reinforced part and the wooden beam at the bottom of specimen B2Y as the load increases. When the specimen enters the yielding stage, the reinforcement contact area at the tensile zone is co-tensioned and the gap gradually increases. Eventually, the specimen peels off laterally along the core-planted reinforcement part, and brittle damage occurs. The ultimate bearing capacity of specimen B2Y is increased by 3.96%. For the bending specimens in group 4, the ultimate bearing capacity of specimen B3Y is only 0.41 times that of specimen B3Z. When the bottom tensile stress of specimen B3Y is large, stress concentration occurs in the reinforcement part, inducing a transverse tensile gap after gradual detachment. The reinforcement in the compression zone is better than that in the tensile zone because the plastic deformation capacity is enhanced after the replacement and reinforcement of damaged parts in the compression zone. However, because stress concentration occurs in the reinforced part of the tensile zone, it is more likely to cause brittle damage. For the B4 group, the ultimate load of specimen B4Z is 0.3 times that of specimen B4Y, while the displacement of specimen B4Z is 0.73 times that of specimen B4Y. This is mainly because with the increase in the load, cracks are formed in the contact area between the screw and beam in the repair section (as shown in Figure 8g), which prevent the repaired section from being stressed together with the wooden beam.

Figure 9f compares the load-span displacement curves of each group of specimens. It is clear that the curve can be divided into two stages: elastic and plastic stages. When the

span displacement of each group of repaired specimens made of Merbau is about 10 mm, the specimens enter the plastic stage from the elastic stage. The stiffness of the reinforced specimen B3Z in the plastic stage is larger than that of the B2 and B4 groups specimens. Within the load range of 152–225 kN, the stiffness of repaired specimen B4Y is smaller than that of group B1 specimens, but the deformation of specimen B4Y is improved to some extent. Compared with the group B1 specimens, the bearing capacity of repaired specimens B2Z, B3Z, and B4Y increase by 13.06%, 38.93%, and 5.08%, respectively.

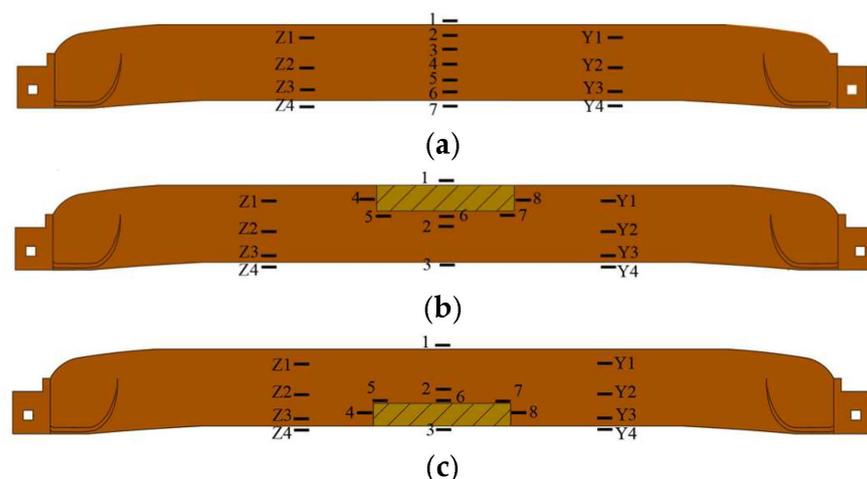
Figure 10. Strain gauge arrangement: (a) specimen B1Z; (b) specimen B3Z; (c) specimen B3Y.

Taking specimens B1Z, B3Z and B3Y as examples, seven measurement points are set at the mid-span section height of the wooden beams, and four points are set along the one-third and two-third span section heights of the timber beam (Figure 10a). The span of the inlay repair group contains three measurement points, and additional measurement points (4, 5, 6, 7, and 8) are on the repaired area. The specific arrangement of measurement points is shown in Figure 10b,c. According to the measured strain at each measurement point with equally spaced distribution in the span section of the specimen, the maximum tensile stress occurs at one-third and two-third height of the specimen at the bottom. It can be seen in Figure 11 that the force-strain curves of the specimen are almost linear. The maximum compressive and tensile strains of the two groups of specimens at one-third and two-third height are larger than that at the corresponding height in the span. For the specimen B3Z, when the load value is up to 260.32 kN, the reinforcement part of the compression zone exhibits extrusion folding. As shown in Figure 11g, the strain value of measurement points 8 and 4 increases at a higher rate, and the maximum compressive strain is 0.00081. The strain values of the measurement points 5 and 7 arranged at the bottom of the reinforced part change consistently. The strain variation is relatively stable, and the maximum compressive strain is 0.0003. This suggests that the stress value on both sides of the upper inlay part changes significantly with the vertical contact part of the original structure, which should be given more attention in the analysis. By contrast, for the specimen B3Y, an increase in the load has no effect on the strain at measurement points 4 and 8 on either end. The rate of strain change at the measurement point 6 is 44.4% of that at the points 5 and 7, but the strain value is 0.0005 greater than at the other measurement points, as shown in Figure 11 h.

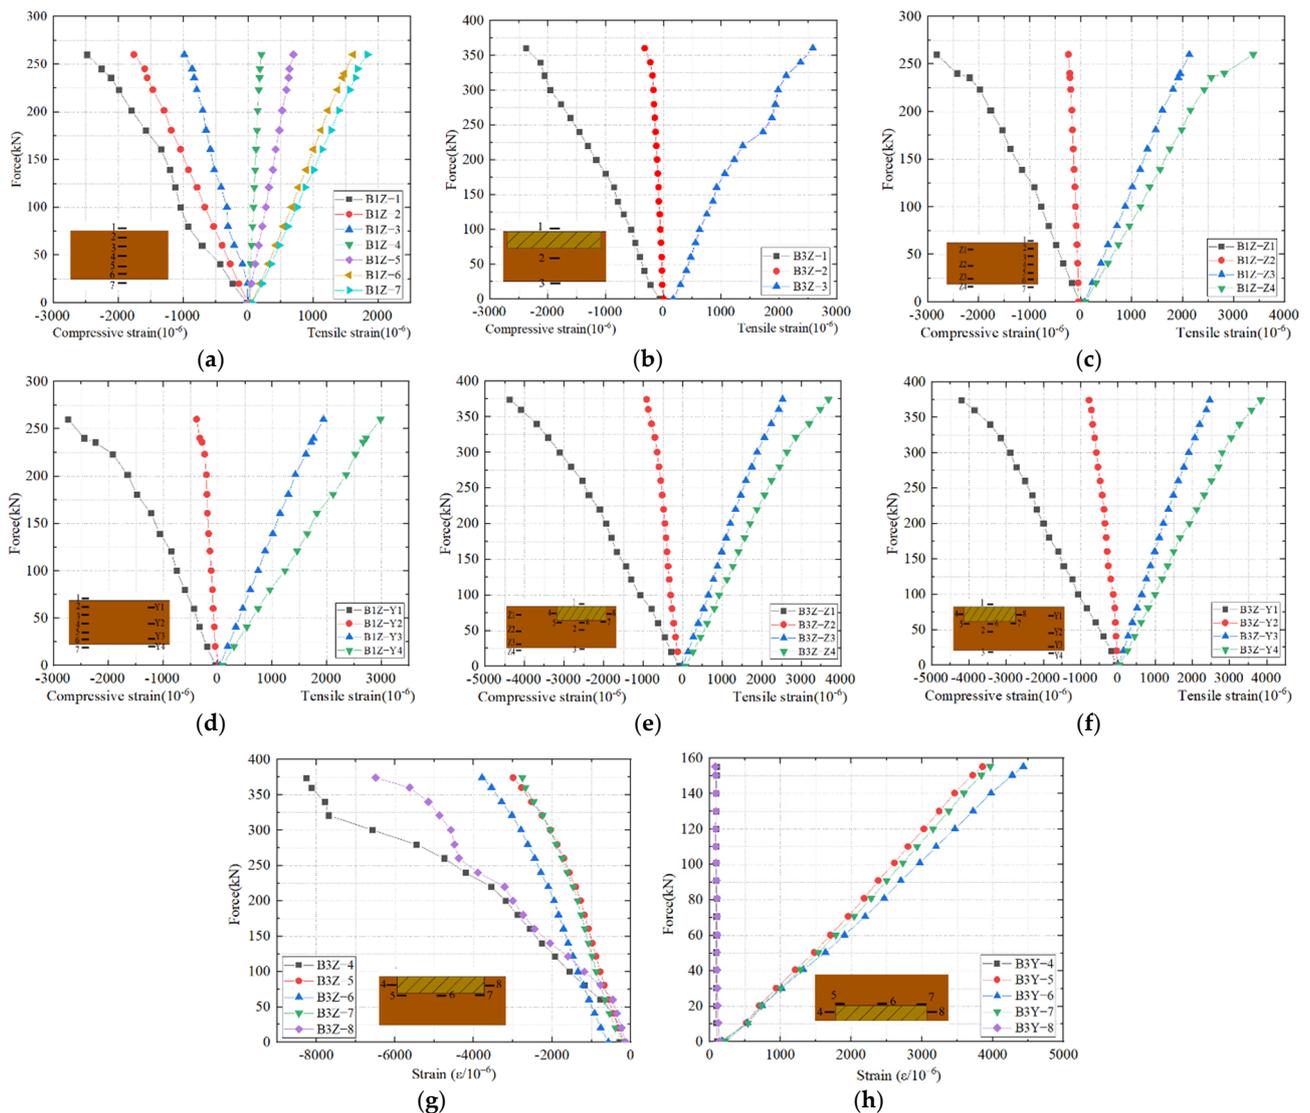
Figure 11. Force-strain curves of the specimens. (a) Span of specimen B1Z; (b) span of specimen B3Z; (c) one-third height of specimen B1Z; (d) two-third height of specimen B1Z; (e) one-third height of specimen B3Z; (f) two-third height of specimen B3Z; (g) repaired area in specimen B3Z. (h) repaired area in specimen B3Y.

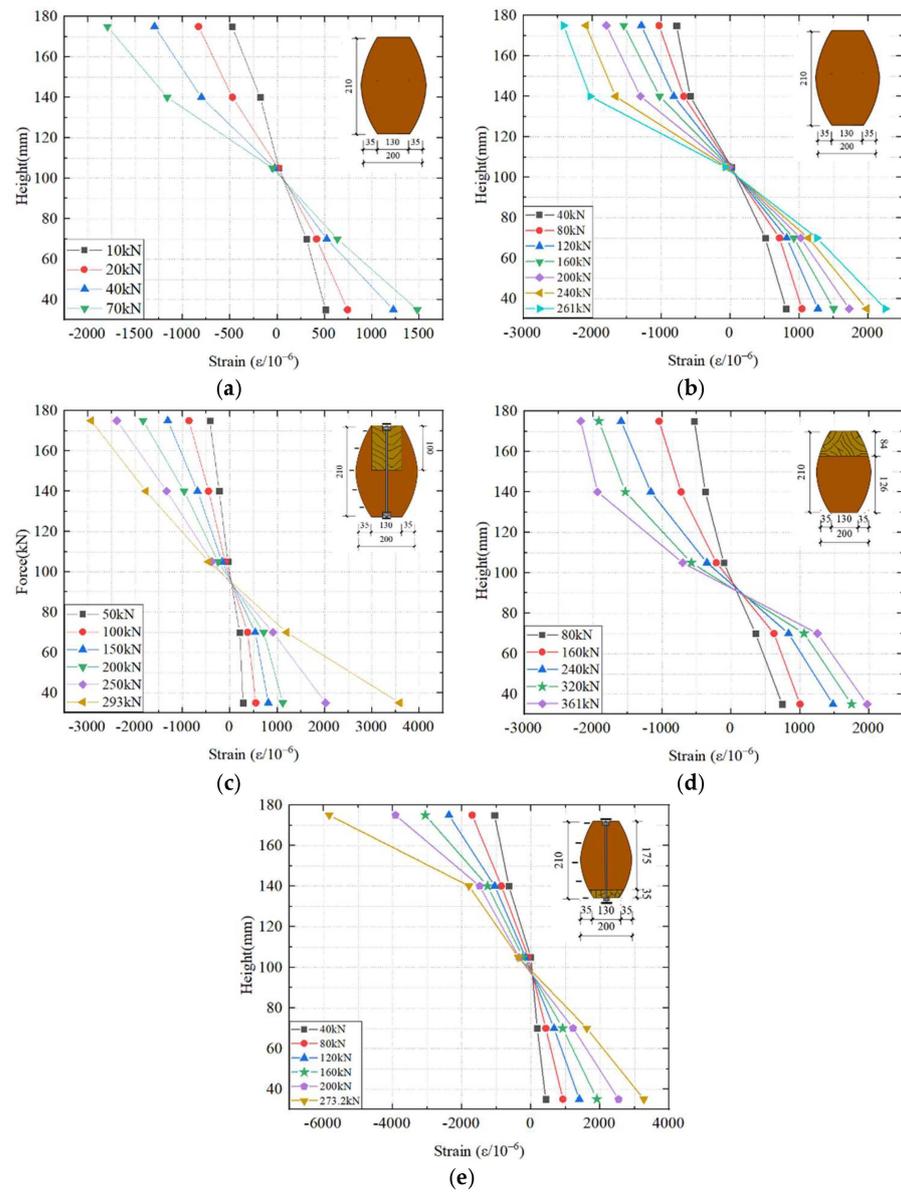
Figure 12. Strain distribution at the mid-span section. (a) Specimen B0Z; (b) specimen B1Z; (c) specimen B2Z; (d) specimen B3Z; (e) specimen B4Y.

Taking specimens B0Z, B1Z, B2Z, B3Z, and B4Y as examples, Figure 12 demonstrates the strain variation with load at each measurement point along the mid-span section height of the specimens. It can be seen that the height of each group of specimens along the mid-span section is linearly related to the wood fiber strain during the early stage of loading. With the increase in the load, the height of the neutral axis of the specimen without initial damage remains constant. Among other groups, the specimens B2Z and B4Y move toward the top of the wooden beam in the neutral axis due to the increase in the strain of the tensile zone with the increase in load. Since the wooden fibers in the compression zone are folded, the neutral axis of specimen B3Y moves toward the bottom of the wooden beam, and elastoplastic deformation occurs.

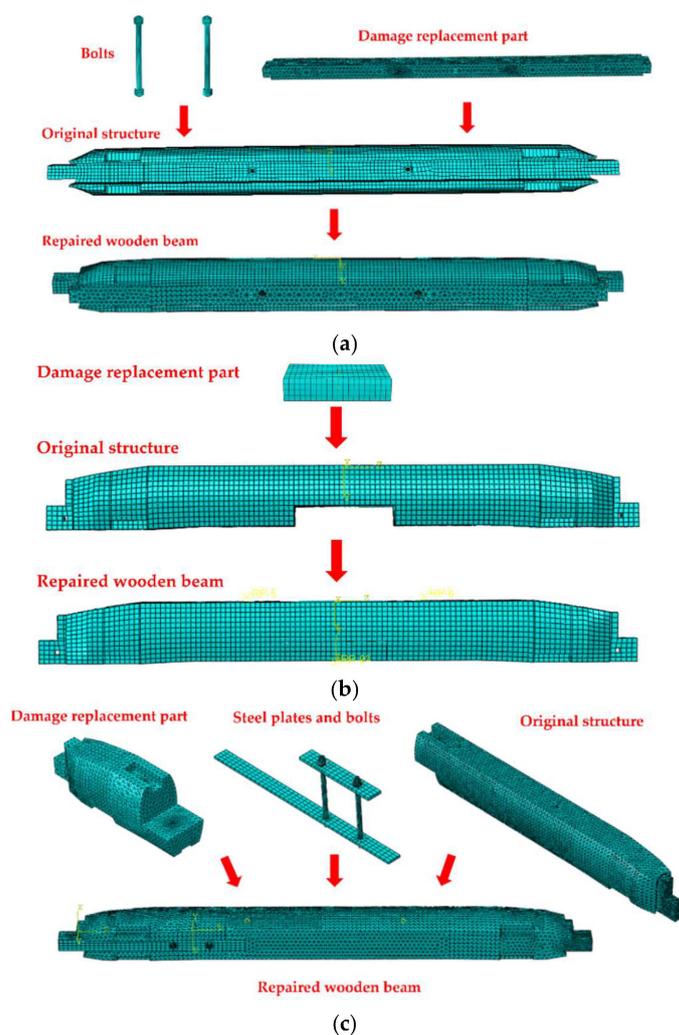
Figure 13. Finite element models: (a) core repair; (b) inlay repair; (c) complete tenon repair.

For the partial damage of wooden beams, the three repair methods were numerically examined with the same structural dimensions as the test specimens. The surface of the wooden beam had a rounded chamfer with a radius of 6 mm in the section direction. The replacement part was of the same size as the damaged part. The contact surfaces between the plate and bolt were set to “tie” constraint. The coefficients of friction of wood to wood and steel were 0.35 and 0.3, respectively [42]. The stiffness constant of adhesive was 200 N/mm^3 . Figure 13 shows the numerical models of the three different repair methods.

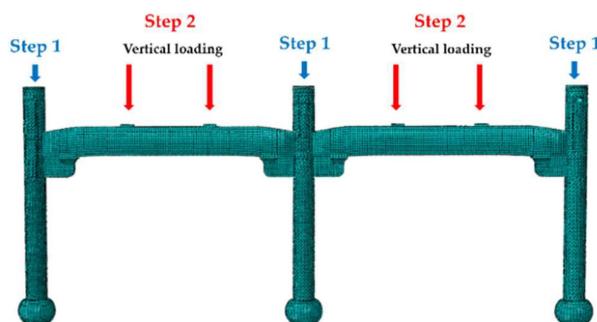
Figure 14. Meshing of models.

The structure and dimensions of the five groups of single-story, two-span timber frame models are the same as those of the test model. The wooden column model has a height and radius of 1800 and 90 mm, respectively. The bottom end of the column is set to a fixed restraint with the stone foundation. Figure 14 presents the mesh generation scheme of the planar wooden frame. An elastic-plastic model of wood anisotropy is defined by using the nine elastic engineering constants (as shown in Table 4) and the generalized Hill yielding criterion. Due to the anisotropy of wood, the directions of wooden beam, key, and alternate finch material must be assigned separately. The force surface is set at the top of the wooden column and the third equivalent point of the wooden beam, and the motion coupling constraint is established with the loading point. A constant load of 20 kN is applied to the top of three wooden columns in “Step1,” and the wooden beam load is applied in “Step2”. To consider the adhesion between the reinforced part in specimen B3Z and the original structure, an adhesive contact is used to connect the two parts. Considering the slip effect, the wood-wood and wood-steel plate contact surfaces are set to hard contact. The connection of Guanjian to the wooden beam and column is set as “tie” constraint. Eight-node linear hexahedral cells (C3D8R) are employed in the simulated wooden beam, spar, and key, and four-node linear tetrahedral cells (C3D4) are adopted in the wooden columns, core reinforcement part, and tenon reinforcement part. To improve the calculation efficiency, the grid division size is set to 20 mm.

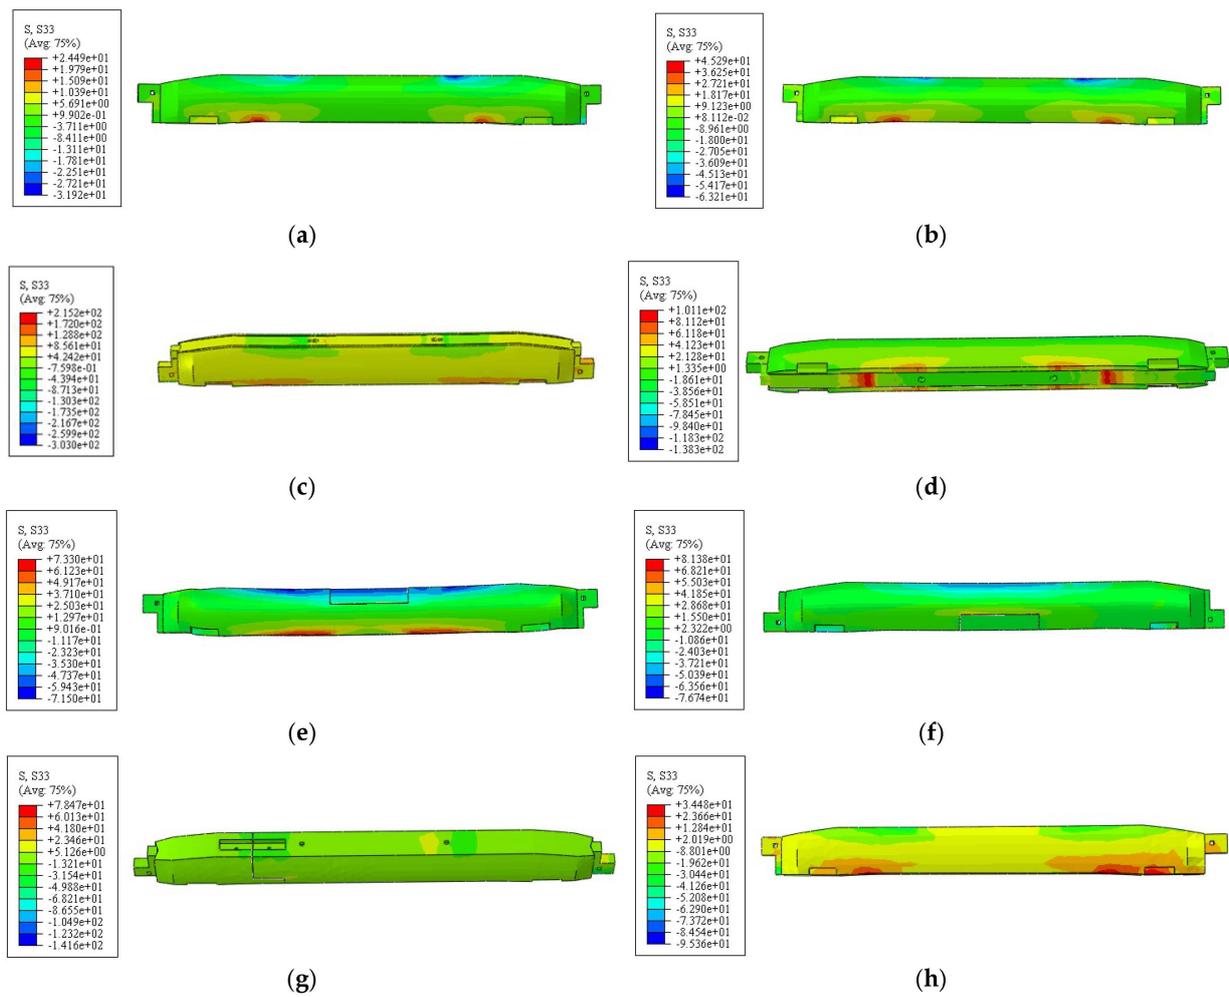
Figure 15. Stress cloud of specimens in the parallel direction: (a) group 1; (b) group 2; (c) specimen B2Z; (d) specimen B2Y; (e) specimen B3Z; (f) specimen B3Y; (g) specimen B4Z; (h) specimen B4Y.

Figure 15 shows the “S33” stress cloud parallel to the grain direction of the wooden beam. It can be seen that the stress concentration area at the bottom mainly appears at 1/3 and 2/3 of the length. The maximum compressive stress of group B1 is 63.21 MPa, and the maximum tensile stress is 45.29 MPa. In the group 3, the maximum stress of specimen B2Z at the top of the repaired part is 42.42 MPa, and the maximum stress at the bottom of the repaired part of specimen B2Y is 101.1 MPa. The stress value along the 1/2 section height of specimen B2Y is larger than that of the unreinforced group. For specimen B3Y, the adhesive layer is about to reach the plastic, and the top of the corresponding repaired part is open to the bonding surface of the structure. It can be seen from Figure 14f that stress concentration occurs at the top bonding position. With the increase in the load, horizontal and transverse tensile cracks appear on the bonding surface. For specimen B4Z, the stress at the transverse contact part between the repaired part and the original structure gradually increases. In general, the numerically obtained damage morphology of the specimens is consistent with the experimental results.

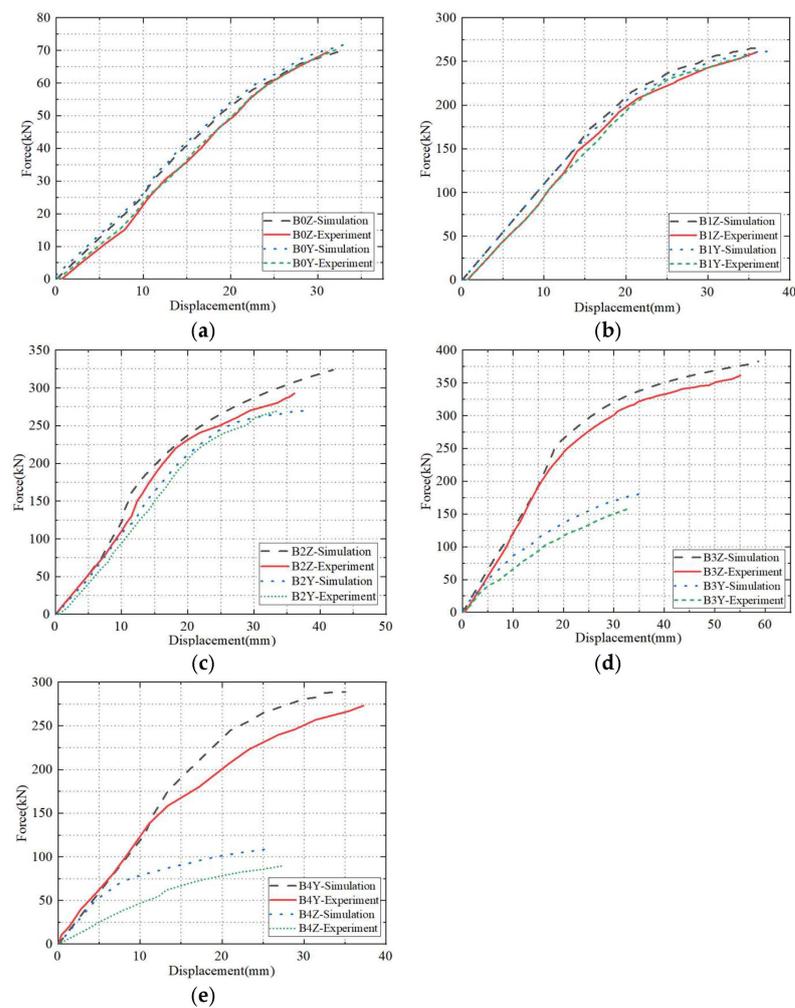
Figure 16. Comparison of force-displacement curves: (a) group 1; (b) group 2; (c) group 3; (d) group 4; (e) group 5.

A comparison between the experimental and simulated force-displacement curves is presented in Figure 16. The experimental and numerical results for the ultimate load and stiffness are listed in Table 5. Except for the specimens B3Y and B4Z, the error between the experimental and numerical results for each specimen is within 20%. For specimen B3Y, the tensile fracture strength and shear yield strength of the epoxy resin decrease with time, and this strength reduction problem is not taken into account in the viscous contact setup used in the simulation model. For specimen B4Z, as the load increases, the steel plate gets detached from the original structure, and the repaired part cannot be jointly stressed with the original structure. The comparison results in Table 5 indicate that the performance of the repaired specimens is in the following order: B3Z > B2Z > B4Y > B2Y > B3Y > B4Z. A comparison between test observations and finite element simulation is presented in Figure 17.

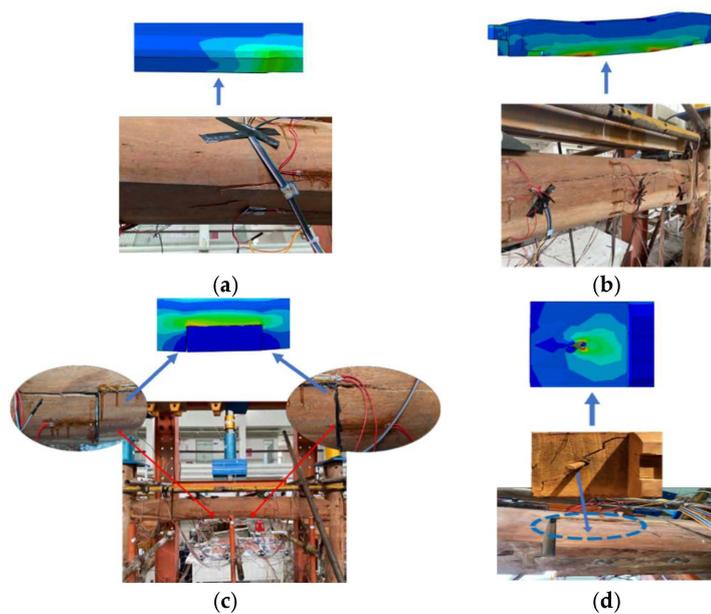
Figure 17. Comparing test observations and finite element simulation: (a) specimen B1Y; (b) specimen B2Y; (c) specimen B3Y; (d) specimen B4Z.

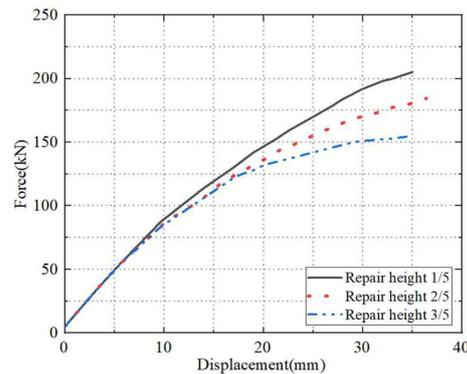
Figure 18. Force-displacement curves with different repair heights in lower inlay method.

To investigate the effect of repair height on the load-bearing performance of wooden beams reinforced by the lower inlay method, 1/5, 2/5, and 3/5 of the span section are considered as the repair height. Figure 18 shows that the bearing capacity of wooden beam with 1/5 height is 1.11 times that of the beam with 2/5 height and 1.32 times of beam with 3/5 height. The simulated values of ultimate load under different repair heights are listed in Table 6. It is clear that as the repair height of the wooden beam continues to increase, the decrease in its bearing capacity of the wood beam gradually increases.

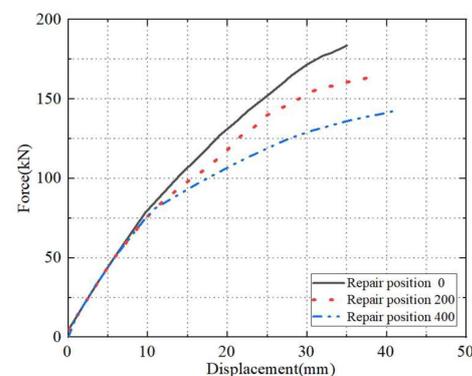
Figure 19. Force-displacement curves with different repair positions in lower inlay method.

To study the effect of repair position on the load-bearing performance of wooden beams reinforced by the lower inlay method, the strengthened part with center distance of 0, 200, and 400 mm are considered. Figure 19 shows the load-displacement curves of the wooden beam with different repair positions. The simulated values of ultimate load under different positions are listed in Table 7. It can be seen that the farther the repair position is from the center of the span, the worse the bending performance of the wooden beam.

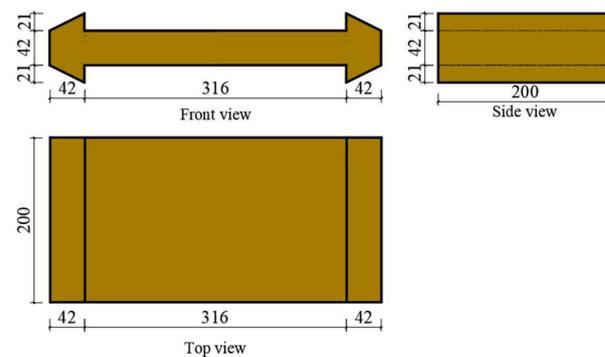
**Figure 20.** Geometric dimension of lower dovetail inlay form (units: mm).

According to the test results, a novel form of dovetail inlay named B3N is proposed with reference to the dovetail joints, as shown in Figure 20. The effect of inlay repair form on the load-bearing performance is evaluated by B3N modeling. The stress cloud diagram is shown in Figure 21. Figure 22 shows the force-displacement curves of the wooden beam with different repair forms. The maximum load capacity and maximum stress of specimens B3N and B3Y are compared in Table 8. It can be seen that the stress value of the upper contact part in B3N is smaller compared than that in B3Y, which effectively prevents the stress concentration. The bearing capacity of B3N is 27.09% higher than that of B3Y, which proves the effectiveness of the proposed dovetail inlay form for repair.

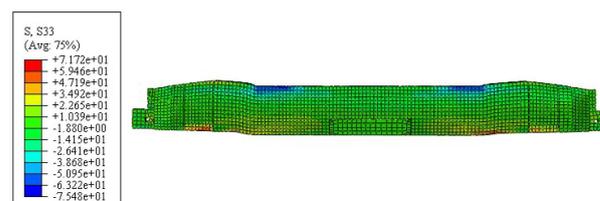
**Figure 21.** Stress cloud image of lower dovetail inlay form.

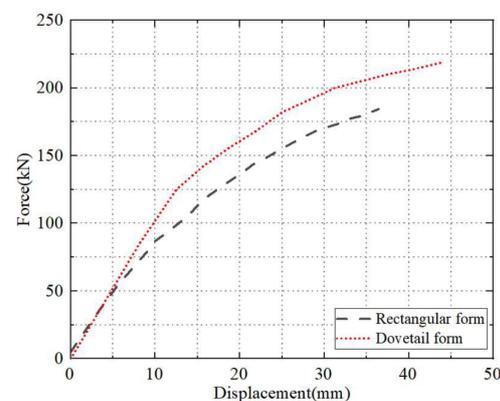
**Figure 22.** Force-displacement curves of dovetail form and rectangular form.
