In-Plane Behaviour of Unreinforced Masonry Strengthened with a Structural Glass Window: A Proof of Concept

Keywords: unreinforced masonry (URM); in-plane; strengthening; structural glass

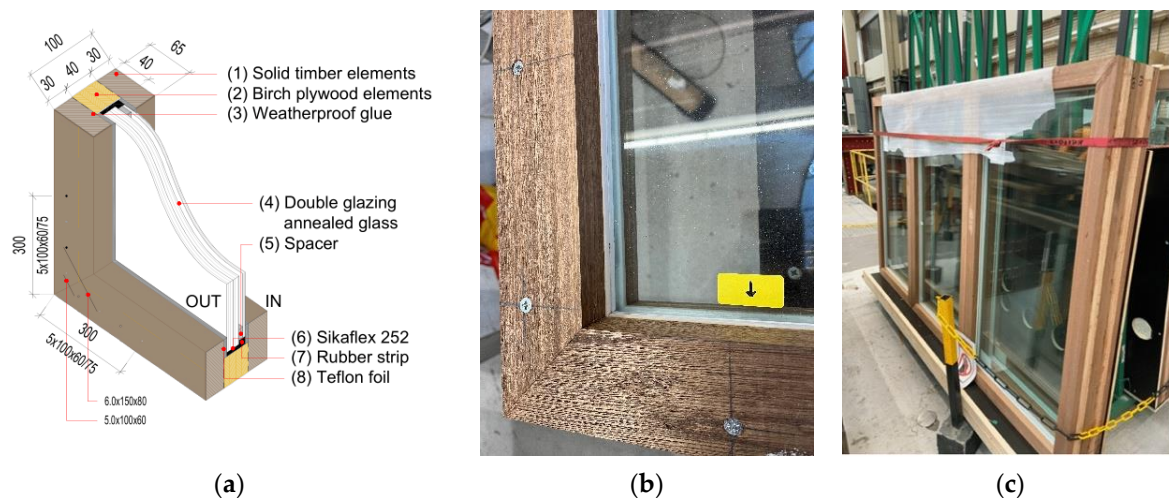
Figure 1. Structural glass window prototype: (a) 3D view with components, (b,c) final product.

The timber frame is composed of outer parts in solid timber “Meranti” (1) with a cross-section of 30×65 mm, and a central part in birch plywood “Okoume” (2) with a cross-section of 40×40 mm. The plywood used had a characteristic class of F15/20 for strength and E35/40 for stiffness. Solid timber horizontal and vertical members are joined together in a miter joint using weatherproof wood glue for exterior use (3) and wood screws 5×150 mm and 5×100 mm. On the other hand, plywood elements are joined in a basic joint using only the same glue. The central part of the frame is fastened to the external parts using, in addition to the same glue, wood screws 5×100 mm.

The double-glazing system (4) comprises two, 10 mm thick annealed glass panes laminated together with dimensions (length \times height) of 640×1370 mm, and one 4 mm single panel with dimensions (length \times height) of 620×1350 mm. The 10.10 mm and 4 mm thick glass panels are spaced by a 4 mm thick acrylic spacer (5) to promote the thermal and moisture seal.

The connection between the 10.10 mm thick glass panel and the central part of the timber frame in plywood is made by a 5 mm thick polyurethane adhesive layer in Sikaflex-252 (6) that extends circumferentially over the entire depth of the glass panel (20 mm). The adhesive should also accommodate natural deformations of the structure due to seasonal temperature changes. Information about the structural properties of the adhesive is reported by Huveners [6]. A 10 mm thick rubber strip (7) is used to fill the space between the central part of the timber frame and the 4 mm glass panel and avoid any load transfer to the latter. In addition, 5 mm Teflon foils (8) are placed between the glass panels and the timber frame to guarantee a low friction contact surface on the faces of the glass.

The window prototype is reported in Figure 1 and was built with outside dimensions (length \times height \times thickness) of 730 \times 1460 \times 100 mm to fit into a window opening of dimensions 780 \times 1510 mm. The gap of 25 mm circumferentially left between the window and the surrounding masonry is used to connect the window to the existing masonry. The window prototype mainly consists of a timber frame, a double-glazing unit with a 20 mm thick structural layer of annealed glass, and a semi-rigid adhesive.

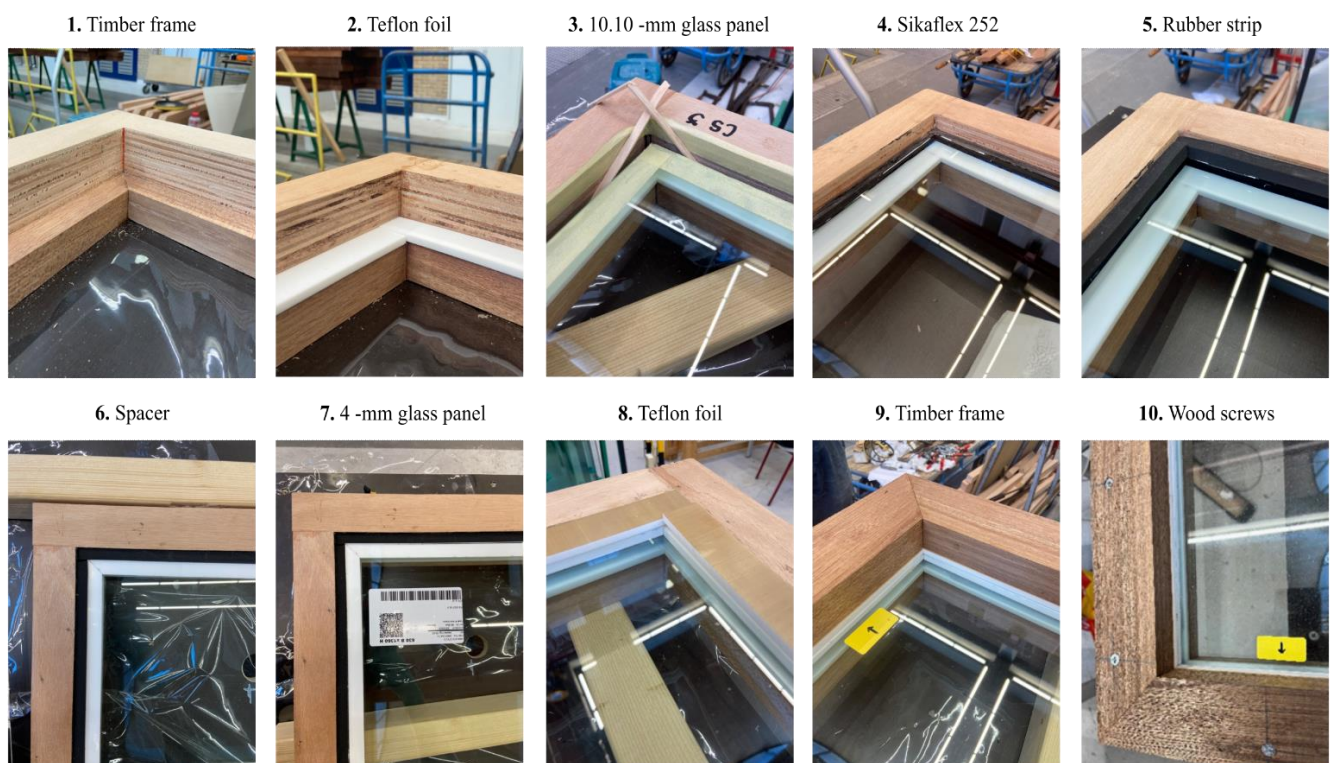
Figure 2. Overview of the structural glass window construction.

The construction of the window prototype was performed at TU Delft Macrolab/Stevin laboratory following the procedure reported in Figure 2.

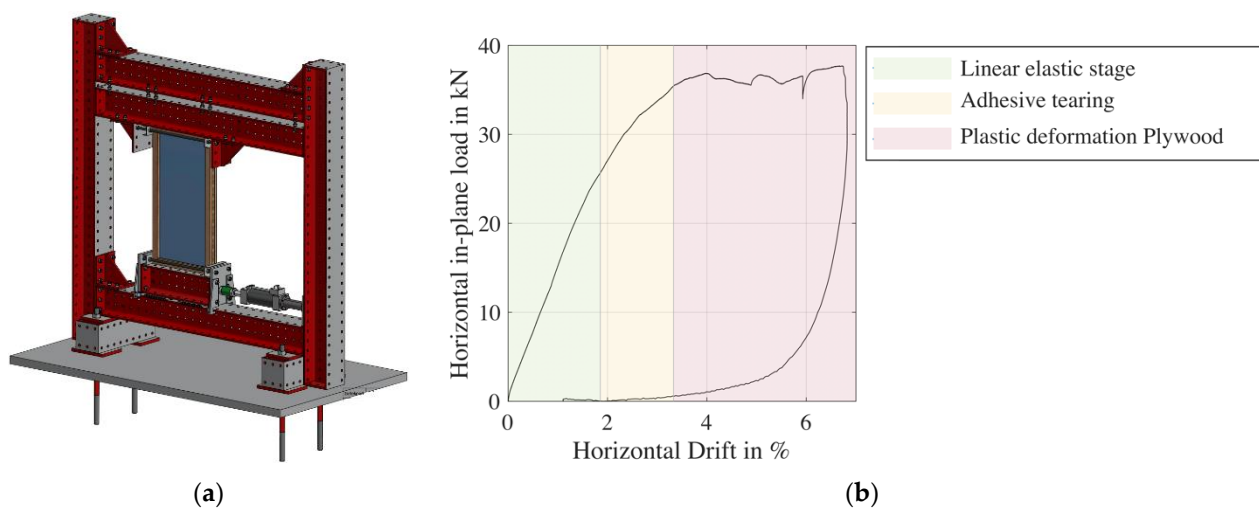
To understand the behaviour of the window prototype and evaluate its capacity, a quasi-static in-plane test on the standalone prototype was performed (Figure 3a). During the test, the window was loaded in a double clamp configuration by imposing a displacement at its bottom right corner while its top part remained fixed. The resulting capacity curve

(Figure 3b), expressed as horizontal in-plane load vs. horizontal drift, showed elasto-plastic behaviour that can be divided into three subsequent phases as follows. In the first stage, the load was transferred through the adhesive without tearing, leading to a linear elastic behaviour of the window. The linear elastic stage is depicted in green and is followed by a second stage in which tearing of the adhesive occurs. Tearing of the adhesive started at a drift of 1.9% and concluded at 3.3% when direct contact between the glass panel and the wooden frame occurred after crushing of the adhesive. During the last phase, the glass panel rotated inside the wooden frame compressing and deforming the horizontal plywood elements. At the end of the test, these plywood elements showed residual plastic deformation with a glass penetration of around 10 mm.

Figure 3. In-plane test on the standalone window: (a) test set-up, (b) obtained capacity curve.

A numerical study supported by the presented experimental campaign will be employed to explore how the prototype's design can be upgraded to overcome the aforementioned drawbacks. In particular, the numerical models will investigate whether the window's plastic behaviour (Figure 3b) can be activated for lower lateral displacements to master the lack of dissipated energy obtained with the proposed wall's geometry. Factors influencing the window's plastic behaviour will, therefore, be analysed: adhesive thickness and mechanical properties (stiffness and strength) of the adhesive and plywood. On

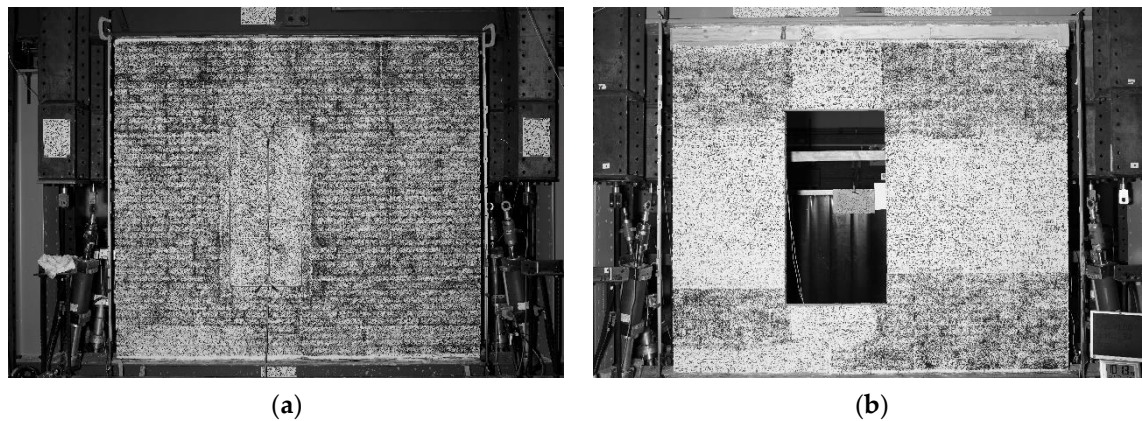
The specimen consisted of a full-scale single-wythe (100 mm thick) masonry wall with an asymmetric window opening in which the herein exposed prototype was installed (Figure 4a). In addition to the latter, a nominally identical unstrengthened masonry wall (Figure 4b), tested in previous studies under the same configuration and with similar loading protocol but without the structural glass window in the opening, was considered to evaluate the performance of the strengthening measure. While the strengthened wall, herein denoted TUD-COMP56, was built and tested in 2022, the unstrengthened wall, denoted TUD-COMP41, was built in 2017 and tested in 2017 and 2018 by Korswagen et al. [4,5]; Table 1 lists the material properties obtained in the construction period of both walls. The geometry and type of masonry considered aimed to replicate typical Dutch houses of the period before 1950 in the Netherlands. In particular, the walls were built in running bond using solid clay bricks and a 1:2:9 (cement: lime: sand proportions by volume) mortar [7]. The masonry units had a nominal dimension (length \times height \times thickness) of $210 \times 50 \times 100$ mm and compressive strength f_b of 28.31 MPa [8], experimentally determined accordingly to EN 772-1 [9]. The specimens had a 10 mm mortar joint and were built in controlled laboratory conditions by a professional bricklayer. Each wall was constructed on a steel beam by gluing the first masonry course with “Sikadur 30”. After construction and a hardening period, a steel beam was glued on top of the last masonry course with the same glue and was connected to the bottom beam via lateral steel columns and bars. This steel frame was used to transport the wall into the set-up and, via the top beam, apply the desired pre-compression and lateral force during the test.

Figure 4. Front view of the in-plane walls with the DIC black-and-white pattern applied: (a) strengthened (TUD-COMP56) and (b) unstrengthened (TUD-COMP41) specimen where the glass and timber frame are also painted.

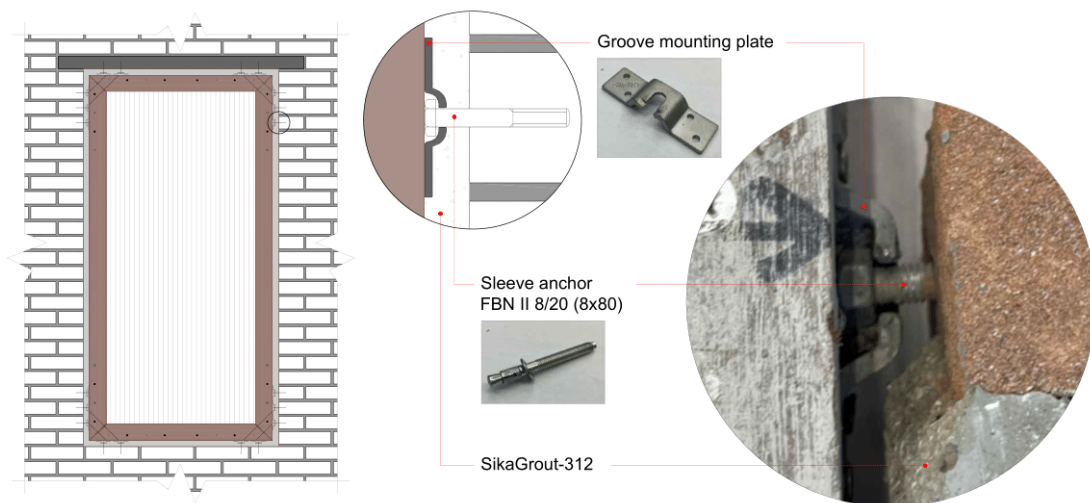
In the case of the strengthened wall, the prototype was installed once the wall was settled inside the set-up and the overburden was applied. In particular, the window was connected mechanically to the surrounding masonry using the connection solution shown in Figure 5. The mechanical connection was localized at the corners where maximum stresses are concentrated. It mainly consisted of groove mounting plates, fixed to the window's wooden frame with wooden screws 4×40 mm, and sleeve anchors with a diameter of 8 mm and a length of 80 mm, installed in the masonry previously pre-drilled at the specified locations. In this manner, the window was slid into the opening. The gap left between the window and the surrounding masonry was then filled with SikaGrout-312.

Figure 5. Window installation. The window is mechanically anchored to the masonry and concrete lintel and its perimeter is filled with grout.

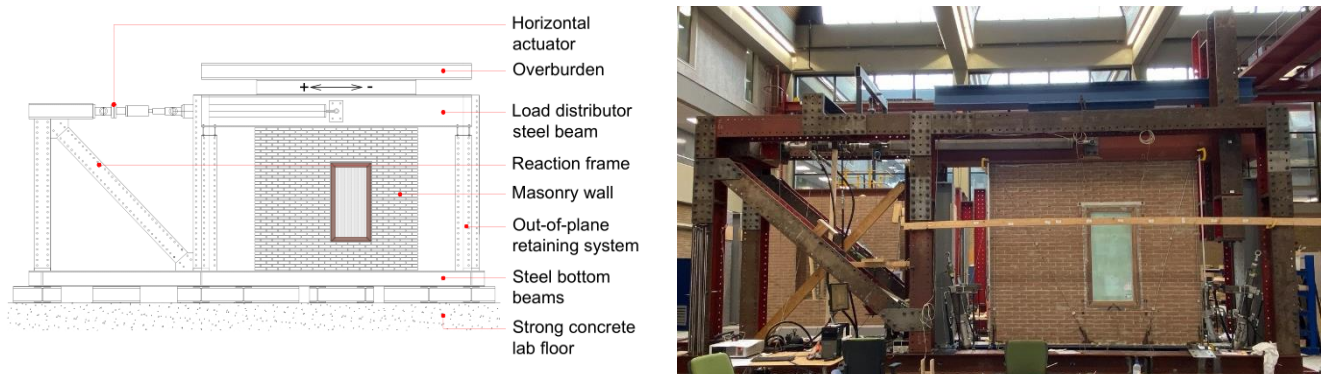
The set-up adopted for lateral loading of both full-scale walls is shown in Figure 6. It consists of a steel frame, anchored at the stiff laboratory floor, in which the wall is settled. In particular, the bottom steel beam on which the specimen is built is connected to the bottom cross-beams of the steel frame to prevent uplift. Instead, the top beam, glued after construction to the last masonry course, is connected to a 100-kN hydraulic jack to induce the prescribed horizontal displacement to the specimen. The weight of the top beams results in a constant overburden of 0.12 MPa that mimics the load of ground-floor walls of typical two-story Dutch houses. The test is performed in a cantilever configuration, with the top beam free to displace and rotate in plane. During the test, the wall was monitored through digital image correlation (DIC) on the front side and sensors on the back side.

Figure 6. In-plane test set-up looking at the back of the wall (without DIC pattern).

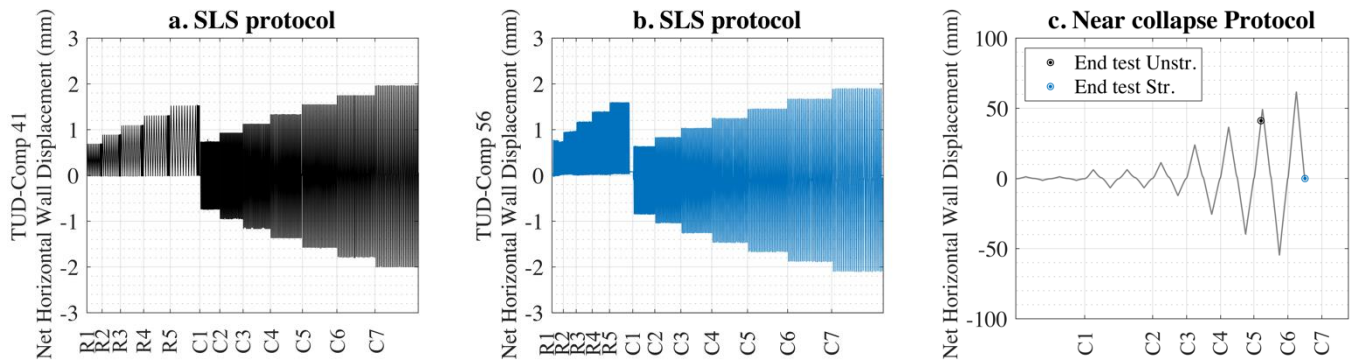
The walls were tested under a displacement-controlled procedure following a cyclically increased loading protocol (Figure 7). The protocol comprised a first part up to the serviceability limit state (SLS), and a second part up to ultimate limit states (ULS). The SLS part of the protocol was defined by Korswagen et al. [4,5,10] to investigate the initialization and propagation of cracks induced by repeated low vibration levels, typical of the light earthquakes in Groningen (The Netherlands). The ULS part of the protocol was representative of an expected Groningen-type earthquake and was derived by Mariani [11]. The SLS part consisted of a first repetitive part with 5 incremental steps and a subsequent (two-way) cyclic part with 7 incremental steps. For the two walls, the repetitive part of the SLS protocol was slightly different in terms of the number of repetitions per displacement

step that were implemented: while, in the strengthened wall, 30 repetitions with the same loading rate (0.125 mm/s) were applied, in the unstrengthened wall, 20 repetitions were applied with two different loading rates (the first 10 repetitions at 0.0125 mm/s and the last 10 at 0.125 mm/s).

Figure 7. Loading protocol: (a) SLS part unstrengthened wall; (b) SLS part strengthened wall; (c) ULS part for both walls.

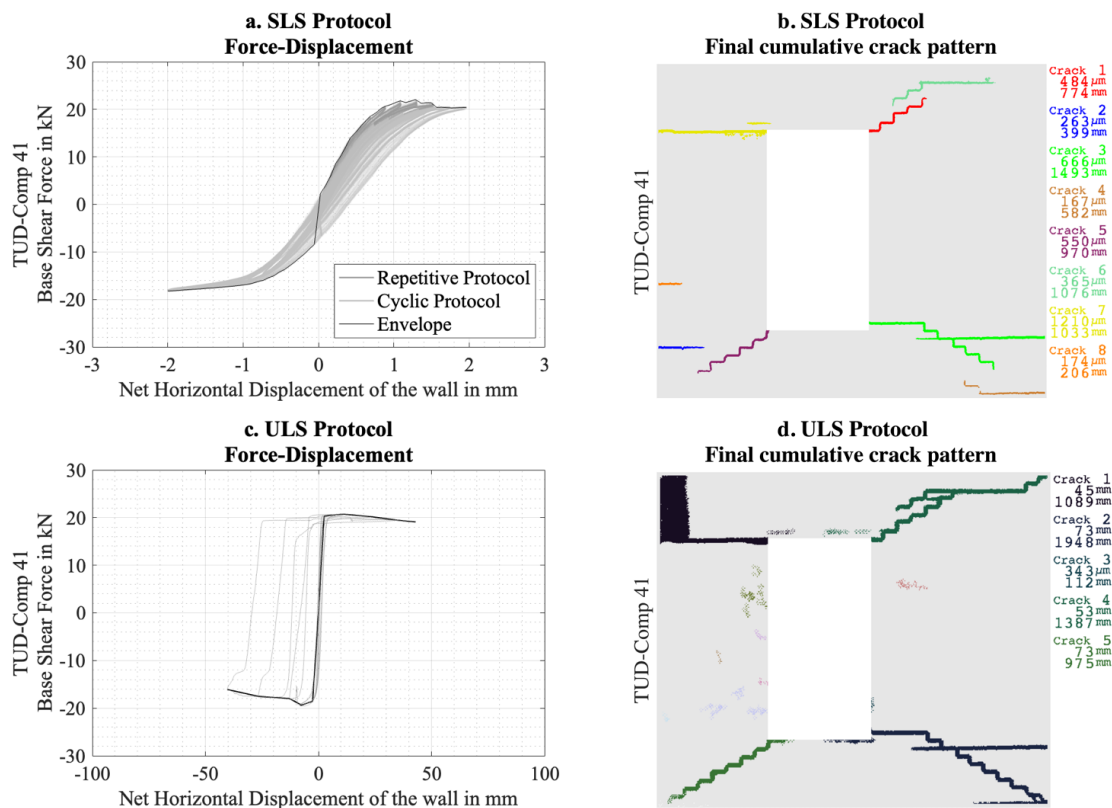
Figure 8. Results obtained on the unstrengthened wall (TUD-Comp41) in terms of base shear force versus net horizontal displacement curve and final cumulative crack pattern for the SLS and ULS protocol.

In this section, the results obtained in terms of base shear force versus net horizontal displacement of the wall, final cumulative crack pattern, deformed shape, and failure mechanism for the unstrengthened (Figures 8–10) and strengthened (Figures 11–13) walls are presented. The net horizontal displacement of the wall was calculated as the displacement of the top beam with respect to the external reference excluding possible rotations of the set-up.

Considering the unstrengthened case, a maximum base shear force of +22.1 kN (at 1.28 mm displacement, 0.05% drift) and −19.5 kN (at −7.0 mm displacement, 0.26% drift) was obtained, with an initial stiffness of 37.6 kN/mm, evaluated in the first repetition of the protocol at 40% of the maximum force (8.3 kN). The ultimate displacement, evaluated at a residual capacity of 80%, was 40 mm (1.6/−1.5% drift). No significant out-of-plane displacements were reached during the test as the maximum displacement was 8 mm (8% of the wall thickness). The onset of cracking occurred at the first repetition of the protocol with the horizontal crack at the bottom left side of the short pier (Crack 2 in Figure 8b) and at the top left corner of the window opening (Crack 7 in Figure 8b). The evolution of the crack pattern resulted mainly in diagonal cracks from the window corners, causing a rocking behavior of the piers and sliding of the masonry portion above the window opening and the larger pier with respect to the rest (Figure 10).

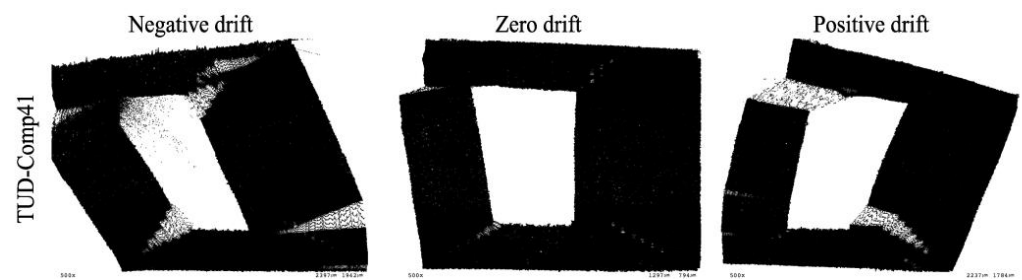
Figure 9. Deformed shape, magnified 500 times, of the unstrengthened wall (TUD-Comp41) resulting from the SLS protocol at a displacement of 2.125 mm (0.085% drift) [5].

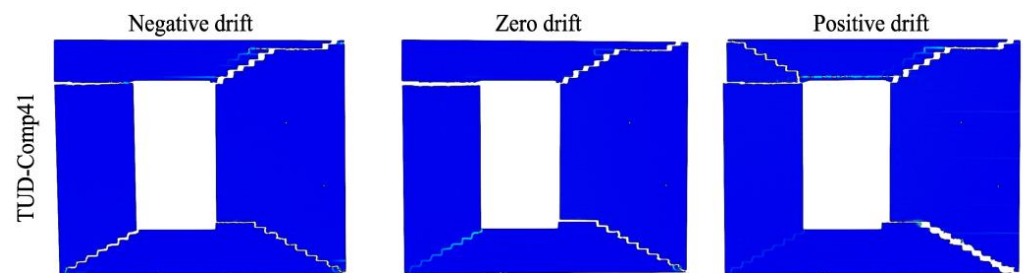
Figure 10. Failure mechanism of the unstrengthened wall (TUD-Comp41) resulting from the ULS protocol at a displacement of 40 mm (1.6/−1.5% drift).

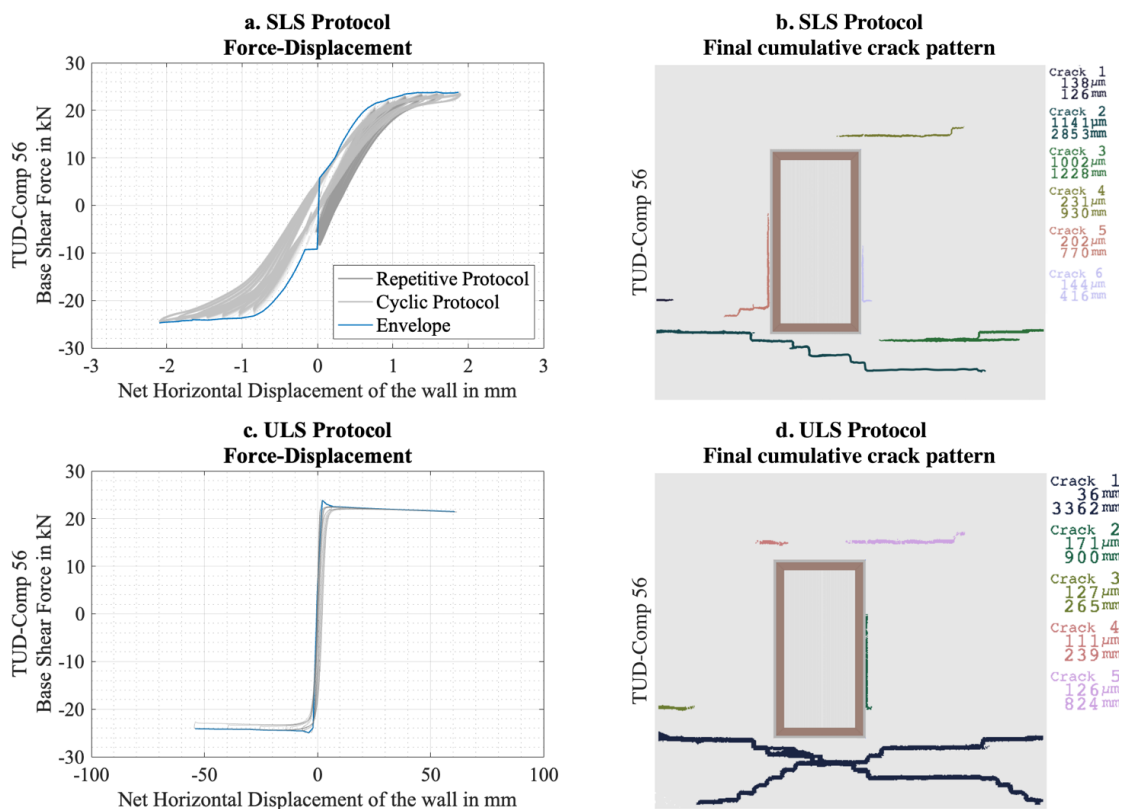
Figure 11. Results obtained on the strengthened wall (TUD-Comp56) in terms of base shear force versus net horizontal displacement curve and final cumulative crack pattern for the SLS and ULS protocol.

Considering the strengthened case, a maximum base shear force of +23.9 kN (at 1.58 mm displacement, 0.06% drift) and −25 kN (−3.9 mm displacement, 0.14% drift) was obtained, with an initial stiffness of 44.6 kN/mm, evaluated in the first repetition of the protocol at 40% of the maximum force (9.6 kN). The onset of cracking occurred at the first repetition of the protocol with the two horizontal cracks at the bottom left side of the pier of lower length (Crack 1 and Crack 2 in Figure 11b). The evolution of the crack pattern resulted in two diagonal cracks at the masonry portion below the window opening. The latter cracks grew through the entire length of the wall, leading to rocking of the masonry portion above the aforementioned cracks as a whole piece (Figure 13). The test was stopped before reaching the ultimate displacement when the complete rocking mechanism was confirmed, i.e., at approximately 60 mm (corresponding to a drift of 2.3/−2.0%) and a residual capacity of 90% and 96%, respectively, in the positive and negative directions. Although leading to an underestimation of the ultimate displacement, the latter position is herein considered as the ultimate to allow future investigations of the specimen in a different boundary condition that might better force the glass panel to activate. In fact, with the presented cantilever configuration, no contact between the glass panel and timber frame was observed during the test: the maximum relative displacement, measured from the DIC at the end of the test, was −0.4 mm in both loading directions. The window remained in the linear elastic stage (Figure 3b) for the entire duration of the test: maximum wall drift in the first and second stages of the protocol was 0.1% and 2%, respectively. Regarding the

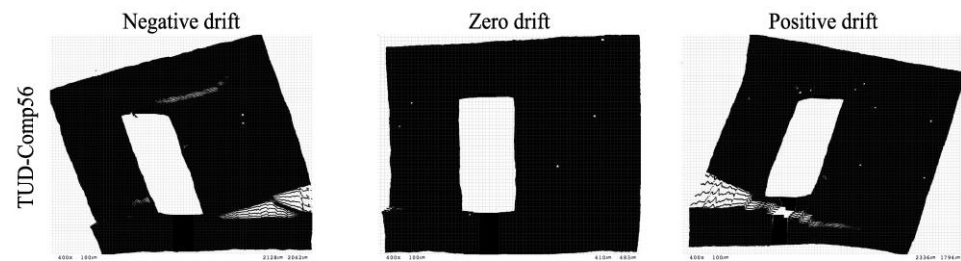
Figure 12. Deformed shape plots (500 times magnified) of the strengthened wall (TUD-Comp56) resulting from the SLS protocol at a displacement of 2.125 mm (0.085% drift).

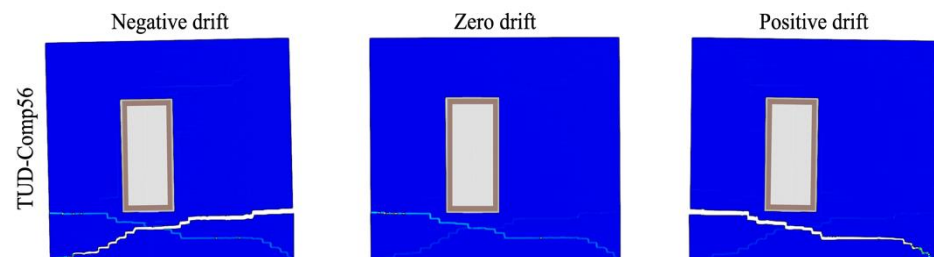
Figure 13. Failure mechanism of the strengthened wall (TUD-Comp56) resulting from the ULS protocol at a displacement of 60 mm (2.3/−2.0%).

The change in failure mechanism to rocking cracks at the bottom, which is characteristic of walls without openings in a cantilever configuration, suggests that the window prototype forced the wall to behave as a whole as if no opening was present. The installation procedure was therefore successfully implemented to connect the proposed strengthening technique to the surrounding masonry. In windows with larger openings or with floor-to-ceiling openings, the strengthening window would likely provide larger gains in terms of improved stiffness and energy dissipation.

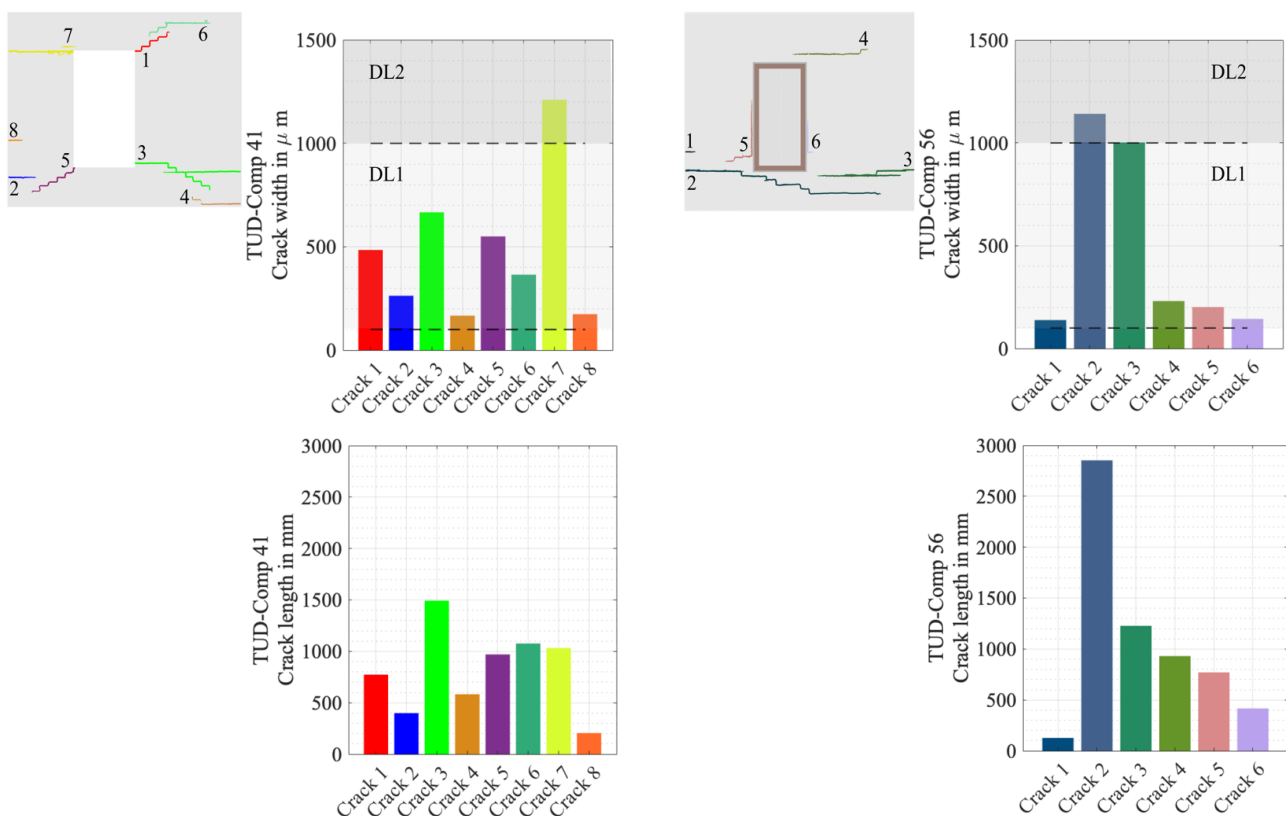
Figure 14 shows the comparison in terms of crack width and length obtained from the final cumulative crack pattern of the first stage of the protocol. In comparison with the unstrengthened wall, the strengthened configuration showed a lower number of cracks overall, with lower width but higher length. The damage was mainly concentrated in the masonry portion below the window opening, while it was more spread in the unstrengthened wall. Although an increment of 18% of the initial stiffness was observed in the strengthened configuration, no influence of the structural glass window was observed regarding the onset of cracking and final damage level reached from the first stage of the protocol. In fact, the first cracks appeared at the first repetition of the protocol in both cases considered herein, and a similar damage parameter Psi (Ψ) of 2.6 was computed. However, the increased stiffness would likely lead to a smaller displacement if the wall was subjected to seismic vibrations at its base; however, this depends on the dynamic behaviour of the wall and its interaction with the vibrations, and needs to be investigated further.

Figure 14. Performance during the SLS phase in terms of crack width and length.

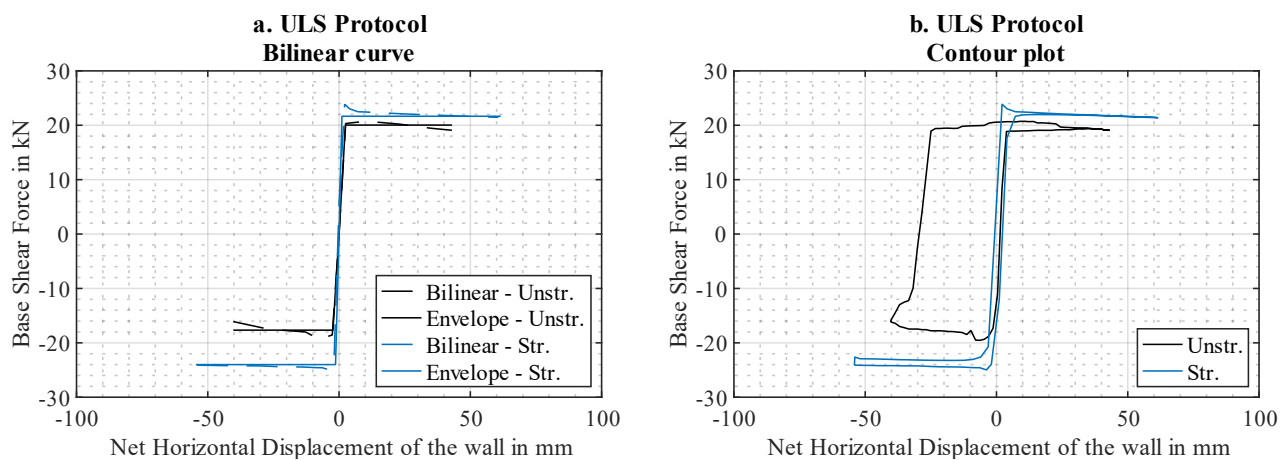
Figure 15a shows the equivalent bilinear curve computed according to the formulation of Magenes et al. [13] with the parameters listed in Table 2, while Figure 15b shows the contour plot to visualize the amount of energy released during the test, i.e., the enclosed area. By comparing the equivalent bilinear curves, a substantial increment in terms of stiffness (+142%, +136%), ultimate displacement (+43%, +35%), maximum base shear force (+8%, +36%), and ductility (+220%, +135%) was obtained in the strengthened configuration. However, the latter showed a substantial decrease in terms of dissipated energy (−83%) that can probably be attributed to the different failure mechanisms observed. In fact, while the strengthened wall showed only rocking, the unstrengthened one also showed sliding. In addition, the horizontal displacements reached during the tests were not sufficient for the adhesive to tear, and, therefore, for including the additional dissipation source through friction and crushing of the timber.

Figure 15. Performance during the ULS protocol: (a) equivalent bilinear curve and (b) contour plot.
