Article

Improvement in Accuracy of a Multi-Joint Robotic Ultrasonic Inspection System for the Integrity of Composite Structures

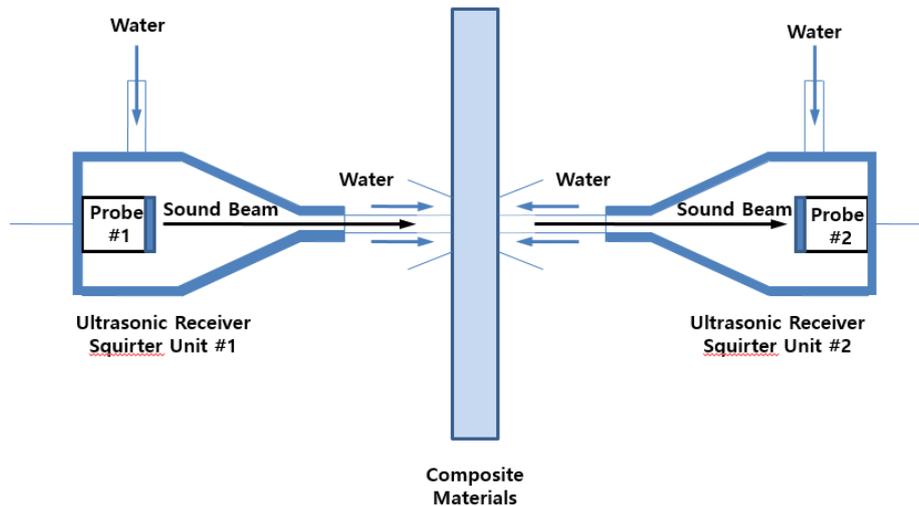
In the TTU method, ultrasound is generated by one sensor and received by the other sensor while water is injected through the squirters on both sides, as shown in Figure 1; the water is used as a couplant and it must be continuously injected. The sound pressure of the received ultrasound varies, depending on the acoustic impedance or attenuation/scattering. The defects are detected by scanning the area that is to be inspected and representing the sound pressure change of the scanned area on a two-dimensional (2D) plane. The sound pressure at the receiver varies, depending on the acoustic impedance, attenuation, and scattering. The acoustic impedance results in a change in the sound pressure of ultrasound, which is reflected or transmitted at an interface, because it propagates from one medium to another or to a defect. The reflection and transmission coefficients of ultrasound at an interface are determined by Equations (1) and (2) at normal incidence.

Figure 1. Through-transmission ultrasonic method with squirter.

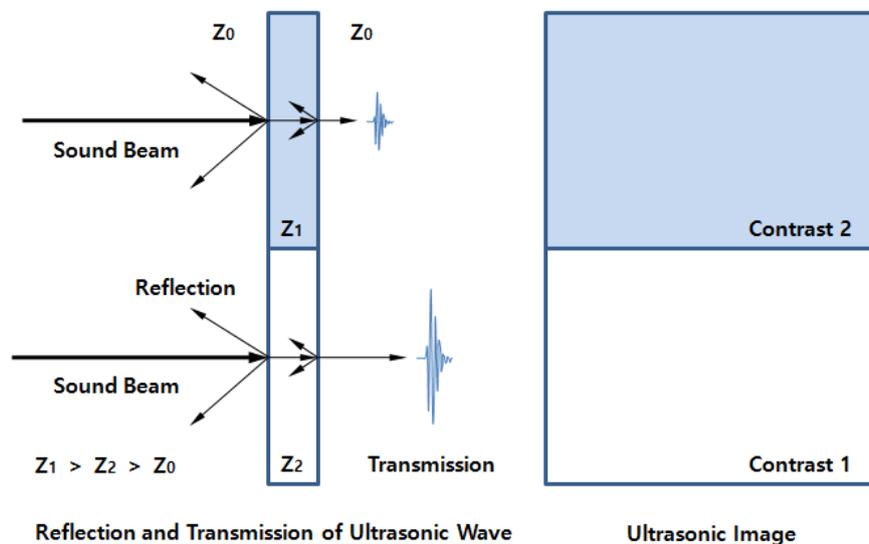
As shown in Figure 2, when ultrasound propagates into another medium, the sound pressure received by the opposite side varies depending on the impedance of the medium. If the magnitude of this sound pressure is represented on a 2D plane, it can be expressed with different contrasts, as shown on the right. When the obtained ultrasonic images are evaluated, intact and defective parts exhibit different sound pressures, making it possible to determine the presence of a defect.

Figure 2. Ultrasonic image of a material with different impedances.

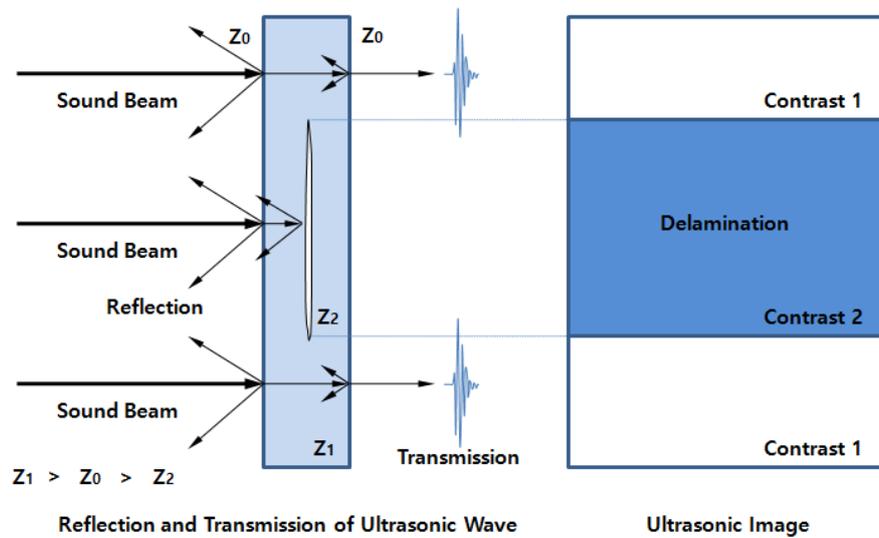
Figure 3 shows the case of delamination, which is a defect that frequently occurs in composite materials. The delaminated part causes total reflection (100%) of ultrasound due to the air layer formed. The parts of the structure that receive ultrasound and those that do not (as a result of total reflection) clearly show differences in the transmitted sound pressure. Delamination can be detected by finding such differences in sound pressure in ultrasonic images.

Figure 3. Ultrasonic image obtained from a delamination layer.

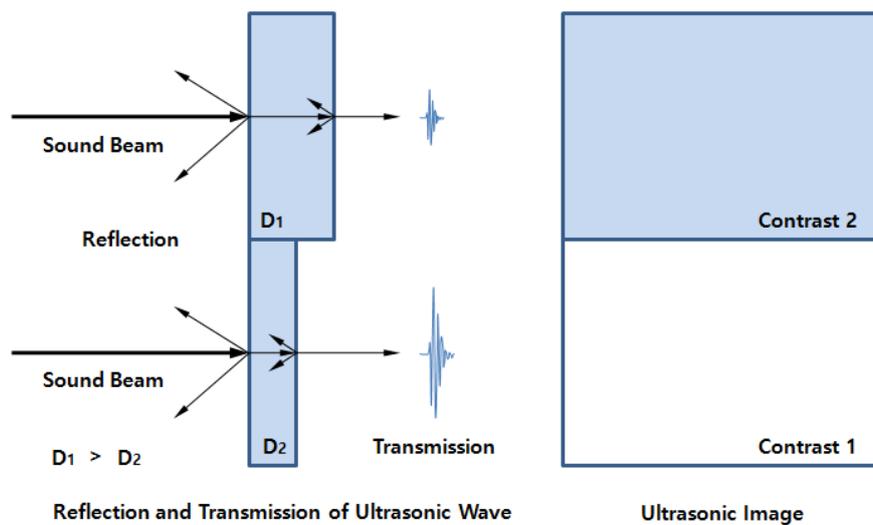
A defect that frequently occurs in composite materials along with delamination is a void, as shown in Figure 4. Ultrasonic scattering occurs on the surface of a void, resulting in a difference in sound pressure between an intact part without a void and a defective part with a void. The defects can be detected using this difference in the sound pressure.

Figure 4. Change in ultrasonic sound pressure due to a void.

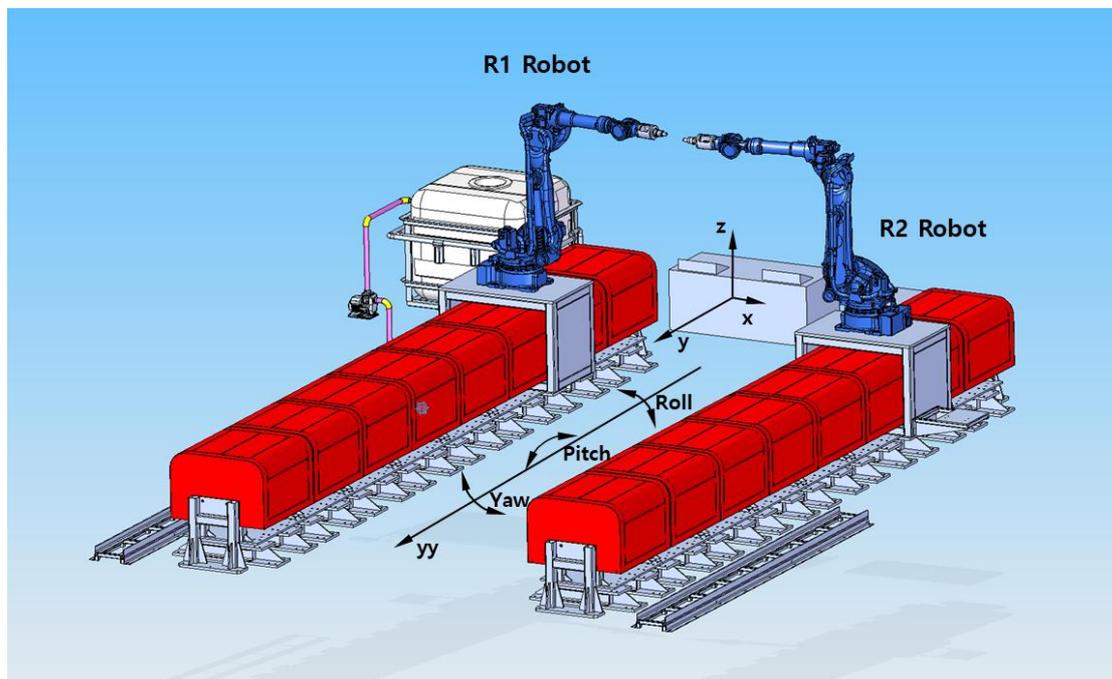
We addressed the problem of misinterpreting an intact part for a defect when the sound pressure changes due to the misalignment of the two sensors, which is caused by the deformation of the mechanism. Consequently, an algorithm was developed that is capable of measuring the degree of deformation by a stepwise procedure that involves using a 3D laser measuring instrument, calculating the correction values based on the measurements, and compensating for the axis misalignment. This algorithm first follows a motion along the bogie axis (yy -axis) after setting the coordinate system, as shown in Figure 5; it also measures the coordinate values of the x -, y -, and z -coordinates at the robot control point position to correct the coordinate misalignment of coordinates due to the deformation of the mechanism. In this instance, it is assumed that the control of the traveling multi-joint robot is accurate and that deformation occurs only in the bogie that moves the robot.

Figure 5. Robot coordinate setting for collecting coordinate values.

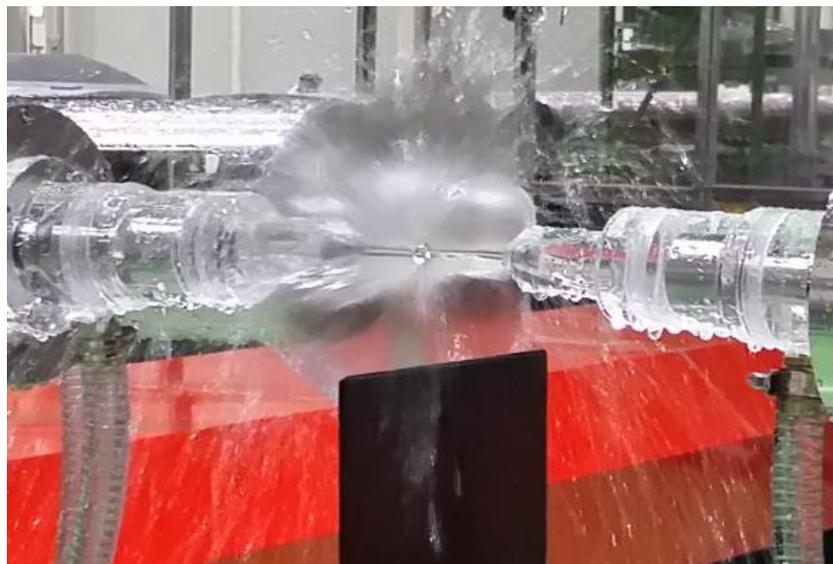
First, to examine the axis misalignment of the system intuitively, the water columns of the two robots were accurately aligned with no product to be inspected, as shown in Figure 6. Data were acquired while the robots were moved by 100 mm in the z direction and by 650 mm in the y direction, in 3 mm intervals; the data were expressed as 2D images. The frequency of the ultrasonic sensor was set to 0.5 MHz. Regarding the ultrasonic sound pressure, the linear scale was set to 50% and the log scale to 80%.

Figure 6. Shape of the squirter.

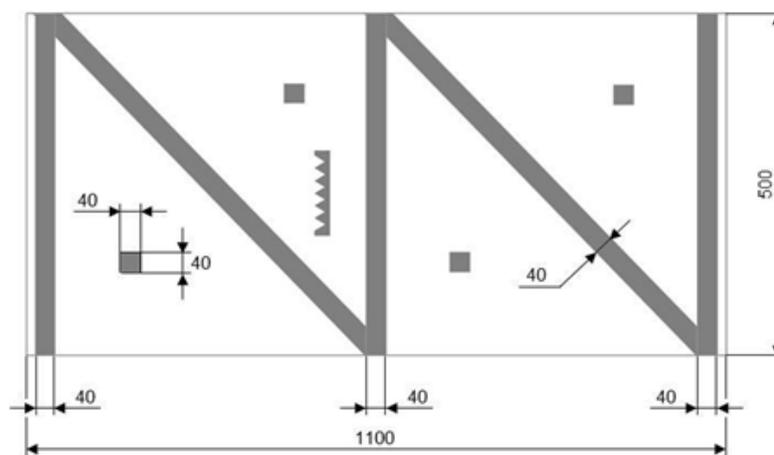
To verify the performance of the algorithm, a reference specimen that simulated artificial defects was fabricated, as shown in Figure 7.

Figure 7. Shape and dimension of reference specimen (mm).

The geometry and simulated defects of the specimen were fabricated in accordance with the Airbus standard. The specimen was scanned to acquire an image before compensating for the misalignment of the bogie axis, as shown in Figure 8. Another image was also acquired after performing the pitch and yaw corrections. The images were compared and analyzed. In addition, for a composite material specimen without defects, the images obtained before and after correction were compared and analyzed.

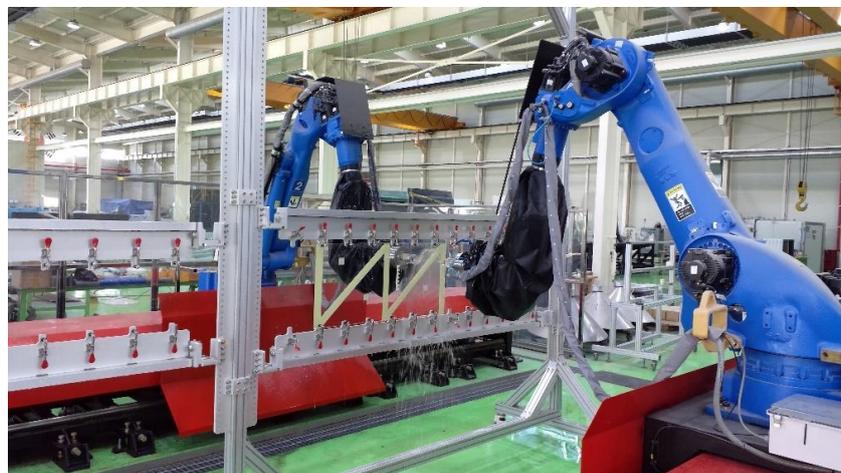
Figure 8. Scanning for reference specimens with artificial defects.

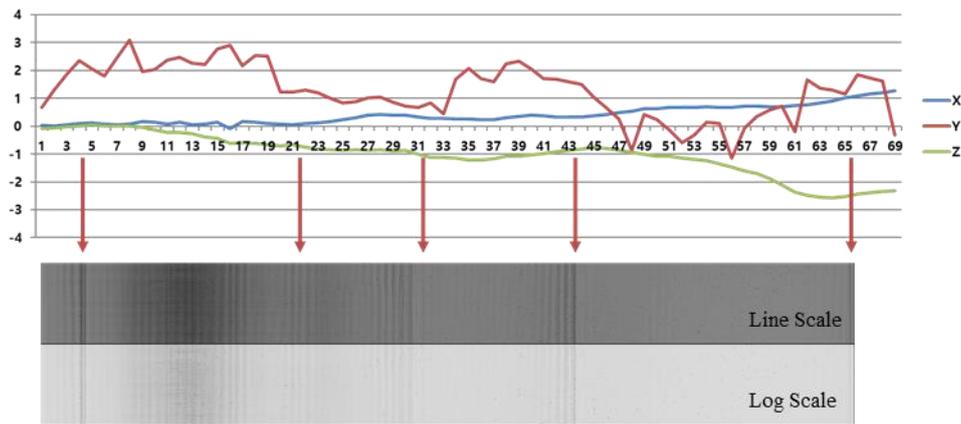
Figure 9 shows the ultrasonic image acquired in the absence of the specimen and the position coordinate values for three axes, which were measured using the laser tracker during transport of the bogie axis to identify axis misalignment. As shown in Figure 9, the ultrasonic image acquired during the transport of the bogie axis was observed to include dark and bright sections, which appear to have occurred because of the change in sound pressure caused by axis misalignment.

Figure 9. Image of x -, y -, and z -axis misalignment for the R1 and R2 robots.

In the case of the y -axis, the intensity of the ultrasound sharply decreased at positions where there were rapid changes on the coordinate axis, resulting in the formation of dark images. The misalignment of the y -axis had the greatest effect on the ultrasonic image. The x -axis, which represents the distance between the robots, had a lower effect on the change in sound pressure.

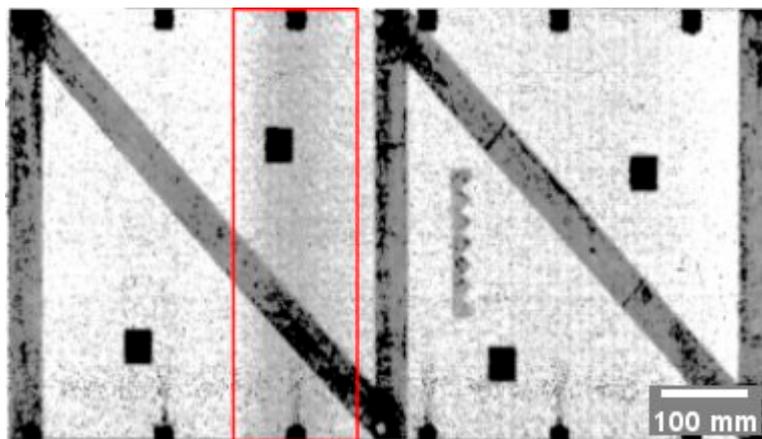
(a) Before correction

Figure 12 shows C-scan images of the reference specimen that were captured before and after implementing the corrections; the specimen was fabricated to verify the validity of the correction algorithm. C-scan is a method of taking plane images using a signal measured by the TTU method. Here, only pitch and yaw corrections were performed, as in the previous case. As shown in Figure 12a, a relatively dark image appeared within the red box before correction because the received sound pressure was reduced by axis misalignment. This characteristic can be mistaken for delamination or the presence of voids during actual composite material inspection. To address this problem, axis misalignment was corrected by applying the developed algorithm, then an image was acquired from the same specimen. Figure 12b shows that the changes in contrast that appeared before the correction were almost completely removed. This confirmed that the developed algorithm could accurately correct the axis misalignment.

Figure 12. C-scan images of the specimen with simulated defects.

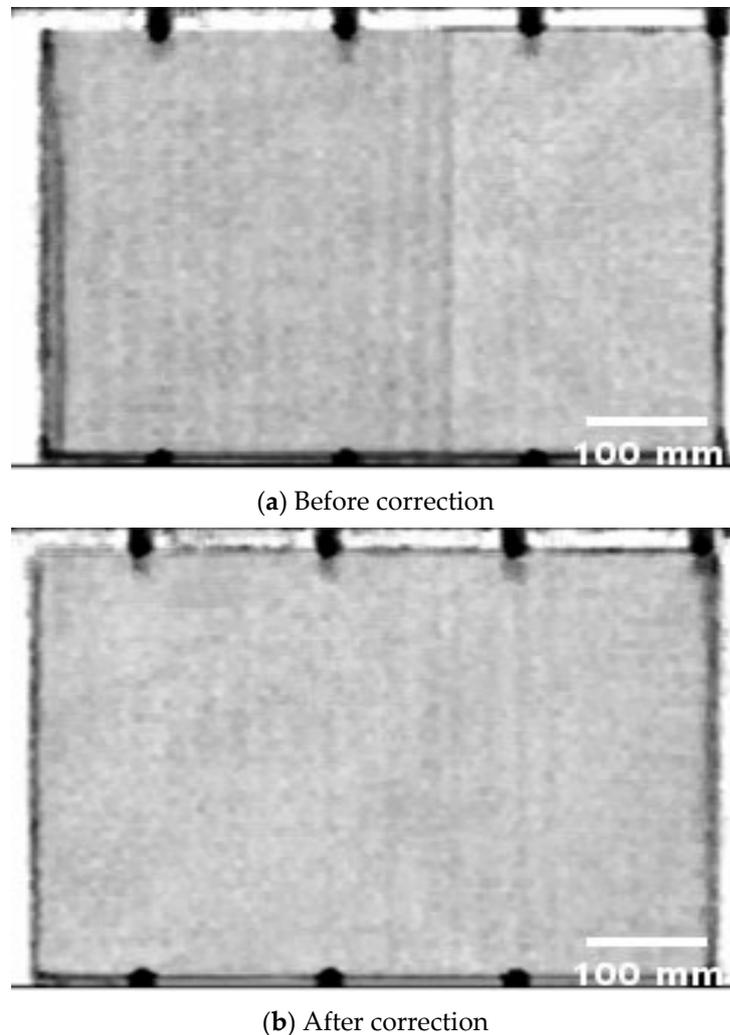
The same experiment was performed with the actual composite material specimen; the results are shown in Figure 13. As with the results of the reference specimen, the majority of the changes in image contrast caused by axis misalignment were removed after correction.

Figure 13. Ultrasonic images of the actual composite material specimen.
