Effect of Fine Particle Peening Using Hydroxyapatite Particles on Rotating Bending Fatigue Properties of β -Type Titanium Alloy [†]

Abstract: Fine particle peening (FPP) using hydroxyapatite (HAp) shot particles was performed to improve the fatigue strength and form a HAp transfer layer on a beta titanium alloy (Ti-22V-4Al). The surface microstructures of the FPP-treated specimen were characterized using scanning electron microscopy, micro-Vickers hardness testing, energy dispersive X-ray spectrometry, X-ray diffraction, and electron backscattered diffraction. A HAp transfer layer with a thickness of 5.5 μm was formed on the surface of the Ti-22V-4Al specimen by FPP. In addition, the surface hardness of the Ti-22V-4Al was increased, and high compressive residual stress was generated on the specimen surface by FPP. Rotating bending fatigue tests were performed at room temperature in laboratory air over a wide cycle-life region (10^3 – 10^9 cycles). In the long cycle-life regime, the fatigue strength at 10^7 cycles of the FPP-treated specimen became higher than that of the untreated specimen. This result is attributed to the formation of a work-hardened layer with high compressive r

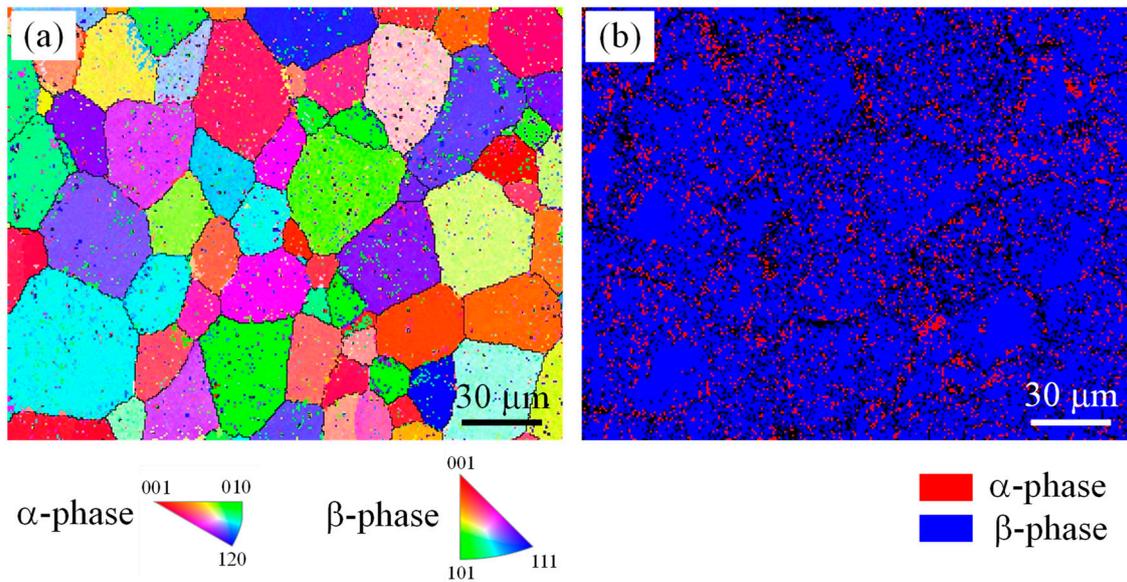
Figure 1. EBSD analysis of microstructure: (a) inverse pole figure (IPF) map; (b) phase map.

Figure 6 shows the image quality (IQ), inverse pole figure (IPF), and phase maps for the cross section of the FPP-treated specimen analyzed by EBSD. In Figure 6b,c, there was no noticeable difference in microstructure as compared with the microstructure of the substrate (Figure 1) even beneath the surface. Thus, no change in microstructure, such as crystal grain refinement, occurred as a result of FPP using HAp particles.

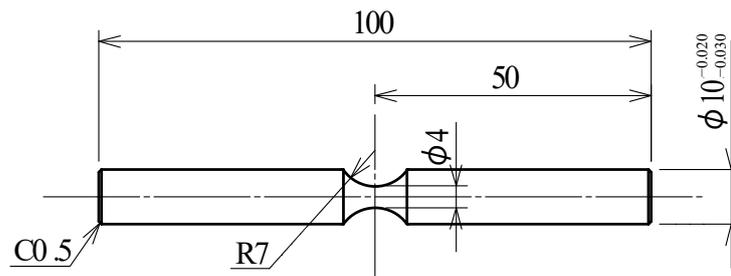
Figure 2. Specimen configuration.

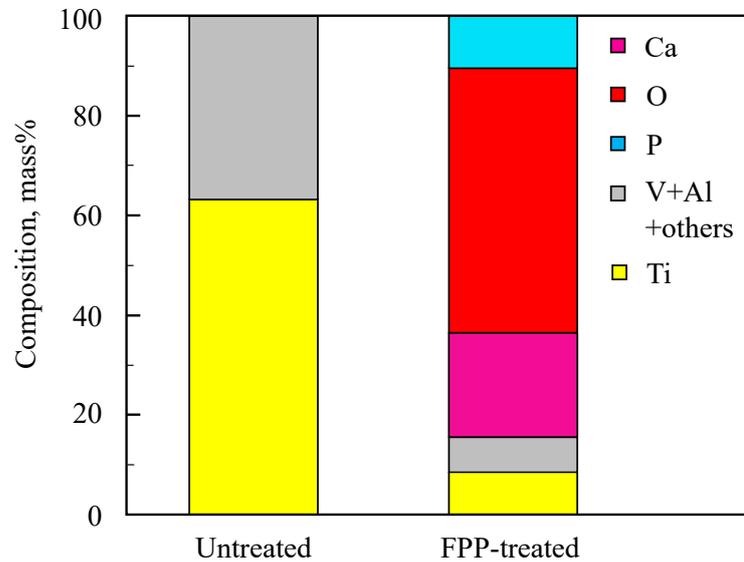
Figure 4 shows the elemental composition of each specimen surface analyzed by EDS. Ca, P, and O were detected and accounted for 84% of the composition of the FPP-treated

specimen surface. Therefore, the HAp was definitely transferred on the surface of the titanium alloy, because the amount of HAp constituent elements clearly increased.

Figure 4. Elemental composition of untreated and FPP-treated specimen surface determined by EDS analysis.

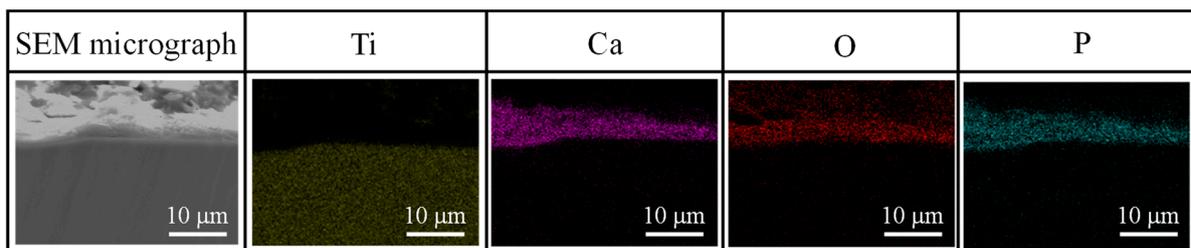
To investigate the thickness of the HAp layer, we observed the cross section of an FPP-treated specimen. Figure 5 shows the cross-sectional SEM micrograph and EDS maps of the FPP-treated specimen. Ca, O, and P, which are contained in the HAp shot particles, were detected on the Ti alloy substrate. Thus, it was again confirmed that the HAp layer was formed on the Ti-22V-4Al alloy. Figure 5 also reveals that the HAp layer was inhomogeneously formed at the FPP-treated surface. The equivalent thickness of the HAp layer was calculated from Equation (1), assuming that the HAp layer, which consisted of HAp shot particles transferred onto the surface, was uniformly formed over the entire surface [23]:

Figure 5. SEM micrographs and EDS maps for cross section of FPP-treated specimen.

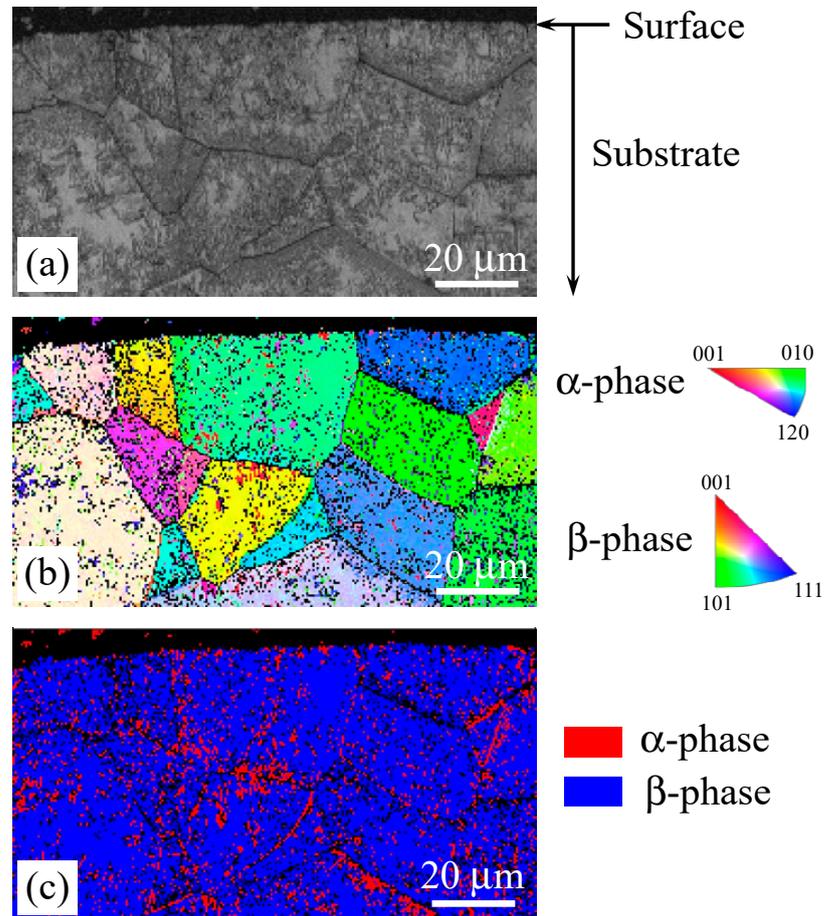
Figure 6. EBSD analysis for cross section of FPP-treated specimen: (a) image quality (IQ) map; (b) IPF map; (c) phase map.

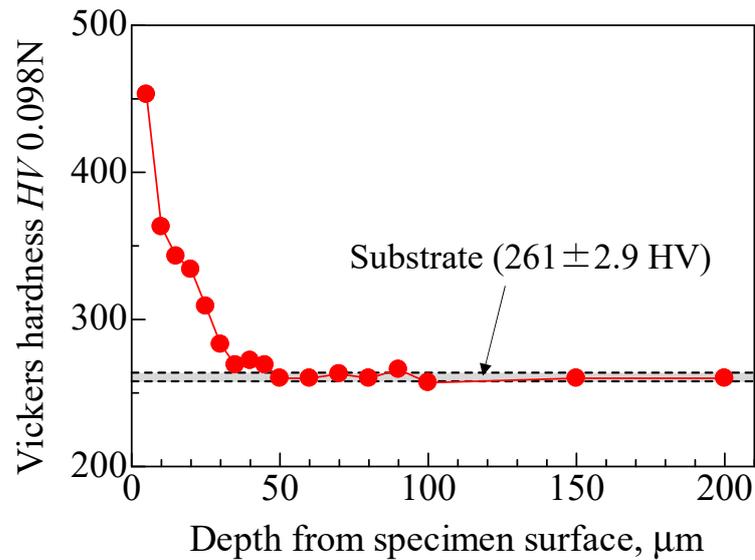
Figure 7 shows the distribution of Vickers hardness at various cross-sectional depths for the FPP-treated specimen. The hardness on the surface of the FPP-treated specimen was 453 HV. Compared with the substrate (261 ± 2.9 HV), the surface became 73% harder. The interior hardness of the FPP-treated specimen decreased with increasing depth and corresponded to that of the untreated specimen at a depth of 30 μm . In other words, the thickness of the work-hardened layer formed by FPP was approximately 30 μm .

Figure 7. Distribution of Vickers hardness at various cross-sectional depths for FPP-treated specimen.

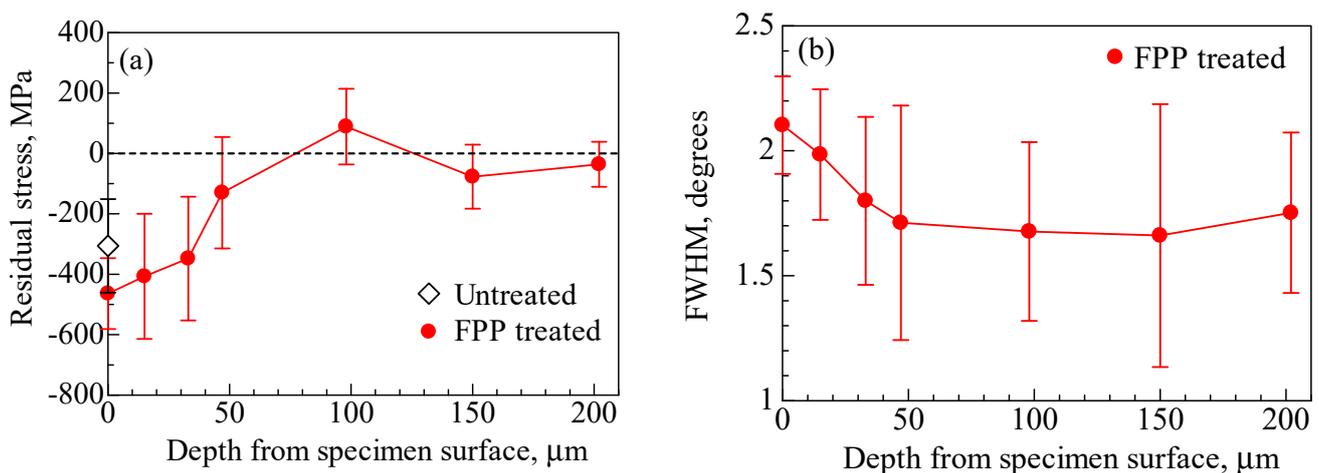
Figure 8 shows the distribution of the residual stress and the XRD FWHM at various cross-sectional depths for the FPP-treated specimen. As shown in Figure 8a, the compressive residual stress on the surface of the untreated specimen was 306 MPa. This residual stress was caused by buff finishing. The thickness of the surface layer, at which compressive residual stress was generated, was approximately 50 μm . As a result of the comparison of the FWHM profile (Figure 8b) and the Vickers hardness profile (Figure 7), it is clear that both profiles show a very similar behavior. It is well known that FWHM values are useful means to characterize the degree of work hardening, since they usually correlate well with the hardness in soft and medium-hard mechanically surface-treated materials [26]. Therefore, it is confirmed that the depth of work hardening was approximately 50 μm .

Figure 8. (a) Residual stress and (b) FWHM values as a function of depth into the surface of FPP-treated specimen.

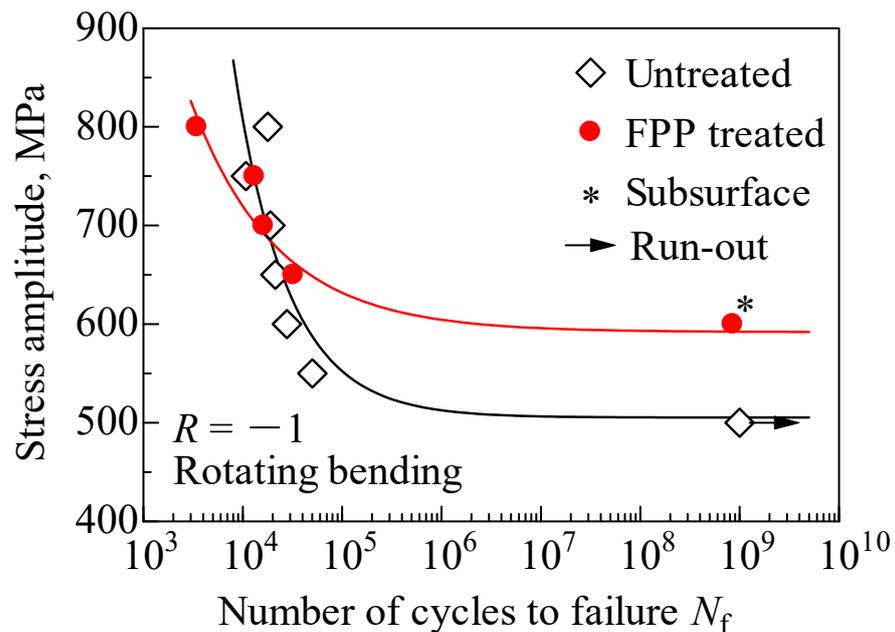
Figure 9 shows the results of the rotating fatigue tests for the untreated and the FPP-treated specimens. In this figure, data points with an arrow indicate the run-out of the specimen, which was not failed until the number of stress cycles was 10^9 . In each specimen, a fatigue limit was not clearly observed so that the $S-N$ curve was determined based on the curve of the $S-N$ model in the JSMS standard regression models [27]. Regression $S-N$

Figure 9. S–N diagram for untreated and FPP-treated specimens.

At high stress levels greater than 700 MPa, there is no improvement in fatigue life by FPP; nevertheless, a work-hardened layer and high compressive residual stress were generated at the specimen surface. As shown in Figure 3, SEM observation of the FPP-treated specimen surface indicated the rough surface formed by FPP. It is suggested that the asperity formed on the specimen surface can be a crack starter and deteriorate the fatigue life. On the other hand, at low stress levels lower than 700 MPa, the fatigue life of the FPP-treated specimen was longer than that of the untreated specimen. The FPP-treated specimen failed at $\sigma_a = 600$ MPa, the fatigue life was $N_f = 1.0 \times 10^9$ cycles, and the subsurface fracture mode was observed. In shot-peened specimens, fatigue crack initiated from the surface of the specimen at a high stress level, while at a low stress level, fatigue crack initiated from the subsurface [28,29]. The same phenomenon is assumed to have occurred in the FPP-treated specimen. Furthermore, if more fatigue tests are performed for the FPP-treated specimen, the duplex S–N characteristics [30] may appear.

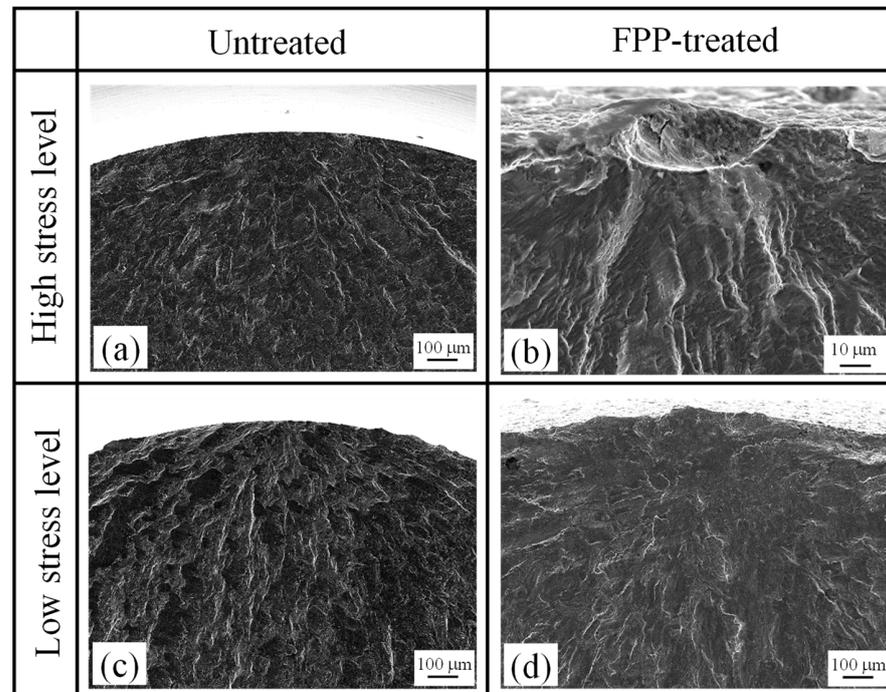
The fracture surfaces of all failed specimens were examined using SEM to determine the fatigue fracture mechanism. Figure 10 shows the SEM micrographs of the crack initiation site in each specimen failing at high and low stress levels. At a high stress level ($\sigma_a = 800$ MPa), a fatigue crack was initiated at the specimen surface in the untreated specimen. No defect was found at the crack initiation site, and the fatigue crack was caused by crystal grain slip. On the other hand, in the case of the FPP-treated specimen, a defect was found at the crack initiation site, and it was formed by the collision of HAp shot particles with the specimen surface during the process of FPP. Therefore, the reason the fatigue strength was not improved was that even though a work-hardened layer was generated, the high compressive residual stress caused the formation of defects during the FPP process, and they became crack starters. At a low stress level ($\sigma_a = 600$ MPa), in

the untreated specimen, a fatigue crack was initiated at the specimen surface, the same as when the specimen failed at a high stress level. In the case of the FPP-treated specimen that failed at a low stress level of 600 MPa, it seems that the crack initiated below the specimen surface. Thus, the subsurface-initiated fracture mode occurred in this case. However, no defect (inclusion or defect) was found at the crack initiation site.

Figure 10. SEM micrographs showing crack initiation site of untreated specimen and FPP-treated specimen failing at (a,b) high ($\sigma_a = 800$ MPa) and (c,d) low ($\sigma_a = 600$ MPa) stress levels.

As can be seen in Figure 10, the FPP-treated specimens showed different failure modes at high and low stress levels. Figure 11 shows a schematic illustration of the fracture mechanism for the FPP-treated specimen. Figure 11a indicates a crack initiated at the surface of the substrate (surface-initiated fracture), and Figure 11b indicates a crack initiated below the surface of the substrate (subsurface-initiated fracture). As shown in Figures 7 and 8, based on the results of Vickers hardness and residual stress measurements, the thickness of the work-hardened layer and the depth of compressive residual stress were approximately 30 μm . Therefore, the resistance to crack initiation became high near the specimen surface, and the crack initiated below the specimen surface. Consequently, the fatigue crack was initiated below the surface of the substrate at a low stress level.

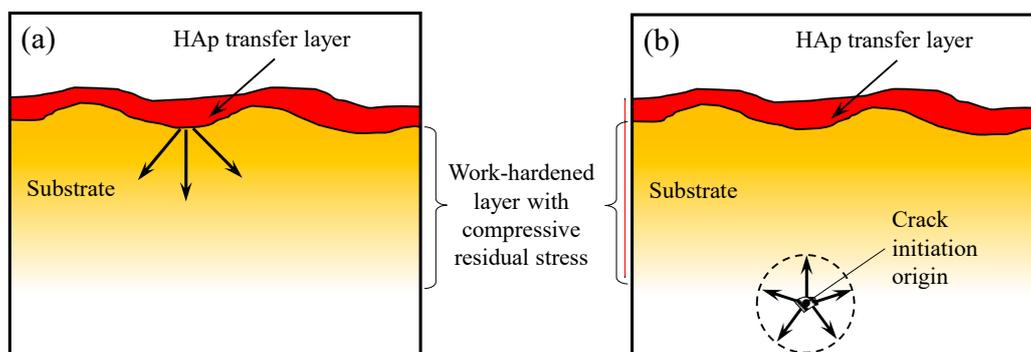
Figure 11. Schematic illustration of fracture mechanism for FPP-treated specimen failed at (a) high and (b) low stress levels.
