Comparing Structural Casualties of the Ro-Ro Vessel Using Straight and Oblique Collision Incidents on the Car Deck

Keywords: maritime incidents; straight and oblique collisions; finite element approach; energy ratio; rupture strain

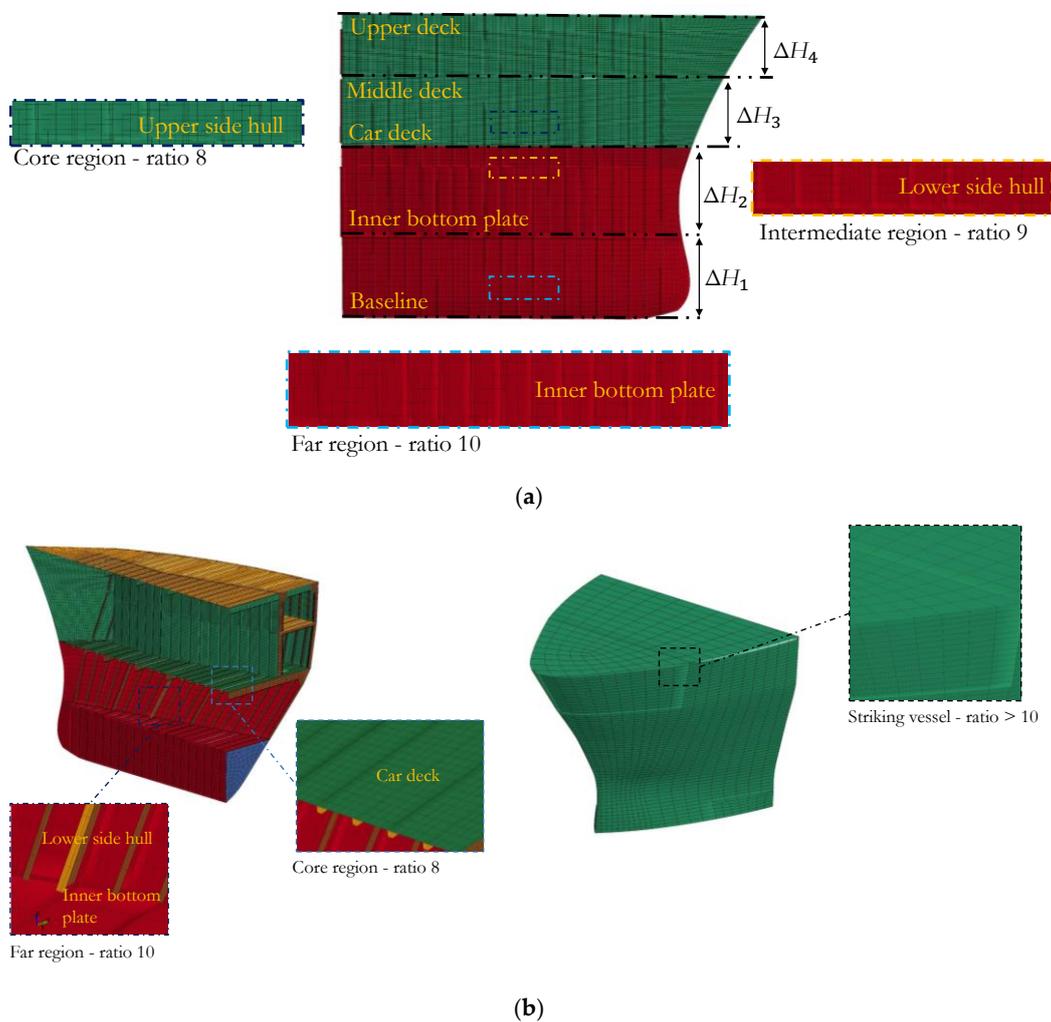
Figure 2. The geometry of the idealized struck vessel: (a) Boxes highlight the mesh configuration on the side hull, and (b) Detail of meshing on the inner structure and the striking vessel.

Two vessels were used in this study with the Ro-Ro used as the struck vessel and cargo as the striking vessel as shown in Figure 2. The struck ship was idealized as a deformable body with an inner structural arrangement such as inner shell, frame, and girder. On the contrary, the striking vessel was defined as a rigid body modelled on bow geometry without inner structure. These assumptions were implemented to focus the damage observation on the struck vessel. Furthermore, by deploying a rigid striking vessel, the worst damage was estimated due to its inability to undergo deformation and cause larger damage than a deformable striking ship.

Based on these configurations, other settings were demanded on the deformable structures to ensure the rupture are well captured. In this case, the discretion of large model was an important task to be conducted, and after several works in the fields of impact engineering and crashworthiness, such as [20,28], the implementation of meshing size based on the ratio of element length and member thickness is proven capable of producing good results. The same strategy was applied in this work with

the finest-smallest mesh of ratio 8 at the core, largest ratio 10 at the far, and ratio 9 at the intermediate region of contact. Moreover, since the striking vessel was modelled as a rigid object, the larger mesh was used to increase the efficiency of the calculation process conducted through nonlinear finite element (NLFE) ANSYS LS-DYNA. Furthermore, the large structures underwent discretization into more than 70,000 element number, and explicit methodology was chosen to calculate configuration due to its effectiveness in estimating the characteristics of impact engineering [29].

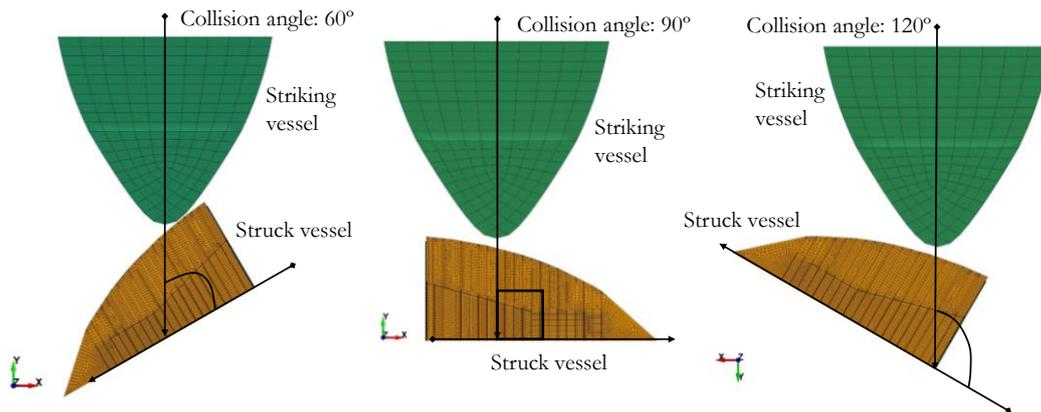
Figure 3. A variety of collision angle applied to the scenarios.

The accidental load was defined as the collision between two vessels with the striking vessel hitting the designated target on the struck vessel's side shell. Specifically, the target was placed on the car deck of the Ro-Ro below the upper and middle decks. However, in order to investigate several structural performances of the card deck, different collision angles, 60° , 90° , and 120° , were applied on the scenario configuration according to the Cartesian coordinate system. Even though the 60° and 120° are actually the same degrees in different quadrants, different results were expected due to the curve geometry of the struck vessel. The collision geometry of the NLFE analysis is presented in Figure 3.

During vessel collision, the striking speed applied was 12 knots or approximately 6 m/s with restrained rotational displacements. The struck vessel was made constant (not moving) with the fixation attached on the edge of decks, inner bottom plate, and side transverse frame. Moreover, since collision is the main subject of this study, contact, involving frictions, is an inevitable phenomenon. Therefore, automatic contact surface-to-surface model was used to idealize the interaction of surface geometry between the struck and striking vessel, and the values of friction coefficient were set at $\mu_k = 0.57$ and $\mu_s = 0.74$ for kinematic and static values respectively.

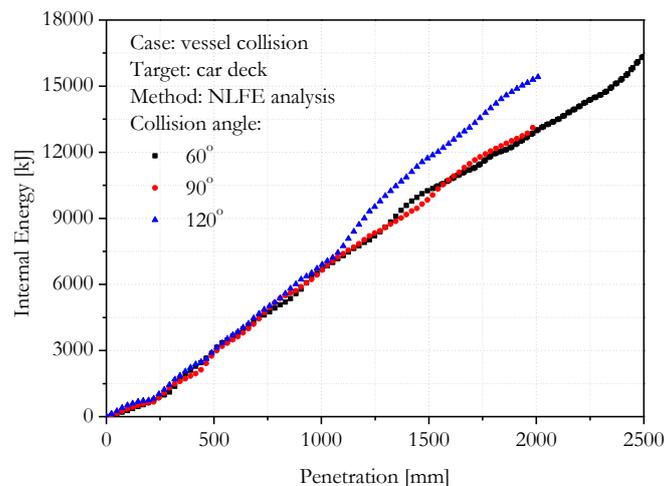
Figure 4. Summary of the internal energy based on the proposed cases.

The structural assessment of the struck vessel was first conducted by observing behaviours of the internal energy, which was included in the crashworthiness criteria. The graph below illustrates the numbers of structural members destroyed on impact as well as the level of the expected damage. Figure 4 shows the collision angle 60° to have produced the highest energy level, followed by 120° and 90°, consecutively. The results also indicated that the destruction of the struck vessel in oblique collision 60° lasts longer, which may be important background regarding high energy pattern. Through the representation of the internal energy at the end of the collision a shown in Figure 5, a parabolic shape was produced when the collision angle was in its vertex or lowest point.

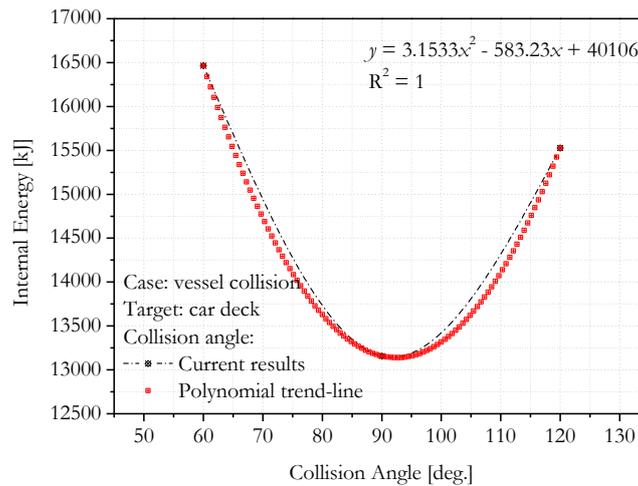
Figure 5. Pattern of the internal energy on a variety of collision angle.

This phenomenon suggested that during side collision, the side hull is more prone to oblique collision than a perpendicular one or perfect T-collision. This statement is founded on the less energy observed in the angle 90°, which shows that less damaged structure occurred after the collision process.

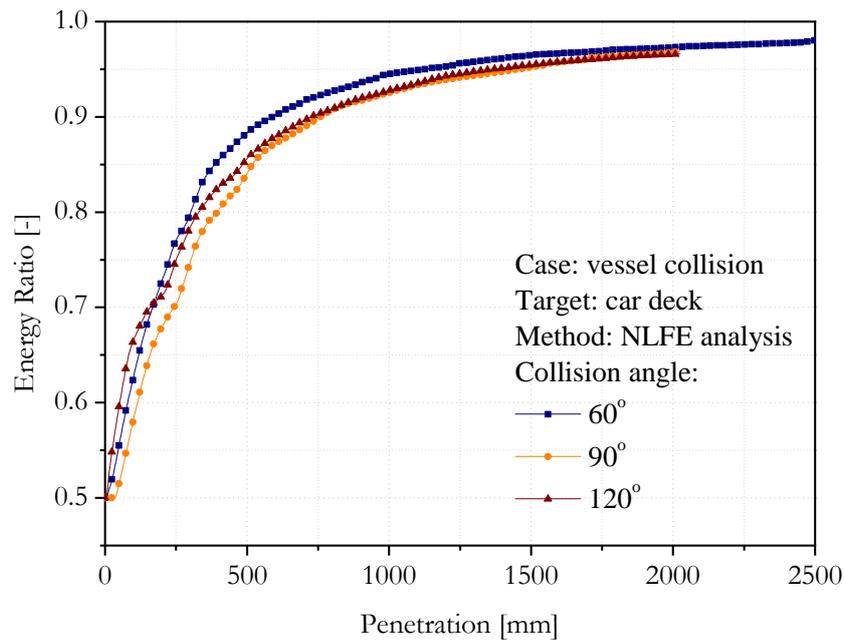
Figure 6. Ratio of the internal energy to the kinetic energy during collisions.

This is the proportion of the total energy in a system to the initial energy, as shown in the mathematical expressions in Equations 2 and 3. However, if the left-hand side falls below the right hand, it is possible to conclude that energy is being absorbed artificially, perhaps by an hour-glassing phenomenon, which may occur due to major damage of the idealized structures. This fundamental calculation was matched with the results in Figure 6 where the ratio was found not to be perfectly one since some energy was affected by an hourglass. However, a very satisfying condition was indicated as the final results for all cases exceed 95%, and the hourglass proportion less than 5%. A more specific discussion on hourglass is presented in the next sub-section.

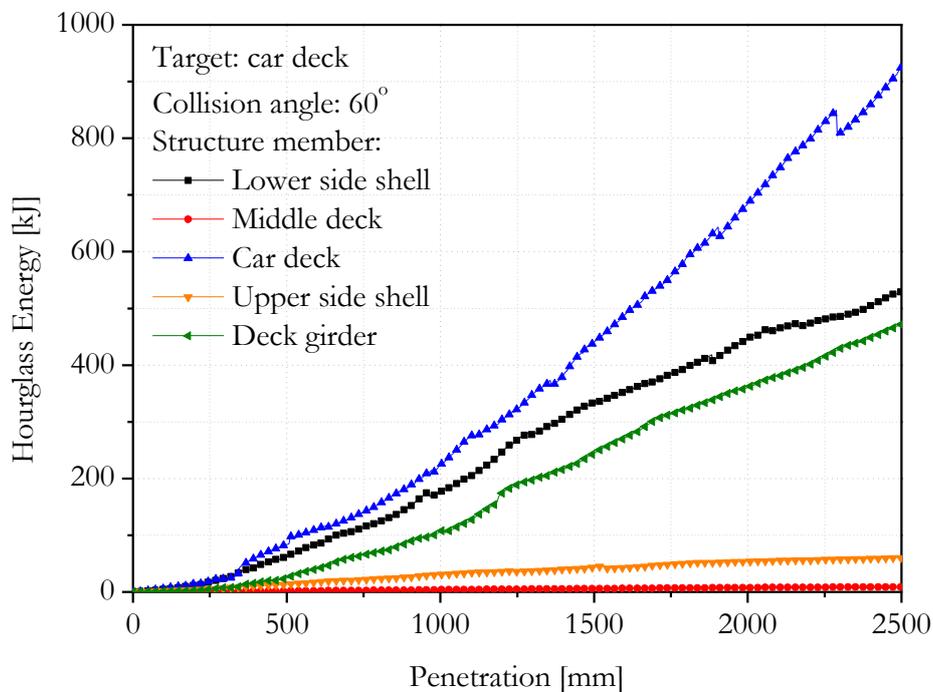
Figure 7. Hourglass energy of the collision angle 60°.

Hourglass is a behaviour of a numerical model to be deformed in non-physical ways or geometrically due to the excessive artificially applied load. As initially predicted in the discussion of the energy ratio, a very small part of the energy was artificially absorbed by hourglass and the results presented in Figures 7–9 show compatibility with the prediction, even though it is minor.

The summary of the designed collision cases indicated the T-collision shown in Figure 8 to have produced the lowest hourglass energy compared to the oblique cases in Figures 7 and 9. However, a detail observation has the ability to identify the most contributing member in the hourglass phenomenon. Furthermore, the tendency of the car deck was observed to have produced the highest level, followed by the lower side hull, deck girder, upper side, and middle decks, respectively. It was especially found that the upper side and middle decks have extremely low hourglass with approximation in the range of 0–50 kJ. Moreover, associating the result of this subsection with the expected damage pattern after vessel collision showed a higher level of damage is experienced by a

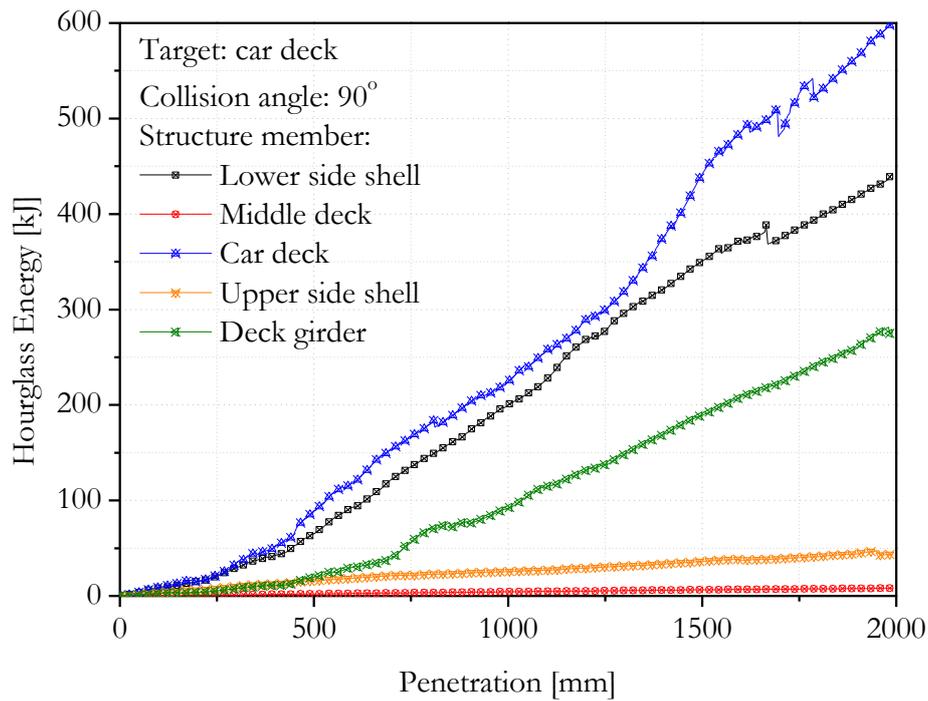
Figure 8. Hourglass energy of the collision angle 90°.

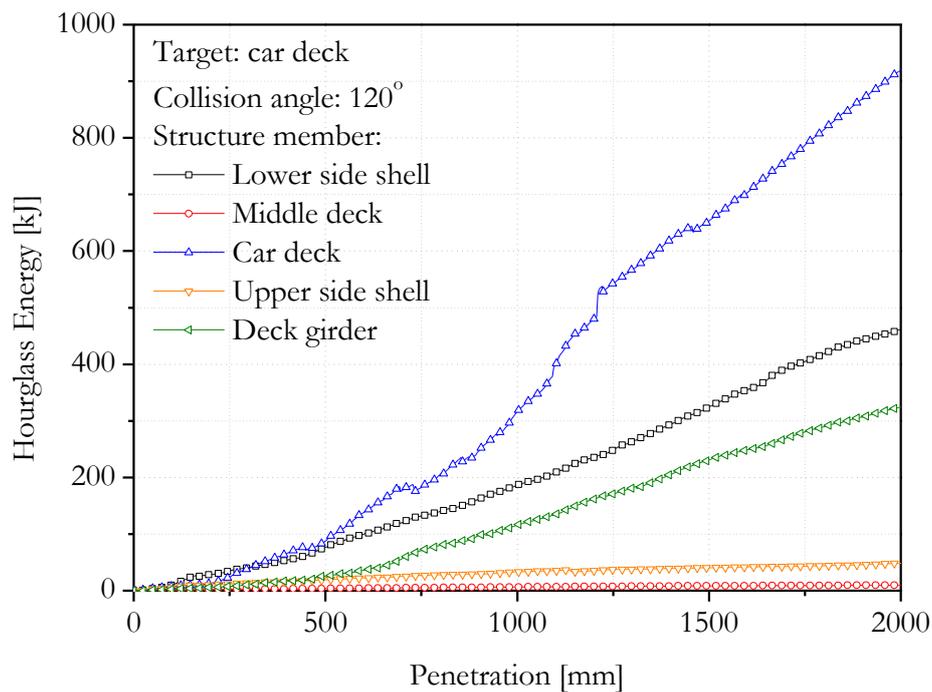
Figure 9. Hourglass energy of the collision angle 120°.

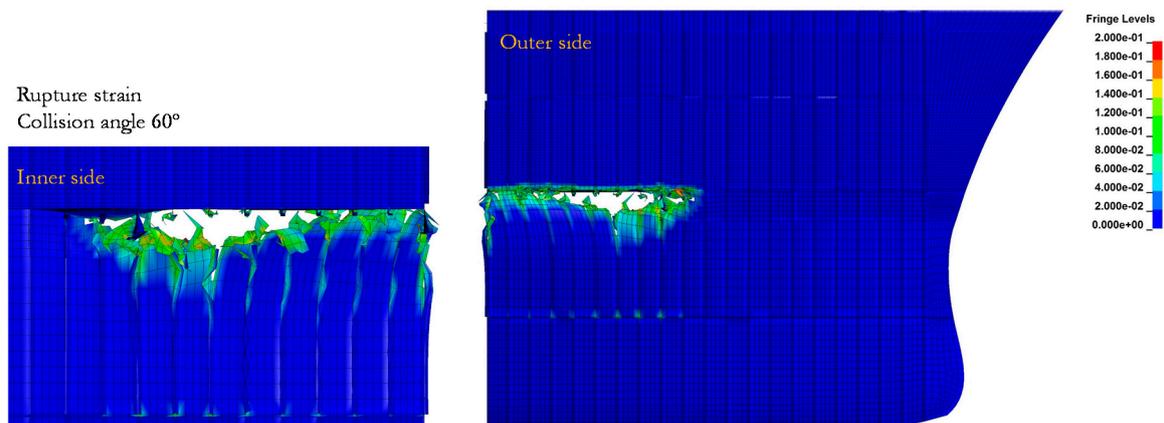
Figure 10. Contours of the strain near the car deck: Angle 60°.

As defined in the numerical configuration, rupture is experienced by a material when the ultimate strain is exceeded due to accidental load. In case of the vessel collisions, the strain distribution on the struck vessel reached a quite long extent in oblique collisions of 60° and 120° as shown in Figures 10 and 11. The strain observed indicated that the earlier contact of the side part of the striking vessel and struck vessel occurred before the tip of the striking vessel hit the target. This pattern is very different compared to the T-collision, as shown in Figure 12. This illustration showed the opening on the struck vessel was perfect with the tip of the striking vessel which penetrated the target straight to the transverse direction. Therefore, due to more local damage on the struck vessel, the internal energy and hourglass for angle 90° were lower than the oblique cases.

The observation of the damage pattern showed the most side frame on the oblique collision 120° was folded on the lower part while the upper part was crushed and pushed on the direction of the striking angle. Furthermore, the curved geometry on the fore-peak section made the crushing pattern of two oblique collisions different even though the angle size is the same according to the Cartesian diagram. In terms of the damage extent, the collision in 60° caused longer tear on the connection of the car deck and lower side shell influenced by deeper penetration. Moreover, the calculation of the penetration in the same depth predicted the damage length to be similar in terms of size.

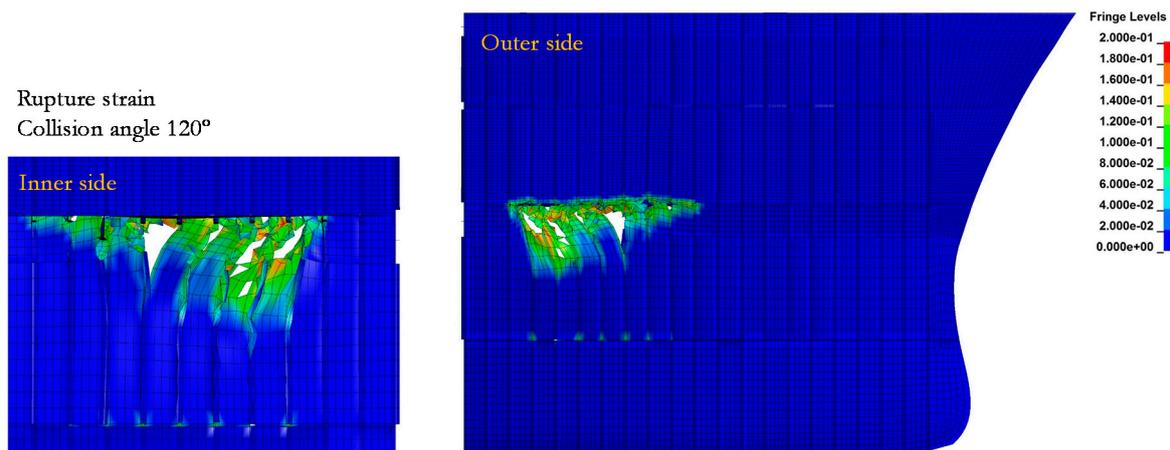
Figure 11. Contours of the strain near the car deck: Angle 120°.

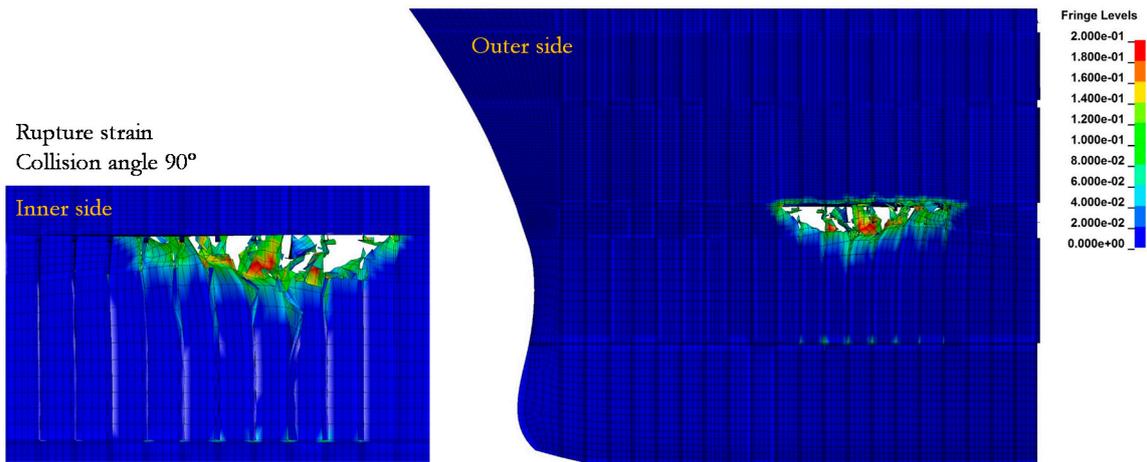
Figure 12. Contours of the strain near the car deck: Angle 90°.

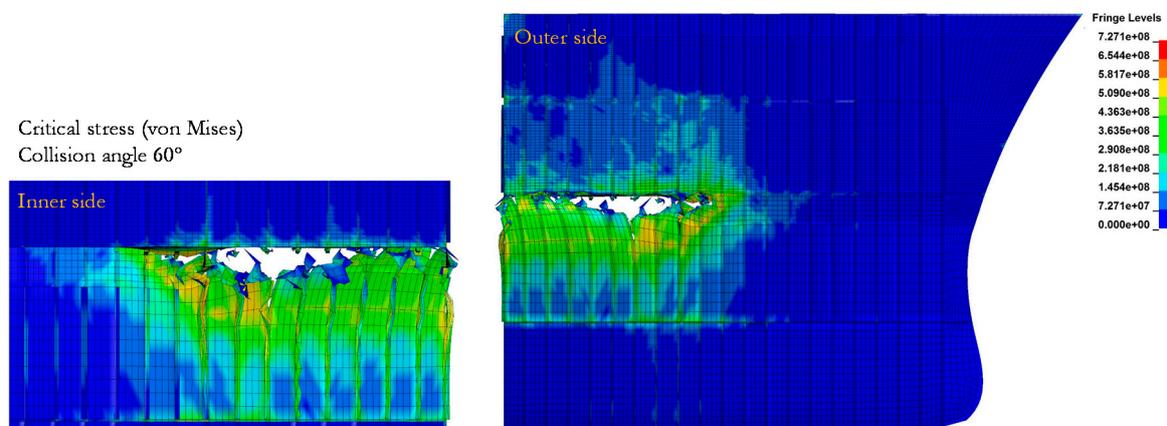
Figure 13. Critical stress (von Mises formulation) of the collision Angle 60°.

The stress in the current structural assessment was conducted to investigate the total number of members affected due to the car deck. According to the critical stress presented by von-Mises formulation in Figures 13–15, the affected members for the three cases were similar, and they include car deck (main target), girder, lower hull, upper hull, and middle deck. However, despite these similarities, high-stress intensity occurred quite extensive on the lower hull of the collision case 90°. It is, therefore, possible to come up with the estimation that the collision would continue, and the part covered by high stress would experience the earliest rupture, and the element removed in the calculation. It was also noted that the oblique collisions and T-collision have a quite distinct extent in terms of damage and stress with the former having the tendency to form an incision rather than deep-focus penetration produced by the latter on the struck vessel.

The inflicted damage due to a variety of penetration styles influenced the stress contour on the side hull. Moreover, the oblique collisions in Figures 13 and 15 caused stress distribution to the longitudinal direction of the struck vessel, while the T-collision in Figure 14 caused high-stress intensity on the lower part of the hull opening which was explicitly distributed on the lower side hull, including its local components, such as shell and frame. This condition indicated the hull part was in a critical state before the larger tearing occurred and a deeper penetration was expected to lead to the same pattern on the side hull. A similar case is found on the 120° collision angle with the red contours spotted on the connection between the car deck and side hull. However, this spot was not a complete failure during an interaction between two ships, and the stress was intact at the end of the collision process. Therefore, the tearing length may reach this spot if a larger part of the striking bow penetrates the struck ship on impact.

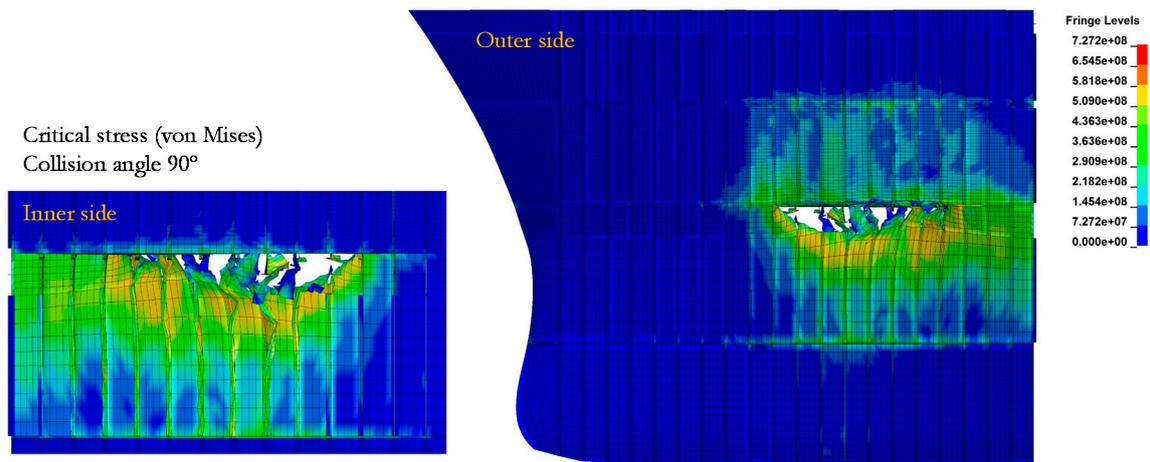
Figure 14. Critical stress (von Mises formulation) of the collision angle 90°.

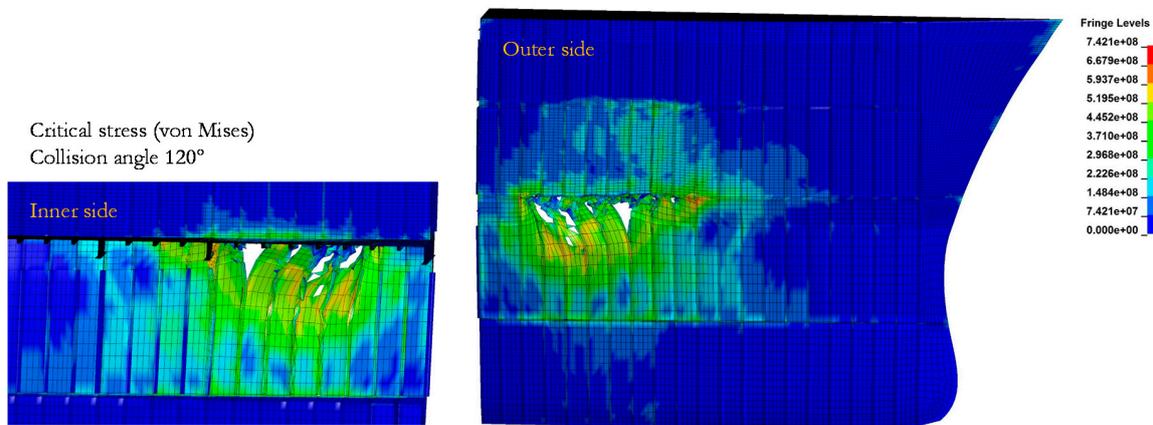
Figure 15. Critical stress (von Mises formulation) of the collision angle 120°.
