Crack Healing in Mullite-Based EBC during Thermal Shock Cycle

Abstract: Crack healing phenomena were observed in mullite and mullite + Yb₂SiO₅ environmental barrier coating (EBC) materials during thermal shock cycles. Air plasma spray coating was used to deposit the EBC materials onto a Si bondcoat on a SiC_f/SiC composite substrate. This study reveals that unidirectional vertical cracks (mud cracks) formed after several thermal shock cycles; however, the cracks were stable for 5000 thermal shock cycles at a maximum temperature of 1350 °C. Moreover, the crack densities decreased with an increasing number of thermal shock cycles. After 3000 thermal shock cycles, cracks were healed via melting of a phase containing SiO₂ phase, which partially filled the gaps of the cracks and resulted in the precipitation of crystalline Al₂O₃ in the mullite. Post-indentation tests after thermal shock cycling indicated that the mullite-based EBC maintained its initial mechanical behavior compared to Y₂SiO₅. The indentation load–displacement tests revealed that, among the materials investigated in the present study, the mullite + Yb₂SiO₅ EBC demonstrated the best durability during repetitive thermal s

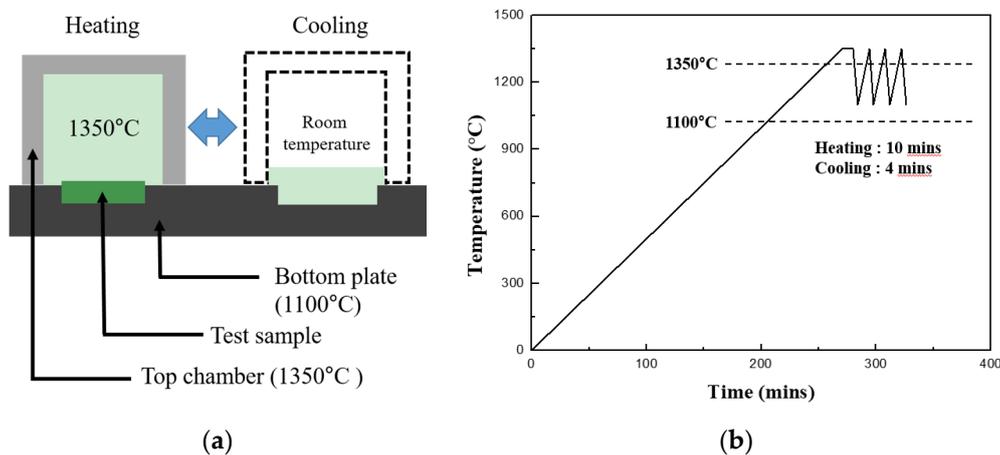
Thermal shock tests were performed to evaluate the durability of the EBC against repetitive thermal fatigue. The thermal shock was induced using a laboratory-made horizontal thermal shock machine in which the chamber could be moved horizontally by a motor. The schematic diagram of the thermal shock test is shown in Figure 1a. The test samples were placed on a fixed hotplate such that the substrate was positioned to receive heat from the lower part of the hot plate, and the coating layer was exposed to the top to receive heat from the chamber. First, the test samples placed on the hotplate were maintained at a temperature of 1100 and 1350 $^{\circ}\text{C}$ in the upper coating layer after the heating chamber was closed; the heating rate was 5 $^{\circ}\text{C}/\text{min}$. After the target temperature had been maintained for 10 min, the upper chamber was moved to expose the sample to room temperature for 4 min as shown in Figure 1b, and then the chamber was moved back to expose the sample at 1350 $^{\circ}\text{C}$ again. This cycle was defined as one cycle, and repetitive thermal shocks were applied for a maximum of 5000 cycles.

Figure 1. (a) Schematic of the thermal shock test from 1350 $^{\circ}\text{C}$ to room temperature; (b) temperature profiles during the thermal shock tests in this study.

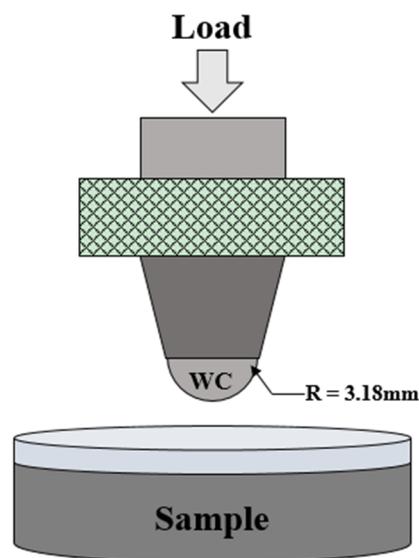
Spherical indentations were induced to compare and evaluate the mechanical behavior before and after the thermal shock test. The schematic diagram of spherical indentation is shown in Figure 2. Indentation load–displacement curves were obtained during indentation tests. A tungsten carbide ball with a radius of $r = 3.18$ mm was attached to the jig of a universal testing system (Instron 5567, Boston, MA, USA) and the pre-load was applied to the coating layer to $P = 10$ N at a rate of 3 N/min. The load was then applied to $P = 500$ N at a rate of 0.1 mm/min. The load was removed at the same rate as soon as the load had reached $P = 500$ N. The displacement was measured with an extensometer during load changes. Tests were conducted on more than five areas of the coating layer of the test specimens, and the indentation load and displacement results were averaged and plotted. The relative hardness was calculated from relative displacement after unloading in each indentation load–displacement and compared [23–26].

Figure 2. Schematic of a spherical indentation using a WC ball with a radius of 3.18 mm in this study.

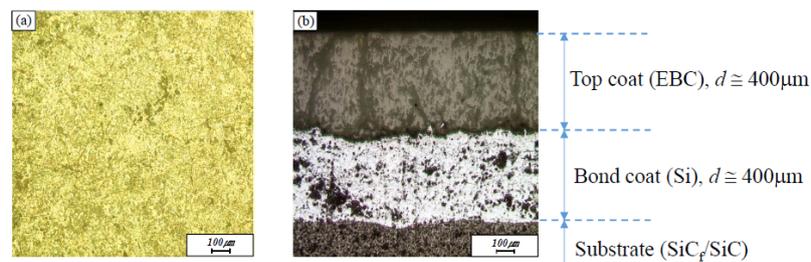
The cracks formed on the surface and cross section of the EBC coating layer by thermal shock were observed by optical microscopy, as shown in Figure 3. Thermal shock tests were carried out at 1350 °C on the coating surface of the sample and at 1100 °C on the bottom of the sample because a gas turbine operating at 1600 °C is cooled simultaneously by the cooling gas through the flow path. Mud-type cracks formed on the surface. After 100 thermal shock cycles, cracks developed in the EBC layer fabricated by APS, as shown in Figure 3a. We considered that these cracks developed because of the difference in thermal expansion coefficients between the EBC coating and the metal sublayer. Several researchers have observed and reported mud cracks in EBCs [8]. However, cross-sectional observations of these cracks reveal that they formed in a direction perpendicular to the interface, not parallel to the interface. The vertical cracks shown in Figure 3b propagated through 400 μ m of thickness; their propagation stopped at the top of the bondcoat layer. Such cracks can be stable if they do not induce horizontal cracking along the interface between the EBC and the sublayer, but rather tolerate strain caused by stress, thereby contributing to preventing delamination of the coating layer [27,28].

Figure 3. Optical micrographs of the (a) surface and (b) cross section of EBCs after 100 thermal shock cycles at 1350 °C.

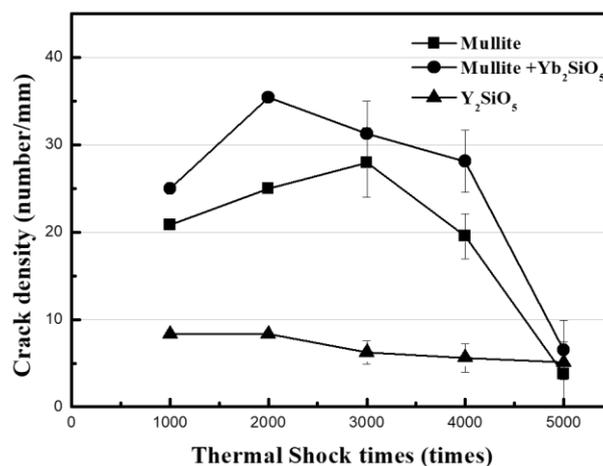
The results of the measurements of the crack density developed on the surface of the EBC by thermal shock are shown in Figure 4. The periodic repetition of heating and cooling in turbine systems, and especially an abrupt stop of the system, will exacerbate crack formation. Therefore, the stability of cracks was evaluated by thermal shock tests. The mullite-based EBCs (i.e., the mullite and mullite + Yb_2SiO_5 EBCs) were not delaminated when the thermal shock cycle of exposure to room temperature was repeated for 5000 cycles while the coating material was maintained at 1350 °C and the SiC_f/SiC substrate material was maintained at 1100 °C. Even though a crack is generated initially, interface delamination does not occur because vertical cracks are formed. That is, an initially developed crack in the EBC layer is very stable. Although the Y_2SiO_5 EBC was stable for 4000 cycles, interface delamination occurred after 5000 thermal shock cycles. The crack density on the surface of a sample after each 1000 cycles in the thermal shock test was measured and plotted in Figure 4. As shown in the graph, the changes in crack density depend on the EBC material. The crack density did not substantially change compared with the initial crack density in the case of Y_2SiO_5 , whereas the crack density of the mullite-based EBC increased slightly and then drastically decreased after 3000 cycles. Furthermore, it exhibited a substantial decrease in crack density after 5000 cycles.

Figure 4. Plot of crack density of EBCs after each 1000 cycles of the thermal shock test at 1350 °C.

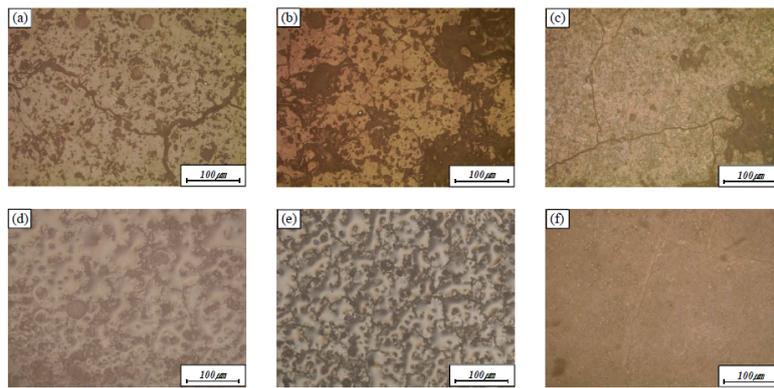
The optical microscope images in Figure 5 show the surfaces of the mullite, mullite + Yb_2SiO_5 , and Y_2SiO_5 after 2000 and 4000 cycles of thermal shock, indicating crack healing. Although obvious cracks are observed after 2000 cycles of thermal shock irrespective of the EBC material (Figure 5a–c), surprisingly, the surface cracks were not observed after 4000 cycles of thermal shock (Figure 5d–f). In the case of Y_2SiO_5 , relatively large macrocracks developed and were maintained without the formation of microcracks; thus, the crack density did not substantially change. By contrast, the population of microscale cracks increased at 2000 cycles and new phases covered the surface completely at 4000 cycles in the mullite-based EBC.

Figure 5. Optical micrographs of the surface of the EBCs after the thermal shock test at 1350 °C: (a) mullite, 2000 cycles; (b) mullite + Yb_2SiO_5 , 2000 cycles; (c) Y_2SiO_5 , 2000 cycles; (d) mullite, 4000 cycles; (e) mullite + Yb_2SiO_5 , 4000 cycles; and (f) Y_2SiO_5 , 4000 cycles.

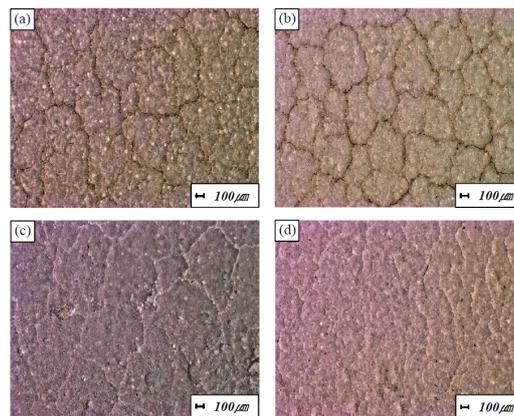
The cracks on the surface of the mullite-based EBC after 5000 cycles of thermal shock were observed with a high-resolution optical microscope, as shown in Figure 6. The optical microscope images of the surfaces of the mullite-based EBC after 100 cycles are also presented in the figure. Although mud cracks were noticeable after 100 cycles of thermal shock, the crack gaps were clearly filled after 5000 cycles of thermal shock.

Figure 6. High-resolution optical micrographs of the surface of the EBCs after the thermal shock test at 1350 °C: (a) mullite, 100 cycles; (b) mullite + Yb_2SiO_5 , 100 cycles; (c) mullite, 5000 cycles; and (d) mullite + Yb_2SiO_5 , 5000 cycles.

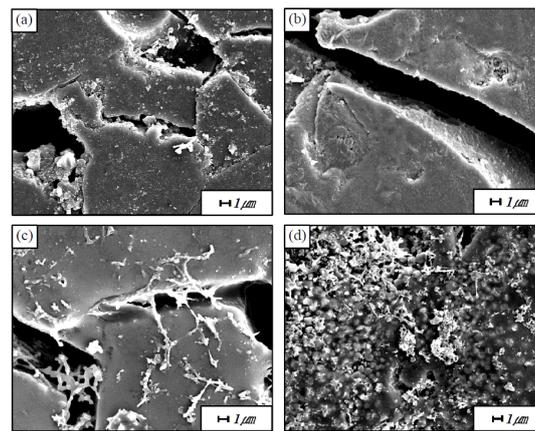
Figure 7 shows the cracks of the mullite-based EBC after 100 and 5000 thermal shock cycles, as observed at high magnification by SEM. Only cracks and grains are observed after 100 cycles of thermal shock; cracks are observed around the grain. By contrast, after 5000 thermal shock cycles, new phases are formed to fill the gaps and cover the cracks. The results of the EDS composition analysis of these phases indicate that they contain only Si and Al, which are the constituents of mullite. We therefore speculate that the mullite itself underwent a change when repeatedly exposed to high temperatures.

Figure 7. SEM micrographs showing the microstructure on the surface of the EBC after thermal shock test at 1350 °C: (a) mullite, 100 cycles; (b) mullite + Yb_2SiO_5 , 100 cycles; (c) mullite, 5000 cycles; (d) mullite + Yb_2SiO_5 , 5000 cycles.

XRD analysis was performed on the EBC materials after 5000 thermal shock cycles for the analysis of the phases formed around the cracks, as shown in Figure 9. In the case of the mullite material, an Al_2O_3 phase was detected in addition to the mullite phase. Therefore, the newly formed phases in Figures 7 and 8 are attributed to mullite that melted under repeated thermal shock cycles at high temperature. We speculate that the low-melting-point phases containing SiO_2 migrated into the cracks, filling the gaps of the cracks, and that the Al_2O_3 phases precipitated as crystalline phase during cooling. In particular, Al_2O_3 phases are considered desirable because they exhibit excellent oxidation and corrosion resistance at high temperatures and can therefore resist oxidation and corrosion of EBC materials after crack healing. Similarly, an Al_2O_3 phase was detected along with the mullite, Yb_2SiO_5 , and $\text{Yb}_2\text{Si}_2\text{O}_7$ phases in the case of the mullite + Yb_2SiO_5 material, as shown in Figure 9b. However, in the case of Y_2SiO_5 , Y_2O_3 , and SiO_2 phases were detected along with Y_2SiO_5 and $\text{Y}_2\text{Si}_2\text{O}_7$ phases, as shown in Figure 9c. The Y_2SiO_5 phase melts at high temperatures and is decomposed into crystalline Y_2O_3 and SiO_2 , similar to the process that occurs in the mullite-based EBC.

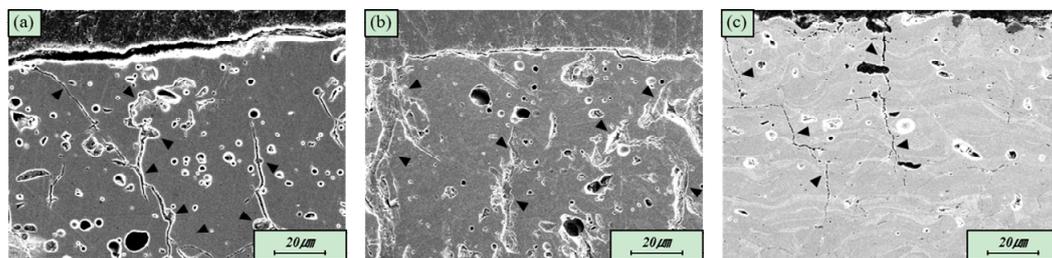
Figure 8 shows the cracks on the cross-section of the mullite, mullite + Yb_2SiO_5 , and Y_2SiO_5 after 5000 thermal shock cycles, as observed by SEM. Each arrow in the mullite, mullite + Yb_2SiO_5 indicate crack healed region. On the other hand, each arrow in the Y_2SiO_5 indicate cracked region. Only cracks are observed after 5000 cycles of thermal shock in the case of Y_2SiO_5 (Figure 8c). By contrast, after 5000 thermal shock cycles, new phases are formed to fill the gaps and cover the cracks, and this result is more pronounced in the mullite + Yb_2SiO_5 (Figure 8b).

Figure 8. SEM micrographs showing the microstructure on the cross-section of the EB after thermal shock test at 1350 °C: (a) mullite, 5000 cycles; (b) mullite + Yb_2SiO_5 , 5000 cycles; and (c) Y_2SiO_5 , 5000 cycles.

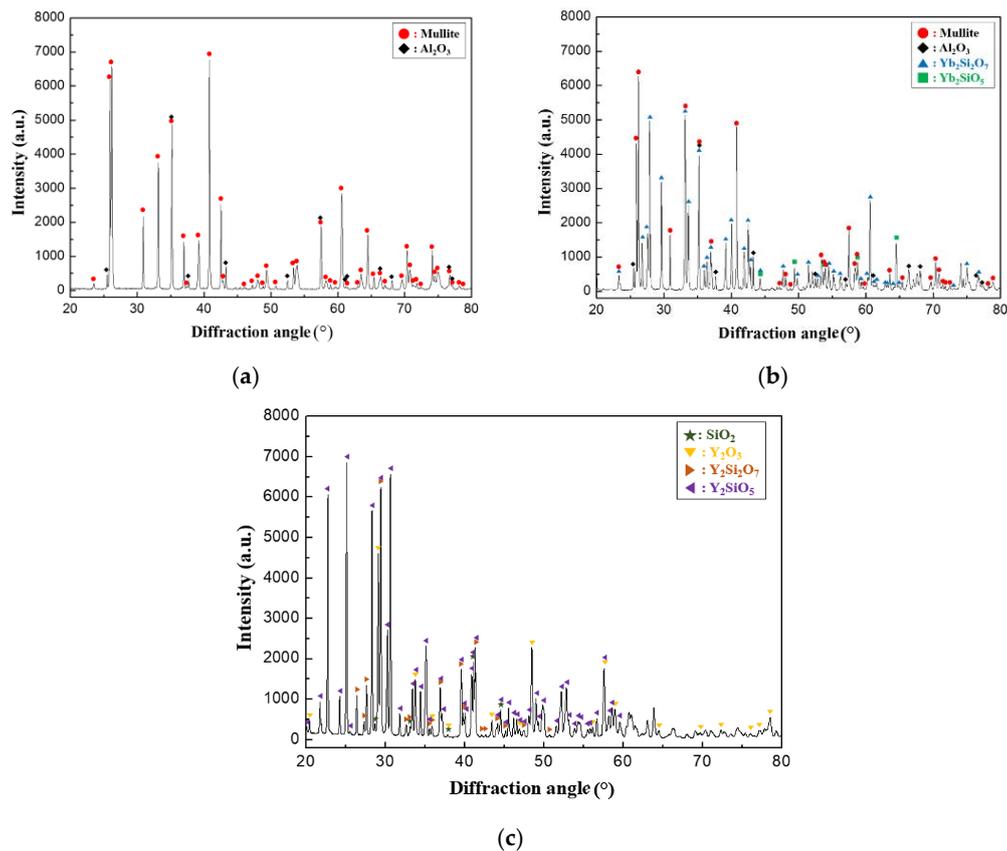
Figure 9. XRD patterns of (a) mullite, (b) mullite + Yb_2SiO_5 , and (c) Y_2SiO_5 after 5000 thermal shock cycles at 1350 °C.

around the gap of the cracks. A crystalline phase of Al_2O_3 was detected by XRD analysis. We considered that the mullite phase melted at high temperatures and filled the gaps of the cracks and that a crystalline phase of Al_2O_3 was precipitated during cooling, resulting in crack healing. Crystalline SiO_2 and Y_2O_3 phases were observed in the case of Y_2SiO_5 .

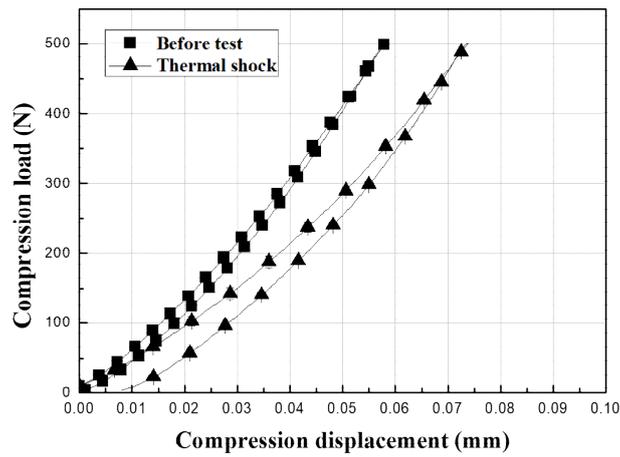
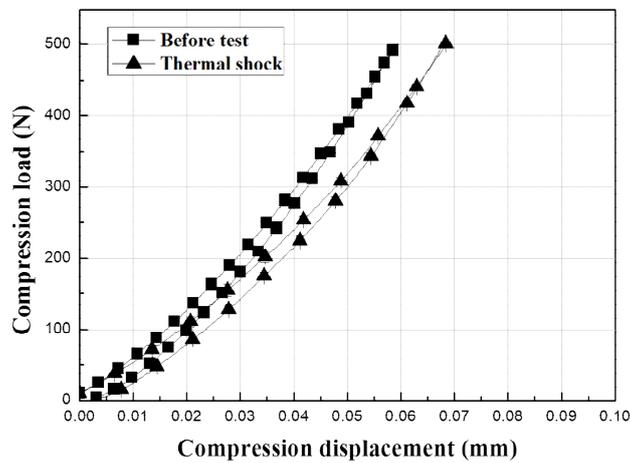
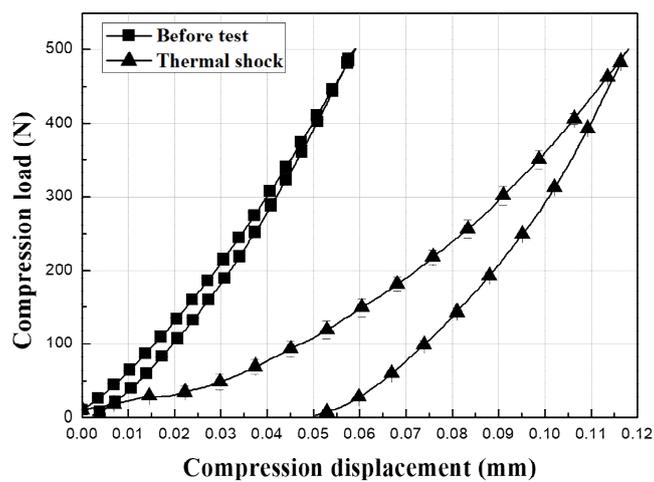
The surfaces of the EBC materials were contacted with a WC ball with a radius of 3.18 mm to a load P of 500 N and then unloaded to determine the mechanical behavior after crack healing, as shown in Figure 10. The graphs show the test results for the sample before the thermal shock and the sample after 5000 thermal shock cycles. The Y_2SiO_5 EBC shows a large change from elastic to plastic after 5000 thermal shock cycles, as shown in Figure 10c because the test was carried out on the delaminated coating samples. By contrast, the load–displacement behavior of the mullite-based EBCs, which did not exhibit interfacial delamination even after 5000 thermal shock cycles, did not substantially differ from their initial indentation load–displacement behavior, as shown in Figure 10a,b. In the case of mullite, the residual displacement related to the hardness of the material was slightly increased after thermal shock, and the tangential slope of the stress–strain at unloading, which is related to the modulus of elasticity, decreased after thermal shock [10,25,26,31]. Thus, the hardness and elastic modulus of the sample decreased by 5000 thermal shock cycles. The decrease in the mechanical properties is attributed to cracks even though the sintering of the material during repetitive exposure to high temperatures occurs [32,33]. However, the hardness and elastic modulus of the mullite + Yb_2SiO_5 did not substantially change even after 5000 thermal shock cycles. Therefore, the initial mechanical properties of the mullite + Yb_2SiO_5 were recovered by crack healing.

Figure 10. Plot of indentation load–displacement curves of (a) mullite, (b) mullite + Yb_2SiO_5 and (c) Y_2SiO_5 using a WC ball with a radius of 3.18 mm at load $P = 500$ N.

Figure 11 shows the change in the relative hardness of the material, as revealed by analysis of the residual displacement of the indentation load–displacement curves in Figure 10. The hardness value before the thermal shock test is assumed to be 100%, and the hardness value after 5000 cycles of thermal shock is plotted in percent. As shown in the graph, the mullite + Yb_2SiO_5 maintains its initial hardness value. These results indicate that the mullite + Yb_2SiO_5 is a potential EBC material because gas turbine coating materials exposed to repeated thermal cycles must not only not exhibit interfacial delamination due to the thermal shock but also resist impact and wear due to external FOD.

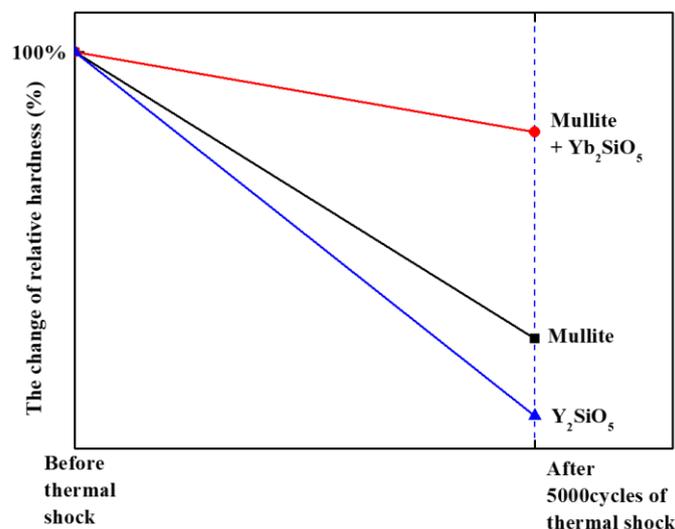
Figure 11. Hardness changes of EBC materials during thermal shock tests.
