Comparing the Repair of Veneered Zirconia Crowns with Ceramic or Composite Resin: An in Vitro Study

Hattanas Kumchai *, Patrapan Juntavee, Arthur F. Sun and Dan Nathanson

Department of Restorative Sciences & Biomaterials, Goldman School of Dental Medicine, Boston University, Boston, MA 02118, USA; juntavee@bu.edu (P.J.); asun@bu.edu (A.F.S.); dnathan@bu.edu (D.N.)

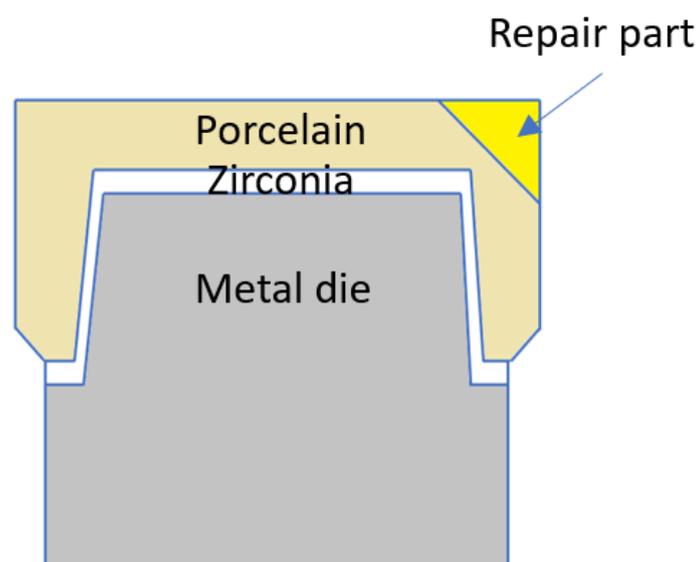
Figure 1. Cross sectional view of specimens used with labeled composition. Cutting plane containing the plane of symmetry of the repaired part and the cylinder axis.

For this in-vitro study, identical zirconia specimens were made and veneered with porcelain. Specimens were prepared with identical “chips” (“artificial defects”) in the porcelain veneer, for repairs with different materials. Table 1 presents the experimental groups and the materials used in this study. Four experimental groups were assigned in this study for various materials used to repair the chipped veneered specimens (N = 40, n = 10 per group). Figures 1 and 2 show the design and dimensions of the specimens.

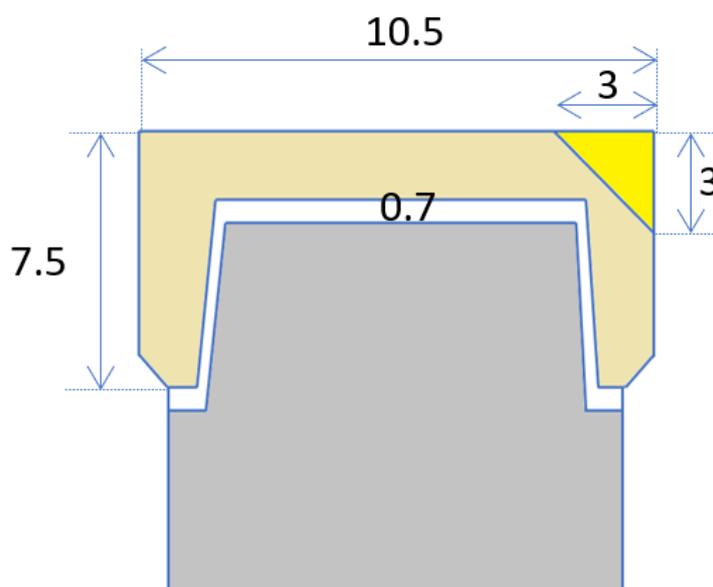
**Figure 2.** Cross sectional view of specimens with standard dimensions in millimeters. Cutting plane containing the plane of symmetry of the repaired part and the cylinder axis.

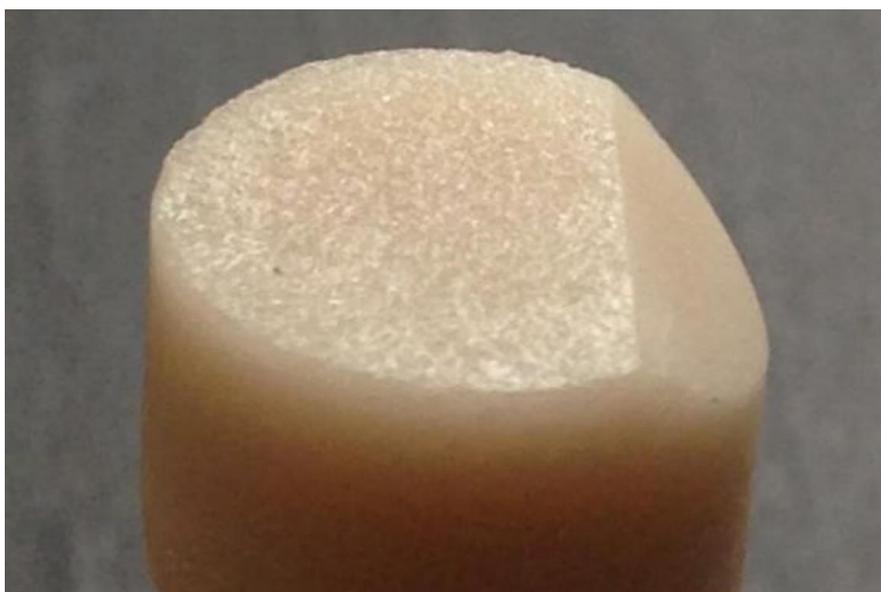
Figure 3. Beveled crown.

Cemented crowns were put in a customized stub. This stub allowed the crowns to be placed at 45 degrees to the wafering blade of the Isomet 2000 Precision saw (Buehler, USA). A bevel-cut on the porcelain veneer (45 degree, 3 mm width) was made on one side of each crown with 15LC diamond-wafering blade mounted on an Isomet 2000 Precision Saw. The cuts were made at 800 rpm with 300 g of load with cooling provided by a dual-nozzle water irrigation system. Figure 3 shows the crown after beveling.

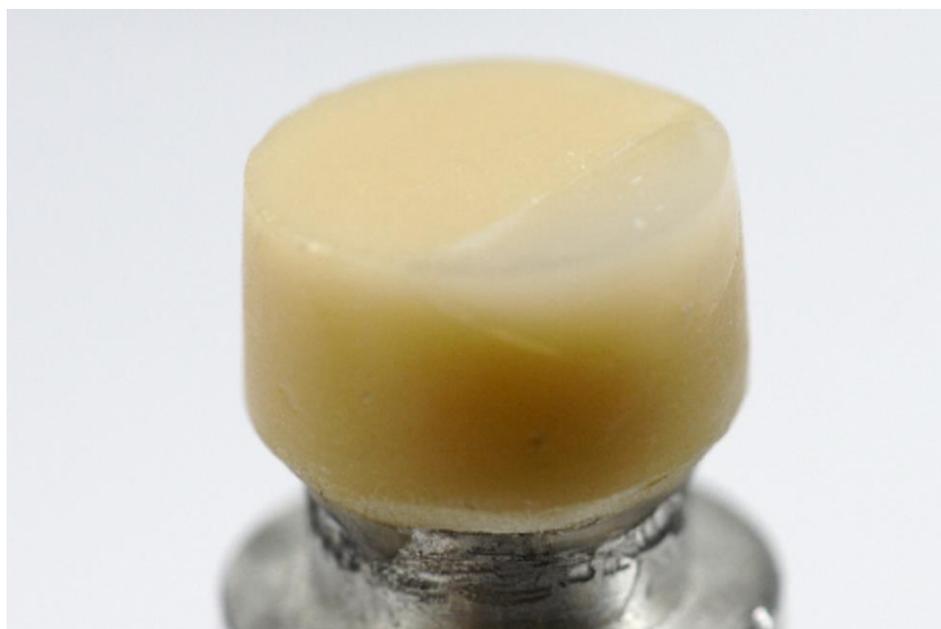
Figure 4. Repaired specimen with bonded ceramic.

Group D: The repair parts were milled using IPS e.max CAD (Ivoclar Vivadent). The spurs were cut after the milling. The occlusal surface of the parts was polished with rubber wheel at the occlusal surface. The parts were then subjected to crystallization firing using Programat EP5000 furnace (Ivoclar vivadent) and glazed on the occlusal surface simultaneously using IPS e.max CAD Crystall glaze paste (Ivoclar Vivadent). The cementing of the repaired parts to the crowns was done as previously mentioned in group C. Figure 4 shows specimens after repairing with bonded ceramic.

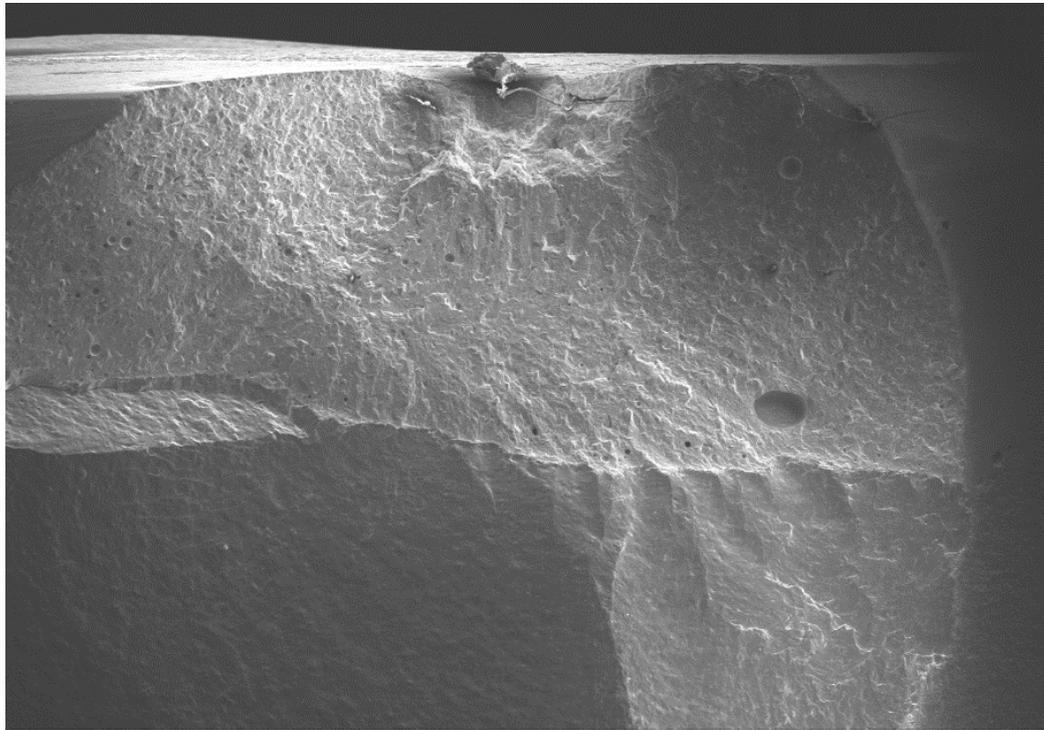
Figure 5. SEM micrograph of the fractured veneered-zirconia crown repaired with Tetric EvoCeram at magnification of 22 \times .

All of the selected specimens demonstrated catastrophic failures (Figures 5–8). They all exhibited similar fracture patterns. The fracture origin was from the top of the contacting point between ball load and specimens. The crack then propagated in a downward direction.

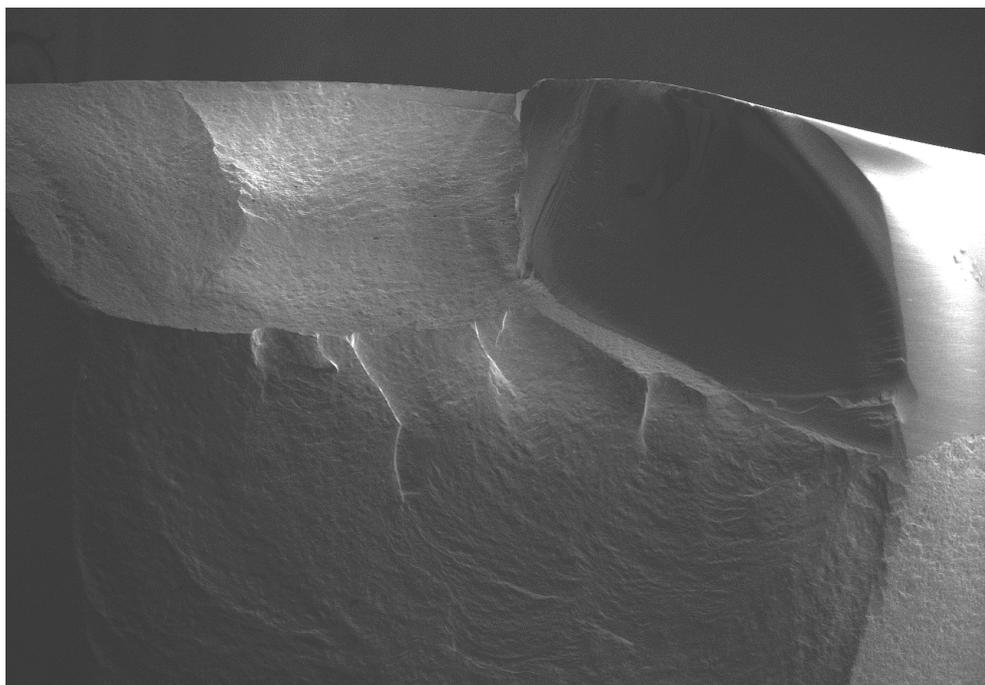
Figure 6. SEM micrograph of the fractured veneered-zirconia crown repaired with G-aenial Universal Flo at magnification of 22 \times .

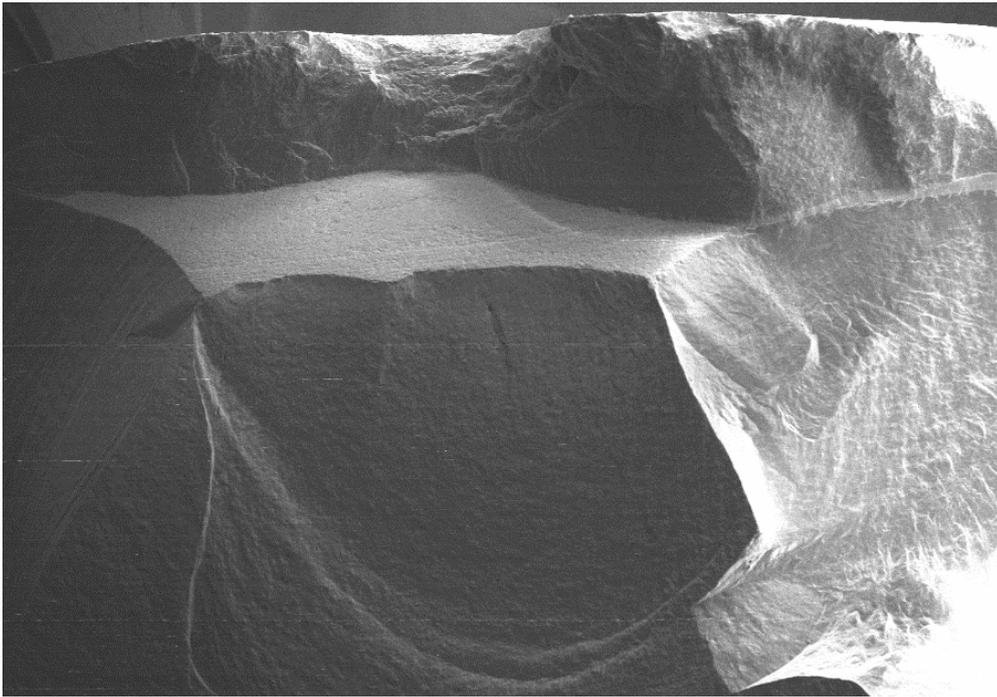
Figure 7. SEM micrograph of the fractured veneered-zirconia crown repaired with Vita Triluxe Forte at magnification of 22 \times .

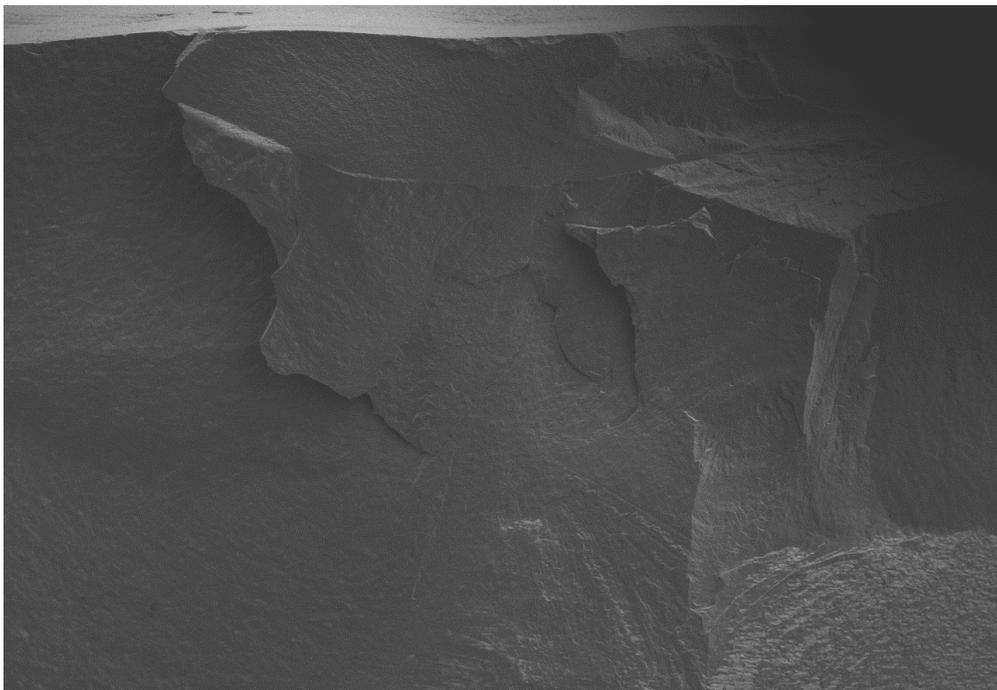
Figure 8. SEM micrograph of the fractured veneered-zirconia crown repaired with IPS e.max CAD at magnification of 22 \times .
