# Impact Characteristics and Repair Approaches of Distinct Bio-Based Matrix Composites: A Comparative Analysis

**Keywords:** bio-composite; bio-based polymers; vacuum assisted resin infusion (VARI); resin re-infiltration; self-healing; compression after impact (CAI)

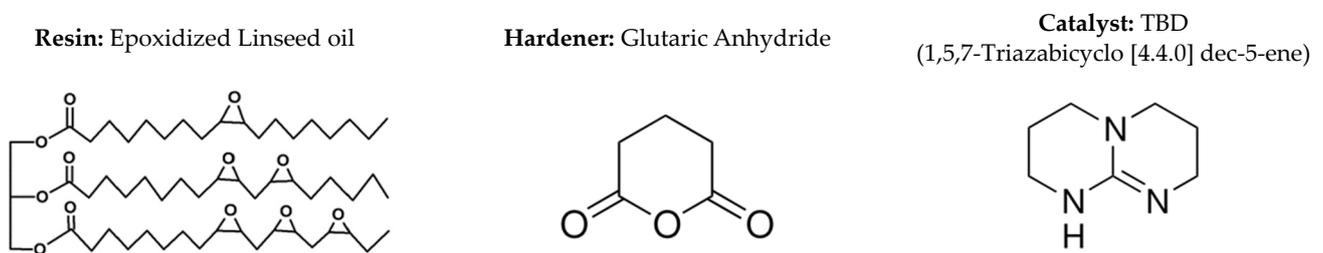
**Figure 1.** Chemical structure of epoxidized linseed oil [44], glutaric anhydride [45] and TBD [46].

The bio-based epoxy matrix comprises Epinal b.poxy IR78.31 (with a bio-based resin content of 37.58%) and Epinal IH77.11 amine hardener supplied by bto-epoxy GmbH (Amstetten, Austria). The resin and hardener are mixed in the ratio of 100:25 by weight. The bio-based vitrimer matrix system consists of three components: the resin (Epinal NFL 10.20-A4.00) is a commercial epoxidized linseed oil (ELSO) with an epoxy equivalent weight of 174 g/mol, the catalyst (TBD, 1,5,7-Triazabicyclo[4.4.0]dec-5-ene) with a purity >98% is supplied by bto-epoxy GmbH (Amstetten, Austria) and the hardener (Glutaric anhydride) with a purity >95% is from Sigma-Aldrich Handels GmbH (Vienna, Austria). The chemical structures of the materials are illustrated in Figure 1. The resin and curing agents are mixed at a ratio 100:34 by weight, with 10 mol% TBD (by weight) added, as this serves as an effective catalyst for transesterification reaction. Since ELSO constitutes the primary component of the resin system, it comprises approximately 70% to the bio-based content.

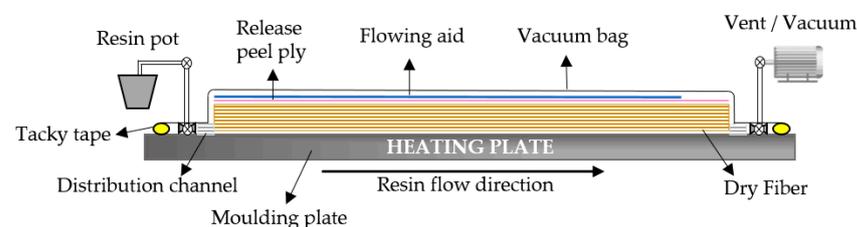
The composite laminates were fabricated using the Vacuum Assisted Resin Infusion (VARI) method, employing a single-sided rigid mold and vacuum bagging to apply vacuum pressure. The schematic illustration of the VARI composite manufacturing process is provided in Figure 2.

**Figure 2.** Schematic of VARI setup.

In this study, two composite materials are processed and investigated, Flax-Bio-based Epoxy Composite (FBEC) and Flax-Bio-based Vitrimer Composite (FBVC). To produce the FBEC laminates, dry preforms were laid on a mold with a distribution channel previously treated with a release agent. A release peel ply was positioned over the preform to facilitate separation during vacuum bagging, while a resin distribution media was employed to enhance resin flow velocity. The mold was sealed with vacuum bag and sealant tape, and

consolidation was achieved by applying vacuum pressure through the vent tube. The inlet tube was secured, and the mold temperature was set to 60 °C with a vacuum pressure of −0.97 bar. Before infusion, a vacuum drop test was conducted on the layup to detect any bag leakage. The resin-hardener mixture was degassed under vacuum to eliminate air bubbles. Infusion took place by creating a differential pressure between the vent and inlet. Upon complete infusion, both the inlet and vent were clamped, maintaining pressure until the resin cured for 180 min. Subsequently, the mold was cooled to room temperature, and the composite panel was demolded.

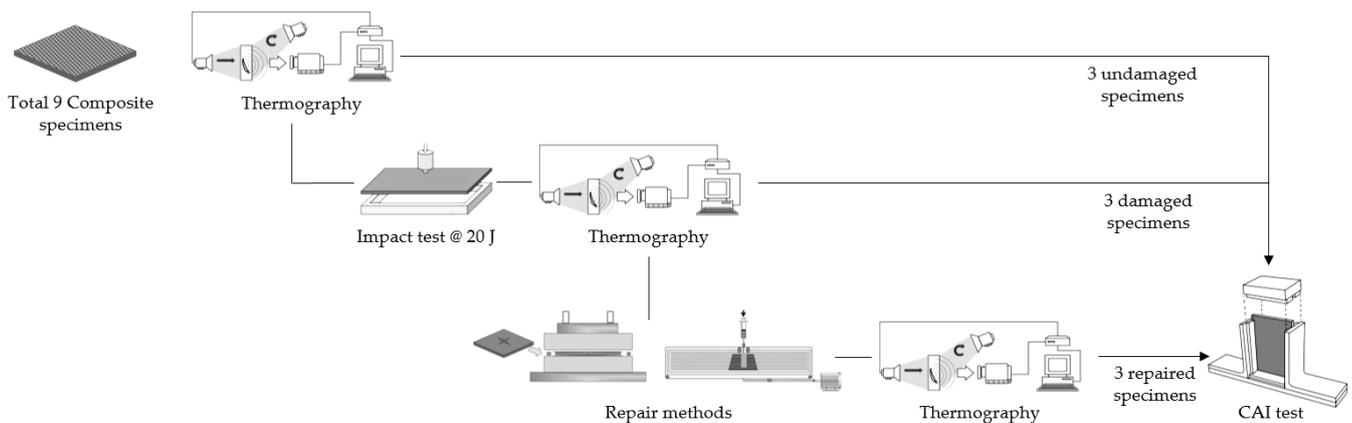
Figure 4. Schematic representation of repair activities.

An outline of the impact testing is shown schematically in Figure 3, and a comprehensive overview of the repair activities is depicted in Figure 4 for each set of FBEC and FBVC plates, respectively.

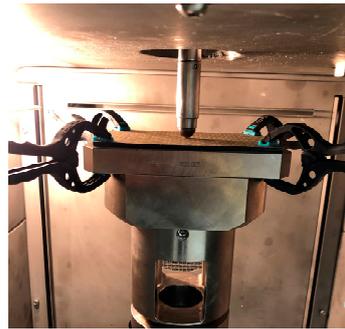
A CEAST 9350 instrumented drop tower (Instron, Norwood, MA, USA) was utilized for the impact testing of composite laminates according to the standard ASTM D7136 [47]. A hemispherical impactor with a diameter of 20 mm, equipped with a force sensor, was employed. Throughout the test campaign, the drop height was maintained at 200 mm, and the velocity at 1.98 m/s remained constant. Each specimen was carefully positioned within the impact support fixture and securely fastened at the four corners using identical clamps, as depicted in Figure 5. The impact energy levels were varied by adjusting weights, resulting in energy settings of 10 J, 15 J, and 20 J, respectively. For each energy level, three specimens of FBEC and FBVC, respectively, were subjected to impact testing.

Figure 5. Drop tower impact test.

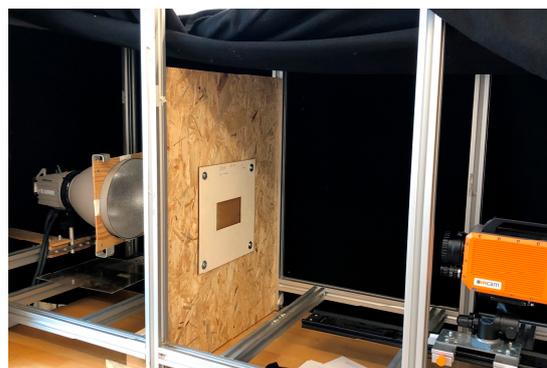
Infrared thermography utilizes a heat source, represented by a flash lamp, along with an IR camera to generate thermal images of the specimens. It offers qualitative and quantitative analysis of defects by utilizing thermal diffusivity data from the damaged zone. Detection of defects through flash thermography relies on the surface temperature's time-dependent response to a thermal impulse. Through a transmission configuration, IR thermography detects defects in the specimens using the flash lamp positioned 360 mm away from the specimen, and the IR camera placed at the distance of 630 mm from the specimens, as depicted in Figure 6. Images are captured over a 100 s interval at a frequency of 5 Hz. Subsequently, all images undergo normalization using an averaging code in MATLAB (Version: 9.12), with reference to the maximum temperature.

Figure 6. Active flash thermography setup.

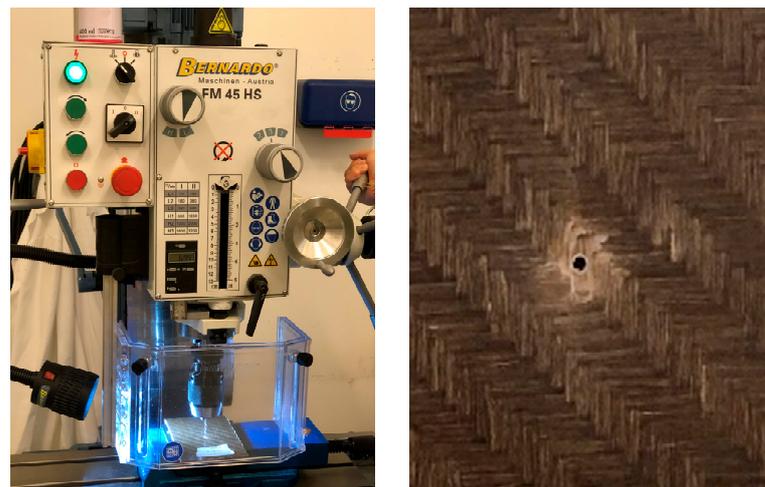
A resin injection hole is added to the FBEC specimen. Instead of vent holes, a vacuum is used from the rear side to displace air and inject resin. Microcrack networks and delamination provide pathways for resin flow during vacuum operation. A High-Speed Steel (HSS) twist drill with a 2 mm diameter is used for drilling. The drilling is carried out with a press table drill, the FM 45 HS model from Bernardo (Linz, Austria), as depicted in Figure 7. The drilling operates at 2000 rpm rotational speed and 0.05 mm/rev feed rate. The drilling depth is set at 75% of the specimen's total thickness.

**Figure 7.** Impacted specimens drilling: drill equipment (left) and drilled impacted specimen (right).

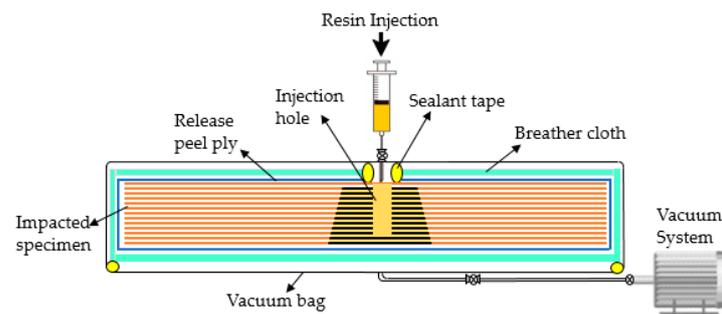
Figure 8 illustrates the resin reinfiltration approach, where the impacted specimen is enveloped by a release peel ply and a breather cloth, creating a channel for displaced air and resin to flow uniformly from the rear side. A vacuum bag is carefully applied to establish a controlled environment, while sealant tape ensures proper sealing and resin introduction solely through the designated injection hole. Inlet and outlet tubes, along with valves, are appropriately positioned, and the vacuum system is activated to detect and resolve any air leaks through adjustments to the sealant tape. The injected resin maintains the same resin (Epinal b.poxy IR78.31) to hardener (Epinal IH77.11) weight ratio as the infusion resin (100:25) and is prepared in a sufficient quantity to fill a 20 mL syringe. The syringe remains positioned atop the damaged specimen through the inlet valve throughout injection phases. Upon activating the vacuum system and addressing any air leaks, the injection process commences by opening the inlet valves. The resin flows into the injection hole in the damaged zone, aided by the vacuum displacement. Maintaining a pressure of  $\sim 1$  bar from the syringe ensures effective resin injection into the damaged area.

**Figure 8.** Schematic of resin infiltration repair setup.

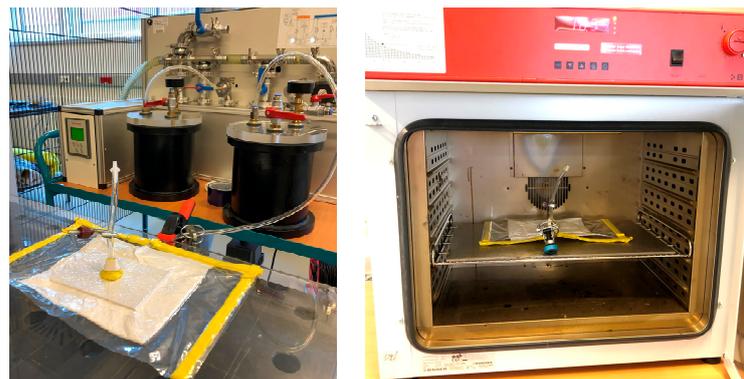
Following a duration of 15 min, the injection procedure was halted by shutting the inlet and outlet valves, as illustrated in Figure 9. Then, the syringe was removed, and the outlet tube was detached. The entire assembly was transferred to an oven set at 80 °C, where it underwent curing for 1 h. Upon completion of the curing phase, the consumables—namely, the vacuum bag, release peel ply, and breather cloth—were delicately removed from the repaired specimen. The resin infusion effectively filled the voids created by the drilling process, and any remaining traces of sealant tape were meticulously eliminated from the surface of the repaired specimen.

**Figure 9.** Resin infiltration repair approach: repair setup after injection (left) and oven curing (right).

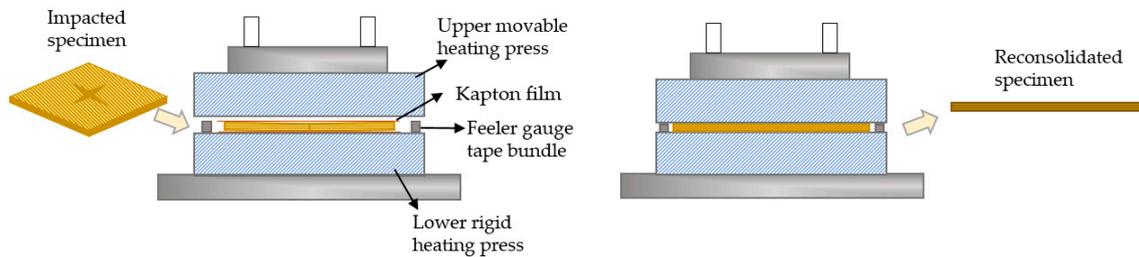
In this investigation concerning the FBVC specimen, the expected vitrimer transition temperature is 160 °C, as referenced in [56], and maintaining the resin above its  $T_g$  for at least 3 h is crucial for alleviating internal stresses within the material and encouraging the development of vitrimeric characteristics. The reconsolidation repair approach employed in this study is depicted in Figure 10. The impacted specimen is positioned on a press WPK 3500 S from Wickert (Landau, Germany), preheated to 160 °C. To prevent the specimen from adhering to the press surface, Kapton<sup>®</sup> Polyimide film from DuPont<sup>™</sup>, Wilmington, DE, USA is strategically positioned both above and below it. Before commencing the repair procedure, the thickness of each specimen is precisely measured. Subsequently, a bundle of feeler gauge tape, matching the original thickness of the specimen, is strategically placed alongside it, as depicted in Figure 10. This strategic placement ensures that the

flexible specimen maintains its original thickness, preventing excessive compression during pressing. This prevents ply displacement and misalignment in the composite laminate, preserving its structural integrity during heating and repair.

**Figure 10.** Schematic of reconsolidation repair setup: impacted specimen is placed on press at 160 °C (left) and reconsolidated (healed) after four hours (right).

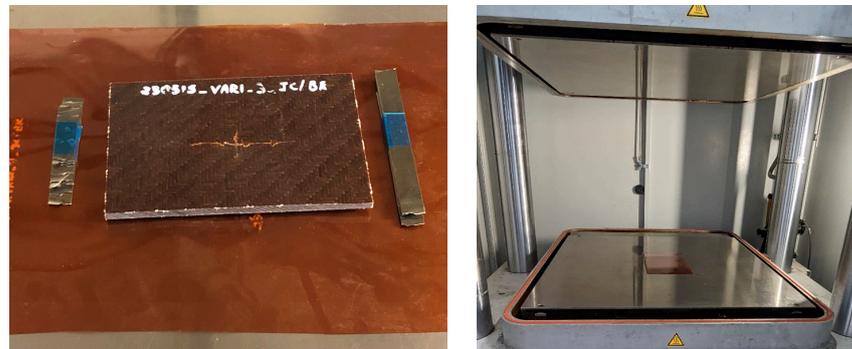
Upon reaching a temperature of 160 °C on both sides of the press, a careful arrangement is made with the polyimide film, specimen, and bundles of feeler gauge tape, as illustrated in Figure 11. Subsequently, the press is gradually lowered until it contacts both sides of the specimen. The press is then gently brought down in a controlled manner to restore the specimen's shape, which had been deformed due to the impact. As the press approaches the point where the feeler tape bundles naturally create a stopping point on both sides, a consistent compressive load of approximately 5 kN is maintained. This load persists throughout the entire reconsolidation process, spanning a duration of 240 min for each individual specimen. After the 240 min interval has elapsed, the press is carefully disengaged, and the specimen is subsequently extracted.

**Figure 11.** Reconsolidation repair approach: impacted specimen between gauge tape bundles (left) and press with heating mold (right).

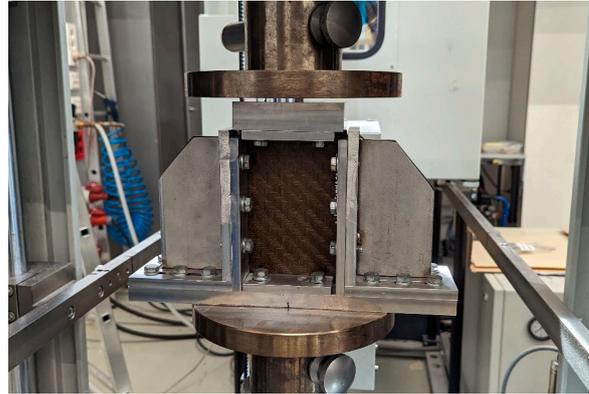
The specimen was placed in the CAI fixture, as illustrated in Figure 12. The fixture supports the specimen along all four edges, with adjustability according to the specimen's thickness. The top (loading) plate, not directly attached to the lower portion of the fixture,

slides over the specimen's top edge to provide simple support. Short side rails ensured a gap between them and the top plate during compression testing. The assembled fixture, with the specimen installed, is positioned unconstrained on the flat base of universal testing machine Z250, Zwick Roell (Zwick GmbH and Co., Ulm, Germany) and compressive loading is applied directly to the top plate by a platen in the crosshead of the testing machine. Tests are conducted at a crosshead speed of 0.5 mm/min until a sudden drop in the load–displacement curve is recorded.

**Figure 12.** Compression after impact testing.

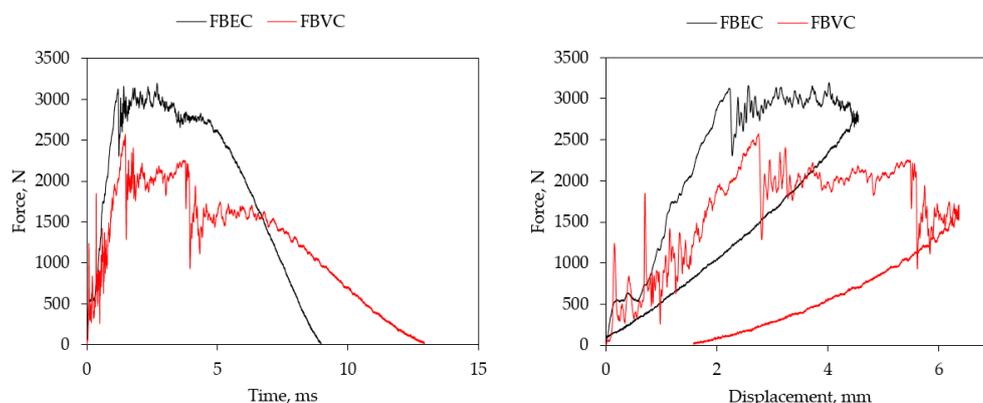
The sensor instrumentation integrated into the drop tower enables the measurement of various impact-related parameters, including contact force, duration, and displacement records of the impactor. Figure 13 displays distinct graphs derived from this dataset: (a) force versus time and (b) force versus displacement at an energy level of 10 J for both FBEC and FBVC, respectively. Owing to the similarity in trends observed at energy levels 15 J and 20 J, the graphical presentation for these levels is excluded.

**Figure 13.** Impact characteristic at impact energy level 10 J: force vs. time (left) and force vs. displacement (right).

Figure 13 (left) depicts force versus time curves that exhibit an asymmetric bell shape, corresponding to the loading and unloading phases of the specimen. A significant oscillation is seen, which is attributed to the elastic wave response and vibrations within the impact system elements (samples, impactor, and boundary conditions) [58]. The force response demonstrates non-linear behavior until it reaches the peak force, which represents the critical force associated with the initial significant drop. This drop occurs due to local internal damage, such as delamination, matrix cracking or fiber-matrix failure within the composite. Following the critical force, an unloading phase ensues, attributable to rebound or composite failure.

The force–displacement response during an impact event offers valuable insight into damage progression within the composite specimen. In all impact cases, specimens experienced deformation upon contact with the impactor but rebounded without severe perforation. Displacement values were calculated using force measurements representing the deformation of the impacted surface and the movement of the impactor. Figure 13 (right) illustrates force–displacement curves showing partial rebounding corresponding to loading and unloading conditions, respectively. The ascending part also provides information about the impact stiffness of the specimen. Peak deformation in the specimens corresponds to the maximum displacement value obtained from the force–displacement graph. Despite noise, the graph exhibits two or more points of zero slope, possibly indicative of cracks, tears, or failure of individual components in the specimen.

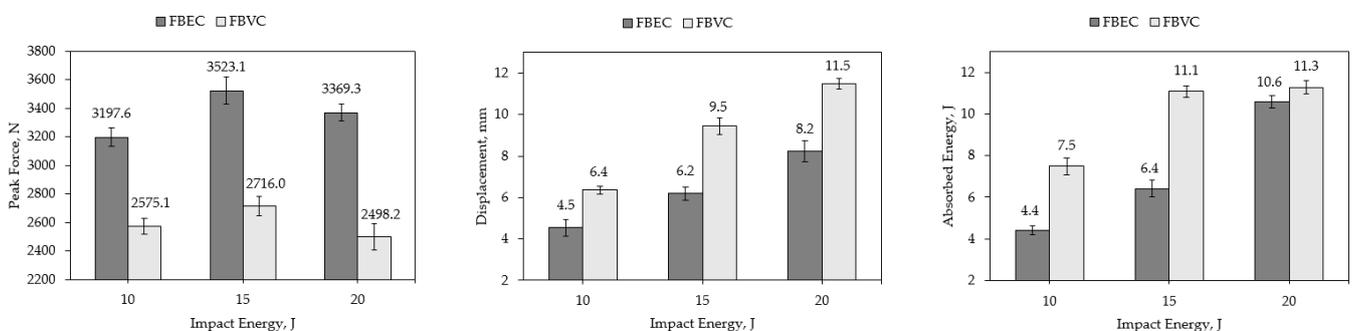
Furthermore, Table 1 provides the averaged peak force, absorbed energy, and displacement corresponding to various impact energy levels for both FBEC and FBVC, respectively. Figure 14 (left) shows the peak force at different energy levels. A notable observation is that, across all three energy levels (10 J, 15 J, and 20 J), the peak force of the FBEC surpasses that of the FBVC by 21%, 25%, and 29% at 10 J, 15 J, and 20 J, respectively. However, the contact time is remarkably greater for the FBVC than for the FBEC, by approximately 38%. This difference can be attributed to the inherent brittleness of the FBEC. Moreover, contact time increases with the applied energy and depends on the matrix utilized. Hence, as the energy level increases, the damage progresses, resulting in a corresponding increase in contact time.

**Figure 14.** Impact characteristics at varied energy levels: peak force (left), displacement (middle) and absorbed energy (right).

Figure 14 (mid) graphically represents the averaged displacement at various energy levels. It is evident that the peak displacement of the FBVC is higher compared to the FBEC. Indeed, a permanent deformation after impact is observed at 15 J and 20 J, which could be attributed to the nature of the vitrimeric matrix. Notably, the FBVC samples exhibit substantially higher displacement values corresponding to 34%, 42%, and 33% at 10 J, 15 J, and 20 J, respectively, than the FBEC, as indicated in Table 1. This difference indicating the enhanced ductile characteristics of the vitrimer sample. A similar trend is observed for the evolution of the maximum displacement as the applied impact energy increases. The averaged absorbed energy is presented graphically in Figure 14 (right). A significant increase in absorbed energy is observed for the FBVC compared to FBEC. The difference between the absorbed energy of the FBVC and the FBEC corresponds to 52%, 53%, and 6.3% for the impacted energies at 10 J, 15 J, and 20 J, respectively.

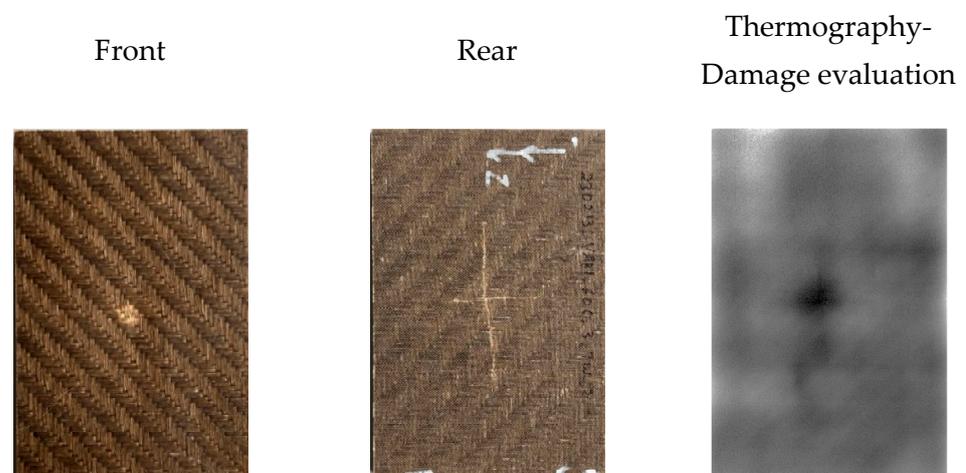
Figure 15 offers a comprehensive comparison between visual inspection and thermography inspection of the rear side of impacted FBEC. It is apparent from the images that fiber breakage occurs in composites across all impact energy levels. On the rear side of the impacted specimens, observable cracks emerge. The size of these cracks amplifies with higher impact energy levels, eventually forming a distinct cross-shaped pattern. This phenomenon can be attributed to the balanced structure of the woven flax fabric, which distributes the impact forces and results in the formation of characteristic damage patterns. However, upon observing the thermographic images, it becomes evident that a significant elevation in surface temperature above the impacted zone occurs. This increase was attributed to the impedance encountered as heat flowed through the delaminated layers, with the damage mechanism intensifying along with an increase in the impact energy level. The thermographic analysis unveils irregularly shaped damage concentrated at the center of the impact zone.

**Figure 15.** Front, rear and thermography image of FBEC impacted specimen.

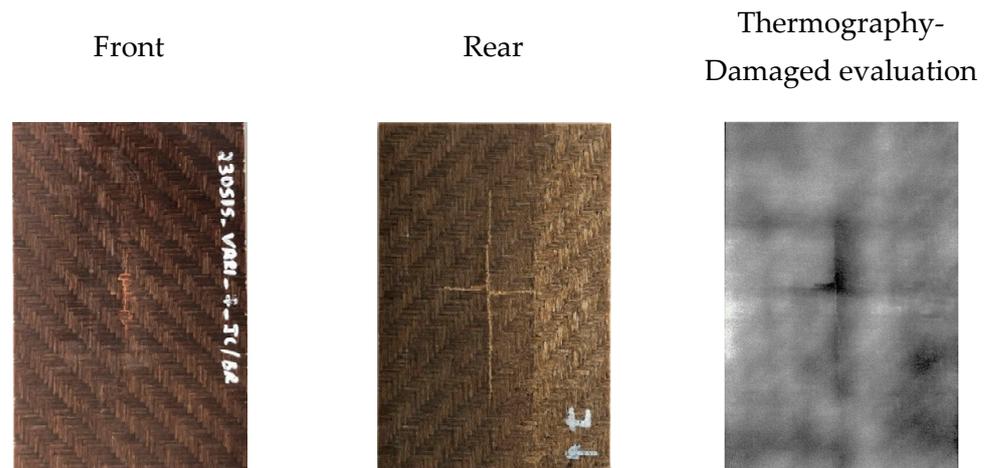
A detailed comparison between visual inspection and thermography of impacted specimens of FBVC is shown in Figure 16. At lower impact energy levels, no visible damage or indentation is observed on the front side of the specimen. However, a crack is observed forming a cross-shaped pattern. At higher energy levels, visible damage is observed on the front side of the specimens resulting in significant deformation. Thermography analysis clearly shows the formation of a dominant cross-shaped fiber breakage crack on the rear side of the specimen, signifying internal damage that follows along the fiber.

**Figure 16.** Front, rear and thermography image of FBVC impacted specimen.

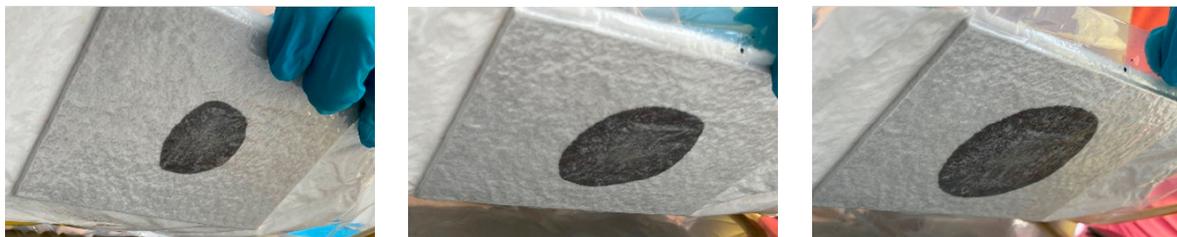
Figure 17 visually highlights a significant event during the resin reinfiltration process. Over a span of 10 min, it becomes apparent that resin continuously flows through the injection hole into the interior of the specimen, extending towards the rear side. The assistance provided by the vacuum system is crucial in facilitating this flow, with the volume of resin still increasing. This observation emphasizes the effectiveness of the reinfiltration process in delivering resin to the damaged area within the specimen. The dynamic representation depicted in the figure captures the ongoing flow, illustrating the successful displacement of air and the consistent infiltration of resin, thereby contributing to the repair of the impacted region.

**Figure 17.** Reinfiltration repair process: after 1 min (left), after 5 min (middle) and after 10 min (right).

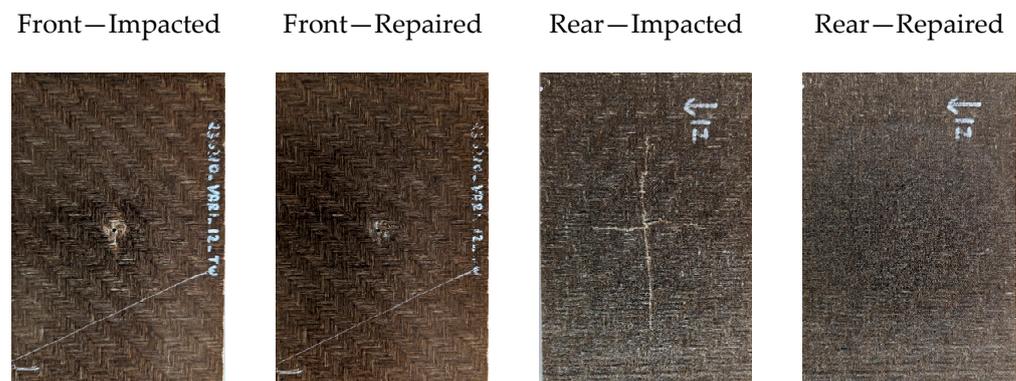
Moreover, considering the aesthetic transformation of the restored composite, both before and after the repair, Figure 19 offers a direct comparison, presenting the same specimen previously identified as the repaired one. Both the front and rear sides of the specimen are displayed. While the front section of the plate remains largely unchanged, a noticeable transformation is observed on the rear side. Upon closer examination, it becomes evident that the injected resin has created pathways through the impacted zone, radiating from the center of the specimen towards the outer regions. This radial resin flow, upon the completion of the injection process, covered a radius of approximately 45

mm. This resulting resin distribution effectively concealed the cross-shaped crack that had developed in a layer of the composite, along with the adjacent matrix, subsequent to the impact event. This visual representation is indeed remarkable, as the repair process not only restored a portion of the composite's original strength but also effectively concealed the aesthetic imperfection.

**Figure 19.** Comparison before and after repair via reinfiltration.

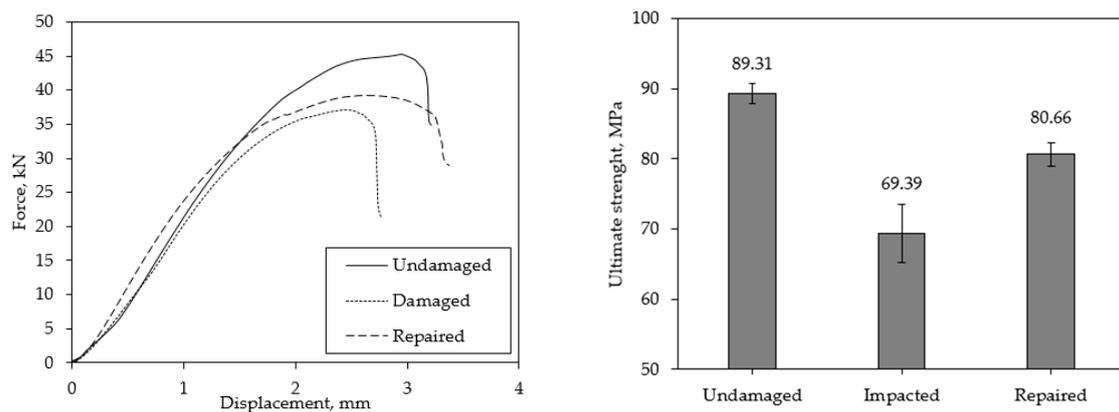
Figure 20 illustrates load–displacement graphs and the CAI compression strength of representative pristine, damaged, and repaired FBEC specimens. All specimens exhibited non-linear behavior before experiencing sudden failure. However, damaged specimens demonstrated a gradual decrease in load, resulting in failure at 77.6% of the ultimate compressive strength of undamaged specimens. In contrast, repaired specimens experienced a significant load decrease at the point of failure, similar to undamaged specimens. Notably, repaired specimens retained 90.3% of the ultimate compressive strength observed in undamaged specimens.

Undamaged specimens exhibited failure at the CAI fixture loading points, similar to the finding in [59]. This is a common occurrence in unnotched/undamaged composite compression specimens. Typically, failure reveals as crushing at the top contact surface or buckling in the free-length between the contact surface due to the absence of significant stress concentrations in the specimen. Consequently, failure initiates at minor stress concentrations created by the test fixture, specifically at the top of the plates supporting the specimen sides. In contrast, both damaged and repaired specimens experienced failure through the damage zone, as significant stress concentrations are present at this location due to the impact.

**Figure 20.** Load–displacement graph of specimens from CAI testing (left) and CAI compression strength of undamaged, damaged and repaired FBEC specimens (right).

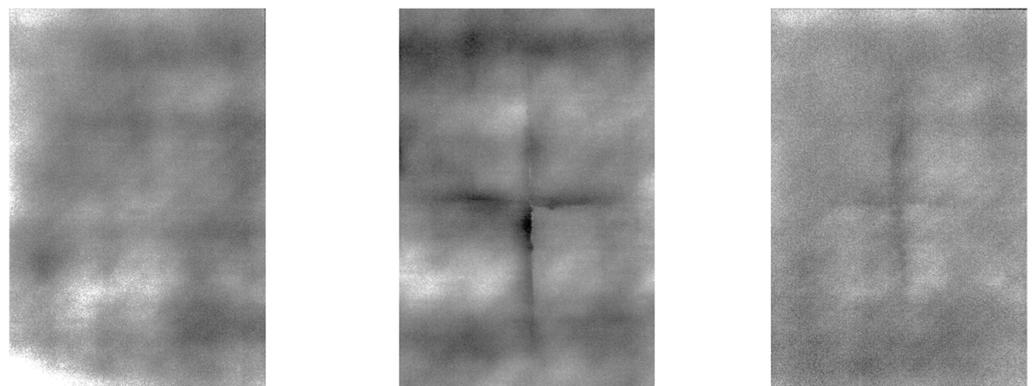
The reconsolidation repair process was qualitatively assessed through the application of flash thermography. Across all specimens, it was noted that reconsolidation resulted in a more consistent appearance in the repaired specimens, as depicted in Figure 21. Despite the presence of distinct cross-section marks stemming from fiber breakage caused by the impact, the repair method effectively addressed matrix cracks and delamination through pressure and high temperature, fulfilling its intended purpose. The presence of bright white spots near the edges of the specimen in the thermograph images can be attributed to an imperfect fit between the specimen holder and the specimen during the thermography procedure. This issue arises due to the potential for light from the flash lamp to leak around the holder in case it fails to conform securely to the shape of the specimen.

**Figure 21.** Thermography sequence of FBVC specimens: undamaged (left), damaged (middle) and repaired (right).

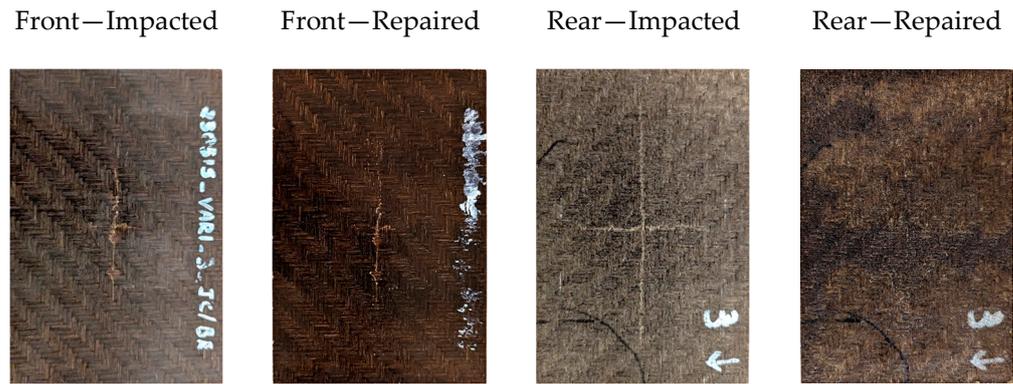
Concerning the visual alteration of the restored composite, both prior to and following the repair, Figure 22 facilitates a thorough comparison. The specimen is presented from both its frontal and rear aspects. While the front section of the specimen undergoes minimal change, a prominent transformation is evident on the rear side, effectively sealing the cracks displayed in the distinct cross pattern resulting from the impact test. Furthermore, there is a noticeable shift towards darker coloration observed.

Figure 22. Comparison before and after repair via reconsolidation.

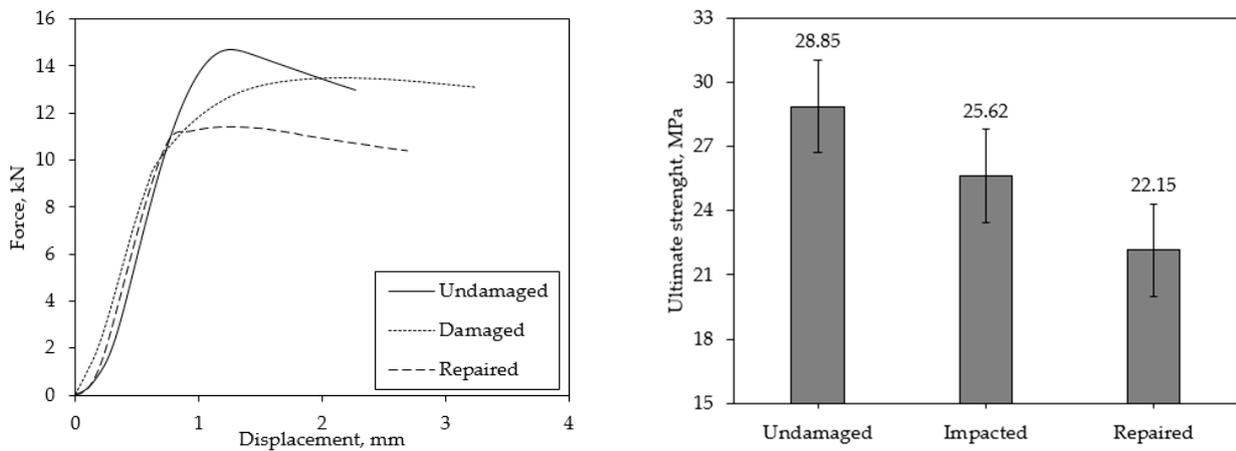
Figure 23 illustrates load–displacement graphs along with the CAI compression strength for representative pristine, damaged, and repaired FBVC specimens. Every specimen demonstrates non-linear behavior. Notably, the load applied to the repaired specimens is considerably lower than that of the damaged specimens. Specifically, the ultimate compressive strength of damaged specimens decreases to 88.7% compared to undamaged specimens, whereas the ultimate compressive strength of repaired specimens drops to 76.7% when compared to undamaged specimens. Undamaged specimens experience failure characterized by crushing at the top contact surface or buckling in the free-length between the contact surface. In contrast, both damaged and repaired specimens fail due to the opening of cracks in the damage zone.

Figure 23. Load–displacement graph of specimens from CAI testing (left) and CAI compression strength of undamaged, damaged and repaired FBVC specimens (right).

The outcomes of the reconsolidation repair for the FBVC differed significantly from the initial expectations. Figure 23 strongly suggests that the repair process not only failed to restore the mechanical properties of the damaged specimens but, instead, resulted in a decline. The ultimate load in compression after impact for the repaired specimens was lower than that of the corresponding damaged specimens, as evidenced by the presented data. This decline in the result can be attributed to the thermal degradation of flax fiber. Several studies in the literature have explored the thermal stability of flax composites [60–62]. Flax, being a natural fiber with a high cellulose content, typically contains around 80% cellulose, leading to increased flammability. Additionally, the mechanical properties of jute or flax undergo change at temperatures around 170 °C, as noted in [63]. Exposure of flax fibers to 120 °C results in moisture loss and wax degradation, as indicated by findings from reference [64]. Moreover, [65] indicates a decline in the storage modulus and an increase in the loss factor beyond 150 °C. Furthermore, [66] has reported that post-curing at high temperatures

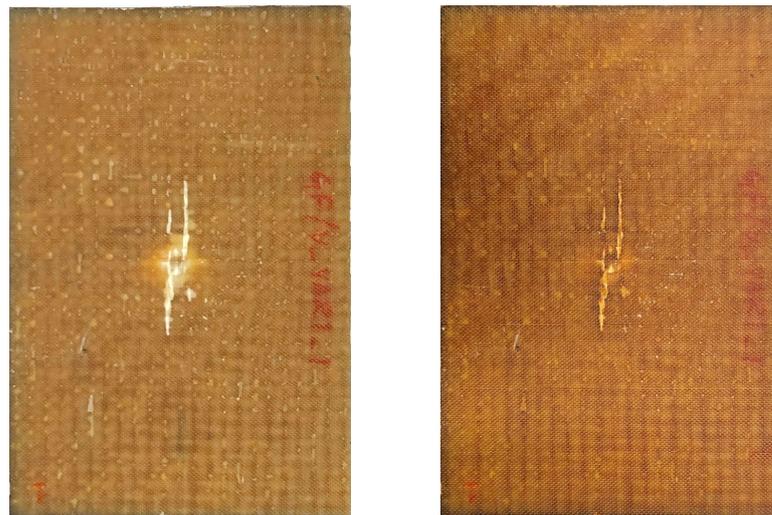
Regarding the visual transformation of the restored GBVC, both before and after the repair, Figure 24 enables a thorough comparison. That the specimen undergoes a prominent transformation is evident. Additionally, there is a noticeable shift in coloration observed.

**Figure 24.** Comparison of GBVC specimens: before reconsolidation (left) and after reconsolidation (right).

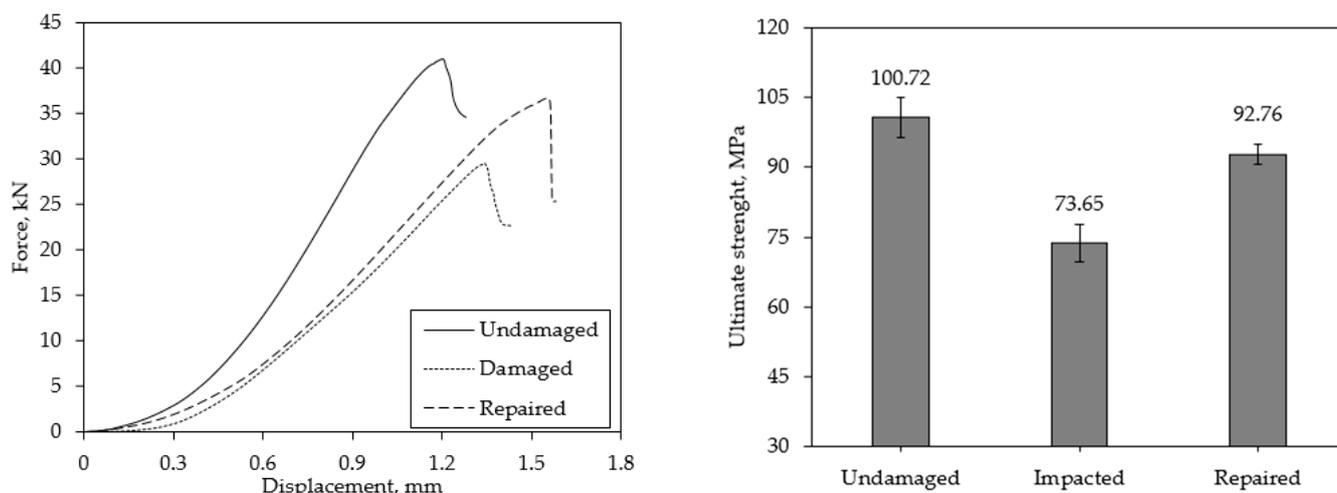
Figure 25 depicts load–displacement graphs and the CAI compression strength of representative pristine, damaged, and repaired GBVC specimens. All specimens exhibited non-linear behavior before experiencing sudden failure. The load applied to the repaired specimens surpasses that of the damaged specimens. Specifically, the ultimate compressive strength of damaged specimens drops to 73.1% compared to that of undamaged specimens, while the repaired specimens regained over 92.1% of its ultimate compressive strength when compared to undamaged specimens. The failure pattern resembles that of the FBVC.

**Figure 25.** Load–displacement graph of specimens from CAI testing (left) and CAI compression strength of undamaged, damaged and repaired GBVC specimens (right).
