Advances in Damage Monitoring Techniques for the Detection of Failure in SiC_f/SiC Ceramic Matrix Composites

Abstract: From a disruptive perspective, silicon carbide (SiC)-based ceramic matrix composites (CMCs) provide a considerable temperature and weight advantage over existing material systems and are increasingly finding application in aerospace, power generation and high-end automotive industries. The complex structural architecture and inherent processing artefacts within CMCs combine to induce inhomogeneous deformation and damage prior to ultimate failure. Sophisticated mechanical characterisation is vital in support of a fundamental understanding of deformation in CMCs. On the component scale, “damage tolerant” design and lifing philosophies depend upon laboratory assessments of macro-scale specimens, incorporating typical fibre architectures and matrix under representative stress-strain states. This is important if CMCs are to be utilised to their full potential within industrial applications. Bulk measurements of strain via extensometry or even localised strain gauging would fail to characterise the ensuing inhomogeneity when performing conventional mechanical testing on

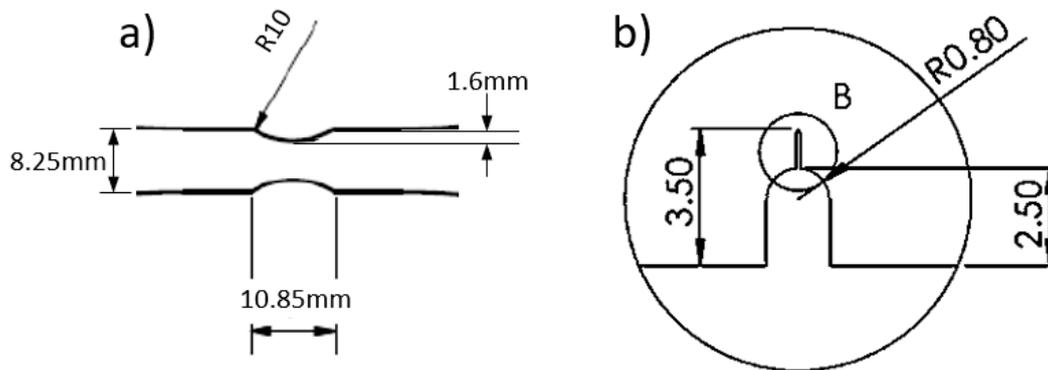
Figure 1. Schematic detail of the notch incorporated into (a) double edge notched (DEN)1 and (b) single edge notched (SEN) and DEN2 specimens.

Mechanical specimens were extracted from these panels, retaining the original as processed panel surfaces, including both double edge (DEN) and single edge notched (SEN) axial coupons of varying geometries. Waisted specimens utilised a shallow form of the notch with 10 mm radius, which reduced the net section gauge width to 5 mm (Figure 1a). These specimens were used as a control tool for correlating the DIC and extensometer signals. The main bulk of the investigation was performed using specimens incorporating 0.8 mm radius notches with a sharp slit ($1\text{ mm} \times 0.114\text{ mm}$) incorporated at the notch root (Figure 1b). The width of the load bearing net section was 23 mm for DEN and 26.5 mm for SEN specimens. The absolute values of applied test stresses are deemed proprietary, and therefore test stresses would be quoted as normalised against the peak cyclic stress employed for the very first room temperature test (Sample #1).

The tests reported here were performed with the intention to assess damage development under tension in SiC_f/SiC CMC coupons under tensile loading. The initial portion of the investigation would use two waisted samples incorporating DEN1 notches (see Figure 1a) and designated Control #1 and #2, which were tested in a monotonic fashion at a rate of 1 mm/minute under position control to verify the calibration and accuracy of the equipment described later in this section. Bulk displacement data were measured using a twin arm, strain gauge extensometer, lightly sprung against the machined edge of the specimen with the contact points spanning the axial extent of the notches. The original gauge length of the extensometer was 25 mm (see Figure 2a).

In order to assess progressive damage development in the subsequent SEN and DEN2 specimen designs (see Figure 1b), a single room temperature fatigue test was first performed, also in the air, on a DEN specimen (Sample #1). This test was performed under constant amplitude load control, using a 15 CPM (1-1-1-1 trapezoidal) waveform at $R = 0.1$, with the peak cyclic stress selected to induce fatigue rupture within the order of 10^3 cycles.

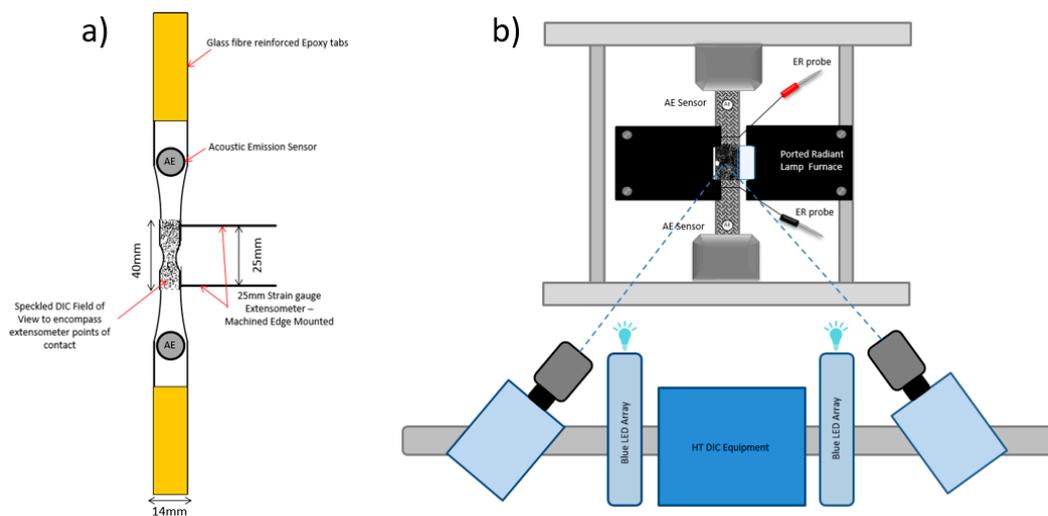
Figure 2. Schematic showing generic set up for (a) Control specimens #1 and #2 and (b) the location of acoustic emission (AE) sensors, digital image correlation (DIC) line of sight, radiant lamp furnace and electrical resistance (ER) probe placement for Samples #1 to #4.

Tests were performed on an Instron 6284 electric screw driven test rig utilising water cooled MTS 647 hydraulic wedge grips (for full schematic, see Figure 2). Tests at elevated temperature employed a short height, radiant lamp and split furnace. Specimen temperature was controlled using type N thermocouples in contact with the surface of the test coupon at the extremities and centre of the gauge section. Two Vallen AE probes were attached to the specimen extremities at either end of the load train and outside the furnace (i.e., a total separation of 100 mm). Throughout the course of the mechanical tests, these recorded elastic waves emitted from the composite and Vallen AMSY-6 software were used to analyse the acoustic energy output of each 'event'. Threshold events were simulated prior to testing by breaking the lead of a mechanical pencil against the gauge section adjacent to each sensor. Subsequent events were thereby filtered to ensure only those emanating from between the sensors were

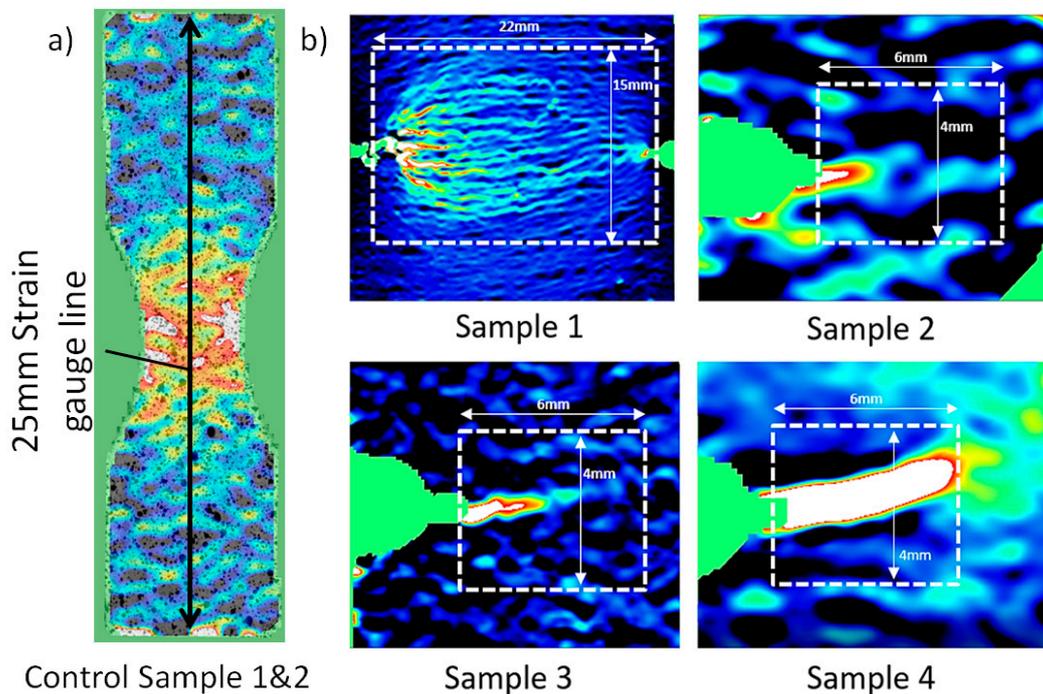
Figure 3. Relative size and positions of virtual strain gauges; (a) lines for specimens Control #1 and #2 and (b) boxes for Samples #1 to #4.

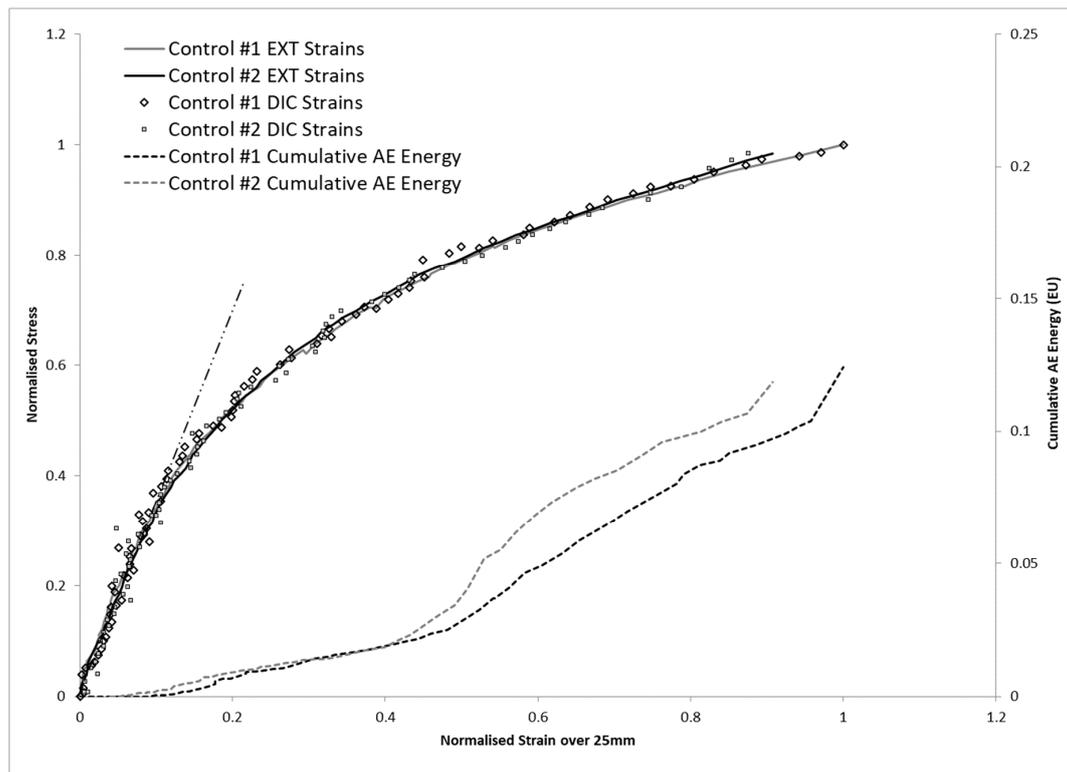
The constitutive behaviour of specimens Control #1 and #2, tested at room temperature, is represented in Figure 4. In each case, the axial strain as measured from the extensometer was compared to the averaged uni-axial strain measured using DIC. The latter was calculated by defining two original points on the imaged machined edge surface, mirroring the locations of extensometer contact on the adjacent edge (i.e., with a 25 mm separation). Excellent agreement between this data was noted throughout the course of the test, validating the accuracy of the DIC technique.

Figure 4. Room temperature response of Control #1 and #2. EXT: extensometer; DIC: digital image correlation; AE: acoustic emission.

Progressive damage was also monitored during these tests via acoustic emission. Figure 4 superimposes a record of the cumulative AE energy released as a function of normalised axial bulk strain. In both cases, AE activity remained low while the CMC was under near-proportional loading; however, the rate of AE energy accumulation increased once beyond the limit of proportionality and approaching bulk fracture.

Instantaneous DIC images that were previously employed to define bulk strains plotted in Figure 4 were sampled to inspect the local distribution in strain within the composite. Selected strain maps are illustrated in Figure 5 for Control #1 and #2. Figure 5a,b show the normalised cumulative acoustic energy alongside the associated DIC strain maps. Figure 5c,d then illustrate higher magnification versions of the same DIC strain maps.

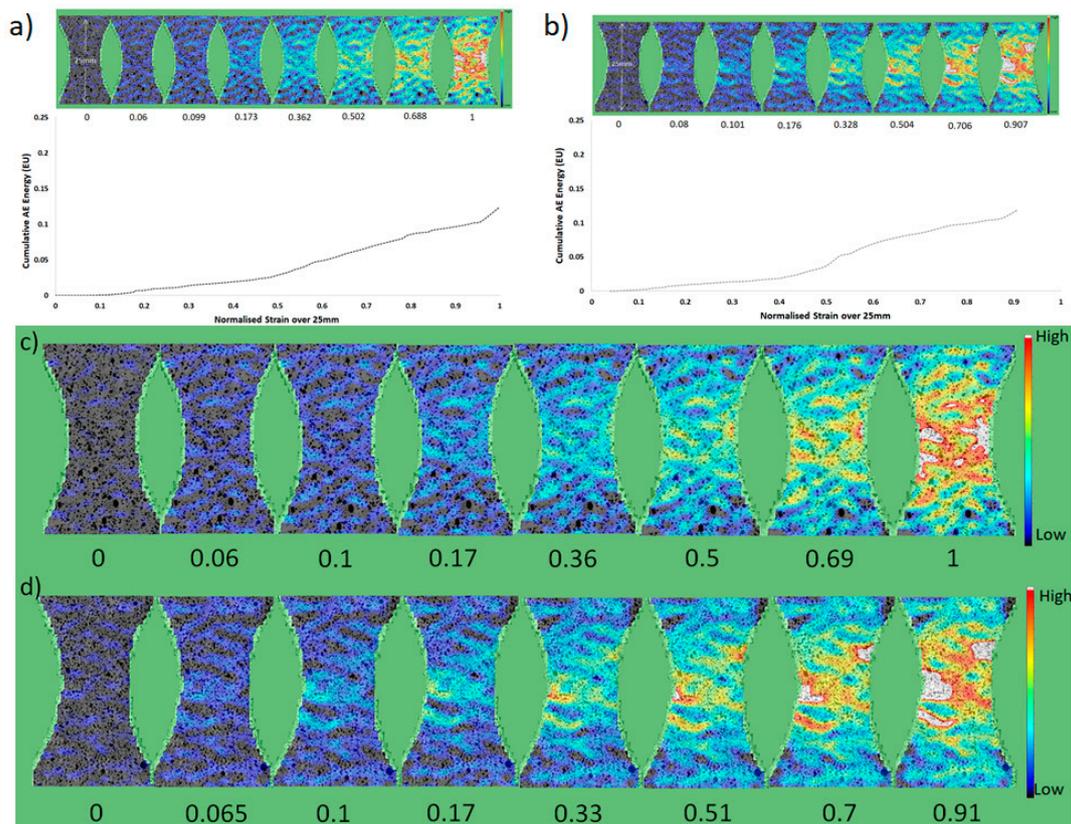
Figure 5. Strain maps of (a) specimen Control #1 and (b) Control #2, compared to acoustic emission (AE) data. Enlarged digital image correlation (DIC) strain maps for (c) specimen Control #1 and (d) Control #2.

For either specimen, the distribution of strain became highly localised throughout the course of the test, particularly once the limit of proportionality was exceeded. Strain “hot spots” appeared to develop in specimen Control #2 at a slightly lower value of bulk strain compared to Control #1. Despite the waisted, shallow form of the double edge notches, regions of high localised strain were displaced well away from the plane of the net section. The individual high strain regions increased in size horizontally during loading, until opposing regions from either flank coalesced as ultimate failure ensued. When viewed as a function of time on load, significant damage was accumulated immediately prior to fracture.

The trends observed in the cumulative AE response of the specimens were consistent with the evidence from the DIC strain maps. In both tests, as the rate of AE energy increased, the most prevalent strain hot spots appeared in the DIC maps.

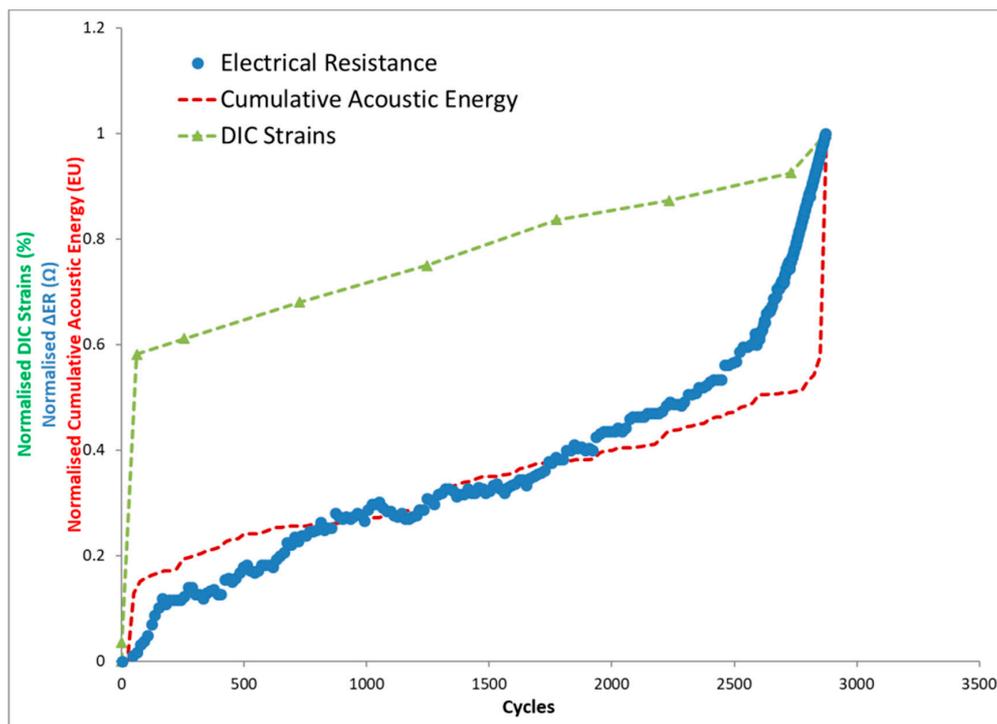
A conservative approach was taken when selecting the loading conditions for the initial room temperature fatigue test on Sample #1. To avoid premature overload and to allow the ER readings to stabilise, the test was deliberately initiated at a relatively low cyclic peak load condition (0.13 normalised stress). Once no discernable increases in ER or AE signals were detected, the peak cyclic load was increased after ~10,000 cycles. Such steps were repeated until relevant increases were noted. Only the data pertinent to the final loading block are presented (Figure 6), effectively ignoring any damage associated with the early stage/low stress loading regimes.

Figure 6. Normalised electrical resistance (ER), digital image correlation (DIC) strain and cumulative acoustic energy versus cycles, Sample #1 [2].

During this test, the trends in data from the different monitoring techniques correlated well. Each method indicated a rapid increase in response over the first 200 cycles leading to a near steady rate of signal accumulation during the remaining stages of the test. During the final 500 cycles, the ER measurements indicated an apparent onset in failure. The AE response increased rapidly, immediately prior to rupture. The specimen failed in a typical catastrophic fashion after approximately 2800 cycles. No definite indication of failure location was noted from the associated DIC measurements.

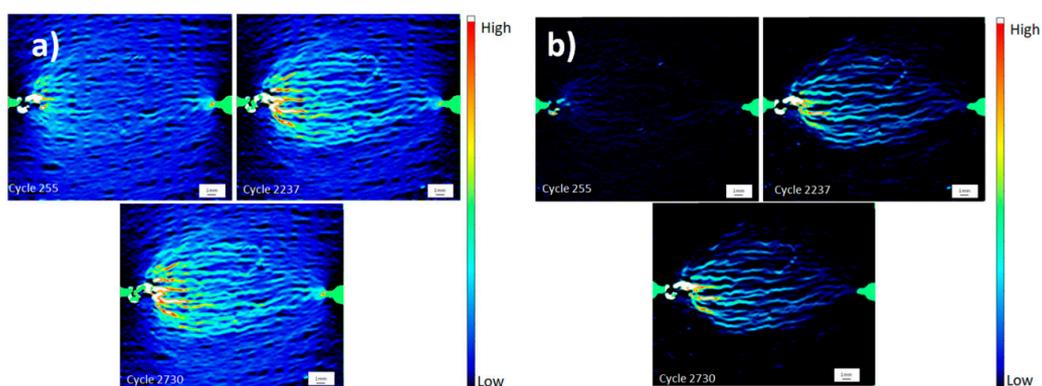
The DIC strain maps presented in Figure 7 illustrate the distribution of damage during the test ($N = 225$ onwards). Distinct, narrow zones of localised high strain developed and preferentially extended from the tip of the left-hand notch. The strain maps relate to images recorded at (a) the peak stress and (b) minimum stress conditions of the quoted cycles.

Figure 7. Digital image correlation (DIC) strain maps relating to the (a) peak and (b) minimum stress condition imposed at $N = 225$, $N = 2237$ and $N = 2370$, Sample #1 [2].

Areas of residual strain were noted at the trough of the loading cycle. Regions that previously displayed the highest localised strain values at the peak of the cycle remained in a permanently strained

state post unloading, indicating permanent damage retained in the composite. Damage inboard of the right-hand notch was restricted to a very localised region at the tip of the machined slit feature, and this strain was fully recovered on unloading, even during $N = 2730$ which occurred immediately before catastrophic failure.

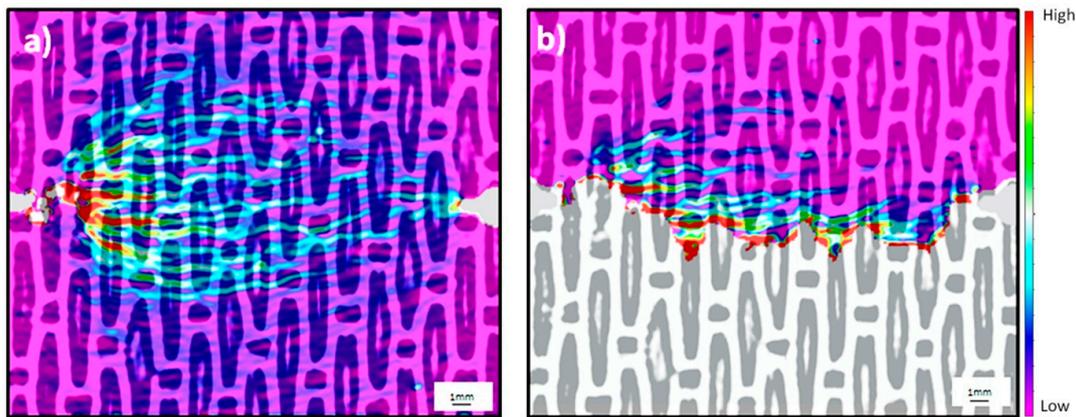
The images in Figure 8 show the surface fibre architecture, as recorded using the “surface profile” function of the DIC imaging system, superimposed onto two strain maps obtained at (a) $N = 2730$ under peak stress and (b) from the one half of the ruptured specimen at $N = 2800$ and zero applied stress. Note this form of imaging was only possible for the room temperature test.

Figure 8. Surface strain (a) pre-failure, (b) post-failure in relation to the surface fibre architecture [2].

The images indicate that the tip of the left hand pre-machined sharp slit was located adjacent to a longitudinal, 0° fibre tow, slightly inboard of this front face surface. Fourteen distinct longitudinal tows were identified across the net section. Viewing from left to right, the horizontal regions of concentrated high strain traversed the consecutive longitudinal tows with minimal deviation; however, the number of individual damage zones increased with each tow away from the slit. The maximum height of the damage zone correlates spatially with the sixth longitudinal tow, beyond which the zone contracts towards the right-hand side of the specimen.

Figure 8b illustrates that the localised regions of permanent, residual strain are concentrated immediately adjacent to the flanks of the fracture surface. The areas of highest residual strain traversed both fibre and matrix phases exposed at the surface. Previously strained regions, more than ~ 10 mm, displaced from the fracture plane have been recovered in a fully elastic fashion. There was a minimal deviation of the major crack away from the net section plane, and only limited fibre pull out across the fracture surface.

Distinct differences were detected by DIC in the strain field developed at room and elevated temperatures. Figure 8 provides a clear example of a distributed damage zone, with isolated regions of high strain extending horizontally across the field of view. Multiple cracks developed within these strained areas and were associated with the transverse fibre tows. In contrast, the region of high strain relating to the high-temperature fatigue tests was consistently localised to a single zone (Figures 12, 14 and 20, for example) and eventually a single dominant crack developed to promote ultimate failure. The fracture surfaces from the tests performed at 800 °C also demonstrated more restricted fibre pull out. This behaviour is consistent with a reduction in crack density with increased temperature reported for a range of SiC matrix CMC systems, notably incorporating various classes of fibre and interface phase [15,18] and has been attributed to a moderate reduction in brittle behaviour.

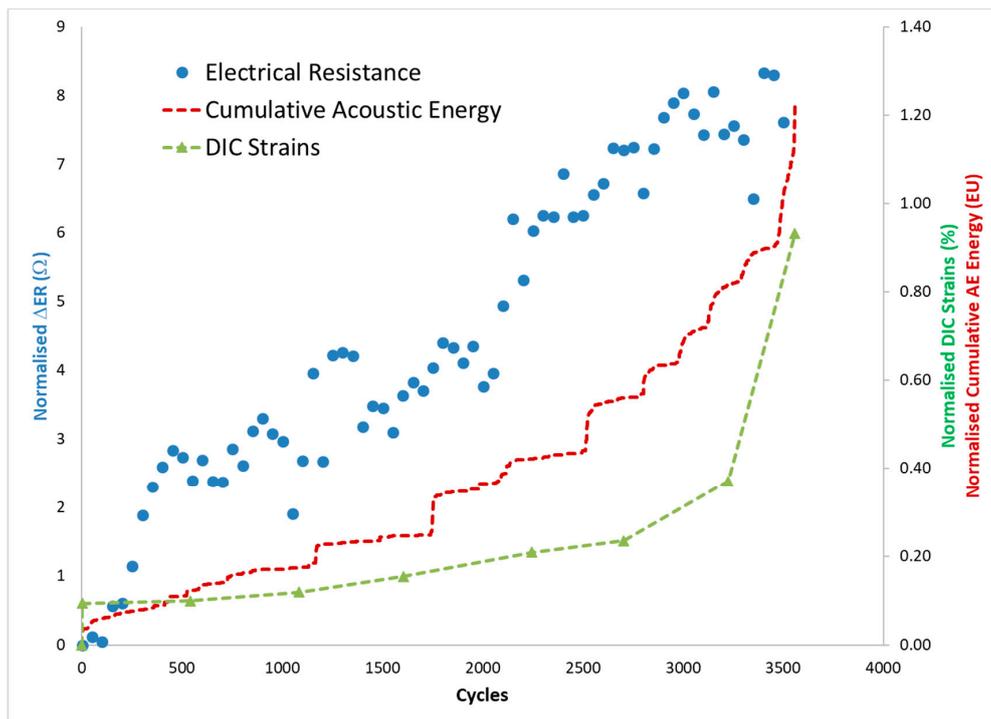
Sample #2 was tested at 800°C , and a normalised peak cyclic stress of 0.6 was observed. Figure 9 displays electrical resistance, strains calculated via DIC and the acoustic response as a function of applied cycles.

Figure 9. Normalised electrical resistance (ER), digital image correlation (DIC) strain and cumulative acoustic energy versus cycles, Sample #2 [2].

The resistance data measured from this specimen displayed a higher degree of scatter compared to the previous room temperature test. The overall trend, however, again displays a rapid increase over the first 500 cycles, which then slows to a more gradual increase with successive cycles. There was no significant change in the rate of resistance accumulation immediately prior to failure; however, compared to the room temperature response of Sample #1, the total ER increase during the course of this test approached 700%, a distinctly high value. DIC and AE data displayed a consistent response. Both AE and DIC presented relatively stable values over the first 1600 cycles; however, both indicated an acceleration toward failure. The gradient continued to increase until failure ensued in a rapid fashion around 3500 cycles.

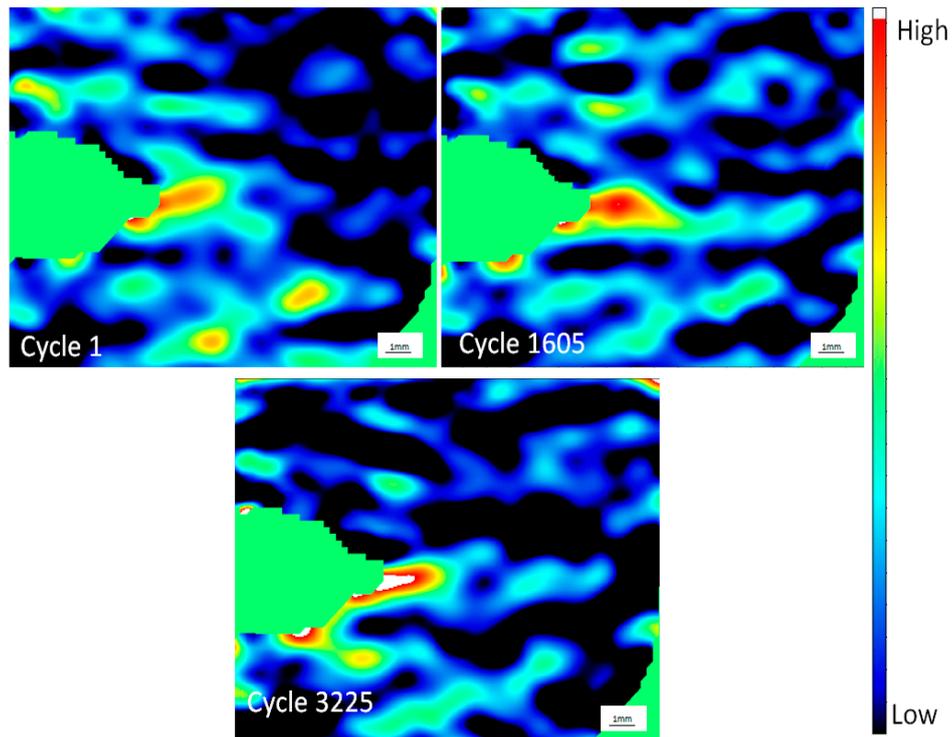
The DIC strain maps measured during the course of this test provided some success in detailing the inhomogeneous strain field (Figure 10); however, the degradation of the speckled high-temperature paint and the effects of thermal drift affected the resolution of the maps. Regardless, some useful information was obtained, with high localised strain detected at the tip of the notch slit immediately during the first load cycle, with the expansion of this region progressing over the course of the test.

Figure 10. Digital image correlation (DIC) strain maps relating to Sample #2, tested at 800 °C [2].

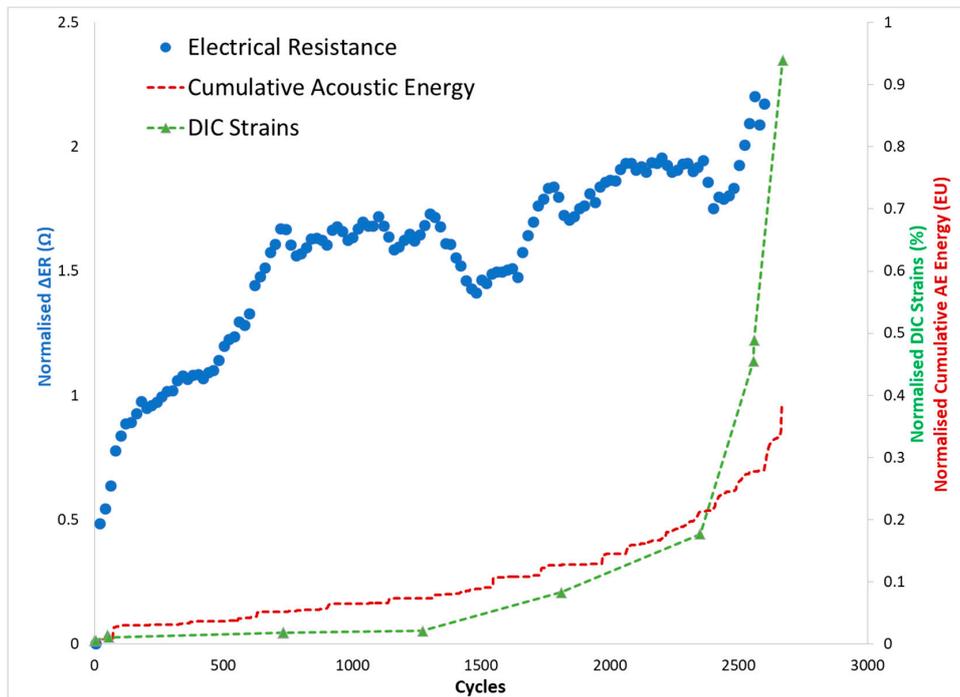
Figure 11 shows the results of the test on Sample #3, performed at normalised stress of 0.5. This test gave greater success in terms of DIC, benefitting from the improved image resolution due to changes in the speckle paint and employment of a temperature tolerant glass furnace window. On this occasion, both AE and DIC strain measurements indicated a more gradual increase approaching the failure event. ER was unable to predict the onset of failure given the degree of scatter during the course of the test.

Figure 11. Normalised electrical resistance (ER), digital image correlation (DIC) strain and cumulative acoustic energy versus cycles, Sample #3 [2].

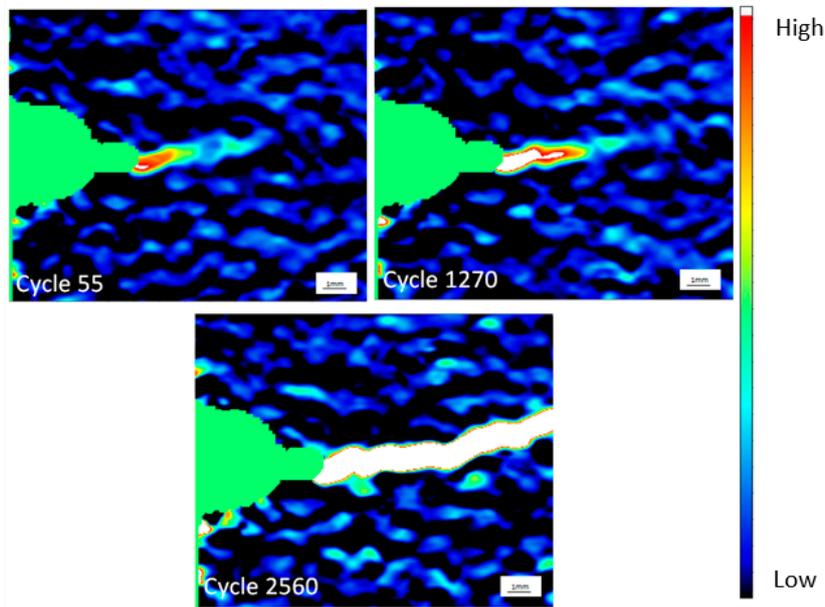
From the DIC strain maps, a small region of high strain was detected immediately ahead of the notch slit tip as early as N = 55 into the test period (Figure 12). This region grew in both lateral and axial size during successive cycles until the damage zone extended beyond the field of view, illustrated by the map taken at 2560 cycles. It should be emphasised that the specimen remained load bearing at

this point, although the area coloured white in the associated strain map was actually associated with a visible, well-defined crack at this stage.

Figure 12. Digital image correlation (DIC) strain maps relating to Sample #3, tested at 800 °C [2].

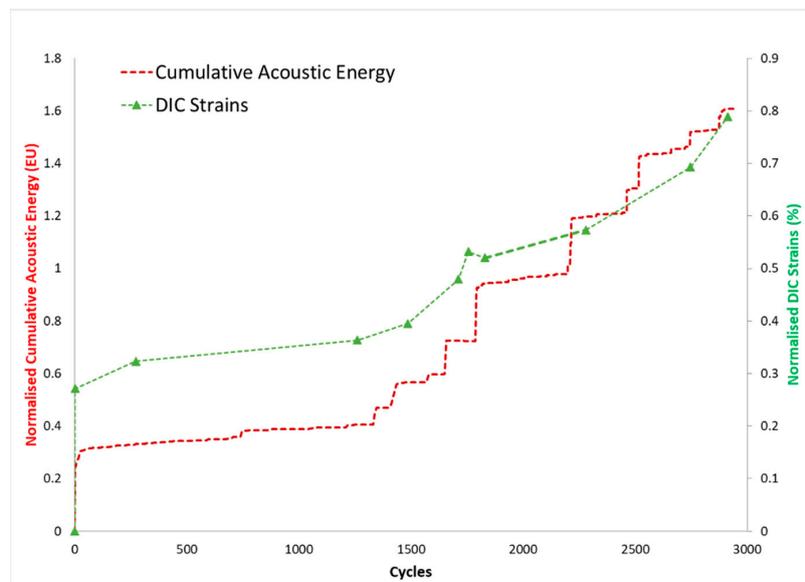
Unfortunately, no reliable ER data were recorded from Sample #4 due to inferior probe contacts. However, both AE and DIC indicated a significant and immediate increase as loading commenced, followed by a period of relative stability to approximately 1300 cycles. Beyond this stage, there was a marked increase in the rate of average AE accumulation which encompassed distinct steps in the signals (Figure 13). The associated DIC maps detected the development of a region of high strain emanating from the tip of the notch slit (Figure 14).

Figure 13. Normalised digital image correlation (DIC) strain and cumulative acoustic energy versus cycles, Sample #4 [2].

The spatial origins of the individual AE events that combined to constitute the accumulated energy data, plotted in Figure 13, were determined from the time of flight analysis (Figure 17). Those events corresponding to the central 80 mm hot zone of the furnace were displayed. During the first 700 cycles, events were distributed randomly along with the sample between the extremes of the hot gauge section. A concentrated band of events was then evident over a period of approximately 300 cycles, focused on the horizontal plane through the centre of the notch. A period of relatively low activity then followed until another group of events on the same central plane was detected shortly after 1500 cycles. The DIC images in Figure 14, taken at these instances, indicated a corresponding broadening of the damage zone in the axial direction. The distinct steps in cumulative acoustic energy were mirrored by an increased density in individual events focused within the central gauge section, approximately ± 20 mm above and below the notch.

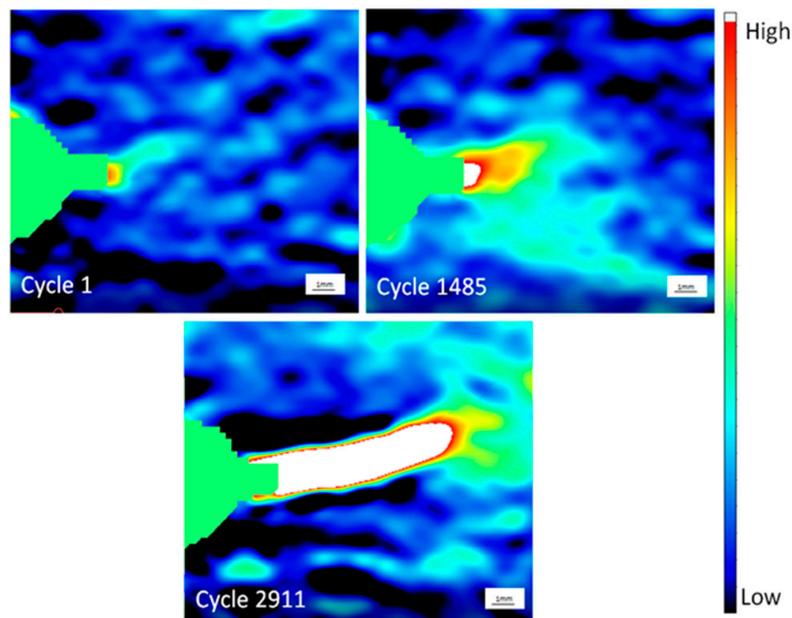
Figure 14. Digital image correlation (DIC) strain maps relating to Sample #4, tested at 800 °C [2].

Destructive polishing of the specimen exposed the same crack interacting with transverse fibres on a sub-surface plane, viewed under scanning electron microscopy, as shown in Figure 16a. As the crack interacted with a bundle of longitudinal fibres, viewed on the same polished plane, evidence of multiple micro-cracks in the matrix phase immediately juxtaposed to individual fibres was noted (Figure 16b). A combination of bridging and fractured fibres were evident within the complex damage zone; however, the damage was restricted to a relatively small distance away from the plane of the main crack, noting that the vertical field of view in the image was restricted to approximately 100 μm . This correlated well with the region of high strain indicated by the DIC images, as shown in Figure 14.

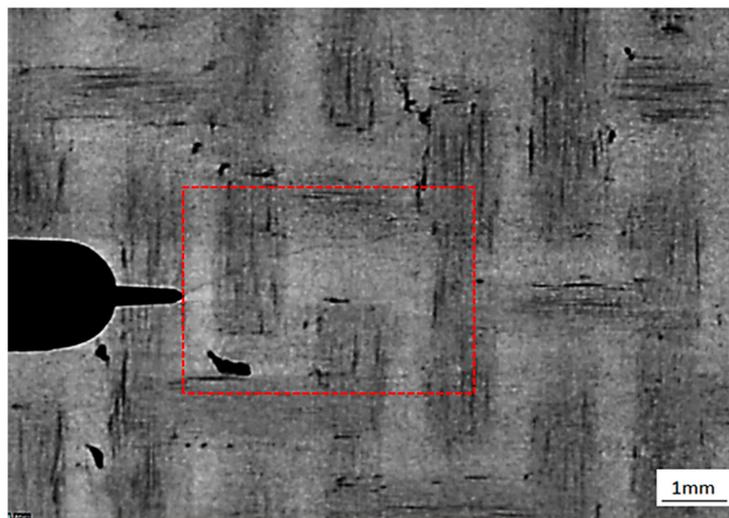
By terminating the fatigue loading, Sample #4 was extracted from the load train and assessed under XCT, where a fine crack was detected traversing across four longitudinal fibre tows (Figure 15). The plane of fracture was inclined slightly relative to the tensile load axis.

Figure 15. X-ray computed tomography (XCT) inspection of a crack in Sample #4 [2].

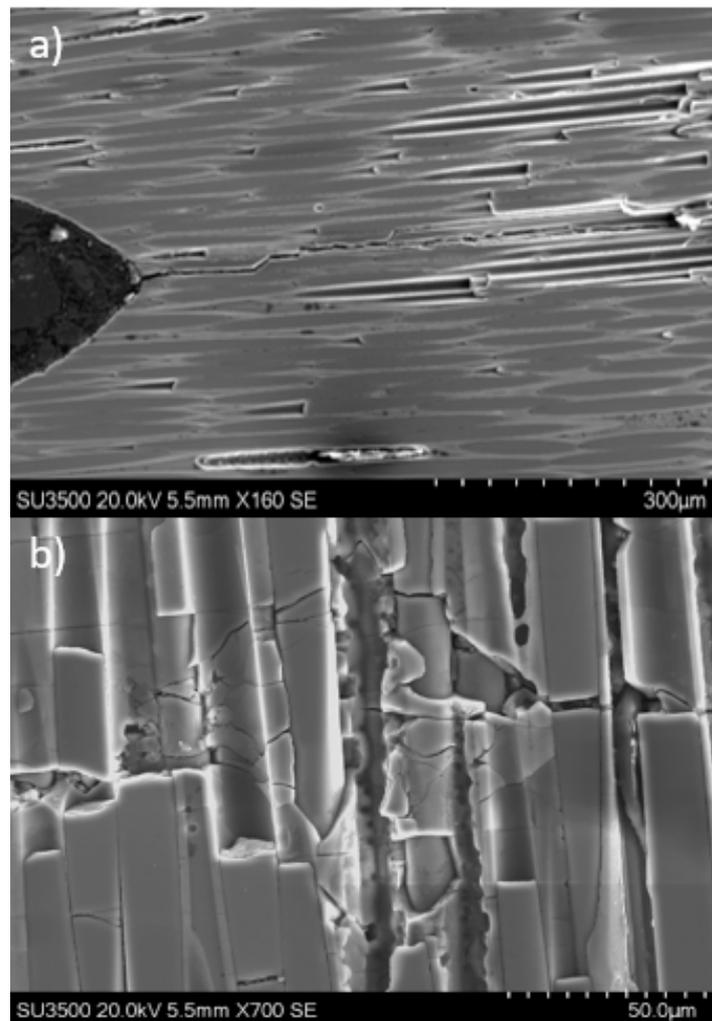
Figure 16. (a) SEM image of the singular dominant crack emanating from the notch tip, Sample #4 (b) Complex damage zone associated with the same crack traversing a longitudinal fibre bundle [2].

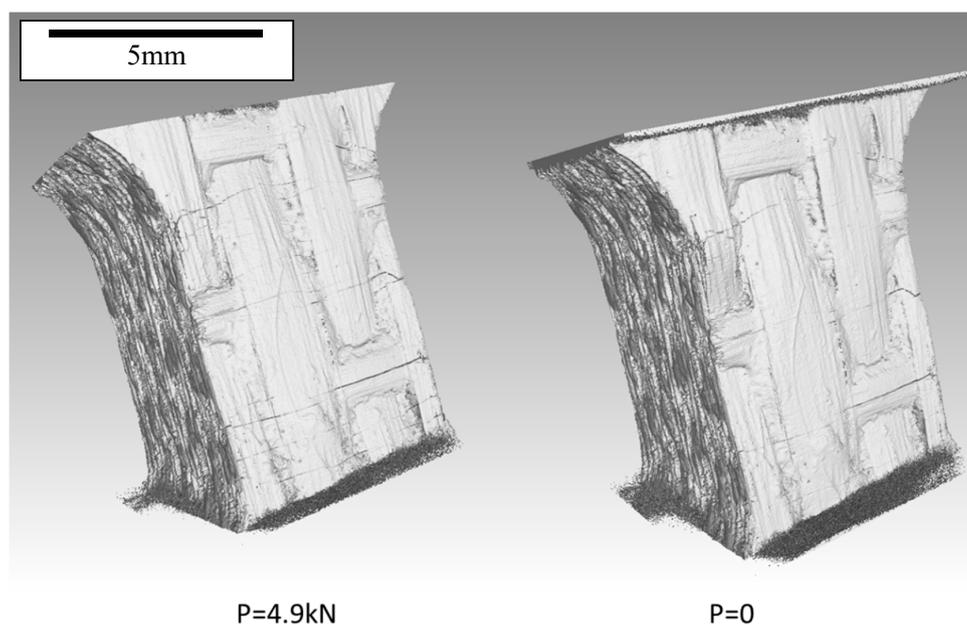
Figure 18. 3D perspective of crack closure.

The scope of the work presented here primarily employed XCT inspection as a “post mortem” technique, post mechanical testing and unloading of the test specimen. XCT offers by far the greatest resolution for defining CMC architecture and process artefacts which can subsequently be correlated to damage and failure mechanisms. This makes XCT a valuable inspection tool. Despite the relatively high cost associated with the technique, the pre-production inspection of components via CT can be justified [13]. One drawback of this technique is that by employing relatively large scale test samples, the likes of which were tested in this investigation, it is difficult to image under load due to size constraints within the X-ray chamber. Despite the evidence gained from AE monitoring, in particular, optical inspections of post-tested specimens failed to identify surface cracking to the extent expected. Our recent studies employing in-situ X-ray tomography have provided evidence as to why this may occur, by demonstrating the extent of crack closure occurring during unloading [14]. An example of XCT scanning whilst the sample was under load is included in Figure 18. The detection of surface cracking under optical or even scanning electron microscopy after unloading is often impossible.

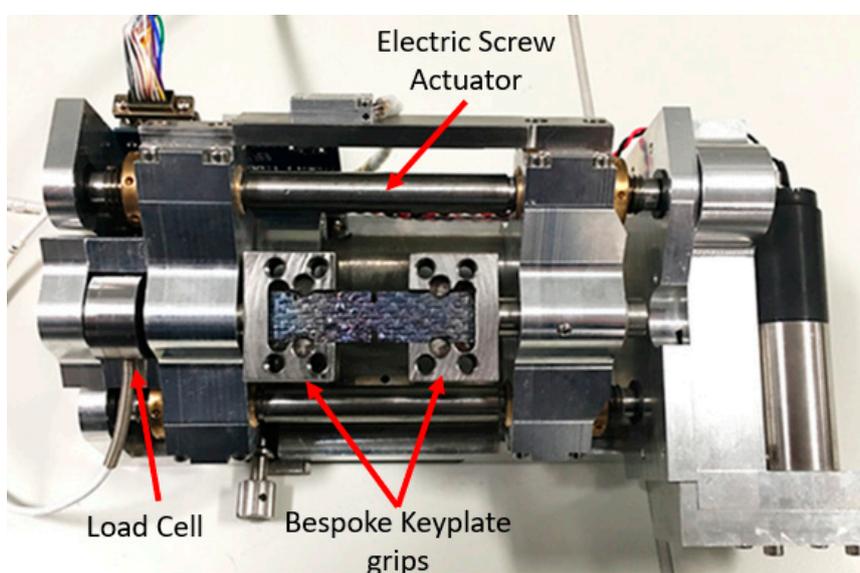
Figure 19. In-situ SEM tensile stage with a bespoke gripping system for CMCs.

fatigue tests using DIC and AE were interrupted prior to ultimate failure and removed from the standard fatigue test frame to be transferred to an in-situ SEM tensile loading stage. This aspect of the assessment was conducted at room temperature. The loading rig employed was a commercially available tensile stage integrated within the evacuated chamber of a conventional tungsten element SEM. Specific grips were designed and manufactured to interface with the CMC samples. The design of the tensile stage incorporates a fixed end grip and opposing moving actuator. During loading, the sample would naturally shift across the SEM field of view. Therefore, a stepped loading technique was employed to facilitate tracking of the original field of view between the opposing notches, and occasional re-focusing of the image was necessary. A single test was terminated after 39,000 combined fatigue cycles based on the rapid increase detected in AE energy. The central gauge section of the original test sample was carefully sectioned to remove the tab ends and retain a segment of 60 mm total length, incorporating the double edge notches in the mid-length position. Four small locator notches of 1 mm radius were machined towards the new specimen extremities using diamond tooling to enable load transfer between the grips and specimen alignment. A key-plate was then applied to assist load transfer and resist slippage within the grip. The test rig and gripping design are illustrated in Figure 19.

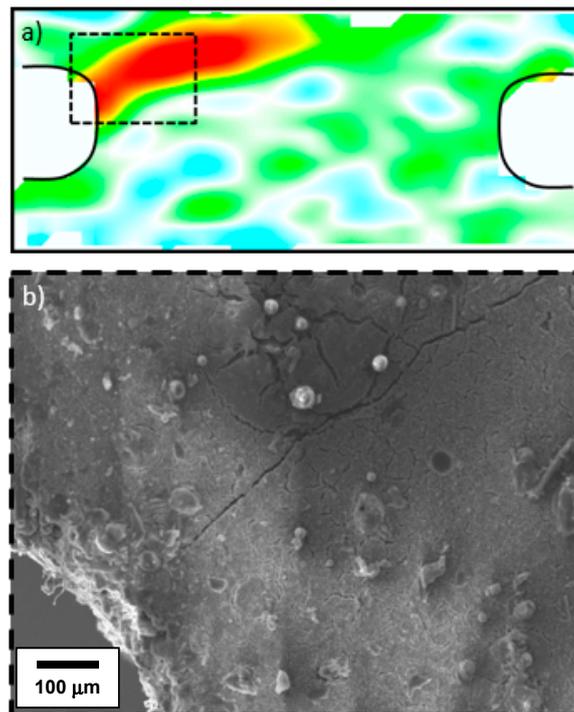
Figure 20. (a) Digital image correlation (DIC) strain map at the termination of the test; (b) associated crack viewed under zero load.

The DIC image recorded immediately prior to unloading had indicated a clear region of damage associated with the left-hand notch (Figure 20a). On transferring the central portion of the sample to the SEM tensile stage and viewing this region under high magnification secondary electron imaging, a fine crack could be detected correlating to the DIC region of high strain (Figure 20b). In-situ loading was then applied to this sample to deliberately open the pre-existing crack. Analysis of the SEM records using the DIC software produced a sequence of strain maps to illustrate the associated crack opening displacement (COD) (Figure 21). Within this field of view, no additional cracks became apparent during the loading ramp.

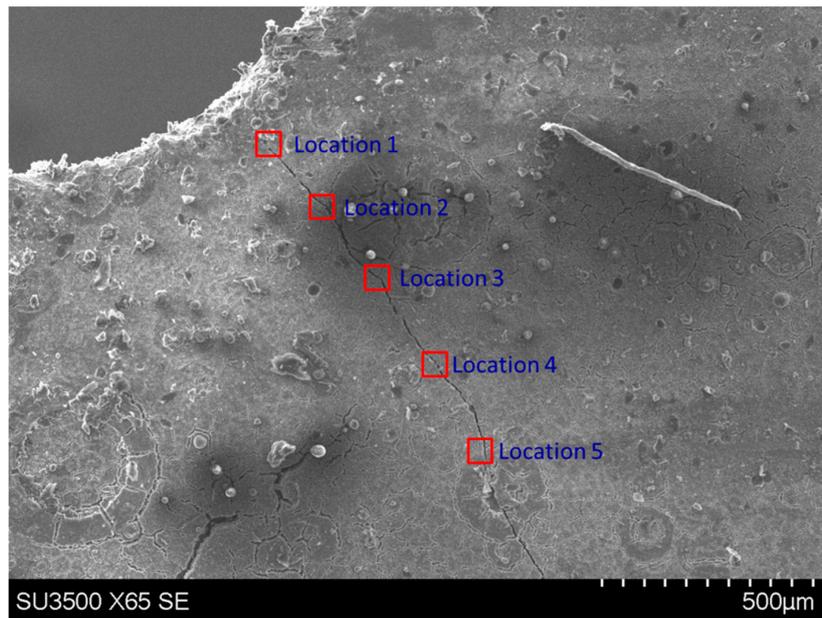
Figure 22. Locations for crack opening displacement (COD) measurements.

Using the commercially available photo editing software AxioVision, COD measurements were recorded as a function of applied stress at five near equally spaced locations along this crack, at positions indicated in Figure 22. The measured displacements are presented in Figure 23. COD was essentially directly proportional to applied stress. Whilst the local compliance was very similar at four of the locations, the displacements were consistently lower at location #2.

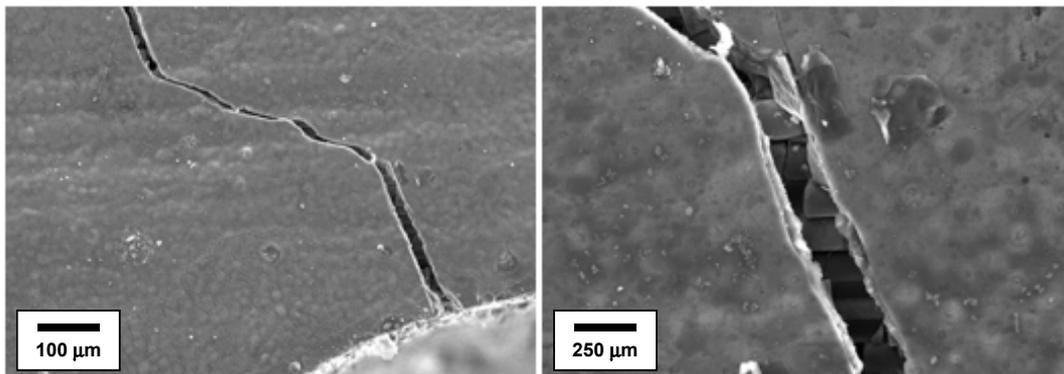
Figure 24. Crack viewed on the reverse face exposing sub-surface bridging and fractured fibres.

The reverse face of the same notch was also inspected under in-situ SEM loading. A single crack was again evident, initiated slightly offset from the notch root (Figure 24). The SEM images taken at two stages during loading not only illustrate the surface matrix crack opening but also allow visibility of the local sub-surface fibres.

The application of this in-situ SEM technique has enhanced the ability to locate pre-existing surface breaking fatigue cracks in tested CMC samples. More critically, the sub-structure relating to these cracks was obscured until inspected under load (Figure 24). Once opened and viewed under load, the evidence of local fibre/matrix de-cohesion and bridging was noted. However, examples of fracture in selected individual fibres were also observed. The crack opening displacement measurements detailed in Figures 22 and 23 illustrated a direct relationship between COD and loading; however, not all points along the crack opened to the same extent. This could indicate that compliance measured at the sample surface is extremely sensitive to the integrity of fibres and their interface to the matrix immediately beneath the local surface.

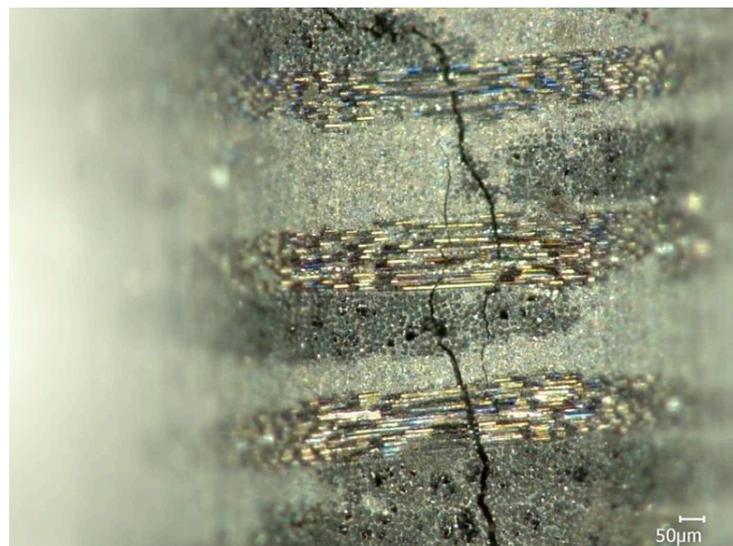
Figure 25. Through thickness crack path along the notch root.

The optical inspection of the lateral edge of the coupon illustrates the through-thickness cracking along the root of the notch (Figure 25). The macroscopic crack breaks the front and rear surfaces at a single location on each face; however, a complex path is evident as the crack traverses through the consecutive plies with examples of crack bridging and crack displacement evident. Such complexity in the crack path is representative of the pseudo-toughness demonstrated by CMCs compared to monolithic forms of ceramics.

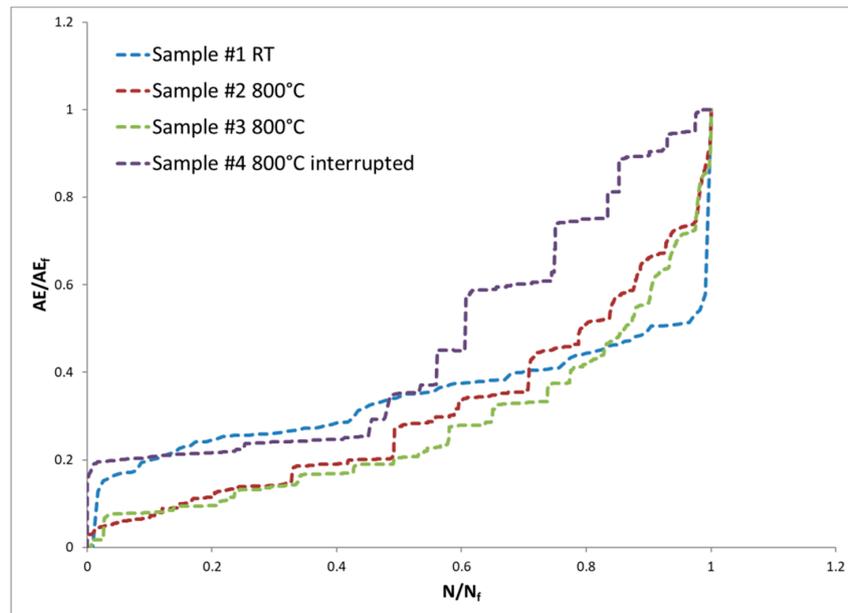
Figure 26. Normalised acoustic emission (AE) response from Samples #1 to #4.

Under fatigue loading, the cumulative AE signals invariably detected early stage damage within test coupons of various geometry, with activity noted during the very first loading cycle. This was mirrored by a characteristic acceleration in emissions as failure was approached. Figure 26 attempts to illustrate the general sigmoidal trends in AE measurement through normalising both the accumulated

AE energy and cyclic fatigue life against their respective final values (AE_f and N_f) of Samples #1 to #4. These combined data represented behaviour in four separate samples over a similar period of fatigue life immediately prior to rupture (i.e., lives between 2500 and 3500 cycles) at two distinct temperatures. One notable difference was evident relating to the test temperature. Whilst the increase in AE signal at room temperature remained relatively gradual, all of the 800 °C tests illustrated marked steps in the recorded accumulated energy signals. It is suggested that the elevated temperature response could indicate repeated episodes of environmental incubation (oxidation) and subsequent mechanical damage.
