Article Discovering Vegetation Recovery and Landslide Activities in the Wenchuan Earthquake Area with Landsat Imagery

Citation: Zhong, C.; Li, C.; Gao, P.; Li, H. Discovering Vegetation Recovery and Landslide Activities in the Wenchuan Earthquake Area with Landsat Imagery. *Sensors* **2021**, *21*, 5243. https://doi.org/10.3390/ s21155243

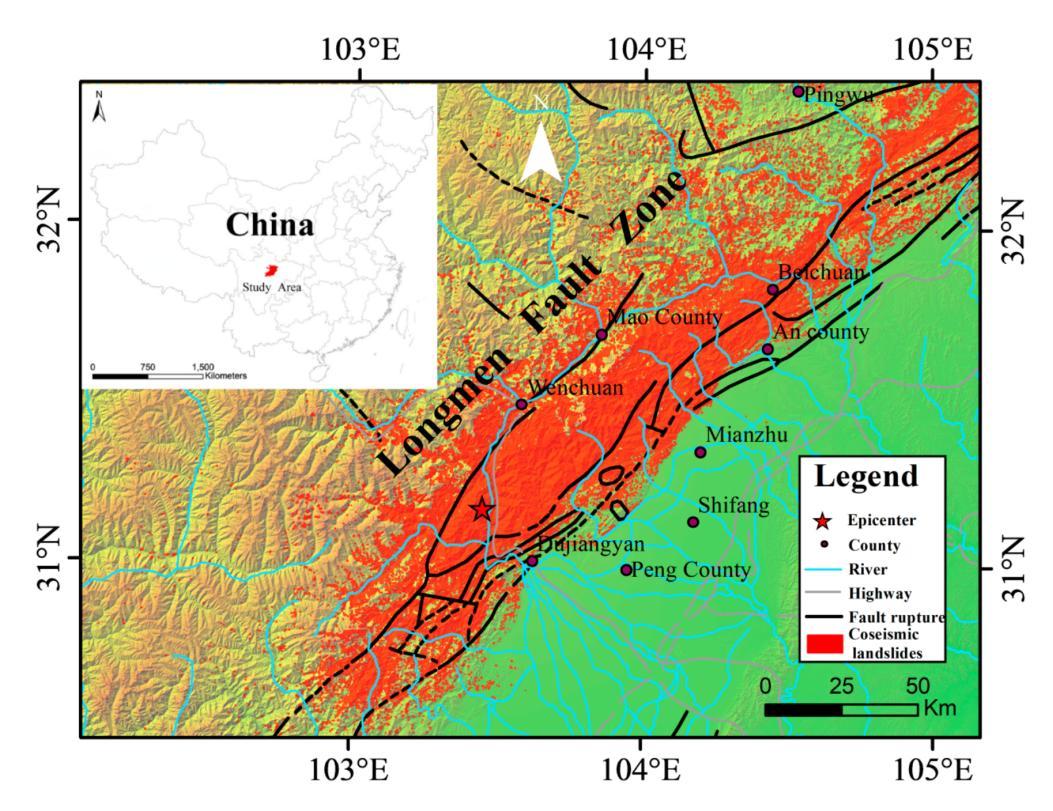
Figure 1. Study area map showing landslides triggered by the 2008 Wenchuan earthquake, fault rupture, location of Wenchuan, Beichuan, etc.

As shown in Figure 1, most post-seismic landslides happened within the Longmenshan fault zone, the junction of the front edge of the Qinghai–Tibet Plateau and the Sichuan Basin. The area is characterized by mountainous landscapes (e.g., high mountains and deep valleys), which were created by strong neotectonic movement. The Longmenshan fault zone consists of several fault ruptures including the Maowen fault, Yingxiu–Beichuan fault, and the Dujiangyan–Anxian fault [29], where earthquakes or geohazards may happen at some time. The area has a temperate monsoon climate. The annual mean sunshine duration, temperature, and precipitation are 1600 h, 12.9 °C, and 719.7 mm, respectively. Most rainfall happens in the growing season (May to September), which probably raises the risk of landslides, debris flows, and other disasters. In the area, eight vertical natural climate zones are identified along with the altitude rising from southeast to northwest. More than 60% of this area had moderate or high vegetation coverage before the known earthquake.

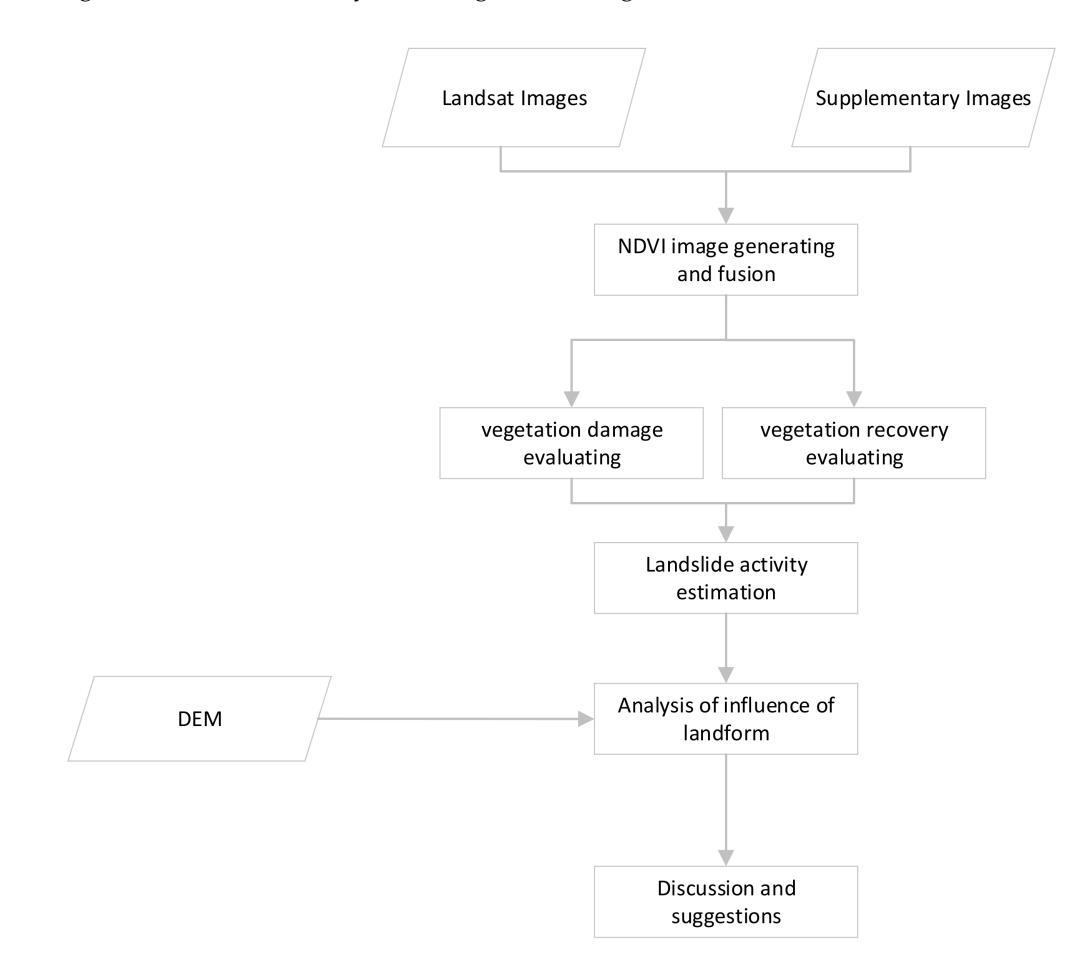
Figure 2. A Flowchart of this study.

The flowchart of this study is shown in Figure 2. First, *NDVI* images from the growing season of each year were generated and fused using the MVC method; secondly, the vegetation damage after the earthquake was estimated by comparing the *NDVI* images before and after the earthquake; thirdly, the vegetation recovery status was evaluated by calculating the difference between the *NDVI* right after the earthquake and the *NDVI* of a following year; then, a landslide's activity was estimated roughly according to its vegetation recovery status; fifthly, the influence of the landform factors on vegetation recovery and landslide activity was analyzed; at last, discussion and suggestions for regional landslide stability and mitigation were given.

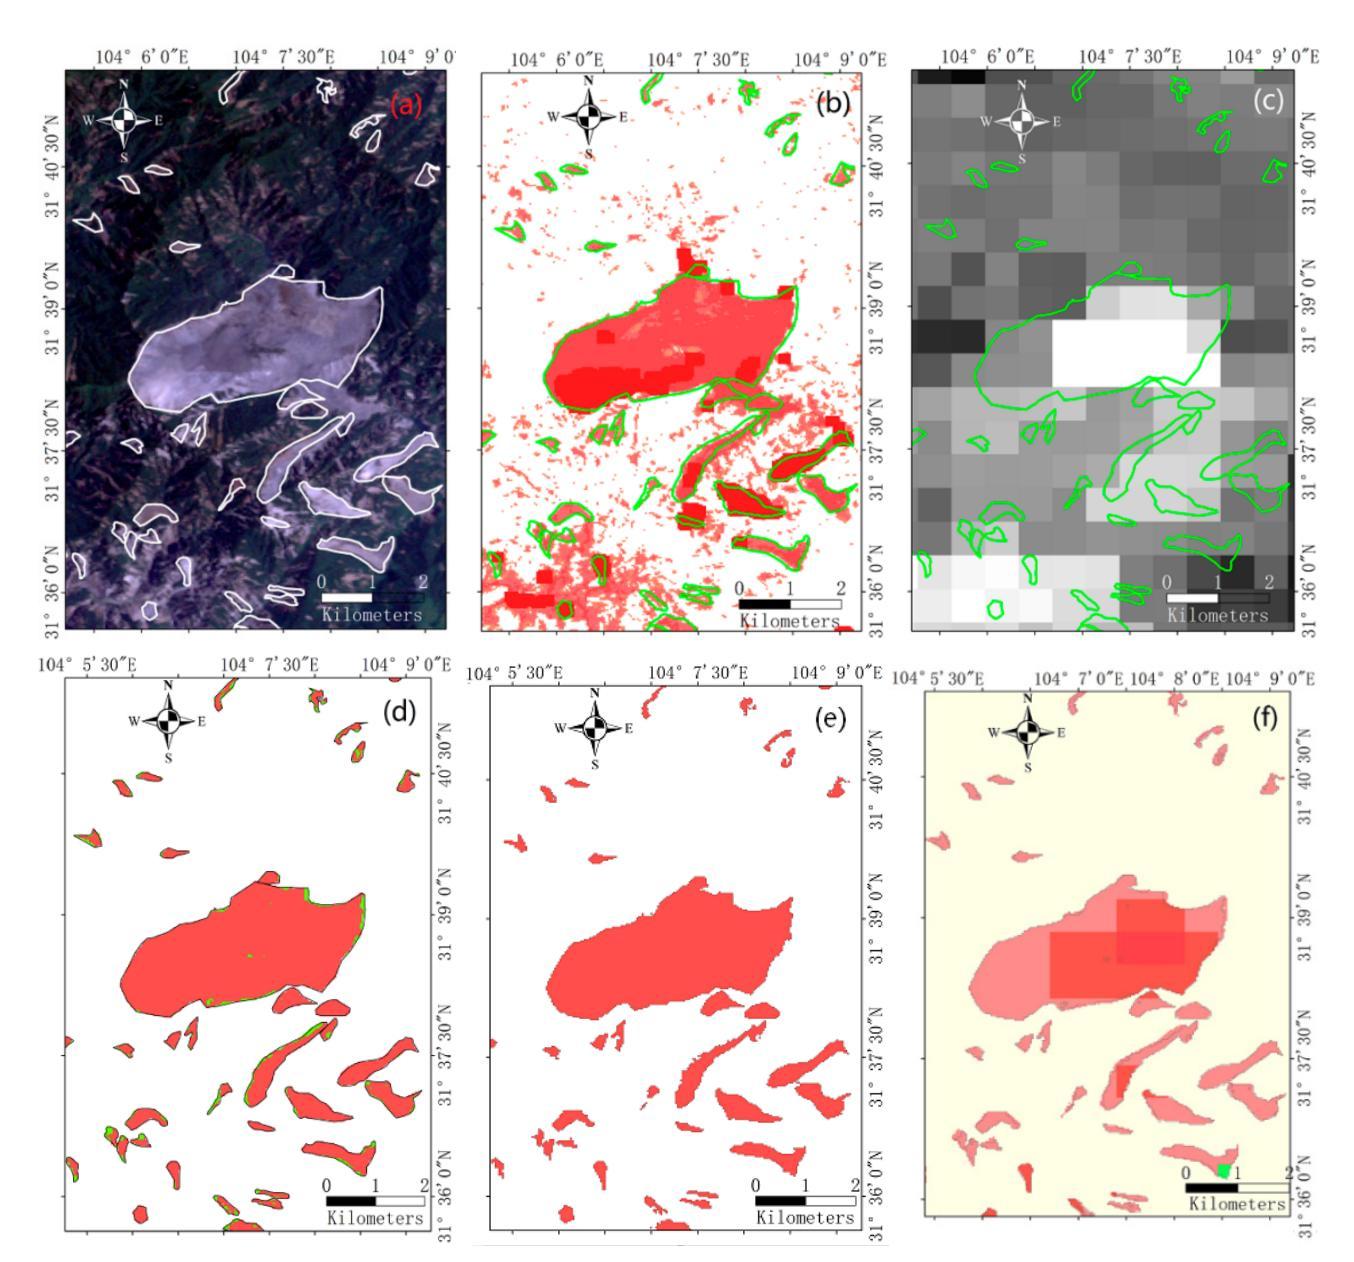
Figure 3. Examples of *VDA* analysis: (**a**) landslide polygons and the Landsat TM image in 2008; (**b**) landslide polygons and the *VDA* map (the bright red indicates the greatest *VDA* level); (**c**) landslide polygons and the MODIS NDVI image in 2008; (**d**) *VDA* of selected landslides, where *VDA* FALSE is in green; (**e**) landslide pixels, where *VDA* FALSE areas in panel (**d**) are removed; (**f**) the *VDA* map obtained from MODIS NDVI. All displayed landslides are greater than 50 Landsat pixels, and the greatest known one is the Daguangbao landslide (7.12 km²).

An example of the whole vegetation damage map (see Figure S1) was shown in Figure 3. In Figure 3b,d, most landslide pixels in red had TRUE *VDA*, only a few pixels got FALSE *VDA* (in green in Figure 3d). Errors around landslides boundary were probably caused by mixed pixels or matching errors between landslide polygons and the image. Errors in landslide might come from image noises. Both errors were carefully checked with original Landsat images (Figure 3a) and removed (as shown in Figure 3e). In Figure 3b, the *VDA* level of each landslide pixel was displayed, while most landslides were less than one pixel of MODIS *NDVI* image (shown in Figure 3c) and detailed vegetation damage could not be found from the corresponding *VDA* map (shown in Figure 3f).

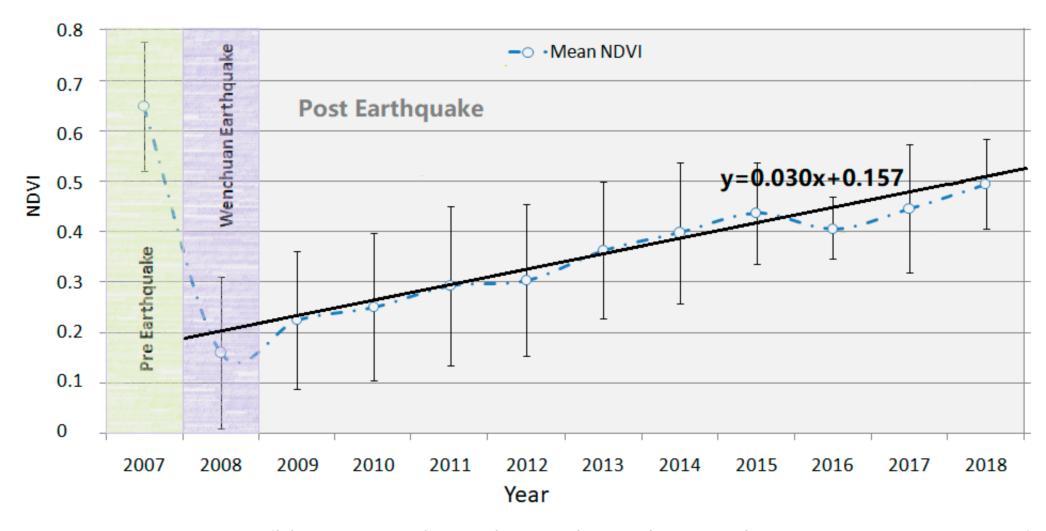
Figure 4. Mean NDVI (blue scatter plot with error bar indicating the root mean square error) of landslide pixels between the years 2007 and 2018.

As shown in Figure 4, the mean *NDVI* of landslide pixels was about 0.65 before the earthquake, and then sharply declined to 0.17 after the 2008 earthquake. From 2009 to 2018, the *NDVI* slowly increased with a clear trend (0.03/year) and approached 0.5 at the end. This general trend is in accord with previous studies in the earthquake affected area based on Landsat image [26], though their study region and time may be a little different. It should be pointed out that about 16.57% of landslide pixels were removed as they were covered by clouds, snow, or haze and could not be repaired by fusing all *NDVI* images in one year.

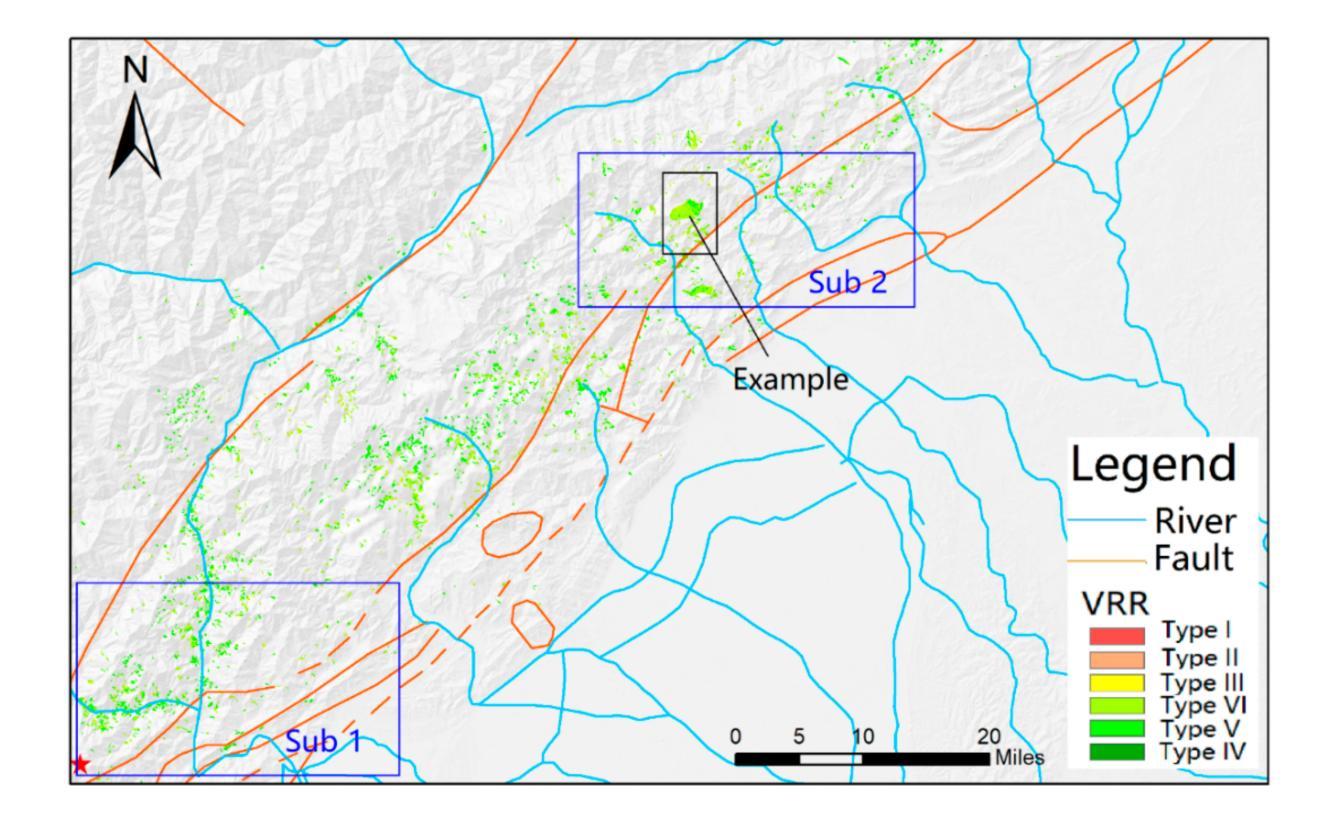
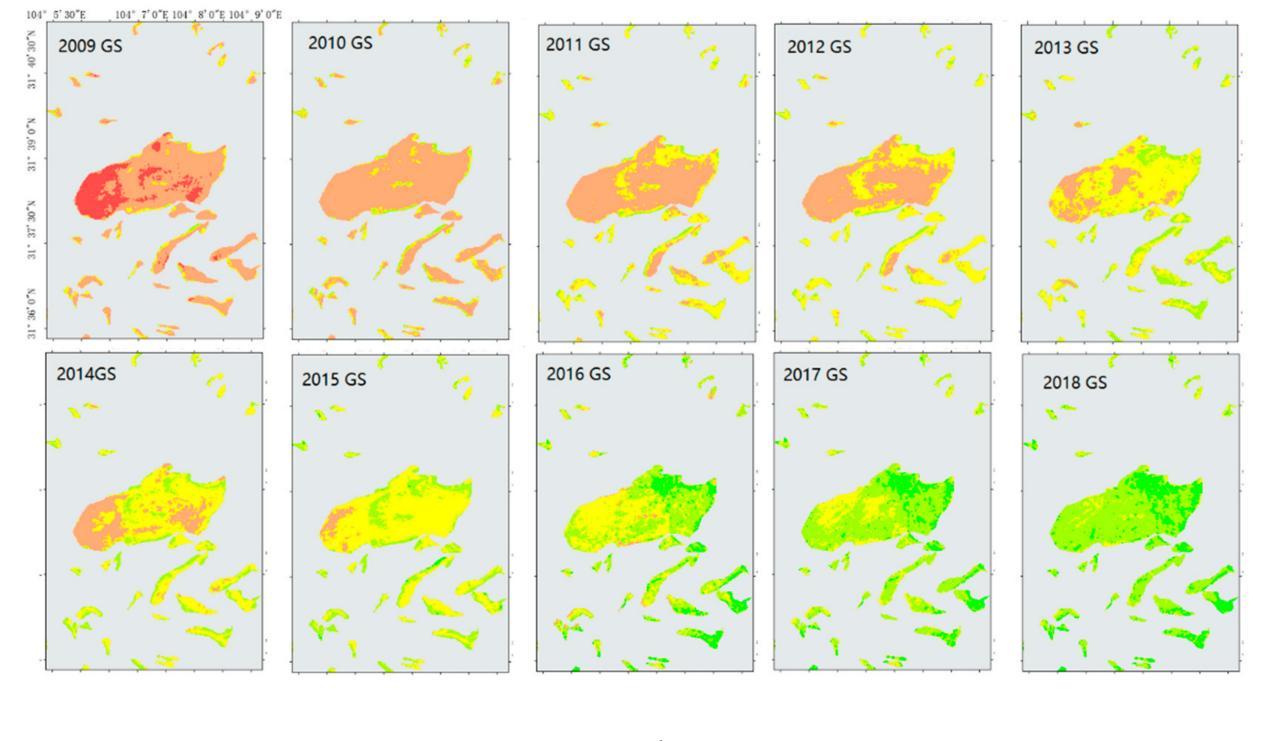
Figure 5. The VRR map. (**a**) the overall *VRR* map of 2018, and (**b**) an example of vegetation recovery process during the study years. Here, GS stands for growing season. The sub-regions in the *VRR* map are used for analyzing the influences of the epicenter, fault ruptures, and rivers, as shown in Figure 7.

Figure 5 shows the overall vegetation recovery map of 2018. According to the map, vegetations of most landslides were well recovered (*VRR* is Type IV or Type V) in 2018. It is seen that the spatial distribution of *VRR* was not related to the distance from the landslides to the epicenter or fault ruptures. Landslides located in the Longmenshan Fault Zone (between the Maowen Fault and the Yingxiu–Beichuan Fault) and those outside the fault zone, had similar *VRRs*.

The yearly *VRR* maps of a subregion around the Daguangbao landslide is taken as an example to show spatial-temporal patterns and details of landslide vegetation recovery. In general, vegetation recovery patterns of this area are in accord with that shown in Table 3, with a remarkable fact that the *VRR* of the Daguangbao landslide was apparently lower than that of surrounding landslides in each year. It indicates the vegetation of the greatest landslide was serious damaged and hard to recover. Detailed investigation on the Daguangbao landslide revealed that eastern part had the largest *VRR* followed by the central part and west part, which can be explained by several reasons. First, the western part was the main scarp of the landslide [5], whose vegetation and soil were seriously destroyed by the earthquake and secondary landslides. Second, this part was much higher than other parts (elevation difference between the west and east is greater than 1500 m). Then, the climatic conditions for vegetation growth, e.g., temperature, sunlight duration, and water in this part, were much worse, which also limited vegetation recovery. For other smaller landslides, inner spatial variability of vegetation re-growth was also witnessed.

Figure 5 shows the spatial distribution of *VRR* was not related to the distance of landslides to the epicenter or fault ruptures. Subregions (e.g., Sub 1 and Sub 2) showed similar *VRR* distribution, implying that vegetation possessed similar growth condition (e.g., temperature, precipitation, and landforms, etc.) at a regional scale. In target area 1 (Figure 7a), landslides along rivers had a higher *VRR* level; while in target area 2 (Figure 7b), that phenomenon was not observed. This suggests that there is no evident relationship between *VRR* distribution and the distance to rivers.

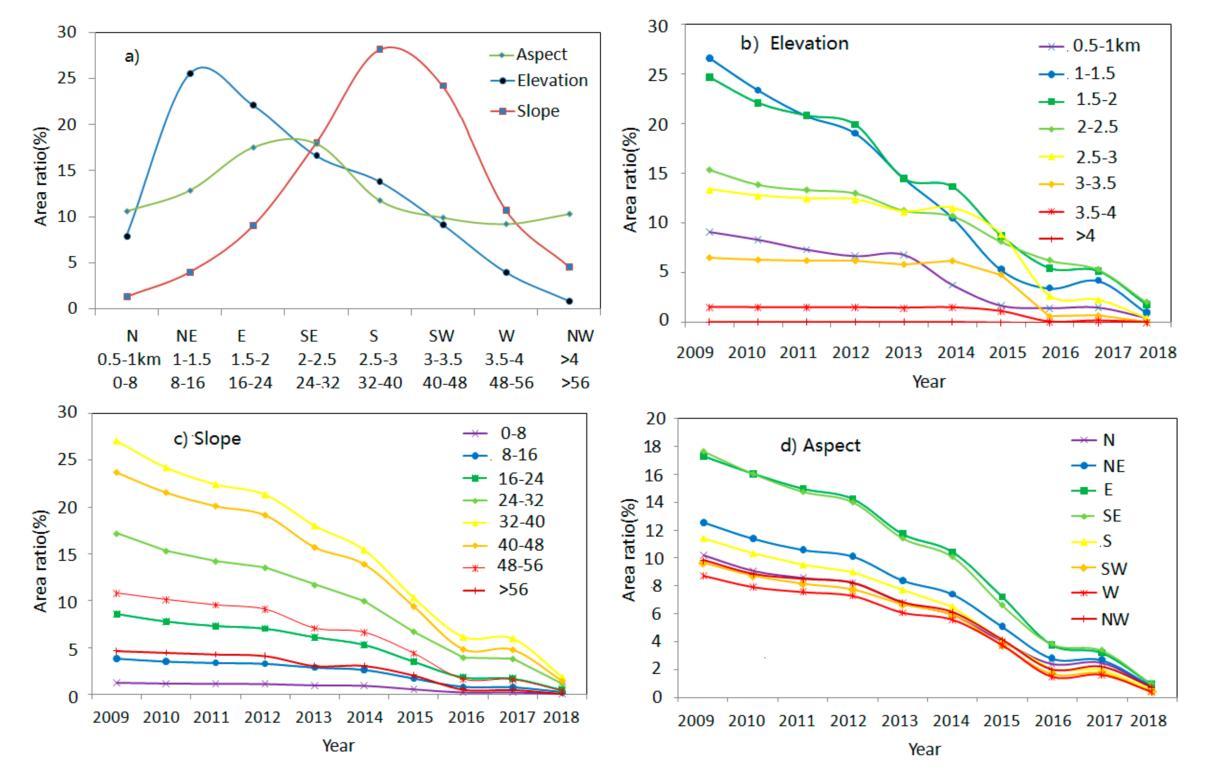
Figure 6. The influences of landform factors on active landslides. (**a**) Post-seismic landslides at different landforms; (**b**) active landslides at different elevation, (**c**) aspect, and (**d**) slope.

According to Figure 6a, landslides are mainly observed to occur at elevations from1000 to 2000 m, on slopes from 32° to 48°, and in the eastern and south-eastern slope directions, which is in agreement with previous research [15,30]. The area percentage of active landslide clearly decreased at all elevations, slopes, and aspects from 2009 to 2018, with remarkable spatial variability (as shown in Figure 6b–d).

In Figure 6b, the area percentage of active landslide at elevations from 1000 to 3000 m decreased much quicker than that at others. At these elevations, vegetation could recover better, due to higher temperature, more sunlight duration, and water. Landslides at elevations from 500 to 1000 m were probably in deep valleys, where sunlight is insufficient. At high mountains (>3000 m), vegetation recovery was limited by low temperature, serious clouds and snow, and soil and water losses. In Figure 6c, the area percentage of active landslide at moderate slope $(24^{\circ}-48^{\circ})$ reduced faster than that at others. At steeper slopes (>48°), surfaces covered by exposed bedrock or a little soil, were not suitable for vegetation growth [11,27]. At gentle slopes (<24°), landslides were not easily triggered; thus, their percentage was small, and the change was not evident. In Figure 6d, the area percentage of active landslide at slope directions E and SE reduced more quickly, while those in other aspects had a similar decrease rate. This may be explained by the fact that vegetation in these aspects was more benefitted by the SE monsoonal system.

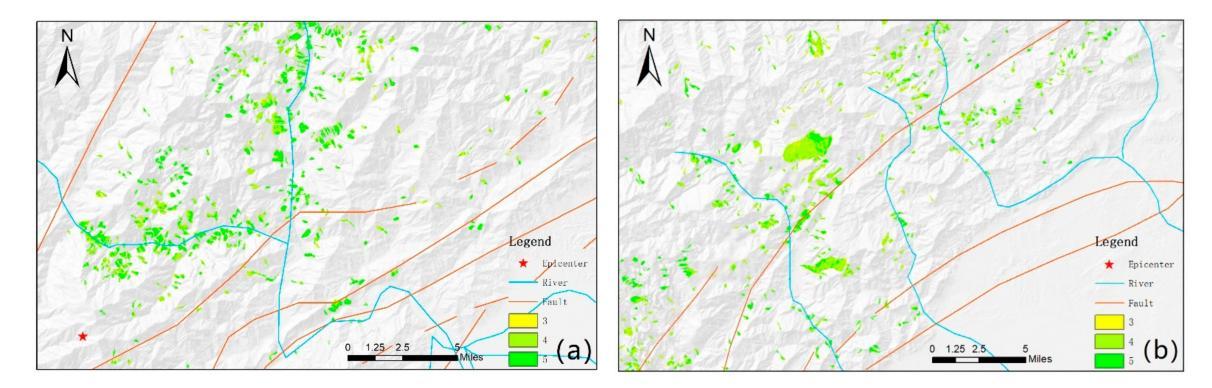
Figure 7. The partial *VRR* map of 2018 with the epicenter, faults, and rivers; (**a**) target area 1; and (**b**) target area 2. The blurred patch at the southwest of Figure 6c is a defect in the original DEM.
