Communication Failure Reason of PI Test Samples of Neural Implants

Jürgen Guljakow * and Walter Lang

Institute for Microsensors, Actuators, Systems (IMSAS), University of Bremen, Otto-Hahn-Allee 1, 28359 Bremen, Germany

Abstract: Samples that were meant to simulate the behavior of neural implants were put into Ringer's solution, and the occurring damage was assessed. The samples consist of an interdigitated gold-structure and two contact pads embedded between two Polyimide layers, resulting in free-floating structures. The two parts of the interdigitated structure have no electric contacts and are submerged in the solution during the experiment. The samples were held at temperatures of 37 and 57 °C in order to undergo an accelerated lifetime test and to compare the results. During the course of the experiment, a voltage was applied and measured over a resistance of 1 kOhm over time. Arduinos were used as measuring devices. As the intact samples are insulating, a sudden rise in voltage indicates a sample failure due to liquid leaking in between the two polyimide layers. Once a short-circuit occurred and a sample broke down, the samples were taken out of the vial and examined unde

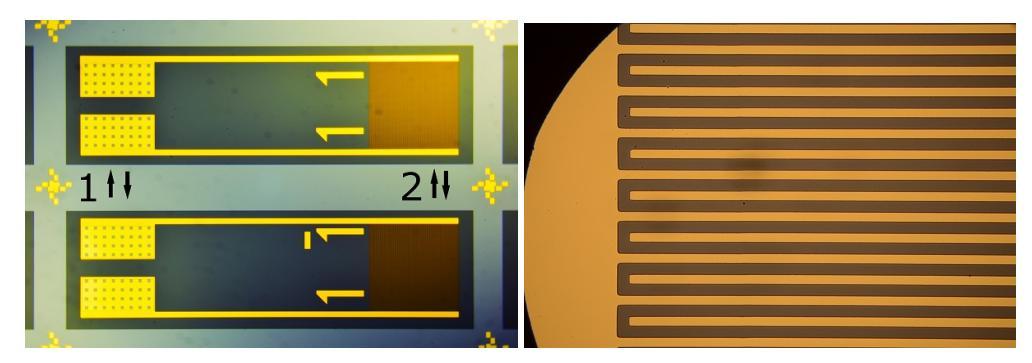
Figure 1. Samples that were used for the tests. (a) Two samples, after production; 1 marks the rectangular contact pads and 2 marks the squared interdigitated (ID) structure. (b) Magnified area with interdigitated structure. The structures have a width of 10 μ m.

The samples consist of two polymer layers and a structured gold layer and can be seen in Figure 1 on the left side. The production process of these samples can be seen in Figure 2. In the first step, a silicon wafer was coated with polyimide (U-Varnish-S, UBE), which was cured in a vacuum at temperatures of up to 450 °C. After curing, a 300 nm thick gold layer was deposited onto the surface via DC-Sputtering, structured (step 3), and a second layer of polyimide was deposited. The ID structure consists of 10 μ m wide fingers, with 10 μ m space between each. As a last step, the samples were separated by a reactive ion etch step. During the etching process, the PI layer on the contact pads was removed to make contacts possible. The interface between the two polyimide layers is depicted as a black line in step 4 in Figure 2.

In Figure 1, two similar samples can be seen that have two different numbers. The idea here was to numerate the samples in order to establish whether there is a relationship between the state of the samples and the measured current once failure occurred. This measure made analysis easier, as a large number of samples, 41, was used.

The state of the samples as prepared, which can be seen in Figure 1, is representative of all samples that were used for the experiments. On both sides, the electrodes connecting the contact pads to the interdigitated structures are clearly visible. The "fingers" of the ID structure have no direct contact. On several samples, small black spots were visible, which might be either a speck of dust or a minor defect. Defects did not lead to failure in any case of isolation or following delamination—or rather, no such observation was made. As those defects are spread evenly over the whole surface, it can be expected that resulting failures would occur at random positions over the whole surface. This was not observed. Figure 4 shows one sample where delamination took place, leading to the loss of adherence between most parts of the ID structure. In detail such damage can be seen in Figure 5. Another example is Figure 6, that shows the state of a sample after a long-term-experiment, from both sides. We see clearly that the delamination occurred on one side, closer to the edge of the sample. These two samples demonstrate the state of many samples after the experiment.

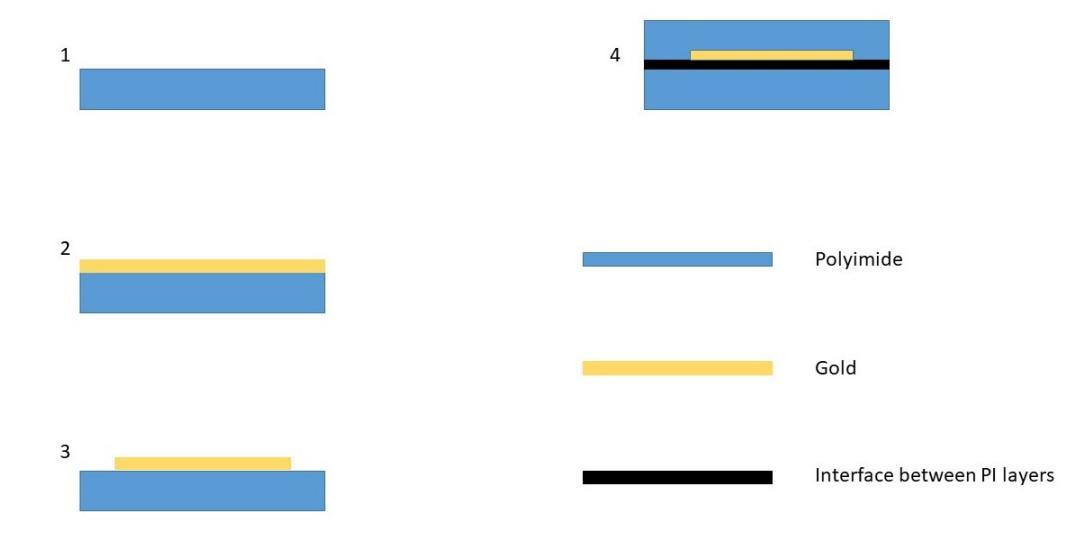
Figure 2. Steps in the production process of a sample. The first step is the deposition and curing of PI, followed by gold deposition (step 2), gold structuring (step 3) and spin-coating and curing of a second PI layer (step 4). Sample separation via ion etching is not depicted here.

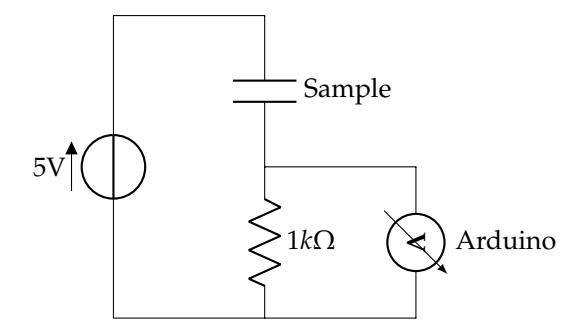
Figure 3. Schematic of the electric circuit used to monitor the state of the samples. A breakdown of the sample will cause a voltage step from 0 V to above 4 V.

The samples were lifted from the wafer, contacted with wires and electrical conductive glue, and the contacts were sealed with an epoxy-glue and partly put into vials that were later filled with Ringer's solution so that the interdigitated (ID) part of the samples was in the solution and the part with the electric contacts was outside of the solution. The ID part can be seen in Figure 1, where it is marked with the number 2. That part was lowered into the Ringer solution so far that the ID structure was submerged. A voltage of 5 V was applied and read out by an Arduino that measured the voltage drop over a 1 kOhm resistance directly behind the sample. Figure 3 shows the circuit that was used for the measurements. A voltage of 5 V DC was chosen due to practical reasons, as earlier works [45,53] have shown, in which the damages are easier to see because the dissolution of gold takes place. The sample functions as an insulator under these conditions.

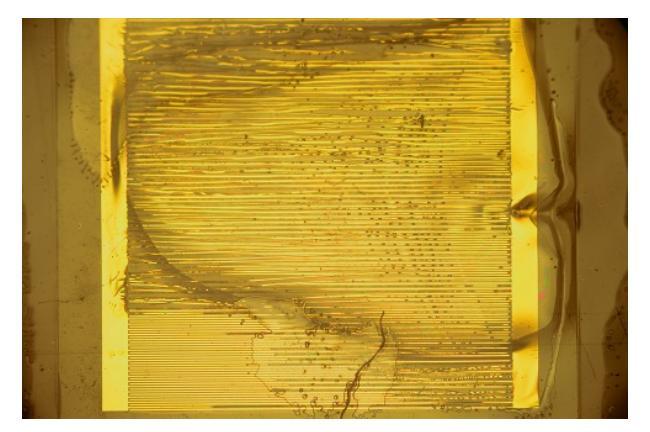
Figure 4. Sample after failure. Nearly the whole area used by the ID structure is delaminated.

In 36 of 37 samples, similar delamination as in Figures 4–6 was visible. There was the formation of one small liquid pocket between two fingers of the ID structure in one case. That happened at a temperature of 37 °C, which was also the only case, when no delamination of bigger parts of the samples occurred. Apart from that case, the observed damage was always similar and independent from temperature. All samples were examined for defects beforehand. Several samples had minor defects that were deemed too small to be a reason for concern. Those defects were spread out evenly over the surface of the samples. Considering their positions, the even formation of solution-pockets over the surface of the ID structure was expected. As the delamination is either present on one side, or over the whole surface, defects or pin-holes were ruled out as a reason for failure; thus, the intrusion over the interface between the two PI layers seems the most likely. No relationship was observed between the time that the samples broke down and were taken out and the state of the samples. That means that the level of destruction of the samples could not be traced to the time that they passed in the vials after the delamination took place. Longer times did not lead to a state similar to that seen in Figure 4.

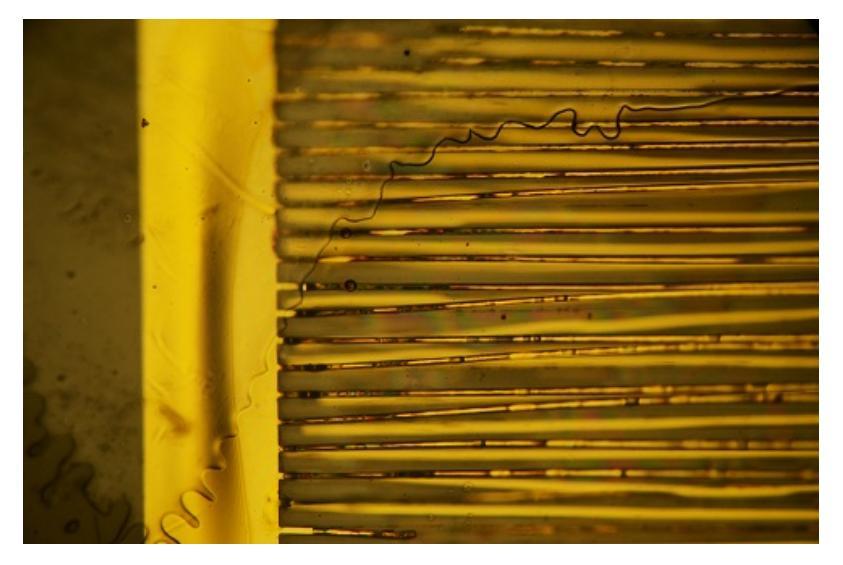
Figure 5. Sample after failure with visible delamination. Detachment of both layers is clearly visible as one layer is focused while the other is not.

Figure 5 offers a clear example of delamination. The failure is similar to the one shown in Figure 6, only magnified. Due to the limited depth of field of the microscope, several gold strands are in focus, while the other ones are out of focus. One part of the gold structure adheres to one PI layer, while the other adheres to the other PI layer. The dislocation of the gold strands hints at a weak adhesion between gold and polymer and delamination after failure.

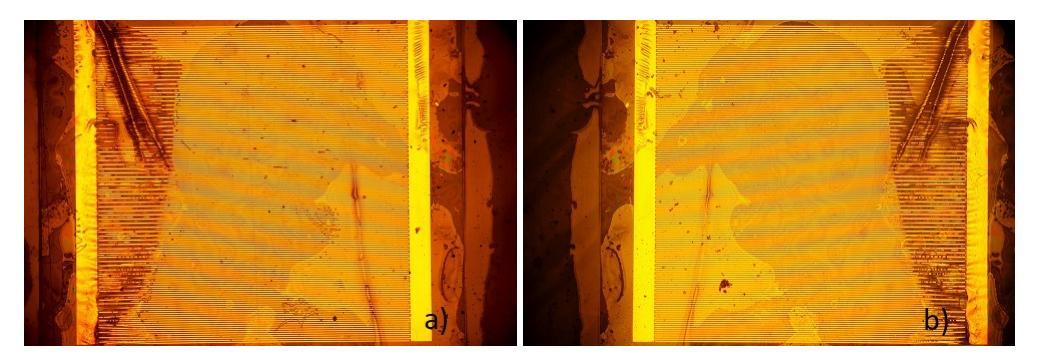
Figure 6. Sample after failure. Delamination is similar to most samples, as the delamination occurs on one side and leads to delamination in that area. (**a**) Sample from one side. (**b**) Same sample from the other side.

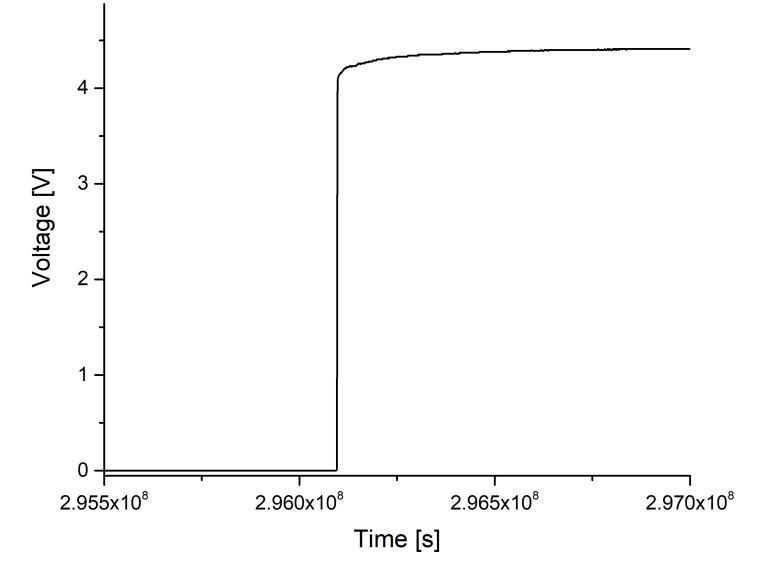
Figure 7. Failure over time. Measurement of voltage.

Figure 7 depicts the voltage over time of a typical failure. Typically, the voltage either increased abruptly from 0 V to above 4 V or rose over the course of several seconds from 0 V to several mV, only to rise instantly to over 4 V. Once it was over 4 V, very little changed over time and the current stayed constant or underwent minor changes, such as the slow, decelerating rise that can be seen in Figure 7. A spread of the measured voltages between 4 and 4.9 V was observed, resulting in sample resistances between 20 and 250 Ohm. Due to the scale of the time frame and employed voltage, the destruction appears as an abrupt change in voltage. In all but one case, the behavior was similar. In that exception, the failure happened between two ID-fingers, where water leaked in and formed contact between the two strands. Here, the voltage rose to a level of about 4 V and oscillated strongly. The test was stopped after slightly more than 458 days for the 37 °C samples and 423 days for the samples that were kept at 57 °C. The conclusion that can be drawn from these tests is that failure normally occurs in the interface between two layers, which is depicted as a black line in Figure 2. After the formation of electric contact, delamination extends sufficiently fast to lower the resistance nearly abruptly to a low level in the order of hundreds of Ohm.

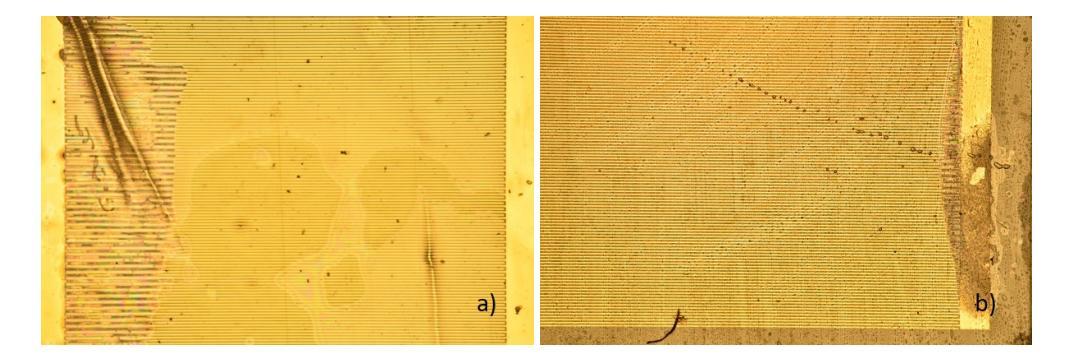
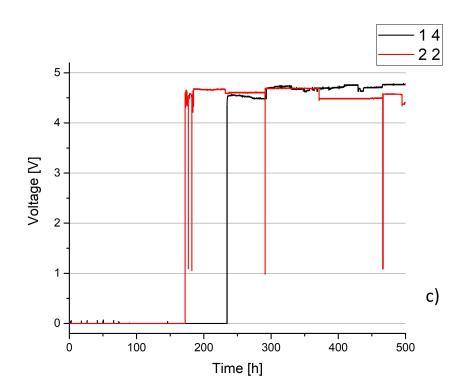
Figure 8. Cont.

Figure 8. Two samples with different affected areas and strong variations in voltage. (**a**) Sample on the left, number 1 4, indicated as black. (**b**) Sample on the right, number 2 2, indicated as red (**c**) Voltage over time with visible changes.

In Figure 8, two vastly different states of deterioration are depicted. While the sample on the left has visible delamination in the left part of the sample, we see only minor deterioration on the right, but with visible changes to the sample, as gold is dissolved. Over the course of several hundred hours, both samples did not have stable voltages. In both cases, the voltages changed strongly.

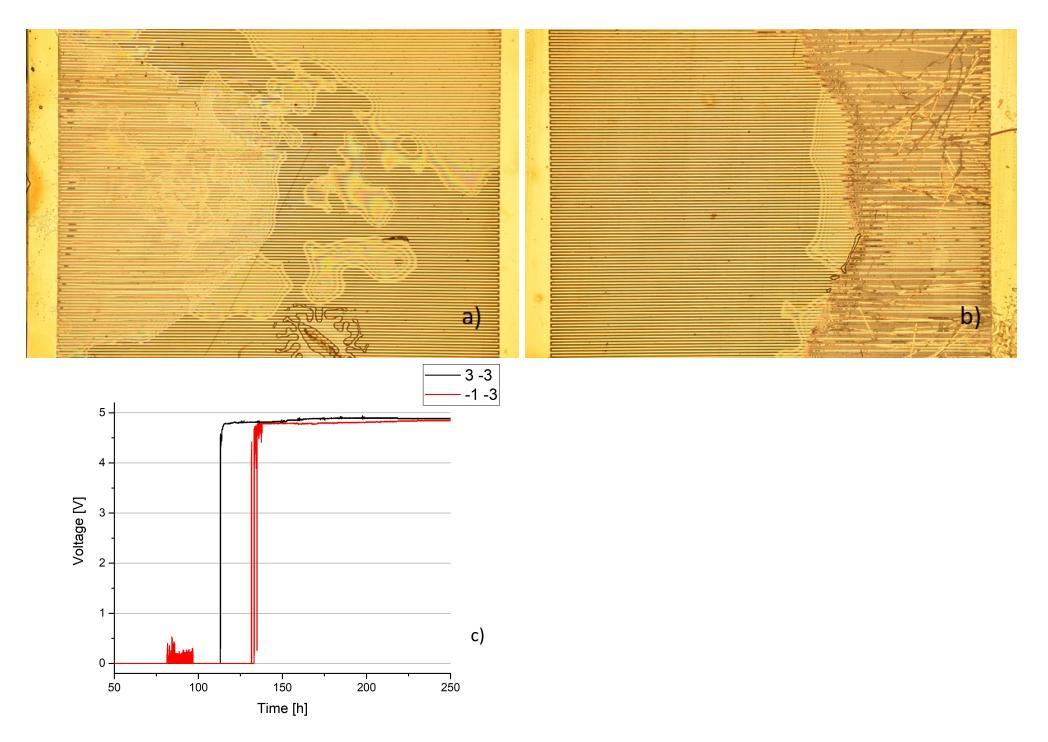
Figure 9. Two samples that reach a constant voltage shortly after failure. (a) Sample on the left, number 3 -3, indicated as black. (b) Sample on the right, number -1 -3, indicated as black. (c) Voltage over time with minor changes.

Figure 9 shows two samples with different outcomes concerning a similar surface. We see further that before the failure of the sample on the left, there were minor voltage surges till the voltage rose to nearly 5 V after failure. The sample on the left only has an intrusion of Ringer's liquid, leading to a very thin film inside of the sample, while on the right, many gold strands lost adhesion to the surface. In both cases, a similar voltage was achieved.

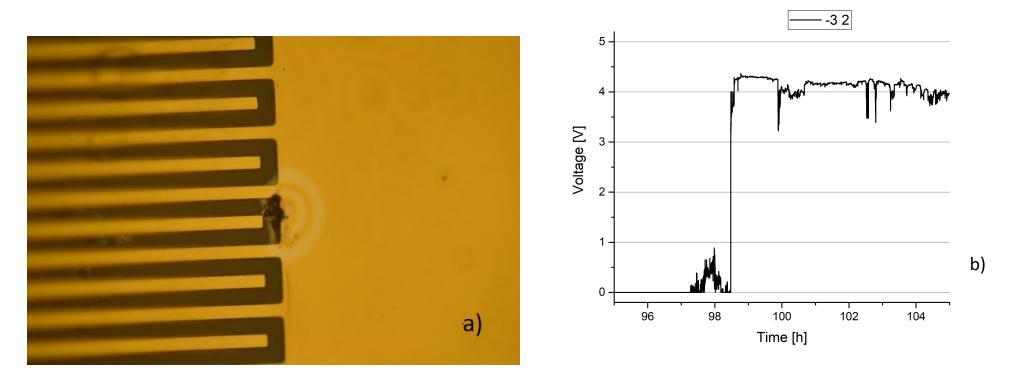
Figure 10. Minor defect that led to failure after 152 days. (**a**) Pin-hole in the PI layer of the sample led to failure. (**b**) Voltage over time.

The left side of Figure 10 shows a defect in the polyimide layer that lead to sample failure. As the failure occurred several months after the start of the experiment, it can be ruled out that the failure was present initially. On the right, we see the voltage over time. The voltage differs from the four samples above as it is only at a level close to 4 V, thus slightly lower, and it fluctuates.

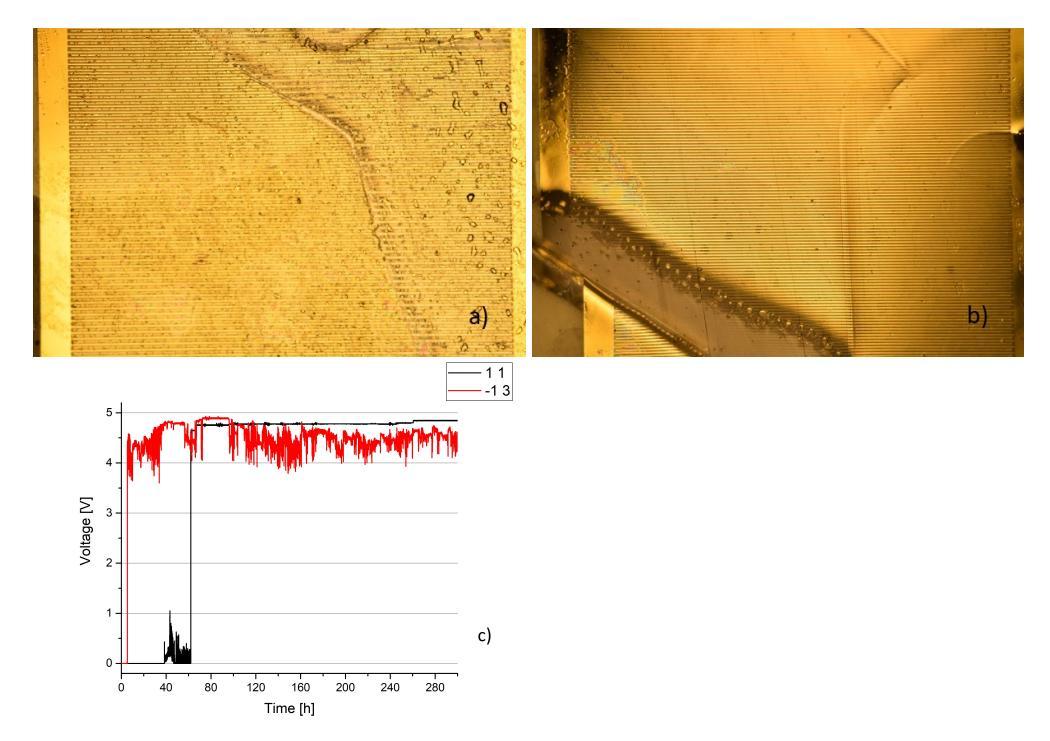
Figure 11. Two samples with minor deterioration. (a) Sample on the left, number 1 1, indicated as black. (b) Sample on the left, number -1 3, indicated as red. (c) Voltage over time, with clearly visible differences.

Two samples with minor damages can be seen in Figure 11. While optically they look similar, their electric behavior is vastly different, as can be seen in the lower figure. The resistance of the sample on the left reaches one level and remains there with minor changes over several hundred hours. At the same time, the voltage of the sample on the left fluctuates strongly between 4 and 5 V and rarely below 4 V. While the voltage similar to sample 1 1 occurred more often in the samples that were held at a temperature of 37 °C, sample -1 3 is more typical for samples that were held at 57 °C. At least 8 of the 16 samples from one measurement batch show similar fluctuations, while no such fluctuation takes place at a temperature of 37 °C, except for the sample seen in Figure 10. Considering this difference, it is realistic to assume that the results of accelerated lifetime tests are only partially transferrable between two tests at different temperatures.

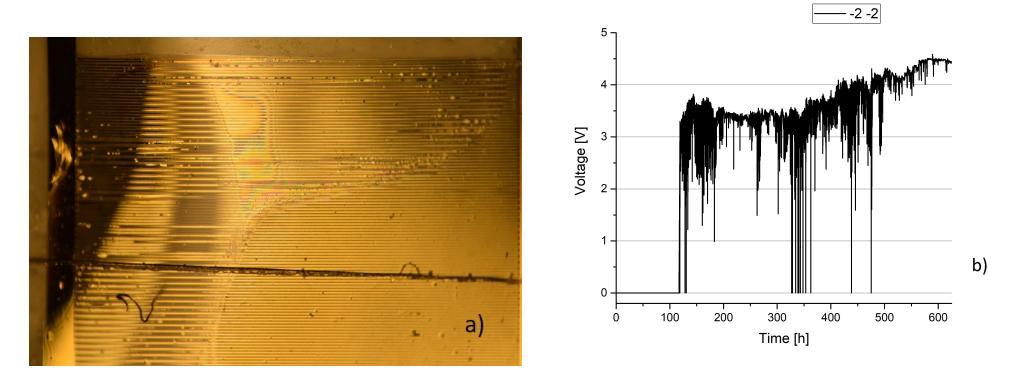
Figure 12. Sample 2 2. Delamination is similar to most samples, as the delamination occurs on one side and leads to delamination in that area. (a) Magnified area, where damage occured. (b) Voltage over time.

The sample, seen in Figure 12, shows a sample after failure. While its state is not vastly different from the samples presented in this work, the voltage changes over time were not

similar to any other observed sample. This difference might be due to a different failure reason than the other samples.
