Article **Enhancing Structural Health Monitoring with Acoustic Emission** Sensors: A Case Study on Composites under Cyclic Loading

Doyun Jung * D and Jeonghan Lee

Korea Atomic Energy Research Institute, 111 Daedeok-daero 989-gil, Yusenong-gu, Daejeon 34057, Republic of Korea * Correspondence: jungdoyun@kaeri.re.kr

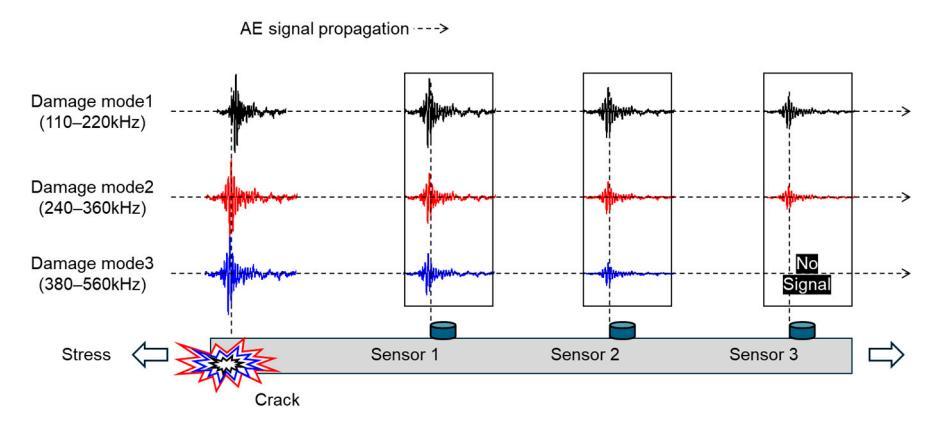
Figure 1. Effect of AE signal propagation characteristics from diverse damage modes on AE analysis: frequency dependence of attenuation.

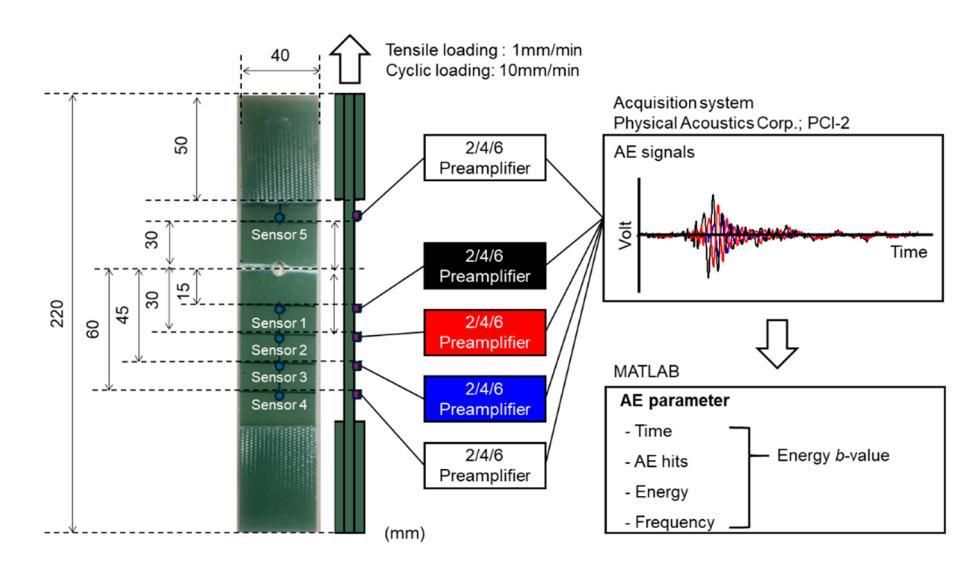
Here is a step-by-step description of the experimental procedure (Figure 2):

- i. Material: GFRP sheets with a 2 mm thickness, comprising glass fibers and epoxy resin arranged in a plain-woven fabric configuration.
- ii. Specimen Design: Woven GFRP plate specimens designed according to ASTM D3039 standards [45], including a center hole. The hole is created using a drill specifically designed for composite materials, resulting in a 2 mm-diameter hole at the center.
- iii. Prevention of Damage: GFRP tabs are attached to each end of the specimen to prevent damage from the test jig.
- iv. Tensile Testing: A universal testing machine (AGI; Shimadzu Corp., Kyoto, Japan) is employed for conducting the tensile tests. The crosshead speed is set at 1 mm/min (tensile loading), with cyclic loading at 10 mm/min.

Figure 2. Experimental procedure for analyzing broadband AE signals in woven GFRP specimens with central hole.

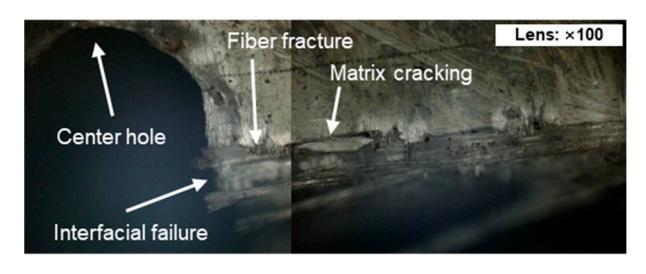
Figure 3 shows the fracture surface of a woven GFRP specimen that failed due to cyclic loading. Near the center hole, matrix cracking, interfacial failure, and fiber fracture were observed. Consequently, the AE sensors detected signals of broadband frequencies originating from more than three defects [37,38].

Figure 3. Fracture surface analysis of woven GFRP specimen under cyclic loading: observations of matrix cracking, interfacial failure, and fiber fracture.

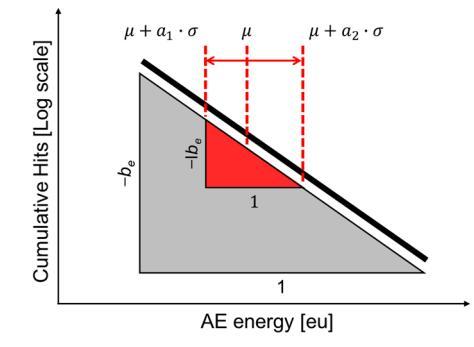
In the AE field, often considered microseismology, the *b*-value is extensively used to assess fracture processes. Similar to its application in engineering, the *b*-value in AE is associated with the number and amplitude of events. High *b*-values are linked to numerous small-amplitude AE events, like those from microcrack formation and slow crack growth, while low *b*-values indicate faster-growing or unstable crack formation. The *b*-value systematically changes during various stages of the fracture process, serving as a valuable indicator for estimating failure development. The composite material used in this study has a wide-frequency range, so it is necessary to select representative intervals and use their values. Therefore, Equation (2) was adopted into Equation (3) and defined as follows, where $a_1 = a_2 = 3$. The definition is illustrated in Figure 4.

Figure 4. Representation of *Ib*_e-value for composite material in the study.

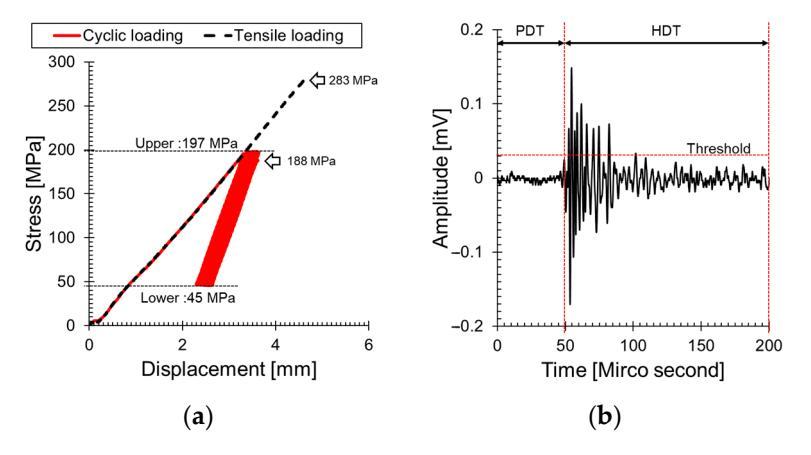
Figure 5a illustrates the stress–strain curve of GFRP under tensile loading and cyclic loading. A tensile strength of 238 MPa was calculated for GFRP under tensile loading. By setting 70% of this value as the upper limit (197 MPa) and 45 MPa, the initial occurrence of AE signals, as the lower limit, the cyclic loading range was determined. The GFRP failed during the cyclic loading test at the 423rd cycle, with a stress of 188 MPa. This stress

is lower compared to tensile loading, as fatigue failure occurs due to repetitive loading, leading to crack initiation and propagation. Simultaneously, this experiment provides insights into how the b_e -value responds to the occurrence and propagation of cracks.

Figure 5. Behavioral analysis of woven GFRP under tensile and cyclic Loading: (**a**) stress–strain relationship and (**b**) acoustic emission signal response (See Table 1).

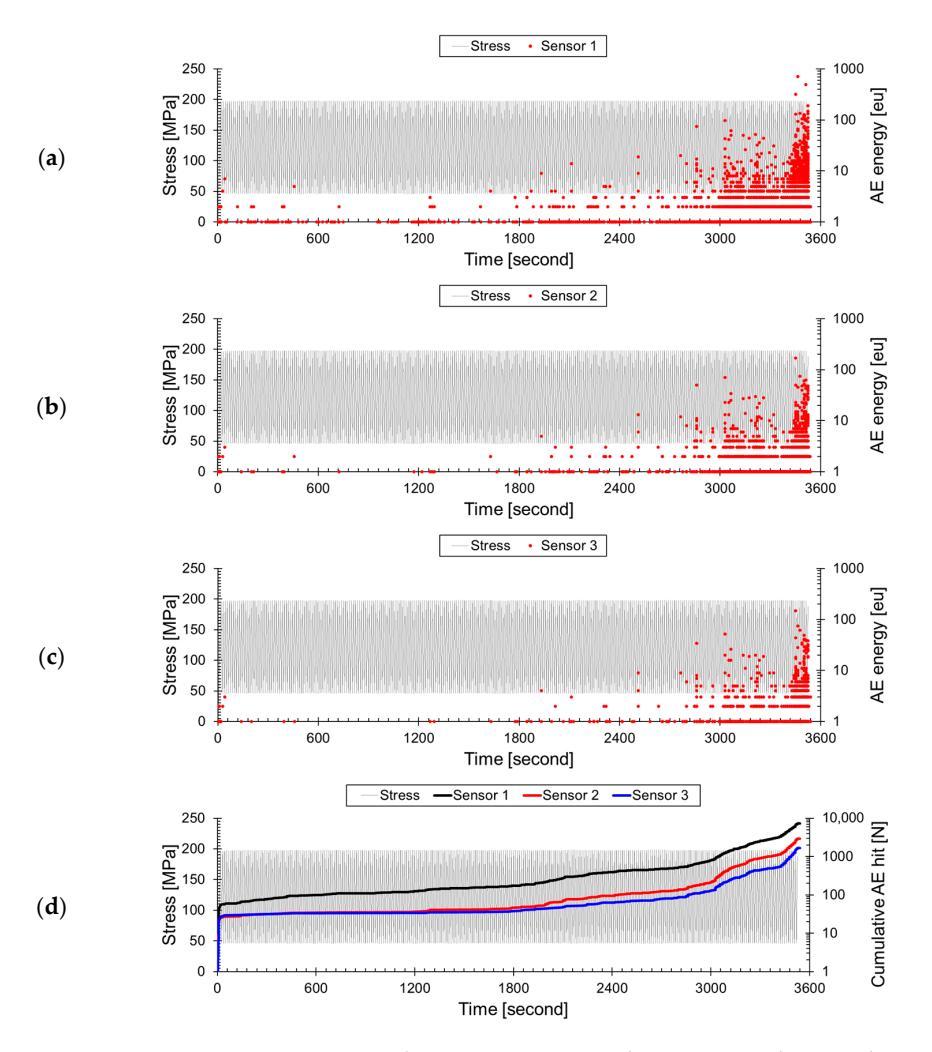
Figure 6 shows the results of converting the measured AE signals into AE energy during cyclic loading. In Figure 6a, AE energy progressively increased from 0 to 423 cycles. The AE energy of 7 eu recorded between 0 and 42 s is related to the formation of cracks. From 1931 s (9 eu) onward, a significant amount of AE energy is exclusively measured. This phenomenon is related to the Felicity effect, where AE signals are emitted before the previous maximum load. This occurrence is frequently observed in composite materials, including the GFRP specimen used in the test, indicating the growth of cracks. Until 3551 s, the maximum AE energy steadily increased to 707 eu, and this trend closely resembles the peak amplitude. Figure 6b,c shows the attenuated AE energy measured at propagation distances of 30 mm and 45 mm. These signals also consistently increased from the initiation of crack formation to the final failure. To clarify the attenuation effect, the cumulative hits of the calculated AE signals in Figure 6a-c were represented in Figure 6d. As the distance from the crack increased by 15 mm, the AE signals with AE energy decreased. However, the attenuation rate of the AE signals over time varied for each sensor. The failure behavior of composite materials is typically investigated to observe interface failure and fiber fracture occurring before matrix cracking [47,48]. Additionally, although the frequency ranges may vary among researchers [24,25,41], the general order is an increase in frequency corresponding to matrix cracking, interfacial failure, and fiber fracture. The AE signals generated near the final failure originate from matrix cracking, resulting in relatively low attenuation. On the other hand, a high attenuation ratio of matrix cracking and interfacial failure is observed in the crack initiation zone. For this reason, the difference in time-attenuation ratio (distance between the lines) is observed in Figure 6d.

Figure 6. Variation in AE Energy with Increasing AE signal propagation distance during cyclic loading of GFRP: (**a**) 15 mm, (**b**) 30 mm, (**c**) 45 mm, and (**d**) cumulative hits at each propagation distance.

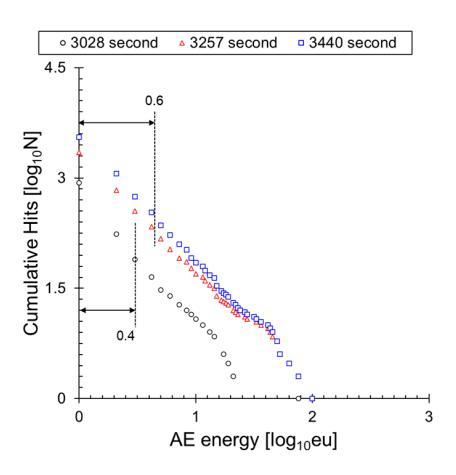
Figure 7 shows the frequency distribution of the AE energy measured at Sensor 1 according to Equation (3). The b_e -value proposed by Sagasta et al. [36] utilizes the slope of the entire frequency distribution. Cracks in various materials, including composite materials, typically occur after the initiation of microcracks, followed by the development of macrocracks. From the perspective of AE signals, microcracking refers to the phenomenon characterized by the occurrence of numerous small-sized cracks. Therefore, in regions where microcracking predominates, a significant number of AE signals with low energy

are generated, leading to a decrease in the b_e -value (3028 s to 3257 s). On the contrary, the occurrence of macrocracking, characterized by the formation of a single large-sized crack, results in an increase in the b_e -value (3257 s to 3440 s). The trend of increasing or decreasing b_e -values can be utilized to assess the structural integrity of a system, with an increase associated with microcracking and a decrease indicative of macrocracking. A similar occurrence is observed in the b_e -value proposed by Gutenberg et al. [31]. When computing the Ib_e -value with Formula 3, we employed an interval of 0.02 for the frequency distribution and measured the slope after excluding non-accumulative intervals. We marked the representative interval of the frequency distribution, selected based on the mean and standard deviation, with an arrow at position 6. The slope was calculated using the method of least squares each time the AE signals reached multiples of 5.

Figure 7. Change of frequency distribution.

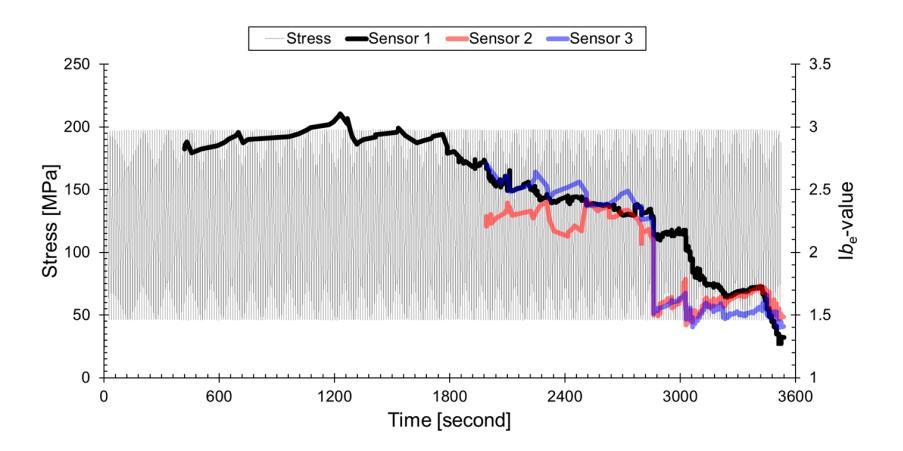
Figure 8 displays the time series plot of Ib_e -values along with stress. The calculation of Ib_e -values commenced after the accumulation of 200 data points. The Ib_e -values steadily decreased to 1.25 after the commencement of calculations. Unlike the dynamic approach of evaluating structural integrity using the trend of values, as seen in the *b*-value, the Ib_e -value employs a more static method that heavily relies on the actual values. In a normal condition, the Ib_e -value ranges from 3 to 2.75. As the material progresses from crack growth to final fracture, the Ib_e -value decreases from 2.75 to 1.25. Many researchers assess the structural integrity by designating a specific value of Ib as the threshold for discontinuing the use of the structure. However, this study does not provide evaluation metrics as the Ib_e -value

was calculated using only a limited number of GFRP specimens. The most significant finding in this study is our confirmation of the powerful performance of the Ib_e -value, demonstrating its potential for evaluating the structural integrity of composite materials using this method. On the other hand, the *lb*_e-value exhibited an overall decreasing trend as the propagation distance increased up to 45 mm. This phenomenon is attributed to the frequency dependence of the damping in the previously mentioned composite material. For a more detailed explanation, the AE energy frequency distribution measured up to 3028 s is illustrated in Figure 9a, concurrently with the representation of representative intervals based on Formula (3). Figure 9b illustrates the variations in peak frequency with propagation distance under identical conditions. The signals measured at Sensor 1 exhibited uneven attenuation over a propagation distance of 30 mm, leading to a change in the curve's shape and consequently causing a variation in the Ib_e -value. This phenomenon arises in the cracks of GFRP that exhibit broadband signals due to factors such as matrix cracking, interfacial failure, and fiber fracture. Each damage mode is characterized by a unique frequency and exhibits varying rates of attenuation. Consequently, it is observed that signals in the high-frequency range attenuate more rapidly than those in the low-frequency range [42–44]. This propagation characteristic is clearly depicted and validated in Figure 9b. Thus far, we have utilized the Ib_e -value results obtained from AE signals emitted from the center hole as a basis for discussing the applicability of composite materials. It has been confirmed that the Ib_e -value, along with previously proposed metrics such as b_e -value and *lb*_e-value, can be used to evaluate cracks in composite materials. However, since the values vary with the propagation distance, more extensive research is needed to understand this phenomenon.

Figure 8. Time series analysis of Ib_e -values in relation to stress in woven GFRP: demonstrating the static evaluation approach for structural integrity.
