Article Influence of Blind Spot Assistance Systems in Heavy Commercial Vehicles on Accident Reconstruction

Thomas König *, Daniel Paula 🔍, Stefan Quaschner and Hans-Georg Schweiger D

CARISSMA Institute of Electric, Connected and Secure Mobility (C-ECOS), Technische Hochschule Ingolstadt, Esplanade 10, 85049 Ingolstadt, Germany; daniel.paula@thi.de (D.P.); hans-georg.schweiger@thi.de (H.-G.S.) * Correspondence: thomas.koenig@thi.de

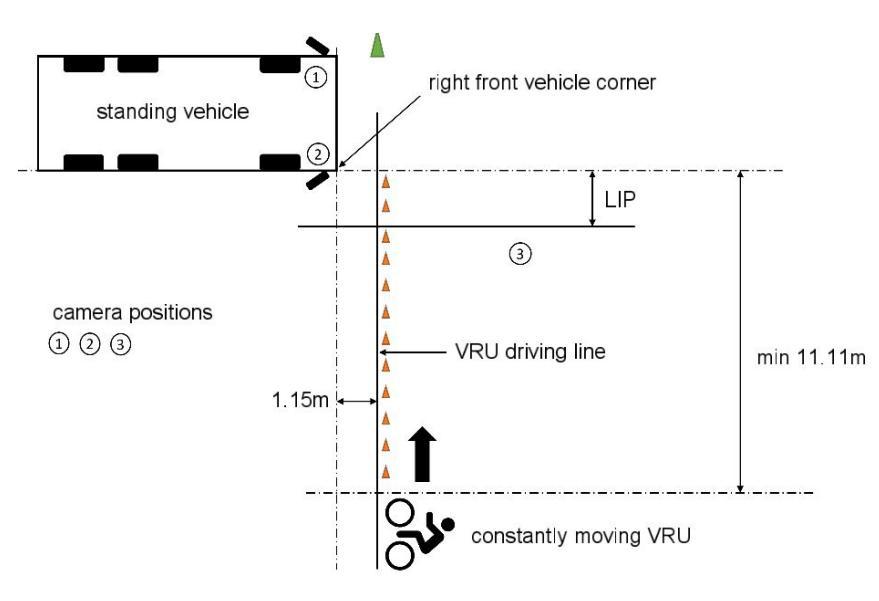
Figure 1. Static experimental setup with the VRU crossing the front of the commercial vehicle.

The test setup for the first static test with a VRU crossing in front of the vehicle was taken from UN-ECE R151, as shown in Figure 1 below [9] and supplemented by further test speeds. The figure particularly explains the distances between the VRU's driving line and the front of the vehicle and the start distance of the VRU.

The tests were conducted at VRU speeds of 5 km/h, 10 km/h, 15 km/h, and 20 km/h as described in Table 1. The speed measurement was carried out by a speedometer mounted on the bicycle, which determines the driving speed from the wheel rotation speed to an accuracy of 1 km/h. In each case, the latest possible point in time—the so-called last information point (LIP)—was determined in a speed-adjusted manner at which the blind spot assistance system would have to point out the approaching VRU so that the commercial vehicle driver could safely avoid a collision due to a braking reaction. The LIP is given as a distance value measured between the VRU and the right front corner of the vehicle.

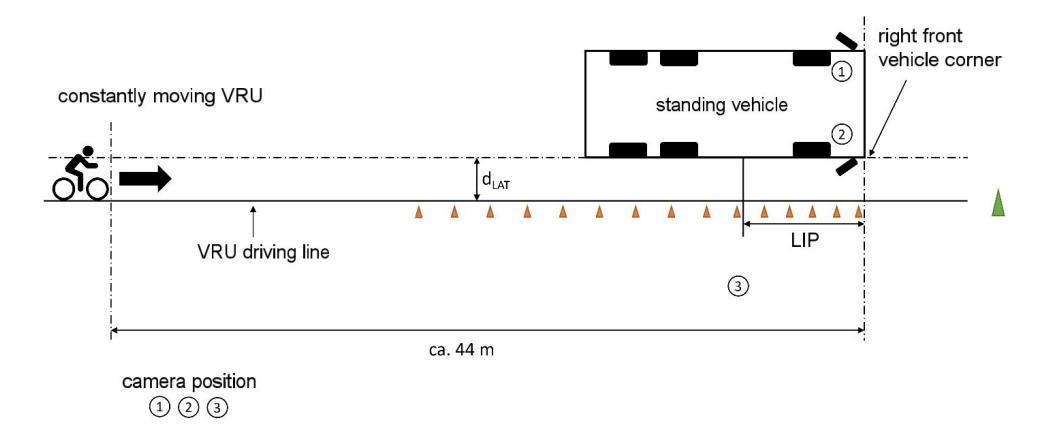
Figure 2. Static experimental setup with VRUs driving parallel to the commercial vehicle.

In the second static test described in Figure 2, according to UN-ECE R151 [9], a VRU moved parallel to the longitudinal axis of the commercial vehicle from the rear to the front along its right-hand side. In contrast to UN-ECE R151, two lateral distances of 1.25 m and 4.25 m (d_{LAT} in Figure 2) were investigated in the tests. The VRU started about 44 m behind the front of the commercial vehicle to make sure that the starting point was out of the detection range of the sensor systems.

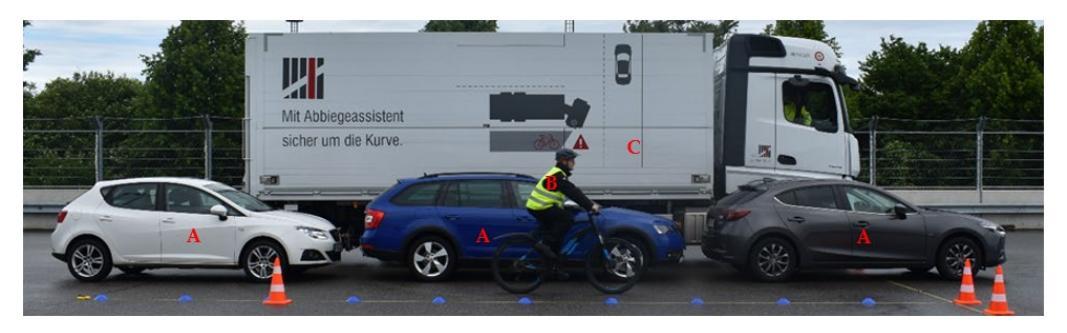
Figure 3. Static test setup with vehicles (A) as visual obstruction between the VRU (B) and the sensors of the commercial vehicle (C).

Furthermore, the tests were carried out with a lateral distance of 4.25 m in an additional passage with a visual obstruction produced by parked vehicles between the commercial vehicle and the VRU (shown as an example in Figure 3, tests 2.11 to 2.15 in Table 2). To guarantee that the worst-case scenario is tested, we ensured that the cars were parked right in front of the sensors on the side of the commercial vehicle. The gaps between the cars were made as small as possible. The lateral distance between the right side of the commercial vehicle and the parked cars was about 1 m and about 1.5 m between the left side of the cars and the VRU.

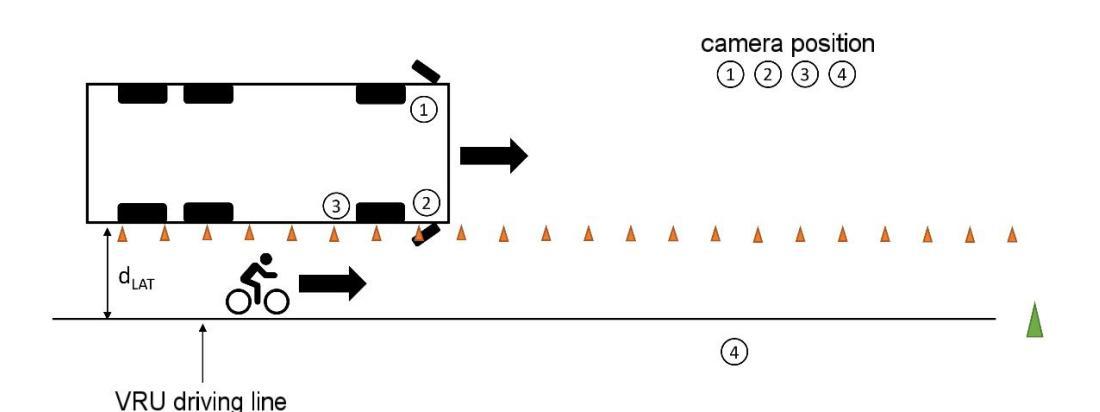
Figure 4. Dynamic test setup with parallel movement of commercial vehicle and VRU.

Similarly, and following the ADAC's investigations [1,10,19], dynamic tests were carried out in which the commercial vehicle and the VRU moved parallel to each other at different speed constellations with lateral distances of 1.25 m and 4.25 m, respectively, as described in Figure 4 and Table 3.

First, an equal driving speed of 10 km/h and 20 km/h for both vehicles, respectively, was investigated. Here, both vehicles started together and the experiment began when both reached the test speed. Furthermore, reciprocal overtaking maneuvers were depicted, in which one road user with a speed of 20 km/h overtook the other one moving with a constant speed of 10 km/h.

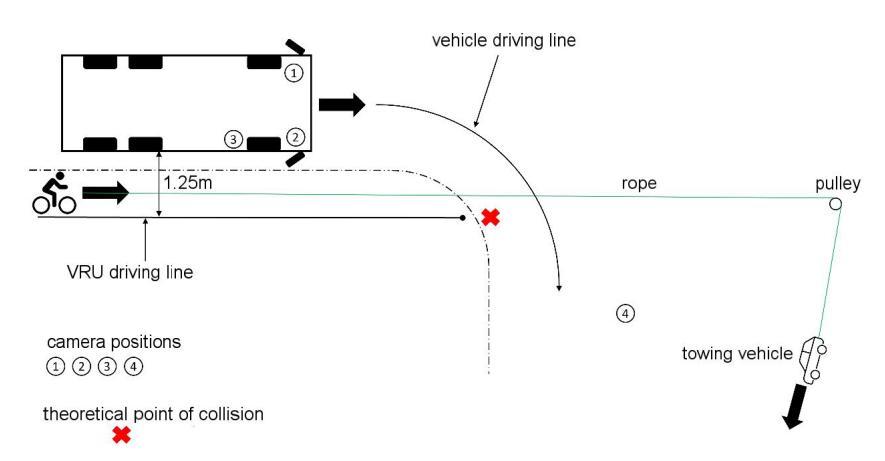
Figure 5. Dynamic experimental setup with the intersection of the movement corridors.

In the dynamic tests described above, based on UN-ECE R151, no intersection of the commercial vehicle and VRU trajectories, and thus no immediate risk of collision, was provoked. Accordingly, as intended, a maximum of the information signal from the turning assistance system can occur. For this reason, a further test setup has already been designed by the ADAC, which can also be used to provoke the occurrence of the warning signal of the blind spot assistance system. From an initially parallel movement of the commercial vehicle and the VRU with a lateral distance of 1.25 m, the commercial vehicle turns right at a defined point as shown in Figure 5. The VRU is represented by a bicycle dummy pulled by a test vehicle at a defined speed, as a collision between the two road users can occur without timely intervention by the commercial vehicle driver [1,10,19].

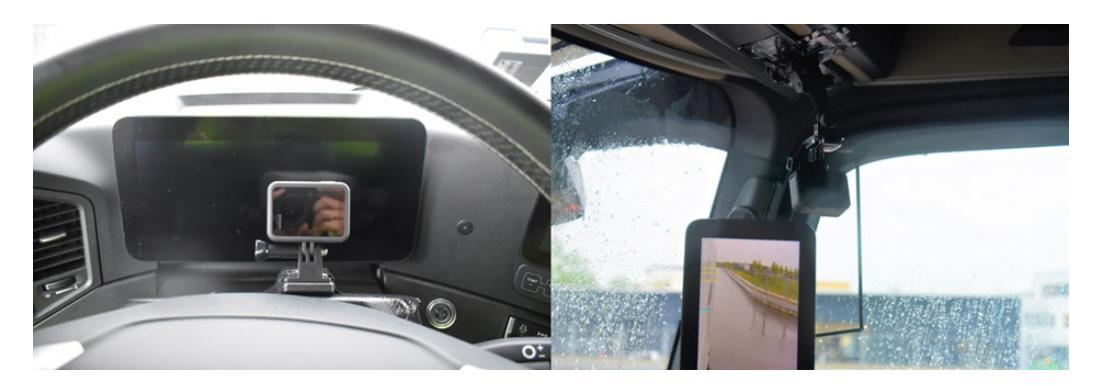
Figure 6. Mounting action cameras to record instrument cluster display and mirror fields of view.

The experiments were recorded from several perspectives with video cameras. For this purpose, several compact action cameras of the type HERO8 Black from the manufacturer GoPro Inc. from San Mateo (CA, USA) were mounted on the driver's cab of the respective freight vehicle, which filmed the driver's perspective to the front, to the instrument cluster (Figure 6 right), and to the exterior mirrors on the right A-pillar (Figure 6 left). Another GoPro HERO8 Black was attached to the outside of the cab to record the movement of the VRU parallel to the road vehicle. In addition, the test sequence was filmed using two XA30 video cameras mounted on tripods from the manufacturer CANON from Tokyo (Japan) from the perspectives shown in the test sketches above. Action cameras were placed in front of the instrument display and the a-post inside the truck's cabin, and outside at the right side of the cabin to film the VRU. The positions of the video cameras were chosen to film the wRU from the front and in a 90° angle from the side.

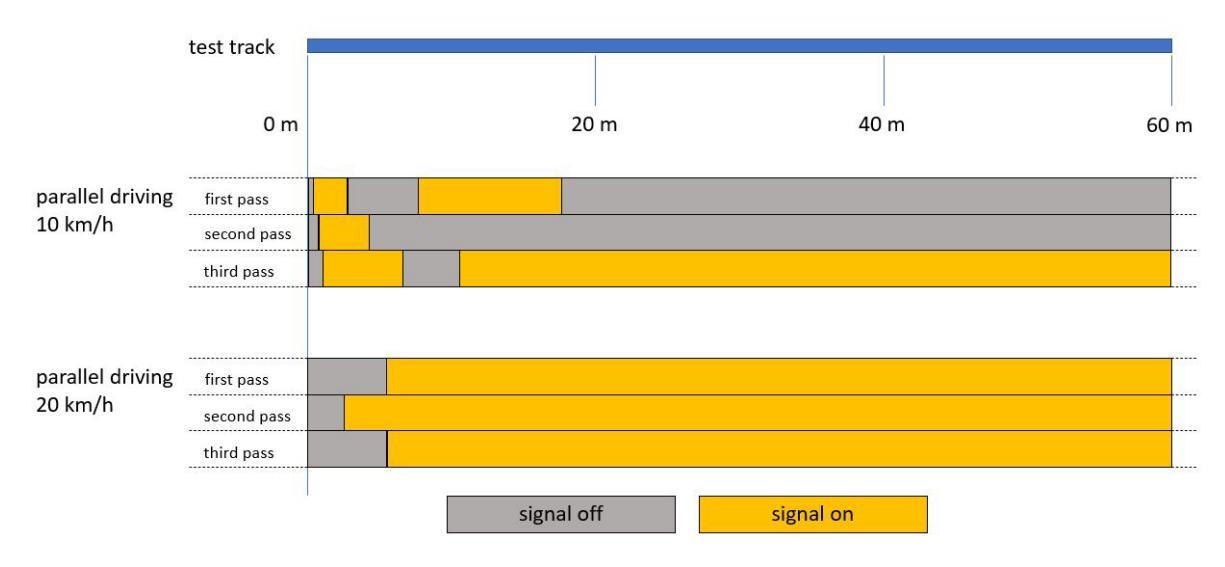
Figure 7. Time course of the information signal during tests in parallel travel at the same speed at a lateral distance of 1.25 m without visual obscuration.

If the truck overtook the VRU traveling at 10 km/h at a speed of 20 km/h, the information signal would be triggered as soon as the VRU entered the detection range of the blind spot assistance system from the front. If, on the other hand, the VRU overtook the truck at the opposite speed ratio, the information signal would be triggered when the VRU entered the detection zone from behind. If both test participants were moving at the same speed of 10 km/h, an irregular response behavior would be observed (see Figure 7). Shortly after the start, the information signal was triggered and deactivated again after a few meters. Only in one of the three runs did the signal subsequently remain for the rest of the way. If the test was run at a speed of 20 km/h instead, it would take longer for the signal to be activated, but the signal remained continuously until the end in all three runs.

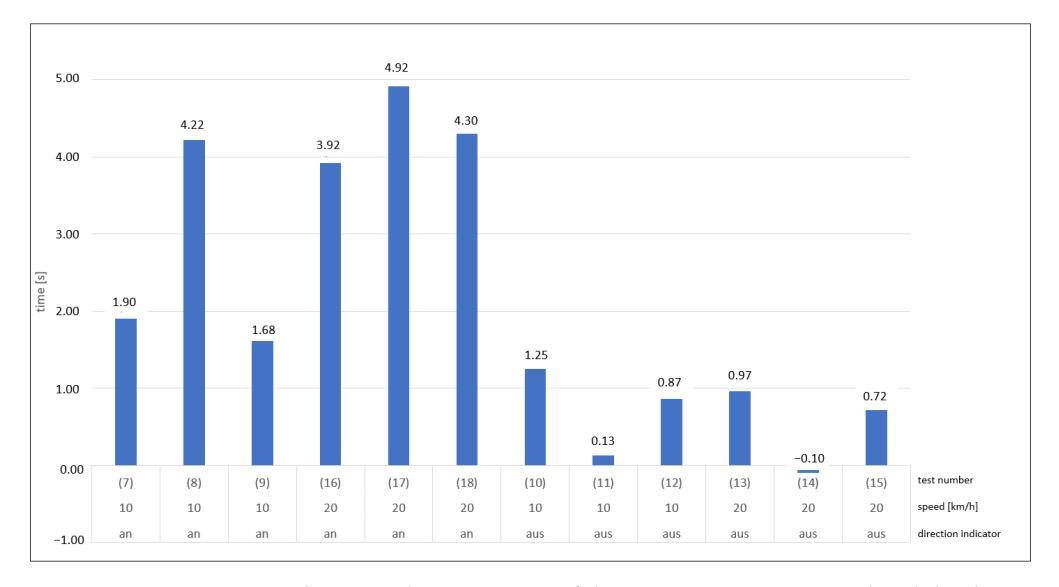
Figure 8. Remaining time between the occurrence of the acoustic warning signal and the theoretical collision.

In the dynamic tests with a simulated turning process of the commercial vehicle and a resulting crossing with the movement path of the VRU, the temporal response of information and warning signals to the vehicle driver was evaluated in particular as shown in Figure 8. In this setup, only the Mercedes test vehicle was tested in twelve runs. It was found that if the turn signal was not engaged, the information signal would be triggered first. If, on the other hand, the turn signal was activated, the warning signal would be triggered directly in four out of seven cases, and not the information signal first. Since the driver could not notice the visual signal if he did not look toward the A-pillar or into the instrument cluster at the moment of triggering, the following observations were based on the acoustic warning signal, which can be perceived regardless of the direction of gaze. The acoustic signal was triggered on average 0.1 s after the visual signal. First, the time was calculated for each run, which remained after the triggering of the acoustic warning signal until the theoretical collision. As shown in Figure 7, in cases (7)–(9), (16), (17), and (18), the turn signal was engaged on the right. In cases (7) and (9), it can be seen that they had a lower remaining time. In experiment number (7), the turn signal was not activated immediately at the start of the experiment, but only in the course of the approach. In the case of test number (9), the sequence and execution were observed correctly, so that here, a delayed detection by the assistance system can be assumed. Furthermore, it is noticeable that in the test runs (10)–(15) without the direction indicator switched on, the remaining time until the theoretical collision is on average more than four times shorter. The negative time indicated in test (14) means that here the warning signal did not occur until after the collision.

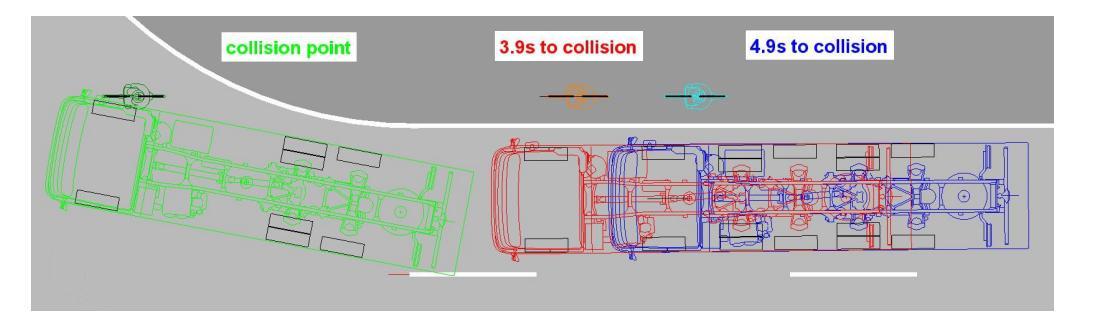
Figure 9. Shutter release range of the blind spot assistance system when the direction indicator is activated.

The dynamic turning tests result in a considerable difference in the triggering times for the warning message depending on the driver's timely actuation of the right-hand direction indicator during the pre-collision phase. If the direction indicator was activated early, the warning signal would be triggered 3.9 s to 4.9 s before the calculated theoretical collision point during four test runs (Figure 9). In one case, the acoustic warning was issued 1.9 s before the collision, as the direction indicator was activated late. In a test run with the direction indicator activated, the acoustic warning was triggered 1.7 s before the point of a collision without any obvious cause.

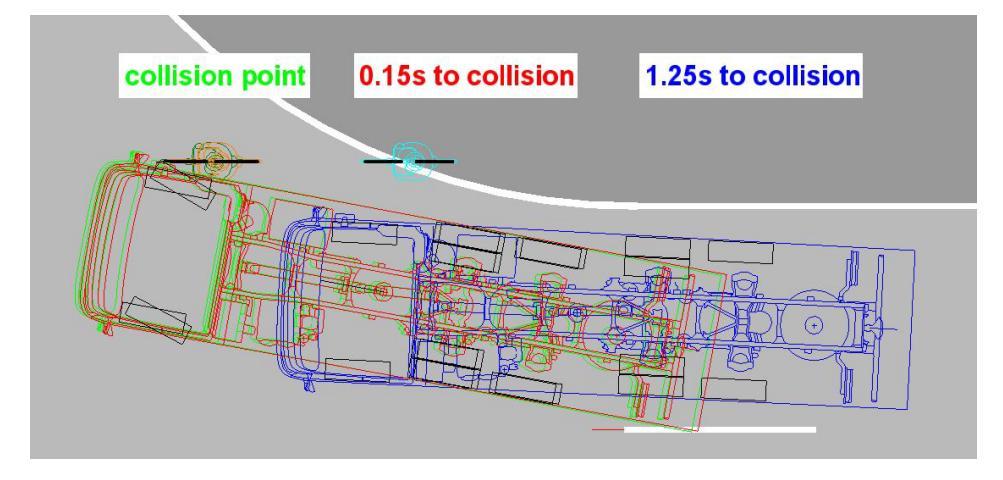
Figure 10. Blind spot assistance system triggering range without direction indicator activated.

Without actuating the direction indicator, the blind spot assistance system is activated by the steering angle to the right, resulting in significantly later response times. In five test runs, the acoustic warning signal was triggered 0.15 s to 1.25 s before the calculated collision point. In one test, the warning appeared at 0.1 s after the collision (Figure 10).

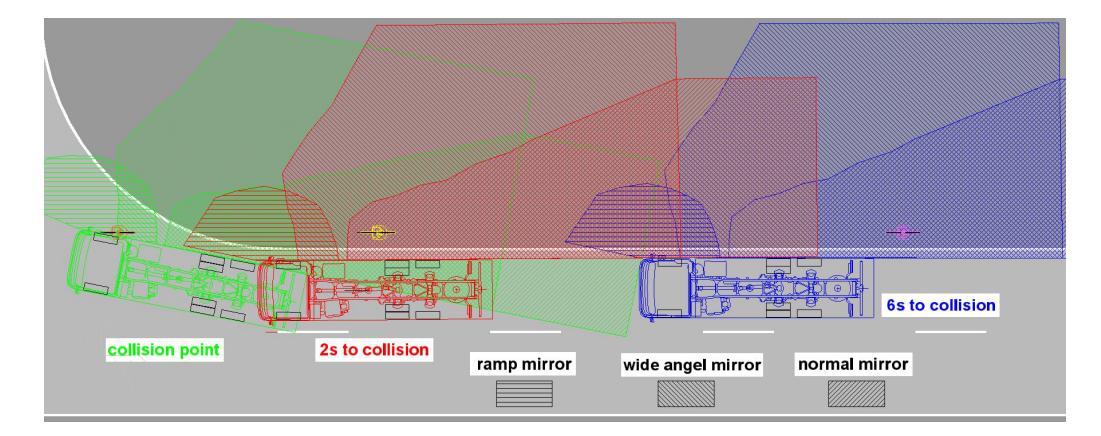
Figure 11. Perceptibility of the VRU in different indirect fields of view during the approach.

Figure 11 shows the reconstruction result of the same traffic accident constellation without considering a blind spot assistance system. Here, it was investigated when the VRU would be recognizable to the commercial vehicle driver in the reconstructed approach constellation, in which indirect fields of view are presented via exterior mirrors or camera systems. The area visible in the exterior mirrors of the Mercedes test vehicle to the right of the vehicle was measured and drawn into a scaled plan view. Figure 11 shows that the VRU is typically perceptible in at least one indirect field of view over several seconds before the collision.

Accordingly, the accident would always be avoidable for the commercial vehicle driver when looking into the respective exterior mirror or the respective monitor at the right time. Since, as described, the driver's gaze could be more comprehensible, from a purely technical point of view, neither an objective reaction prompt point can be defined, nor a meaningful avoidability analysis can be carried out in this accident constellation. According to the current state-of-the-art system, only a legal assessment of the avoidability for the commercial vehicle driver can be carried out here, considering the traffic situation. In the future, more attention will have to be paid to the activity status of the right-hand direction indicator and the time of activation. It must be kept in mind that the driver behaves in accordance with the rules when activating the direction indicator at an early stage.

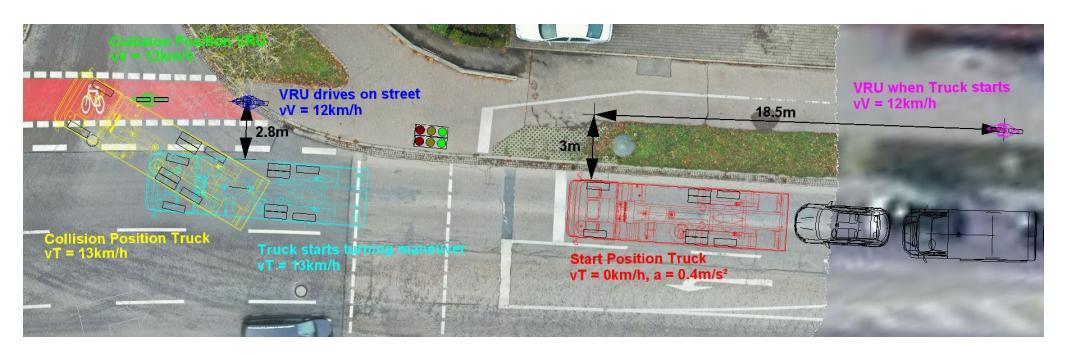
Figure 12. Typical accident between a VRU and a right-turning commercial vehicle.

The knowledge gained has to be integrated into the common practice of traffic accident analysis with turning commercial vehicles and VRUs. To illustrate this, the following case study of a typical turning accident will serve as an illustration: At an inner-city intersection, a truck is in the front position at a red light. Since the truck wants to turn right at the intersection, the right-hand direction indicator is activated. Separated by a 2 m wide green strip, a cycle path runs parallel to the road, on which a cyclist approaches at a roughly constant speed of 12 km/h. When the truck starts after the traffic light changes to green, the cyclist is 18.5 m behind the cabin of the truck. Due to local conditions, the lateral distance between the right side of the truck and the cyclist's driving line is 3 m. Since the truck driver does not notice the cyclist in the right wing mirror, he starts the turning maneuver at a speed of 13 km/h. At this point, the cyclist is 2.8 m to the right of the truck and 3 m behind the truck cabin. At unchanged speeds, the cyclist collides with the side of the truck immediately behind the front axle. Figure 12 shows the described situation.

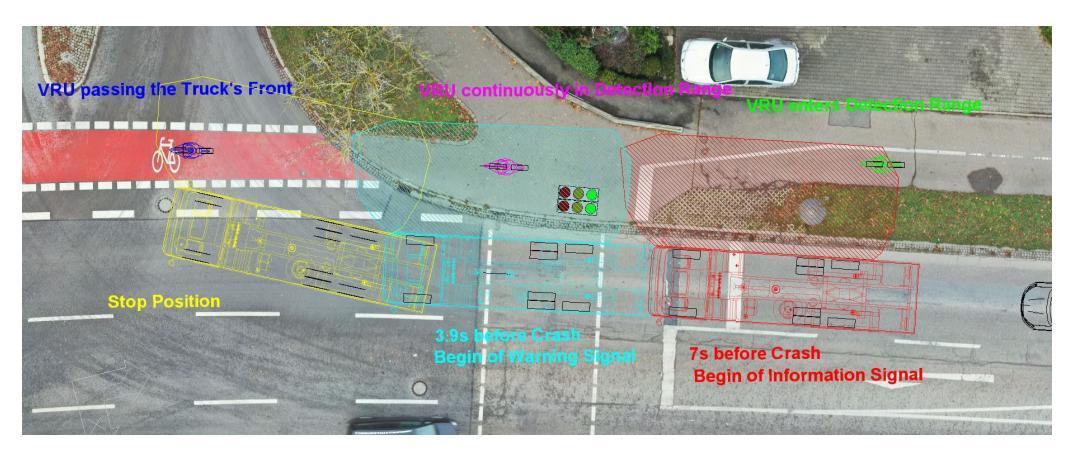
Figure 13. Situation with a perfectly working blind spot assistance system.

If the truck is equipped with a radar-based blind spot assistance system that is fully functional, the accident could be easily avoided by the system as shown in Figure 13. About 7 s before the collision, the cyclist enters the detection range of the radar sensors from behind. Due to the truck's starting process after switching traffic lights, the cyclist is faster than the truck at this time. From this point on, a visual information signal is issued by the blind spot assistance system. It is known from the tests carried out above that the visual and audible warning signal is activated no later than 3.9 s before the collision when the right-hand direction indicator is activated. Even if the driver only reacts to this latest

possible warning signal, in this case study, he still has the reaction time of 1.4 s to initiate braking and stop the truck before crossing the driving line of the cyclist.
