Induction Motor Broken Rotor Bar Detection Based on Rotor Flux Angle Monitoring

Mitja Nemec[®], Vanja Ambrožič *, Rastko Fišer[®], David Nedeljković and Klemen Drobnič[®]

Department of Mechatronics, Faculty of Electrical Engineering, University of Ljubljana, Tržaška 25, 1000 Ljubljana, Slovenia; mitja.nemec@fe.uni-lj.si (M.N.); rastko.fiser@fe.uni-lj.si (R.F.); david.nedeljkovic@fe.uni-lj.si (D.N.); klemen.drobnic@fe.uni-lj.si (K.D.) * Correspondence: vanja.ambrozic@fe.uni-lj.si; Tel.: +386-1-4768-286

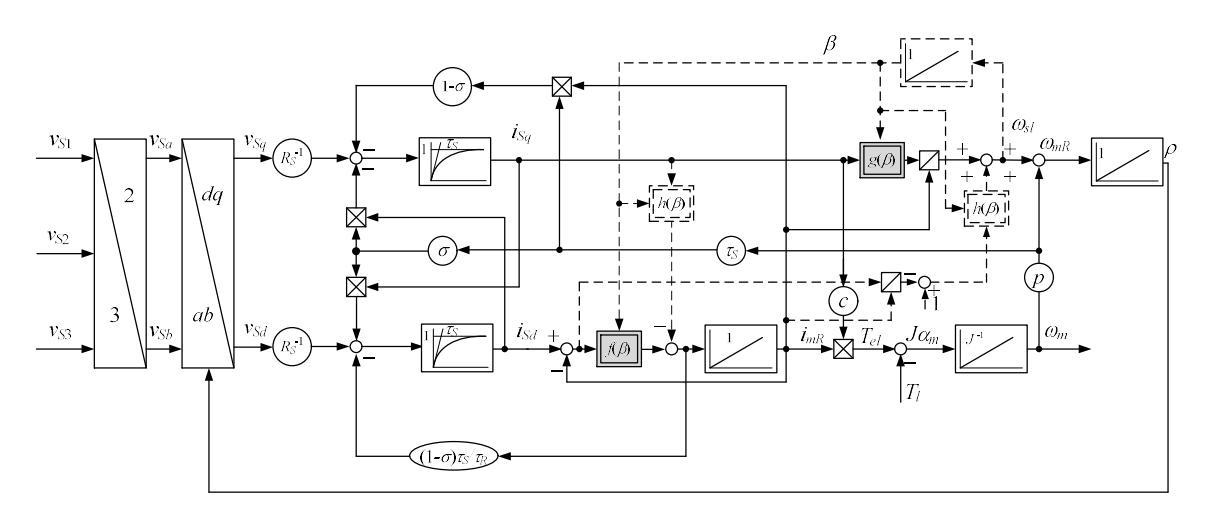
Figure 1. Simplified block scheme of a voltage-fed induction motors (IM) with broken rotor bars (BRB) in a rotor field reference frame; in the case of a healthy rotor, dashed lines and blocks are omitted, while the blocks in gray become C_{temp}/τ_R .

Figure 1 shows the block scheme of the simplified model of IM with BRB resulting from Equations (4)–(12) [42], where T_l stands for load torque. The model has been tested on a motor (see Table A1 in Appendix A) with a different number of bars drilled. The MCSA results obtained from measured currents of a grid-supplied motor were compared to the simulation results of the model from Figure 1. For illustration purposes, two spectra are shown in Figure 2.

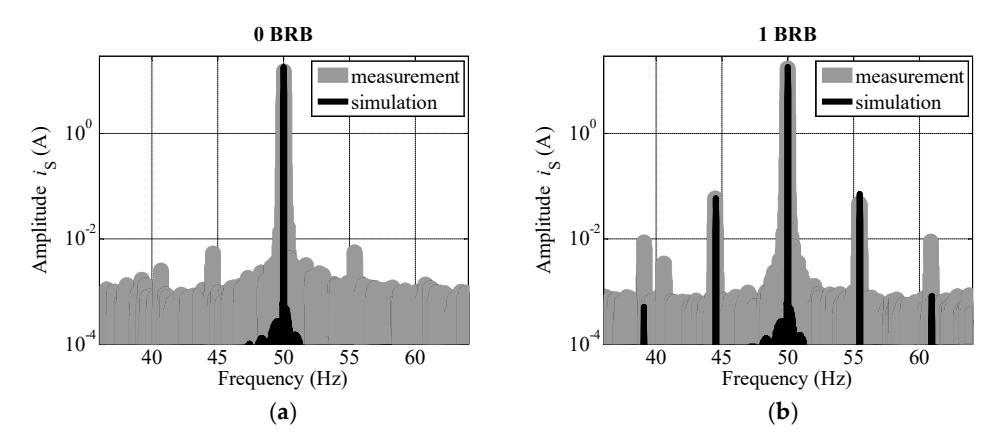
Figure 2. Measured and simulated Motor Current Signature Analysis (MCSA) of the stator phase current for a motor at load torque T_l = 30 Nm: (**a**) with no BRB; (**b**) with one BRB.

A close match between the model and experimental results is achievable only if the model parameters precisely match the actual ones. Besides inertia, which affects the left/right side-band distribution, rotor time constants τ_{RD} and τ_{RQ} also have to be determined precisely [41,43]. Additionally, we can observe some side-band components even with healthy rotor, due to manufacturing imperfections.

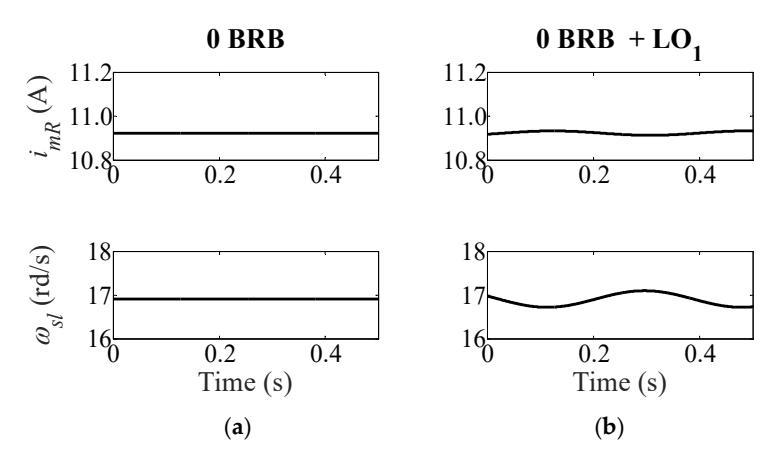
Figure 3. Healthy motor's i_{mR} and ω_{sl} at: (a) constant load $T_l = 30$ Nm; (b) oscillating load LO₁ $T_l = 30 \pm 0.3$ Nm at 2.7 Hz.

Case 1: A healthy motor with a constant load: As expected, in a healthy motor with a constant load $(T_l = 30 \text{ Nm})$, magnetizing current i_{mR} and slip frequency ω_{sl} remain constant (Figure 3a).

Case 2: A healthy motor with a superimposed oscillating load: When a sinusoidal load torque is superimposed on a constant load, e.g., $T_l = 30 \pm 0.3$ Nm at 2.7 Hz, denoted with LO₁ (see Table A2 in Appendix A for various applied oscillating load conditions), only the magnetizing current remains practically constant, while ω_{sl} (thus i_{Sq}) oscillates with the load torque frequency (Figure 3b).

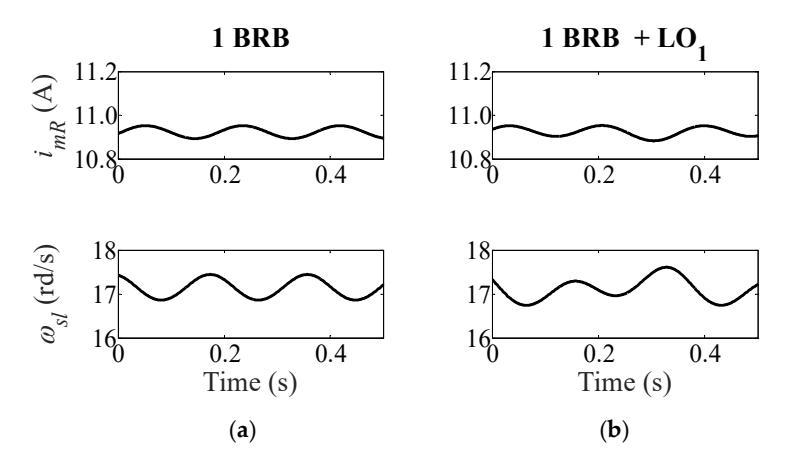
Figure 4. Faulty motor's i_{mR} and ω_{sl} at: (a) constant load $T_l = 30$ Nm; (b) oscillating load LO₁ $T_l = 30 \pm 0.3$ Nm at 2.7 Hz.

- Case 3: A faulty motor with a constant load: In Equation (4) the magnetizing current contains the oscillation caused by the fault (factor $f(\beta)$). The same applies to Equation (5), where the term with factor $h(\beta)$ can be neglected, as it is much smaller than the first part. Nevertheless, the slip frequency contains oscillations, caused by the fault (factor $g(\beta)$), as shown in Figure 4a.

- Case 4: A faulty motor with a superimposed oscillating load: In this case (LO₁) the magnetizing current in Equation (4) oscillates due to the load oscillation (i_{Sq}) and the oscillation caused by the fault (factor $f(\beta)$). The same applies to Equation (5), where the term with factor $h(\beta)$ can be neglected, as i_{mR} tracks i_{Sd} . Again, the slip frequency contains non-sinusoidal oscillations that are caused by the fault (factor $g(\beta)$) and by the load (i_{Sq}), as shown in Figure 4b.

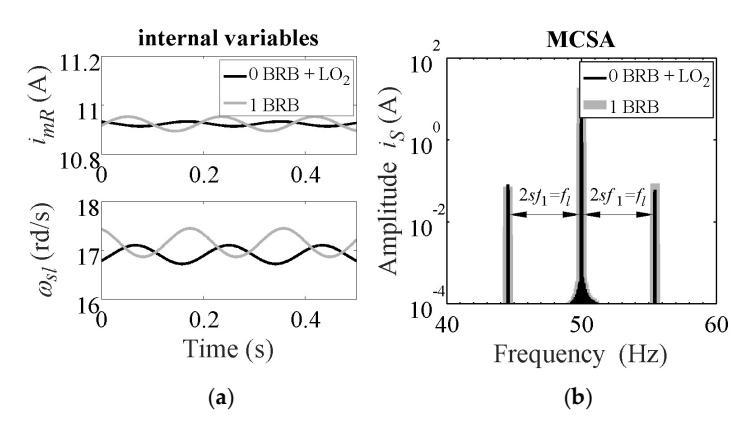
Figure 5. Healthy motor with LO₂ ($T_l = 30 \pm 0.3$ Nm at 5.46 Hz) and faulty motor (1 BRB) with false positive detection: (a) i_{mR} and ω_{sl} ; (b) MCSA of stator current.

Load LO_2 applied to a healthy motor (Section 3.1, case 2) may blur the fault detection, as MCSA exhibits the same characteristic spikes expected from a faulty motor at constant torque (Figure 5b). Both the slip frequency and magnetizing current in the healthy and the faulty motor are almost equal (Figure 5a).

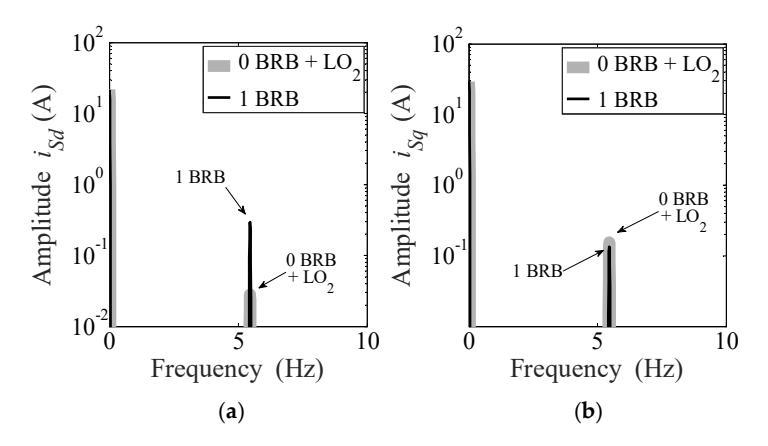
Figure 6. Ambiguous BRB fault detection at LO₂ ($T_l = 30 \pm 0.3$ Nm at 5.46 Hz): (**a**) spectra of i_{Sd} ; (**b**) spectra of i_{Sq} .

However, if spectral analyses of current components i_{Sd} and i_{Sq} in RFRF (Figure 1) are performed, a clear difference may be observed, especially in the *d* axis (Figure 6). This fact is utilized in certain detection methods based upon a reactive current or reactive power measurements [29,32,33], which makes them robust to load oscillations. However, at high load oscillations and/or weak fault signatures, where reactive current oscillations are similar, these methods still struggle.

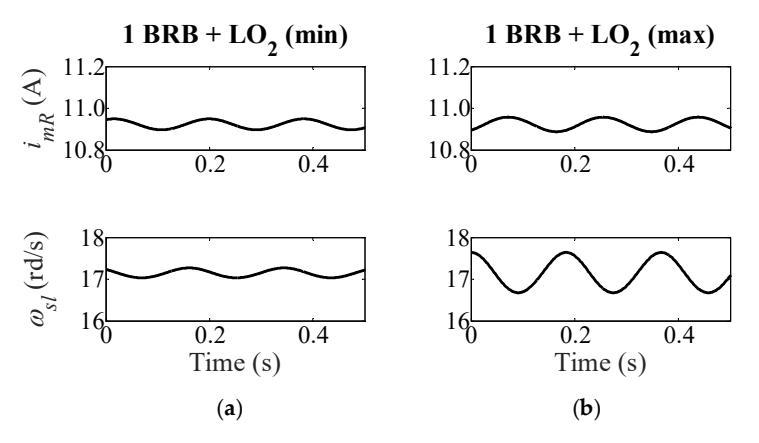
Figure 7. Faulty motor's i_{mR} and ω_{sl} at oscillating load LO₂ ($T_l = 30 \pm 0.3$ Nm at 5.46 Hz) causing either their: (**a**) suppression; (**b**) amplification.

A special situation of 3.2., case 2 occurs if both terms on the right in Equation (4) oscillate at $2sf_1$, either amplifying or suppressing each other, depending on their phase relation (Figure 7). This phenomenon was analyzed in [29], where detection based upon reactive power oscillation was subject to phase relation between oscillation due to the fault and the load oscillation. A faulty motor under certain load amplitude (e.g., LO₂ in Figure 7a) behaves almost like the healthy motor under an oscillating load, thus hindering the fault detection.

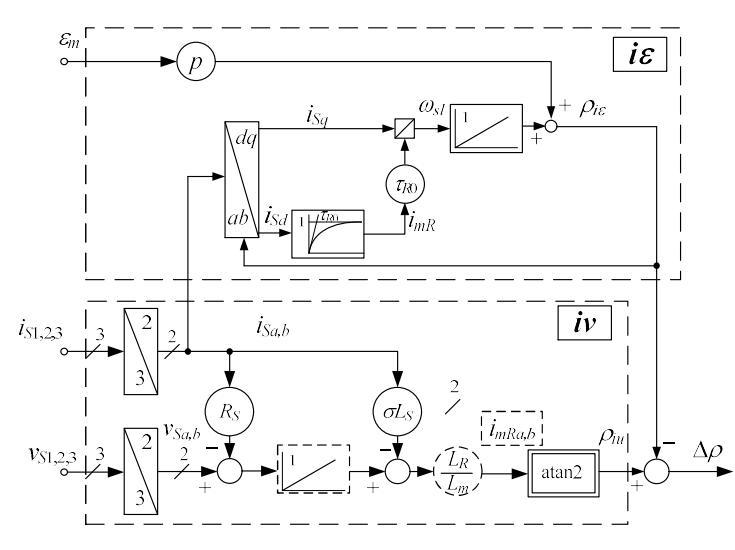
Figure 8. Current-voltage (*iv*) model of IM with stator parameters and current-angle (*i* ε) model with initial τ_{R0} of a healthy motor.

While the simplified model of IM (Figure 1) offers a different perspective on motor operation during fault and/or load oscillations, it does not provide a direct way for detecting BRBs. However, there is a model from which the correct slip frequency ω_{sl} and magnetizing current i_{mR} can be obtained without exact knowledge of rotor parameter(s). The *iv* estimation model is based upon the stator voltage and current measurement (see Figure 8, bottom) [44]. Instead of a notoriously problematic open-loop integrator which is present in stator equations, a closed-loop variant is implemented [45]. However, it might be replaced by first order lag as well. This model is mostly used for sensorless estimation of the rotor magnetizing current \mathbf{i}_{mR} (or rotor flux). In our case, only the rotor flux angle ρ is required; hence, factor L_R/L_m^2 , present in \mathbf{i}_{mR} equations, is irrelevant thus leaving the model independent from any rotor parameter. With this model, the correct magnetizing current and slip angular frequencies (the latter by differentiating the difference between rotor flux angle ρ and rotor angle ε_m can be obtained for both a healthy and a faulty motor, with or without load oscillations, assuming known stator parameters in the *iv* model.

First, a monitoring system from Figure 8 is applied to a healthy (0 BRB) and faulty (1 BRB) motor supplied by a sinusoidal voltage at constant load (Figure 9a), assuming initial rotor temperature ($C_{temp} = 1$). The rotor time constants of a simulated faulty rotor were tuned in order to fit the model to the actual motor for both the simulations and subsequent experimental verification. In a faulty rotor (1 BRB), the difference $\Delta \rho$ between rotor field angles from two models contains an offset and oscillations. The offset is owed to the fact that the average time constant of a faulty motor ($\tau_{RD} + \tau_{RQ}$)/2 differs from τ_{R0} used in the *ie* model. The oscillations are at exactly twice the slip frequency, as expected for a faulty motor. The amplitude of $\Delta \rho$ with a healthy motor (0 BRB) is zero due to $\tau_R = \tau_{R0}$.

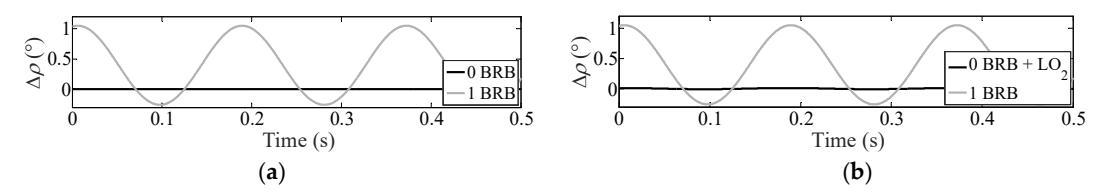
Figure 9. Observed $\Delta \rho$ for healthy and faulty motors at: (**a**) constant load $T_l = 30$ Nm; (**b**) additional load oscillations at $2sf_1$ (LO₂, $T_l = 30 \pm 0.3$ Nm at 5.46 Hz).

We can further investigate an extreme case (Figure 5), where MCSA at 0 BRB would generate a false positive due to load oscillations (LO₂) at $2sf_1$ (Section 3.3.1). In such a case, when the MCSA of a healthy motor is equal to the MSCA of a faulty motor, the fault signature in $\Delta\rho$ remains unaffected by load oscillations (Figure 9b). Hence, both parts of Figure 9 look almost identical.

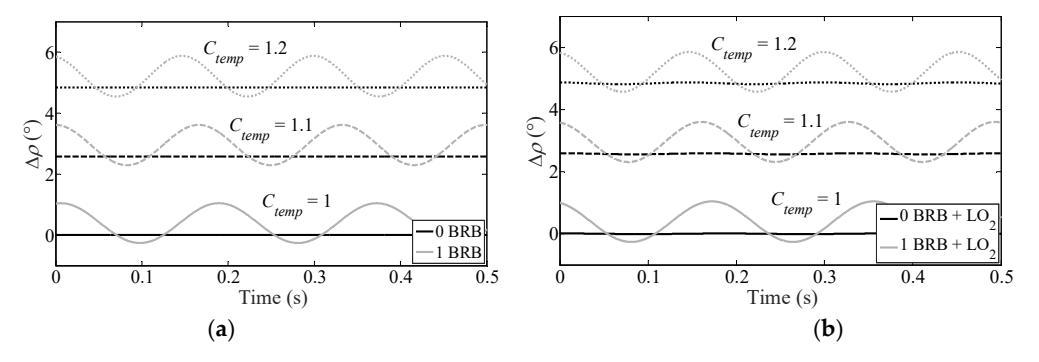
Figure 10. Observed $\Delta \rho$ at 0 BRB and 1 BRB with: (a) constant load T_l = 30 Nm; (b) additional load oscillations at $2sf_1$ (LO₂, T_l = 30 ± 0.3 Nm at 5.46 Hz) for $C_{temp} \ge 1$.

As the temperature increases ($C_{temp} > 1$), the motor time constants (0 BRB: τ_R ; 1 BRB: τ_{RD} , τ_{RQ}) decrease below the initial model's constant τ_{R0} . Nevertheless, the amplitudes of oscillations in $\Delta \rho$ remain equal, while only its offset increases (Figure 10a—without, Figure 10b—with low load torque oscillations), whereas the slip slightly rises due to higher rotor resistance R_R .

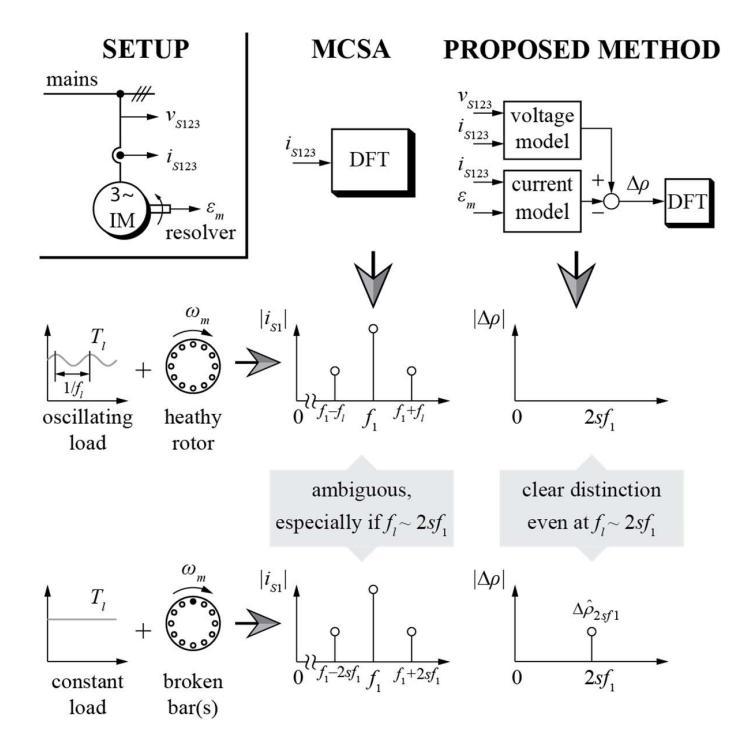
Figure 11. MCSA and proposed method in case of equal stator current spectra.

Figure 11 illustrates the basic differences between the proposed method and MCSA, where load oscillations interfere with MCSA, because they can produce the same side-bands as the fault would. On the contrary, the proposed procedure is immune to load oscillations. However, it should be emphasized that no method is effective if the motor is running at no-load (steady state), as in such case side-band components $2sf_1$ are negligible and also no oscillating load is present on the shaft.

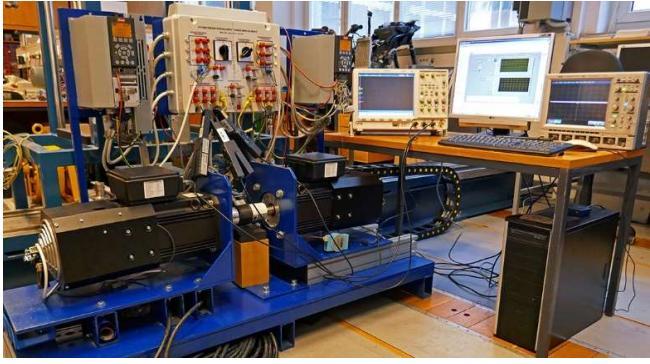
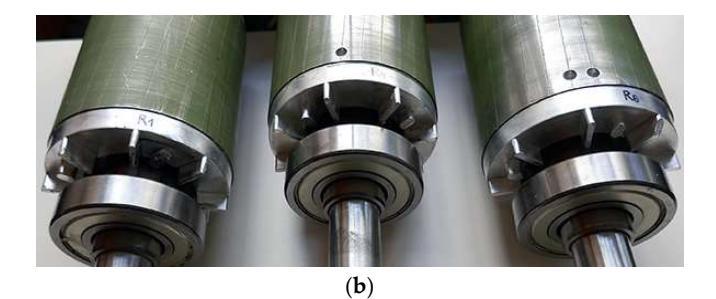
Figure 12. Experimental setup: (**a**) testbed comprises two coupled torque-controlled induction machines with active brake machine able to produce low frequency load oscillations; (**b**) tested batch of rotors having 0, 1, and 2 BRBs.

Measurements of rotor angle, stator voltages, and currents were performed on an induction motor supplied by sinusoidal voltage (see Appendix A), while the mechanical load was emulated by a coupled torque-controlled induction motor (testbed shown in Figure 12a). In order to test the validity of the modeling and diagnostic approach, a series of experiments has been performed for combination of different parameters, including:

- numbers of BRBs (0: healthy rotor; 1 BRB; 2 adjacent BRBs—see tested rotors in Figure 12b),
- constant load torques ($T_l = 20 \text{ Nm}$ and $T_l = 30 \text{ Nm}$),
- oscillating load torques (LO₃: $T_1 = 20 \pm 3$ Nm at 2 Hz; LO₄: $T_1 = 30 \pm 3$ Nm at 2 Hz, see Table A2).

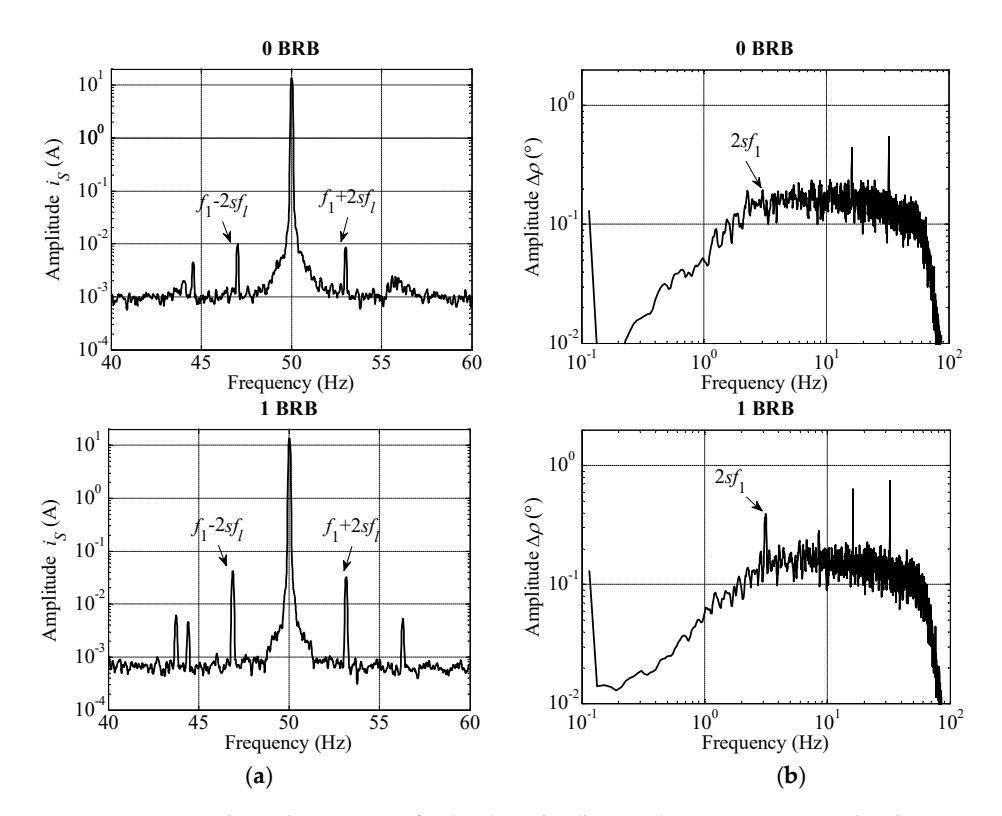
Figure 13. Experimental results in case of 0 (top) and 1 (bottom) BRB at constant load $T_l = 20$ Nm: (a) stator current spectra with visible arising side-band components $\pm 2sf_1$ due to BRB; (b) flux angle difference spectra $\Delta \rho$ with visible arising side-band components $\pm 2sf_1$ due to BRB.

In Figures 13 and 14 measurements of stator current spectra (MCSA approach-left) and rotor flux angle difference $\Delta \rho$ spectra (proposed method-right) at different load conditions and different rotor fault states are presented. Their comparison clearly demonstrates the effectiveness and advantage of the proposed method in differentiating BRB from load oscillation, thus reducing the possibility of false BRB fault detection.

Figure 13 shows examples of spectra in case of the constant load torque $T_l = 20$ Nm and rotors having 0 BRB (top), and 1 BRB (bottom), respectively. In spectra of both observed variables (stator current (Figure 13a) and rotor flux angle difference (Figure 13b)), the side-band components at $2sf_1$ stick out, when a rotor fault is present (1 BRB). In such cases, most conventional detection methods work well and a risk for false BRB fault diagnosis is small.

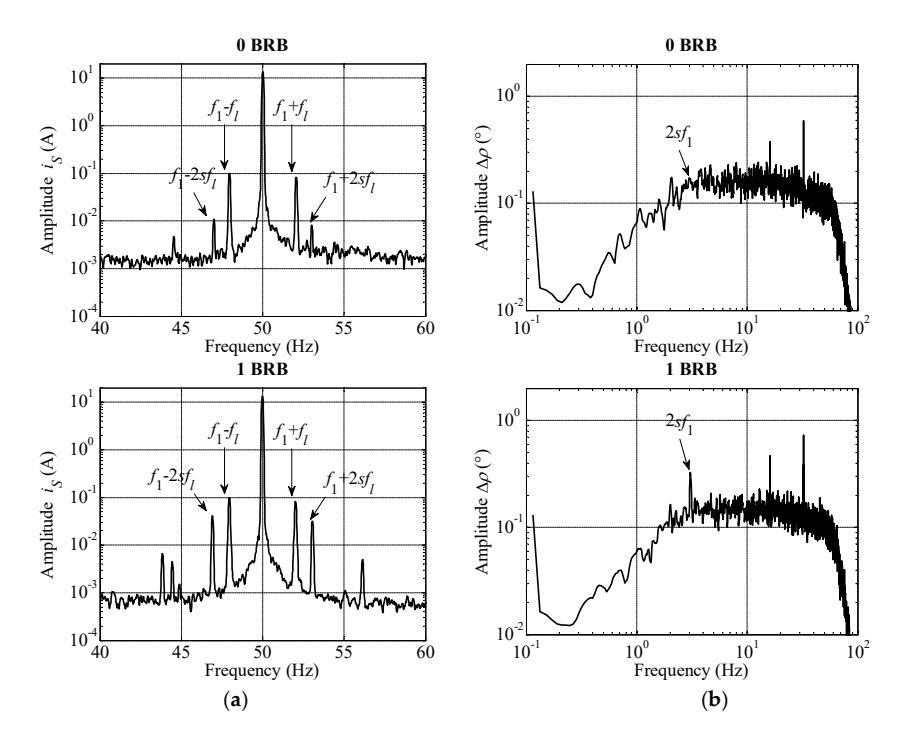
Figure 14. Experimental results in case of 0 (top) and 1 (bottom) BRB at oscillating load LO₃ $T_l = 20 \pm 3$ Nm at 2 Hz: (**a**) stator current spectra with visible arising side-band components $\pm 2sf_1$ due to BRB and constant side-band components $\pm f_l$ due to LO₃; (**b**) flux angle difference spectra $\Delta \rho$ with visible only arising side-band components $\pm 2sf_1$ due to BRB.

The same experiment, but this time for the case of oscillating load torque LO₃ ($T_l = 20 \pm 3$ Nm at 2 Hz), is shown in Figure 14. While in stator current spectra (Figure 14a) both side-band components, i.e., due to BRB at $\pm 2sf_1$ and due to LO₃ at $\pm f_l$, are present, in rotor flux angle difference $\Delta \rho$ spectra (Figure 14b) only frequency components due to BRB exist. The absence of load oscillation components $\pm f_l$ proves the benefit and reliability of the proposed method in avoiding possible false positive BRB detections when load oscillates near $\pm 2sf_1$, as already demonstrated in Figure 11.

Note that the load oscillation frequency $f_l = 2$ Hz is intentionally slightly different from the double slip frequency $2sf_1$ to avoid side-band components overlapping and to enhance the visual clearness of diagrams (Figure 14). Note also that in measured stator current spectra some reduced side-band components can be observed even in case of the heathy rotor (0 BRB) due to manufacturing imperfections of rotor cages (Figure 13a top, Figure 14a top).

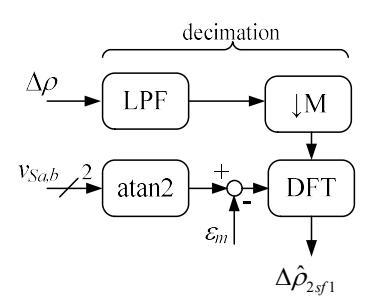
Figure 15. Extraction of fault indicator $\Delta \hat{\rho}_{2sf1}$ from the $\Delta \rho$ signal.

In order to extract $\Delta \hat{\rho}_{2sf1}$, a signal-processing algorithm with minimal processing effort is adopted (Figure 15). As the fault indicator is in order of a few Hz, the $\Delta \rho$ signal is firstly decimated (through low-pass filter—LPF, and down-sampling— \downarrow M). Since the rotor angle is measured, the slip angle can be easily calculated as a difference between the electrical rotor angle and stator voltage angle. Hence, twice the slip angle is used for Discrete Fourier Transform (DFT) calculation of the remaining $\Delta \rho$ signal. The resulting value of $\Delta \hat{\rho}_{2sf1}$ is the fault indicator.

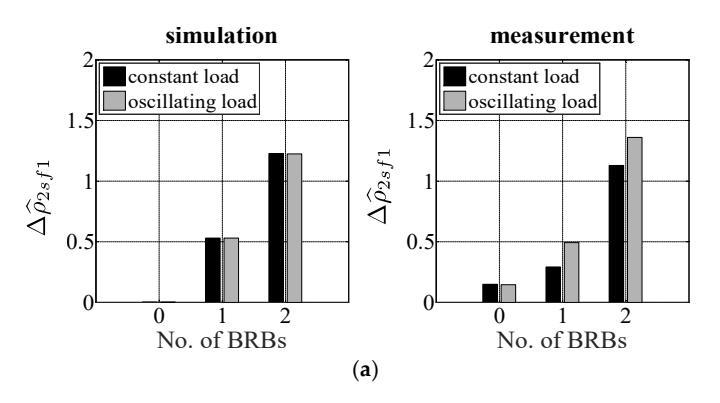
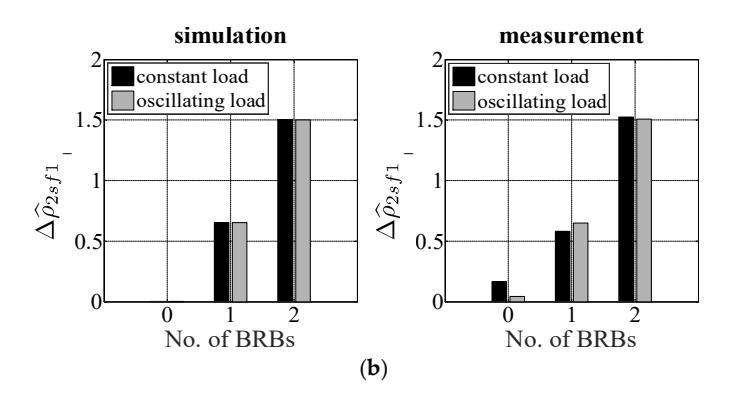
Figure 16. Fault indicator at: (a) constant load $T_l = 20$ Nm (black), and LO₃ $T_l = 20 \pm 3$ Nm at 2 Hz (gray); (b) constant load $T_l = 30$ Nm (black), and LO₄ $T_l = 30 \pm 3$ Nm at 2 Hz (gray). As expected, load oscillations have almost no effect on fault indicator.

A set of simulations and measurements is shown in parallel in Figure 16. In all cases the model time constant (τ_{R0}) corresponds to the constant τ_R of a healthy motor (0 BRBs). Of course, τ_{R0} differs from constants τ_{RD} and τ_{RQ} in a motor with 1 and 2 BRBs. Black bars show the results for constant load $T_l = 20$ Nm (Figure 16a) and $T_l = 30$ Nm (Figure 16b). The results obtained with an oscillating load LO₃ and LO₄ are presented in grey.

Figure 16 clearly shows that $\Delta \hat{\rho}_{2sf1}$, when used as a fault indicator, is independent of load oscillations, as the amplitude of $\Delta \hat{\rho}_{2sf1}$ depends only, and only on the rotor fault condition. Additionally, the simulation and experimental results match very well, confirming the validity of the dynamic model.

Nevertheless, the experimental results show that even with a "healthy" IM, the fault indicator $\Delta \hat{\rho}_{2sf1}$ is not zero. This fact, as already emphasized, is owed to manufacturing imperfections, which result in a slightly asymmetrical cage. In order to avoid this false positive, the threshold for detecting 1 BRB may be set at twice the value measured previously on a "healthy" motor. In the case of 2 BRB this threshold is exceeded by much more.

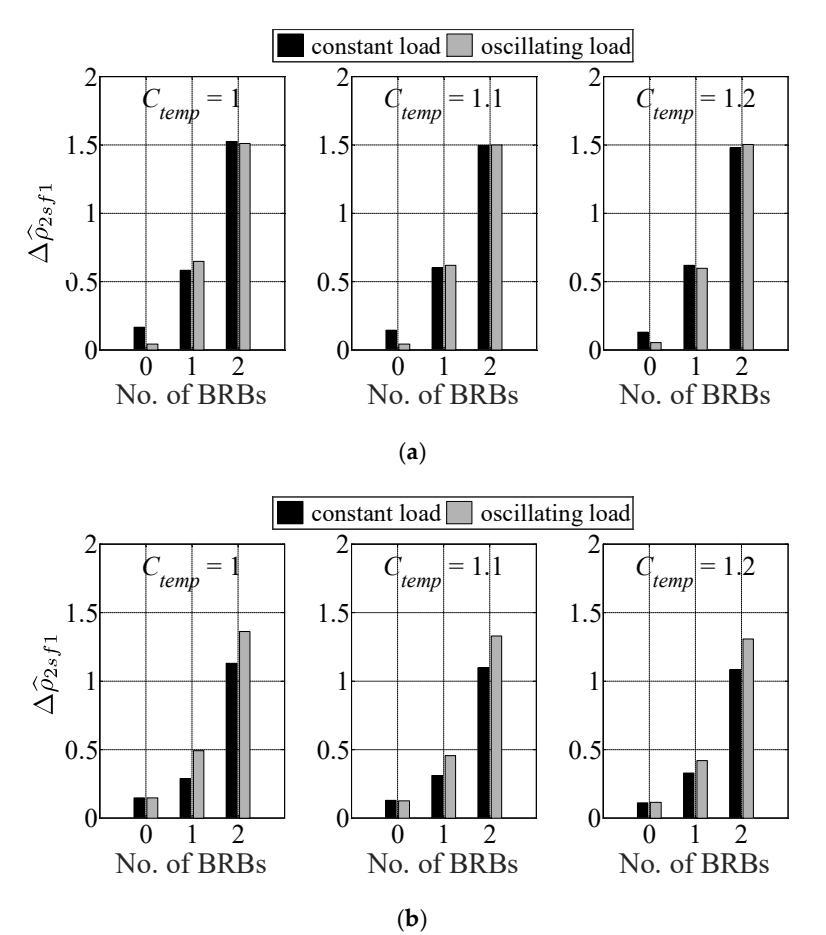
Figure 17. Influence of erroneous model time constants with or without additional oscillations measurements at: (a) constant load $T_l = 20$ Nm (black), and LO₃ $T_l = 20 \pm 3$ Nm at 2 Hz (gray); (b) constant load $T_l = 30$ Nm (black), and LO₄ $T_l = 30 \pm 3$ Nm at 2 Hz (gray). Parameter mismatch has almost no effect on the fault indicator.

Next, a set of experiments has been performed in order to prove the robustness of the method (Figure 17). This test emulates alteration of the rotor resistance due to heating ($C_{temp} > 1$), when actual time constants τ_R (healthy motor) and τ_{RD} , τ_{RQ} (faulty motor) decrease below their initial value τ_{R0} . Model time constants differ by up to 20%, with respect to their correct value. The fault indicators are completely independent on the temperature difference between the model and actual machine.
