A Review of the Degradation of Photovoltaic Modules for Life Expectancy

Abstract: Photovoltaic (PV) modules are generally considered to be the most reliable components of PV systems. The PV module has a high probability of being able to perform adequately for 30 years under typical operating conditions. In order to evaluate the long-term performance of a PV module under diversified terrestrial conditions, outdoor-performance data should be used. However, this requires a wait of 25 years to determine the module reliability, which is highly undesirable. Thus, accelerated-stress tests performed in the laboratory by mimicking different field conditions are important for understanding the performance of a PV module. In this paper, we discuss PV-module degradation types and different accelerated-stress types that are used to evaluate the PV-module reliability and durability for life expectancy before using them in the real field. Finally, prevention and correction measures are described to minimize economic losses.

Citation: Kim, J.; Rabelo, M.; Padi, S.P.; Yousuf, H.; Cho, E.-C.; Yi, J. A Review of the Degradation of Photovoltaic Modules for Life Expectancy. *Energies* **2021**, *14*,

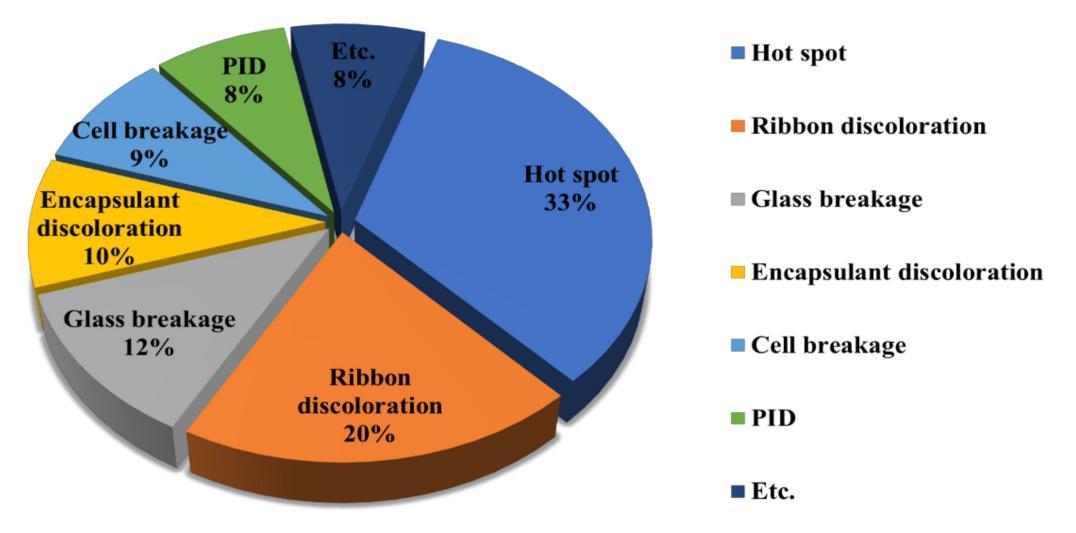
Figure 1. Representative degradation modes of silicon PV modules for the last 10 years.

The dependability and lifespan of PV systems rely mostly on the efficiency of the PV system and its various degradation patterns [4,5]. PV-module failure information has been available since the early 1970s. According to data reported by the National Renewable Energy Laboratory (NREL) in 2017, as shown in Figure 1, the most common

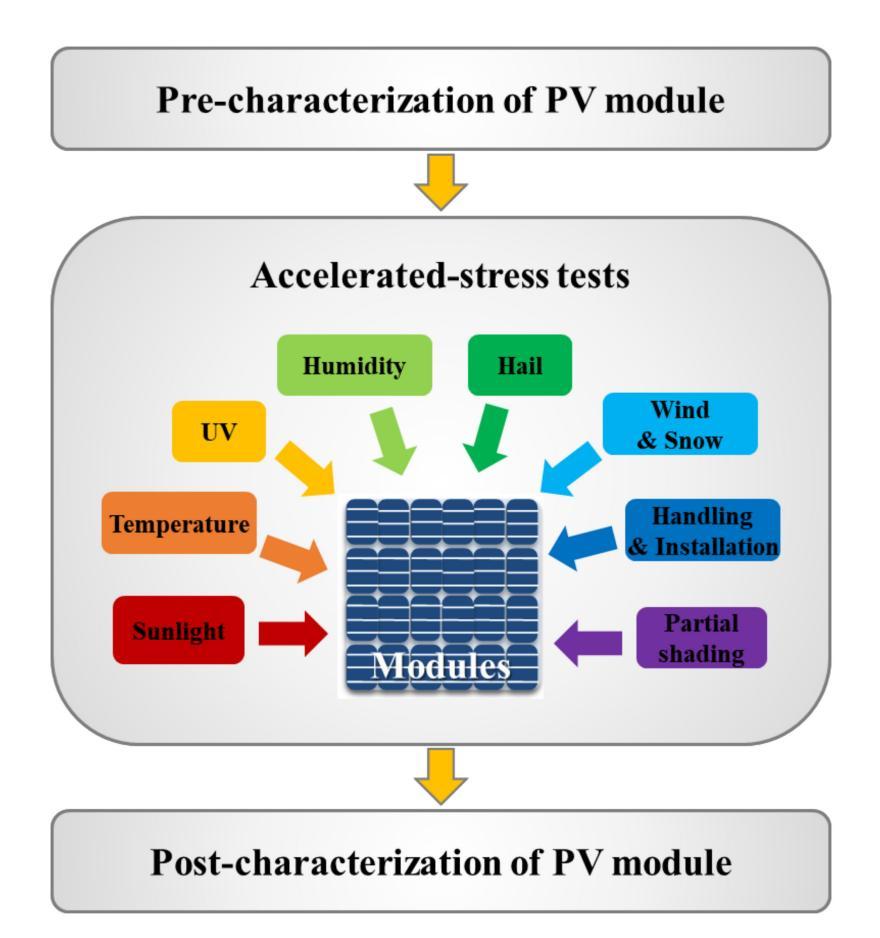
Figure 2. Conceptual representation of the AT of PV modules.

Figure 2 shows the conceptual representation of the AT program on the modules. The developed PV modules should undergo the standard qualification test programs established by the International Electrotechnical Commission (IEC) standards (IEC 61215 for terrestrial photovoltaic modules) and must be developed for comparative and lifetime test programs. In order to understand the testing sequence, the IEC 61215 qualification standard is shown in Figure 3 [29]. In this paper, we discuss different types of degradation, accelerated-stress tests, levels, and prioritization to expand the life expectancy of the PV module by means of IEC 61215.

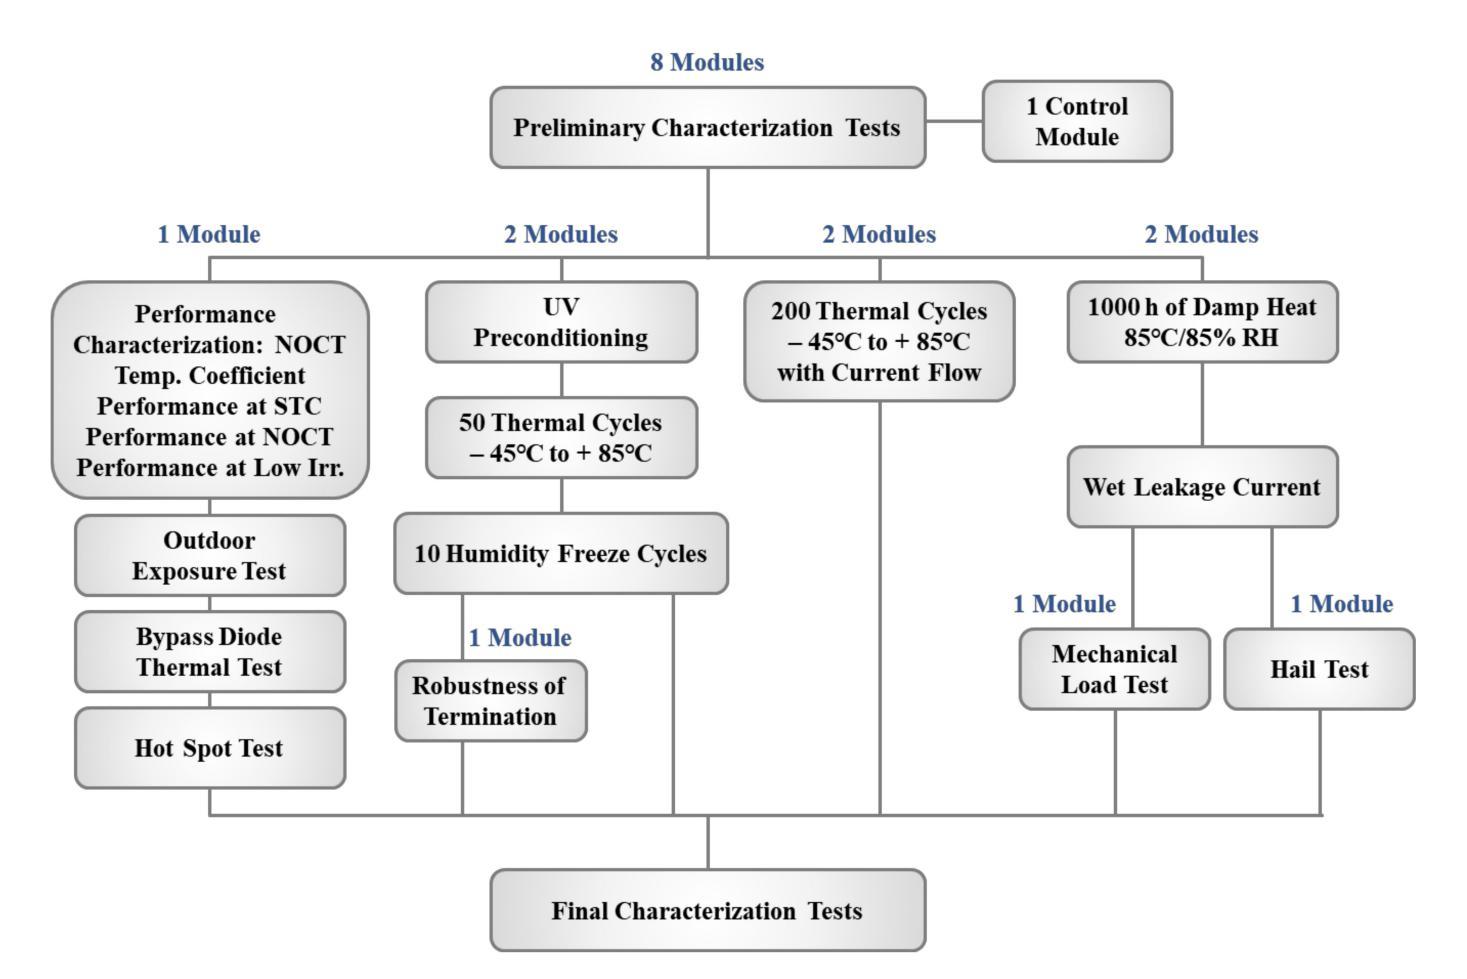
Figure 3. Test sequences of IEC 61215 qualification testing program for PV modules.

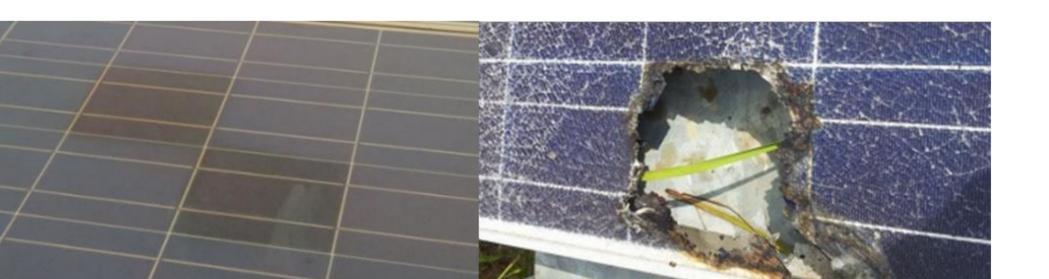
Figure 4. PV module with hot spots.

Hot spots are areas of a photovoltaic module with high temperatures that may damage the cells or other parts of the unit, as shown in Figure 4 [38]. The causes of hot spots may be a variety of cellular interferences comprising fractional shadows, cell mismatches, or interrupted connections between cells [39]. In the event of a short circuit, if the PV cell fails, the voltage will reverse and become equal to and opposite to that of the other cells in the series. This faulty solar cell places a burden on the other cells and creates relatively high heat-dissipation positions, thereby forming hot spots [40,41].

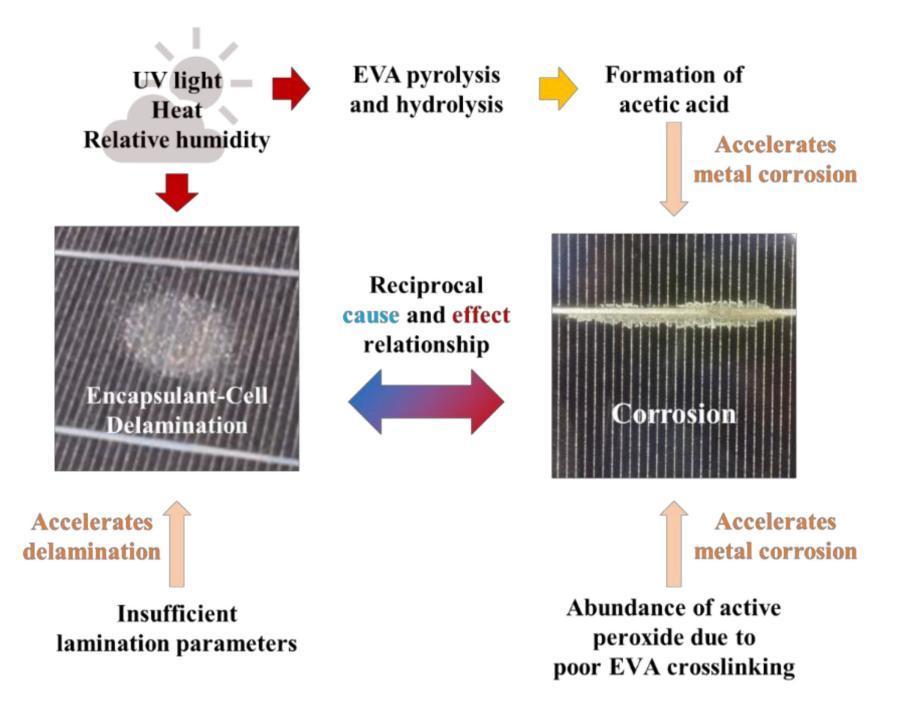
Figure 5. Corrosion mechanism in silicon solar cells [42,44,45,48]. H₂O and O₂ enter through the backsheet or frame edges and penetrate a delaminated encapsulant-cell gap; hydrogen gas is formed during corrosion. The gas bubbles can grow and merge, which increases delamination.

Corrosion in photovoltaic modules is initiated and accelerated by several factors simultaneously and has a reciprocal cause-and-effect relationship [43]. Figure 5 shows a summary of the corrosion mechanisms in PV modules reported in previous studies. They are in agreement regarding the corrosion effect, which is a result of the deterioration of the EVA encapsulant [43,48–50]. Some studies have focused on EVA delamination problems caused by insufficient lamination parameters and environmental conditions [43,48]. Others have focused on the formation of acetic acid by using pyrolysis and hydrolysis after moisture and high-temperature exposure [49,50].

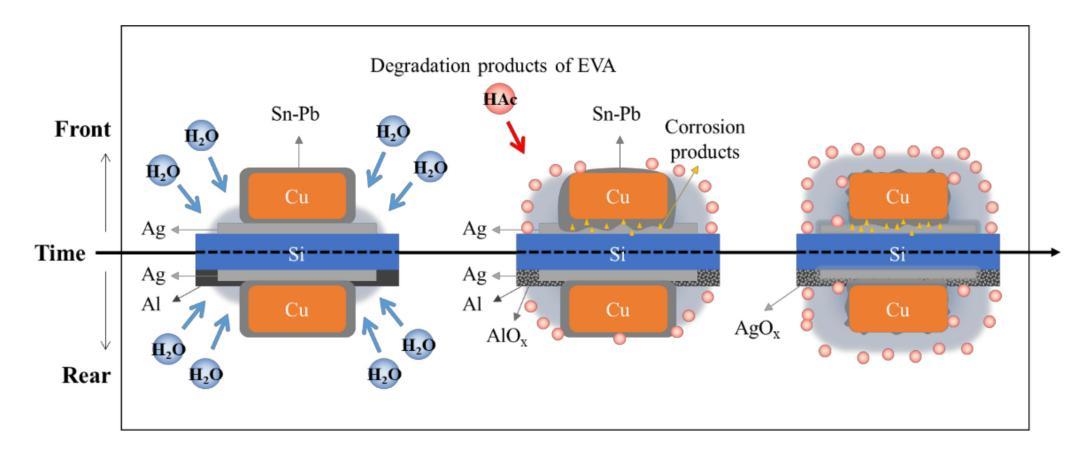
Figure 6. Corrosion steps at the front and rear sides of a solar cell.

Figure 6 shows the corrosion stages and interactions among the galvanic pairs. Corrosion in PV modules results in a gradual increase in series resistance and power loss. The oxidation potentials of Al/Al(III), Pb/Pb(II), Sn/Sn(II), Cu/Cu(II), and Ag/Ag(I) were -1.662, -0.358, -0.136, 0.337, and 0.799 V, respectively [42,51].

Higher corrosion rates occur in metals with lower oxidation potentials because they act as sacrificial anodes in galvanic couples. On the front side of the solar cell, corrosion begins to occur at the edges of a solder joint upon contact with water. Then, the corrosion will slowly move toward the center, resulting in a decrease in the Ag-solder contact, thus increasing the series resistance [51]. At the rear side, the aluminum contact and solder joint corrode first. As the corrosion progresses and metal is consumed, other metals will also begin to corrode.

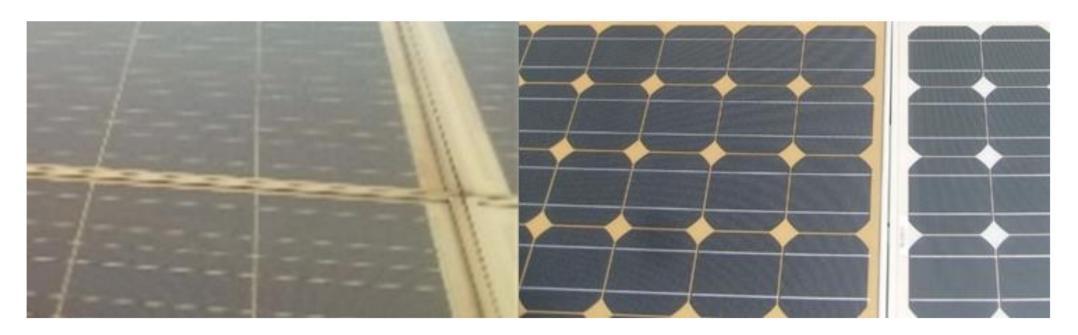
Figure 7. Discolored solar cells.

The color change may occur in a different area, rather than next to the PV module. This may mean that the discoloration originates from the polymer of the encapsulation, such as EVA. Moreover, the EVA fails to disseminate in the same method in all cell parts in the same manner [53]. The discolored photovoltaic cells are shown in Figure 7.

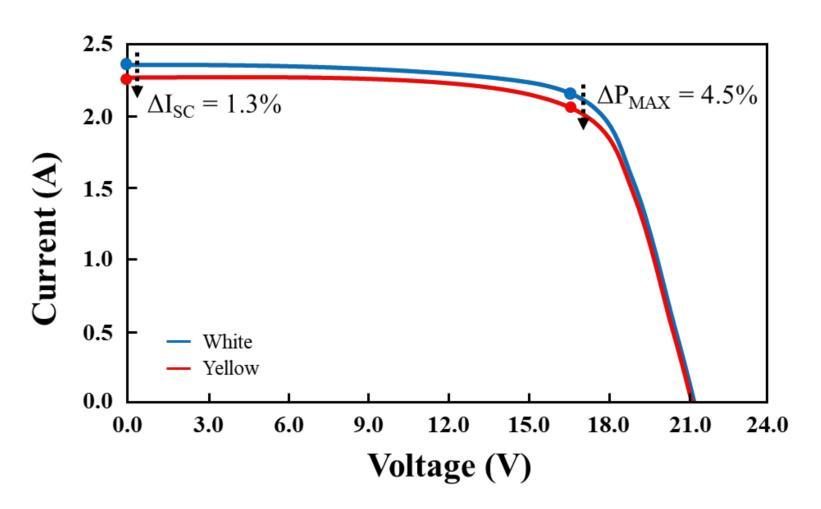
Figure 8. Comparison of the I-V (current vs. voltage) curve properties of new and discolored photovoltaic solar modules.

In recent years, most studies on the degradation of crystalline silicon photovoltaic modules have focused on the degradation of EVA [50,57,58]. Realini conducted research between 1982 and 2003, which enabled him to show a relationship between the electric features of the device and the color of the housing [59]. The color change causing partial changes to the surface of the PV module will cause the short-circuit current (I_{sc}) of the PV module to deteriorate. The I_{sc} decomposition range can be lower than the nominal value by 6% to 8% and for complete discoloration, it can range from 10% to 13%. The maximum power (P_{max}) of the PV module is correspondingly reduced, owing to the color change of the module, as shown in Figure 8 [59].

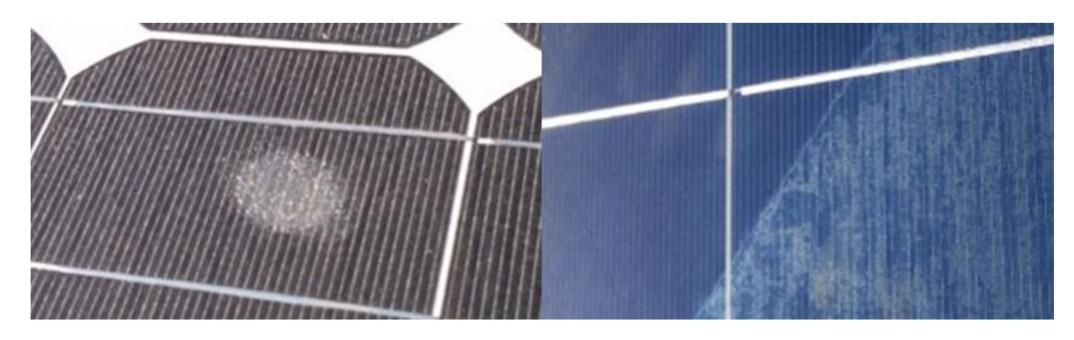
Figure 9. PV module with a delamination.

Adhesion loss (termed delamination) occurs between the encapsulation polymer and the solar cell or between the solar cell and the windshield. This is a key problem because it has dual properties: increased sunlit consideration and the diffusion of water into the equipment housing [35,60]. When the discharge occurs at the edge of the device, it will be more serious because it not only reduces the energy consumption but also causes electrical hazards to the device and the entire module.

Spills are more common in warm and humid climates. They allow moisture to enter the equipment and often cause extensive physical and chemical damage, for example, corrosion of metal for the equipment assembly. Figure 9 shows photovoltaic module delamination with a drain flange. Delamination occurs when the EVA loses its adhesive strength under high-humidity and high-temperature conditions, especially around the ribbon [48].

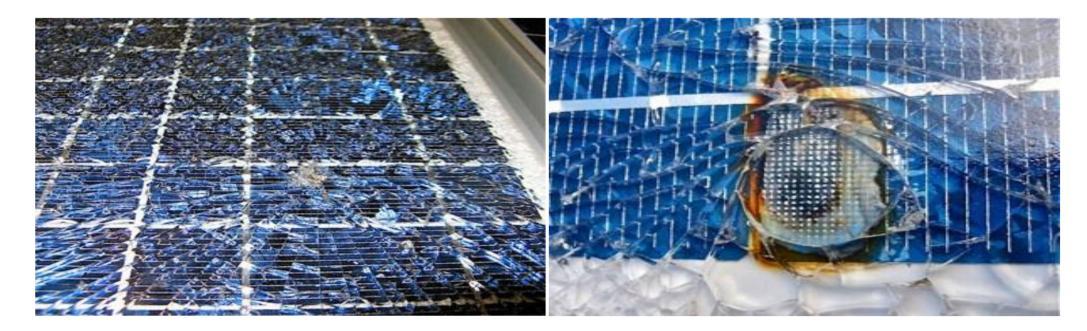
Figure 10. PV module with broken glass and cell burn.

Broken glass significantly degrades photovoltaic modules. Most of the time, this occurs when installing or maintaining the PV module, specifically when transporting the equipment to the installation site [61]. Damaged or broken equipment can still operate normally. A cracked polycrystalline PV module may run for several years while producing significantly less energy, as shown in Figure 10. However, this increases the risk of electric shock and moisture penetration. Fractures and flaws are typically accompanied by different types of degradation, such as wear, color changes, and cracks [33].

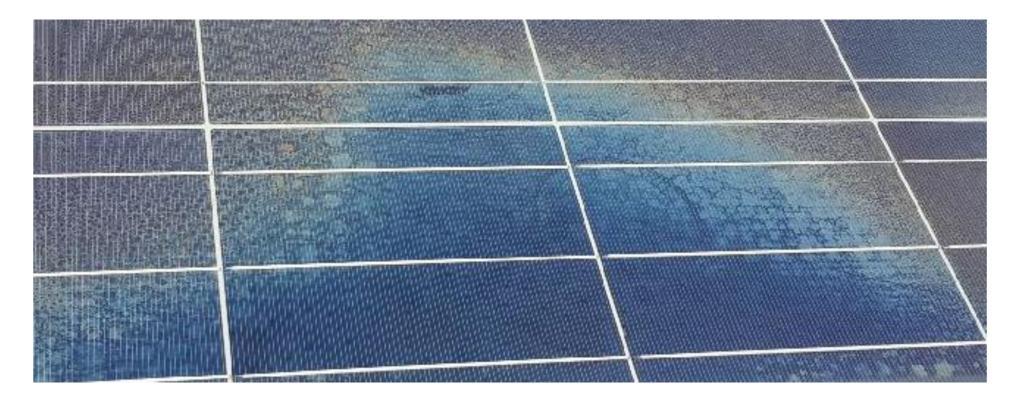
Figure 11. Bubbles in a PV module.

Figure 11 shows a photovoltaic module with many bubbles on the back and front. They typically appear at the midpoint or corner of the solar cell and this is possibly because of the poor cell bonds due to the high temperature. Placing a photovoltaic cell in front of the device can reduce the radiation entering the device that separates light and increases its reflection [35].

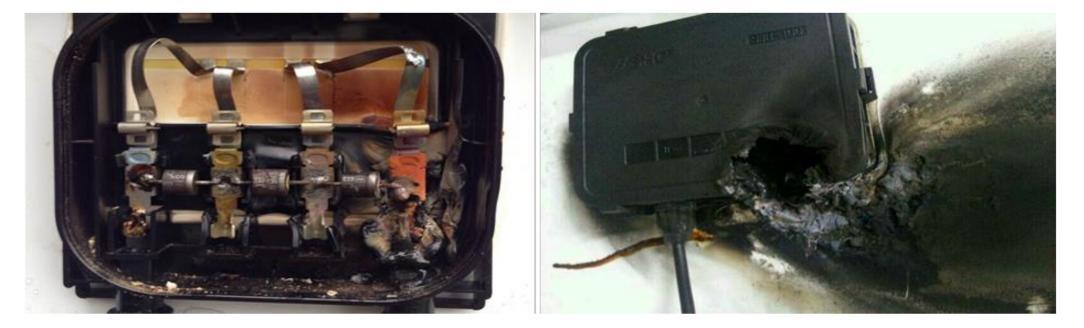
Figure 12. Junction box failures.

Figure 12 shows the failure of junction boxes. Major failure modes include burned bypass diodes and junction boxes, which in extreme cases increases the risk of fire. Major causes include excessive stress in the system, poor fixing of the junction box to the backsheet, badly closed lid, moisture, and improper wiring [70]. Junction boxes typically contain bypass diodes to protect the cells in case of shadowing or cell problems. However, Zhao Wu et al. confirmed that separating the diode from the junction box can prevent the temperature rise and failure [71].

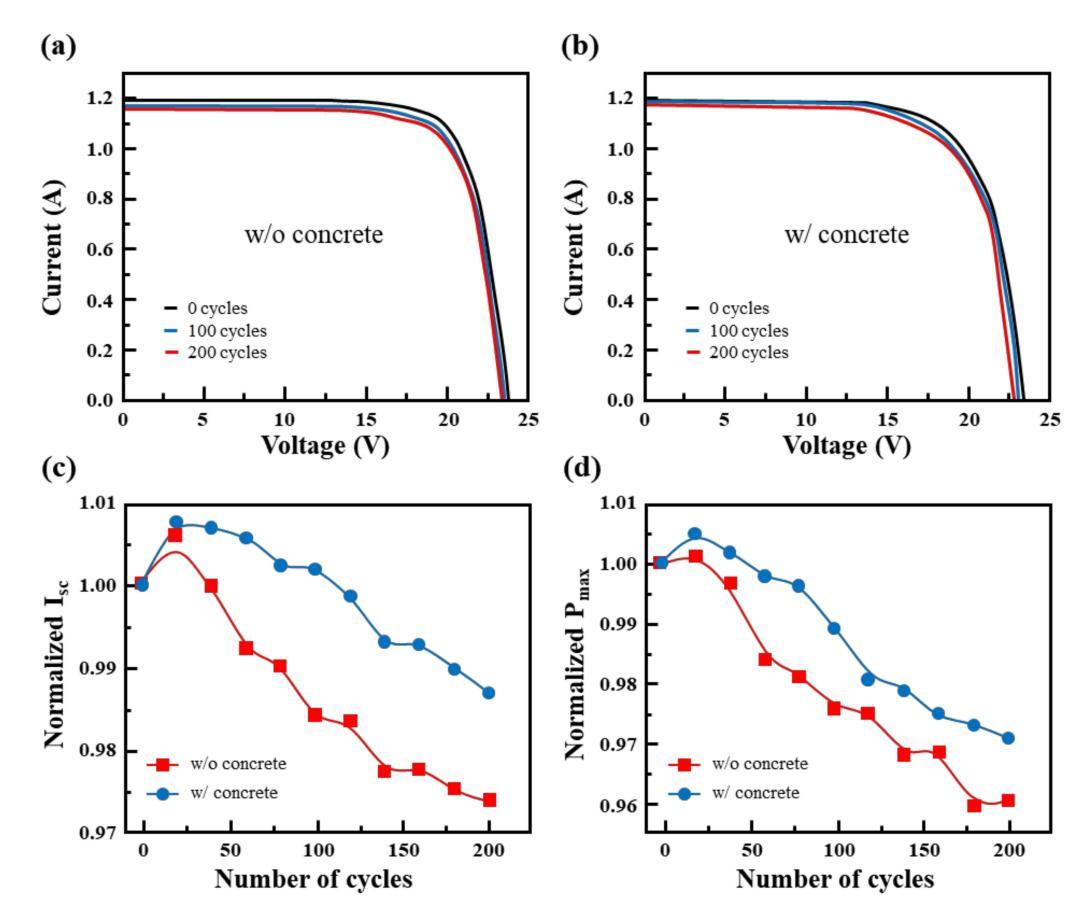
Figure 13. I-V characteristics before and after 100 and 200 thermal cycles for a PV module (**a**) without and (**b**) with concrete. The difference of (**c**) I_{sc} and (**d**) P_{max} values before and after 100 and 200 thermal cycles for a PV module without and with concrete.

A study by Khan et al. [78] explains the failure and degradation behavior of a c-Si PV module installed over a concrete slab that occurred during a TC stress test. A connection between the TC duration and the device was established. In this study, the authors used monocrystalline PV modules with an area of 1540 cm² and a rigid module (fixed on a concrete slab) consisted of 36 cells with an Al frame (cell area = 31.2 cm²). The ability of the module to withstand fatigue, thermal mismatch, and other stresses caused by temperature fluctuations was evaluated for 200 thermal cycles in a climate chamber. Figure 13 depicts the measurement of the I-V characteristics for both PV modules before and after TC (100 and 200) and a clear sign of an increase in the series resistance. The power losses after 200 thermal cycles were approximately 3% and 4% in the cases without and with concrete, respectively. This is mainly related to the thermal exhaustion of the PV module.

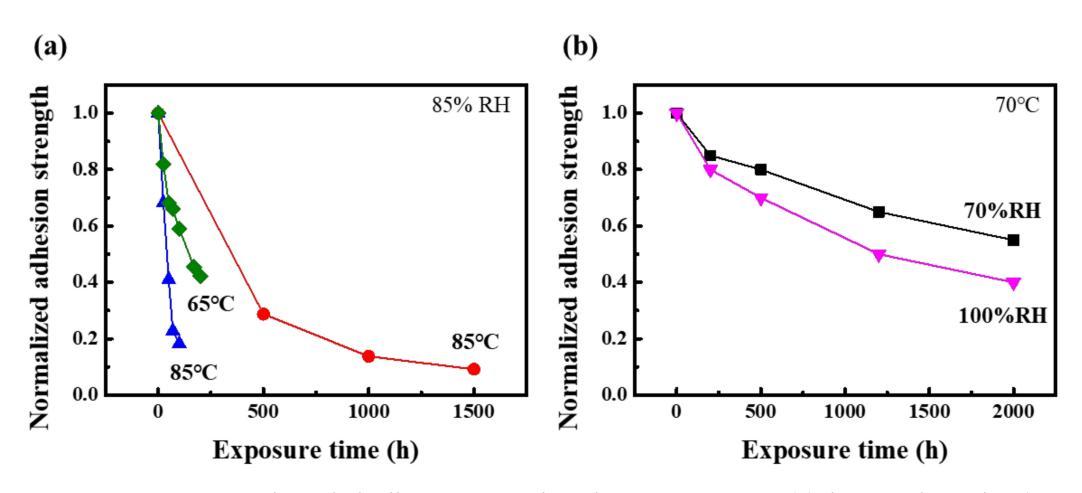
Figure 14. Variation in degraded adhesion strength with exposure time at (**a**) the same humidity (85% RH) with different temperatures and (**b**) the same temperature (70 $^{\circ}$ C) with different humidities.

The degradation of the adhesion strength of the glass-encapsulant interface after damp-heat tests is shown in Figure 14 with variations in temperature and relative humidity [82–84]. When comparing Figure 14a,b, which possess the same conditions of $85 \,^{\circ}C/85\%$ relative humidity (RH), the difference in the degradation rate is due to the difference in the initial adhesive strength. The adhesive strength shown in Figure 14a, which is initially low and decreases rapidly, even in a small amount of time. The adhesive strength shown in Figure 14b, which is initially large, decreases relatively slowly. It can be observed that the degradation is affected by both temperature and humidity, as the degradation is accelerated both when only the temperature is high and when only the humidity is high.

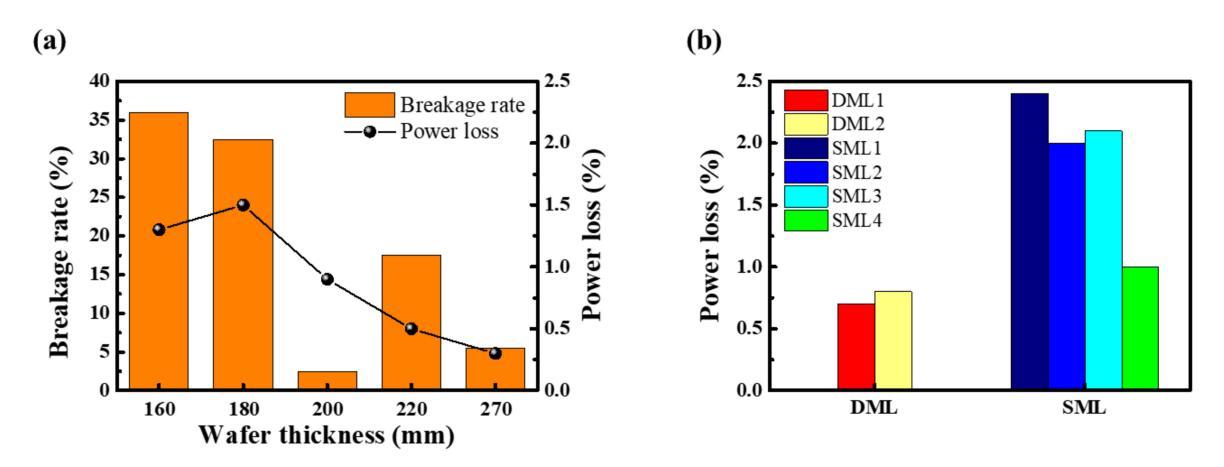
Figure 16. Degradation rate of a PV module with (**a**) breakage rate and power loss according to thickness after DML tests and (**b**) comparison of power loss between DML and SML tests.

Analyzing the breakage rate and power loss according to the thickness of the wafer revealed that both the breakage rate and the power loss increased as the thickness decreased after DML tests [96]. Figure 16b shows the power loss of the module before and after SML and DML tests. The power losses are slightly higher in the static-load modules than in the surviving dynamic-load modules [97].
