Article Old and Modern Wooden Buildings in the Context of Sustainable Development

Abstract: Construction is a powerful industry that is not indifferent to the environment. Neither the maintenance of buildings in a proper technical condition nor their eventual demolition is indifferent to the environment. The main threats to the environment are still the inefficient use of construction materials and energy needed for their production and installation, as well as the emission of harmful substances to the environment at the stage of operation of buildings and their demolition. This article discusses the importance of wood as a renewable material in terms of its physical and mechanical properties. The restoration of forest areas is of great importance to the global ecosystem and the sustainable development system, reducing the threat of global warming and the greenhouse effect by reducing CO₂ levels. In addition, demolition wood can be reused in construction, can be safely recycled as it quickly decomposes, or can be used as a source of renewable energy. The preservation of existing timber-framed buildings in good condition contributes to a lower consumption of this raw material for r

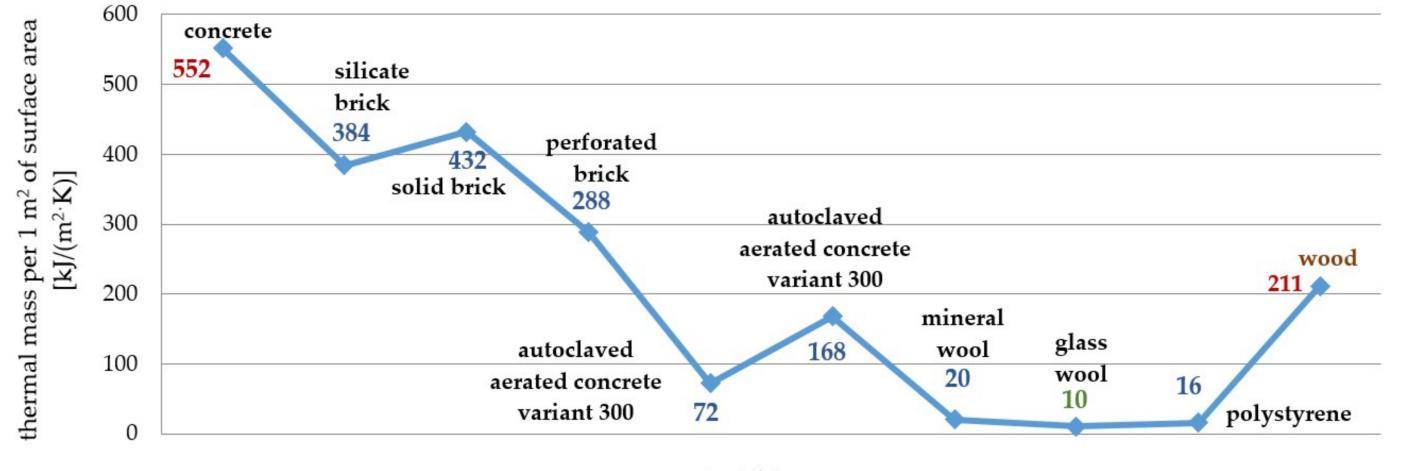
THERMAL MASS - THERMAL CAPACITY OF BUILDING MATERIALS

The thermal mass of wood (Figure 1) is average compared to other materials commonly used in construction. The heat capacity of wood is more than twice that of concrete, but at the same time more than 10 times higher than insulating materials such as mineral wool and polystyrene, which is both an advantage and disadvantage. During warm and cold periods, it will be an 'average' heat regulator of the internal microclimate of rooms, accumulating it during warmer periods and giving it away during colder periods. Wood is also not a good heat insulator in light of the current requirements for building envelopes. Its thermal conductivity coefficient λ is in the range of $0.13 \div 0.22 \text{ W/(mK)}$, which depends on the direction of heat flow, respectively, across and along the fibres. The thermal insulation properties of wood are $17 \div 11$ times more favourable than those of concrete and $4 \div 6$ times less favourable than those of mineral wool and foamed polystyrene. Wood is a good building material, but more as a structural element than as a thermal insulation layer of a partition.

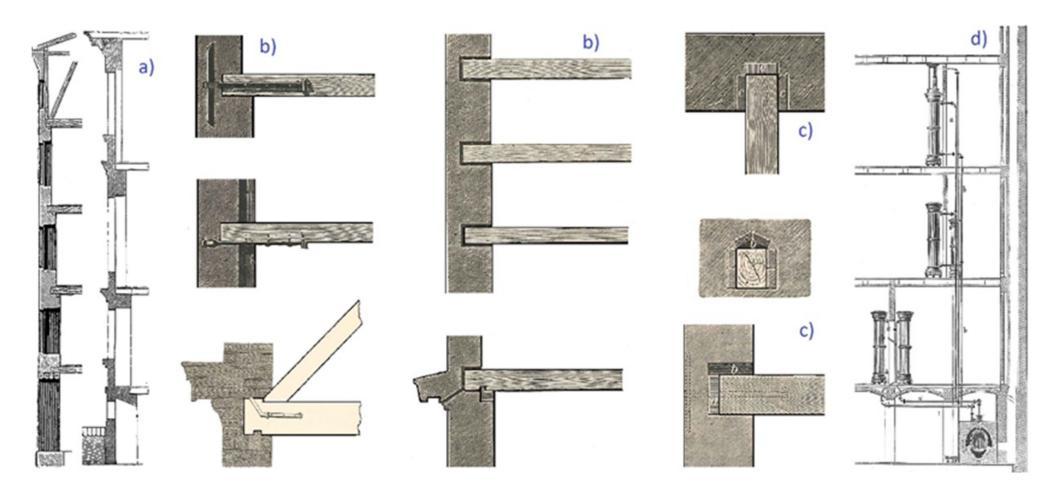
Figure 2. Principles of anchoring floor beams in the walls of 19th century buildings: (a) wall crosssection, (b) details of setting the wooden beams (c) details of setting the wooden beams, (d) central heating installation (19th century), based on [88].

Figure 2 shows, based on [88], a typical wall and ceiling layout from the 19th and first half of the 20th century in residential and public buildings. Such buildings are now thermally modernised to reduce operating costs by limiting heat loss.

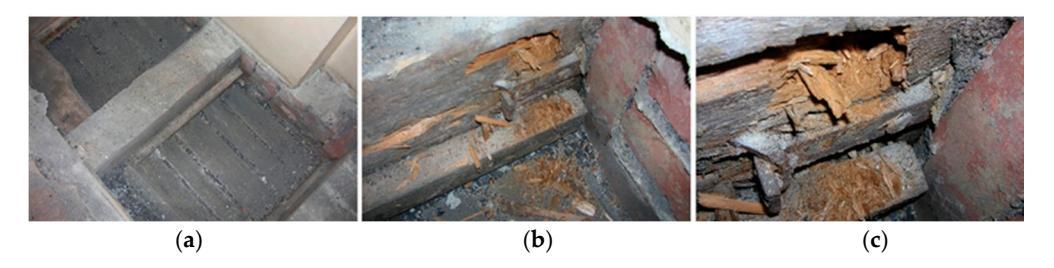
Figure 3. Examples of a damaged floor in the support and buttress zones: (**a**) no externally visible damage, (**b**,**c**) advanced brown decay of wood inside the same beam.

Many years of research and observation of the structures mentioned above have confirmed that irreversible damage was most often caused to the ends of the wooden ceiling joists embedded in the external walls (Figure 3). Most of the time, it only became apparent during a building disaster or when ceilings were replaced.

Calculations carried out on a model of the envelope based on the standard [94] using Physibel Trisco v.12w software clearly indicated the possibility of cyclic loading of the ends of floor joists embedded in external walls with negative temperature (Figure 4(1a,b,2a,b)). The condensation of moisture within the envelope caused by the temperature difference on both sides during the autumn–winter period and its subsequent drying out during the spring–summer period will not be indifferent to the wood embedded in the masonry, which is at risk of biological corrosion. Furthermore, soggy timber in the low temperature zone of $-6 \degree C$ (Figure 4(1a,b)) and $-8 \degree C$ with an insulated wall (Figure 4(2a)) will be exposed to frost damage and its fluctuating moisture content causing swelling and shrinkage may permanently damage it. Wood may also undergo brown decay caused by basidiomycosis, followed by brown staining and spalting (Figure 3).

Temperature distribution and moisture migration within a building envelope will always be the determining factors for its serviceability and durability. Current European regulations require complete elimination of moisture, the probability of surface condensation of moisture in rooms, the moisture caused by condensation over the years, and corrosion of materials installed in partitions. Insulation of partitions on their internal sides will considerably improve their thermal insulation parameters and the microclimate of rooms, but an incompetent application of this method, without justification by appropriate thermal and moisture calculations, will lead to the opposite effect than expected, with a high probability of their damage and built-in materials with low resistance to biological corrosion. Physical phenomena occurring inside building envelopes, including historic buildings, should always be taken into account to protect them from partial or total degradation (Figure 3).

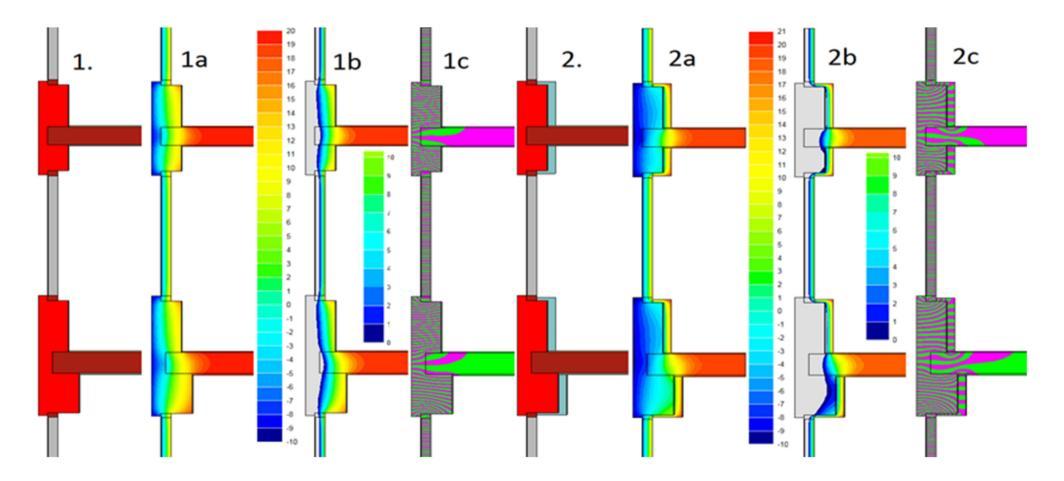
Figure 4. Models of temperature distribution in the external wall in the place of the support of wooden ceiling beams: (**1**,**2**) model of the partition in its original state (after thermal insulation from the inside), (**1a**,**2a**) temperature distribution field, (**1b**,**2b**) temperature distribution field limited by an isotherm of 0 °C, (**1c**,**2c**) lines of density of heat fluxes in the zones of support of ceilings on the wall.

Figure 4 shows the temperature distribution in the cross-section of the facade wall of the 19th century with windows, in which the ends of the wooden ceiling joists were embedded for two variants: in the unaltered state and after internal insulation with a material with a thermal conductivity of $\lambda \leq 0.045 \text{ W/m}^2\text{K}$ and a thickness of 10 cm at an ambient temperature of $t_z = -10$ °C and an internal air temperature of $t_w = +20$ °C. Figure 7 shows the results of thermal imaging of an external wall, insulated inside with 10 cm thick mineral wool and finished with drywall, where its fixed steel frame is clearly visible (a model of the above wall is shown in Figure 4).

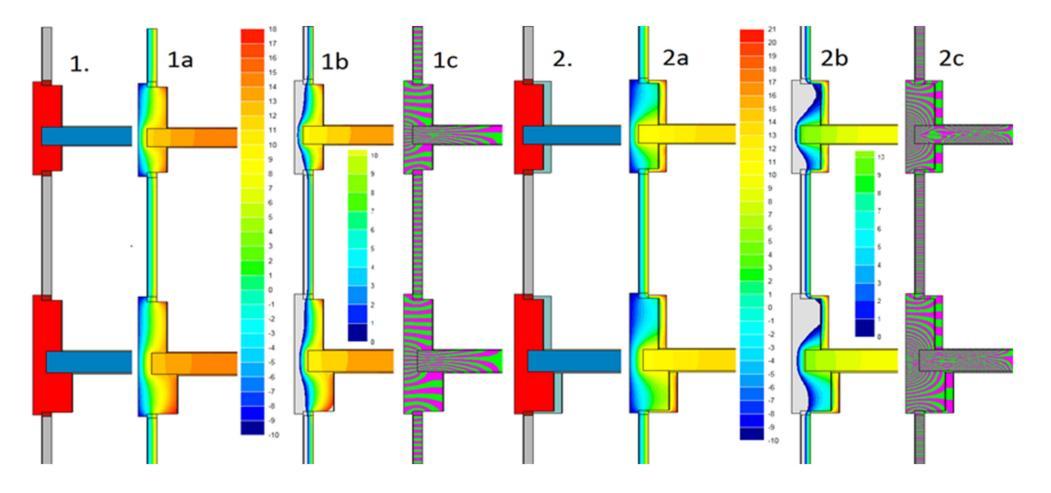
Figure 5. Models of temperature distribution in the external wall, in place of the support of iron or steel ceiling beams: (**1**,**2**) model of the partition in its original state (after insulation from the inside), (**1a**,**2a**) temperature distribution field, (**1b**,**2b**) temperature distribution field bounded by an isotherm of 0 °C, (**1d**,**2d**) lines of density of heat fluxes in the zones of support of ceilings on the wall.

In Figure 5(1b,2b), the temperature distribution fields bounded by the 0 °C isotherm are shown. The ends of the steel beams, being good conductors of heat, are located here in a temperature range of +10 °C in the uninsulated wall and +9 °C in the internally insulated wall. This isotherm configuration is very favourable for unprotected beams, although these areas generate considerable heat losses (Figure 6). The problem may be that the outer layer of masonry covering the ends of the beams is too thin and may not be sufficient to protect the iron (steel) from rainwater penetration and hence corrosion. However, leaving such buildings without adequate protection leads to significant and uncontrolled heat loss. There are still many such buildings in Central and Eastern Europe, which, due to their historical character, cannot be, e.g., insulated from the outside, while insulating the partitions in which they are located (from the inside) increases the problem of heat loss.

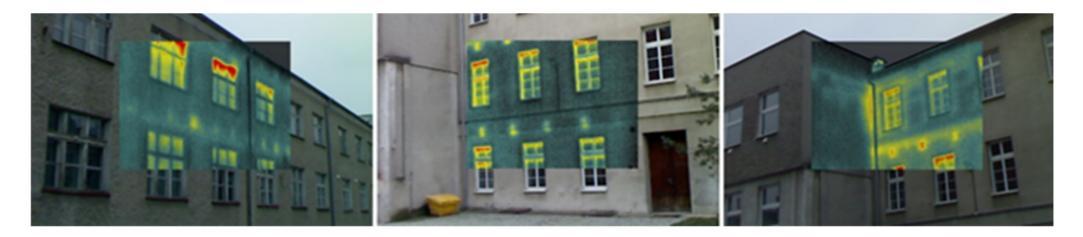
Figure 6. Location of point thermal bridges where steel beams are embedded in the external wall—the ends of the beams are clearly visible.

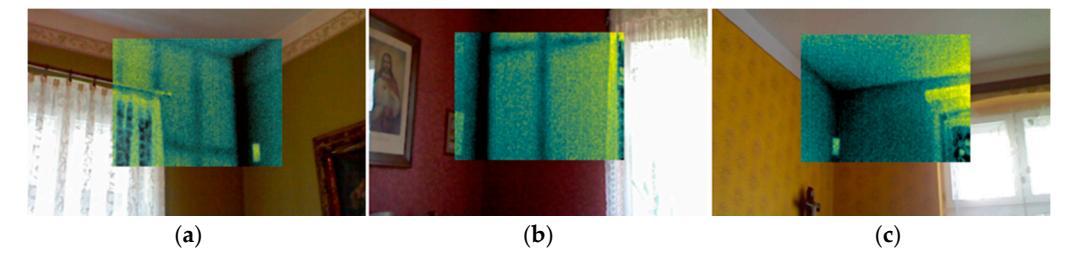
Figure 7. Thermogram of half-temperature distribution in the external front wall, insulated from the inside with 10 cm mineral wool and finished with plasterboards, (**a**) south-west corner of the first floor, (**b**) south-east corner of the second floor, (**c**) north-west corner of the second floor with an attic ceiling insulated from the outside on both sides with a layer of 10 cm foamed polystyrene.

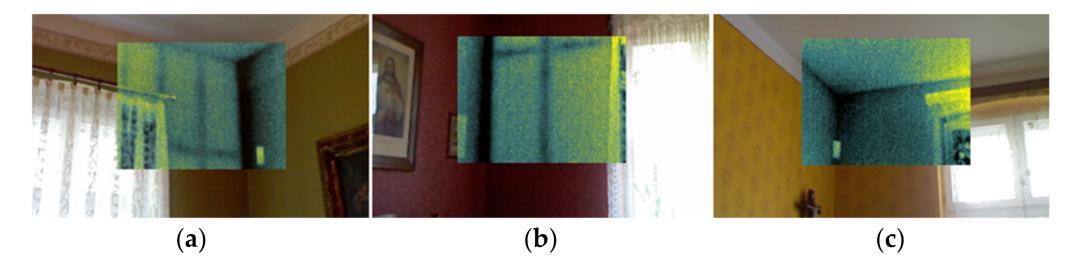
Figure 8. Diagram of the temperature distribution at the junction of the external walls of the building (Figure 5a), with the front wall insulated from the inside and the gable wall from the outside: (a) view of the wall, (b) thermal bridge system in the place of the grate and in the corner, (c) temperature diagram covering the corner— $\Delta T = 3.4$ °C.

Figure 8 clearly shows the linear thermal bridge between two external walls, one insulated inside and the other outside. The temperature difference between the fully insulated surface and the corner (where the insulation is discontinuous) is approx. +3.4 °C (the thermovision test was performed at $t_z = 0$ °C, $t_w = +20$ °C and $\varphi_w = 50$ %).

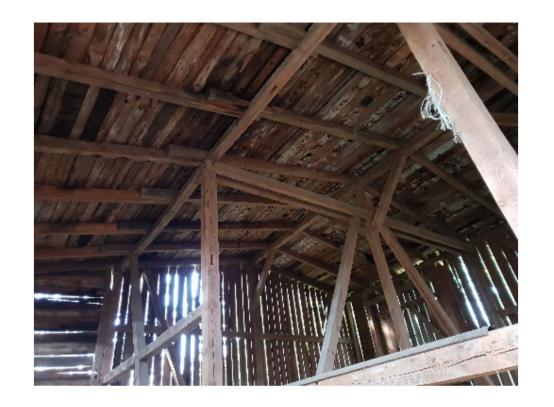
Figure 11. View of the bearing structure.

An example of the degradation of a timber structure is the 1900's barn building shown in Figure 10. Biological corrosion processes have led to a significant weakening of the load-bearing capacity of sections, significantly affecting the load-bearing capacity of timber frames. Therefore, adequate static and strength analyses of the system were carried out. The actual view of the girders is shown in Figure 11, which shows the losses caused by biological corrosion.

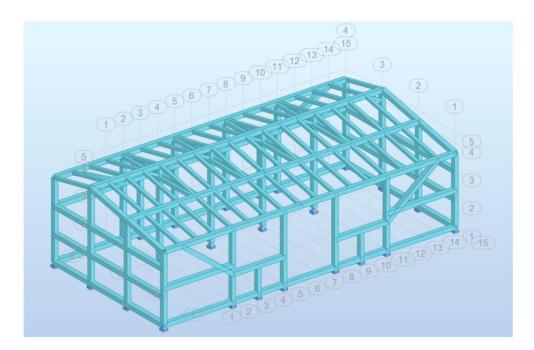
Figure 12. Construction model.

The structure model (Figure 12) was created in Autodesk Structural Analysis Professional 2018 software, reflecting the connections between individual structures through redundancy in the bar joints, especially taking into account the cutoff points of the main columns of load-bearing structures, which were reflected by means of hinges and the introduction of claddings enabling the application of loads. The dimensions of the sections are presented and are in Table 1. Verification was carried out according to the set of PN-EN standards [96,122], which are generally considered up to date, but according to the authors, the set of PN standards [123–125] would be adequate.

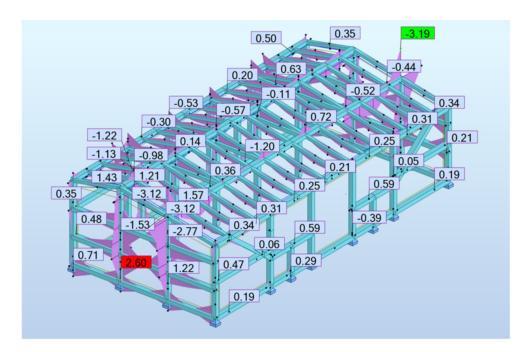
The static analysis (Figure 13) showed instability of the first type at the place of introduction of additional hinges, which means the presence of an element of zero value on the diagonal of the stiffness matrix. In the case under consideration, this type of instability is caused by the mechanical instability of the structure because part of the structure has become a mechanism—the parameters of the structure supports (number, type, and position of supports) are not sufficient.

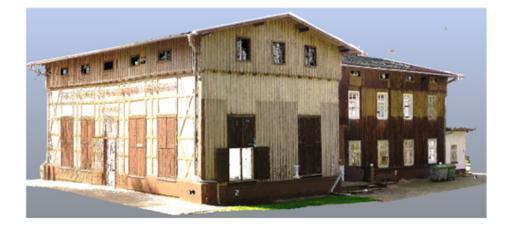
Figure 14. Casino elevation 3D scan.

The 3D HDS scanner used proved to be an excellent tool for obtaining a detailed inventory of the object. The device created a point cloud, which, when processed, gave a very accurate, three-dimensional image of the object. The inventory made in this way was used for further work. The observed deflection (Figure 16) of the roof structure is caused by many years of use of the object.

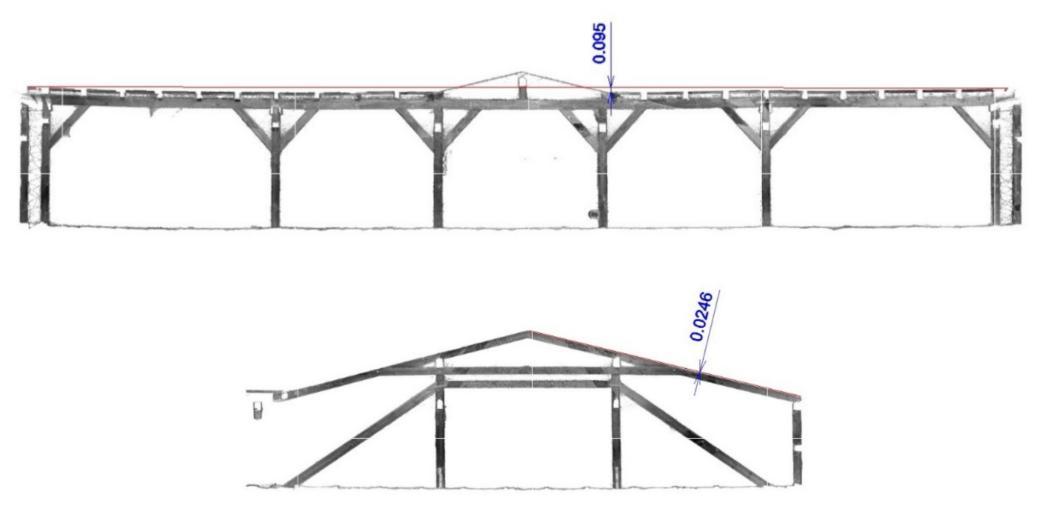
Figure 16. Section through the roof with deflection measurements.

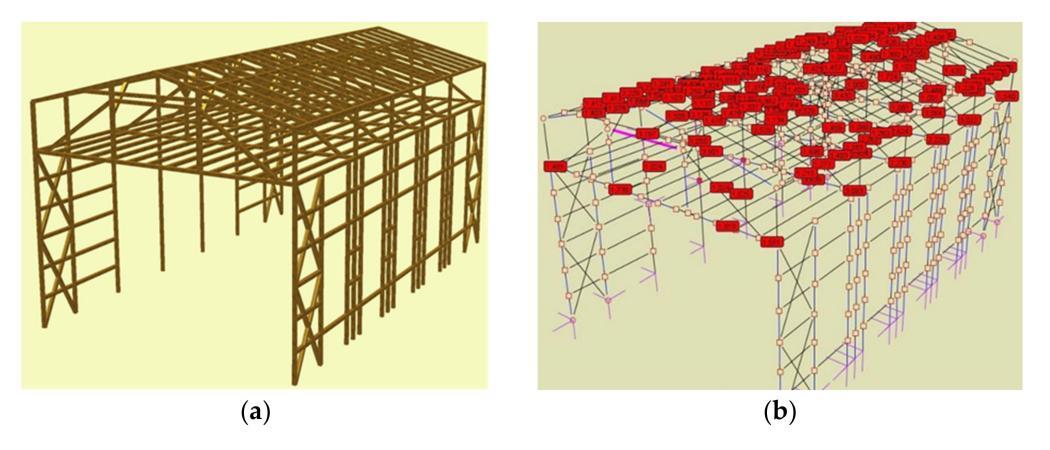
Figure 17. Skeletal structure model of the main segment (**a**), and elements with exceeded bearing capacity (**b**).

In Figure 17a, a structure calculation diagram is given, together with an indication of elements that may not meet the load-bearing capacity condition. Furthermore, the calculation results clearly show that the displacements are considerably exceeded, especially for the columns, but the ballast provided by the brick fill is not taken into account in the calculation model.

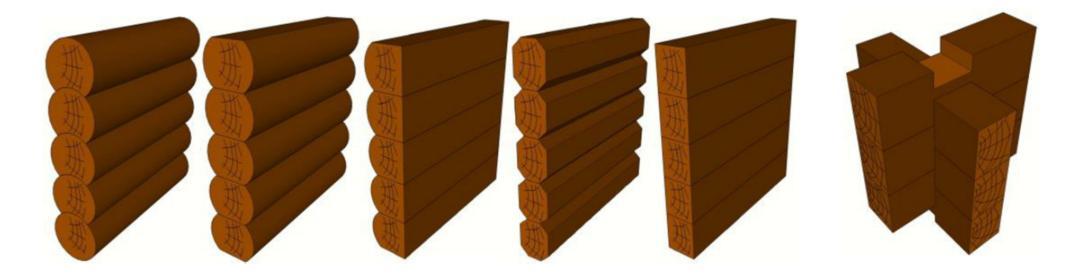
Figure 19. Method of making wooden beam walls.

Figure 19 shows the principle of creating wall connections on the beam. Particularly noteworthy here are the tightness of the connections of the individual beams and the uniformity of the partitions in the corners (nodes) of the buildings, even after 200 years of use. The walls made in this way constituted a uniform structure throughout their entire surface, with small thermal bridges at the horizontal joints of the beams (Figure 20).

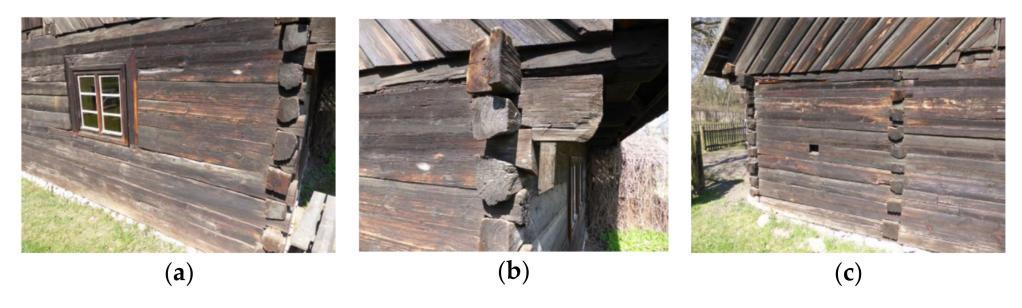
Figure 20. Wall beam connections in traditional construction: (a) north site, (b) south site, (c) east site.

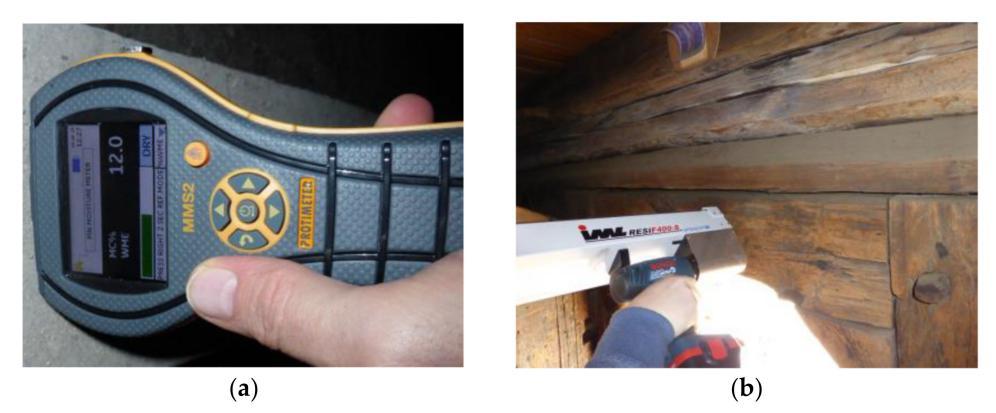
Figure 21. Wood testing: (a) by moisture measure meter and (b) by resistograph.

The moisture of the wood mass was measured using a Protimeter MMS2 moisture meter (Figure 21a). The moisture mass content of the wood did not exceed 15% at any of the measurement locations. Examination of the wood using a resistograph did not show any loss in its structure greater than 10% of the active cross-section of the elements (Figure 21b).

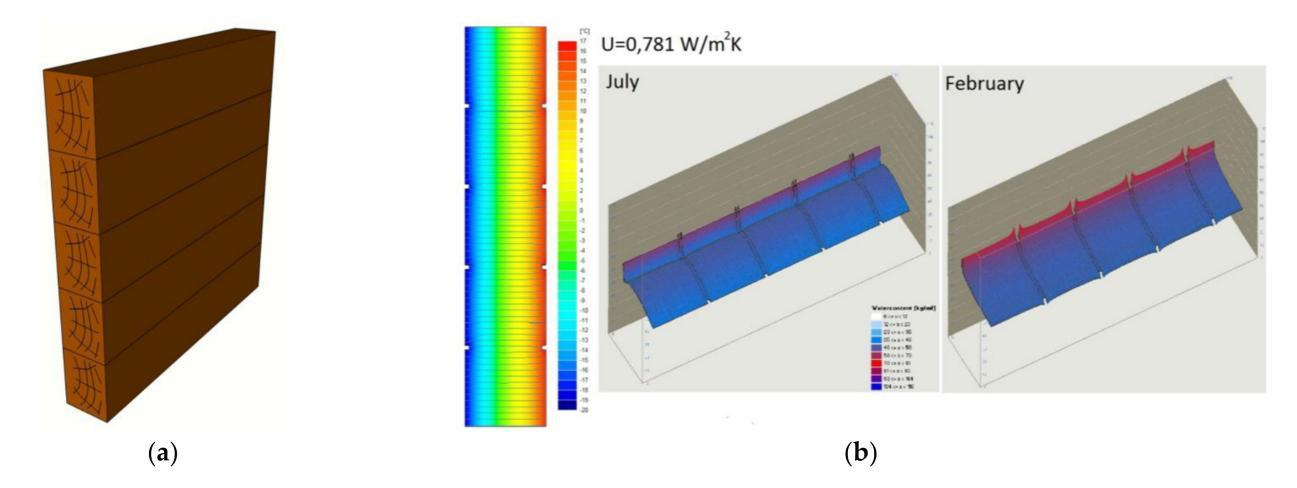
Figure 22. Results of simulation calculations for an average wall made of wooden logs: (**a**) isotherms of temperature distribution from -20 °C on the external side to +20 °C on the internal side, (**b**) humidity distribution on the wall in summer and winter.

Figure 22 shows the distribution of temperature and moisture in a homogeneous tie wall made of wooden logs. A homogeneous (parallel) adiabatic pattern of heat flux can be clearly seen, indicating the stability of the wall structure (Figure 22a). Furthermore, the moisture level in the interior of the wall and its internal surface showed small variations (Figure 22b). Simulation calculations were carried out for a wall approximately 20 cm thick using Physibel Trisco 13v software (temperature distribution) and WUFI 2D software (moisture content).

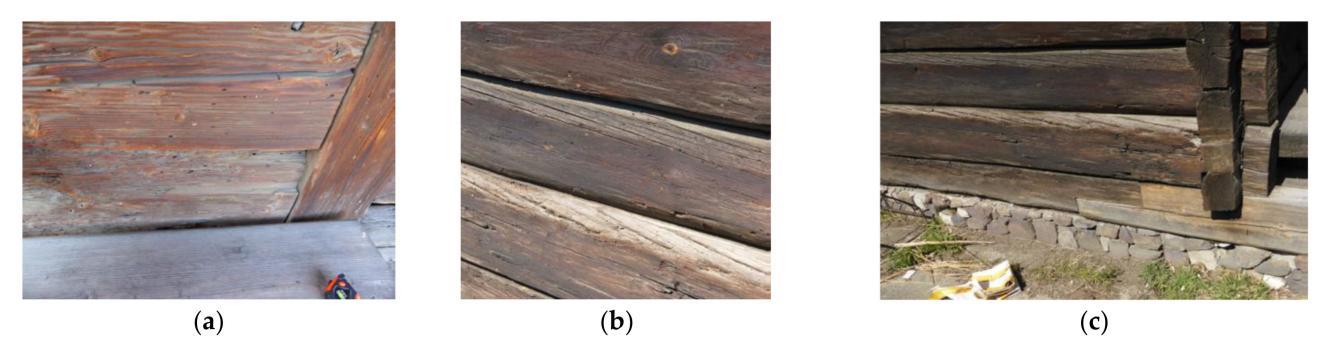
Figure 23. Biological infestation of wood: (**a**) exit hole of the insect, Common Furniture Beetle (Anobium punctatum); (**b**) exit holes of the insect, House Longhorn Beetle (Hylotrupes bajulus); (**c**) brown decay of the sill beam (part of which has been replaced with a new one) and the beam immediately above it.

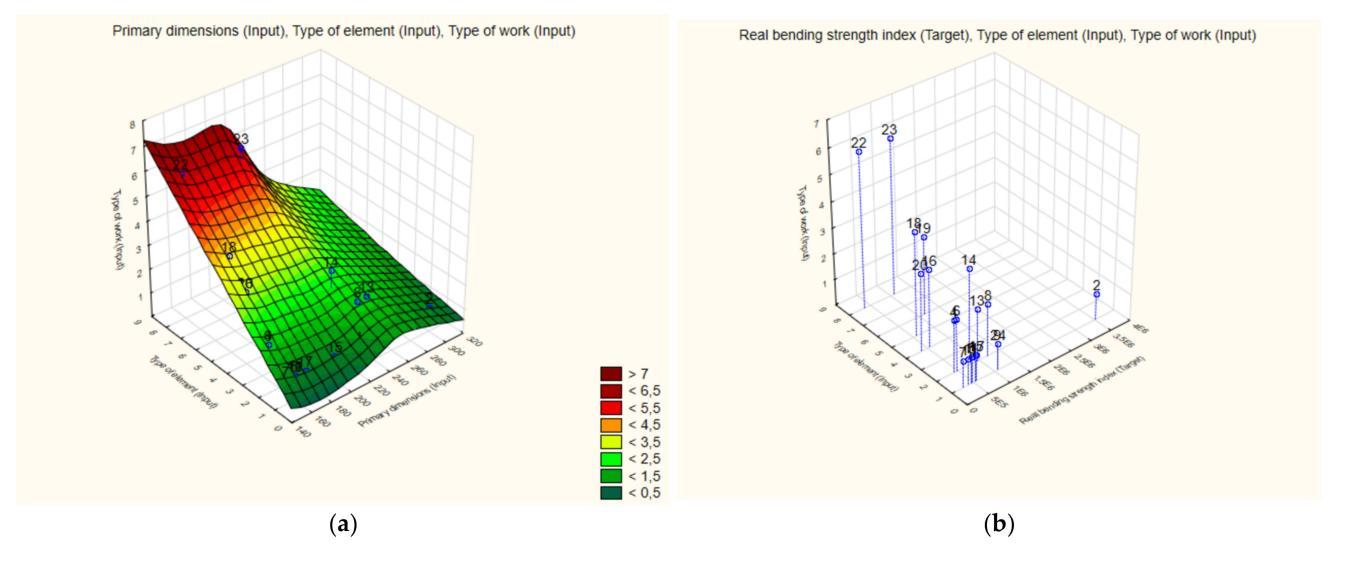
Figure 26. Prediction results: (**a**) 3D plane distribution conditional on work type, element type and original dimensions, (**b**) 3D histogram conditional on work, type, element type and actual strength index.

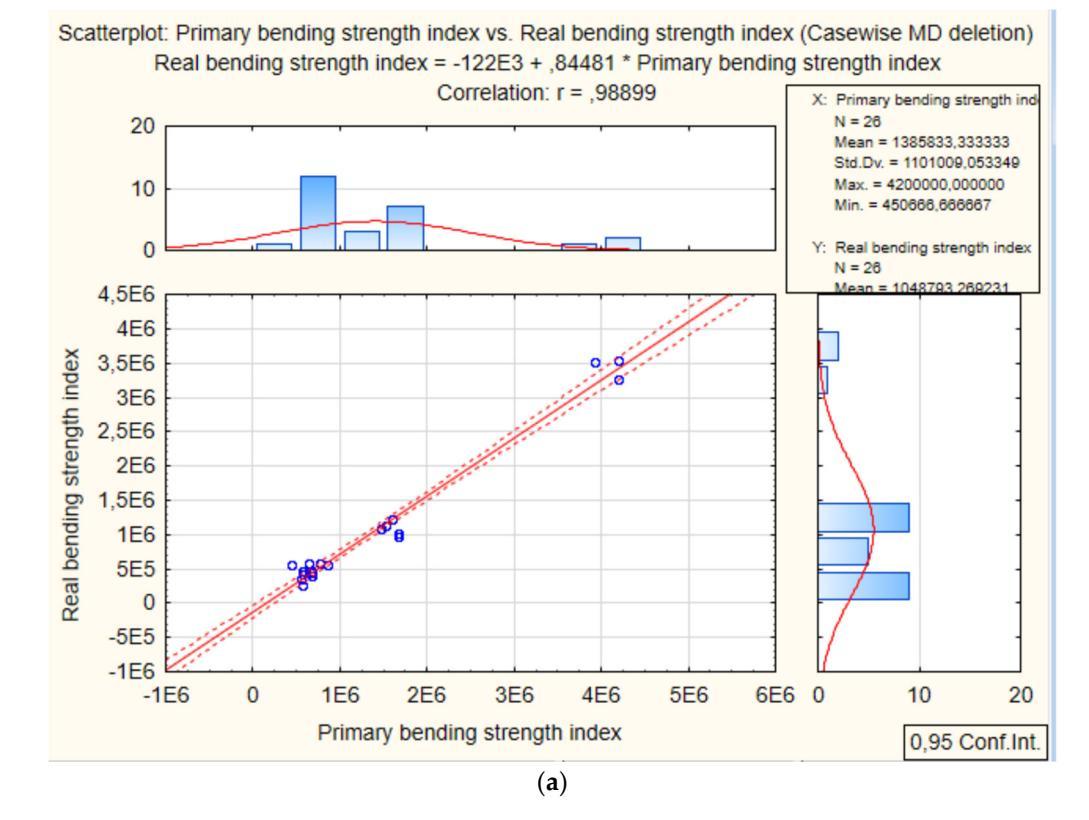
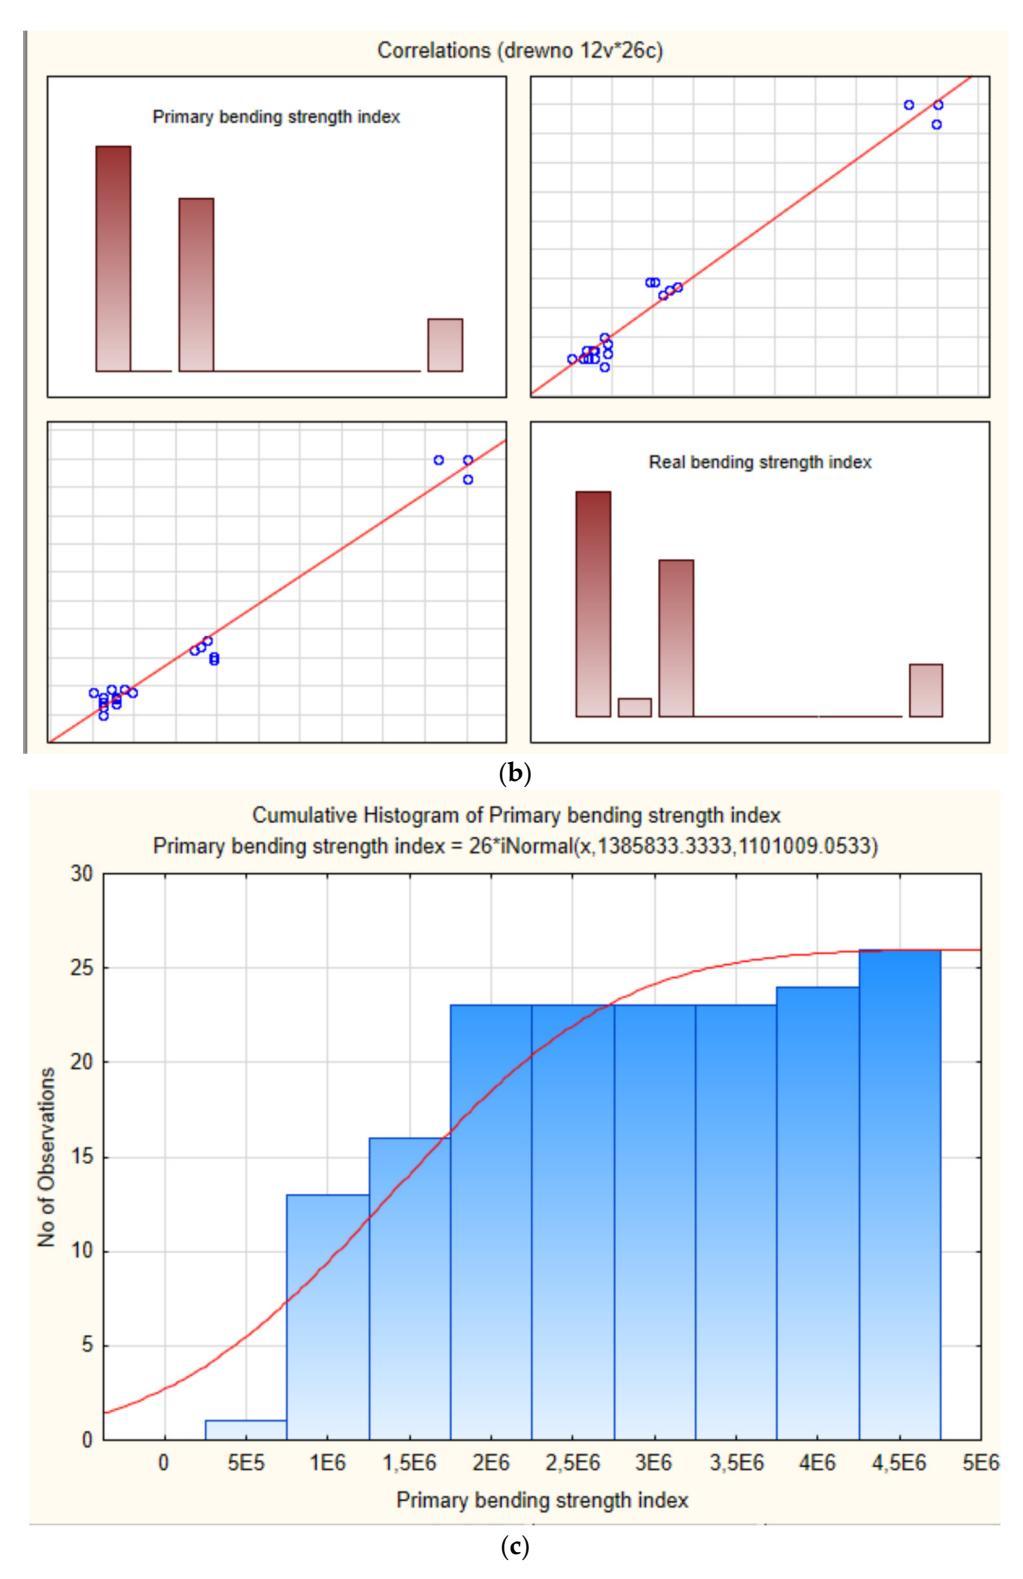
Figure 27. Statistics of the dependence of the actual strength index on the original strength index: (a) scatterplot primary bending strength index, (b) correlations, (c) cumulative histogram of primary bending strength index.
