Citation: Sokolski, P.; Sokolska, J. A Method of Comparative Evaluation of the Drive Units of Two Bucket Elevators—A Case Study. *Energies* 2021, 14, 7439. https://doi.org/ 10.3390/en14217439

Therefore, this article presents the results of research and comparative analyses of the technical condition of two drive units in twin bucket elevators operating in the fuel supply system of a power plant in Poland.

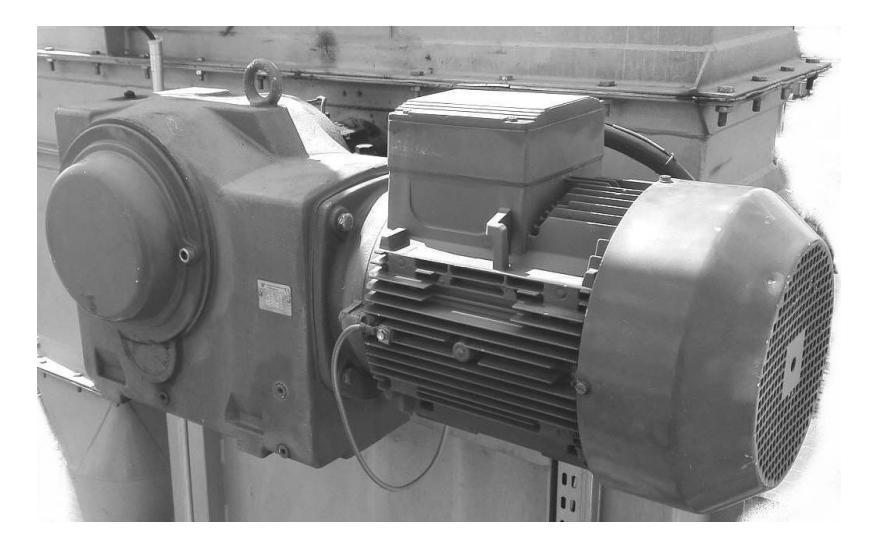
Figure 1. Drive unit of one of the studied bucket elevators.

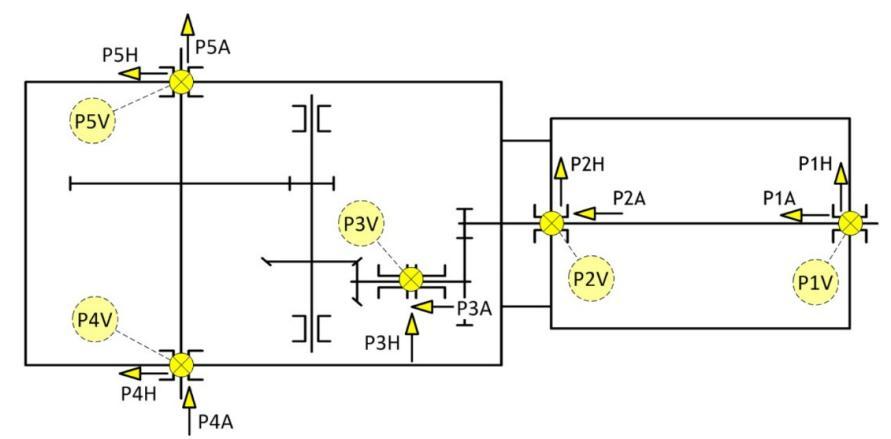
During the tests, the velocity and acceleration of vibrations were measured at the following 5 points located on the bearing housings of both drive units (Figure 2):

- Two points, P1 and P2, located on the engine bearing units;
- Three points, P3, P4 and P5, located on the bearing units of the gear.

Figure 2. Location of measuring points on the drive unit.

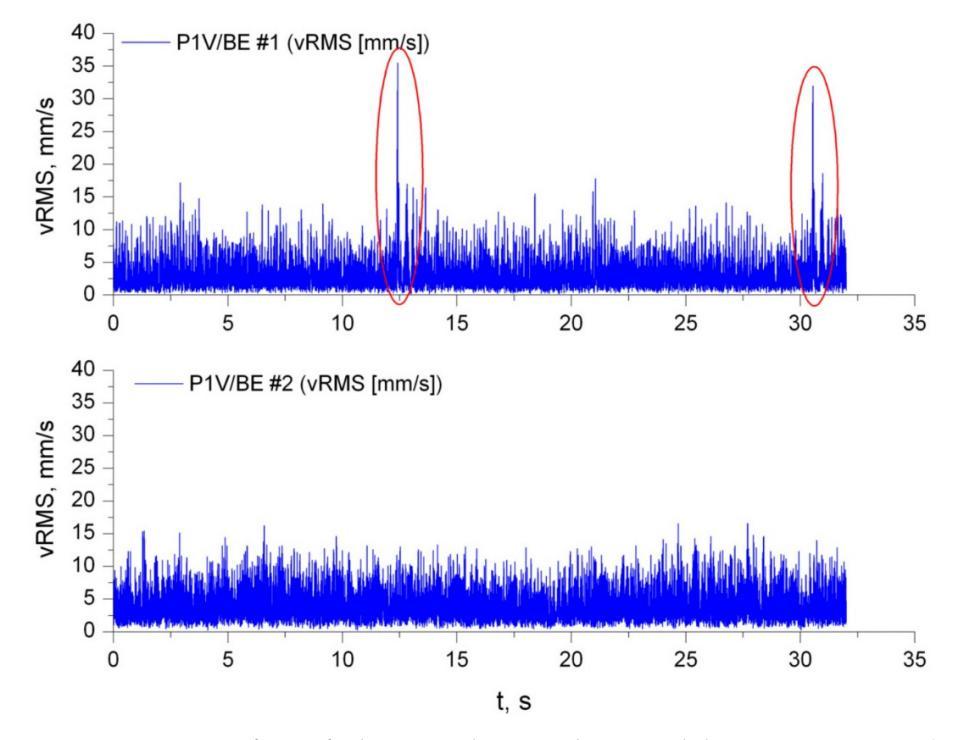
Figure 3. Time waveform of vibration velocity in the vertical direction in point P1 (on the outer bearings of the driving motors) in bucket elevators BE#1 (**upper diagram**) and BE#2 (**lower diagram**). Two extreme peaks in BE#1 are marked with red and explained below.

However, in the first bucket elevator, BE#1, there were quite high Peak values that occurred periodically in the vibration velocity signals, and they could not have been caused by the operation of the drive unit. The repeat time of these Peaks was approximately 19 s (Figure 3), which is equal to a full circulation time of the bucket chain: $T_{ch} = L/v = 19.5$ s (where: *L* is the length of the chain and *v* is the speed of the chain).

On this basis, these Peaks were recognized as a symptom of a local defect of the bucket chain, e.g., seizure of a pin joint in chain link. This is an additional diagnostic conclusion that is not directly related to the drive unit, but to the overall technical condition of the traction system of the bucket elevator BE#1.

The highest values of the Crest factor and Impulse factor measured in bucket elevator BE#1 were caused by the high Peak values of vibration velocity (Figure 3). The higher level of vibration severity at points P1 and P2, as compared to other measuring points, was

Moreover, there was a local defect in the bucket chain in elevator BE#1 that caused quite high Peak values of vibration velocity. These peak values occurred periodically and were observed especially in points P1 and P2 located on the electric drive motor (Figure 3).

This conclusion is slightly different than that from the deterministic estimation in the time domain using the classic Crest factor and the Impulse factor. The single Peaks of vibration velocity that occurred in the BE#1 elevator (Figure 3) formally increased the Crest factor and Impulse factor values. However, these Peaks were recognized as a symptom of a local bucket chain flaw in BE#1 elevator and were not caused by the drive unit.

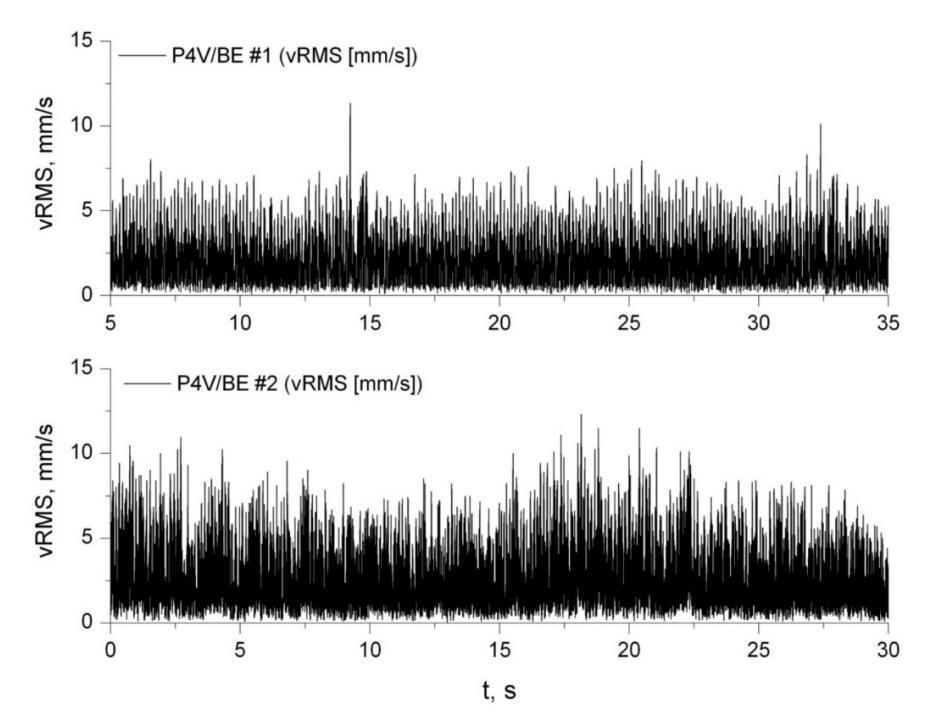
Figure 4. Time waveform of vibration velocity in the vertical direction at point P4 (on the bearings on the left-hand-side of output shafts) in bucket elevators BE#1 (**upper diagram**) and BE#2 (**lower diagram**).

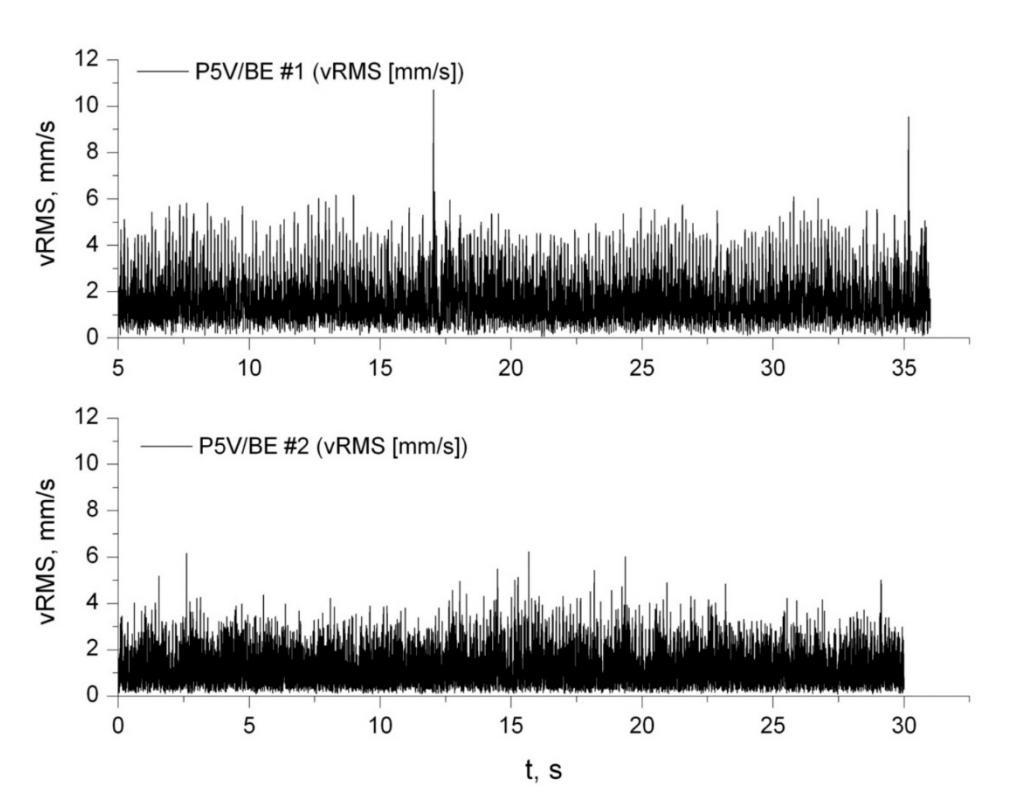
Figure 5. Time waveform of vibration velocity in the vertical direction at point P5 (on the bearings on the right-hand-side of output shafts) in bucket elevators BE#1 (**upper diagram**) and BE#2 (**lower diagram**).

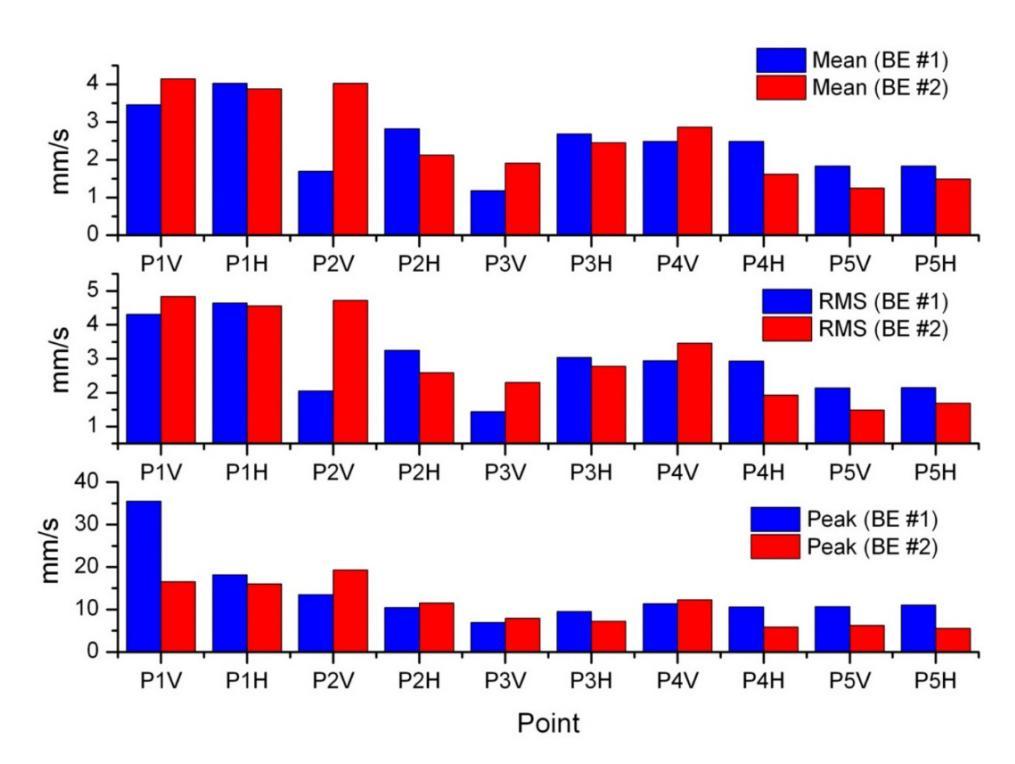
Subsequently, basic simple estimators, such as Mean Value, Peak Value, RMS, Crest Factor, and Impulse Factor were determined for each vibration signal. These estimators are more useful in the time domain analysis when assessing the technical condition of machines. The results are shown in Figures 6 and 7.

Figure 6. Mean, RMS and Peak values of vibration velocity in the drive units of the tested bucket elevators BE#1 and BE#2.

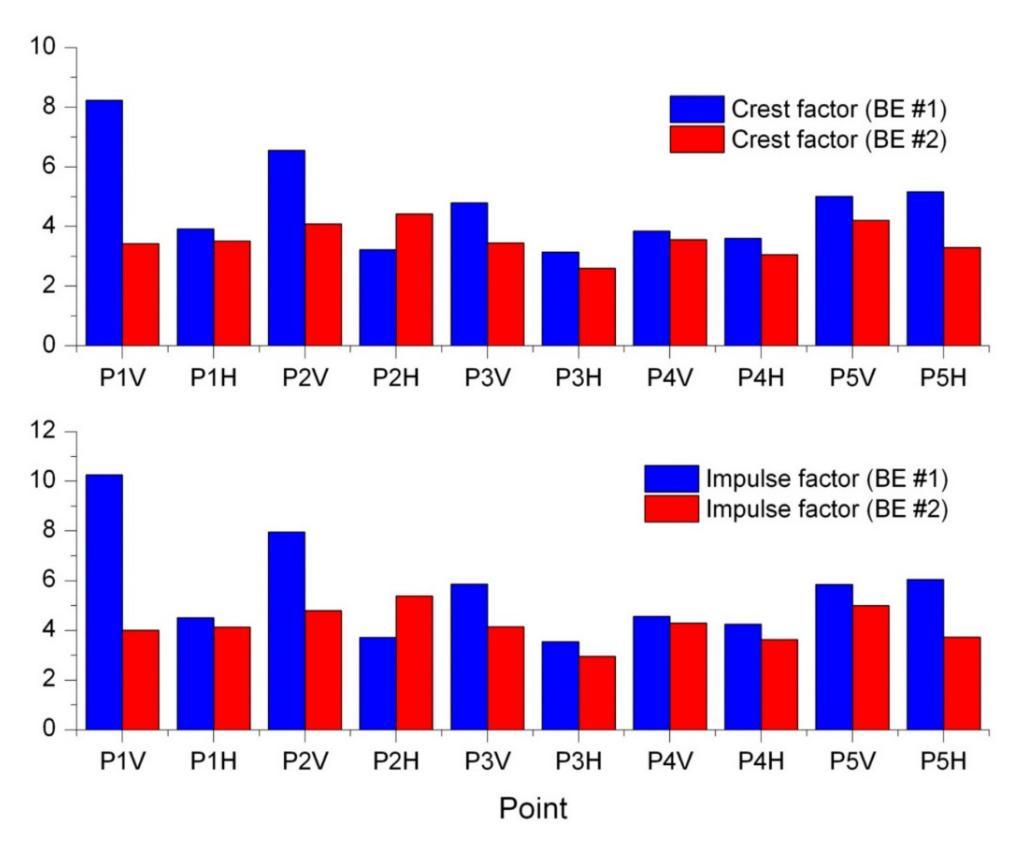
When used as diagnostic measures, higher values of these velocity signals are considered as symptoms of a worsening condition of the drive unit under evaluation. The analysis of diagnostic signals in the time domain showed that the highest vibration intensity occurred in the motor bearing units, with slightly smaller values occurring in elevator BE#1 than in elevator BE#2 (Figure 7).

Figure 7. Crest factor and Impulse factor of vibration velocity in the drive units of the tested bucket elevators BE#1 and BE#2.

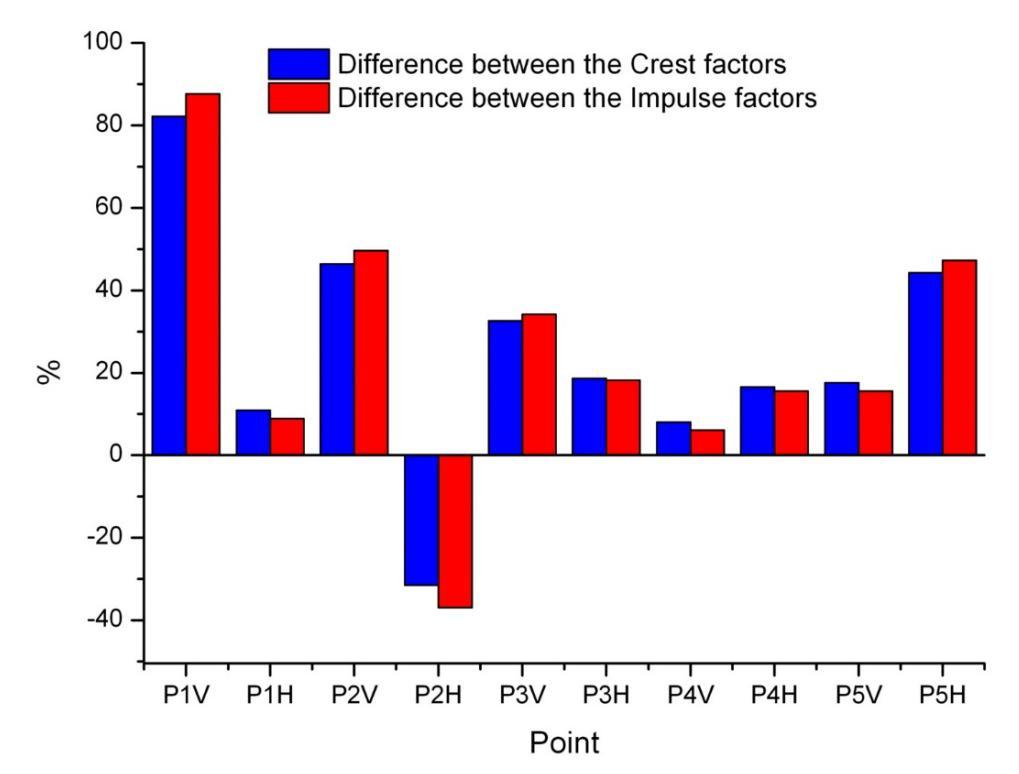
Figure 8 shows differences between the values of the Crest factor and Impulse factor at points P1 to P5 in the drive units of elevators BE#1 and BE#2. The differences between the vibration intensity level in both drive units were assessed on the basis of an additional index of relative difference W_{CF} adopted in this study and defined as the ratio of the difference between the Crest factor values (*CF*) to their average value at respective measurement points P1–P5:

Figure 8. Relative differences between the Crest factor and the Impulse factor of vibration velocity at the measuring points of the tested drive units.

The values of the W_{CF} coefficient are shown in Figure 8. A positive value of $W_{CF} > 0$ means that the Crest factor at a given point in the drive unit of BE#1 is higher (vibration intensity is greater) than the one for the corresponding point in the drive unit of BE#2 and vice versa: a negative $W_{CF} < 0$ means a lower vibration intensity in the measuring points in the BE#1 group (as compared to the BE#2 group).

The maximum differences in the Crest factor and Impulse factor values occurred at P1 points (in the vertical direction) in the motor bearing units and they reached the level of 80–90% (Figure 8). This was due to the presence of large, single Peaks of vibration velocities in bucket elevator BE#1. These peaks were identified as a symptom of local bucket chain damage, most probably a partial seizure of the pin joint.

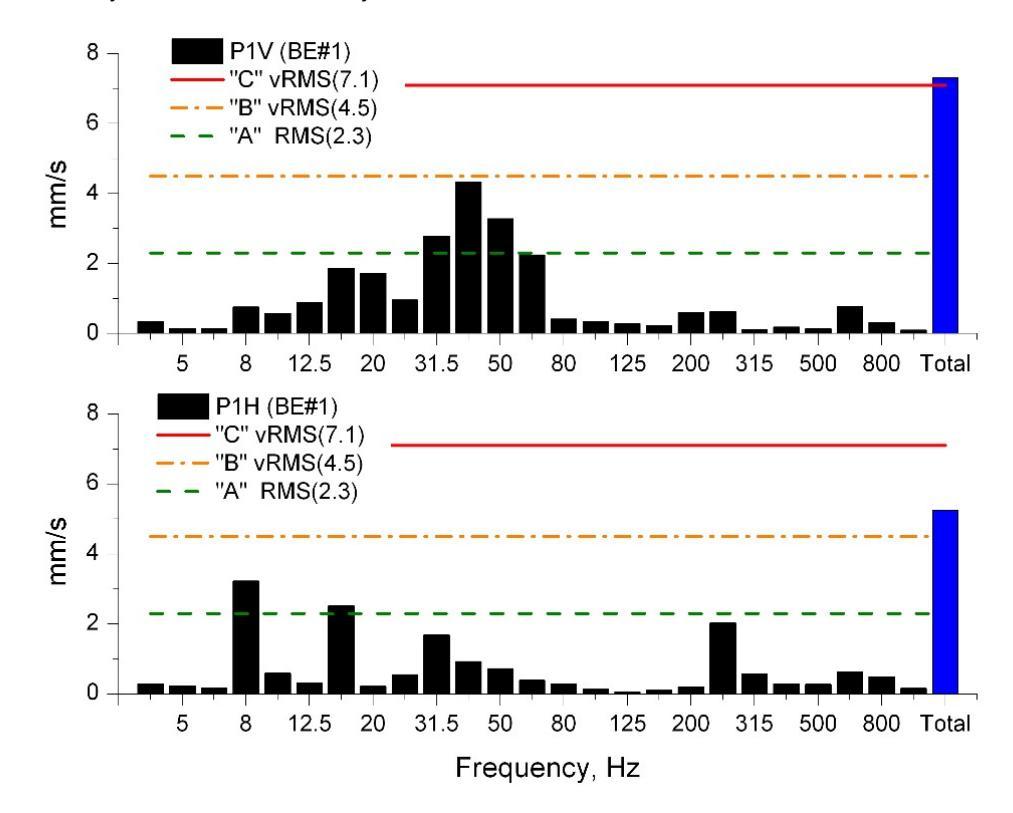
Figure 9. Typical spectrum of the RMS vibration velocity at point P1 in bucket elevator BE#1: in the vertical direction (**top**) and in the horizontal direction (**bottom**). The column with the total value is marked in blue.

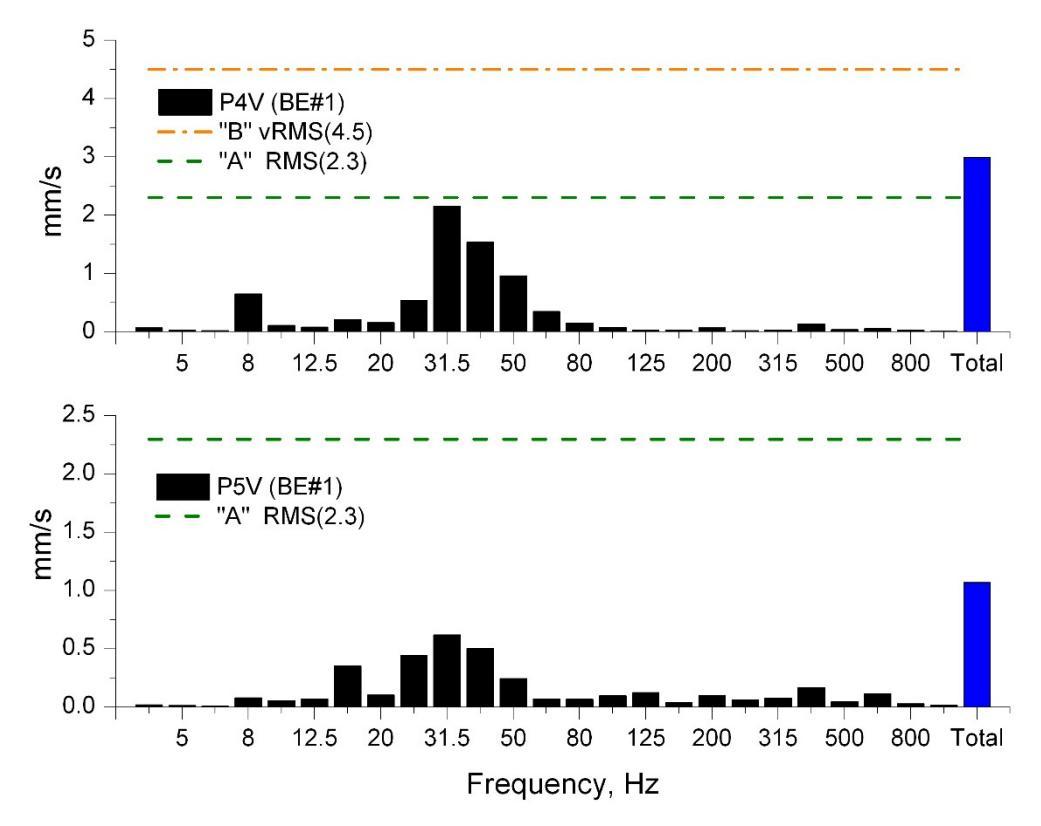
Figure 10. Typical spectrum of the RMS vibration velocity in the vertical direction at points P4 (**top**) and P5 (**bottom**) on the output shaft in bucket elevator BE#1. The column with the total value is marked in blue.

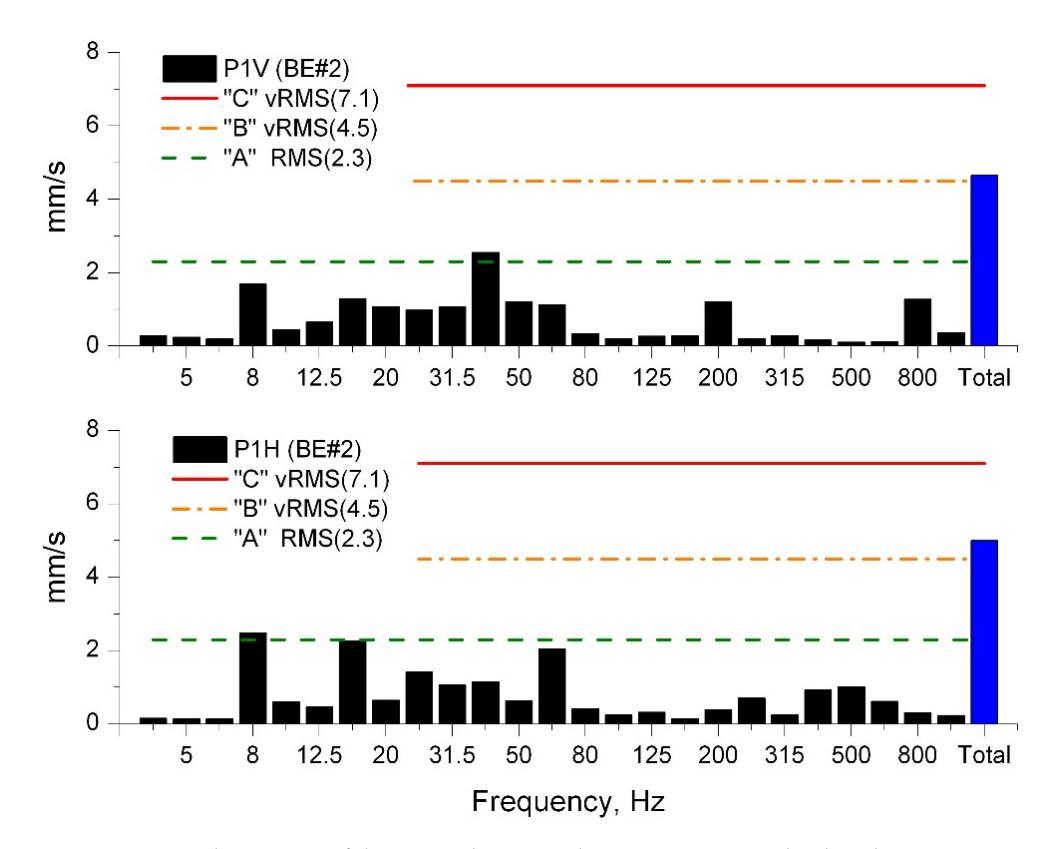
Figure 11. Typical spectrum of the RMS vibration velocity at point P1 in bucket elevator BE#2: in the vertical direction (**top**) and in the horizontal direction (**bottom**). The column with the total value is marked in blue.

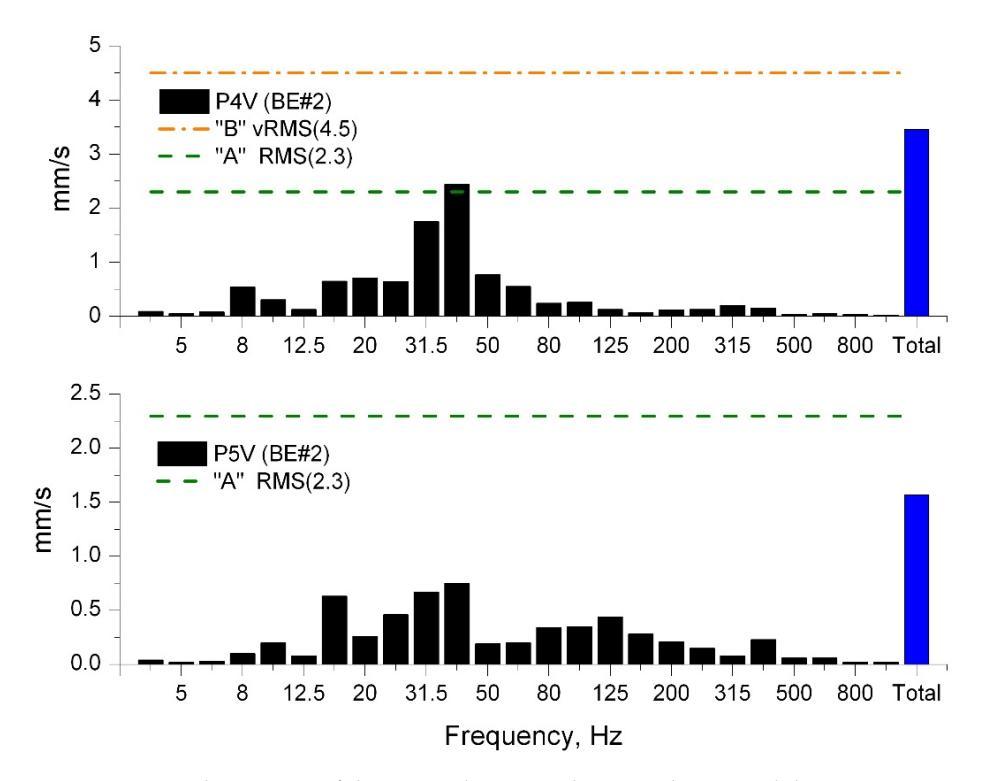
Figure 12. Typical spectrum of the RMS vibration velocity in the vertical direction at points P4 (**top**) and P5 (**bottom**) on the output shaft in bucket elevator BE#2. The column with the total value is marked in blue.

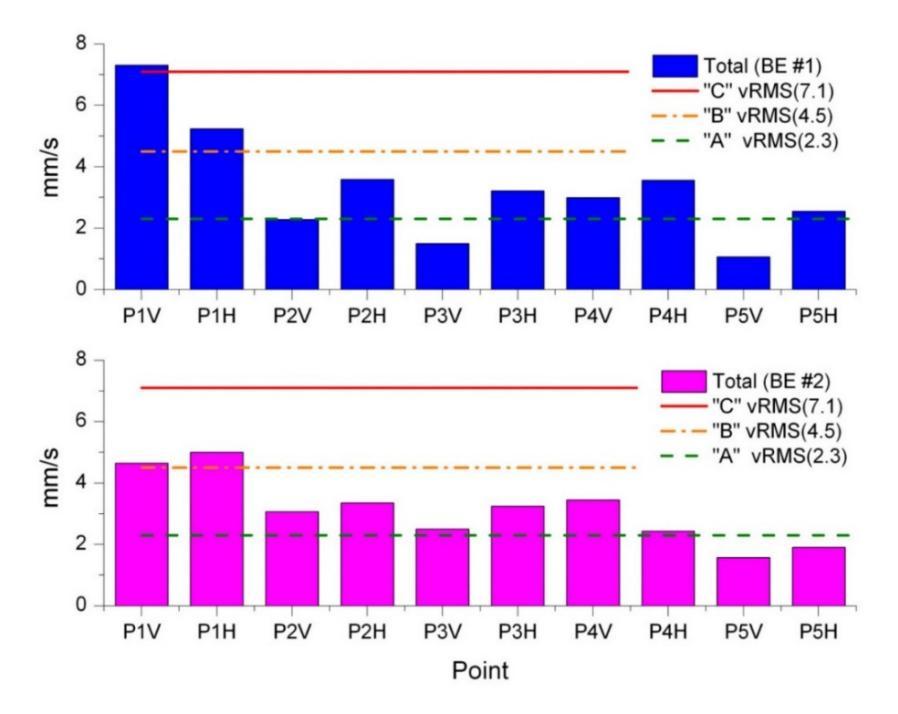
Figure 13. Comparison of the total values of the RMS velocity in points P1 to P5 of the tested drive units of elevators BE#1 (**top**) and BE#2 (**bottom**).

The broadband analysis of the vibration velocity at the measurement points shows that the vibration severity of both tested elevators was virtually equal. Only for measurements in the vertical direction at point P1V of bucket elevator BE#1, the total value of vibration velocity was higher in comparison with point P1V on bucket elevator BE#2. This difference was caused by high peaks generated by the local defect of the bucket chain in elevator BE#1 (Figure 3).

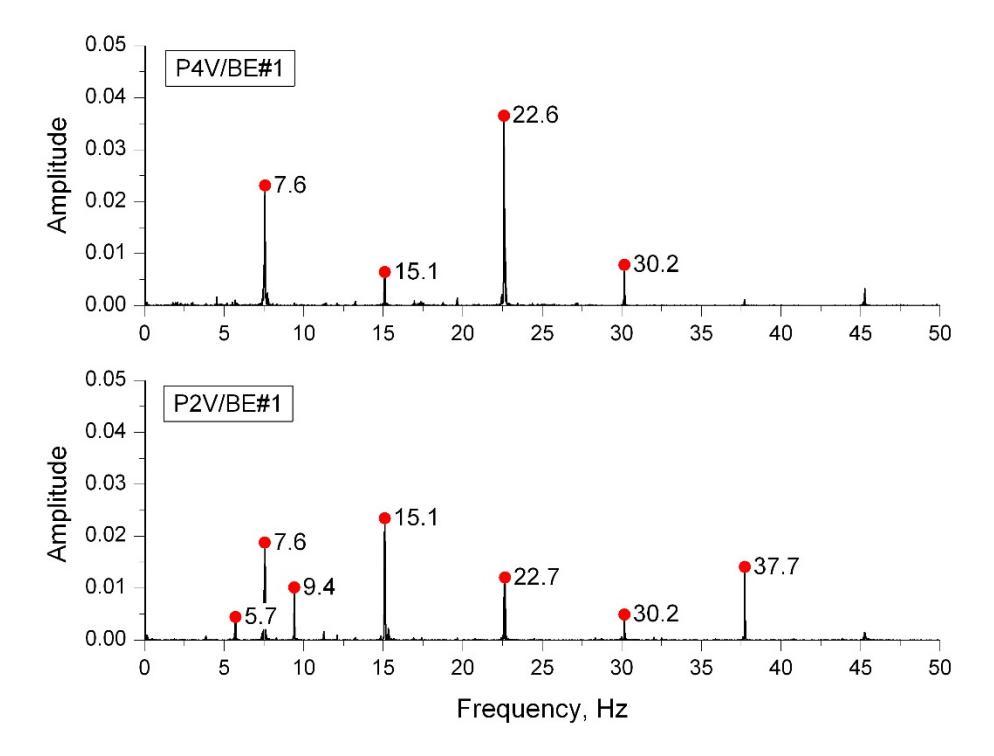
Figure 14 shows examples of results for two selected points, P2 (motor bearing unit) and P4 (bearing unit of the gear output shaft), in the BE#1 bucket elevator drive unit.

Figure 14. Narrow-band spectra of the RMS vibration velocity at points P2 and P4 in the drive unit of bucket elevator BE#1 (the numbers in the graphs indicate the characteristic frequencies in Hz).

Based on the analysis of the spectrograms, we identified the characteristic frequencies that make up the spectra. In particular, the frequency $f_0 = 7.6$ Hz was generated by the bucket chain and was the frequency at which the respective buckets passed through the drive drum. Additionally, the frequency $f_1 = 22.6-22.7$ Hz was consistent with the frequency of rotation of the drive shaft (motor shaft).

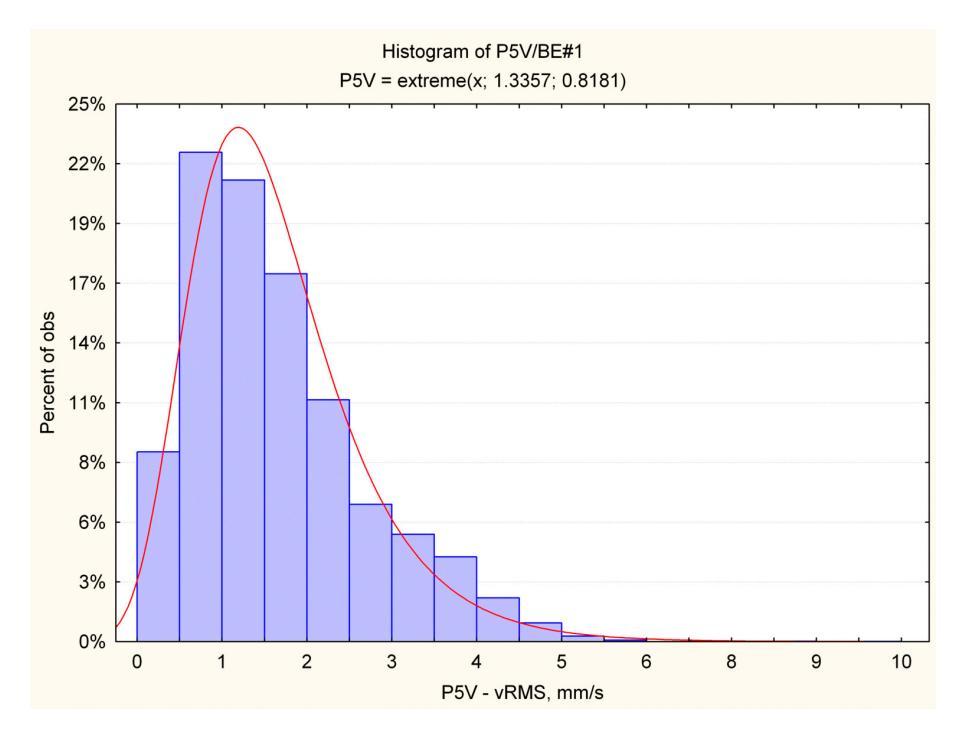
Figure 15. Histogram of vibration velocity v_{RMS} and the estimated Gumbel Extreme Value model for point P5 (in the vertical direction) in bucket elevator BE#1.

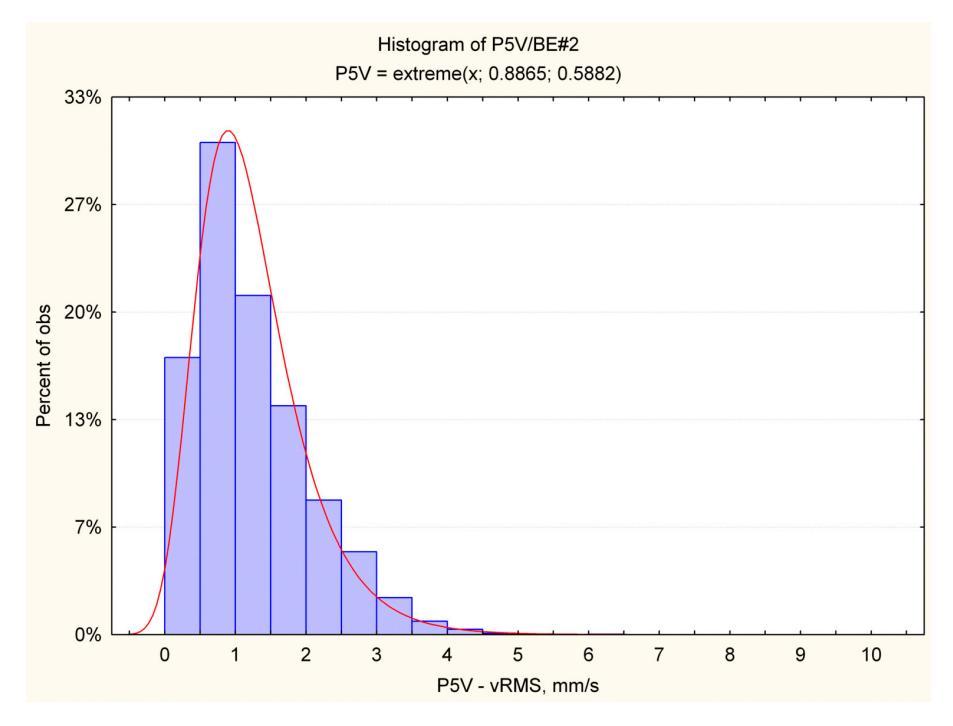
Figure 16. Histogram of vibration velocity v_{RMS} and the estimated Gumbel Extreme Value model for point P5 (in the vertical direction) in bucket elevator BE#2.

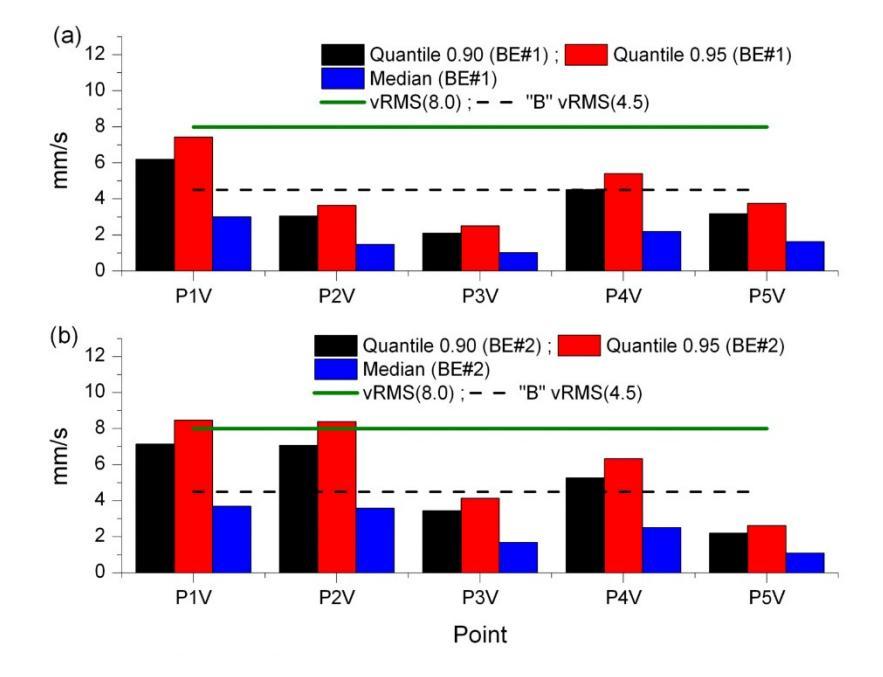
Figure 17 shows the relevant Quantiles $Q_{0.90}$, $Q_{0.95}$ and the Mode of vibration velocity in the measurement point P5 in both tested elevators. The lines mark the upper limits of vibration severity for the "B" zone, i.e., $v_{\text{RMS}} = 4.5 \text{ mm/s}$ (according to the ISO-10816-3 Standard) and $v_{\text{RMS}} = 8.0 \text{ mm/s}$ (according to the less restrictive recommendation shown in Table 2).

Figure 17. Quantiles of vibration velocity at the measuring points (in the vertical direction) in the tested bucket elevators: (**a**) BE#1 and (**b**) BE#2.

Compared to other approaches, the larger values of quantiles $Q_{0.90}$, $Q_{0.95}$ in the probabilistic approach characterized a higher level of vibration intensity and were symptoms of a worse technical condition of both drive units.

The comparative assessment of both drive units made using the probabilistic approach based on quantiles $Q_{0.90}$ and $Q_{0.95}$ of vibration velocity showed that the BE#1 drive unit was characterized by a lower vibration severity, which means that this unit was in better technical condition than the drive unit of the BE#2 elevator. The assessment of the technical condition of the BE#2 drive unit is influenced by the relatively higher vibration intensity of the motor bearing units (points P1 and P2) as compared to the BE#1 drive unit motor.
