Article Evaluation of Frost Impact on Traditional Ceramic Building Materials Utilized in Facing Walls

Abstract: This paper takes into consideration the performance of traditional bricks as part of a building exterior wall finish. Exterior wall materials change their properties when exposed to external environment. This process is extended over time and its intensity is closely related to microstructure, moisture and freeze-thaw cycles. Two methods of freeze-thaw durability tests were used in this study: standard and defined by the authors. The authors' method incorporated the actual conditions of masonry unit function in exterior wall finish, i.e., cyclical effects of precipitation water, changes in temperature and air humidity. The laboratory test study included 50 freeze-thaw cycles. Three characteristic ranges of pore dimensions were indicated in the analysis: below 0.1 µm, between 0.1 and $3.0 \ \mu m$ and above $3 \ \mu m$. Based on the method of freeze-thaw durability testing, the areas of microstructure changes were determined. The obtained results were related to the absorption of ceramic building materials. The authors' method confirms the usage of traditional ceramic bui

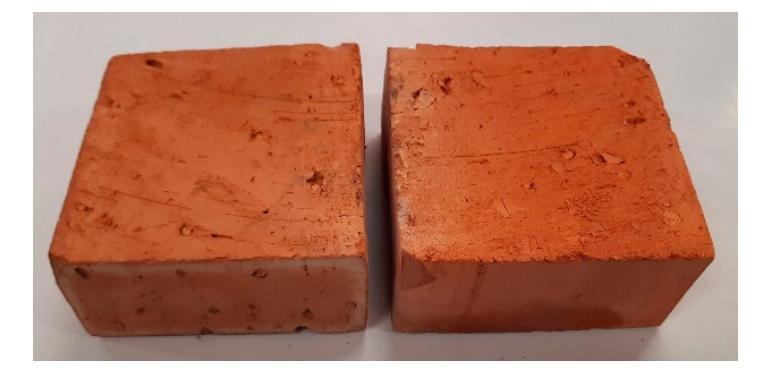
Figure 1. A brick sample used for tests.

The tested products belong to the group of masonry units to be used in walls protected against water penetration [1], with dimensions $250 \times 120 \times 65$ mm (Figure 1). Their quality parameters are summarized in Table 2.

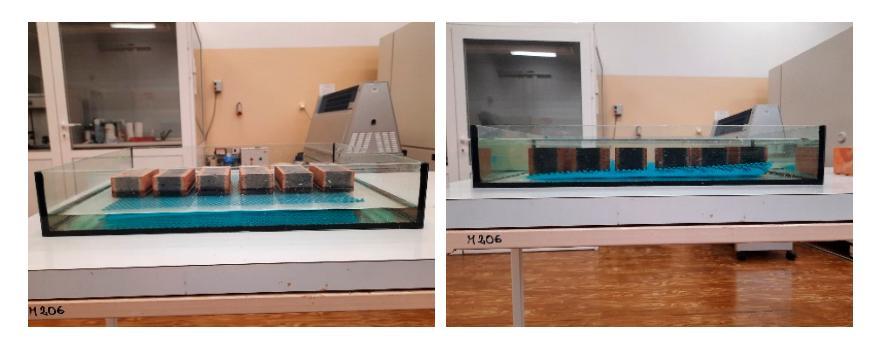
Figure 3. Absorption test.

The absorption test was carried out with a soaking method of 6 brick samples. The samples were dried to a fixed weight at +40 °C, then weighed to the nearest 0.1%. The samples were placed in a vessel with supports of non-corrosive material. Then, they were flooded with water at room temperature up to $\frac{1}{2}$ of their height, after 3 h the water was replenished up to the level of $\frac{3}{4}$ of the sample height and after 3 h the water was replenished again until they were completely submerged (Figure 3).

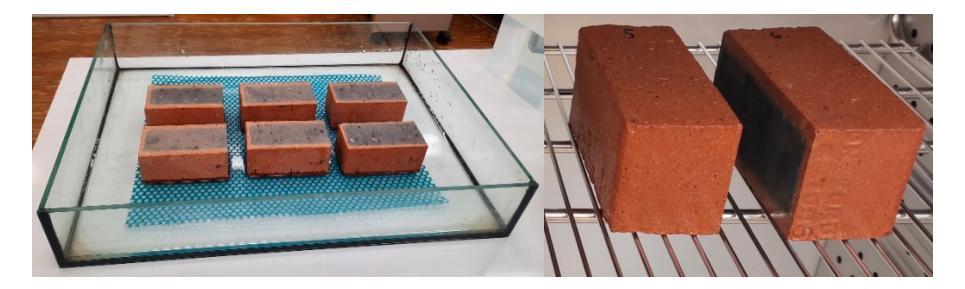
Figure 4. Sample conditioning in the authors' freeze-thaw durability method.

In the first case, the samples were placed in a water container and saturated to a fixed weight. Then, the brick surfaces were dried from excess water and placed in a freeze-thaw durability test chamber (Figure 4). Fifty freeze-thaw cycles were assumed in the temperature range of -18 to +18 °C.

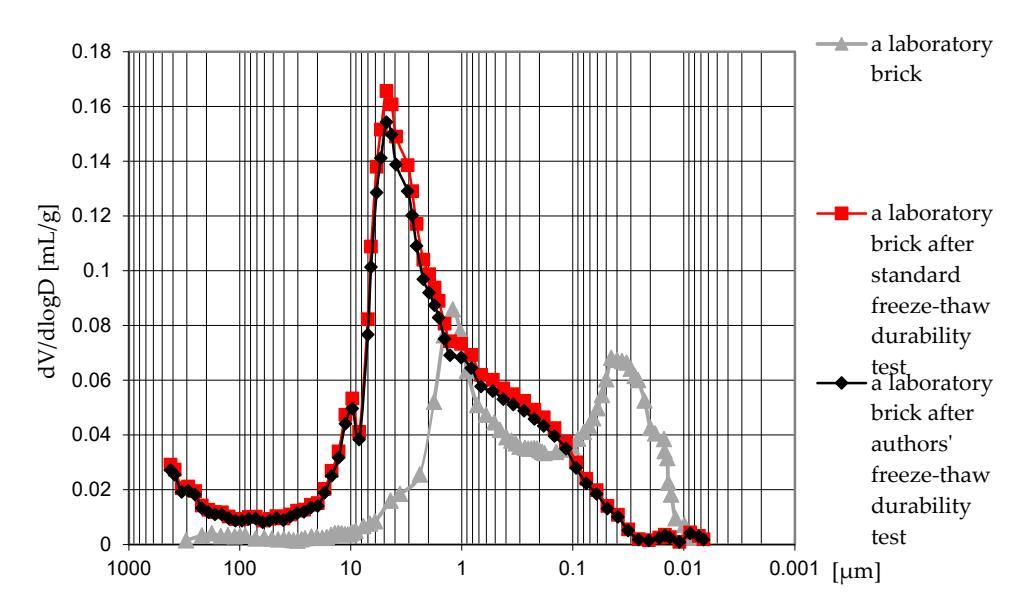
Figure 5. Differential curve of pore size distribution in test samples.

Lower value of porosity was obtained in the case of the material after treatment with the authors' method of freeze–thaw durability tests (–1.94%). In the case of the critical degree of water saturation of masonry units, the difference was –0.67%. The factor that essentially differentiates the features of the material covered in this study is the dominant pore diameter and porosity structure. The initial material exhibits a bimodal arrangement, typical for ceramic building materials, with dominant pores of 1.3 μ m and 0.045 μ m in diameter (Figure 5). In the analyzed cases, there is one dominant diameter, the value of which is much higher (for the samples after the authors' freeze–thaw durability test of 5 nm, and after the method of critical degree of water saturation of masonry units of 4.5 μ m (Figure 5), respectively. The obtained dominant diameters above 3 μ m are within the range to be considered safe from the point of view of frost damage. The differential curve plots of the pore size distribution of the tested brick samples are presented in Figure 6.

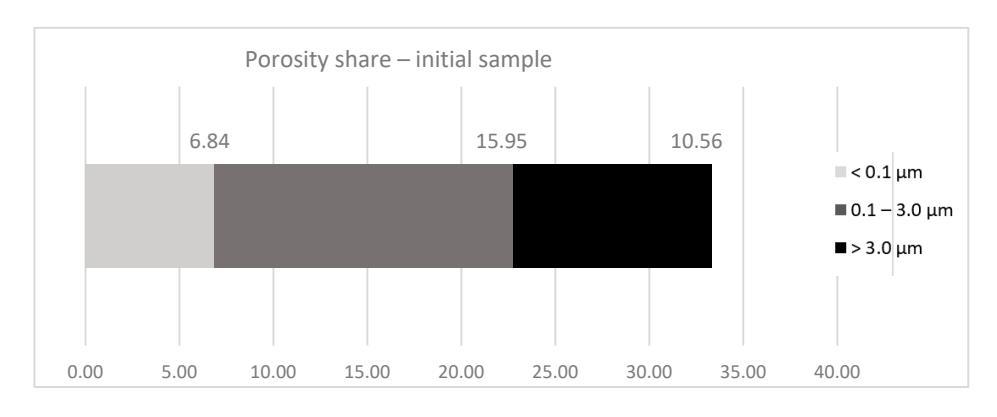
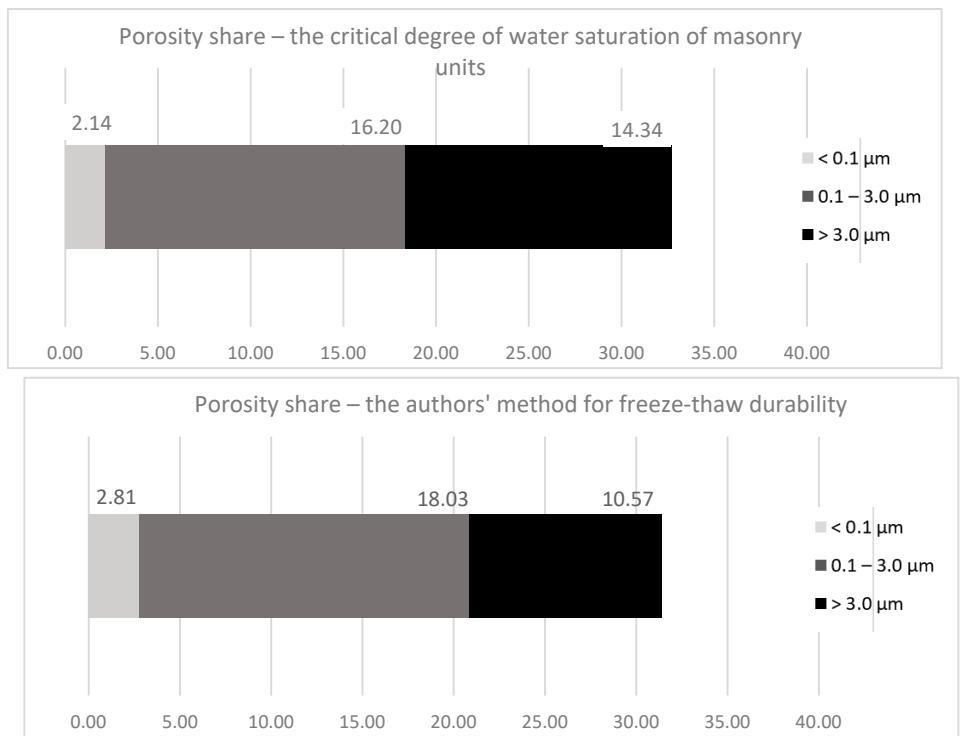
Figure 6. Typical porosity ranges in the tested clay bricks.

The form of frost damage is closely related to the pore distribution (Figure 6). In the initial material, the total porosity was 33.35% with a share of 15.95 percentage points from 0.1 to 3.0 µm in diameter. The remaining 10.56 percentage points were occupied with pores above 3 μ m in diameter, and 6.84% with pores below 0.1 μ m in diameter. In the samples that faced the authors' freeze-thaw durability test, the total porosity was 31.41% with the pore share in the range of $0.1-3.0 \ \mu m$, increasing to 18.03 percentage points. The share of pores with diameters greater than 3.0 µm is maintained at the same level. There was a significant decrease in the share of pores below 0.1 μ m at 2.81 percentage points. For the method of critical water saturation degree of masonry units, the total porosity was 32.68%, with a similar share of pores in the range of $0.1-3.0 \ \mu m$ (16.20 percentage points). There was a significant increase in the share of pores above 3.0 µm by 3 percentage points compared to the initial material. The share of pores below 0.1 μ m decreased three times to 2.14 percentage points. In all analyzed cases, frost damage increased the share of porosity in the range of 0.1 to 3.0 μ m. With cyclic freezing and thawing, it was found that pores below 0.1 µm were also responsible for the porosity structure changes. Frost influence damages them, resulting in increased pore size.
