# Article Damage Evolution Characteristics of Back-Filling Concrete in Gob-Side Entry Retaining Subjected to Cyclical Loading

Abstract: The back-filling body in the gob-side entry retaining is subject to continuous disturbance due to repeated mining. In this study, uniaxial and cyclical loading tests of back-filling concrete samples were carried out under laboratory conditions to study damage evolution characteristics with respect to microscopic hydration, deformation properties, and energy evolution. The results showed that, due to the difference in the gradation of coarse and fine aggregates, the cemented structure was relatively loose, and the primary failure modes under cyclical loading were tensile and shearing failure, which significantly decreased its strength. With an increasing number of loadings, a hysteresis loop appeared for the axial strain, and the area showed a pattern of decrease-stabilization-increase. This trend, to a certain extent, reflected the evolution of the cracks in the back-filling concrete samples. The axial, radial, and volumetric plastic strain curves of the back-filling concrete samples showed a "U" shape. The plastic strain changed in three stages,

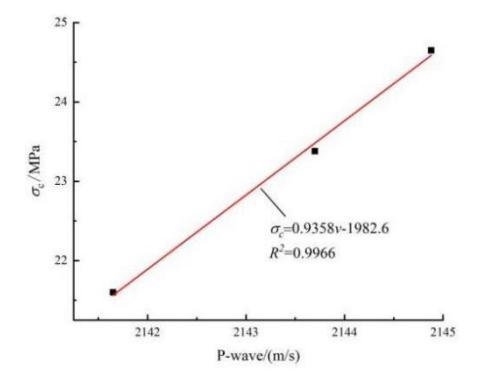
Figure 1. Relationship between uni-axial compressive strength and p-wave velocity.

Based on the mechanical conditions of the back-filling body in the gob-side entry retaining, a cyclical loading test was set up in an indoor laboratory. The linear correlation between the compressive strength and the ultrasonic wave velocity was established based on the results of uniaxial loading (Figure 1). The loading path is shown in Figure 2. First, the compressive strength  $\sigma_c$  of the samples was first predicted based on the linear correlation ( $\sigma_c = 0.9358v - 1982.6$ ) and the initial wave velocity, then the upper and lower limit of the cyclical load was determined ( $\sigma_{min} = 0.4\sigma_c$ ,  $\sigma_{max} = 0.8\sigma_c$ ), as shown in Table 1. The

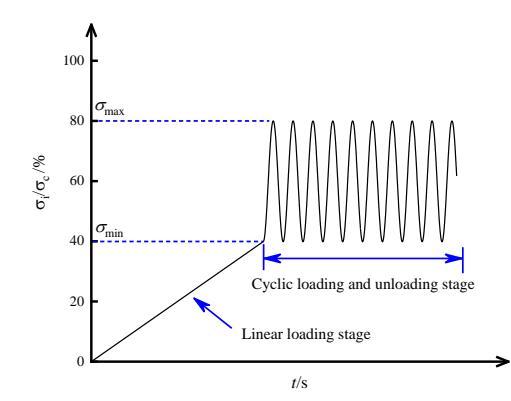
Figure 2. Cyclic loading method.

load was applied under force control and the loading process was as follows: (1) In the first stage, the sample was linearly loaded at a speed of 0.2 kN/s to  $\sigma_0 = 0.6\sigma_c$ ; (2) in the second stage, sine wave cyclical loads were applied to the sample (amplitude: 0.4–0.8 $\sigma_c$ , frequency: 0.4 Hz) until sample failure. Ultrasonic testing was carried out continuously throughout the entire loading cycle. After data processing, the parameters related to the strength, deformation, and failure of the sample and the energy evolution under cyclical loading were obtained.

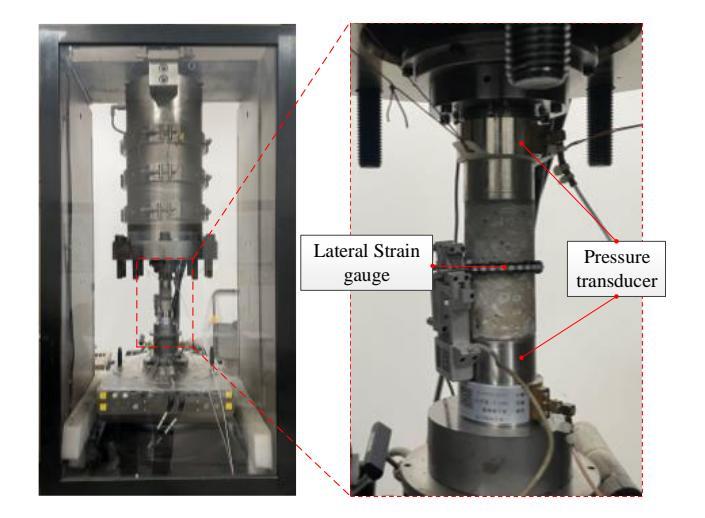
Figure 3. Sample loading device and ultrasonic pressure transducer layout.

The MTS815 material testing machine was used via electro-hydraulic driven operation (Figure 3). The axial load capacity was 2300 kN, the upper limit of confining pressure was 140 MPa, and the accuracy of the pressure transducer was 0.001 kN. Deformation was measured with an axial extensioneter and a circumferential extensioneter. The measuring

An ultrasonic system was used for damage accumulation monitoring (Figure 3). The transmitting and receiving transducers were arranged on the upper and lower ends of the samples, and a coupler was applied to ensure good contact between the sample and the transducer. The resonance frequency (HYN, 55 KHz) and damping meet the requirements for mechanical testing of concrete materials. A waveform generator actively transmitted a pulse signal (main frequency: 90 kHz; amplitude: 10 Vpp). After receiving the pulse signal, one end of the transducer generated instantaneous vibration. The vibration propagated in the sample and was then received by the transducer on the other end. The data acquisition frequency was 10 Mpoints/s, and the duration was 5 ms.

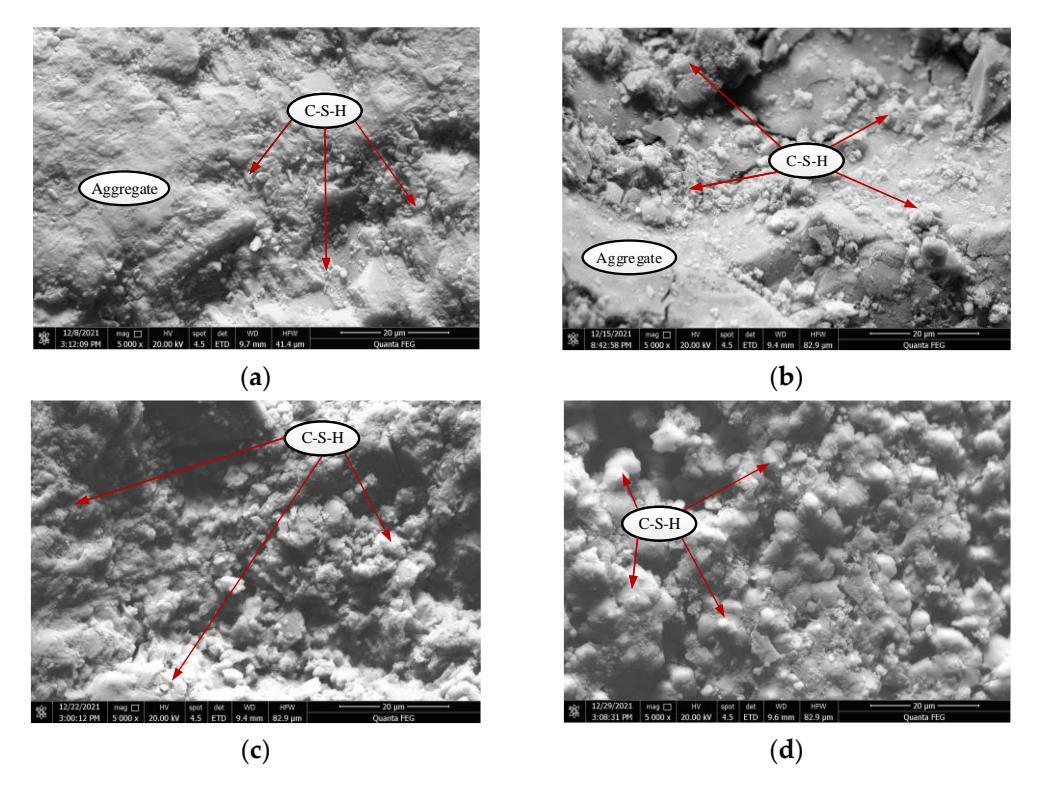
The microscopic morphology of the back-filling concrete samples with different curing periods is shown in Figure 4 (magnification 5000×). At 7 days of curing, a small amount of hydration product calcium-silicate-hydrate (C-S-H) particles was seen around the aggregate, as shown in Figure 4a. Note that the longer the curing period of the back-filling concrete, the better the crystallinity of the hydration product. Figure 4b shows that the surface was rough, containing particles bound by C-S-H, and the structure of the concrete samples was relatively loose at 14 days. Increasing the curing period gradually increases the amount of hydration product, and a large number of links formed between C-S-H and the aggregates, while the internal pores were continuously filled, which enhanced the strength of the aggregate–cement interface, as shown in Figure 4c,d. Overall, a large number of micropores and cracks were formed in the concrete samples, which had strong heterogeneity.

**Figure 4.** Scanning electron microscope of back-filling concrete at different ages. (**a**) 7 days; (**b**) 14 days; (**c**) 21 days; (**d**) 28 days.

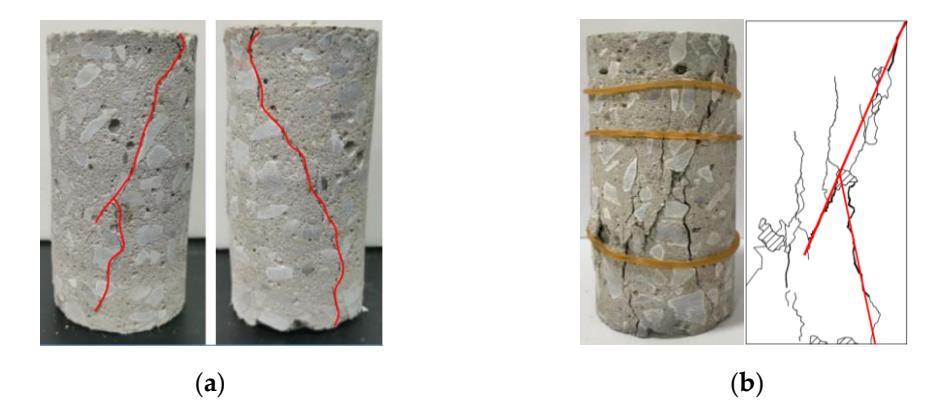
The fracture patterns of the samples under different loading paths are shown in Figure 5a,b. In Figure 5a, the red lines represent the main cracks and the thin black line represents the secondary cracks. When the loading path was changed from uniaxial loading to constant-amplitude cyclical loading, the main cracks were connected upon sample failure, accompanied by a large number of secondary cracks. The number and density of macroscopic cracks increased significantly in Figure 5b. Specifically, a large number of cracks appeared parallel to the principal stress direction. The shear failure zone showed a large number of fragments and localized exfoliation.

**Figure 5.** Fracture characteristics of back-filling concrete samples under different loading paths. (**a**) J-1 sample uniaxial loading path; (**b**) J-11 sample under cyclic loading path.

During the loading process, lateral deformation of the sample was large, and there was clear volumetric expansion. This was mainly because the load did not decrease to 0 kN during the unloading phase, and damage accumulated under cyclical loading. When the

samples were damaged, a macroscopic crack penetrating the whole sample appeared, and the failure modes were mainly tensile and shearing failure. In addition, the peak ultimate failure load of the samples decreased significantly under cyclical loading. The intensity reduction ratio was 20.99–31.49% of that obtained during uniaxial compressive loading (Table 1), i.e., the load-bearing performance of the concrete sample declined significantly.

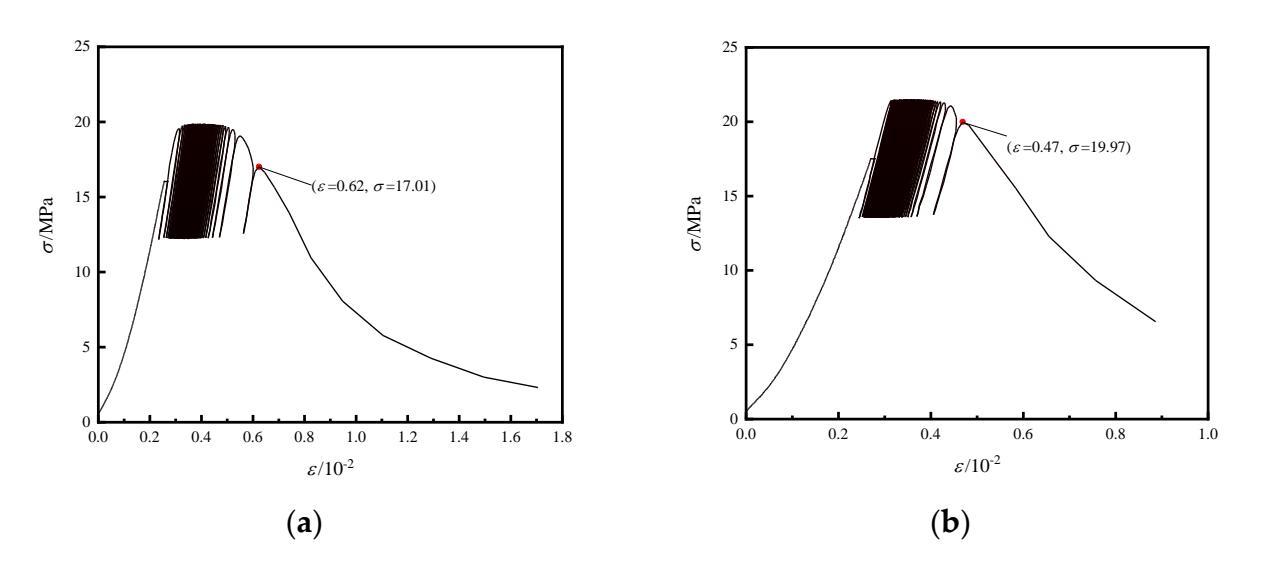
As Table 1 shows, the total number of loading cycles of the J-4 sample was 55 times and the J-19 sample was 95 times in the two groups' samples, and J-4 and J-19 are selected as the representatives of both groups of samples. The stress–strain curve of the concrete samples subjected to cyclical loading is shown in Figure 6a,b, The failure stress of the concrete samples was relatively close, and the stress–strain curves showed hysteresis loops. With the increase in the loading cycle, the area of the hysteresis loop gradually increased. The reason for this was that each loading cycle led to new damage to the internal samples, and the damage continued to accumulate, resulting in a continuous increase in the axial strain on the sample. The lower load limit was above 0 kN, thus, the micro-cracks generated during cyclical loading were always in a compressive state, and the cumulative plastic strain gradually increased. Compared with J19 in Figure 6b, sample J4 exhibited more obvious ductility during fatigue failure as shown in Figure 6a.

Figure 6. Stress–strain curves of cyclic loading and unloading concrete samples. (a) J-4; (b) J-19.

With the increased loading cycle, irreversible deformation of the concrete samples increased and showed a nonlinear increasing trend. Macroscopically, the sample showed clear volumetric expansion and fatigue failure.

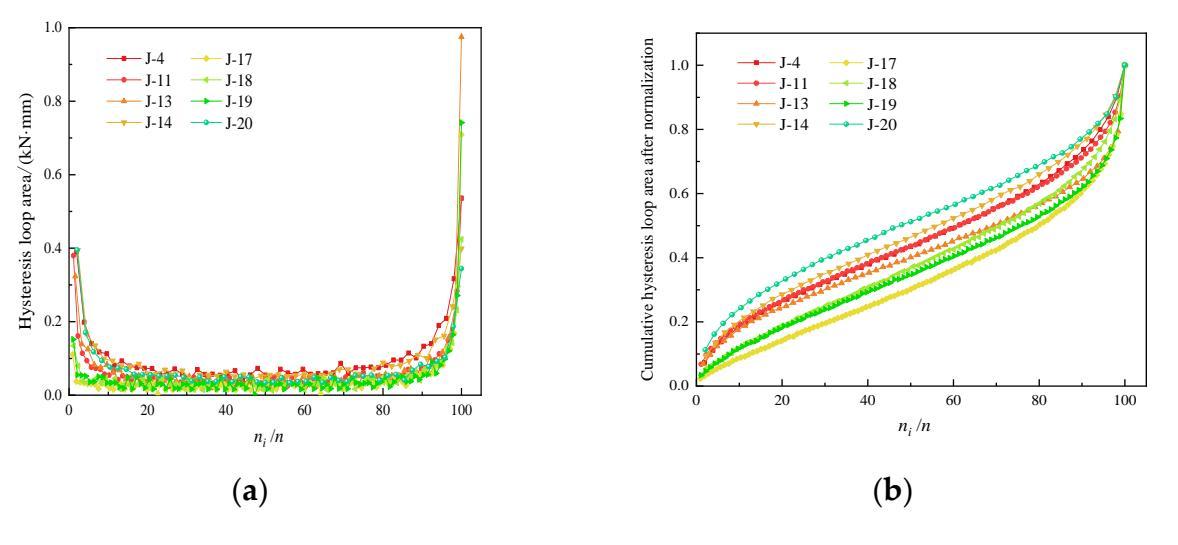
Based on the maximum hysteresis loop area before failure, the area of the plastic hysteresis loop in each loading cycle was normalized. Taking the ratio of the total number of loading cycles to the number of cycles at fatigue failure as the *x*-axis,  $n_i/n$  represents the total number of loading cycles to the number of cycles at fatigue failure, and the variation of the area of the plastic hysteresis loop with the number of loading cycles is obtained (Figure 7). Figure 7a notes that as the number of loading cycles increased, the area of the plastic hysteresis loop at each time showed a staged pattern of decrease–stabilization–rapid increase and showed a "U" shape. The loading stress in the first loading cycle ( $\sigma_{max} = 0.8\sigma_c$ ) exceeded the yield strength of the concrete material, and the sample entered the plastic deformation stage. There was a large amount of plastic deformation, indicated by the large

area of the plastic hysteresis loop. After unloading, the elastic deformation recovered, and the area of the plastic hysteresis loop decreased significantly.

**Figure 7.** Variation rule of hysteresis loop area of cyclic loading and unloading. (**a**) Hysteresis loop area each cycle. (**b**) Normalized cumulative hysteresis loop area.

With the progression of cyclical loading, the cracks in the samples were in a constant compressive state, and the plastic strain continuously accumulated, although the sample was still in a stable condition. In the later stage of cyclical loading, the area of the plastic hysteresis loop in a single cycle gradually increased with increasing amplitude, indicating an increasing degree of fatigue damage. Once macroscopic cracks penetrated the sample, the load-bearing performance greatly declined.

Figure 7b shows that the area of each hysteresis curve was normalized, and the normalized cumulative hysteresis loop area showed a nonlinear increase with the increase in the number of cycles, and its growth rate showed a trend of "decrease–stable–increase".

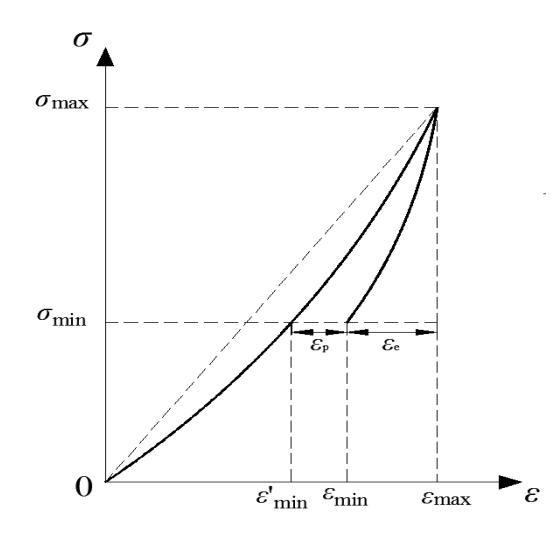
Figure 8. Schematic diagram of strain parameters.

The elastic strain  $\varepsilon_e$ , plastic strain  $\varepsilon_p$ , and volumetric strain  $\varepsilon_v$  of the concrete samples subjected to cyclical loading were calculated to quantify the evolution of the plastic strain. The physical implications of elastic and plastic strains are shown in Figure 8, and the elastic and plastic strains are calculated as [23]:

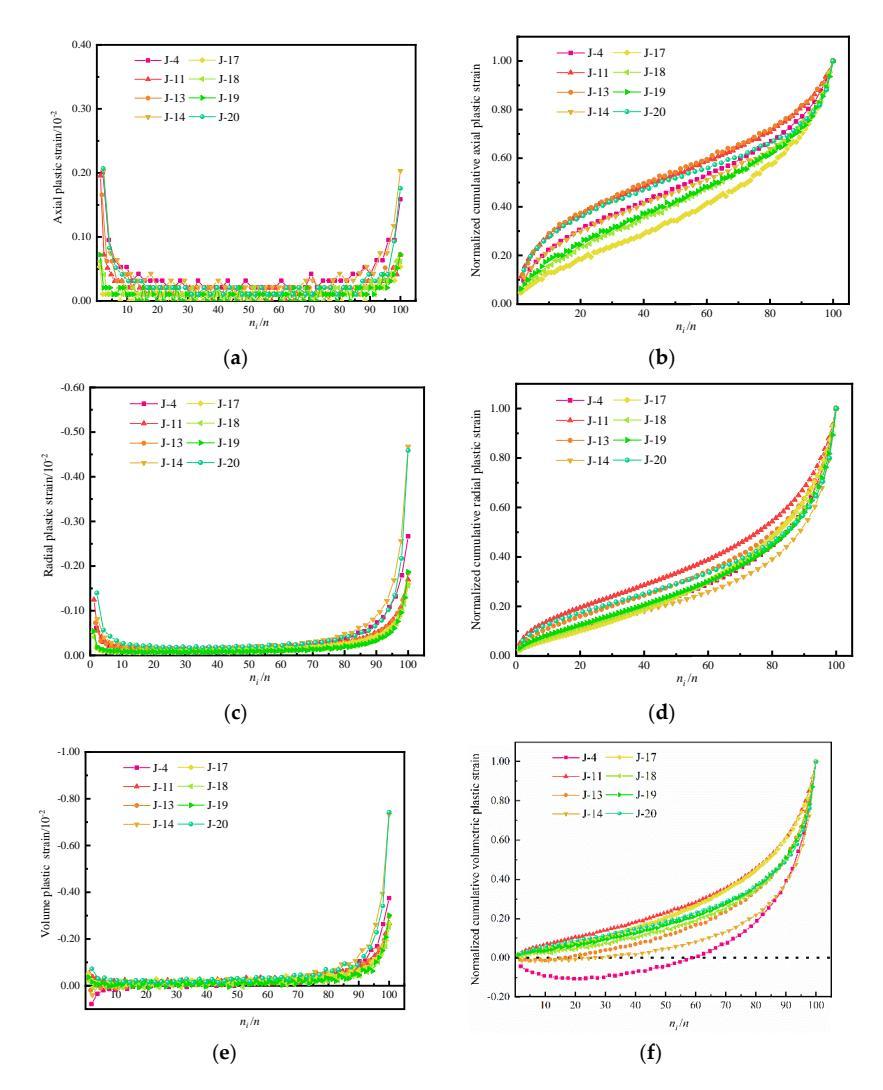
Figure 9a–f show the relationship between the axial strain, radial strain, and volumetric plastic strain of some samples (J-4, J-11, J-13, J-14, J-17, J-18, J-19, and J-20) and the number of loading cycles.

**Figure 9.** Variation curve of plastic strain with cyclic loading and unloading times. (**a**) Axial plastic strain; (**b**) normalized accumulative axial plastic strain; (**c**) radial plastic strain; (**d**) normalized accumulative radial plastic strain; (**e**) volumetric plastic strain; (**f**) normalized accumulative volumetric plastic strain.

Note from Figure 9 that the variation of the axial, radial, and volumetric strains with the number of loading cycles was essentially consistent, showing a "U" shape. The plastic strain presented a staged pattern of a rapid decrease–stabilization–a rapid increase. Thus, the variation of plastic strain showed clear stage characteristics. n is the total cycle number of each sample, the cycle number of the demarcation point between the rapid decrease and stabilization stages was set as  $n_1$ , and the cycle number of the demarcation point between the stabilization stage and the rapid increase stage was set as  $n_2$ . The  $n_1$  and  $n_2$  values of each sample are shown in Table 2.

As one can see from Figure 9a,c, in the early stage, the loading stress was above the yield stress, which led to a large amount of plastic deformation. After unloading, the elastic deformation was recovered, and the axial and radial deformations decreased significantly. In the late stage, the internal cracks propagated due to repeated compression and the degree of fatigue damage increased, as indicated by the increasing axial and radial plastic deformation. Then, cracks penetrated the sample, and the plastic deformation increased dramatically to the maximum value, and the sample underwent shearing-tensile failure, and significant radial cracks developed.

With increasing loading cycles, the plastic strain gradually accumulated, yet the sample was still in a stable state. The accumulative velocity of axial plastic strain first increases and then decreases with the increase in the loading cycles as shown in Figure 9b,d. During the cyclical loading process, the volumetric strain showed a significant nonlinear increasing trend as shown in Figure 9e. In the initial stage, the volumetric plastic strain of the J-4, J-13, and J-14 samples had a positive increment, indicating that axial compressive deformation was much larger than radial expansion deformation. However, the positive increment was small and rapidly became negative, indicating that there were few initial cracks in the concrete sample and micro-cracks were initiated. Furthermore, the volumetric strain gradually changed from axial compression deformation to radial expansion deformation. For the J-11, J-17, J-18, J-19, and J-20 samples, the initial volumetric strain had negative increments, showing clear radial volumetric expansion as shown in Figure 9f. As cyclical loading continued, the internal micro-cracks were repeatedly squeezed and propagated, and the proportions of axial, radial, and volumetric plastic strains all gradually increased. In addition, the growth rate of the plastic strain increased sharply before sample failure (80.00–85.19% of the total number of cycles) as shown in Table 2. As a result, primary and secondary cracks were connected, and the concrete sample was damaged.

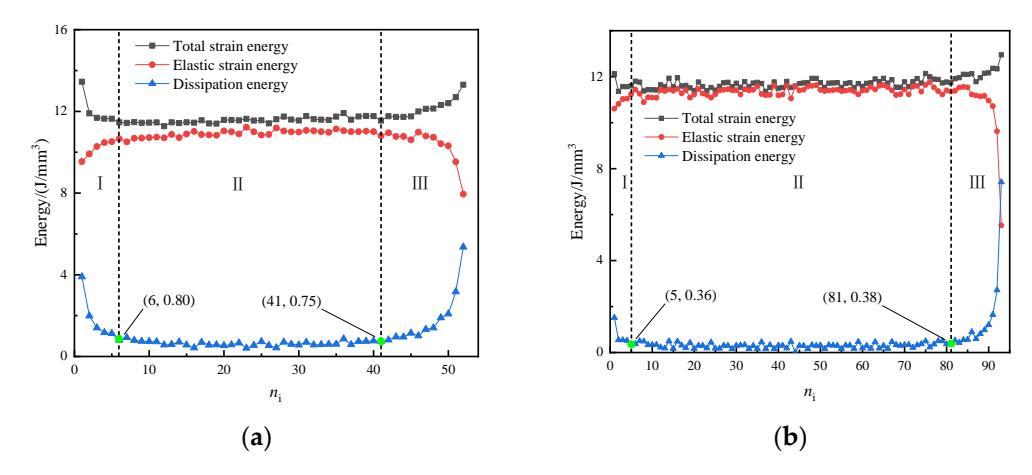
Figure 10 shows that elastic strain energy first increased with the increasing loading cycles, then stabilized with small fluctuations, then decreased rapidly before sample failure. Furthermore, the total strain energy and dissipated energy of the concrete samples had similar trends with obvious stage characteristics under cyclical loading. The total strain energy and dissipated energy were high in the early stage due to the first cycle having higher loading and deformation; with increasing loading cycles, they decreased first and then stabilized and increased rapidly in the late stage. The slope change of curve was taken as the basis for stage. The turning point of dissipated energy rapidly decreases to stability with small fluctuations was taken as the stage segmentation point from stage I to II, such as Figure 10a (6,0.80) and 10b (5,0.36). The turning point of dissipated energy steadily develops to a rapid increase was taken as the stage segmentation point from stage II to III, such as Figure 10a (41,0.75) and 10b (81,0.38). And Failure of the concrete samples was accompanied by a large increase in dissipated energy.

Figure 10. Energy evolution curve of back-filling concrete sample. (a) J-4; (b) J-19.

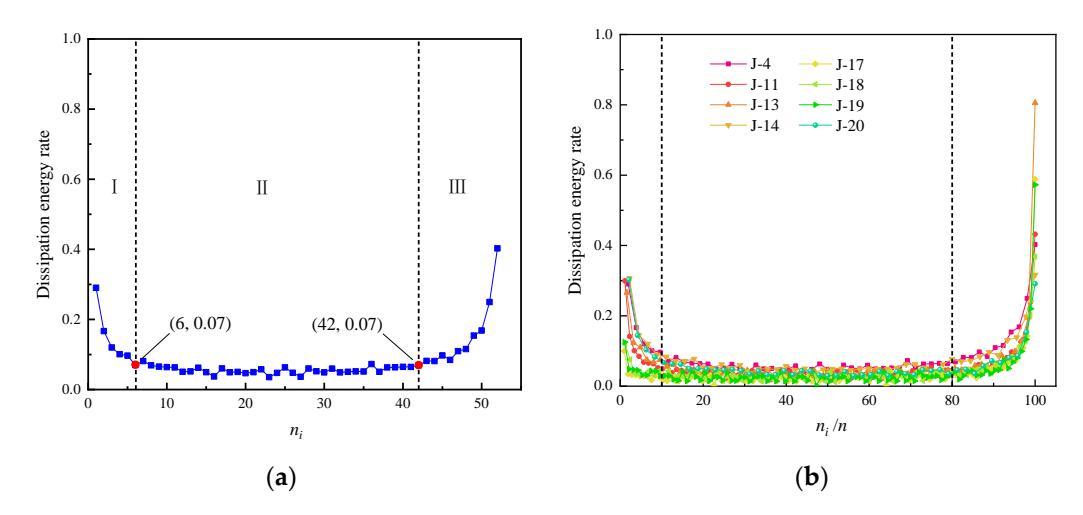
**Figure 11.** Variation of dissipation energy rate with the number of cycles. (**a**) Dissipation energy rate change curve of J-4 sample. (**b**) Stage division of dissipation energy rate of samples.

Note from Figure 11 that the energy dissipation rate shows a pattern of sharp decreasesteady fluctuation-rapid increase with increased loading cycles. Take J-4 sample for example, the slope change of energy dissipation rate curve was taken as the basis for three stages. The turning point of energy dissipation rate sharp decrease to steady fluctuation was taken as the point from stage I to II, such as Figure 11a (6,0.07). The turning point of energy dissipation rate steadily develops to a rapid increase was taken as the point from stage II to III, such as Figure 11a (42,0.07).

According to the slope of the energy dissipation rate curve, the energy dissipation process can be divided into three stages (I, II and III):

Initial dissipation stage I (0–10% of the cycle): In the early stage of cyclical loading, the loading stress in the first cycle exceeded the yield stress, resulting in large plastic deformation and crack development. Thus, energy dissipation was large, and the plastic strain energy rate accounted for 30% of the total strain energy. After the first cycle, the number of new micro-cracks gradually decreased, the plastic deformation increment decreased sharply, and the plastic strain energy decreased gradually. The energy dissipation rate decreased sharply, while the accumulated elastic strain energy increased gradually.

Stable dissipation stage II (10–80% of the cycle): As cyclical loading continued, the lower stress limit in the unloaded state did not return to zero, there was compaction of internal pores and cracks and propagation of micro-cracks, and plastic deformation continued increasing with a small increment. The energy dissipation rate was maintained at 0.02–0.08 at this stage, and there was a small fluctuation. Most of the energy was converted into elastic strain energy, and energy dissipation was small.

Rapid dissipation stage III (80–100% of the cycle): With increased loading cycles, the micro-cracks gradually propagated to form large cracks, and the large cracks gradually penetrated to form macro-cracks. Plastic deformation increased rapidly at this stage, plastic strain energy density increased, and the energy dissipation rate increased significantly until the sample failed.

As shown in Figure 11a, before the failure of the J-4 sample, the amount of change and the change in speed of both the plastic strain and energy parameters increased significantly, indicating that the plastic strain and energy dissipation rates could predict the failure of the concrete samples.
