Article Numerical Investigation of Longitudinal through Voids in Tunnel Secondary Lining Vaults and Steel Plate Strengthening

Keywords: tunnel lining; longitudinal through void; numerical investigation; steel plate strengthening

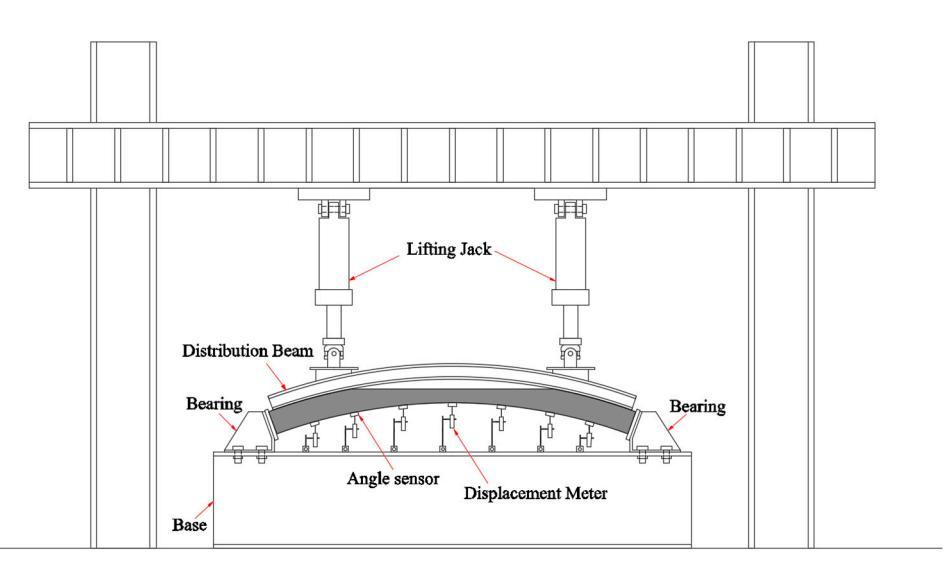
Figure 1. Layout of the loading system.

To explore the damage mechanism of voids, a static loading experiment was performed on the partially voided specimens of the vault. As shown in Figure 1, double hydraulic actuators were used for loading, and I-beams that were matching the curvature of the upper surface of the specimen were used for load distribution. The test revealed that the majority of the damage was localized around the boundary of the void (Figure 2). In order to verify these test results, a numerical model was established by the concrete damage plasticity model (CDP). The numerical results verified the test results, and they also proved the feasibility of the CDP simulation method in the study of void lining damage.

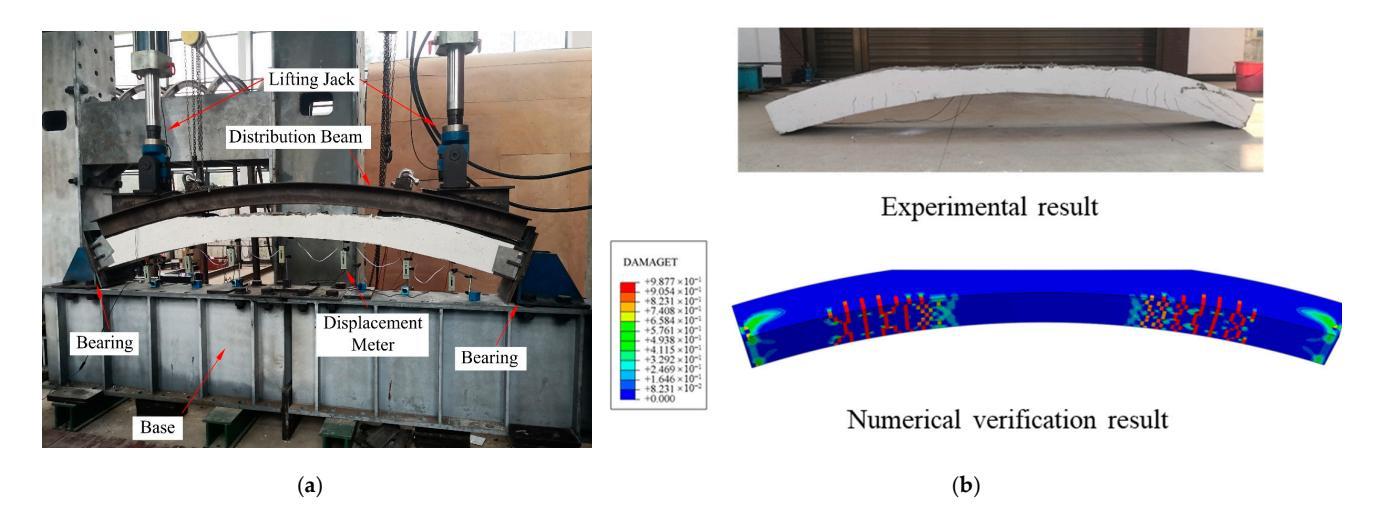
Figure 2. Experimental setup and results: (**a**) experiment device; (**b**) experimental result and numerical verification.

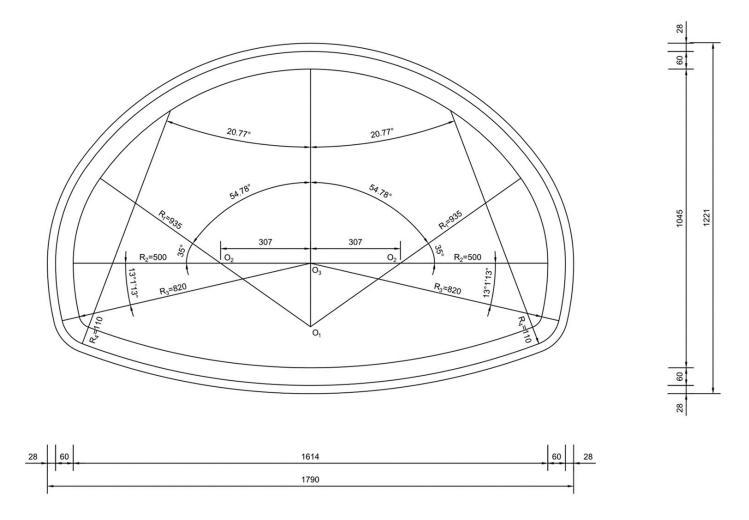
Figure 3. Lining dimensions.

Figure 3 displays the dimensions of the tunnel lining. The initial support was 28 cm, and the thickness of secondary lining H was 60 cm. The numerical model (Figure 4) was 80 m long, 80 m high, and 36 m thick, including three secondary lining pouring cycles. The secondary lining of the middle mold was a voided lining, while the front and rear linings were complete linings.

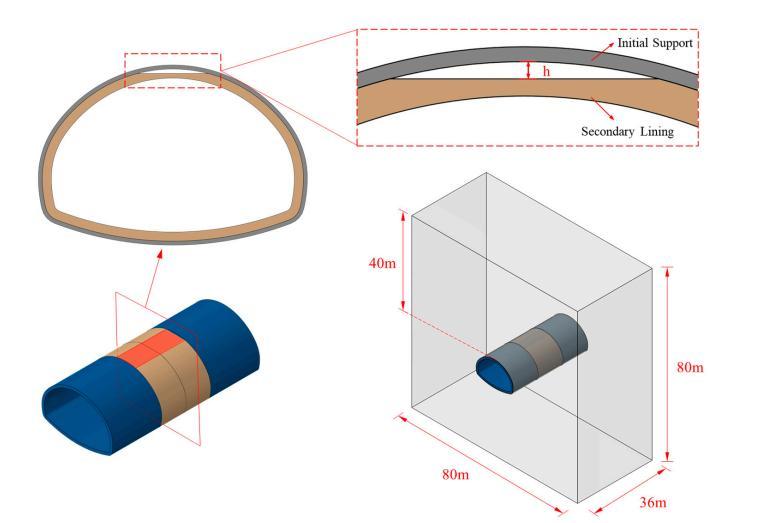
Figure 4. Model design.

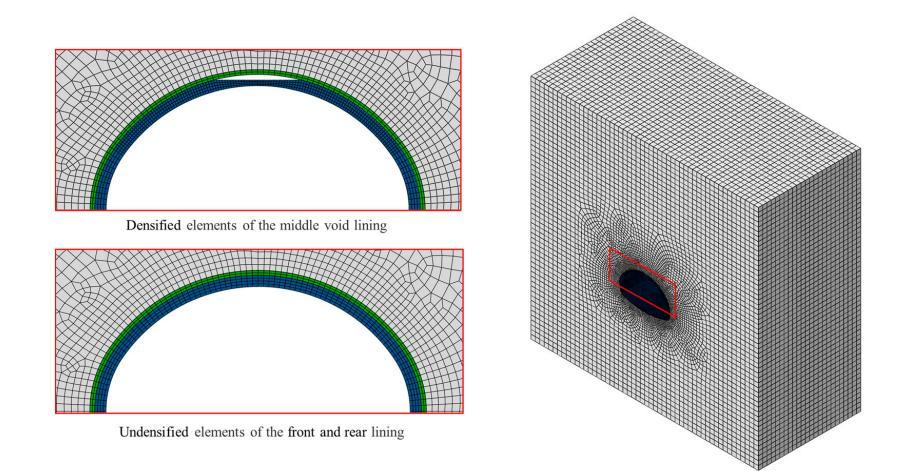
Figure 5. Element scheme.

As shown in Figure 5, the model was simulated by the C3D8R solid element. The initial support adopted two element layers, and the surface grid size was 15 cm \times 14 cm. The secondary lining adopted four element layers; the surface grid size was 30 cm \times 15 cm and the vault lining elements were densified within the 110° central angle. A sensitivity analysis was conducted on the lining units in the densified region. Four different sizes of lining surface units were considered: 10 cm \times 15 cm, 15 cm \times 15 cm, 30 cm \times 15 cm, and 50 cm \times 15 cm. The results revealed challenges in achieving convergence with a unit size of 10 cm \times 15 cm, while a significant deviation in the computed results was observed with a unit size of 50 cm \times 15 cm. To ensure both convergence and accuracy, a grid size of 15 cm \times 15 cm was ultimately chosen for simulating the lining. The lining element nodes were aligned with the surrounding rock element nodes to make the calculation results more accurate.

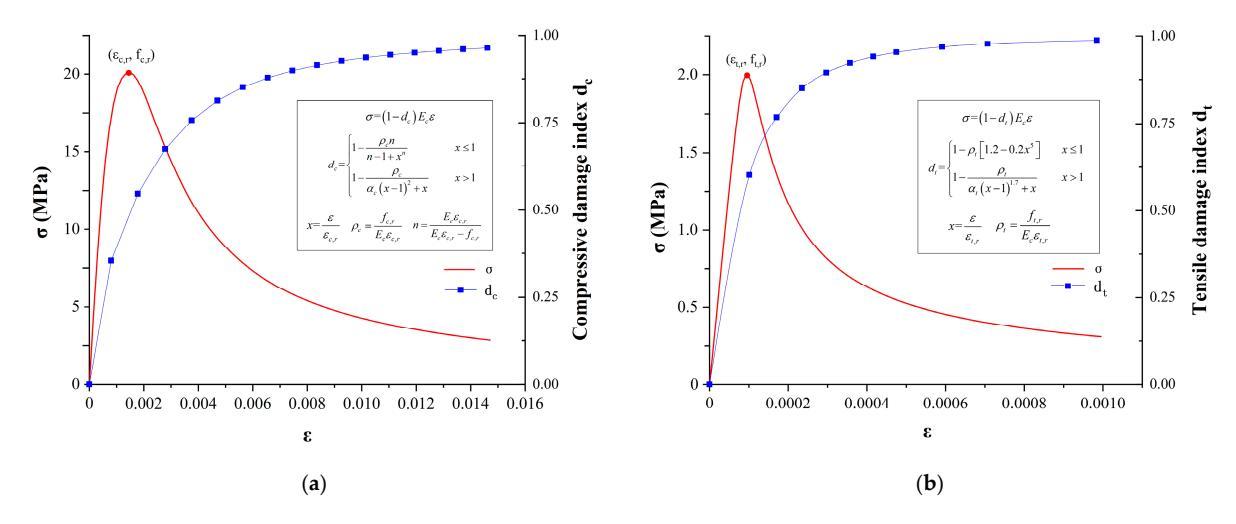
Figure 6. Stress–strain curve and damage factor for C30 concrete: (**a**) compression conditions; (**b**) tensile conditions.

The concrete damage plasticity (CDP) method is a constitutive model used to simulate the behavior of concrete under both plastic deformation and damage accumulation. It combines the concepts of plasticity and damage mechanics to capture the complex response of concrete under various loading conditions. The CDP method considers the evolution of plastic strains, damage variables, and their mutual interactions, providing a comprehensive framework to predict the structural response and failure of concrete structures. As shown in Figure 6, the plastic damage parameters used in this article were calculated using the following method: firstly, the stress–strain curve of concrete according to the Code for the Design of Concrete Structures (GB 50010-2010, 2015 Revised Edition) was obtained, and then the damage factor based on the parameter values in the stress–strain curve was calculated. The damage factor was calculated using the Najar damage theory [33].

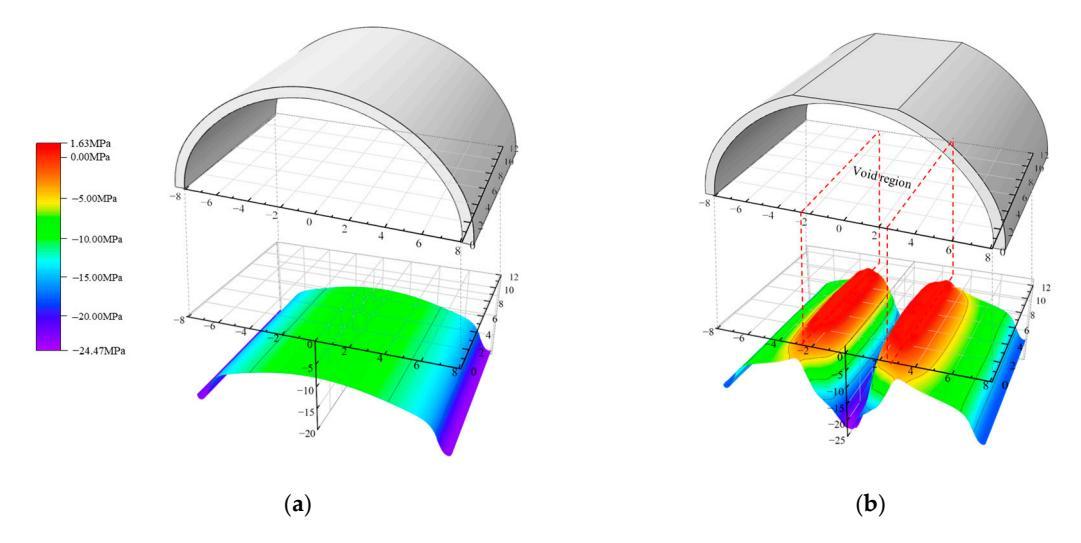
Figure 7. Circumferential stress on the lower surface: (a) V0; (b) V(3/4).

Figure 7a,b show the circumferential stress on the lower surface of the lining when there were no voids and a 3H/4-high void, respectively. The lining without the void was in a state of compression as a whole, while the stress state of the void lining changed significantly. Voids led to a tensile zone at the void boundary on the lower surface of the lining, representing an adverse force state. It can be seen that the critical section was at the position of 6 m in the longitudinal direction.

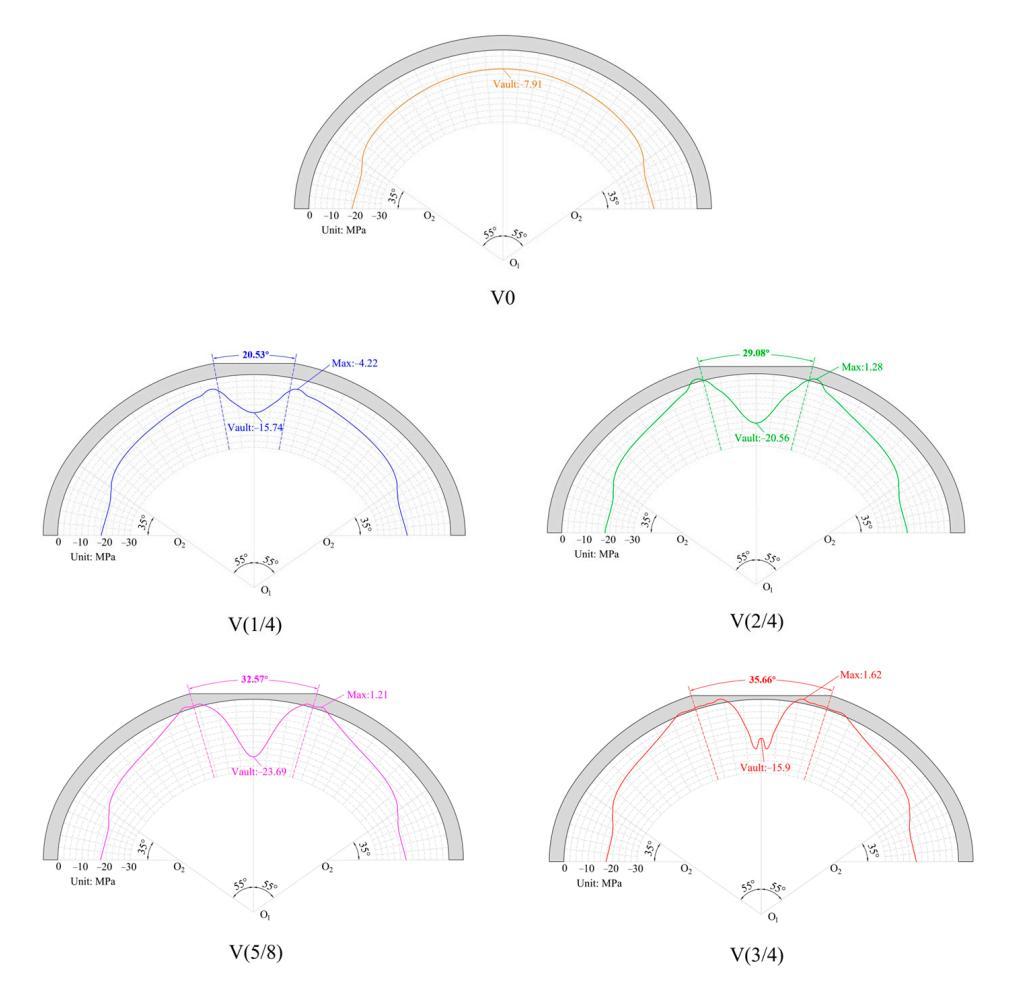
Figure 8. Circumferential stress of the critical sections.

The circumferential stress of the critical sections under each working condition is shown in Figure 8. From the figure, it is evident that the lining without the void was in a state of compression, and it was relatively uniform. The compressive stress within the vault section was 7.91 MPa. However, voids caused significant changes in the circumferential stress. When the void height was H/4, the compressive stress at the void boundary decreased to 4.22 MPa, and there was a trend toward tensile stress. The compressive stress within the vault section was 15.47 MPa, which increased by 95.57% compared with the lining without a void. When the void height was H/2, tensile stress occurred at the void boundary. The circumferential span of the tensile stress was 119.46 cm, and the maximum tensile stress was 1.277 MPa, but it did not reach the concrete tensile strength. The compressive stress of the vault further increased to 20.56 MPa, which was an increase of 159.92% compared with the lining without a void. When the void height was expanded to 5H/8, the maximum circumferential tensile stress was 1.214 MPa, and the circumferential tensile stress span expanded to 213.3 cm. The compressive stress of the vault further increased to 23.69 MPa, which was an increase of 199.49% compared with the lining without a void. In contrast with the H/2 void height, the maximum circumferential tensile stress of the void at 5H/8did not improve much. This indicates that the compressive stress exceeded the compressive strength here, and that the concrete stiffness degraded. Similarly, when the void height was 2 H/3, the maximum tensile stress at the void boundary was 1.62 MPa, and the range of the tensile stress further increased to 444.18 cm. The compressive stress at the vault reduced to 15.9 MPa, indicating that the vault stress exceeded the compressive strength, and the stiffness degraded.

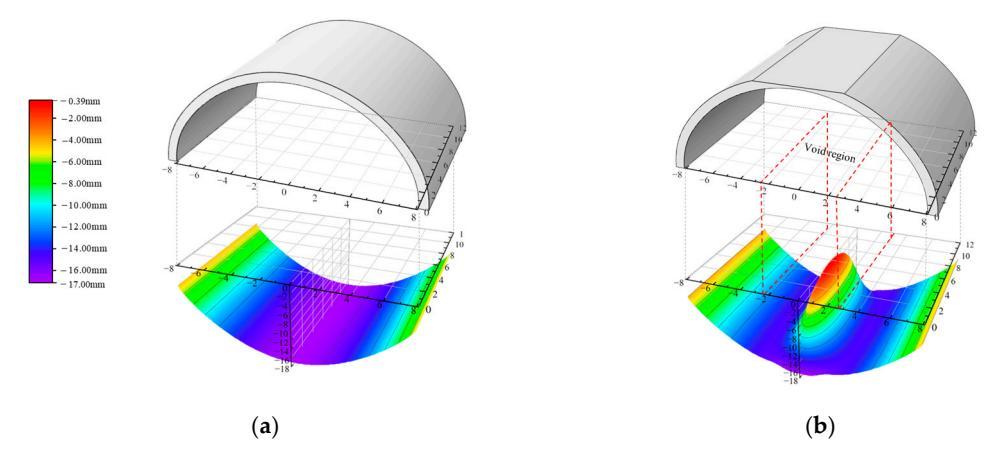
Figure 9. Vertical deformation: (a) V0; (b) V(3/4).

Figure 9a,b show the vertical deformation of the lower surface when there was no void and when the void height was 3H/4, respectively. As depicted in the figure, the influence of the void on the vertical deformation mainly concentrated in the void range, which manifested as an upward uplift of the lining. Moreover, constrained by the adjacent two mold linings, the void lining also showed characteristics of being high in the middle and low on both sides in the longitudinal direction. The critical sections were at the position of 6 m in the longitudinal and circumferential directions.

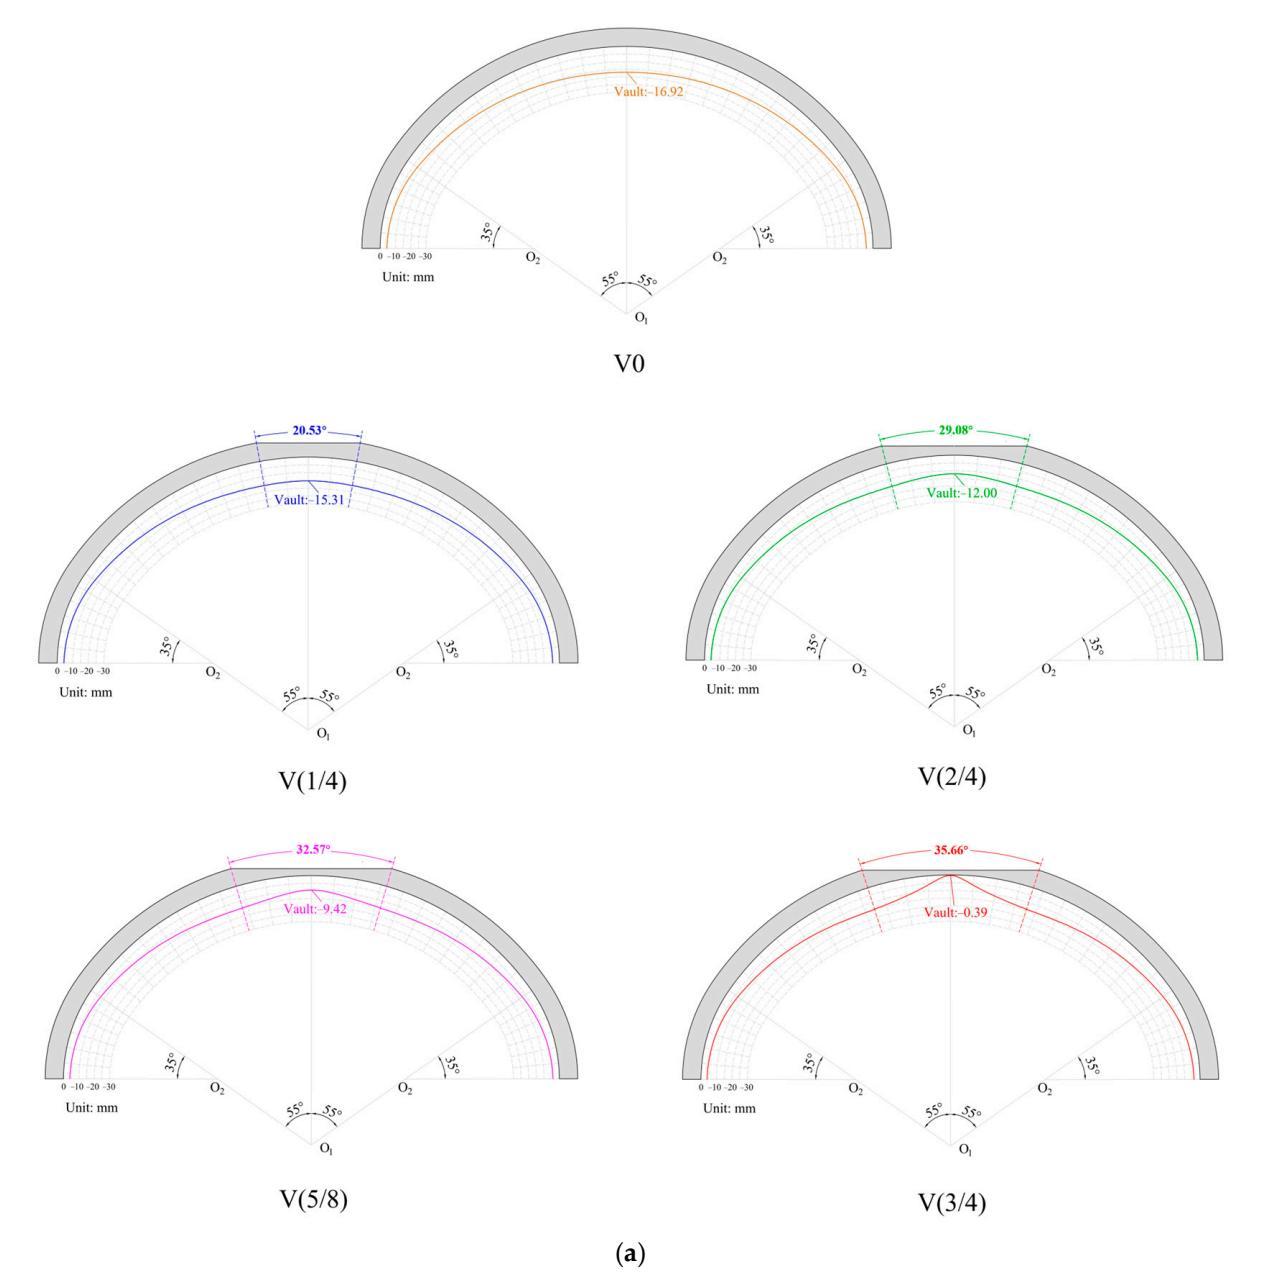
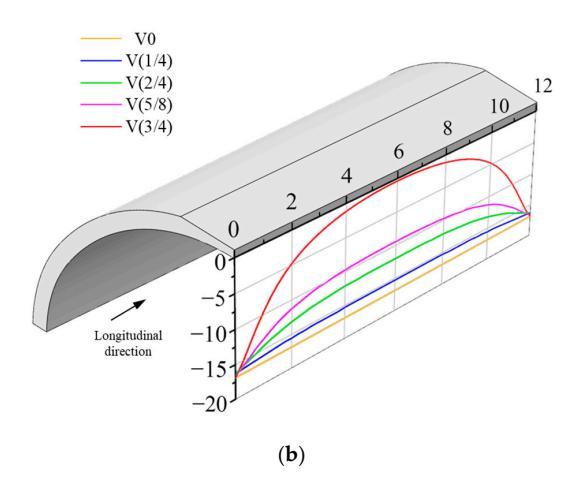
Figure 10. Vertical deformation of critical section: (**a**) circumferential critical section; (**b**) longitudinal critical section.

To analyze the variations in the vertical deformation under different void heights, the illustrations in Figure 10a,b demonstrate the vertical deformation of the critical sections. The vault area was identified as the location from the circumferential perspective where the presence of the void had the most significant impact on the vertical deformation. When there was no void in the lining, the vertical deformation of the vault was -16.9 mm. When there was a void with a height of H/4, the vertical deformation of the vault changed to -15.3 mm, which was 1.6 mm higher than that of the non-void lining. As the height of the void increased, there was a gradual rise in the relative uplift observed at the vault position. When the void height was 3H/4, the vault bulge was the most obvious, and the vertical deformation of the vault a void. From the longitudinal view of the vault, the vertical deformation showed the characteristics of being "high in the middle and low on both sides". The vertical deformation near the construction joint was hardly affected by the void, but the bulge in the middle increased with the increase in the void.

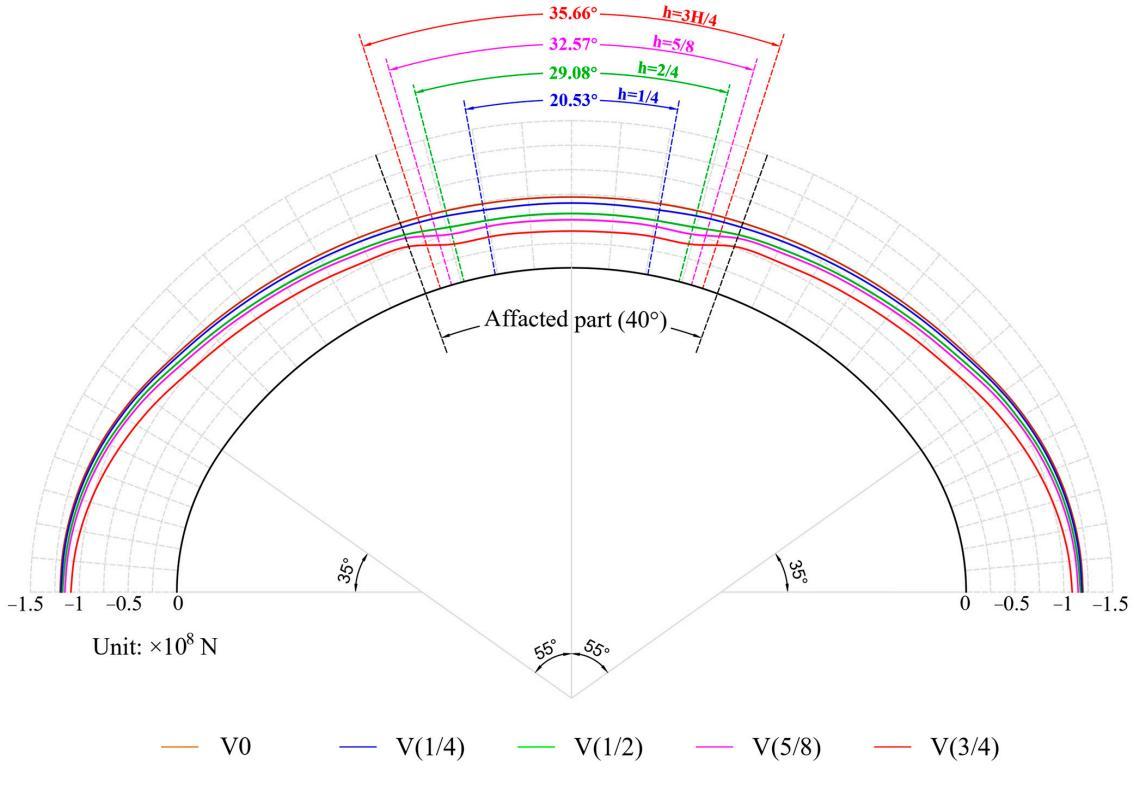
Figure 11. Axial force.

Figure 11 depicts the axial force variation curve of the upper half arch of the void lining, with the negative value representing compression. On the whole, the voids led to a decrease in axial force, and the decrease range increased as the height of the void increased. The axial force in the void range was less than that in the nonvoid part, which was more obvious when the void height was large. Figure 12a,b show the axial force at the vault and at the void boundary, respectively. The figure illustrates a gradual decrease in the axial force with an increase in void height. At the vault position, the axial force was 7.223 × 10⁸ N with no void, and the axial force decreased by 8.56% and 23.3% when the void heights were H/4 and H/2, respectively. When the void height increased to 5H/8 and 2H/3, the axial force at vault reduced by 32.23% and 48%, respectively, compared with that without the void.

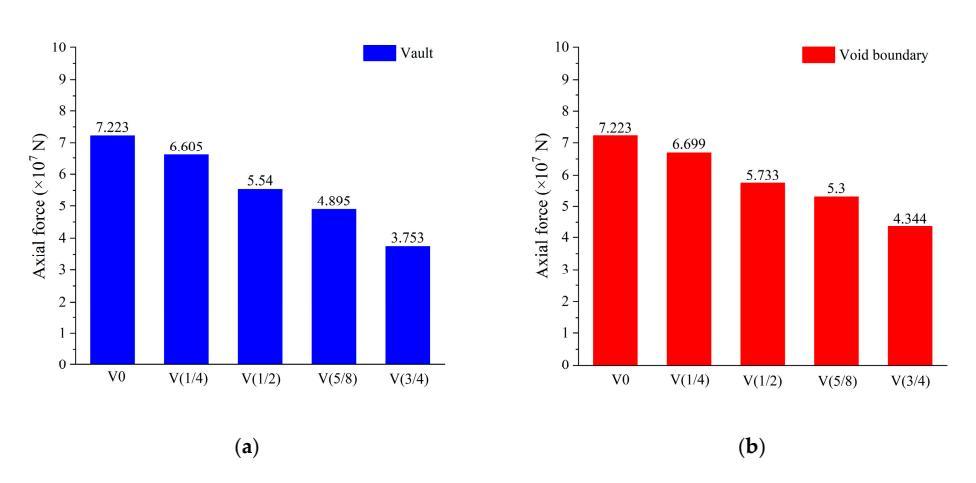
Figure 12. Vertical deformation at special positions: (a) vault; (b) void boundary.

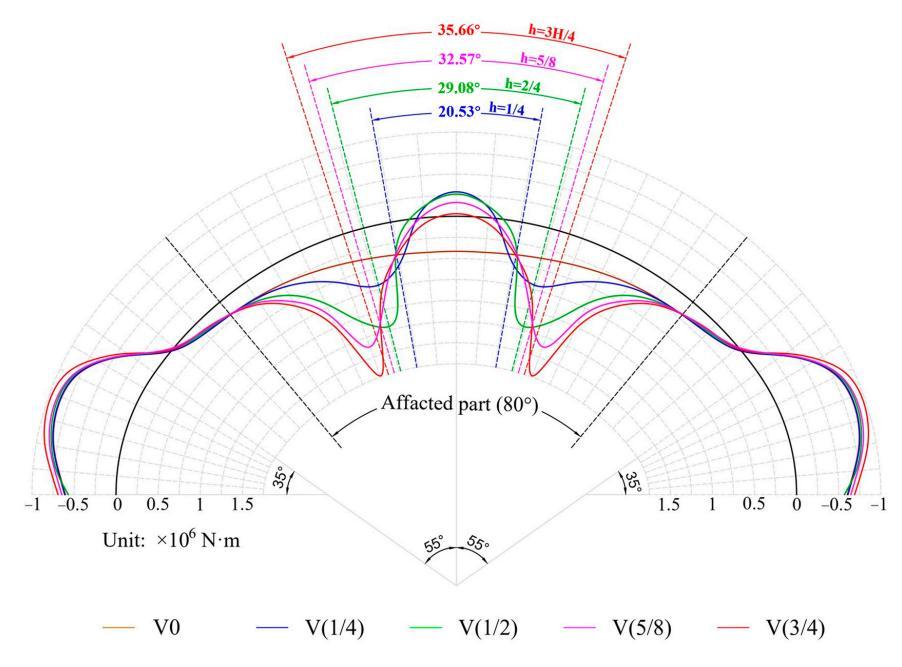
Figure 13. Bending moment.

Figure 13 shows the distribution of the bending moment along the circumferential critical section, with the tension on the lower surface being positive. As can be seen from the figure, the voids caused significant changes in the bending moment distribution, but the influence was mainly concentrated in the 80° range on both sides of the vault. In the absence of voids, the positive bending moment at the vault reached its maximum and gradually diminished toward both sides. Once the void occurred, the bending moment at the vault decreased rapidly and turned to the upper side tension. At the same time, the bending moment at the void boundary also increased rapidly. Figure 14 depicts the bending moment at the vault and void boundary. Only when there was no void was the bending moment of the vault positive; that is, the lower part was in tension. When the lining was voided, the bending moment at the vault became negative; that is, the lower part was compressed and the upper part was tensioned, which also corresponded to the compression damage on the lower surface of the vault. At the void boundary, the bending moments were positive; that is, the lower surface was in tension. With the increase in the void height, the bending moment gradually increased from 1.661×10^6 N·m to 5.887×10^6 N·m, which also corresponded to the tensile damage on the lower surface of the void boundary.

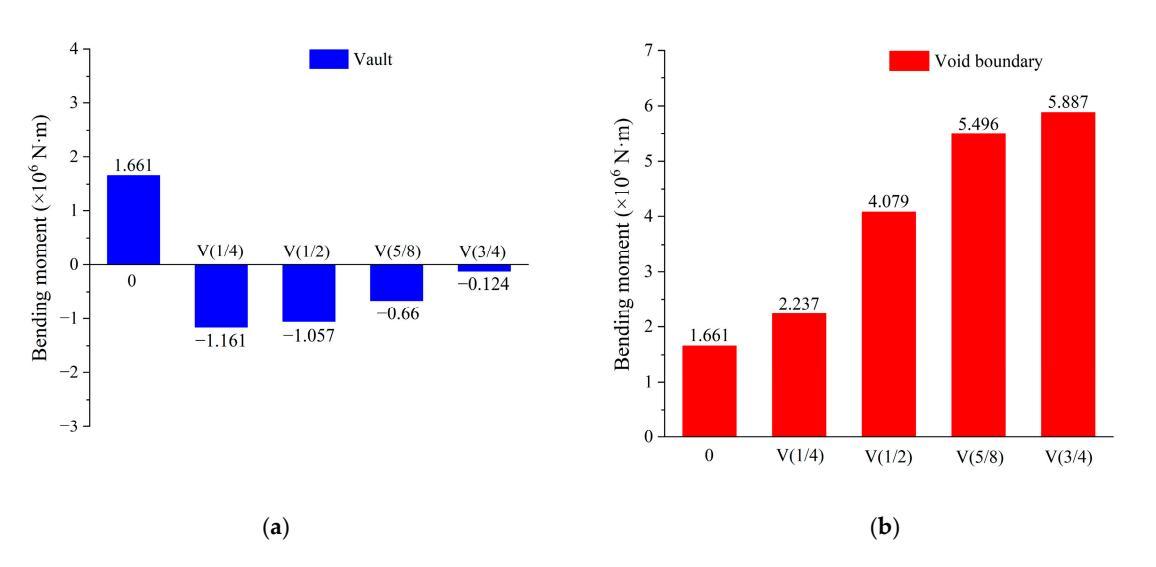
Figure 14. Bending moment at special positions: (a) vault; (b) void boundary.

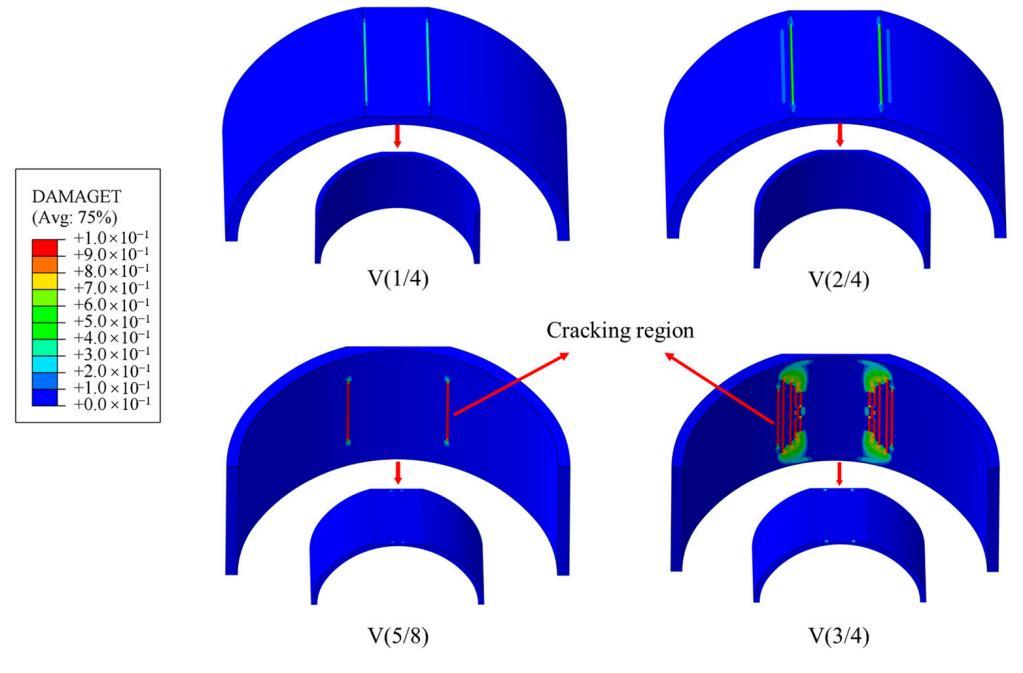
Figure 15. Tensile damage.

Figure 15 shows the results from tensile damage of the lining under various void heights. The lining without any voids had no obvious damage and is not listed. When there was a void in the vault, the damage showed a certain law with the increase in void height. When the void height was H/4 and H/2, the tensile damage of the secondary lining concentrated at the void boundary of the upper surface, the damage degree was small, and the length was short. When the void height increased to 5H/8, the damage on the upper surface of the secondary lining disappeared, and obvious cracking damage began to appear on the lower surface. It developed longitudinally along the void boundary, but the range was small, and there was only one along the left and right boundaries. When the void height continued to increase to 3H/4, the number of longitudinal cracks on the lower surface increased significantly, and each void boundary increased to five cracks, which indicated that the range of the tensile zone increased significantly, and the degree of damage intensified. However, at the position close to the construction joint, the tensile damage was limited due to the restraint of the front and rear lining.

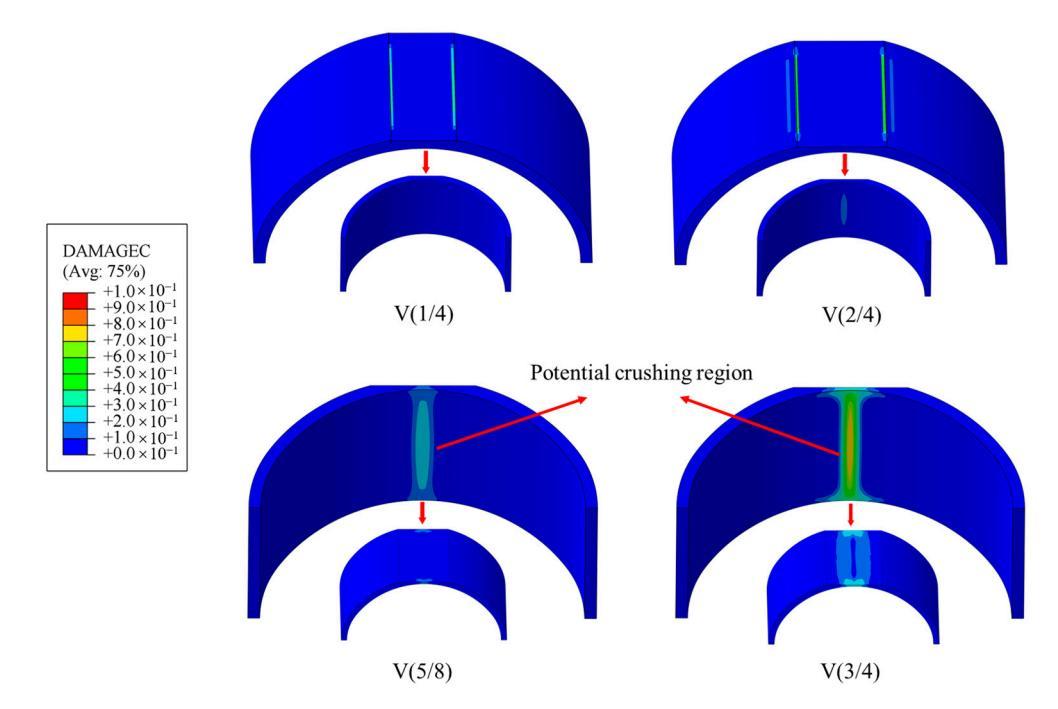
Figure 16. Compression damage.

In terms of compression damage, as shown in Figure 16, when the height of the void was H/4, noticeable compression damage was observed on the outer surface of both sides of the void boundary, but the damage value was only 0.11, which is small. When the void height was H/2, the damage degree at the void boundary of the outer surface expanded to about 0.17, and damage began to occur at the midspan of the lower surface. As the void height continued to increase, the compression damage state of the lining changed significantly. Compressive damage on the inner surface primarily occurred under conditions with larger voids. When the void height reached 5H/8, the central region of the inner surface exhibited damaged areas, with a maximum damage value of 0.26. However, when the void height reached 3H/4, the maximum damage value at the central position of the inner surface increased to 0.84, indicating significant compressive damage in the lining at the vault region. This suggests the potential risk of concrete spalling or even structural collapse.

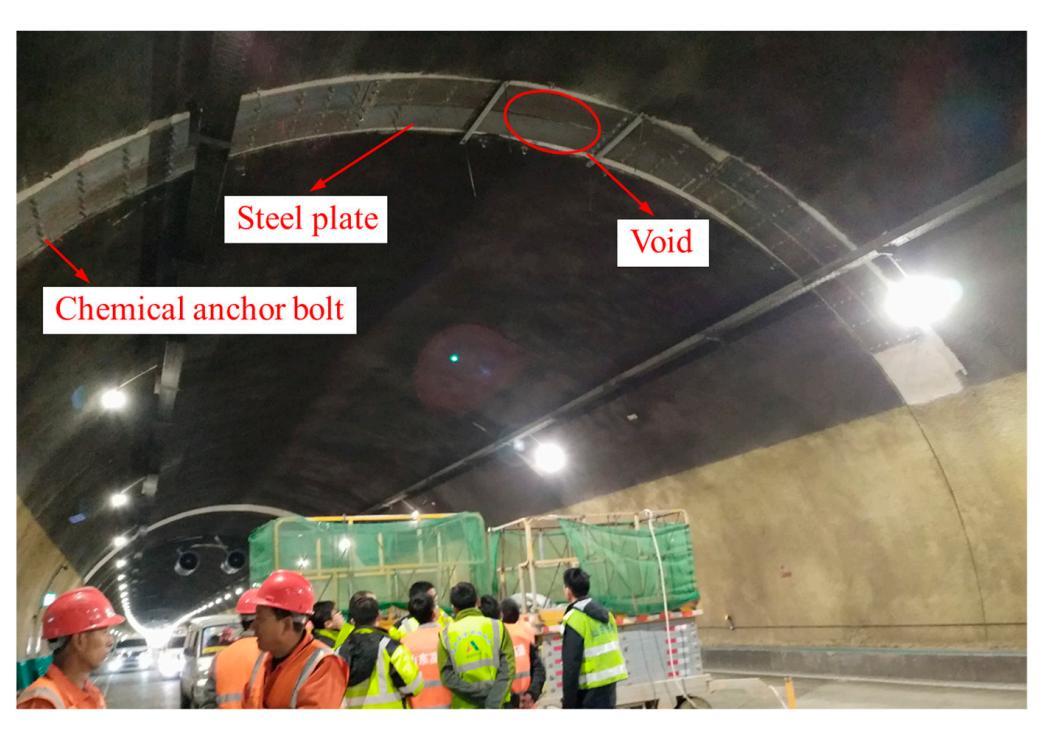
Figure 17. Steel plate strengthening site.

Figure 17 shows the steel plate strengthening scheme of a tunnel. According to the simulation of the void lining, the stress concentration caused by the void was near the void boundary, and there was no large stress located far from the void boundary. Therefore, the void and the vicinity of the void boundary were the main positions that were to be strengthened.

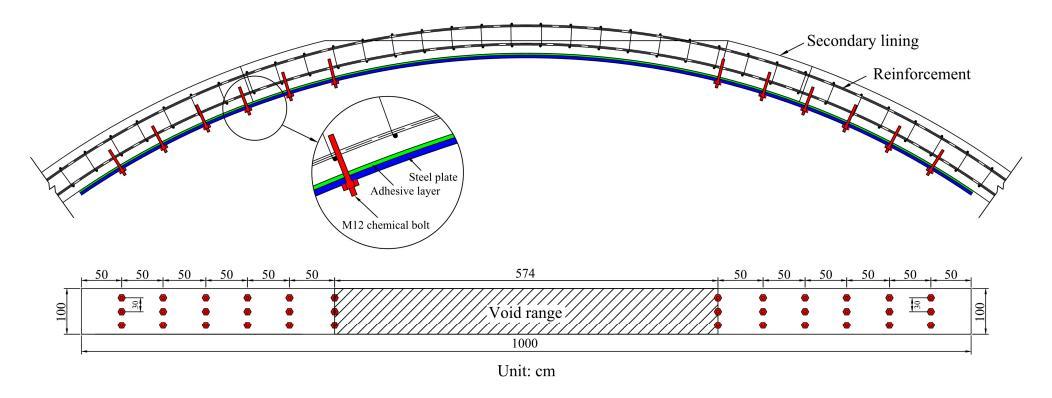
Figure 18. Steel plate strengthening scheme.

According to the simulated stress concentration area, Figure 18 illustrates the scheme for steel plate strengthening. The steel plate was 10 m long, 1 m wide, and 1 cm thick. The steel plate and the lining surface were bonded with epoxy adhesive and reinforced with M24 chemical anchor bolts.

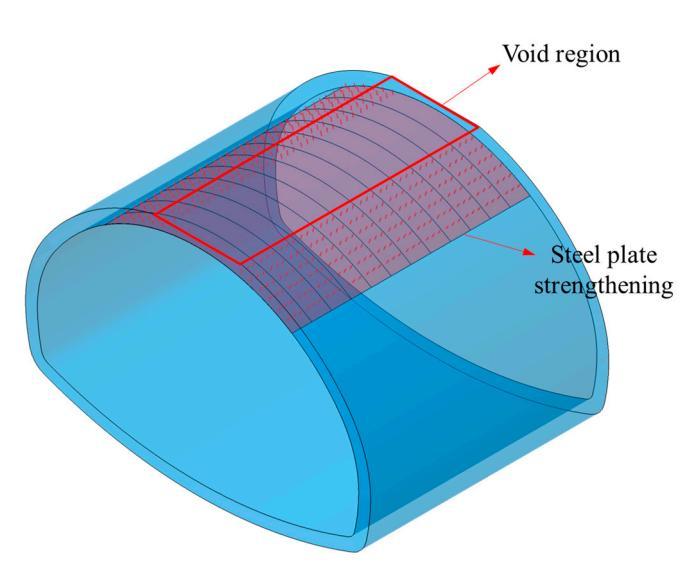
Figure 19. Model setup.

The steel plate strengthening scheme was applied to the void 3H/4 lining to study its strengthening effect. In the simulation model shown in Figure 19, the M24 chemical anchor bolts were simulated by beam element, with a circular section and a diameter of 24 mm. The bolt elements were embedded into the interior of the lining elements through embedded region constraints; the steel plate was simulated with a shell unit with the unit thickness set to 10 mm. The steel adopted a bilinear constitutive law. The elastic modulus was 210 GPa, and the yield stress was 235 Mpa. The contact between the steel plate and the lining was set to cohesive contact. The normal strength was 30 Mpa, the shear strength was 20 Mpa, and the total plastic deformation was 0.008 mm.

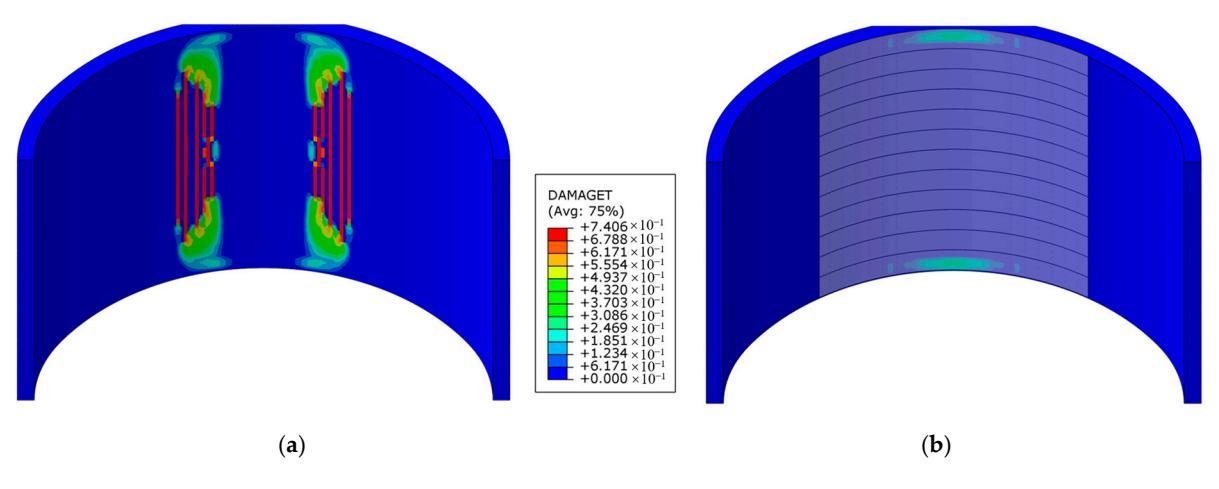
Figure 20. Damage comparison of steel plate strengthening: (**a**) unstrengthened lining; (**b**) strengthened lining.

Figure 20 shows the comparison between the damage of the strengthened lining and the unstrengthened model. It can be seen from the figure that, after steel plate strengthening was applied, tensile damage at the void boundary was completely eliminated. These findings indicate that implementing steel plate reinforcement could effectively mitigate damage to the lining resulting from voids.

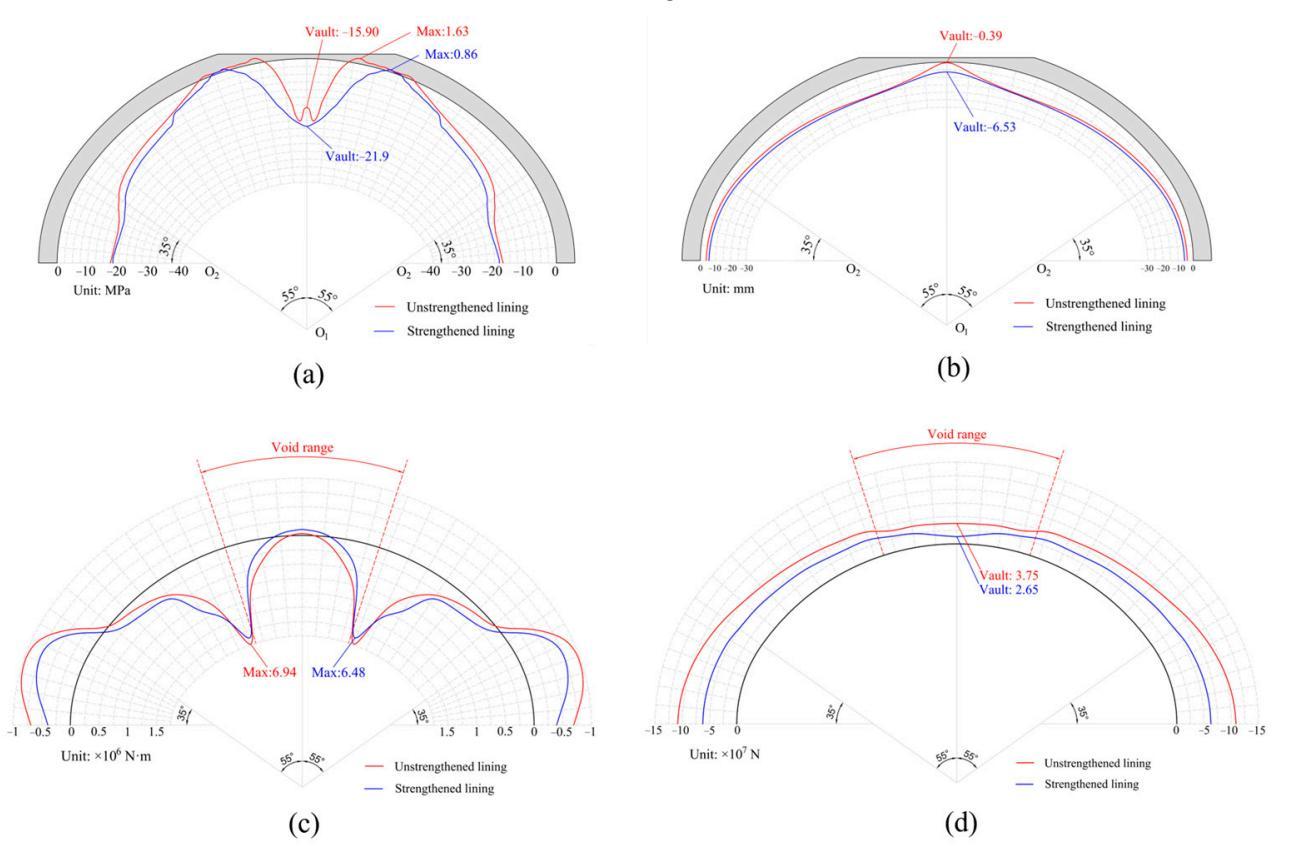
Figure 21. Comparison of internal force of strengthened and unstrengthened void lining: (**a**) circumferential stress; (**b**) vertical deformation; (**c**) bending moment; (**d**) axial force.

The internal force and deformation of the lining model strengthened with steel plates are shown in Figure 21. The maximum circumferential stress on the inner surface of the strengthened lining was 0.86 MPa, which was 47.24% lower compared to the unreinforced lining. The range in positive stresses at the void boundary of the strengthened lining significantly reduced from 2.22 m to 0.614 m, indicating that the tensile damage at this location was effectively improved. The concrete at the vault was obviously compressed, and the vault lining of the unstrengthened model yielded and showed compression damage; however, there was no damage to the vault of the strengthened lining, and the concrete was not plastic yielding. The vault's vertical deformation in the strengthened lining was reduced from 0.39 mm to 6.53 mm, and the deformation difference between the vault and the void boundary reduced from 14.11 mm to 8.58 mm. The overall deformation of the strengthened lining was more coordinated. These findings indicate that employing steel plate strengthening can effectively mitigate uplift of the vault caused by the presence of

voids. Due to the fact that the steel plate did not significantly change the cross-sectional size, there was no significant difference in the bending moment between the strengthened and unstrengthened linings. The maximum bending moment at the degassing boundary was reduced from 6.94×10^6 N·m to 6.48×10^6 N·m, a reduction of only 6.63%. However, the axial force of the void lining strengthened with steel plates decreased overall, with the axial force at the vault decreasing from 3.75×10^7 N to 2.65×10^7 N.
