Article Investigation of Damage and Creep for Bedding's Carbonaceous Slate with Chemical Erosion Effect

Abstract: Tunnel projects in the southwestern mountainous area of China are in full swing. According to the tunnel burial depth, structural characteristics, and chemical erosion environments of the Lixiang railway tunnel, carbonaceous slate specimens obtained in the field were taken to experimentally investigate the physical, mechanical, and creep characteristics of the bedding's slate specimens after chemical erosion. The results of scanning electron microscopy (SEM) indicate that chemical erosion leads to internal damage in the carbonaceous slate specimens, and the internal damages are increasing with the increase of erosion days. Moreover, the specimens' ultrasonic test (UT) results prove that specimens with smaller bedding angles suffer a more serious erosion and induce more internal cracks. Under conventional triaxial compression conditions with 40 MPa of confining pressures, the conventional triaxial compressive strength (σ_s) decreases with the decrease of the bedding angle and the increase of erosion days, and the failure modes of the specimens are mainly controlled by o

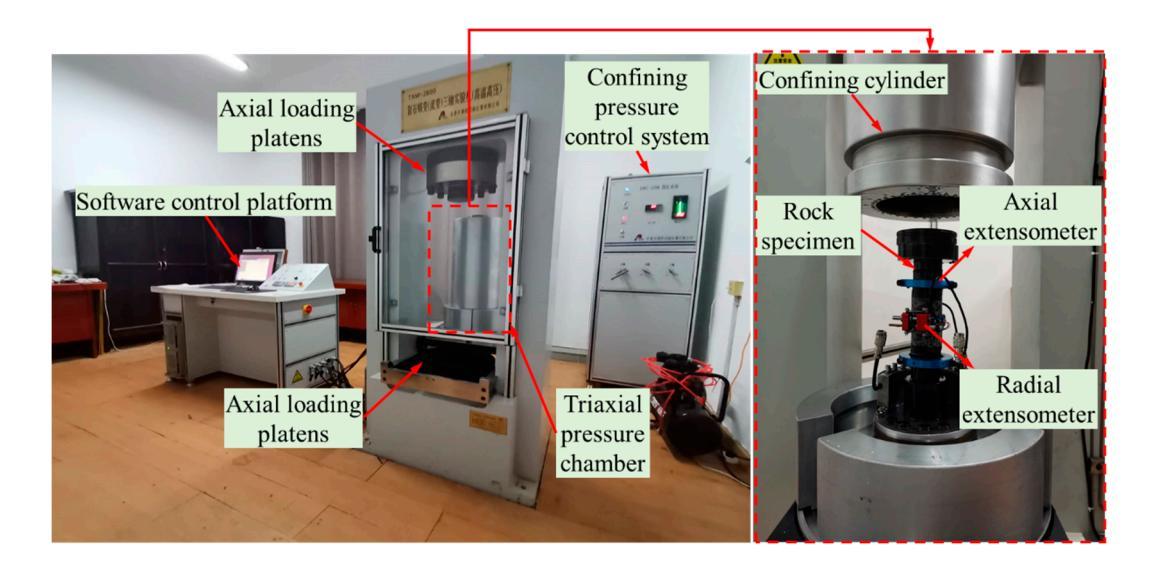
Figure 1. Photographs of the test apparatus.

The conventional triaxial compression tests and the triaxial creeping tests were performed on a servo-controlled rock mechanics testing system, TYJ-2000 (as shown in Figure 1), which consists of axial loading platens, a triaxial pressure chamber, a confining pressure control system, and a software control platform. The TYJ-2000 rock mechanics testing system can conduct conventional rock triaxial compression tests and creep tests under high temperatures and high pressures. The maximum axial load of the testing system is 2000 KN, and the maximum confining pressure is 100 MPa.

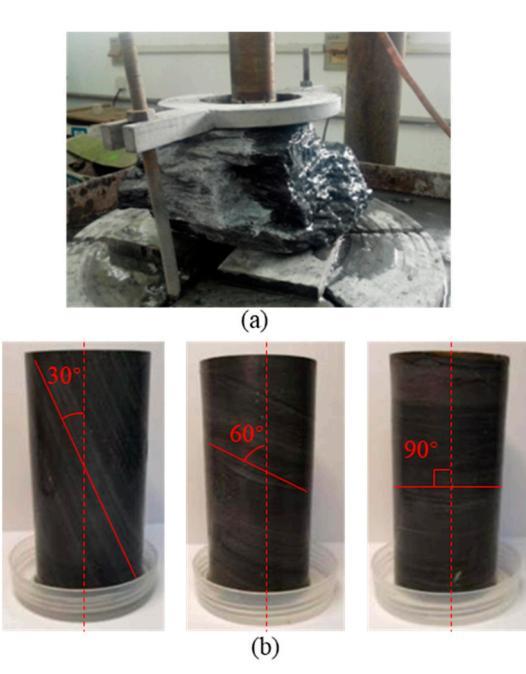
Figure 2. (a) Slate block; (b) specimens with different bedding angles.

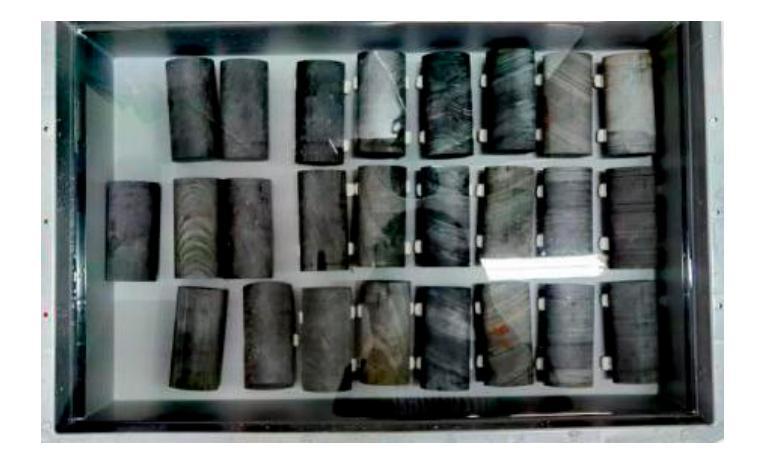
Figure 3. Photograph of the specimen's erosion process.

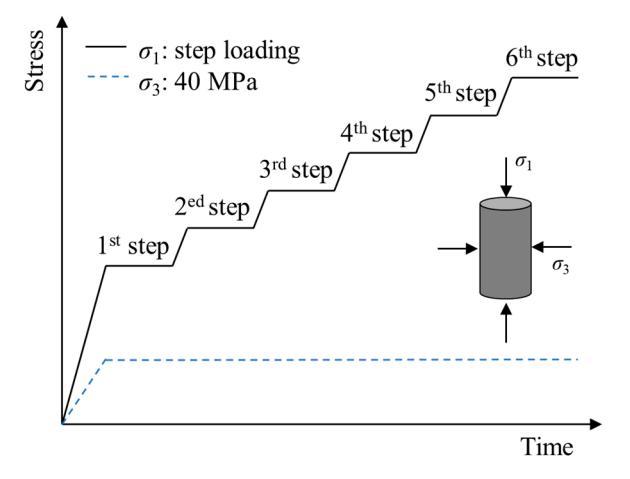
Figure 4. Stress paths for the triaxial creep test.

(2) During the triaxial creep test, confining pressures were increased to 40 MPa at the rate of 0.10 MPa/s. The axial pressure was step-loaded at a rate of 0.20 MPa/s, the first step was loaded to 0.4 times the conventional triaxial compressive strength (σ_s), and the subsequent load of each step increased by 0.1 times the σ_s until creep failure occurred in the specimen (as shown in Figure 4).

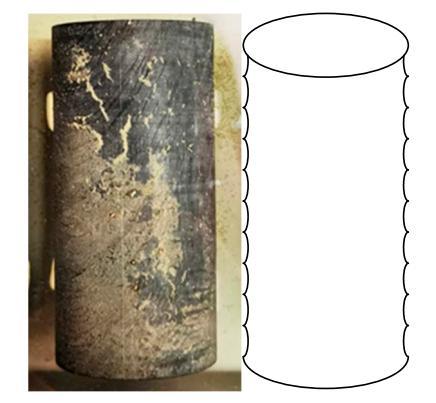
Figure 5. Photograph and schematic diagram of surface damage after chemical solvent erosion.

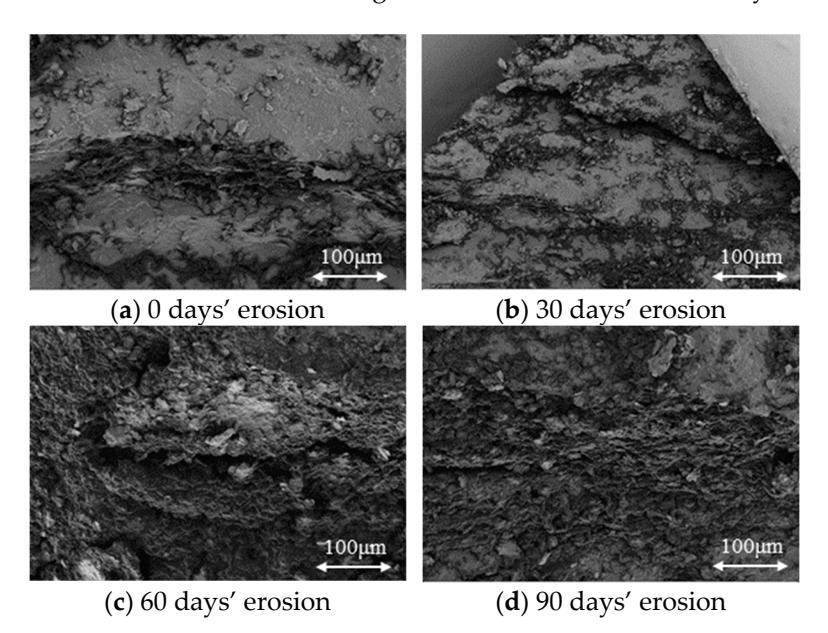
Figure 6. Typical SEM images of specimens under different erosion days.

To conduct SEM, 20 thin slices (no more than 2 cm in length and width) of slate specimens with four different erosion days were taken along the bedding plane. Typical SEM images of the specimens under different erosion days are shown in Figure 6. According to the images, it can be found that the specimens without erosion (0 days' erosion) present a stepped structure, and the step surface is relatively flat and compact. For the specimens after 30 days' erosion, there are many small and loose blocks on the surface of the stepped structure, and some micro-cracks emerged in the specimen slice. For the specimens after 60 days' erosion, the edges and corners of the stepped structures are fuzzy and loose, showing a pit-like structure; moreover, the micro-cracks are the largest and most obvious among the four kinds of slices. For the specimens after 90 days' erosion, the stepped structure, and a lot of micro-cracks are filled or buried by

loose and small blocks. Therefore, it can be concluded that the internal cracks induced by chemical erosion are increasing with the increase of erosion days.

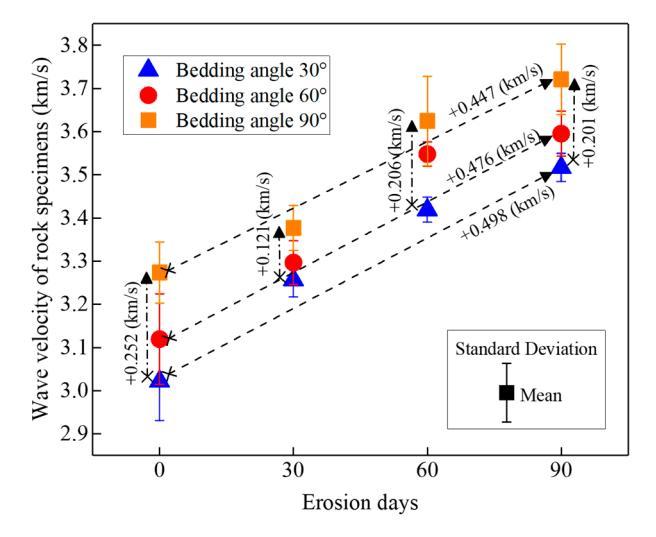
Figure 7. Wave velocity of specimens with different bedding angles with different erosion durations.

Figure 7 shows the wave velocity of specimens with different bedding angles and different erosion duration days. According to the descriptive statistics of three specimens under the same states (the same bedding angle and erosion days), it is found that the standard deviations of the wave velocity for the specimens are less than 0.1, which means the difference in the measured values is very small for specimens under the same states. Therefore, it is believed that the differences among the specimens under the same states are small.

Moreover, according to the analyses of the mean values for specimens under the same erosion days, the velocity of the ultrasonic longitudinal wave increases with the increase of the bedding angle. For example, for specimens under 30 days' erosion, the increasing amount of wave velocity is 0.121 (km/s) when the bedding angle increased from 30° to 90° . This means that specimens with smaller bedding angles suffered serious erosion and induced more internal cracks. On the other hand, for specimens with the same bedding angles, it shows that the velocity of the ultrasonic longitudinal waves increases with the increase of erosion days. For example, for specimens with a 30° bedding angle, the increasing amount of the wave velocity is 0.498 (km/s) when the erosion days increased from 0 days to 90 days. The principal reason for this phenomenon is that the greater the erosion days, the more liquid will fill the microscopic cracks in the rock specimens. The

effect of liquid filling on acoustic waves is greater than that of internal cracks induced by chemical erosion.

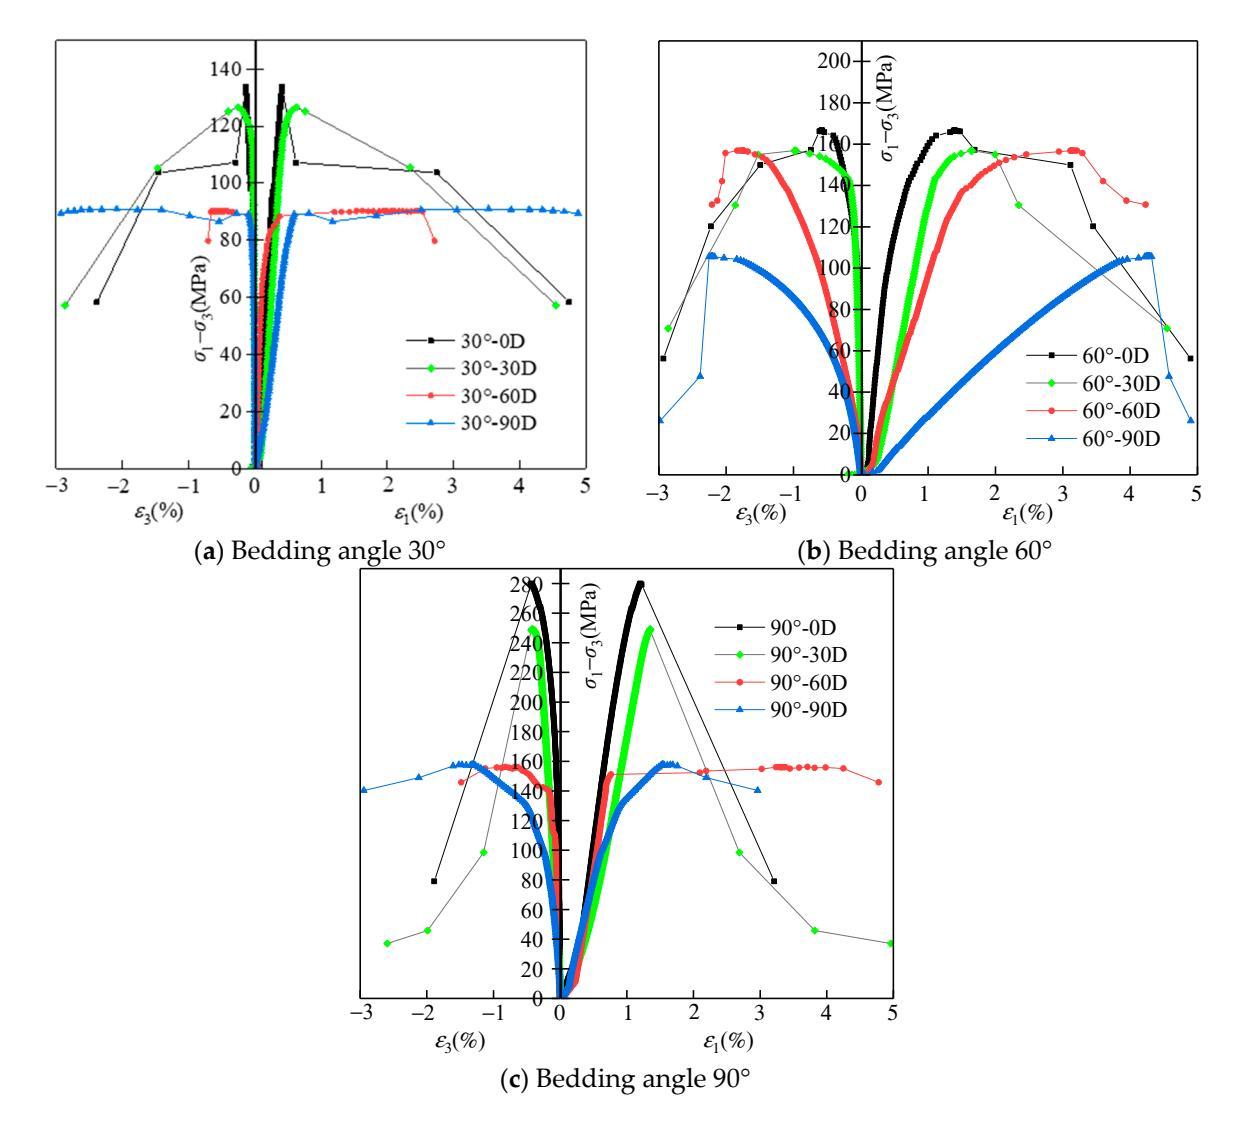
Figure 8. Stress-strain curves of specimens under triaxial compression tests.

The stress-strain curves of specimens under conventional triaxial compression tests are shown in Figure 8. Before the peak of deviation stress ($\sigma_1 - \sigma_3$), the stress–strain curves increased linearly, indicating elastic deformations of the specimens. After the peak of the deviation stress, the stress-strain curves of the specimens with different bedding angles and erosion days are diverse. For the specimens with 30° and 90° bedding angles, under short-term erosions (0 days' erosion and 30 days' erosion), the specimens' stress dropped sharply, with little strain increase, indicating a brittle failure, whereas, for the specimens with 30° and 90° bedding angles, under long-term erosions (60 days' erosion and 90 days' erosion), the specimens' stress drop after failure is small, and there is a great strain increase, indicating ductile failure. The variations of stress–strain for the specimens with a 60° bedding angle are discrepancies from that of the specimens with 30° and 90° bedding angles. Under four different erosion days, the specimens with a 60° bedding angle all showed brittle failure features in the stress-strain curve. However, the specimens with a 60° bedding angle showed greater axial and radial strain at the peak of the deviation stresses than the specimens with 30° and 90° bedding angles, and the values of the axial and radial strain at the peak of the deviation stresses increased with the increase of erosion days. The reasons for this discrepancy phenomenon for the specimens with a 60° bedding angle can be interpreted by the fracture modes analysis in the next section.

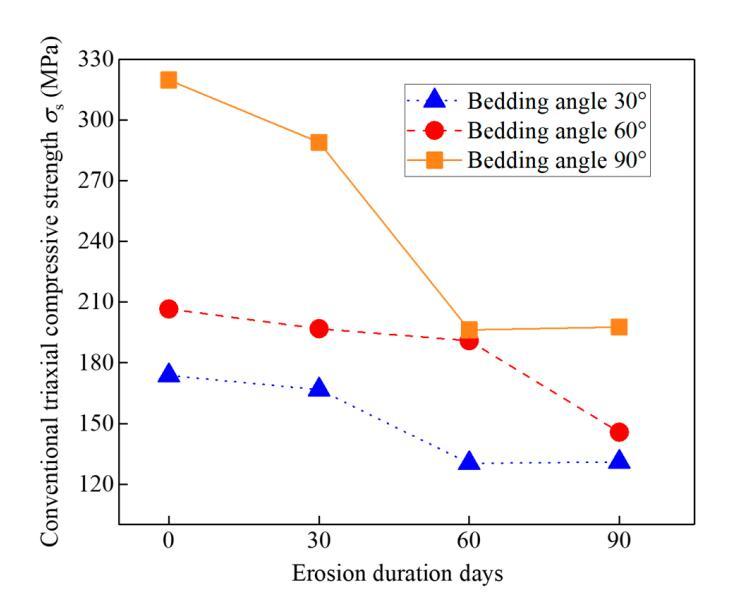
Figure 9. Conventional triaxial compressive strength with different bedding angles and erosion days.

Based on the stress–strain curves, the conventional triaxial compressive strength (σ_s) of specimens can be obtained by adding 40 MPa of confining pressure to the peak of deviation stresses. Figure 9 shows the relationship of the σ_s with the bedding angle and erosion days. For specimens under the same erosion days, the σ_s decreased with the decrease of the bedding angle. This result can be explained by the variation of the wave velocity for the specimens with different bedding angles; in Section 3, it proves that the specimens with a smaller bedding angle exhibited a lower wave velocity because they suffered serious erosion and induced more internal cracks; more internal cracks in specimens will induce a lower σ_s . On the other hand, for the specimens with the same bedding angle, the σ_s decreased with the increase of erosion days. This conclusion is consistent with the results of the SEM images for the specimens under different erosion days, as shown in Figure 6, which indicates long-term erosion will induce more internal cracks and loose structures, and loose structures will result in lower σ_s . Moreover, for the specimens with a 90° bedding angle under 0 and 30 days' erosion, their σ_s is greater than that of the other specimens; this is because they suffered slight erosion, and at the same time, the 90° bedding structure was vertical to the axial stress, which made them harder to break.

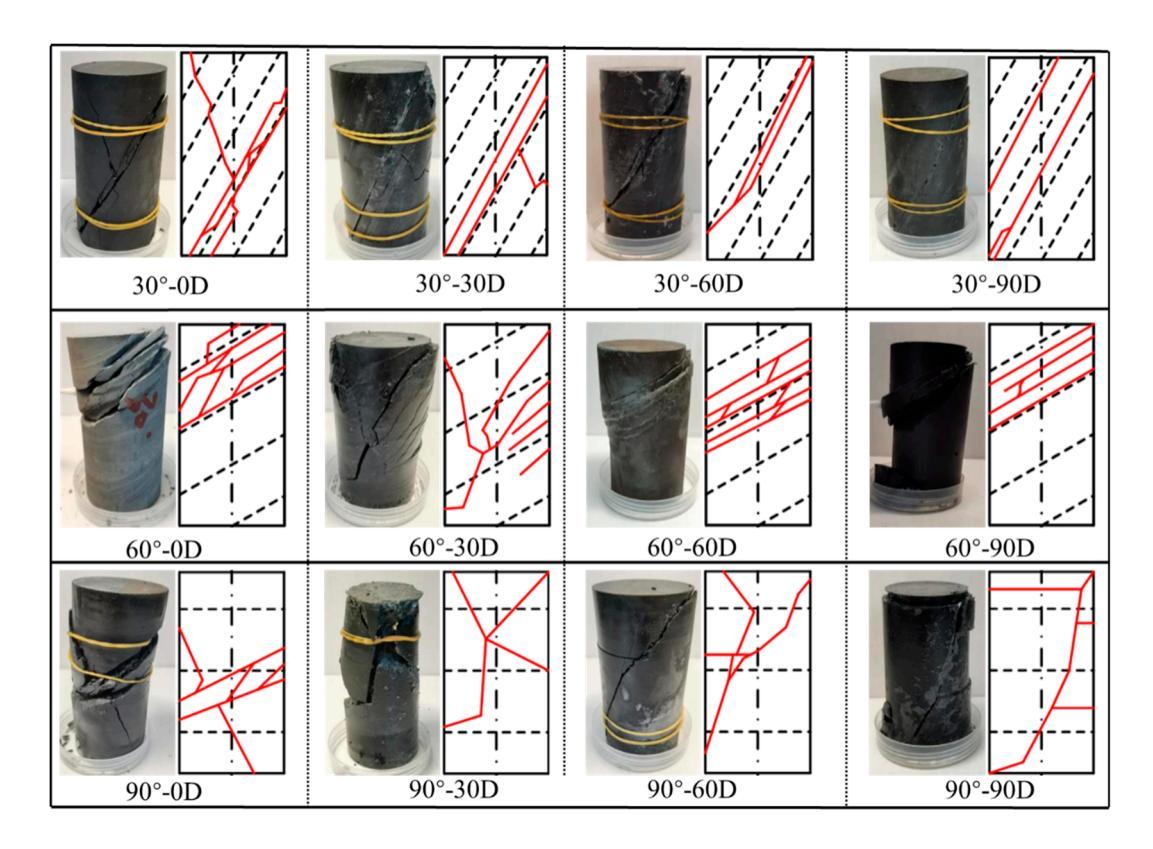
Figure 10. Failure modes and failure sketches of specimens under triaxial compression tests.

A deep understanding of the failure behavior of rock is important for the prediction and protection of engineering disasters. In this paper, the failure modes of specimens with different bedding angles and erosion days under conventional triaxial conditions were analyzed and compared. Figure 10 shows the failure modes and failure sketches of specimens under triaxial compression tests. It can be found that under conventional triaxial conditions, for specimens with 30° bedding angles, the main fractures in the specimens are connected diagonally along the bedding inclination, and X-shaped small secondary cracks are visible; moreover, with the increase of erosion days, the fractures along the bedding inclination are more obvious, and secondary cracks are rarer. For specimens with 60° bedding angles, there are several cut-through fractures propagated along the bedding inclination, resulting in spalling failure, which explains why the specimens with 60° bedding angles show greater axial and radial strain than that of the specimens with 30° and 90° bedding angles. Furthermore, with the increase of erosion days, the cut-through fractures changed from scattered to concentrated. For specimens with 90° bedding angles, the specimens under short-term erosion (0 days' erosion and 30 days' erosion) are relatively broken and show a common X-type conjugate inclined to plane shear failure, whereas the specimens' failure under long-term erosion (60 days' erosion and 90 days' erosion) are controlled by shear failure, together with horizontal cracks.

In conclusion, the failure modes of specimens with different bedding angles and erosion days under conventional triaxial conditions are affected by the bedding's inclination angle. The failure modes of the specimens are mainly controlled by oblique shear fractures and accompanied by the occurrence of slip dislocation fractures between the bedding inclination. Especially with increasing erosion days, the fracture development along the bedding's inclination angle is gradually obvious, which indicates that chemical erosion accelerates the corrosion of the interlayer.

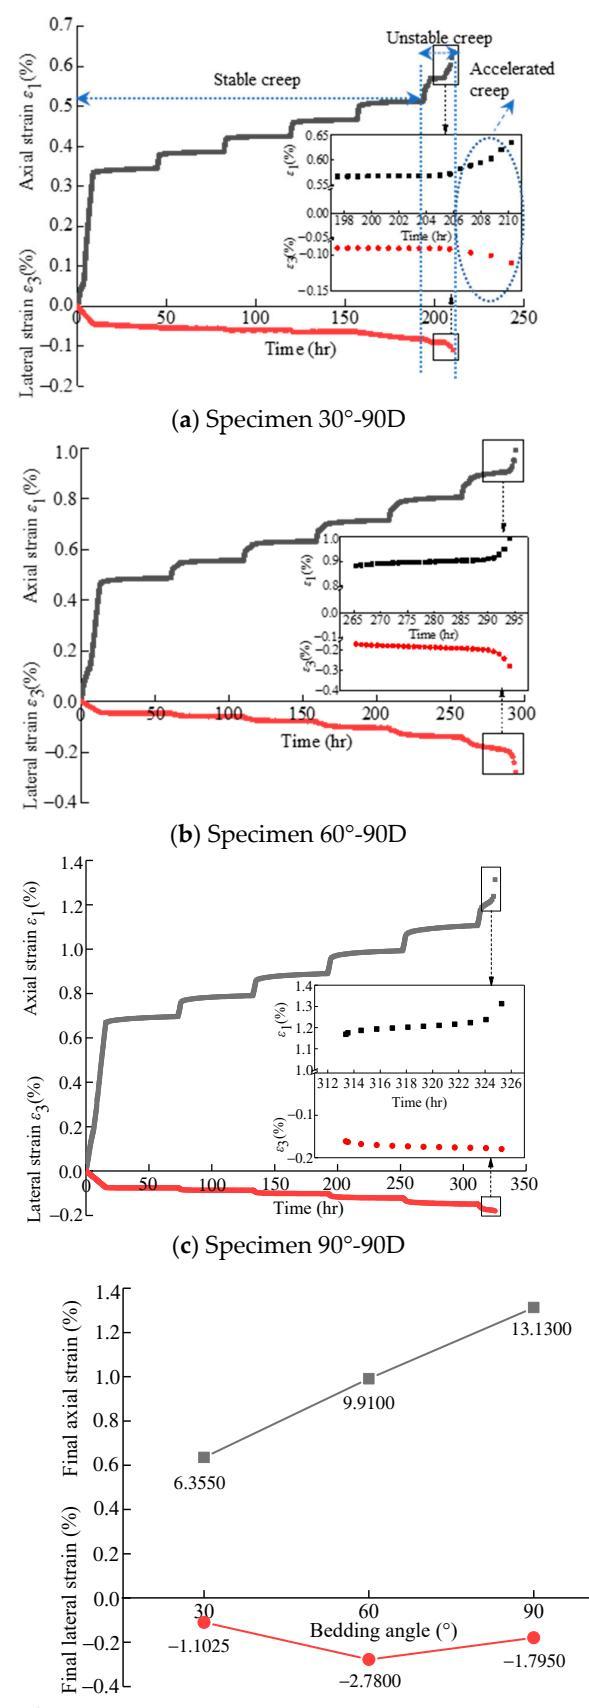
(d) Final strains of specimens with different bedding angles

Figure 11. Creep curves and final strains of specimens with different bedding angles after 90 days of erosion.

According to the experimental scheme, the triaxial creep tests under a confining pressure of 40 MPa were carried out on the specimens with bedding angles of 30°, 60°, and 90° after 90 days of erosion. The strain–time curves of the creep tests for the specimens with different bedding angles after 90 days of erosion are plotted in Figure 11. It can be found that at the last step of loading, the creep of the specimen changed from a stable creep to an unstable creep, resulting in specimen failure. At the same time, an unstable accelerated creep occurred suddenly, indicating sudden brittle specimen failure.

Moreover, comparing the strain-time curves of specimens with bedding angles of 30° , 60° , and 90° after 90 days' erosion, it is obvious that the axial deformations of accelerated creep stages increase with the increasing of the bedding angles; thus, the final axial strain increases (as shown in Figure 11d), whereas the lateral deformations of the accelerated creep stages are different. For the specimens of 30° -90D, the lateral deformations of the accelerated creep stage increase inconspicuously; for the specimens of 60° -90D, the lateral deformations of the accelerated creep stage increase obviously; for the specimens of 90° -90D, the lateral deformations of the accelerated creep stage increase obviously; for the specimens of 90° -90D, the lateral deformations of the accelerated creep stage increase obviously; for the specimens of 90° -90D, the lateral deformations of the accelerated creep stage increase obviously; for the specimens of 90° -90D, the lateral deformations of the accelerated creep stage increase obviously; for the specimens of 90° -90D, the lateral deformations of the accelerated creep stage indicate the difference in the failure modes for specimens with different bedding angles under creep tests, which will be interpreted next in Section 5.2.

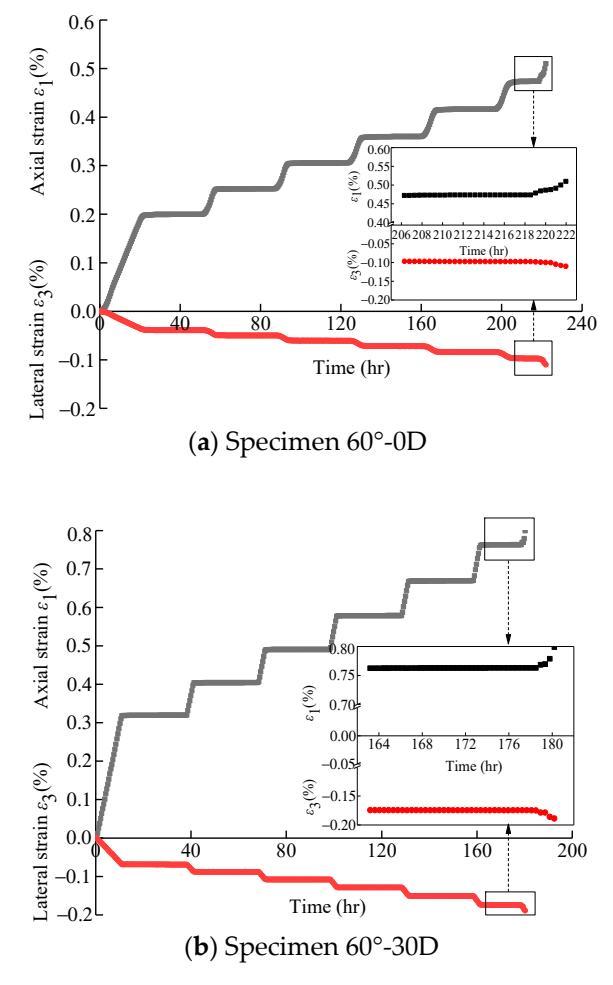
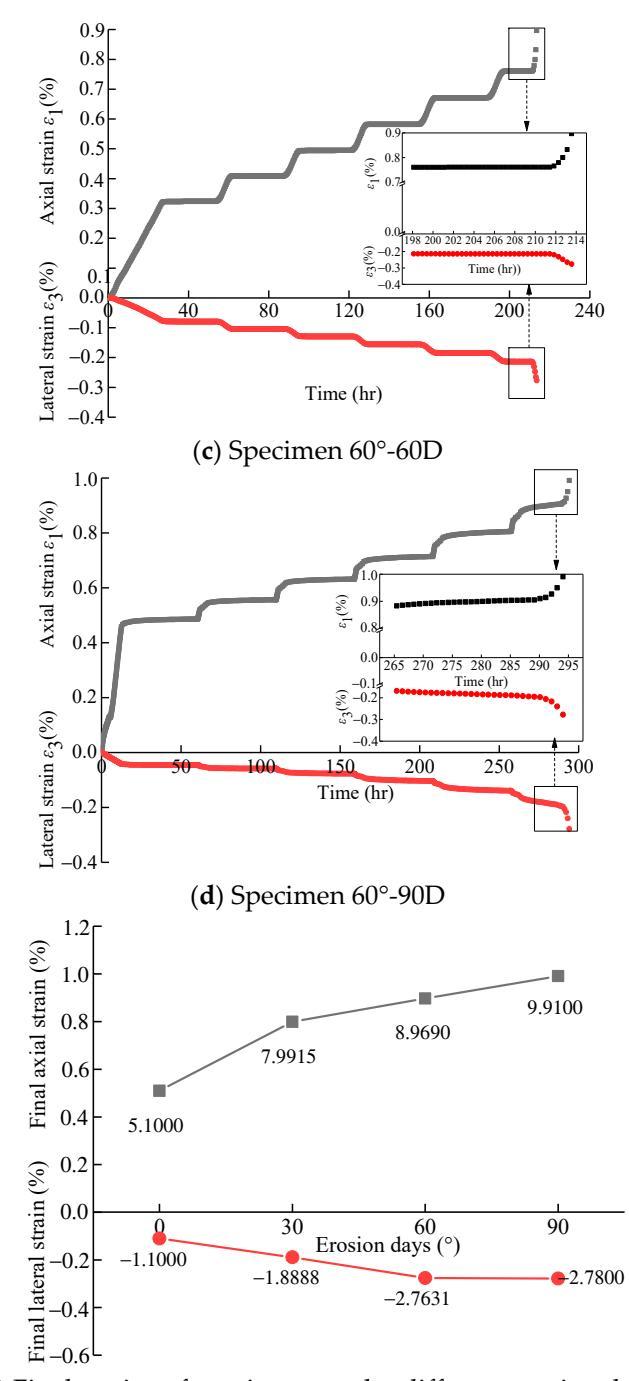
Figure 12. Creep curves of specimens with a bedding angle of 60° under different erosion days.

According to Sections 4.1 and 5.1, there are discrepancies in the deformation characteristics for specimens with a 60° bedding angle under conventional triaxial tests and creep tests compared with 30° and 90° bedding angles. Thus, triaxial creep tests under a confining pressure of 40 MPa were carried out on the specimens with 60° bedding angles after 0, 30, 60, and 90 days of erosion. The strain–time curves of the creep tests for specimens with different erosion days are plotted in Figure 12. It can be found that for the specimens under long-term erosion (60° -60D and 60° -90D), the specimens' unstable accelerated creep occurred more suddenly than that of the specimen under short-term erosion (60° -0D and 60° -30D), indicating a more sudden brittle specimen failure for the specimens under long-term erosion. Moreover, the final axial and final lateral deformations increase with the increase of erosion days (as shown in Figure 12e), which means the longer the erosion days, the greater the deformation.
