Seismic Behavior of Concrete Columns Retrofitted with a Brace-Type Replaceable Steel Link

Abstract: This paper presents the results of a combined cyclic loading test on a single reinforced concrete column which was retrofitted with a newly proposed brace-type replaceable steel link. A total of four retrofitted reinforced concrete columns, with the length of the brace as a variable, were fabricated and tested. A companion column without retrofitting was used as the control specimen. The test results indicate that the proposed brace-type replaceable steel link can be effective in retrofitting the concrete columns, resulting in improvements in the strength, stiffness, and energy dissipation of columns. We observed that the maximum load increases by at least 87%, effective stiffness increases by 44%, and energy dissipation capacity increases by 91% when compared with non-retrofitted specimen.

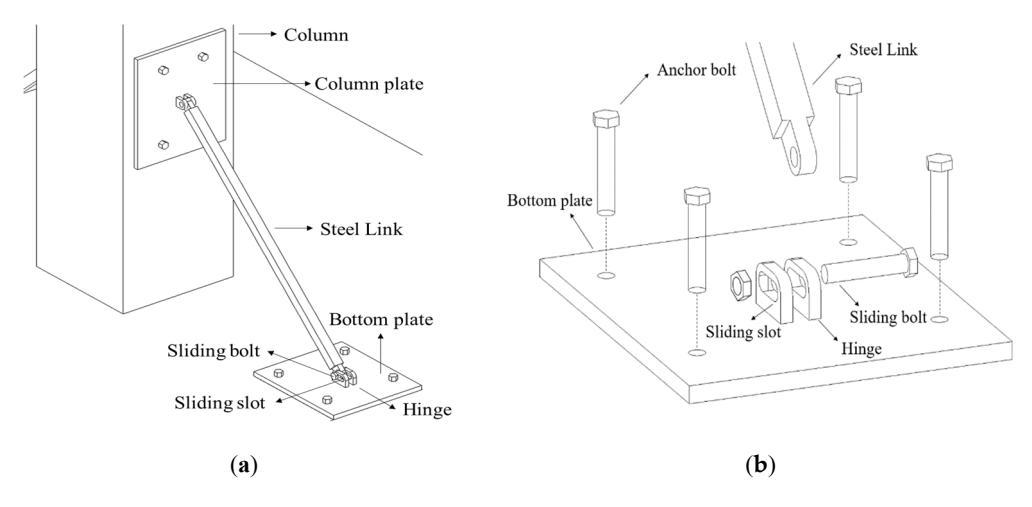
Figure 1. Scheme of the replaceable steel link (RSL) system: (**a**) applications of RSL; (**b**) components of the RSL system.

Unlike conventional braces, the RSL system does not have a gusset plate with complicated details, and it can be diagonally connected between a column and a beam, or a column and a slab. The retrofitting scheme of the proposed system is shown in Figure 1. The RSL system consists of one steel link and two steel plates for attaching the steel link to the column and beam or slab. The steel plate attached to the column is fixed by steel links with bolts. The steel plate attached to the beam or slab is welded to a hinge with a slot, and the steel link and hinge are fastened by a sliding bolt. The steel link dissipates energy as the bolt in the sliding slot moves with frictional force due to the lateral displacement occurring in the column. When the lateral displacement of the column increases, the bolt can no longer move, and from this point the steel link behaves like a brace. Buckling or deformation in the steel link is induced before the longitudinal reinforcement of the column.

The steel link can absorb the deformation energy by moving along the displacement of the column through the sliding slot, creating friction between the sliding bolt and the slot. The capacity for the stiffness and deformation of the column can be set by adjusting the allowable range of movement of the sliding bolt in hinge. The position of the plate attached to the column and beam or slab, and the link length according to the desired retrofit length, can be adjusted. Even if the steel link is buckled or failed in an earthquake, it can be replaced with a new one for the next earthquake. An additional advantage of the RSL system is that a single column can be selectively retrofitted. Seismic retrofit performance can be enhanced even if applied only to the plastic hinge region in column, which can be constructed in little space and causes no inconvenience in using the building during and after the construction.

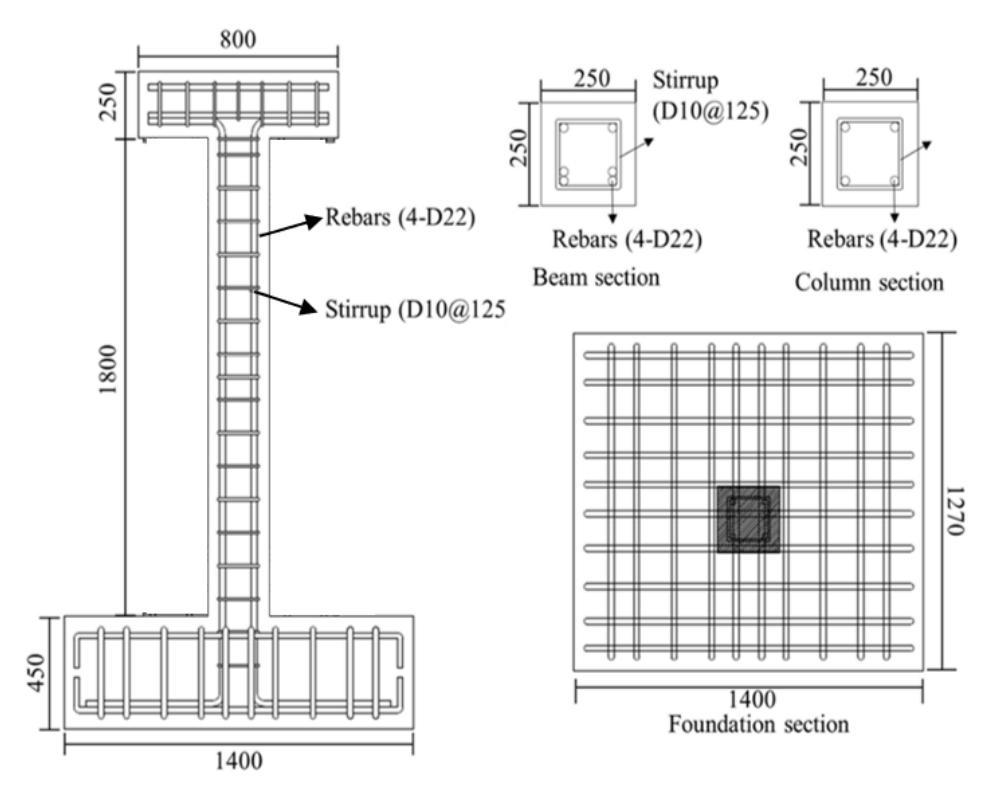
Figure 2. Details of an RC column (m).

where *L* is the column length, f_y is the yield strength of the longitudinal reinforcement, and d_b is the diameter of the longitudinal rebar. The types and variables of the specimens are shown in Table 1, and the details of the specimens are shown in Table 2. Figure 2 shows the geometry and reinforcement details for the specimens. All specimens have a square column with a height of 1.8 m and a cross section of 250×250 mm². An upper beam for loading and a foundation for fixing the specimen were manufactured. The upper beam also had a cross

section of 250 mm \times 250 mm and a length of 800 mm, and the foundation had a cross section of 1400 mm \times 1270 mm and a depth of 425 mm. The diameter of the longitudinal rebar and transverse rebar were 22 mm and 10 mm, respectively, for the column, upper beam and foundation. All specimens on which the experiment was performed were reinforced with stirrup with a 90° hook to apply non-seismically details. The concrete used was 24 MPa and all specimens were allowed to cure for more than 28 days before testing.

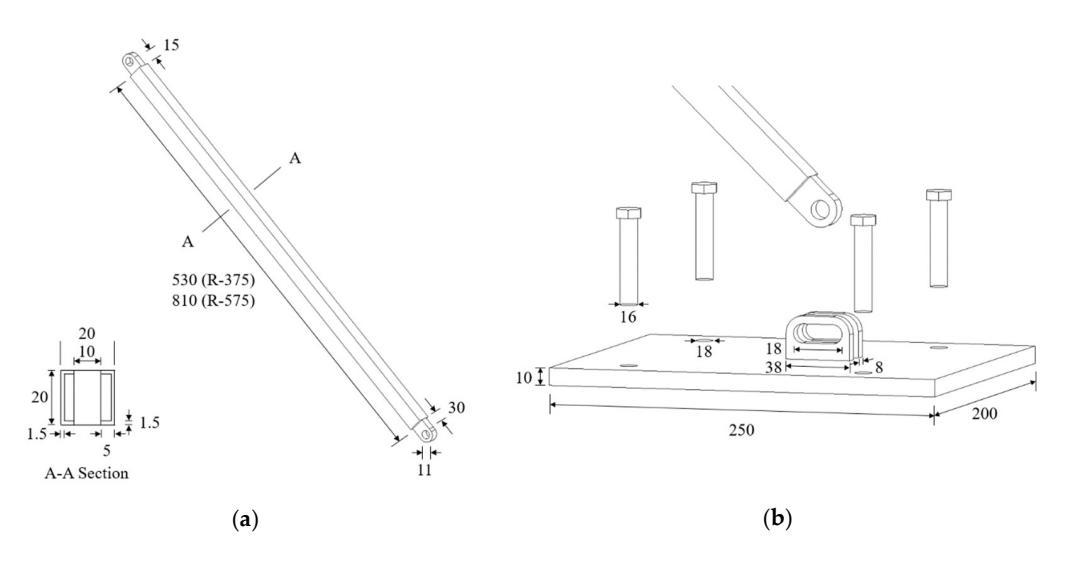
Figure 3. Dimensions of the RSL system (mm): (a) Steel link; (b) Bottom plate.

Two RSLs were installed on the left and right sides of the column. The RSL systems were attached using a total of eight anchor bolts for each system, each with an insertion length of at least 100 mm. Four anchor bolts with a diameter of 16 mm and an effective length of 100 mm were constructed. The pulling strength of anchor bolts was checked with the Hilti PROFIS Engineering Program [13] and developed based on ACI 318-19 [14]. Steel with a yield strength of 275 MPa was employed for the RSL system. The dimensions of RSL system are shown in Figure 3.

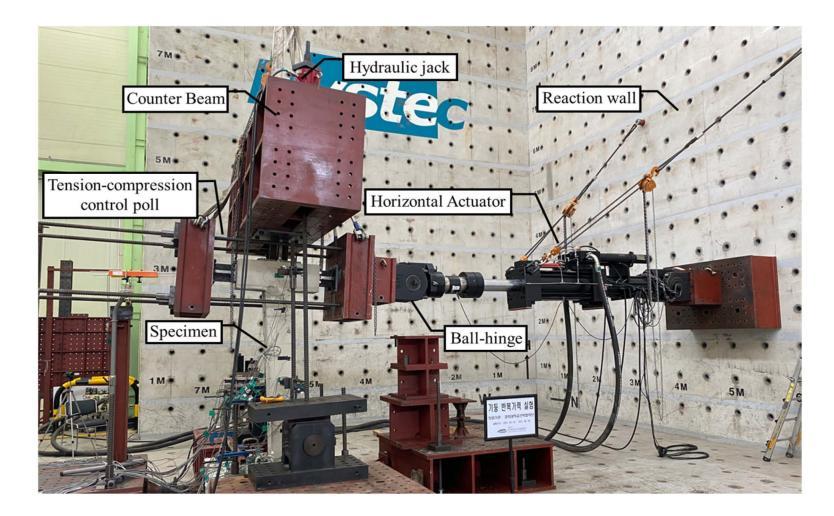
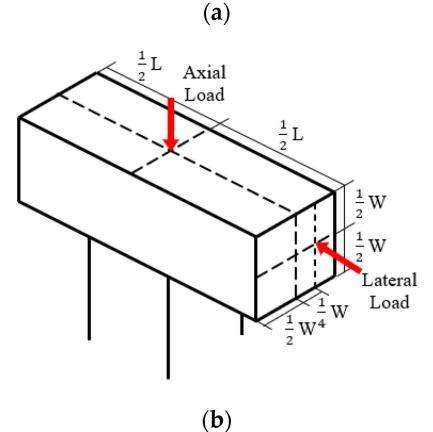
Figure 4. Experimental setup for the combined cyclic loading test: (a) Test setup; (b) Loading method.

The cyclic loading test setup is presented in Figure 4. The columns are subjected to combined loading from an axial force, including bending and a torsion moment during seismic excitations due to the multi-directional characteristics of earthquakes. The behavior

of columns subjected to combined loading should be considered as essential for evaluating the seismic performance. In this paper, cyclic loading was applied to the upper beam with eccentricity of 65 mm to consider torsion, using a hydraulic actuator with a maximum load of 1000 kN as shown in Figure 4b. The actuator was installed between the reaction wall and the test specimen. The upper beam and the actuator were totally fixed to apply lateral load in both directions. The constant axial load was 255 kN, which is 17% of the axal load capacity of the column.

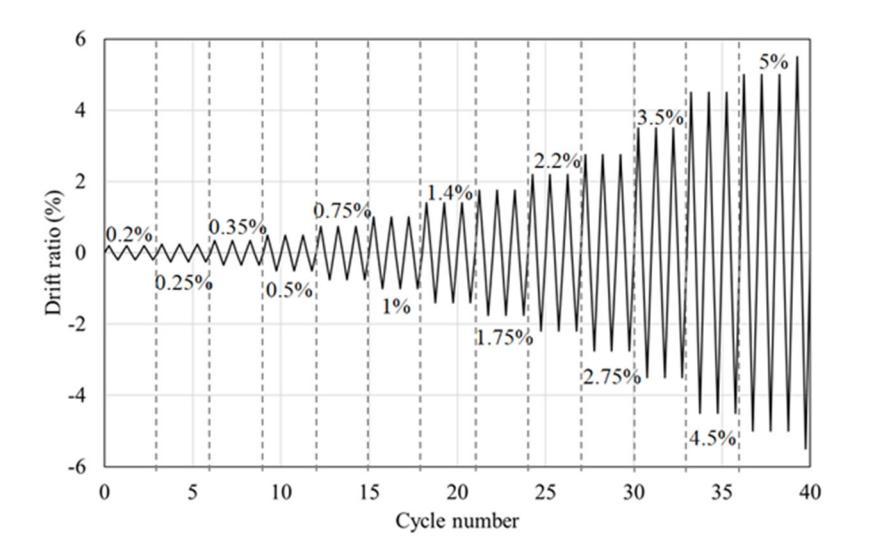
Figure 5. Loading Protocol.

The foundation was fixed to the floor by six anchor bolts to prevent any interference with the experiment results. The loading method was referenced to the load protocol given in ACI 374.1 [15], which states that the initial drift ratio should be within a range that confirms the linear elastic behavior, the subsequent drift ratio should not exceed 0.25%, and the subsequent step should be neither too large nor too small. As shown in Figure 5, the load protocol was set to be cycled three times for each drift ratio, followed by an incremental increase to 105 mm; this corresponded to a maximum drift ratio of 6%.

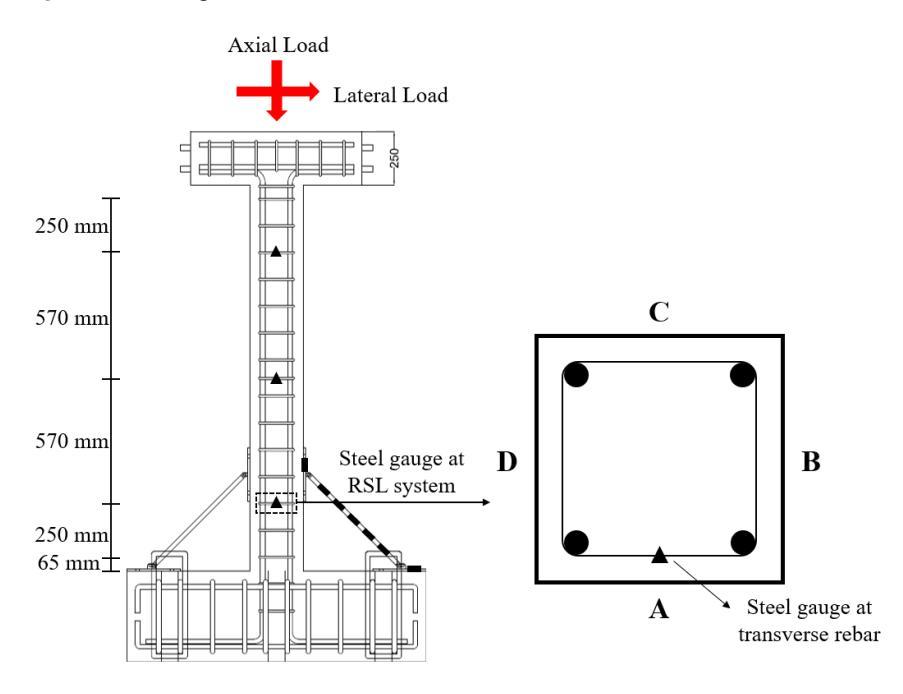
Figure 6. Locations of strain gauges.

Each retrofitted column was instrumented with 10 strain gauges attached to the transverse rebars, and RSL system. Transverse rebar strain gauges were placed at 65 mm, 875 mm, and 1685 mm above the foundation, and they were attached on only one side. RSL system strain gauges are attached one on each steel plate and five on the steel link. The locations of the strain gauges and names of the sides are shown in Figure 6. The surface of the specimen was named in alphabetical order in the counterclockwise direction, starting with A from the surface where the actuator was installed.

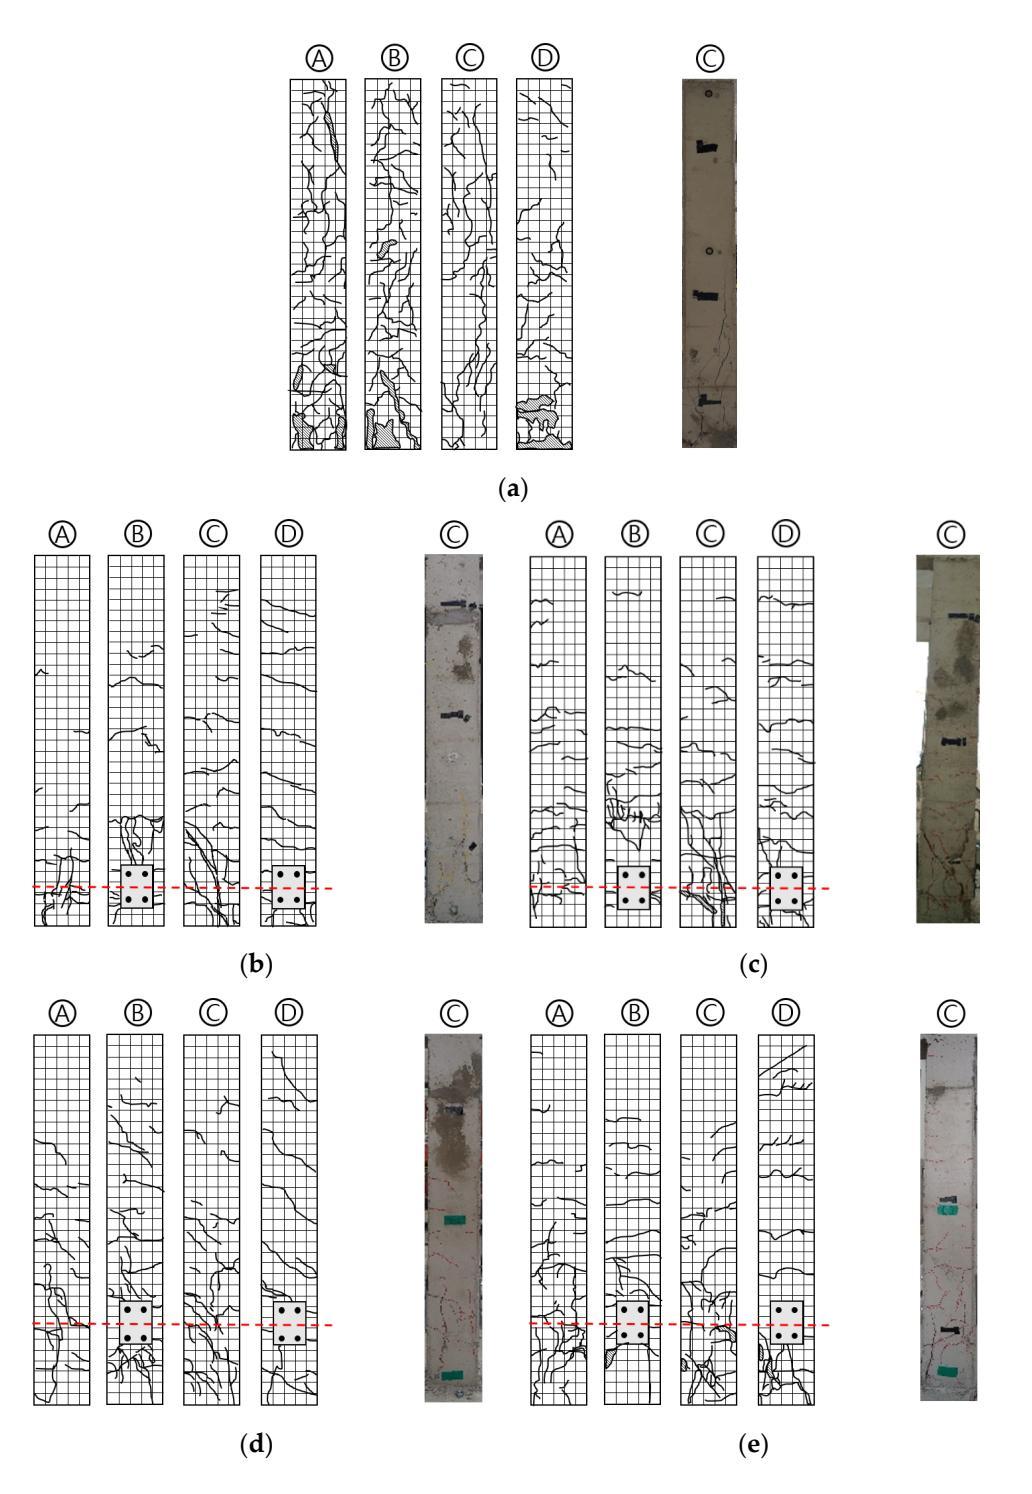
Figure 7. Crack patterns and failure of the specimens: (**a**) NR; (**b**) R-375-1; (**c**) R-375-2; (**d**) R-575-1; (**e**) R-575-2.

The crack patterns and C sides of each specimen after the experiment are shown in Figure 7. At the drift ratio of 0.75% for all specimens, initial flexural cracks appeared evenly on the middle of the C side of the actuator. All specimens started with the occurrence of initial flexural cracks, and the flexural cracks gradually spread widely as the load increased. After that, as shear cracks occurred, the spalling of the concrete became severe and the experiment was terminated. For the NR specimen (the non-retrofitted RC column), flexural cracks began to occur in earnest at the drift ratio of 1%, and shear cracks at the drift ratio of 1.4% as the lateral load increased. As the drift ratio increased, the flexural cracks widened, resulting in the occurrence of diagonal tension cracks between the existing cracks; then destruction and spalling of concrete occurred, followed by shear failure. At the drift ratio of 2.75%, the experiment was terminated at the drift ratio of 4.5% due to destruction of the bottom of the column, when the lateral load fell below 85% of the maximum load.

In the case of R-375-1, shear cracks initially occurred at the drift ratio of 2.2%. The width of the shear cracks increased significantly from the drift ratio of 4.5%, the concrete began to spall, and the bottom of the specimen was severely spalled at drift ratio of 5% and was finally failed. The behavior of R-375-2 was similar to that of R-375-1 because they had equal details, and the shear cracks initially occurred at the drift ratio of 2.2%. The R-375-2 specimen was failed at the drift ratio of 5%. The R-375 specimens had a greater drift ratio of crack occurrence than the NR specimen. The R-575 specimens incurred the initial shear crack at the drift ratio of 2.75%, which was larger than NR and R-375 specimens. The

performance of suppressing the occurrence of shear cracks was better for R-575 specimens than for R-375 specimens. The experiments on both R-575 specimens were terminated at drift ratio of 4.5%.

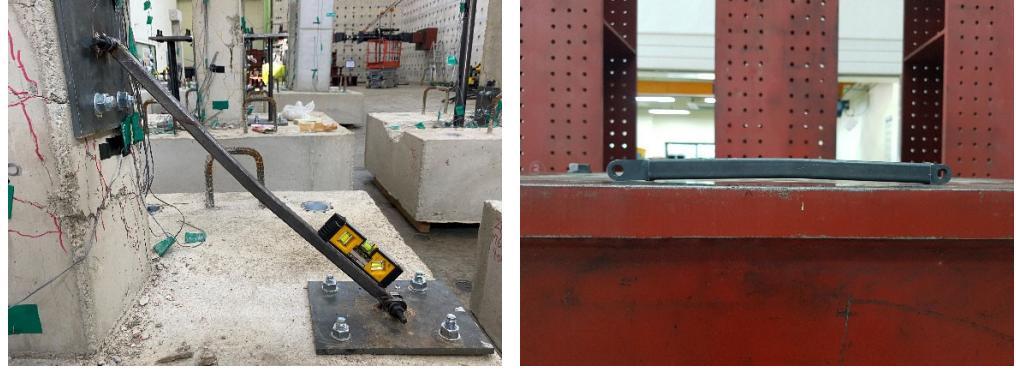
Figure 8. The buckled steel links: (**a**) Buckled steel link of R-575 specimen; (**b**) Buckled steel link of R-375 specimen after detaching.

The main differences between the non-retrofitted specimen and retrofitted specimens were the frequency of occurrence of flexural cracks and the location of shear cracks. With the NR specimen, the entire surface was covered with flexural cracks and shear cracks, and concrete spalling occurred severely at the plastic hinge region. However, in the case of retrofitted specimens, only flexural cracks often occurred only in upper end, and shear cracks did not occur much. Comparing the retrofitted specimens with different retrofit length, cracks occurred more intensively at the height at which the plate was fixed to the column. Since the anchor bolt is inserted through the column of more than 100 mm, cracks can easily occur. Therefore, cracks in the R-575 specimens occurred higher in the lower part of the column than in the R-375 specimens. Shear crack occurred at a smaller drift ratio in R-375 than R-575, but the final failure of R-575 occurred earlier than R-375. There was no bolt loosening in any of the specimens, which means the plates anchored to the column and foundation were not damaged, and the steel link had the desired retrofit effect, absorbing all the stress properly. The buckled steel link is shown in Figure 8, and the sliding effect of the RSL system is shown in Figure 9.

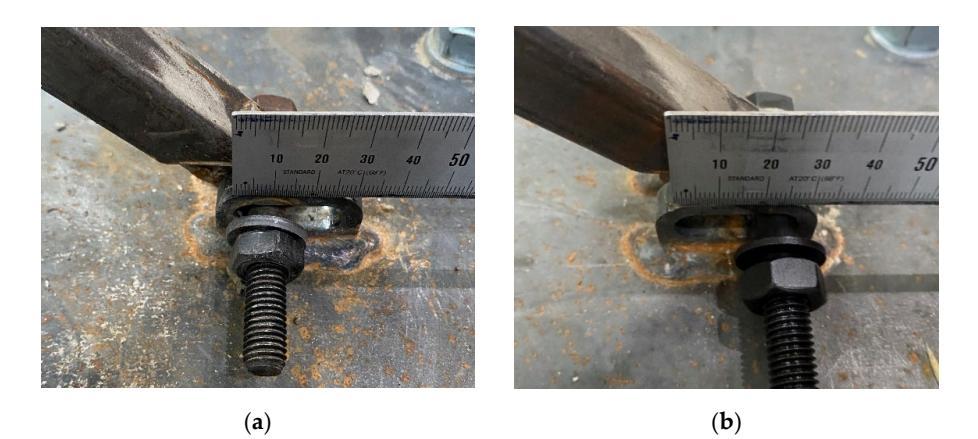
Figure 9. The sliding effect of RSL system: (**a**) Hinge before applying lateral load; (**b**) Sliding bolt reaching the end of the sliding slot.

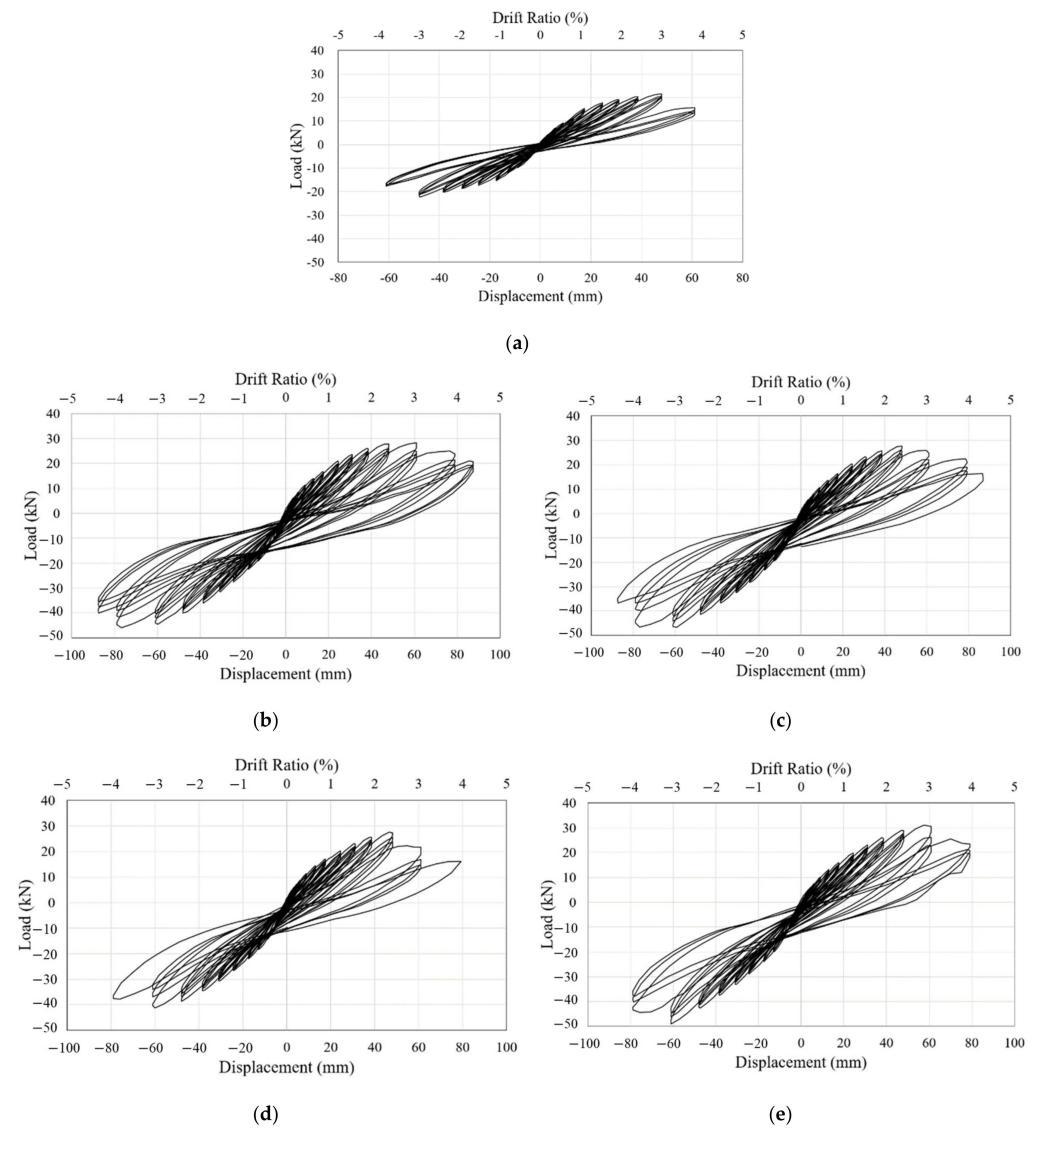
Figure 10. Load-displacement curves of the specimens: (**a**) NR; (**b**) R-375-1; (**c**) R-375-2; (**d**) R-575-1; (**e**) R-575-2.

The hysteretic behaviors of each specimen according to the cyclic lateral load are shown in Figure 10, along with the load-displacement curves for all of the specimens. All of the

maximum lateral loads according to the drift ratio can be found in the envelope curves for the specimens, shown in Figure 11. Analysis of hysteretic curves is performed considering the energy dissipated during cycles, the secant stiffness degradation of subsequent cycles, and the degradation of strength between two consecutive cycles at the same drift level. In common with all the specimens, the lateral load gradually increased as the experiment progressed and then decreased after reaching the maximum load. When the maximum loads of the specimens were reduced to about 80% to 85%, the experiments were terminated due to failure of the lower part of the RC column. The energy dissipation curing cycles can be evaluated as the area of the hysteretic curve. It can be seen that the area of the specimen retrofitted with the RSL system is wider than that of the un-retrofitted, NR specimen. The degradation of secant stiffness and strength of the retrofitted specimens R-375 and R-575 was smaller than that of the NR specimen. The secant stiffness degradation is mainly affected by the cracking. It was demonstrated that the proposed retrofitting system is effective in crack control as well as energy dissipation.

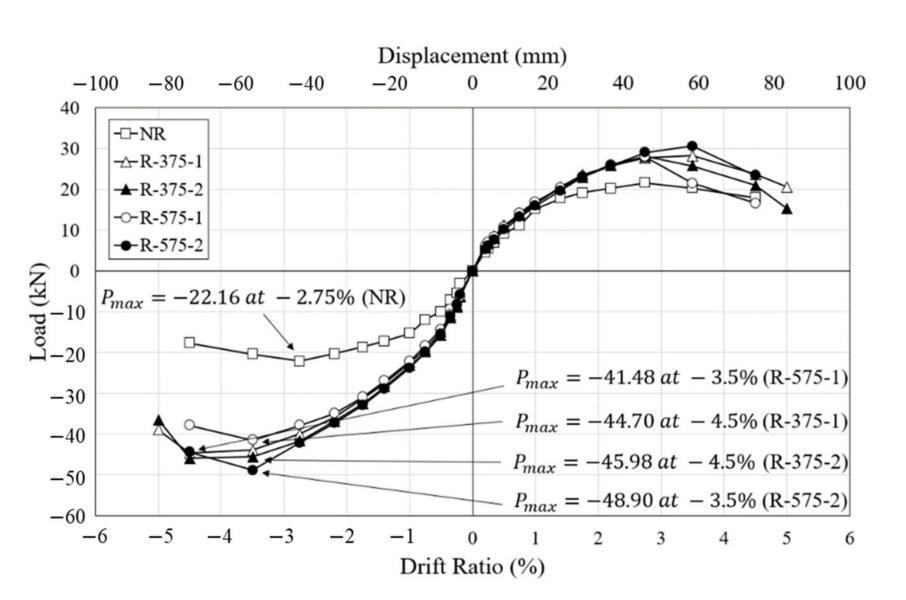
Figure 11. Envelope curves.

As shown Figure 11, the initial stiffness of all specimens was almost identical. It was demonstrated that retrofitting with the RSL system has little effect on the initial stiffness of the concrete column. The maximum lateral load of the NR specimen was 22.16 kN at the drift ratio of 2.75%, after which, due to widened shear cracks at the bottom of the column, the concrete spalled and the lateral load was reduced. The maximum load subsequently decreased to 17.64 kN, which was about 80% of the maximum load at the drift ratio of 4.5%. In the R-375 specimen, the maximum loads were reached at the drift ratio of 4.5%. The maximum lateral loads of R-375-1 and R-375-2 were 44.70 kN and 45.98 kN, respectively, which were about 2.02 times and 2.08 times the maximum load of the NR specimen. The maximum loads of R-375-1 and R-375-2 decreased to 35.55 kN and 36.54 kN, respectively, which were about 80% and 79% of the maximum load of the NR. R-375-1 nd R-375-2 were destroyed by severe shear cracks and spalling of concrete at the drift ratio of 5%. The maximum lateral loads of R-575-1 and R-575-2 were 41.48 kN and 48.90 kN, respectively, at the same drift ratio of 3.5%; these were about 1.87 times and 2.21 times the maximum load of the NR. In terms of load-carrying capacity, the specimens retrofitted with the RSL system show the upper bound on the backbone envelopes. The R-575-2 specimen had the highest lateral strength, followed by the R-375-2 specimen, and the NR specimen, respectively. The load-displacement response of the retrofitted column was considerably improved with the employed retrofitting techniques. When comparing the average maximum loads of R-375 and R-575, there is only a difference of 0.3%. Since there is little difference in these experimental results, the plastic hinge length was not an important factor in retrofitting the RC columns.

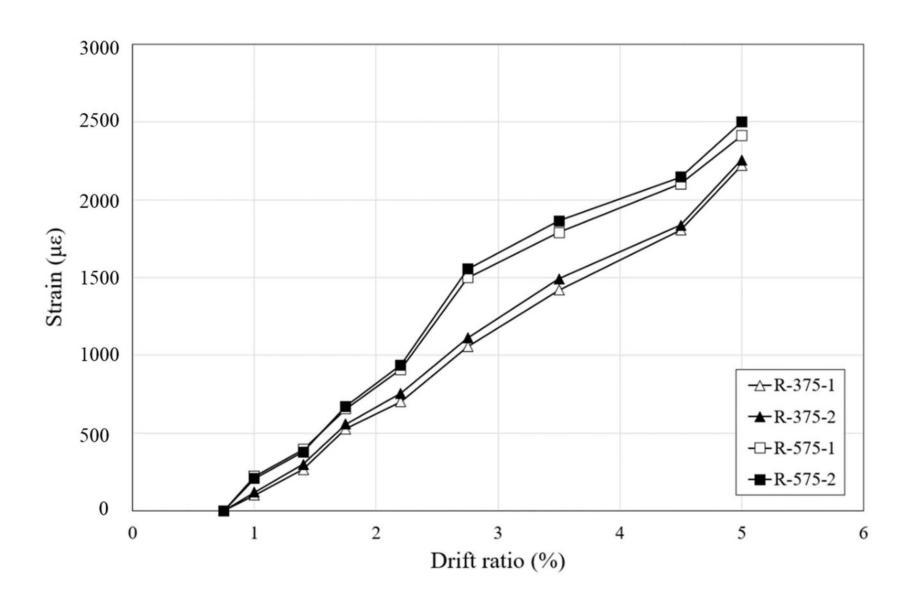
Figure 12. Strain-drift ratio curves of RSL system.

To check whether the RSL system effectively loaded the stress, strain gauges were attached to the steel link to measure the strain. The strain-drift ratio graph, shown in Figure 12, displays the strain measured at the center of the steel link, which loaded the greatest stress among the five locations. The RSL system installed on all specimens did not deform until the drift ratio of 0.75% was reached, and at the drift ratio of 1% the sliding bolt connected to the steel link reached the sliding slot. The steel link then began receiving load and measuring the strain value. As the lateral load increased, buckling and yielding were reached. Specimens with a retrofit length of 375 mm showed a similar pattern and yielded at a drift ratio of 2.75%, and specimens with a retrofit length of 575 mm yielded at a drift ratio of 2.2%. This is because the buckling load was smaller due to the larger slender ratio of longer steel link.

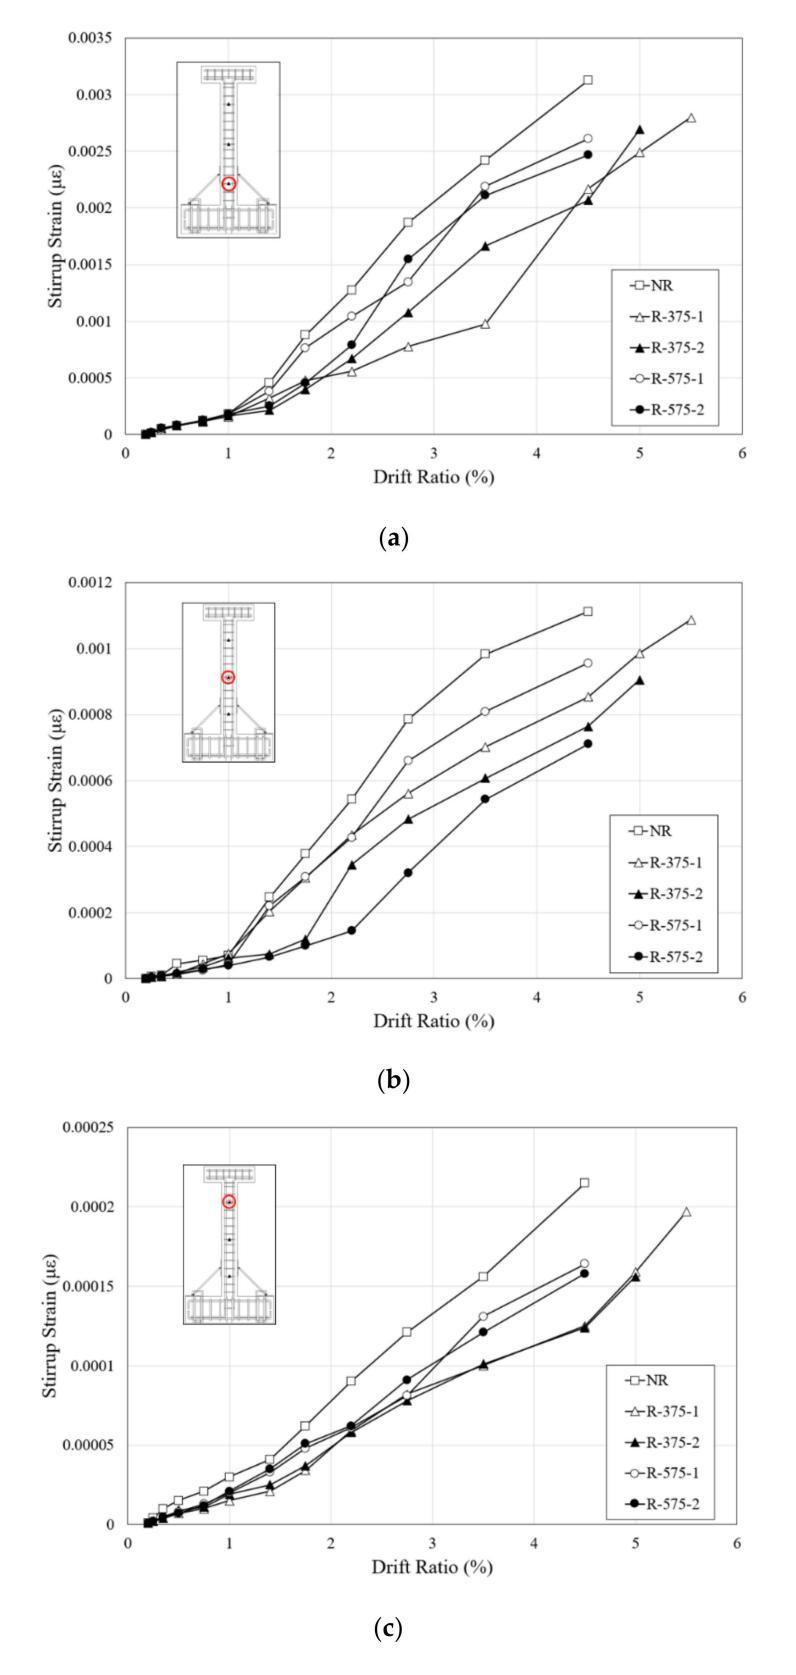
Figure 13. Stirrup strain-drift ratio curves: (a) Bottom; (b) Middle; (c) Top.

Since the experiments on all the specimens were terminated as a result of shear failure, strain on the stirrups showed the shear force applied to the RC columns. Figure 13 shows the stirrup strain-drift ratio relationships of the specimens, and they are divided by the height strain gauges that were attached as aforementioned. With the development of diagonal cracks in the columns, the strain on the stirrups increased. The strain on the stirrup of the NR specimen increased rapidly with the process of loading after the shear cracks occurred, and the stirrup at the bottom of the column yielded before the maximum load. The increase in strain continued as the load was applied. However, the strains on the stirrups of the retrofitted specimens were much smaller than in the NR specimen, which indicates that retrofitting with the RSL system provided strong resistance to lateral load. As the drift ratios of the initial occurrence of the shear cracks and the maximum loads of all the specimens were different, there were various sections with dramatic increases in the stirrup strain. As stress was concentrated in the plastic hinge region of the columns, the lowest stirrups had the greatest strain, the middle stirrups had less, and the lowest strain was measured at the highest stirrup. In the NR specimen, the strain in the stirrups at bottom and central parts of the column increased with the expansion of the width of the shear cracks. On the other hand, the stirrups of the R-375 and R-575 specimens had lower strain than the NR specimen. This means that the RSL system more effectively suppressed the expansion of the cracks developed in shear failure surfaces.

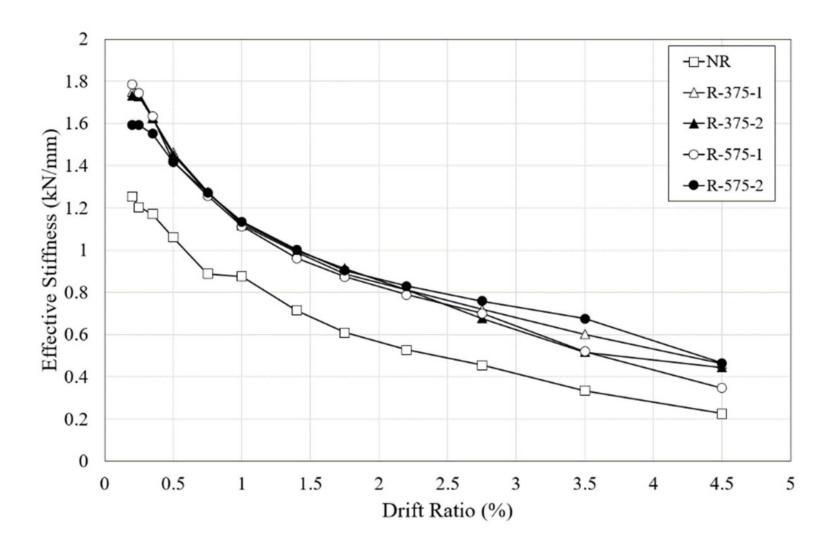
Figure 14. Variation of effective stiffness according to drift ratio.

To evaluate the seismic performance of each specimen based on the test results, effective stiffness was calculated as the slope of the stiffness for each test specimen according to the drift ratio. The variation of the effective stiffness is shown in Figure 14. Stiffness is an important factor to evaluate improved seismic performance because the smaller the decrease in effective stiffness, the longer the stiffness of the specimen is maintained.

For the NR column, the value of the effective stiffness was 1.254 kN/mm at a drift ratio of 0.2%, which was the first drift ratio; this increased to 1.204 kN/mm at a drift ratio of 0.25%, which was the second drift ratio. When the initial flexural cracks occurred, the initial effective stiffness of 1.101 kN/mm decreased by approximately 29% at a drift ratio of 0.75%. Since the effective stiffness at a drift ratio of 0.5% was 1.061 kN/mm, which was only 15% less than the initial effective stiffness, the stiffness of the specimen remained high until just before the initial crack occurred. The sum of the effective stiffness values at all of the drift ratios was 9.32 kN/mm.

The retrofitted specimens generally had higher effective stiffness values than the NR specimen. The initial effective stiffness values of the R-375 and R-575 specimens were found to be about 58% and 53% larger on average, respectively; their respective total effective stiffness values were found to be about 46% and 44% larger on average. Thus, similar to the load-displacement relationships, the length of the retrofit system proved not to be an important factor in retrofitting RC columns.

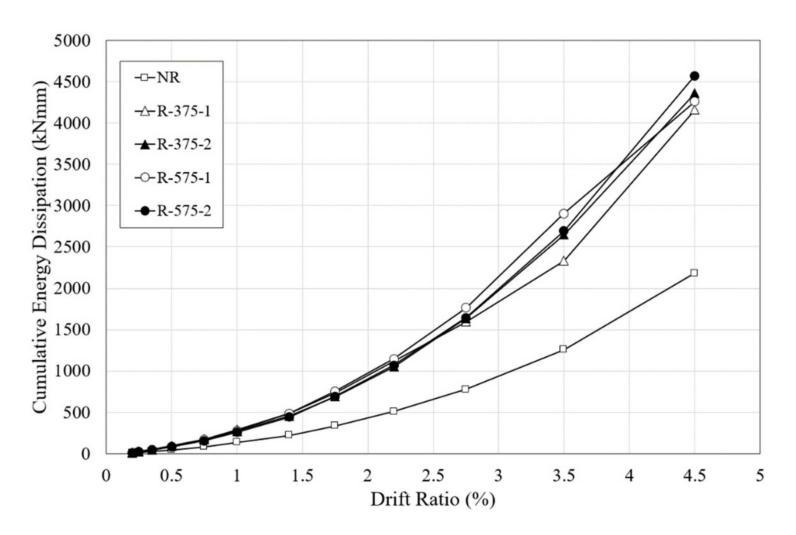
Figure 15. Cumulative energy dissipation capacity according to drift ratio.

The energy dissipation capacity is another important factor when evaluating seismic performance, as well as the ability of a structure to absorb applied seismic energy. The cumulative energy dissipation capacity of all the specimens analyzed here is shown in Figure 15, and is calculated as the area under the load-displacement curve. The cumulative energy dissipation capacity was calculated up to a drift ratio of 4.5%, as experimental assessments of the NR, R-575-1, and R-575-2 specimens were terminated right after the drift ratio of 4.5%. In the initial cycles, at the drift ratio of 0.75% the energy dissipation response of all the specimens was comparable. After the drift ratio of 1%, the retrofitted specimens showed a significantly improved energy dissipation than the un-retrofitted specimen. The R-375 and R-575 specimens showed significant recovery and yielded energy dissipation after 1.5% drift ratio.

It can be observed from the Figure 15, all of the retrofitted specimens dissipate higher energy in each cycle than the NR specimen. The total energy dissipation capacity of the NR specimen was 2181.94 kN·mm, compared with 4158.84 kN·mm in the R-375-1 specimen and 4359.47 kN·mm in the R-375-2 specimen. The average cumulative energy dissipation capacity of the R-375-1 and R-375-2 specimens was 4259.16 kN·mm, which was about 1.95 times that of the NR specimen. The cumulative energy dissipation capacities of the R-575-1 and R-575-2 specimens were 4262.07 kN·mm and 4570.53 kN·mm, respectively. Their average cumulative energy dissipation capacity was 4416.3 kN·mm, which was about 2.02 times of that of the NR specimen. This marked difference in energy dissipation may be attributed to the resistance crack opening or lateral displacement by the RSL system. This clearly proves that the retrofitting effect was noteworthy in both lengths of the RSL system, but the difference in energy dissipation capacity according to the retrofit length was insignificant.
