# Article Microstructure and Cavitation Damage Characteristics of GX40CrNiSi25-20 Cast Stainless Steel by TIG Surface Remelting

**Abstract:** Cavitation erosion degrades the surface of engineering components when the material is exposed to turbulent fluid flows. Under conditions of local pressure fluctuations, a nucleation of gas or vapor bubbles occurs. If the pressure suddenly drops below the vapor pressure, these bubbles collapse violently when subjected to higher pressure. This collapse is accompanied by the sudden flow of the liquid, which is manifested by stress pulses capable of causing plastic deformations on solid surfaces. Repeating these stress conditions can cause material removal and ultimately failure of the component itself. The present study aims to reduce the negative impact of this phenomenon on the mechanical systems components, using the TIG local surface remelting technique. Cavitation erosion tests were performed in accordance with the ASTM G32-2016 standard on samples taken from a cast high-alloy stainless steel. The alloy response for each melting current value was investigated by measuring mass loss as a function of cavitation attack time and by analyzing

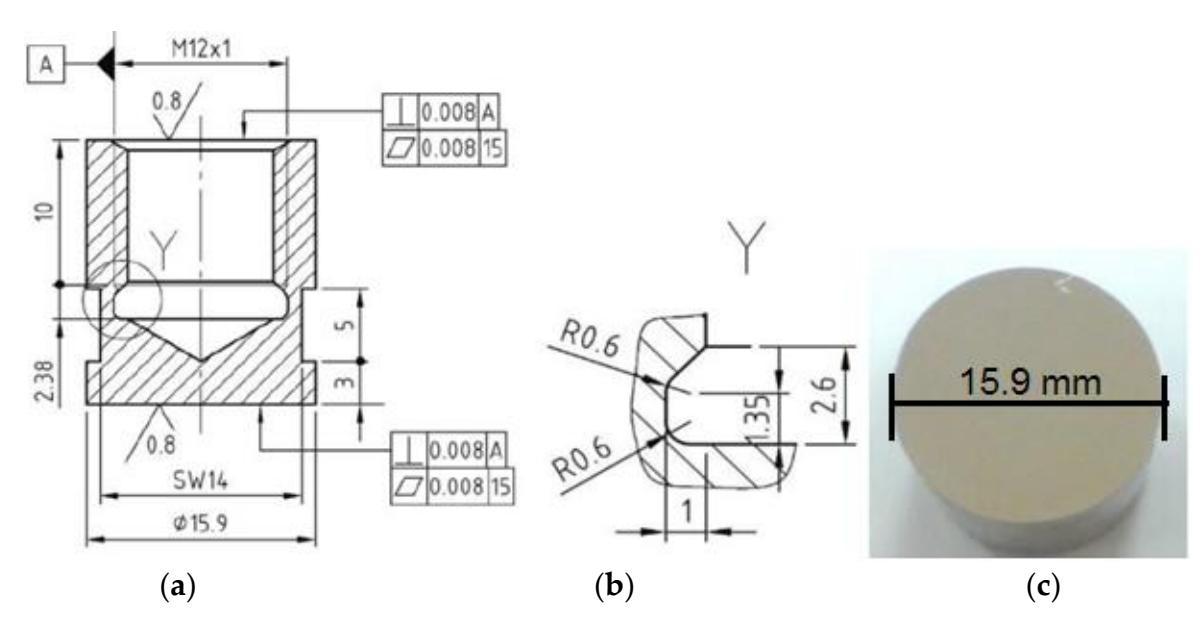
**Figure 1.** Cavitation sample: manufacturing details: (**a**) axial section through the sample, (**b**) detail of the Y area (thread clearance), (**c**) photo image of the sample surface, before the start of the cavitation attack (dimensions are in mm, according to general tolerance ISO 2768 1&2 standard).

From cast steel bars, GX40CrNiSi 25–20, (1.4848): EN 10295 (heat treated by annealing for homogenization 1100 °C/8 h/furnace), of the chemical composition C = 0.38%, Cr = 25.20%, Ni = 20.8%, Si = 1.62%, Mn = 1.49%, Mo = 0.34%, p = 0.031%, S = 0.027%, Fe = bal.%, cylindrical samples were made,  $\phi$  40 mm × 60 mm. Their surface was modified using the local TIG remelting technique, with a non-fusible electrode and using welding currents of different intensities (Is = 100 A; Is = 150 A; Is = 200 A). The other technological parameters were kept constant: electric arc voltage, Ua = 10–11 V; welding speed, vs. = 15 cm/min; electric arc length, L = 2 mm; the step between rows, p = 3 mm. The TIG welding equipment used for the local surface remelting of the front cylindrical samples  $\phi$ 40 mm × 60 mm was a MW-300 inverter source from the Fronius company. Later, according to the model shown in Figure 1, cavitation samples were machined, and the expose surface was polished, on a Buehler Phoenix Beta device to a roughness Ra = 0.2–0.8 µm.

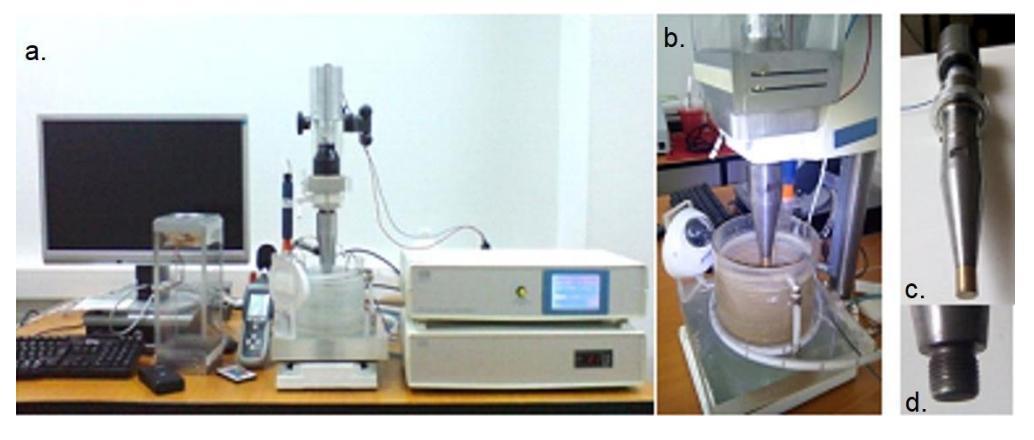
**Figure 2.** The vibrating device with piezoceramic crystals: (**a**) overview of the device with the computer control system; (**b**) image during the cavitation test (sample immersed in water); (**c**) mechanical vibration system (piezoceramic transducer with amplitude amplification system (buster, sonotrode and cavitation sample); (**d**) threaded end of the sonotrode for fixing the sample.

The experimental researches were carried out in the cavitation laboratory of the Timişoara Polytechnic University, on the vibrating device with piezoceramic crystals (Figure 2), which is controlled by a computer and equipped with an automatic control system of the functional parameters that define the cavitation hydrodynamic process. This type of device allows for the testing of different types of materials at intense cavitation erosion regimes, thus considerably reducing the samples attack duration, compared to existing situations, or using other methods of generating the cavitation phenomenon (the case of the tunnel hydrodynamic [20] or of the rotating disk device [21–23]).

The functional parameters of the device are:

- power of the electronic ultrasound generator, 500 W;
- vibration frequency,  $20,000 \pm 2\%$  Hz;
- vibration amplitude, 50 μm;
- sample diameter:  $15,9 \pm 0.05$  mm;
- power supply: 220 V/50 Hz;
- testing liquid: distilled water, having a temperature of  $22 \pm 1$  °C.

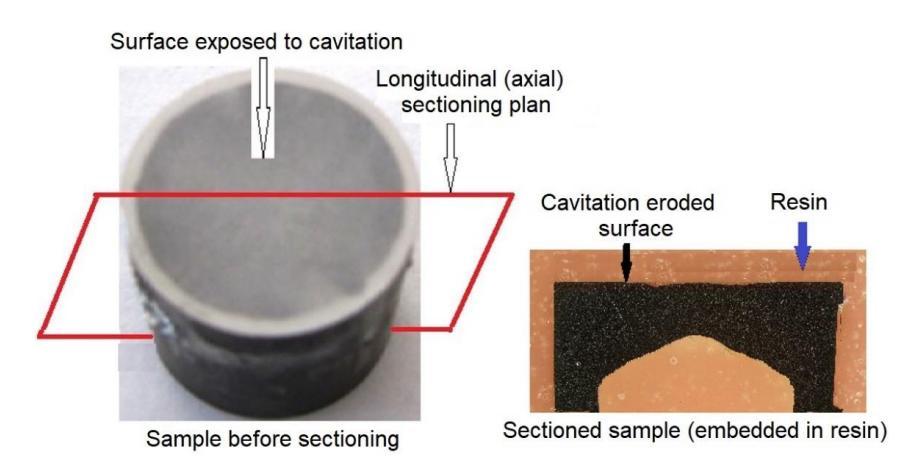
Figure 3. Sample preparation for optical and scanning electron microscopy investigation.

Both at intermediate attack durations and at the end of the 165 min on the degraded surfaces, the surface topography was investigated using both the optical stereomicroscope OLIMPUS SYX7 and the scanning electron microscope TESCAN VEGA 3 LMU Bruker EDX Quantax. Following the cavitation tests, the samples were longitudinally sectioned (Figure 3) and metallographically prepared for examination using both the Leica DM2700M optical microscope and the scanning electron microscope of the edge layer where erosion cracks are initiated and propagated by cavitation.

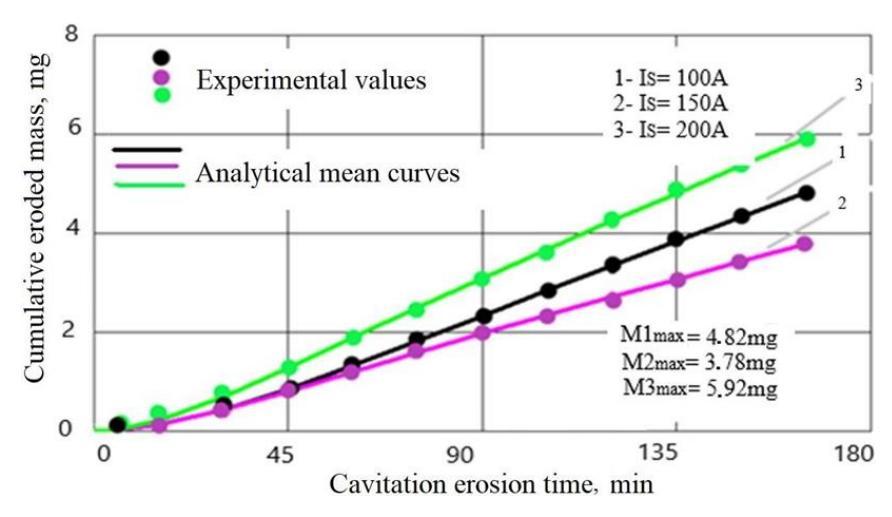
Figure 4. Mass losses of GX40CrNiSi25-20 steel at different remelting current intensities.

The evolution of the mass losses and the erosion rate according to the cavitation attack time for the three values of the surface melting current are shown in Figures 4 and 5. For comparison, Figures 6 and 7 show the same types of curves for the samples that were not surface remelted.

The TIG process of local surface remelting achieves the modification of the microstructure without adding a new material. Following its application, it was expected to achieve homogenization and finishing of the microstructure and dissolution/redistribution of precipitates or inclusions while the properties of the substrate can be preserved. As can be observed from these diagrams, the GX40CrNiSi25-20 steel with the TIG remelted surface where an intensity current of Is = 150 A was used (samples 2 Figure 4), has the lowest mass loss compared to the same, but unmelted, steel (samples from Figure 6). For values of the remelting current of 150 A, the most favorable hardening situation occurs both through the granulation finishing and through the formation of a solid solution. The heat cycle characteristic for this remelting current value favors the precipitation of fine secondary carbides from the austenite and prevents the formation of eutectic carbides. Implicitly, the same can be said about the erosion rate, which is lower when the steel surface is remelted with a current of intensity Is = 150 A. In the case of the samples where the current of 150 Awas used (samples 2 Figure 5), the mass loss is 27% lower than when using a current of 100 A (Sample 1, Figure 4) and 56% lower than when remelting with a current of 200 A (Sample 3, Figure 4). At the same time, compared to the regime with Is = 100 A, the decrease in erosion rate is over 39%, and compared to the regime with Is = 200 A, the decreasing in erosion rate is about 60%. The total cumulative mass loss for the regime with Is = 150 A(Mtot. = 3.78 mg), compared to the initial state (without remelting, Mtot. = 22.89 mg) decreases by more than six times, and the mass loss rate, according to the value of towards which the curve v(t) tends to stabilize, (vs = 0.145 mg/min. for the initial non-remelted surface, respectively vs = 0.029 mg/min. for the remelted surface at a current of 150 A), is reduced by about five times.

The approximation of the experimental values by the curves described by analytical equations, both for the mass losses (Figures 4 and 6) and for the related erosion rates (Figures 5 and 7), was necessary because, according to ASTM requirements G32-2016, they offer a behavior tendency and evaluation, by comparison, of the surface resistance, depending on the parameters values defined by them (Mtot.—after 165 min of cavitation attack, vmax.—the maximum of the curve v(t) and vs—final level value towards which the v(t) curve tends).

Comparing the results shown in Figures 4 and 7, it can be seen that the decrease in the cumulative masses from the end of the cavitational attack, in the case of the TIG electric arc remelting process, led to an increase in the cavitation resistance, the erosion rate and the cumulative mass losses being approximately 5–6 times higher in the unmelted samples:

$M_{2max}$  și  $v_{2s}$  are the values of mass losses and rates shown in the diagrams from Figures 4 and 5. In the above relations Mmax., Mtot., Mtot. and vs. are the values defined by the M(t) and v(t) curves recorded for GX40CrNiSi25-20 steel with a non-remelted surface.

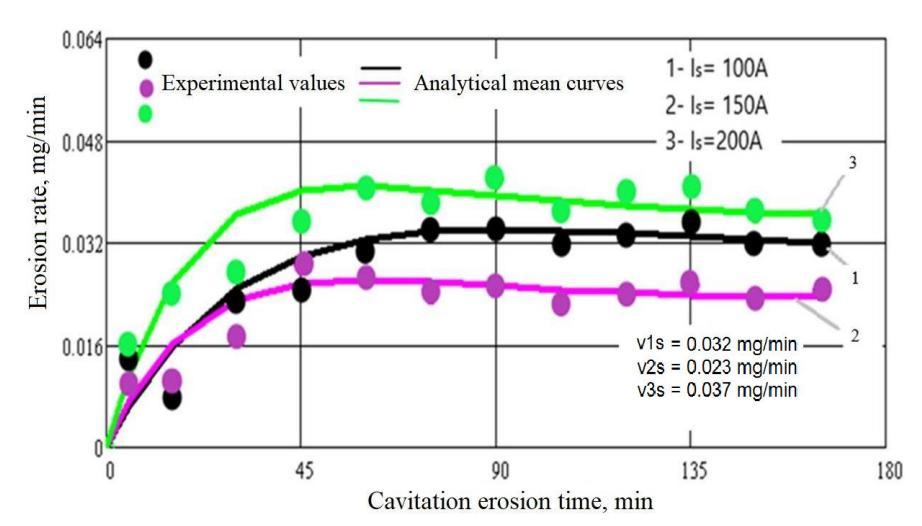
Figure 5. Erosion rate of GX40CrNiSi25-20 steel at different remelting current intensities.

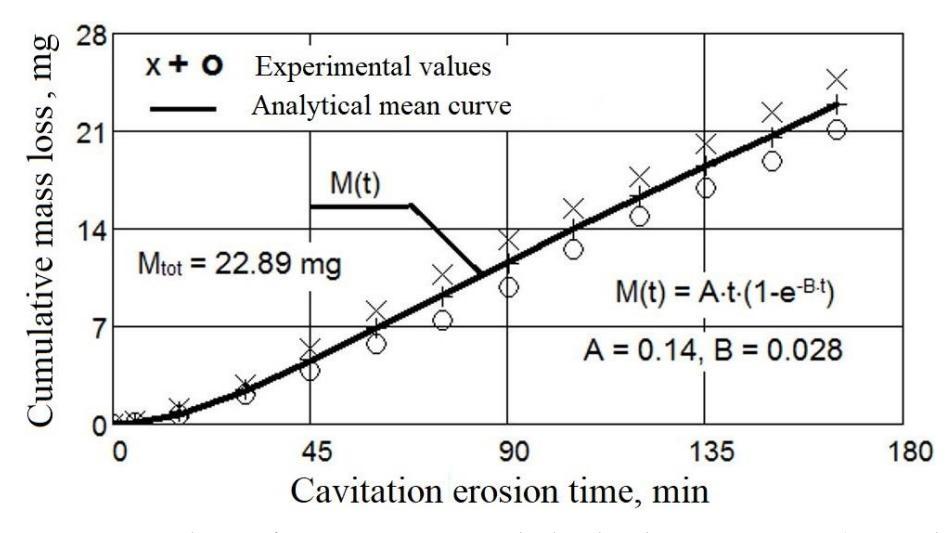
Figure 6. Mass losses of GX40CrNiSi25-20 steel related to the cavitation time (no remelting).

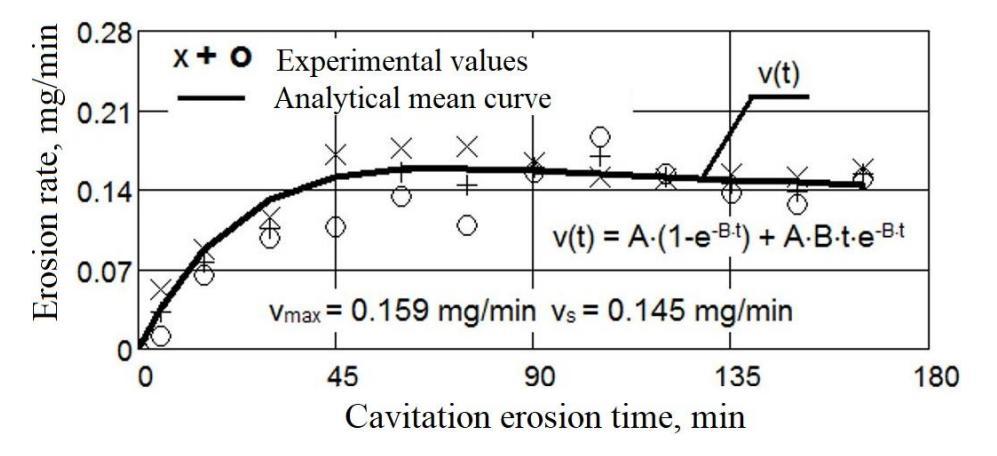
Figure 7. Erosion rate of GX40CrNiSi25-20 steel related to the cavitation time (no remelting).

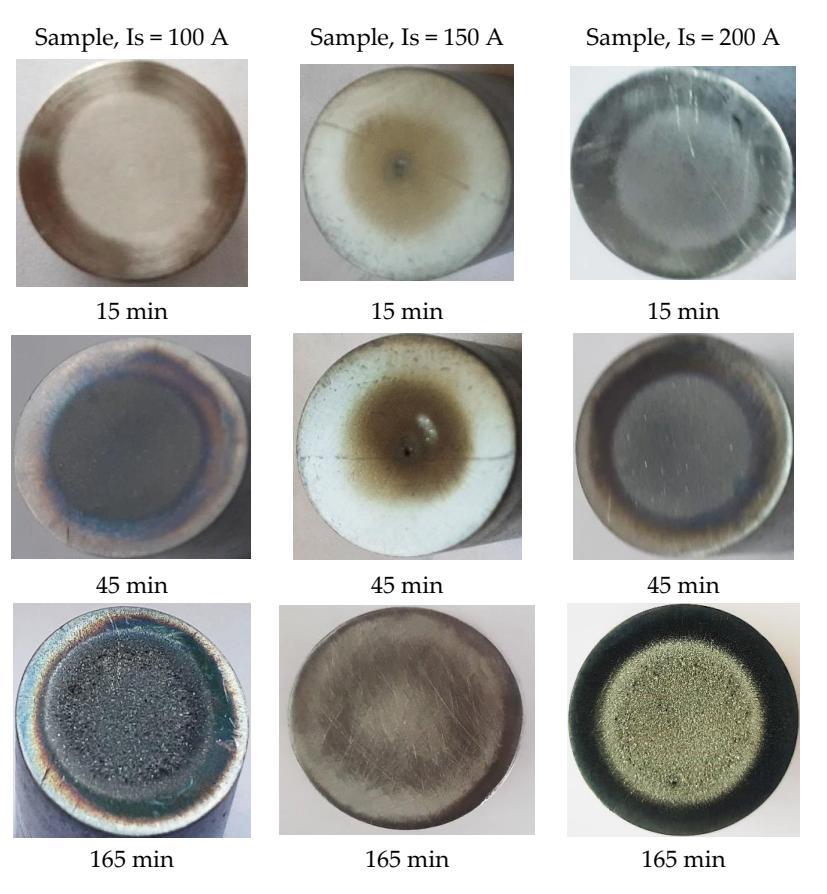
**Figure 8.** The macrographic image of the TIG surface remelted sample, with different current intensities, after the cavitation attack.

The images shown in Figure 8 reveal common elements of behavior and resistance, but also differences in the cavitation surfaces destruction, as a result of the different TIG remelting parameters regime. The main observations that emerge are:

- regardless of the heat adopted regime, the erosion is manifested by the appearance of a peripheral ring, which advances towards the center surface with the increase in the duration of the cavitation attack; the damage is in the form of pitting, as a result of cyclic stresses, created by the impact with the cavitational microjets;

- as cavitation duration increases, the resulting surface roughness for the remelting current Is = 200 A is the most affected, showing that the use of this TIG regime leads to the lowest wear resistance;

- the best resistance to the vibrating cavitation demands is obtained by the remelted surface Is = 150 A, the destruction evolution in terms of area and depth being the most advantageous. The SEM image in Figure 9 proves this fact;

- the use of a remelting current Is = 100 A leads to an intermediate interaction between its other two values;
- the photographic images obtained are in full agreement with the results provided by the specific cavitation curves in Figures 4 and 5.

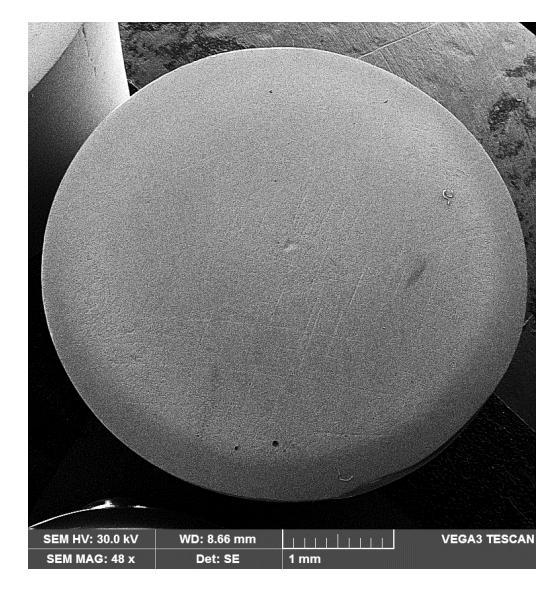
Figure 9. SEM macrograph of theTIG remelted surface with Is = 150 A and tested for cavitation 165 min.

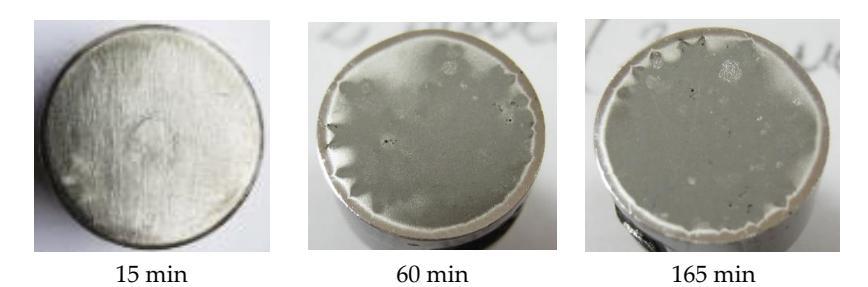
In Figure 10, for comparison, the photo images are shown, taken at certain times, of the eroded surface for the GX40CrNiSi 25-20 steel samples, tested in the initial state, and of annealing (without remelting the surface). Figure 11 shows the SEM image of the annealed sample surfaces tested for cavitation 165 min. The jagged appearance of the outer

area in the cavitated surface is due to the intradendritic microsegregations of the alloying elements present in high concentrations in the steel chemical composition. Comparing the images from Figures 9 and 11 clearly demonstrates that the local TIG remelting leads to a significant improvement in the cavitation erosion resistance.

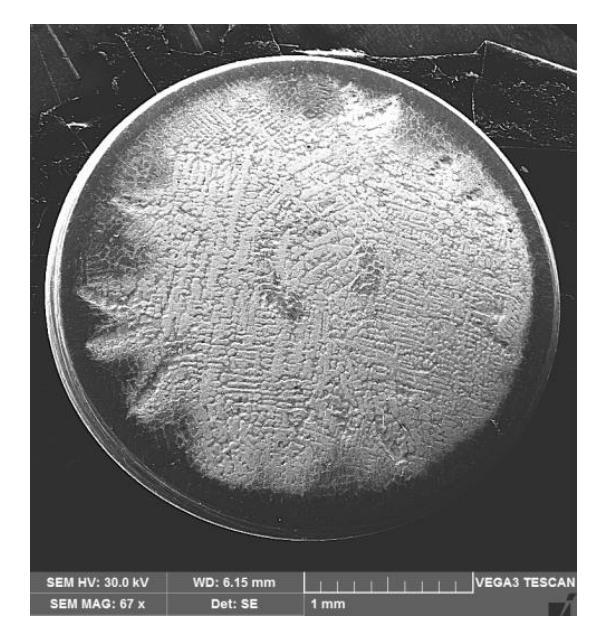
Figure 11. SEM macrograph of the unmelted surface tested by cavitation after 165 min.

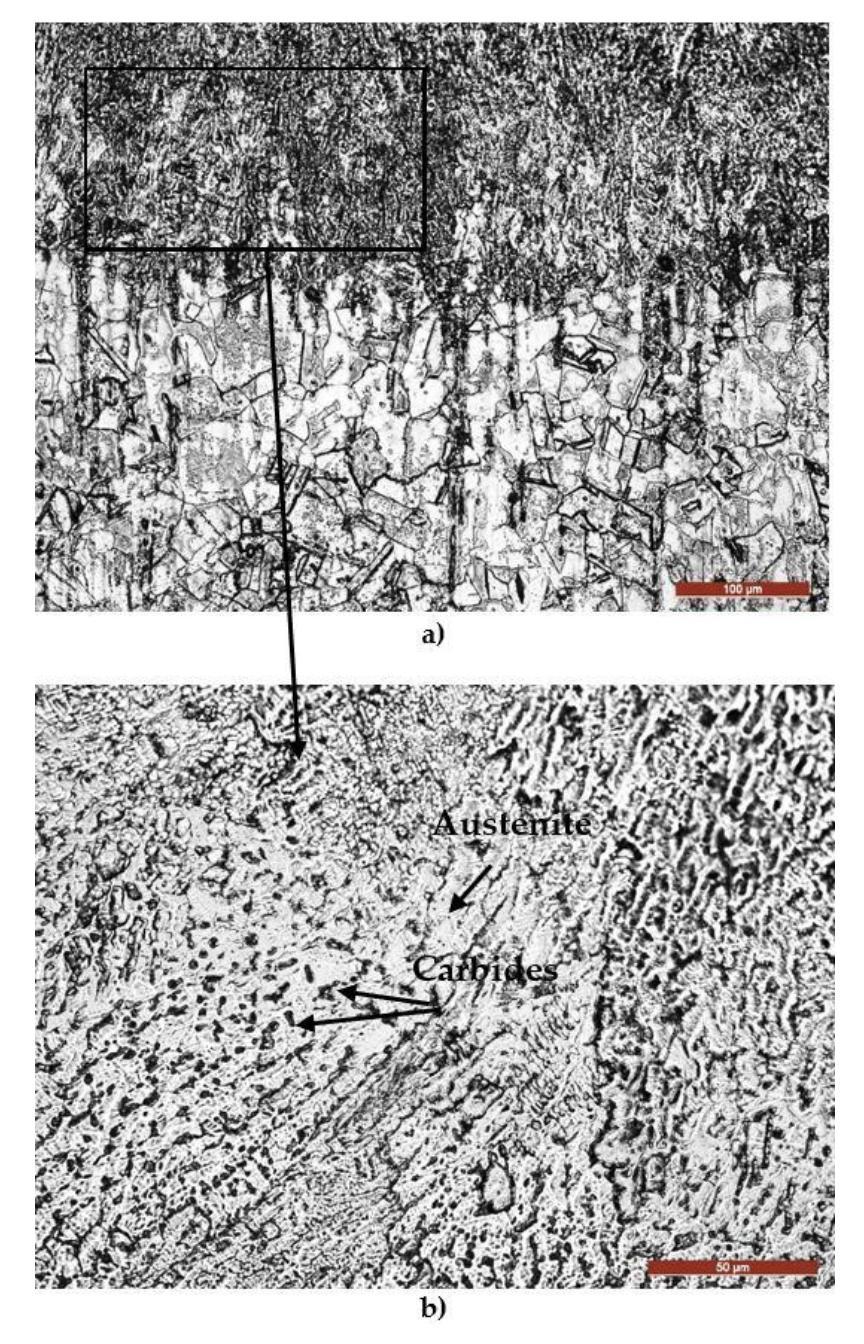
**Figure 12.** The microstructure of the layer—substrate system during the local TIG surface remelting with Is = 150 A: (a)—layer—substrate interface; (b)—remelted layer.

The micrographic examination of the longitudinal section through the cavitation samples that were TIG remelted (Figure 12) proves that this surface-ennobling process is manifested by the accentuated grain finishing and implicitly of the microstructure (austenite + carbides), with consequences for the pronounced improvement of the resistance to cavitation erosion degradation.

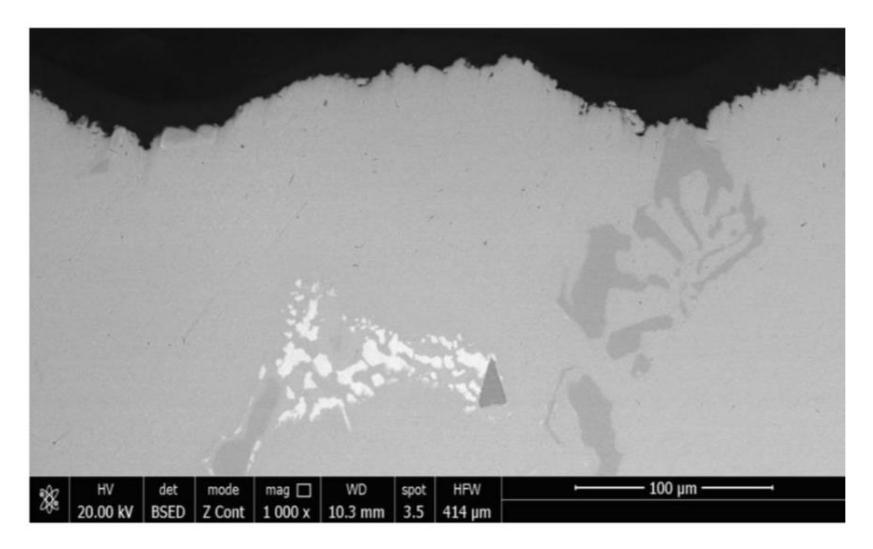
**Figure 13.** SEM microscopy of an unetched section through the surface of the reference samples (annealed).

Figures 13 and 14 show some representative images that illustrate the material microstructure degradation in the annealed state, respectively, after the TIG surface remelting with a current of Is = 150 A.

They demonstrate that this form of degradation is predominantly mechanical and is characterized by a surface percussion as a result of the implosion of the gas bubbles in the liquid mass when its temperature is constant and the pressure drops to a certain critical value. Since the steel analyzed is part of a highly alloyed class, cast in pieces, it presents a heterogeneous structure (austenite + carbides) [1]

From the presented micrographs, it can be seen that the initiation of degradation takes place on the boundaries of the austenite grains, where the carbide particles are present, microstructural constituents with the lowest resistance to cavitation. As erosion progresses, attack occurs in the solid solution matrix  $\gamma$  (austenite). Because of the accentuated granulation finishing and the microstructure through the local surface remelting, the appearance of the cavitation surface is much more uniform compared to the material reference state (Figures 13 and 14b).

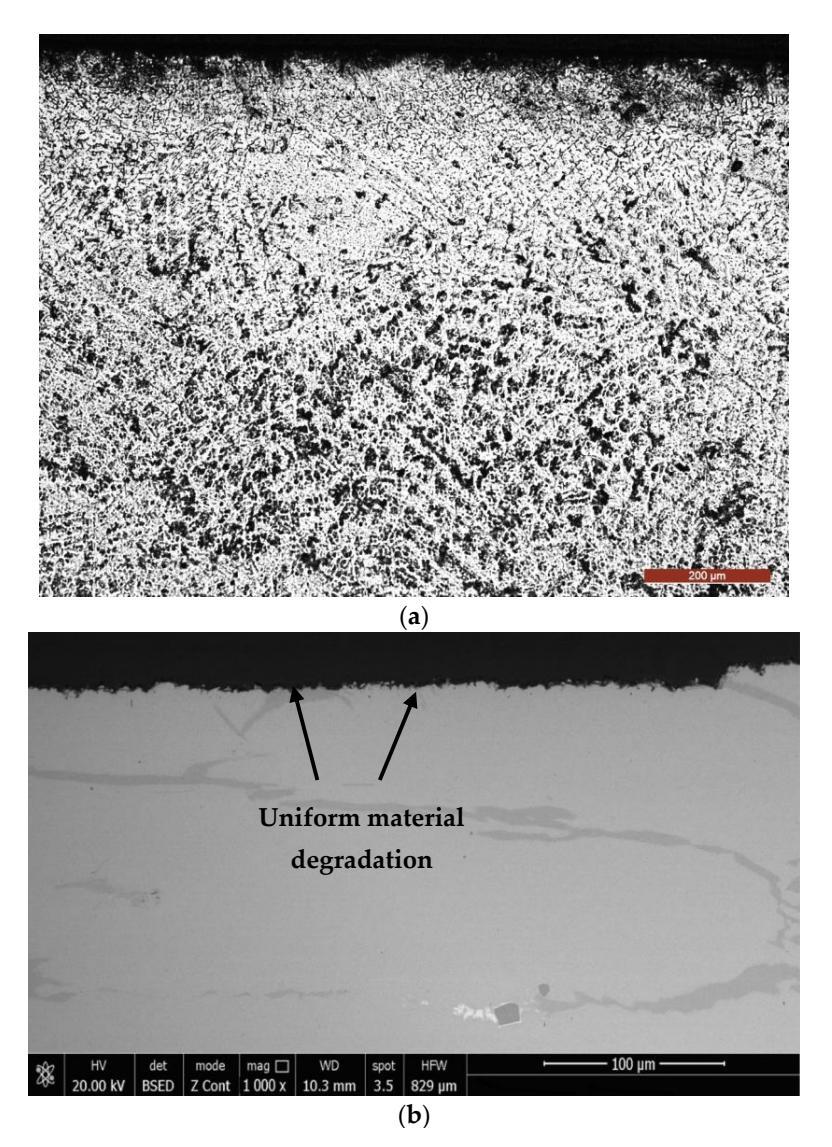
**Figure 14.** SEM microscopy through the remelted layer with Is = 150 A and after 165 min cavitation time: (a)—Villela etched; (b)—unetched.

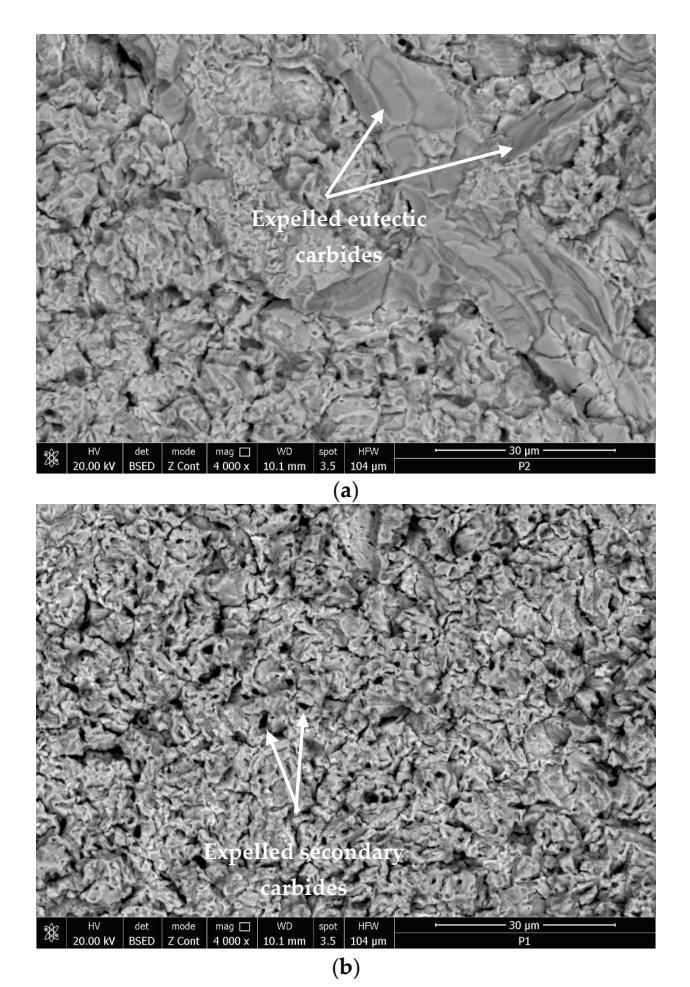
**Figure 15.** The microfractographic image of the cavition surface for 165 min. (**a**)—annealed structural state; (**b**)—TIG surface remelting with Is = 150 A.

The typical topographies of the cavitation surfaces for the samples heat-treated through annealing for homogenization and subsequently TIG surface remelted highlight a preferential degradation of the grains boundaries, where the hard and brittle carbide particles are present (Figure 15a,b). This surface modification technique leads to a structure with a high degree of fragmentation and finishing, which favors an increase in hardness and other mechanical resistance characteristics [13–15].
