# Microstructural Degradation and Creep Property Damage of a Second-Generation Single Crystal Superalloy Caused by High Temperature Overheating

Abstract: Nickel base superalloys are widely used to manufacture turbine blades, and overheating poses a serious threat to the safe service of turbine blades. In this study, a second-generation nickel base single crystal superalloy was taken as the research object, and we carried out the overheating treatment at 1100 °C and 1300 °C, and then tested the creep properties at 1000 °C/300 MPa and 1100 °C/130 MPa. Through systematic analysis of creep properties,  $\gamma/\gamma'$  phases, and creep voids, the effects of overheating on the microstructures and creep properties of the experimental superalloy were revealed. The results demonstrate that the effect of overheating at 1100 °C on the microstructure of the experimental superalloy can be ignored, and the effect on the creep property is limited. The degree of  $\gamma'$  dissolution is gradually increased and the creep property is reduced with overheating time extending at the overheating temperature of 1300 °C.

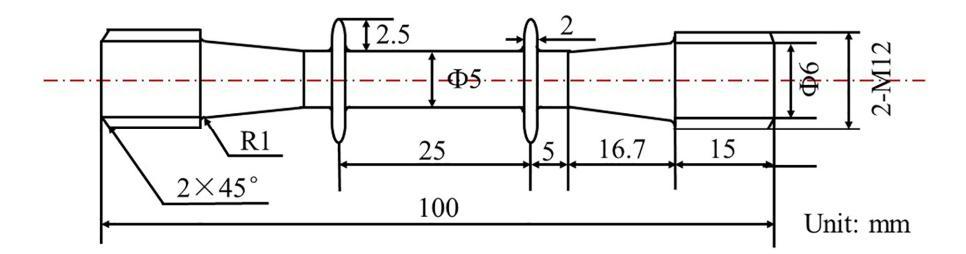
Figure 1. Sketch of the creep specimens.

To study the effect of overheating on the microstructure evolution, the overheating temperature was set at 1100 °C and 1300 °C, and the overheating duration was set as 5 min, 60 min, and 120 min, followed by air cooling. The solid bars after overheating treatment are sectioned into creep specimens. The sketch of the creep specimens is shown in Figure 1, which had a diameter of 5 mm and a length of 25 mm within the gauge length. The creep tests were carried out at 1000  $^{\circ}$ C/300 MPa and 1100  $^{\circ}$ C/130 MPa in air according to national standard GB/T 2039-2012, which is similar to International Standard ISO 204: 2009. An RDL-100 creep machine produced by Sinotest Equipment Co., Ltd. equipped with HEIDENHAIN ST 1288 extensioneter was used to conduct the creep tests. The heating rate was set as 300 °C/h, and the stress was kept 200 N during the heating process. The creep stress started loading after the specimens kept at the creep temperature for 0.5 h, and the stress kept constant during the whole creep process. For the overheated and creep specimens, the fracture morphologies and microstructures were observed using a NIKON LV150 optical microscope (OM), ZEISS SUPRA 55 and a FEI Inspect F50 fieldemission scanning electron microscope (FE-SEM). The average size of the  $\gamma'$  precipitates was measured using Image-pro software, and the volume fraction of the  $\gamma'$  precipitates was determined using the posture method and PS software.

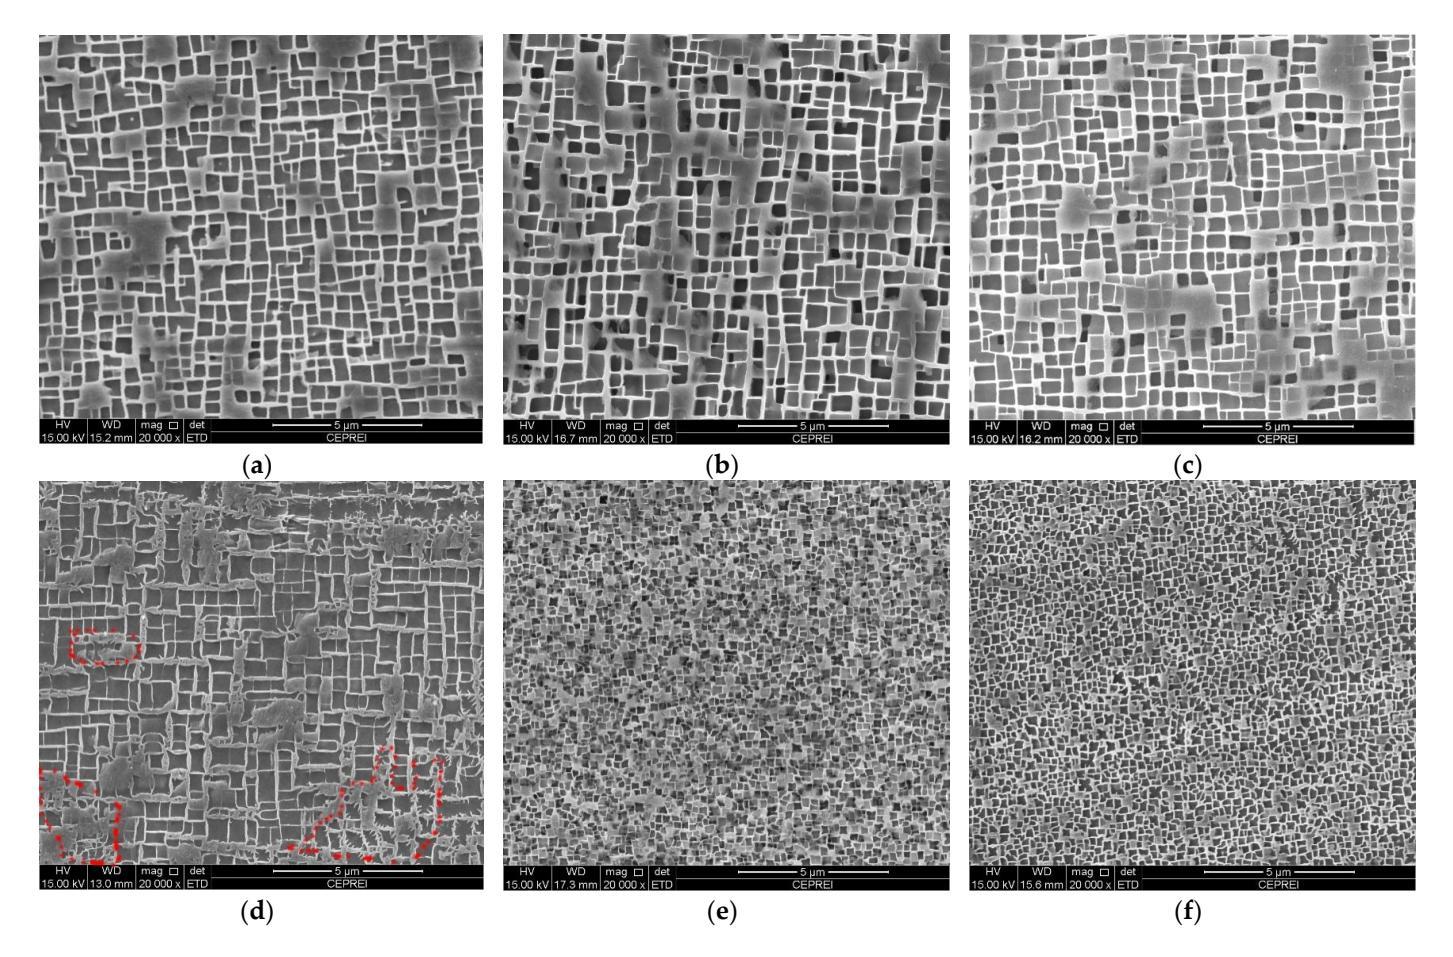
Figure 2 presents SEM-SE images showing the morphologies of  $\gamma/\gamma'$  phases in the dendrite core regions of the investigated superalloy after overheating at 1100 °C and

1300 °C. The  $\gamma'$  precipitates maintained a relatively cuboidal morphology after overheating at 1100 °C (Figure 2a–c), which was close to that after the standard heat treatment, indicating that the  $\gamma'$  precipitates were basically not degraded. The  $\gamma'$  precipitates were obviously dissolved when overheating temperature increased to 1300 °C, and the overheating duration had an obvious effect on the dissolution degrees. Figure 2d shows the morphology of  $\gamma'$  precipitates after overheating at 1300 °C for 5 min. The  $\gamma'$  precipitates were partially dissolved or coarsened, making the edges and corners uneven and serrated, as shown in the red box. When the overheating duration was extended to 60 min or 120 min, the size of the  $\gamma'$  precipitates was obviously smaller and evenly distributed, indicating that the primary  $\gamma'$  phase had been completely dissolved after the overheating treatment. The fine and uniform  $\gamma'$  particles were secondary  $\gamma'$  precipitates forming during the cooling process after the overheating treatment (see Figure 2c,d).

**Figure 2.** SEM-SE images of the  $\gamma/\gamma'$  phases in the dendrite core regions of the experimental superalloy after overheating at (a) 1100 °C/5 min; (b) 1100 °C/60 min; (c) 1100 °C/120 min; (d) 1300 °C/5 min; (e) 1300 °C/60 min; (f) 1300 °C/120 min.

The volume fraction and average size of the  $\gamma'$  precipitates in the dendrite core regions were counted after overheating, and the results are listed in Table 1. It is shown that the volume fraction and average size of the  $\gamma'$  precipitates were 66.2% and 0.46 µm, 65.6% and 0.48 µm, 64.4% and 0.50 µm after overheating at 1100 °C for 5 min, 60 min, and 120 min, respectively. With the extension of the overheating duration, the volume fraction and average size of the  $\gamma'$  precipitates decreased slightly, but was close to that after the standard heat treatment [15]. When the overheating temperature reached 1300 °C, the volume fraction of the  $\gamma'$  precipitates was reduced to about 60%, and the average size was even reduced to 0.24 µm. For example, after overheating at 1300 °C for 60 min, the volume fraction and average size of the  $\gamma'$  precipitates were reduced to 58.4% and 0.24 µm, respectively. Obviously, the laws presented by the statistical data results of the  $\gamma'$  phase were consistent with those presented in Figure 2.

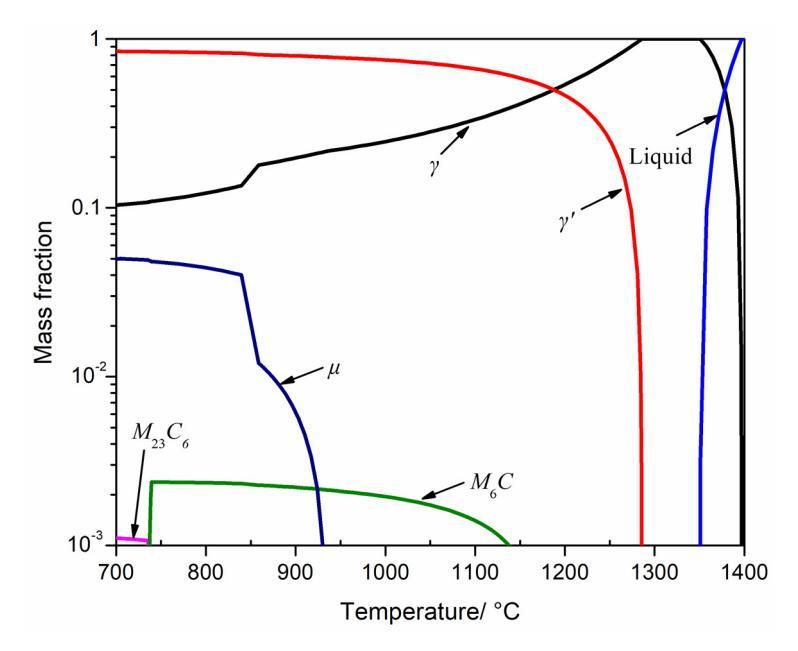
Figure 3 shows the phase equilibrium diagram of the investigated alloy between 700 °C and 1400 °C, the relevant data are listed in Table 2. Figure 3 further demonstrates that the equilibrium mass fraction of the  $\gamma'$  phase is 66.7% and 0 at 1100 °C and 1300 °C, respectively. Therefore, when the experimental superalloy was exposed to overheating at 1100 °C, no obvious degradation of the  $\gamma'$  phase occurred (Figure 2a–c). The  $\gamma'$  phase dissolution temperature is much higher than 1100 °C, but lower than 1300 °C (Figure 3). Through analysis of the slope change of the mass fraction vs. temperature curve, it can be figured out that when the temperature rises from 700 °C, the  $\gamma'$  phase content decreased slowly. When the temperature rises to about 1200 °C, the  $\gamma'$  phase content began to decrease significantly. At 1300 °C, the primary  $\gamma'$  precipitates trend to completely dissolve back into the  $\gamma$  matrix. The above thermodynamic calculation results are consistent with the experimental results (Figures 2 and 3).

**Figure 3.** Phase equilibrium diagram of the experimental superalloy between 700 °C and 1400 °C using Pandat software 2018 version based on PanNi 2018 database.

Table 2 lists the mass fraction of  $\gamma$  phase,  $M_6C$  carbides,  $M_{23}C_6$  carbides, and  $\mu$  phase at the equilibrium state of 1100 °C and 1300 °C. Only the mass fraction of  $M_6C$  carbide is larger than 0, while also small enough to be ignored. Because no  $M_6C$  carbides,  $M_{23}C_6$  carbides, or  $\mu$  phase precipitates were found in the standard heat-treated microstructure, and there was no precipitation power for the three precipitates at the overheating temperatures, thus no precipitation behavior of the  $M_6C$  carbides,  $M_{23}C_6$  carbides, and  $\mu$  phase was found in the overheated microstructure.

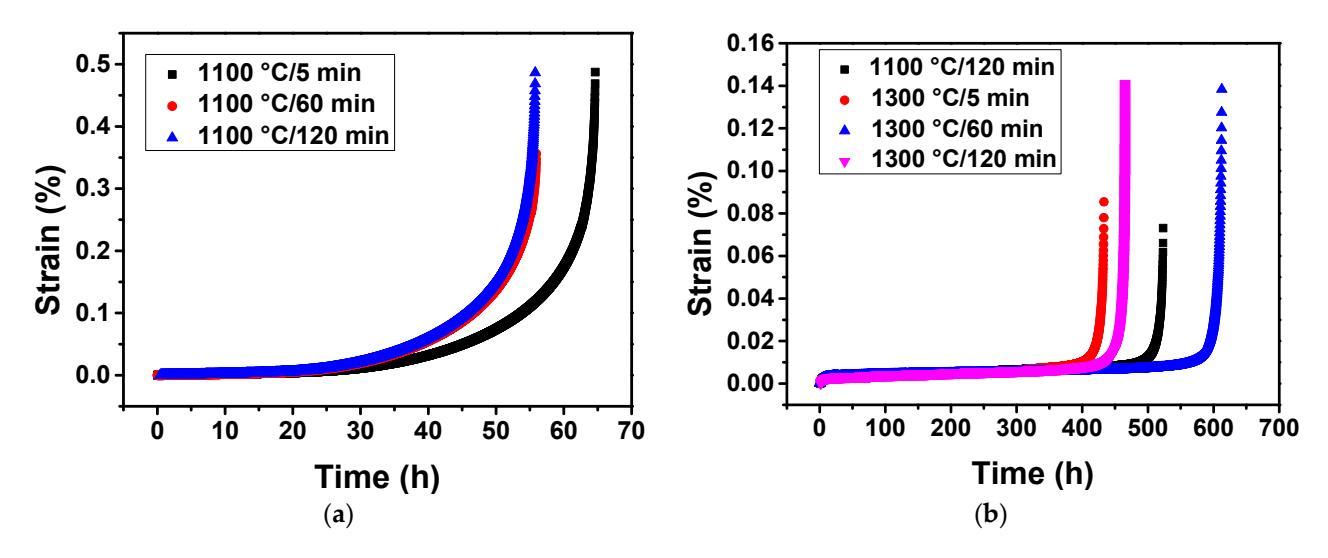
Figure 4a illustrates the creep strain vs. time curve under 1000 °C/300 MPa of the experimental superalloy after overheating at 1100 °C. The results show that the superalloy had the longest creep life of 64.6 h after being exposed to 1100 °C/5 min. The creep life of the superalloy was 55.9 h and 55.7 h after being exposed to 1100 °C/60 min and 1100 °C/120 min, respectively. This means that the creep life of the superalloy was obviously reduced when the overheating duration was extended from 5 min to 60 min. However, when the overheating duration was extended to 120 min, the creep life did not decrease significantly.

**Figure 4.** Curves of creep strain vs. time under creep condition 1000 °C/300 MPa for specimens overheated at 1100 °C/5 min, 1100 °C/60 min, and 1100 °C/120 min (**a**); under creep condition 1100 °C/130 MPa for specimens overheated at 1100 °C/120 min, 1300 °C/5 min, 1300 °C/60 min, and 1300 °C/120 min (**b**).

Figure 4b demonstrates the creep strain vs. time curve of the superalloy under 1100 °C/130 MPa after overheating at 1300 °C. The creep life of the superalloy was 523.2 h and 465.1 h after overheating exposure to 1100 °C/120 min and 1300 °C/120 min, respectively. The creep life of the superalloy was significantly reduced with the increase of overheating duration. On the other hand, the creep life of the superalloy was 433.2 h, 612.5 h, and 465.1 h after overheating for 5 min, 60 min, and 120 min, respectively. This indicated that the creep life of the superalloy was significantly increased when the overheating duration extended from 5 min to 60 min at 1300 °C, while the creep life of the alloy was significantly reduced when the overheating duration was extended to 120 min. The creep

life was the longest under the measured conditions at 1300  $^{\circ}$ C/60 min, and the reasons need further analysis.

The  $\gamma'$  phase is the main strengthening phase in nickel base superalloys, and its volume fraction and size have a great influence on creep life [16]. Combined with the volume fraction and size statistics of the  $\gamma'$  phase after overheating at 1100 °C (Table 1), a higher volume fraction and smaller average size of the  $\gamma'$ -phase precipitates may promote a longer creep life of the overheated specimens.

By comparing the volume fraction and size data of the  $\gamma'$  phases after overheating (Table 1), we can confirm that overheating exposure to 1300 °C causes significant degradation of  $\gamma'$  phases, and this is the main reason for the decrease of creep life. In general, the optimum volume fraction of  $\gamma'$  phases in nickel base single superalloys is about 65% [17]. Considering the changes in average size were obvious, while the volume fraction of the  $\gamma'$  precipitates was slightly lower than 65%, the significant decrease of the creep life was mainly due to the decreased size or the decreased volume fraction (Table 1, Figure 4b). In general, the creep life of nickel base superalloys reaches the maximum value at a certain size of  $\gamma'$  precipitates, and reduces with a larger or smaller size [17]. In addition, the optimum size of  $\gamma'$  phases may vary due to the change in the alloy composition. This study shows that for the experimental superalloy, the average size of the  $\gamma'$  phases decreased from 0.50 µm to 0.24–0.29 µm would significantly reduce the creep life at 1100 °C/130 MPa.

value of  $\Omega$  was to 1), the more  $\gamma/\gamma'$  phase interfaces, the fewer the  $\gamma$  phase channels, the more the movement of dislocations parallel to the stress axis is blocked, the slower creep rate. Therefore, for the specimen overheating treated to 1100 °C/5 min, the complete raft structure (with the highest  $\Omega$  value) had made a certain contribution to its excellent creep performance (Figure 4a).

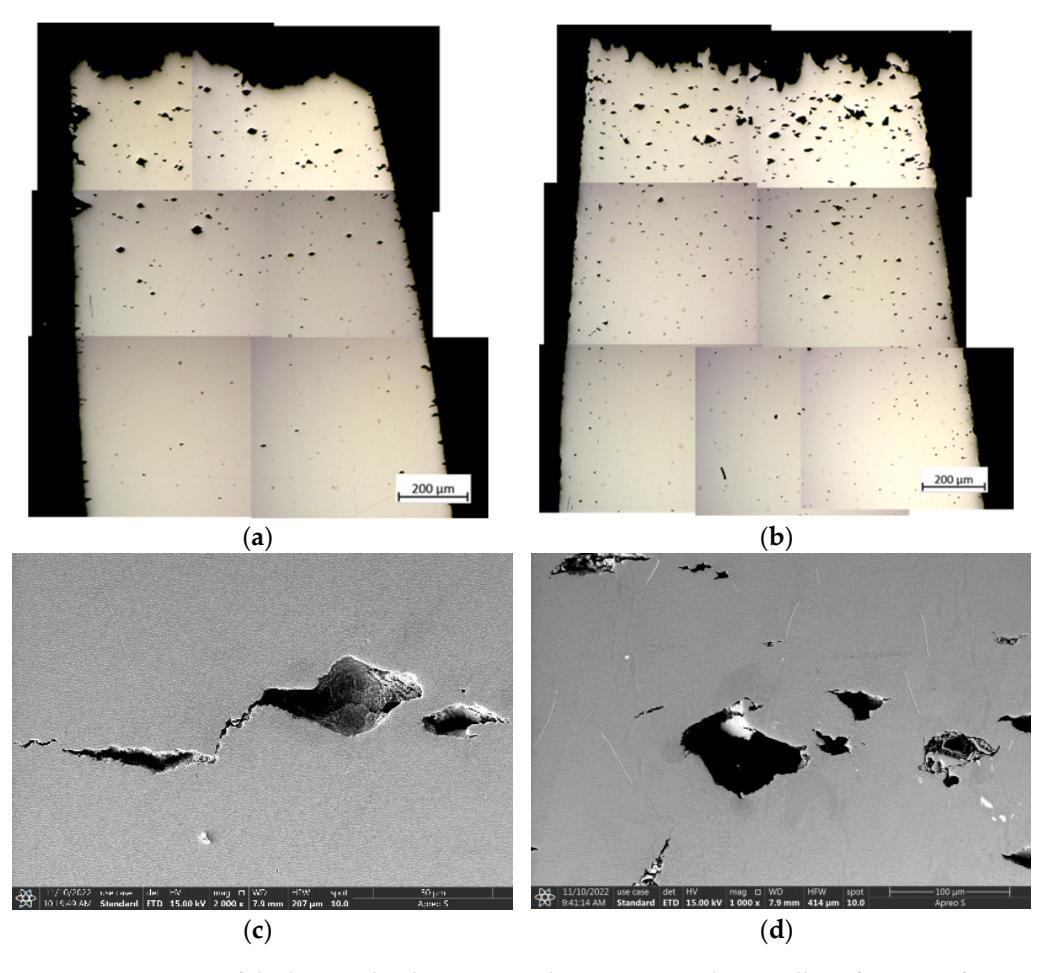
The fracture morphology in the longitudinal section of the creep specimens under  $1000 \,^{\circ}C/300$  MPa was observed. The results showed that there was a certain degree of necking near the fracture surface of each specimen. In addition, a large number of secondary cracks can be observed near the main cracks at the edge of the specimens. With the increase of the distance away from the fracture surface, the density and size of cracks and cavities in the specimen show a decreasing trend (Figure 5a).

**Figure 5.** OM images of the longitudinal sections in the experimental superalloy after creep fracture at 1000 °C/300 MPa after overheating at 1100 °C/120 min (**a**) and 1300 °C/120 min (**b**); SEM images of the cracks in the longitudinal sections of the experimental superalloy after creep fracture at 1000 °C/300 MPa after overheated at 1100 °C/120 min (**c**) and 1300 °C/120 min (**d**).

The metallographic microstructures in the longitudinal sections of the creep fracture specimens under 1100 °C/130 MPa were also investigated. The results showed that the necking phenomenon and cracks distribution law in the specimens at 1100 °C/130 MPa were basically consistent with those in the fracture specimens at 1000 °C/300 MPa. However, the size of creep cavities in the creep fracture specimens at 1100 °C/130 MPa was larger overall in comparison with that in the specimens at 1100 °C/120 MPa. In particular, the specimens subjected to overheating treatment at 1300 °C/120 min and then creep fracture at 1000 °C/300 MPa had the densest creep pores and cracks. This may be because more initial cavities and microcracks were produced in the experimental superalloy under the condition of overheating treatment at 1300 °C/120 min (Figure 5b). During the creep process, denser cavities are more prone to grow into creep cavities and serve as stress concentration points for crack initiation. This also reflects that the specimens after overheating treatment at 1300 °C/120 min concentration than the other specimens.

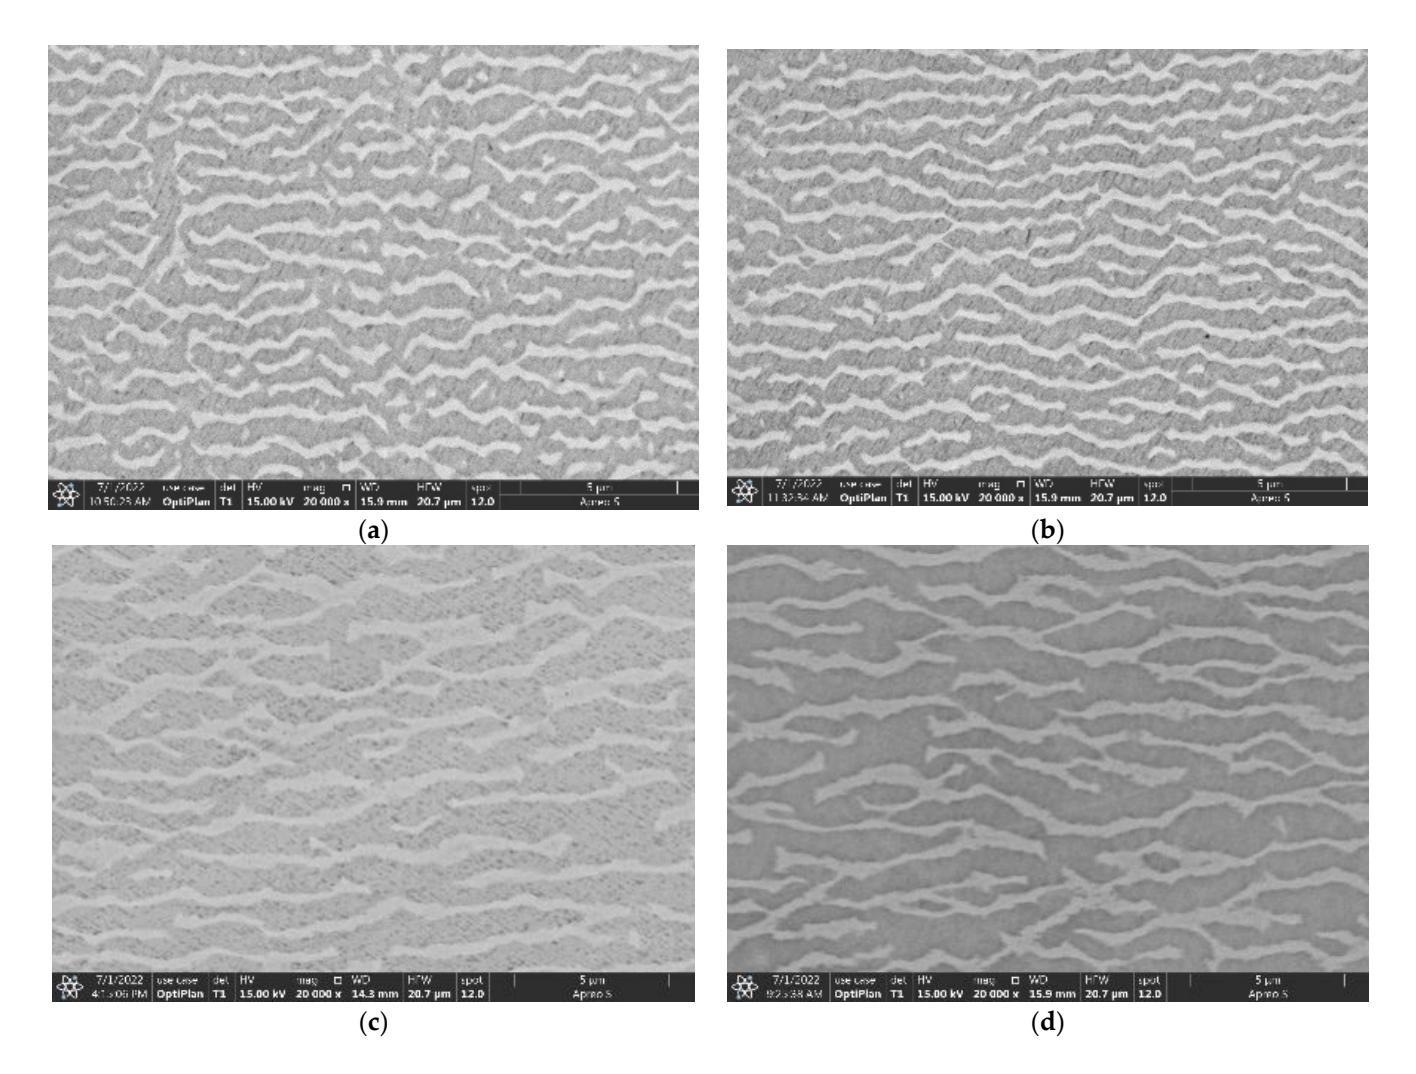
Figure 6a,b present SEM-SE images showing the morphologies of  $\gamma'$  precipitates in the dendrite cores of the longitudinal sections after creep fracture at 1000 °C/300 MPa after overheating exposed 1100 °C. The  $\gamma'$  precipitates suffered obvious rafting (i.e., parallel to (001) plane) in the direction perpendicular to the stress, and a certain degree of coarsening connection occurred in the direction parallel to the stress. For the three kinds of specimens with overheating for 5 min, 60 min, and 120 min, the morphologies of the  $\gamma'$  phase were basically close.

**Figure 6.** SEM-SE images of the  $\gamma'$  precipitates in the dendrite cores of the longitudinal sections of the experimental alloy after creep fracture at 1000 °C/300 MPa after overheating exposed 1100 °C/5 min (**a**) and 1100 °C/120 min (**b**); SEM-SE images of the  $\gamma'$  precipitates in the dendrite cores of the longitudinal sections of the experimental alloy after creep fracture at 1100 °C/130 MPa after overheating exposed 1100 °C/5 min (**c**) and 1100 °C/120 min (**d**).

The morphologies of the  $\gamma'$  precipitates in the dendrite core regions of the longitudinal sections after creep fracture at 1100 °C/130 MPa were also observed, and are shown in Figure 6c,d. The  $\gamma'$  rafting also occurred in the fracture specimens, and the thickness of the  $\gamma'$  rafts increased obviously in comparison with those of the fractured specimens at 1000 °C/300 MPa. On the one hand, this may be due to the fact that the creep temperature at 1100 °C was relatively high and was easy to cause  $\gamma'$  raft. On the other hand, the volume fraction of the  $\gamma'$ -phases after overheating at 1100 °C was lower than that at 1000 °C, and was easy to form a thicker  $\gamma'$  raft.

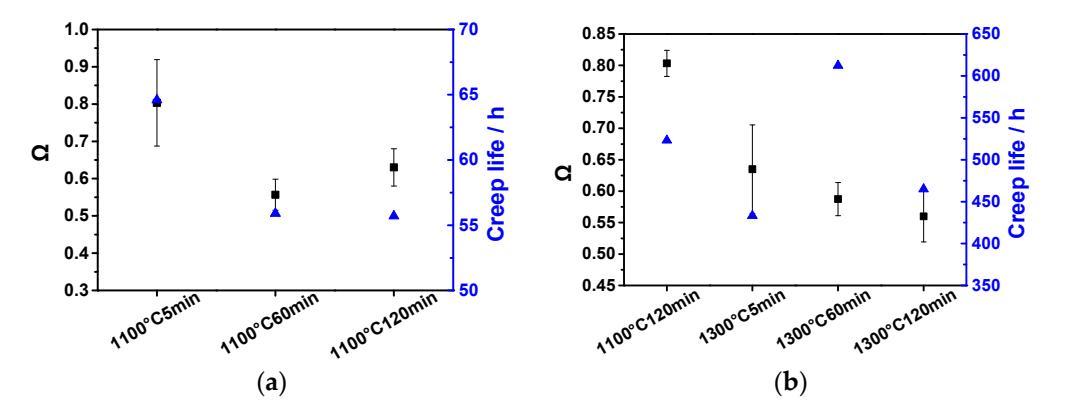
The integrity of the  $\gamma'$  raft is statistically analyzed and compared with the creep life. The results showed that there was a certain difference in the integrity of  $\gamma'$  rafting formed in the experimental superalloy under the creep condition of 1000 °C/300 MPa (Figure 7a). The specific performance was that the specimens overheated treated at 1100 °C/5 min had more complete rafting structures, while the integrity of the  $\gamma'$  rafting structures of the two specimens with longer overheating duration decreased significantly. The creep life was closely related to  $\gamma'$  raft integrity, and the specimens with higher raft integrity had a longer creep life.

**Figure 7.** The integrity of  $\gamma'$  raft ( $\Omega$ ) in the dendrite core regions of the longitudinal sections of the experimental alloy and creep life under 1000 °C/300 MPa (**a**) and 1100 °C/130 MPa (**b**) after suffering overheating treatments.

It has been shown that the single crystal superalloy with a straight and complete raft structure during creep can obtain better creep properties than that with bent and bifurcated raft structures [23]. The higher the integrity of raft microstructure (i.e., the closer the

The integrity of  $\gamma'$  raft in the creep specimens on the condition of 1100 °C/130 MPa for different overheated specimens had a certain difference. The specimens overheating treated to 1100 °C/120 min had a complete raft structure, and the integrity of  $\gamma'$  raft decreased significantly with the increase of the overheating duration. the creep life was closely related to the raft integrity, and the specimens with higher raft integrity had a longer creep life. This is because the higher raft integrity, the more  $\gamma/\gamma'$  phase interfaces, the more the movement of dislocations parallel to the stress axis was blocked, and the creep rate decreased.
