# Article Corrosion Behavior of Incoloy<sup>®</sup>800H, Hastelloy<sup>®</sup>G35<sup>®</sup> and 316L Stainless Steel in the Molten Eutectic Fluoride Mixture FLiNaK and Its Vapors

**Abstract**: This paper discusses the findings of a corrosion experiment which investigates a transition area which is between the lower area and upper area of the sample. In this experiment, the lower half of the sample surface is exposed to molten salt and the upper half of the sample surface is exposed to the vapors generated by molten FLiNak salt. Incoloy®800H and Hastelloy®G35® alloys and 316L stainless steel were selected for the corrosion experiment on the basis of their Cr content. The experiment was conducted at 600 °C for a period of 100 h. The results of the experiment show that, in the transition area, no abrupt change in corrosion mechanism takes place; the experiments also give us information on how the degree of degradation varies across the three areas of the samples. The experiment also showed two distinct corrosion mechanisms operating in the test samples: intergranular corrosion in the SS316L stainless steel test sample and continuous corrosion in Hastelloy®G35®. The results also sho

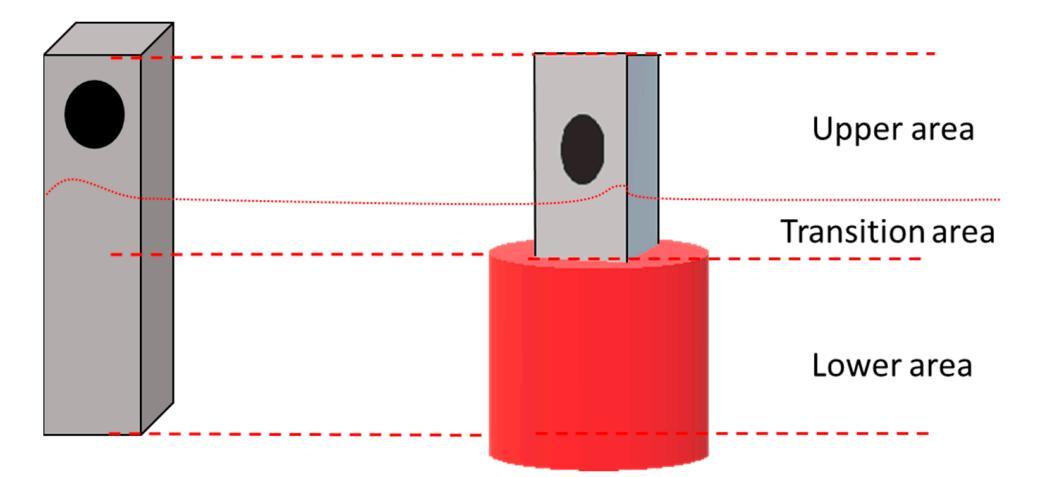
Figure 1. The image shows the three area of the sampe which are invstigated.

To obtain data from all three areas (molten salt area, transition area, and volatility and off-gases area), this experiment submerged the sample halfway into the molten salt area, exposing the other half to the vapor, thereby creating the required three areas (molten salt area, transition area and vapor-exposed area) in one sample. By doing so, the sample will provide information on corrosion mechanisms in (i) the molten salt environment, (ii) the area in close proximity to the molten salt (transition area) and (iii) the area where volatility and off-gases generated by the FLiNaK salt come into contact with the surface of the sample.

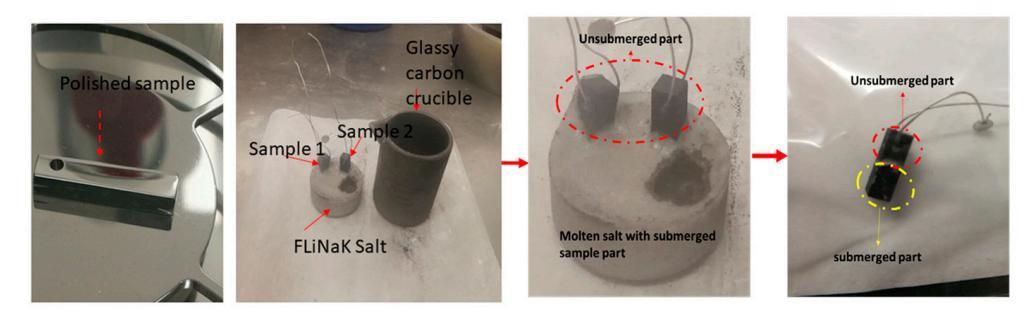
**Figure 2.** Sequence of processes taking place in the corrosion experiment. The two images on the left show the polished sample and the experimental procedure, and the second two images show the post-experiment process.

The crucible and its contents were then heated to 600 °C for a period of 100 h in an argon atmosphere. After the stipulated time of 100 h, the furnace was turned off and allowed to cool spontaneously to room temperature. Finally, after the completion of the experiment, the samples were separated from the solid salt, as shown in Figure 2.

Mass change data from the literature show different patterns according to the type of exposure to the molten salt: samples which were completely submerged in the molten salt environment showed mass loss, as in articles [17,30]. In contrast, samples which were not submerged in the molten salt, but only exposed to volatiles and off-gases from the molten FLiNaK salt, as in refs. [21,31], showed mass gain. However, in this experiment, where one half of each of the three test samples was immersed into the salt (submerged sample part) and the other half only exposed to the vapors (unsubmerged part) (see Figure 2), the sample shows overall mass loss.

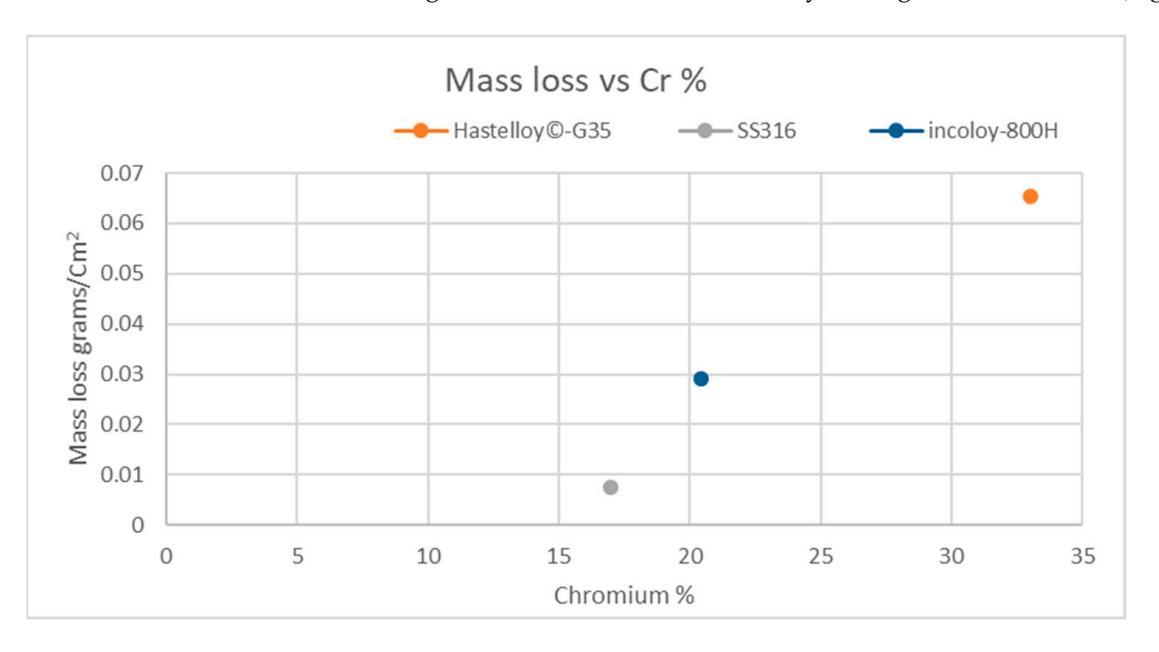
Figure 3. Graph showing that the mass loss in grams/cm<sup>2</sup> increases with Cr content in the samples.

In this experiment, the mass loss of the three test samples shows a correlation between Cr content in the test samples and the mass loss; Hastelloy<sup>®</sup>-G35<sup>®</sup> has the largest mass loss, followed by Incoloy<sup>®</sup>-800H and finally SS316L stainless steel, which shows the lowest mass loss. Thus, the higher the content of Cr in the alloy, the higher the mass loss (Figure 3).

Immersion of the test sample halfway into the molten salt bath, leaving it semi-exposed to vapors at high temperatures, revealed that higher Cr content in the alloy leads to higher mass loss of the alloy (see Figure 3). This finding is consistent with the data of other research, in which Ni-based alloys with different Cr contents were tested for corrosion resistance in molten FLiNaK salt [33,34]. It suggests that mass loss is dependent on the Cr content of the alloy rather than on the corrosion environment.

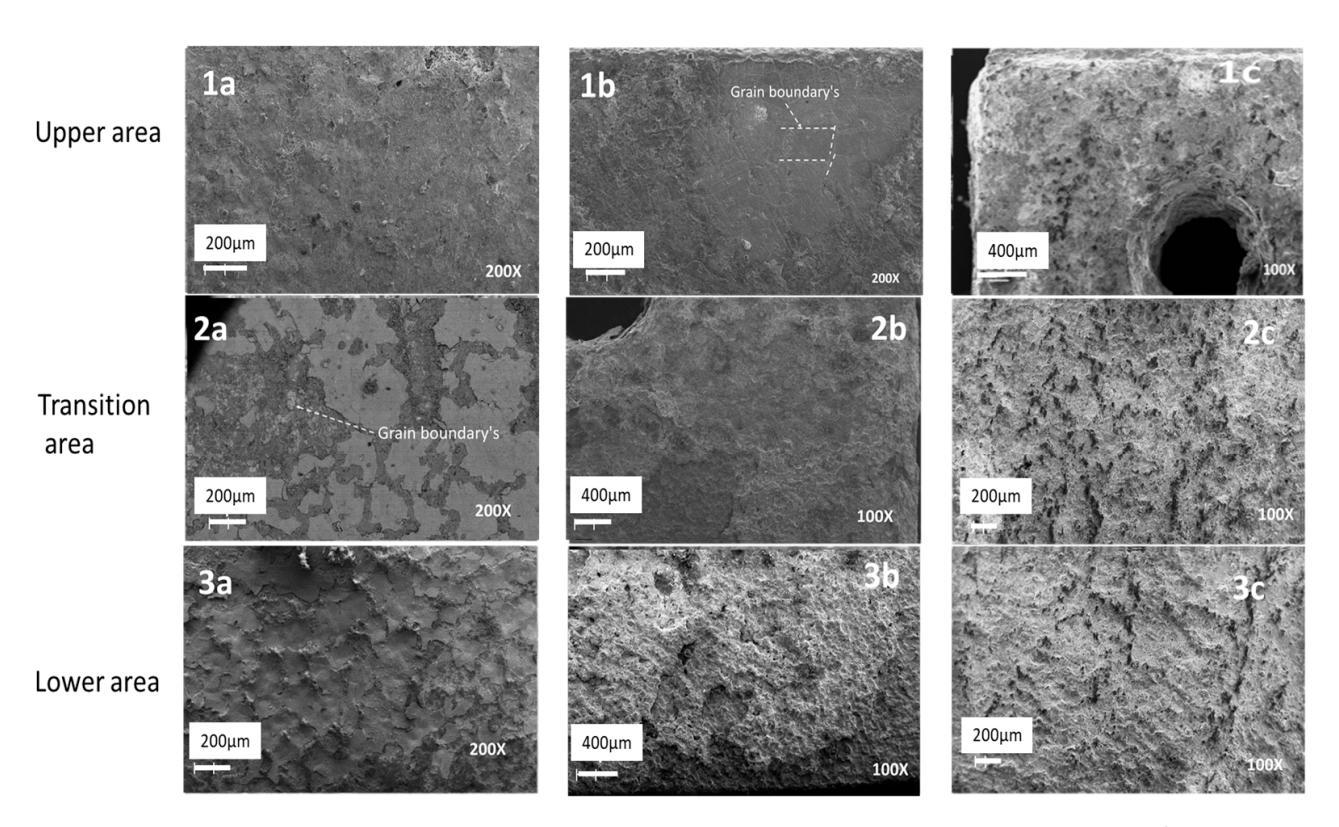
**Figure 4.** The surfaces of the three areas of SS316L stainless steel (**1a–3a**), Incoloy<sup>©</sup>-800H (**1b–3b**) and Hastelloy<sup>®</sup>G35<sup>®</sup> (**1c–3c**) are shown in the image.

Images of the surface morphology are shown in Figure 4. Starting from the upper left, Figure 4 image 1a shows (at  $200 \times$  magnification) the upper area of the SS316L sample, which was exposed to the high-temperature volatiles and off-gases from the molten salt. The upper area has a smooth surface and does not show much degradation from the corrosion process. Below the "upper area" is the "transition area" (Figure 4, image 2a at  $200 \times$  magnification), which was in close proximity to the molten salt (or, in some cases, may have come into contact with the molten salt during the experiment). The transition area shows a grain boundary marked with a white arrow (Figure 4, image 2a at  $200 \times$  magnification) and corrosion scale covering part of the surface. The lower area, which was in contact with the molten salt, shows a high degree of degradation. The surface of the lower area is covered with a corrosion layer (See Figure 4 image 3a).

The upper area of the Incoloy<sup>©</sup>-800H sample shows grain boundaries and a smooth surface indicated with white dashed lines (Figure 4 image 1b at  $200 \times$  magnification). The smooth surface is similar to the upper area of SS316L. The transition area in closer proximity to the molten salt has high degradation (Figure 4 image 2b at  $100 \times$  magnification). The lower area, where molten salt has come into contact with Incoloy<sup>®</sup>-800H, is also highly degraded (Figure 4, 3b at  $100 \times$  magnification) and partially covered by a corrosion layer.

The Hastelloy<sup>®</sup>-G35<sup>®</sup> sample shows a high degree of degradation in all three areas, regardless of whether or not they have come in contact with the molten salt (Figure 4 images 1c, 2c, and 3c).

Analyzing the surface morphology of the test samples, it is clear that the lower zones of the three test samples are highly degraded. The degradation is clearly caused by the interaction of the molten salt and the sample surfaces (see Figure 5). In the case of the lower areas of the SS316L, the degradation clearly showed an intergranular corrosion mechanism to be operating (see Figure 6), which is consistent with the finding of ref. [30].

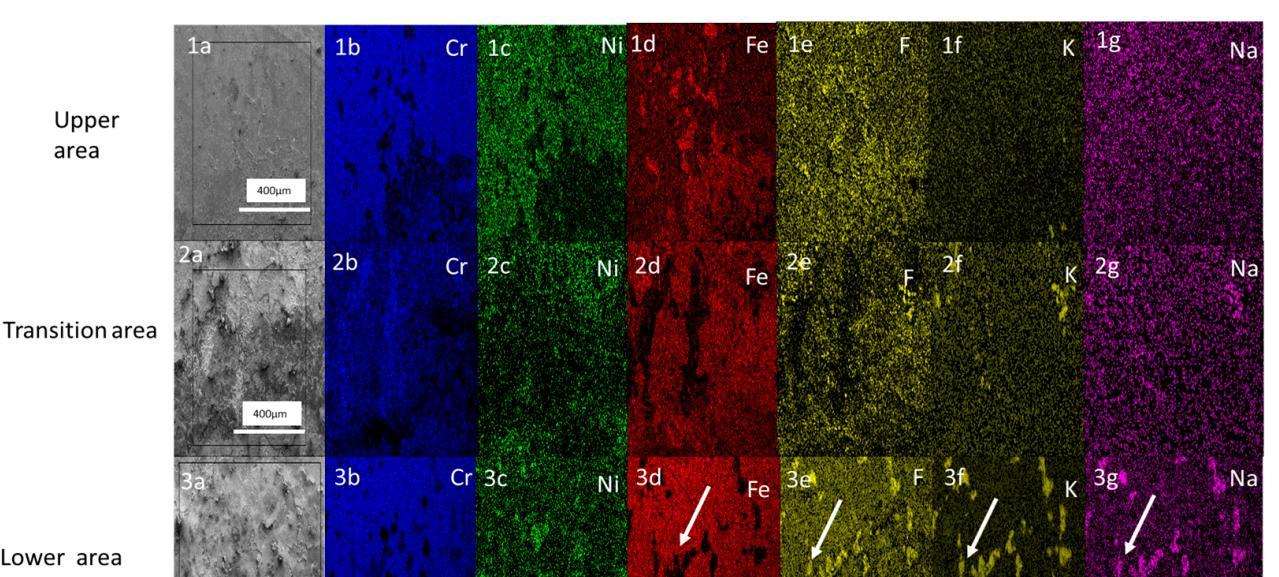
Lower area

Figure 5. Surface elemental mapping of the SS316L test sample's three areas. Images (1a-1g) show the elemental distribution of the upper area of the sample. Images (2a-2g) show the elemental distribution of the transition area. Images (3a-3g) show the elemental distribution of the lower area. The white arrows in the images 3d–3g show the grain boundary.

The elemental mapping of the lower area of the SS316L stainless steel test sample (see image 3a–3g, Figure 5) shows a high concentration of F, K and Na together (see image 3e–3g, Figure 5), which is marked with a white arrow in each image. In contrast, there is no visible Fe and Cr concentration in those places where F, K and Na are present in the EDX mapping of the lower area (see images 3b–3d, Figure 5). The areas of high deposition of K, F and Na can be assumed to be grain boundaries and the corrosion mechanisms can thus be assumed to be intragranular corrosion. This concurs with previous findings of corrosion at grain boundaries [32].

Comparing the findings of the elemental mapping in the transition area (see image 2a–2g, Figure 5) with the elemental mapping in the lower area, it can be observed that grain boundaries were not visible in the transition area and that a high concentration of F, K and Na is also absent along the grain boundary, unlike in the lower area of the sample surface. The comparison of the upper area with the lower area also shows no indication of grain boundaries (see image 1a-1g, Figure 5).

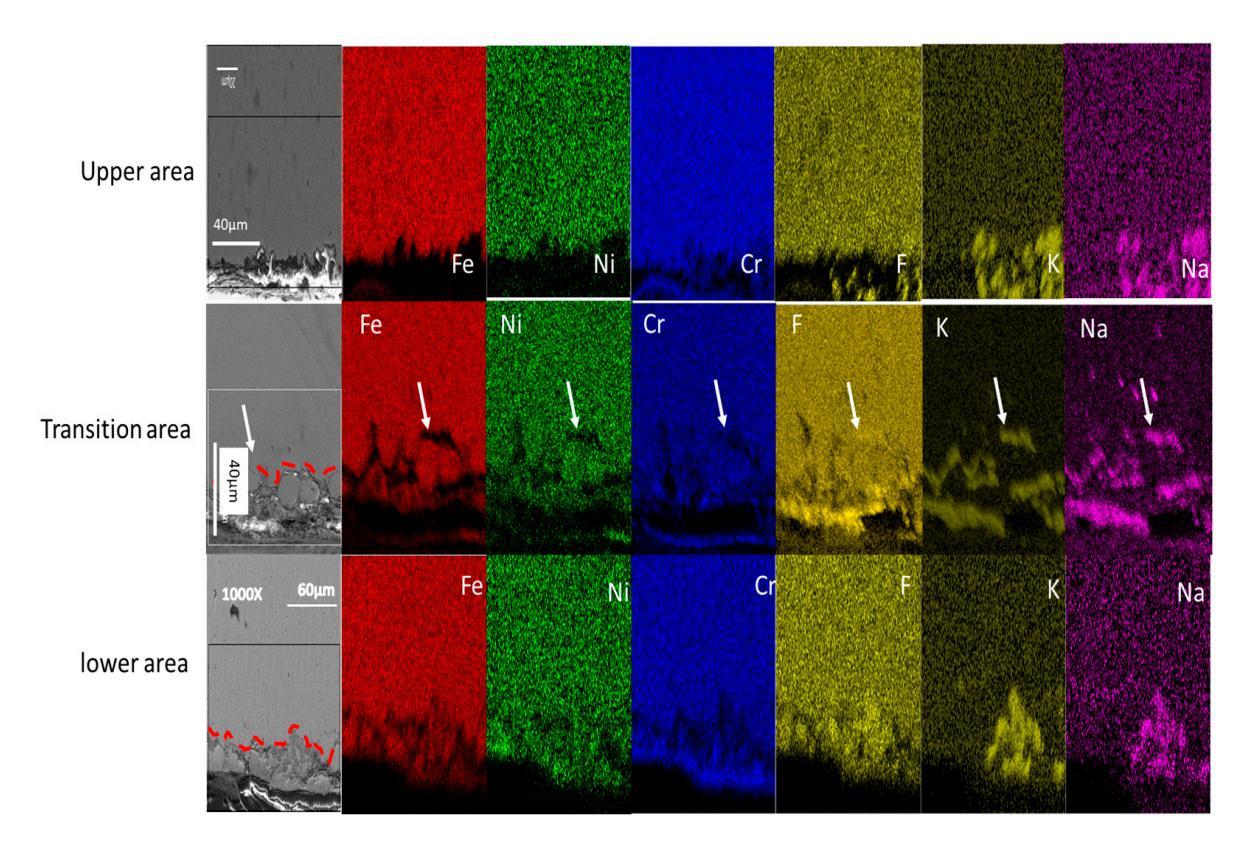
**Figure 6.** Cross section of SS316L stainless steel with the depth of penetration of the elements into the base metal.

The lower area is taken as a reference with which to compare the two other areas (the transition area and the upper area), as in the previous section. In the lower area, it is clearly visible that grain boundaries have been most strongly affected and that intergranular corrosion is driving the corrosion in SS316L stainless steel. The EDX mapping of the cross section shows that F, K and Na had diffused along the grain boundaries of the SS316L stainless steel sample, as shown by the white arrows (Figure 6). The EDX mapping also shows low concentration of Cr, Ni and Fe along the grain boundary, also shown by arrows in Figure 6.

In the transition area, grain boundaries with intergranular corrosion were also visible, as seen in the areas indicated with white arrows close to the surface. F, K and Na also penetrated into the metal matrix in a similar way as in the lower area.

In the upper area, the depth of corrosion was very shallow and it was hard to determine the corrosion mechanism, but F, K and Na had penetrated into the metal matrix in this case as well, as shown in the first row of Figure 6.

When comparing the transition area with the lower area, only small differences can be observed for both the SS316L stainless steel and Incoloy<sup>©</sup>-800H test samples. In the transition area, a corrosion layer was observed in both the SS316L stainless steel and Incoloy<sup>©</sup>-800H test samples and, to some extent in the SS316L stainless steel, grain boundaries were exposed (see Figures 6 and 7).

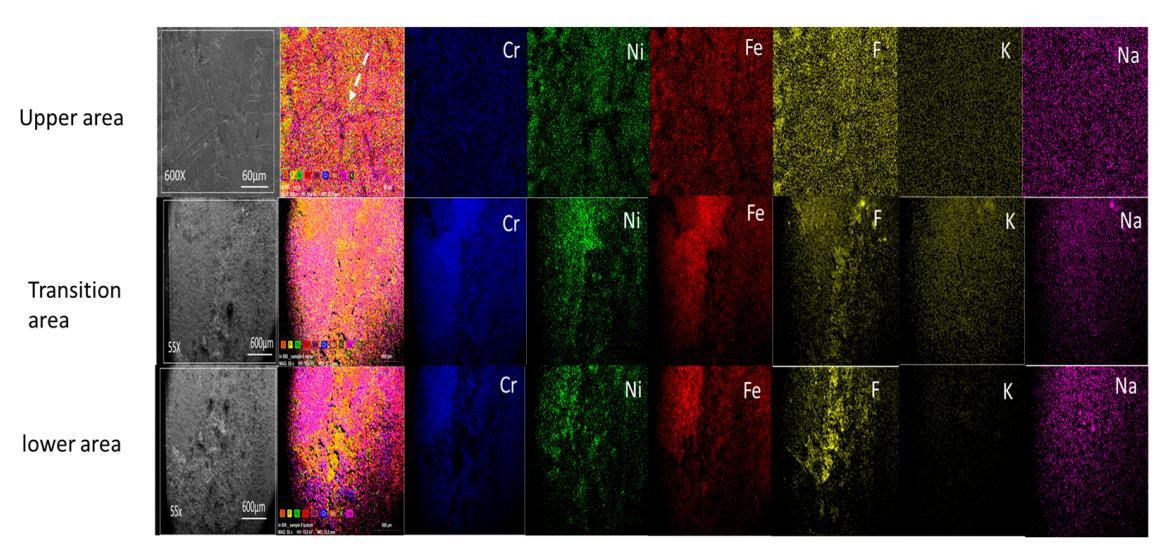
**Figure 7.** Surface mapping of Incoloy<sup>®</sup>-800H. The image also shows grain boundary in the upper area, as indicated by the white arrow.

The elemental mapping of the lower area of the Incoloy<sup>®</sup>-8000H (see Figure 7) does not reveal any grain boundaries or clearly reflect any corrosion mechanism, unlike the SS316L stainless steel lower area (see image 3a–3g, Figure 5); this may be because the surface is covered by a corrosion layer. The transition area does not reveal any grain boundaries or corrosion mechanism either. However, in the upper area, there are grains and grain boundaries visible, as indicated with white arrows (top row of Figure 7), indicating that intergranular corrosion is the corrosion mechanism in the upper area for Incoloy<sup>®</sup>-800H.

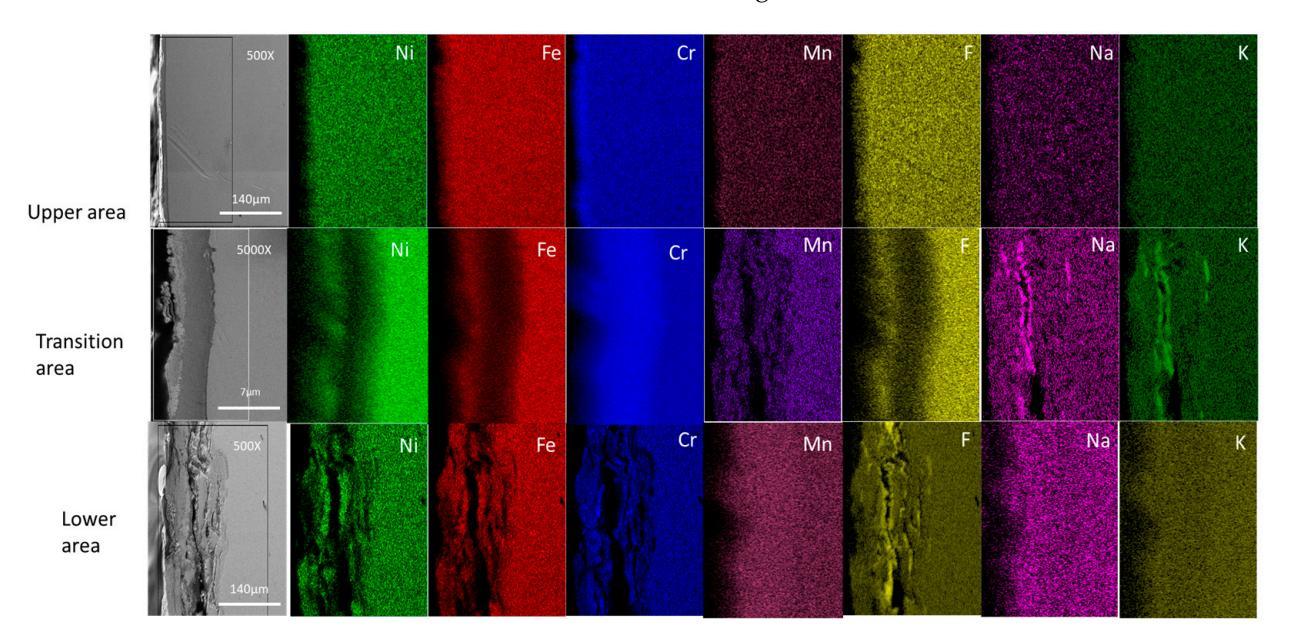
Figure 8. Cross section of Incoloy<sup>®</sup>800H.

The mapping of the cross section did not show any indications of the corrosion mechanism. However, the lower area has a high degree of degradation, with diffusion of F, Na and K into the metal, as shown in Figure 8.

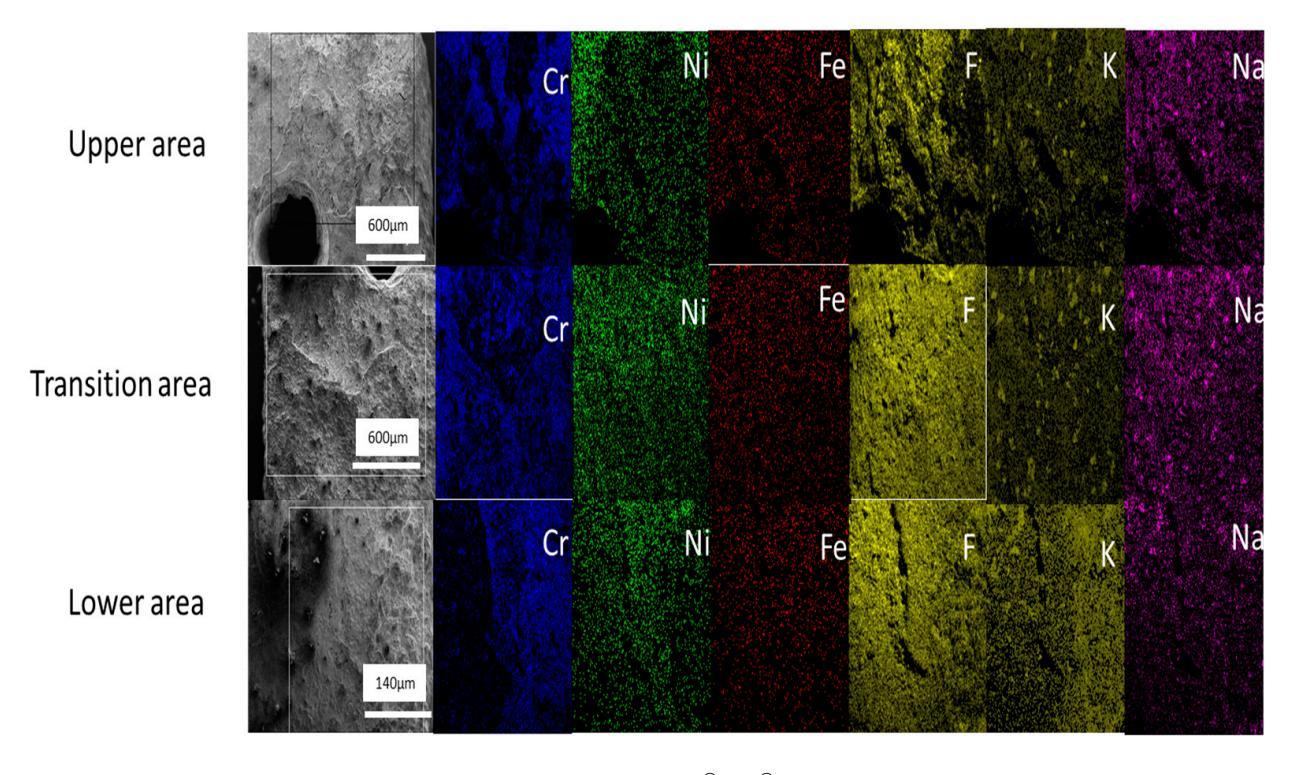
Figure 9. Surface mapping of Hastelloy<sup>®</sup>G35<sup>®</sup> with concentration of different elements on the surface.

Surface mapping of Hastelloy<sup>®</sup>G35<sup>®</sup> did not reveal any preferential corrosion mechanics in any of the three areas of the test sample surface (Figure 9), as was seen in SS316L stainless steel and, to a slight extent, in Incoloy<sup>®</sup>-800H.

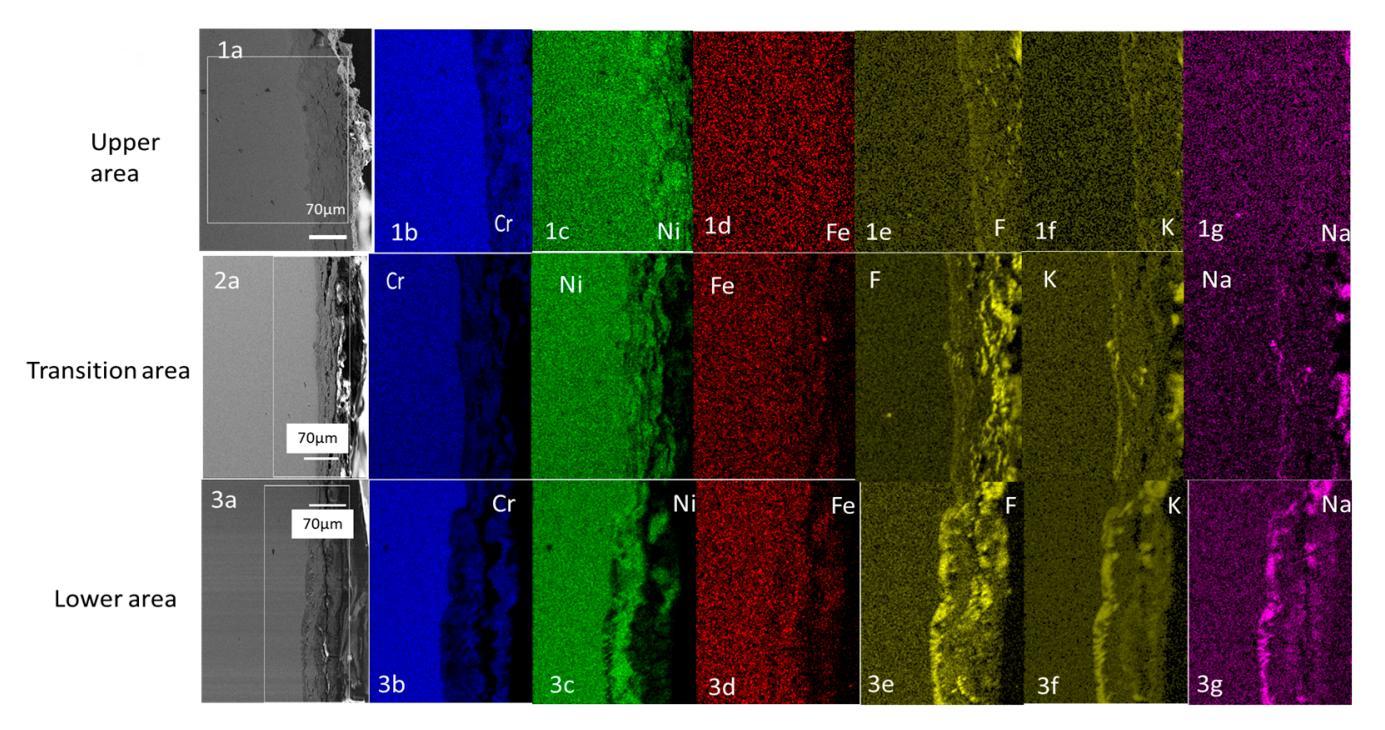
**Figure 10.** Cross-sectional elemental mapping of Hastelloy<sup>®</sup>G35<sup>®</sup> is shows. Images (**1a–1g**) show the elemental distribution of the upper area. Images (**2a**) show the and the consecutive images to its right show shows the elemental distribution of the transition area. Images (**3a–3g**) show the elemental distribution of the lower area.

Cross-sectional mapping of the Hastelloy<sup>®</sup>G35<sup>®</sup> does not show intergranular corrosion in any of the three areas (Figure 10). Starting with the lower area, it is clear that there was a continuous inward diffusion of F, K and Na into the metal matrix, up to a depth of 70  $\mu$ m. The outward diffusion of Cr and Fe remained constant.

Next, the transition area shows an inward diffusion of F, K and Na, but the concentration was lower than the concentration of F, K and Na in the lower areas. However, the depth of corrosion remained the same. The outward diffusion of Cr, Fe and Ni remained the same as in the lower area.

Finally, in the upper area, the F, K and Na inward diffusion was low when compared to the transition and lower areas; this is because the amounts of F, K and Na encountered by the upper area (which was only in contact with the vapors) are much lower than the amounts encountered by the areas in contact with bulk FLiNaK. Therefore, penetration of the sample was far lower. The outward diffusion of Cr, Fe and Ni was slightly higher than the inward diffusion of F, K and Na in the upper area.

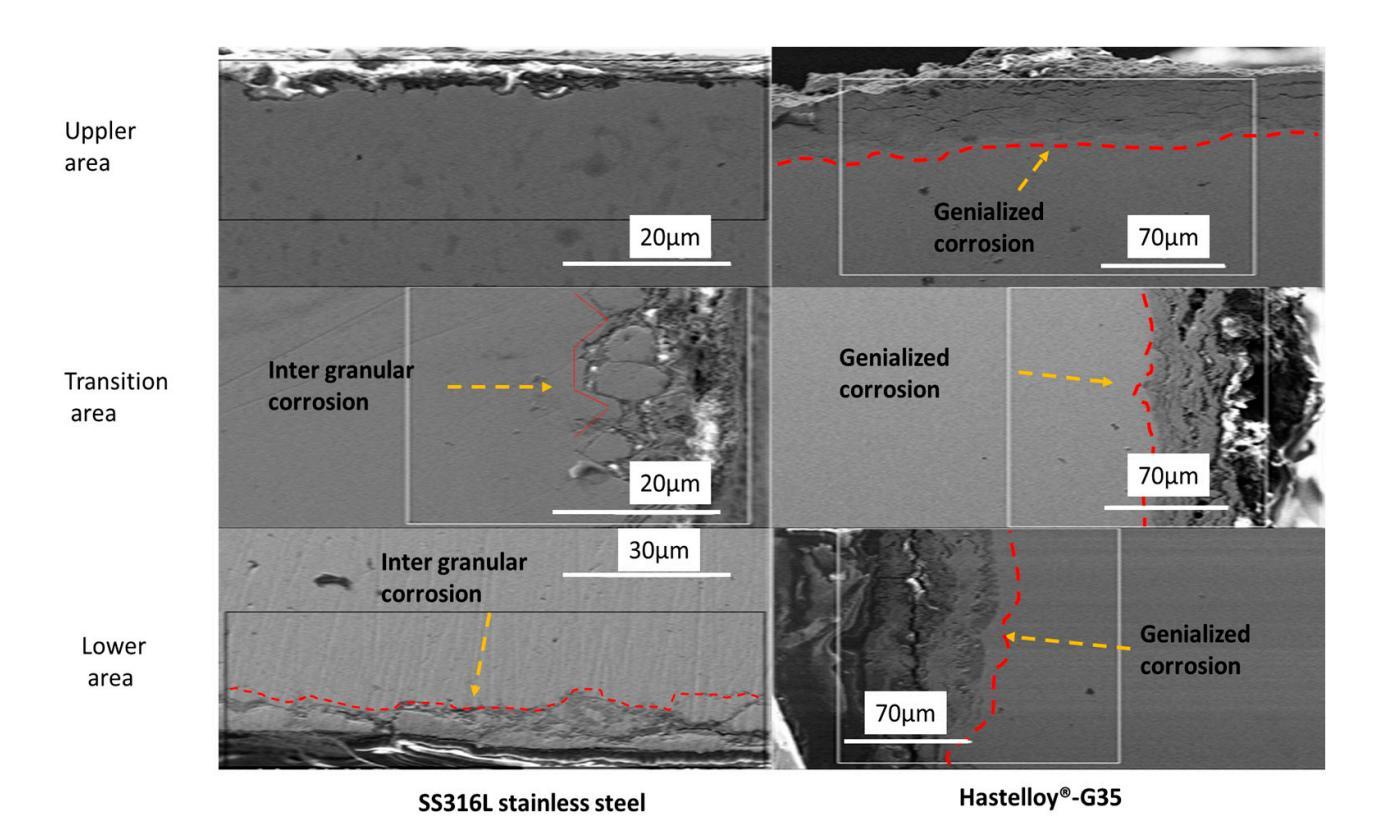
**Figure 11.** Cross sections of SS316L stainless steel and Hastelloy<sup>®</sup>G35<sup>®</sup>. The SS316L sample shows intergranular corrosion. In the Hastelloy<sup>®</sup>G35<sup>®</sup> sample, general corrosion can be seen.

When compared, the SS316L stainless steel and Hastelloy<sup>®</sup>G35<sup>®</sup> test sample cross sections show two distinct corrosion mechanisms operating in the FLiNaK salt environment (See Figure 11). In SS316L, intergranular corrosion was found to be the operating mechanism for corrosion. On the other hand, Hastelloy<sup>®</sup>G35<sup>®</sup> did not have any specific dominant mechanism such as that seen in the SS316L test sample. In Incoloy-800H, the data from other research also show intergranular corrosion [34], the same as for the SS316L test samples.

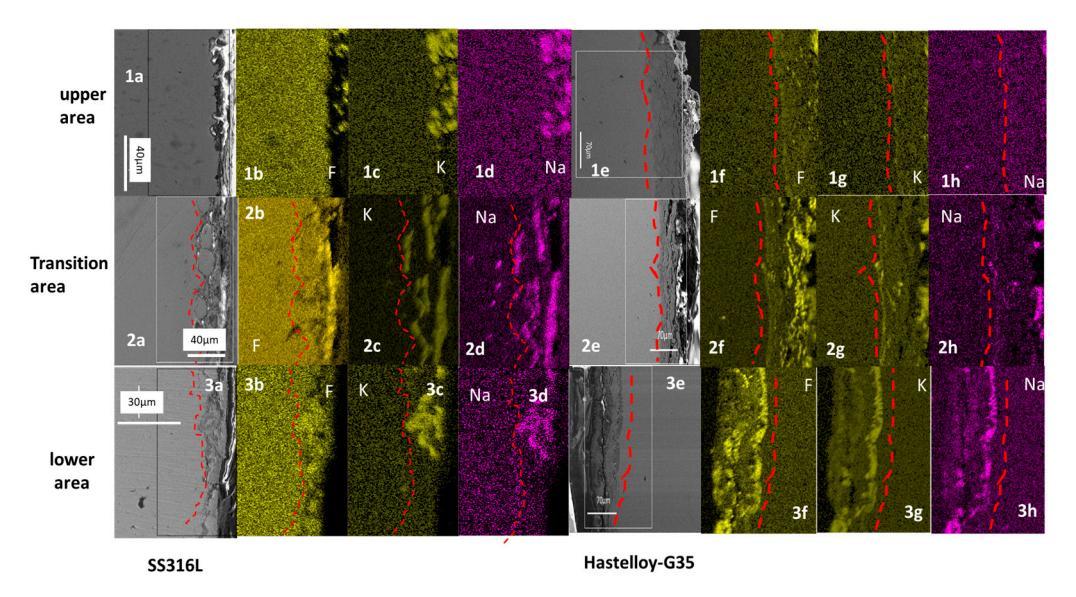
**Figure 12.** Cross-sectional mapping of the upper area (**1a–1d**), transition are (**2a–2d**) and lower (**3a–3d**) of SS316L.the upper area of (**1e–1h**), transition area of (**2e–2h**) and lower are of (**3e–3h**) ofHastelloy<sup>®</sup>G35<sup>®</sup> areas area shown.

EDX mapping of the SS316L cross section shows inward diffusion of F, K and Na (see Figure 12) into the metal matrix. The thickness of the corrosion layer in the lower and transition areas was around 20  $\mu$ m, using the scale in Figure 12 for measurement. However, the depth of corrosion in the upper area was shallow and hard to measure (see Figure 11), which confirms that, if the alloy does not come into contact with the molten salt or it is far away from it, the corrosion will be shallow.

In contrast to the SS316L cross section, in the Hastelloy<sup>®</sup>G35<sup>®</sup> cross section the inward diffusion of F, K and Na was different in each area. In the lower area, the inward diffusion was high, as can be seen in Figure 12, images 3e–3h. As we move to the transition area, the inward diffusion of F, K and Na becomes smaller. This indicates that, in the case of Hastelloy<sup>®</sup>G35<sup>®</sup>, the further away the surface from the molten salt, the lower the corrosion when compared to the lower areas. The upper areas show even lower inward diffusion of F, K and Na, due to corrosion from vapors being dominant there.
