Article Material's Strength Analysis of the Coupling Node of Axle of the Truck Trailer

Abstract: Road transport plays an important role in the transport of goods and people and is important for the national economy. Damage usually excludes the means of transport from operation, which causes disruption of supply chains. One such damage is the failure of the suspension system of the vehicle or trailer, which usually occurs when the vehicle is heavily loaded. Such a defective system has been analyzed in this publication. Mathematical apparatus and finite element method (FEM) numerical simulations were used. A dangerous axle cross-section in terms of load was indicated and the maximum stresses in this area were calculated for two types of roads. On highways, the stress at the critical point was 199 MPa, and on uneven roads it increased to 304 MPa, which is comparable to the yield point. It was found that the second form of vibration may cause stresses in the damage area, but the excitation frequency would have to be quite high. The probability of such a load and failure event occurring is low under operating conditions.

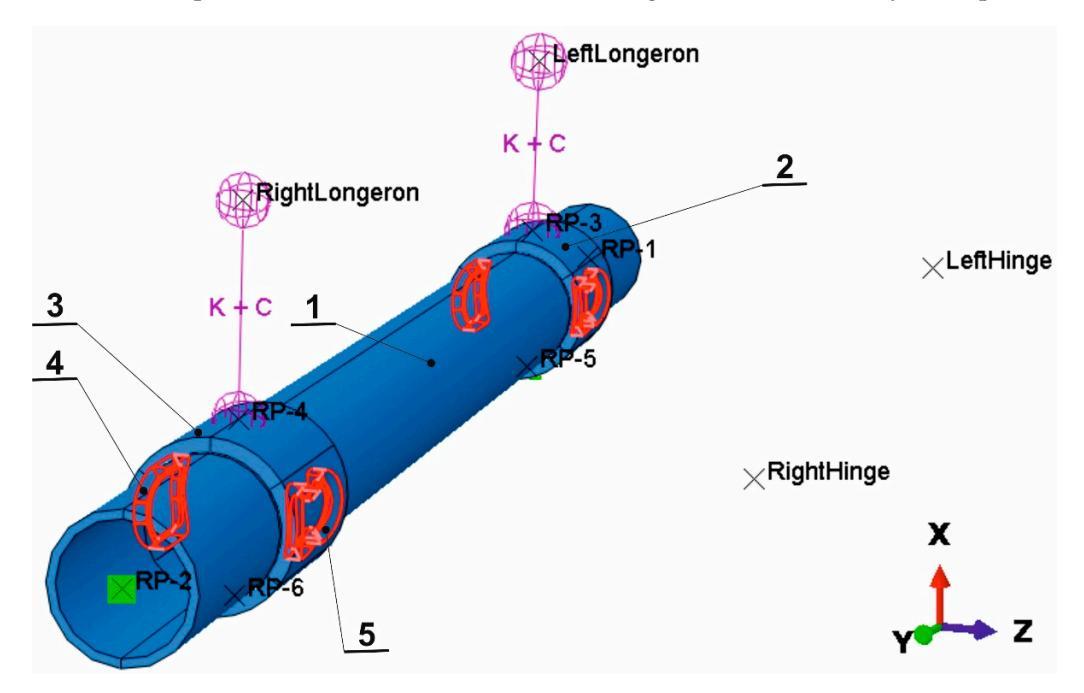
Figure 1. Assembly of the axle with constraint points on longerons and hinges: 1—axis; 2, 3—bushings; 4, 5—angle welds. RightLongeron, LeftLongeron, RightHinge and LeftHinge points have a rotational degree of freedom round the *Y* axis only. Between points RightHinge and RP-4, as well as RP-6, is rigid body type connection to the wishbone and a similar part is in model at the left side. Vehicle front at right.

Numerical simulations were carried out to check the location of potential stress concentration points. The model described in publication [29] was used for the simulation (Figure 1). The axis model (tube) contains 10,120 elements (20,424 nodes) type C3D4R with reduced integration. The mesh elements of the tube were intentionally denser in the area of their interaction with both bushing parts. A similar number of elements (9528) and nodes (15,052) consist of two bushings. For both parts, the mesh of C3D4R elements had been refined at the area of contact with the welds. Welds (for tying bushings and tube) were meshed with C3D4 elements (at least 10,785). The wishbones were modelled as a rigid body (not shown in Figure 1) between points (LeftHinge and RightHinge) and appropriate bushing.

The numerical model prepared in the described way was used to analyze the stress distribution in the axle material. The location of the zone of greatest stresses and their values were analyzed in terms of the possibility of damage observed on the real object. Additionally, the model was used to check the mode and frequency of the natural vibrations of the axis. This analysis was used to verify the values taken for the simulation and to

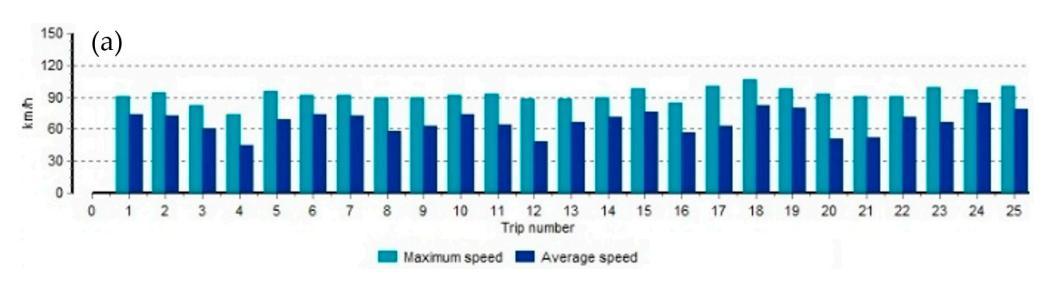
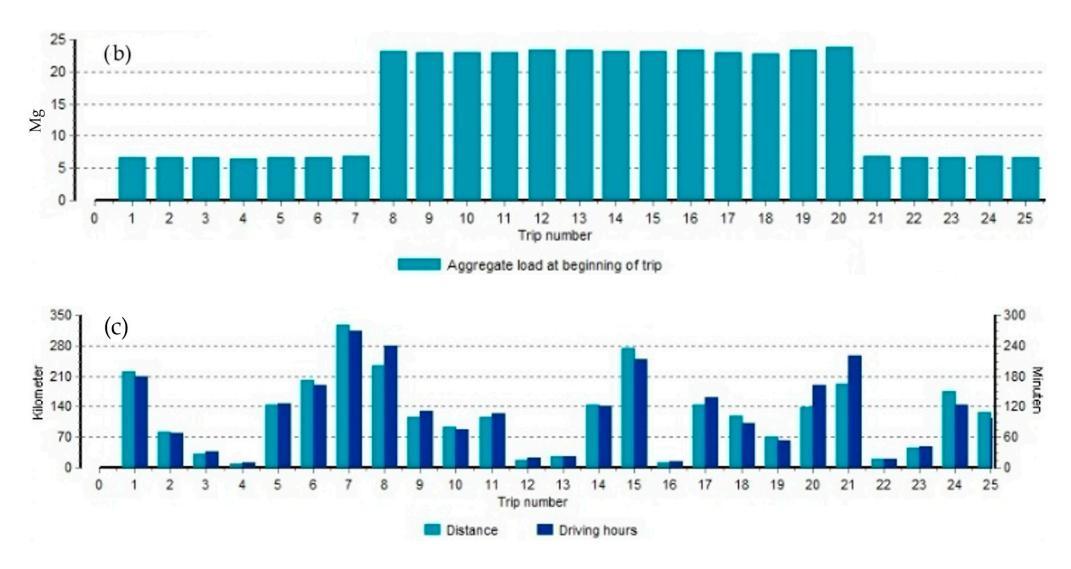
In Figure 2, we can see that the maximum speed was exceeded during almost every trip, with a speed of 90–110 km/h. In the load chart, we see journeys when the semi-trailer was running unloaded or with a small load and journeys when the semi-trailer was fully loaded. Comparing the speed and semi-trailer load diagrams, we see that the speeds were exceeded even when the semi-trailer was fully loaded.

Figure 2. Characteristics of transportation parameters: speed (a), load (b), distance and time (c).

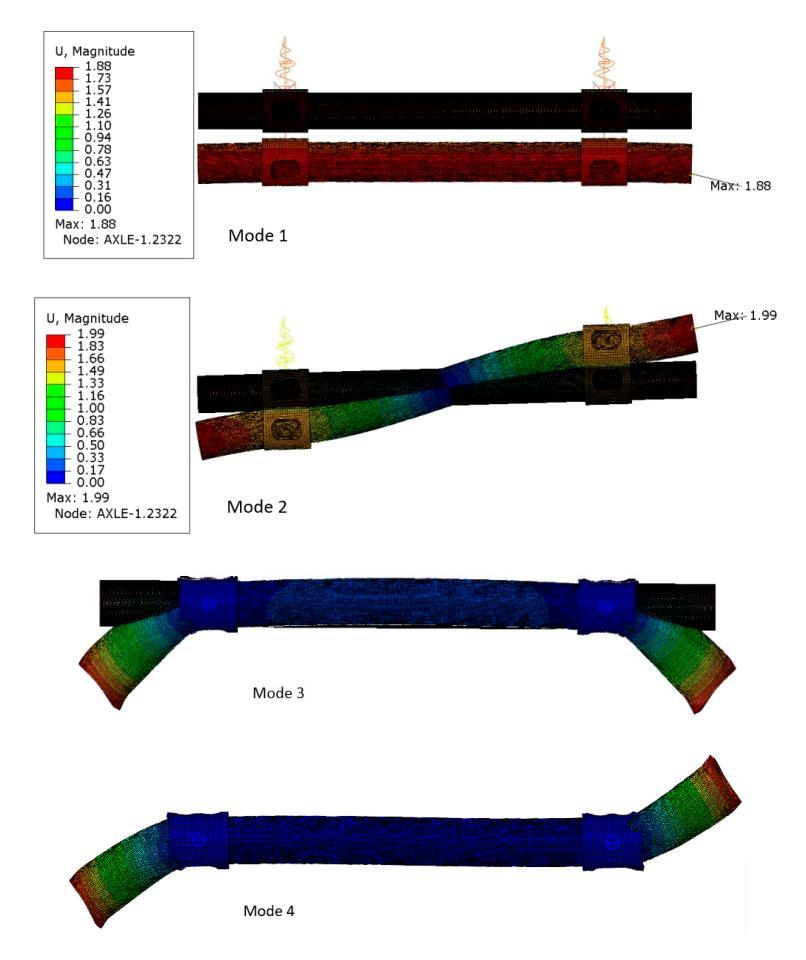
Mode 1 and 2 take place in a vertical plane (Figure 3). The first mode of vibration has the character of uniform deflection of the complete axis. In addition to the mass of the axle, the frequency of the vibrations is therefore affected by the stiffness of the suspension spring elements. At an excitation frequency of 24 Hz, with a deflection of less than 2 mm, the entire axis vibrates in the vertical direction. The figure shows the same deflection of the suspension springs for mode 1. For this reason, this mode of vibration cannot generate stresses in the material. The vibration period in this case is about 41 ms. Therefore, if the vehicle was moving at a speed of 90 km/h (a value close to the maximum speed in Figure 1), this mode of vibration would occur when the wheel passes over bumps on the road spaced approximately every 1 m.

Figure 3. Modes of natural vibrations of the axle. Modes 1 and 2—view from the back side, modes 3 and 4—top view. Deformation scale factor 130.

The second mode of vibration also depends on the stiffness of the elastic elements of the suspension. Unlike the first form, this one involves the generation of stresses in the material, because the right and left sides of the axis deform in opposite directions—up

Mode 3 and mode 4 (Figure 3) are only in a horizontal plane. In this case, the maximum axle deflection of 2.16 mm occurs only on the outside of the wishbones. The excitation frequency necessary to induce these vibration modes is about 149 Hz, which is almost 3 times higher than for mode 2. The occurrence of such an excitation frequency is unlikely under operating conditions. The difference in the natural frequency for modes 3 and 4 does not exceed 0.32 Hz, which is less than 3%.

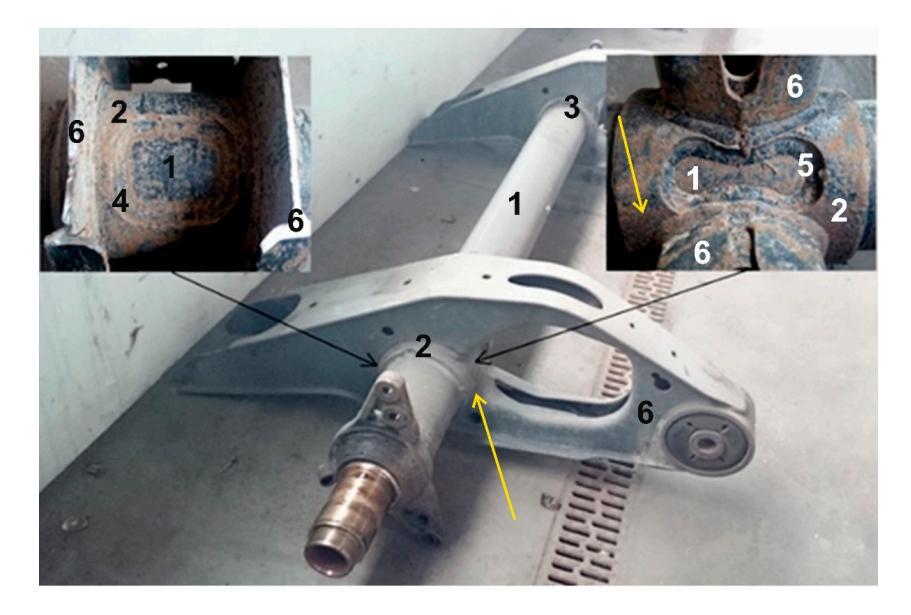
Figure 4. Mounting points for brackets and couplings: 1—axis; 2, 3—bushings; 4, 5—welds; 6—arm. The fracture origin area is pointed out by yellow arrows.

The test object consists of round profile axle, couplings with welded brackets, shock absorbers, airbags, rubber bushings, wheel hubs with disc brake system and other fasteners. Mounting points for brackets and axle couplings are shown in Figure 4.

Examining the fastening of the brackets and couplings (Figure 4) we see that the total area of contact of the coupling with the axis is 84,811 mm². The area of the welds on which the sleeve joint with the shaft is reinforced is 8628 mm². During the destructive studies and the examination of the fracture (Figure 5), we notice that the contact area has changed due to welding. The coupling is detached from the axis and we can say that the axis is "held" only by the welds, which make up only 10% of the total contact area in the project [31–33].

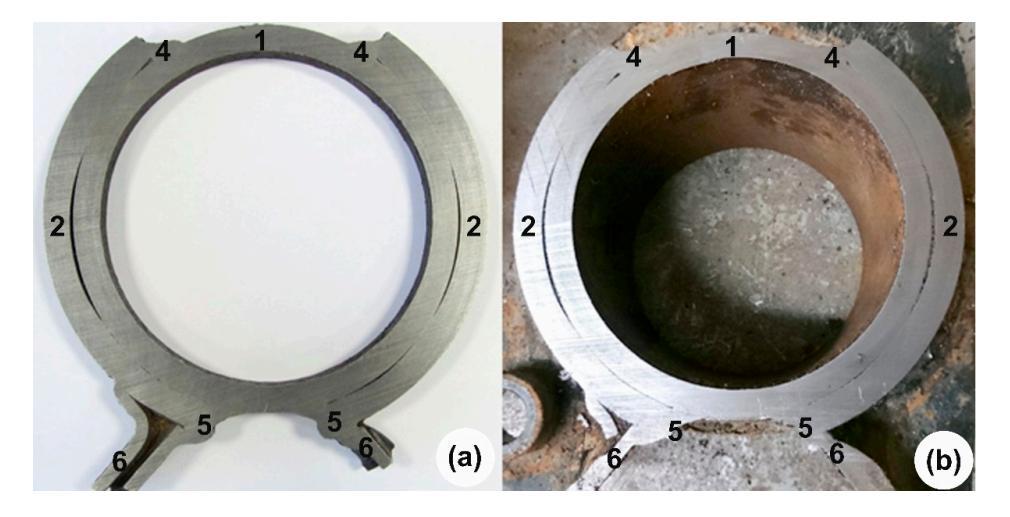
Figure 5. Two sides of the same cross-section at welds of the axis unit: (**a**)—broken side; (**b**)—unbroken side. The numerals mean: 1—axis; 2—bushing; 4, 5—angle welds; 6—arm.

We see that there is a gap between the shaft and the coupling connection, in places up to 1.5 mm (Figure 5a). To make sure that this is not the result of a fracture, but a construction, we also cut the part of the shaft without the fracture. In Figure 5b), we see that there is also a gap in the cross-section of the fractured side of the shaft between the shaft and the coupling joint. This confirms the assumption that the gap is not a consequence of a fracture [34]. The measurement of the welded joints shall assess the conformity of the joints, their arrangement and the amounts of defects observed during the visual inspection: inclusions, accumulations, cuts, indentations, convexities or depressions in the seam surface, fractures of the seam surface size and deviations in geometrical parameters.

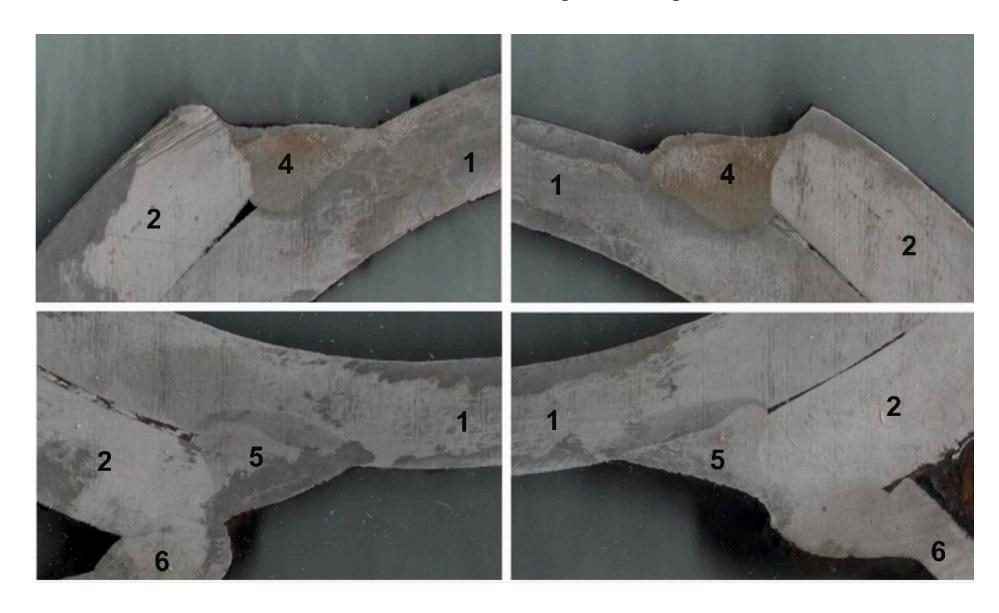
Figure 6. Cross-section of angle welds: 1-axis; 2-bushing; 4, 5-angle welds; 6-arm.

The integrity of the weld seam was inspected and no cracks were observed. After the section of the axle at the welded joints (Figure 6), the cross-sections of the welds were inspected. Defects observed: 402—Non-weld (insufficient weld), 500—Shape defects (irregular geometry of the weld, imperfect shape of the outer surface of the weld, different geometries of the cross-sectional area, cross-sectional areas of the weld vary from 6 to 20%), 505—Insufficient weld edges, 509—Depression (formed by gravity; the amount of the weld metal on the axle metal is higher than on the coupling metal; significantly greater thermal impact area), large angular seam asymmetry (excessive structural unevenness), 513—Uneven width (large seam width tolerances), 514—Uneven surface, 602—Splashes (added metal droplets spattered by welding and adhering to the base and hardened seam metal).

For welded joints, the area of thermal exposure close to the weld limit is of great importance. The range of thermal effects of the test seam is very different: from 1 mm to 3.5 mm. The metal heats the seam almost to the melting point. At that point, the metal is overheated, so this area usually determines the strength of the welded joint.

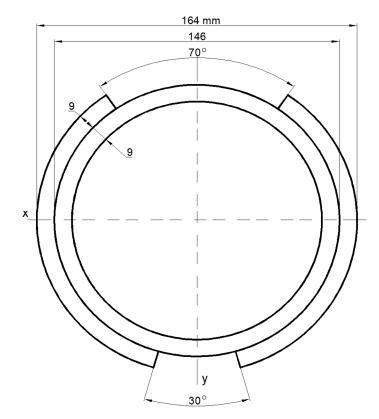
The geometry of the cross-section is calculated as a complex figure consisting of an annular tube with two external brackets (Figure 7). Additional areas in the cross-section of the welds and corbels (Figure 5) are unvalued. The moments of inertia of the cross-section of the axle are determined as a sum of the central annular tube and the two external brackets.

Figure 7. Axis cross-section geometry for solution of moments of inertia.

In cases when (according to Figure 7) values of particular angles and radiuses are equal:

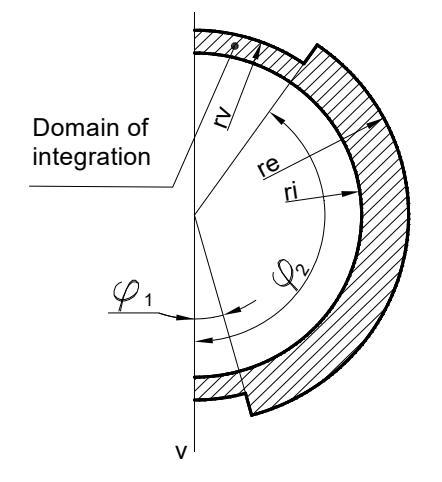
Due to symmetry, only half of the area is used as a domain of integration (Figure 8) for a solution of the polar moment of inertia.

Figure 8. Domain of integration.

Using integration Formula (1) for a defined domain (Figure 8) from vertical axis v:

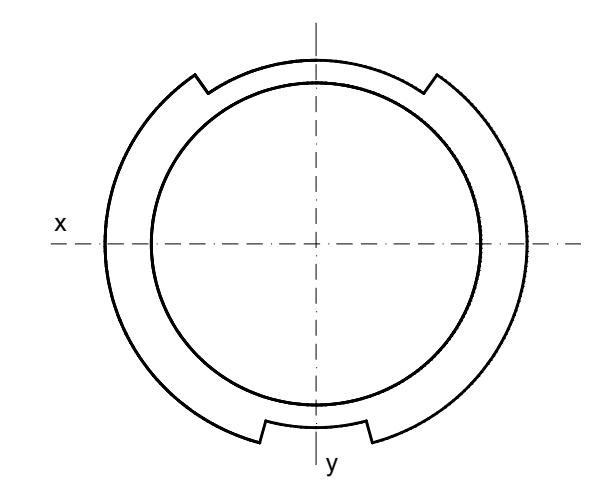
Figure 9. Area for determine moments of inertia.

The area of the cross-section and moments of inertia around the x and y axes (Figure 9) are solved and checked with CAD program.

The geometrical parameters of cross-section: area $A = 7030 \text{ mm}^4$; moments of inertia: $I_x = 15.6 \cdot 10^6 \text{ mm}^4$; $I_y = 21.7 \cdot 10^6 \text{ mm}^4$.

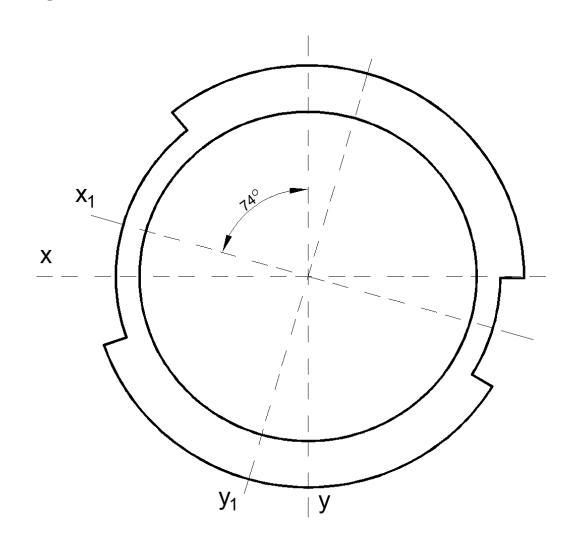
Figure 10. Area to determine moments of inertia with rotation.

The real orientation of the cross-section of the axle is rotated with an angle of 74 degrees (Figure 10).

The moments of inertia around the horizontal and vertical axis: $I_{x1} = 21.2 \cdot 10^6 \text{ mm}^4$; $I_{y1} = 16.2 \cdot 10^6 \text{ mm}^4$. The polar moment of inertia and section modules will be used to determine maximal stresses in the cross-section and the finding of critical points.

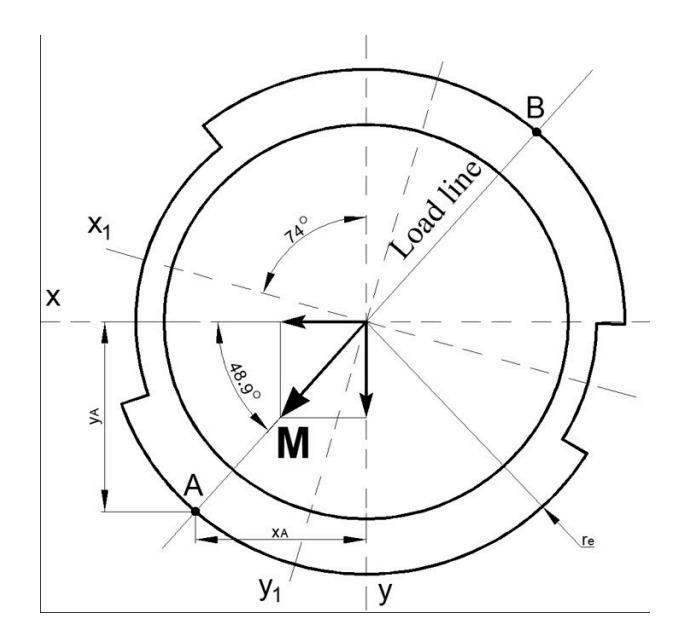
Figure 11. Sum moments and load line direction.

Both bending moments can be replaced with resultant vector sum \mathbf{M} (Figure 11). This sum moment is acting on a plane which is termed as a load plane. The intersection of the load plane with the cross-sectional plane is the load line.

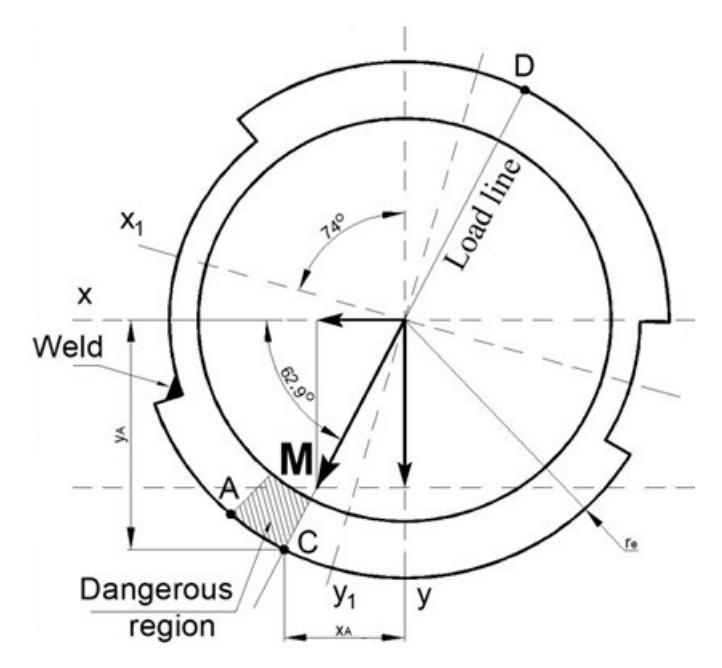
The load line changed direction due to increasing the bending moment about the x axis (Figure 12). The angle of the moment vector was calculated according to the equation:

Figure 12. Load line direction and rotation of coordination system.

It can be seen that the second term of the sum in Equation (12) has the greatest influence on the stress value. With unchanged values of other parameters, a 20-degree left rotation of the system shown in Figure 12 could cause such an increase in stresses that they would reach the fatigue stress limit. The same effect could be caused by changing the direction of action of the unchanged value of the total moment M by about 20 degrees to the right. In this case, the angle would not be 62.8 but 42.8 degrees.
