Article Damage Detection in FRP-Reinforced Concrete Elements

Pranit Malla ^{1,*}^(D), Seyed Saman Khedmatgozar Dolati ¹^(D), Jesus D. Ortiz ², Armin B. Mehrabi ^{1,*}^(D), Antonio Nanni ²^(D) and Jiayi Ding ³^(D)

Abstract: Fiber-Reinforced Polymer (FRP) composites have emerged as a promising alternative to conventional steel reinforcements in concrete structures owing to their benefits of corrosion resistance, higher strength-to-weight ratio, reduced maintenance cost, extended service life, and superior durability. However, there has been limited research on non-destructive testing (NDT) methods applicable for identifying damage in FRP-reinforced concrete (FRP-RC) elements. This knowledge gap has often limited its application in the construction industry. Engineers and owners often lack confidence in utilizing this relatively new construction material due to the challenge of assessing its condition. Thus, the main objective of this study is to determine the applicability of two of the most common NDT methods: the Ground-Penetrating Radar (GPR) and Phased Array Ultrasonic (PAU) methods for the detection of damage in FRP-RC elements. Three slab specimens with variations in FRP type

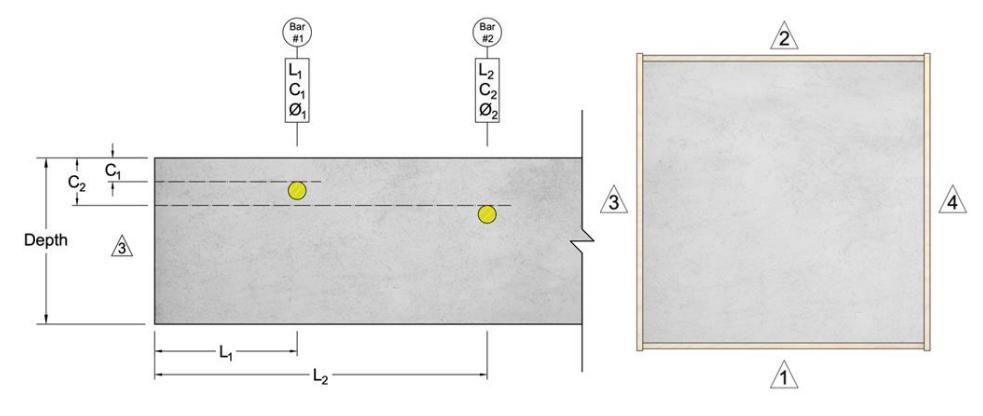
Figure 1. Labeling of slab specimens.

Each specimen was constructed and marked according to the layout depicted in Figure 1. Every slab is designated by an alphabet (O, P, and Q), and each side is assigned a number (ranging from 1 to 4). The direction of measurement is defined by the starting point and the endpoint numbers of the measurement.

Table 2 provides the geometrical details of the slab specimens, including the distance of the bars from the edge, cover depth, bar diameter, bar material, and slab thickness, following the conventions shown in Figure 1.

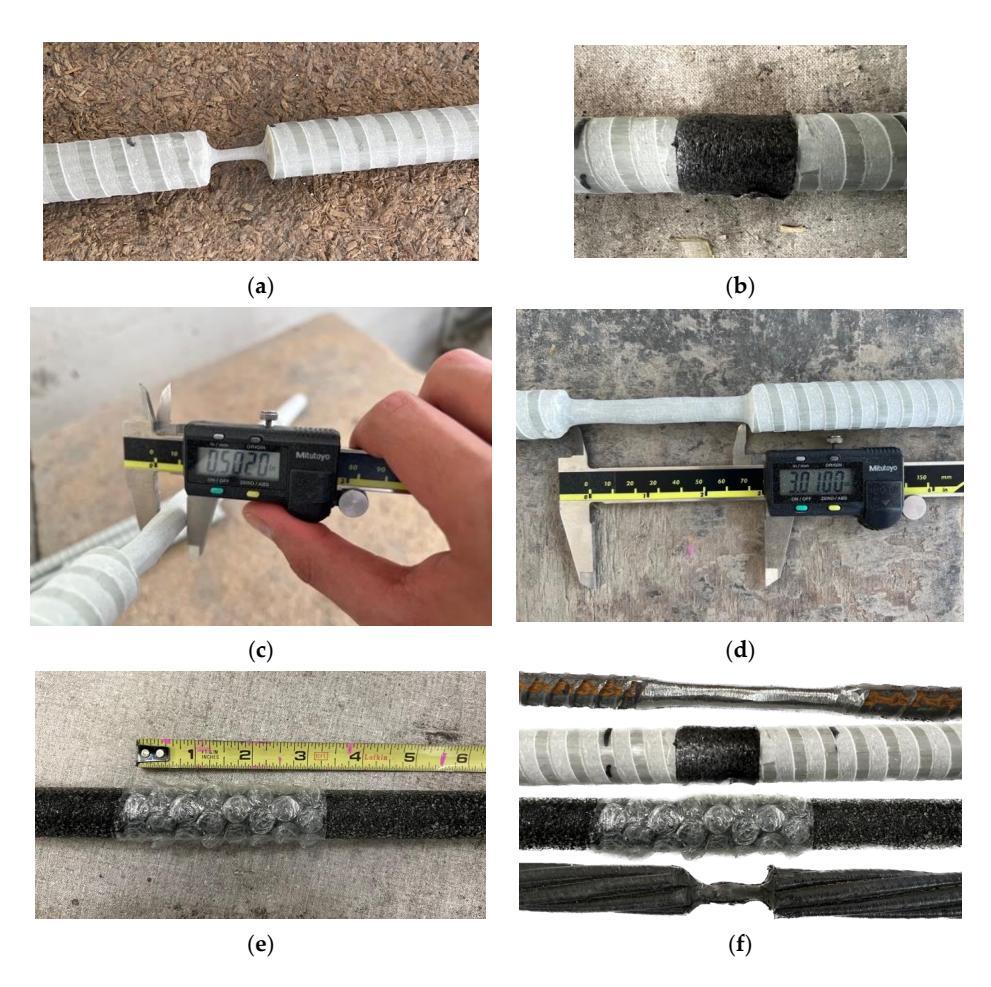
Slabs O and P contain defects in the bars. These defects correspond to bar rupture, a loss of cross-sectional properties, and debonding. To produce the bar rupture, the cross-section was reduced almost to breakage and then covered with a polyethylene tube to prevent the concrete from penetrating the defect and filling the void, as shown in Figure 2a,b. Cross-sectional property defects were produced by reducing the cross-section by 50% of its initial area and then covering it with polyethylene to prevent the concrete from filling the removed volume, as shown in Figure 2c,d. The loss of cross-sectional "properties" was simulated through the reduction in the cross-sectional "area" only for the experimental purpose of this paper. It should be noted that such an extreme reduction in the cross-sectional "properties" does occur under harsh environmental conditions. The aim is to explore the capability of NDT methods in detecting the variation in damage levels. Finally, the debonding defect was simulated by covering the bar with bubble wrap to generate a thin layer between the bar and the concrete (see Figure 2e,f). Figure 3 shows the location of the different defects and their dimension details.

Figure 2. Damage introduced in bars. (a) Cross-section rupture, (b) covered rupture defect, (c) reduction in cross-section, (d) 3 inches of cross-section defect, (e) 3 inches of debonding defect, (f) different defects in bars.

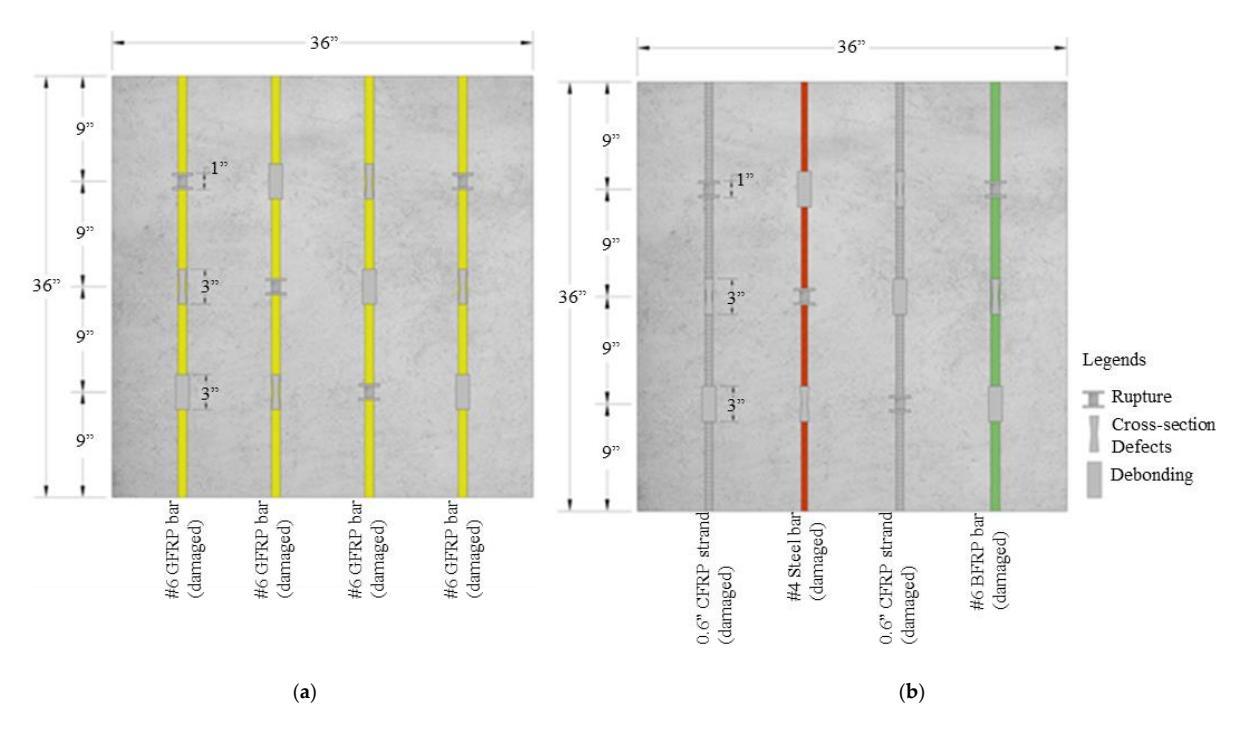
Figure 3. Slab specimen with simulated damage in bars, Slab O (a) and Slab P (b).

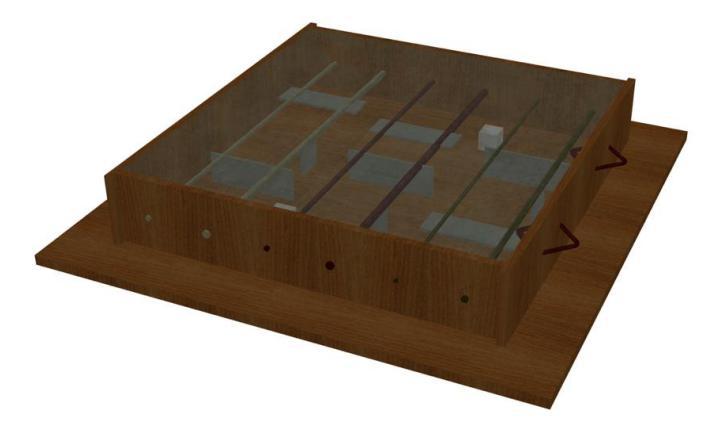
In Slab Q, four types of defects in the concrete were simulated to evaluate the feasibility of different NDT methods. Delamination, flexural and split cracks, as well as voids in the concrete were simulated in Slab Q using thin architectural polystyrene foam held in place with the use of epoxy, as shown in Figures 4 and 5. This specimen includes steel, glass, and carbon FRP #4 and #6 bars.

Figure 4. Three-dimensional scheme of Slab Q with simulated damage in the concrete.

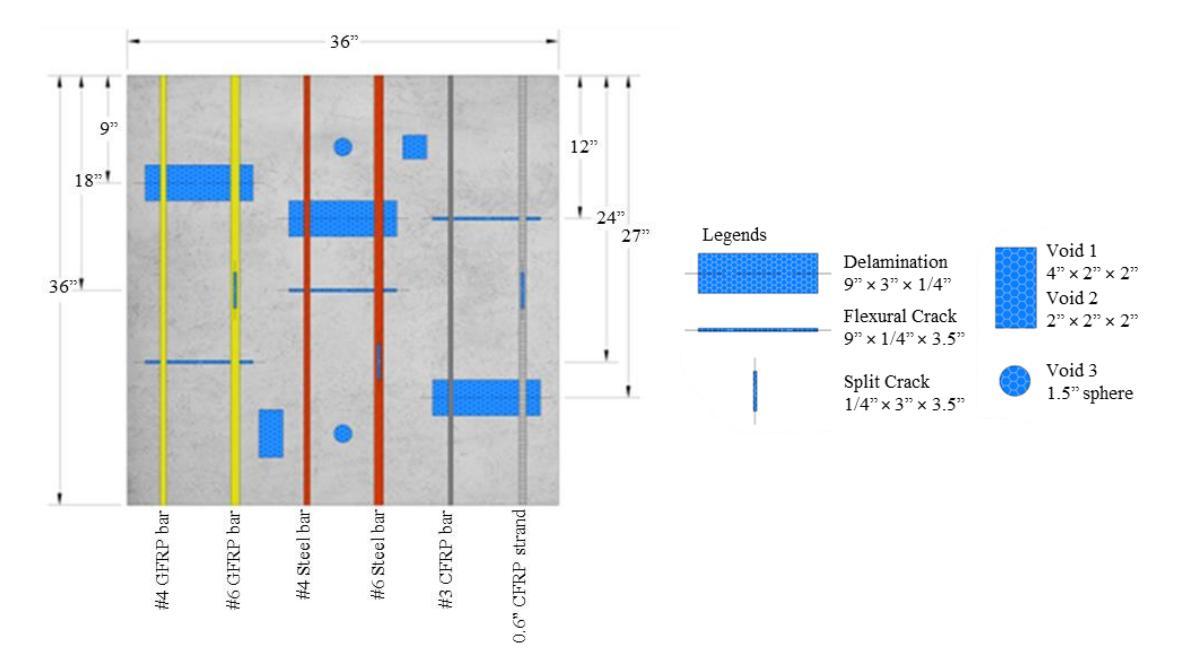
Figure 5. Dimension details of Slab Q with simulated damage in the concrete.

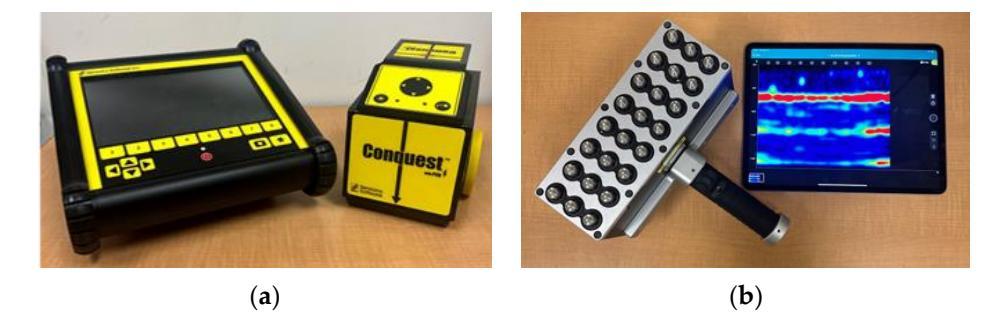
Figure 6. NDT devices used: (a) GPR device, (b) PAU device.

The GPR system used in this experiment was a Conquest 100 Enhanced GPR (Sensors and Software Inc., Mississauga, ON, Canada) with a monostatic GPR antenna with a center frequency of 1000 MHz. GPR tests were carried out using both individual line scans and comprehensive grid scans. The line scans served as an initial survey to provide a preliminary understanding of the internal structure, including the orientation of reinforcements and the depth of exploration, by producing a cross-sectional image along the scan direction. However, this method proved to be time-consuming and labor-intensive due to the need to interpret multiple line scans. To streamline the process, grid scans were introduced, involving systematic GPR data collection along a predefined grid covering the test area. The grid's line spacing, set at 2 inches for this study, directly influenced the resolution of the collected data, with closer spacing yielding higher-resolution images and easier data interpretation. The data from grid scans produced depth slice images, offering a cross-sectional view parallel to the specimen's surface, facilitating a detailed analysis of the internal features.

The PAU device used for this experiment was a Pundit Live Array Pro device (Screening Eagle Technologies, Zurich, Switzerland) with 8×3 dry-contact Pundit array transducers. The PAU line scan was performed by moving the array of ultrasonic transducers along a specified line of inspection. Each scan at distinct positions was combined to form a continuous cross-sectional image perpendicular to the surface. For area scans, a stripe scan technique was employed, moving the transducers perpendicular to the line of inspection. Each stripe scan produced a line scan with a width equal to that of the PAU device, and these scans were stitched together to create a depth slice view. This view represents a cross-section parallel to the scanned surface, which can be further developed into a comprehensive 3D iso-surface model. A previous study by the authors [36] can be further explored for in-depth information on the applicability of GPR and PAU techniques for the inspection of structural elements reinforced with FRP.

As mentioned in the introduction section, this paper aims to determine the detectability of damage in FRP reinforcements and FRP-RC elements using GPR and PAU devices (Figure 6). GPR is a real-time NDT method used to analyze the internal characteristics of civil structures. It operates on the principle that electromagnetic waves are reflected back when they hit a boundary between two materials with different dielectric constants [40,41]. The technique involves transmitting electromagnetic waves into the material under investigation and capturing the waves that are reflected from any irregularities within it. These irregularities could include boundaries between different materials, such as those between concrete and bars, or interfaces created by subsurface anomalies like voids, cracks, and instances of debonding or delamination in concrete [42]. Despite its potential, research on the application of GPR for inspecting FRP-RC elements is limited and its efficacy as a reliable NDT technique for this application remains unexplored. This study aims to investigate the feasibility of using GPR to detect damage in FRP bars.

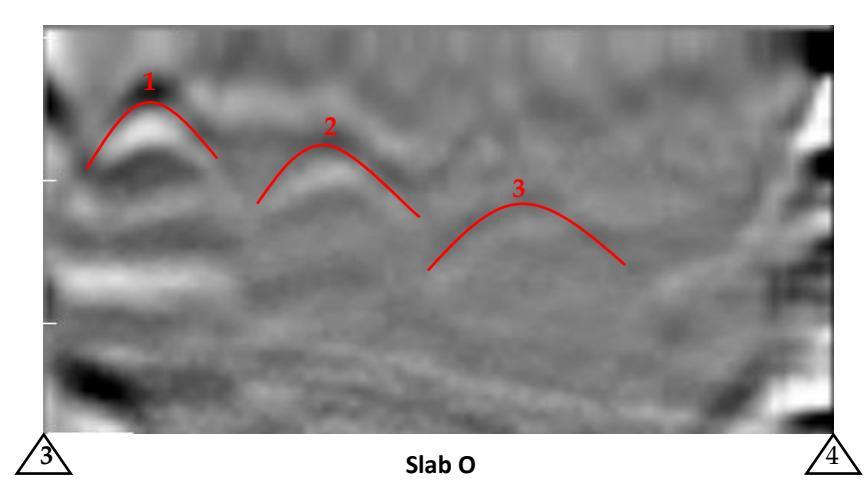
In order to detect damage in FRP bars, it is first important to determine whether the GPR device is able to detect the bars itself. The line scans (B-scans) of the slabs O, P, and Q were obtained for the sole purpose of checking bar detectability before taking the detailed area scan which can be used in the field inspection for the real-time detection of damage. Figure 7 shows the GPR response of a line scan collected perpendicular to the embedded bars in the longitudinal direction (from the reference edge 3 to 4) over Slab O. The top of the hyperbolic shape (i.e., inverted U shape) in the figure indicates the location of the bars.

Legends: 1 = GFRP bar 1, 2 = GFRP bar 2, 3 = GFRP bar 3

Figure 7. Line view for bar detection carried out before defect/damage detection (Red markings are superimposed/added on test results to indicate distinctive features).

The GPR line scan of only one of the slabs (Slab O) is presented in this paper for the sake of brevity and Table 3 summarizes the results of the line scan test of all the other slabs. The line scans of Slab P and Q are presented in Appendix A, Figure A1.

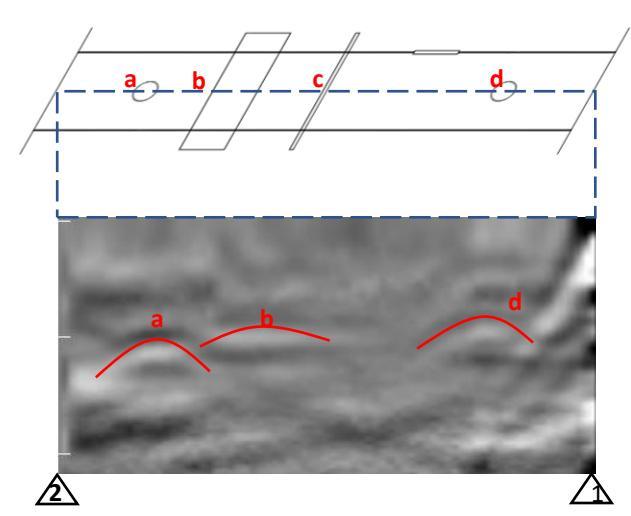
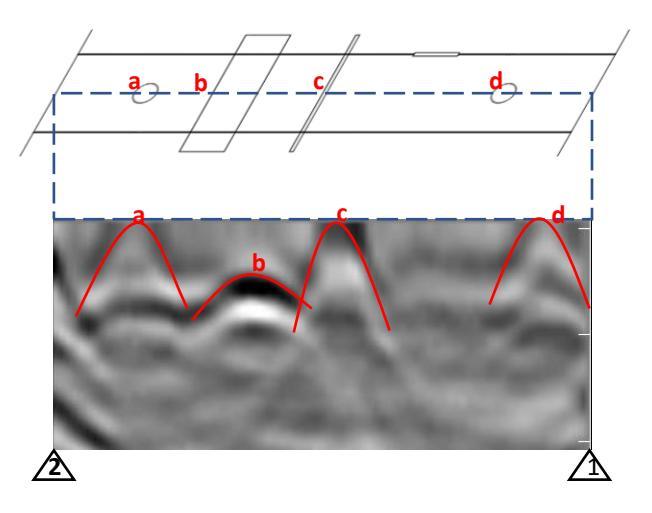
it is clear that GPR would not be able to detect bar damage with a larger concrete cover. Slab Q, on the other hand, did not have any damage in the embedded bars but the damage was introduced to the concrete in the vicinity of the bars (in some cases below those bars). In addition to taking line scans perpendicular to the embedded bars in Slab Q, line scans were also taken at the center of the slab parallel to the bars to detect the damage introduced to the concrete. Two such line scans were taken, one from the top surface and the other from the bottom surface (after flipping the slab upside down), which are shown in Figure 8. It can be seen that more damage was visible from the bottom surface than from the top surface because the damage was closer to the bottom. The line scans conducted from the top surface could not detect vertical damage (flexural and split cracks) at all. Moreover, it can be seen that the hyperbolas for vertical damage (damage "c" in Figure 8) are narrower and taller than those for horizontal damage (damage "b" in Figure 8), which are wider and shorter. The damage "a" and "d" in the line scan carried out from the bottom surface (flipped Slab Q) appears to have been located at the surface, which is erroneous. This could be attributed to the use of small polystyrene foam cubes as a base for securing this damage (ping pong balls representing voids) at the bottom of the formwork.

Legends: a/d = Spherical void, b = Concrete delamination, c = Flexural crack

Figure 8. Line views for concrete defects/damage at c/c of Slab Q (red markings are superimposed/added to test results to indicate distinctive features).

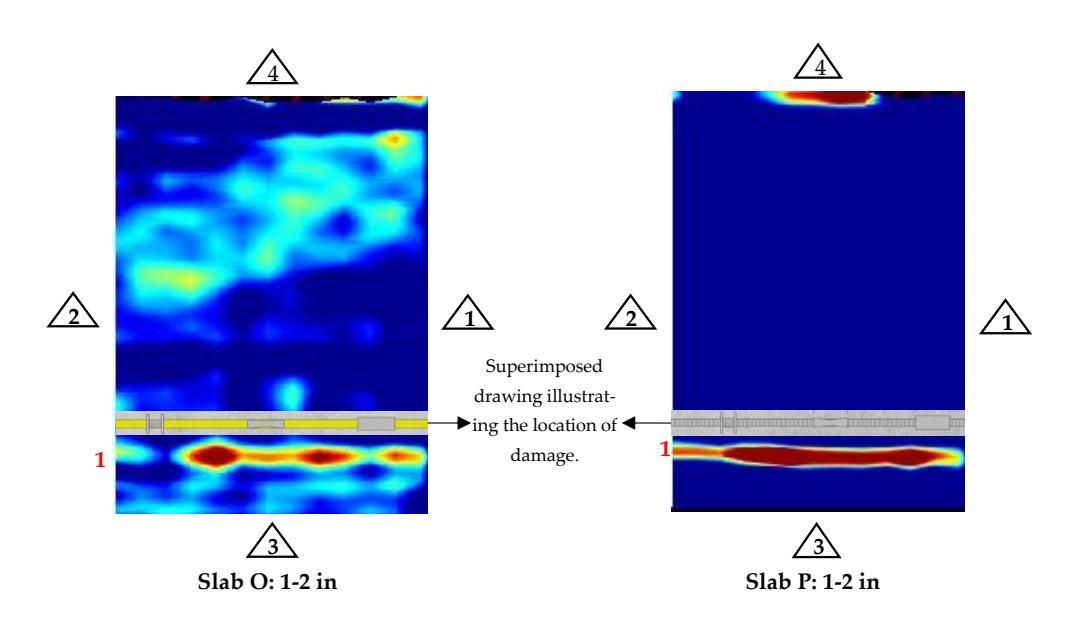
In Slab O with damaged GFRP bars, GPR successfully identified various forms of damage, including rupture, cross-sectional properties reduction, and debonding in Bar 1, as shown in Figure 9. However, the damage in Bar 2 is not quite distinguishable (see Appendix A, Figure A2). The bar itself is not as clearly visible as Bar 1, which is also because the already weak signal from GFRP bars (compared to steel bars) becomes even weaker with increasing depth. Further, while Bar 3 was detectable during the line scan, it was not visible in the depth slice due to its comparatively weaker signals relative to those from Bars 1 and 2. Thus, it was observed that the GPR exhibited limitations in detecting GFRP bars situated at greater depths, rendering it ineffective in identifying damage in these deeper-embedded GFRP bars. Consequently, it can be concluded that GPR's damage detection capability is primarily confined to GFRP bars located at shallower depths.

Legends: 📕 = Rupture, 📖 = Cross section defects, 📖 = Debonding, 1 = GFRP bar 1 for slab O and CFRP strand 1 for slab P

Next, depth slices (C-scans) taken with GPR to determine the damage detectability for each of the constructed slabs (Slab O, P, Q) are shown in Figures 9 and 10. To generate the depth slices, data collection was conducted longitudinally from reference edges 3 to 4, with a consistent spacing of 2 inches.

The GPR depth slice results for Slab P varied in efficacy for detecting damage across different reinforcement materials. Specifically, for the CFRP strand located near the surface, GPR failed to identify any damage (see Figure 9). However, for the CFRP strand positioned at a depth of 3.5 inches, there were faded indications of damage (see Appendix A, Figure A2). In contrast, GPR exhibited comprehensive damage detection capabilities for the steel bar, identifying all present damage (see Appendix A, Figure A2). The BFRP bar presented a unique challenge; GPR was unable to detect it, particularly in the presence of dominant signals from the steel bar and CFRP strands. Consequently, damage in the BFRP bar remained undetected. However, it is worth noting that if the slab was only reinforced with

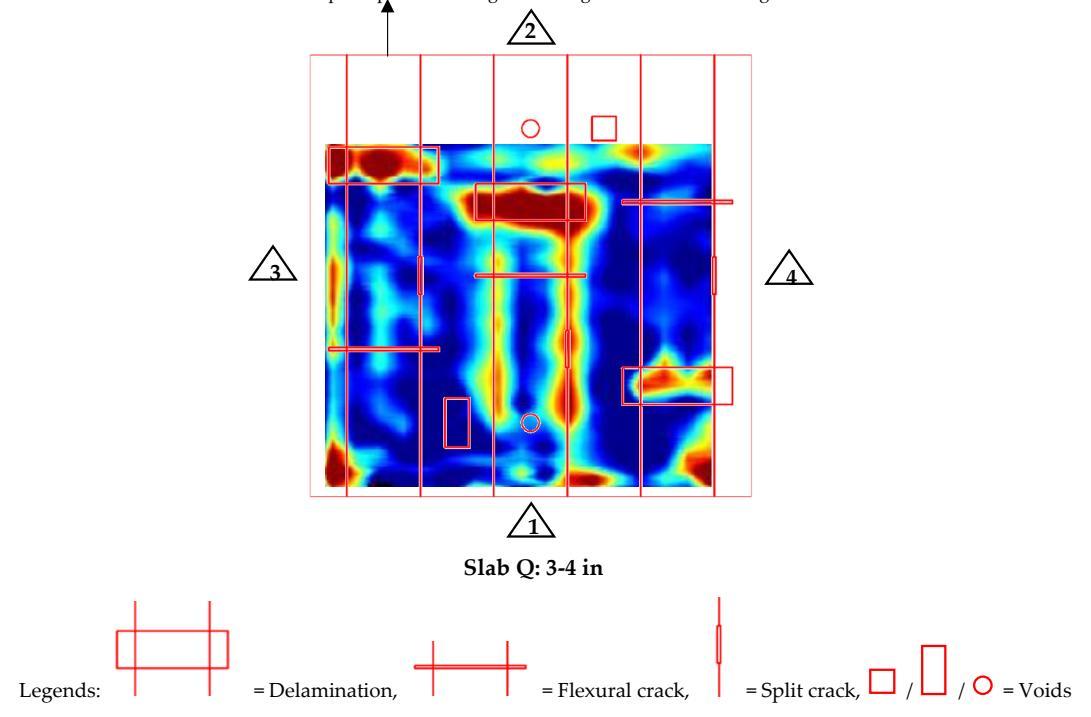
Superimposed drawing illustrating the location of damage.

Figure 10. Depth slices of slabs for defect/damage detection in concrete.

The depth slice of slab Q shown in Figure 10 illustrates GPR's capability to clearly identify delamination within the concrete slab. However, its performance was limited when it came to the detection of deeper vertical cracks. In contrast, when the GPR test was conducted over the bottom surface of the slab, it proved adept at identifying shallower vertical cracks and voids (see Appendix A, Figure A3). These findings underscore the nuanced performance of GPR in detecting different types of defects in concrete, highlighting its selective sensitivity to various forms of damage depending on their nature and depth within the elements.

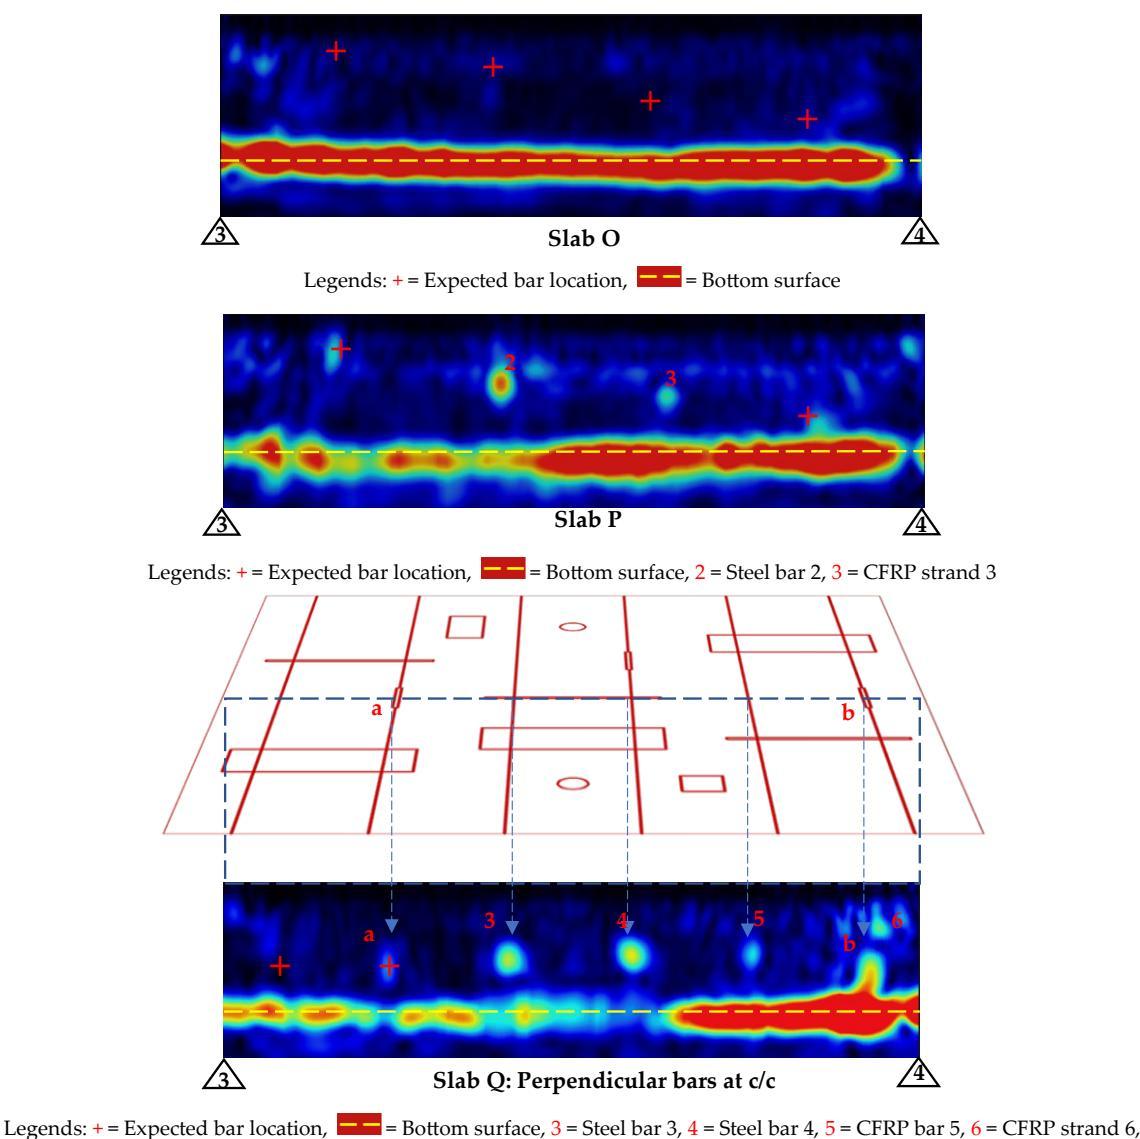
The PAU line scans were taken with a similar approach used for GPR line scans for first detecting the bars as shown in Figure 11. For Slab O, no GFRP bars were detectable, and for Slab P, the steel bar (Bar 2) and the CFRP strand (Bar 3) were clearly detectable. Similarly, for Slab Q, the steel bars (Bars 3 and 4) were clearly detectable. Further, there were also some indications of vertical cracks (labeled a and b in Figure 11).

a/b = Split cracks

Figure 11. PAU line views for bar detection before damage detection.

Similarly for Slab Q, while the CFRP bar (Bar 5) and CFRP strand (Bar 6) seem to be visible in the line scan (Figure 11), they were not visible on the depth slices (Figure 14), which could be because the signals from the damage in concrete (delamination) dominated over the weaker signal from the CFRP bar/strand.

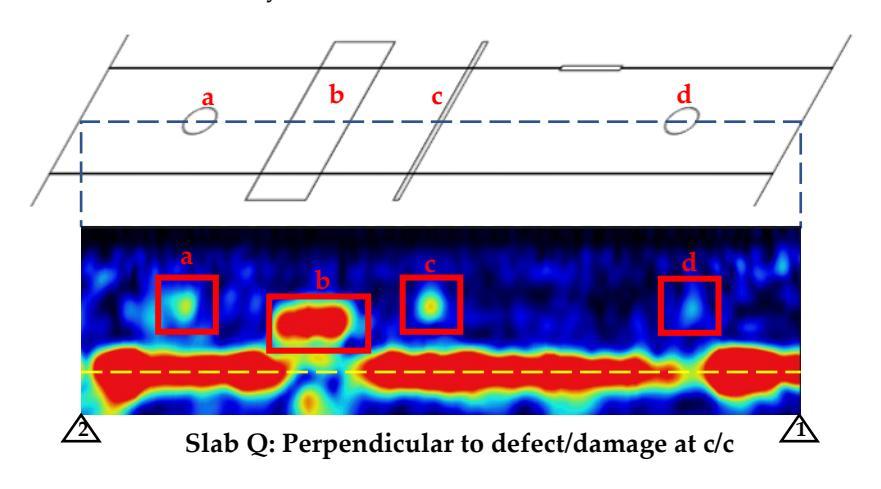
In addition to performing line scans perpendicular to the embedded bars in Slab Q, line scans were also conducted at the center of the slab parallel to the bars to detect the damage introduced in the concrete, as shown in Figure 12. It can be seen that the horizontal delamination (labeled as b in the figure) was distinctly visible but the vertical cracks (labeled as c in the figure) were only visible as a dot at the top point of the crack where it initiates (instead of being visible as a vertical line). Similarly, the voids (labeled as a and d in the figure) were also visible but not as distinct as the delamination, which could be because they were smaller in size.

Legends: + = Expected bar location, = Bottom surface, a/d = Spherical void, b = Delamination, c = Flexural crack

Figure 12. Line view for concrete defects/damage at c/c of Slab Q using PAU.

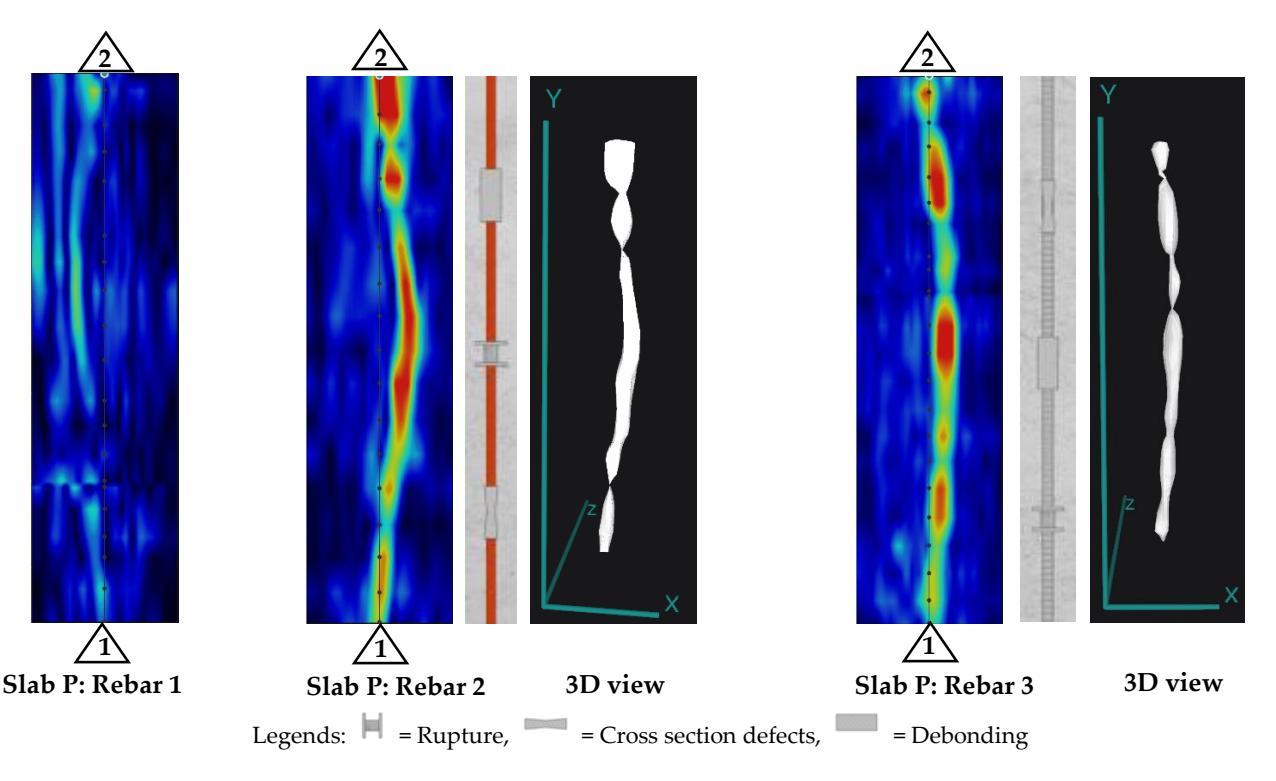
As expected, since GFRP bars could not be detected using PAU (as mentioned earlier in the PAU line scan results), the area scans over Slab O did not yield any damage detection. However, the depth slices and 3D view of PAU tests for Slabs P and Q (shown in Figures 13 and 14) produced some promising results.

Figure 13. Depth slices of slabs for damage detection in bars using PAU.

It can be observed that Bar 2 and Bar 3 in Slab P do not appear to be straight. This is because Bar 2 (steel bar) had a kink because of a rupture at its mid-length resulting in a shift during casting, making it look like a bent bar. Similarly, in the case of Bar 3 (CFRP strand), the detected shape appears to be curved since these strands were flexible and

curved outwards and downwards (sag) during the concrete pouring process. The CFRP strand had the tendency to bend to its transported coiled shape. It should also be noted that although it seemed the CFRP strand closer to the top surface (Bar 1) was visible in the line view (Figure 11), upon conducting the area scan over the strand, the detection proved not distinct enough for the entire strand (Figure 13). Only a portion of the strand at the mid-span was visible, which could be due to the fact that it sagged at the center with the weight of the concrete during casting, therefore increasing its depth from the top surface and making it free of surface reflections. These nuances of the PAU test results obtained from Slab P further illustrate the precision of PAU devices in detecting the geometrical orientation of the steel bar and CFRP strands embedded in concrete.

In the context of damage detection in FRP bars, from the results of Slab O, it is evident that the PAU test cannot detect embedded GFRP bars at any depth and hence it also cannot detect any damage in GFRP bars. In slab P, the PAU was unable to detect the CFRP strand situated closer to the top surface. Additionally, its capability was limited when it came to the BFRP bar, rendering it ineffective in identifying damage within these BFRP bars. In contrast, PAU displayed comprehensive detection capabilities for the steel bar, with all damage, including the rupture at the bent position, being clearly identifiable. This clarity in damage detection was further enhanced when viewed in a 3D perspective. However, the damage in the CFRP strand at an intermediate depth, specifically Bar 3, was not as readily discernible as those in the steel bar. The presence of damage in this strand could be interpreted from the non-uniform color scale along the detection path, with red being the stronger signal and green to yellow being the weaker signal associated with defective/damaged areas.

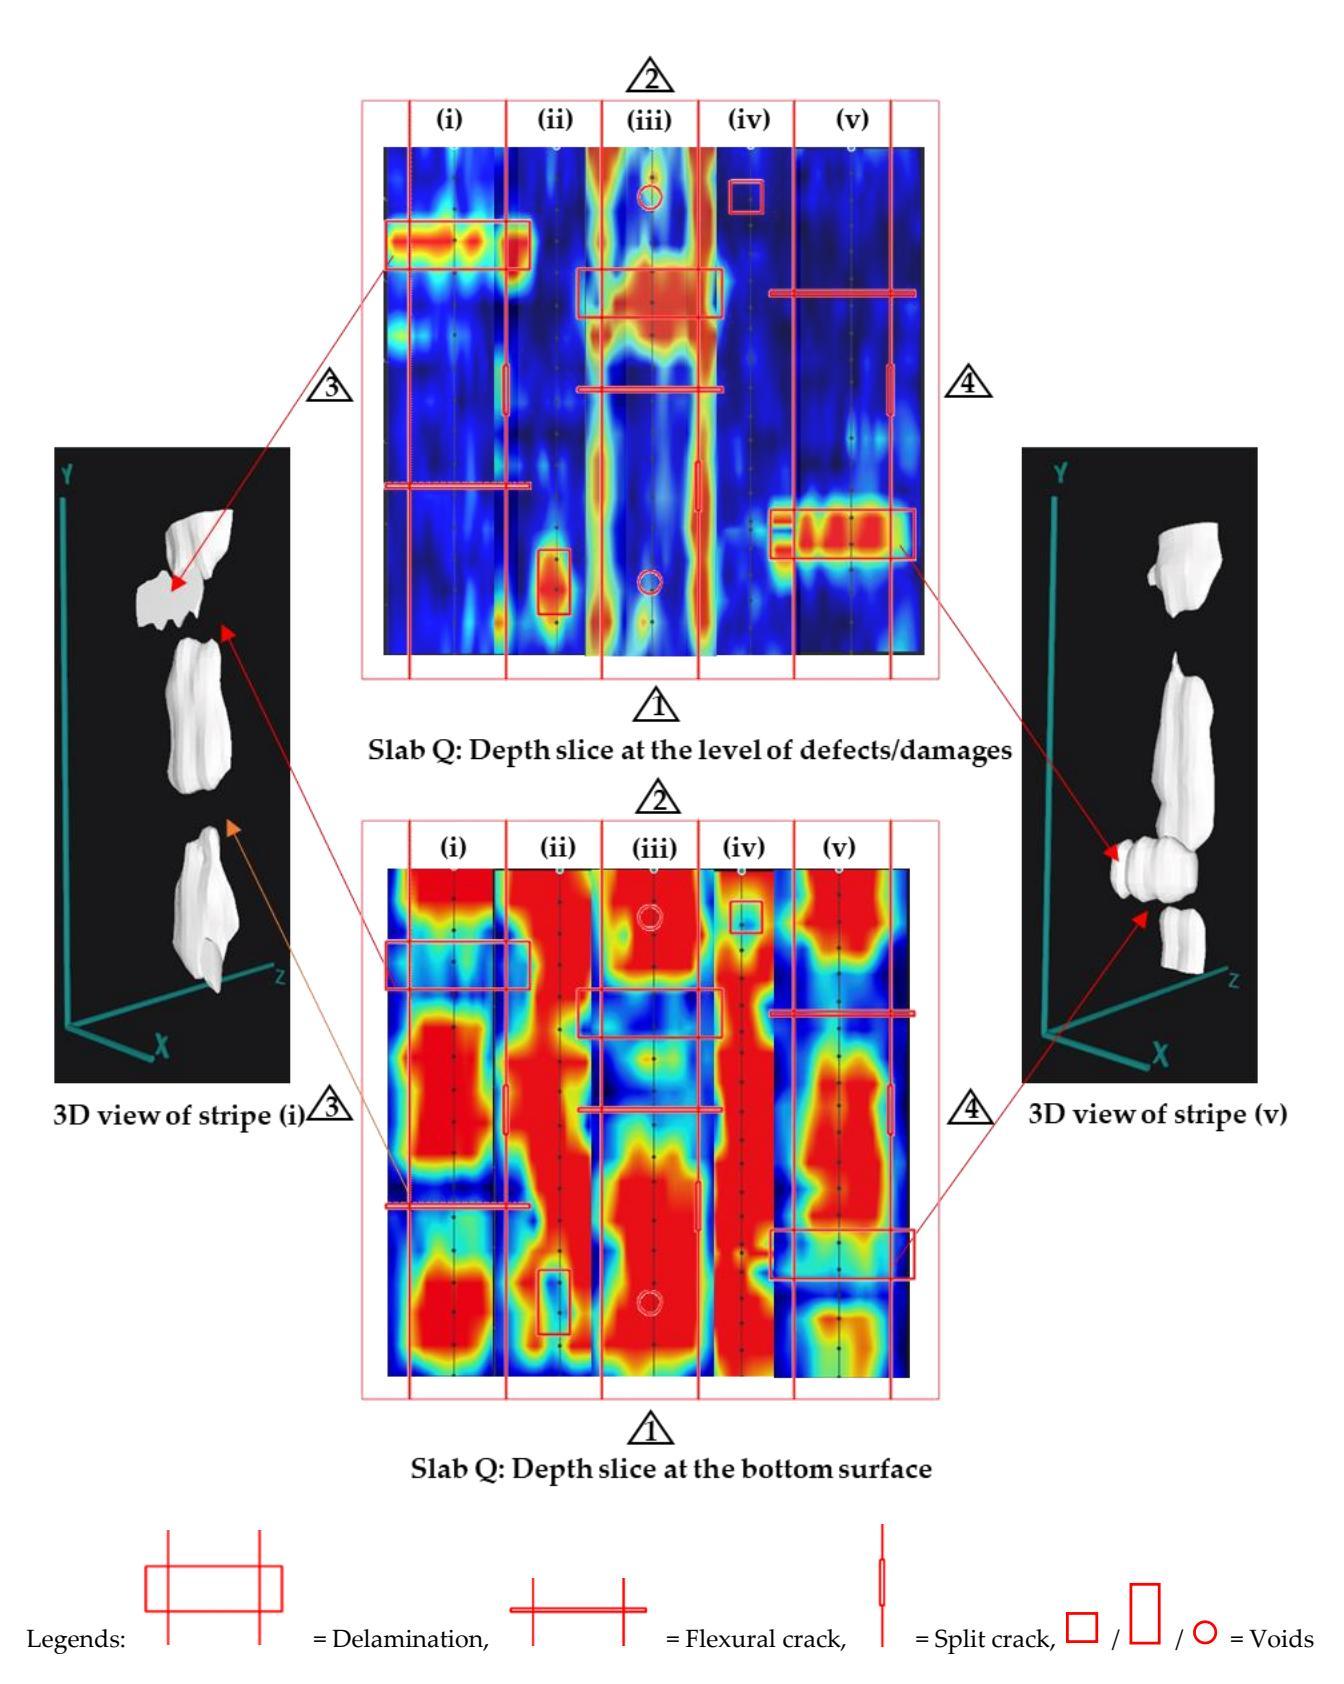
Figure 14. Depth slices of slabs for damage in concrete detectability tests using PAU.

Finally, for Slab Q, the PAU was adept at clearly identifying horizontal delamination and voids within the slab. Regarding the detection of vertical cracks in concrete (flexural and split cracks), although the direct detection proved challenging, these cracks could be inferred from the observed discontinuities or gaps present at the slab's bottom reflection [46], shown at the bottom center image and the 3D views shown in Figure 14. The bottom surface of the slab specimen is not visible below delamination and cracks because these discontinuities prevent the propagation of ultrasonic waves below them and may even trap the waves to bounce back and forth between them and the top surface, resulting in multiple equally spaced reflections [47].

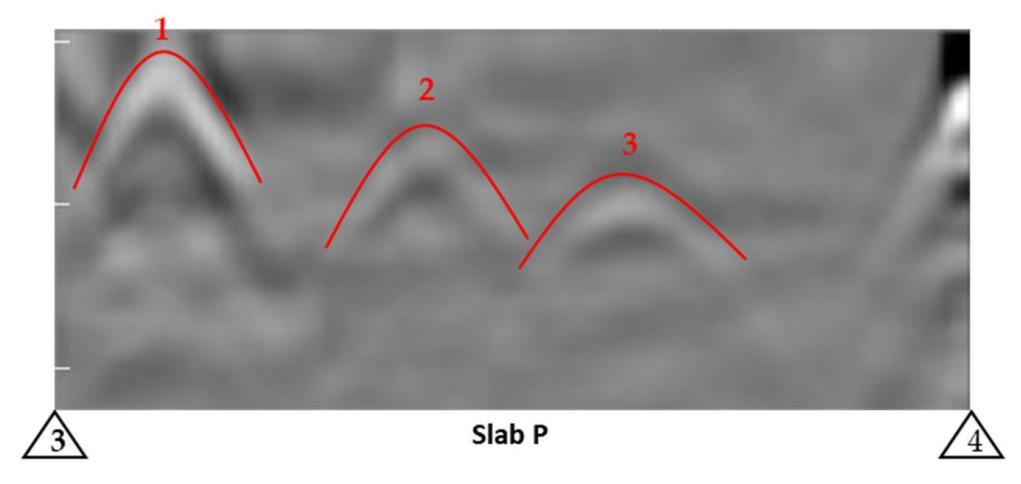
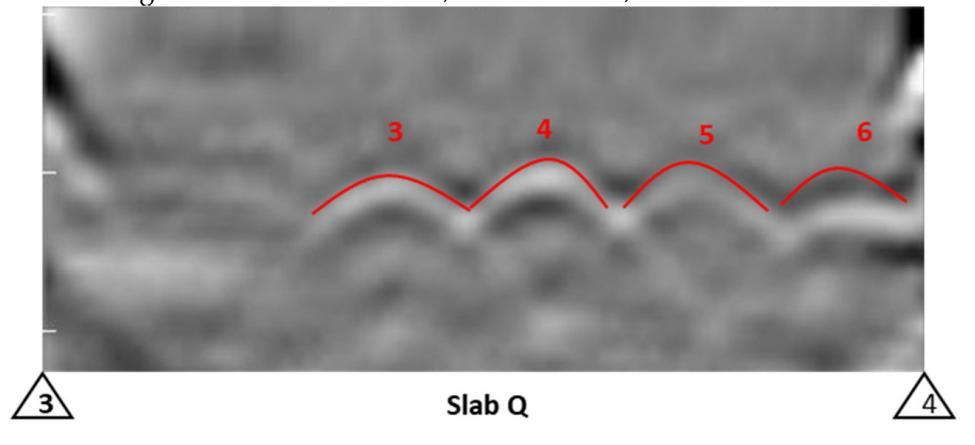
Legends: 1 = CFRP strand 1, 2 = Steel bar 2, 3 = CFRP strand 3

Legends: 3 = Steel bar 3, 4 = Steel bar 4, 5 = CFRP bar 5, 6 = CFRP strand 6

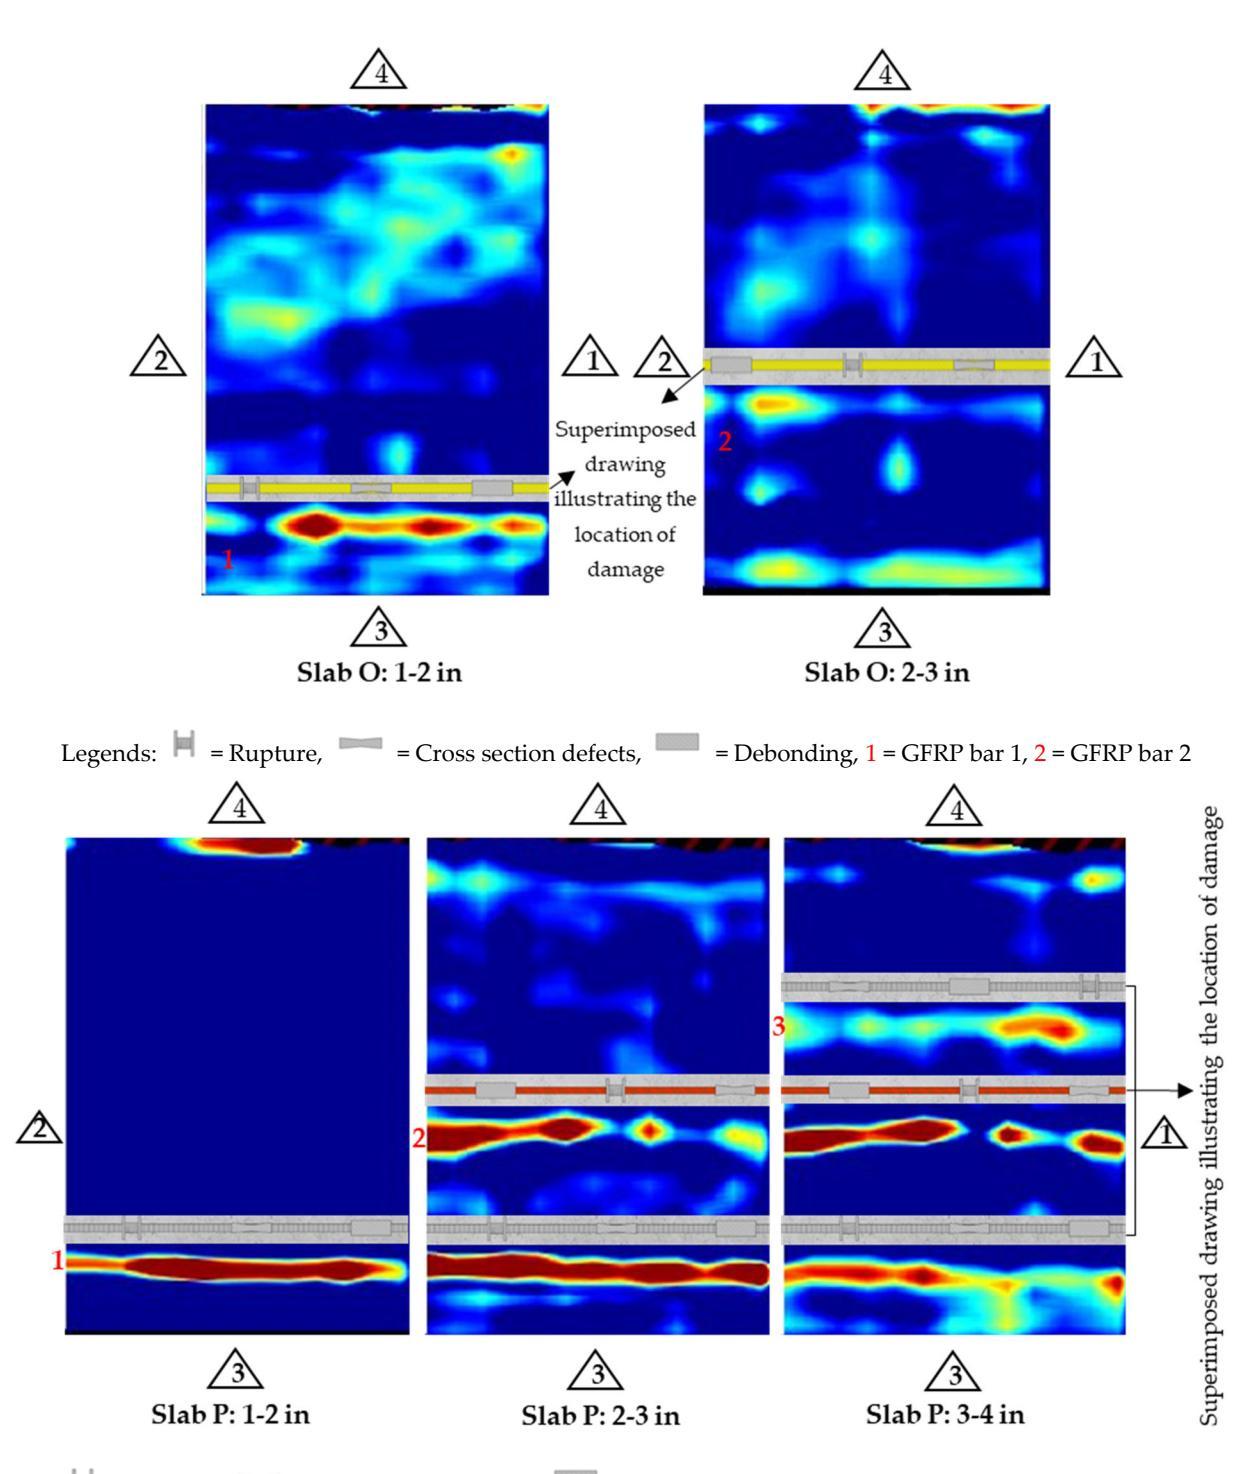
Legends: = Rupture, = Cross section defects, = Debonding, 1 = CFRP strand 1, 2 = Steel bar 2, 3 = CFRP strand

Figure A2. Depth slices of slabs O and P for damage detection in all the bars.

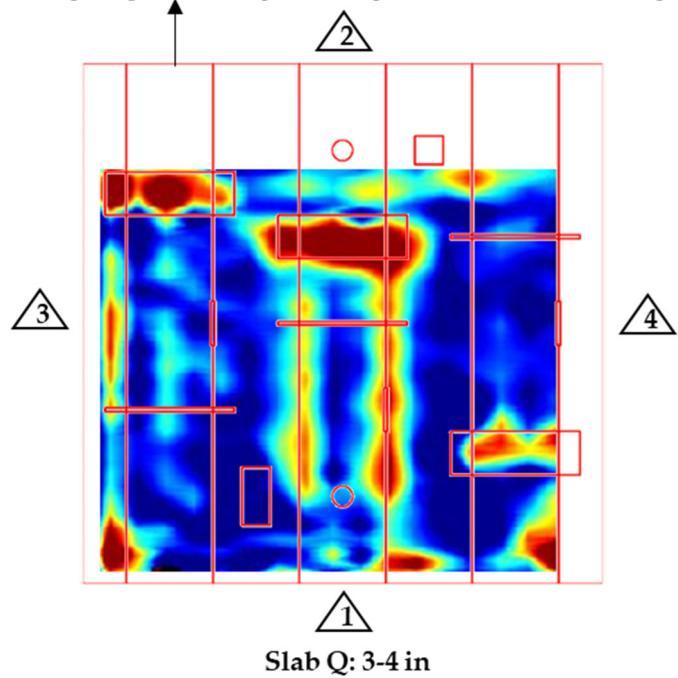
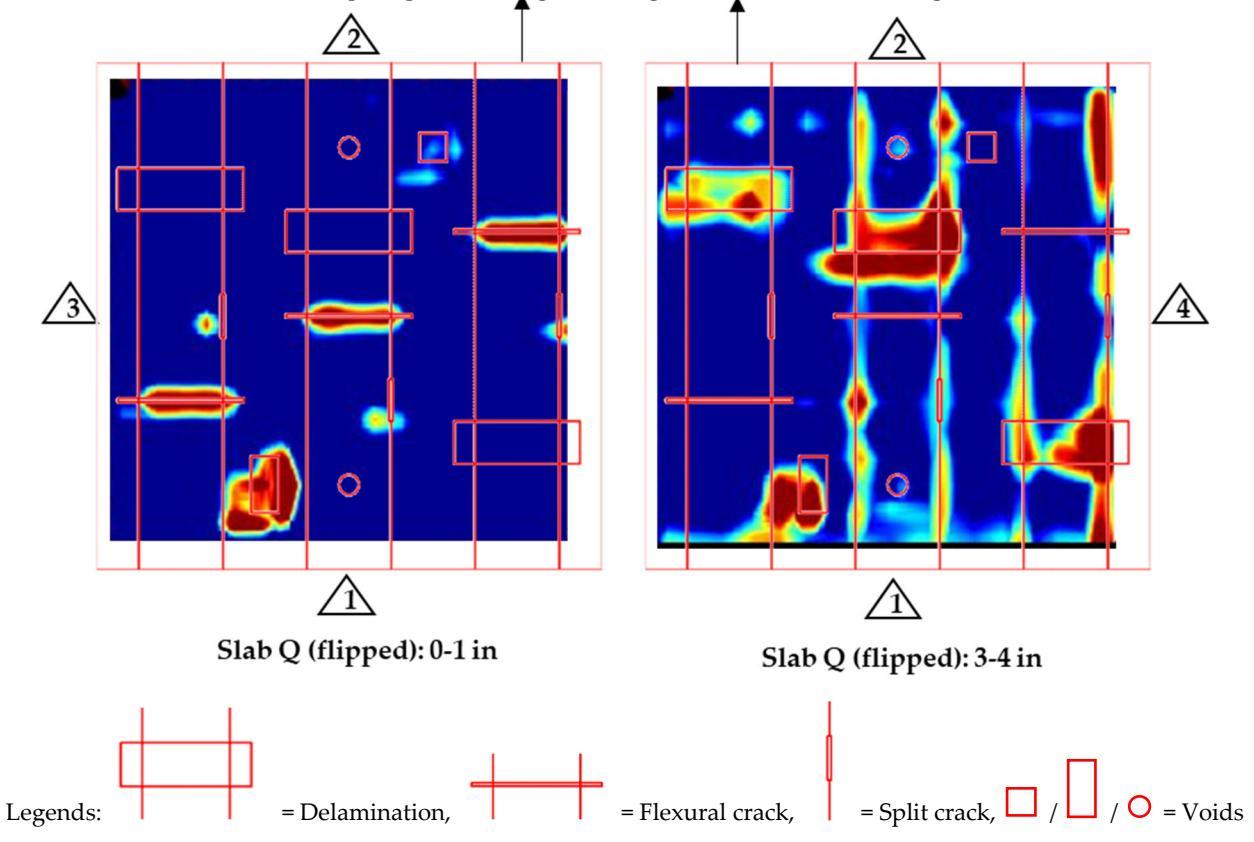
Superimposed drawing illustrating the location of defects/damage

Figure A3. Depth slices of slab Q for damage detection in concrete (from top and bottom surface).
