Article Multitemporal Total Coliforms and *Escherichia coli* Analysis in the Middle Bogotá River Basin, 2007–2019

Abstract: Currently, one of the main environmental problems that need to be addressed is the pollution inflicted upon different ecosystems by anthropic activities. One example of this problem can be seen in the Bogotá River, a major river in the Cundinamarca department of Columbia and the main water source supplying the Bogotá savannah, which reaches the Colombian capital city. The Bogotá River is highly affected by effluents and wastewater of domestic and industrial origin, among others. These pollutants are generated and accumulated throughout the entire basin, without ever receiving any type of treatment. The pollution levels to which the Bogotá River is subjected can be determined with the calculation of environmental indices, including microbiological contamination indicators such as total coliforms (TC) and fecal coliforms, which include Escherichia coli, Enterobacter, Klebsiella, Serratia, Edwardsiella, and Citrobacter bacteria, living as independent saprophytes. This paper assesses the quality of the water in the Bogotá River, using microbiological indicators a

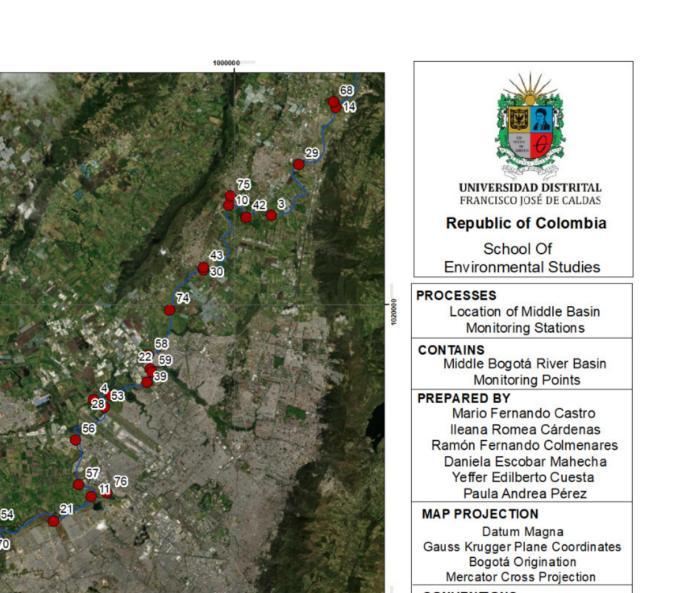
Figure 1. Location of Middle Basin Monitoring stations located with the identification number described above, Bogotá River approach. Source: prepared by the authors, 2021.

For the last 12 years, the Environmental Laboratory of the CAR has studied the middle basin of the Bogotá River, performing microbiological analysis in 35 monitoring stations, taking as a reference the highest values, these being the most representative of the study. The sampling frequency was in the two seasons of the year, taken as the high-water and low-water seasons, which indicate the rainy and dry periods. For the development of microbiological analysis, two periods were identified. They were given the numbers 01, which includes the months from January to June, and 02, which includes the months from July to December. This designation is added after specifying the year of sampling, for example, 2014-02. The numbering of each station corresponds to the identification provided in the data by the CAR; these numbers do not have a sequential order. The monitoring stations are described below: Quebrada La Tenería (No. 68), upstream of Chía (No. 14), Chía Municipal Discharge (No. 29), downstream of Chía (No. 3), Limnigrafica (LG) bridge (Pte). La Balsa station (No. 42), River Frio (No. 75), downstream River Frio (No. 10), Cota Municipal Discharge (No. 30), LG Pte. La Virgen station (No. 43), River Chicú (No. 74), Limnimetric (LM) Vuelta Grande (No. 58), Juan Amarillo Bypass (No. 22), El Salitre WWTP (No. 59), El Cortijo (No. 39), Jaboque discharge (No. 28), Engativá discharge (No. 27), Engativá downstream (No. 4), La Ramada (No. 53), LG Pte. Cundinamarca (No. 56), LM Hacienda San Francisco (No. 57), River Fucha (No. 76), downstream River Fucha (No. 11), Gibraltar pump (No. 24), LG La Isla (No. 54), Rio Tunjuelo (No. 70), downstream River Tunjuelo (No. 13), Rio Balsillas (No. 72), River Soacha (No. 79), Soacha cannel (No. 23), LG Las Huertas (No. 55), Mondoñedo bridge (No. 60), upstream Salto Tequendama (No. 18), San Antonio. Tequendama municipal discharge, Quebrada La Cuy (No. 31), Quebrada Honda (No. 67), and downstream Quebrada Honda (No. 9). Of the abovementioned stations, the ones closest to the urban area can be seen in Figure 1.

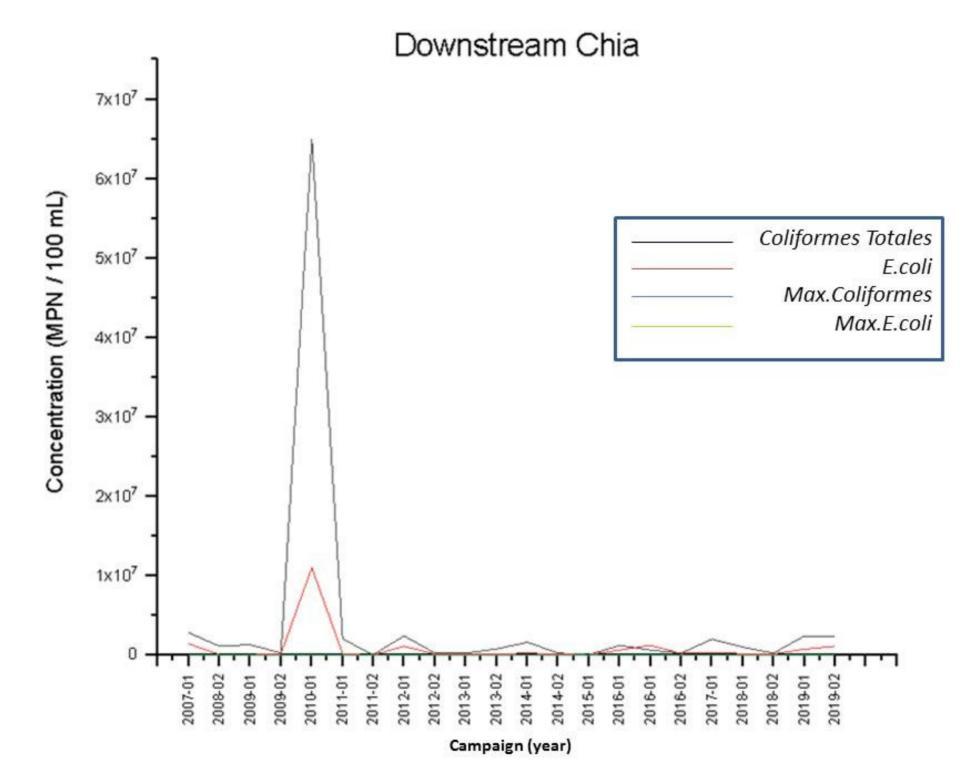
Figure 2. Downstream Chía concentration chart. Source: prepared by the authors, 2021.

The Chía municipality discharge station (No. 29) reported a maximum concentration of 2.50×10^7 MPN/100 mL for TC and 1.70×10^6 MPN/100 mL for *E. coli* in the 2008-02 period. In addition, in 2014-02, these concentrations increased from the previous year to 1.60×10^7 MPN/100 mL for TC and 4.60×10^6 MPN/100 mL for *E. coli*. The third station is the downstream Chía station (No. 3), which reports concentrations of 6.50×10^7 MPN/100 mL for TC and 1.10×10^7 MPN/100 mL for *E. coli* in 2010-01, as may be observed in Figure 2, below.

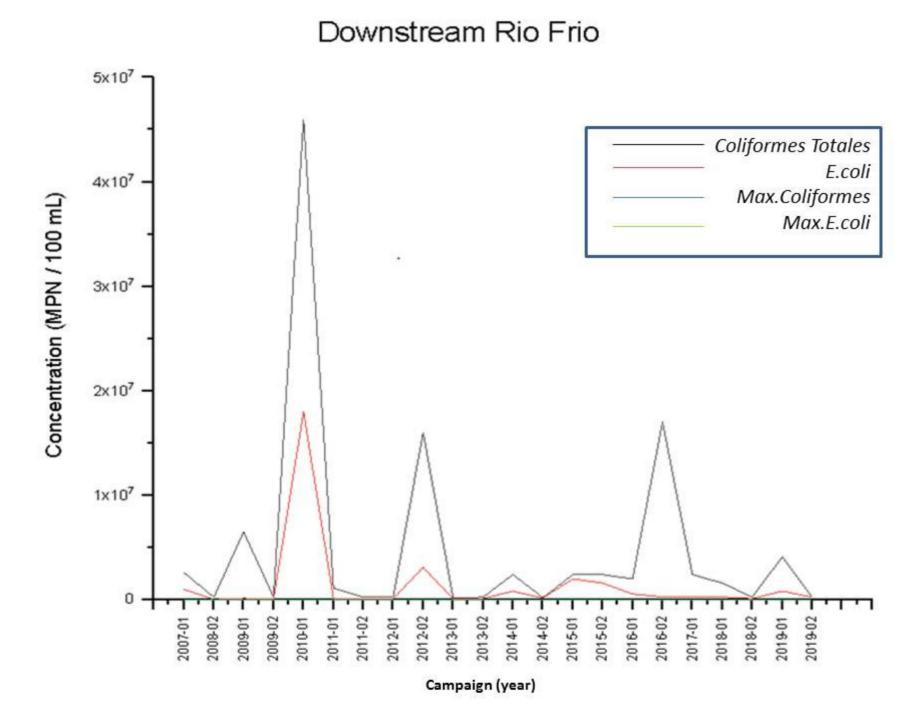
Figure 3. Downstream Rio Frio concentration chart. Source: prepared by the authors, 2021.

Subsequently, at the downstream Rio Frio station (No. 10), concentrations remained high, as evidenced in 2010-01, when the station reported TC concentrations of 4.60×10^7 MPN/100 mL and *E. coli* concentrations of 1.80×10^7 MPN/100 mL; in 2016-02, TC values were observed of 1.70×10^7 MPN/100 mL, while the concentration of *E. coli* decreased (2.70×10^5 MPN/100 mL) (Figure 3).

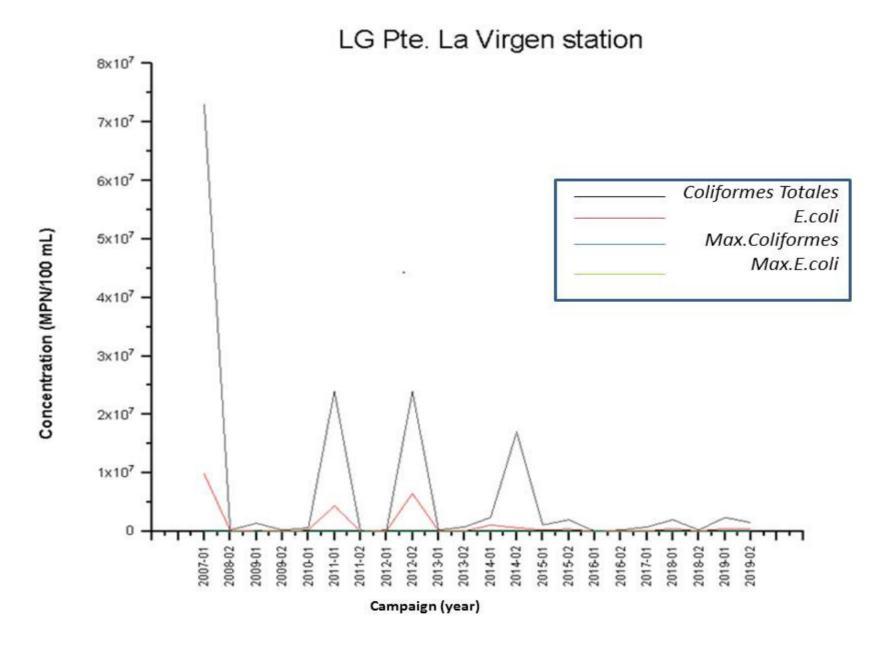
Figure 4. LG Puente La Virgen station concentration chart. Source: prepared by the authors, 2021.

The next monitoring point was the Puente La Virgen station (No. 43), where maximum concentrations were reported in 2007-01, with values of 9.80×10^6 MPN/100 mL for *E. coli* and 7.30×10^7 MPN/100 mL for TC. An overall decrease in coliforms was observed at this station for 2019-01; TC concentrations were 2.40×10^6 MPN/100 mL and *E. coli* concentrations were 5.00×10^5 MPN/100 mL (Figure 4).

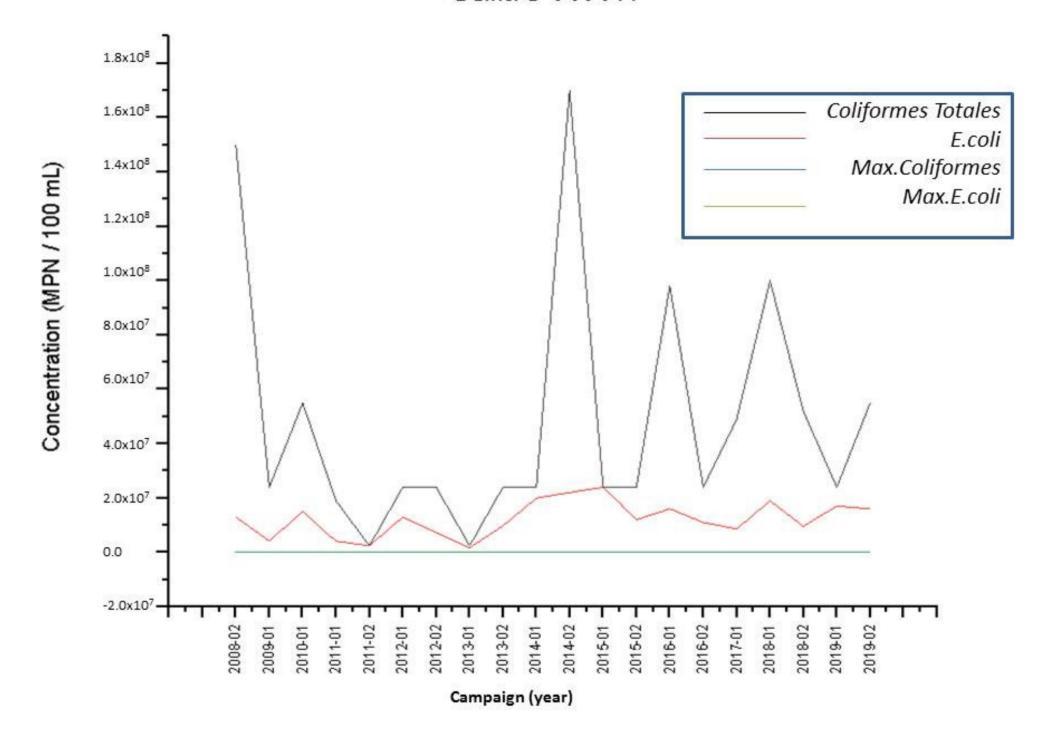
Figure 5. El Salitre WWTP concentration chart. Source: prepared by the authors, 2021.

Station No. 59, located at the discharge (channel) of the El Salitre Wastewater Treatment Plant reported high TC concentrations of 1.50×10^8 MPN/100 mL and *E. coli* concentrations of 1.30×10^7 MPN/100 mL for 2008-02. Although the plant has been in operation since 1999, high levels of contamination at 2.0×10^3 MPN/100 mL of TC were still being reported in 2008. In fact, 6 years later, in 2014-02, concentrations had increased significantly to 1.70×10^8 MPN/100 mL for TC and 2.20×10^7 MPN/100 mL for *E. coli*, as can be observed in Figure 5.

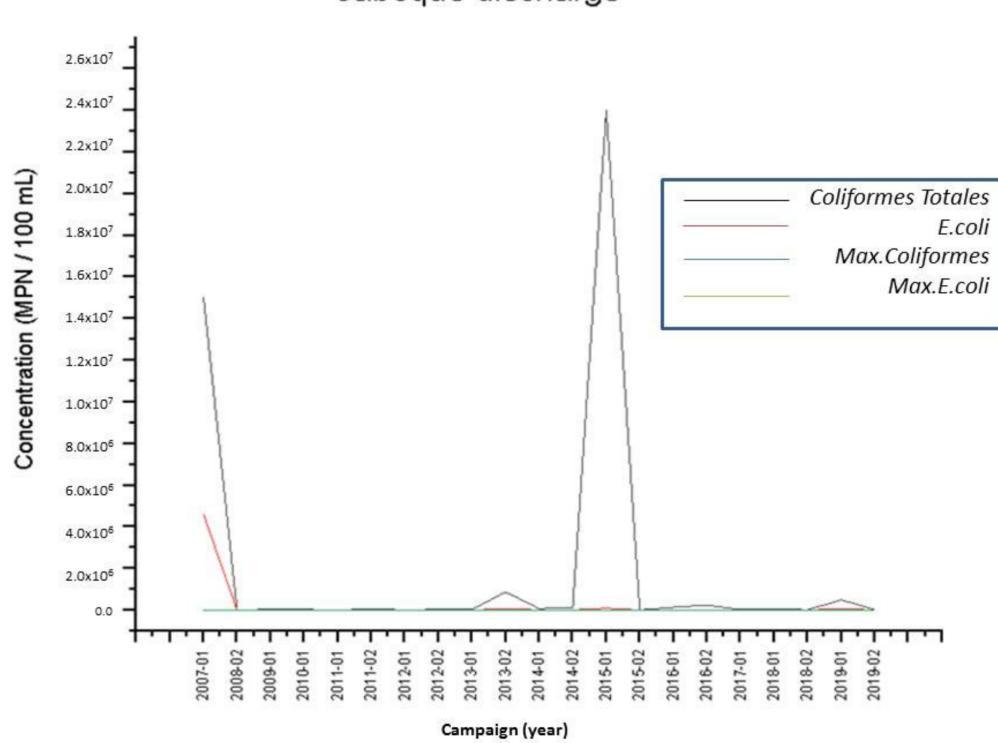
Figure 6. Jaboque discharge concentration chart. Source: prepared by the authors, 2021.

and *E. coli* concentrations of 8.20×10^6 MPN/100 mL. These concentrations are extremely high compared to the concentrations reported by the Jaboque discharge station (No. 28), which are lower than the rest of the stations mentioned. For example, in 2011-01, TC concentrations only reached 4.70×10^3 MPN/100 mL and *E. coli* concentrations reached $<1 \times 10^2$ MPN/100 mL, as shown in Figure 6. However, a peak was reported in 2015-01 with the presence of TC concentrations of 2.40×10^7 MPN/100 mL and *E. coli* concentrations of 9.8×10^4 MPN/100 mL.

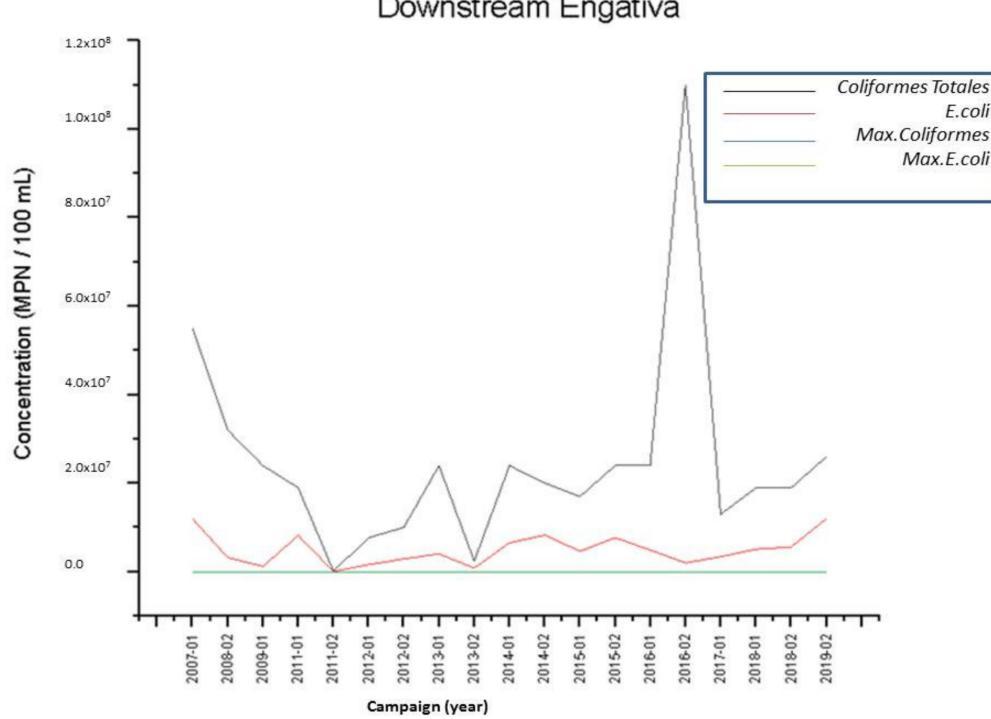
Figure 7. Downstream Engativá concentration chart. Source: prepared by the authors, 2021.

The downstream Engativá station (No. 4) reported concentrations in 2016-02 for TC of 1.1×10^8 MPN/100 mL and 2.0×10^6 MPN/100 mL for *E. coli*, reaching a significant increase; to date, these results far exceed the permissible limits provided for in Decree 1594 from 1984 (Figure 7).

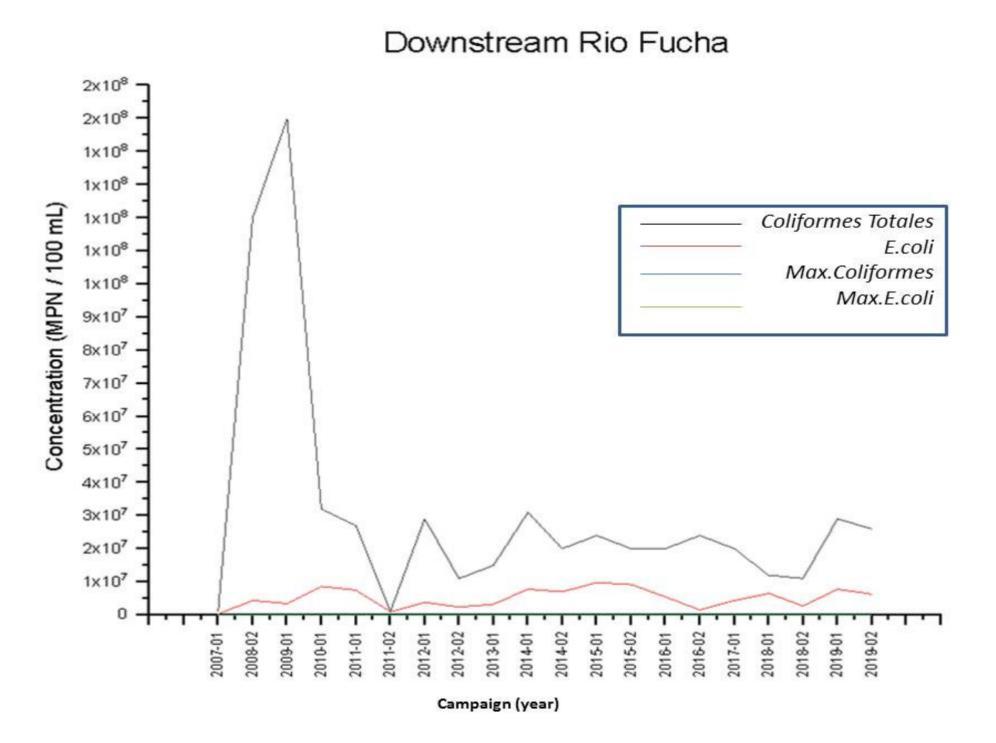
Figure 8. Downstream Rio Fucha concentration chart. Source: prepared by the authors, 2021.

In 2009-01, the downstream Rio Fucha station (No. 11) reported TC concentrations of 1.5×10^8 MPN/100 mL and *E. coli* concentrations of 3.4×10^6 MPN/100 mL (Figure 8). The microbiological load was extremely high, showing that concentrations of TC and E. coli were maintained over the years.

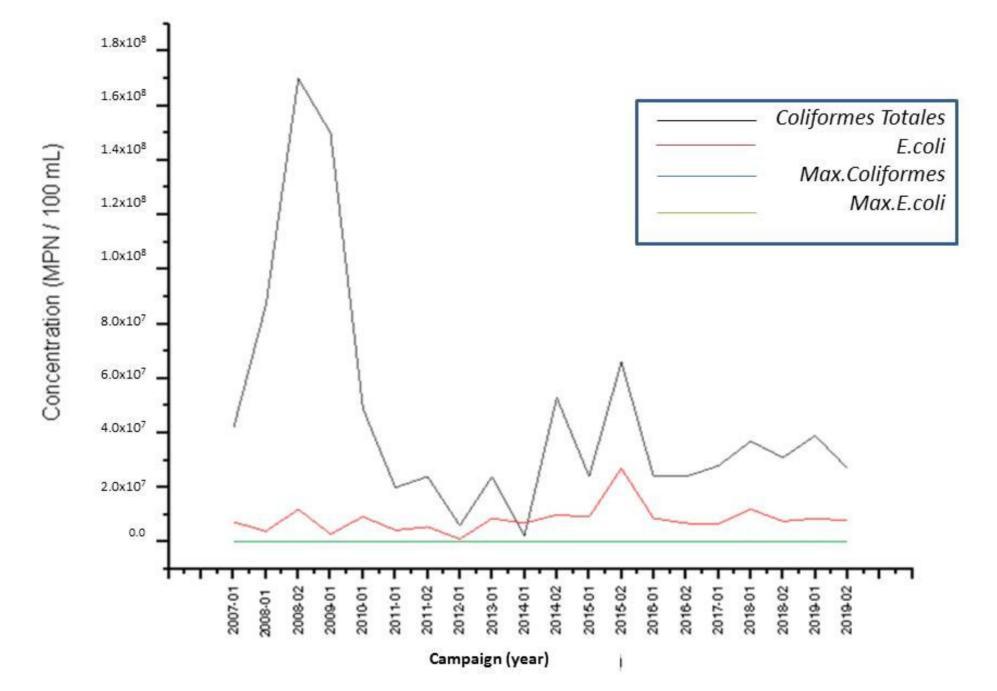
Downstream río Tunjuelo

Figure 9. Downstream Rio Tunjuelo concentration chart. Source: prepared by the authors, 2021.

The lower basin of the Tunjuelo River covers an area of 390 km² from the Cantarrana dam to the mouth of the Bogotá River [35]. In the downstream Rio Tunjuelo station (No. 13), in 2008-02, TC concentrations reached a maximum value of 1.7×10^8 MPN/100 mL and *E. coli* concentrations reached 1.2×10^7 MPN/100 mL, which indicates that there was a high contribution of wastewater and industrial waste throughout its course. In 2019-01, the same level of contamination was observed, with TC concentrations of 3.9×10^7 MPN/100 mL and *E. coli* concentrations of 8.6×10^6 MPN/100 mL. This station is affected by anthropic influences from the urban periphery (Figure 9).

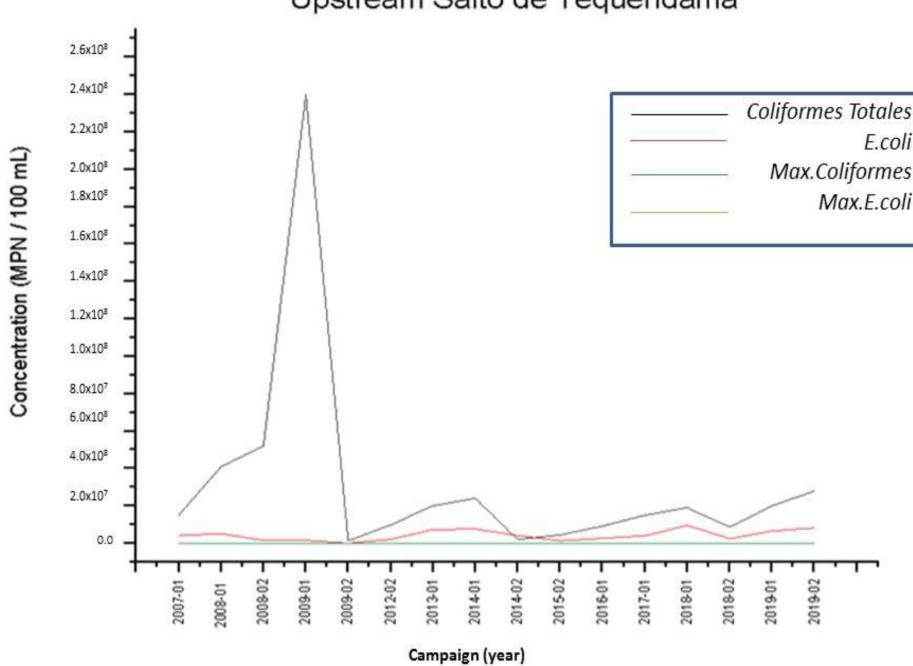
Figure 10. Upstream Salto de Tequendama concentration chart. Source: prepared by the authors, 2021.

At the station before reaching Tequendama Falls (the upstream Salto de Tequendama Station No. 18), a significant number of coliforms was recorded. In 2009-01, TC concentrations were at 2.4×10^8 MPN/100 mL and *E. coli* concentrations were at 1.5×10^5 MPN/100 mL (see Figure 10).

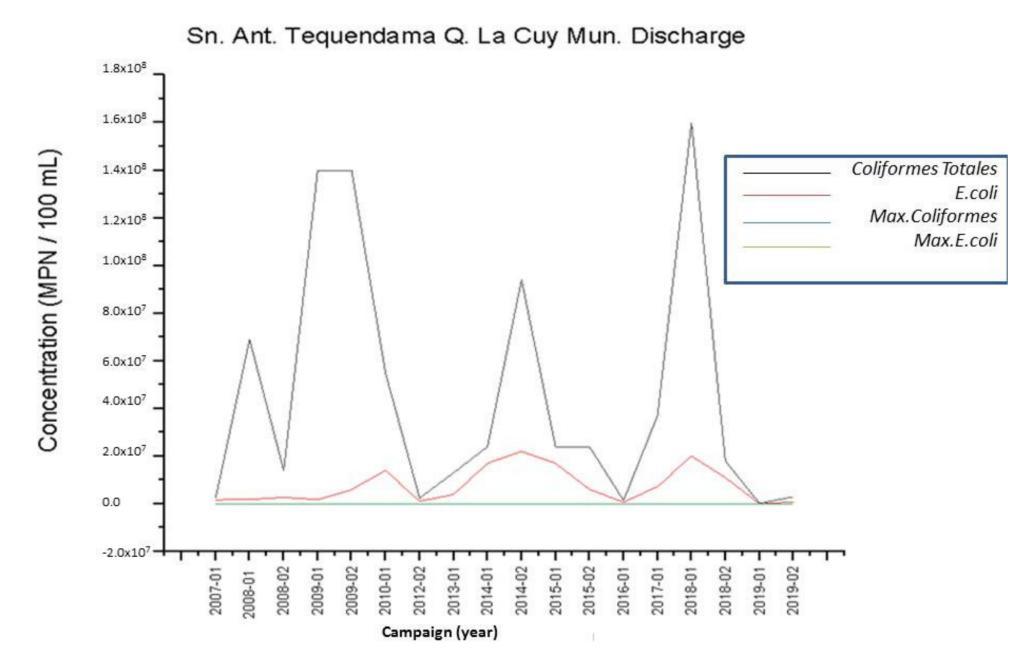
Figure 11. San Antonio Tequendama Quebrada, La Cuy Municipio. Discharge concentration chart. Source: prepared by the authors, 2021.

At the Quebrada La Cuy station (No. 31), San Antonio Tequendama municipal discharge, an all-time-high percentage of coliforms was again recorded, In 2018-01, TC concentrations were at 1.6×10^8 MPN/100 mL and *E. coli* concentrations were at 2.0×10^7 MPN/100 mL (see Figure 11).

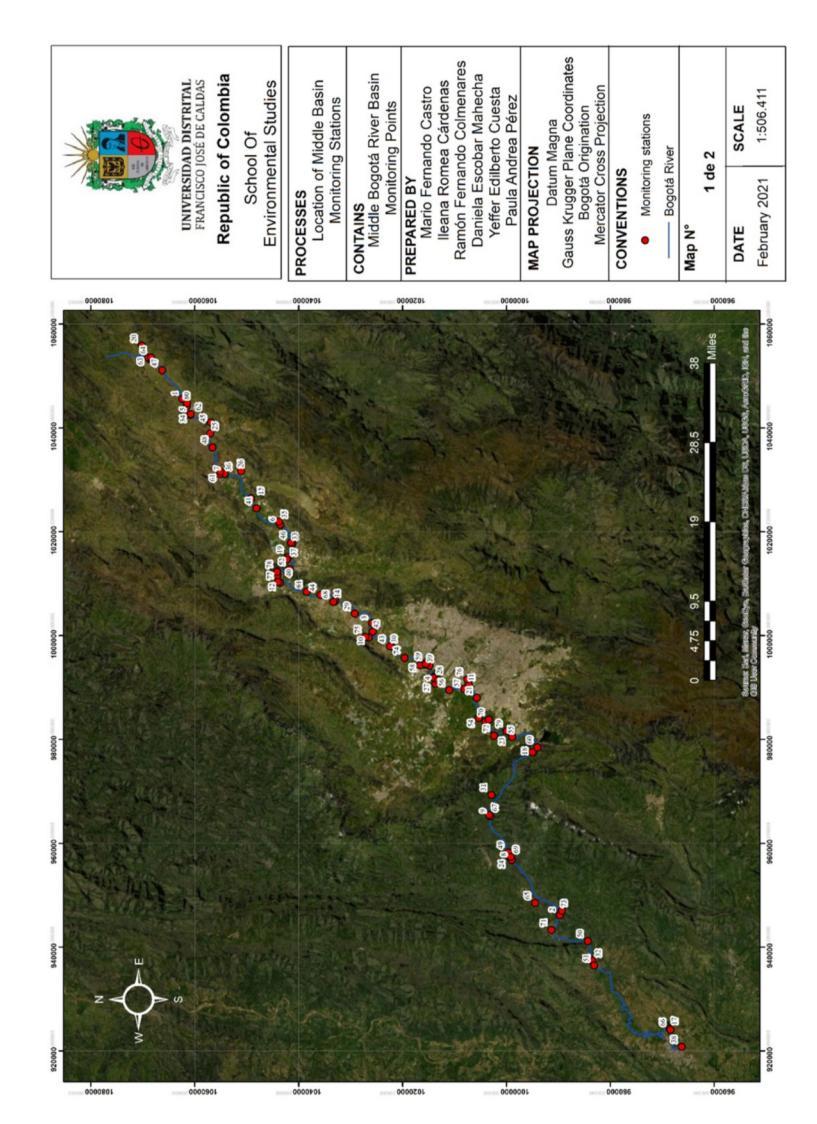
Figure A1. Bogotá River monitoring stations. Source: prepared by the authors, 2021.

The middle basin of the Bogotá River corresponds to the section located between the monitoring stations, as shown in Figure A1: Quebrada La Tenería (No. 68) and downstream Quebrada Honda (No. 67). This river basin receives discharges (either directly or indirectly) from the municipalities of Chía, Cota, Tenjo, Subachoque, El Rosal, Funza, Madrid, Mosquera, Bojacá, Facatativá, Soacha, Tena, San Antonio del Tequendama, and part of the discharges from Cajicá, but especially the discharges from the Capital District of Bogotá. Its main tributaries in this section are the discharges from the Frio, Chicú, Balsillas, Salitre, Fucha, Tunjuelo, Soacha rivers, and the La Cuy and Honda streams. The data of the stations in this study were provided by the Corporación Autónoma Regional de Cundinamarca (CAR).
