Article Identify and Monitor Growth Faulting Using InSAR over Northern Greater Houston, Texas, USA

Feifei Qu, Zhong Lu *^(D), Jin-Woo Kim^(D) and Weiyu Zheng

Abstract: Growth faults are widely distributed in the Greater Houston (GH) region of Texas, USA, and the existence of faulting could interrupt groundwater flow and aggravate local deformation. Faulting-induced property damages have become more pronounced over the last few years, necessitating further investigation of these faults. Interferometric synthetic aperture radar (InSAR) has been proved to be an effective way for mapping deformations along and/or across fault traces. However, extracting short-wavelength small-amplitude creep signal (about 10–20 mm/yr) from long time span interferograms is extremely difficult, especially in agricultural or vegetated areas. This study aims to position, map and monitor the rate, extent, and temporal evolution of faulting over GH at the highest spatial density using Multi-temporal InSAR (MTI) technique. The MTI method, which maximizes usable signal and correlation, has the ability to identify and monitor faulting and provide accurate and detailed depiction of active faults. Two neighbori

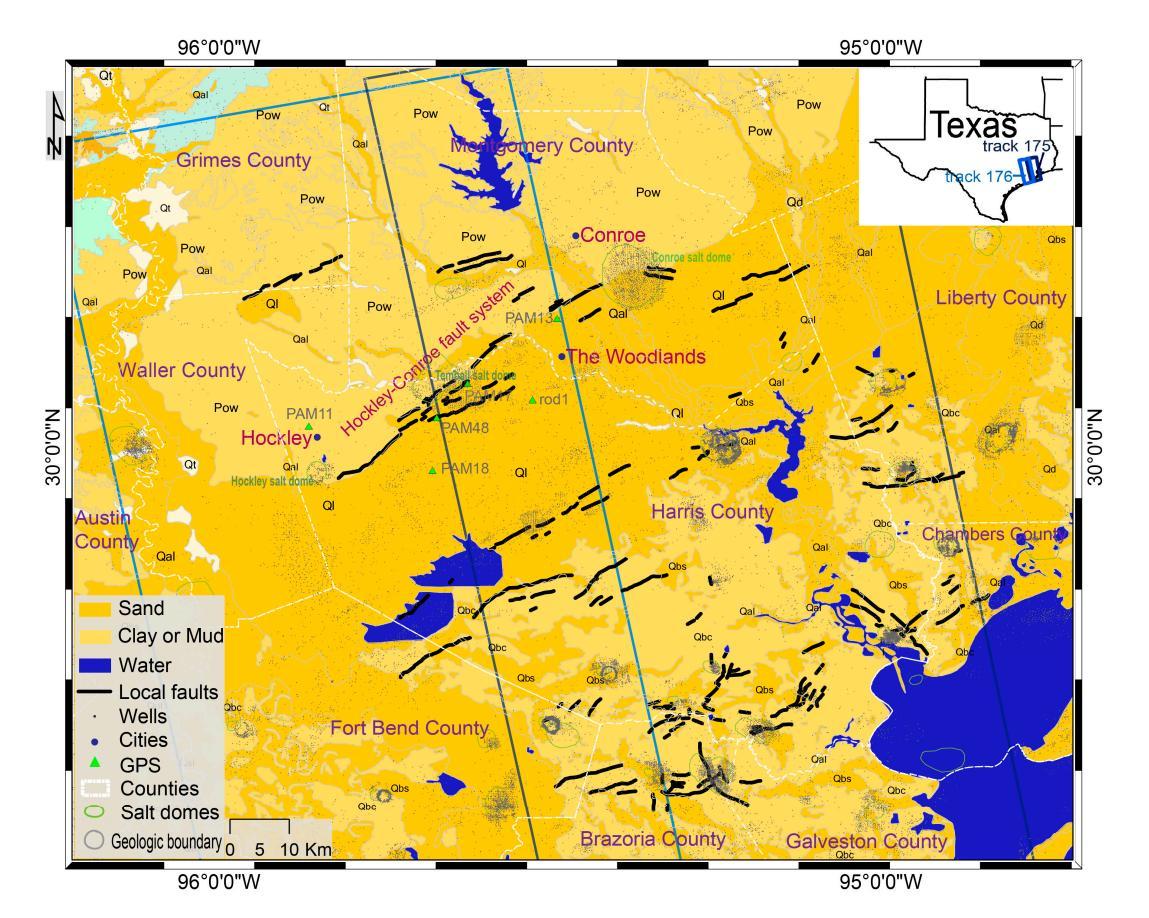
Figure 1. Geological map of GH [8], where colors represent generalized lithology, and black letters (Ql—Lissie Formation; Pow—Willis Formation; Qb—Beaumont Formation; Qbs—Beaumont Formation (sand); Qbc—Beaumont Formation (clay); Qal—Alluvium; Qt—Fluviatile terrace deposits) and grey lines show distribution of the major geologic units [1]. Faults (marked by black lines) [9,10], hydrocarbon wells (small grey dots [11]), GPS benchmarks (green triangles), salt dome positions (green polygons) and county boundaries (white dashed lines, county names are labeled by purple letters) are superimposed. The blue and black rectangles show coverage of two neighboring Advanced Land Observing (ALOS) data. The Texas State district is shown as an inset map on the upper-right corner.

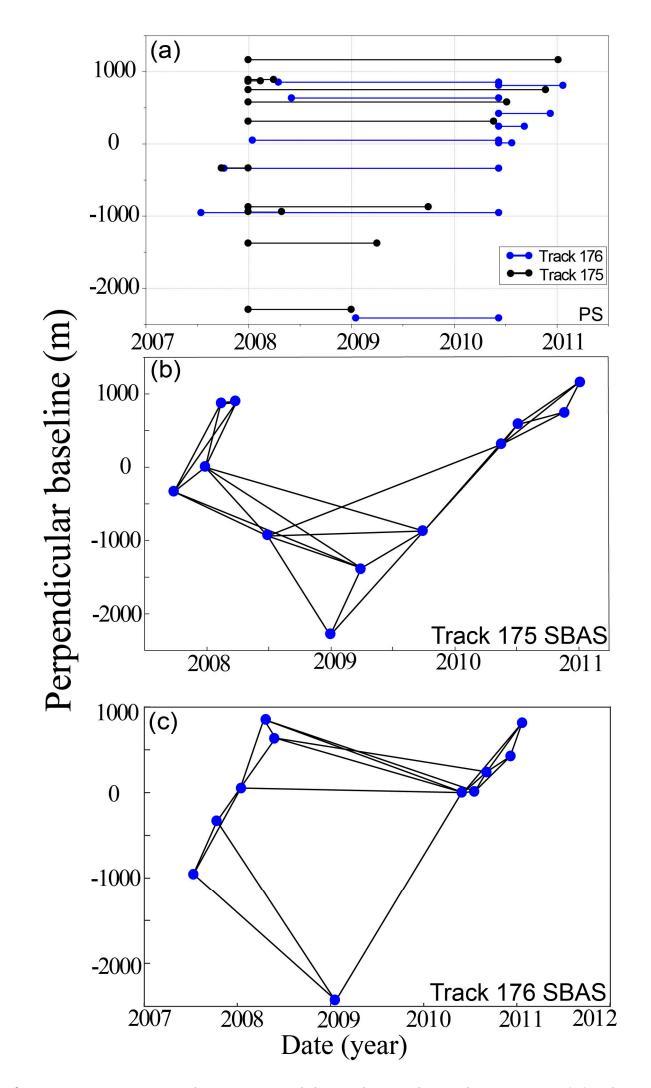
Figure 2. SAR interferograms spatial-temporal baseline distributions: (**a**) shows PS-InSAR (single master) interferograms of both two tracks: blue segments indicate 11 interferograms generated by ALOS path 175, with 20071227 as the master image; black segments represent 10 interferograms generated by ALOS path 176, with 20100605 as the master image; (**b**,**c**) SBAS (multiple master) interferograms with temporal and perpendicular baseline thresholds of 350 days and 1200 m, respectively.

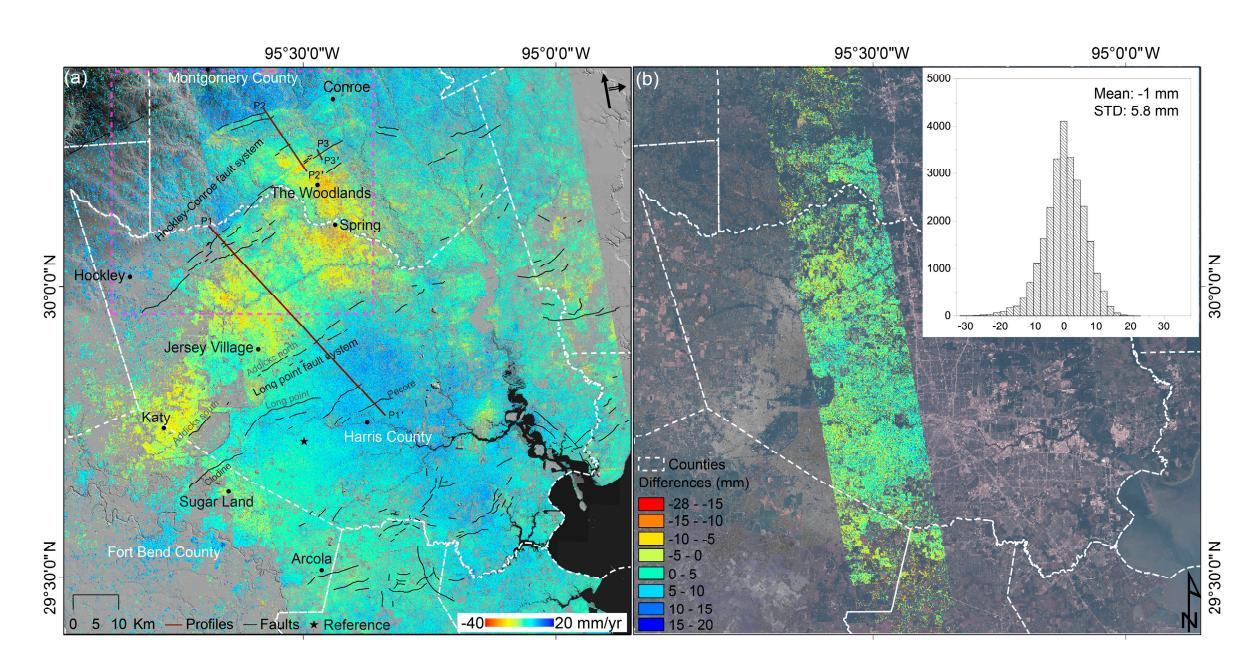
Figure 3. (a) Annual line-of-sight (LOS) deformation map derived from ALOS datasets, which shows a mosaic of two ALOS tracks 175 and 176. The negative values represent ground surface movement away from the satellite. The pink box in (a) indicates our main study area used for the discussion of InSAR results in Figure 5; the dark red lines are profiles across the active faults (labeled as P#P#'). (b)Vertical displacement difference derived from path 175 and 176 by assuming the observed InSAR deformation is vertical; the corresponding statistical histogram of (b) is an inset on the upper-right corner.

Figure 3a shows coincident subsiding distributions and magnitudes between the observations from two ALOS tracks. As the same spatial-temporal cover of the two datasets, we compared the vertical deformation rates in the area of overlap from two ALOS displacement maps. The InSAR derived deformations along LOS direction of SAR, we then projected InSAR measurements to vertical direction referring to the corresponding incidence angles, by assuming the deformation is fully vertical. Figure 3b shows the difference map of two adjacent tracks while an inset on the upper-right corner of Figure 3b shows the corresponding histogram. The standard deviation of the whole common area is approximately 5.8 mm (Figure 3).

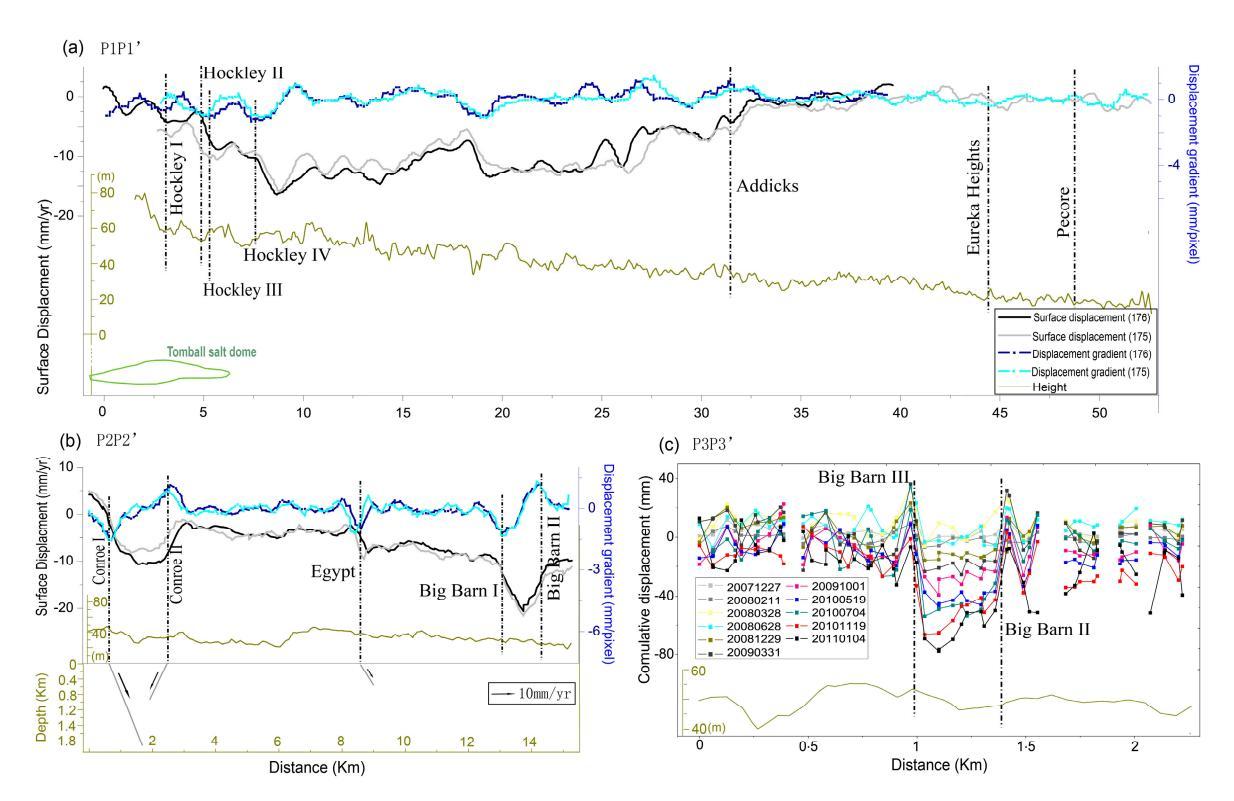
Figure 4. Annual (**a**,**b**) and time-series (**c**) subsidence result from interferometric synthetic aperture radar (InSAR) along three profiles whose positions are shown on Figure 3 as P#P#'. Dark yellow lines show the corresponding surface height. The rough sketch of some integrated faults' geometry is shown at the bottom of (**b**). Green polygon in (**a**) shows approximate location of Tomball salt dome, whose underground depth is not clear. Dash lines represent fault locations.

Figure 4 shows profiles of the LOS annual displacement (a,b) and cumulative displacement (c) along the cross-fault lines of P#P#' marked on Figure 3a. Sharp displacement gradient changes or discontinuous are evident across a majority of faults, and two sides of a fault normally have different surface displacements (Figure 4). Fault activities during 2007–2011 are not as significant as that before 2000 at the Long Point fault system and Addicks fault system, and [53] concluded that the rate of creep is about 10–15 mm/yr. The faults in the northern Greater-Houston were still active, with a creep rate of 10–20 mm/yr at Hockley fault system and about 10 mm/yr at the Conroe fault system (Figure 4).

The InSAR time-series deformation results also indicate the continuous differential movement of Hockley and Conroe Fault System (Figure 4c). The most active fault, the Big Barn Fault, presents a high deformation gradient of about 80 mm during the ALOS period (3.5 years) from 2007 to 2011. The cumulative deformation gradients of other faults are around 40–80 mm. The influence area of each fault is around 0.3–1 km (Figure 4). The mapped faults generally parallel the Gulf Coast line, dipping from northwest to southeast, showing consistency with the scarps of the surrounding terrain and the regional faults pattern [1].

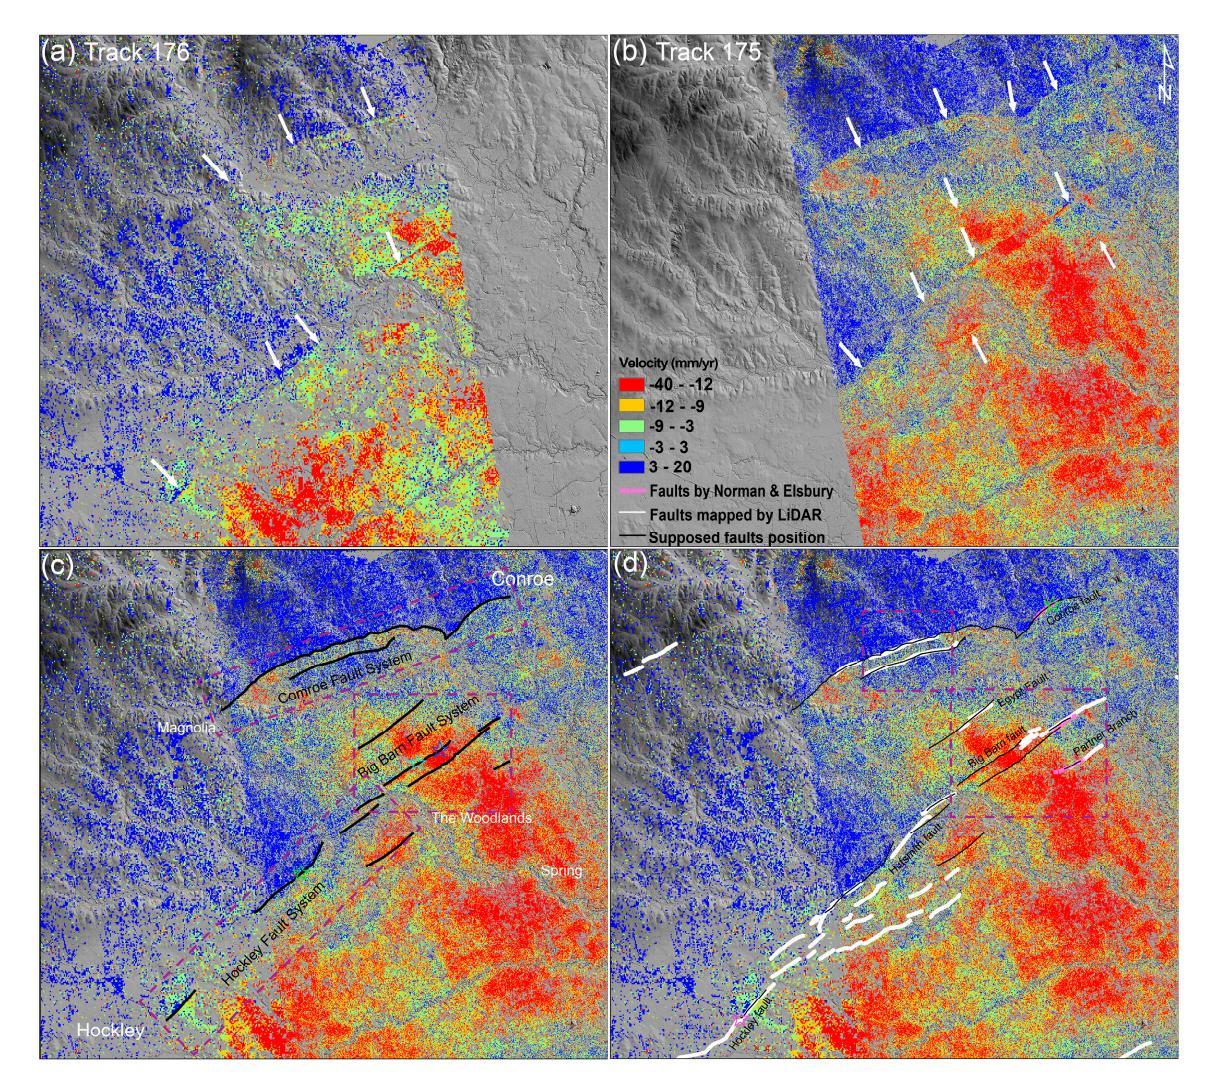
Figure 5. Enlarged deformation maps over northwestern Houston, whose location is outlined by pink dashed rectangles in Figure 3, from two adjacent ALOS-1 paths: (a) Path 176; (b) Path 175; (c,d) Both Path 175 and Path 176. The white arrows in (a) and (b) represent zones of high deformation velocity gradient (differential movement). White lines represent the faults mapped by LiDAR [10] and pink dashed lines show the faults published by Norman and Elsbury (1991), while newly revealed fractures by our Multi-temporal InSAR (MTI) processing are in black lines. The purple boxes in (c) indicate the three discovered faults systems, while the middle one (the same as the bottom purple box in (d)) is also used for InSAR results validation in Figure 6b. The top purple box in (d) shows an area that will be used for fault activity model analysis in Section 5. The colored stars in (c) and (d) mark positions for field survey and validation in Figure 6a,c–g.

from the very end of the Hockley Fault to its terminus at Interstate 45. At least 5 segments of the Big Barn Fault System could be imaged by InSAR (Figure 5c), which have not been formally named by USGS in their database but are mentioned and/or studied by several researchers [31,37,80]. Extensive deformation and damages to nearby businesses and residences within the vicinity of the fault were reported by local residents within the last decade, but no fault activities were reported in this area before. The full Conroe Fault System has not been reported or studied by other researchers, and two faults with a length of 34.3 km and 11.8 km were identified by InSAR maps for the first time, running northeast from the northeast of Magnolia to the city of Conroe. In addition, two segments of the InSAR-mapped faults (within the top purple rectangle in Figure 5c) were also shown by [28], however, without names and discussions by them (Figure 5d). While the Conroe Fault System has not been formally named by USGS in their database, [80] referred one segment (the top dashed pink line on Figure 5d) as the Conroe fault. The agreement between InSAR-mapped faults traces with those from [80], which indicates that the InSAR-discovered fractures constitute parts of the Big Barn Fault

Our InSAR deformation maps have successfully imaged significant LOS displacement anomalies across the known fault location (Figure 5). The discontinuity lines run just on the LiDAR-mapped fault traces at some points, indicating our results are basically consistent with the faults mapped by LiDAR (white lines in Figure 5d), but with the added benefits of low-cost and very wide coverage. The Hockley Fault was extensively investigated with a variety of geophysical methods to illuminate the subsurface character of this fault: seismic [28,34,81], magnetic [36], conductivity [36], gravity [28,34,36], GPR [24,25,28] and resistivity imaging [24,25,36]. All methods imaged fault-like signatures, such as a steep slope over the fault location from the conductivity data, different magnetic values associated with the fault sides, and fault-related gravity anomalies, across the Hockley Fault (at the intersection with Highway 290), which all confirm the position of the Hockley Fault trace. Figure 6a displays a

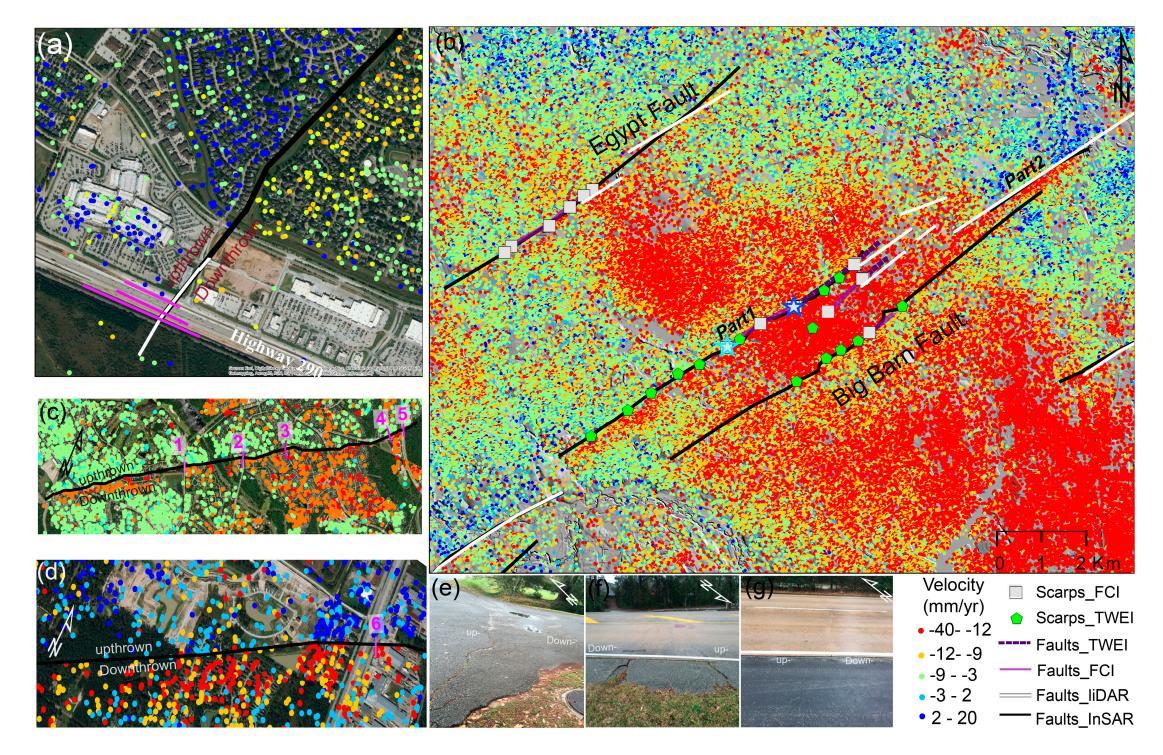
Figure 6. (a) Enlarged deformation map of Hockley fault, whose location is shown as a pink star in Figure 5d. (b) Enlarged deformation map around Big Barn Fault System, whose location is outlined by the large purple dashed rectangle in Figure 5d. Scarp positions are from FCI and TWEI, and the faults they mapped are based on the scarp locations in the field. (c,d) show the enlarged deformation maps of Part 1 and Part 2 (labeled on (b)) of Big Barn faults, respectively, and the pink lines and numbers display six of the seven field sites of geophysical survey conducted in [37] (the other site is beyond the scope of (b)). White lines represent the faults mapped by LiDAR [28], while newly revealed fractures by our MTI processing are in black lines. (e–g) show the photos taken in the field investigation, whose locations are marked as colored stars in (b) and in Figure 5c (green star for (e), light blue star for (f) and blue star for (g)).

fault anomaly whose location is consistent with the Hockley Fault mapped by previous researchers at precisely the same location [36].

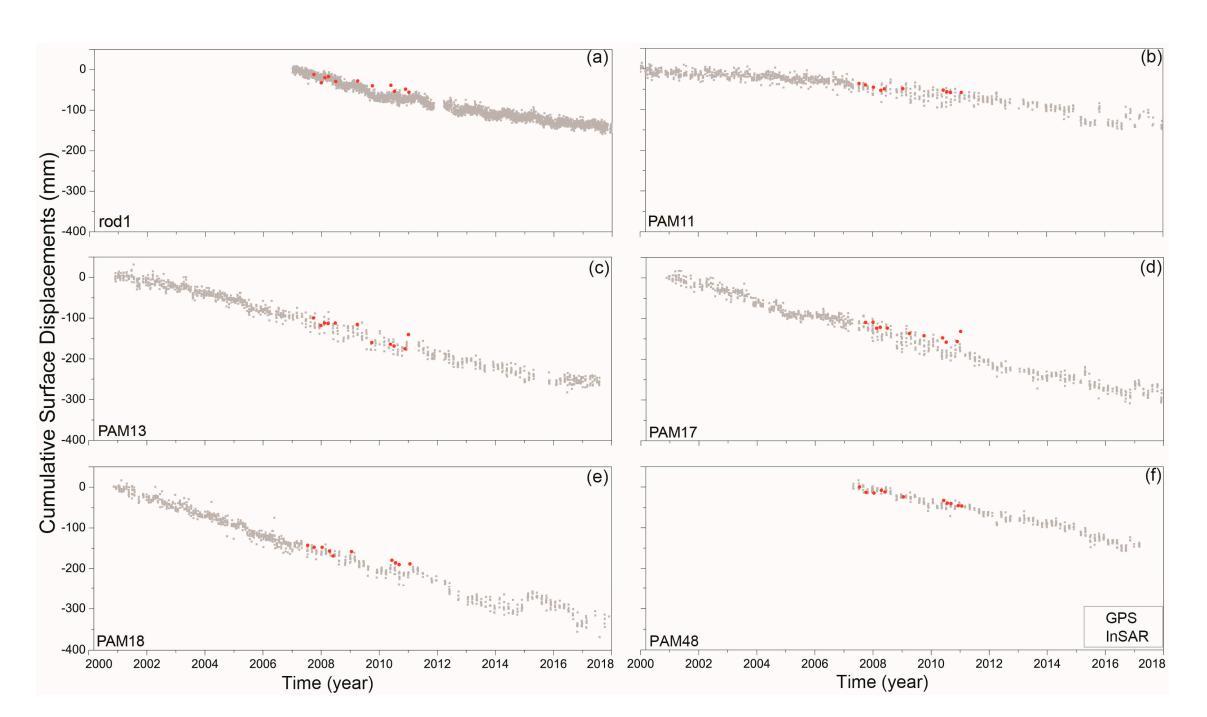
Figure 7. Comparison between InSAR-mapped time-series ground surface displacement and GPS observations at 6 stations.

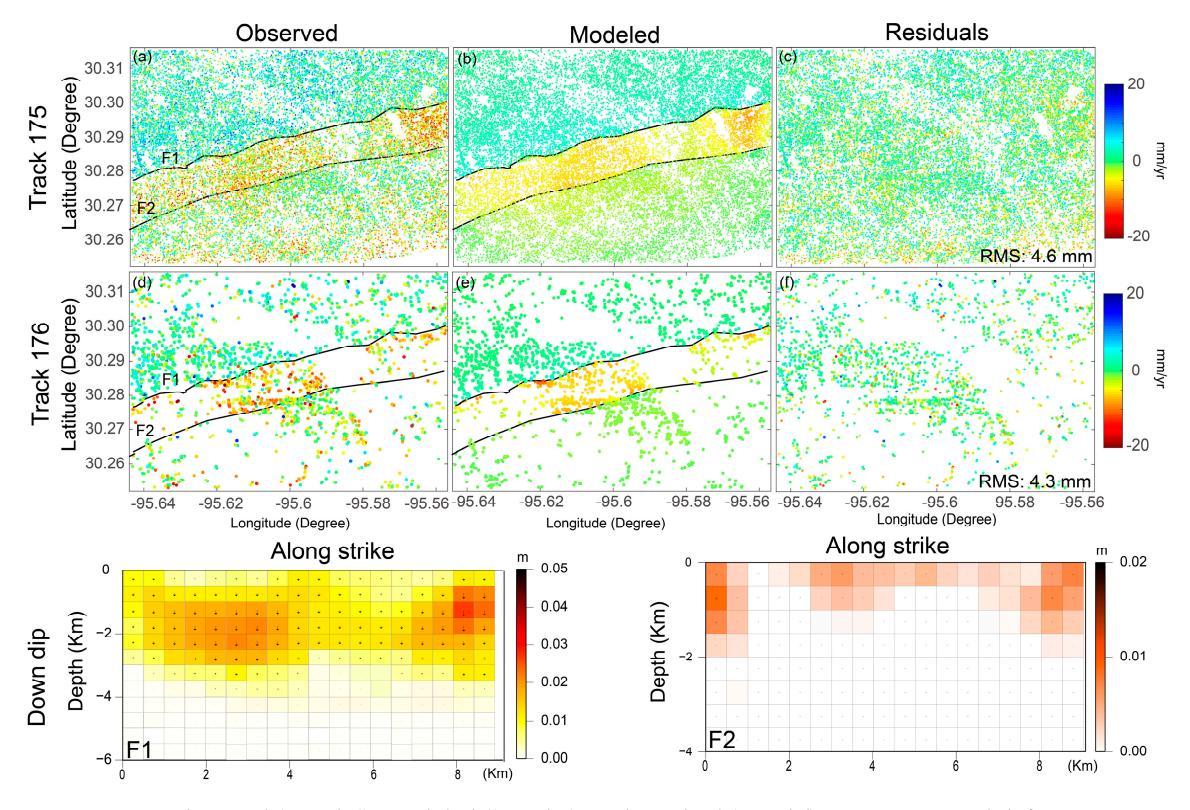
Figure 8. Observed (**a** and **d**), modeled (**b** and **e**), and residual (**c** and **f**) average vertical deformation maps of the two independent tracks (i.e., 176 and 175) of InSAR data. The black line shows the location of the fault. (**g** and **h**) show slip rate distribution maps of fault F1 and F2, respectively.

We compared results derived by the estimated slip model with InSAR observations in Figure 8, and both independent InSAR tracks, i.e., track 176 (Figure 8a-c) and 175 (Figure 8d-f), show consistent fault parameters results. The overall picture of land surface deformation was well reconstructed through the best-fit slip distribution model (Figure 8b,e). The RMS of the residuals is ~5 mm, which drops into the range of observations uncertainties. The result reveals slip rates of F1 and F2 are heterogeneous along the fault traces, which range from negligible dip motion to a peak value of 27 mm/yr with average slip rates of 13 mm/yr for F1 and 7 mm/yr for F2, respectively. The average locking depths are about 2 km (up to 4 km, F1) and 0.75 km (up to 2 km, F2) along the fault parallel direction indicating that the Conroe Fault is active within a very shallow locking depth (Figure 8g-h). While no published research exactly proves the modeled slip rates, there are good aspect of demonstrations on other segments of the Conroe Fault and surrounding faults (system). The authors of [3] concluded that the fault movements of GH were intermittent throughout any given year with an average rate of 12.7 mm/yr from 1966 to present, and indicated a slip rate of 18 mm/yr at the very east section of the Conroe Fault (top pink line on Figure 5d) in 1987 [80]. The slip rate of the nearby Hockley Fault System was suggested to be 10.9 mm/yr (by differentiating the 2001 and 2008 LiDAR measurements) and -13.8 mm/yr (GPS observations) [28]. GPR data indicated the nearby Hockley Fault System faulting to at least 300 m deep [28], and the nearby Big Barn Faults were thought to be active above depths of 1200 to 1500 m below ground surface through the study of well logs [3]. The borehole and well logs, as well as the seismic reflection data delineated a majority of faults presented at 1000-4000 m below the surface in the GH region [17,88].

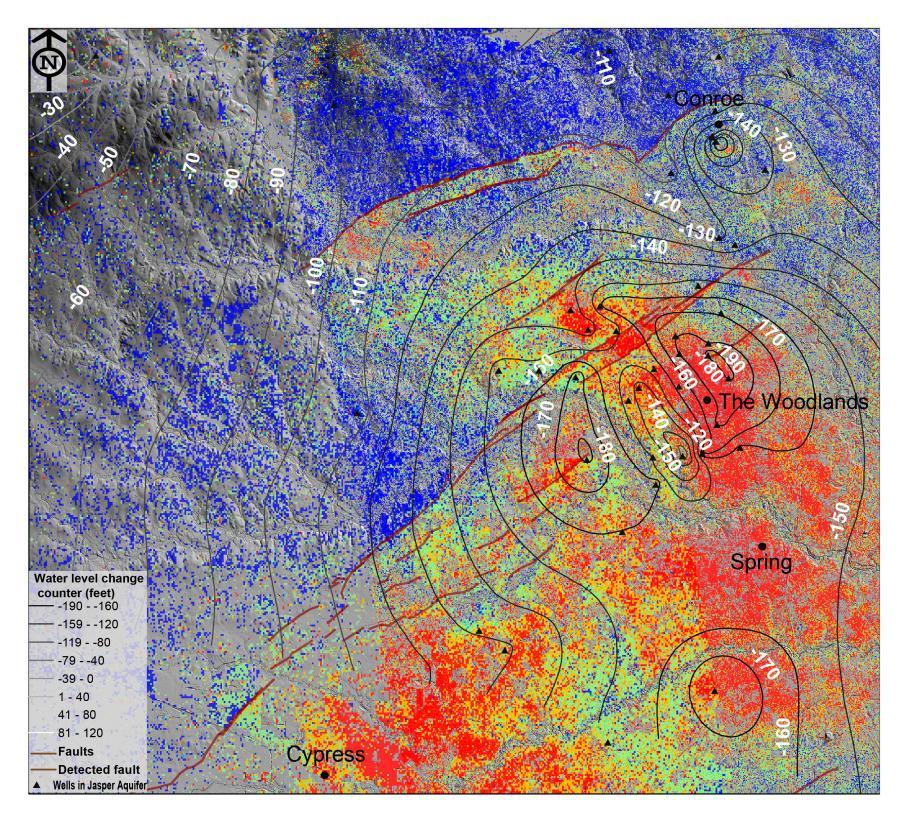
Figure 9. InSAR-observed deformation rate from 2007 to 2011 and the contoured groundwater elevation change at Jasper aquifer for the period 2000–2011 [104]. Black triangles show location of groundwater wells in Jasper aquifer that were used to derive the water level change counters.
