Article Direct Observation of Discharge Phenomena in Vibration-Assisted Micro EDM of Array Structures

Gero Esser 🕩 and Jiwang Yan *🕩

Department of Mechanical Engineering, Faculty of Science and Technology, Keio University, Yokohama 223-8522, Japan

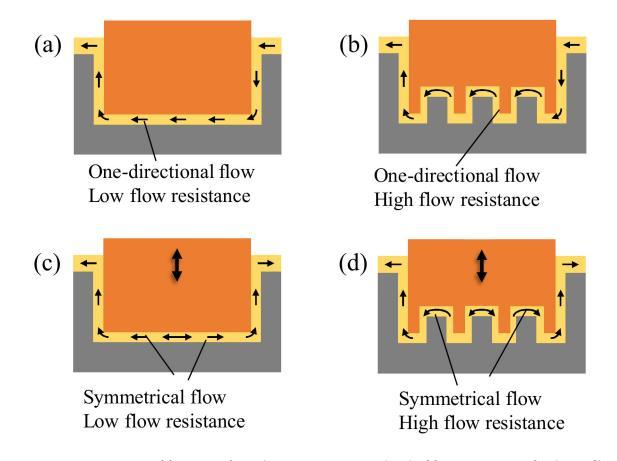
The schematic in Figure 1 illustrates the flow field in the gap in micro EDM of single and array electrodes with/without tool vibration. A higher flow resistance results from the array electrode geometry with a long, curved gap. This is associated with a more difficult machining without tool vibration. In general, the tool vibration generates a symmetrical fluid motion in the center region of the electrode end towards the side gap. In the gap of the array electrode, the flow is symmetrical in the center but one-directional towards the side areas. The effects of the difference in local flow direction and flow resistance on the non-uniformity of machined surface accuracy are unknown.

Figure 1. Effect of vibration and difference of the flow field (**a**) single electrode without vibration, (**b**) array electrode without vibration, (**c**) single electrode with vibration, (**d**) array electrode with vibration.

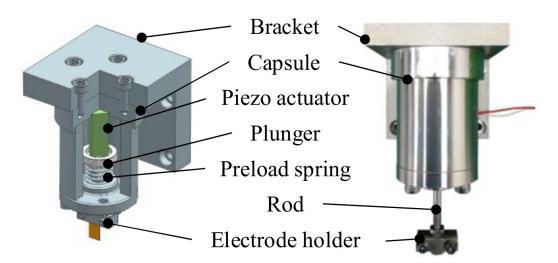
An actuator was required to generate the vibration motion of the tool electrode. A piezoelectric actuator was selected due to the fast response time and high acceleration. The design and verification process described in [29] was followed. The vibration unit illustrated in Figure 2 was designed using a piezoelectric transducer (AE0505D16F, Tokin Co., Sendai, Japan). The frequency and amplitude of the driving voltage were controlled to set the desired displacement. The axial and radial tool motion was analyzed by a laser displacement sensor (LK-H025, Keyence, Osaka, Japan), and low radial movement was confirmed. The vibration modes in Table 1 were selected for the experiments. Throughout this paper, we use the term amplitude for the peak-to-valley amplitude of the vibration motion.

Figure 2. Cross-section and overview of the components of the vibration unit.

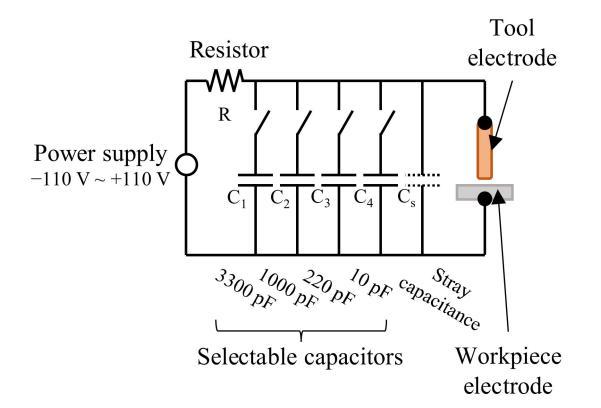
A resistor-capacitance (RC) type EDM machine (MG-ED72, Panasonic, Kadoma, Japan) was used to conduct the experiments. As seen in Figure 3, the discharge energy was controlled by setting the voltage and capacitance of the EDM circuit. The experimental parameters of the machine are detailed in Table 2.

Figure 3. Schematic of the resistor–capacitor type EDM circuit.

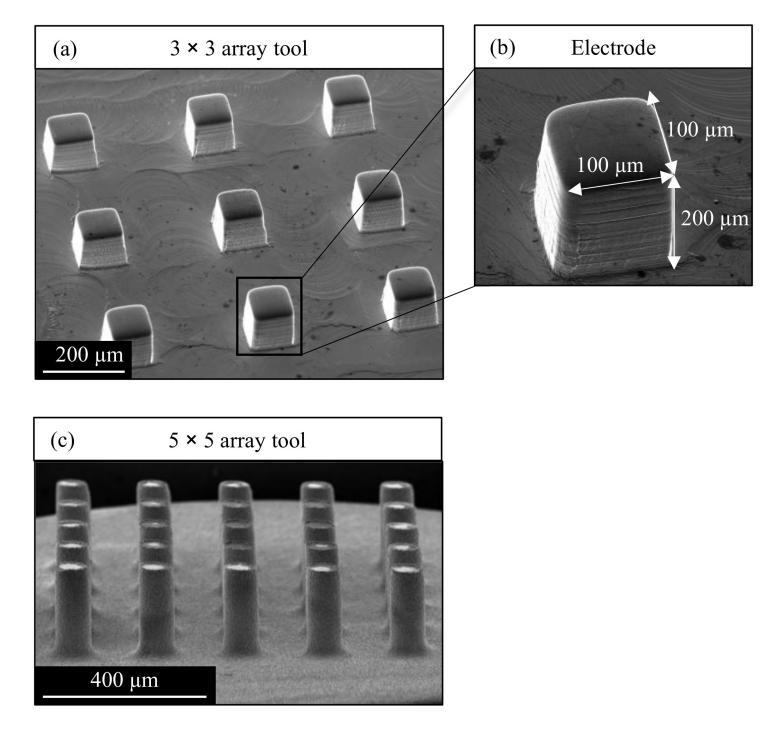
Micro EDM experiments with arrays of 9 and 25 electrodes were performed, and the effect of tool vibration on the machining process was investigated. Figure 4a illustrates the tool array of 9 rectangular electrodes with a size of 100 μ m by 100 μ m and a height of 200 μ m. The electrodes were fabricated from a copper rod of 2 mm diameter by micro

milling as it is economical and less time-consuming than other manufacturing methods while achieving sufficient accuracy for the observation experiments. The top surface of the array was hand polished to remove burrs from micro milling and to increase the surface reflectivity of the electrodes to ease the high-speed camera observation. Before the experiments, the tool and workpiece were cleaned in an ultrasonic bath with EDM oil. Tool arrays of 25 cylindrical electrodes are illustrated in Figure 4c. The arrays were fabricated from copper material by reverse EDM to achieve higher accuracy and smaller spacing of the electrode diameter of 80 μ m, spacing of 200 μ m, and electrode length of 200 μ m was achieved.

Figure 4. SEM image of the tool array electrodes used in this study. (**a**) Tool array of 9 rectangular electrodes (**b**) Detailed view of an electrode of the array (**c**) Tool array of 25 cylindrical electrodes.

The tool wear was studied by SEM microscopy after a single use of the tool. Compared to the tool before use in Figure 4b, the rounded edges of the array used at 50 Hz and 3 μ m vibration in Figure 22a indicate significant wear. The tool wear also caused the formation of craters on the top surface of the electrodes. Deposition of carbon and debris can be seen as black material in the upper part of the electrodes.

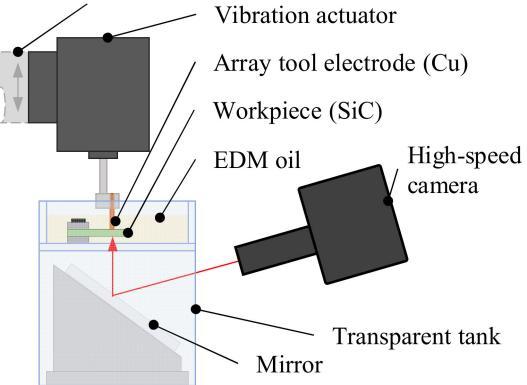
The observation was conducted by a high-speed camera (FASTCAM Mini AX50, Photron Ltd., Tokyo, Japan). The settings of the high-speed camera are shown in Table 3. The experiment setup is illustrated in Figure 5 and was based on previous studies on direct gap observation [2,24,30]. As seen from the schematic in Figure 6, the vibration unit was connected to a signal generator and amplifier and mounted to the *z*-axis of the micro EDM machine. The tool electrode was attached to the vibration unit. The SiC workpiece was installed in an acrylic tank and submerged in the dielectric fluid. A mirror was placed on an inclined stand beneath the tank. The high-speed camera and high luminance lights were set up in front of the micro EDM machine. The discharge gap was observed through the transparent SiC workpiece from below via the mirror.

Figure 5. Schematic of the setup for the direct observation of the discharge gap.

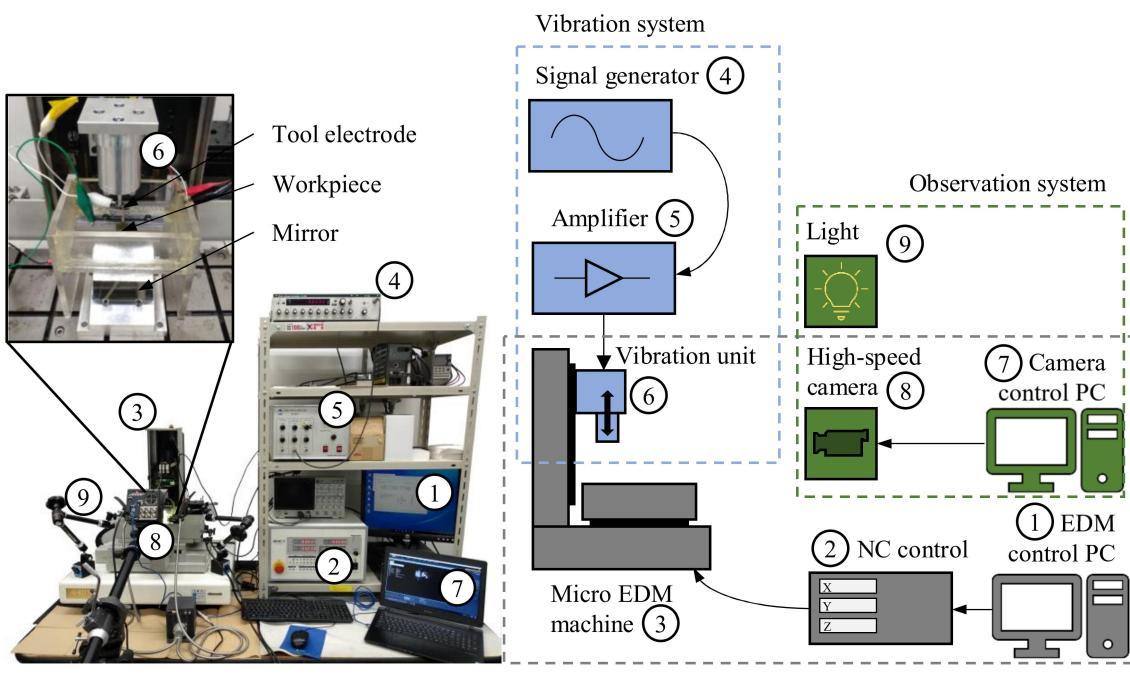
Figure 6. Block diagram representation and photo of the experiment setup.

Die sinking EDM was performed, and the machining progress was tracked. The gap observation settings were optimized to show only the discharges and minimize the interference of bubbles, debris, and other effects. The video recording was started after the electrode reached a machining depth of 50 μ m. Machining showed significant differences at this depth, and suitable evaluation results were obtained due to low interference of reflections on the recorded videos.

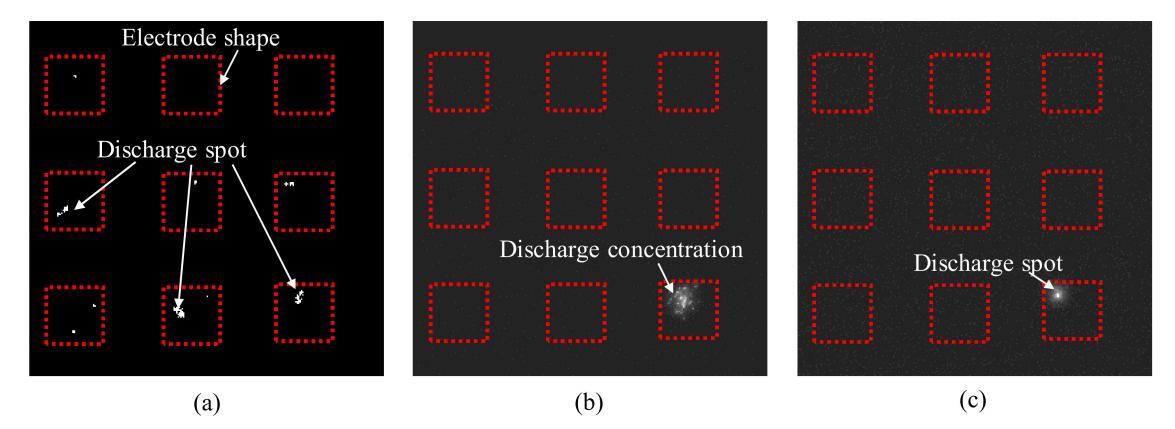
In contrast to machining without vibration, where discharges occurred randomly, tool vibration led to a periodic discharge. In regular intervals, the discharges were stopped or only observed sporadically. In the experiments, three different discharge states were observed through the videos. Generally, multiple discharge spots were distributed over several electrodes of the array. Figure 7a shows a single frame recorded during this regular machining state. Occasionally discharges occurred concentrated on a single electrode in a high number. This discharge concentration is visible as a bright area in Figure 7b. The discharge concentration usually occurred at the end of the regular discharge period. Intense discharge continued for an extended time in the vibration cycle, even after regular discharge on the other electrodes was stopped. The discharge concentration phenomenon often appeared repeatedly over multiple vibration cycles. Infrequently, single bright spots, as shown in Figure 7c, that remained for several consecutive frames were observed. In most cases, this phenomenon followed a discharge concentration. The bright spot was assumed to be caused by arcing or short-circuiting when debris particles formed a bridge between the tool and the workpiece. The bright spot phenomenon often observed after the discharge concentration in the videos provides additional support for the findings of Shitara et al. [24] that discharge concentration might be a precursor to short-circuiting.

Figure 7. Different discharge states observed at 50 Hz and 5 μ m vibration with the EDM parameters specified in Table 2: (a) unform distribution, (b) concentration at a single electrode, (c) single discharge spot.

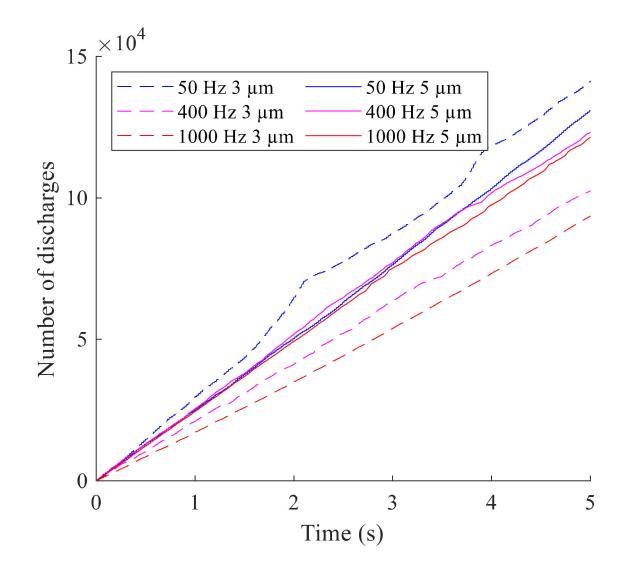
The video was evaluated by thresholding the grayscale video frames in MATLAB. The location and number of the bright discharge spots in each frame were detected. The number of discharges with tool vibration is illustrated in Figure 8. The highest discharge rate was recorded for vibration at 50 Hz and 3 μ m, but irregularities were seen twice. All other vibration modes showed good linearity. The discharge rates at 50 Hz, 400 Hz, and 1000 Hz with an amplitude of 5 μ m were higher than the discharge rates at 400 Hz and 1000 Hz with 3 μ m amplitude.

Figure 8. Number of discharges over the recording time.

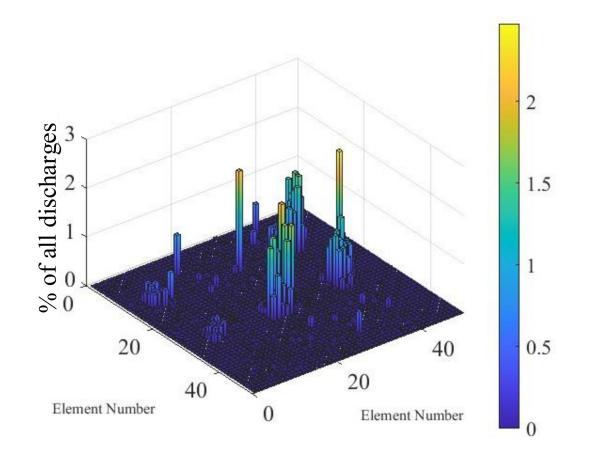
The frames were partitioned in a grid of 50 by 50 elements, and the number of discharge spots in each element was counted. Without tool vibration, only a small number of discharges were observed, concentrated on a few electrodes of the array. This resulted in the highly non-uniform distribution, as shown in Figure 9.

Figure 9. Distribution of discharges without tool vibration and the EDM parameters specified in Table 2.

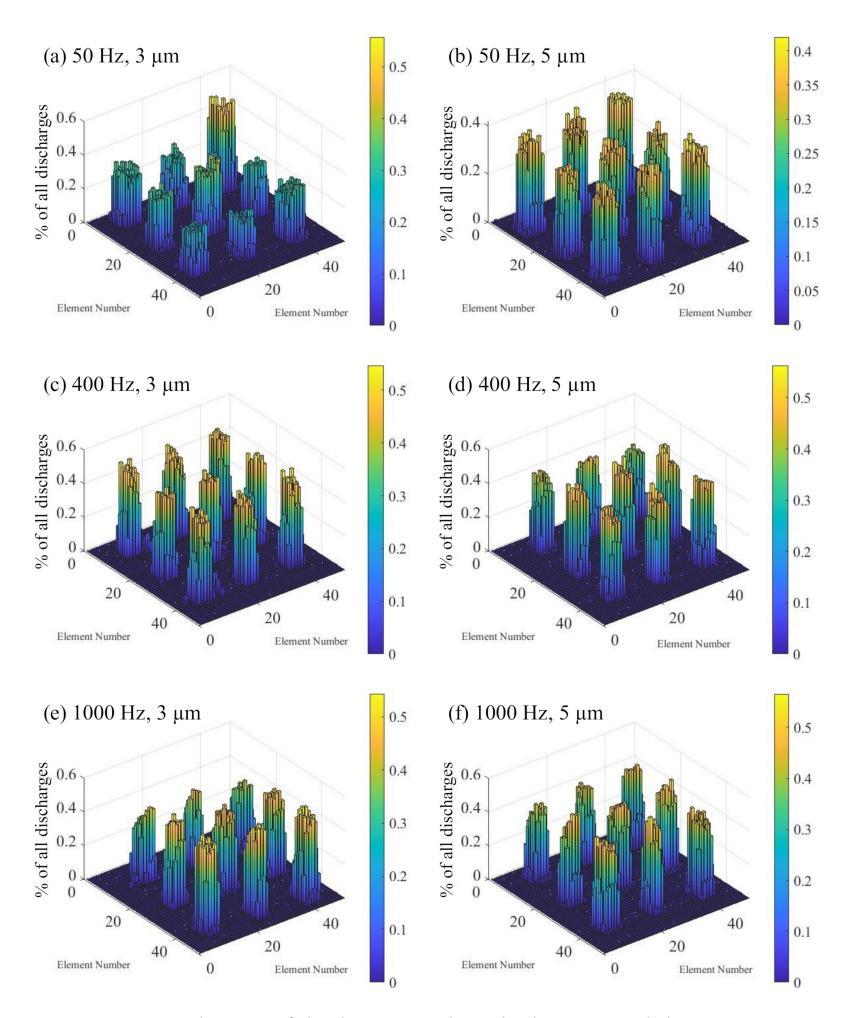
Such non-uniform distribution was also observed during vibration-assisted EDM at 50 Hz and 3 μ m amplitude. As illustrated in Figure 10a, a much higher number of discharges was observed on the top-right electrode, while the number of discharges on the center electrode was slightly increased. The gap observation video showed that this was a result of discharge concentration. The discharge concentration was observed twice on the top-right and once on the center electrode during the recorded timespan.

Figure 10. Distribution of discharges with tool vibration and the EDM parameters specified in Table 2. The vibration frequencies and amplitudes are: (**a**) 50 Hz, 3 μ m (**b**) 50 Hz, 5 μ m (**c**) 400 Hz, 3 μ m (**d**) 400 Hz, 5 μ m (**e**) 1000 Hz, 3 μ m (**f**) 1000 Hz, 5 μ m.

The distribution of discharge spots for the vibration mode of 50 Hz and 5 μ m amplitude is given in Figure 10b. The uniformity of the discharge distribution was significantly increased. This indicates higher stability of the machining process. The recorded video showed that discharge concentration occurred once on the bottom-right electrode. However, the concentration continued only for a few vibration cycles and did not influence the discharge distribution. Subsequently, the bright spot phenomenon was observed in the location where the discharge concentration occurred.

The discharge distributions at 400 Hz and 1000 Hz with both 3 μ m and 5 μ m amplitude are illustrated in Figure 10c–f. Machining at these vibration parameters showed good uniformity. A correlation of the discharge uniformity to the frequency or amplitude of the vibration was not identified for these parameters. Compared to the 50 Hz and 5 μ m vibration result, the distribution was slightly less uniform. The reasons for this can be found in the higher variation of the discharge numbers in the elements on individual electrode positions. An uneven electrode surface may have resulted in regions with more discharges. Elevations could have been caused by the adhesion of debris or deposited carbon from the EDM oil. A gradual decrease of discharges across the array was observed in some cases, such as at 400 Hz and 5 μ m. A higher concentration of debris may have increased the discharge number in one electrode area. It is also possible that some discharges were not visible due to a brightness gradient of the lighting in the gap.

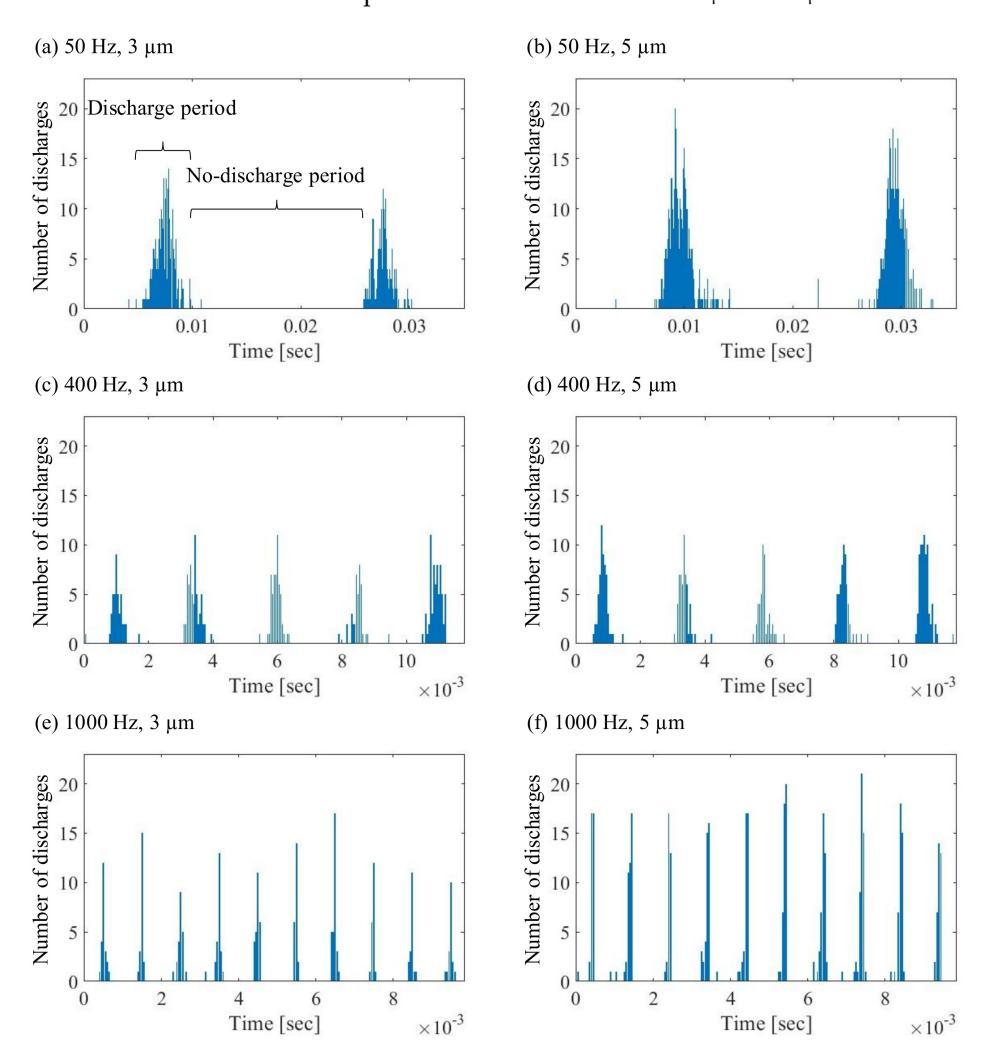
The duration and intensity of the periods with/without discharge were analyzed. The number of discharge spots detected per frame at an arbitrary position is displayed in Figure 11. With increasing frequency, the beginning and end of the discharge periods became more apparent as the number of stray discharges decreased. The duration and number of discharges of the discharge periods was evaluated, and the average discharge intensity over the recorded video is illustrated in Table 4. There was a significant correlation between the vibration amplitude and the intensity of the discharge rate. At all observed vibration frequencies, a higher rate of discharge spots during the discharge period was found when the vibration amplitude was increased from 3 μ m to 5 μ m.

Figure 11. Discharge periods with the parameters specified in Table 2. The vibration frequencies and amplitudes are: (**a**) 50 Hz, 3 μ m (**b**) 50 Hz, 5 μ m (**c**) 400 Hz, 3 μ m (**d**) 400 Hz, 5 μ m (**e**) 1000 Hz, 3 μ m (**f**) 1000 Hz, 5 μ m.

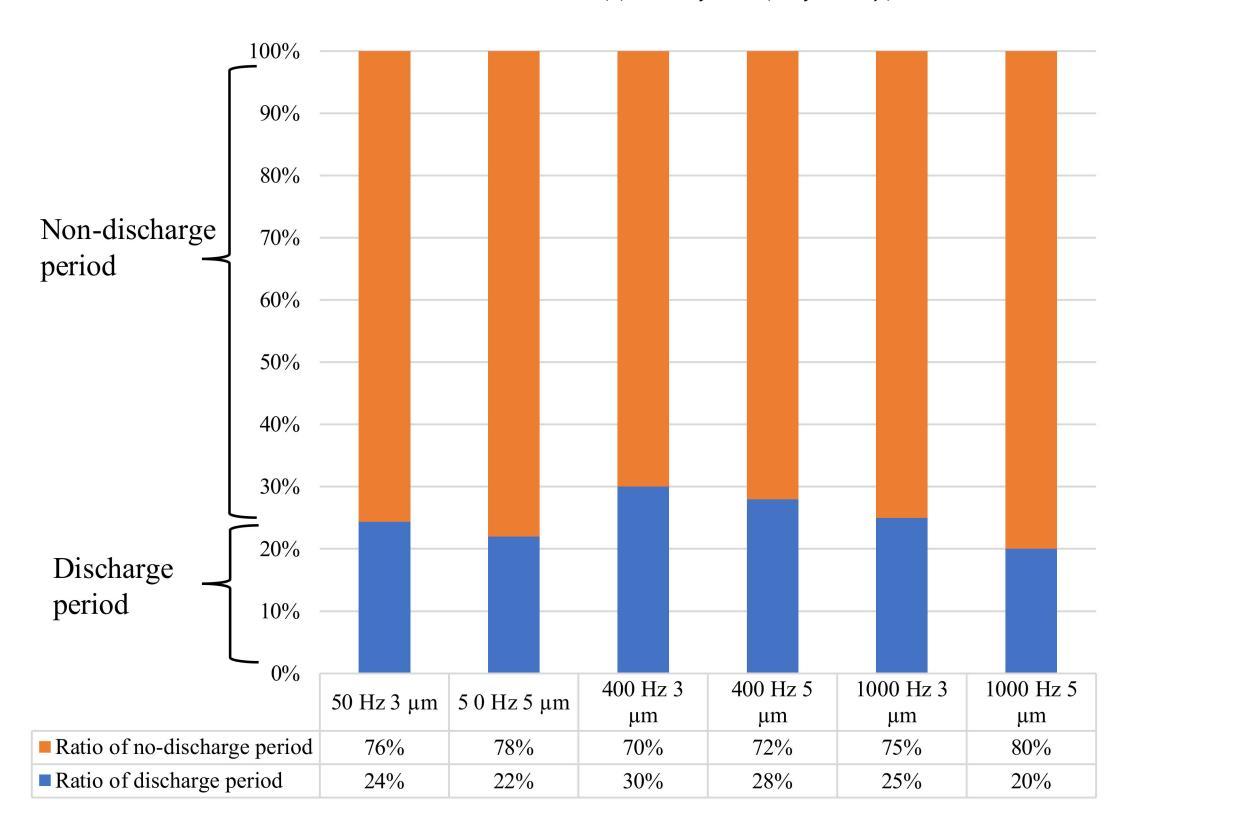
Figure 12 shows the ratio of the average discharge period duration to the average no-discharge period. It was found that an increase of both the vibration frequency and amplitude led to a shorter discharge period. This was attributed to the relation of the vibration parameters and the electrode velocity, as detailed in Equation (1). The electrode velocity, v, varies with the time, t. The vibration frequency and amplitude are denoted by f and \hat{a} , while φ is the phase shift.

Figure 12. Ratio of the average discharge period and no-discharge period duration in the vibration cycle.

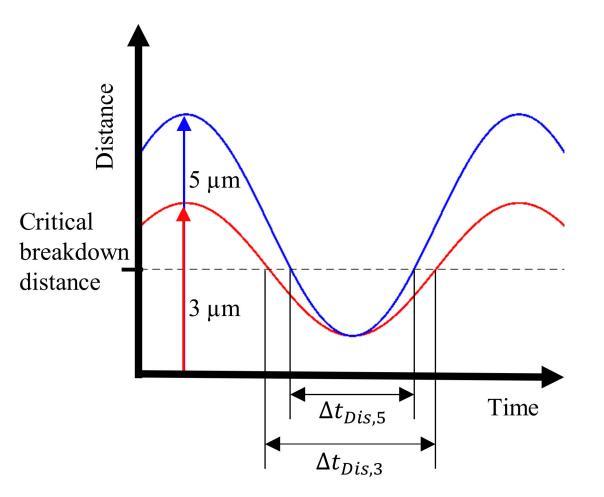
The tool follows a sinusoidal trajectory, and increasing frequency and amplitude of the vibration leads to a higher electrode velocity. As shown in Figure 13, the residence time of the tool in the beneficial discharge range decreases when the amplitude is changed from $3 \mu m$ to $5 \mu m$.

Figure 13. Distance of the tool electrode to the workpiece surface during one vibration cycle.

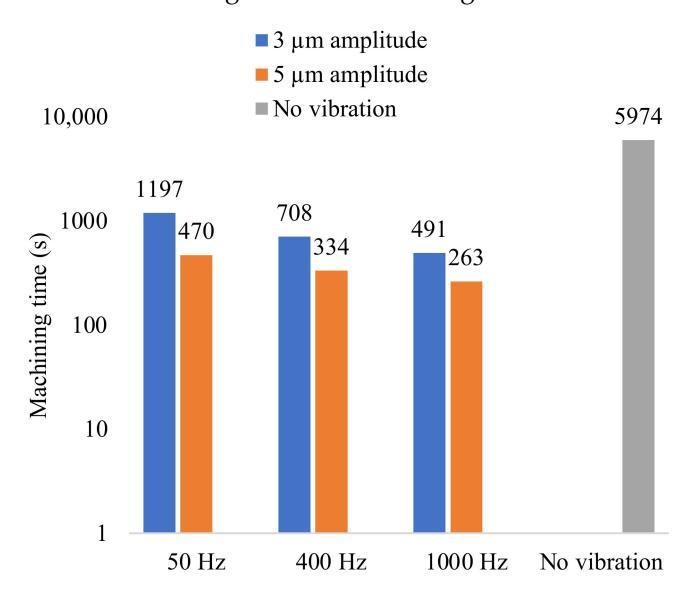
The progression of the tool was recorded, and the machining time to a depth of 80 μ m is illustrated in Figure 14. The highest machining time was recorded without vibration. As seen from the tool feed in Figure 15, the tool progression followed the specified feed rate of 5 μ m/second for only about 5 μ m and then slowed down significantly. The machine control performed a reciprocation motion of the tool after abnormal discharge was detected to flush debris from the gap. This jump motion occurred frequently, indicating bad flushing conditions and regular short-circuiting.

Figure 14. Machining time for a depth of 80 μ m with the parameters specified in Table 2.

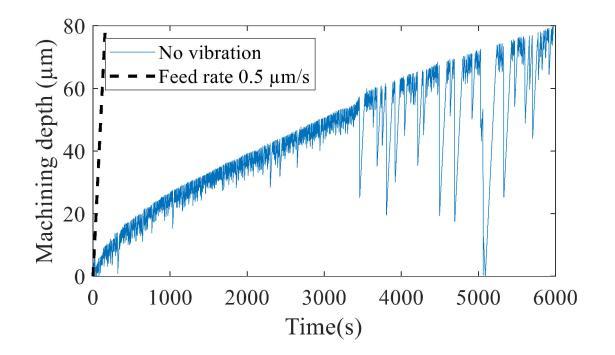
Figure 15. Tool feed without vibration and the parameters specified in Table 2.

The tool electrode feed with vibration over the machining time is illustrated in Figure 16. At a vibration with 3 μ m amplitude, the machining rate followed the feed rate to a higher machining depth than without vibration. Tool jump motion did not occur up to a machining depth of 30 μ m at 50 Hz and 400 Hz and up to 40 μ m at 1000 Hz. The machining rate progressed slower from that point on. The frequency of tool reciprocation increased with a higher machining depth but remained less frequent than without vibration, as seen in Figure 15.

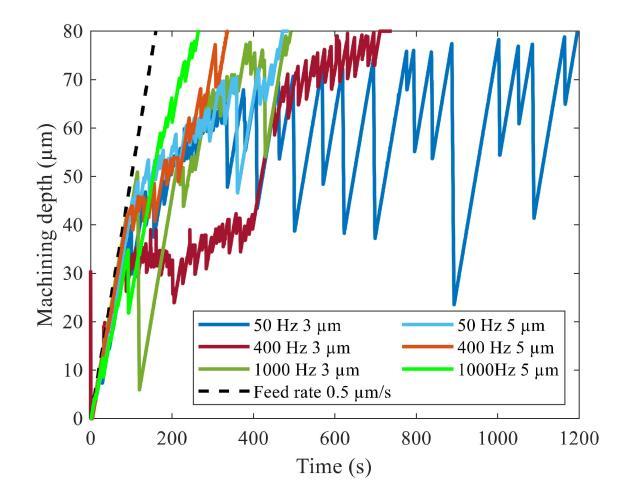
Figure 16. Tool feed with vibration and the parameters specified in Table 2.

The range of stable machining was further increased at a vibration amplitude of 5 μ m. Increasing tool jump motion was observed after a machining depth of 40 μ m at a vibration frequency of 50 Hz and 400 Hz. At 1000 Hz, tool reciprocation became more frequent after a machining depth of 55 μ m was reached. The jump motion was less frequent than at 3 μ m machining. The beneficial effect of tool vibration on the machining time is therefore attributed to better machining conditions that reduce the frequency of tool retraction.

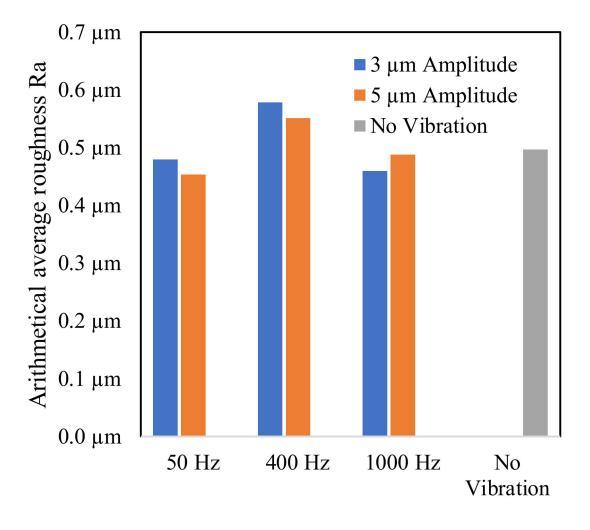
The arithmetic average roughness, Ra, of the array cavities was measured. Due to the small size of the cavities, a non-standardized measurement was performed. A scanning pitch of 0.5 μ m, a sampling pitch of 0.5 μ m, and a cutoff length of 0.25 mm were used. The mean value of the nine cavities of each array was calculated. As illustrated in Figure 17, machining with vibration at 50 Hz and 1000 Hz led to similar surface roughness to that without vibration. The surface roughness was slightly higher at 400 Hz vibration. In addition, as a general trend, a higher vibration amplitude decreased the surface roughness, except at 1000 Hz frequency.

Figure 17. Average roughness of the array cavities.

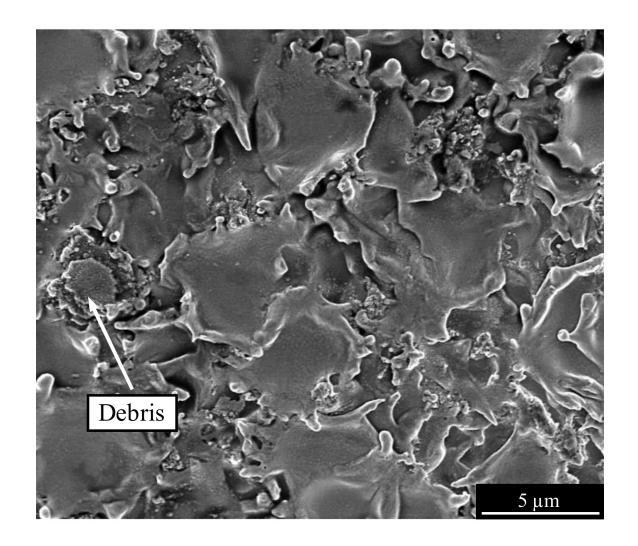
Figure 18 shows an SEM image of the workpiece surface machined without vibration. The surface is characterized by large flat craters without distinctive crater walls. The density of the discharge craters was low, and adhesion of debris particles was visible.

Figure 18. SEM image of the workpiece surface machined without vibration and the parameters specified in Table 2.

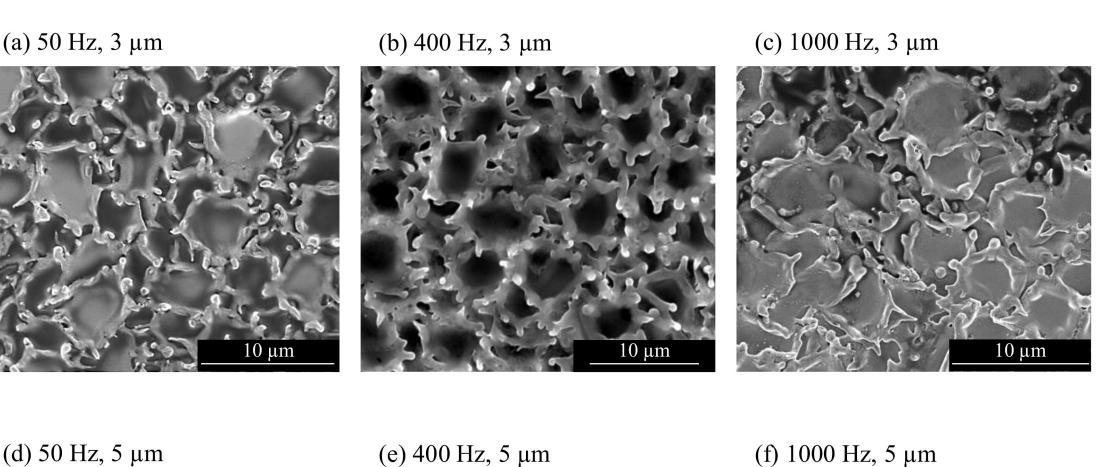
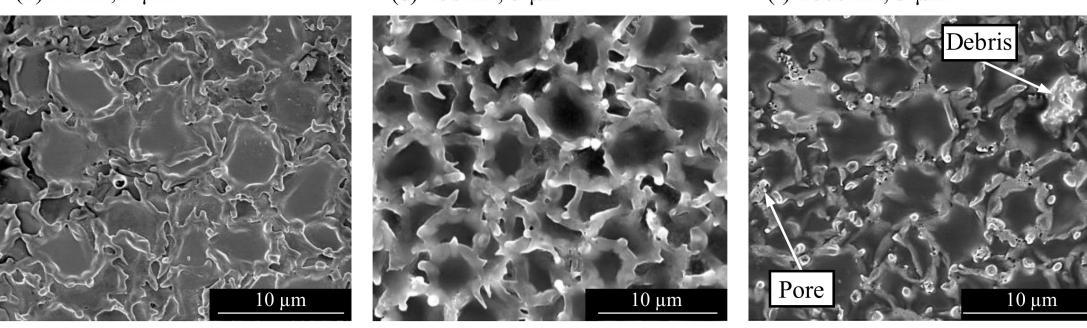
The SEM images in Figure 19 show the sample surfaces machined with tool vibration. Compared to Figure 18, the density of the discharge craters is higher, and the discharge craters are smaller but deeper. The SEM observation of the sample surface in Figure 19 revealed differences in the crater size and shape with different vibration parameters. At 50 Hz and 1000 Hz, the discharge craters appeared flat with thin walls. The surfaces machined at 400 Hz frequency in Figure 19c,d showed deeper craters. The thickness of the crater walls was higher, with more remolten material on the crater edges. The sample machined at 1000 Hz and 5 μ m in Figure 19f also showed a few adhered debris particles and porosity of the crater walls. This might have caused the higher roughness despite smaller crater depths compared to machining with vibration at 1000 Hz and 3 μ m.

Figure 19. SEM image of the workpiece surface with the parameters specified in Table 2. The vibration frequencies and amplitudes are: (a) 50 Hz, 3 μ m (b) 50 Hz, 5 μ m (c) 400 Hz, 3 μ m (d) 400 Hz, 5 μ m (e) 1000 Hz, 3 μ m (f) 1000 Hz, 5 μ m.

The observation of the workpiece surface and measurement of surface roughness indicated that the discharge craters changed with different vibration settings. As Wang et al. [33] reported, a higher amplitude of the electrode vibration can lead to a shallower crater depth as a result of a shift in the discharge plasma origin. This might be a reason for the decrease in surface roughness from 3 μ m to 5 μ m vibration amplitudes at the frequencies of 50 Hz and 400 Hz. Another reason might be that the crater density at a larger amplitude is higher, which causes more overlaps among the craters, and in turn, lower roughness.

A higher discharge energy can melt more workpiece material, resulting in a correlation to the crater size [34]. The variance of the crater size indicates changing discharge energy at different vibration parameters. This could result from a difference in the gap width. A changing gap width is also demonstrated by the increasing intensity of the discharges at higher frequencies. With a smaller gap width and high discharge intensity, the risk of debris adhesion is increased, which was observed on the workpiece machined at 1000 Hz and 5 μ m vibration. The workpiece machined without vibration provides evidence of a high concentration of debris in the gap, resulting in low discharge energy with small craters and a high probability of debris adhesion.

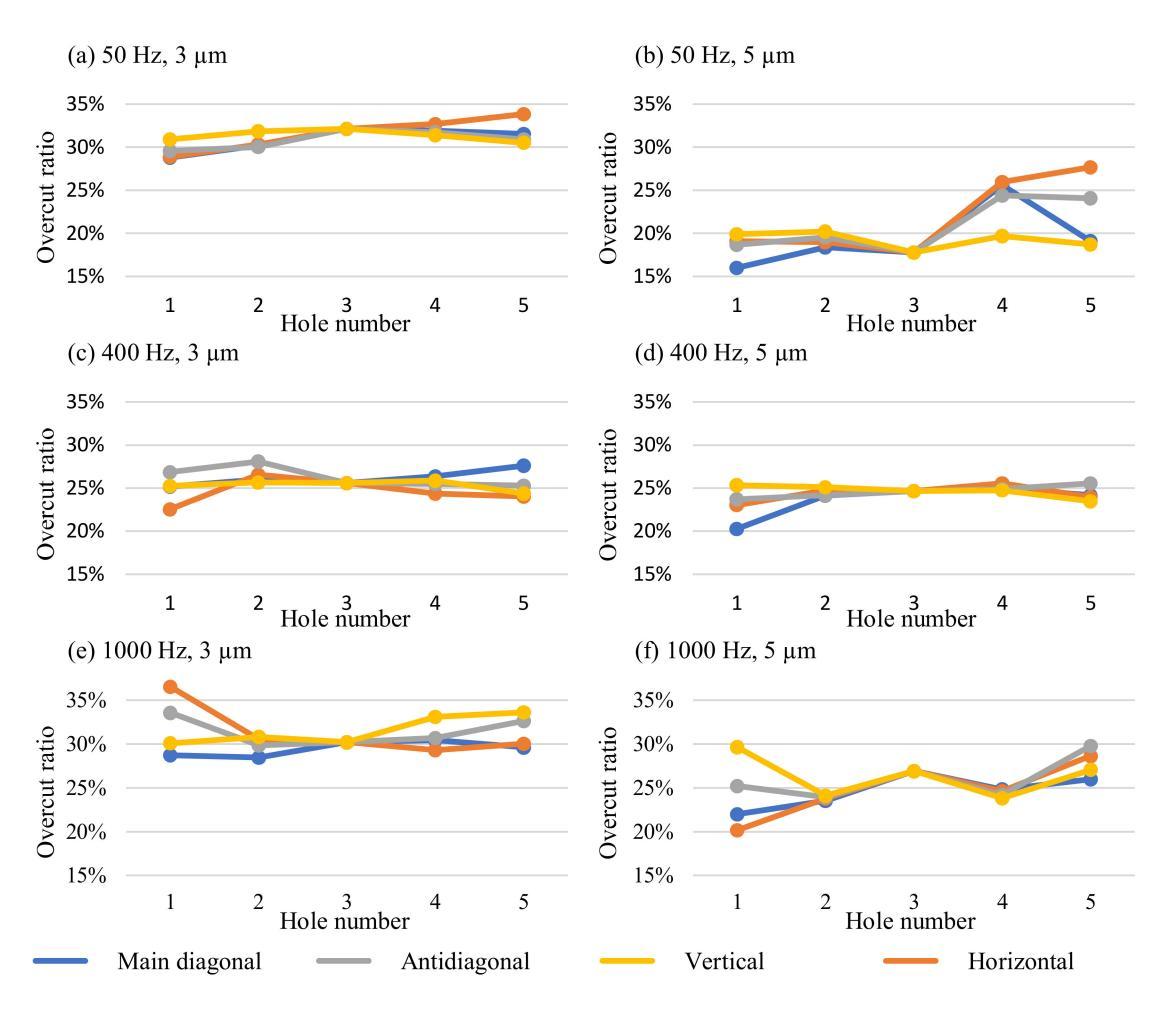
Figure 20 illustrates the overcut of the arrays. The evaluation was performed along the array's main diagonal, antidiagonal, horizontal, and vertical directions. It must be noted that the variance of hole number 3 is zero, as it represents the central hole along with all evaluation directions.

As illustrated in Figure 20a, the array machined at 50 Hz and 3 μ m showed a higher overcut in the center of the array, which matched the results of previous studies. A standard deviation of 1.31% from the mean overcut ratio of 30.95% was obtained. The overcut ratio at 50 Hz and 5 μ m was smaller, with a mean value of 21.31%. Linked to the decreased overcut ratio is a smaller gap width. This might explain the non-uniform overcut seen in Figure 20b as a cause of a more difficult debris removal through the smaller side gaps. The standard deviation of the overcut ratio was 3.47%. Machining at 400 Hz and 3 µm resulted in a mean overcut ratio of 25.48%. The values for the individual holes of the array machined at 400 Hz and 3 μ m are illustrated in Figure 20c. The irregularity of the overcut ratio was smaller than at 50 Hz and 3 µm vibration, as indicated by the standard deviation of 1.2%. At 400 Hz and $5 \mu m$, the best uniformity of the hole overcut ratio was achieved with a standard deviation of 1.09%. As demonstrated by Figure 20d, a uniform overcut in the center of the array and deviations with smaller overcut at the edges were observed. The mean overcut ratio was 24.23%. Figure 20e shows the overcut at 1000 Hz and 3 μ m. There was a high variance of the overcut ratio at the edges of the array, while the uniformity increased towards the center. This was also represented by the standard deviation of 2.13%. The mean overcut ratio of 31.28% indicated a higher gap width. A similar trend was observed at 1000 Hz and 5 µm, as detailed in Figure 20f. A scattered overcut ratio on the edges was recorded that caused a high standard deviation of 2.74%. As seen by the higher overcut ratio, the gap width increased towards the center. The variance of the overcut decreased likewise. A mean overcut ratio of 25.98% was obtained.

The higher overcut around the edges of the array was unexpected. One possible explanation would be that debris from the electrodes in the center is transported to the outside by the vibrating movement. The debris is sucked back in the holes at the edges of the array and leads to the increased debris concentration in these areas. In earlier findings, a larger hole diameter was attributed to bad debris flushing from the center holes of the array. Hole arrays machined at 400 Hz and 1000 Hz with 5 μ m vibration amplitude are compared in Figure 21. A higher variance of the hole diameter can be seen in Figure 21b.

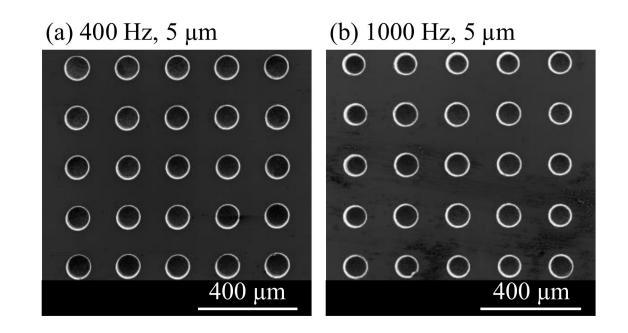
Figure 21. SEM images of 5×5 arrays (a) Machined with vibration at 400 Hz and 5 μ m amplitude (b) Machined with vibration at 1000 Hz and 5 μ m amplitude.

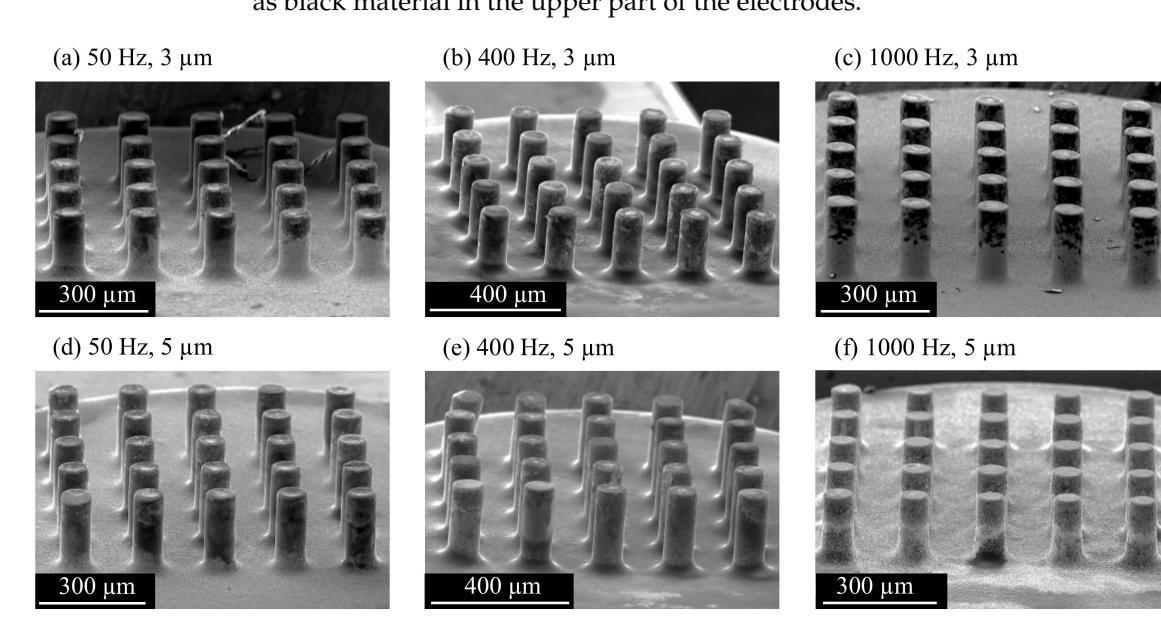
Figure 22. SEM images of the 5×5 array tools after use with the parameters specified in Table 2. The vibration frequencies and amplitudes are: (a) 50 Hz, 3 µm (b) 50 Hz, 5 µm (c) 400 Hz, 3 µm (d) 400 Hz, 5 µm (e) 1000 Hz, 3 µm (f) 1000 Hz, 5 µm.

The effects of wear were smaller on the array used at 400 Hz and 3 μ m vibration. As shown in Figure 22b, craters were formed on some electrodes, mainly in the center of the array. A similar amount of carbon and debris was deposited on the electrode surface. The array used at 1000 Hz and 3 μ m experienced less wear, as indicated by the sharper edges and flat electrode top faces in Figure 22c. Less material was deposited on the electrodes, leaving discharge craters visible. The tools used with a vibration amplitude of 5 μ m showed

a similar wear characteristic. High wear with craters in the electrode center was observed at 50 Hz vibration frequency in Figure 22d. Carbon and debris were deposited mainly on the electrode side faces, and the amount was smaller compared to the tool used at 50 Hz and 3 μ m. The tool wear was significantly smaller after machining at 400 Hz and 5 μ m, and no craters were formed on the electrodes, but a high build-up of material can be seen on the electrodes in Figure 22e. Vibration at 1000 Hz and 5 μ m resulted in minimal tool wear. The edges of the electrodes were only slightly rounded, and the top surface remained flat, as shown in Figure 22f. Very little debris and carbon was deposited on the side faces, but a layer of material formed on the top surfaces of the electrodes.

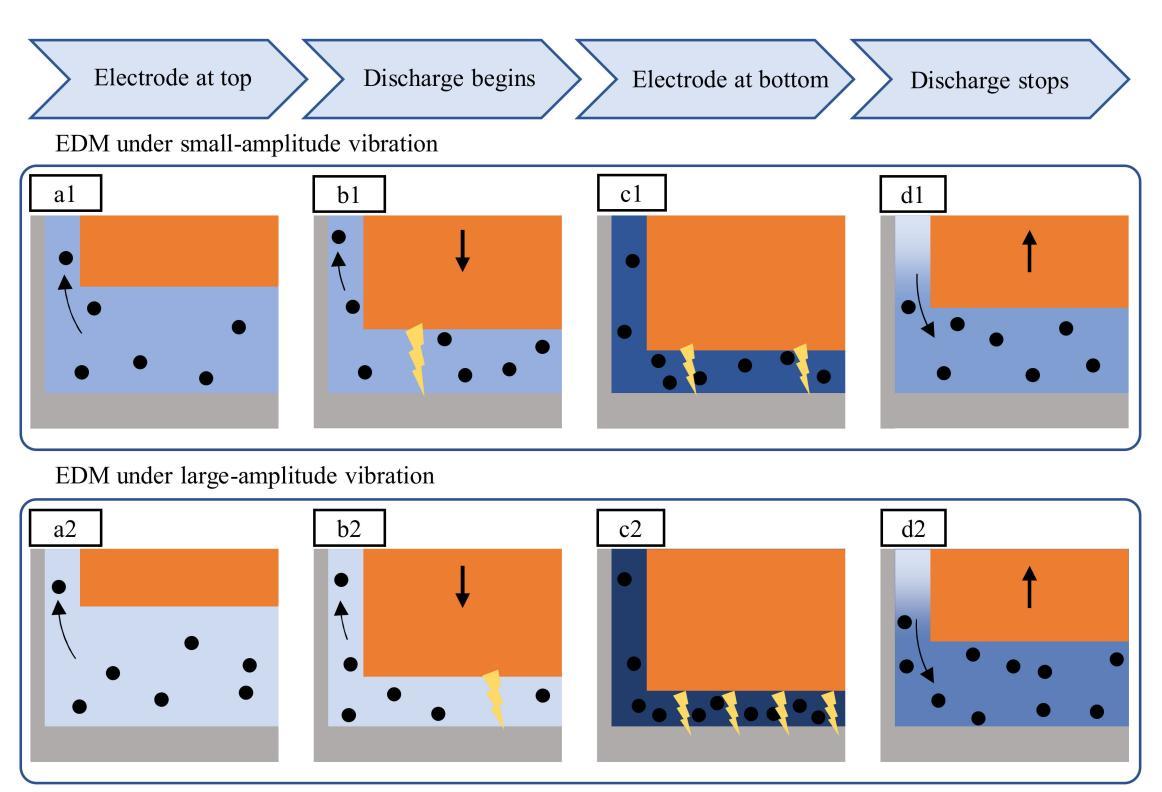
It was observed in this study that the discharge intensity increased with higher amplitudes. Figure 23 compares the interaction of debris and discharges over one vibration cycle at low and high amplitude vibration. Due to the flushing of debris formed in the previous vibration cycle, the debris concentration in the gap is low when the electrode is in the top position, as shown in Figure $23(a_1,a_2)$. It is assumed that more effective flushing at higher amplitudes contributes to a lower debris concentration in Figure 23(a2). Therefore, the dielectric breakdown strength is higher. The first discharge of the cycle at the higher amplitude in Figure 23(b2) occurs at a smaller gap width, compared to the lower amplitude seen in Figure 23(b1). This discharge forms new debris particles in the gap, and the debris concentration increases. The rising debris concentration leads to a reduced breakdown strength and facilitates more discharges. Due to the smaller fluid volume at the higher amplitude, the debris concentration in Figure 23(c2) is significantly higher than in Figure 23(c1). More discharges are triggered as a result of the drastically reduced breakdown strength. As these discharges also release new debris particles, a self-reproduction effect of the discharges is achieved. This situation promotes the overlapping of craters, leading to a decrease in surface roughness, as seen in Figures 17 and 19. When the tool electrode moves upwards, new fluid enters the gap and reduces the debris concentration. The discharge process stops when the tool electrode surpasses the critical breakdown distance to the workpiece, as seen from Figure 23(d1,d2).

(The color change of working fluid indicates the debris concentration changes)

Figure 23. Mechanism of the increase of the discharge intensity with a higher vibration amplitude. (a1) Electrode at top, (b1) discharge begins, (c1) electrode at bottom, and (d1) discharge stops under small-amplitude vibration; (a2) Electrode at top, (b2) discharge begins, (c2) electrode at bottom, and (d2) discharge stops under large-amplitude vibration.

The concentrated discharge phenomenon might occur when the debris concentration becomes extremely high towards the end of the regular discharge period. As a consequence of the very low breakdown strength, the concentrated discharge can continue while the regular discharge is stopped. The gap observation showed that the discharge concentration was more likely to subside with tool vibration before arcing could occur. This provides evidence that the discharge period is linked to the material removal rate, as the material removal rate benefits from a high discharge rate and low frequency of short-circuiting. The tool vibration parameters must be carefully selected to achieve the optimum machining conditions. If the frequency is too low, the discharge period will continue too long, and short-circuiting will occur. If the frequency is too high, fewer discharges per cycle will occur, and the machining efficiency is reduced.
