Article Wall Materials and Manufacturing Techniques for Korean Ancient Mural Paintings (Great Gaya, 6th Century)—Discovery of Shells Used in Wall Plaster and Identification of Their Processing Status

Abstract: This study used morphological analysis to identify the materials used for the wall plaster in the Goa-ri Tomb and elucidate the wall manufacturing techniques by determining the processing conditions for the plaster ingredients through a calcination experiment. A glossy nacreous layer (or folia layer) and an adductor muscle scar were identified on the ventral of the shell. The shell section was confirmed in the form of a lens-like prismatic layer (or chalky layer) inserted between the nacreous layer (or folia layer). The calcinated samples showed clusters of polygonal particles of different sizes. The experiment confirmed a process of particles in plate-type–bedded structures converting into shapeless particles followed by recrystallization. The samples calcinated at 650 °C and 750 °C mostly showed plate-type–bedded structures. According to the results of the study, the plaster used on the Goa-ri Tomb walls was confirmed to be made of oyster shells. The existence of many inco

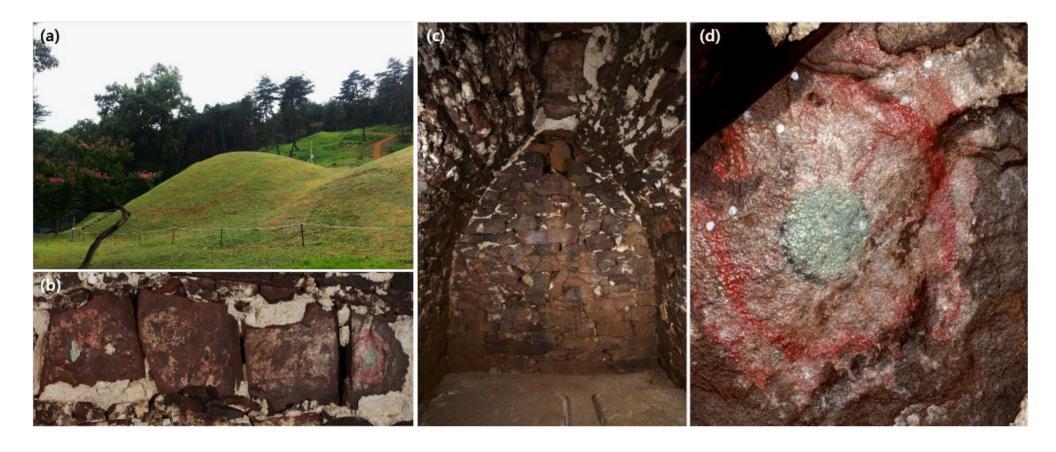
Figure 1. Overview of murals in the Goa-ri Tomb. (a) Outside. (b) Mural paintings of ceiling on burial chamber. (c) Status of burial chamber. (d) Mural painting details.

The Goa-ri Tomb is a stone chamber tomb in burial mounds discovered in 1963. The tomb walls are made of natural rocks covered with plaster, on which the murals were painted (Figure 1). Excluding the paintings on the ceiling and main chamber, most of the wall murals were missing at the time of their discovery [1,2]. According to previous literature, the plaster used on the mural walls was created by mixing inorganic materials. A chemical composition analysis showed that the materials were likely shell fragments [3,4].

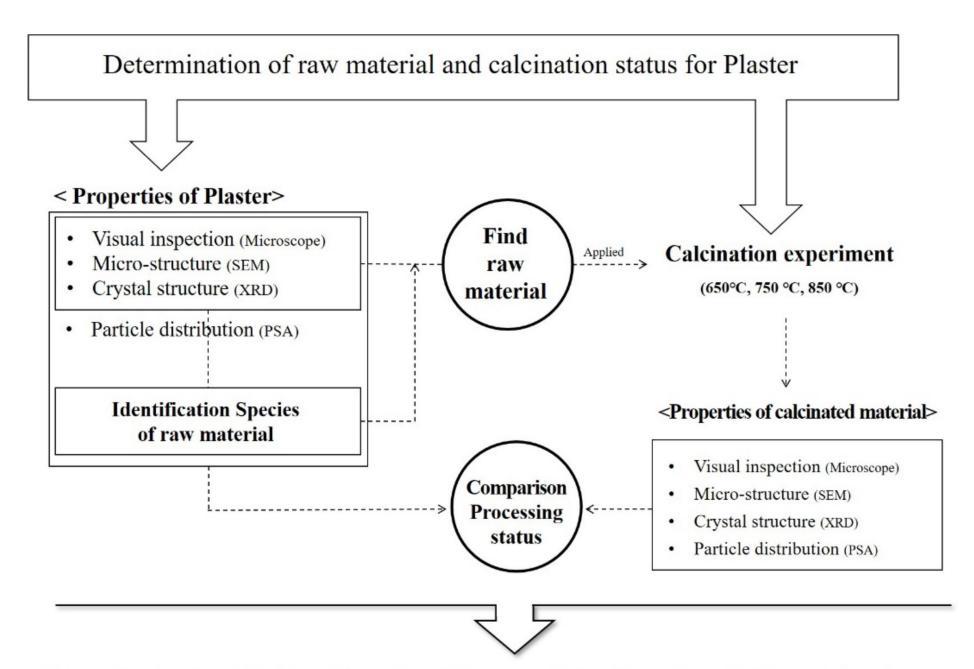
Figure 2. Flowchart of a research process for discovering wall manufacturing techniques.

Figure 2 describes the research process used to identify the wall-building techniques. First, the material characteristics and ingredients of the plaster used on the tomb walls were identified through chemical analysis. Then, the processing techniques for the plaster were identified by calcinating the ingredients and analyzing their physical properties.

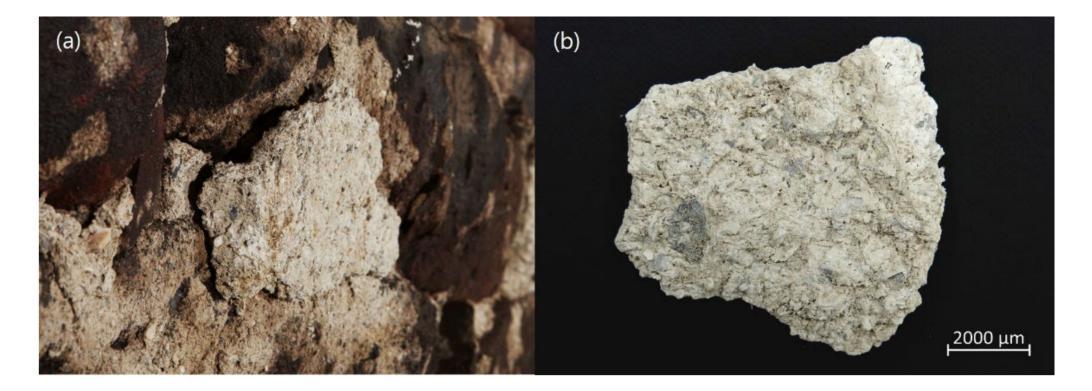
Figure 3. Plaster sample by control group: (a) Sampling points. (b) Plaster sample details.

Figures 3–5 and Table 1 show the samples used to identify the plaster ingredients and compare the processing conditions. These samples were collected from the western wall of the main chamber. The samples were grouped into fragments, presumed to be of shells, and fine powder.

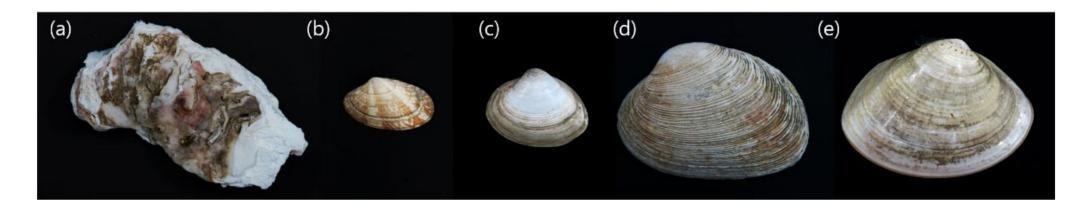
Figure 4. Shell samples for identification of materials by the experimental group: (**a**) CR-A (**b**) CR-B. (**c**) CR-C. (**d**) CR-D. (**e**) CR-E.

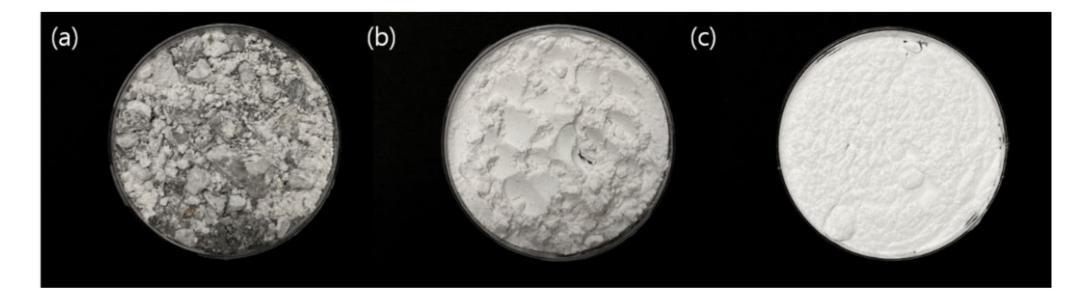
Figure 5. Calcinated samples by the experimental group: (a) CC6. (b) CC7. (c) CC8.

A naked-eye observation of each sample confirmed variations depending on the calcination temperature. The sample calcinated at 650 °C, maintained its shell shape after calcination and manifested a dark gray color. At higher temperatures, the samples lost their ability to maintain their shell shapes and showed whiter colors (Figure 5). The findings indicate a process where the organic materials in the shells are degraded and converted

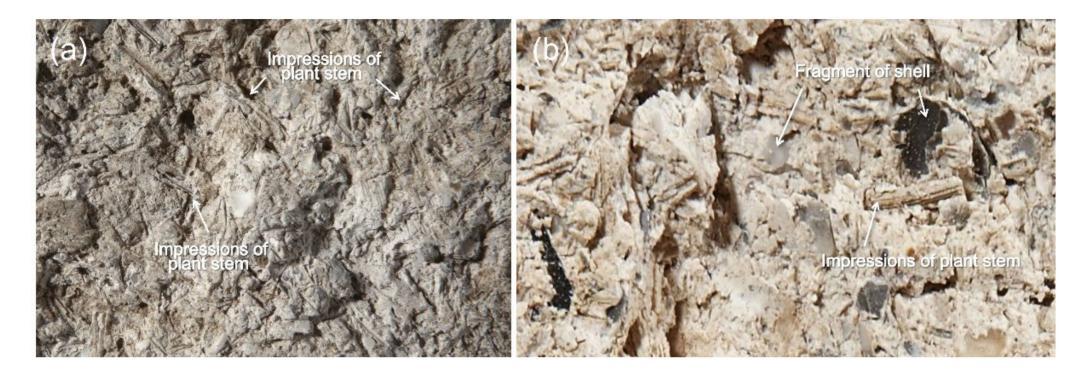
Figure 6. Surface of plaster: (**a**) Image of indentations, presumably caused by the surface of plant stems. (**b**) Image of gray fragments (like shell) mixed in the plaster.

The wall plaster used in the Goa-ri Tomb is made of white particles and does not contain sand. Semi-transparent crystalline materials with irregular shapes are mixed with black or gray fragments. The gray fragments mixed in the plaster vary in size, and some yellow fragments were also found. The plaster samples show many indentations, presumably caused by the surface of plant stems cut into 0.5- to 1 cm-long pieces (Figure 6).

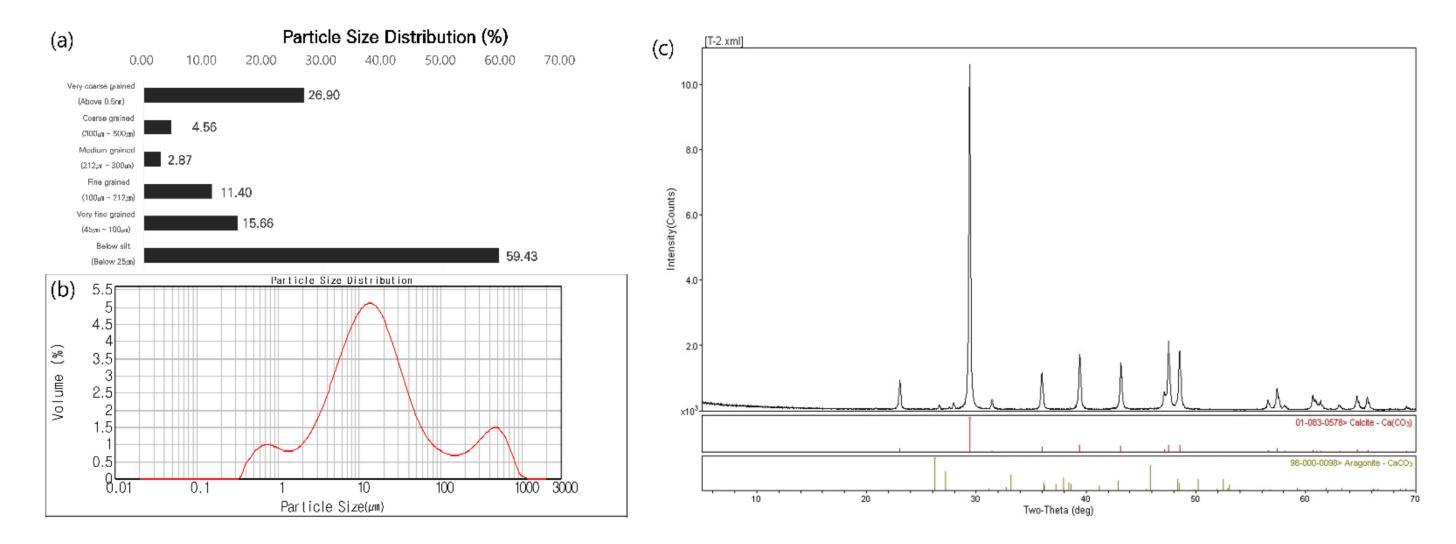
Figure 7. (a) Particle size distribution of plaster sieved using standard stainless sieves. (b) Graph of laser diffraction particle size analysis for plaster. (c) X-ray diffractometer (XRD) spectrum of plaster.

Figure 7a,b shows the particle distribution ratio of plaster. Particles of 0.2 mm or larger are estimated to be shells, and it is confirmed that they occupy about 45% or more. As a result of laser particle size analysis on particles of fine grain or smaller classified in the plaster, the ratio of less than 25 μ m was high, and the ratio of particles of 10–50 μ m was high compared to the ratio of particles of approximately 10 μ m or less.

For precise analysis of the materials consisting of the plaster, the samples were divided into possible shell fragments and aggregates of fine powder. An XRD analysis of the fragment samples (PF) and the fine powder aggregates (PFP) showed that the diffraction peak is 29.4° and 39.3°; thus, the main component was identified as calcite, mostly consisting of calcium carbonate (CaCO₃) (Figure 7c). The microstructures of the samples include polygonal, pillar-type, and plate-type structures of calcite particles aggregated in different sizes and shapes (Figure 8a). Most of the PF particles had sharp edges and showed bedded structures where the particles were stacked in long plates (Figure 8b). In particular, the PFP particles consisted of shapeless particles and polygonal particles in bedded structures. Those with bedded structures formed plate-type structures. However, they were observed to be in the process of changing into shapeless chunks with small surfaces (Figure 8c,d). The plate-type—bedded structures observed in the samples were found in organisms rather than minerals. The shapeless particles seem to have been created by recrystallization after decarboxylation caused by the calcination process.

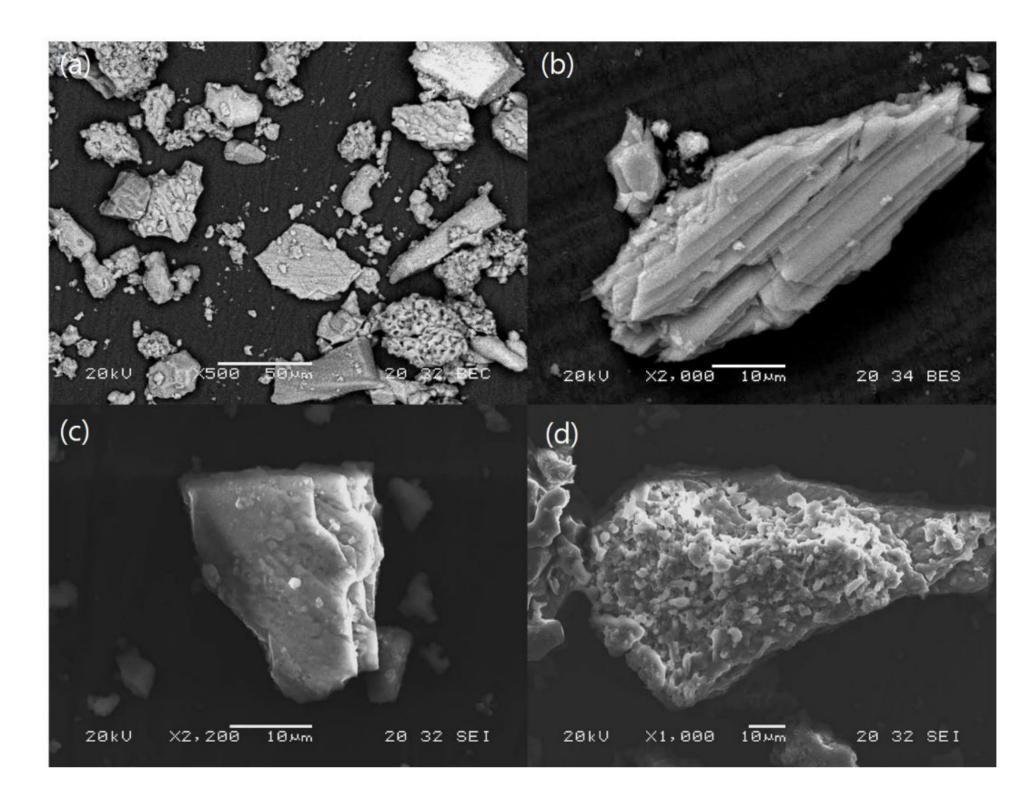
Figure 8. Scanning electron microscope (SEM) image: (a) Plaster. (b) PF. (c,d) PFP.

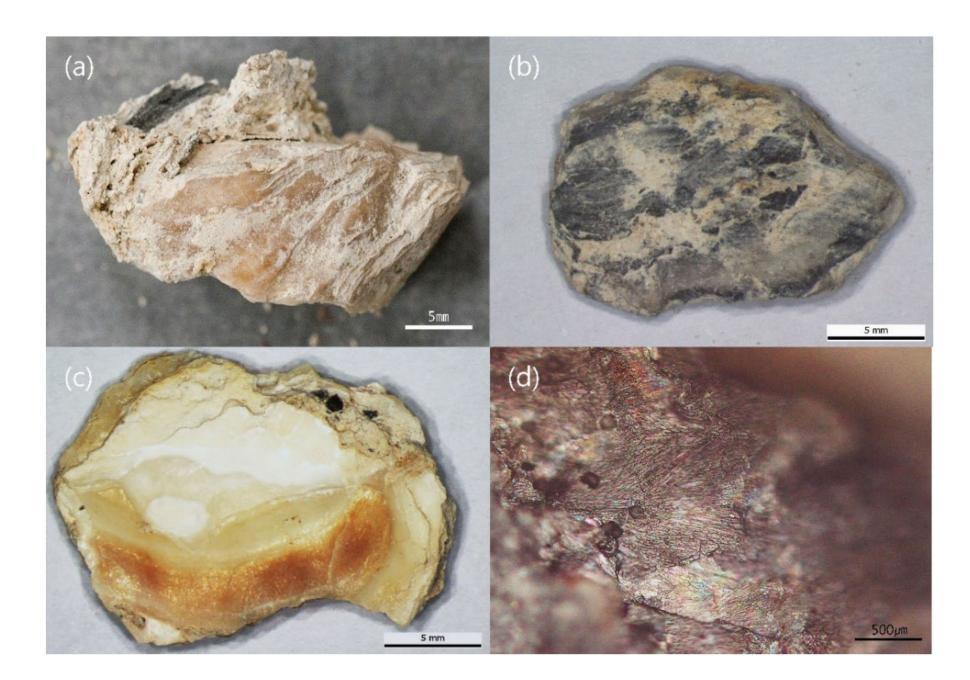
Figure 9. Sample details of shell fragment in plaster: (**a**,**b**) Surface of shell fragment. (**c**) Ventral of the shell. (**d**) Optical images of glossy area by chitinous substance in nacreous layer (or folia layer).

To identify the plaster material, the morphological classification of the shell fragments was performed. The layered structure of the foliar and the shape of the radial ribs in the shells suggest that they are bivalves [6] (Figures 9 and 10a). In general, to classify shells to the species level, the shape of the shell (accuration rate, expansion rate), the structure of the shell surface (existence of growth line or longitudinal rib), and the shape of the umbo should be considered [7]. However, it is not easy to classify samples lacking some morphological characteristics to the species level. Therefore, the characteristics appearing in the shells of plaster were compared with the characteristics of other shells.

A light brown layer is observed on the surface of the plaster shell sample. This is presumed to be the shell epidermis formed in the outermost layer of the shell. Under the shell epidermis, the prismatic layer (or chalky layer) and the nacreous layer (or folia layer) appear repeatedly (Figures 9a and 10a). As a result of observation after washing for

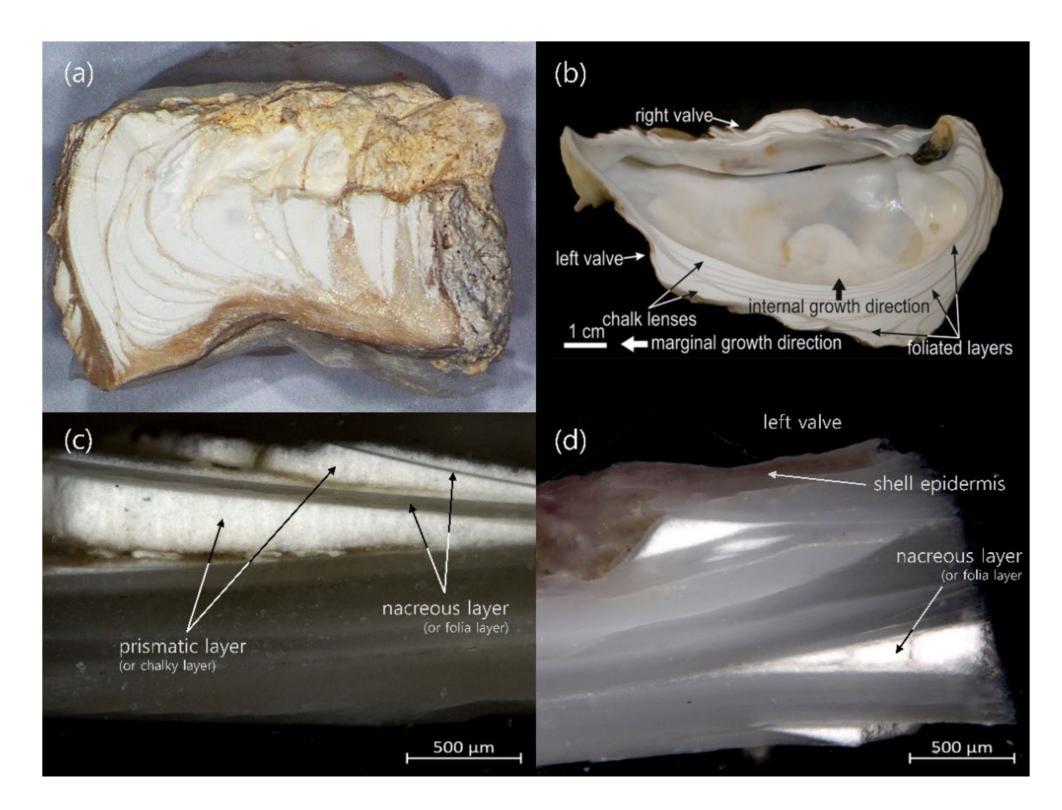
Figure 10. Comparison between the cross-section of shell fragments in plaster and oyster shell: (**a**) Cross-section of shell fragment in plaster. (**b**) Cross-section of oyster shell (Reprinted with permission from Ref. [8]. Copyright 2018, copyright Antonio, G.C et al., licensed under CC-BY 4.0. (**c**) Optical images of cross-sectional shell fragment in plaster. (**d**) Optical images of cross-sectional oyster shell.

a clear comparison of the shell, a glossy nacreous layer (or folia layer) and an adductor muscle scar were identified on the ventral of the shell. The shell section is confirmed in the form of a lens-like prismatic layer (or chalky layer) inserted between the nacreous layer (or folia layer). The prismatic layer (or chalky layer) is opaque and milky white, but the nacreous layer (or folia layer) appears as translucent yellow (Figures 9c,d and 10a). As a result of comparing the cross-sectional structure of other shells, it is confirmed that the characteristics observed in the shells of Goa-ri Tomb wall plaster are similar to those of the oyster shells (Figures 10 and 11). Therefore, the material used for the plaster is suggested to be of the family Ostreidae.

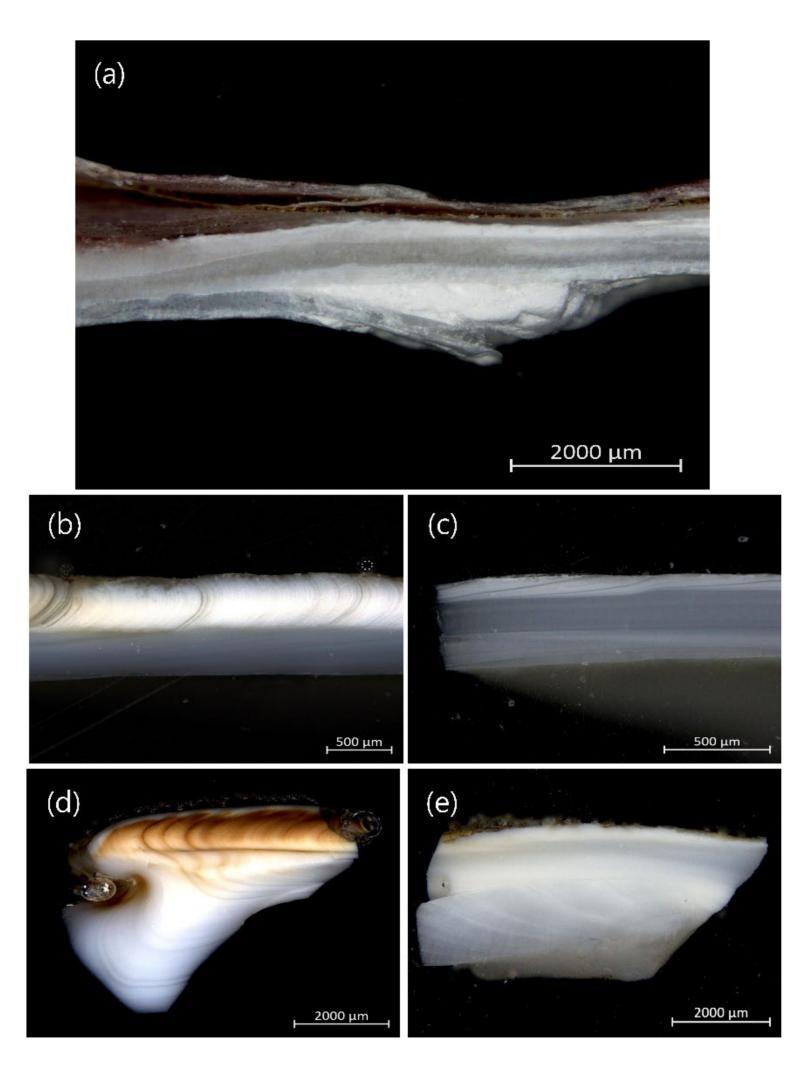
Figure 11. Optical images of cross-sectional sample: (a) CR-A. (b) CR-B. (c) CR-C. (d) CR-D. (e) CR-E.

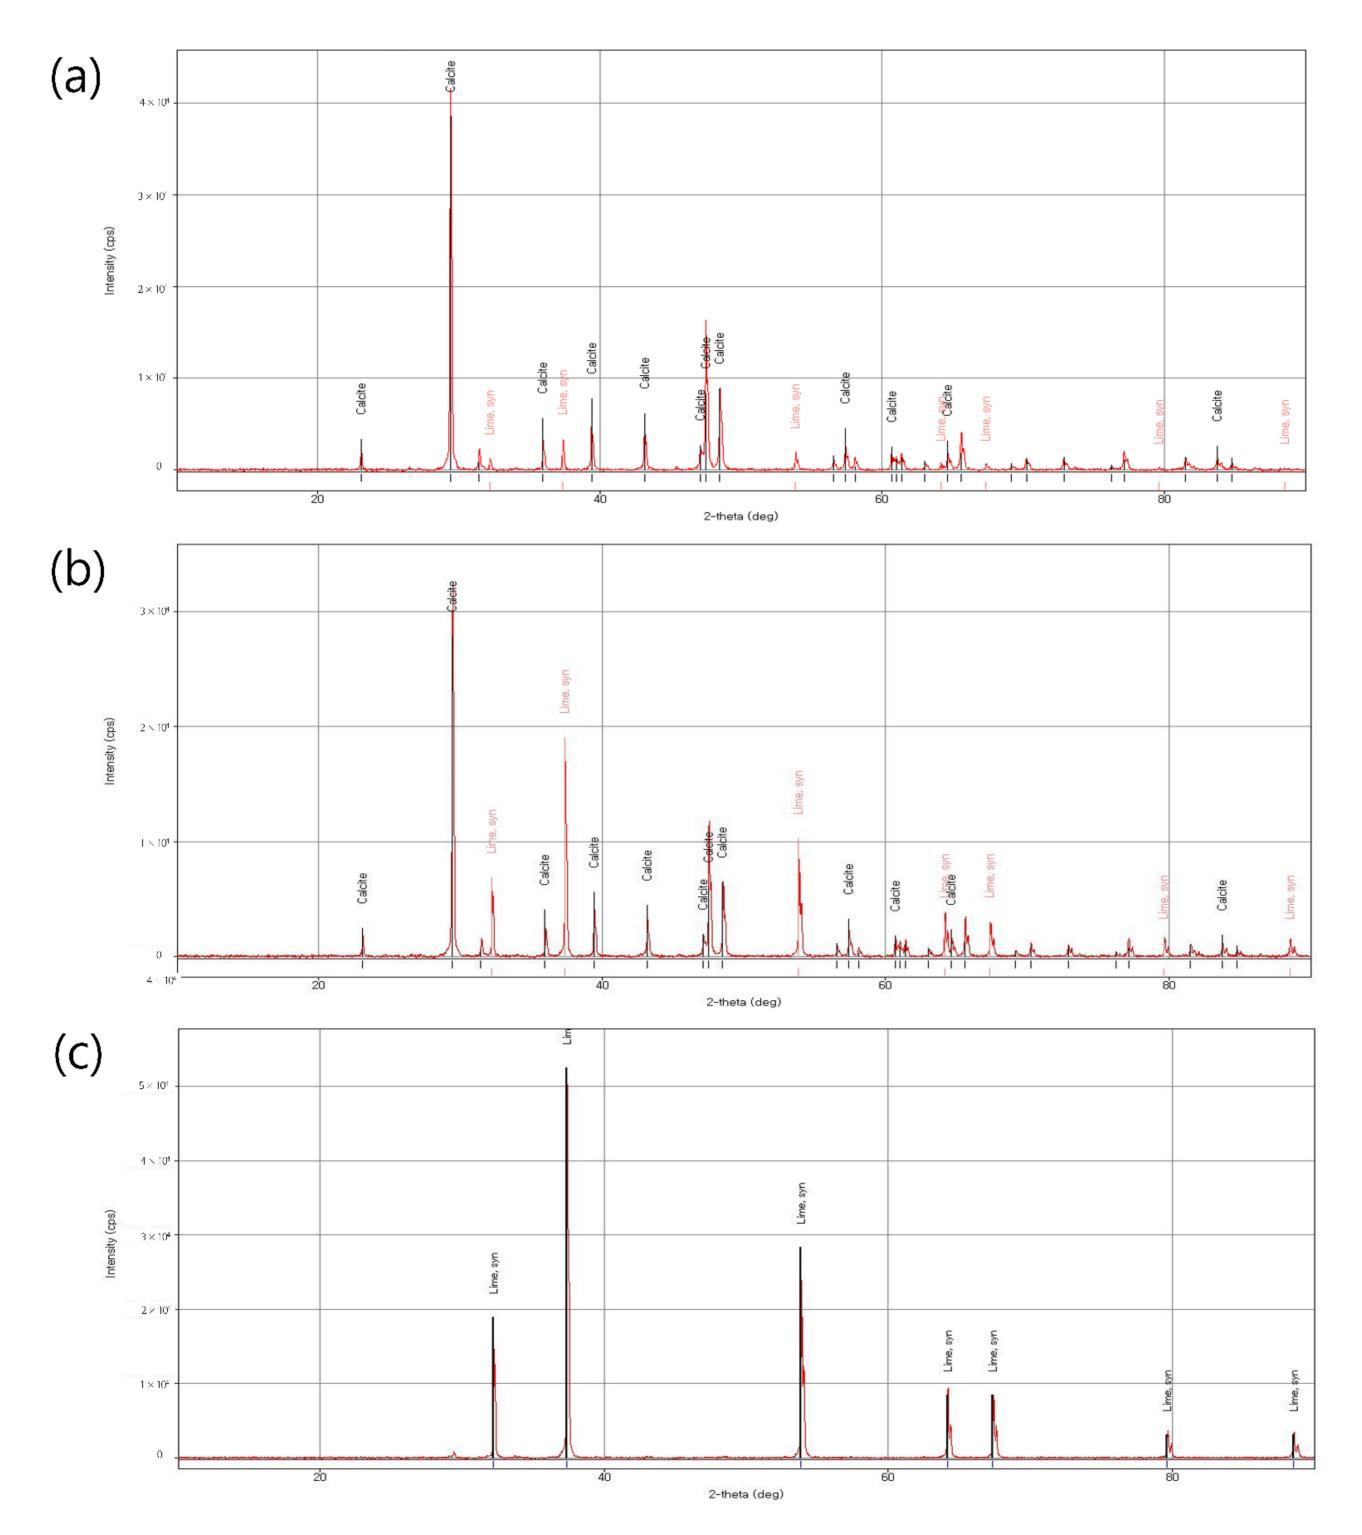
Figure 12. X-ray diffractograms (XRD) of calcinated samples: (a) CC6. (b) CC7. (c) CC8.

An observation of the crystalline structures at different calcination temperatures showed that the samples calcinated at 650 °C and 750 °C had crystalline structures of CaCO₃ and CaO. The sample calcinated at 850 °C only showed CaO structures. In contrast, the sample calcinated at 750 °C showed a higher peak strength for CaO and a lower peak strength for CaCO₃. The XRD spectrum of the samples indicates a process whereby the CaCO₃ in the shells is converted to calcium oxide at higher temperatures (Figure 12).

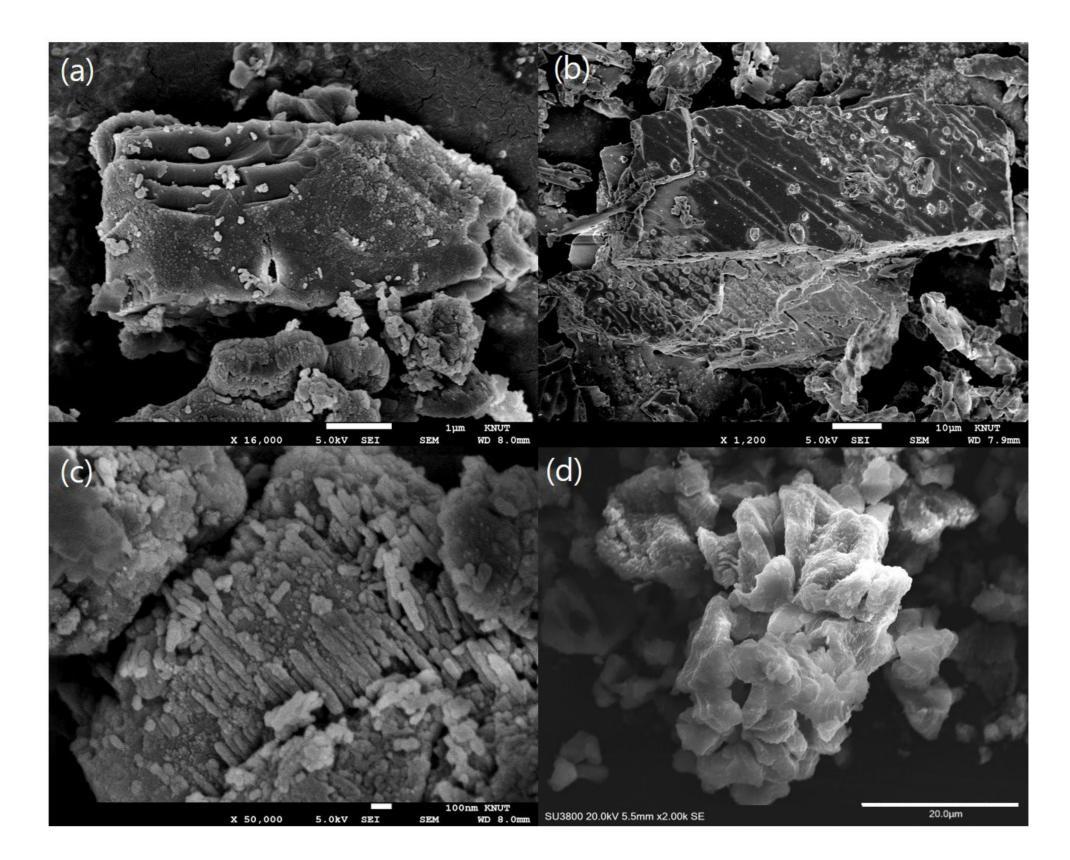
Figure 13. Scanning electron microscope (SEM) image: (a) CC6. (b) CC7. (c,d) CC8.

Based on these findings, the microstructures of the shell particles were observed. The calcinated samples showed clusters of polygonal particles of different sizes. The experiment confirmed a process of particles in plate-type–bedded structures converting into shapeless particles followed by recrystallization (Figure 13). The samples calcinated at 650 °C (CC6) and 750 °C (CC7) mostly showed plate-type–bedded structures, whereas the sample calcinated at 850 °C (CC8) had smaller shapeless particles with sharp edges.

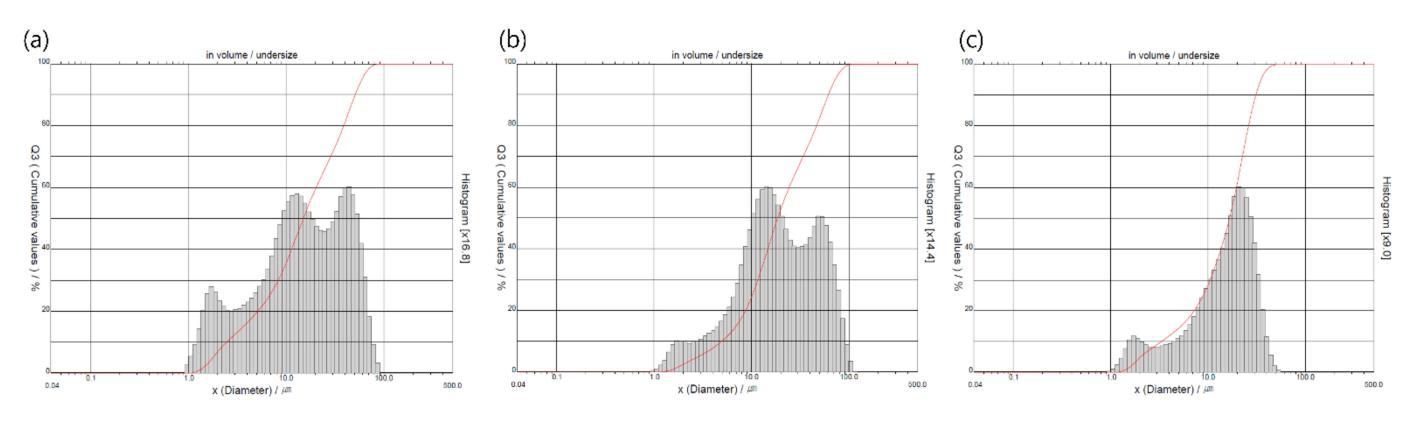
Figure 14. Particle size distribution graphs: (a) CC6. (b) CC7. (c) CC8.

The distribution of particles constituting the smaller than the fine-grained size of shells was identified at different calcination temperatures (Figure 13, Table 2). The particle size distribution graph of the samples calcinated at 650 °C and 750 °C showed a bimodal distribution, and the graph of the sample calcinated at 850 °C showed a unimodel distribution. It was confirmed that the mean diameter (D50) and the volume moment mean (D [3,4]) tended to decrease as the calcination temperatures increased (Figure 14). The results reflect changes in particle structure and size according to the change in calcination temperature, and are confirmed to be similar to previous studies that the specific surface area of shells decreases due to sintering during heat treatment [9,10].
