# Article Damage Monitoring of Composite Adhesive Joint Integrity Using Conductivity and Fiber Bragg Grating

Chow-Shing Shin \* D and Liang-Wei Chen

Department of Mechanical Engineering, National Taiwan University, No. 1, Sec. 4, Roosevelt Road, Taipei 10617, Taiwan

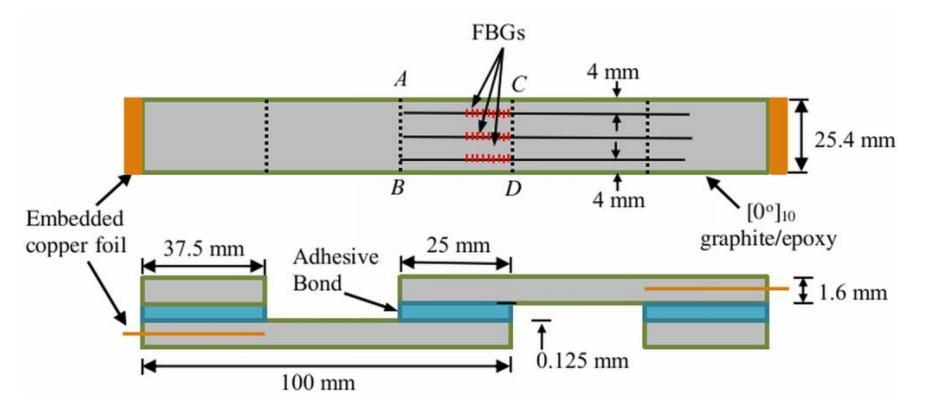
Figure 1. Dimensions and layout of the single lap joint specimen.

100 mm  $\times$  25.4 mm strips were cut from a 220 mm  $\times$  220 mm 10-ply uni-directional graphite-epoxy laminate. Single lap joint specimens with dimensions shown in Figure 1 were fabricated by gluing together two strips with conductive epoxy resin. The fiber direction in the composite is along the loading axis. Copper foil was pre-embedded at the end of the composite strips to allow for conductivity measurement. The areas to be joined were sanded, and masking tape was applied to the immediate vicinity beyond the boundary of the joint area. The purpose of the tape was to prevent excess glue from forming additional but unpredictable adhesion between the two parts. Excess glue is difficult to clean off thoroughly, especially with the optical fibers in place. Three optical fibers were embedded in the joint as spacers. The bond line was approximately as thick as the diameter of the optical fiber, i.e., 125 μm. In some of the specimens, there were FBGs in the optical fibers to act as sensors. The FBGs on the right, middle, and left sides are designated FBGL, FBGM, and FBGR, respectively. Stress analysis of single lap joint [75] indicated that for each of the stress components, stress concentration occurs right at or very close to the longitudinal edges of the joint (AB and CD in Figure 1). These will therefore be the most likely locations for initial damage and debonding to occur. Previous work [76] showed that an FBG along the loading direction straddling the longitudinal joint edge is more sensitive than other configurations in detecting joint damage. As the FBGs cannot cover the whole joint length, they were placed on one side of the joint so that their endpoints were slightly outside one longitudinal edge of the joint (see Figure 1) to stand a better chance of detecting damages.

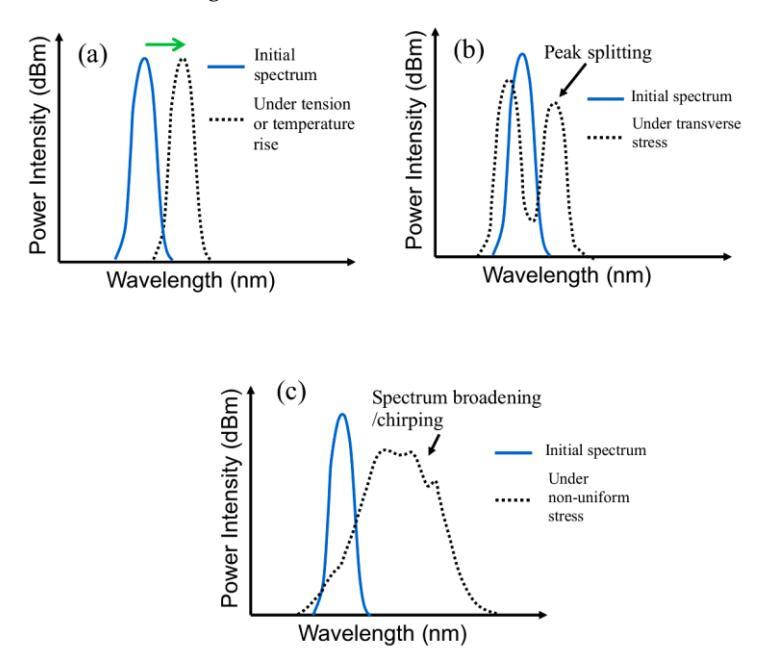
**Figure 2.** Schematic diagram to show FBG spectrum changes under (**a**) tensile stress or temperature rise, (**b**) transverse stress, and (**c**) non-uniform stress along its length.

Temperature change will change  $\Lambda$  and n, respectively, through thermal expansion/contraction and the thermo-optics effect [77]. For a freely standing FBG, this will lead to a shift of the whole reflected spectrum, such as that shown in Figure 2a. Typically for an FBG with  $\lambda$  = 1550 nm, a 1 °C rise shifts the spectrum by approximately 10 pm towards the longer wavelength. The above effects will superimpose if both temperature change and mechanical stress are applied to the FBG. When a compressive strain or a

drop in temperature occurs, the spectrum shifts in the opposite direction towards the shorter wavelengths.

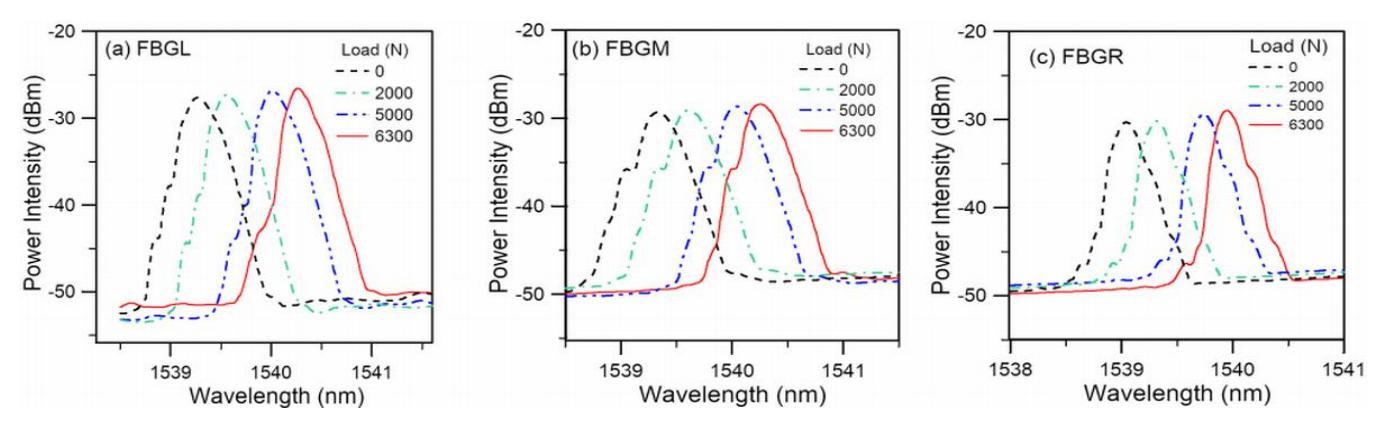
Figure 3. FBG spectra at various loadings in a typical tensile specimen.

Figure 3 shows the spectra from the three FBGs in a typical tensile specimen under different loading. With progressively increasing load, the spectra shift towards longer wavelengths. Only slight changes in the spectrum shapes are evident up to 6300 N. This was the load after which the last spectra were recorded before failure and corresponding to approximately 95% of the failure load.

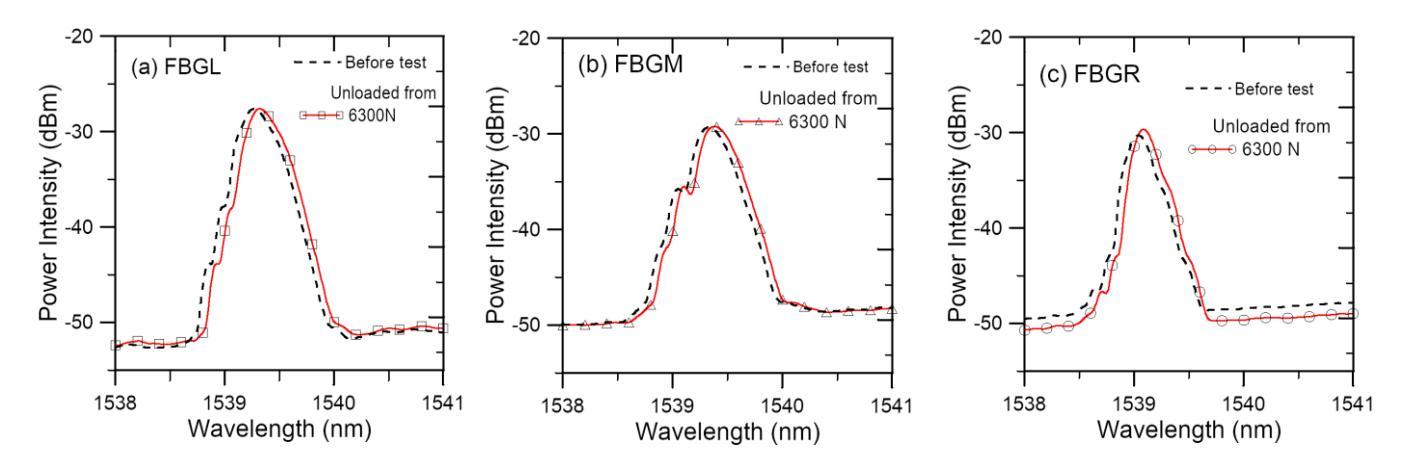
**Figure 4.** Load-free spectra measured after progressively loading up to 6300 N (~95% of failure load) in a typical tensile specimen.

To isolate any contribution of joint damages from that of applied load on the spectral shapes, load-free FBG spectra were measured on unloading after progressively loading up and are shown in Figure 4. Only the initial spectra and the last spectra measured before tensile failure are shown for clarity. The intermediate spectra during the course of loading lay between these two extremes and changed very little. In each of the spectra from the three FBGs, a slight shift to the longer wavelength is evident. However, the shape of the waveforms remained nearly unchanged. This trend was observed in 21 out of 24 FBGs. In these FBGs, not only the fully unloaded spectra but also the spectra measured on unloading to 400 N exhibited the same phenomena. Of the remaining three FBGs, one showed a progressively deformed waveform and the other two showed increasing background intensity, which gradually masked the peak. A shift in the peak wavelength with an unchanged waveform shape suggests that some uniform permanent tensile deformation has occurred, while the original strain distribution along the FBG has not been disturbed. The latter implies that any internal damages, if occurred, have not been serious enough to cause local stress concentration to perturb the strain field along the FBG.

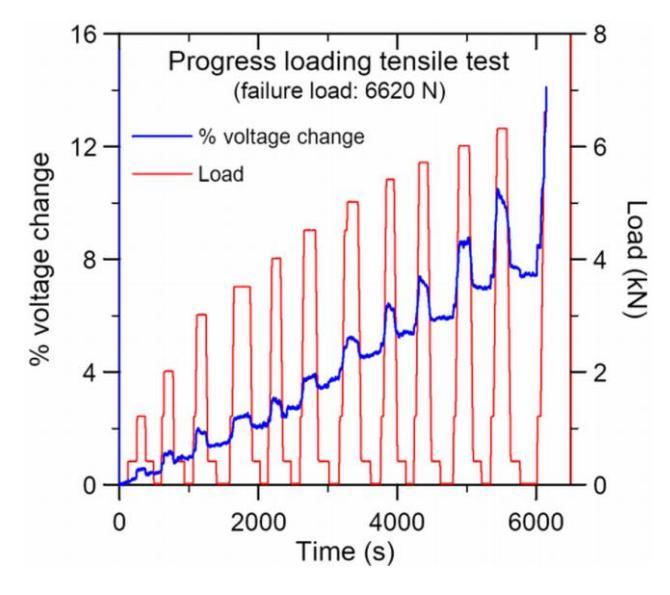
Figure 5. Percentage voltage change on progressive loading up and unloading.

The percentage voltage changes during the progressive loading up and unloading of the above specimen is shown in Figure 5. It is clear that not only does the voltage drop and thus the resistance of the lap joint specimen increases with load, but also that part of the increase is irreversible. The latter is evident from the percentage voltage change after unloading to 400 N and 0 N in each loading–unloading cycle. This trend was observed in 22 out of 25 tensile specimens. The remaining three specimens showed fluctuation within  $\pm 1\%$  changes toward the end of the tests. Of those showing an increasing resistance with load, the load-free percentage change in voltage after unloading from 95% of the failure load varied widely from approximately 3% to 30%, with an average of 7%.

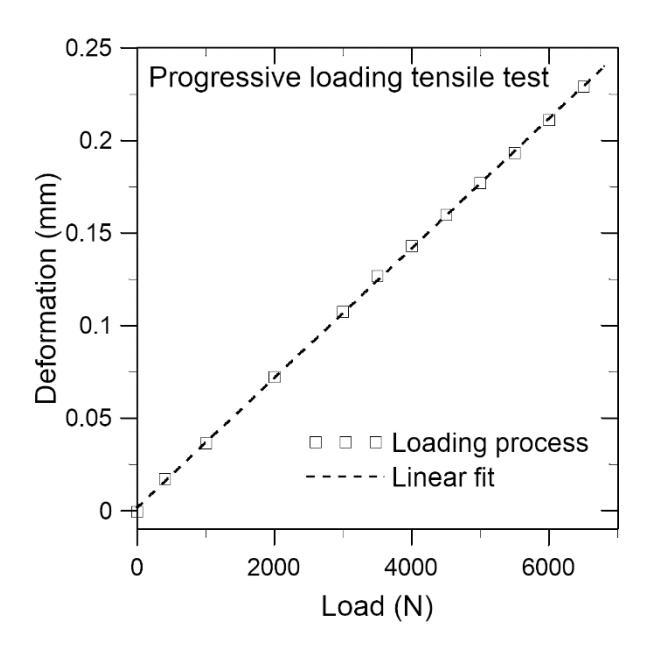
Figure 6. Specimen elongation versus maximum load for each progressive loading cycle.

A graph depicting the specimen elongation against the maximum load at each progressively loading-up cycle (Figure 6) shows that the data points virtually lie on a linear fit up to 98% of the failure load. This suggests that the deformation is essentially elastic. The corresponding peak shifts of the unloaded spectra of the three embedded FBGs, which are much more sensitive deformation sensors, corroborated with this induction. They recorded small permanent tensile strains of 40–60  $\mu\epsilon$  after various loading cycles in this specimen. From Figure 6, a deformation of 60  $\mu\epsilon$ , or 0.0015 mm out of the 25 mm long adhesive joint, corresponds to an applied load of approximately 40 N. Figure 5 shows that the voltage changes by 0.52% under 1200 N. Thus, a loading of 40 N, or deformation of 60  $\mu\epsilon$ , by itself should only lead to a negligibly small conductivity change. Therefore, the observed 7% voltage change after unloading from 95% of the failure load may be attributed to damages inside the joint.

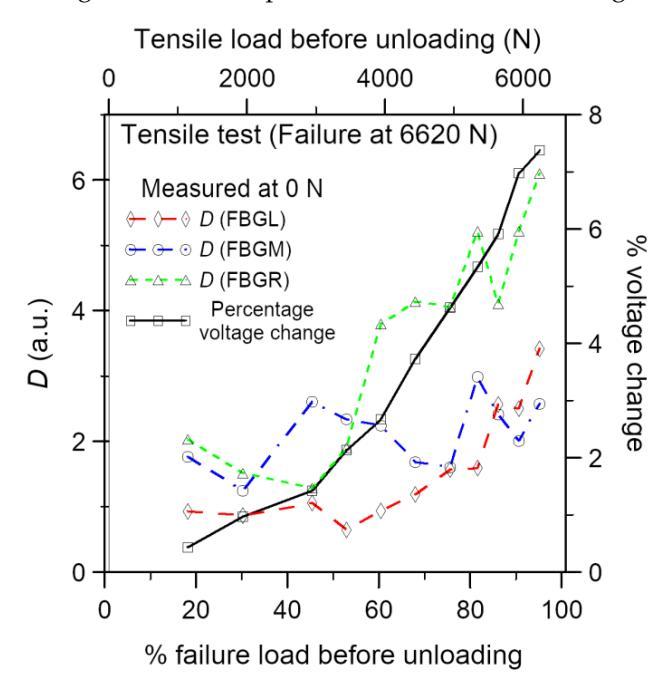
**Figure 7.** Load-free percentage voltage change and the three FBG spectra against the maximum load of the loading–unloading cycle.

To compare the results of damage sensing by the FBGs and conductivity changes, the distortion in the load-free FBG spectra after progressive loading has been quantified with the *D* value proposed above. Figure 7 shows these load-free *D* values and percentage voltage changes at zero load against the previous maximum load reached in the loading–unloading cycle. On progressively loading up, the percentage voltage change increases monotonically to approximately 7% near specimen failure. The *D* value for the FBGR spectra closely follows the same trend. The rising trend of the *D* values from FBGL starts somewhat later at approximately 50% of the failure load. That of FBGM fluctuates and shows no clearly increasing trend. The differences among the three FBGs may be caused by different amounts of localized damage near the corresponding FBG. The *D* values involved range from 1 to 6. As noted in Figure 4 above, these correspond to barely discernible changes in the FBG spectra, and the internal damages involved are believed to be small.

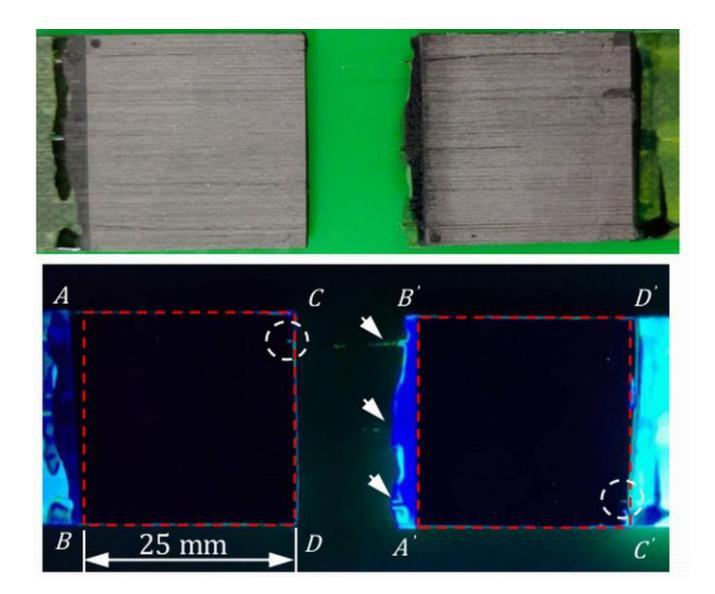
**Figure 8.** Fractured adhesive joint observed under visible light (**top**) and UV light (**bottom**) after fluorescent penetrant treatment.

In two of the progressively loaded tensile specimens, tests were interrupted after loading up to close to the failure load. The specimens were soaked in fluorescent penetrant, baked dry thoroughly, and pulled to failure. Figure 8 shows the fracture surfaces on the two halves of an adhesive joint specimen lying side by side under visible and ultraviolet light in a dark environment. This specimen was loaded to 5820 N (92% of the batch tensile strength) before soaking in the fluorescent penetrant. The maximum D values recorded among different FBGs was 7, and the percentage voltage change was 5% just before penetrant treatment. The red dotted squares in Figure 8 are the boundary of the joint. Alphabet pairs such as A & A' represent the same points in the original lap joint specimen. The bright green color outside the joint boundary is the remnant of the dried penetrant. As pointed out above, maximum stress and deformation occur at both longitudinal edges AB and CD, which are the most likely place to find indications. Within the joint boundary, everywhere except inside the white dotted circle showed no fluorescent indication. Inside the white dotted circle, a straight-line indication approximately 1 mm in length can be seen on corresponding locations on both halves. The shape of this indication is not typical of micro-cracking or debonding failure. Incidentally, this is the location of one of the optical fibers (indicated with white arrows) and may be the result of a small lack of bonding under the optical fiber. The above observations show that at a load that is above 90% of the failure strength, the joint was still largely intact. Essentially, the same phenomena were observed in another similarly treated specimen. The above observation corroborates the phenomenon that the characteristic FBG waveform remained virtually unchanged in shape, even when close to the failure load. We may tentatively assume that D values below 7 and a percentage change of voltage within 5% are associated with insignificant internal damages and no debonding.

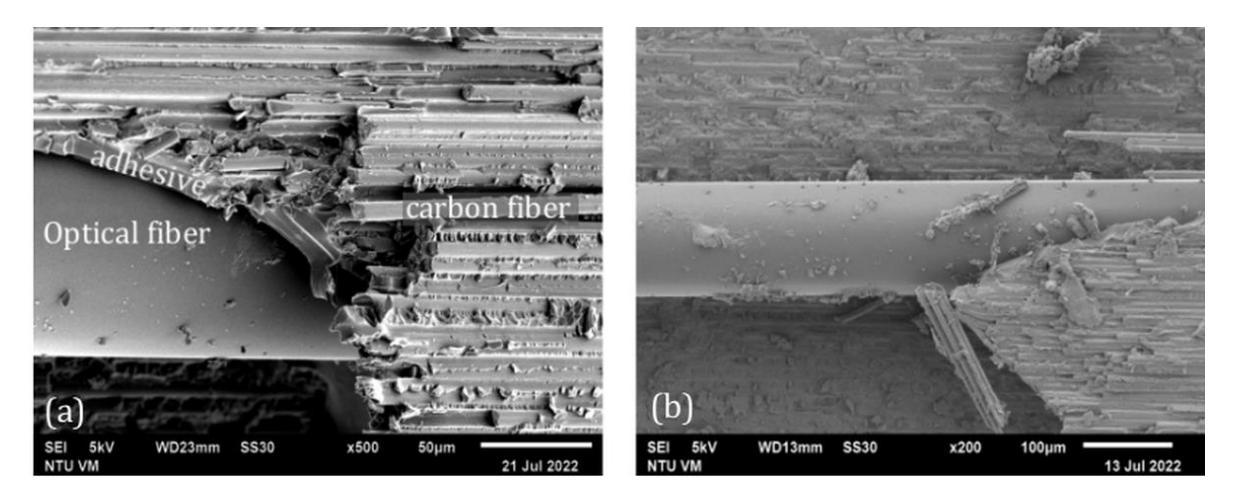
**Figure 9.** Typical SEM fractographs from two progressively loaded tensile specimens. (**a**) higher magnification; (**b**) lower magnification.

Typical scanning electron microscope (SEM) fractography for two different tensile specimens is shown in Figure 9. Dominating the fracture surfaces are carbon fibers, with epoxy resin between the fibers. Final failure clearly occurred in the carbon fiber epoxy composite adherent close to the adhesive–composite interface. Apart from occasional debris, the surface of the optical fibers is very smooth without any remnant adhesive attached. On the left micrograph, a thin layer of epoxy adhesive can be seen between the optical fiber and the composite adherent. This layer of adhesive appears to have been debonded from the optical fiber. Interfacial bonding between the optical fiber and the epoxy

adhesive is probably relatively weaker than the adhesive, leading to cleavage at the optical fiber-adhesive interface during failure. This is in marked contrast to the SEM fractographs in our previous paper [46], which shows that the optical fiber is fully covered with adhesive after failure. Cracking and deformation of this attaching adhesive can be seen all over the optical fiber exterior. The reason for this difference may be that the CNTs added for conductivity purposes may also have reinforced the epoxy to make the adhesive stronger. The inferior adhesive strength to interfacial strength in Ref. [46] facilitated extensive microcracking and fracture in the adhesive, while the adhesive was still well bonded to the optical fiber. Localized strain concentration and perturbation due to internal damages in the vicinity of the optical fiber is easily transferred to the grating. This explains the early and significant changes in the unloaded FBG spectrum shapes after approximately 70% of failure strength in Ref. [46]. In the current case, the stronger reinforced adhesive probably limited its own micro-cracking and so the FBG spectra remained unchanged in shape, even beyond 90% of the failure load. Better adhesive strength also corroborates the lack of debonding fluorescent indication along the longitudinal edge.

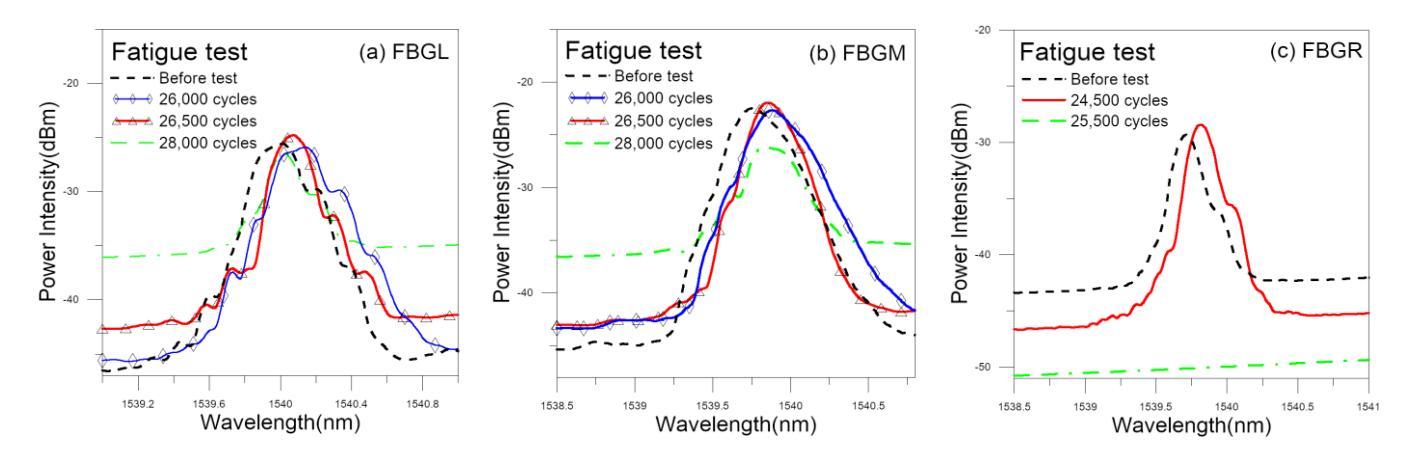
Figure 10. Load-free spectra measured in a typical fatigue specimen after various loading cycles.

A number of specimens have been subjected to cyclic loading, with the spectra of the embedded FBGs monitored periodically. Again, FBG spectra were recorded with the specimens unloaded to 400 N and 0 N. Figure 10 shows some of the spectra from a typical fatigue specimen. During the initial loading cycles, the waveform mainly shifts gradually to the right, with nearly no change in shape. When the specimen is getting close to final failure, marked changes in the waveform shape of the spectra start to occur. The starting point for this change varies with specimen, but in general it occurs after 80% of fatigue life has elapsed. Figure 11 shows the spectral shape changes quantified in D value. For FBGL and FBGM, the waveform shape starts to change significantly at 26,000 cycles, or 91% of fatigue life. Their D values remained below 5 before this and rose sharply afterward. For FBGR, the intensity of the spectrum increased at about 20% of fatigue life without significantly changing in the waveform shape. This persisted to 24,500 cycles, or 86% of life. The reflected peak disappeared in the next measurement. This makes the D value jumps to above 10 at the beginning and stays between 8 and 14 for the rest of life until the disappearance of the FBG spectrum at 25,500 cycles. It is not clear whether the above phenomena are due to a malfunction of the optical fiber or the effect of localized damage in the joint. The majority of FBGs (30 out of 35) behave in a similar way as FBGL and FBGM.

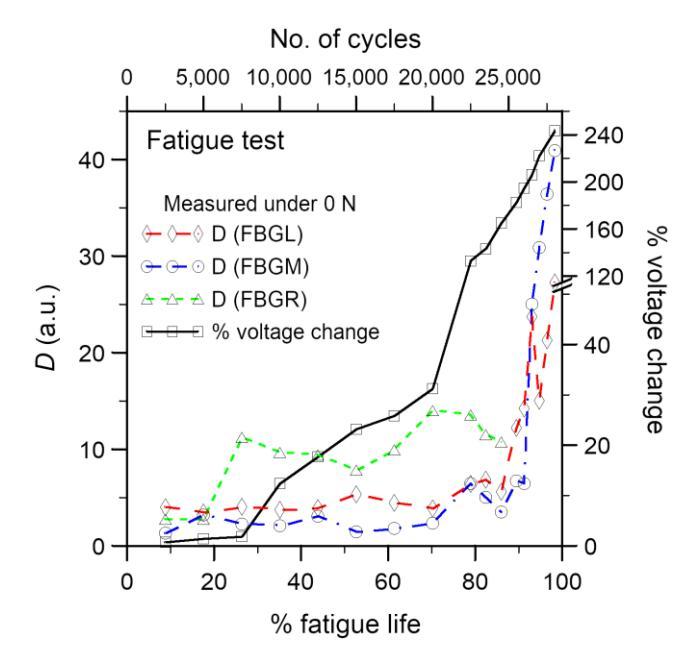
**Figure 11.** Load-free *D* values from three FBGs and the percentage voltage change development in a typical fatigue specimen.

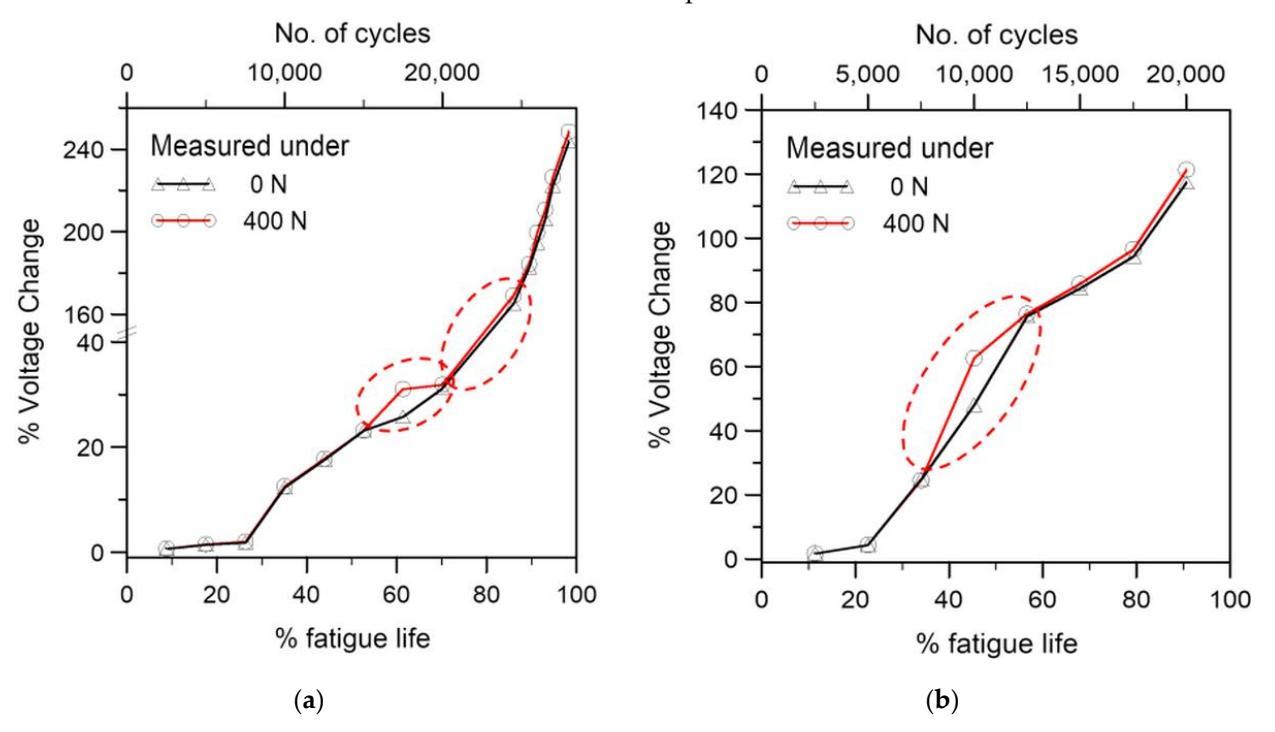
**Figure 12.** Comparison of percentage voltage change development measured at 0 N and 400 N in two fatigue specimens, note the difference at (**a**) 60% life; (**b**) 45% life.

A comparison of the percentage voltage changes after unloading to 400 N and 0 N may reveal some finer details about the nature of the joint damage. Figure 12 compares these for two fatigue specimens. Figure 12a is the same specimen as that in Figures 10 and 11. The difference between the percentage changes in voltage under 400 N and 0 N are within a few tenths percent initially. This corroborates a previous observation that an applied loading of 1200 N changed the voltage by 0.52%, and so the difference between 400 N and 0 N are

minimal. However, at some point in life, the 400 N reading is more than 2% higher than the 0 N reading (e.g., at 60% life in Figure 12a and 45% life in Figure 12b). As cyclic loading continues, their difference reverts to a much smaller value. This kind of phenomenon has been marked with red dotted ellipses in Figure 12. This probably occurred when part of the broken contacts/increased inter-tube distances in the CNT network due to fatigue damage was undone by recovery of elastic deformation by fully unloading but was held open by the 400 N load. On further damage development, this part of broken contacts/increased inter-tube distances in voltage changes under 400 N and 0 N reverted to a fraction of a percent.

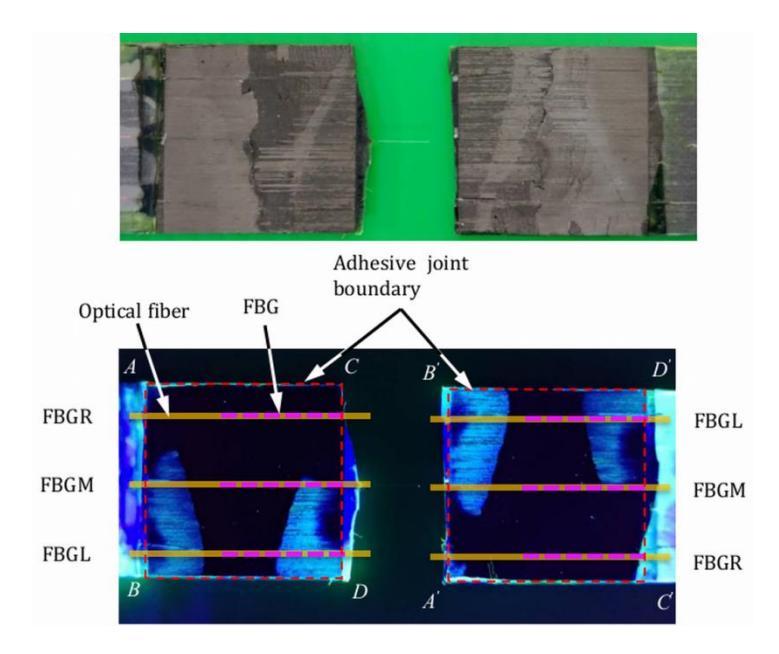
**Figure 13.** Fatigue-fractured adhesive joint observed under visible light (**top**) and UV light (**bottom**) after fluorescent penetrant treatment.

In some specimens, cyclic loading was interrupted when the percentage change in voltage reached either 10% or 15%. These specimens were then soaked in fluorescent penetrant and baked dry before cyclic loading was resumed until failure. Unlike that in the tensile tests, fluorescent indications on the adhesive joint can be seen in all fatigue specimens examined. Figure 13 shows a typical fractured joint under visible and UV light. Figure 14 shows the development of the percentage change in voltage and the D values in the same specimen. The percentage change in voltage reached was 15% just before penetrant treatment. Schematic representations of the optical fibers and relative locations of the FBGs (pink dotted lines) have been drawn on the joint in Figure 13. Clear fluorescent markings are evident under FBGL and FBGM. No indication is seen in the vicinity of FBGR. Incidentally, the D values from the FBGL and FBGM spectra rose to above 30 just before penetrant treatment (Figure 14). The shape of the spectrum from FBGR showed no significant change, and this was reflected in the D values, which remained below 4 throughout. It is worth pointing out that FBGR has not responded to the debonding approximately 4mm away under FBGM, suggesting that the sensing capability of FBG is highly localized.

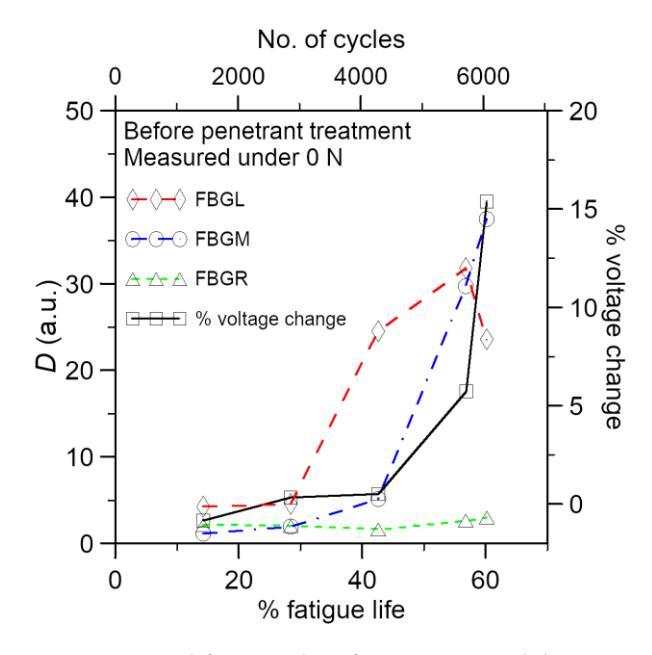
**Figure 14.** Load-free *D* values from 3 FBGs and the percentage voltage change development before the application of fluorescent penetrant in a fatigue specimen.

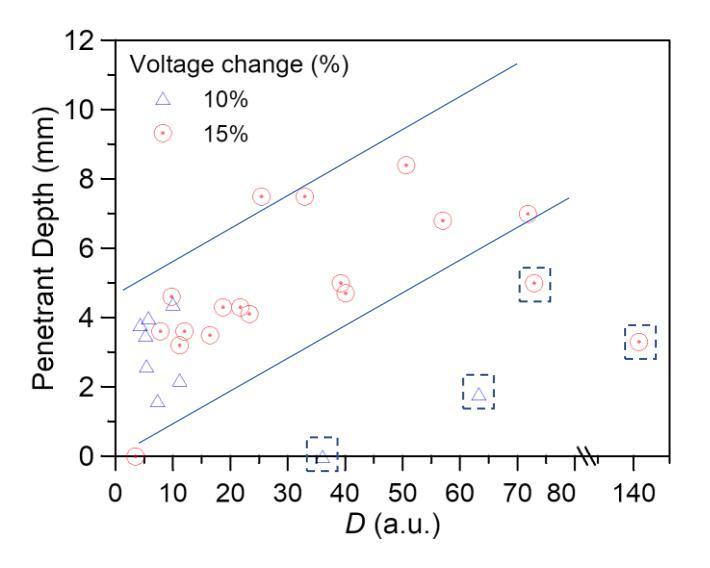
**Figure 15.** *D* values just before penetrant treatment versus the debonding length under or in the close vicinity of FBGs.

The depth of penetration of the fluorescent indications immediately under or within 1 mm vicinity of each FBG has been measured. These are plotted against the *D* values of the corresponding FBG spectra just before penetrant treatment in Figure 15. Apart from a few points (symbols boxed in dotted squares), the data fall roughly onto a scatter band, suggesting a strong correlation between the *D* value and the de-bonded depth. The boxed points that fall out of the scatter band are from the 5 FBGs with abnormal behavior in spectrum development, possibly due to malfunction. No debonding was evident in the penetrant examination of the tensile specimens, and *D* values remained below 7. These data from the tensile specimen fall into the same scatter band in Figure 15. Summarizing the above observations, it may be concluded that although the *D* value from the FBG spectrum is only loosely quantitative, it helps to relate the condition of debonding damage in the adhesive bond around the FBG in both the tensile and fatigue specimens.

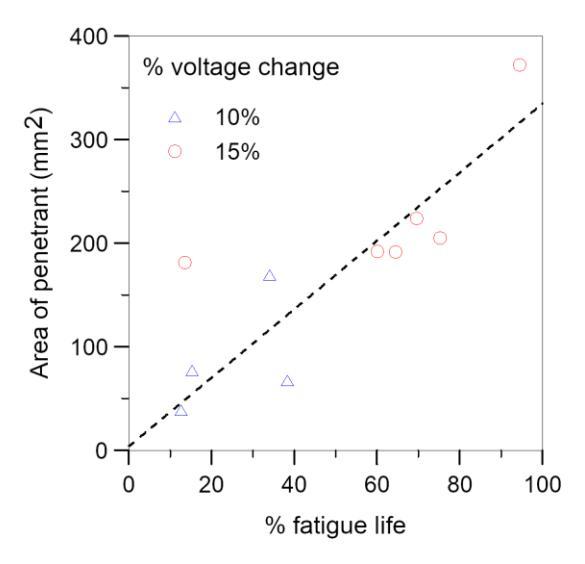
Figure 16. De-bonded area at different percentages of fatigue life.

Figure 16 shows the area of debonding against the fractional fatigue life spent just before penetrant treatment. Within experimental scatters, the fatigue life spent is roughly directly proportional to the de-bonded area. The data also indicated that the same percentage voltage changes could amount to widely different de-bonded areas and elapsed percentage fatigue lives. Thus, although the percentage voltage change helps to reflect the occurrence of debonding, it is not a good quantitative parameter to correlate directly with the de-bonded area or elapsed fatigue lives.

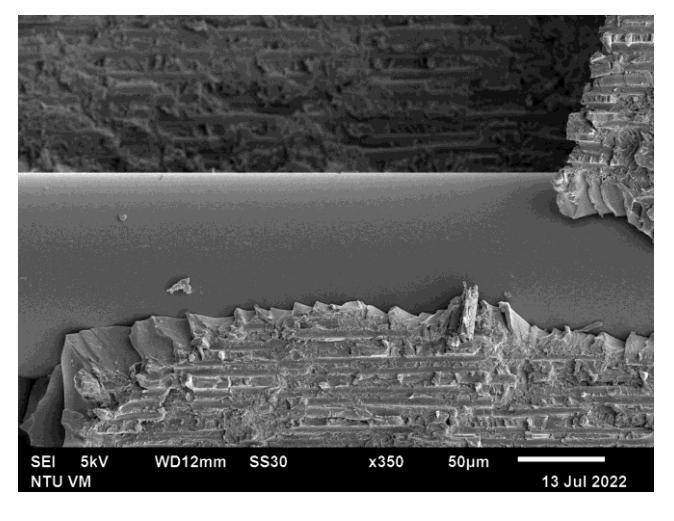
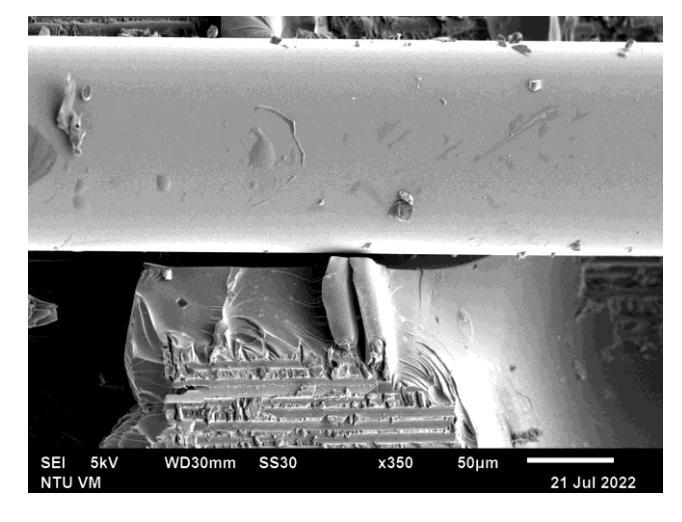
**Figure 17.** Typical SEM fractographs from two fatigue specimens showing (**a**) smooth optical fiber surface and (**b**) smooth optical fiber surface and secondary crack in adhesive.

Figure 17 shows typical SEM fatigue fractographs of the adhesive joint from two different fatigue specimens. Similar to the tensile failure cases, fractures mainly occurred in the composite lamina adjacent to the adhesive joint. The surface of the optical fibers appears to be very smooth and de-bonded from the adhesive. A secondary crack in the adhesive roughly perpendicular to the optical fiber can be seen in Figure 17b. This suggests that the spectral shape changes in the FBG spectra as well as the percentage voltage change throughout the cyclic loading may be contributed to by microcracking in the adhesive as well as debonding near the adhesive interface.
