Article Cr-Free Anticorrosive Primers for Marine Propeller Applications

Abstract: Marine propellers work under severe service conditions, where they commonly suffer from mechanical, electrochemical, and biological corrosion damage. The major mechanical corrosion involves cavitation, erosion, and impingement corrosion. On the other hand, the major electrochemical corrosion involves galvanic corrosion and electrolysis. As a result, consideration of both desired mechanical and electrochemical properties is necessary when designing a marine propeller coating. In this study, a PVB (polyvinyl butyral) and an epoxy coating were formulated without corrosion inhibitors to investigate the desired coating properties for marine propeller applications. The two coatings were compared with a Cr-containing commercial marine propeller coatings. It was found that it is desirable for marine propeller coatings to be flexible to avoid cracking and flaking; to be able to withstand high pH in order to resist cathodic disbondment (electrolysis); to have adequate primer–substrate adhesion; and, ideally, to be able to self-heal when the coating is damaged (cavitation). It was found that the PVB-ZO coating

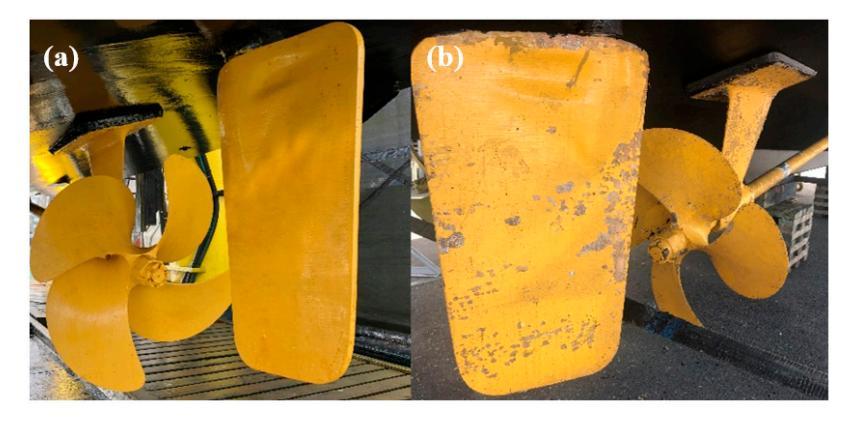
Figure 1. (a) Commercial primer applied just before launching, (b) after 16 months of field trial.

Several commercial products are available on the market, developed by leading marine paint companies such as Propspeed, International, and Hempel. Figure 1 shows the results of a commercial coating system after 16 months of field trial. The coating system was developed explicitly for propellers. Figure 1b shows that the commercial coating system has excellent performance even after 16 months of testing. Although the coating system suffered damage in the cavitation-prone area, most parts of the coating showed excellent adhesion to the underwater running gear.

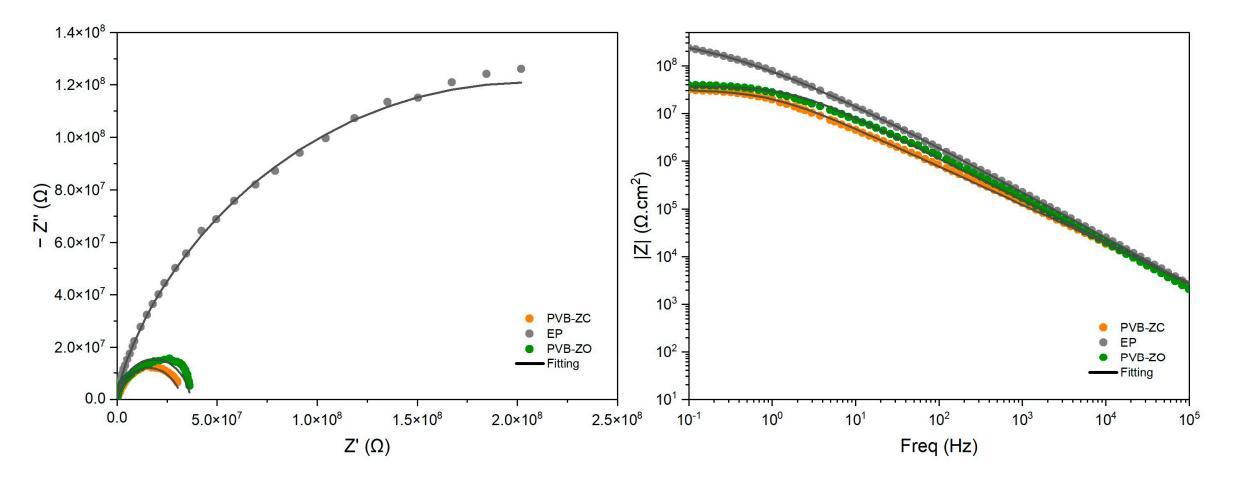
After 30 min of immersion, it was observed that EP exhibited the highest barrier performance, whereas PVB-ZC had the lowest barrier performance. A direct comparison of the semicircle diameters from the Nyquist plot (Figure 2) provided a quick assessment of the barrier properties of the primers. This comparison was also reflected in the Bode plot, where the impedance modulus of EP at $|Z|_{0.1\text{Hz}}$ was the highest and, for PVB-ZC, it was the lowest. $|Z|_{0.1\text{Hz}}$ is a useful parameter for determining the protective ability

of the primers, as more information about the coating performance can be found in this low-frequency range. The $|Z|_{0.1\text{Hz}}$ value in the low-frequency region decreases over time as the coating absorbs and becomes saturated with the electrolyte. As the coating starts absorbing the electrolyte solution, it shows both capacitive and resistive behaviour in the Bode plots [18,19]. Typically, if a coating has a $|Z|_{0.1\text{Hz}} \ge 10^6 \ \Omega \cdot \text{cm}^2$, this gives an indication that the coating provides an adequate level of corrosion protection [18].

The EIS test is a widely used technique to monitor the degradation behaviour of coatings over time. Being a non-destructive technique, one advantage of using EIS is that it is able to detect early stages of electrolyte penetration even when there are no visible changes in the coating [17]. It measures the change in interfacial properties, such as the coating impedance, which is the ability of a material to resist the flow of an AC current. In other words, EIS provides information on the barrier properties of the coating since the impedance decreases when water is absorbed by the coating. EIS is also a useful tool for predicting the corrosion resistance and service life of organic coatings applied to metallic surfaces. In this study, each primer was subjected to EIS testing for up to 100 days in 3.5 wt.% NaCl solution. The obtained Nyquist and Bode plots were analysed and are presented below (Figures 2 and 3).

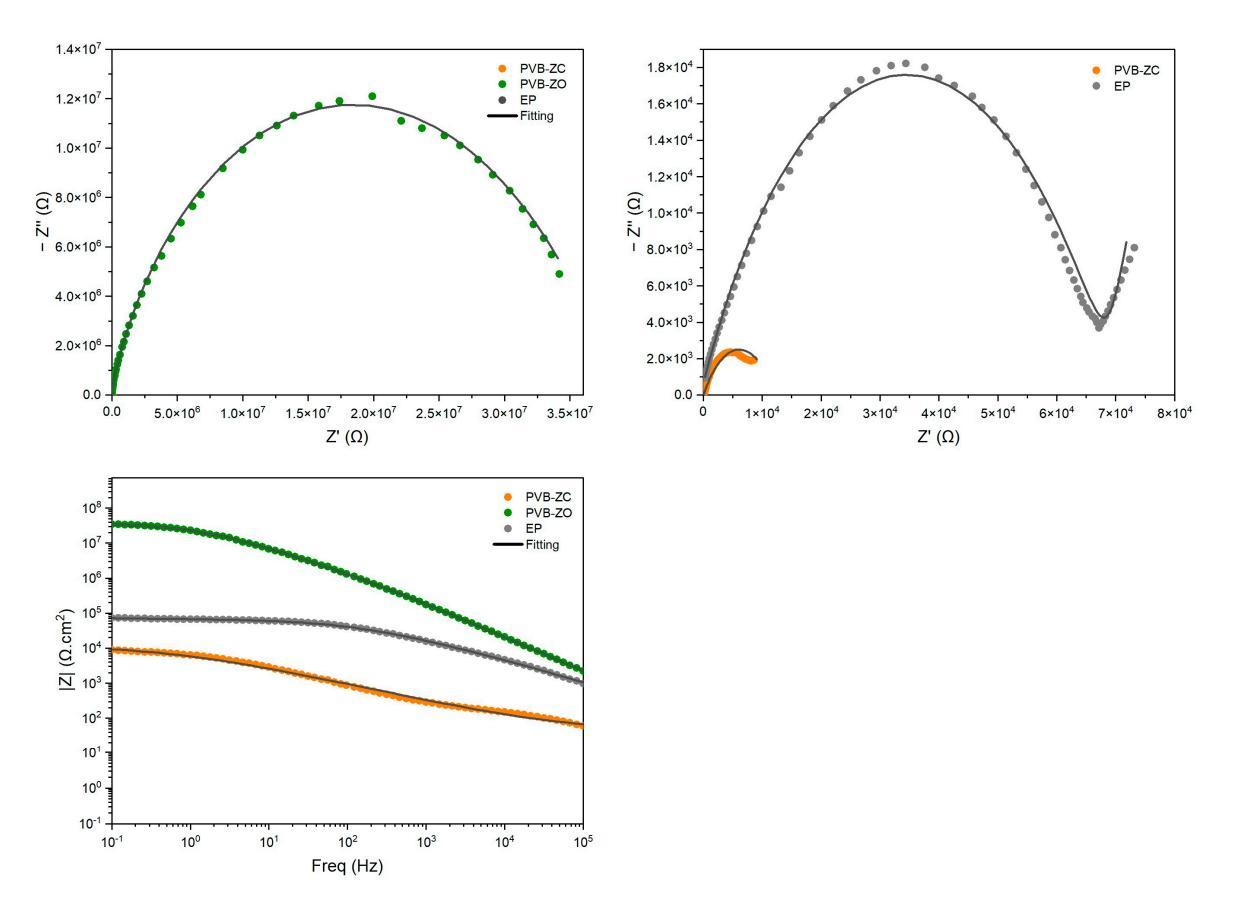
Figure 3. EIS results after 100 days of immersion in 3.5 wt.% NaCl. Nyquist plot (**left**), zoomed-in Nyquist plot (**right**), and Bode plot (**left bottom**).

After 100 days (Figure 3), it was observed that PVB-ZO had the highest barrier properties and adequate corrosion protection, while PVB-ZC exhibited the lowest performance, as was the case at 30 min. Therefore, it can be concluded that PVB-ZC is more permeable than the other two primers, and that PVB-ZO has more resistance to water penetration, maintaining its barrier properties. By examining the Nyquist plot of EP at 100 days, it is noted that there is an inclined line at approx. 45° in the low-frequency region. This is the Warburg diffusion, depicting the diffusion process at the coating–metal interface [18]. Although EP has a higher crosslinking density and a higher $|Z|_{0.1\text{Hz}}$ at the beginning, the value gradually decreased, meaning that the coating absorbs the electrolyte continuously.

The Bode plot clearly indicates that PVB-ZO maintained almost constant $|Z|_{0.1\text{Hz}}$ values before and after 100 days of immersion, demonstrating its excellent barrier properties. Conversely, PVB-ZC has the largest decrease in $|Z|_{0.1\text{Hz}}$ values, suggesting its corrosion protection mechanism is inhibitive rather than barrier based. This indicates that a certain degree of porosity is necessary for PVB-ZC to allow CrO_4^{2-} ions to diffuse and travel easily in the coating matrix, ultimately passivating the exposed substrate. EP, on the other hand, showed a near-constant decrease in $|Z|_{0.1\text{Hz}}$ values over time without any increases. This may be attributed to EP's reliance purely on barrier protection without any anticorrosive pigments, implying that corrosion will initiate as soon as water penetrates the coating and reaches the substrate. Without any anticorrosive pigments to slow down corrosion, the barrier performance of EP will continuously decrease until the coating fails completely.

This improved performance could be attributed to the incorporation of ZnO in the primer formulation, which enhances its water resistance. The coating performance can be monitored by the change in shape of the Bode plot curves [19]. When an AC current is applied to a coating under good condition, a capacitor is used to describe the coating. This is also indicated in the Bode plot, where it exhibits a straight line with slope -1 at almost all frequencies for the capacitive region [18]. However, as the coating absorbs electrolyte, its deterioration can be observed by the development of resistive region (the curve towards the low frequency region becomes a plateau) on the Bode plot. This change was also observed in Figure 3, especially for PVB-ZC and EP.

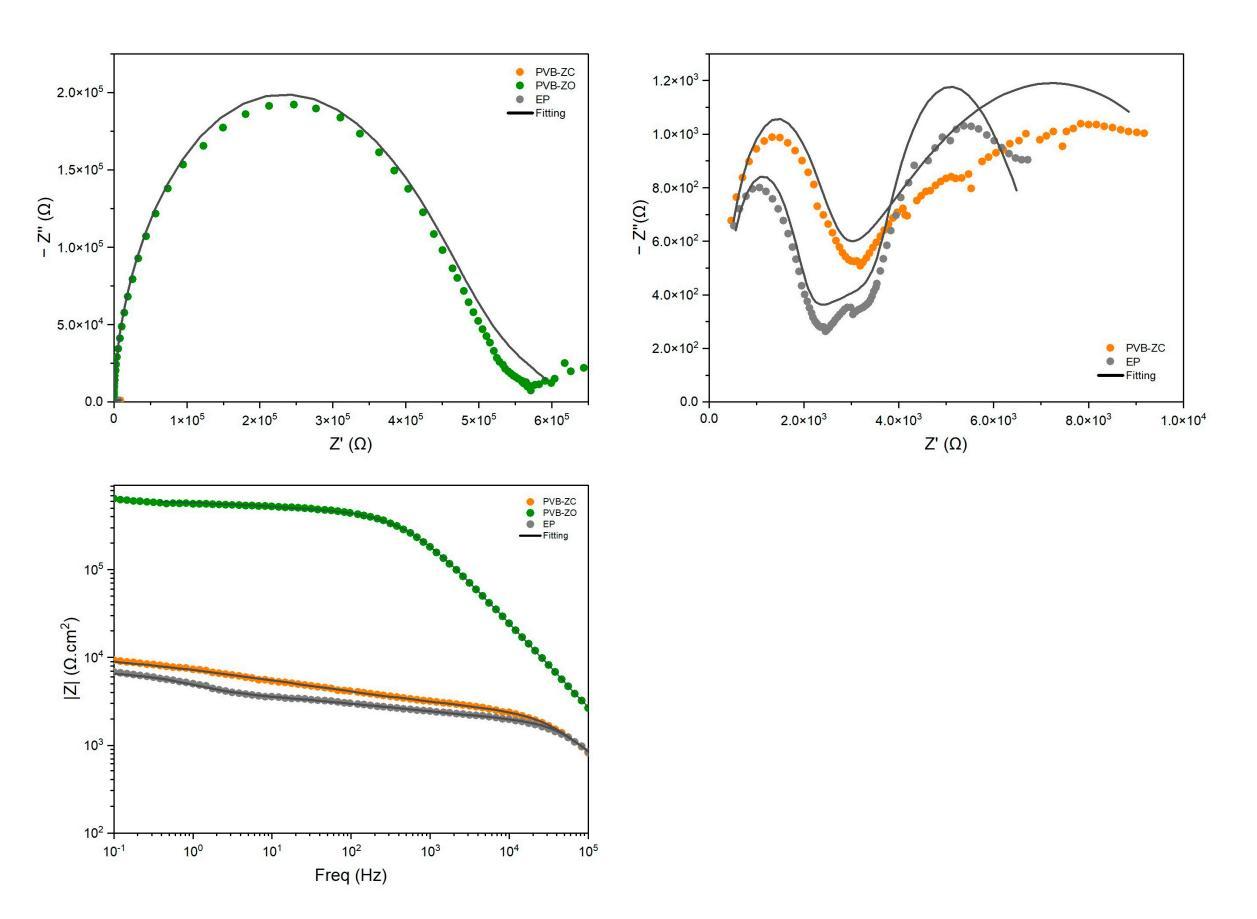
Figure 4 illustrates the barrier properties of the coatings at 30 min of immersion. PVB-ZO demonstrates the highest barrier performance, while PVB-ZC and EP exhibit similar performance. However, PVB-ZC has the highest barrier performance after 100 days (Figure 5) and the $|Z|_{0.1\text{Hz}}$ value increases from 10^4 to $10^{4.7}$. In contrast, both PVB-ZO and EP experience a continuous decrease in barrier properties, reaching a similar level after 100 days. This can be due to the absence of active corrosion inhibitors in their formulations, which would typically form a protective layer over the exposed metal surface. However, PVB-ZO incorporates ZnO in its formulation, enhancing the primer's toughness and water resistance [21].

Figure 4. Damaged EIS results after 30 min Nyquist plot (**left**), zoomed-in Nyquist plot (**right**), and Bode plot (**left bottom**).

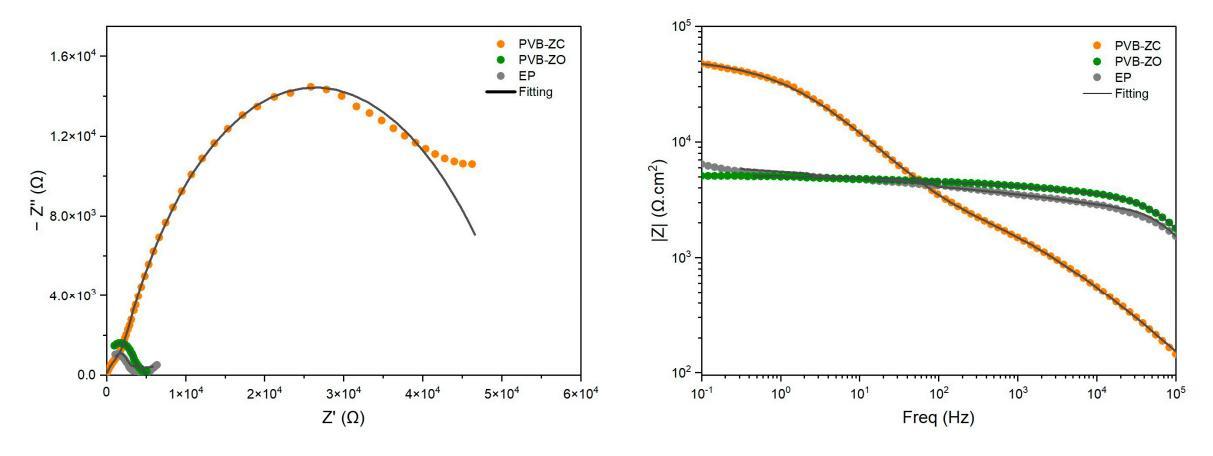
Initially, PVB-ZO exhibited higher barrier performance than EP. However, the key difference is that PVB-ZO experienced a more significant decrease, while EP maintained its barrier properties to a greater degree. This discrepancy may be attributed to the solubility of ZnO in dilute acids and bases [22]. As a result, ZnO dissolves at the cathodic sites under alkaline conditions (high pH), leading to a reduction in barrier properties. While ZnO has been reported to possess anticorrosive properties [21], these were not observed in the damaged EIS test.

In contrast, PVB-ZC incorporates zinc chromate as a corrosion inhibitor. Consequently, when the substrate is exposed to the electrolyte, it undergoes passivation, leading to an increase in $|Z|_{0.1\text{Hz}}$ over time. Although corrosion under the coating was assessed by the formation of the two semicircles at 30 min (Figure 4), there was only a single Nyquist semicircle after passivation at 100 days (Figure 5). Therefore, the artificially scratched EIS test proves to be more suitable for evaluating the passivation ability of PVB-ZC and other primers that exhibit self-healing properties.

Figure 5. Damaged EIS results after 100 days. Bode plot (left) and Nyquist plot (right).

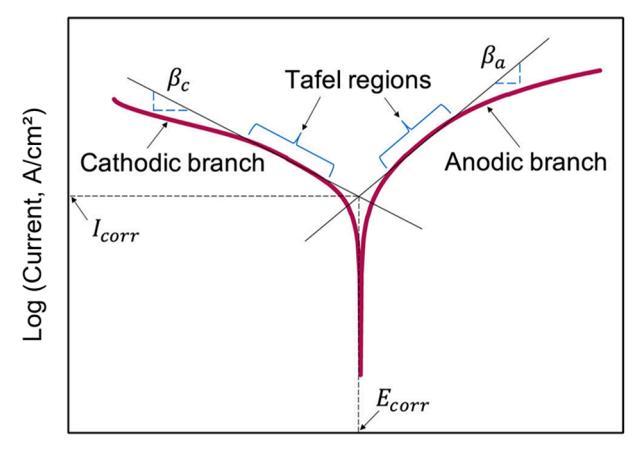
Cathodic (–) \leftarrow Potential, V vs. RE \rightarrow Anodic (+)

Figure 6. Analysis of a typical Tafel plot. Reproduced from ref. [18], copyright (2017), with permission from John Wiley & Sons Inc.

The potentiodynamic polarization test is another electrochemical test carried out in this study, which gives a better understanding of the corrosion process by measuring the thermodynamics and kinetics of corrosion. Given that the corrosion process involves both cathodic (i.e., oxygen reduction reaction) and anodic reactions (i.e., metal oxidation), which can be accelerated by scanning the sample over a narrow potential range while monitoring the current. By extrapolating the cathodic and anodic slopes in the linear regions of the Tafel plot, the corrosion potential (E_{corr}) and corrosion current density (I_{corr}) can be determined (Figure 6). As a result, PDP tests can provide insights into the susceptibility of coated metals to corrosion and predict the long-term damage effects. E_{corr} indicates the level

of protective ability of the coating towards the substrate, while I_{corr} signifies the rate of electrolyte penetration into the coating. Usually, a high E_{corr} value and a low I_{corr} value is preferred for good corrosion resistance, which indicates less corrosion tendency and improved corrosion resistance, and a delay in the electrolyte uptake at the coating–metal interface, respectively [18].

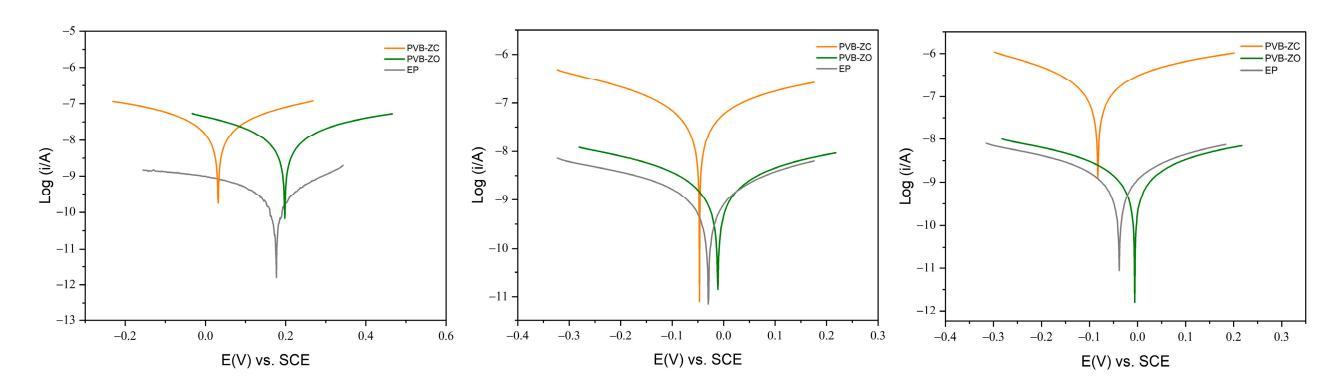
The corrosion kinetics of the three primers were examined over a 100-day period (Figure 7), and the corresponding changes in E_{corr} and I_{corr} over time are presented in Figure 8. It was observed that PVB-ZC exhibited a continuous decrease in E_{corr} over time, while PVB-ZO and EP maintained a relatively constant E_{corr} . Similarly, PVB-ZC showed a continuous increase in I_{corr} , whereas PVB-ZO and EP maintained a relatively stable I_{corr} . A high E_{corr} is preferable as it indicates that the sample is more likely to accept electrons, favouring reduction reactions to protect the substrate. On the other hand, a lower I_{corr} is desirable as it suggests retarding of the electrolyte diffusion through the coating–metal interface. According to this theory, it can be concluded that PVB-ZC gradually loses its barrier protection over time, leading to an increased rate of electrolyte penetration. This finding aligns with the results obtained from the non-scratched EIS analysis, where PVB-ZC exhibited lower barrier protection and higher porosity compared to the other primers. This discrepancy arises from the fact that PVB-ZO and EP primarily rely on barrier protection mechanisms, while PVB-ZC is based on inhibitive protection mechanisms.

Figure 7. Potentiodynamic polarization test results at 3 h, 50 days to 100 days (left to right).

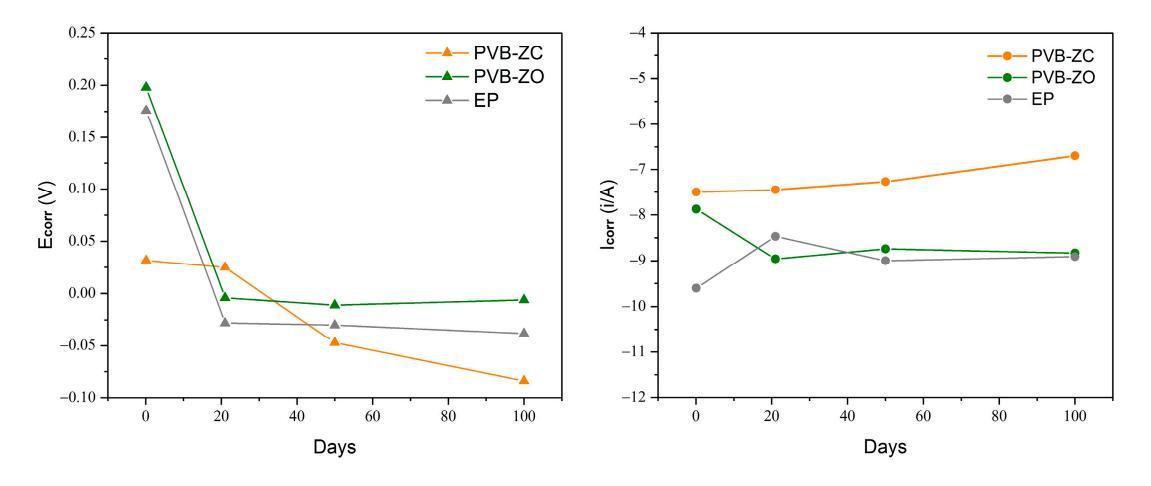
Figure 8. Changes in *E*_{corr} (left) and *I*_{corr} (right) over time.

The changes in E_{corr} and I_{corr} also showed that PVB-ZO and EP are mostly based on barrier protection mechanisms as the behaviour of the changes are similar (also they do not have any active corrosion inhibitive additives in their formulation). The PDP test also shows that ZnO does not demonstrate any anticorrosive properties but barrier enhancement. The PDP results at Day 100 also align with the scratched EIS results, where the final I_{corr} values are similar for PVB-ZO and EP, and E_{corr} are also closer together. The similar performance between EP and PVB-ZO after 100 days of immersion are demonstrated both by EIS and PDP test.

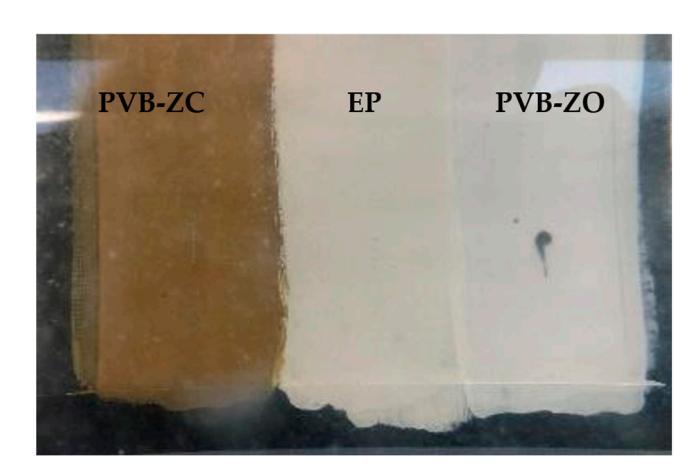
Electrolysis or stray current corrosion is a common type of corrosion that occurs on immersed marine propellers. In freshwater environments, electrolysis may not be as severe as in seawater, where the high conductivity due to chlorine ions exacerbates the corrosion process. Figure 9 illustrates the appearance of the panel immediately after the test commenced. The area surrounding the PVB-ZO scratch turned black within just 30 s of immersion. In contrast, no evident damage was observed on the other two primers, although bubbles were observed from the scratched area for all three primers, possibly indicating the formation of hydrogen gas.

Figure 9. Appearance of the coated bronze plate after 30 s of immersion in the electrolysis tank.

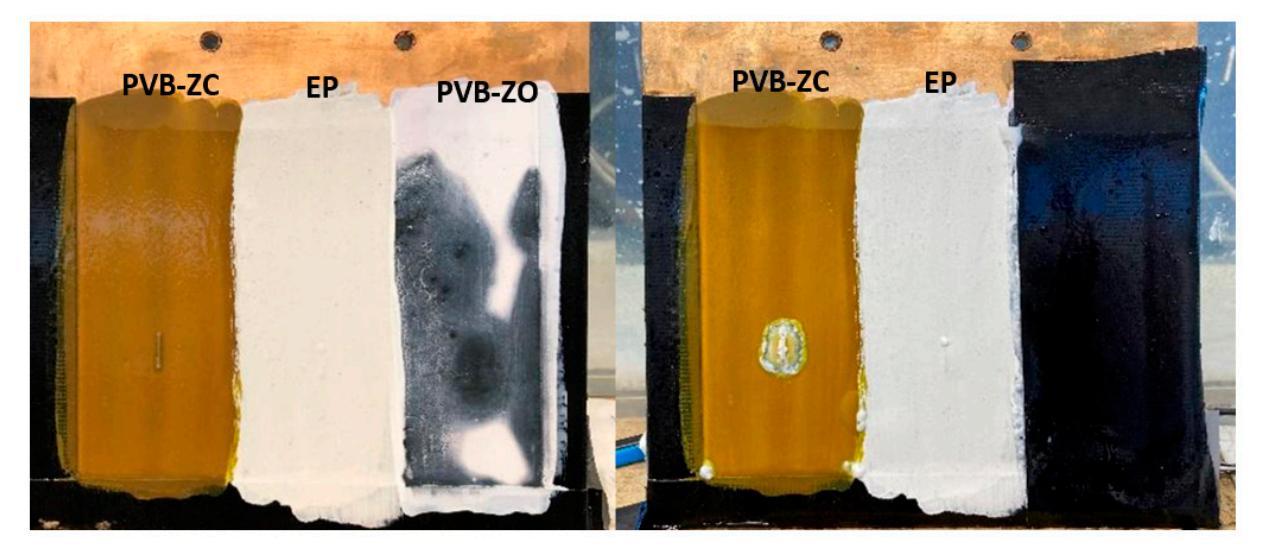
After 20 min (Figure 10), the blackened area on the PVB-ZO primer continued to expand across the coated region, and appeared to detach from the substrate, indicating potential cathodic disbondment. At this point, PVB-ZC and EP remained in good condition. After 40 min, PVB-ZO had completely failed, resulting in the removal of the black film. Some damage was observed on the PVB-ZC primer, although the region around the scratch

did not peel off but instead exhibited a silverish colour on the substrate. EP, on the other hand, demonstrated the highest resistance to electrolysis, as no coating peeling or dissolution was observed. However, the observed performance of EP could be attributed to its recommended DFT being 200 μ m whilst the other coatings were only 16 μ m and 50 μ m for PVB-ZC and PVB-ZO, respectively.

Figure 10. Appearance of the coated plate after 20 min (left) and 24 h (right) of testing.

The electrolysis test reveals that PVB-ZO develops a blackened colour when the current passes through the coated bronze plate. The detached black film, observed in the failed coating region, is likely due to the cathodic disbondment of scratched film. Figure 17 illustrates a stray current in a typical coated pipeline system, similar to the stray current corrosion observed in propellers except for the fact that the anode is not covered by a coating and a different substrate was used. The process of cathodic disbondment initiates at the anode, where a DC current flows and dissolves the anode to metal ions. These metal ions then react with H₂O to form metal oxide, depositing on the corroded area of the anode. On the cathodic side, oxygen reduction and hydrogen evolution occur, producing H₂ and OH⁻ ions. These species migrate along the interface between the coating and substrate, producing bubbles and forming a highly alkaline environment. This weakens the adhesion between the coating and substrate, causing cathodic disbondment of the coating from the substrate [26].

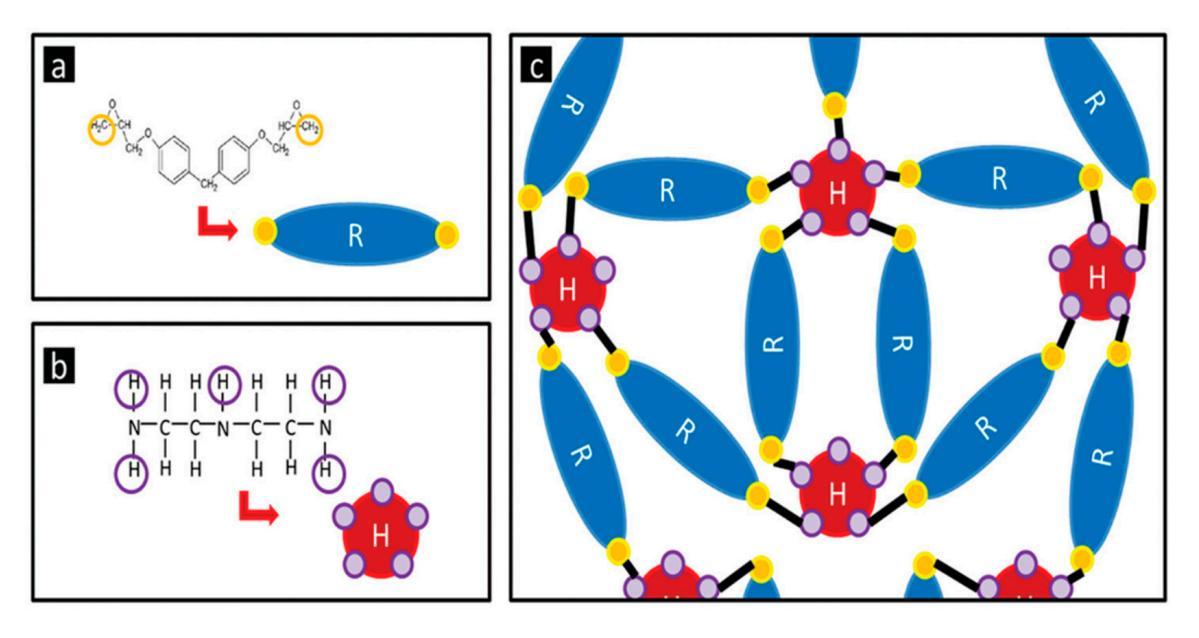
Figure 11. Molecular structure of an epoxy resin with two active sites (**a**), a polyamine curing agent with five active sites (**b**), and the crosslinked structure (**c**). The black solid lines represent the covalent bonds. Reproduced from [24], copyright (2015), with permission from Sage Journals.

Among the primers, PVB-ZO exhibits the lowest hardness due to its film formation process, which relies solely on solvent evaporation. On the other hand, PVB-ZC is harder than PVB-ZO but softer than EP. EP has a much higher microhardness due to a different film-forming mechanism. Epoxy resin requires a hardener to induce the crosslinking density to form a solid film. The hardener opens the epoxide ring and forms crosslinks across the chemical structure (Figure 11). This increase in the crosslinking density of the coating matrix results in a higher microhardness for EP than the other two coatings.

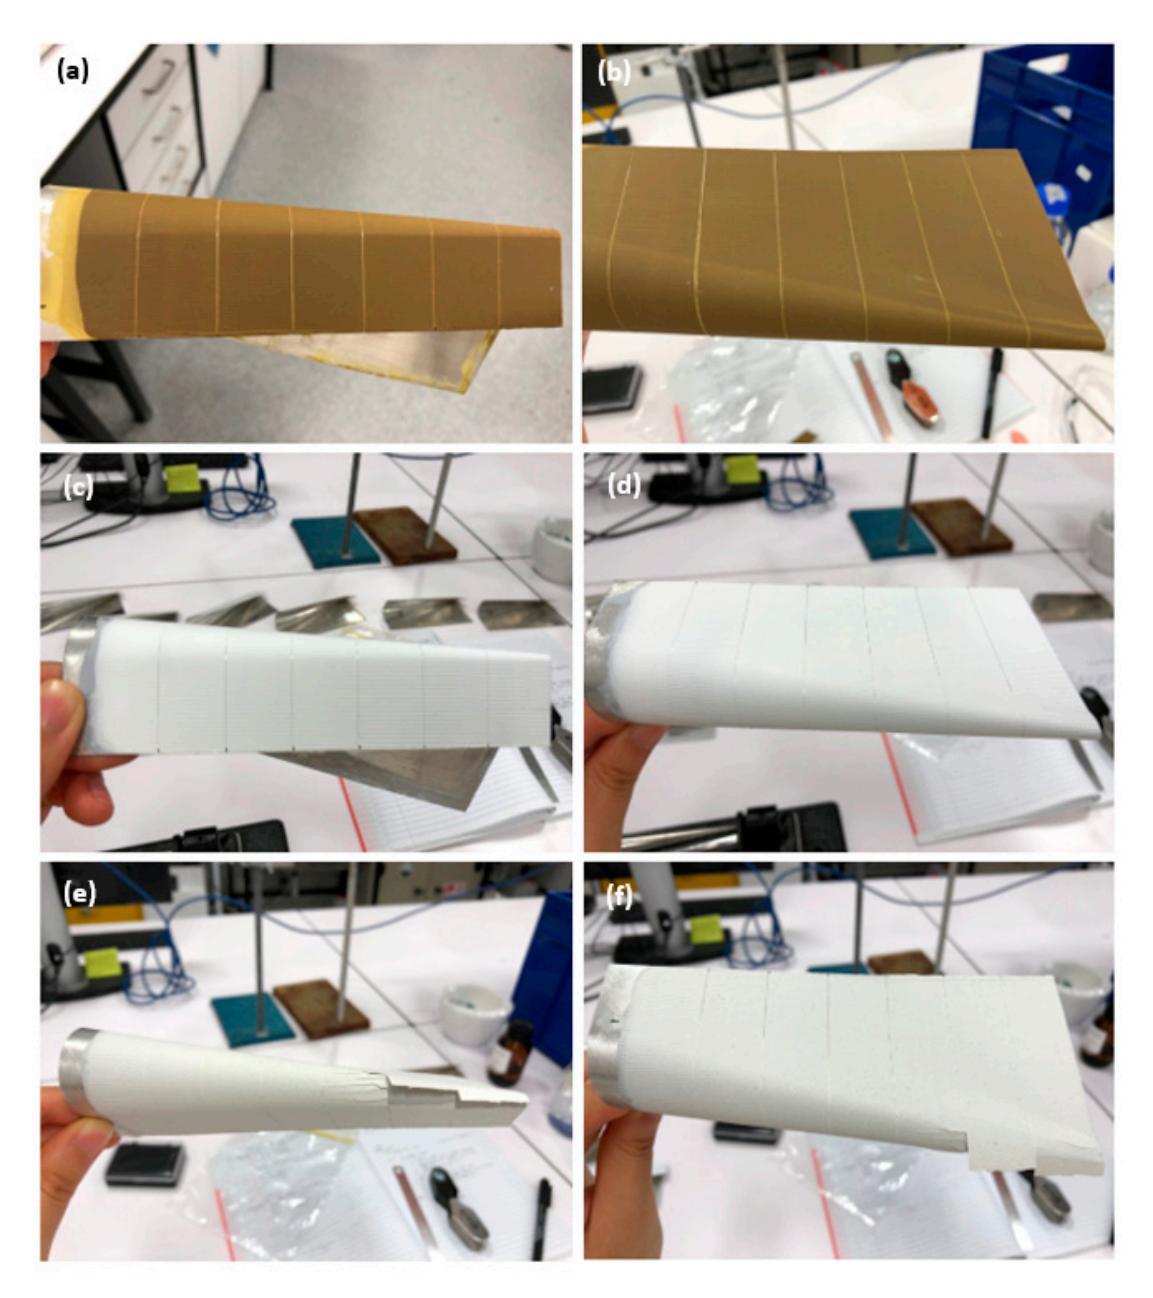
Figure 12 illustrates the results of the conical mandrel bend test. Notably, PVB-ZC exhibited no cracking even in the vicinity of vertical artificial scratches, demonstrating excellent flexibility. Similarly, PVB-ZO displayed good flexibility during bending, showing no signs of cracking. However, EP exhibited cracking upon bending, and two out of three replicates exhibited peeling from the substrate. Furthermore, a section of EP at the small end of the conical diameter detached completely.

Figure 12. Conical mandrel bend results before immersion: (a,b) PVB-ZC, (c,d) PVB-ZO, and (e,f) EP.

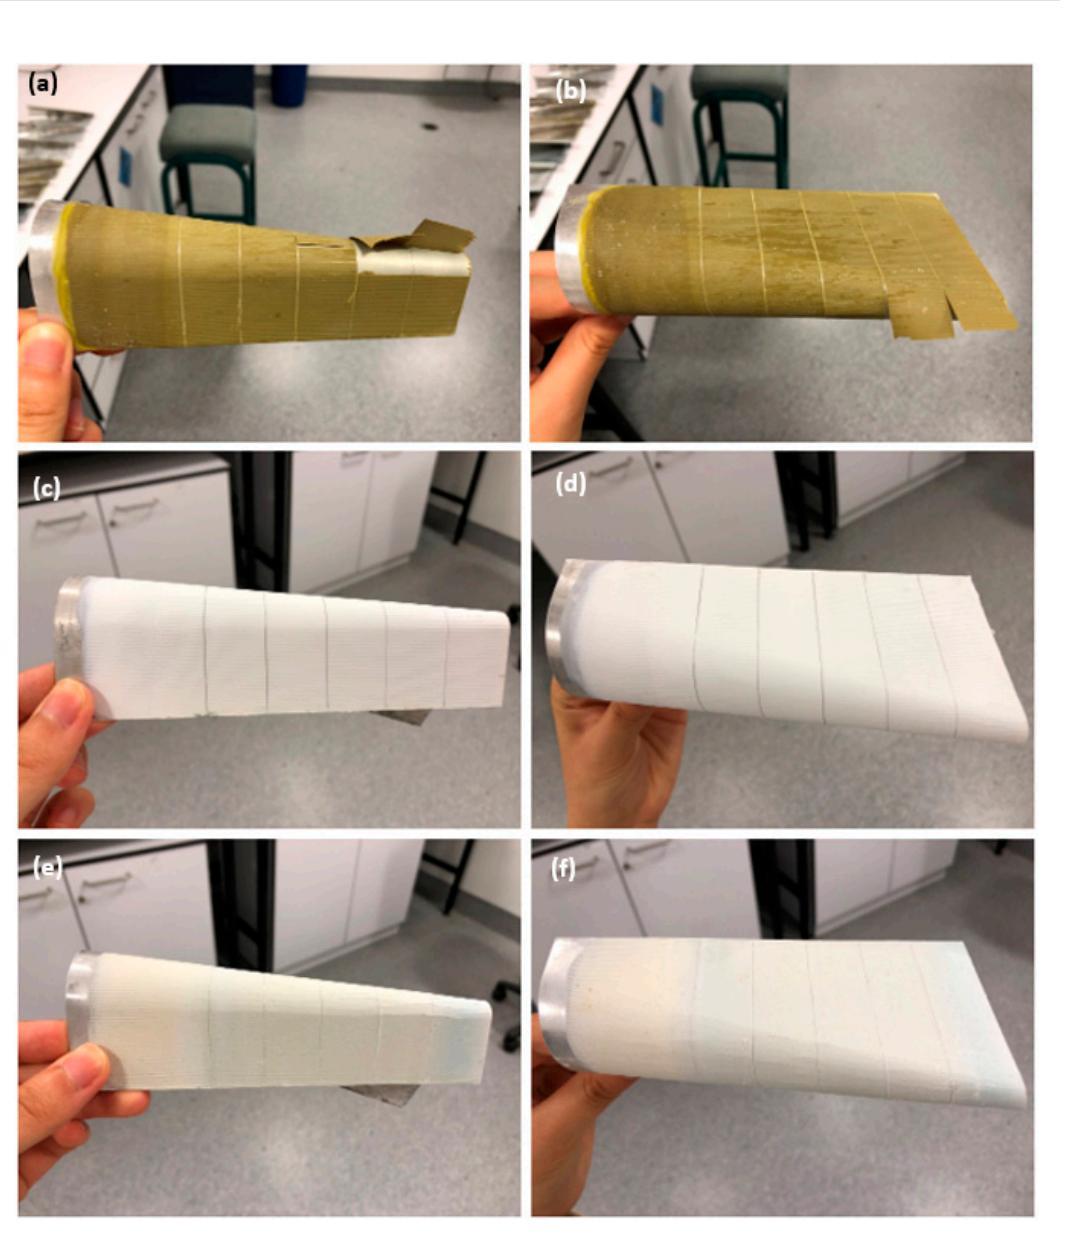
However, the results took a different turn after immersing the samples in 3.5 wt.% NaCl for 80 days. The PVB-based systems performed differently, becoming more brittle following immersion as shown in Figure 13. PVB-ZC exhibited noticeable cracking and peeling from the substrate, indicating decreased flexibility. Similarly, PVB-ZO displayed cracking around the small cylinder diameter at one end, although no peeling was found. On the other hand, all replicates of the EP showed improved flexibility after immersion. While some cracking was still present, its flexibility was increased compared to the pre-immersion condition, and no peeling was observed.

Figure 13. Conical mandrel bend results after 80 days immersion in 3.5 wt.% NaCl: (**a**,**b**) PVB-ZC, (**c**,**d**) PVB-ZO, and (**e**,**f**) EP.

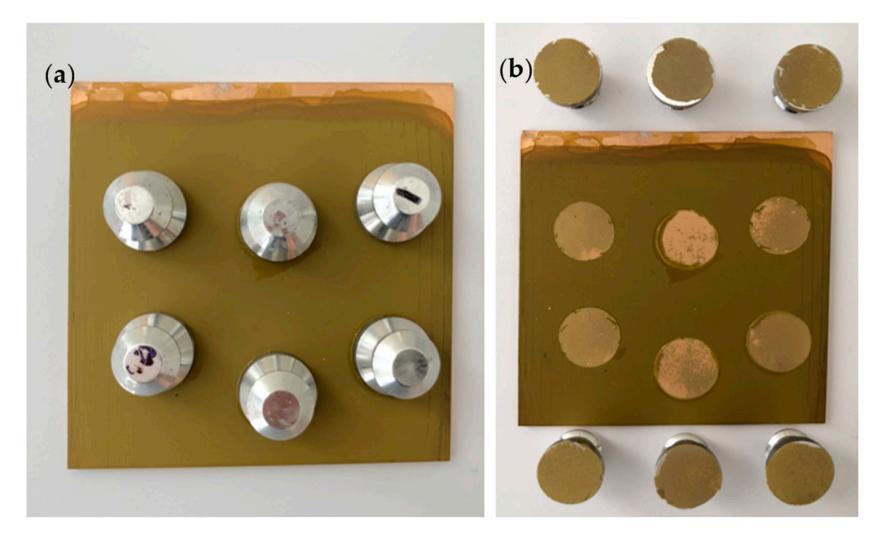
The dolly failure surfaces showed that PVB-ZC exhibits a combination of adhesive and cohesive failures. Its average pull-off adhesion is 4.79 MPa. On the other hand, EP has the lowest adhesion with an average of 3.20 MPa. Similar to PVB-ZC, the dolly failure surfaces of EP also show a mix of adhesive and cohesive coating failures. In contrast, PVB-ZO demonstrates the highest adhesion with a value of 5.93 MPa. Unlike the other two primers, PVB-ZO predominantly exhibits cohesive failures, indicating that the fracture occurs within the coating rather than at the coating-substrate interface. This characteristic highlights PVB's superior adhesion and makes it more desirable as it reduces the risk of continuous peeling when the coating experiences repetitive damage.

Figure 14. The pull-off adhesion test of PVB-ZC before (a) and after (b) pulling.

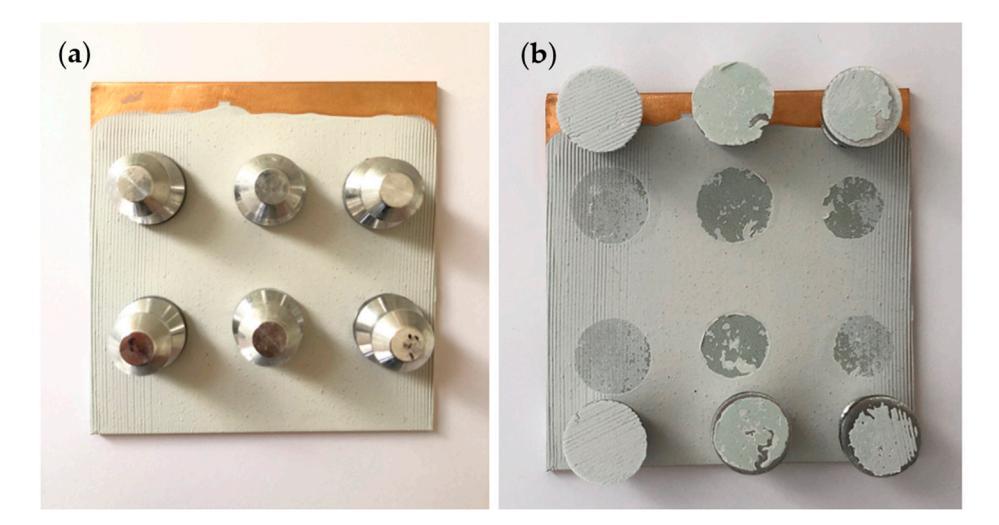
Figure 15. The pull-off adhesion test of EP before (a) and after (b) pulling.

EP has the lowest pull-off adhesion than the other two primers and the failure dolly surfaces showed mostly adhesive failure. The high microhardness and brittleness of EP might cause the low adhesion and adhesive failure. The low dry pull-off adhesion also serves as a complimentary result to explain the peeling observed for the dry conical mandrel bend test.

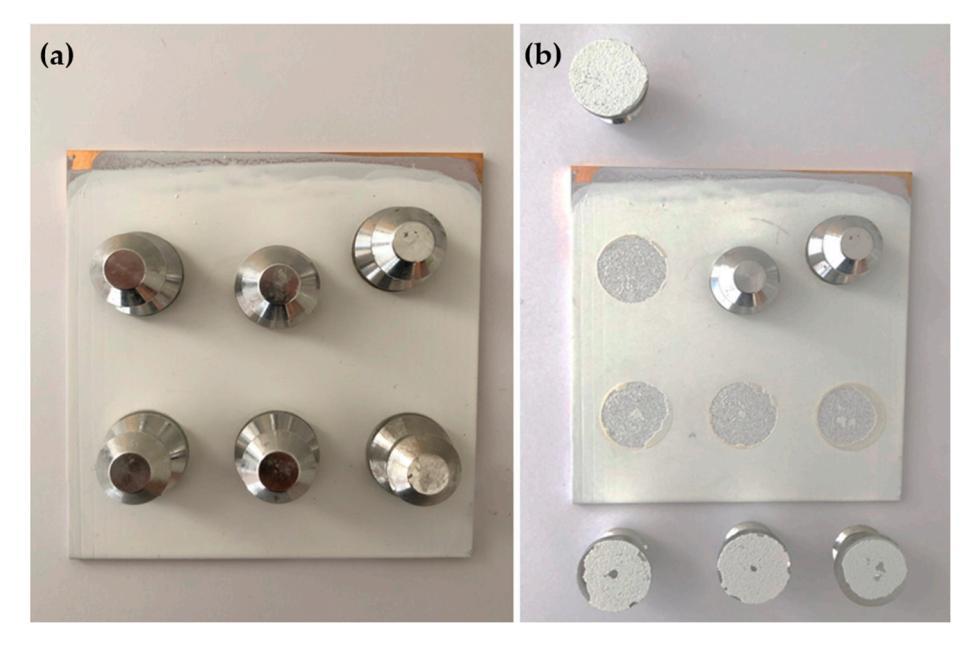
Figure 16. The pull-off adhesion test of PVB-ZO before (a) and after (b) pulling.

PVB-ZO has the highest dry pull-off adhesion, which could be due to the excellent adhesion properties of PVB resin to metal substrates. However, with the same resin base, PVB-ZC has a lower dry pull-off adhesion than PVB-ZO. This might be due to the effect of zinc oxide particles to increase the dry adhesion. The observed failure modes in PVB-ZC adhesion test exhibited a combination of cohesive and adhesive failure and can be attributed to the formation of 3D organic–metallic polymer matrix and possibly the low vol.% of the solid content compared with PVB-ZO, which reduced the cohesive force in the coating.

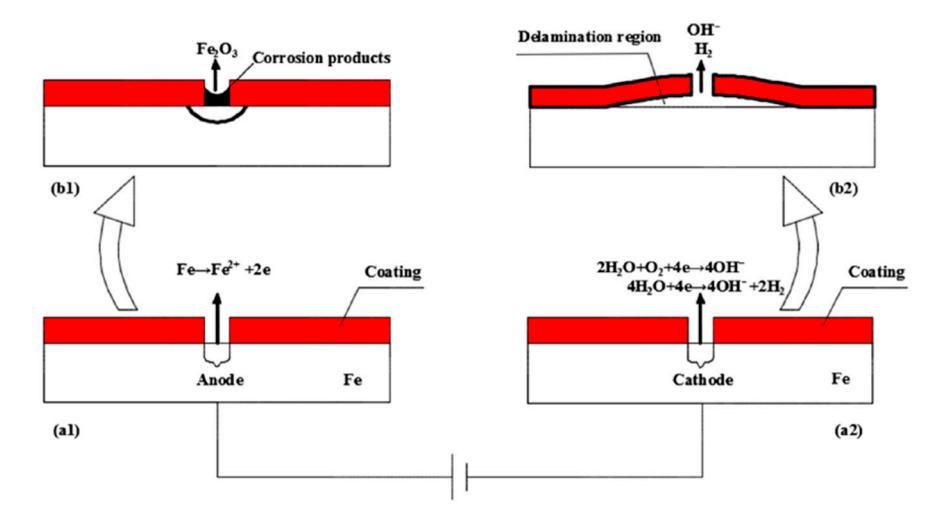
Figure 17. Schematic of the cathodic disbondment mechanism of pipeline under DC stray current. Dissolution of anode into metal ions (**a1**), forming metal oxide corrosion products on the anode (**b1**). Oxygen reduction reaction and hydrogen evolution occur at the cathode (**a2**), forming OH⁻ ions and hydrogen gas, causing coating delamination (**b2**). Reproduced from Ref. [26], Copyright (2019), with permission from MDPI.

The cathodic disbondment mechanism of PVB-ZC is expected to be similar to that of PVB-ZO, considering the consistent sample preparation procedure and configuration. However, a notable distinction lies in the presence of zinc chromate in PVB-ZC, which operates through a different protective mechanism. The passivation ability of $CrO_4^{2^-}$ ions may account for the formation of the silver-coloured area. However, the film formed is thin, with a thickness of less than 100 nm. Therefore, this observation may suggest the occurrence of reduction reactions and subsequent deposition of specific metal ions. A more comprehensive analysis is needed to investigate the nature of the silver-coloured film further.
