Article Characteristics and Formation Mechanism of Water-Eroded Ground Fissures in the Weihe Basin of China

Keywords: Weihe basin; water-eroded ground fissures; fault activity; heavy rainfall

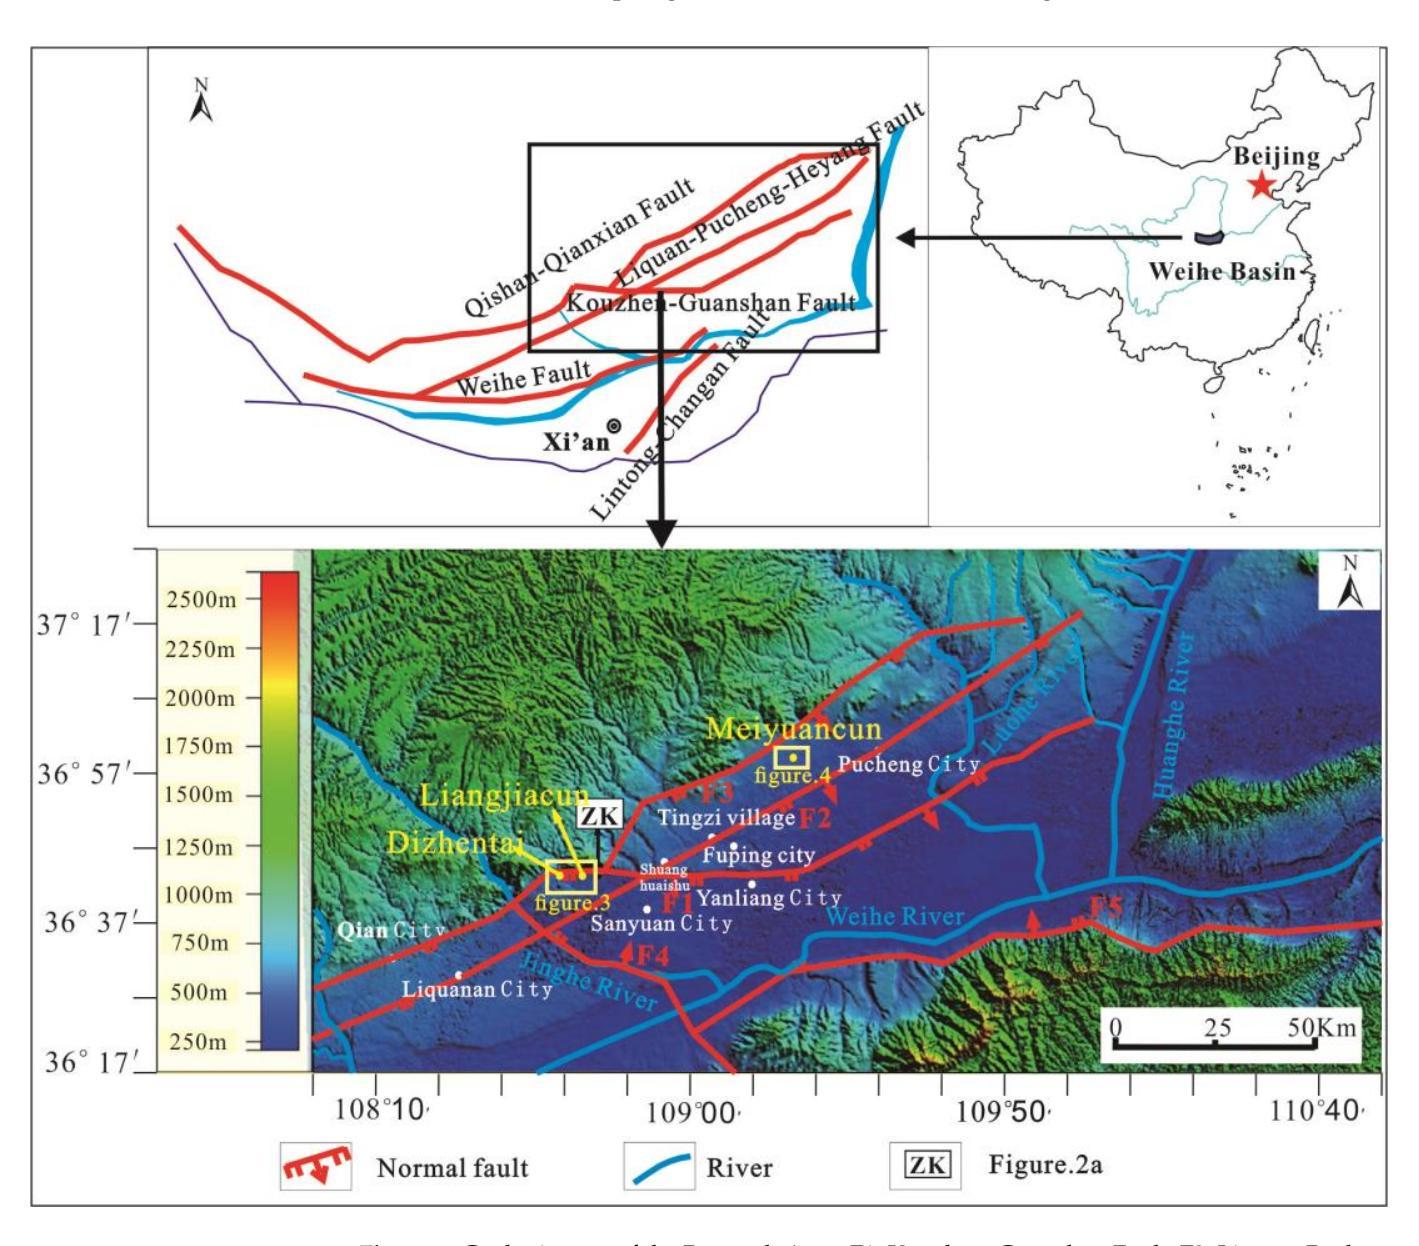
Figure 1. Geologic map of the Research Area: F1, Kouzhen–Guanshan Fault; F2, Liquan–Pucheng– Heyang Fault; F3, Qishan–Qianxian Fault; F4, Jinghe–Chanhe fault; F5, Weihe fault.

The study area is mainly controlled by two faults, namely the Kouzhen–Guanshan Fault (F1) and the Liquan–Pucheng–Heyang Fault (F2) (Figure 1). The Koutun–Guanshan Fault is a concealed normal fault with a total length of 150 km, trending east–west and dipping southward at an angle of 50° to 70°. The fault displacement of Quaternary strata reaches up to 200 m, and in Guanshan Town, there is a difference in thickness of 1300 m of the Neogene strata between the two sides of the fault, reflecting the characteristics of a sedimentary fault. The Liquan–Pucheng–Heyang Fault is a normal fault with an overall NE–SE trend and a dip angle of 40° to 60°, with a total length of 170 km.

The Meiyuancun ground fissure is developed between the Qishan–Qianxian Fault (F3) and the Liquan–Pucheng–Heyang Fault (F2) (Figure 1). The fissure appeared in a cornfield in Meiyuan Town, with a length of about 200 m and a trend of NW326° (Figure 4a). According to local villagers, the fissure appeared after the Wenchuan earthquake on 12 May 2008, and was formed suddenly after heavy rain on the night of 6 June 2008. Jinlishan, about 7.5 km to the north, is a fluviatile plain with the terrain high in the northwest and low in the southeast (Figure 4e). The fissure caused surface cracking in farmland, with a maximum width of 30–40 cm, mainly developing as bead-shaped sinkholes (Figure 4d), and in some local areas, it developed in a linear shape (Figure 4a–c), but the overall size of the fissure is not large, and it extends a short distance along the trend.

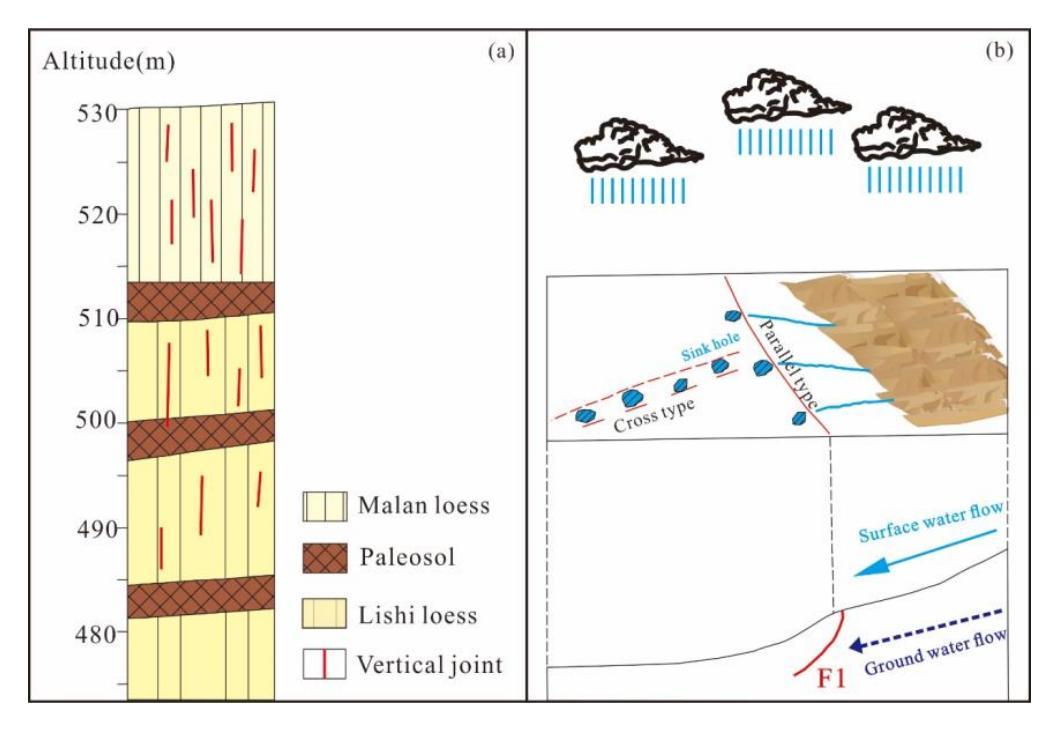
Figure 2. Lithology and topography of the study area: (**a**) stratigraphic characteristics of loess and paleosol; (**b**) rainfall and topographical characteristics.

The geological strata in the study area have the characteristics of alternating loess and paleosoil (Figure 2a). Loess has good permeability while paleosoil soil has good impermeability. This feature lays the foundation for the expansion of underground cavities. Surface water infiltrates into the first layer of paleosoil or clay layer through hidden fissures and water conduits, and then gathers to erode the easily eroded loess (Figure 10a). Part of the eroded soil migrates downward along the fissures with the infiltrated water, while the other part migrates laterally with the groundwater flow. With the continuous migration of eroded particles, small cavities are formed (Figure 10b). Under repeated erosion, small cavities develop into larger cavities (Figure 10c) and then expand upward to form sinkholes (Figure 10d).

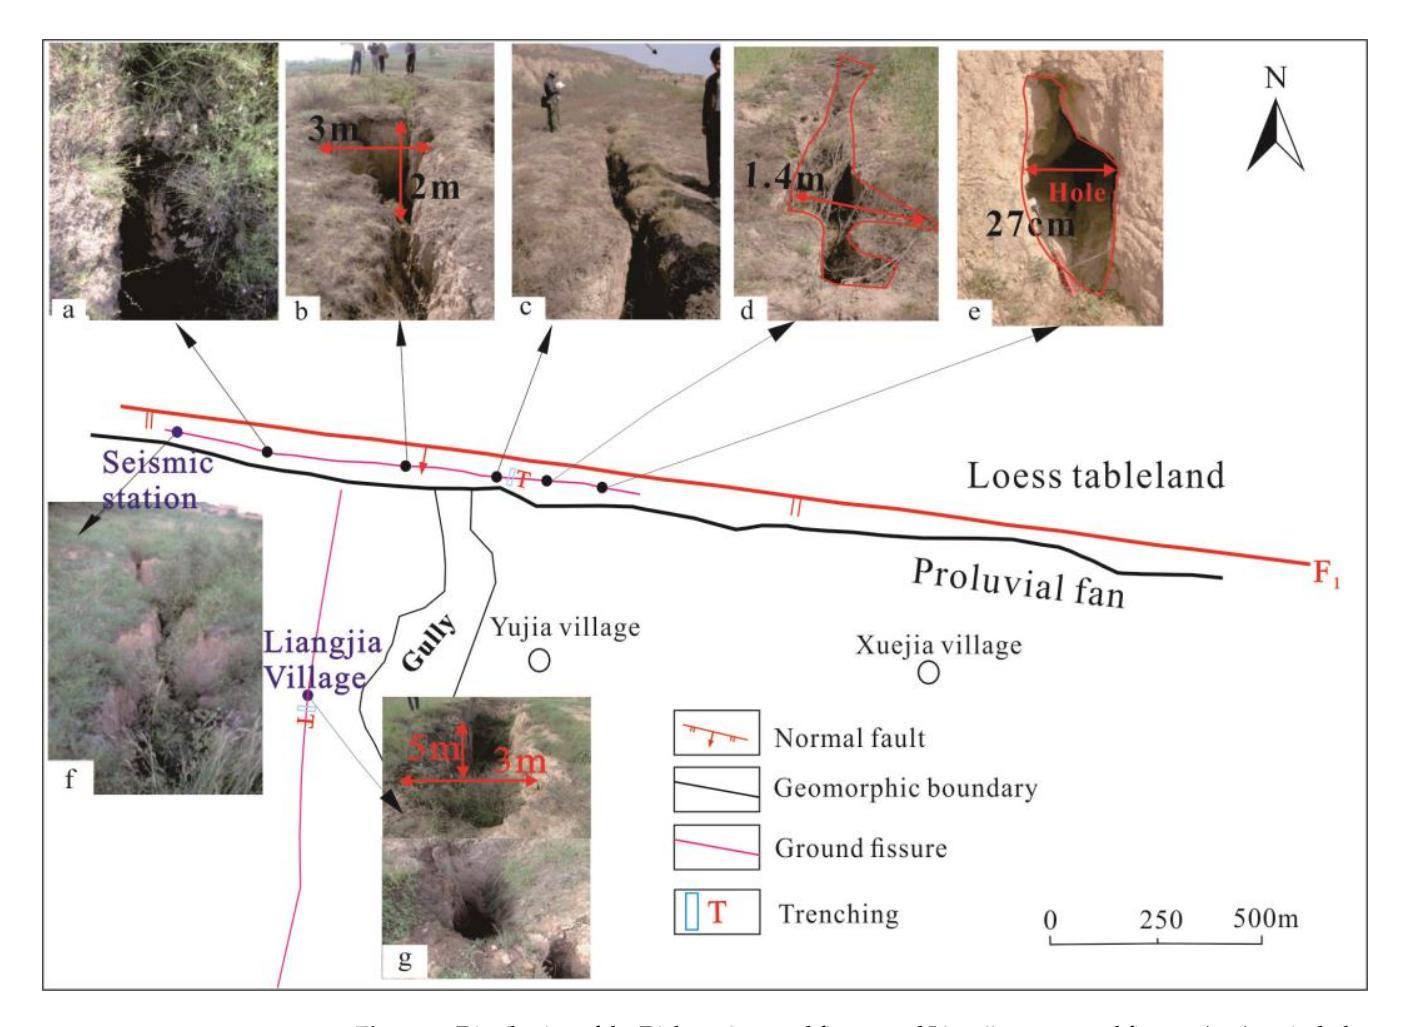
Figure 3. Distribution of the Dizhentai ground fissure and Liangjiacun ground fissure: (a–g) typical photos.

The Dizhentai ground fissure is situated at the junction of the towering Cuoe Mountains and the proluvial fan in front of the mountain. The terrain slopes down gradually from north to south. This fault is about 1500 m long, and its direction ranges between $90^{\circ}-100^{\circ}$. It is distributed intermittently in a zigzag pattern, parallel to the Kouzhen– Guanshan fault, within 100 m of the upper plate. The main fault provides an advantageous parallel-type channel (Figure 2b). The surface features of the fissure include fissures and large bead-like sinkholes, some of which are continuous along the fissure and have a significant horizontal opening without any filling material. Along the fissure zone, six sets of typical photographs have been distributed, which include three fissures (Figure 3b,c,f), tow sinkholes (Figure 3a,d), and one loess hole (Figure 3e). The fissures are relatively long with good continuity, while the loess hole has a maximum inner diameter of 27 cm with a loose soil texture, indicating that it belongs to a shallow loess hole. Due to the effect of rainfall, the maximum opening width of the fissure on the surface reaches 1 m, indicating a depth of more than 5 m.

The Liangjiacun ground fissure is located south of the Kouzhen–Guanshan margin fault, with higher elevation to the north and lower elevation to the south. The fissure is about 2000 m long, trending SE150°–SW210°, intersecting with the Kouzhen–Guanshan fault and exposed within 2 km of the upper plate of the Kouzhen–Guanshan fault. The main fissure provides an advantageous cross-type channel due to its strike-slip property (Figure 2b). The surface features of the fault include large bead-like sinkholes, which are mainly distributed within 2 km of the upper plate of the Kouzhen–Guanshan fault. The maximum surface cracking width of the fault reaches 3 m, indicating a depth of up to 5 m (Figure 3g). After heavy rainfall, the activity of the fault significantly increases, with the length, width, and depth of the cracks and sinkholes noticeably increasing.

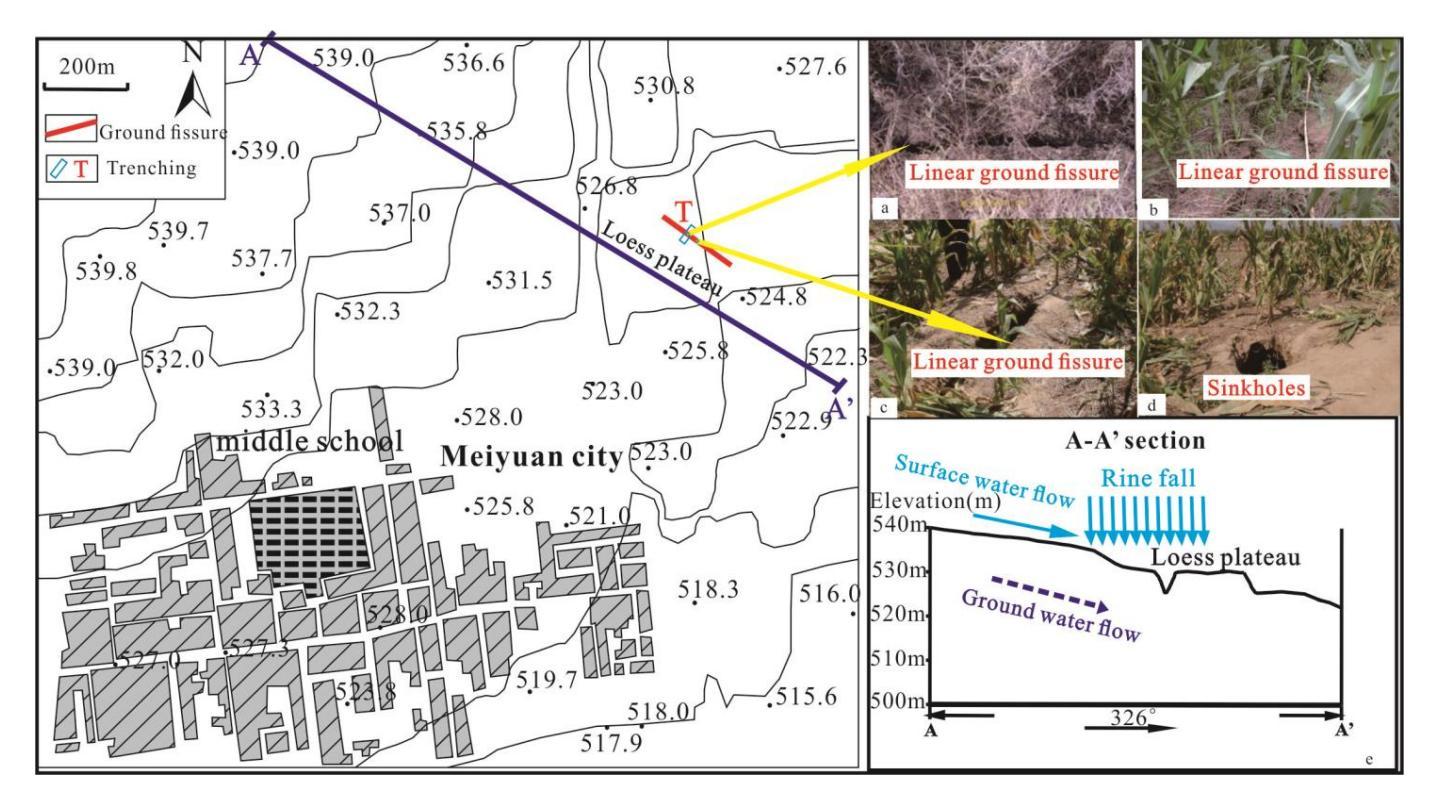
Figure 4. Distribution and topographic map of Meiyuan ground fissure: (**a**–**d**) typical photos; (**e**) A-A' section.

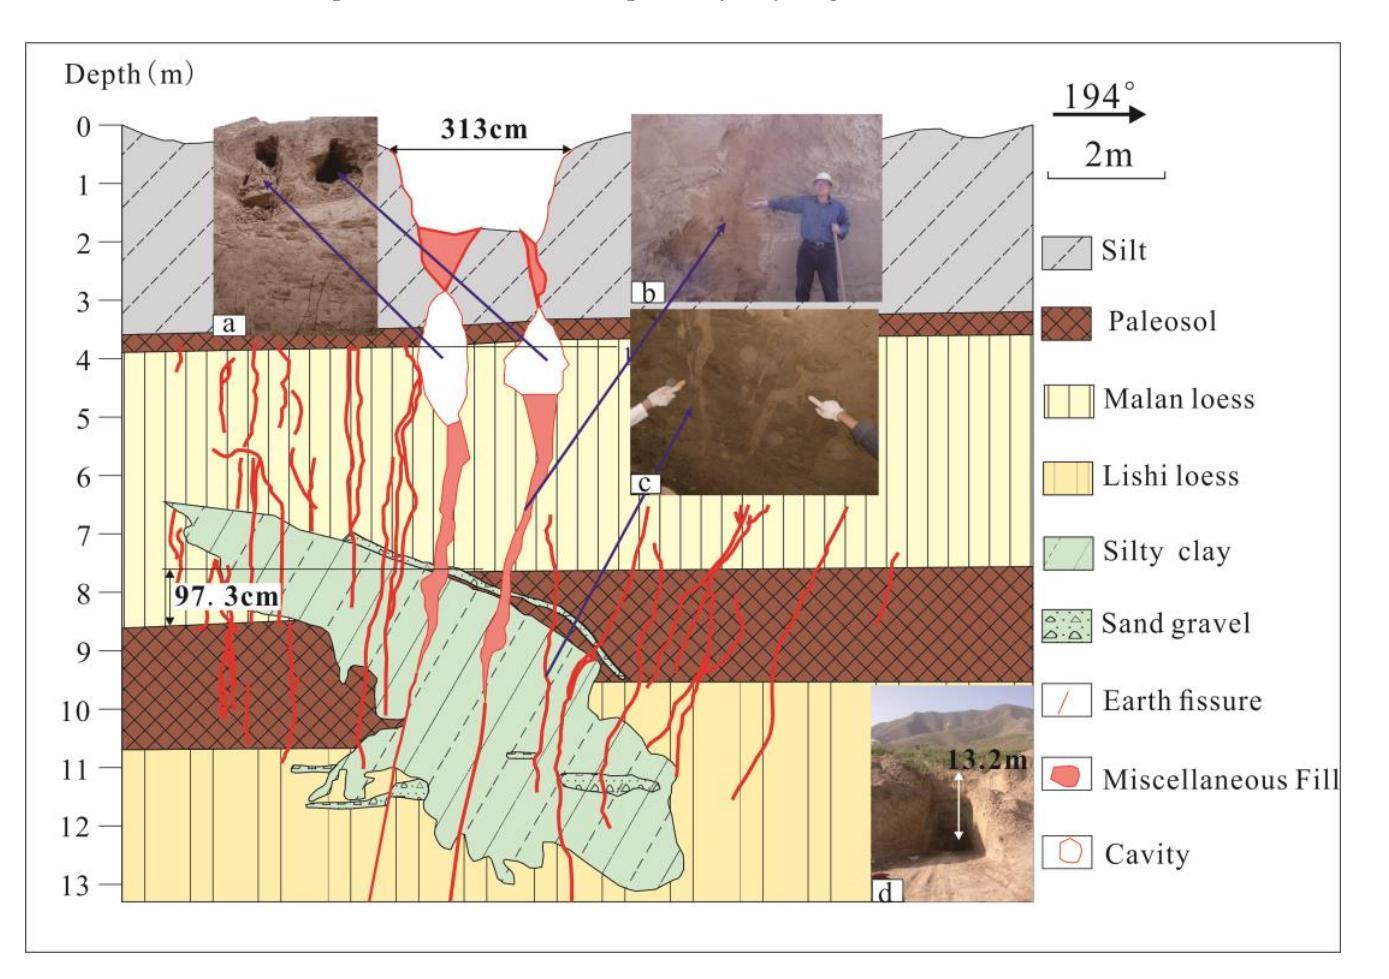
Figure 5. Trenching of the Dizhentai ground fissure: (**a**) cavity photo; (**b**,**c**) typical photos; (**d**) Full sample of exploration groove.

In order to reveal the profile characteristics of the ground fissure, one exploratory trench was excavated, which was 20 m long, 8 m wide, and 14 m deep, at the seismic station in Kouzhen. The trench profile showed six soil layers: silt, paleosol, Malan loess, Lishi loess, silty clay, and sand gravel (Figure 5). The main fissure is nearly vertical and inclined to the north. It forms a "Y" shape with the cross-section combination of the Kouzhen–Guanshan fault. The maximum width of the surface depression is 313 cm, and the depth is about 2 m. At the bottom of the depression, two main fissures extend and have been filled with mixed soil. When the ground fissure extends downward to the first layer of paleosol layer, two cavities appear, with a maximum width of 50 cm and a maximum downward extension of 2 m, both penetrating the clay layer to the Malan loess layer (Figure 5a). The lower fissures of the cavity have been filled, and the opening amount gradually decreases downward (Figure 5b,c). There are about ten secondary fissures around the main fissure zone in the Malan loess layer, and their connectivity is good, penetrating downward to the darker-colored slope accumulation soil layer with a main lithology of gravel layer. In addition, the trench profile also revealed the displacement of the gravel layer, with a vertical displacement of 97.3 cm, indicating strong tectonic activity.

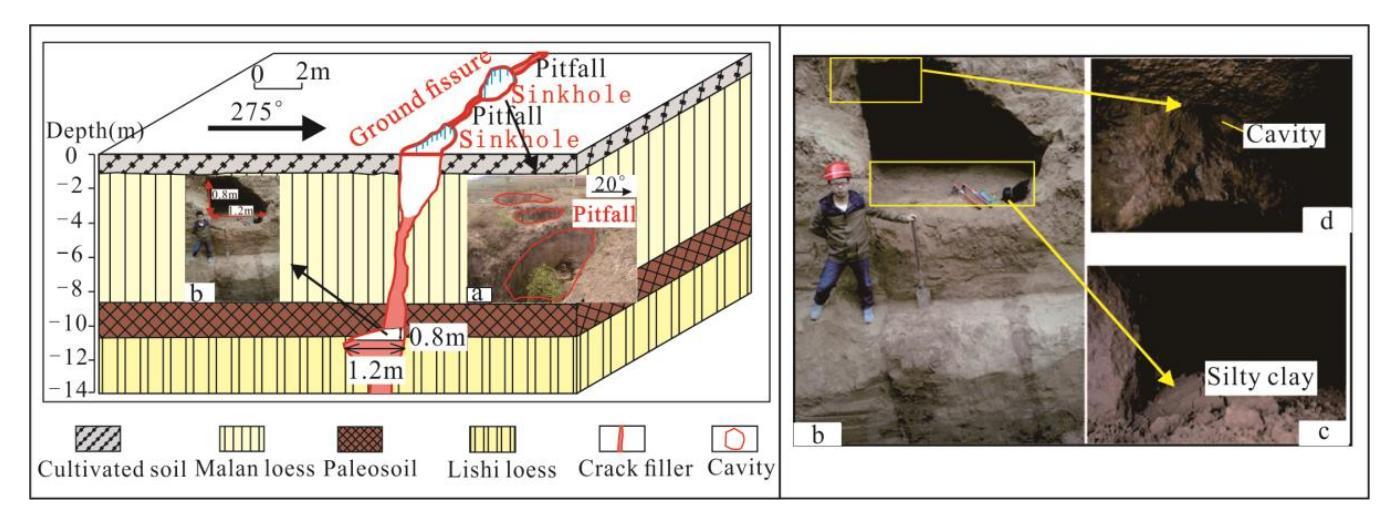
Figure 6. Trenching of the Liangjiacun ground fissures: (a) typical photos; (b–d) cavity photo.

In order to determine the shallow profile structural characteristics of the ground fissure, a large trench measuring 30 m long, 14 m wide and 14 m deep was excavated in Liangjiacun, Jingyang County. According to the trench profile map (Figure 6), the trench revealed the shallow structural features of the ground fissure at Liangjiacun, showing four soil layers: cultivated soil, Malan loess, paleosol, and Lishi loess. The ground fissure opens up greatly on the surface, with a width of about 1.5 m. As it extends underground, the opening decreases rapidly, and below 3 m, the crack width is only about 2 cm. The shape of the shallow part is "funnel-shaped", with the upper part filled with mixed soil and the lower part filled with powdery clay. As the ground fissure extends downward, there is no dislocation in the stratum. When it reaches the bottom of the first paleosol layer, a cavity appears, with a width of about 1.2 m and a height of 0.8 m (Figure 6b). The upper part of the cavity is moist and has many water outlets (Figure 6d), and the bottom is covered with

a layer of powdery clay about 15 cm thick (Figure 6c). An old fissure appears in the lower part, which is filled with powdery clay (Figure 6b).

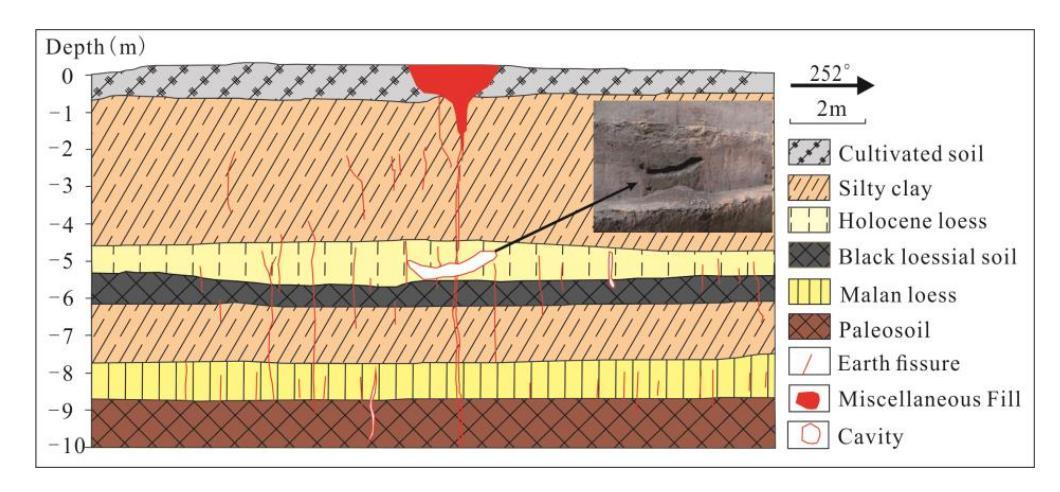
Figure 7. Trenching of the Meiyuancun ground fissures.

A 20 m long, 8 m wide, and 10 m deep trench was excavated in Meiyuan Town, Fuping County. According to the profile diagram of the trench (Figure 7), a total of six soil layers were exposed: cultivated soil, silty clay, Holocene loess, black loess, Malan loess, and paleosol. The profile showed that the fissure was rough, vertical, and extended downward, exhibiting tensile cracking without obvious stratigraphic dislocation. The width of the main fissure was 20–30 cm, and many small fissures developed on both sides of the main fissure. When the main fissure penetrated the first layer of clay, a cavity appeared (Figure 7a), with a maximum length of 1.2 m and a height of 15 cm. There were very few fractures (only 9) developed on the surface of the fissure above the cavity. Many small fissures developed densely on the Holocene loess and paleosol soil layers above the clay layer, with a total of 21. They were generally nearly vertical, rough, and poorly filled. This indicates that the activity of ground fissures in the area has been weak since the middle-late Holocene, and there may have been a strong regional tectonic stress field variation during the early Holocene, which caused a series of rupture deformations in the poorly plastic loess strata under extensional stress.

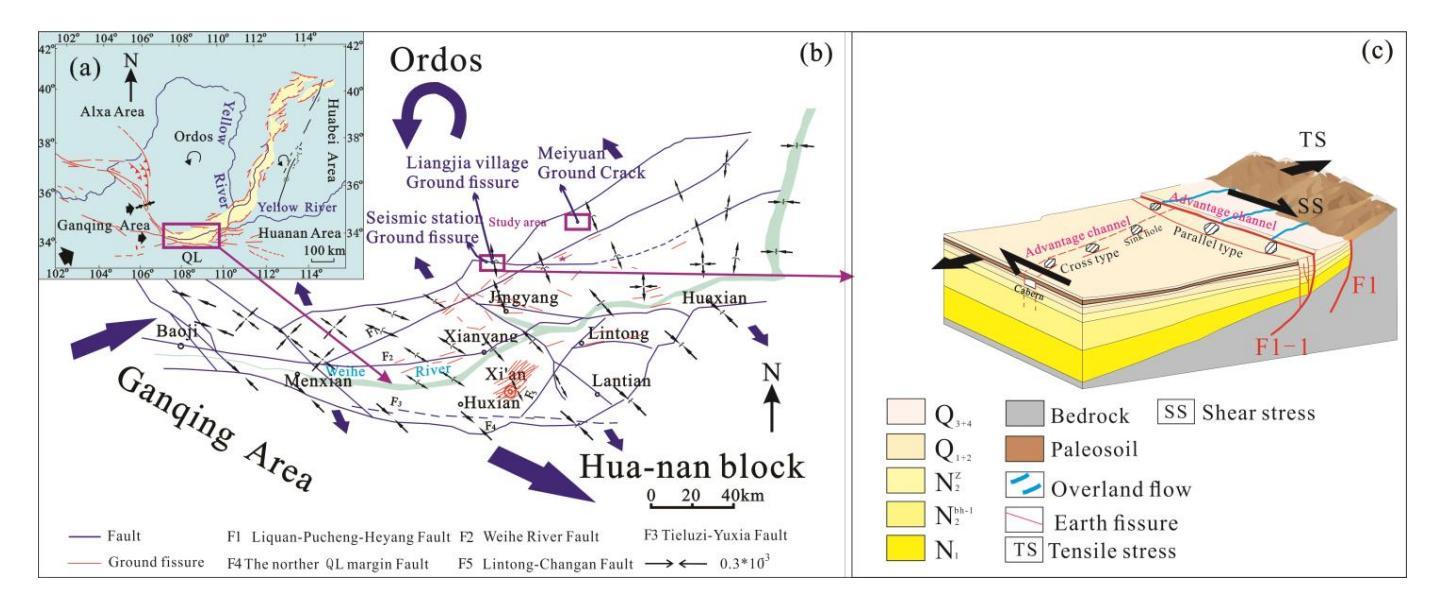
Figure 8. Relationship between regional structure and ground fissures in the Weihe Basin: (**a**) Tectonic activity map of Fenwei Basin; (**b**) Tectonic activity map of Weihe Basin [19] (according to Peng et al., 2018); (**c**) Relationship between ground fractures and tectonic activity.

The study area's ground fissures are located in the north of the Weihe Basin, which is situated at the southern end of the Fen-Wei Graben in China (Figure 8a). The Weihe Basin is located to the east of the Gansu–Qinghai Block, to the west of the South China Block, and to the south of the Ordos Plateau. The modern tectonic activity is intense, and the entire basin is in the NNW–SSE tensional stress field (Figure 8b).

The direction of the Dizhentai ground fissures is consistent with that of the Kou Town-Guanshan fault, belonging to the parallel type. The development of this ground fissure is closely related to the Kou Town–Guanshan fault, and belongs to the "basin-edge fault-controlled" model dominated by the underlying Kou Town–Guanshan fault (Figure 8c). Under the action of the regional NNW–SSE extensional stress field in the Weihe Basin (Figure 8b), the activity of the edge faults causes the hanging wall to drop, forming a tensile stress zone parallel to the fault at a certain distance, and due to the low tensile strength of the loess, joint fissures are easily formed. The relationship between Liangjiacun fissures and faults is a crossing pattern (Figure 8c). They are affected by the right-lateral shearing of the northern front of the basin, which has formed a series of NNW–SSE tensional joints on the hanging wall of the front fault (Figure 8c). These joints are connected with the front

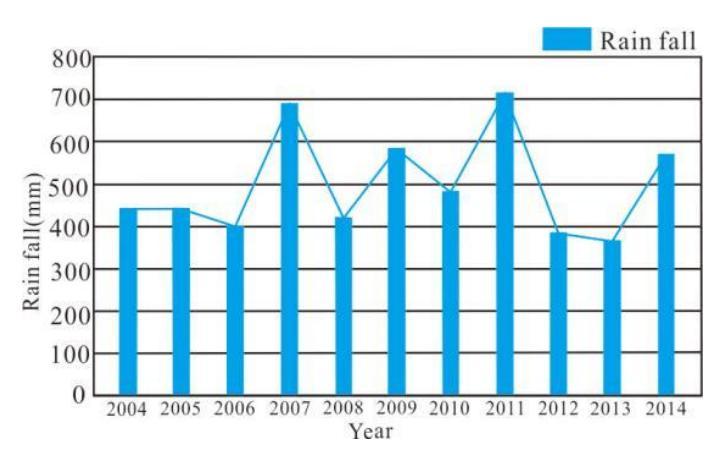
Figure 9. Precipitation Histogram of Jingyang from 2004 to 2014.

According to previous geological investigations, the ground fissures in the research area mainly appear as bead-like or large sinkholes with cavities in the shallow layer, and their activity increases significantly after rainfall. The annual maximum precipitation in the research area is 829.7 mm, and the minimum is 290.1 mm. According to the meteorological bureau's detection (Figure 9) and investigation, the frequency of ground fissure activity was higher from 2007 to 2009, indicating a close relationship between the opening of water-eroded ground fissures and rainfall. The terrain in the research area has a common characteristic of being higher in the north and lower in the south, and the terrain changes in elevation provide potential energy for surface water and groundwater. Under conditions of heavy rainfall, rainwater will flow to low-lying areas, and groundwater in higher areas will also have hydraulic gradients, thus providing lateral flow force. In addition, a large amount of surface water generated by rainfall will flow downward through preferential channels (hidden fissures), thus providing terrain conditions for the development and generation of water-eroded ground fissures.

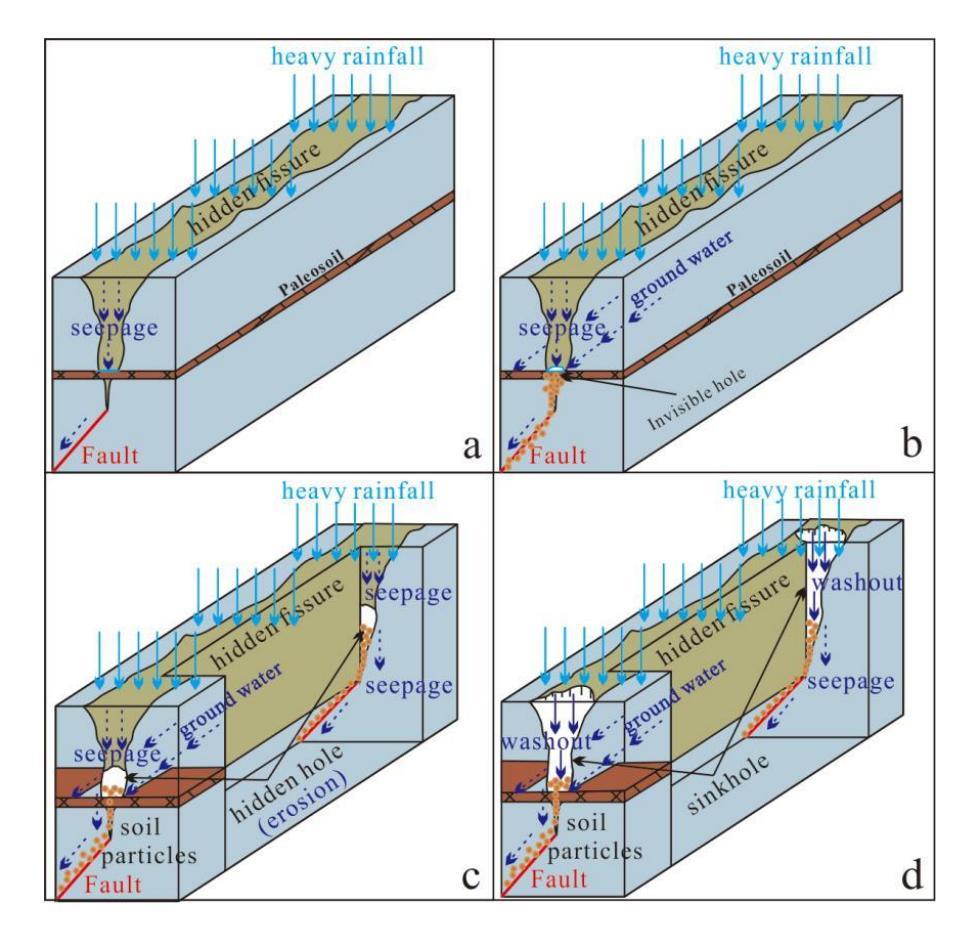
Figure 10. Water erosion process [20] (modified from Wang et al., 2019): (**a**) water collects to form hole; (**b**) cavitation is formed by erosion; (**c**) collapse to form cavity; (**d**), further collapse to form pit.

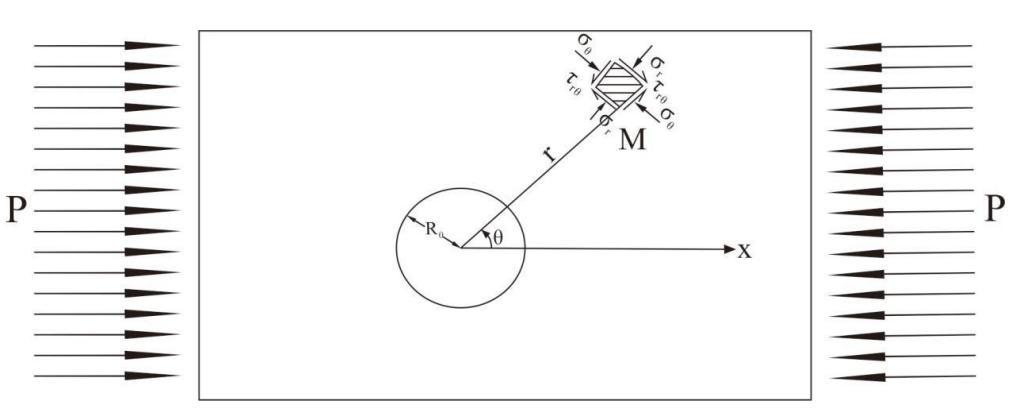
Figure 11. Stress analysis of the Cauchy problem: *P*, compression zone; R_0 , aperture size; $\tau_{r\theta}$, shear stress; and σ_r and σ_{θ} , normal stress.

Formula (1) is the stress calculation formula for the periphery of a central hole in an infinite thin plate solved in a Cauchy problem (Figure 11), the process can be described as follows: *P* is the compression zone, *R*₀ is the aperture size, σ_r is the normal stress in the *r* direction, σ_{θ} is the normal stress in the θ direction, and $\tau_{r\theta}$ is the shear stress. This is applied to the calculation of stress redistribution in the surrounding rock of underground cavities.

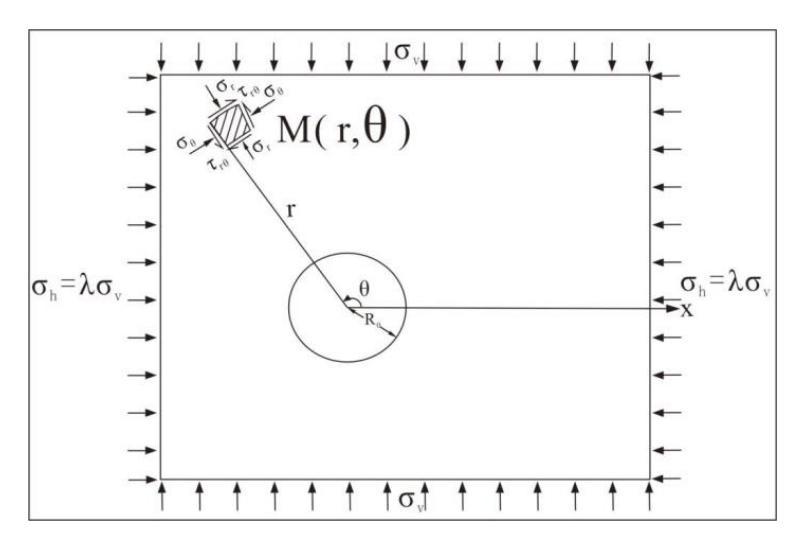
By substituting σ_v into *P*, the stress redistribution caused by the vertical natural stress can be obtained. Combining it with the stress redistribution caused by the horizontal natural stress (σ_h). Where, the relationship between σ_v and σ_h is $\sigma_v = \lambda \sigma_h$. The Formula (2) for the stress distribution of surrounding rock of a circular cavity (Figure 12) can be derived.

From Equation (3), it can be seen that there is only σ_{θ} acting on the tunnel wall, and σ_{θ} is related to the natural stress state and the position θ of the calculation point, and has nothing to do with the size of the cave.

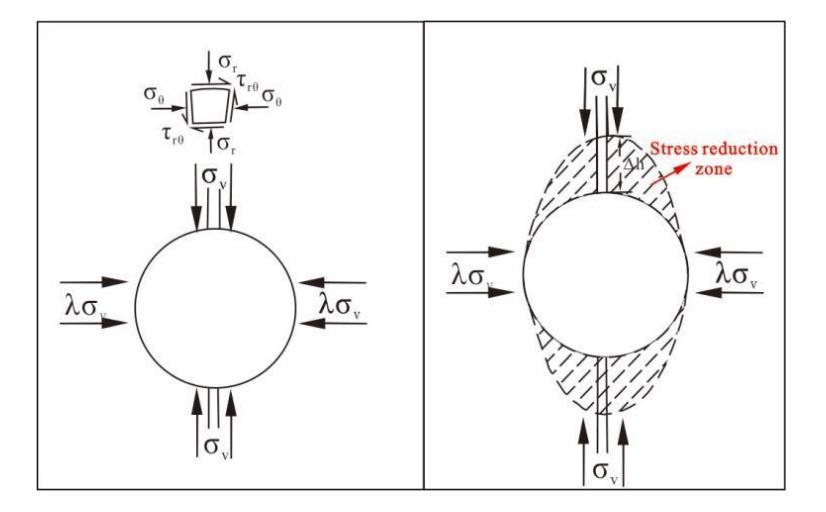
Figure 13. The effect of vertical cracks on redistributed stress: σ_v , vertical natural stress; σ_h , horizontal natural stress; $\tau_{r\theta}$, shear stress; σ_r and σ_{θ} , normal stress; Δh , stress relaxed area.

When there is a vertical crack in the rock and soil, it can be regarded as a weak structural plane intersecting with the borehole wall along the vertical diameter. According to Equation (2), when $\theta = 90^{\circ}$, there is no shear stress on the structural plane; however, when $\lambda < \frac{1}{3}$, tensile stress will be generated at the top and bottom of the borehole. Under this tensile stress, the weak structural plane will be pulled apart, forming a stress reduction zone in an elliptical shape at the top and bottom (Figure 13).

The short axis of the ellipse is the same as the horizontal diameter of the cavity, which is $2R_0$. The long axis is parallel to the structural plane and has a size of $2R_0 + 2\Delta h$, where Δh is determined by the following Equation (4):
