Article Study of Tensile Deformation and Damage Law in Undermatching X80 Pipeline Steel Welded Joints

Abstract: This study used a digital imaging technique (DIC) to obtain the strain distribution at various locations in undermatching X80 pipe girth-weld joints under uniaxial tensile loading. In addition, the microstructure characteristics and deformation patterns in different regions were analyzed by scanning electron microscopy (SEM). The results showed that there was strain heterogeneity between the various regions of the welded joint. Strain concentration existed only in the 12.8 mm base metal heat-affected zone (HAZ) and only in the elastic deformation stage. There was strain concentration in the weld metal (WM) and both sides of the HAZ close to the near-fracture stage, and the maximum deformation was in the WM. When $\varepsilon_M = 12.2\%$, the K_C was 6.27 and the K_F was 1.73, and the K_F was 113% and 152% of the K_C and the K_G , respectively. The large number of slip strips generated indicated serious damage in the WM near the fracture stage. In the elastic deformation stage, the strain concentration of the N1 HAZ was caused by the softened ferrite. The maximum deformat

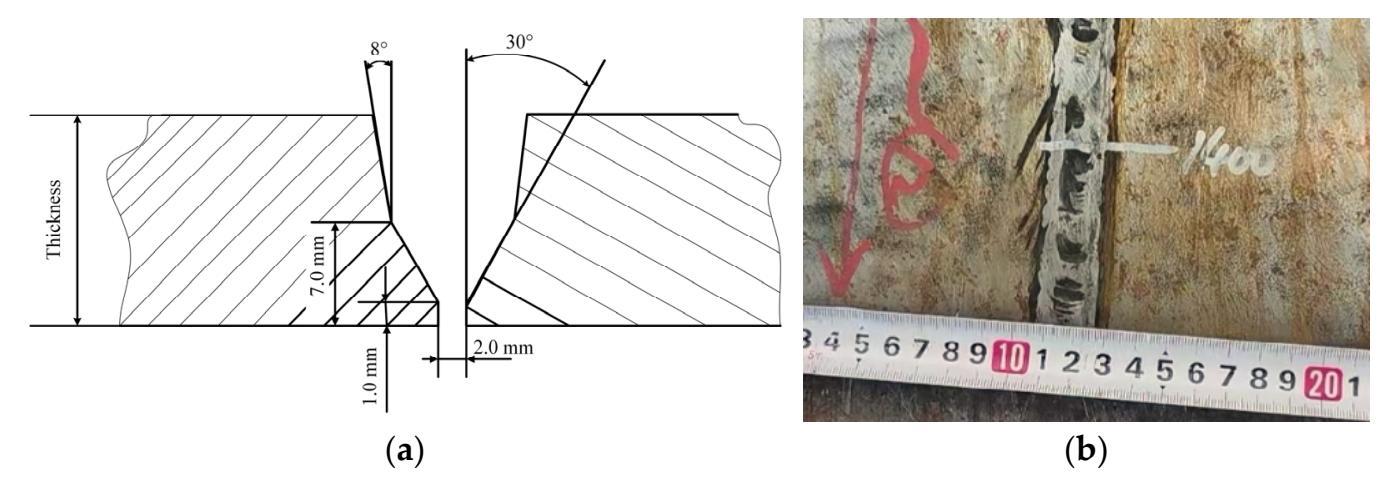
The test material was taken from an actual service X80 steel girth-welded joint. The base metal (BM) on both sides of the welded joint was API X80 pipeline steel with thicknesses of 12.8 mm and 15.3 mm, respectively, which were marked as N1 and N2. The yield strengths of N1 and N2 were 585 and 565 MPa, respectively, and the tensile strengths were 756 and 735 MPa, respectively. The girth-weld joint diameter was 1060 mm, which was an unequal-wall-thickness girth weld. The welding process used for the girth weld was semi-automatic welding. The welding parameters are shown in Table 1, and the groove shape and an image of the finished weld plate are shown in Figure 1. The chemical composition was analyzed by spectral analysis using a Shimadzu PDA-8000 (Shimadzu Corporation, KYOTO, Japan). The chemical composition of the studied X80 pipeline steel conformed to the API 5L standard, as shown in Table 2.

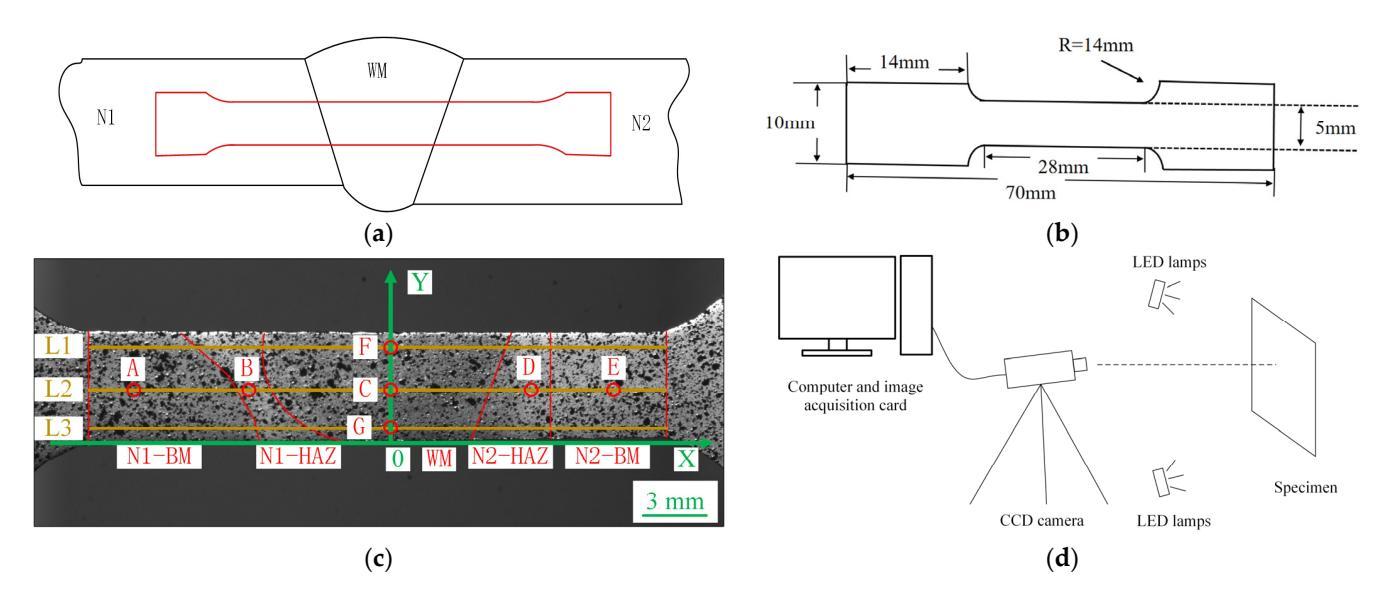
Figure 2. (a) Sampling direction; (b) sample size; (c) zone and mark point locations; (d) DIC system schematic diagram.

The tensile test specimen was a non-standard dogbone shape, the specimen length direction was parallel to the pipe, the WM of the girth weld specimen was located in the middle of the tensile test specimen, and the geometric shape and detailed specimen size are shown in Figure 2a,b.

For the tensile test, a DIC experimental system was used, comparing an Instron 8801 (Illinois Tool Works Inc., Norwood, MA, USA) experimental machine and a Vic-2D DIC system (ACQTEC, Shanghai, China). The image acquisition device consisted of two high-resolution 2448×2048 pixel CCD cameras. The angle of the two cameras in front of the sample was about 30° , and two LED lamps were used for lighting; a DIC system schematic diagram is shown in Figure 2d. The accuracy of the DIC measurements was closely related to the quality of the speckle image. Gray distribution in an image and the selection of subset size are affected by speckle in DIC analysis. Before the DIC test, matte paint was sprayed to make the pattern size 3–5 pixels to ensure the best recognition effect [19,20]. During the stretching process, image acquisition and displacement loading were carried out at the same time, and the subset size was 23×23 pixels, the step size was 5 pixels, the

In order to further determine the tensile deformation characteristics of the girth weld, the positions of the typical points of the specimen were marked. As shown in Figure 2c, the lower edge of the tensile specimen parallel section was taken as Y = 0, and the midpoint of L1 was X = 0. In addition, the Y-axis coordinate values of L1, L2 and L3 were 0.7 mm, 2.5 mm and 4.3 mm, respectively, which were marked for strain analysis from the cover welding to the backing welding. N1-BM, N1-HAZ, WM, N2-HAZ and N2-BM were used to denote the N1 BM zone, the N1 heat-affected zone, the weld metal, the N2 heat-affected zone and the N2 BM zone, respectively. Seven characteristic points were marked for strain analysis and deformation behavior.

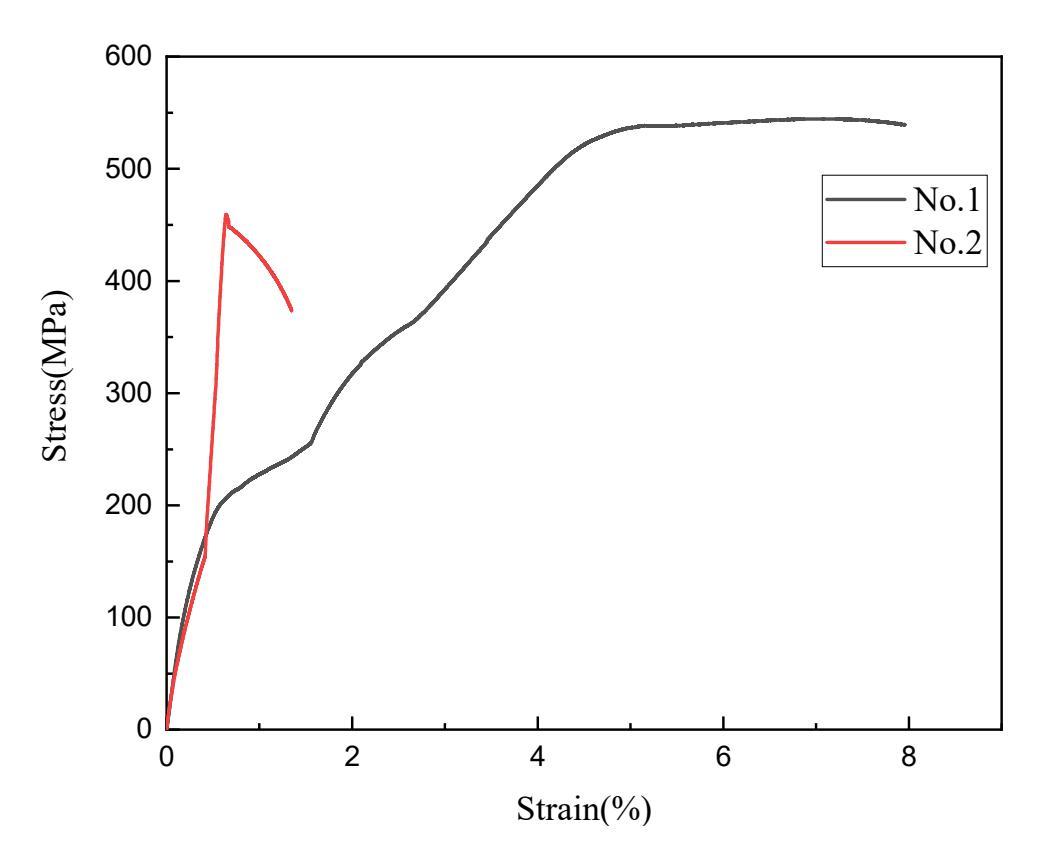
Figure 3. In situ observation of tensile curve.

In order to observe the deformation behavior of the sample, a method of combining the Instron 8801 testing machine (Illinois Tool Works Inc., Norwood, MA, USA) with the JSM 6010 (Japan Electronics Co., Ltd, Tokyo, Japan) SEM was used to conduct the in situ tensile test. After the sample was stretched to the different strain values, loading was stopped, and the sample was removed. The surface deformation of the sample was observed by SEM. In this study, the specimen was stretched twice, and the stress–strain curve of intermittent tension is shown in Figure 3. The first discontinuous tensile test is defined as No.1. When No.1 stopped, the sample was in the stage of uniform plastic deformation. The second discontinuous tensile test was defined as No.2. When No.2 stopped, the stress had decreased rapidly after exceeding the tensile strength, indicating that the sample was in the critical fracture stage. The deformation observation points of each zone are shown as points A–G in Figure 2c. The M–A percentage was calculated by Image-pro plus (6.0, Image-pro plus, USA).

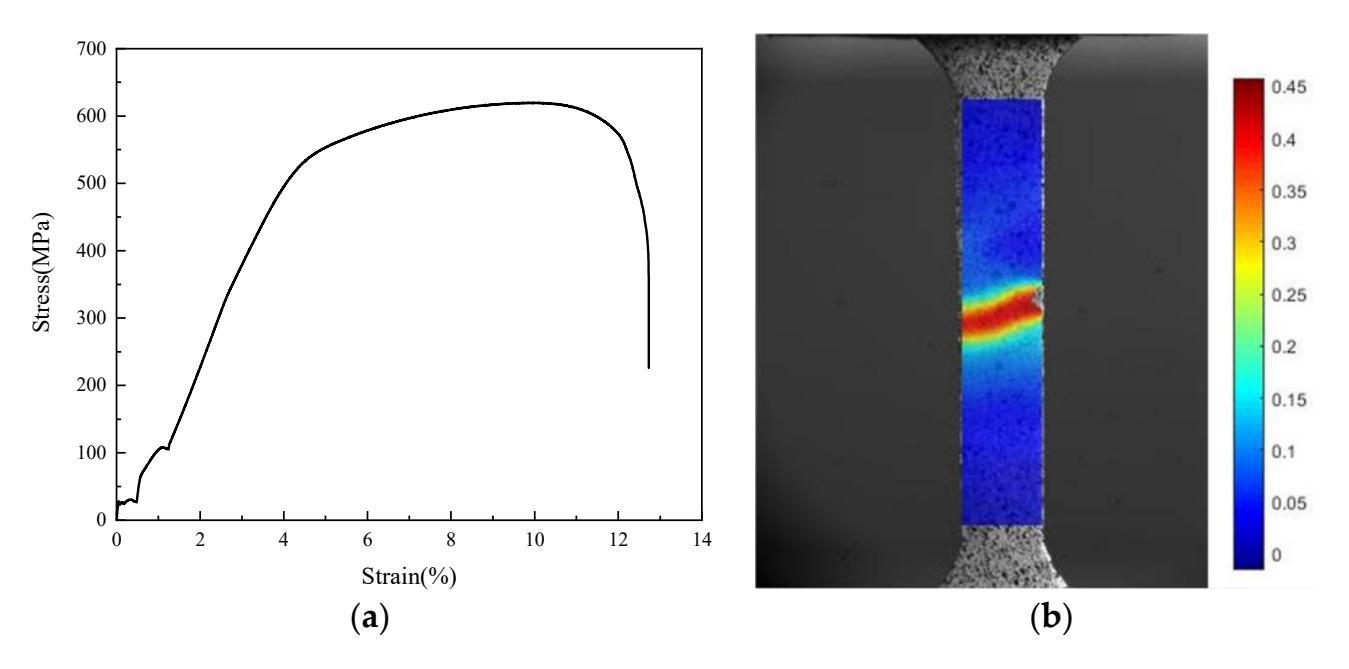
Figure 4. (a) Tensile curve of test specimen; (b) axial strain distribution diagram of specimen at ε_M = 12.2%.

In order to clarify the strain law of welded joints at different deformation times, the stress and strain curve of the sample is shown in Figure 4a. The strain was calculated using the data measured by the displacement sensor, and its strain was defined as the macroscopic strain, represented by ε_M . The ε_M of the specimen was shown in the tensile curve at different tensile stages. The tensile yield strength of the specimen was 497 MPa and the tensile strength was 623 MPa, which also meant that the fracture location of the specimen would be the WM. The distribution diagram of axial strain when $\varepsilon_M = 12.2\%$ is shown in Figure 4b, and there was a serious strain concentration in the WM near the fracture of the tensile sample. The area of the WM in the gauge region was about 51.7 mm² and 37.8% of the gauge region area. When the width of the WM was very small, the strain distribution and deformation behavior of the heat-affected zone and the WM changed. In this experiment, the WM area was large, and only ε_M of the sample was affected. There was no obvious effect on the local strain distribution, deformation mechanism or fracture behavior in the different zones.

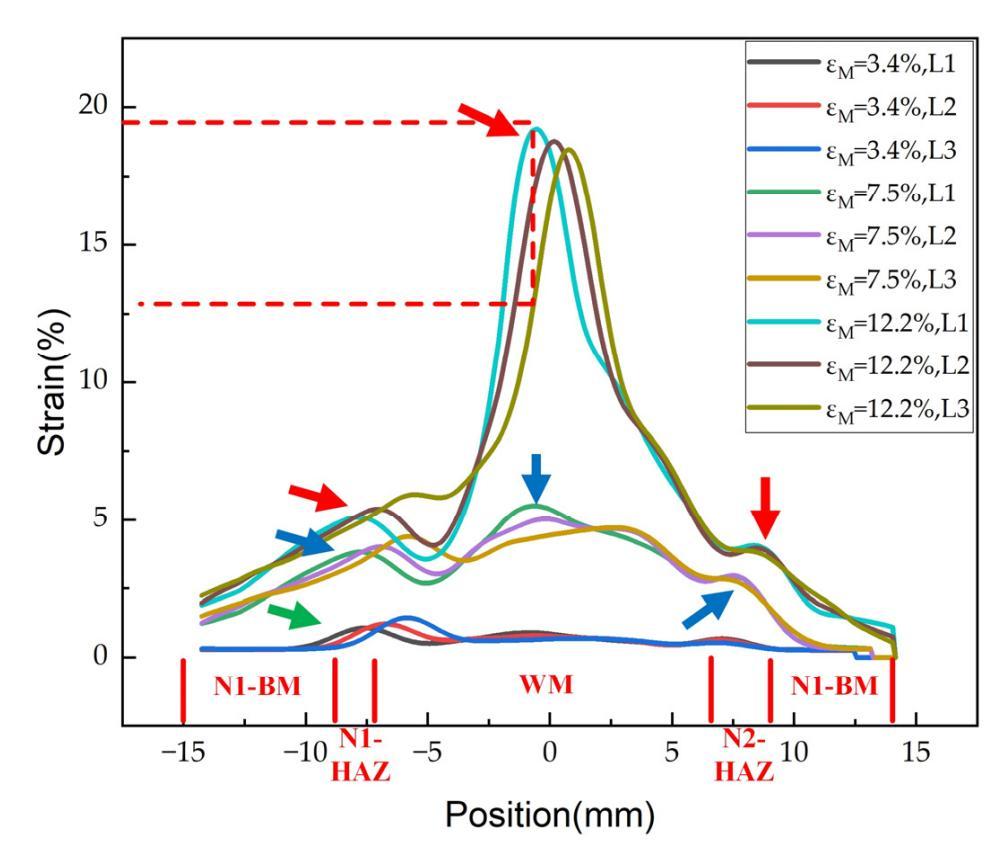
Figure 5. Strain distribution of L1–L3 at ε_M = 3.4%, ε_M = 7.5%, ε_M = 12.2%.

The strain change rule at different stages of the tensile process was inconsistent, as shown in Figure 5. At $\varepsilon_M = 3.4\%$, the sample was in the elastic stage and L1–L3 had a strain concentration area in the N1-HAZ, with the maximum strain value about 1.3%, as shown by the green arrow, and there was almost no deformation in other zones. At $\varepsilon_M = 7.5\%$, after yielding and small plastic deformation, the local strain peak appears in the WM and the HAZ on both sides of L1–L3, as shown by the blue arrow. The maximum strain of the WM and the N1-HAZ were about 5.2% and 4.1%, and the maximum strain of the N2-HAZ was about 3.1%. When $\varepsilon_M = 12.2\%$, the specimen was about to fracture, and the strain concentration phenomenon on both sides of the HAZ still existed. The maximum strain of the N1-HAZ and the N2-HAZ were 5.5% and 4.1%, respectively, which increased slightly to $\varepsilon_M = 7.5\%$. However, the maximum strain in the WM was about 18.7%, and the strain increased significantly, as shown by the red arrow.

When the X coordinates were the same, in the Y direction, the strain of the BM and the HAZ were the same, which indicated that the strain distribution in the thickness direction was more uniform during the entire tensile process. However, in the WM, the strain difference at the same position increased from 1.2% at ε_M = 7.5% to 6.6% at ε_M = 12.2%. With the increase in ε_M , the strain difference in the thickness direction became more obvious.

The microstructure and deformation behavior of different thickness positions in the WM were different, as shown in Figure 7. The welding process was multi-layer and multi-pass welding, and the later pass welding could cause different thermal cycles in the microstructure of the previous pass weld, thus affecting its microstructure. As shown in Figure 7a–c, the structure types of the three points were basically the same, both being granular bainite and polygonal ferrite. The grain size and the distribution and quantity of the M–A were different. The grain at points F and C was larger, while that at point G was smaller. After No.2, slip bands appeared at points F, C and G, but the number of slip bands at point F was greater than that at points C and G, and the distribution of slip bands was denser. There were many slip bands at point F, indicating that the deformation was more serious, which could have caused the strain at this position to be higher than that at points C and G. Test No.2 caused serious deformation of the sample, and the deformation characteristics and deformation mechanism of the WM at this stage were similar to those at adjacent fractures. It could be reasonably inferred that when there was further loading, the uneven distribution of slip bands would remain until fracture, which was consistent with the strain law of the WM with different thicknesses in Figure 5.

In the thickness directions in the WM, when at the same tension stage, the number of slip bands was largest at point F, and the number of slip bands at point C and point G decreased in turn. The distribution of deformation bands was consistent with the strain distribution in Figure 5a. The different deformation amounts and deformation behavior of points F and G were also affected by their different grain sizes and their M–A islands, and the related deformation mechanism was similar to point C. The fracture mechanism was affected by different damage behaviors in different weld zones. From the fracture morphology in Figure 7, it can be seen that dimples were the main microscopic characteristic in the different thicknesses of the weld zone, which is a typical ductile fracture feature [27]. In the process of loading, the deformation mechanism was slip deformation, as shown in Figure 8. With the continuous increase in ε_M , the slip systems at different positions gradually started up and formed dislocation accumulations around the hard phases, such as M–A and carbides, resulting in voids. With further loading, the voids gradually connected with each other to form a large area of dimple characteristics. The amount of slip in the WM was more than that in the HAZ and the base metal zone on both sides, and the micro cracks in the WM were connected and caused WM fracture. Due to the inhomogeneity of the WM, the area with higher hardness had poor plasticity, and quasi-cleavages and micropores would appear. Compared with the position close to the cover weld (Y = 4.3 mm), the dimple area near the root weld area (Y = 0.7 mm) and the single dimple size were reduced, which proved that the plastic deformation of this area was smaller in the final fracture, as shown in Figure 5. The possible reason was that the smaller grain size and denser M-A components caused lower plastic deformation.

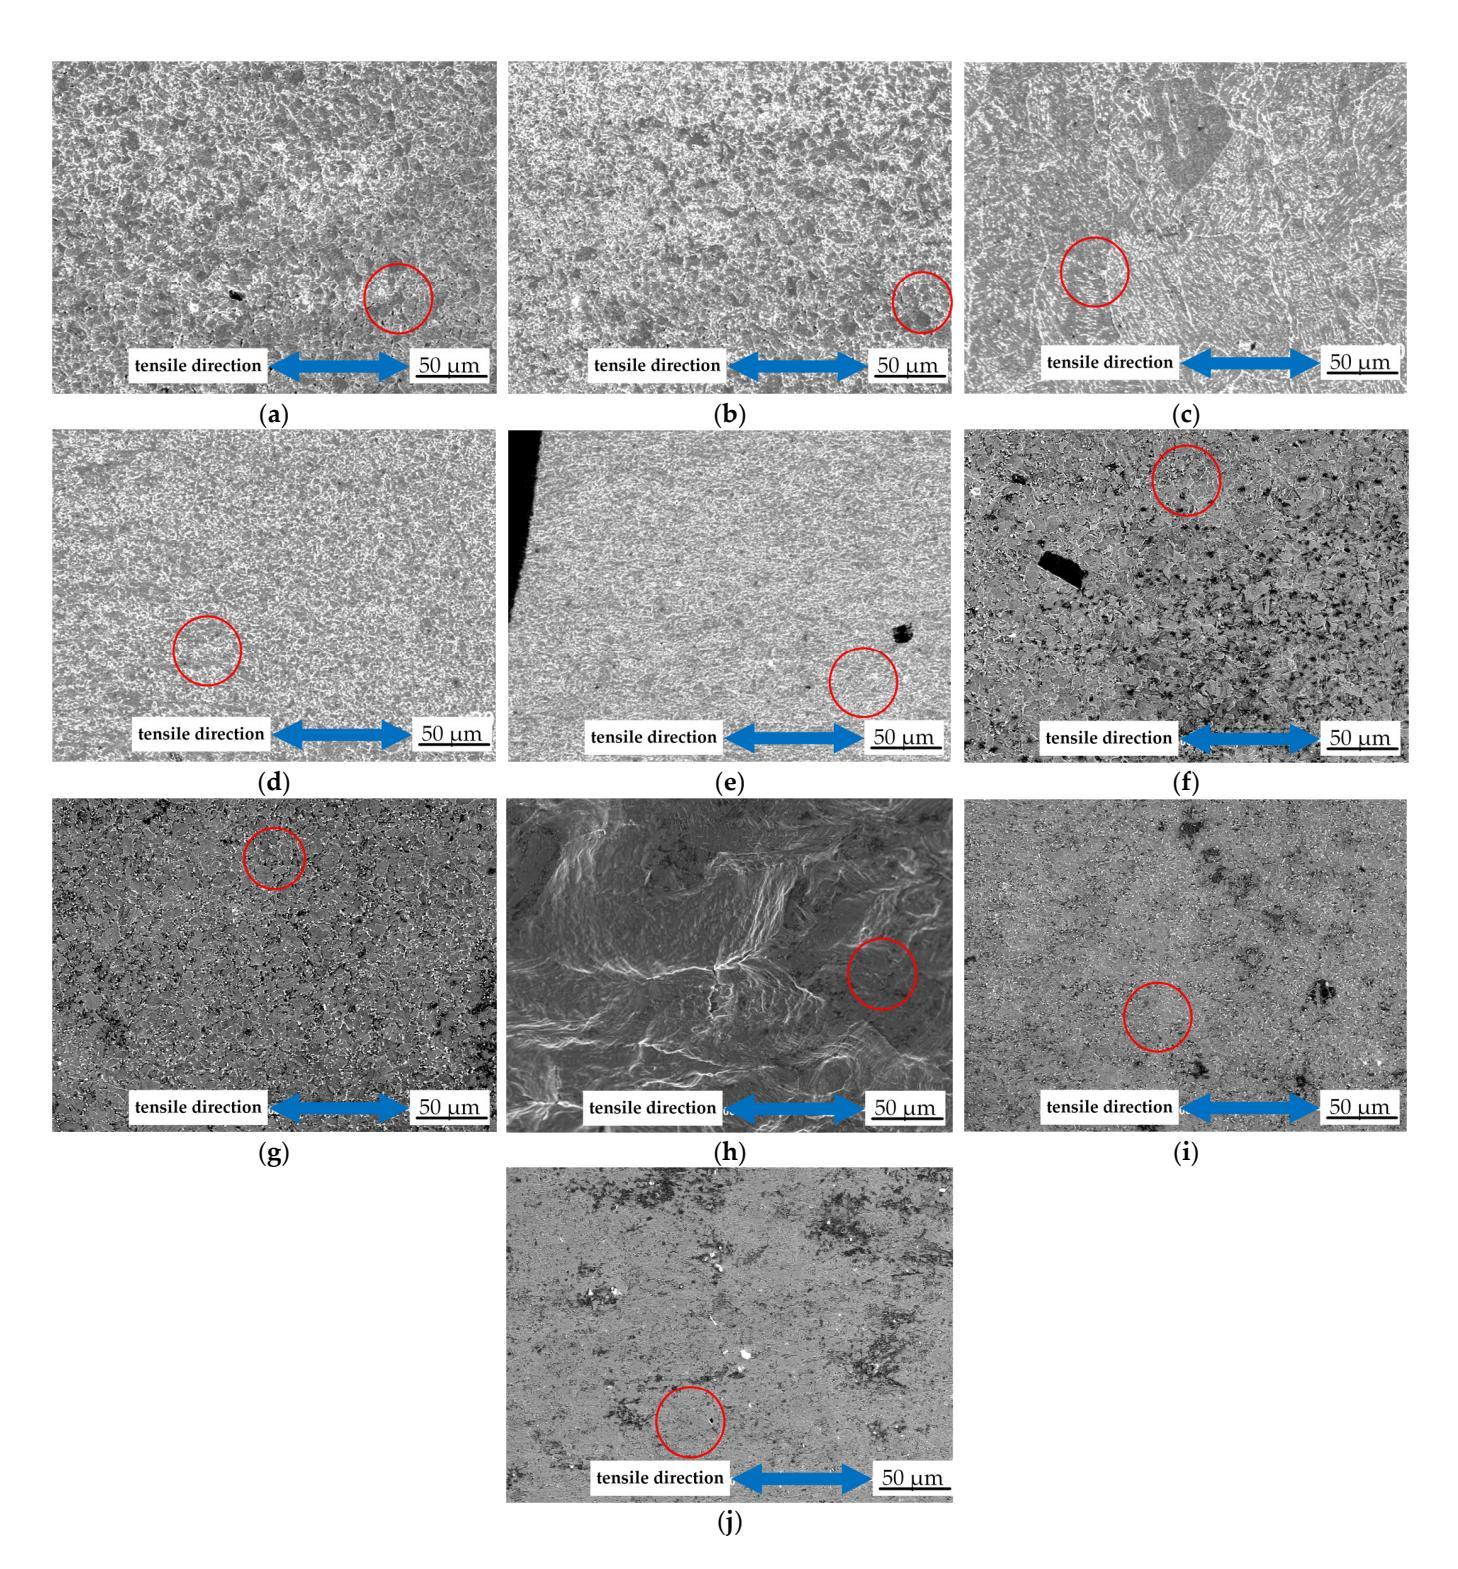
The coordinates A, B, C, D, E, F and G were (-12.18, 2.5), (-6.70, 2.5), (0, 2.5), (6.73, 2.5), (10.57, 2.5), (0, 4.3) and (0, 0.7), respectively. In order to clarify the microstructure characteristics and deformation behavior of different regions, SEM was used to observe the microstructure characteristics and deformation of each check point in different tensile stages. The results are shown in Figures 6 and 7. The check points of each position in Figure 6 were marked with red circles to ensure that the observed positions were the same areas. Point A and point E were composed of polygonal ferrite and granular bainite. The grain sizes of point A and point E were 12 µm and 14 µm, respectively. The content of granular bainite in point E was higher than in point A, the size of ferrite was smaller and the number of smaller sized M-A islands was greater. The number of carbides and M-A islands at the grain boundary of point B and point D increased significantly due to the welding thermal cycle, and the grain size increased unevenly. The grain sizes of point B and point D were, respectively, 9 μ m and 10 μ m, which were smaller than the grain size of the BM. The shape of the grains was more uniform, which was caused by different recrystallization and recovery. At the same time, the size of the M–A islands increased in both HAZs, especially in the N1-HAZ. Compared with other zones, there was larger granular bainite and lath bainite at point C, and the grain size was about 40 µm. There were more M–A islands in the grains of point C, which could also affect tensile deformation behavior. The carbides and M–A islands present at points A–G were, respectively, 10.41%, 12.99%, 13.88%, 15.01%, 14.69%, 11.88% and 13.88%.

After No.2, the morphology characteristics of points A, B, D and E showed no obvious differences from the original state, and there were no tensile holes or cracks on the surface. The increase in strain was caused by a small amount of dislocation movement and small grain deformation. At point C, white slip bands appeared after No.1, with no fixed angle to the tensile stress direction. The observation results of points A–E showed that the

There were no cleavage fractures in the different zones of welded joints after severe plastic deformation (Figure 6), so the increase in strain was mainly controlled by slip. The slip behavior of the welded joints was mainly affected by the nominal deformation, the grain size and the second hard phase, and the grain size of the HAZ and the proportion of hard phase are affected by cooling rate and maximum temperature [23].

necessary dislocations are accumulated in larger grains, which is considered to be one of the important factors causing work hardening [26]. The lower geometric dislocation density could not hinder the generation and movement of dislocations, resulting in a large number of slip bands. A large number of slip bands and tensile cracks appear at point C in the WM due to severe plastic deformation, as shown in Figure 6h.

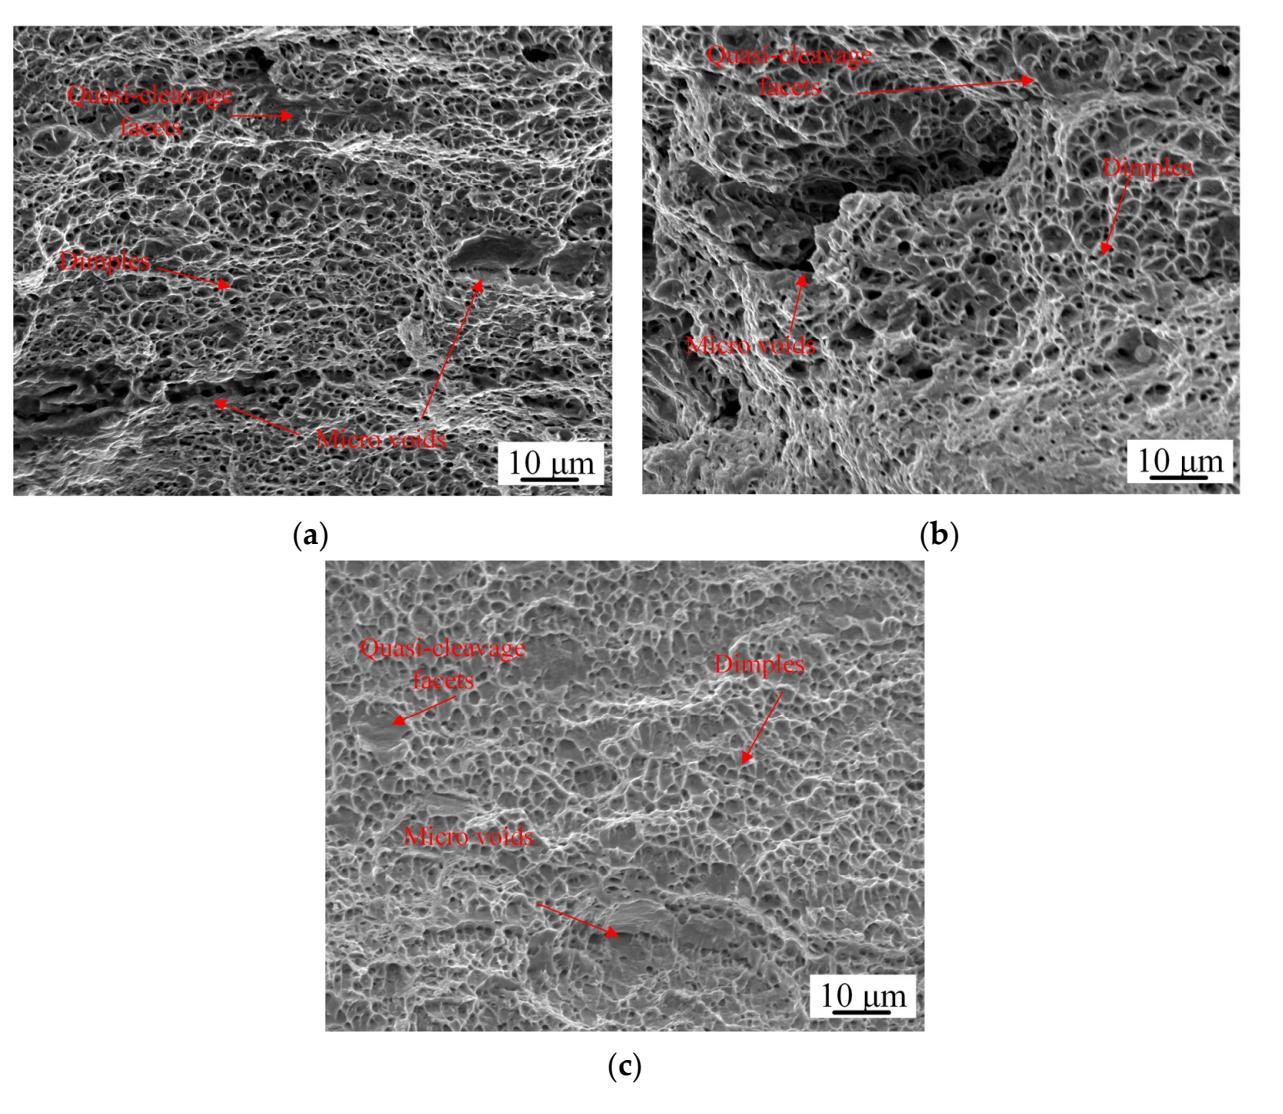
Figure 8. Fracture surfaces of different thicknesses in the WM: (a) Y = 4.3 mm; (b) Y = 2.5 mm; (c) Y = 0.7 mm.

The final fracture position of the sample was the WM. The SEM images of different thicknesses on the fracture surface are shown in Figure 8. Although there were dimples,

microvoids and quasi-cleavage facts in all three positions, different fracture characteristics still existed. Specifically, at Y = 4.3 mm, the proportion of dimples and the single dimple depth were both larger, and the distribution of micropores was more concentrated. The larger microvoids indicated that the local stress changed greatly and that the deformation was uneven during the fracture process. At Y = 2.5 mm, compared with Y = 4.3 mm, the dimples area was reduced, and secondary cracks appeared together with larger-sized micropores, and the quasi-cleavage surface had no obvious change. When Y = 0.7 mm, it was closer to the root welding. There was no larger secondary crack, the depth of dimples decreased, and the quasi-cleavage area increased compared with Y = 4.3 mm and 2.5 mm.
