# Effects of Temperature on Wear Properties and Mechanisms of HVOF Sprayed CoCrAlYTa-10%Al<sub>2</sub>O<sub>3</sub> **Coatings and H13 Steel**

Abstract: In this study, the CoCrAlYTa-10%Al<sub>2</sub>O<sub>3</sub> coatings were prepared by the high-velocity oxygen-fuel (HVOF) spraying. A series of ball-on-disk sliding wear tests were conducted to evaluate the tribological properties of the coatings at different temperatures (25 °C, 200 °C, 400 °C, and 600 °C). The results showed that the average coefficients of friction (COFs) of the CoCrAlYTa-10%Al<sub>2</sub>O<sub>3</sub> coatings were lower than that of H13 steel at different temperatures. The average COFs of the CoCrAlYTa-10%Al<sub>2</sub>O<sub>3</sub> coatings and H13 steel both decreased with increasing temperature. The wear rate of the CoCrAlYTa-10%Al<sub>2</sub>O<sub>3</sub> coatings increased first and then decreased. The microhardness of worn surface of the CoCrAlYTa-10%Al<sub>2</sub>O<sub>3</sub> coatings increased with increasing temperature, while the microhardness of worn surface of H13 steel at 25 °C and 200°C was higher than that at 400 °C and 600 °C. The wear mechanism of the two materials was mainly abrasive wear.

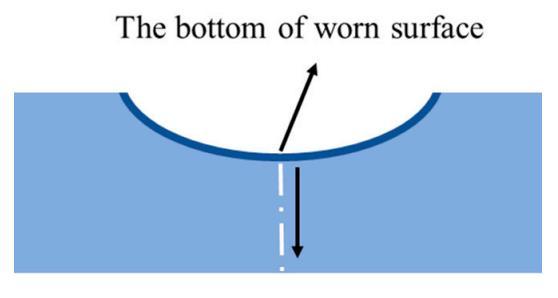
Figure 1. Schematic of microhardness test of the CoCrAlYTa-10%Al<sub>2</sub>O<sub>3</sub> coatings and H13 steel.

In order to study the effect of temperatures on the wear properties and mechanisms of the coatings and H13 steel, the microstructure and phase composition were determined with X-ray diffraction (XRD, Bruker D8-Advanced, Bruker Inc., Karlsruhe, Germany) and SEM (Hitachi S-3400N, Hitachi Inc., Tokyo, Japan) equipped with energy dispersive spectrometer. In order to study the effect of wear on the microhardness of wear surface, the microhardness was measured by a Vickers microhardness tester (HXD-1000TC, Taiming Optical Instrument Inc., Shanghai, China) and from the bottom of the worn surface to the inside along the cross section, as shown in Figure 1. The load and holding times were 0.98 N and 15 s, respectively. In order to ensure the data repeatability, at least 10 measurements were done for each specimen.

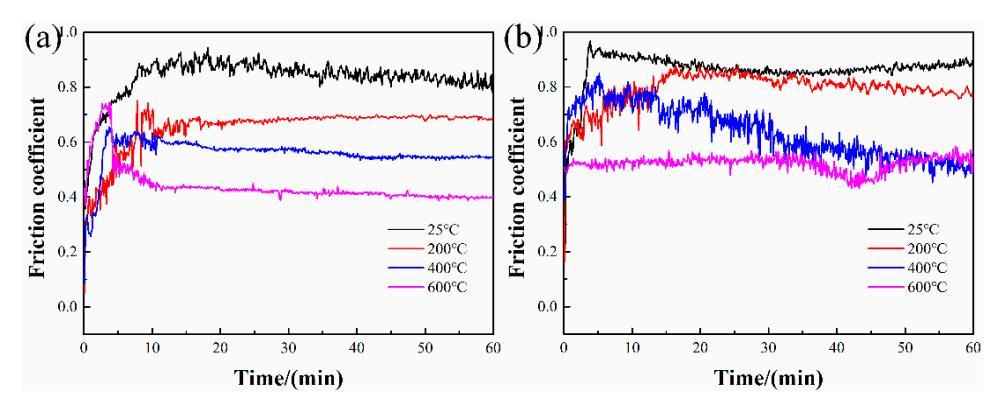
The COF curves against time are shown in Figure 2. The two-stage trend could be distinguished from the COF curves of the CoCrAlYTa-10%Al<sub>2</sub>O<sub>3</sub> coatings at different temperatures. At room temperature, the COF curve of the CoCrAlYTa-10%Al<sub>2</sub>O<sub>3</sub> coating was similar to that of H13 steel testing at different temperatures. A rapid increase to a peak value in the COF curves could be seen within the initial running-in stage and then remained stable, as shown in Figure 2a,b. At the higher temperature, the COF first increased to a peak value within a short duration, then decreased and stabilized for the remainder of test, as shown in Figure 2a. It suggested that the wear mechanism might change, when the temperatures was higher than 200 °C.

**Figure 2.** The coefficient of friction (COF) curves of the two kinds of materials during sliding wear testing at different temperatures: (**a**) CoCrAlYTa-10%Al<sub>2</sub>O<sub>3</sub> coating; (**b**) H13 steel.

The COF curves of H13 steel at 400 °C was quite different from the COF curves at other temperatures, as shown in Figure 2b. The COF curves first increased to a peak value, then slowly decreased and finally stabilized. During the wear process, the flash temperature in the contact area of friction couple was much higher than testing temperature [32]. The temperature of worn surface increased with the wear testing. Meanwhile, the wear properties and COF of H13 steel changed with the increase of worn surface temperature. The peak value of 400 °C was similar to the value of the stable stage at 200 °C. In the final stage of wear testing, the COF curves of 400 °C and 600 °C was close. It might be indicated that the microstructure of the worn surface at the initial stage of 400 °C was similar to that at the stable stage of 200 °C and the microstructure of the worn surface at the final stage of 400 °C was similar to that at the stable stage of 600 °C.

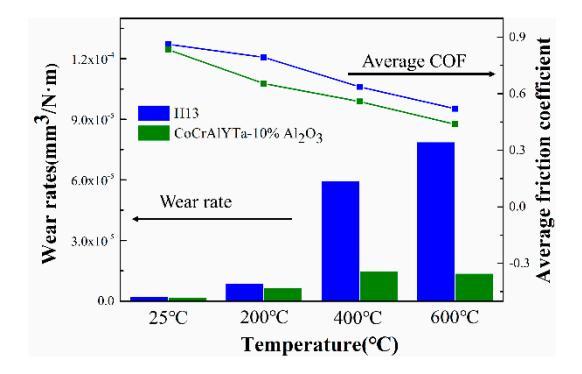
The average COF curves and wear rate are shown in Figure 3. The average COF curves of the CoCrAlYTa-10%Al<sub>2</sub>O<sub>3</sub> coatings were lower than that of H13 steel at different temperatures. The average COF curves of CoCrAlYTa-10%Al<sub>2</sub>O<sub>3</sub> coatings and H13 steel decreased with increasing temperature. When the temperature was 600 °C, the wear rate of the CoCrAlYTa-10%Al<sub>2</sub>O<sub>3</sub> coating was lower than that at 400 °C. At 400 °C, the wear rate of H13 steel was about four times to that of the CoCrAlYTa-10%Al<sub>2</sub>O<sub>3</sub> coating. When the temperature increased to 600 °C, the wear rate of H13 steel was about five times to that of the CoCrAlYTa-10%Al<sub>2</sub>O<sub>3</sub> coating. It indicated that the coatings had excellent wear resistance in the high temperature.

Figure 3. The average COF curves and wear rates of the two kinds of materials at different temperatures.

At the low temperature (or in the initial running-in stage), the volume loss of the coatings and H13 steel was low, which resulted in some debris and grooves appearing on the worn surface, as shown in Figure 9a. With the increase of temperature, sliding wear increased the temperature of the worn surface. Thermal softening (the contact areas between the micro-convex) and adhesive wear led to the increase of wear debris. Subsequently, the abrasive wear gradually increased and the adhesive wear was inhibited. Some debris accumulated in the grooves. If the debris was compacted and sintered on the worn surface, the tribofilms would form on the grooves. If the binding force between the debris was poor, some spalled pits were obvious on the tribofilms, as shown in Figure 9b. With the increase of temperature and wear debris, the continuous tribofilms were formed on the worn surface like the CoCrAlYTa-10%Al<sub>2</sub>O<sub>3</sub> coatings, as shown in Figure 9c. During the wear process, the Al, Co elements in the coatings would form a compact and continues oxide layer under high temperature and block the diffusion of oxygen from the surface to the inside [39]. The wear debris without serious oxidation had good plasticity, so that the wear debris could be sintered together to form tribofilms. When the temperature increased to 200 °C, the tribofilms appeared on the worn surface, as shown in Figure 5d. In addition, the work hardening caused by the plastic deformation and the oxide produced in the wear process effectively improved the microhardness of the worn surface. The tribofilms reduced the cutting effect of abrasive wear on the worn surface. With the increase of temperature, the tribofilms became more and more compact and smooth, which made the average COF of the coatings decreased (Figure 3). At 600 °C, the worn surface had the highest microhardness and the lowest COF, which resulted in the wear rate of the coating at 600 °C was lower than that at 400 °C, as shown in Figure 3.

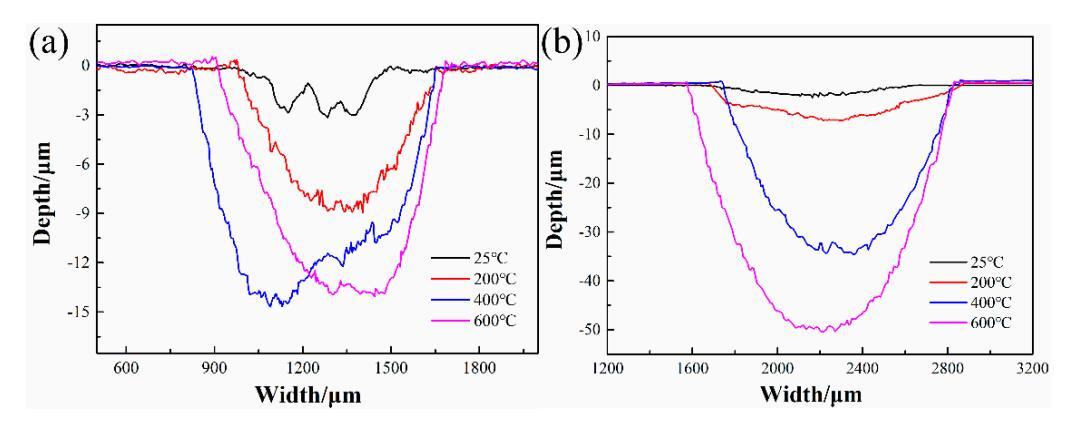
The profile curves of the CoCrAlYTa-10%Al<sub>2</sub>O<sub>3</sub> coatings and H13 steel are shown in Figure 4. When the temperature was higher than 200 °C, the depth and width of wear surface of H13 steel were much larger than that of CoCrAlYTa-10%Al<sub>2</sub>O<sub>3</sub> coatings. As shown in Figure 4a, the uneven curves showed that a large number of grooves existed on the worn surface. As shown in Figure 4b, with the increase of temperature, the volume loss of H13 steel increased. Especially, the volume loss of H13 steel increased dramatically when the temperature was higher than 200 °C.

Figure 4. The wear profiles of worn tracks: (a) CoCrAlYTa-10%Al<sub>2</sub>O<sub>3</sub> coating; (b) H13 steel.

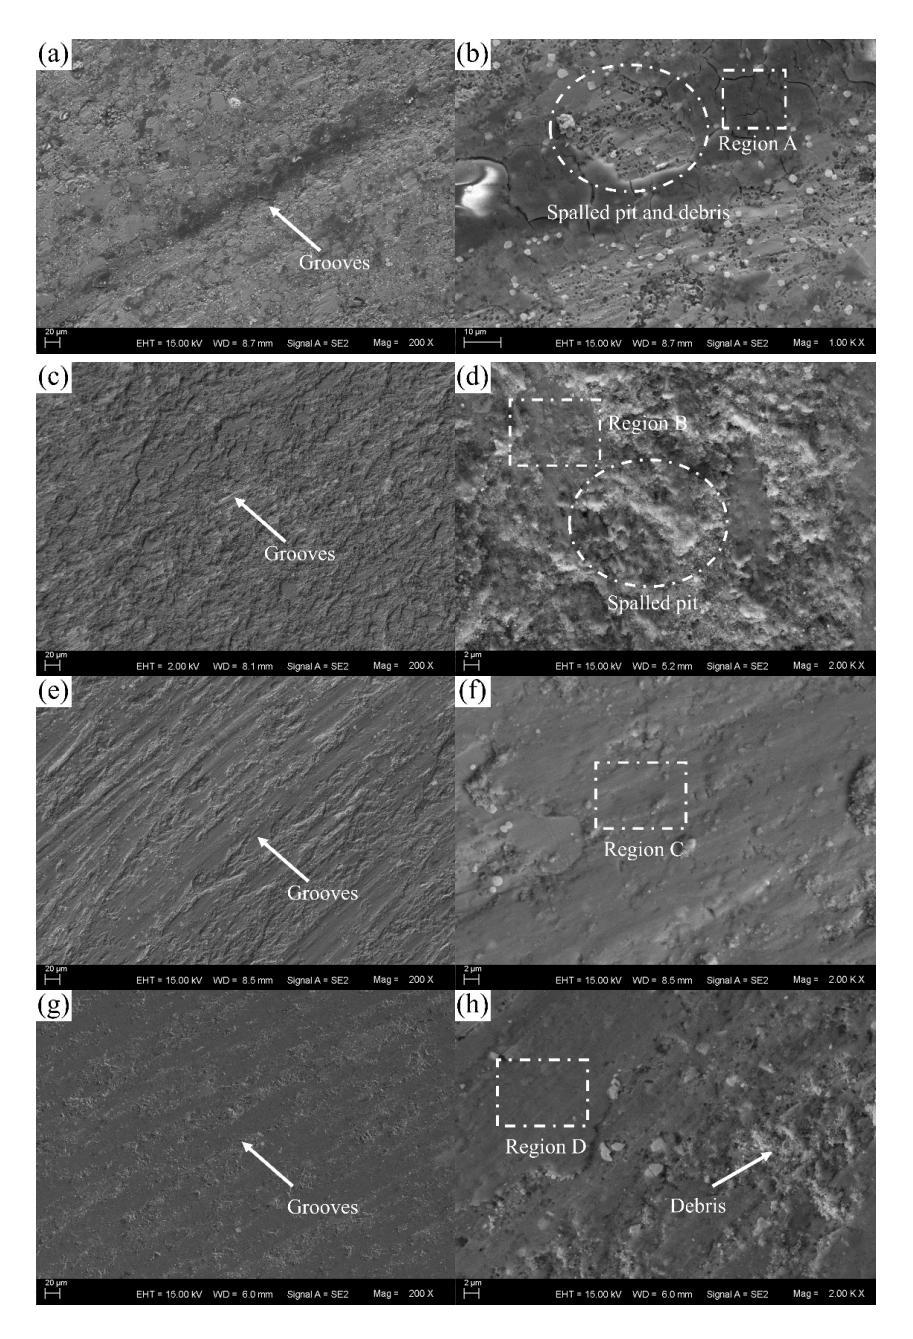
The worn surface images of the CoCrAlYTa-10%Al<sub>2</sub>O<sub>3</sub> coatings at different temperatures are shown in Figure 5. Some discontinuous strip-like tribofilms paralleling with the sliding direction were formed on the worn surface, as shown in Figure 5a. At higher magnification, some white particles (TaC) with a size of 1–2  $\mu$ m were uniformly distributed on the worn surface (Figure 5b), which made the coatings have excellent high temperature mechanical properties [23,26]. In addition, the number of TaC in the tribofilms was lower than that in the coatings, which indicated that the carbide was difficult to sinter into tribofilms. During the wear process, some debris was compacted and sintered on worn surface. But lower temperature and higher friction coefficient made debris difficult to sinter on the worn surface. The brittleness of the tribofilms made microcracks easy to form and propagate, then led to some spalled pits on the worn surface, as shown in Figure 5b.

**Figure 5.** The worn surfaces of CoCrAlYTa-10%Al<sub>2</sub>O<sub>3</sub> coating at different temperatures: (**a**,**b**) 25 °C; (**c**,**d**) 200 °C; (**e**,**f**) 400 °C; and (**g**,**h**) 600 °C.

When the temperature increased from 25 °C to 200 °C, the morphologies of abrasive wear had changed obviously and a large number of grooves appeared on the wear surface, which indicated the abrasive wear was aggravating, as shown in Figure 5c. The continuous tribofilms were formed on the worn surface, which had a significant antifriction effect on the worn surface. The average COF of the CoCrAlYTa-10%Al<sub>2</sub>O<sub>3</sub> coatings decreased from 0.83 to 0.65. As shown in Figure 5d, a large number of spalled pits appeared on the tribofilms, which was caused by the impact and cutting of abrasive particles and the rapid growth of microcracks in the tribofilms under the cyclic stress [33]. As temperature increased from 200 °C to 400 °C, due to the tribofilms were more compact with the increase of temperature, the number of spalled pits on the worn surface decreased rapidly, as shown in Figure 5e. Some TaC and spalled pits were observed on the worn surface, as shown in Figure 5f. It indicated that the spalled pits might be formed by carbide peeling off. Previous research showed that when the fine hard phase was distributed on the worn surface, plastic flow would slowly pull out the hard phase [34].

As shown in Figure 5g, the worn surface was smoother than that of 400 °C. The average COF of 600 °C was the lowest at different temperatures and the wear rate was smaller than that of 400 °C. It indicated that the smooth tribofilms had good protective effect on the coatings. As shown in Table 1, the results of the EDS analysis showed that all elements of tribofilms were similar at different temperatures, which suggested that the microstructure of worn surface was an important factor to high temperature wear resistance. The Y content was too low to be detected. Some finer debris were present in the worn surface, as shown in Figure 5h.

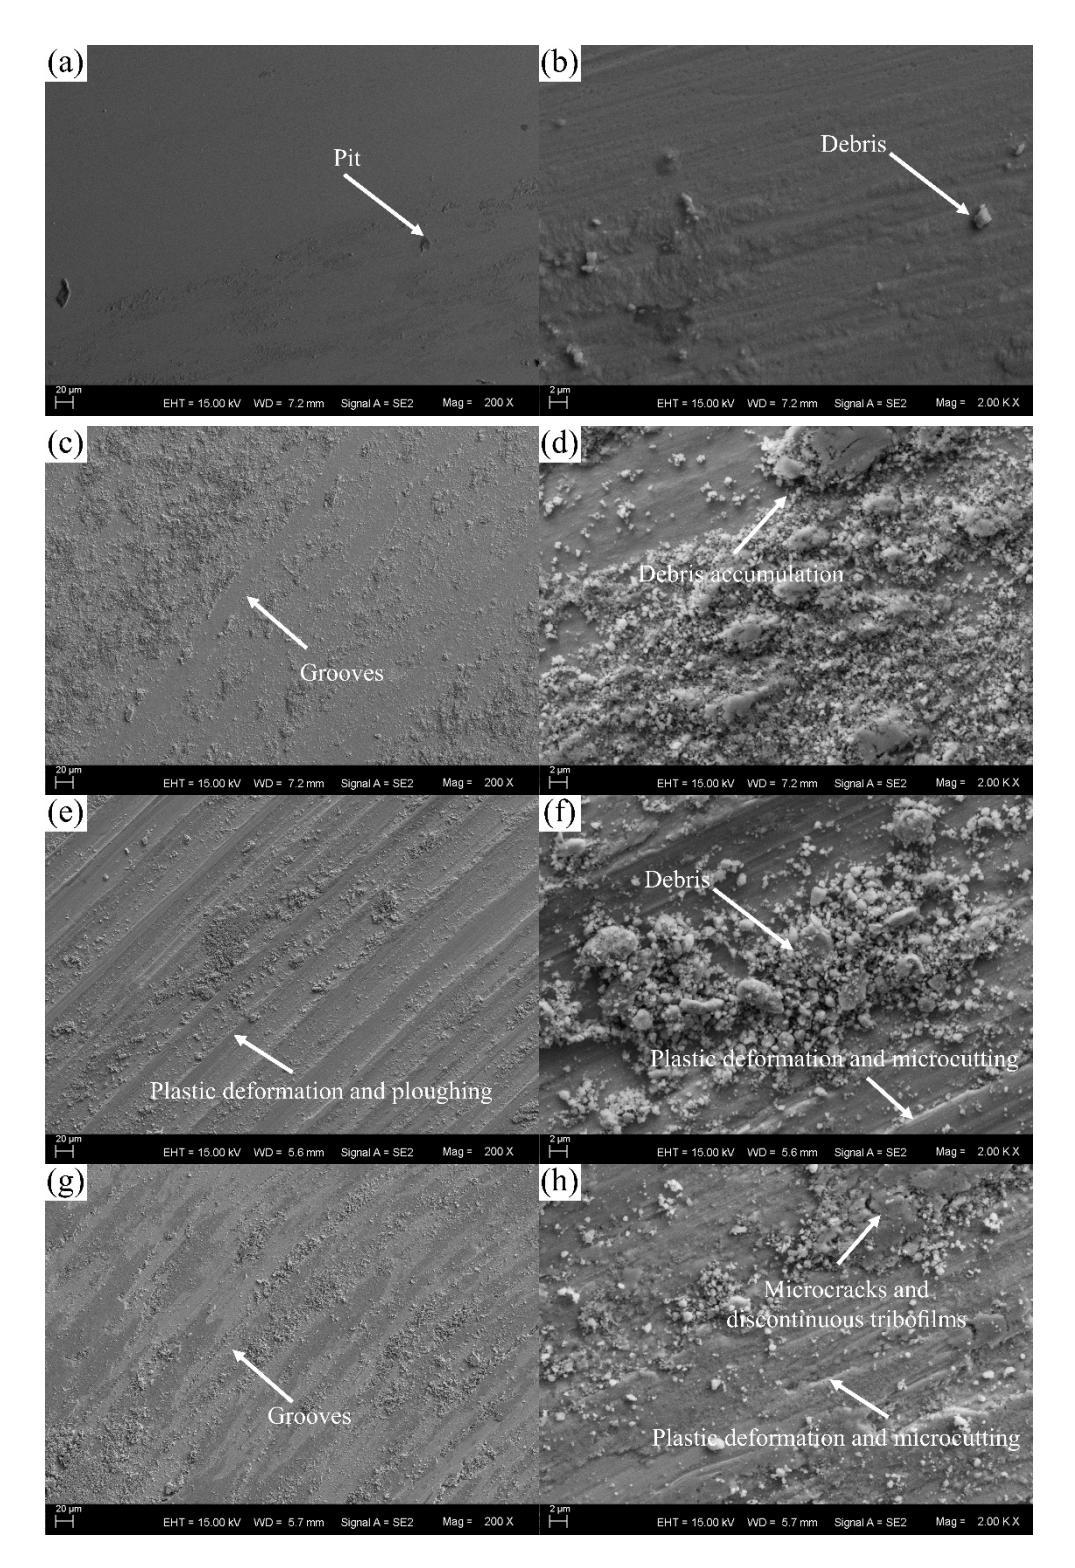
The morphologies of worn surface of the H13 steel at different temperatures are shown in Figure 6. At 25 °C, some pits appeared on the worn surface (Figure 6a), which might be resulted from fatigue wear [13]. At high magnification, a few chip wear debris and micro-ploughing formed on the worn surface, which were caused by the extrusion and cutting action of the micro-convex of Si<sub>3</sub>N<sub>4</sub>, as shown in Figure 6b. With the increase of the temperature, the increasing volume loss of H13 steel resulted in a rapid increase of the wear debris on the worn surface, a large number of wear debris appeared on the worn surface and some debris agglomerated into the lump particles, as shown in Figure 6c. Under high magnification, it could be found that the large particles were poorly bonded to the worn surface as shown in Figure 6d. At elevated temperature of 400 °C, severe micro-cutting and grooves were observed on worn surface (Figure 6e), which were caused by abrasive wear and thermal softening. In addition, the debris accumulated in the grooves (Figure 6f). At elevated temperature up to 600 °C, some discontinuous tribofilms formed on the worn surface, which reduced abrasive wear and friction coefficient, as shown in Figures 6g and 3. At high magnification, the worn surface at 600 °C was smoother than that at 400 °C. Micro-cutting and plastic deformation decreased. A number of discontinuous tribofilms appeared in the grooves and some interlaced microcracks were distributed on the tribofilms, as shown in and Figure 6h. Because of the low binding force between debris, it was difficult to form the dense and continuous tribofilms.

**Figure 6.** The worn surfaces of H13 steel at different temperatures: (**a**,**b**) 25 °C; (**c**,**d**) 200 °C; (**e**,**f**) 400 °C; and (**g**,**h**) 600 °C.

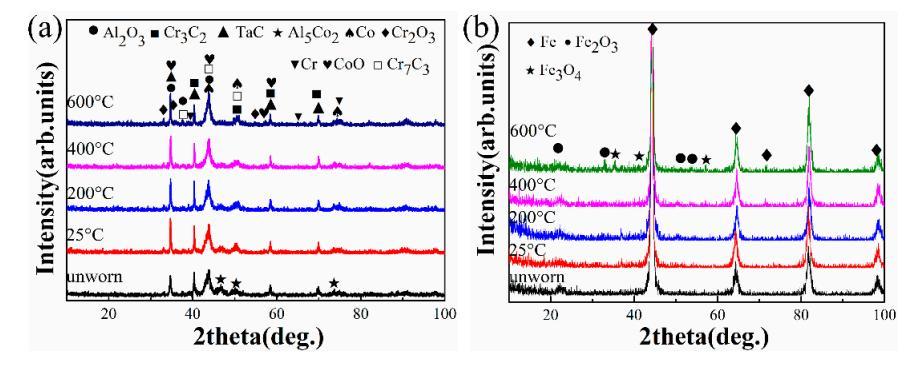
The XRD patterns of the worn surface of the CoCrAlYTa-10%Al<sub>2</sub>O<sub>3</sub> coatings and H13 steel after wear testing were shown in Figure 7. The unworn CoCrAlYTa-10%Al<sub>2</sub>O<sub>3</sub> coating consisted mainly of Al<sub>2</sub>O<sub>3</sub>, Al<sub>5</sub>Co<sub>2</sub>, Co, Cr, Cr<sub>3</sub>C<sub>2</sub>, Cr<sub>7</sub>C<sub>3</sub>, Cr<sub>2</sub>O<sub>3</sub>, and TaC at room temperature, as shown in Figure 7a. The phases of the all worn tracks were basically same. With the increase of temperature, the diffraction peak of Al<sub>5</sub>Co<sub>2</sub> gradually weakened and finally disappeared in the XRD patterns. It indicated that the  $Al_5Co_2$  of the coatings might be oxidized to form the  $Al_2O_3$  and CoO. The H13 steel mainly consisted of Fe and Fe<sub>2</sub>O<sub>3</sub>, as shown in Figure 7b. At 600 °C, the obvious diffraction peaks of Fe<sub>3</sub>O<sub>4</sub> and Fe<sub>2</sub>O<sub>3</sub> were found in the XRD pattern, which indicated that worn surface and debris were both oxidized during the wear process.

**Figure 7.** The unworn and worn surface at different temperatures: (**a**) CoCrAlYTa-10%Al<sub>2</sub>O<sub>3</sub> coating; (**b**) H13 steel.

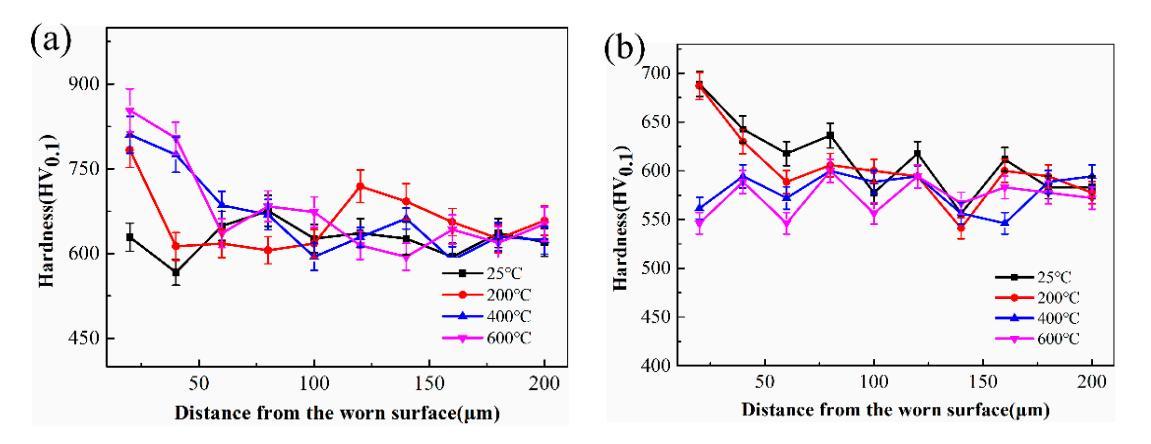
The microhardness profiles along the cross-section of the bottom of worn surface are shown in Figure 8. For the CoCrAlYTa-10%Al<sub>2</sub>O<sub>3</sub> coatings, the microhardness of worn surface increased with increasing temperature, as shown in Figure 8a. When the distance from the bottom of worn surface was higher than 50 µm, the microhardness was similar at different temperatures. It suggested that work hardening and the tribofilms formed on the worn surface [35,36]. The tribofilms were found in the Figure 5d,f,h. At the same time, some studies showed that when the temperature was from 200 °C to 800 °C, the microhardness of the Cr<sub>3</sub>C<sub>2</sub>-NiCr and WC-Co coatings increased with the increase of heat treatment temperature. The decarburization and dissolution of carbide phases in cobalt and NiCr matrix increased the microhardness of the coatings [29,37]. Carbide decarburization might also occur on the surface of worn surface, resulting in the increase of the microhardness of worn surface. As shown in Figure 8b, the results showed the microhardness of H13 steel possessed different rules. At 25 °C and 200 °C, the microhardness of worn surface was almost the same and the microhardness of worn surfaces was higher than that at 400 °C and 600 °C, which might result from work hardening. At 400 °C and 600 °C, the friction heat made the temperature of worn surface higher than testing temperature. The dynamic recovery and recrystallization of the worn surface generated during the wear testing, which prevented work hardening [38]. Meanwhile, it indicated the CoCrAlYTa-10%Al<sub>2</sub>O<sub>3</sub> coatings exhibited higher high-temperature mechanical property than that of H13 steel.

**Figure 8.** The microhardness profiles along the cross-section of the bottom of worn surface: (a) CoCrAlYTa-10%Al<sub>2</sub>O<sub>3</sub> coating; (b) H13 steel.

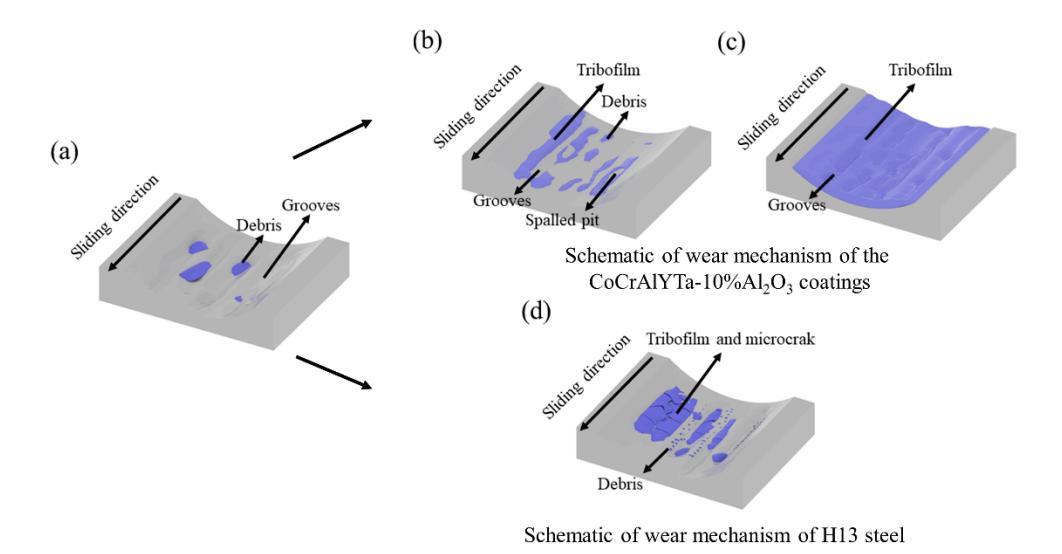
Based on the previous analysis, the schematic diagrams of the evolution of wear characteristics of the CoCrAlYTa-10%Al<sub>2</sub>O<sub>3</sub> coatings and H13 steel are shown in Figure 9.

Figure 9. Schematic of wear mechanism of the CoCrAlYTa-10%Al<sub>2</sub>O<sub>3</sub> coatings and H13 steel.

At 25 °C and 200 °C, the woke hardening improved the wear resistance of H13 steel. When the temperature increased to 400 °C, the microhardness of worn surface decreased and the wear debris did not form the tribofilms. It was difficult to resist the cutting effect of abrasive wear on the worn surface, which caused a sharp increase of wear rate (Figure 3). Even at 600 °C, only some discontinuous tribofilms with a number of microcracks appeared on the worn surface (Figures 9d and 5h). It was mainly formed by debris accumulation rather than sintering. With the increase of temperature, the amount of wear debris increased, which restrained the adhesive wear and reduced the wear. Therefore, the average COF decreased with the increase of temperature, as shown in Figure 3. The wear mechanism of the two materials was mainly abrasive wear. However, due to the influence of tribofilms
