Article Shake-Table Testing of a Cross Vault

Elizabeth Vintzileou^{1,*}, Charalambos Mouzakis², Lucia Karapitta² and Androniki Miltiadou-Fezans³

Keywords: cross vault; shake-table testing; grouting; struts; ties; vertical prestressing

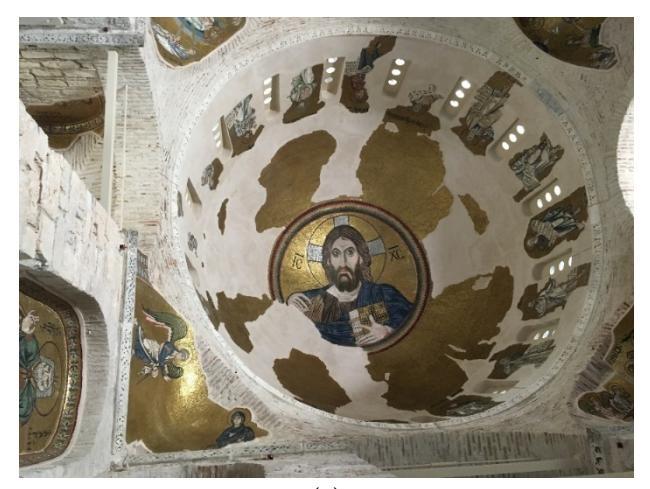
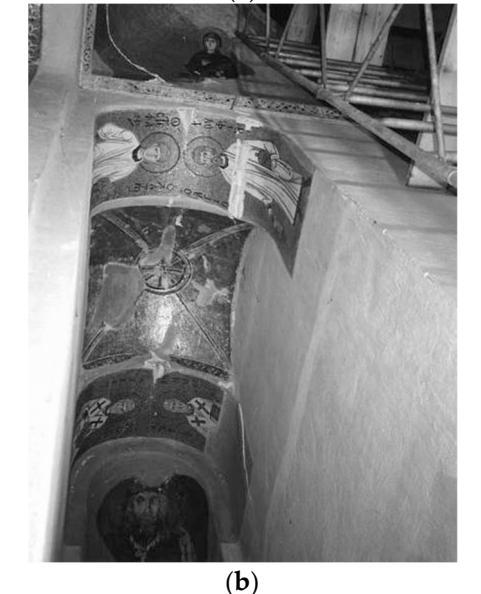
Figure 1. (a) The mosaic of Pantocrator (11th century A.D.) in the cupola and (b) Damage in arches and cross vaults of the Katholikon (main church) of Daphni Monastery, Attica, Greece.

Arches, vaults and domes are frequently met in historical constructions and monuments, such as residential houses, churches, bridges, etc. Those elements, when subjected to vertical loads, are under axial compression. Thus, despite the low-to-medium mechanical properties of masonry, curved elements of limited thickness are able to bridge large spans. A prerequisite for the satisfactory behavior of arches and vaults is their symmetrical loading, a condition that is not satisfied in the case of seismic events. Furthermore, the curved elements transfer to their supports an inclined force. The horizontal component of the thrust causes horizontal displacements to the vertical supporting elements (piers or walls). Rather frequently, the stiffness of the vertical elements is not adequate and, thus, their significant "out-of-plomb" deformations lead to damage of arches and vaults. The problem is aggravated by the fact that the vertical elements are connected to the curved elements at their top, where the vertical loads are of small value and, thus, their out-ofplane stiffness and flexural capacity cannot take profit of a substantial beneficial vertical compression. In a significant number of monuments, precious frescoes, paintings and other decorative elements cover the interior (intrados) of a system of vaults and arches (Figure 1a). Strong earthquakes that occurred during the lifetime of the UNESCO listed Katholikon of Daphni monastery (Attica, Greece) have caused significant damage to the system of vaults and arches (Figure 1b) and to the perimeter walls, and they have led to the loss of extensive portions of the 11th century mosaics. Furthermore, the central cupola, as well as a significant portion of the perimeter walls at its west part, were reconstructed in the late 19th-early 20th century, following two strong earthquakes that occurred at the end of the 19th century [1]. The seismic vulnerability of the system of arches and vaults of the Katholikon, as well as their effect on the supporting vertical elements, are documented in situ: (a) Figure 2 shows the south wall of the church. This wall was partly reconstructed during the major intervention of the early 20th century. The original portion of the wall (towards east) has moved out of its plane, due to the effect of the system of vaults and

arches. This out-of-plane deformation (exceeding 0.20 m at the top of the wall) defines the border between the original part of the wall and that which was reconstructed following the original interior dimensions of the church; (b) In recognition of this vulnerability of the monument, during the interventions of the early 20th century, two stone masonry buttresses (Figure 3) were added in the direction N–S at both sides of the north entrance to the monument, to provide added out-of-plane stiffness to the long perimeter walls of the monument. For reasons that are not sufficiently documented, such buttresses are not present against the south wall of the church.

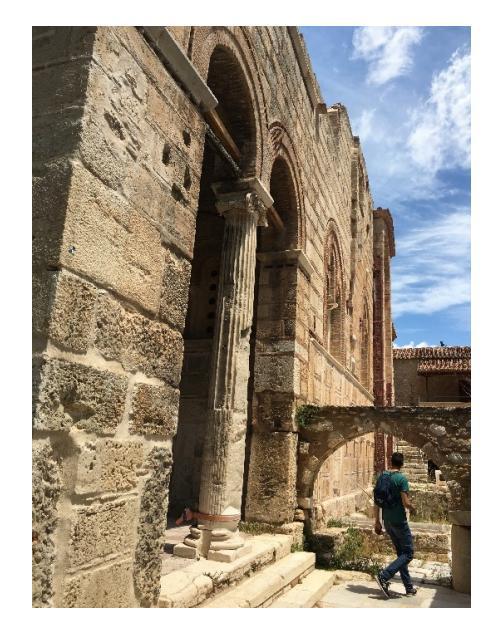
Figure 2. The south wall of the Katholikon of Daphni Monastery. The border between the original wall (towards east) and the reconstructed part (towards west) is visible.

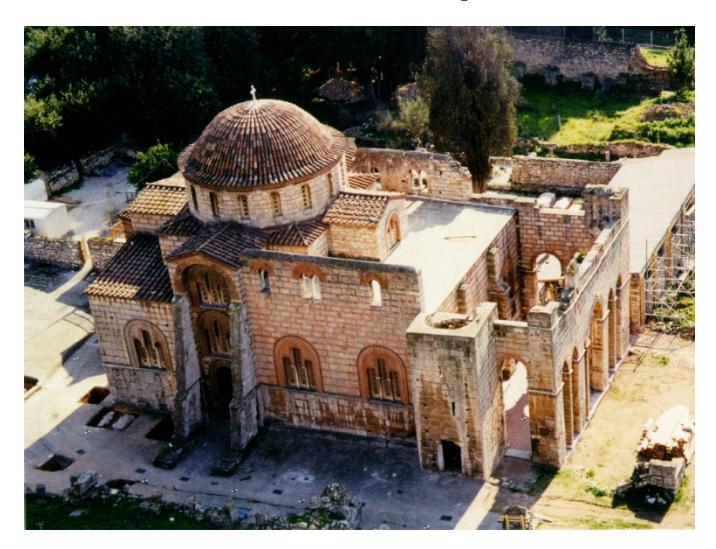
Figure 3. The Katholikon of Daphni Monastery. Observe the two stone masonry buttresses added perpendicularly to the north wall.

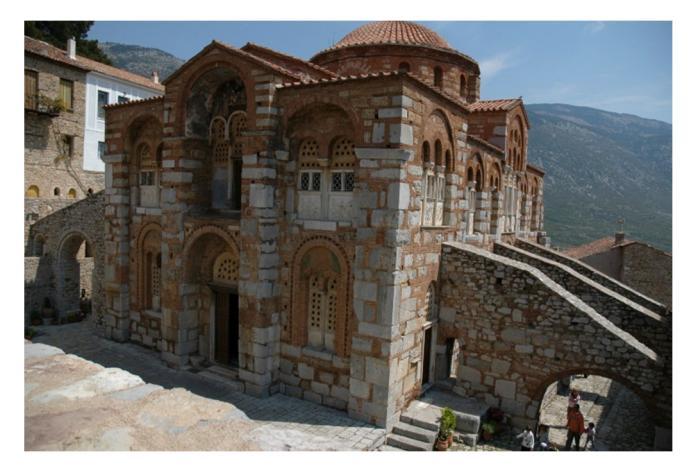
Figure 4. Buttresses against the south and the north walls of the Katholikon of Hosios Loukas Monastery, Boeotia, Greece.

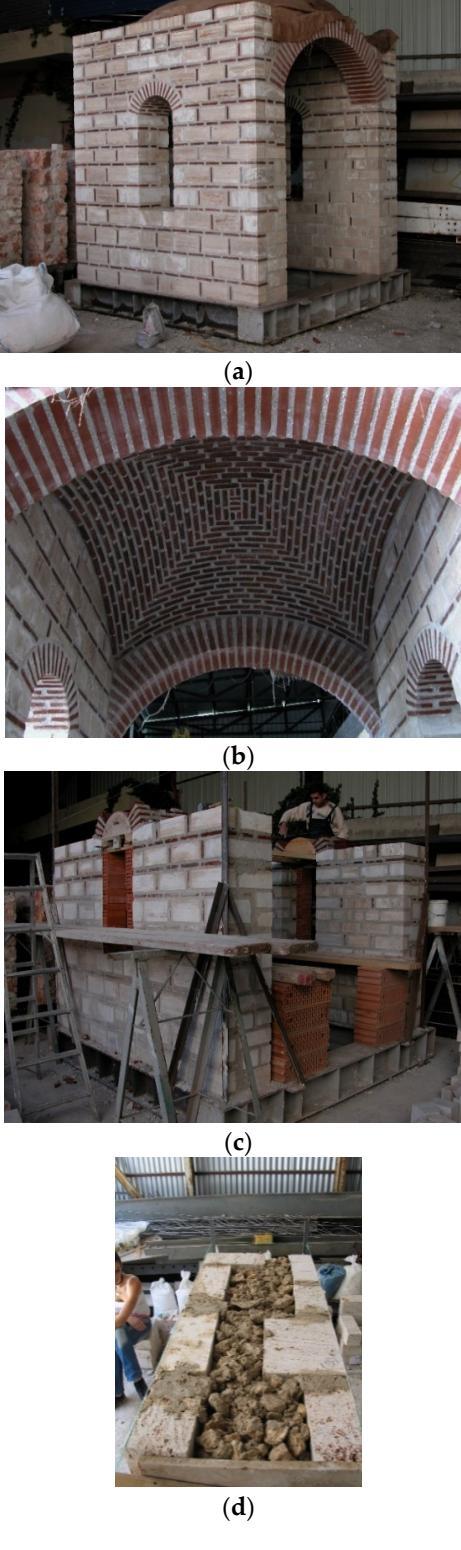
Figure 5. (a) The subassembly, (b) The cross vault (intrados) and (c,d) Construction of piers.

The specimen (Figure 5a) constitutes a 2:3 scaled model of a cross vault (Figure 5b) on two parallel walls (Figure 5c) [3]. The plan dimensions of the specimen are $2.70 \times 2.60 \text{ m}^2$, while the height of the walls is equal to 2.60 m, and the overall height of the specimen equals 2.85 m. The cross vault, with a thickness at its crown equal to 0.20 m, is made of solid bricks having a mean compressive strength equal to 17 MPa and a lime-pozzolan mortar, with a mean compressive strength equal to 4.35 MPa and mean flexural strength of 1.58 MPa [16]. The walls, 450 mm thick, are made of three-leaf stone masonry (Figure 5d), following the construction typology identified in situ [17]. The exterior leaves of masonry are of average thickness equal to 192 mm (the exterior leaf) and 135 mm (the interior leaf), whereas the intermediate leaf (of average thickness 123 mm) is made of a mix of small pieces of stones and mortar, as described in detail in [16]. There are no header stones transversely connecting the exterior leaves of masonry.

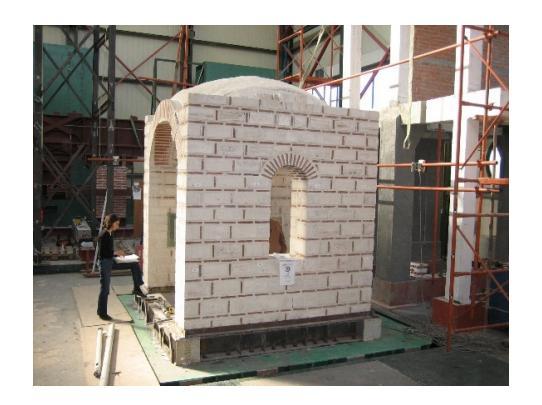
Figure 6. The specimen on the shaking table.

The subassembly is constructed on a steel base made of HEB300 profiles, through which it is adequately fixed on the earthquake simulator for testing (Figure 6). To fix the steel base to the shake table, 36 bolts M30, quality 8.8, were used.

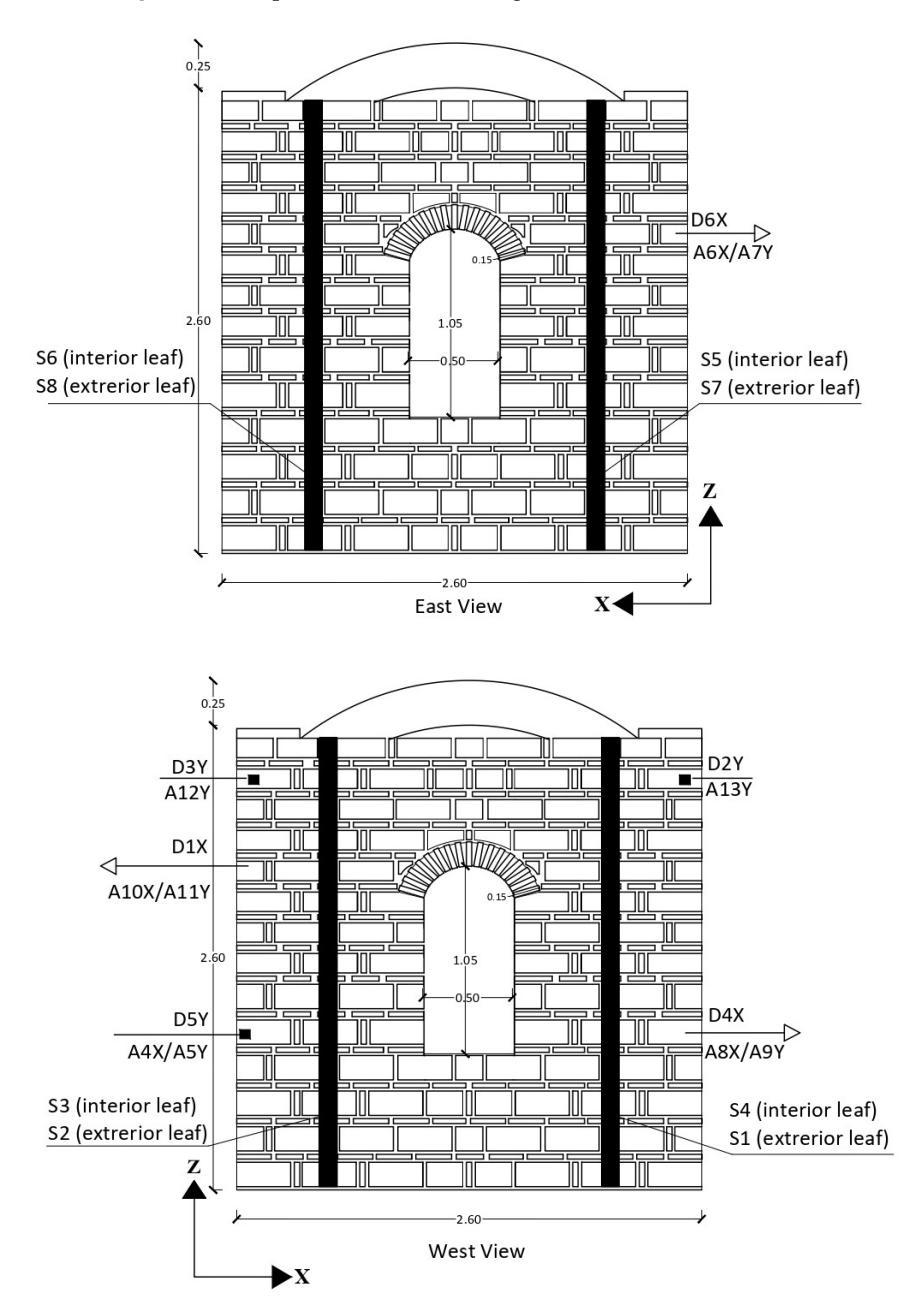
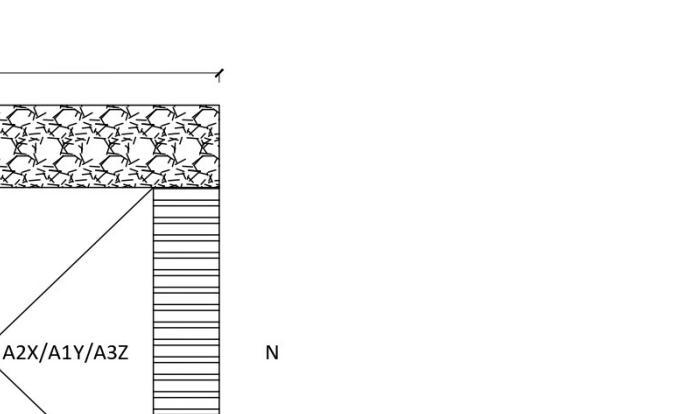
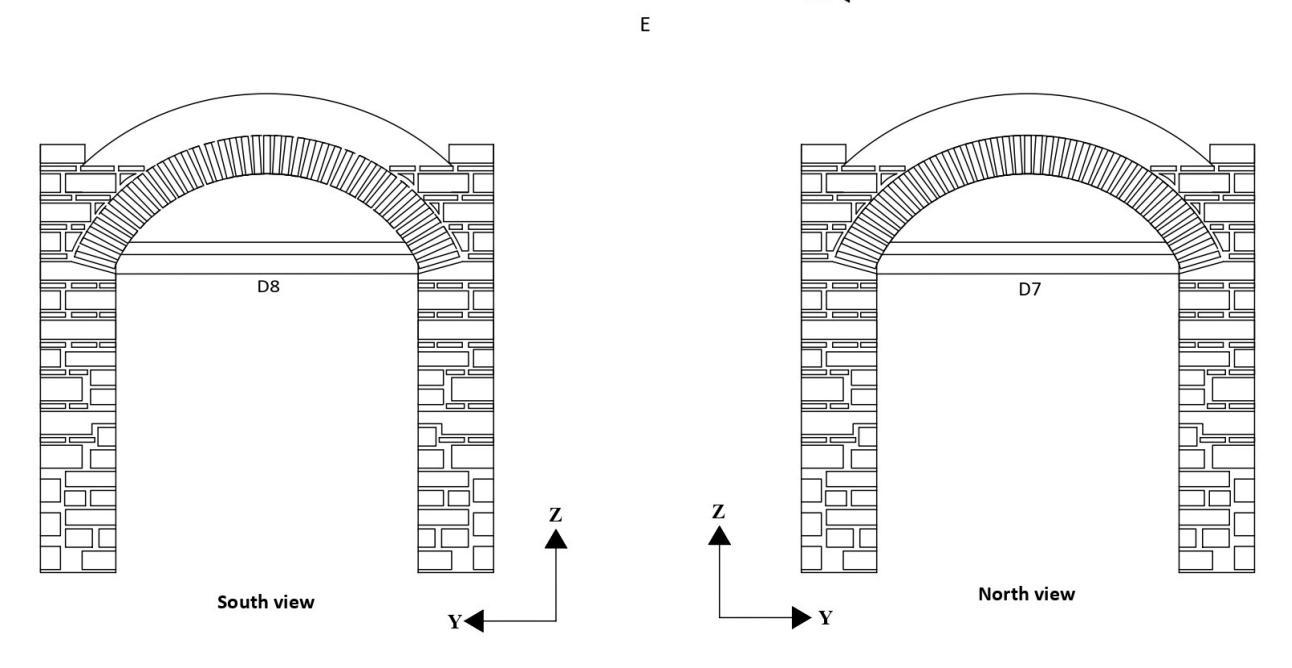
Figure 7. Instrumentation of the subassembly for the series of seismic tests within NIKER project: "A" stands for accelerometers, "D" stands for displacement transducers. Two strain gauges were installed on each CFRP plate (one per face).

During testing, accelerations and displacements were continuously recorded using measuring devices (Figure 7). Accelerometers and displacement transducers were installed in critical locations, while one triaxial accelerometer was installed at the top of the cross vault throughout testing (at as-built and at strengthened state). Finally, during the last series of seismic tests, strain gauges were installed on the CFRP laminates used to provide vertical precompression to the piers, in order to measure their degree of activation.

As shown in Figure 7, an XY accelerometer was installed at the top of the cross vault. The accelerograms recorded by this accelerometer for the final test 13AS are shown in Figure 13. The smaller period of vibration along the strong X direction of the subassembly is illustrated.

As shown in Figure 7, two displacement meters were installed at the top of the piers to measure the changes in their distance, i.e., their out-of-plane displacement during the seismic tests. The positive effect of the interventions, namely, the grouting of the masonry

As shown in Figure 7, the strains in the CFRP plates were measured through strain gauges. After their installation, all eight CFRP plates (in four pairs) were prestressed to the same level, ensuring an average compressive stress of 0.20 MPa in the piers. Nonetheless, as the imposed base acceleration was increasing, the out-of-plane bending moment of the two piers was also increasing. Thus, the CFRP plates located in one pier were more stressed than those located in the other pier. At the final test (13AS), an increase in the initial strain by 50% to 80% was recorded in the plates of one of the piers and a reduction by 20% to 50% in the plates of the other pier. After the completion of testing, an average loss of prestressing of 15% was recorded. In any case, the maximum stress developed in the CFRP plates did not exceed 550 MPa, a value quite small compared to the tensile strength of the plates (=2800.0 MPa).

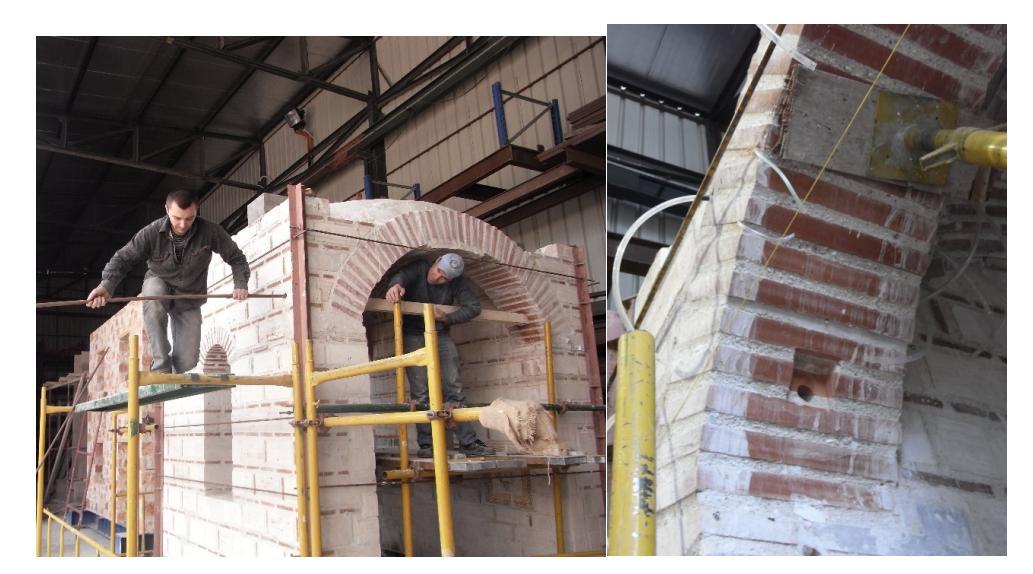
Figure 8. Positioning of timber strut and steel tie in the arch.

The as-built subassembly was subjected to a series of seismic tests that led to significant but repairable damage. This phase I is described in detail in [18]. Subsequently, the subassembly was removed from the table; the cracks occurred during phase I were injected using a hydraulic grout. In addition, two steel ties were positioned approximately at the level of the springing line of the two arches, i.e., along the E–W direction. The diameter of the steel rods was equal to 25 mm, while their yield strength was equal to 235 MPa. Then, the specimen was subjected to a series of uniaxial seismic tests, along the X direction, with the purpose of causing damage to the piers. This phase II is presented in detail in [19]. The specimen was again removed from the shake table. The stone masonry of the piers was homogenized using a hydraulic lime-based grout with a mean compressive strength, at the age of 90 days, equal to 5.3 MPa [20]. Subsequently, the subassembly was again subjected

to a series of uniaxial seismic tests along the strong X direction. Cracks were caused to the piers due to in-plane shear. This phase III is described in detail in [21]. The final phase of testing, on which this work focuses, was performed within the project NIKER. After completion of phase III, the subassembly was subjected to further interventions as follows: (a) All cracks in masonry were filled using a hydraulic lime-based grout, developed within the project NIKER. The mean compressive strength of this grout, at the age of 90 days, was equal to 2.9 MPa [22]. The same grout was used to repair all cracks in the piers and the cross vault; (b) With the purpose of the interventions being to reduce the vulnerability of the cross vault along Y direction, two timber struts with incorporated steel ties (Figure 8) were installed in the north and south arches (Figures 8 and 9). The cross-sectional dimensions of the (class C30) timber ties were 100×100 [mm], whereas the steel ties were smooth, 25-mm diameter rods, of yield strength equal to 235 MPa. As shown in Figure 8, grooves were curved at the intrados of the arches for the accommodation of the timber struts. The struts were drilled throughout their length to allow for the positioning of the steel ties, which were anchored by means of steel plates on the east and west faces of the specimen, as shown in Figure 9. Finally, (c) vertical prestressing was imposed to the masonry piers (Figure 9) using four pairs of CFRP plates. To this purpose, the Sika[®] CarboDur[®] 624 prestressing system was used. The width of the plates is equal to 60 mm, and their thickness equals 2.6 mm. The nominal tensile strength of the plates is equal to 2800.0 MPa and the ultimate strain 1.7%. The modulus of elasticity equals 165 kN/mm². The plates were anchored in the steel base of the subassembly, whereas two slots were drilled in the cross vault at its junction with the piers for the accommodation of the CFRP plates. The prestressing force was equal to 100 kN per pair of plates, resulting in a vertical compressive stress on the piers equal to 0.20 MPa, roughly corresponding to the self-weight of a 10-m-high wall. It is noted that, as the prestress force is applied to a limited masonry area, the local compressive stress at the anchorage of the CFRP plates should not exceed a limiting value (selected to be 50% of the uniaxial compressive strength of masonry). As mentioned in the Introduction, one of the causes of vulnerability of the masonry elements supporting arches, vaults, etc., is due also to the limited vertical load applied to them. Indeed, as the curved elements are at the top of the structure, their self-weight constitutes practically the sole vertical load on the supporting piers. Thus, their out-of-plane flexural resistance is rather small and easily exhausted due to the horizontal component of the thrust imposed by the curved elements. Therefore, the scope of the vertical precompression was to increase the compressive stress on the piers, in order to enhance their out-of-plane flexural capacity and to, thus, postpone their damage. After the application of the interventions, the subassembly was subjected to the final series of biaxial XY seismic tests until failure.

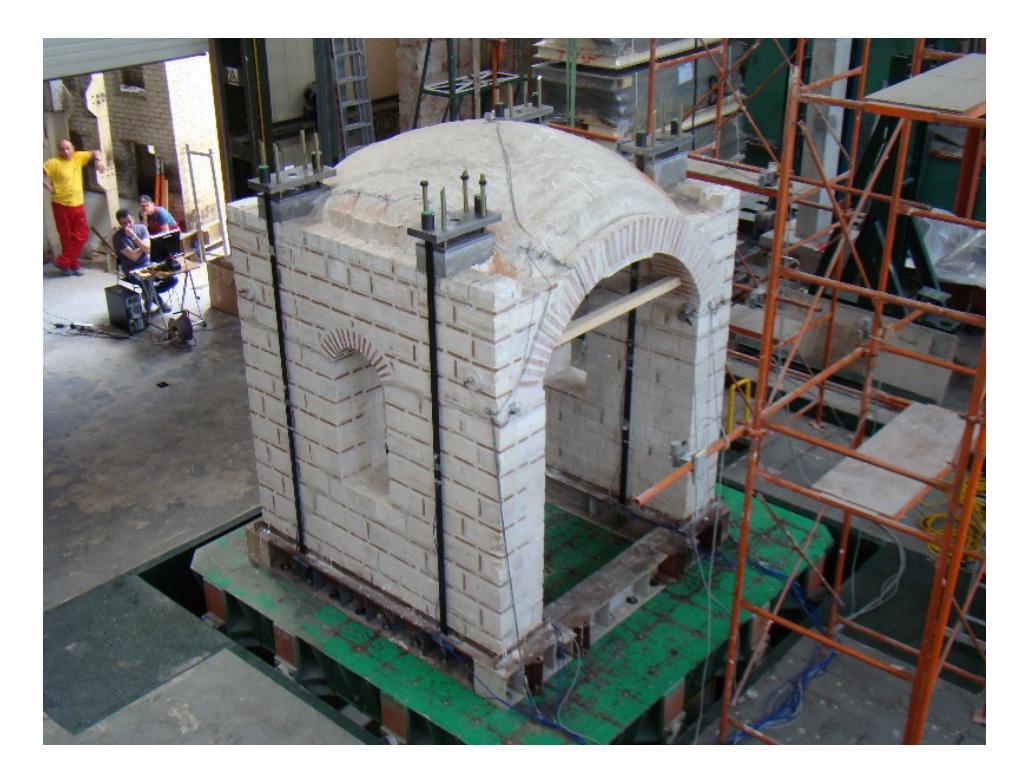
Figure 9. The subassembly on the shake table; application of the vertical prestressing.

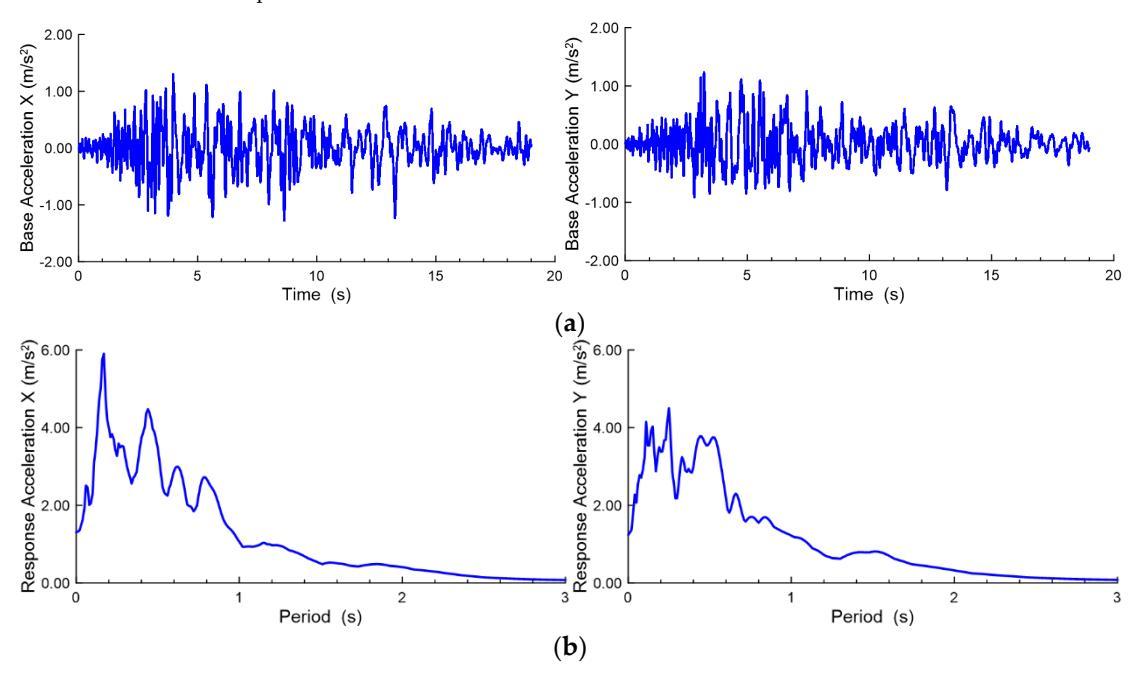
Figure 10. (**a**) The E–W and the N–S components of the Irpinia earthquake accelerograms imposed to the subassembly and (**b**) the respective response spectra for 5% damping.

Series of seismic tests were performed, with gradually increasing maximum base acceleration as described in Table 1. For the seismic tests, the signals recorded at Calitri during the 23 November 1980 Irpinia earthquake (Ms = 6.9) were used. The main characteristics of this event are: (a) its duration, approximately equal to 90 s and (b) the sequence of two main shocks of approximately equal maximum acceleration. For the tests described herein, the first part of the recorded accelerograms were used (Figure 10), namely, the E–W component was imposed along the X direction of the subassembly, while the N–S component along the Y direction. The base motion was scaled stepwise up to 150% for the subassembly at its as-built state (BS) and up to 450% for its strengthened state (AS). This motion has been found to be severely damaging to historical masonry structures and is widely used for the experimental investigation of the seismic response of such structures, both as-built and strengthened (e.g., [6,23]). Additionally, as shown in Figure 10, the spectral accelerations take their larger values in a range of 0.15 s and 1.0 s, i.e., in the range of the fundamental periods of the subassembly along both tested directions. Therefore, this ground motion was expected to lead to severe damages of the subassembly.

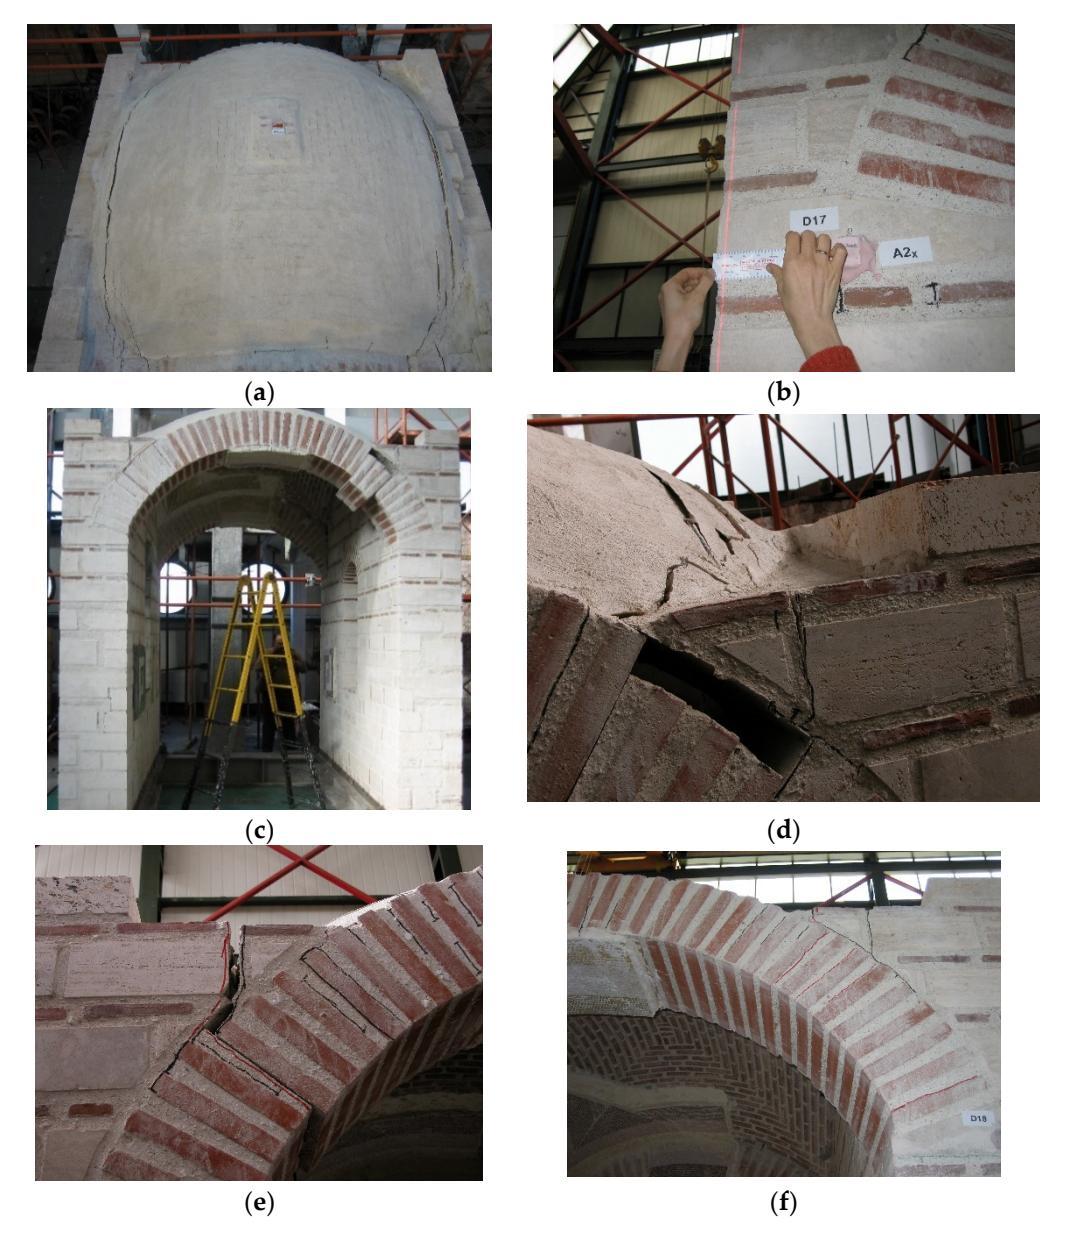
Figure 11. Damage observed in the subassembly at its as-built state, after completion of biaxial seismic tests (after Test 20BS): (**a**) Detachment of the vault from the piers, (**b**) out-of-plane movement of the piers, (**c**) cracks in the arch, (**d**) separation between the vault and the pier (close up), (**e**,**f**) Detachment of the arches from the piers and cracks in the arches.

During the Test 20BS, for 150% Irpinia earthquake, the subassembly has suffered significant damage, as shown in Figure 11. The cross vault was detached from the masonry piers (Figure 11a), as a result of the horizontal component of the thrust. This damage, quite similar to the damage observed in [14], led to an out-of-plomb displacement of the N–E side of the specimen by almost 15 mm (Figure 11b) at the level of the springing line of the arch. The damage to the two arches, compatible with the detachment of the cross vault from the piers, are shown in Figure 11c–f. Indeed, the arches were cracked close to their supports, in continuation of the cracks separating the cross vault from the piers. For this

seismic test, the piers have exhibited slight damage, mainly sporadic horizontal cracks of small width.

It has to be admitted, though, that the relative displacement values presented in Table 4 do not seem to be in agreement with the pathological image of the subassembly, as presented in Figures 11 and 12. This is because the measurements in Table 4 refer to the level of the strut/tie at the intrados of the arches. However, there are large cracks separating the cross vault from the piers, which are not detected by those measurements. Thus, it is more appropriate to list the relative to the base out-of-plane displacements of the two piers, measured by means of the displacement meters D2Y and D3Y (Figure 7). The respective measurements are presented in Table 5. It is to be noted that the displacement meters were not located at the same height in the as-built and the after-strengthening stage of testing. In the as-built stage, the measuring devices were located at the level of the springing line of the arches, whereas at the after-strengthening stage, they were located higher up (Figure 7), as their original location coincided with the location of the strut/tie. By deliberately assuming a linear distribution of displacements along the height of the subassembly, the equivalent values for the as-built case are shown in Table 5, in parentheses. The improvement in behavior in the weak Y-direction after strengthening is apparent. Finally, for the final test, in accordance with the pathology shown in Figure 12, the out-of-plane displacement is almost three times larger than for Test 7AS.

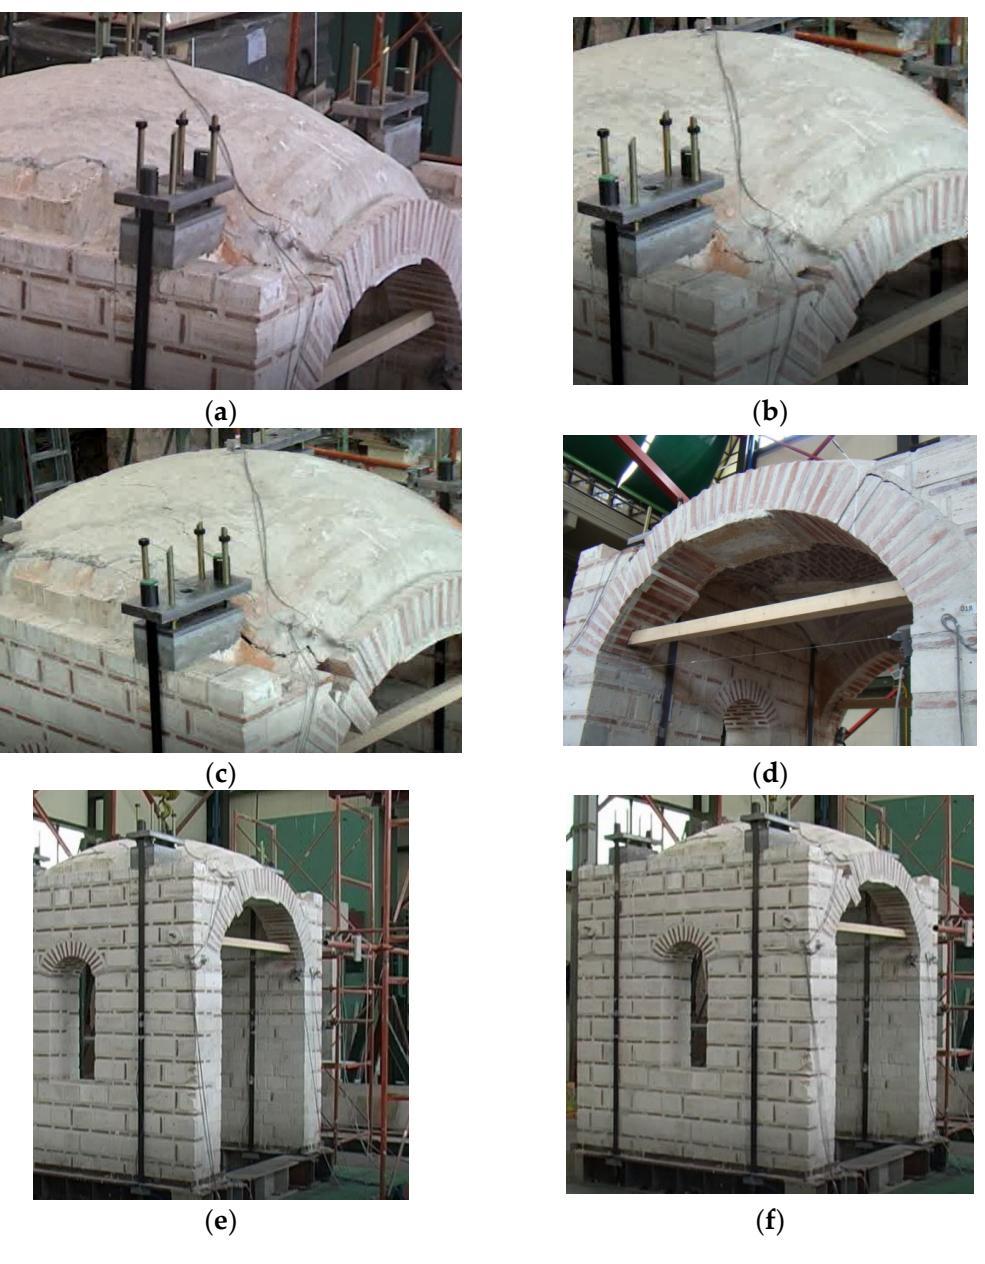
Figure 12. Development of damage to the cross vault and to the arches: (**a**) Test 11AS, (**b**) Test 12AS, (**c**) Test 13AS, (**d**) North arch, Test 13AS, (**e**) South arch, Test 12AS and (**f**) South arch, Test 13AS.

The strengthening of the subassembly using the techniques described in Section 4 did not modify the damage pattern and the mode of failure of the subassembly, as shown in Figure 12. Indeed, the cross vault was separated from the piers, whereas the arches were also severely damaged. Nonetheless, the damage, namely, the separation of the cross vault from the piers, was initiated during Test 9AS (250% Irpinia earthquake), whereas the specimen was able to sustain further seismic tests, up to 13AS (Table 1), with maximum base acceleration 4.5 times that of the original Irpinia earthquake. It should also be noted that the piers remained free of damage throughout the series of seismic tests. However, after the removal of the vertical prestressing, small opening horizontal cracks at the lower portion of the piers were observed.

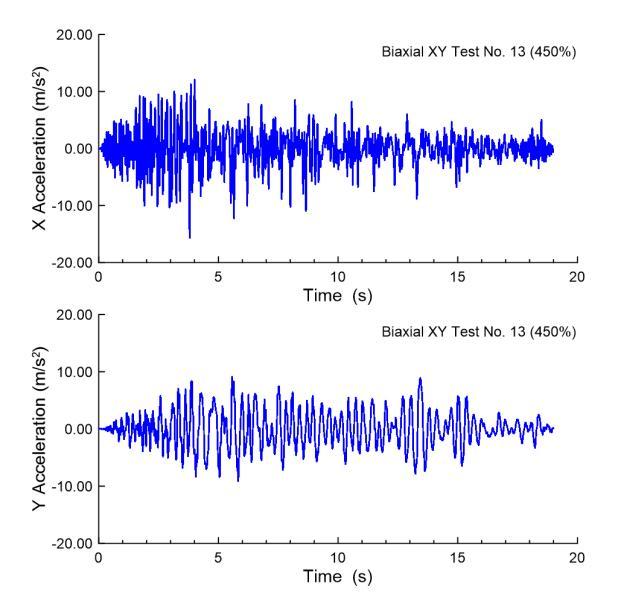
Figure 13. Accelerograms recorded at the top of the cross vault along X and Y directions, Test 13 AS.

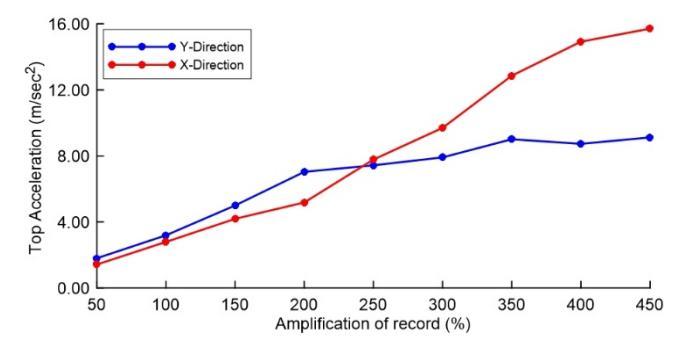
Figure 14. The evolution of the maximum acceleration measured at the top of the subassembly for the seismic tests performed after the final scheme of interventions (Tests 5AS to 13AS).

It is interesting to observe the evolution of the maximum acceleration at the top of the cross vault as the maximum base acceleration increases (Figure 14). Along the strong direction of the subassembly, where practically no damage has occurred until the end of testing, a continuous more or less linear increase in the top acceleration is recorded. This is not the case for the weak Y direction of the subassembly, where the gradual development of damage leads to almost a plateau in the evolution of the top acceleration. In terms of maximum values of acceleration measured before and after strengthening, relevant information is provided in Table 3.
