Article Failure Analysis of Transmission Tower in Full-Scale Tests

Abstract: With the rapid development of Ultra-High Voltage (UHV) transmission lines, it is necessary to study the performance of UHV transmission towers. First, we performed full-scale tests on a transmission tower under seven loading patterns. Then, the test results were compared with the calculation results of the Chinese tower design software Transmission Tower Analysis Program (TTA), and the failure location of the tower and the stress characteristics of the key parts were studied. Finally, we discuss the influence of bolt slippage and a new joint on the tower performance, and propose some design proposals for the current Chinese code, based on the test results. The results show that a bolt slip will significantly increase the displacement of the transmission tower, but the residual displacement can correct it. The new joint design has good mechanical performance. The bracing member at the bottom of the tower leg is located at the connection of the tower leg and the foundation, and there is a significant sudden change in stiffness, which we recommend designing according to 4% of the axial force of the main memb

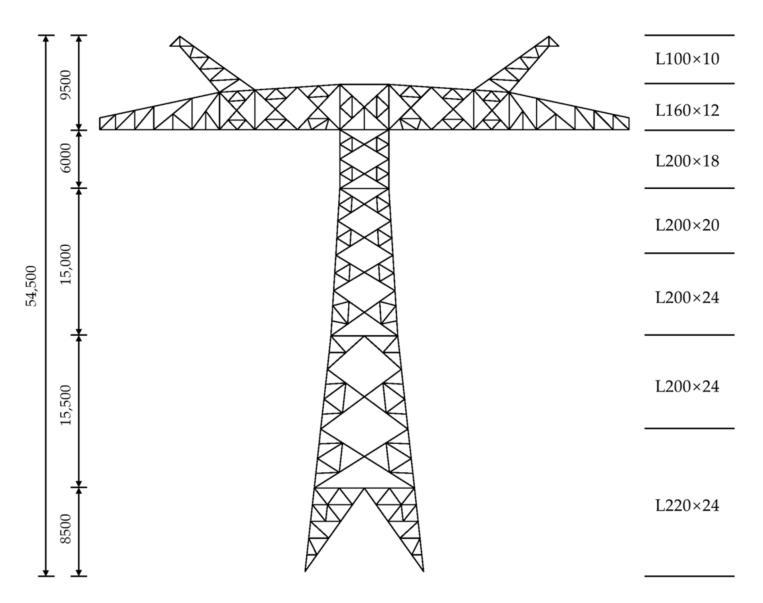
Figure 1. Tower dimensions (unit: mm).

The employed tower is a suspension tower in a heavy icing area in China, with 30 mm design ice. The height is 54.5 m and the base size is 12.08×12.08 m. Q345 and Q420 steels are used for main members, and Q235 is used for the diagonal member. The main members of the tower body are listed in Figure 1. The model of the six-bundle conductor is JLHA4/G2A-900/75; the model of the ground wire is JLB20A-240.

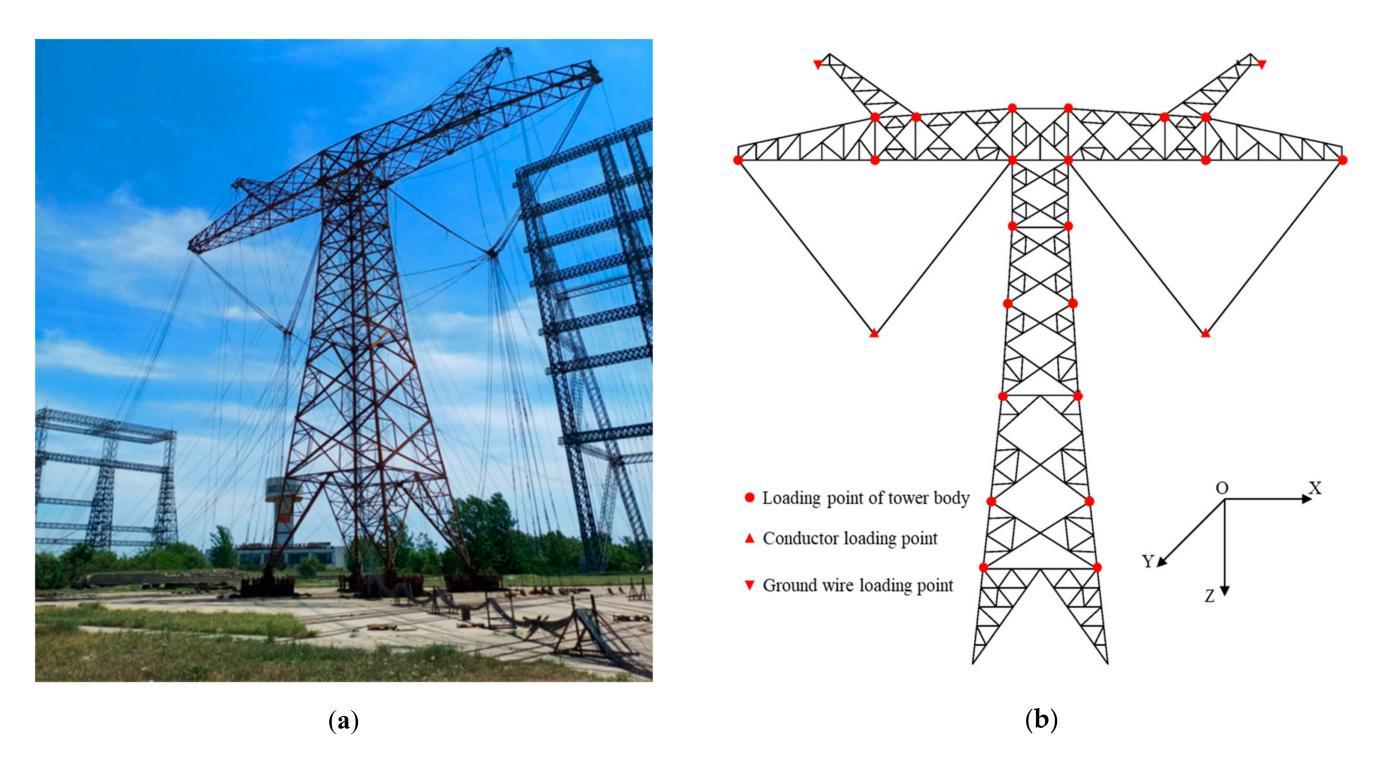
Case 7, the loads are applied as $0\% \rightarrow 50\% \rightarrow 75\% \rightarrow 90\% \rightarrow 95\% \rightarrow 100\% \rightarrow 105\% \rightarrow 110\% \rightarrow 115\% \rightarrow 120\% \rightarrow 125\% \rightarrow 130\% \rightarrow 135\% \rightarrow 140\% \rightarrow 145\% \rightarrow 150\% \rightarrow 100\% \rightarrow 50\% \rightarrow 0\%$. Figure 2 shows the full-scale test facility and loading point diagram.

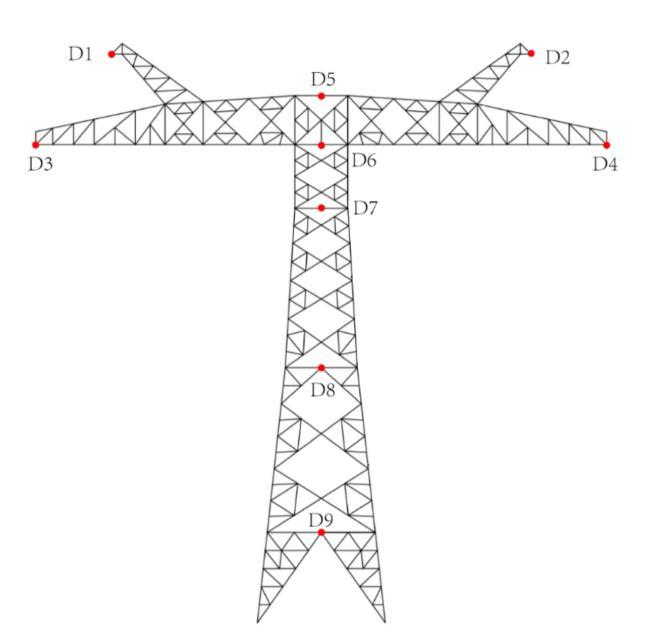
Figure 3. Displacement observation point layout.

Total stations were installed on the front and sides of the tower to observe the displacement of the measuring points on the tower. The selected displacement measuring point should reflect the overall deflection curve of the tower and the maximum displacement of the test tower. The displacement observation points are shown in Figure 3. The strain gauges were used to obtain the strain of the members, and the strain gauges were mainly arranged in the following positions: the important components of the tower, such as the tower body, tower legs, and the cross arm, the member with the larger stress value under each case during the tower calculation, and parts near the joints. The layout of strain gauges is shown in Figure 4. The strain gauges adopt different sticking methods, according to the member specifications and stress characteristics. Generally, for the brace member and the members with less stress, the gauges are placed along the core line on the connecting limb or two limbs. For members with large bending moments, the number of strain gauges should be increased. When there are two or more strain gauges at one strain measuring point, the strain gauges should be placed on the same cross-section of the member.

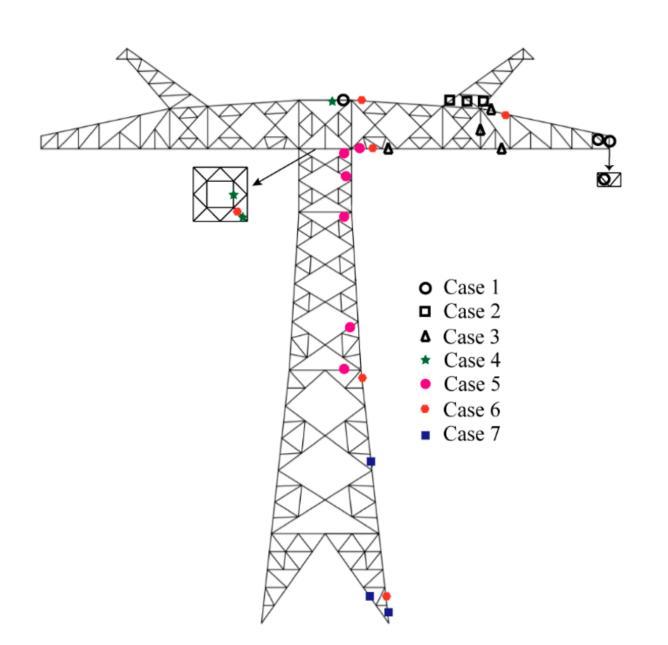
Figure 5. Key observation parts of each load case.

For strain observation, the strains were read after each loading was stable for 1 min; when a loading case was over, each member was carefully checked for damage, making sure no damage occurred, and then the next test case was carried out. The key observation parts, corresponding to each load case, are shown in Figure 5.

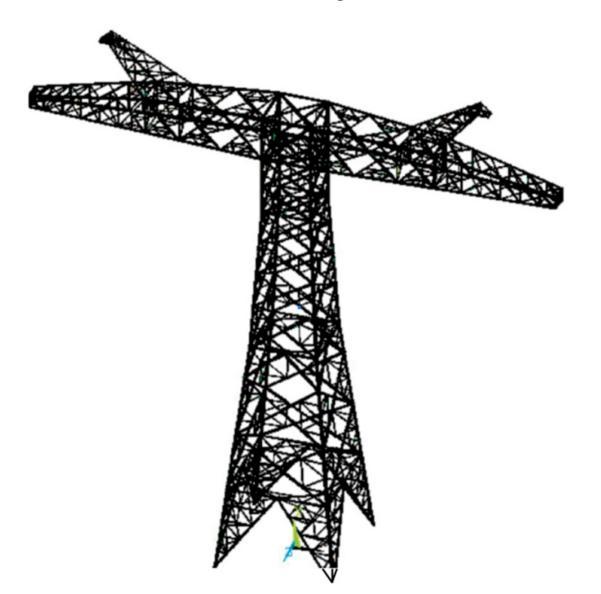
Figure 6. The finite model of the tower.

Only the displacement and strain of a limited number of observation points could be obtained by the full-scale test. For numerical simulation, the stress and displacement distribution of the whole employed tower can be obtained, but the numerical results should be verified by comparing with the test results. In this paper, ANSYS was used to establish the numerical model of the tower. It should be noted that bolt slip was ignored in the modeling, and the BEAM188 element was used to model the transmission tower members. The established numerical model is shown in Figure 6. The calculation results in ANSYS were compared with the calculation results of the current domestic transmission tower design software Transmission Tower Analysis Program (TTA), and the limitations of the current Chinese tower design will be discussed.

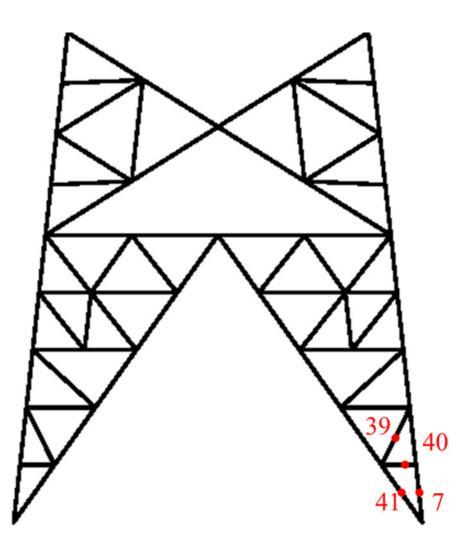
Figure 7. Strain observation point number.

The tower legs bear a relatively large load, which is a common damage position. In this full-scale test, the damage occurs in the tower legs. The strain observation point number for the tower leg is shown in Figure 7, and the test result of the tower legs is listed in Table 3. In Case 5 and Case 6, the axial force of the member, where the No. 40 measuring point is located, accounts for 3.7% and 0.8% of the axial force of the main material member of the tower leg, where the No. 7 measuring point is located, respectively. The force of the bracing member is about 3.7% of the axial force of the supporting main member, which is slightly higher than the 3% specified in the specification.

- (7) The bracing member at the bottom of the tower leg is located at the connection of the tower leg and the foundation, and there is a sudden large change in stiffness. It is recommended to design according to 4% of the axial force of the main member.

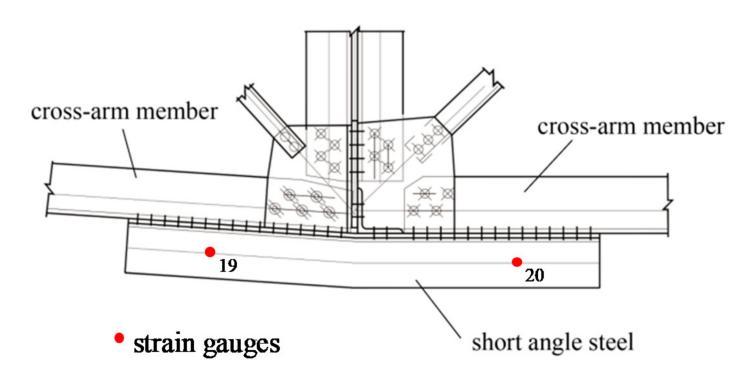
Figure 8. The layout diagram of measuring points.

Figure 8 shows the layout of strain gauges on the short angle steel at the outer back, between the cross arm and the tower body, and the test results of members are shown in Table 4. The applied loads are 100% design loads.

By comparison, in Case 5, the outer back angle steel at the root of the cross-arm is subjected to a greater force, which plays a role in strengthening the root of the cross-arm, while the strengthening effect is not obvious under the maximum bending condition. In addition, under the working conditions, the measured axial force of the cross-arm at the root is 2014.6 kN, and the force transmission of the short angle steel is about 11.3%. In Case 6, the measured axial force of the cross-arm at the root is 1764.1 kN, and the force transmission by the short angle steel is about 3.1%. From the test results, the short angle steel can increase the stiffness of the joint; in Case 6, the short angle steel deforms more, and the axial force is also greater.

- (4) The short angle steel on the outer back of the cross-arm root can effectively increase the stiffness of the joint under the condition of torsion, while the strengthening effect is not obvious under the maximum bending condition.

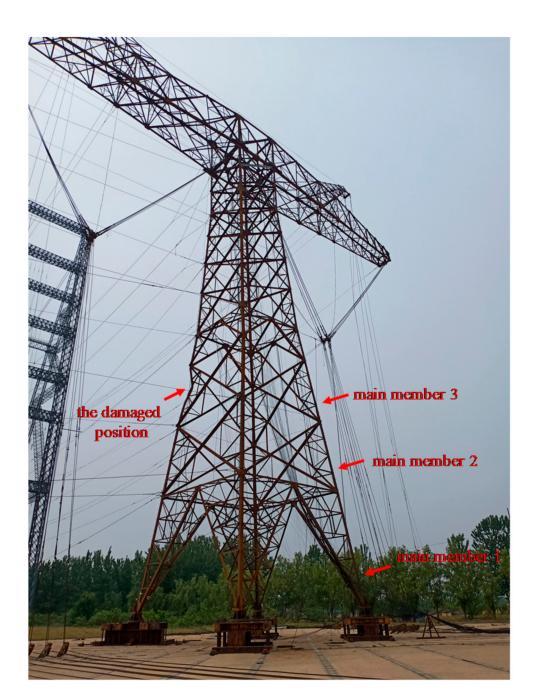
Figure 9. Tower failure.

Two overload scenarios were carried out in this paper. In Case 7, the test tower was damaged, and the damaged position was the main member of the second section at the

upper part of the tower leg (No. 701 member), as shown in Figure 9. The failure load is 118% of the design load. According to China's current Steel Structure Design Standard (GB50017-2017), the theoretical value of failure load is 120% of the design load, which is very close to the test failure load. And the manual calculation process is shown in Appendix A. It should be noted that the test tower was overloaded with the maximum torsion of non-uniform ice (Case 5), and there were serious initial geometric defects and residual stresses in each member, which reduce the actual bearing capacity of the employed tower. Secondly, due to the calculation of Steel Structure Design Standard (GB50017-2017), it is assumed that the tower member is under axial compression. In fact, the main members of the transmission line tower appeared to show large eccentricity when transferring load, due to the changes in specifications and connection. In addition, the bolt slip could also decrease the bearing capacity of the tower. Therefore, after the tower failure, some tower members were tested in metal material experiments. The results are shown in Table 6.

It can be seen from the table that the actual yield strength of Q420B steel for the main member of the tower is, at most, 2% lower than the theoretical yield strength, and the actual yield strength increases by about 10–12% compared with the design value. The strength of the angle steel is not up to the standard, which is also the reason for the failure of the transmission tower and the failure load being less than calculated.

- (6) According to the calculation of the tower, it is reasonable that the failure position of the tower first occurred on the main member of the second section, at the upper part of the tower leg, which is consistent with the predicted position.

(b) In Section 4.4, according to the Chinese steel structure design standard GB50017-2017, the overload condition is calculated. The theoretical value of the failure load is 120% of the design load and the reason has been mentioned in the paper. The calculation process is as follows:

$$\lambda_{\min} = \frac{l}{i_0} = \frac{1543}{39} = 39.65$$
$$\frac{\lambda_{\min}}{\varepsilon_k} = \frac{39.56}{\sqrt{235/420}} = 52.89$$
$$\varphi = 0.842$$
$$N_u = \varphi A f = 0.842 \times 9066 \times 355 = 2709.92 \ kN$$
$$\frac{N_u}{N} = \frac{2709.92}{2260.3} = 1.20$$
