Implementation of a Condition Monitoring Strategy for the Monastery of Salzedas, Portugal: Challenges and Optimisation

Eduarda Vila-Chã 🕑, Alberto Barontini 🕩 and Paulo B. Lourenço *🕩

Department of Civil Engineering, Institute for Sustainability and Innovation in Structural Engineering (ISISE), University of Minho, 4800-058 Guimarães, Portugal

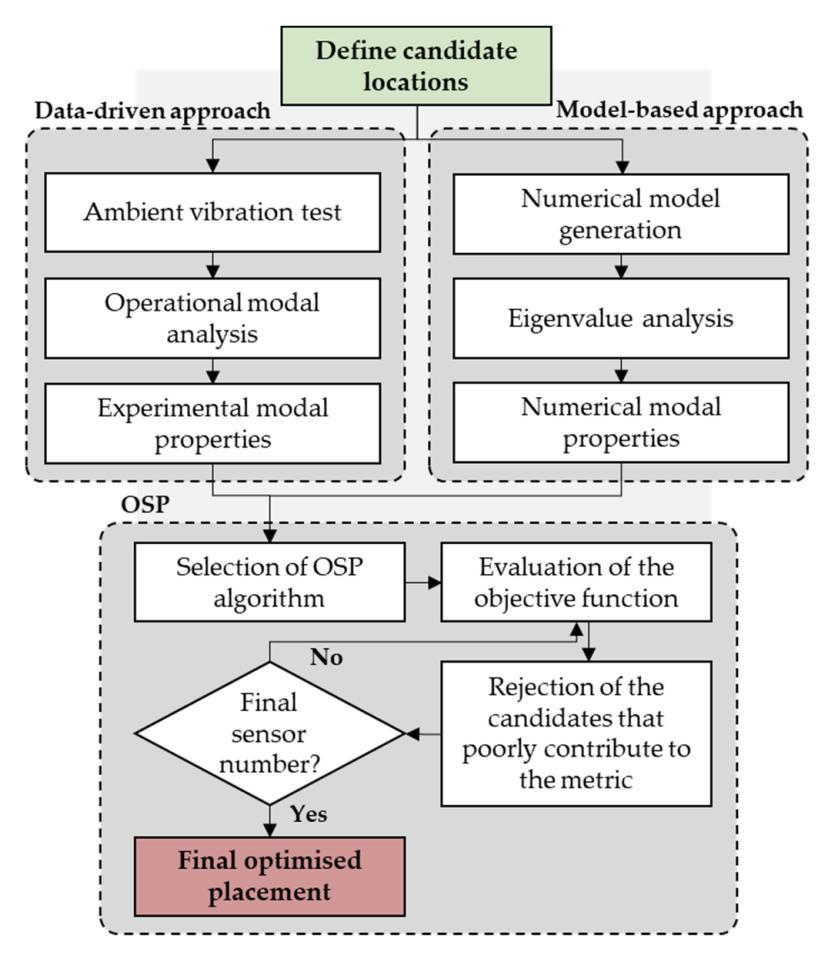
Figure 1. Data-driven and model-based optimal sensor placement framework.

To this end, the following simple OSP approaches are hereafter adopted and compared, in Section 5.3, to identify the reduced set of sensors by applying them directly to the experimentally estimated modal properties: (i) Eigenvector Component Product (ECP); (ii) Mode Shape Summation Plot (MSSP); (iii) Average Drive Point Residue (ADPR); (iv) Weighted Average Drive Point Residue (WADPR); and (v) QR Decomposition (QRD). These heuristic methods provide a sub-optimal combination of placements by ranking the candidates in a single iteration. The ECP method [74] maximises the following index:

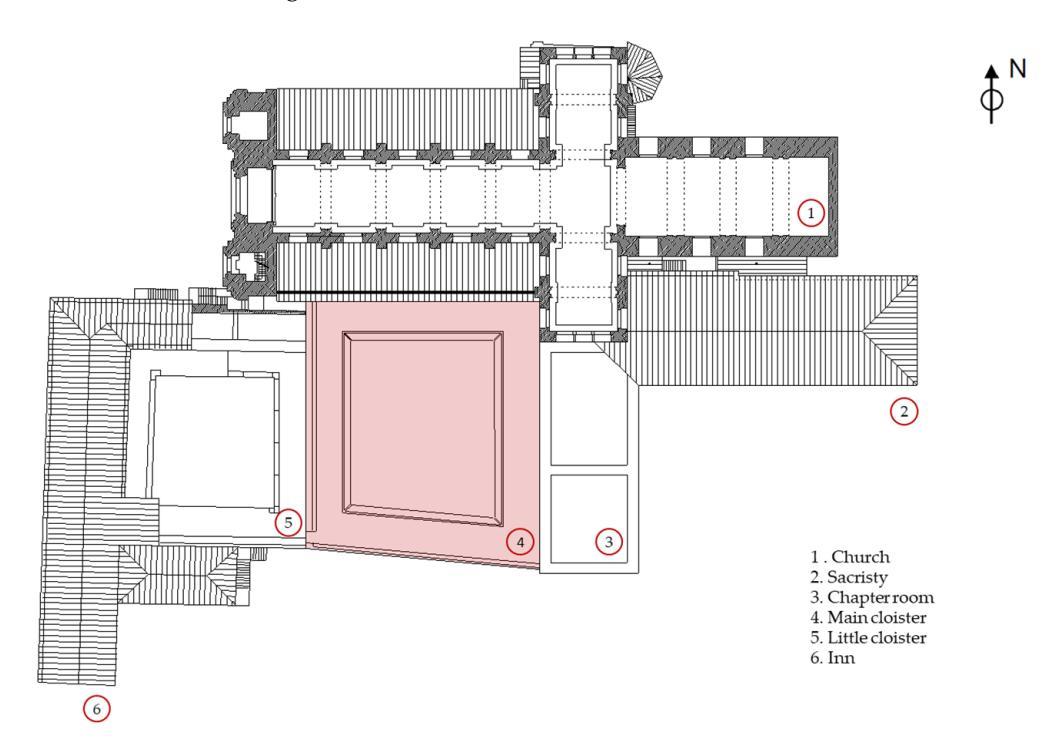
Figure 2. Spatial units of the Monastery of Santa Maria de Salzedas. Main cloister is marked in light red.

The current work focuses on the main cloister, as this area has been characterised by severe damage mechanisms and deterioration processes so several interventions have been necessary over time. The cloister is about 30 m long and 25 m wide and comprises two levels. The first level has round arches covered by cross vaults made of brick masonry with earth filling, whereas the second level has barrel vaults and consists of an enclosed gallery (Figure 5). As shown in Figure 2, the cloister is surrounded by contiguous structures. The north wing communicates with the church, the east wing with the chapter room, and the west wing with the little cloister.

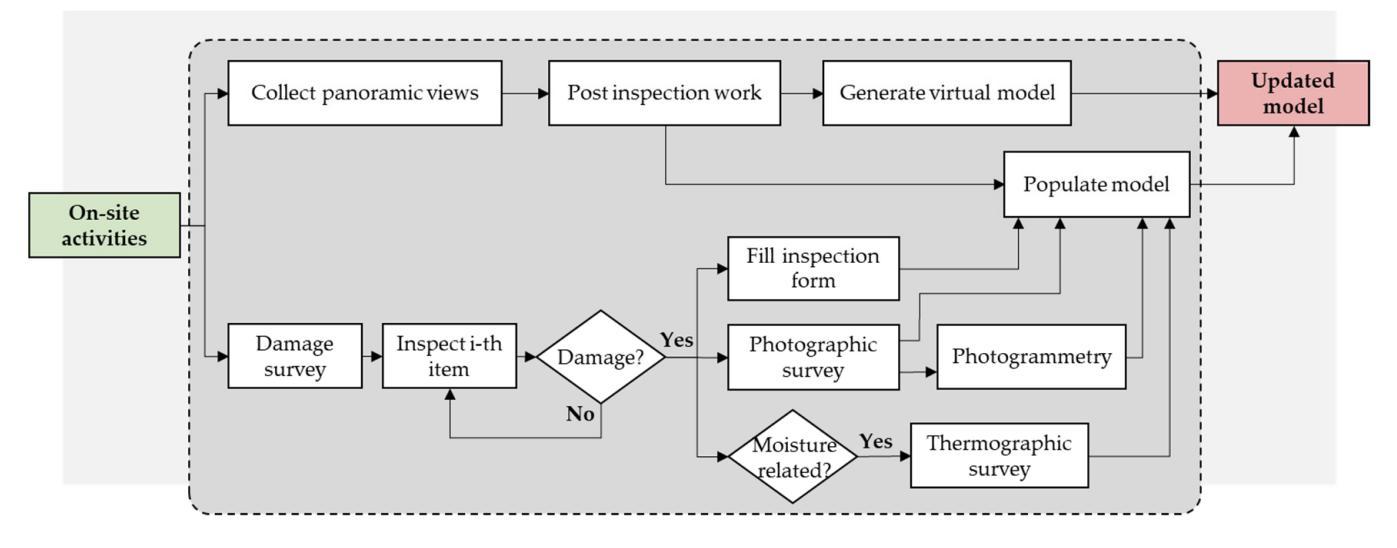
Figure 6. Flowchart of the on-site inspection and digital twin generation process.

In 2022, a comprehensive inspection and diagnosis campaign was carried out to map the state of damage, verify the recent interventions, and collect meaningful data to establish a simple yet informative digital twin of the main cloister, according to a methodology described in the flowchart reported in Figure 6. Prior to the on-site assessment, a documentary search was conducted to collect all available information. Most information was produced before and during the most recent conservation works and encompasses historical and geometrical surveys, structural and geotechnical reports, as well as the intervention design [80].

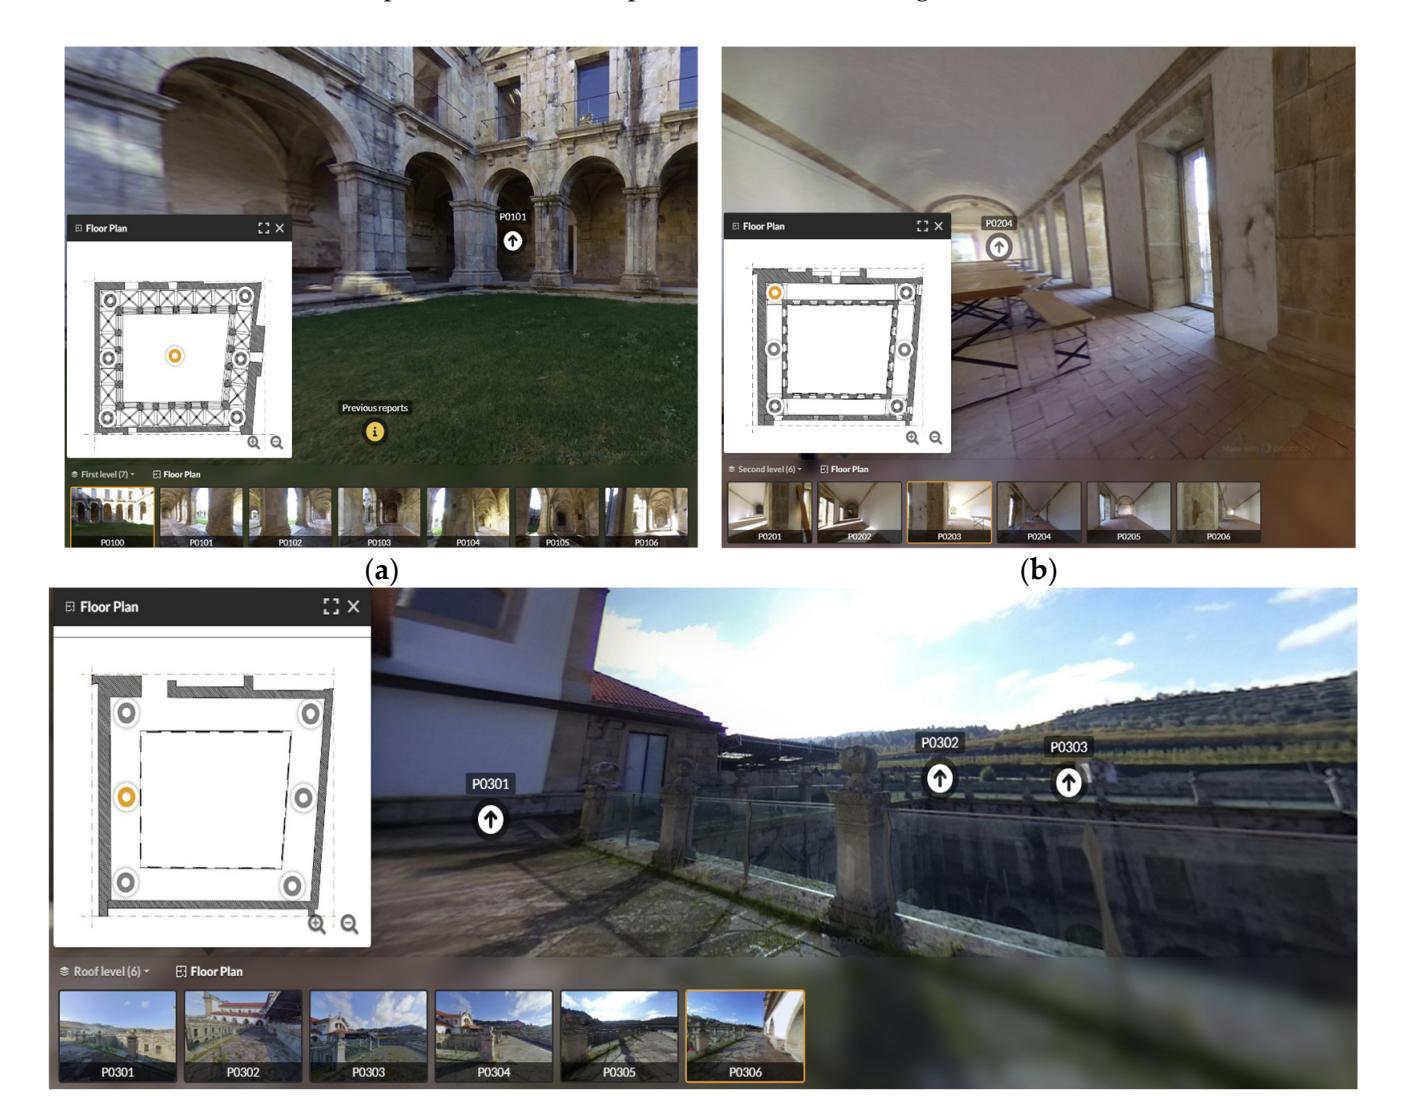
Figure 7. Virtual tour, with navigation options (arrow hotspots, floor plan, or image icon): (**a**) first level; (**b**) second level; and (**c**) accessible roof.

The nineteen 360° panoramic views were interlinked to create a virtual model through the Panoroo software. This model is composed of six pictures for each floor (i.e., one per corner plus two in the middle of the north and south wings) and one picture taken from the courtyard. The virtual model is navigable through the use of hotspots, characterised by arrows, that link distinct 360° pictures, as well as by clicking either on the picture locations, reported in the three plans of the three levels or on the icon of the picture itself (Figure 7). A first layer of linked information was added through dedicated hotspots to store the outcome of the documentary search, including architectural and historical evidence as well as previous technical reports and documents (Figure 8).

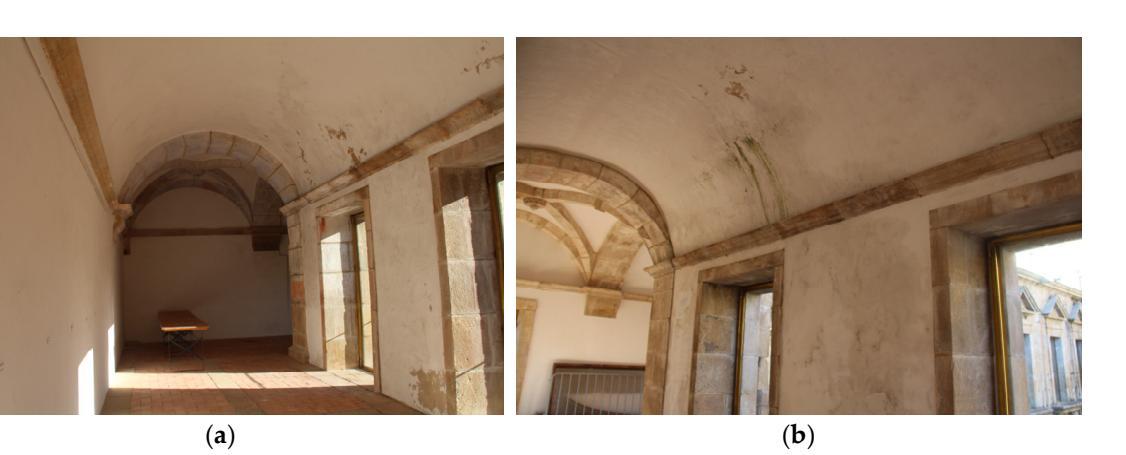
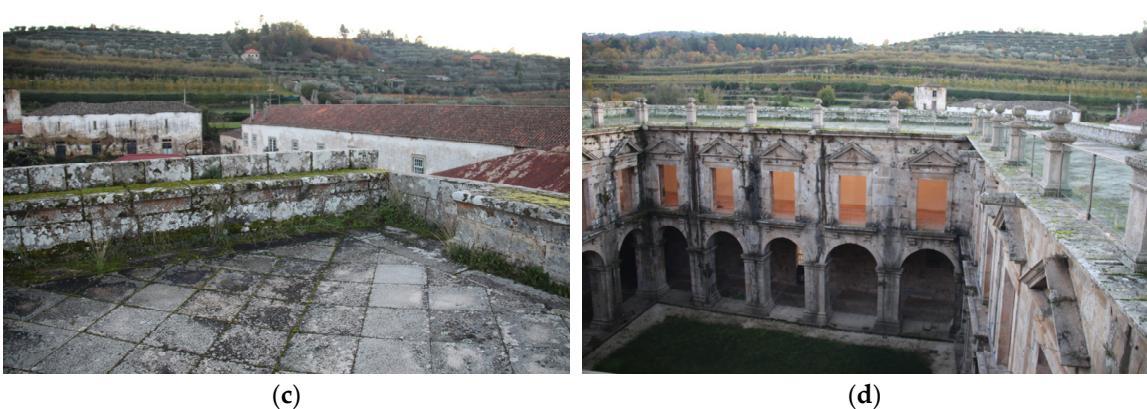
The cloister shows considerable evidence of water infiltration at the second level and moist areas associated with rainfall events (especially in the north Figure 9a and the south wing, Figure 9b). These phenomena are likely due to localised damages to the waterproof membrane and the degradation of the joints in the horizontal surfaces of the accessible roof, string course mouldings, and capping of the walls (Figure 9c). Indeed, the walls lack protection (Figure 9d) and are exposed to frequent rain and freeze-thaw cycles during the winter. A slow and inefficient water flow on the roof surface, further complicated by diffuse biological growth, contributes to the permanence of the water and its penetration through cracks, porosity, and capillarity of the material.

Figure 9. Water infiltration: (**a**) second-level north wing; (**b**) second-level east wing; (**c**) accessible roof; and (**d**) south facade.

- Although the cloister shows considerable evidence of water infiltration associated with rainfall events, likely due to a deterioration of the waterproof membrane and the joints, the area that was the object of the last interventions does not present signs of alterations or reopening of the cracks;
- The structure presents five modes in the range between 4.94 and 15.04 Hz: three global and two local vertical modes of the accessible roof;
- Environmental and operational conditions strongly affect the ambient vibration test. In particular, the negligible traffic, wind, and presence of visitors within the building limit the extent of the ambient vibration;
- The sensor placement was optimised through the tested algorithms to effectively identify the natural frequencies, reducing significantly the number of measurement points.

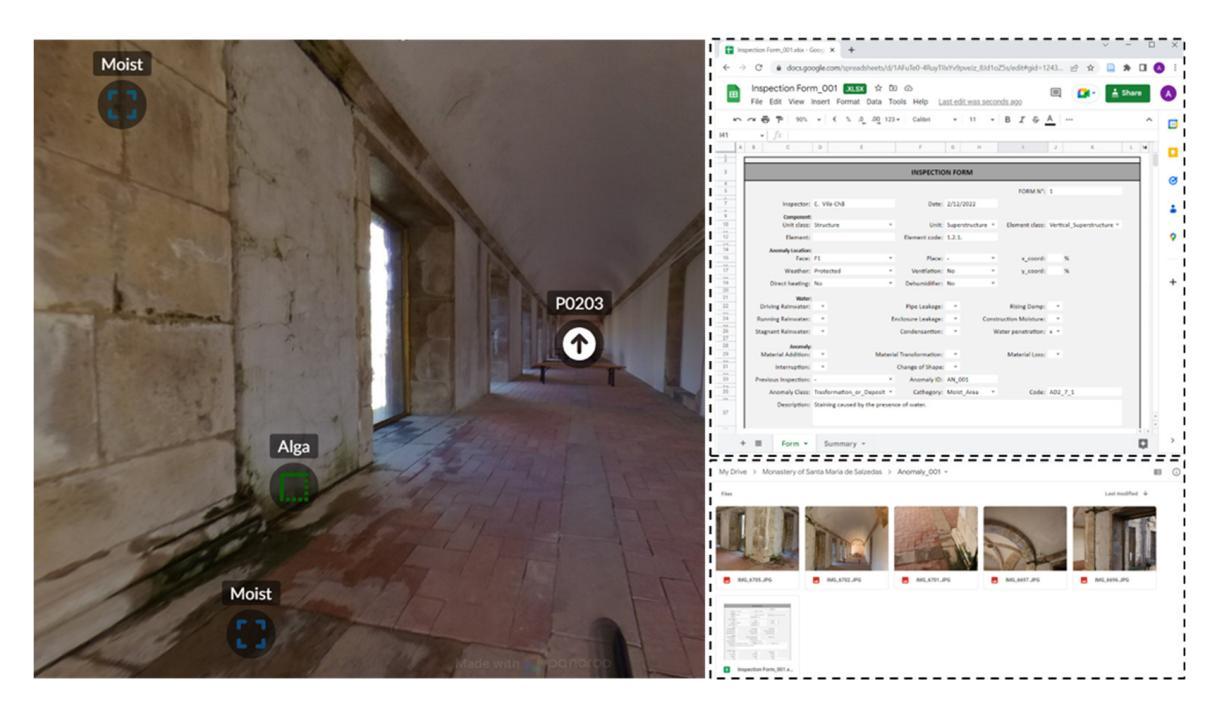
To record what was observed during the visual inspection, the survey results were entered into the digital twin, creating hotspots for the ICOMOS classes. These are linked to distinct online folders dedicated to each identified alteration, which collect the digital inspection form, relevant photographs, and any other associated documents (Figure 10).

Figure 10. Damage survey: damage mapping through hotspots in the virtual model, digital inspection form, and online folder.

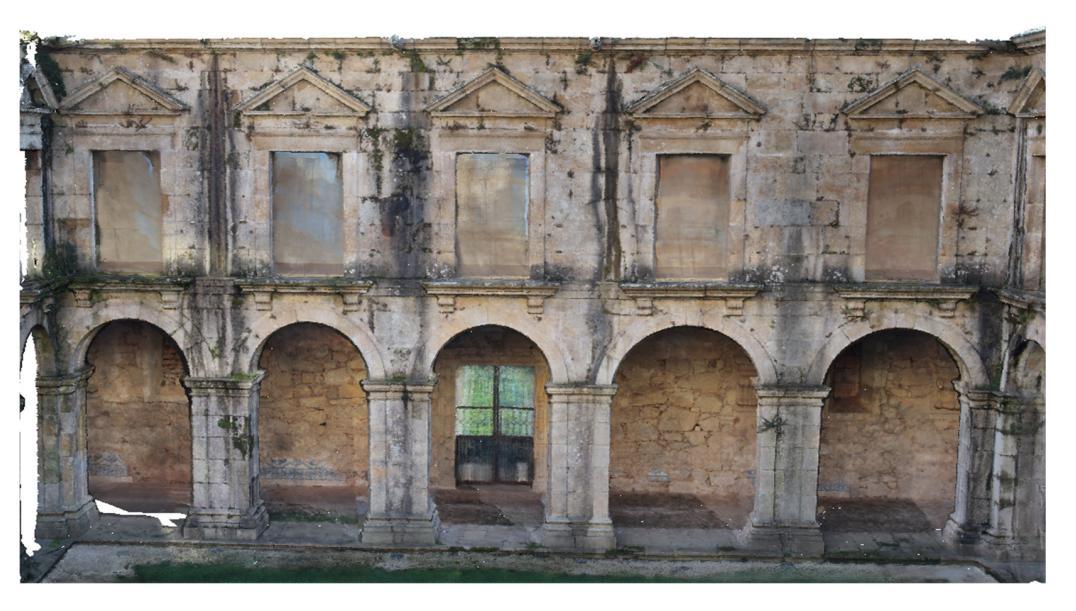
For damage diagnosis purposes, photogrammetry models were developed as baseline data and mapping support (Figure 11). Indeed, the photogrammetric model allows both a future comparison of the point cloud obtained upon following acquisitions and a visual identification of alteration processes. To this end, in the digital twin, a specific hotspot was introduced and linked to an online repository of the photogrammetric survey, including orthophotos and models in interoperable file formats.

Figure 11. Photogrammetric model.

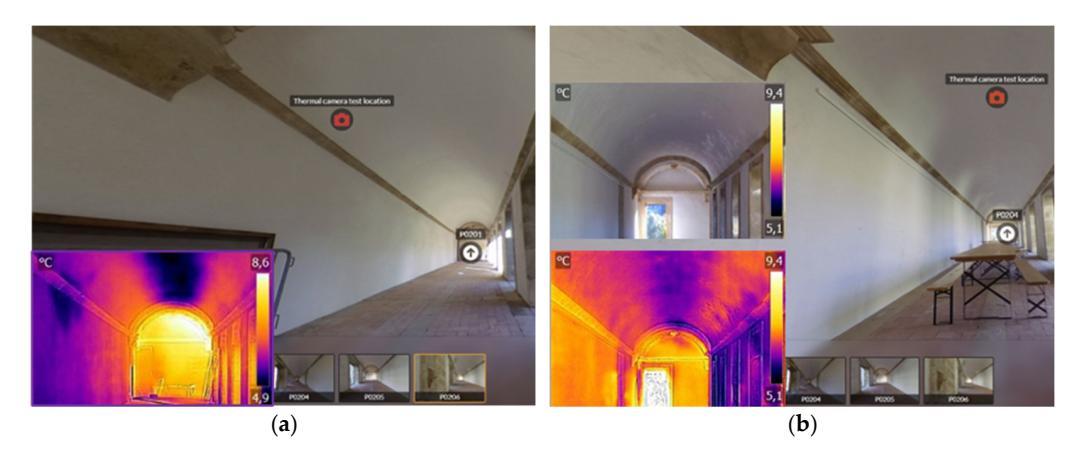
To support the visual inspection, non-destructive tests were carried out, and the outcomes were also stored within the digital model. Given the alterations observed on the two levels of the cloister and the fact that the second level is a close environment and shows spread water infiltration, an inspection with a thermographic camera was conducted in order to identify surface deterioration, hidden damage, humidity, and water penetration paths. Indeed, thermal images have become a reliable tool for damage inspection and diagnosis [82–87]. In Figure 12a,b, the measurement locations in the west and east wings, respectively, are identified together with representative examples of thermal imaging. The results of the inspection allowed us to identify colder spots, likely due to the presence of water within the walls and vaults, that, in some cases, were not evident by visual inspection. These areas largely correspond to the damaged portions of the cloister that were the subjects of recent interventions. Irrespective of that, the plaster is still in good condition, and no evidence of crack reopening was found.

Figure 12. Inspection with a thermographic camera and link through hotspots: (a) West wing and (b) East wing.

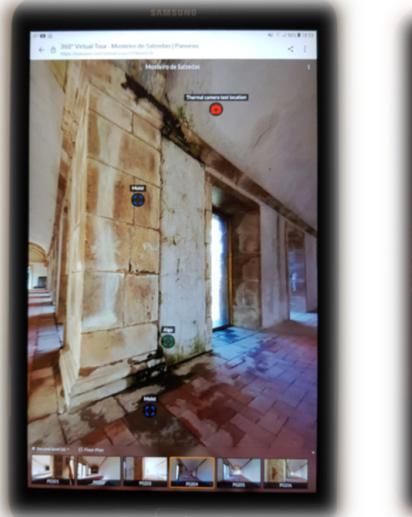
Finally, the feasibility of the virtual model to support on-site inspection and easy collection and updating of the data was tested by operating it remotely on a tablet (Figure 13a). The operator was enabled to navigate the virtual tour, identifying and querying on-site the relevant information stored within the model or in the linked folders. Among them, rapid access to the results of the previous damage mapping was obtained, and the anomaly inspection form was edited (Figure 13b).

Figure 13. On-site navigation, interrogation, and updating of the virtual model: (**a**) inspection of previously identified anomalies and (**b**) inspection form.

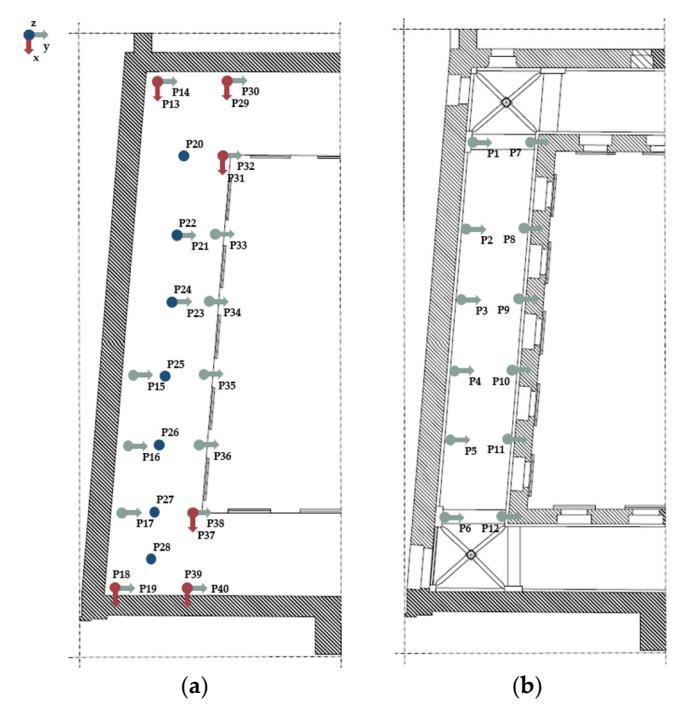
In order to create a baseline of dynamic characteristics for the implementation of a condition monitoring strategy, a dynamic identification was carried out. The AVT focused on the south wing of the cloister and employed 12 high-sensitivity piezoelectric uniaxial accelerometers (model PCB 393B12, 0.15 to 1000 Hz frequency range, 10 V/g sensitivity, ± 0.5 g dynamic range, and 8 µg broadband resolution) in five consecutive setups. Each setup corresponds to a different spatial configuration of the accelerometers, always maintaining two of them as a reference and summing up to a total of 40 acquired degrees of freedom, evenly distributed over the top-most (Figure 14a) and intermediate floor (Figure 14b). Data were recorded through an acquisition system composed of a 4-slot USB chassis model cDAQ-9174 and three 4-channel data acquisition modules model NI 9234 (24-bit resolution, 102-dB dynamic range, anti-aliasing filters, signal conditioning, and 50 kS/s maximum sampling rate per channel).

Figure 14. Sensor deployment, locations, and directions: (a) accessible roof and (b) second level.

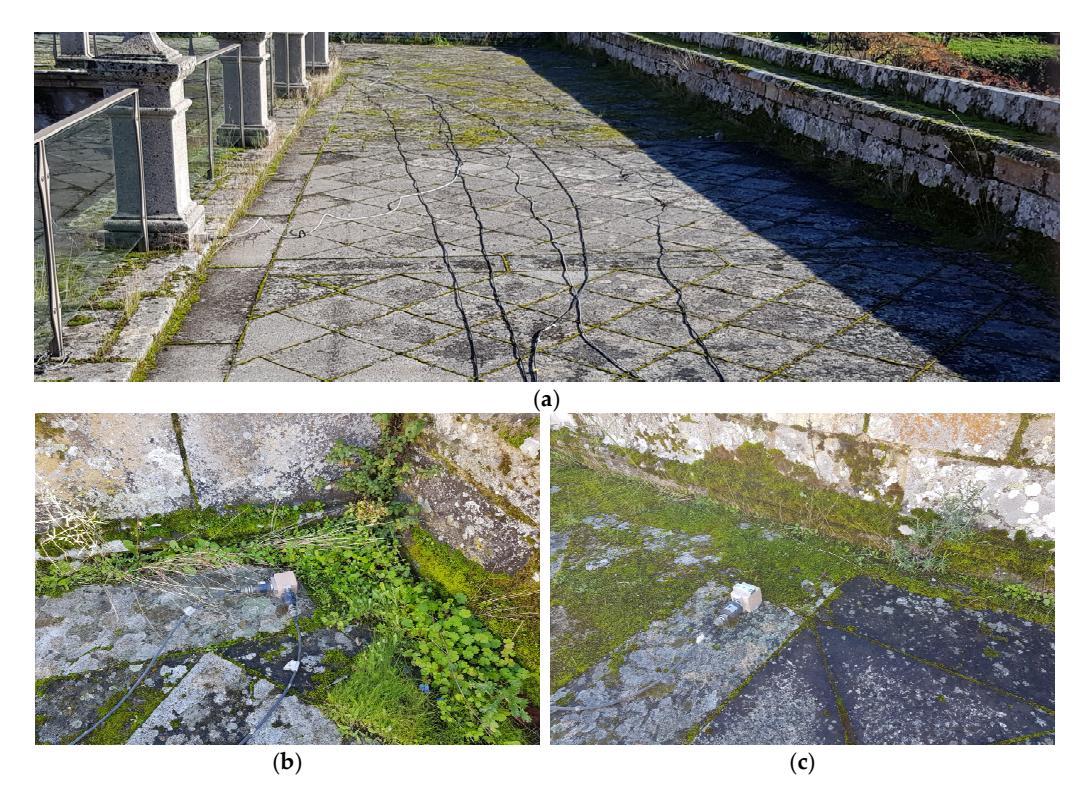
The tests were conducted under low ambient vibration input, mainly due to a light or moderate wind, the limited presence of visitors in the museum, and the negligible traffic in the area. Sources of non-stationary vibration, such as the bells of the church, were avoided. Each acquisition was carried out at 200 Hz with a duration of 20 min to ensure that the records were longer than 2000 times the fundamental period of the system. The signals were acquired during the operation of the museum to prevent downtime. Nonetheless, the test itself interfered with the complete fruition of the cloister as access was partially interrupted during each recording. Moreover, the use of cabled sensors and extension cords to supply the laptop and the acquisition system resulted in a rather intrusive deployment of the monitoring network. Indeed, for some of the setups, the acquisition system was located about 40 m from the closest wall socket, and the accelerometers were distributed in an area of about a 30–40 m radius around the acquisition system itself, connecting the two investigated floors through the windows opened on the inner court (Figure 15a).

Figure 15. Sensor deployment: (**a**) cable distribution; (**b**) reference sensors; and (**c**) biological growth, wet and frozen surfaces close to a sensor location.

On the topmost floor, the harsh open-air environment also affected the operations. In particular, to limit the invasiveness of the test for the required connection of the accelerometer with the system, mechanical joints as well as strong adhesives, which could have damaged the surface of the stone, were avoided. However, the diffuse presence of biological growth and a layer of ice on the stone during most of the day, in some cases, prevented the correct functioning of the hot melt adhesive adopted, limiting the selection of the measurement points and forcing to repeat acquisitions (Figure 15b,c).

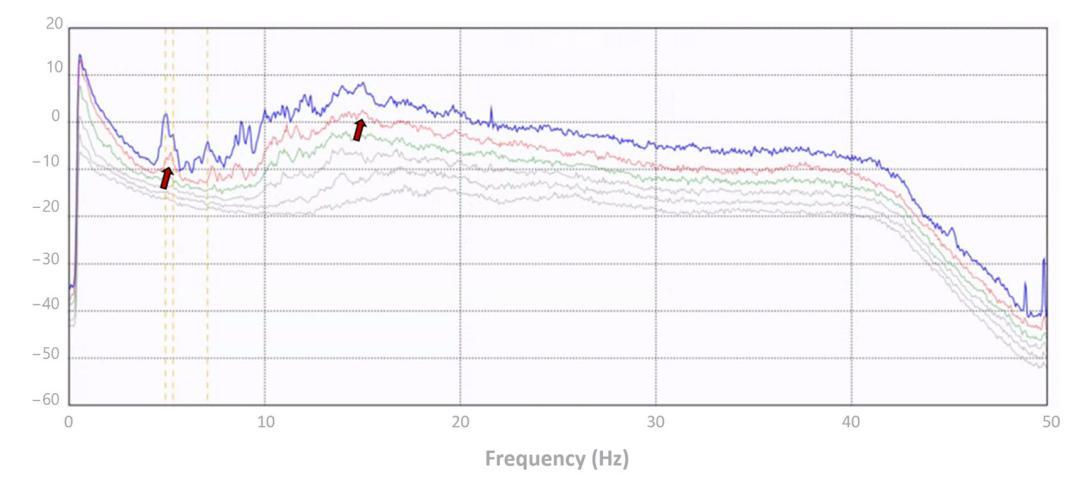
The low extent of the ambient vibration affected the quality of the acquired data, providing a likely low signal-to-noise ratio, which is reflected in the small distance between the first and second singular values in the Singular Values Decomposition (SVD) diagram (Figure 16) [88]. In the same diagram, several candidate peaks appear, arguably caused by nuisances in the acquisitions or local modes of the building complex, which are not clearly distinguishable due to the focus on the south wing of the cloister only. These factors contribute to the difficulties in the estimation of the modes and the failure of automated detection through robust algorithms such as the EFDD or Stochastic Subspace Identification. Therefore, the data processing required a careful inspection of the diagrams, considering different subsets of signals, and five modes were identified with a sufficient degree of certainty. Among them, two couples of closely spaced modes were found. The presence of a peak, although unpronounced, in the second SVD line, helped distinguish them [88]. The natural frequencies, damping ratios, and mode shapes are shown in Table 1 and Figure 17. Finally, the most relevant information regarding this preliminary dynamic identification, including the different setups and sensor positions, acquisition records, and processed data, was collected in a dedicated drive folder linked to the virtual model through an ad-hoc hotspot (Figure 18).

Figure 16. Frequency Domain Decomposition: Singular Value Decomposition diagram; red arrows indicate peaks in the second SVD line popping up to separate closely spaced modes.

again, but considering the five sensors recommended by this method and Figure 21, which reports the SVD diagram. Comparing it with the plot in Figure 16, the ability of the reduced set to ensure effective peak picking emerges, at least for the first three modes, which are even more clear, and for the fifth mode. The identification of the fourth mode is still possible, although affected by more nuisance, as reflected in several closely spaced peaks. A small relative error in the estimation, equal to 2.0%, affects the first natural frequency only (Table 3). It is, thus, confirmed that the heuristic algorithm for OSP ensures a good signal strength and can be successfully adopted to define sensor locations with larger modal displacement and, potentially, larger signal-to-noise ratios.

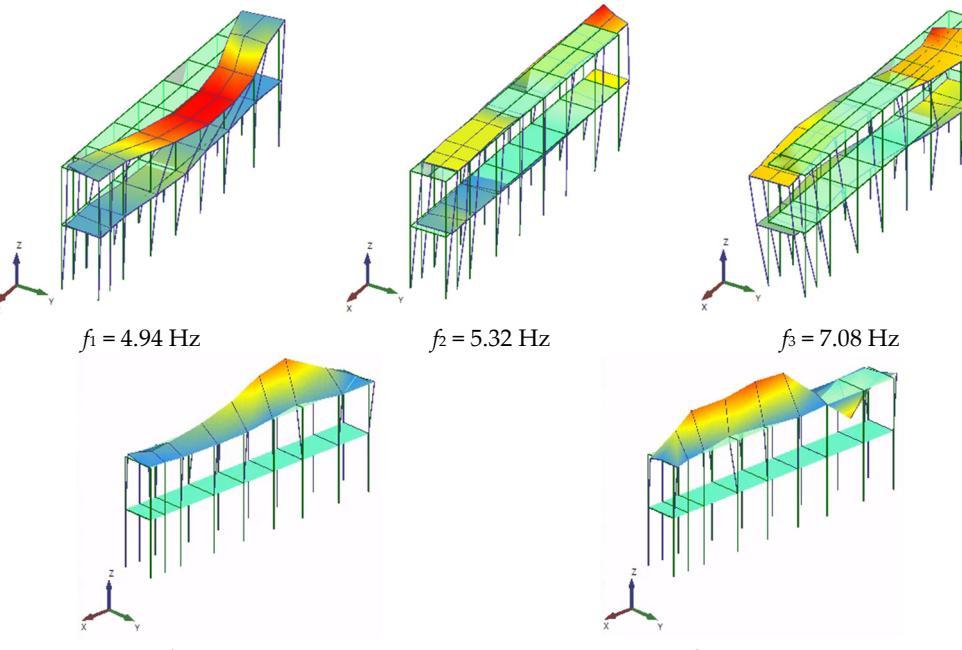
Mode	Natural Frequency [Hz]	Damping Ratio [%]	Description		
1	4.94	1.45	Transversal		
2	5.32	2.56	Longitudinal		
3	7.08	1.34	Transversal		
4	14.65	0.64	Vertical		
5	15.04	-	Vertical

Figure 17. Mode shapes and natural frequencies of the five identified modes.

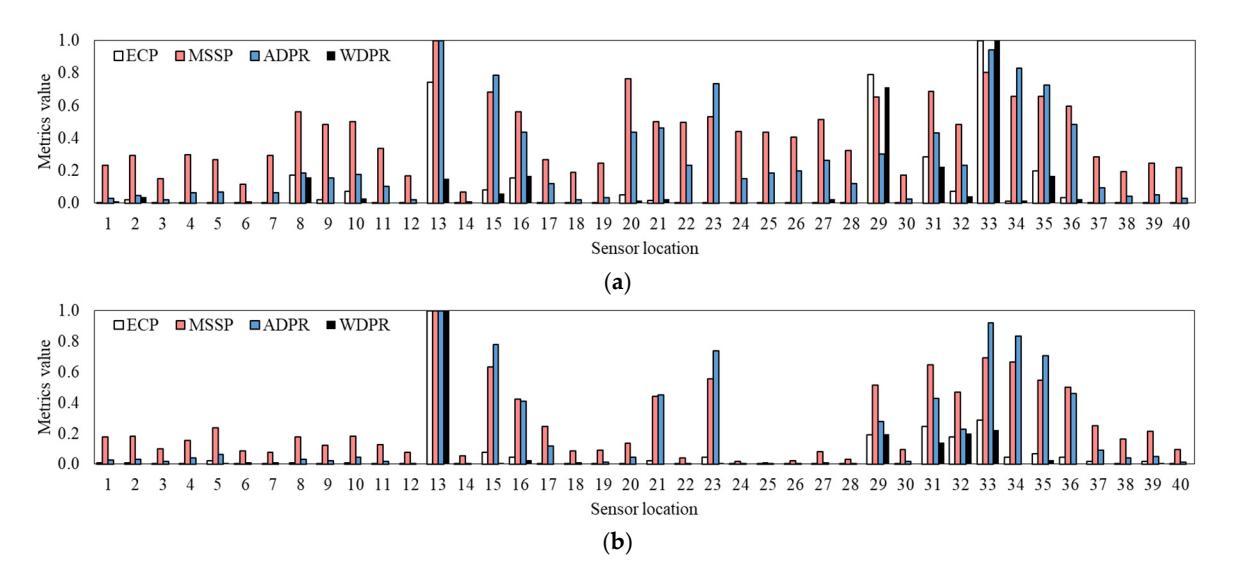
The results of the optimisation through four of the five investigated heuristic methods for five and three target modes are reported in Figures 19a and 19b, respectively. These consist of the value of the metrics to maximize and normalise to a unitary interval for comparison purposes. The results of the QRD are not reported in the plot as this method provides a metric value for a number of sensors equal to the target modes only. Especially when five modes are targeted, quite large variability in the estimation of the relevance of each candidate according to distinct metrics emerges. This is reflected in the final optimum sets, reported in Table 2. Among the tested methods, no one suggests the location of a sensor on the intermediate floor. According to most of the heuristics, the vertical component of the mode shapes plays a negligible role in the identification. This is reflected in the lack of sensors along this direction except for P20 and P27, as suggested by MSSP and QRD. In the longitudinal direction, the presence of position P13 is almost constant, whereas, in the transversal direction, P33 is always recommended together with at least another sensor (e.g., P32, P34, or P35) in any solution except for the ECP targeting three modes.

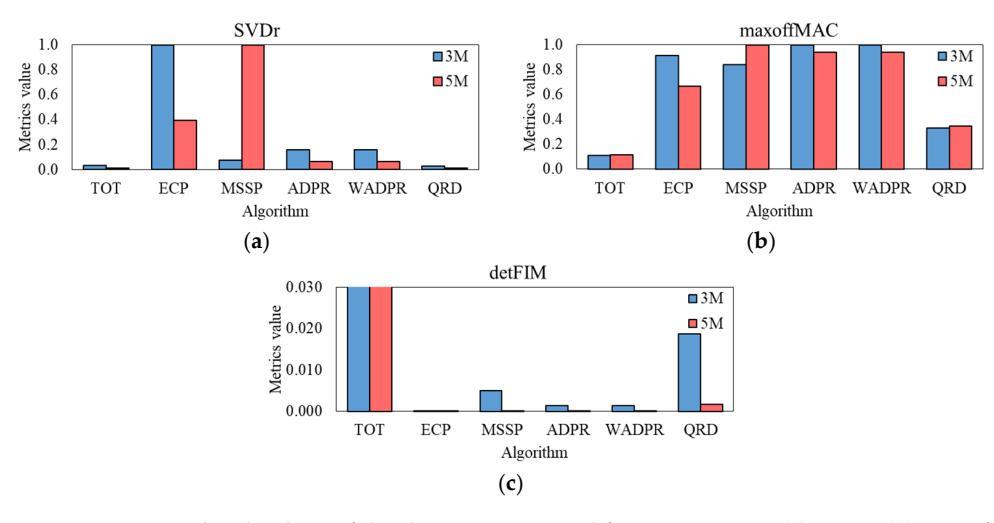
Figure 20 shows the values, normalised to a unitary interval, of the three metrics considered to assess and compare the performance of the five methods. Due to their characteristics, the values assumed by the SVD_r and the moaxoffMAC vary within a limited range, whereas the detFIM obtained over the total number of sensors is extremely larger than the results over the reduced sets. Indeed, for the normalised detFIM metric, the total set scores 1, whereas all the reduced sets are less than 0.02. Nonetheless, the three metrics present the QRD as the best method. Therefore, the dynamic identification is carried out

Figure 20. Normalised values of the three metrics used for comparison: (a) SVDr; (b) maxoffMAC; and (c) detFIM.

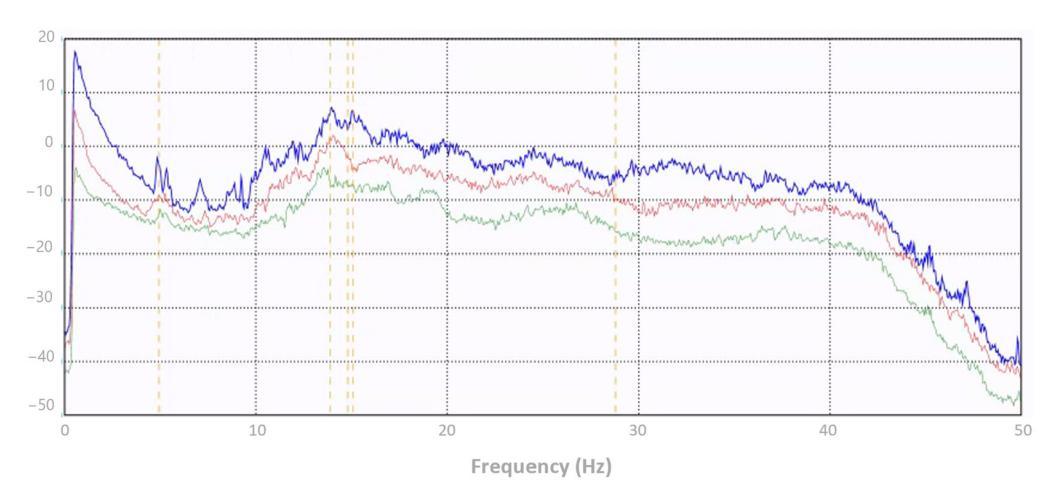
Figure 21. Frequency Domain Decomposition applied to five signals: Singular Value Decomposition diagram.

Mode	TOT f [Hz]	QRD f [Hz]	Δf [%]		
1	4.94	4.83	2.0		
2	5.32	5.32	0.0		
3	7.08	7.08	0.0		
4	14.65	14.65	0.0		
5	15.04	15.04	0.0
