Is the Viscoelastic Sheet for Slamming Impact Ready to Be Used on Glass Fiber Reinforced Plastic Planning Hull?

Patrick Townsend ¹,*¹, Juan Carlos Suárez Bermejo ², Paz Pinilla ², and Nadia Muñoz ¹

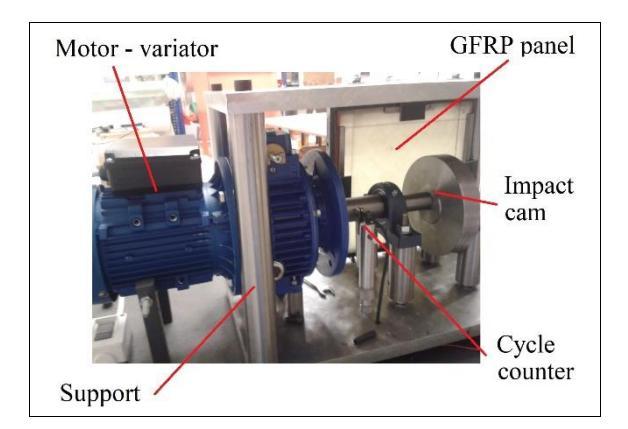
The reproductions of slamming impact were made with the equipment presented in Figure 2. It is composed of a variator-electric motor assembly coupled to a cam with a shaft supported by two flexible supports to dissipate the reaction energy of the cam when pressing the panel and protect the drive from possible excessive lateral loads. The cam is keyed while remaining fixed to the shaft and rotates between 200 to 320 RPM. The panel was installed at its base with gauge screws that allowed exerting pressures between 0 to 1200 kN/mm² and the panel is adjusted crosswise to the cam. A revolution counter was installed, and the temperature control was carried out with a thermal imager, to avoid that the temperature does not reach the glass transition temperature of the material due to friction.

Figure 2. Reproduction equipment for slamming impacts.

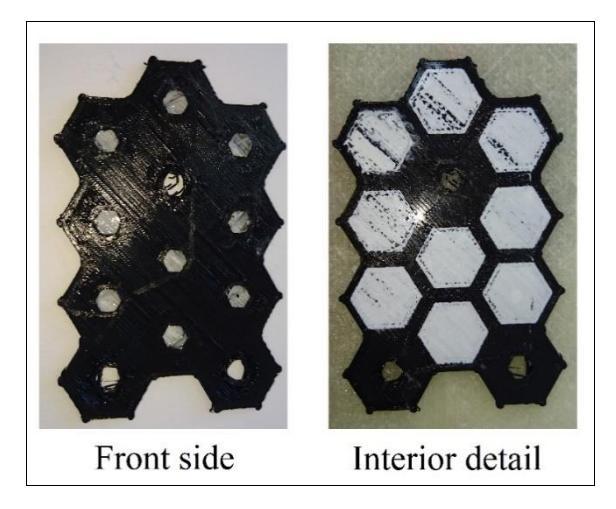
For the manufacture of the viscoelastic sheets, a printer was used with two independent extruders so that there is no contamination between the materials. They were printed on a thermal surface. For the manufacture of the outer capsule, 3 mm acrylonitrile butadiene styrene or ABS was used. A linear thermoplastic polyurethane or TPU was used for the inner elastomer. Figure 3 shows a generic viscoelastic layer. Depending on the manufacturing date for the experiments, the color type of the ABS varies, so there are black and blue.

Figure 3. Generic viscoelastic layer.

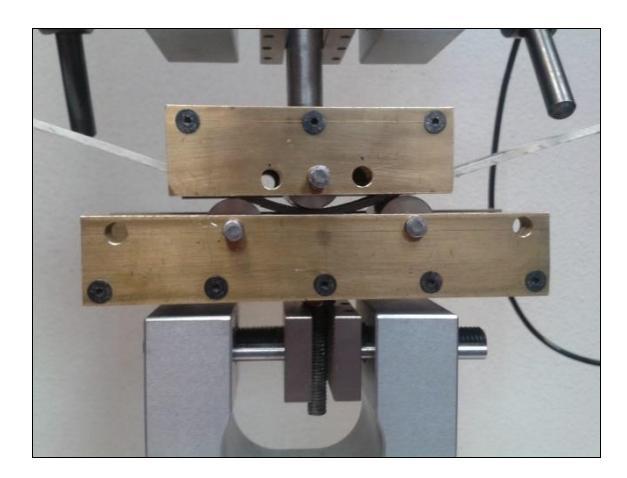
Three-point bending tests were performed to experimentally determine the pressure threshold from which damage begins to occur on the unmodified material. Cured specimens were cut from a panel into strips 15 mm wide by 250 mm long. They were flexed beyond their elastic limit until the

tension machine registers non-linearity, indicating the appearance of the first micro-cracks equivalent to the damage threshold as seen in Figure 4.

Figure 4. Three-point Bending test.

From the results of the three-point bending test to determine the damage threshold of the laminate, it was determined that over the 2300 μ m/m of deformation, the curve was no longer linear and corresponded to the desired threshold.

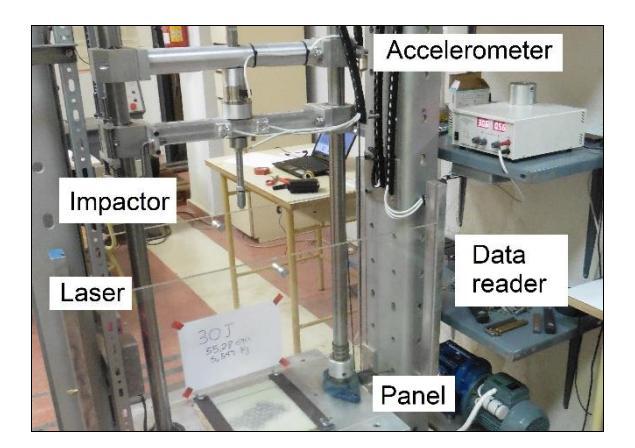
A machine for vertical weight drop testing was built. The impactor carriage falls by gravity on two chrome rails to reduce the effect of friction. The panels to impact were installed at its base, with all its edges embedded. It has an anti-bounce system with a laser reader to control the number of impacts. It has an acceleration sensor or gravitometer installed that sends the information to a data acquisition system and tabulates the acceleration G-force versus the time of impact. The equipment has a frame-shaped structure to which all parts are secured. The impactor was made with electromagnets for holding and launching. The guide bolts allow more weight to be added to it. At the bottom of the impactor it has the impact tip with a magnetized sphere. The number of impacts is controlled with a laser reader. Figure 5 shows the detail of the impact equipment and its parts.

Figure 5. Weight drop impact equipment.

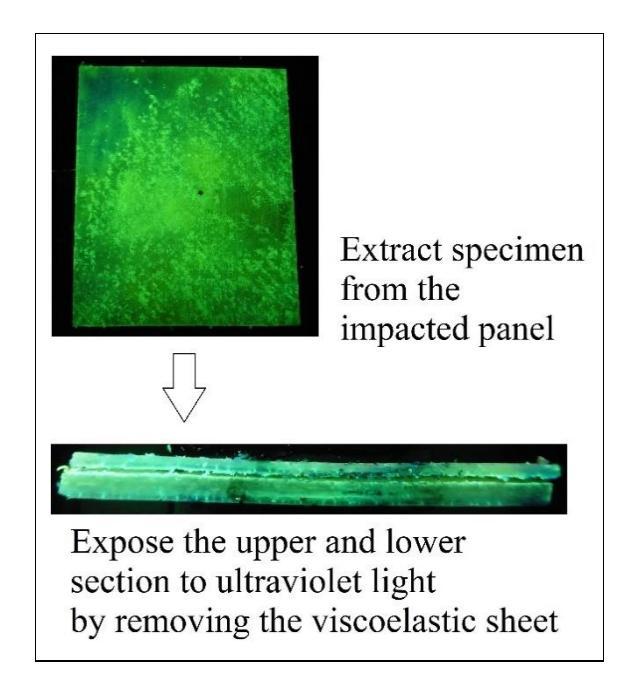
To observe micro cracks within the laminate after impact and to make a comparison between unmodified and modified panels, characterization was performed with fluorescent penetrating inks to expose the sections to ultraviolet light with the procedure presented in Figure 6. The panels in the impact area were cut from 60×60 mm and drilled with a 0.5 mm drill bit, for the purpose of immersing them in a fluorescent penetrating liquid. Sectional cuts were made in the specimens, to observe their different intralaminar delaminations in interlaminar with fluorescent light. In the case of panels with viscoelastic sheet, this was withdrawn during exposure, because it is important to compare the viscoelastic layers protected.

Figure 6. Test evaluation procedure for fluorescent penetrating inks.

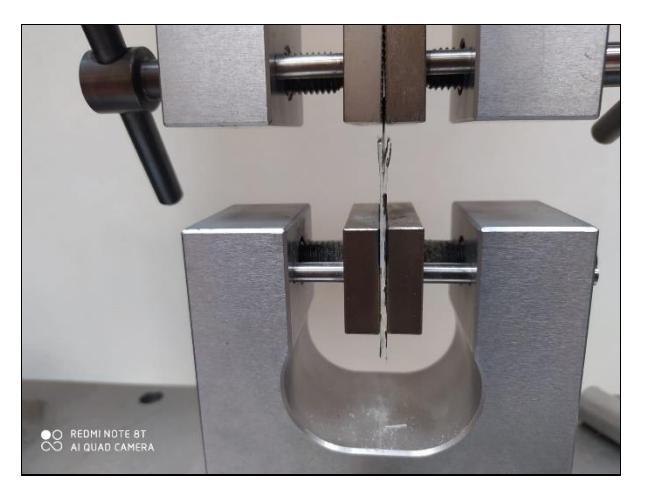
In order to know the adhesion force that the viscoelastic sheet has once cured in the modified panels, shear tests adjusted to the Cohesive model theory were performed to estimate the damage initiation phase force, the maximum force at which detaches the sheet and the behavior of the propagation force of the detachment. For the shear tests, single-layer panels of Mat 200 were manufactured. This allows

the blade to work only on the viscoelastic sheet and the matrix as seen in Figure 7, the universal testing machine was used with a very fine steel blade, which will make the cut parallel to the viscoelastic.

Figure 7. Shear test equipment.

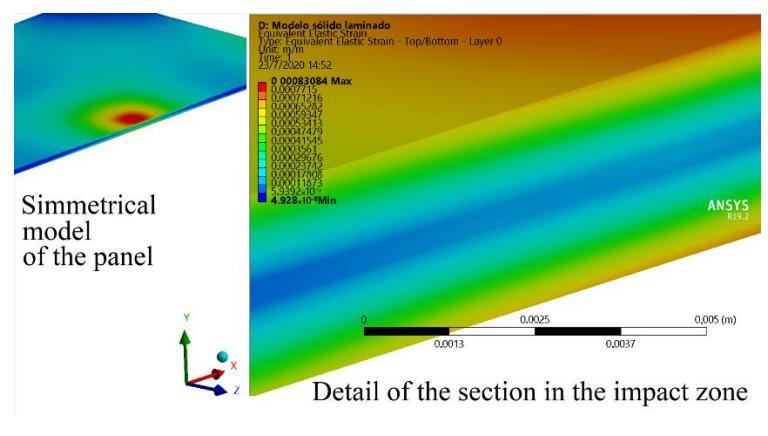
Using the Finite Element Method (FEM), the force that caused deformations equivalent to those that cause damage to the material was estimated in the model. Figure 8 shows the symmetric model with the load at its center and a detail of the section in the impact zone of the same model. The results of the elastic strain have been plotted for a value in the maximum impact zone of 834 μ m/m corresponding to a pressure of 385 kN/m².

Figure 8. FEM model.

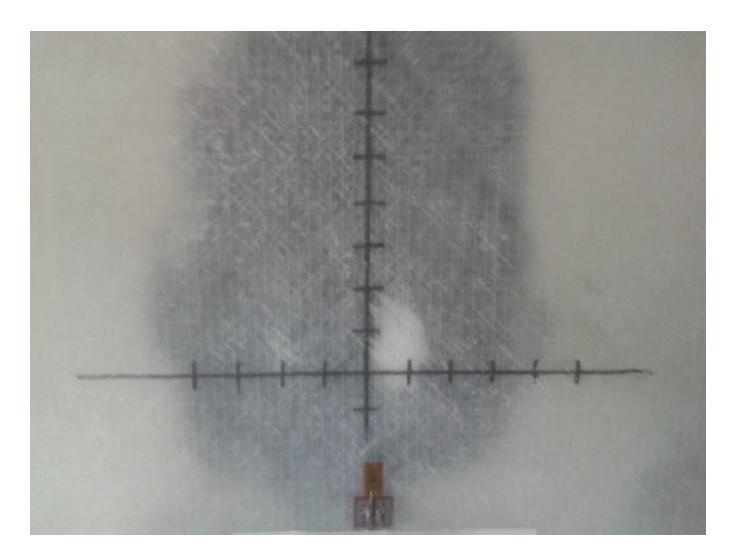
Panel D reached 85% damage in the area of contact with the cam. It was observed that the first micro cracks appeared at 2×10^2 impacts and were already highly visible at 1×10^2 cycles. The first damage observed as slight white shadows were in the areas where the sides of the cam meet. They then lined up toward the center of the contact surface and show the evolution of damage as slamming strokes increase. Figure 9 shows the results of the test.

Figure 9. Evolution of unmodified panel D damage at 0.21×10^5 impact cycles with P = 810 kN/m².

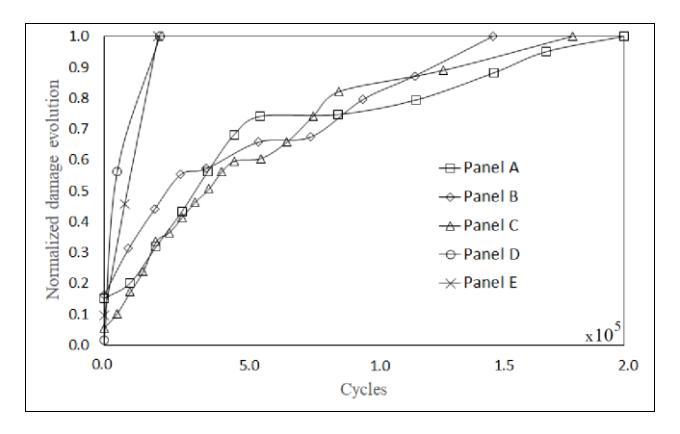
Damage spread could be observed in real time at this pressure level and was first expanded by the penultimate laminated -45° layer on the strain gage side. At the end of the test it was found that breaks had already formed in the panel that passed from side to side in the laminate. Normalizing the percentage of damage between the maximum damage area value for each test in panels A–E. It is observed in Figure 10 that the evolution of the damage has a similar behavior for low energy impacts,

Figure 10. Normalized damage evolution on unmodified panels.

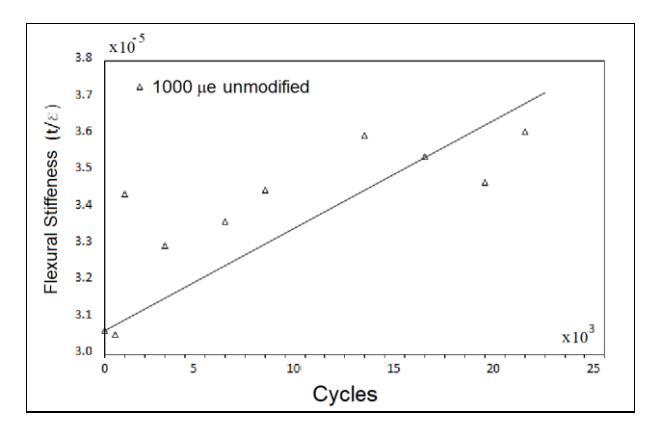
The change in flexural stiffness was evaluated with the results of the strain gage using panel F. In Figure 11 are the results of the for a deformation of $1 \times 10^3 \,\mu$ m/m at the slamming pressure point in the 0.27×10^5 test cycles with a pressure of 420 kN/m². The data has a representative ascending line, which indicates that as the micro cracks increase, the panel loses rigidity. This is in accordance with the type of damage observed on the panel on the opposite side of the impact. These values were calculated from the deformations obtained with the strain gages.

Figure 11. Evolution of flexural stiffness in panel unmodified F up to 0.27×10^5 impact cycles with P = 420 kN/m².

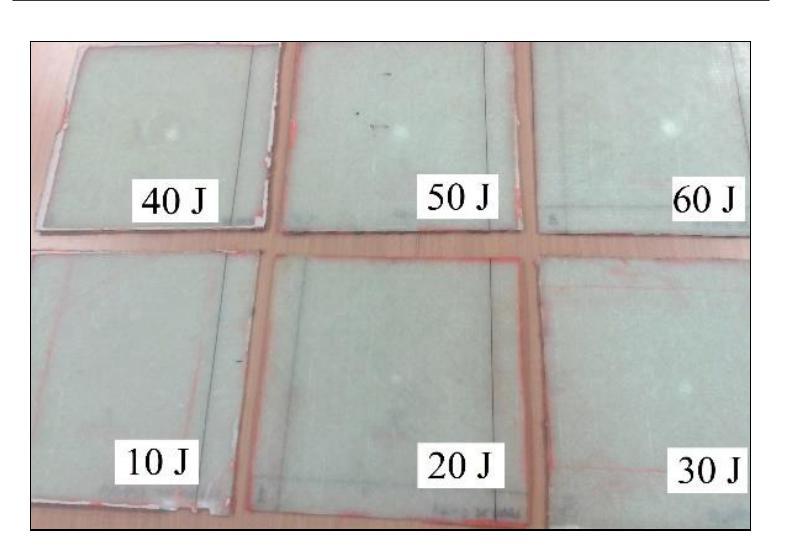
Figure 12 shows the sequence of damage to the panels on the impact side, for the different energies tested with vertical weight drop. The sequence allows visualizing the increase in damage that occurs as the applied energy increases.

Figure 12. Unmodified panels impacted by vertical weight drop test from 10 J to 60 J of energy.

As the impact energy was increased, the microcracks were observed to be oriented in the direction of the fiber. The largest number of observed micro cracks evolved over the 45° layer. To a lesser extent in the 0° layer. Impacts less than 40 Joules can be considered low energy, while those greater than 40 Joules high energy, where the panels already show delamination and deep separation of layers. The phenomenon of slamming is a low energy process, for which the panels impacted at 30 J are the best to be considered for comparison with the panels tested in fatigue.

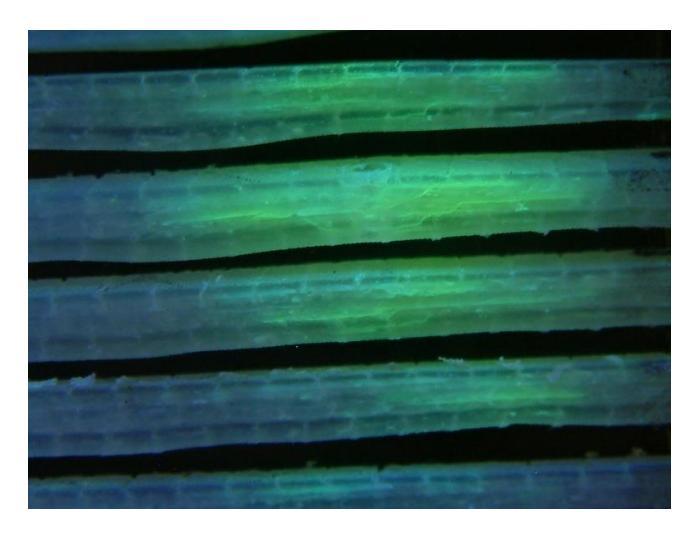
When characterizing the panels tested with penetrating inks, it was observed that they had indeed entered the delamination, being easily seen under ultraviolet light. Sections sequentially are exposed to fluorescent light as seen in Figure 13 for impact at 40 Joules respectively, in which interlaminar delamination can be easily observed.

Figure 13. Unmodified panel sections exposed to ultraviolet light impacted at 40 J.

As expected in a laminated composite material, the breaks in the matrix are vertical and connect with delamination between layers, producing a ladder shape. The breaks observed in the lower layers indicate that the impact energy was converted into damage and was jumping from one layer to another. It is also important to note that according to the orientation of the layers, the delamination moves from left to right starting from the vertical direction of impact.

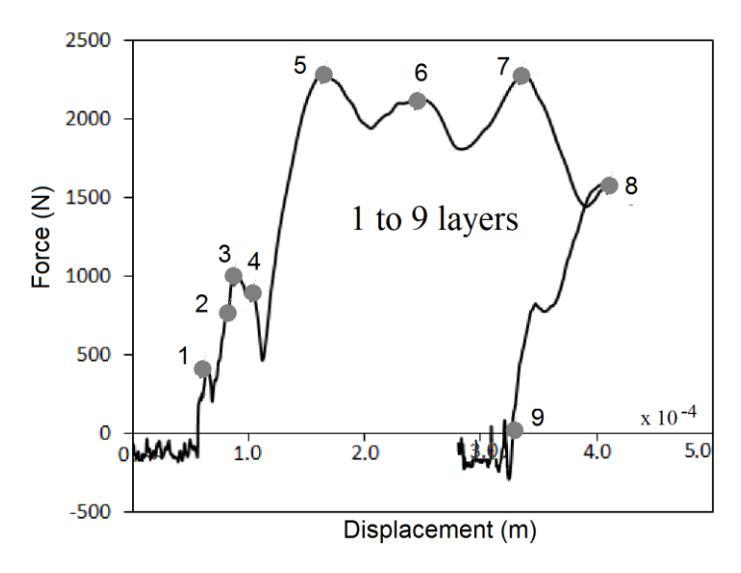
The accelerometer records the acceleration force (G), at a frequency of 104 Hz. According to the suggested equations, they show that the acting force versus displacement has the profiles presented in Figures 14 and 15. The peaks of damage that occurs as the impactor breaks each of the layers. The impactor slows down each time a new delamination occurs. Records the acceleration variations when micro cracks occur in the matrix. In the case of the low energy impact of 30 Joules, the impact force reaches its maximum value by breaking layer 5. Thereafter the layers offer resistance to deformation. In the case of impact at 50 Joules of high energy, the impactor has enough force to continue breaking all the layers until 9 at which it has already bounced.

Figure 14. Comparison of the force vs. displacement diagram for an impact at 30 J in unmodified panel.

The acceleration curve also allows you to compare how fast laminate damage is and which layers absorb the most damage energy. In the case of the 30 Joule curve, between layers 4 and 5 there is a large increase in damage energy, indicating that this layer broke and delaminated. This is in accordance

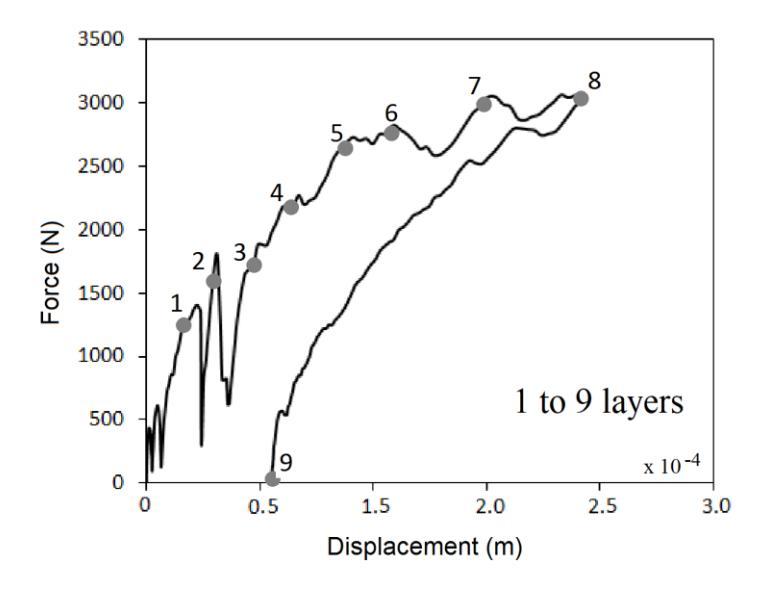
Figure 15. Comparison of the force vs. displacement diagram for an impact at 50 J in unmodified panel.

with what was observed in the sections of the material exposed to penetrating ink and ultraviolet light. In contrast to the panel at 50 Joules, the high energy impact imposes a lot of kinetic speed, and the first layers up to 6 breaks at the same time interval.

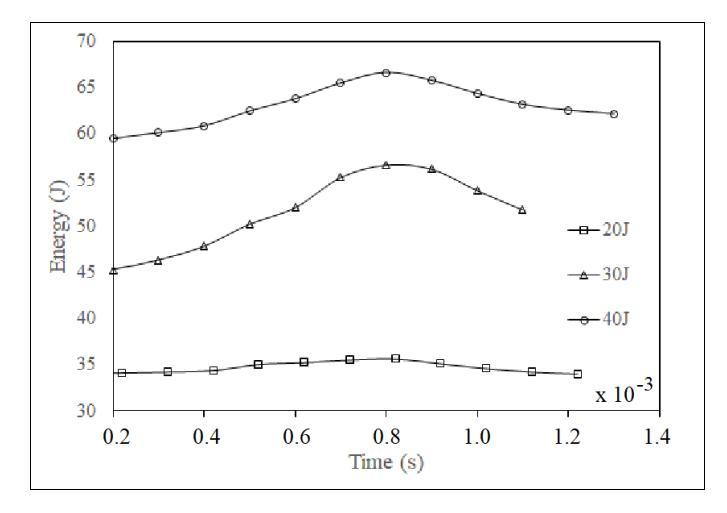
The assessment of the absorbed energy is observed in Figure 16 for impacts of 20, 30 and 40 Joules. The curves clearly show that the panel absorbs energy that is returned in the form of kinetic energy, and over a certain time interval its capacity to absorb energy decreases, indicating that there is more damage within the panel.

Figure 16. Energy absorbed by vertical energy impacts on unmodified panels.

The absorbed energy curve that has the best configuration is the 30 Joule curve, while the 60 Joule curve has an uncharacteristic trend, which is correctly related to the detachment and breakage of the matrix and the fiber that was observed in the test.

In the 20 Joule curve, its little variation is consistent with that observed in the panel after impact. The microcracks and directions of the delamination are very light. This indicates that little energy was transformed into damage and most was returned to the impactor.

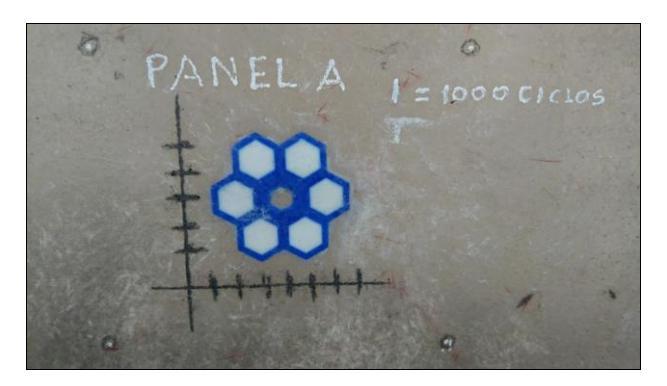
During panel G tests it was observed that over the 1×10^3 cycles, the first microcracks in the matrix were observed on the viscoelastic sheet. It was a high energy test and at the end of the test no delamination or cracks were observed on its surface. Panels K and L showed little damage to the matrix, and these were analyzed for adhesion with shear tests. Panel K is shown in Figure 17, which at 1×10^3 impact cycles already shows the appearance of microcracks, whose damage evolution was not significant.

Figure 17. Modified panel K impacted at 1×10^3 cycles with 343 kN/m² slamming pressure.

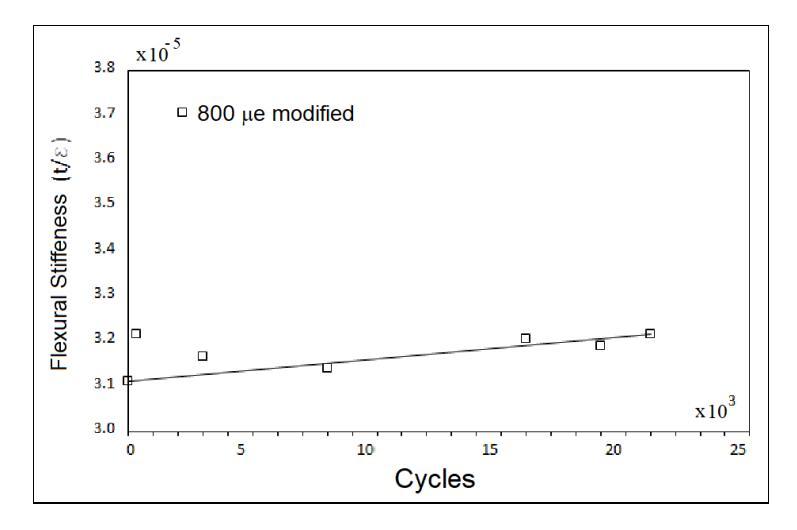
For the modified panel F, 2.7×10^5 impacts were made with a slamming pressure of 343 kN/m², evaluating its change in flexural stiffness. The change versus cycles is presented in Figure 18. It is observed that the representative line has a low magnitude slope and the data tends to change in a lower value. This is related to what was observed during the test, in which few microcracks and damage evolution after impact are observed. The protection of the viscoelastic layer is clearly observed because the damage is minimal on the face after impact. The orientation of fiber damage is not clearly defined. The results are considered good because they have an acceptable tendency, and in high energy levels there is also a concordance in flexural stiffness.

Figure 18. Evolution of flexural stiffness in modified panel F up to 0.27×10^5 impact cycles with P = 343 kN/m².

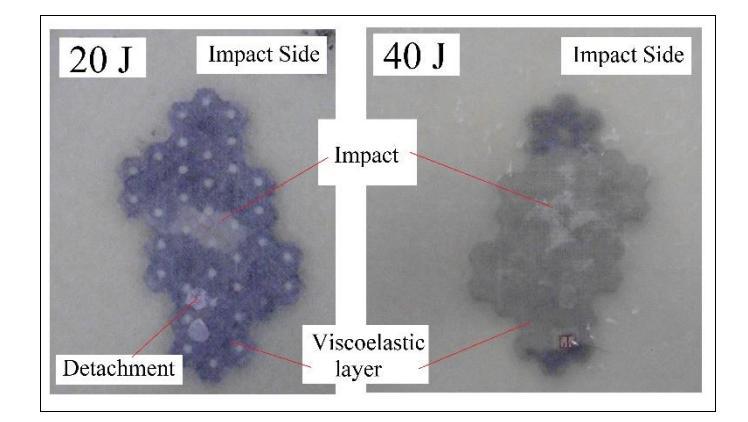
The tests carried out on the panels with a viscoelastic layer with impact energies for weight drop of 20 and 40 Joules are shown in Figure 19. The impact of 20 Joules presents little damage on the surface with little failure of adhesion with the laminate matrix. In contrast, in the 40 Joules panel, the damage is much greater and there is a complete cradle separating the viscoelastic lamina with the matrix. The impact is punctual and there is a noticeable difference with the high energy slamming test. The vertical weight drop tests obtained similar results for the low energy case. Over 30 Joules the data obtained is applicable for a comparison.

Figure 19. Impact tests for gravity weight drop of 30 and 40 J of energy to modified panels.

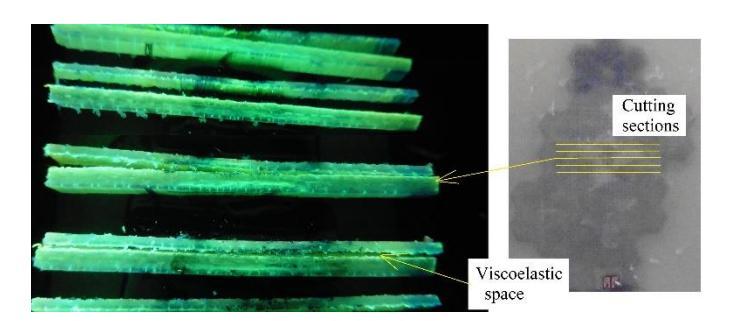
The modified panels were treated in the same way with fluorescent penetrating inks to assess the type of damage. During the cut, the viscoelastic sheet came off. This is seen in Figure 20. It should be noted that the viscoelastic layer came off due to the oil cut. The sections were 2 mm thick and despite the slow cutting speed, this affected their adherence. The cutting speed was very slow and oiled, to prevent fragments of composite material from sticking to the sections and showing erroneous results under fluorescent light.

Figure 20. Characterization with penetrating ink to panels impacted at 40 J and 80 J.

It can be seen in the cross sections that the impacted laminate layers before the viscoelastic layer have damage to the matrix and fiber. The layers after this have little delamination. The matrix shows few vertical breaks and the ladder joints are not clearly visible. Delamination do not take a lateral direction due to the orientation of the layers but appear intermittently and hardly visible. All sections exposed to ultraviolet light show the same behavior. Vertical impact is similar to a fatigue event shown in slamming trials.

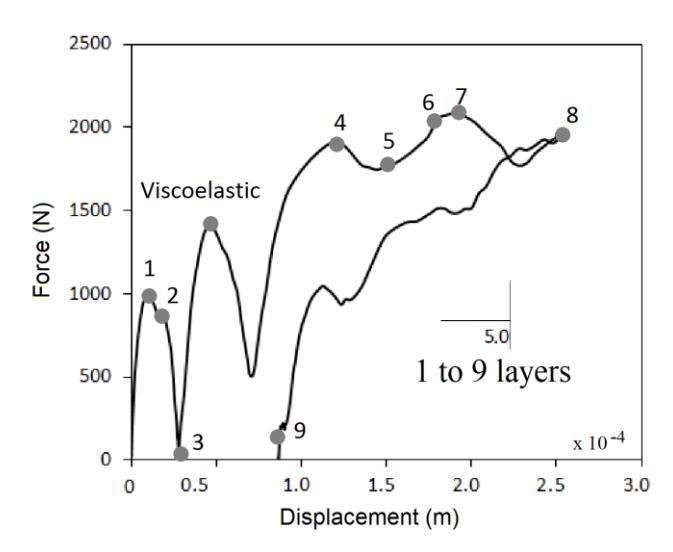
According to the results of the accelerometer and the use of the respective formulation, the behavior of the panel during the impact at 40 and 80 Joules is observed in Figures 21 and 22. It is observed that the impactor breaks layers 1, 2 and 3, and then experiences a decrease in force. This means that the impact force is damped by the viscoelastic layer. The impactor breaks the next layers, from the decreased force causing less damage. Depending on the impact force, the impactor does more or less damage to layer 9 on which it has bounced. Both results, the presence of the viscoelastic sheet is fully identified. At the 80 Joules high-energy impact, the layers broke at similar time intervals, until the interference of the viscoelastic layer. The acceleration curve is clearly marked as it affects the impactor and protects subsequent layers.

Figure 21. Comparison of the force vs. displacement diagram for an impact at 40 J in modified panel.

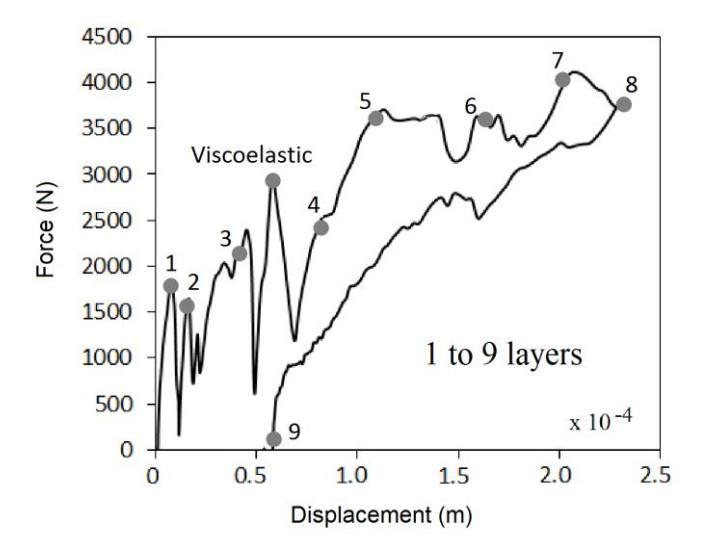
Figure 22. Comparison of the force vs. displacement diagram for an impact at 80 J in modified panel.

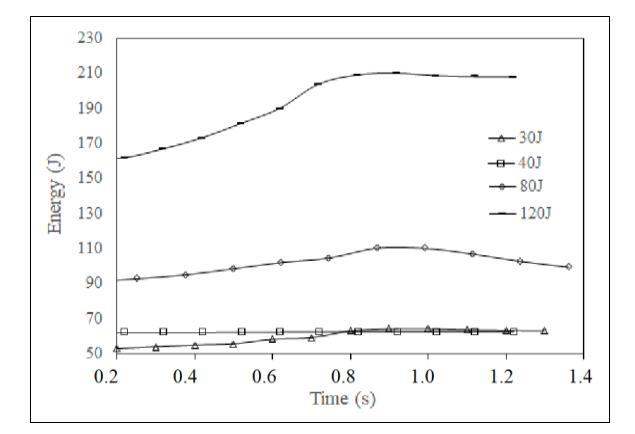
The energy absorbed by the modified panels for impacts of 30, 40, 80 and 120 Joules is shown in Figure 23. It is observed that the panels maintain their capacity to absorb impact energy, which indicates that the damage does not increase proportionally as which increases the impact energy. This is indicative of less damage to the matrix, which accumulates the kinetic energy imposed by the impactor. It is observed that at 120 Joules, the absorbed energy curve does not show the typical tendency of composite materials to high energy impacts. It does not have the ability to return all damage, but it does return

damage energy to the impactor. This is identified in the negative slope in the intervals that the impactor reaches layer number 9. In such a way that the curve clearly shows that the material receives little damage for high energy vertical impacts. This result is unrelated to slamming energy impacts.

Figure 23. Energy absorbed by impact of weight drop tests on modified panels.

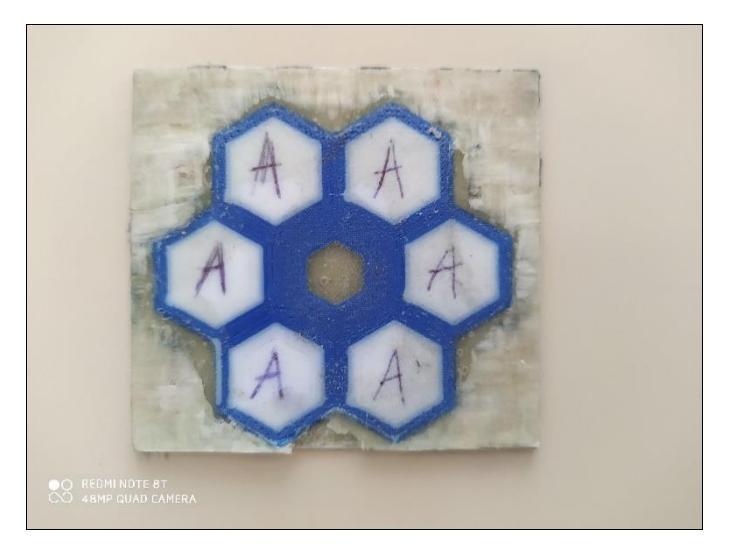
Adhesion tests gave the expected results according to the "Cohesive Theory Model". Panels K and L were shear tested after being subjected to 0.27×10^5 slamming cycles. Figure 24 shows specimen K with the detachment of the viscoelastic. The tests were carried out on two sides in order to have more results to know the behavior of the adhesion of the sheet to the matrix.

Figure 24. Panel K tested with the shear test.

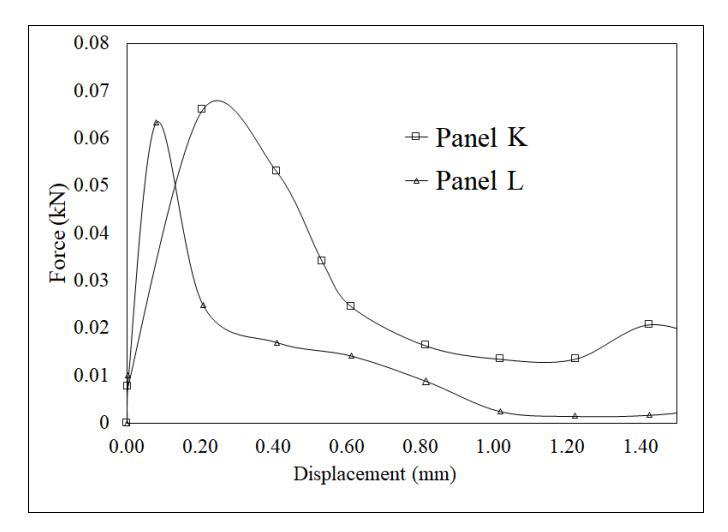
The resulting forces that were obtained in the tests are shown in Figure 25 for panels K and L. The damage initiation phase is clearly identified in each of the tests, and there is little difference in the value of maximum force. That is required for the viscoelastic sheet to peel off. Once detached, the team was able to test the propagation of the detachment of the layer. The maximum force value corresponds to the shear force of the laminate so that the adhesion fails.

Figure 25. Adhesion force obtained with the shear test.

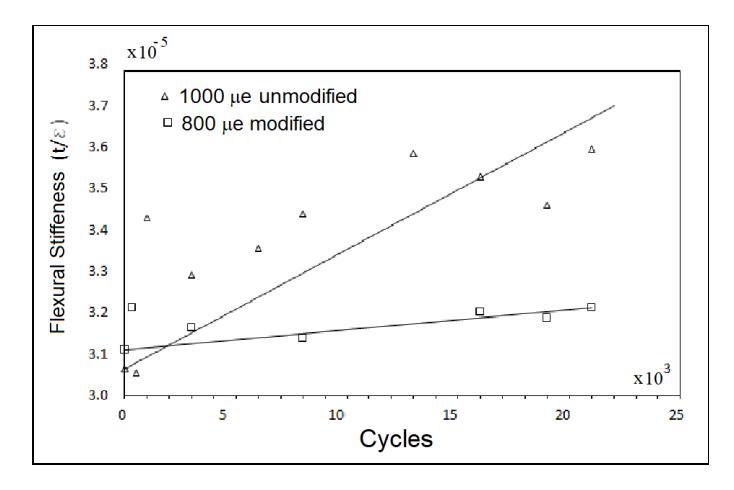
The insertion of a viscoelastic layer effectively mitigates the damage caused by the slamming phenomenon by reproducing the impacts under controlled laboratory conditions. The protection from the damage presented allows to absorb the dissipation of destructive energy, protecting the structure of the ship's hull and increasing its useful life. This brings a new perspective to the design of the ships and their scantlings, since the viscoelastic modification changes the way in which the stress concentrations are distributed in the hull of the boats. Comparing with the flexural stiffness values obtained along the scale of applied cycles, we observe in Figure 26 that over the 5×10^3 , the unmodified and modified panels begin to distance in magnitude. The unmodified panel quickly gains flexural stiffness while the modified panel remains and does not change significantly.

Figure 26. Comparison of the change in flexural stiffness during the slamming test with 0.27×10^5 cycles.

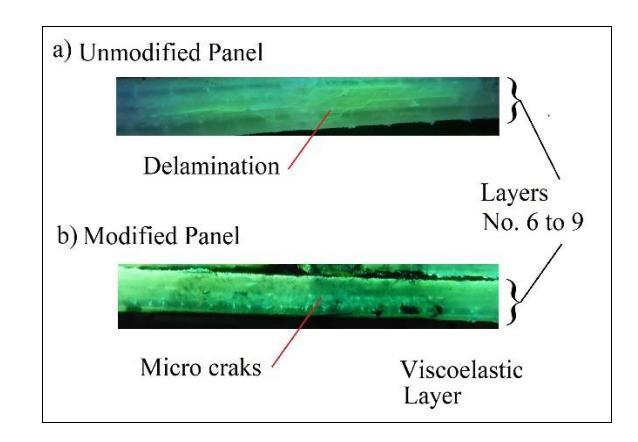
The characterization by fluorescent penetrating inks, allowed us to physically observe how the damage does not propagate in the same way under the layers of the viscoelastic sheet, mixing this damage between the impact shock and the normal tension due to the flexion of the panel on the tensile side. Figure 27 shows two cut sections in the impact area already characterized by an unmodified and a modified panel, both impacted at 40 Joules. In the panel without modifying the interlaminar and intralaminar damages, they are linked, producing internal breaks in the laminate between layers 5 and 9 with important separations to the matrix. On the other hand, in the modified panel, the viscoelastic sheet protects the section of the laminate between layers 6 and 9, which correspond to those subsequent to the sheet. This means that it has returned the energy of damage and therefore little damage is observed on the underside, corresponding to microcracks and no delaminations.

Figure 27. Comparison of the impact section for weight drop at 40 J characterized with fluorescent penetrating inks for unmodified panels (**a**) and modified panels (**b**).

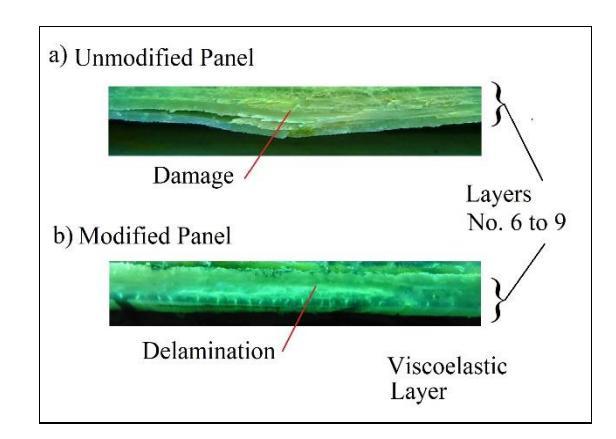
Figure 28 shows the same comparison, but for a test of 80 Joules. Damage to the unmodified panel is very severe and unusable. On the other hand, the damage for the modified panel is less. If there is delamination of layers 6 to 9 that correspond to the layers after the viscoelastic layer, but not in all the layers. Viscoelastic layer protected these layers from severe impact damage.

Figure 28. Comparison of the impact section for weight drop at 80 J characterized with fluorescent penetrating inks for unmodified panels (**a**) and modified panels (**b**).

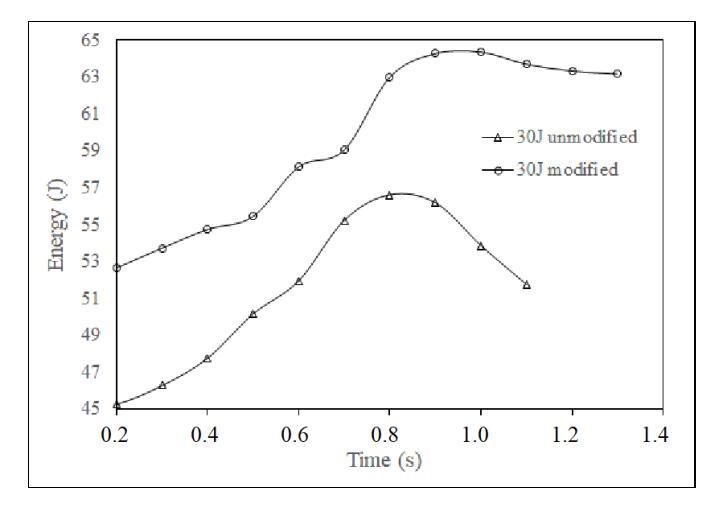
According to these results, when comparing the absorbed energy calculations shown in Figure 29, there is a notable difference in the amount of energy for the same test at 30 Joules of impact. The modified panel absorbs little energy and returns it in a better way demonstrating protection.

Figure 29. Comparison of energy absorbed by impacts of weight drop test.
