Article The Maintenance Effect of Diaphragm-to-Rib Fatigue Cracks in Orthotropic Steel Deck via Steel Plate Reinforcement

Abstract: To investigate the maintenance effect of diaphragm-to-rib fatigue cracks via steel plate reinforcement, finite element models of different-shaped steel plates were established. Stress intensity factors at the crack tip before and after reinforcement were obtained, and the variations in stresses were studied. Polygonal steel plate reinforcements were then carried out on a real bridge based on the finite element calculation results. The changes in stress amplitudes and fatigue damage degrees at the crack tip were analyzed via the rain-flow counting method and Miner's linear damage accumulating theory. The results show that both the polygonal steel plate and the rectangular steel plate could effectively eliminate the stress concentration and restrain the propagation of cracks. The stresses in other parts of the arc notch increased after reinforcement and polygonal steel plates had less influence. After the reinforcement in a real bridge, the cycle number of high stress amplitudes at the crack tip decreased significantly. The fatigue damage degree of the

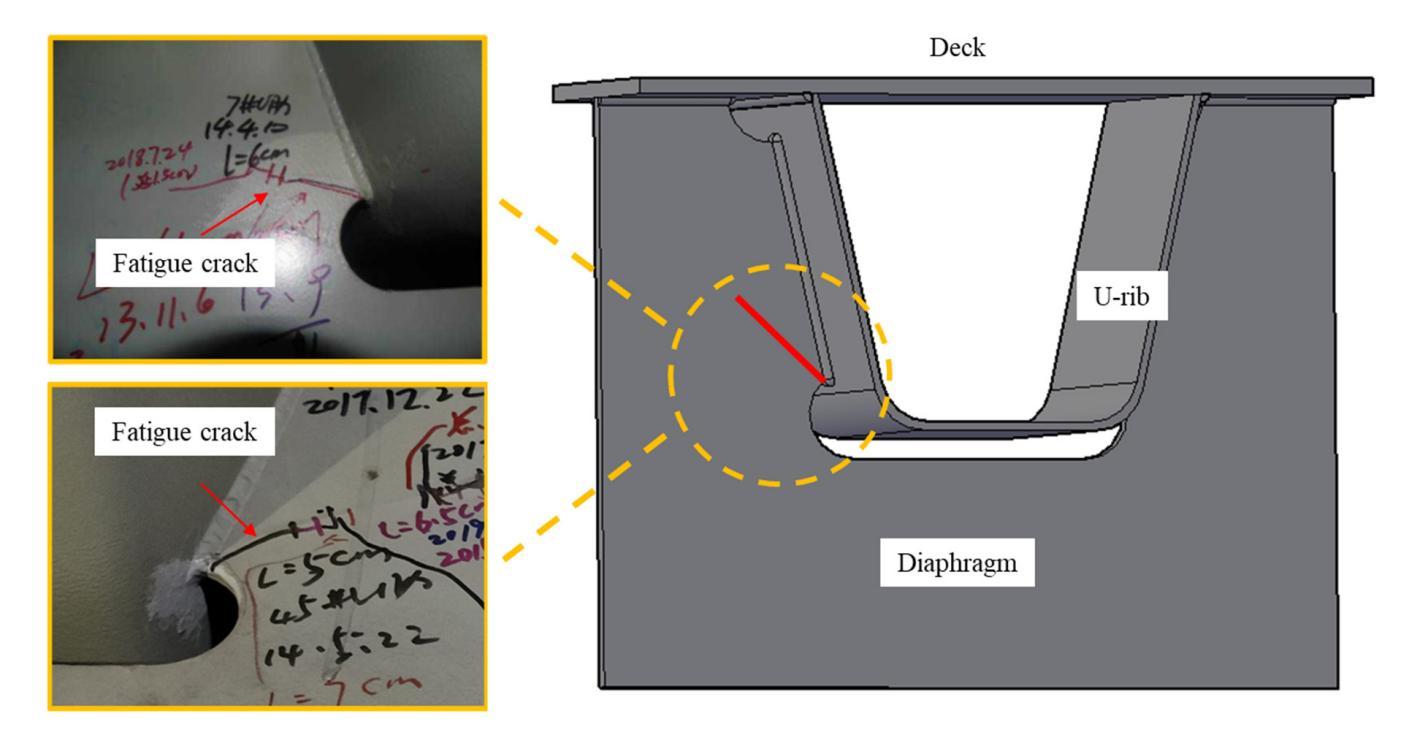
Cyclic vehicle loads result in the deflection of U-ribs in OSDs, which causes the outof-plane deformation of the diaphragm. Consequential stress concentration occurs at the diaphragm-to-rib weld, and fatigue cracking propagates obliquely upward form the bottom of the weld between the diaphragm and the U-rib on the real steel bridges, as shown in Figure 1.

Figure 1. Fatigue cracks formed from the diaphragm-U-rib weld.

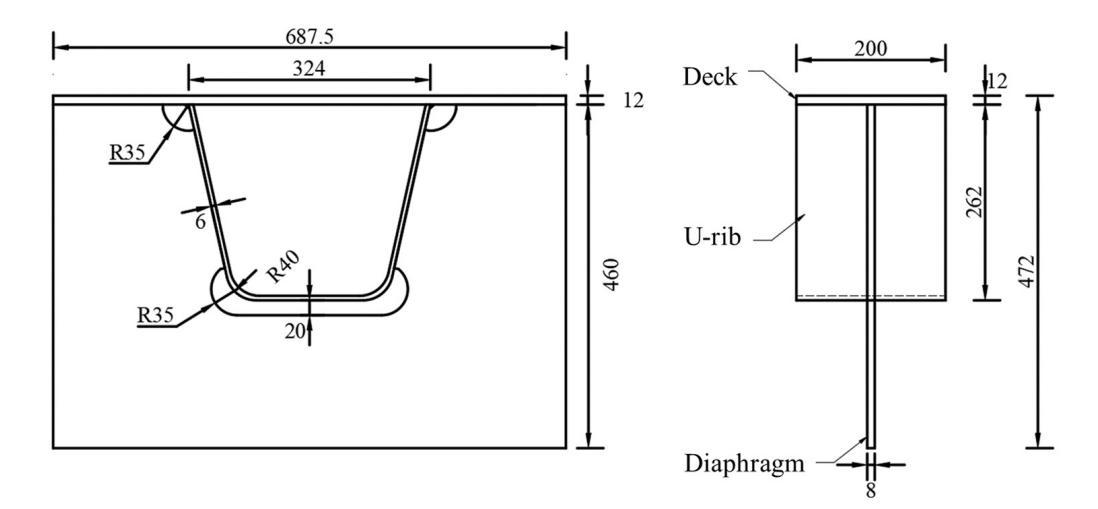
The finite element model was established using ABAQUS, based on the dimensions of the real bridge. The thickness of the deck and the diaphragm was 12 mm and 8 mm respectively. The section size of the U-rib was $324 \times 262 \times 6$ mm. The finite element model is shown in Figure 2.

The material of the finite element model was Q345qD steel, with an elastic modulus of 2.06×10^5 MPa and a Poisson's ratio of 0.3. The model was meshed with hexagonal solid element type C3D8R and tetrahedral solid element type C3D10 with a global mesh size of 20 mm. The meshes of the two sides of the diaphragm-to-rib welds were refined with a mesh size of 1 mm; the transition region was meshed with tetrahedral element type. The deck was fixed constraint. The roof of the model was fixed constraints with full degrees of freedom. The loading area was set on the surface of the diaphragm with an area of

2 mm \times 164 mm \times 45 mm, directly below the arc notch [4]. The reference point was set at 10 mm from the weld toe in the horizontal and vertical directions with a nominal stress of 100 MPa. A rectangular extended finite element method (XFEM) crack was set to the left of the diaphragm-to-rib weld, with a plane size of 90 \times 8 mm and an angle of 45° in the horizonal direction.

Figure 2. Model size (Unit: mm).

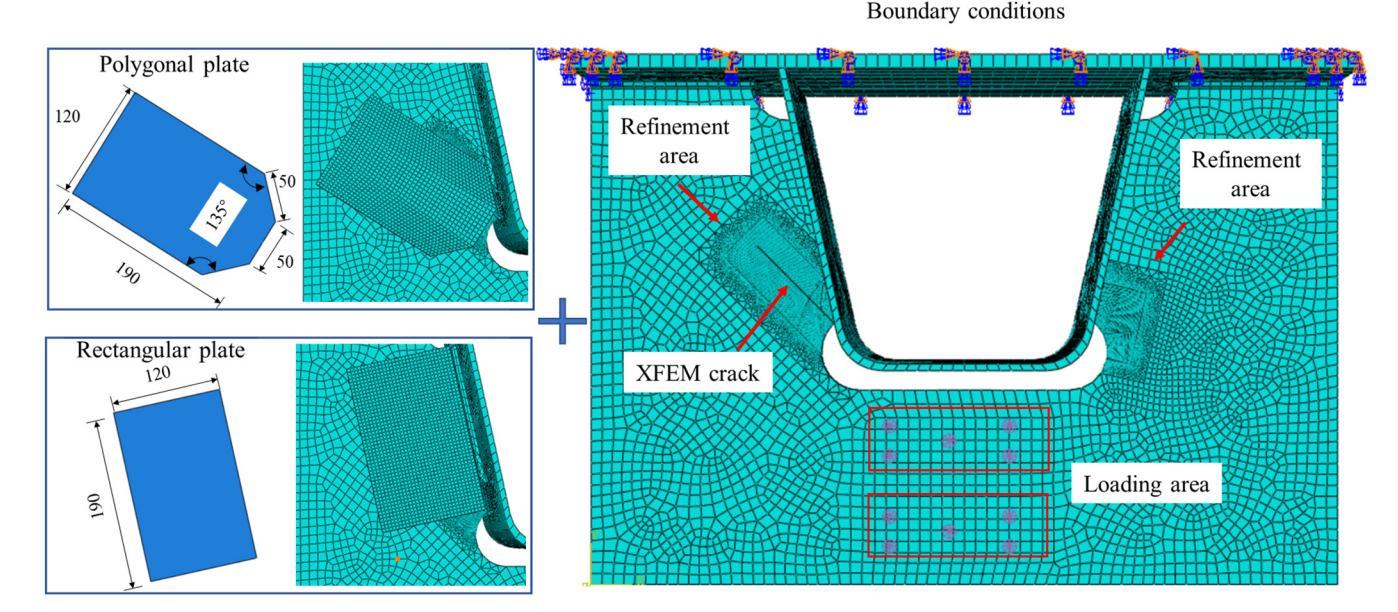
Several studies on cold reinforcement were conducted. One type of rectangular steel plate was employed to attach to the diaphragm-to-rib weld toe for reinforcement [17]. One type of polygonal steel plate was used for the U-rib crack retrofitting via the FEM method [18]. Based on existing studies, two shapes of steel plates were designed to repair diaphragm-to-rib fatigue cracking in this study, as seen in Figure 3. As shown, the size of the polygonal steel plate was 120×190 mm, with triangular cuts in both corners, and the hypotenuse of the chamfer fitted the weld in the model. In the same way, the size of the rectangular steel plate was 120×190 mm with the long edge of plate fitting the weld too. Considering the coordination between the size of the steel plates and the bridge component, the thickness of these plates was set to 8 mm, the same as that of the diaphragm in the model. Binding constraints were adopted to connect the steel plates with the diaphragm.

Figure 3. Finite element models.

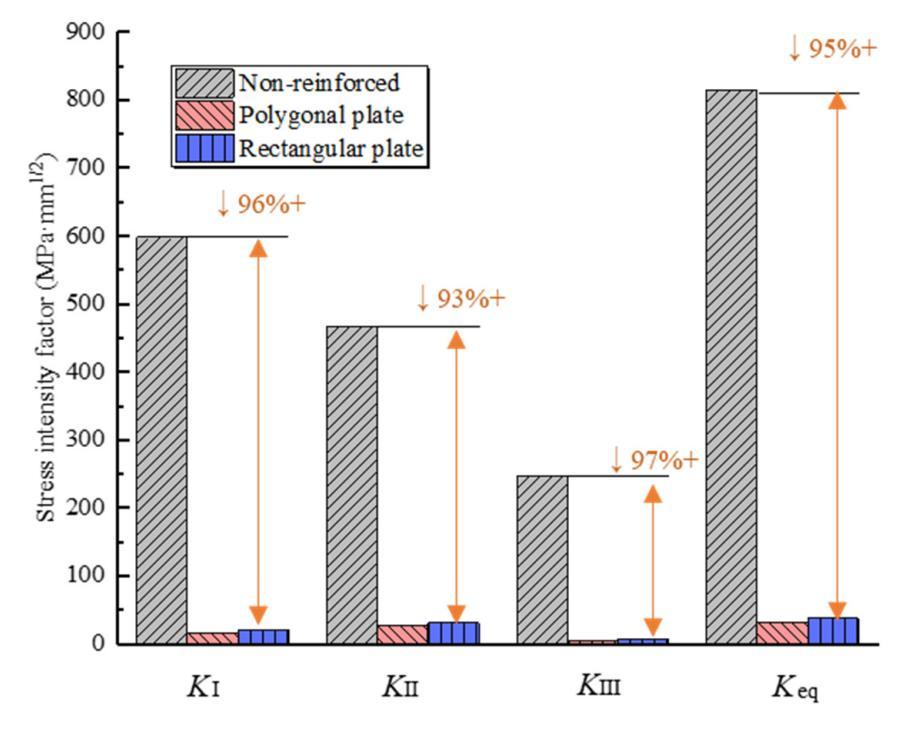
The stress intensity factors obtained via the finite element method are shown in Figure 4. It was seen that the stress concentration at the crack tip was obvious before reinforcement. After the steel plate reinforcement, the stress concentration was reduced, and the stress intensity factors fell by more than 93%. K_{eq} before the reinforcement reached 813.68 MPa·mm^{1/2}, which decreased to 31.75 and 37.70 MPa·mm^{1/2} respectively after being reinforced with polygonal plate and rectangular plate. The values of the stress intensity factors after polygonal plate reinforcement were slightly higher than those after rectangular plate reinforcement. The results indicated that, both polygonal plate reinforcement and rectangular plate reinforcement had a significant effect on hindering crack propagation. In addition, before reinforcement, the crack that grew obliquely from the diaphragm-to-rib weld was shown as a mixed mode crack.

Figure 4. Comparison of stress intensity factors before and after steel plate reinforcement.

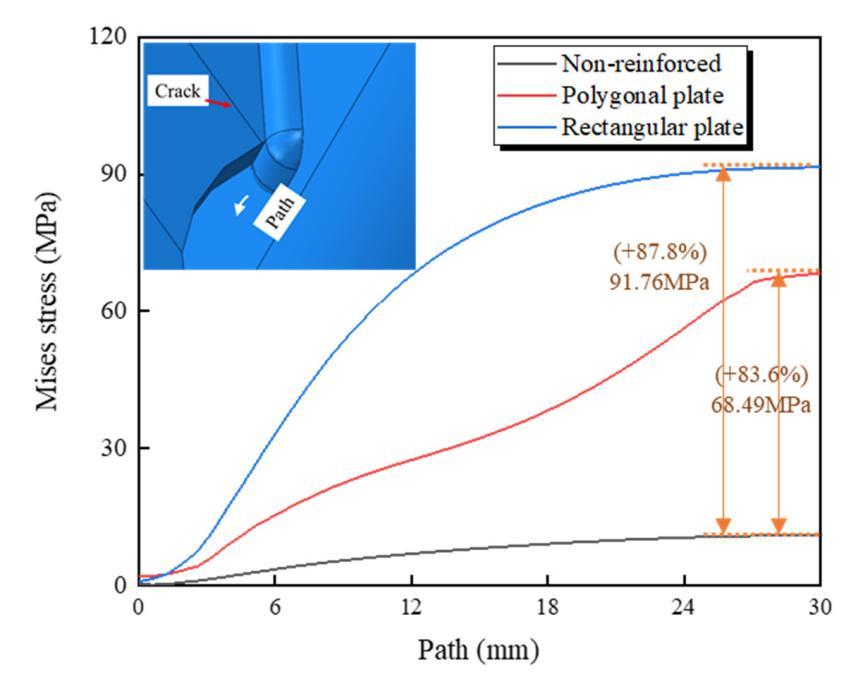
Steel plates took part in bearing loads with the component, while the local stiffness of the structure changed. Stresses at the arc notch on the reinforced side were extracted. The stress path and calculations are shown in Figure 5.

Figure 5. Stress curves at arc notch on reinforced side.

As depicted, after reinforcement, an obvious increase in stress at the arc notch on the reinforced side occurred. Compared with the non-reinforced model, the maximum stress along the path was 68.49 MPa and 91.76 MPa respectively, for the polygonal steel plate and rectangular steel plate, which are increases of more than six times. The stress at the arc notch increased in a parabolic manner when using the rectangular steel plate. Both the polygonal steel plate and the rectangular steel plate caused an increase in stress at the arc notch on the reinforced side. As the crack top bore the majority of the load before reinforcement, the crack continued to propagate under the external force. After reinforcement, the steel plate bore part of the load and the rest was distributed to the arc notch causing a stress concentration at this location. The arc notch was also a typical fatigue detail in OSDs. Compared to the rectangular plate, the stress increase caused by the polygonal plate was smaller.

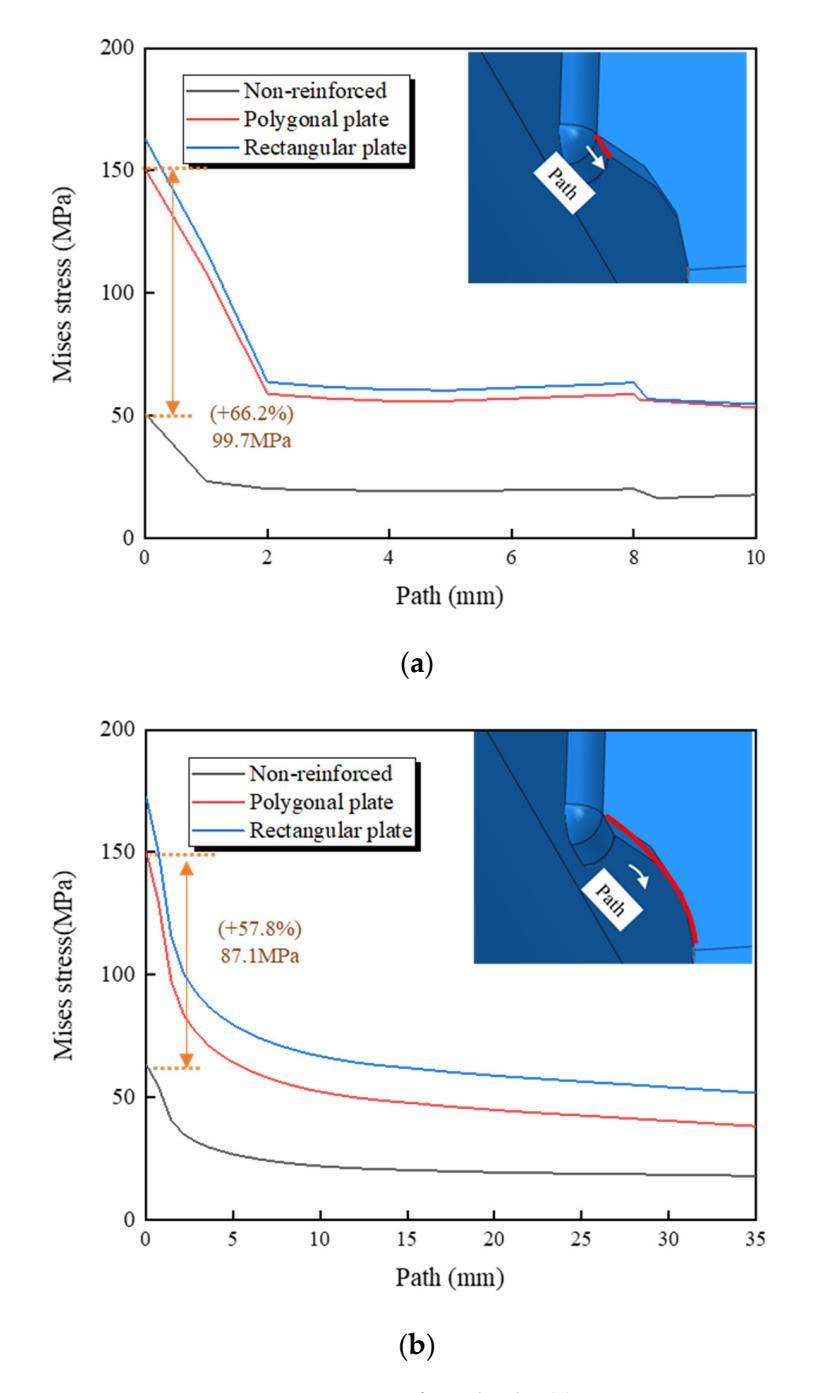
Since the local stiffness of the structure changed after the steel plate reinforcement, the stress distribution on the non-reinforced side also changed; thus, it was crucial to analyze the effect on other locations of the component after the steel plate reinforcement. Therefore, the stresses at the weld toe and the arc notch on the non-reinforced side were extracted and are illustrated in Figure 6.

As seen in Figure 6, after steel plate reinforcement, the stresses at the diaphragmto-rib weld toe and the arc notch on the non-reinforced side increased significantly. The maximum stress at the weld toe increased by more than 99 MPa; the maximum stress at the arc notch increased by more than 87 MPa. The calculations revealed that although the stress concentration at the crack tip improved, the change in local stiffness of the structure led to new high-stress situations at the diaphragm-to-rib weld toe on the non-reinforced side, which can cause fatigue cracking. Moreover, compared with the rectangular plate, the stress increment caused by the polygonal plate reinforcement was smaller, and the degree of stress concentration was lower.

Figure 6. Stress curves on non-reinforced side. (a) Variation in stresses at weld toe; (b) variation in stresses at arc notch.

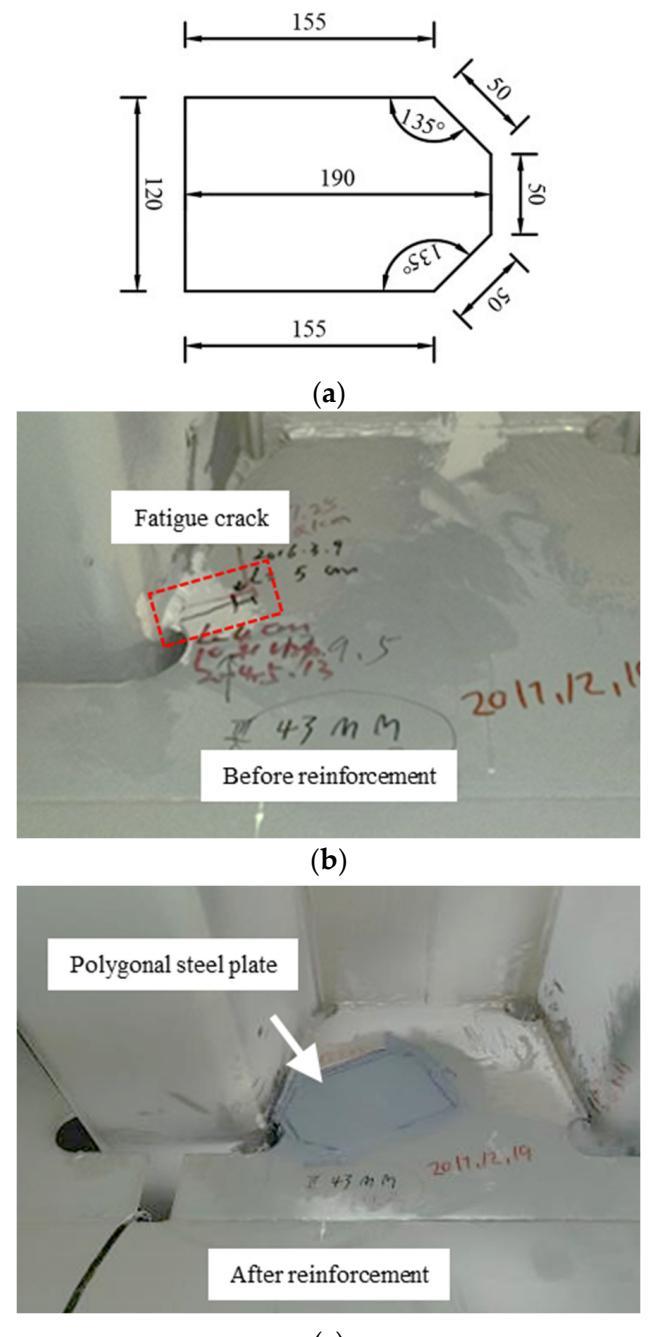
Based on the numerical simulations above, a polygonal steel plate with a thickness of 8 mm was used in the field maintenance and the maintenance was conducted on a real bridge; the plane size is given in Figure 7a. The material of the polygonal steel plate was Q345qD steel, which is the same as that of the real bridge.

A fatigue crack on the diaphragm-to-rib weld on the real bridge was chosen as the test object for this study. The crack was located on the upstream low lane, and its length was approximately 60 mm, as shown in Figure 7b. When a vehicle passed, apparent dislocations could be observed on the crack surface.

Figure 7. Steel plate reinforcement in the field. (**a**) Size of polygonal steel plate, (**b**) before reinforcement; (**c**) after reinforcement.

During field maintenance, the upstream side of the diaphragm was selected as the reinforced surface, and the downstream side was the testing surface. The polygonal steel plate was pasted onto the reinforced surface with a structural adhesive, that would not cause damage to the original structure. Before bonding the steel plate, the surface was polished to remove the coating. The hypotenuse of the chamfer was fitted to the diaphragm-to-rib weld toe, as shown in Figure 7c.

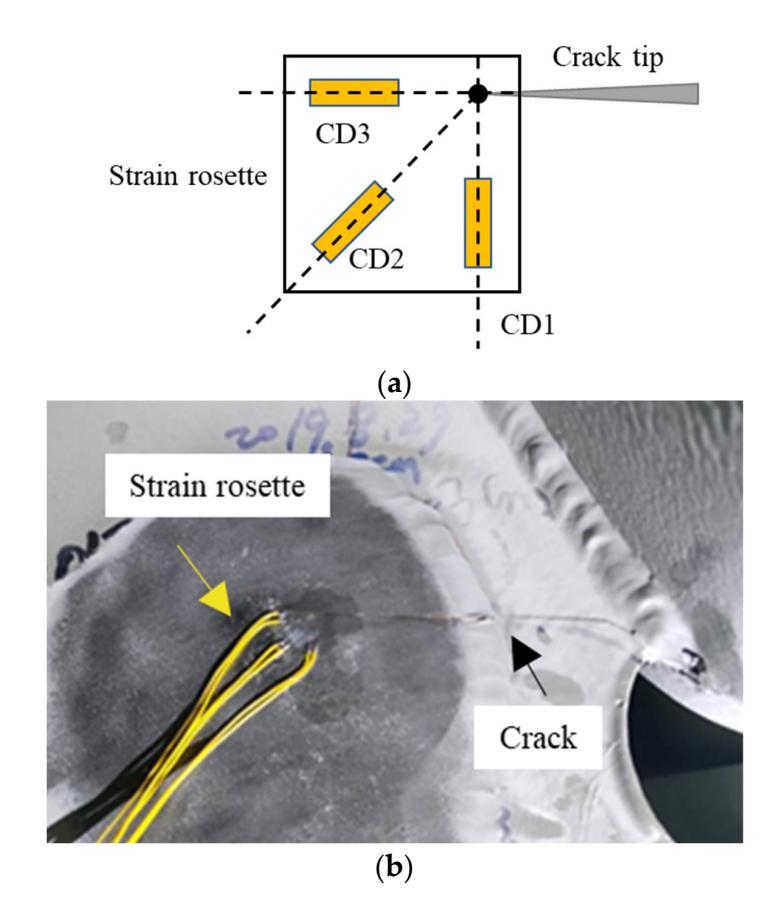
The stress data at the crack tip were recorded with a pasting strain rosette; its layout is shown in Figure 8a. As depicted, the rosette contained three gauges named as CD1 (i.e., perpendicular to the crack), CD2 (i.e., 45° direction to the crack), and CD3 (i.e., parallel to the crack). Before pasting the strain rosette onto the base metal, the crack tip on the testing side was polished to remove the anticorrosive coating, as seen in Figure 8b. The

geometric size of the strain rosette was 10 mm \times 10 mm. The resistance of the strain rosette was 120 Ω , while the sensitivity ratio was 2.0 \pm 1.0%. Strain data before and after the reinforcement were recorded. The monitoring schemes for both tests were carried out from 5 p.m. to 6 p.m. This period was chosen as the traffic flow during this time was relatively large; the measurement time was about one hour.

Figure 8. Measuring point. (a) Layout; (b) field monitoring.

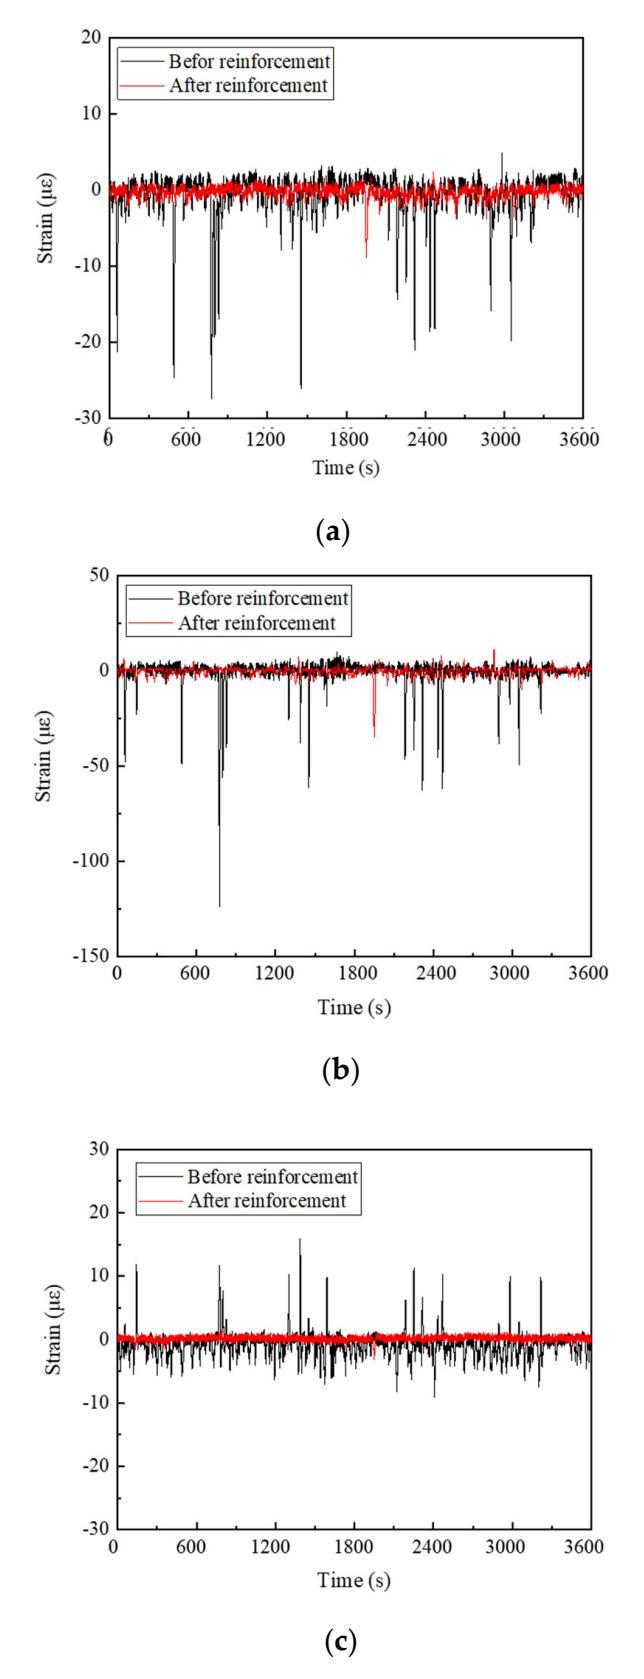
Figure 9 plots the strain records. Before reinforcement, the strain values of CD1 mainly ranged from $-125 \ \mu\epsilon$ to 9 $\mu\epsilon$, and the strain values of CD2 mainly ranged from $-6 \ \mu\epsilon$ to 17 $\mu\epsilon$, while the strain values of CD3 ranged from $-27 \ \mu\epsilon$ to 9 $\mu\epsilon$. As shown, the measuring point area was under tension-compression cyclic loading, which was the main reason for fatigue crack growth.

After reinforcement, the strain values recorded in three directions were reduced significantly. The strain values of CD1 ranged from $-30 \ \mu\epsilon$ to $8 \ \mu\epsilon$, the strain values of CD2 ranged from $-4 \ \mu\epsilon$ to $2 \ \mu\epsilon$, and the strain values of CD3 ranged from $-9 \ \mu\epsilon$ to $3 \ \mu\epsilon$. It was observed that the deformation caused by vehicle passing over the crack was suppressed and that the crack propagation was hindered.

Figure 9. Strain-time history. (a) CD1; (b) CD2; (c) CD3.

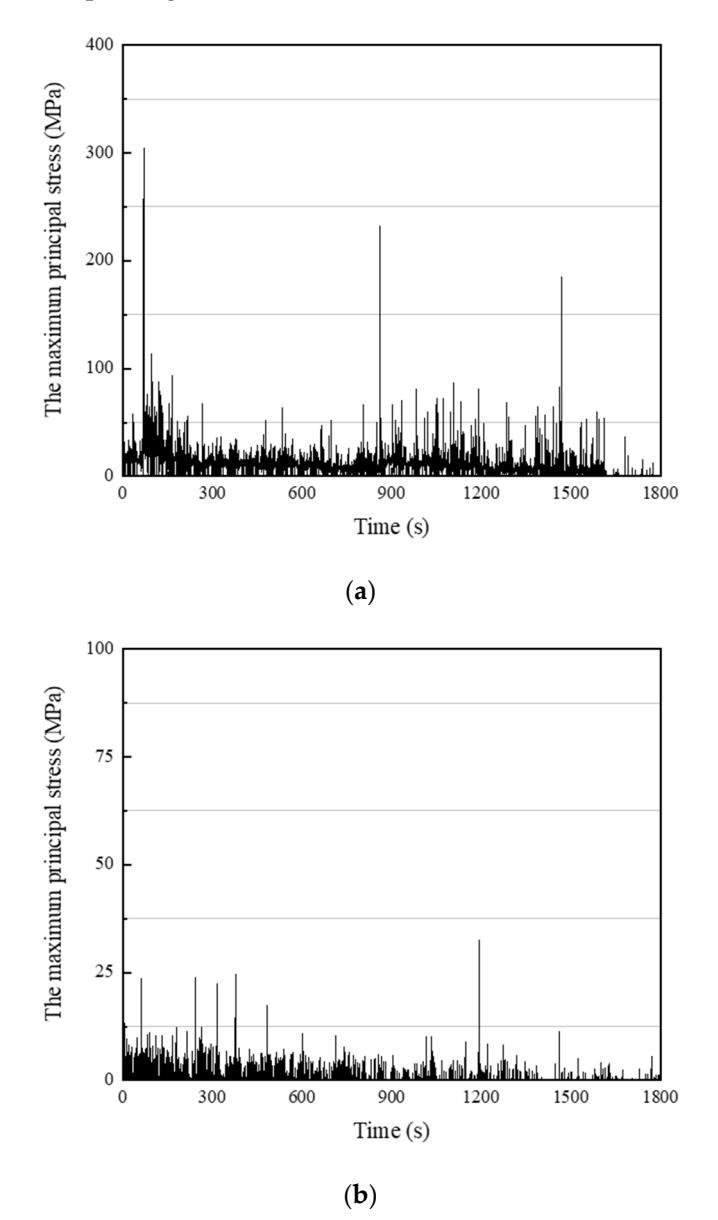
Strain data within 30 min were processed and the results are given in Figure 10. Since negative principal stress indicates compression at the crack tip, the data with negative principal stress were excluded. As shown in Figure 10, the values of σ_{max} decreased. σ_{max} at

the crack tip was significantly reduced after maintenance, and the maximum recorded σ_{max} before reinforcement was 301.12 MPa. This decreased to 32.55 MPa after reinforcement, which was a decline of 89.4%. The stress concentration at the crack tip was improved with the steel plate reinforcement, fatigue performance was enhanced, and the fatigue life was prolonged.

Figure 10. Curves of σ_{max} . (a) Before reinforcement; (b) after reinforcement.

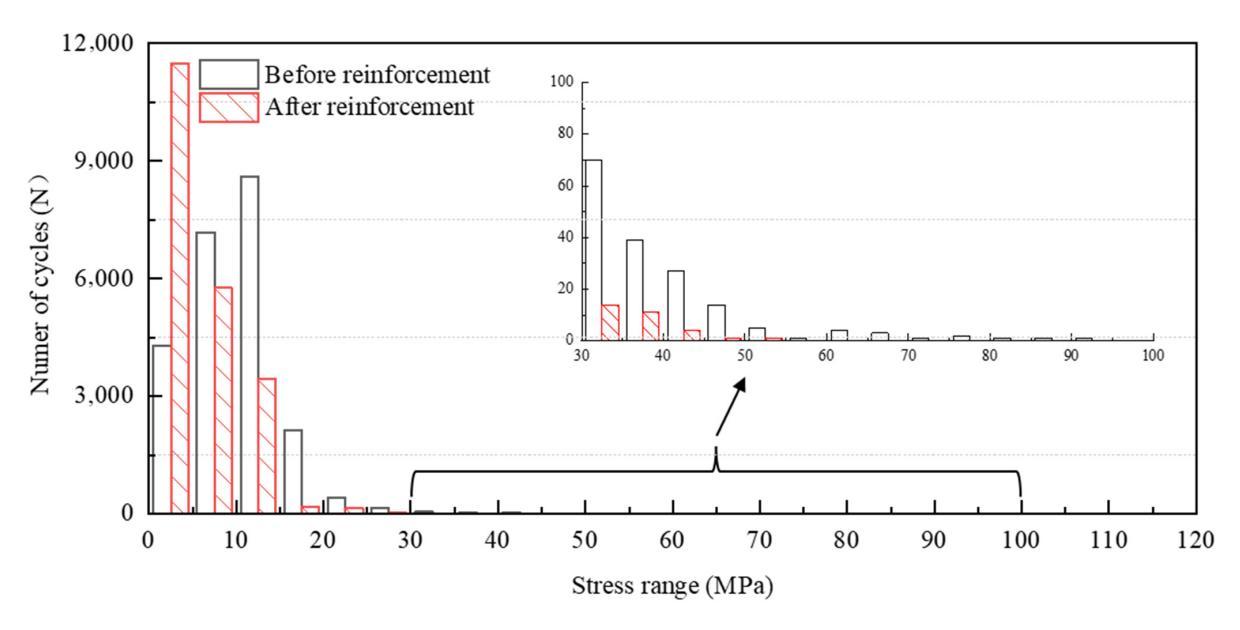
To achieve the stress range spectrum, the rain-flow counting method was adopted to handle the random stress time-history [23]. The data collected with a strain rosette before and after the reinforcement were processed and the final result is presented in Figure 11.

It was observed that, after polygonal steel plate reinforcement, the number of cycles at high stress ranges disappeared obviously. Meanwhile, the low stress ranges increased significantly, and the number of cycles within the [0, 5] MPa range increased a lot. This indicated that polygonal plate reinforcement improved the stress distribution at the crack tip, and the high–stress amplitudes were transformed to low stress amplitudes, resulting in the retardation of crack propagation.

Figure 11. Comparison of stress spectrums.
