Article

Fatigue Strength of Structural Steel-Welded Connections with Arc-Sprayed Aluminum Coatings and Corrosion Behavior of the Corresponding Coatings in Sea Water

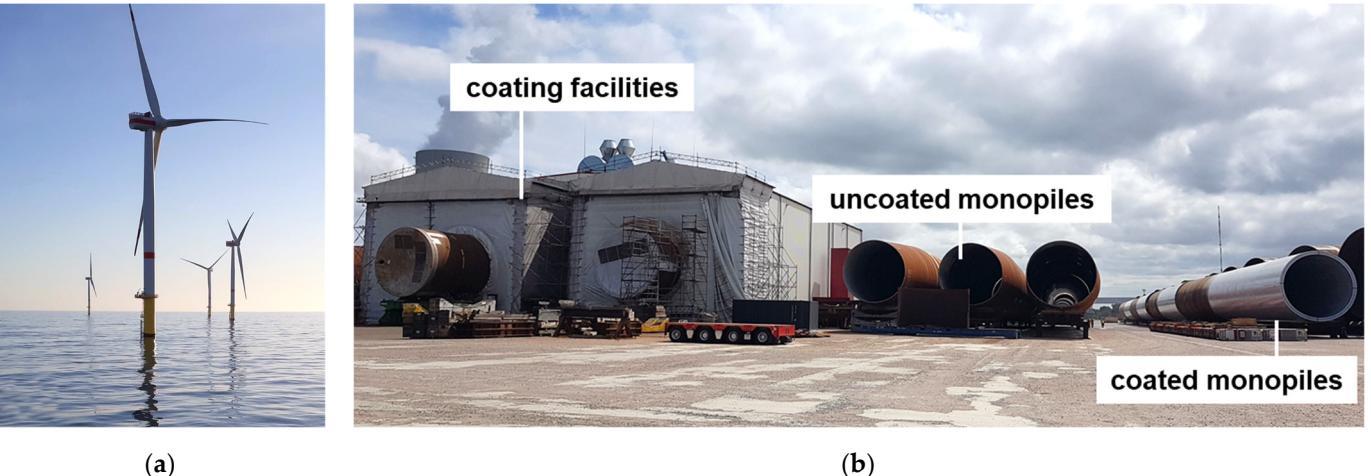
Figure 1. (a) Offshore wind turbines; (b) Facility for thermal spraying of offshore foundations as well as uncoated and coated monopiles.

Until recently, only active (ICCP) and passive (sacrificial anodes) corrosion protection systems have been used in the underwater area of wind turbine foundations. A new and increasingly used method for corrosion protection is the aluminum coating of the entire foundation structure by means of thermal spraying, see Figure 1. Here, the entire structure exposed to seawater is preserved by means of arc spraying with a 99% aluminum coating (Al 99%) as well as an organic sealer [8].

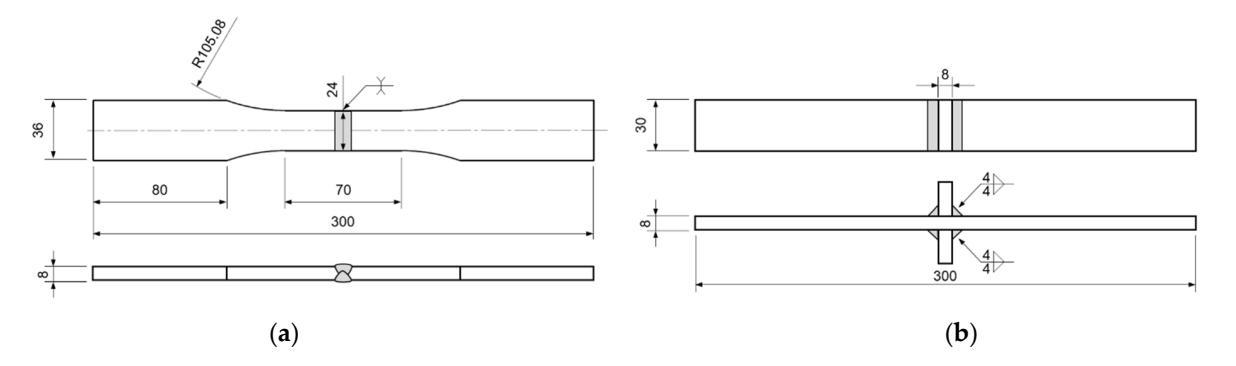
Figure 2. Specimen geometry and welding symbols acc. to ISO 2553 [27] (**a**) Butt joint specimen; (**b**) Specimen with transverse stiffeners.

Based on welded connections typical for steel towers and tower foundations, arcwelded butt joint specimens, as well as specimens with transverse stiffeners, were manufactured from plates of non-alloy structural steel EN 10025-2-S355J2+N [26] with a sheet thickness of t = 8 mm. A S5 SpeedPulse XT welding unit (Lorch Schweißtechnik GmbH) was used for welding. A welding tractor was used for guiding the welding torch to ensure reproducible welding results, a constant heat input, and the constant quality of the welds. After welding, the plates were cut into individual specimens on a band saw. Sharp edges were removed by breaking them manually using a file. Specimen geometries as well as the concomitant welding symbols for the GMAW welds are shown in Figure 2.

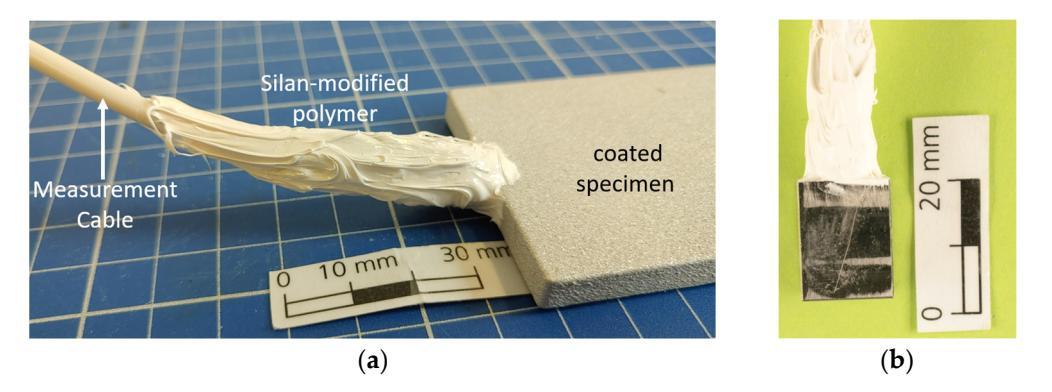
Figure 3. (**a**) The electrical connection of a thermal spray-coated specimen with insulation by silanmodified polymer sealant; (**b**) A bare steel specimen with the electrical connection.

The coated test specimens are made of S355J2+N Steel with a size of 175 mm \times 50 mm \times 5 mm. Prior to arc spraying the steel was blast cleaned to Sa 3 to a roughness between 60 µm and 100 µm according to ISO 8501-1 [34]. The coating thickness ranged between 400 µm and 600 µm due to manual application. The bare steel coupons that simulate damage to the coating were sized at 17 mm \times 13 mm \times 10 mm. All test specimens were provided with a threaded bore with a diameter of 4 mm on the topside for electrical connection. The electrical connection as shown in Figure 3 was established by the standard banana plug measurement cables cut to length and tightened to the coupons. Insulation from the surrounding electrolyte was guaranteed by a silan-modified polymer sealant; with the sealant covering the whole topside of the bare steel coupons and their remaining surface area representing 5% of the surface area of the coated specimens.

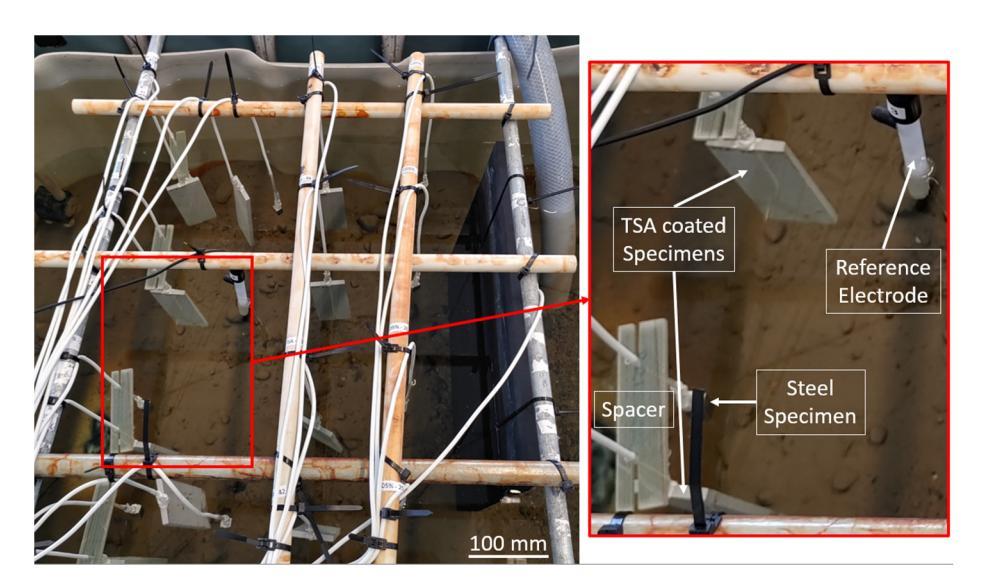
Figure 4. The test setup in IBC with the graphite counter electrode to the right, the reference electrode in the middle, and the specimens arranged around it. The galvanic couples are on the left side. The thermal spray-coated specimens are in the middle of the picture and the bare steel specimens are placed to their right.

Prior to immersion, all specimens were degreased using isopropanol and deionized water. As shown in Figure 4 all configurations were positioned in one IBC around a single Ag/AgCl reference electrode (RE) which was replaced daily. The counter electrode (CE) made from graphite with the dimensions 400 mm \times 400 mm \times 30 mm was placed on the side of the IBC. The specimens were hung by their cables with a fixed distance of 5 cm (minimum) between the galvanic couples.

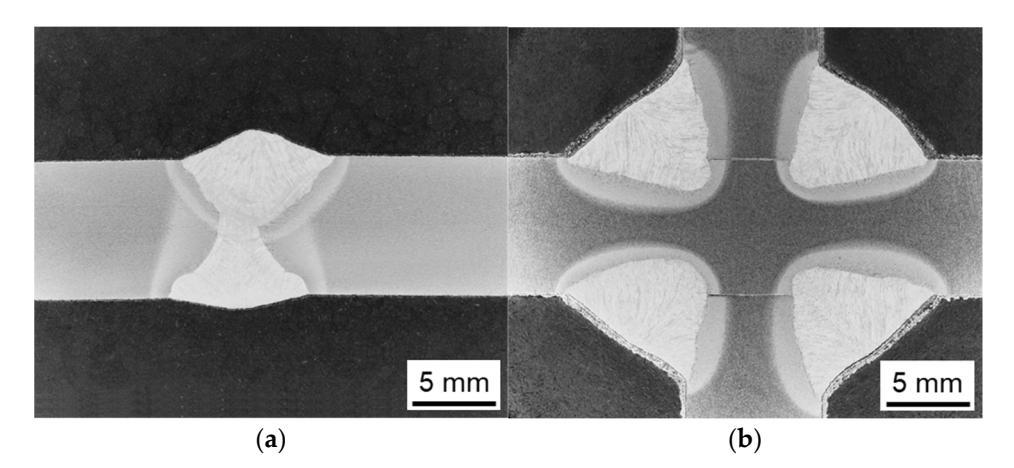
Figure 5. Macro-sections of thermally sprayed specimens, etched with Nital (5%), (**a**) butt-weld; (**b**) fillet weld.

Figure 5 shows the macro sections of a butt-welded specimen and a specimen with transverse stiffeners (both blast cleaned and thermally sprayed). Quality level B according to ISO 5817 [37] was met for the imperfections of the welded joints in the specimens and verified via visual testing.

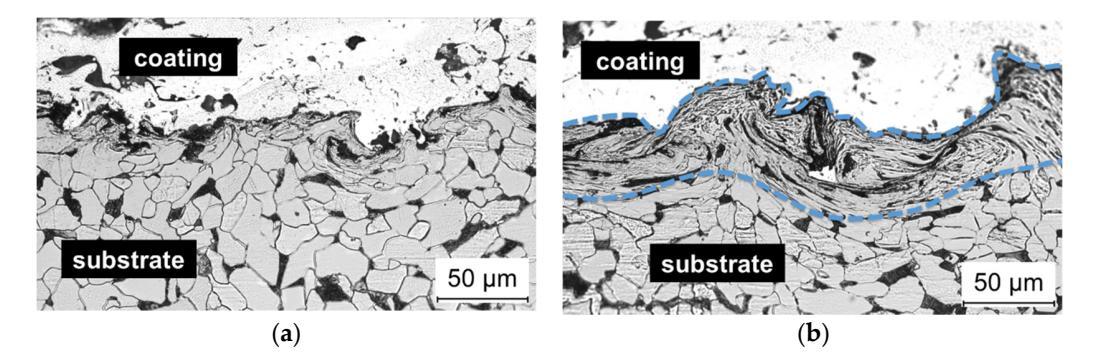
Figure 6. The impact of different surface preparation methods on the base metal microstructure; micro-sections etched with Nital (3%), (**a**) substrate blasted with corundum; (**b**) substrate blasted with steel grit (deformed microstructure bordered by the dashed line).

Regarding surface preparation, grit blasting shows a stronger impact on the near surface microstructure of the steel substrate compared to blasting with corundum. A more severe plastic deformation and a visible compression of the microstructure of the surface material layer can be seen in the micro-section of the grit-blasted specimen compared to the specimen blasted with corundum, see Figure 6.

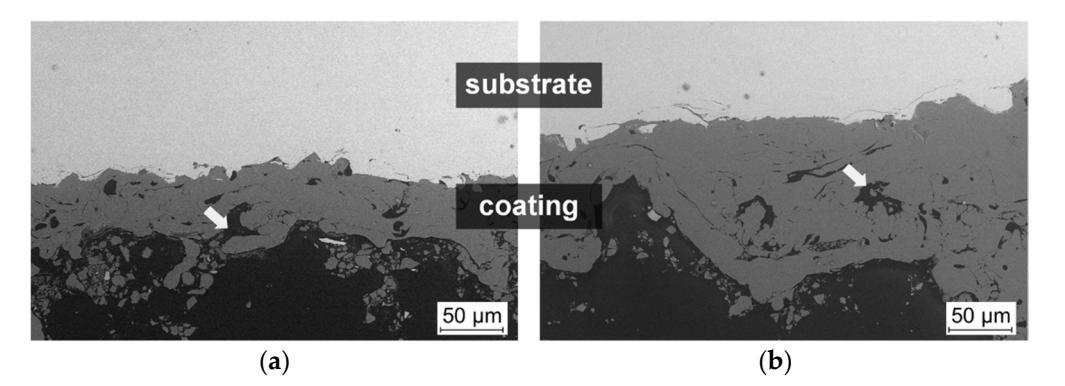
Figure 7. Representative SEM images showing the substrate on top and the coating below (specimen bottom) for the samples blasted with (**a**) corundum; (**b**) grit.

This stronger deformation is also reflected in the subsequent coating analyses. First, it is obvious that the grit-blasted samples exhibit higher coating thicknesses, which are also constant over a larger area in the section, see Figure 7. Apart from this, a typical lamellar morphology with good bonding to the substrate can be observed. Both types of surface preparation share the non-uniform distribution of cluster-like coating defects, which are marked in Figure 7. Yet, these variations are apparently more frequent for the specimens blasted with corundum. In contrast, layered oxides typical for arc spraying are hardly visible. However, coating breakouts can be detected in part for both surface preparations as a result of the polishing process, although they are more pronounced for the specimens blasted with corundum.

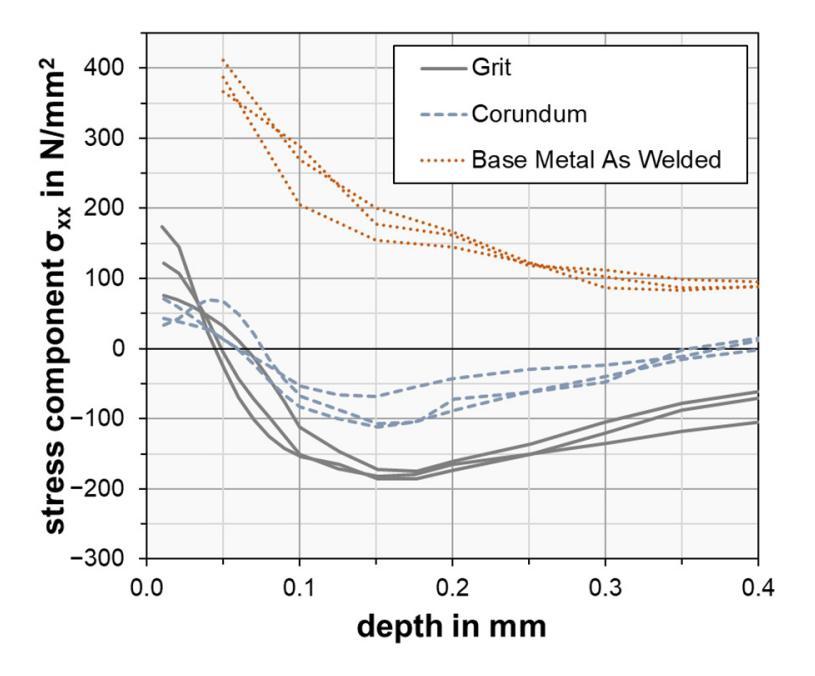
Figure 8. The residual stress measurement results of thermally sprayed specimens previously blasted with grit or corundum and non-treated reference specimens in the as-welded state at the weld toe.

The residual stress measurements show a high amount of compressive residual stresses in the blast-cleaned steel substrate (Figure 8). In the as-welded condition, the untreated specimen shows significant tensile residual stresses in the area of the weld transition. The measurements were performed at a distance of 5 mm from the weld toe in the base material. The compressive stresses in the grit-blasted specimens reach deeper underneath the specimen surface and gain a higher compressive stress value of up to -200 MPa compared to the specimens blasted with corundum, with a compressive stress maximum of about -100 MPa, see Figure 8. At a drilling depth within the range of a coating thickness of approximately 0.05 to 0.1 μ m, a transition from tensile stresses to compressive stresses can be seen in the residual stress depth profiles obtained. Tensile residual stresses in the coating of the specimens are higher in the specimens blasted with steel grit and reach levels of up to 200 MPa, compared to less than a 100 MPa tensile stress in the coating of the specimen blasted with corundum. At a depth of 0.35 mm, nearly no compressive stresses could be measured in the specimen blasted with corundum, whereas the grit-blasted specimen still showed compressive stresses of more than -50 MPa at the same drilling depth.

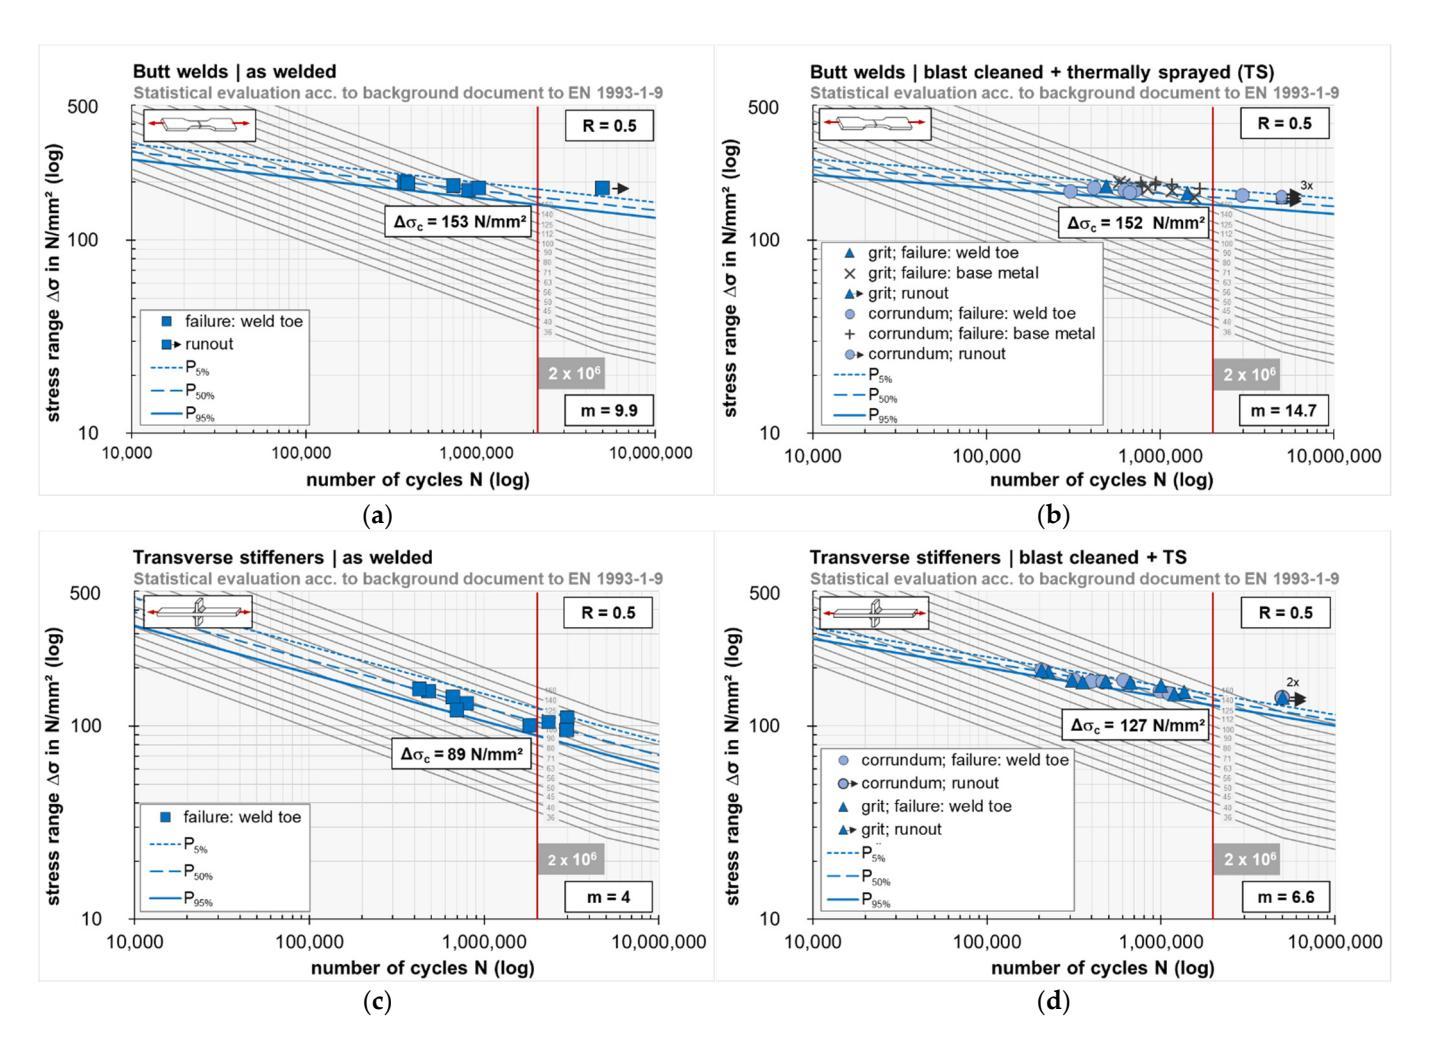
Figure 9. S–N Diagrams. (**a**) butt-welded specimens, as welded; (**b**) butt-welded specimens, blast cleaned and thermal spray coated; (**c**) specimens with transverse stiffeners, as welded; (**d**) specimens with transverse stiffeners, blast cleaned, and thermal spray coated.

Fatigue strength evaluation by statistical analysis with a variable slope according to [40] leads to a characteristic value of the stress range of $\Delta \sigma_{c,var} = 153$ MPa with a slope of $m_{var} = 9.9$ for the butt-welded reference specimens (n = 5). The specimens with transverse attachments show a characteristic value of $\Delta \sigma_{c,var} = 89$ MPa with a slope of $m_{var} = 4.0$ (n = 9). Blast-cleaned and subsequently thermally sprayed butt weld specimens show a nearly identical characteristic value of $\Delta \sigma_{c,var} = 152$ MPa (m_{var} = 14.7; *n* = 8) compared to the non-blasted butt weld specimens. Fractures generally occurred at the weld toe of the specimens. However, with the blast-cleaned and thermally sprayed butt joint specimens, fractures also occurred in the base material area of several specimens (n = 11). Regarding the non-blasted, non-coated specimens, fractures in the base material area did not occur. Blast-cleaned and subsequently thermally sprayed specimens with transverse attachments show a characteristic value of $\Delta \sigma_{c,var} = 127$ MPa (m_{var} = 6.6; n = 18). For both types of specimens, the kind of surface preparation (grit blasting and blasting with corundum) does not seem to make a difference in the fatigue test results. The corresponding S–N diagrams including the testing parameters and characteristic values of the stress range can be seen in Figure 9.

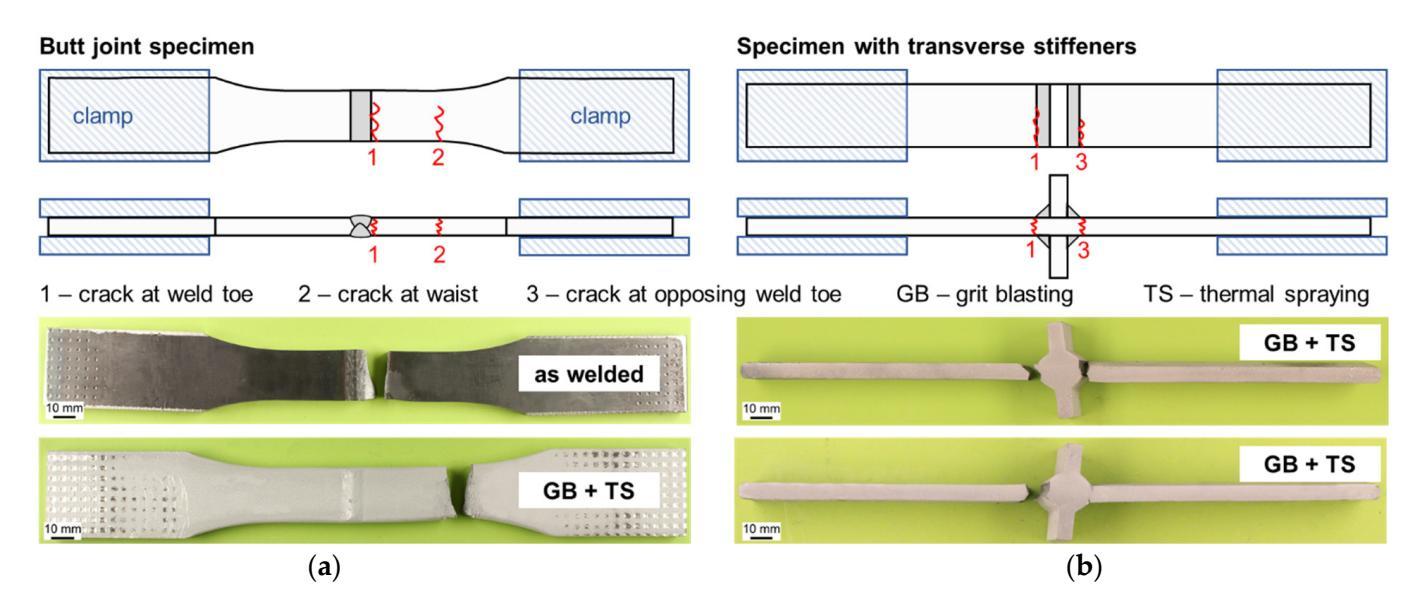
Figure 10. Failure locations. (a) Butt joint specimens; (b) Specimens with transverse stiffeners.

The different types of crack locations are shown in Figure 10. As shown, for some of the specimens with transverse stiffeners, cracks appeared at both sites of the stiffeners simultaneously.

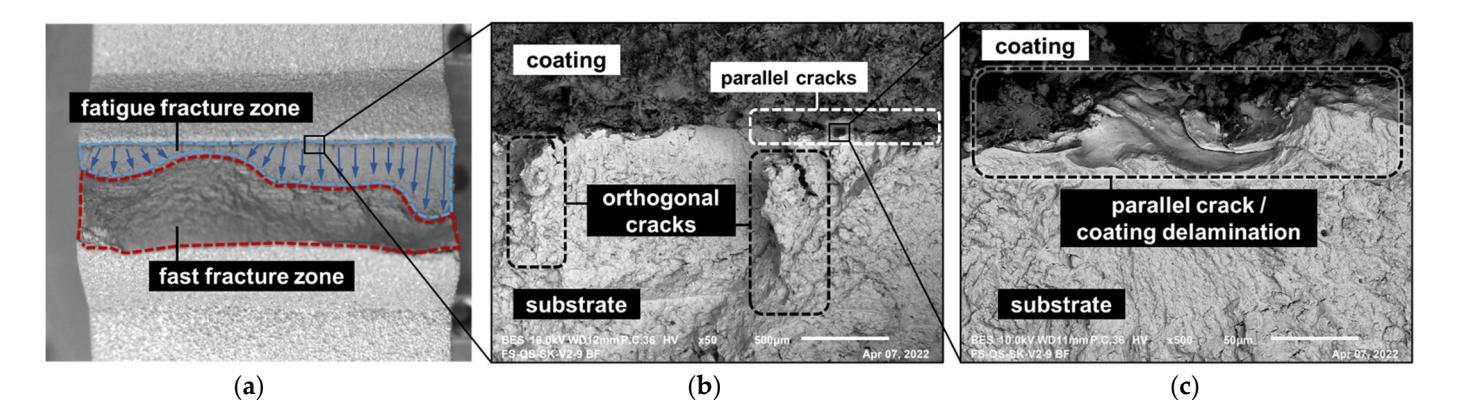
Figure 11. The fracture surface of a grit-blasted specimen with transverse stiffeners. (**a**) Overview image showing the fatigue fracture zone and the fast fracture zone; arrows indicate the origin and direction of fatigue crack propagation. (**b**) The BSE image of the interface area showing different orientations of secondary cracks in the fatigue fracture zone. (**c**) The BSE image of the parallel crack at the interface of the coating.

Concerning the fracture surfaces shown in Figure 11, the fatigue fracture zone with a plain surface orthogonal to load direction and the fast fracture zone with distinct plastic deformation of the material (ductile fracture) can be clearly distinguished. The fatigue fracture zone of substrate and coating is characterized by different types of cracks. While orthogonal cracks with a large opening angle are predominantly observed for the substrate, horizontal cracks are occasionally found in the coating. These mostly occur at the interface or nearby, thus indicating lower adhesion in these areas. Yet, in general the coatings still adhere well to the substrate over most of the observed fracture surfaces. In contrast, orthogonal cracks could not be observed in the coating during the analyses before fatigue testing. Moreover, small particles from the substrate could partly be detected in the coatings (not shown). A single origin of the fatigue fracture could not be found for the specimen shown. Instead, multiple crack fronts originating at multiple points across the weld toe seem to blend together over the width of the specimen. With some of the grit-blasted and thermally sprayed specimens, fatigue cracks occurred at both sides simultaneously or, on the contrary, only at one side of the weld toe. No evidence was found to indicate whether the cracks initiated from the coating or the substrate material. These observations apply to both kinds of surface preparation equally.

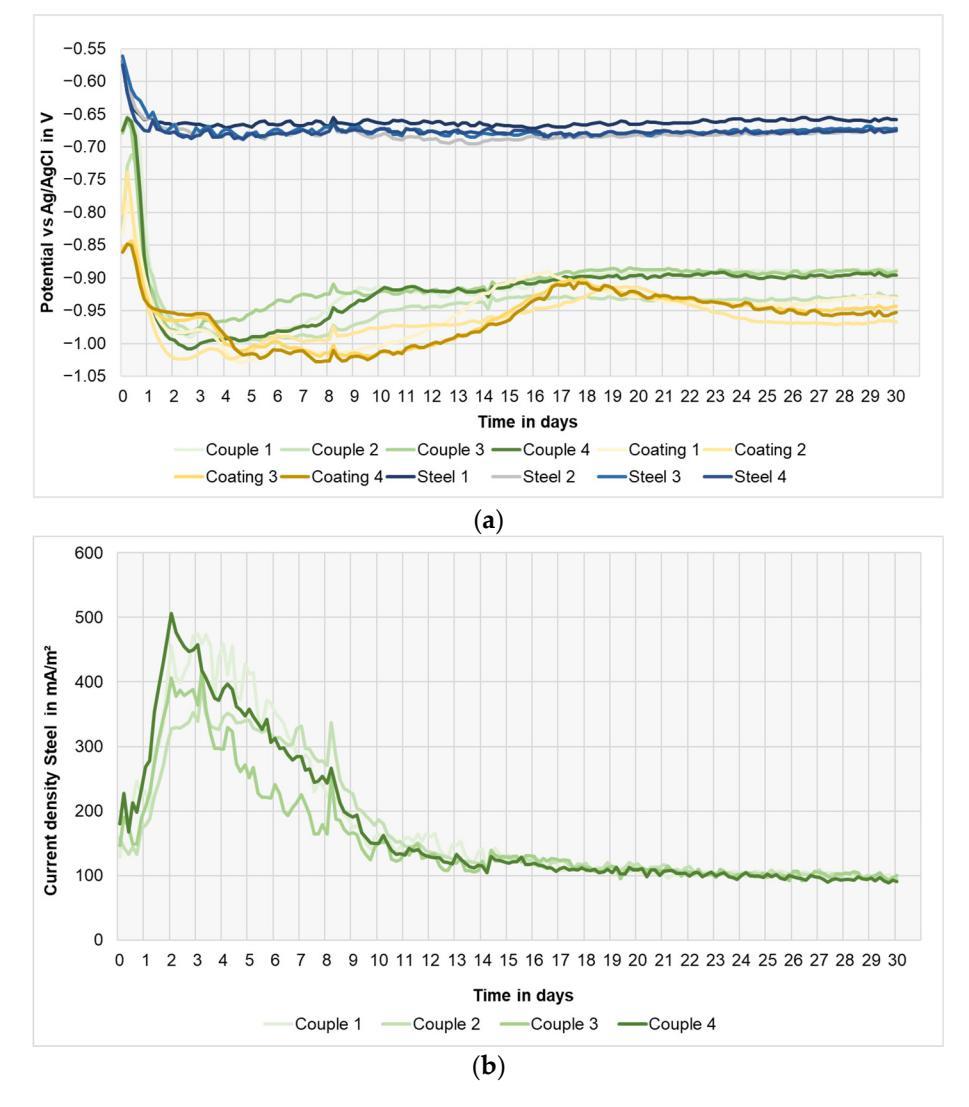
Figure 12. (a) OCP vs. Ag/AgCl of the single specimens and specimen couples over the test duration; (b) Galvanic current density of the thermal spray coated and bare steel specimen couples over exposure time.

Figure 12a shows the OCP values during the immersion. The steel's OCP started at around -0.55 V and stabilized after 3 days of immersion between -0.65 V and -0.67 V, respectively. During the whole immersion time no further changes in the steel's OCP were observed, except for a decreasing difference between measurements. From the initial values between -0.80 V and -0.86 V the coating's solo potential declined within 3 to 10 days to less than -1.0 V. Subsequently, it increased and seemed to stabilize at around -0.95 V by the end of the test duration. The values from the galvanic couples were observed to be in-between these values. The OCP values of the couples started at around -0.65 V and declined within 2 to 3 days to values close to -1.0 V. At the end of the test duration the combined OCP of the galvanic couples ranged slightly higher than those from the stand-alone coating and were in the region of -0.9 V.

The galvanic current density over time is shown in Figure 12b. This was calculated using the surface area of the bare steel specimens. The values of all the couples were initially between 130 mA/m² and 180 mA/m². From the outset of the experiment, the values started to rise reaching their maxima after 3 to 5 days. All maxima lay between 400 mA/m^2 and 500 mA/m^2 . After the maximum was reached, the current density declined with the curve being shaped asymptotically. After 20 days of immersion the values of all

the couples were slightly above 100 mA/m^2 , but still decreasing. At the end of the test all the values were lower than 100 mA/m^2 .

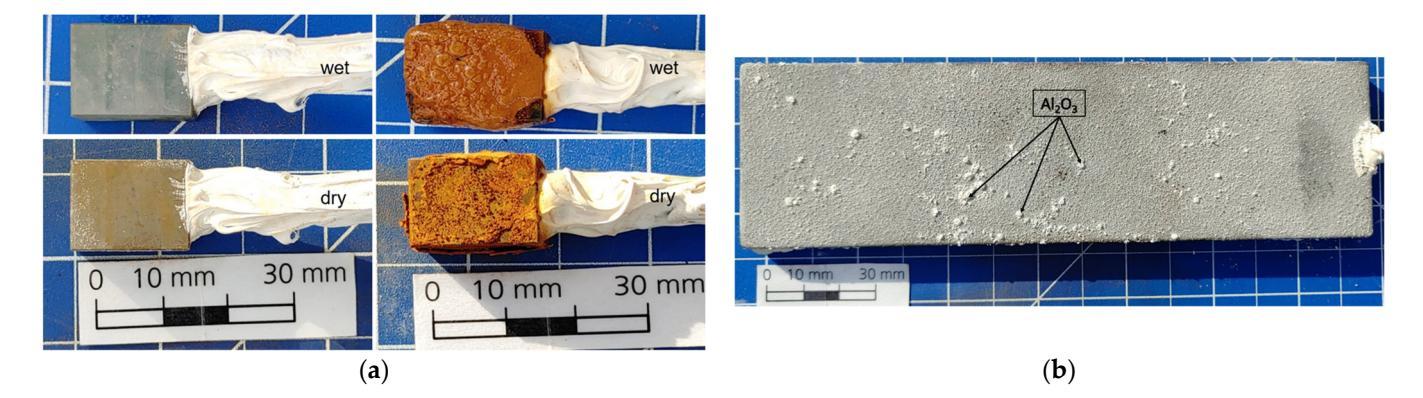
Figure 13. (a) Bare steel specimens after 30 days of immersion in Baltic sea water; (b) a thermal spray coated specimen that was electrically coupled to a bare steel specimen.

Figure 13a presents the difference between a steel specimen that was electrically coupled to a coated specimen on the left side and to stand-alone steel on the right side. The coating cathodically protected the bare steel sufficiently during the test. No signs of corrosion were visible on the surface of any bare steel specimens that were coupled to coated specimens in the wet state directly after being retrieved from exposure. Conversely, a thin layer of corrosion products formed on the earlier-protected bare steel coupled in the dried state. There was no observed effect of the orientation of the steel specimen on the coated plates.

Figure 13b shows the coated specimen that was electrically coupled to the bare steel specimen shown in Figure 13a on the left side. IR Spectroscopy identified the white deposits as aluminum oxide. No optical difference between stand-alone coated specimens and the coated specimens from the galvanic couples after exposure was detected.

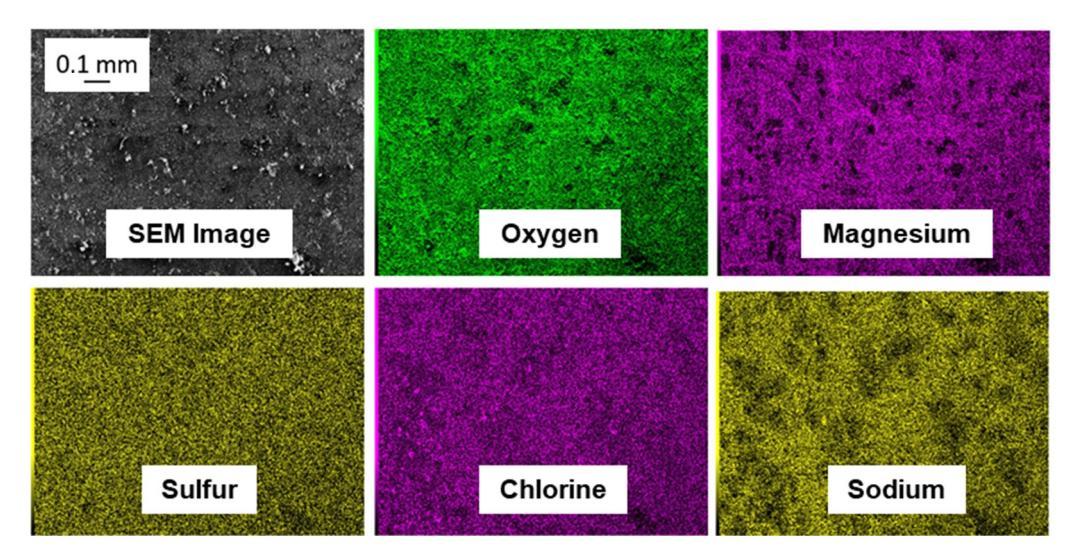
Figure 14. The SEM images and EDX maps of a bare steel coupon that was continually galvanically coupled to a coated specimen.

The SEM analysis of the steel coupon in the dried state primarily showed iron oxides on the surface. This corroded layer was also optically visible and established during drying after the exposure. In addition, sulfur, magnesium, and sodium were also detected. The SEM images and EDX maps shown in Figure 14 demonstrate an even distribution of the corresponding elements.

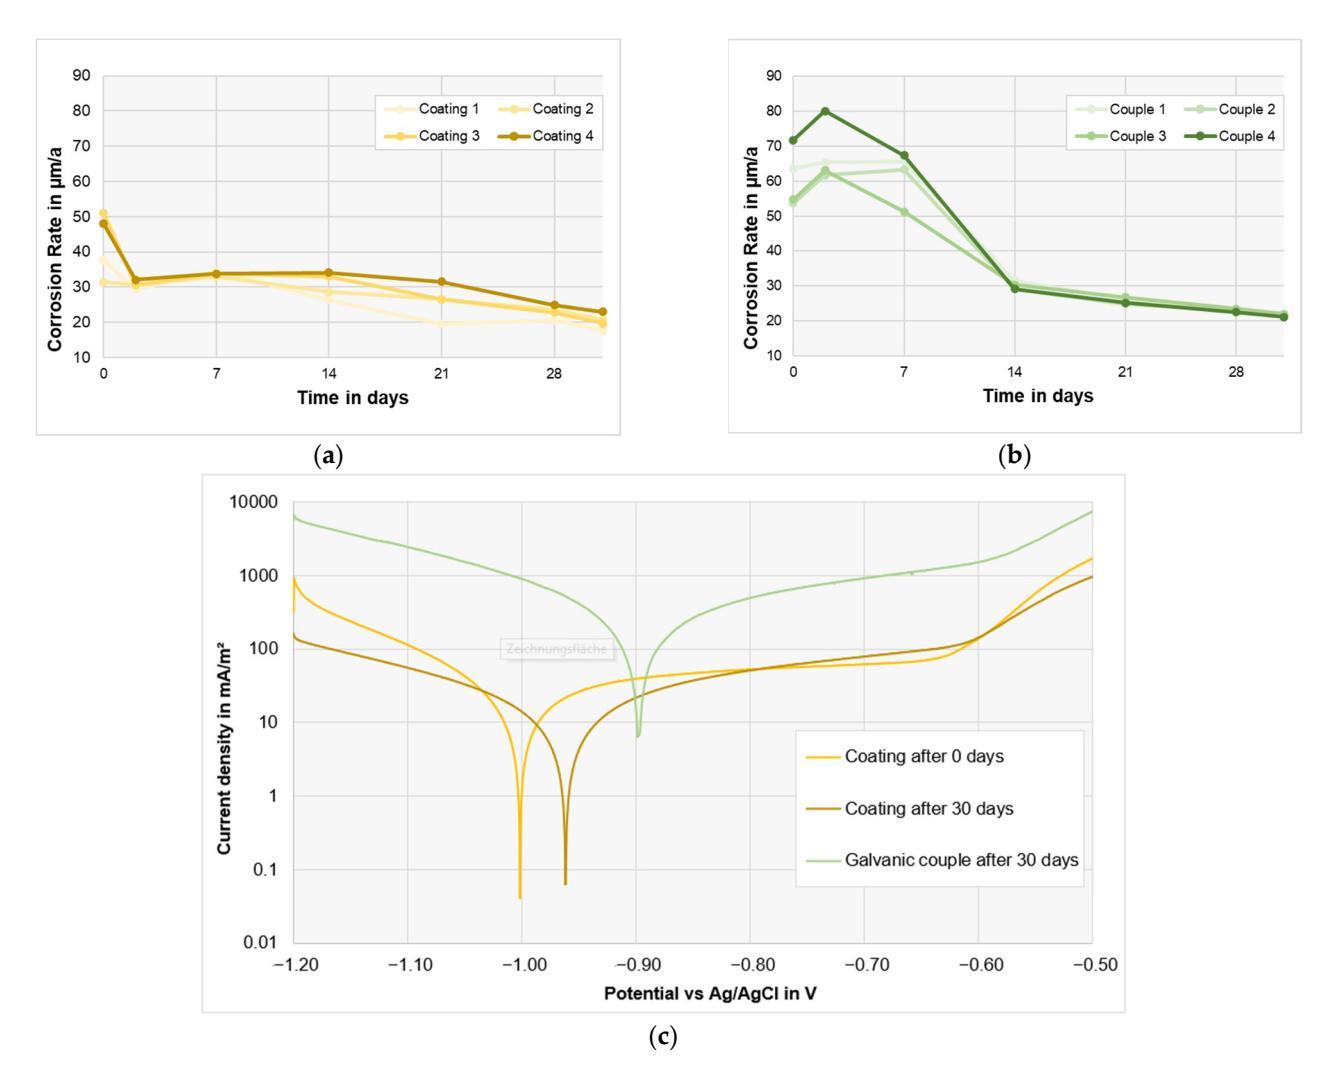
Figure 15. (a) The corrosion rate of the thermal spray coating; (b) The corrosion rate of the galvanic couples; (c) Potentiodynamic polarization curves of the coating at the start of the test, and of the coating and a galvanic couple after 30 days.

Figure 15a shows the corrosion rates of coated specimens and Figure 15b shows the galvanic couples' corrosion rates during exposure. Initially, the values of the stand-alone coating were lower than those for the galvanic couples. They ranged from 30 μ m/a to 50 μ m/a. Over the exposure period the corrosion rates decreased to as low as 20 μ m/a at the experimental completion. The corrosion rates of the galvanic couples—one could also call them a coating with a 5% defect—were initially higher, ranging from 55 μ m/a to 70 μ m/a. Instead of directly decreasing after the start of the test, the values rose to a maximum of 80 μ m/a. During the 14 days it took the galvanic current density to decrease to 100 mA/m², the corrosion rates of the galvanic couples reached the same levels as the stand-alone thermal spray coating with the slope still pointing to even lower values.

Potentiodynamic polarization curves of the coating at the start of the test and of the coating and a galvanic couple after 30 days are displayed in Figure 15c.
