Article Comparative Study of HVOF Cr₃C₂–NiCr Coating with Different Bonding Layer on the Interactive Behavior of Fatigue and Corrosion

Bing He^{1,2,3}, Lijie Zhang^{1,*}, Xiao Yun^{2,3}, Jing Wang^{2,3}, Guangzhi Zhou^{2,3}, Zhikai Chen^{2,3} and Xiaoming Yuan^{1,*}

Abstract: In order to improve material service life under a fatigue and corrosion coupling environment, a high-velocity oxygen fuel (HVOF) Cr₃C₂-NiCr coating with a bonding layer was prepared. The objective was to obtain the optimum bonding layer for the HVOF Cr_3C_2 -NiCr coating, which included a laser cladding (LC) Ni625 layer, extreme high-speed laser material deposition (EHLA) Ni625 layer and HVOF NiCr layer. Fatigue properties of the samples with various bonding layers were investigated by means of a four-point bending fatigue test. Electrochemical impedance spectroscopy (EIS) and the salt spray test were executed after the bending fatigue test to simulate the interactive effect of fatigue and corrosion atmosphere. Failure surfaces were characterized by scanning electron microscopy (SEM) and an energy-dispersive spectrometer (EDS) to indicate the details of corrosion products. Corrosive behaviors of samples were

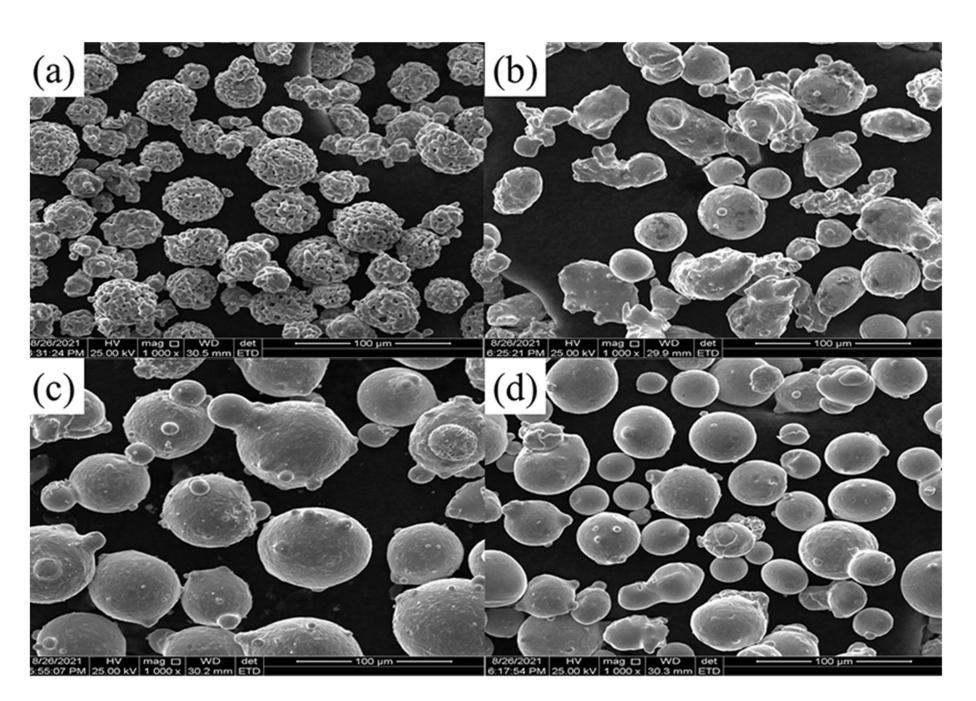
Figure 1. The SEM of used metal powder: (**a**) Cr₃C₂–NiCr; (**b**) NiCr; (**c**) Ni625 of LC and (**d**) Ni625 of EHLA.

The base material was hardened and tempered 42CrMo steel and its chemical composition was illustrated in Table 1. With standard methods, the yield strength of the base material was 750 MPa. The Cr_3C_2 -NiCr powder used for HVOF coating was a mixture of 25% NiCr and 75% Cr_3C_2 in weight (Figure 1a). The NiCr powder (Figure 1b) was composed of 80% Ni and 20% Cr in weight. It should be noted that the powder used for HVOF technology was ranged from 15 µm to 45 µm in demension. The laser cladding powder was Ni625, and its chemical composition was illustrated in Table 2. Dimensions of the powder used for LC (Figure 1c) and EHLA (Figure 1d) ranged from 53 µm to 108 µm and 20–45 µm, respectively.

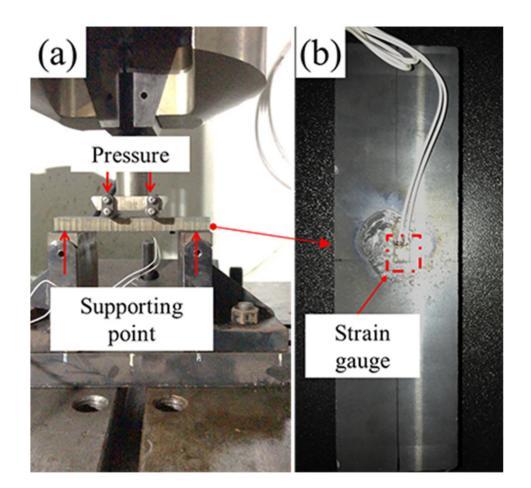
Figure 2. (a) The equipment of dynamic bending fatigue and (b) the details of the tested sample.

In order to study the fatigue behavior of the sample with various coatings, the bending fatigue tests (BFT) were executed by a fatigue test system (MTS Flex Test60, MTS, Eden Prairie, MN, USA), dynamic servo control system (Dyna 900 DTB-S, Dailong, Hangzhou, China) and self-made four-point fatigue bending test unit (as shown in Figure 2a). The distance between the support points was 90 mm and the stress ratio was 0.1. According to the Det Norske Veritas (DNV) test standard, the test loading was determined to be 90% of theoretical yield strength of the substrate and the frequency was ranged of 0.25–1 Hz. As shown in Figure 2b, a strain gauge was glued on the surface. A dynamic signal test and analysis system (DH5922D, Donghua tester, Taizhou, China) was used to measure bending stress of the tested coating in real time. For accuracy of the experiment, three repetitive tests were performed for each group of samples. During the experiment, the testing process was interrupted to detect situation of surface crack every 500 cycles until to 2000 cycles. Once the visible fatigue crack was occurred, the experiment was terminated.

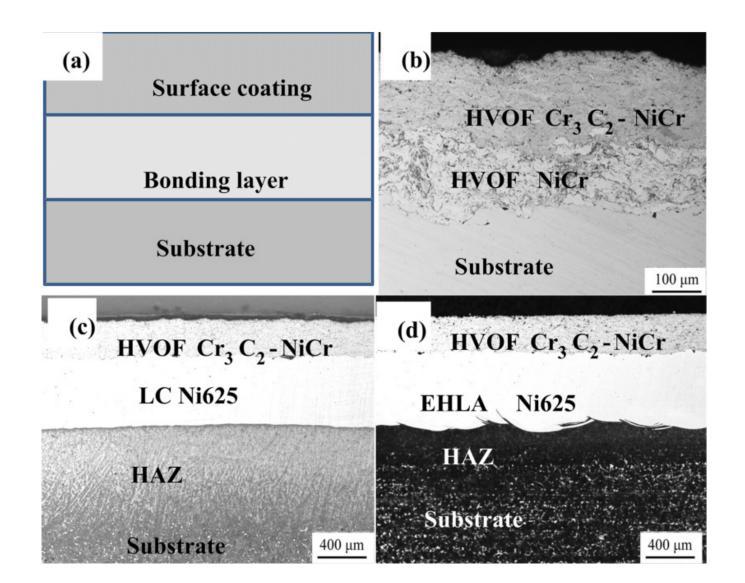
Figure 3. (a) The sketch of the complex coating; (b–d) presents the cross section of Cr_3C_2 –NiCr + NiCr, Cr_3C_2 –NiCr + LC Ni625 and Cr_3C_2 –NiCr + EHLA Ni625.

The cross-sections of NO. 1–3 samples were presented in Figure 3a, including surface coating, bonding layer and substrate. Various layers were separately shown in Figure 3b-d. As shown in Figure 3b-d, the thickness of the Cr₃C₂-NiCr coating was approximately $205 \,\mu\text{m}$, and the porosity of the coating was 0.8%. In addition, all the samples had similar surface-coating features and entirely different bonding-layer features. What is more, a large amount of grey and dark lines was observed, which indicated a lamellar structure of the coating. This was ascribed to the particles to be a semi-melting state before arriving at the bonding layer and some semi-melting particles at the fringe of flame flow to be oxidation. Subsequently, the latter film covered on the deposited film, the oxide was trapped in the interlamination region of the surface coating layer. According to SEM images of the surface coating (Figure 4), a few porosities were detected. With respect to the porosity, it could be regarded as a stress concentration region under fatigue conditions. A large number of unmelted particles (red arrow) were evenly distributed in the bonding phase (blue arrow). According to the EDS results, the unmelted particle and the bonding phase were, respectively, proven to be Cr_3C_2 and NiCr. This particular microstructure can be ascribed to the fact that the input energy could not completely make the refractory Cr_3C_2 melting, whereas the energy was sufficient to melt down NiCr. Additionally, the carbide retention index usually ranged from 0.84 to 0.98 for HVOF technology [26], which implied that Cr_3C_2 has a strong metallurgical bond with NiCr. Thus, the tendency for stress concentration around the hard particles (Cr_3C_2) was subsequently alleviated.

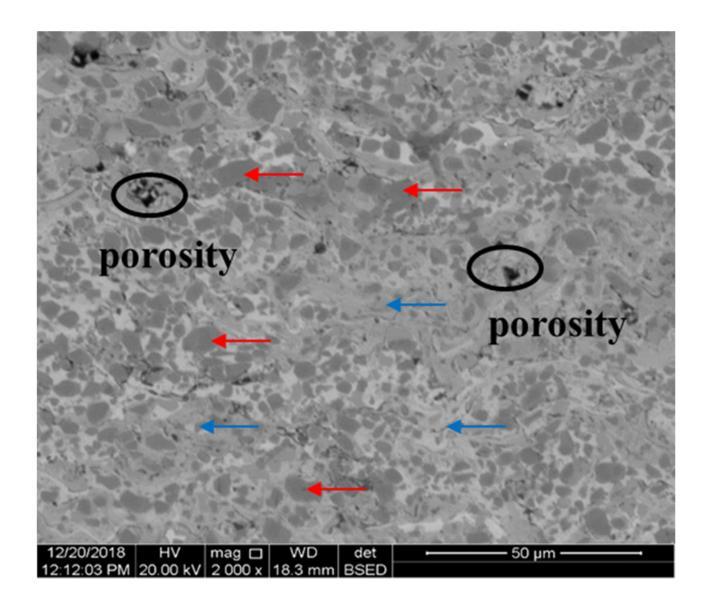
Figure 4. The microstructure of HVOF Cr₃C₂–NiCr surface coating.

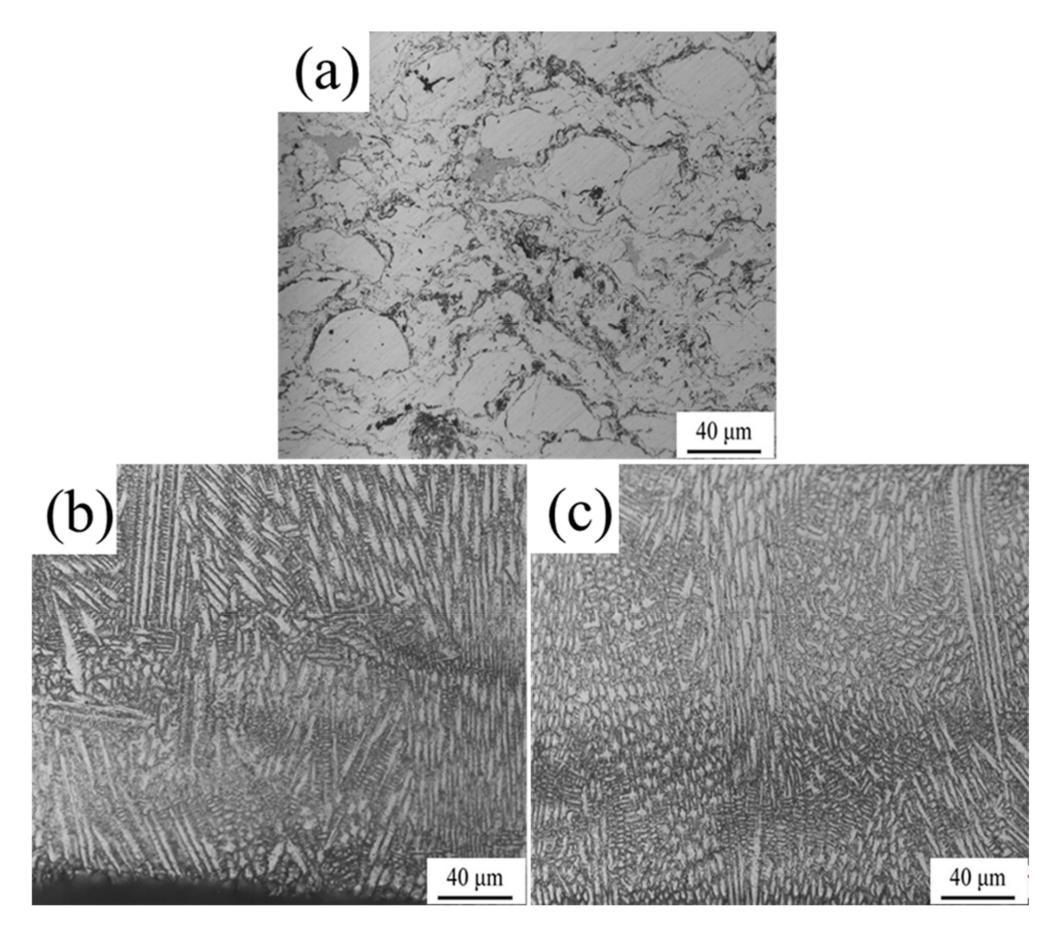
Figure 5. The microstructure of bonding layer: (a) HVOF NiCr; (b) LC Ni625 and (c) EHLA Ni625.

The details of bonding layers were demonstrated in Figure 5. As shown in Figure 5a, the bonding layer of HVOF NiCr displayed similar feature to that of surface coating, whereas there is no visible porosity. The porosity of the NiCr coating was 0.2%. The occurrence of dark lines in the image had the same mechanism in comparison with that in the surface coating. The deposited bonding layer was around 100 μ m. For the laser cladding layer, the microstructure of both layers fabricated by LC and EHLA had the composition of the γ -Ni and Laves phase [25], and the thicknesses of bonding layers were 412 μm and 399 μm under the given parameters, respectively. As shown in Figure 5b,c, the ELHA layer had a much finer crystal size than that of the LC layer. This observed difference indicated that the phase in HAZ of the LC sample had a slower solidification rate leading to enough driving force to crystalize comparing with that of the ELHA sample. This was because the scanning velocity of later was 7.5 times faster than that of the former. This phenomenon was strongly in accordance with previous studies [29]. Additionally, it also confirmed that the ELHA layer had more dislocations and stacking faults in comparison with the conventionally LC layer as the result of an ultrahigh cooling rate under high scanning velocity.

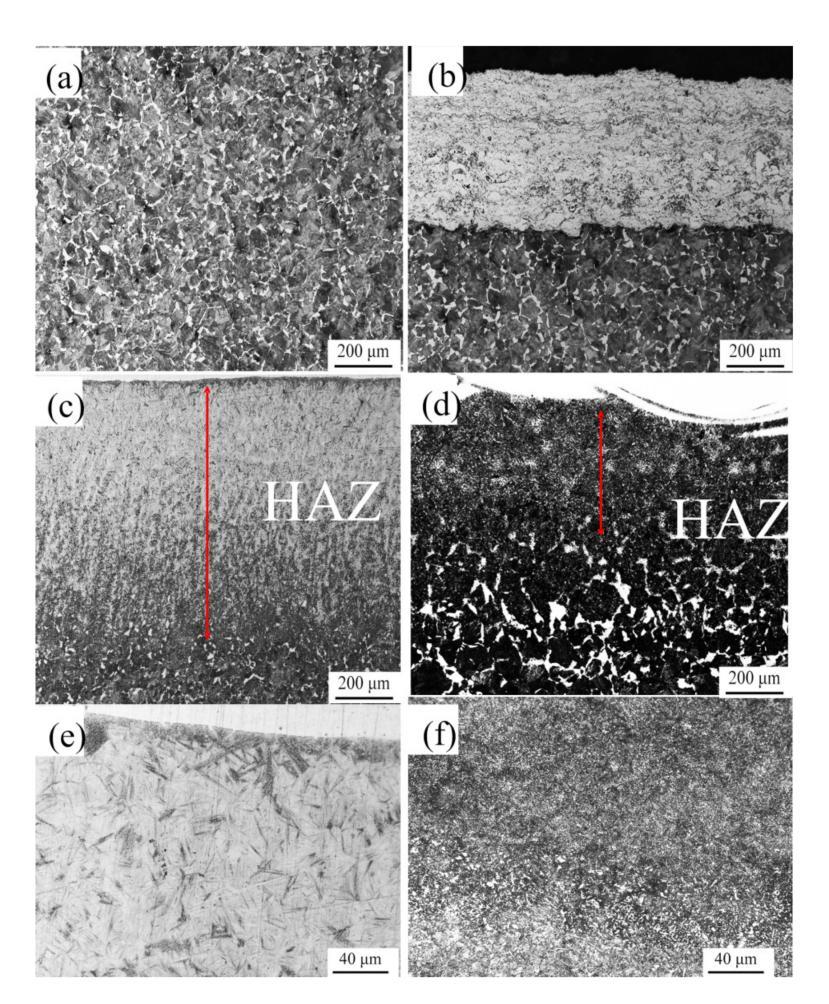
Figure 6. (a) the microstructure of substrate; (b–d) the cross section of No. 1–3; (e) and (f) present the HAZ details of the LC Ni625 and EHLA Ni625 layer.

The details of the interfaces between bonding layers and substrates were shown in Figure 6. Figure 6a indicated the original microstructure which was composed of lamellate pearlite and latticed ferrite. As displayed in Figure 6b, an apparent boundary was discovered between the bonding layer and the substrate, which implied a mechanical bonding type. Additionally, no distinct change on the microstructure of the substrate was detected comparing with the original microstructure of matrix. Thereby, there was no so-called heat-affected zone (HAZ) for the HVOF technique. For the HAZ (Figure 6c,d), the microstructures of the LC and EHLA samples were significantly different in comparison with the original microstructures. The depth of the LC sample was much larger than that of the EHLA sample, whose depth magnitudes are 218 µm and 774 µm, respectively. Furthermore, in the high magnification images, the phase of LC sample's HAZ (Figure 6e) was apparent martensite, whereas that of the EHLA sample's HAZ (Figure 6f) was composed of a small quantity of martensite and a large amount of sorbite. In terms of the difference, the explanations were correspondingly given as follows: as it is known, the process of LC was to feed the molten metal powder into the molten base pool. As a rule of thumb, approximately 80% laser energy is absorbed by the substrate and the remaining energy was used to melt the metal powder for LC treatment. On the contrary, the metal powder was melted above the substrate surface and subsequently deposited in the EHLA treatment. Therefore, around 80% of the laser energy was devoted to melt the metal powder and the remaining laser energy was absorbed by the matrix. The temperature at HAZ of the LC sample rapidly attained to Ac3 as the high heat absorption and subsequently transformed to martensite. As a comparison, the absorbed heat by the ELHA sample HAZ was not sufficient for the microstructure to be fully transformed into austenite, but sufficient to convert to sorbite in large quantities and a small amount of martensite. In addition, the depth of the HAZ was proportional to the absorbed heat, which resulted in the distinct HAZ depths of the LC and EHLA samples.

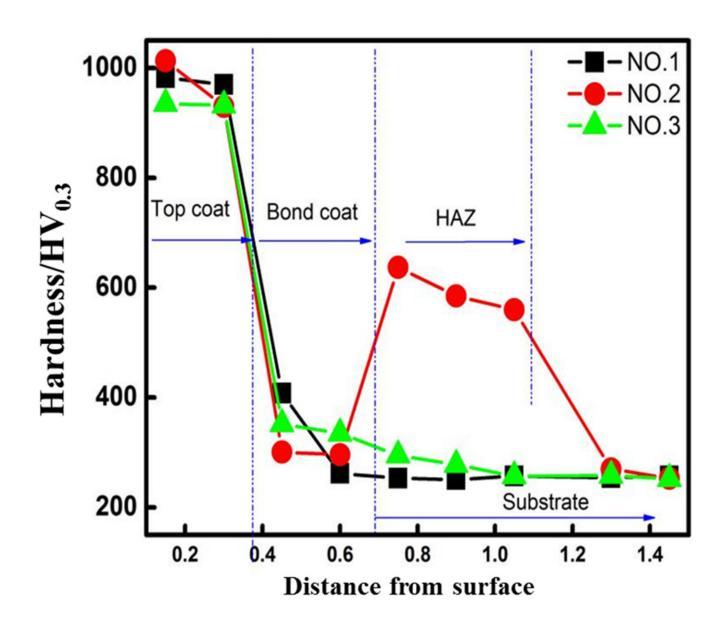
Figure 7. The hardness of samples as a function of the distance from the surface.

Figure 7 plotted the hardness of the complex layer as a function of the distance from the top of surface coating. It was seen that the hardness of Cr_3C_2 –NiCr (HVOF surface coating) was as high as 900 HV_{0.3}, owing to the uniform distribution of rigid Cr_3C_2 particles. For the bonding layer, the fabricated NiCr layer decreased to 408 HV_{0.3} by the absence of rigid particles. Due to the low hardness of this layer, it had reasons to believe that it could not only provide enough toughness, but also eliminated potential stress concentration sources under fatigue condition. For the Ni625 layer fabricated by LC and EHLA, the magnitudes of hardness were 298 HV_{0.3} and 345 HV_{0.3}, respectively. This was because the refinement of the EHLA layer microstructure resulted in a higher magnitude of hardness according to the Hall–Petch relationship [29]. On the other hand, the increase in dislocation density increased surface hardness as well. Regarding to the hardness of HAZ, it was notable that the plot of the LC sample rapidly arose to an average of 600 HV_{0.3} (at HAZ), whereas the plot of the EHLA sample maintained a continuous downward trend. This difference was considered to be the result of the different HAZ microstructures, as previously mentioned.

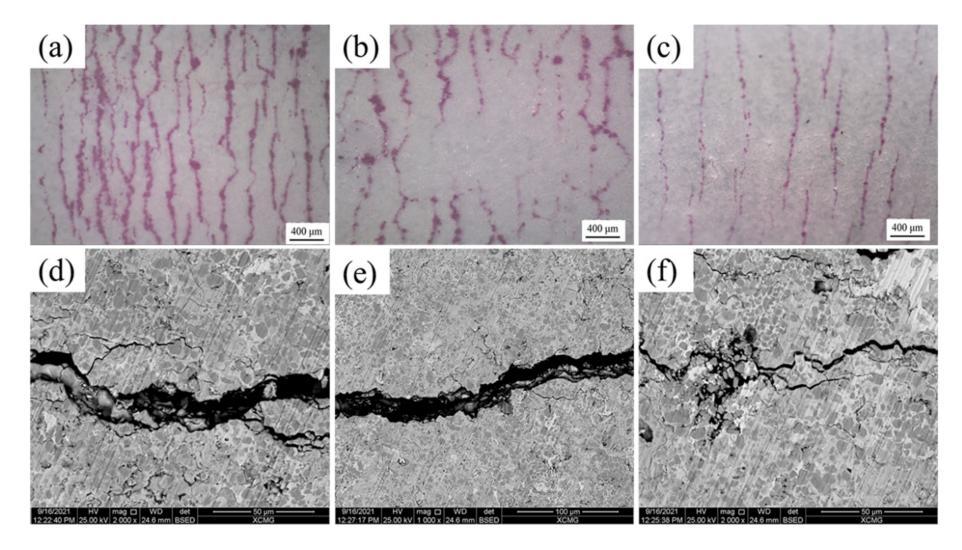
Figure 8. (**a**–**c**) the penetrating tested surface of No. 1–3 after BFT and (**d**–**f**) the high magnification image of fatigue crack.

Figure 8 demonstrated how the penetration testing surface profile of the sample suffered the BFT. Figure 8a indicated the sample with NiCr bonding layer after 500 cycles, where a large amount of intensive and successive macro cracks were presented. No apparent crack was found on the surfaces of samples No. 2 and No. 3. With further testing, the fatigue cracks emerged on the sample No. 2's surface at 1000 cycles (Figure 8b). After 1500 cycles, sample No. 3's surface manifested visible cracks, as presented in Figure 8c. As a comparison, the density (Figure 8a–c) and width (Figure 8d–f) of the cracks on the samples were sorted as: No. 1 > No. 2 > No. 3. Although sample No. 1 underwent the least amount of testing time, the surface damage was much greater than that of No. 2 and No. 3. It can be concluded that No. 1 presented the worst fatigue resistance, followed by No. 2.

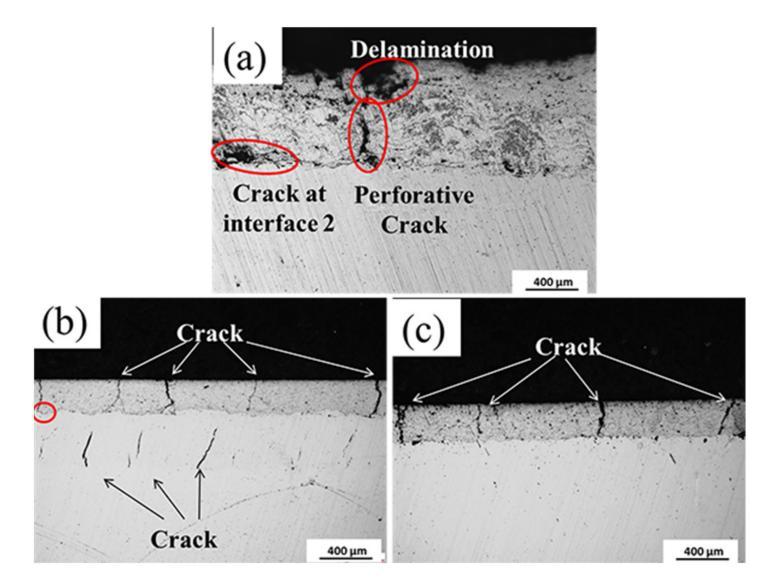
Figure 9. The cross section of the complex coating after BFT: (a) No. 1; (b) No. 2 and (c) No. 3.

In order to investigate the details of the failure, three cross sections were displayed in Figure 9. With respect to Figure 9a, the delamination was correspondingly formed after

the BFT because of the fragile surface. Due to the porous and laminar complex layer, the perforative cracks were prone to be initialized under fatigue condition, which directly exposes the substrate in the air. In addition, cracks were detected at the interface 2 as the poor adhesion with substrate. For sample No. 2 (Figure 9b), not only were cracks formed in the surface coating, but also interior cracks were discovered in the bonding layer. It should be noted that the mentioned cracks were not connected. This was because the cracks initialize from different resources: surface coating and the bonding layer. Additionally, referring to the red circle marked in the image, when the cracks from surface coating arrive at the bonding layer, the mechanical interface deflected it along interface 1. Although cracks were found in the bonding layer and the surface coating, the bonding layer was believed to act as a hinder layer because no perforative crack appears. Therefore, the behavior of fatigue cracks for the complex coating could be concluded as follows. The fatigue cracks occurred in both layers after bending test. As the cycle progresses, the cracks propagated toward to the interface 1. When one crack from one layer arrived at the interface 1, it propagated along the interface 1. When the other crack initialized from the other layer arrives at the interface 1, both cracks connected and propagated toward to the interface 2. Thus, the perforative crack would form at some point in the future, resulting in an exposed substrate. On the other hand, if adjacent cracks in surface coating connected at interface 1 before the crack in bonding layer arriving surface, the delamination would be preferentially incurred.

Regarding sample No. 3 (Figure 9c), cracks were only detected in the surface coating and no apparent crack is found at interface 1. This could well state that the EHLA Ni625 bonding layer can evidently decrease the driving force of fatigue cracks in surface coating due to high toughness. Furthermore, as Shen et al. [30] pointed out, the refined crystal of the EHLA Ni625 layer had high density of grain boundary and dislocation, which effectively delays formation of the fatigue cracks. Hence, no crack formed at the interior of the bonding layer. There was no clear difference between sample No. 2 and sample No. 3. The preferred failure mode could be delamination for sample No. 3 and perforative cracks for sample No. 2 as the cycle progressed.

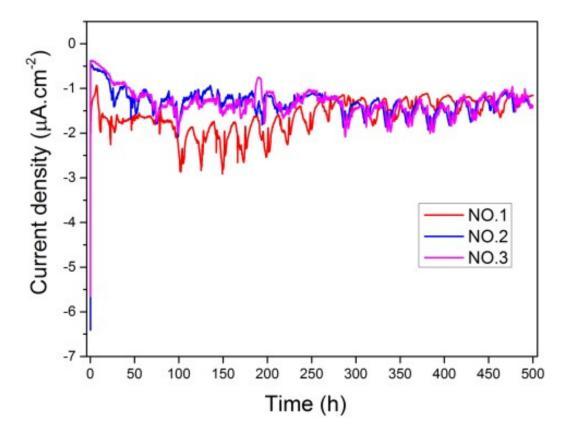
Figure 10. The curves of potentiostatic polarization curve of No. 1–No. 3 without BFT.

The electrochemical behavior of the coatings was investigated by measuring potentiostat polarization curves and EIS. Potentiodynamic polarization curves of samples No. 1, No. 2 and No. 3 coatings during 500 h of corrosion at -350 mV were tested, as shown in Figure 10. There were fluctuations in testing process of current density. The results indicated that final current density of samples No. 1–No. 3 ranged from $-1.4 \,\mu\text{A/cm}^2$ to $-1.2 \,\mu\text{A/cm}^2$. A negative net current showed a cathodic behavior of the coatings and no porosity and micro-cracks penetrating the coating down to the substrate. There was little difference in these three curves, meaning that the corrosion resistance of different coatings under the action of pure corrosion was close. The negative net current indicated the cathodic behaviors of the coatings.

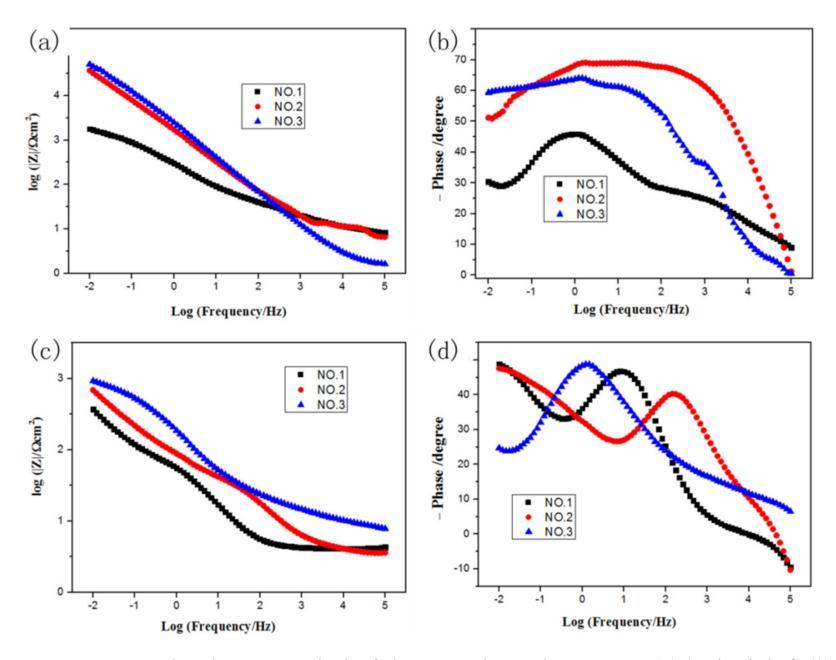
Figure 11. Bode plots recorded of the sample without BFT: (a) $\lg |Z|$ -lgf; (b) phase-lgf; Bode plots recorded of the sample after BFT: (c) $\lg |Z|$ -lgf (d) phase-lgf.

Figure 11 showed the Bode plots of the samples before and after the dynamic bend test. From the data of Figure 11a, both total impedances (|Z|) of samples No. 2 and No. 3 without the dynamic bend test were much higher than that of sample No. 1 at 0.01 Hz. It was proven that the interfacial charge transfer of samples No. 2 and No. 3 was more difficult. As observed in Figure 11b, in the intermediate frequency range of samples No. 2 and No. 3 and No. 3, $\log |Z|$ increased linearly as logf decreases. Moreover, it can be seen that the slope of the line is close to negative 1, which implied that no corrosion occurs. This can be attributed to barrier properties of the bonding layer. In the phase angle-log curve, the impedance diagrams of samples No. 2 and No. 3 in Bode phase angle presented a broad peak, indicating excellent density and barrier characteristics.

As shown in Figure 11c, the total impedance (|Z|) at 0.01 Hz of the samples No. 3 and No. 2 reduced from ~10⁵ to ~10³ after BFT. The total impedance (|Z|) of at 0.01 Hz the samples No. 1 reduced from ~10^{3.5} to ~10^{2.5} for the sample No. 1 after BFT. It was proven that the interfacial charge of the three samples was prone to transfer after BFT. Furthermore, the total impedance (|Z|) at 0.01 Hz from relatively high to low sequence was the sorted as No. 3 > No. 2 > No. 1. The results illustrated the interfacial charge transfer of sample No. 3 was most difficult after BFT. As displayed in Figure 11d, in the phase angle-logf curve, the impedance diagrams of No. 1 and No. 2 samples in Bode phase angle show two obvious peaks. There were predominately two time constants, where one is the inductance arc and the other one was the contain arc. It implied that the corrosion solution reached the interface 2 through the perforative micro-crack formed during the dynamic bend test of samples No. 1 and No. 2. However, this phenomenon did not occur in sample No. 3 due to the excellent corrosive resistance of the EHLA layer.

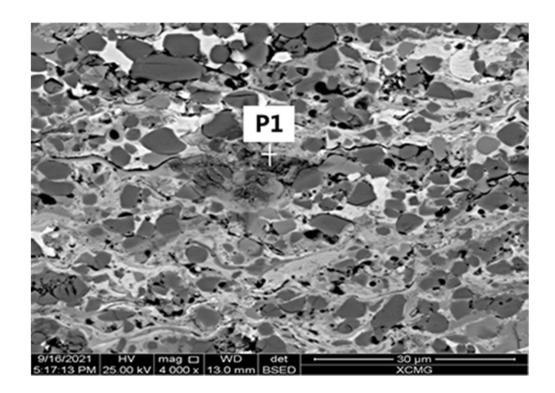
Figure 12. The corrosive surface morphology (3000 h) of all the samples without BFT.

Owing to the excellent corrosive resistance of the surface coating (Cr_3C_2 -NiCr HVOF layer), a small quantity of pitting was found until the NSS test time reached 3000 h for all samples without BFT. The corrosive morphology was shown in Figure 12. In order to further study the corrosion behavior, the EDS was executed on pitting, and the results were shown in Figure 12 and Table 5. As listed, no Fe element was detected and some O element was found, which proves that the corrosion occurred at the Ni–Cr phase.

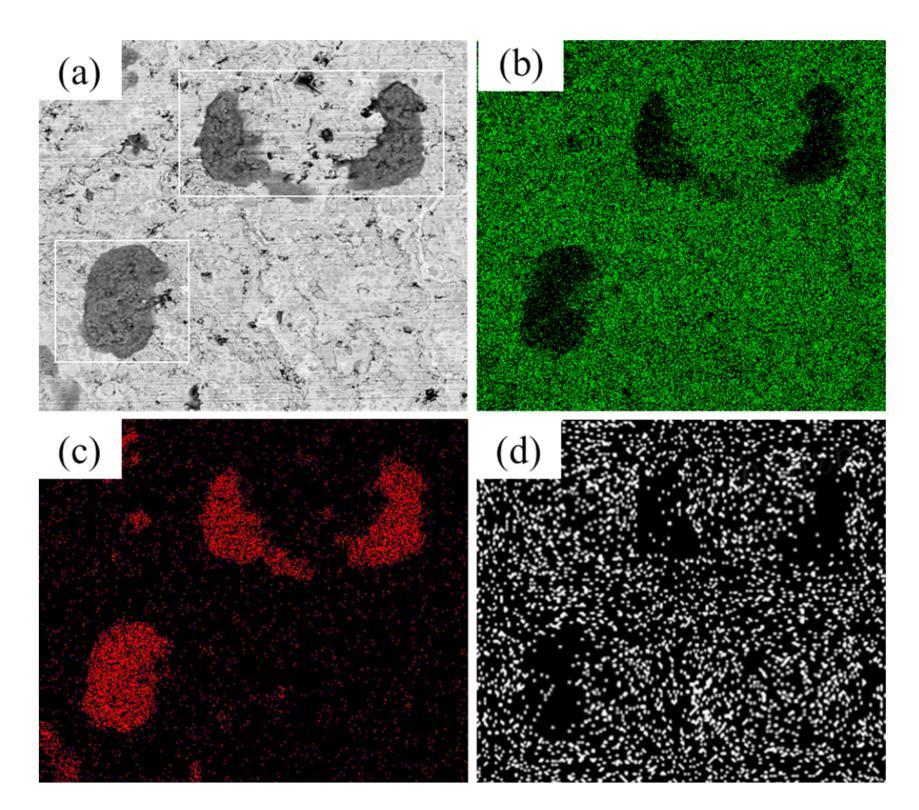
Figure 13. (**a**) The corrosive surface of No. 1 suffered BFT and (**b**–**d**) Mapping EDS of Cr, Fe and Ni elements.

For sample No. 1 suffering the BFT, corrosive morphologies (Figure 13a) were demonstrated in the form of broken surface and formation of through-wall micro-cracks. To identify the corrosion products, EDS was operated on the surface. As the results shown (Figure 13b–d), there was almost 100% Fe element covering the severely corroded area (white rectangle in Figure 13a). This was caused by the fact that the substrate was directly exposed in the corrosive environment after BFT. The ferric oxide overflew though the perforative crack and distributed nearby the cracks. The corrosion behavior in other area was similar to the sample without BFT.

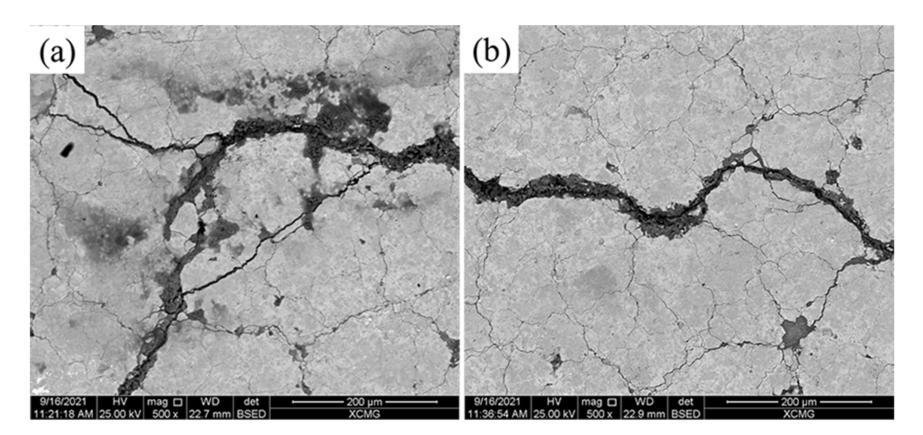
Figure 14. The corrosive surface of (a) No. 2 and (b) No. 3 suffered BFT.

After BFT, the corrosive morphologies of samples No. 2 and No. 3 were similar to the surface profiles of the samples without BFT. It seemed that the surface failure was not accelerated under a combination of corrosion and bending fatigue conditions for the LC and EHLA samples. This was because a large number of cracks appeared on the BFT samples surface, but these cracks did not cross the surface coating and bonding layer. Thus, the laser cladding layer played a significant role in the obstruction of corrosive elements. The main elements involved in corrosion were Ni and Cr, which were the same as those samples without BFT. However, it can be seen in Figure 14 that a large number of tiny cracks formed on the surface in comparison with the sample not undergoing BFT. With respect to the surface profile, the magnitude and width of the micro-cracks presented in Figure 14b were apparently less than those of displayed in Figure 14a. In terms of the formation of these micro-cracks, it was proposed that the corrosion mechanism was stress corrosion, which is attributed to the BFT [31]. The phenomenon could well explain that the impedance modulus decreased by 1–2 orders of magnitude for the BFT samples, comparing with the samples without BFT. As BFT and NSS were not carried out at the same time, the process of surface failure under the combination of corrosion and bending fatigue condition could be dependably speculated. BFT initializes the cracks and stress concentrations, which promoted corrosion behavior. Once Ni and Cr oxides appear, the passivation coating of NiO and Cr_2O_3 would be easily broken under BFT (Figure 15) and etch pits would form as a result. Thus, the stress concentration process was correspondingly accelerated under fatigue conditions due to these etch pits. As the corrosion and fatigue progress, the surface failure was developed to the interior of the layer. As a conclusion, the corrosion and fatigue behavior would be significantly promoted by each other, leading to surface failure.

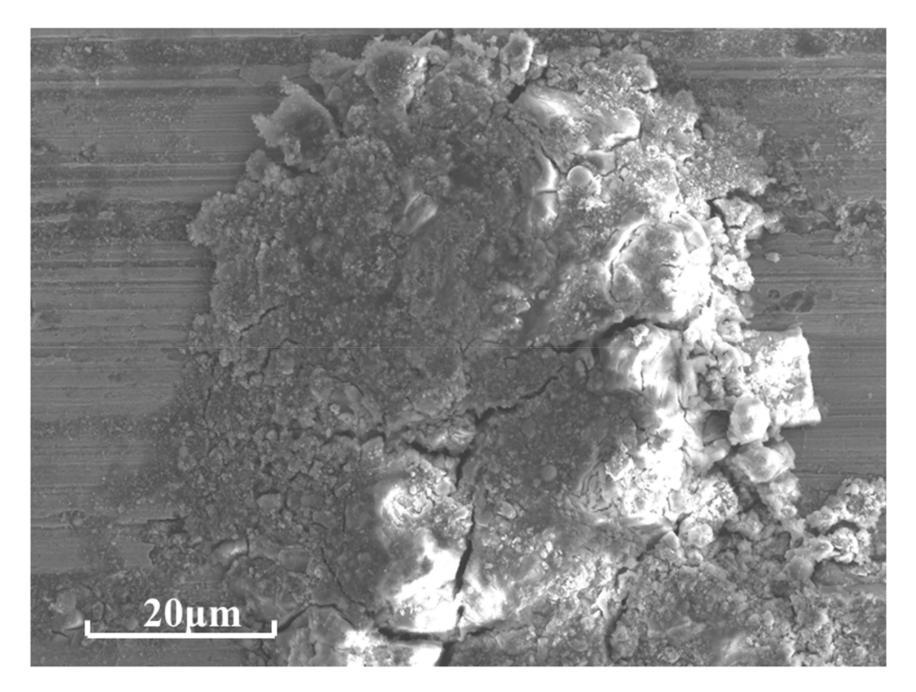
Figure 15. Broken passivation coating of NiO and Cr₂O₃ corrosion products.
