Article Study of the Machining Process of GFRP Materials by Milling Technology with Coated Tools

Keywords: glass fibers; milling; composite systems; coating; tool wear; tool parameters

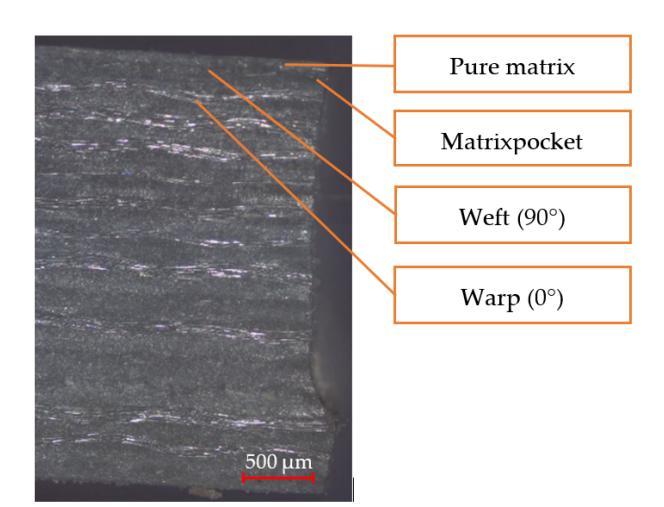
Figure 1. Cut through a 3 mm thick GFRP sample.

The surface of the laminate consists of a thin layer of pure resin with a thickness of $15 \mu m$. The thickness of the resin layer changes as the warp and weft yarns are placed. Next

comes the weft yarn. Below it is the warp yarn and again the weft yarn. The undulation path of the warp and weft yarns in plain weave can be approximately described by a sine function.

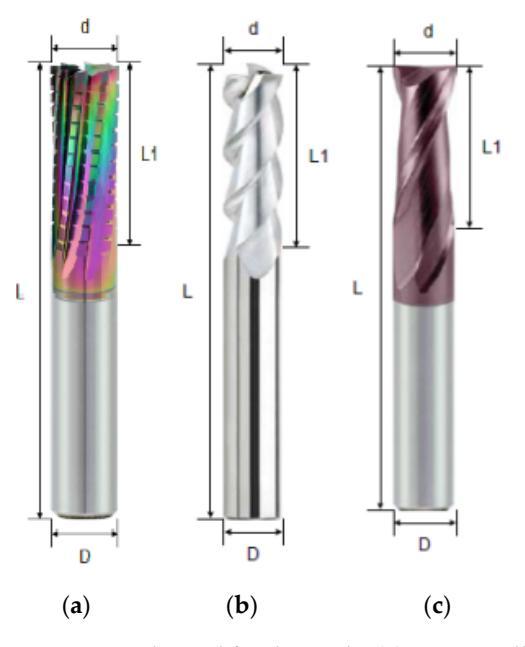
Figure 2. Tools used for the study. (**a**) ECSSF milling cutter; (**b**) A100 milling cutter; (**c**) G550 milling cutter.

The tools used were purchased from the manufacturer Winstar. The tools were of the same diameter, but with different geometry, different coating, and, in the case of the ECSSF cutter, also a different number of teeth, to enable the investigation of different accompanying and subsequent phenomena during milling with these tools. The ECSSF finishing cutter is designed for CFRP/GFRP laminate composite materials; the microhardness of DLC surfaces is between 3300HV0.05 and 4200HV_{0.05}. The carbide cutter A100 is intended for machining non-ferrous metals, aluminum, and aluminum alloys; the microhardness of the CrN coating is between $1200HV_{0.25}$ and $2900HV_{0.25}$. The universal milling cutter G550 is suitable for steel, stainless steel, cast iron, and hardened material up to 55HRC; the hardness of the UNICO surface layer is between $2800HV_{0.05}$ and $3100HV_{0.05}$.

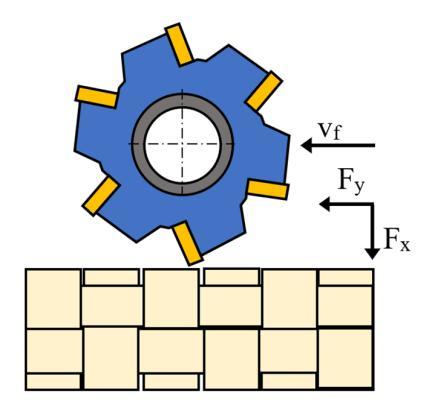
Figure 3. Orientation of the milling tool to the warp yarn.

The milling path was oriented at a 90° angle to the weft yarn, Figures 3 and 4

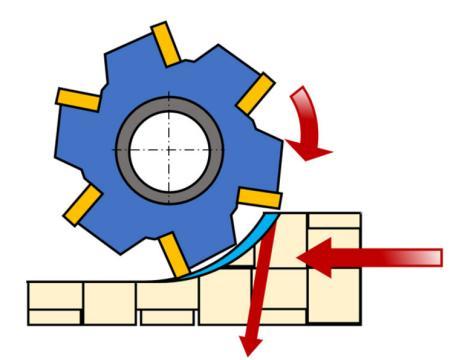
Figure 4. The arrangement of warp and weft yarns from the point of view of delamination during down milling.

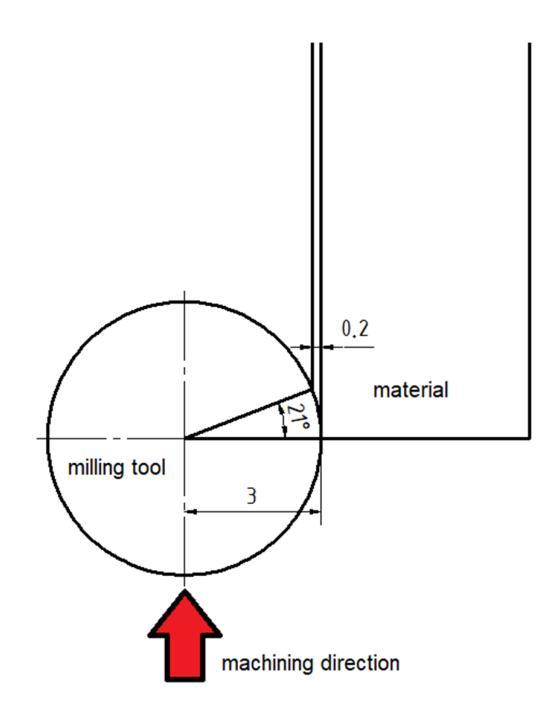
Figure 5. Scheme for calculating the tool path.

As part of the study, circumferential down milling without process fluid was implemented. A 200 mm long board edge was milled. The program for milling on the DMG MORI CMX 600 milling center was written so that in one cycle the tool performed a cutting path of 165 m; therefore, 15 milled sections of 11 m of the tool path with a depth of cut of 0.2 mm were programmed. The length of the tool path was determined according to Equations (1) and (2) and Figure 5.

$$o = \frac{\pi}{180} \times r \times \alpha = \frac{\pi}{180} \times 3 \times 21 = 1.1 \text{ mm.}$$
(1)

$$s = {o \times L \over f_z} = {1.1 \times 200 \over 0.02} = 11000 \text{ mm} = 11 \text{ m.}$$
 (2)

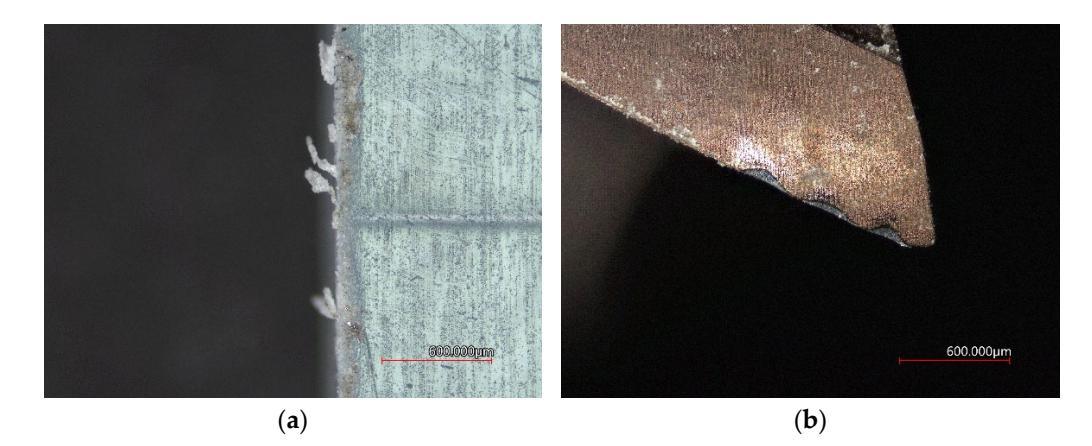
Figure 6. Capture after a tool path of 15×165 m. (a) Laminate thickness 1 mm; (b) G550 milling tool.

Figures 6 and 7 show the milled surface quality of the GFRP laminate and tool wear, for 1 and 3 mm laminate thickness when a G550 cutter, UNICO coating was used. Likewise, Figures 8 and 9 present the results when an A100 cutter, CrN coating, was used. Figures 10 and 11 show the results of using the ECSSF cutter, and DLC coating. Figure 6a shows the surface of a 1 mm thick laminate with slightly protruding twisted warp fibers. Protruding fibers (max. approx. 0.28 mm) are unevenly distributed over the entire machined surface. The machined surface does not have a clear cut, the edge is frayed with a peeling top layer and a damaged polymer matrix.

The images of the tool in Figures 6b and 7b indicate abrasive damage to the tool due to glass fibers. The wear size of the VB tool is $75.40 \pm 0.11 \,\mu\text{m}$ when milling a 1 mm laminate. The number of corrugations corresponds to the number of fabric layers in the laminate.

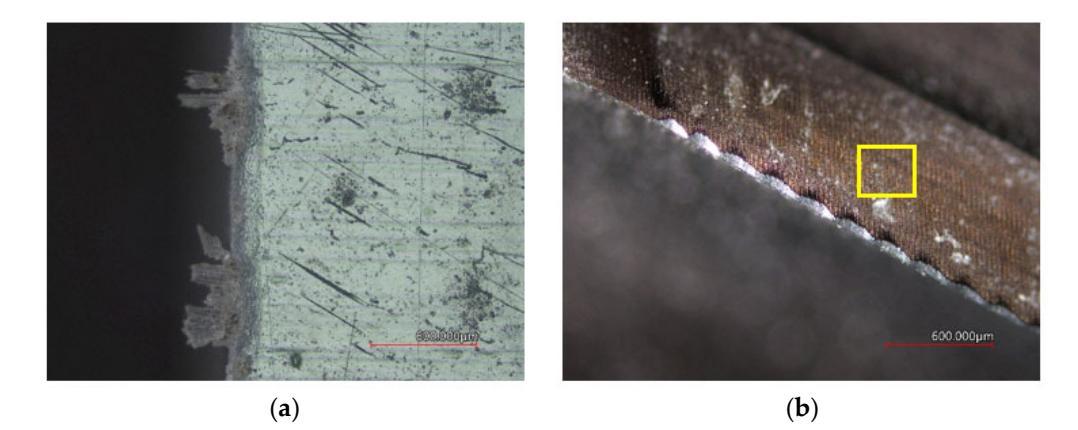
Figure 7. Capture after a tool path of 15×165 m. (a) Laminate thickness 3 mm; (b) G550 milling tool.

Figure 7a shows the machined surface of a 3 mm thick laminate, but with several protruding (max. approx. 0.3 mm) cut weft fibers. The machined edge is frayed, with the top layer peeling off and the polymer matrix damaged.

When milling a 3 mm laminate, the amount of tool wear is $77.50 \pm 0.12 \mu$ m. Further, in Figure 7b, yellow box, abrasive damage to the tool due to protruding fibers is visible.

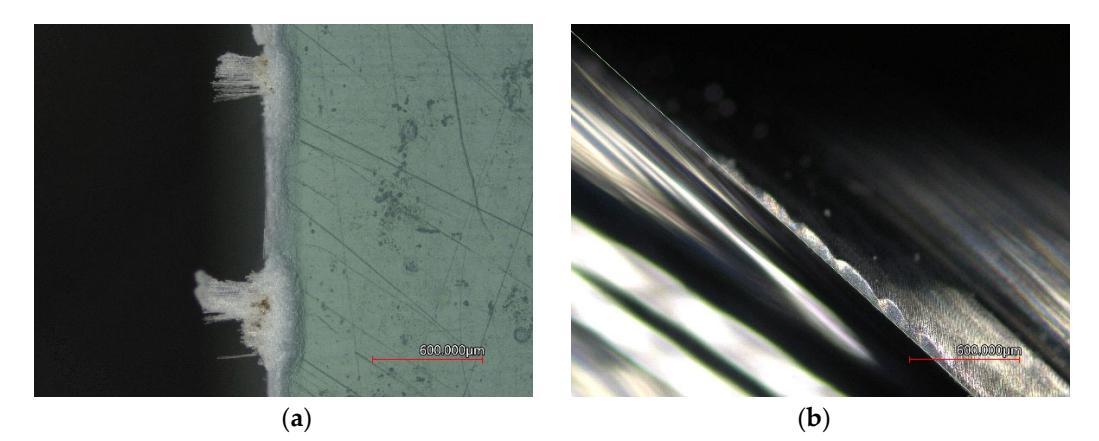
Figure 9. Capture after a tool path of 15×165 m. (a) Laminate thickness 3 mm; (b) A100 milling tool.

Images of the tool in Figures 8b and 9b shows abrasive damage to the tool due to glass fibers. The wear size of the VB tool is $83.10 \pm 0.13 \,\mu\text{m}$ when milling a 1 mm laminate. Again, the number of corrugations corresponds to the number of fabric layers in the laminate. When milling a 3 mm laminate, the amount of tool wear is $74.90 \pm 0.12 \,\mu\text{m}$.

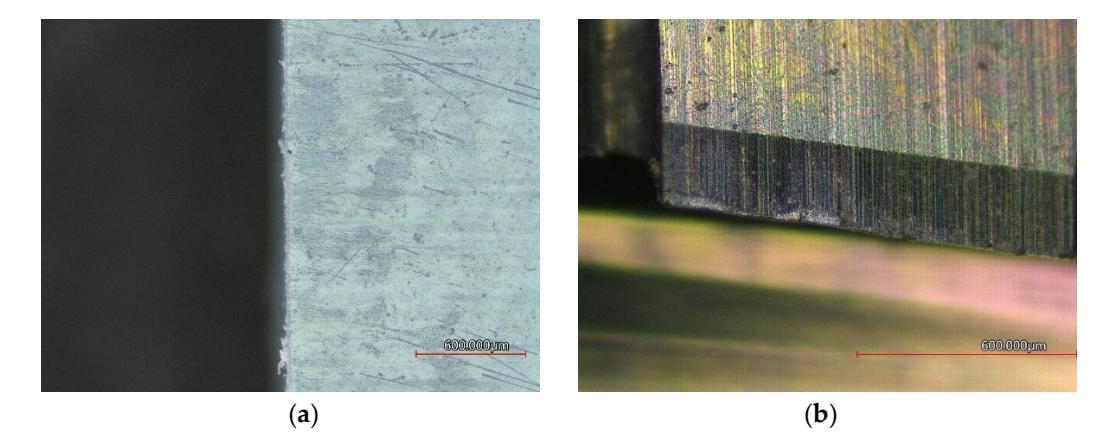
Figure 10. Capture after a tool path of 15×165 m. (a) Laminate thickness 1 mm; (b) ECSSF milling tool.

Figure 10a shows the surface of the laminate with slightly pulled-out protruding warp fibers at the cut point. Figure 11a shows the surface of a 3 mm thick laminate without any fibers; the cut is clean.

Figures 10b and 11b of the tools show abrasive damage to the tool due to glass fibers. The wear size of the VB tool is 59.80 \pm 0.02 µm when milling a 1 mm laminate. When milling a 3 mm laminate, the amount of tool wear is 75.30 \pm 0.12 µm. Again, the number of corrugations corresponds to the number of layers of glass fabric in the laminate.

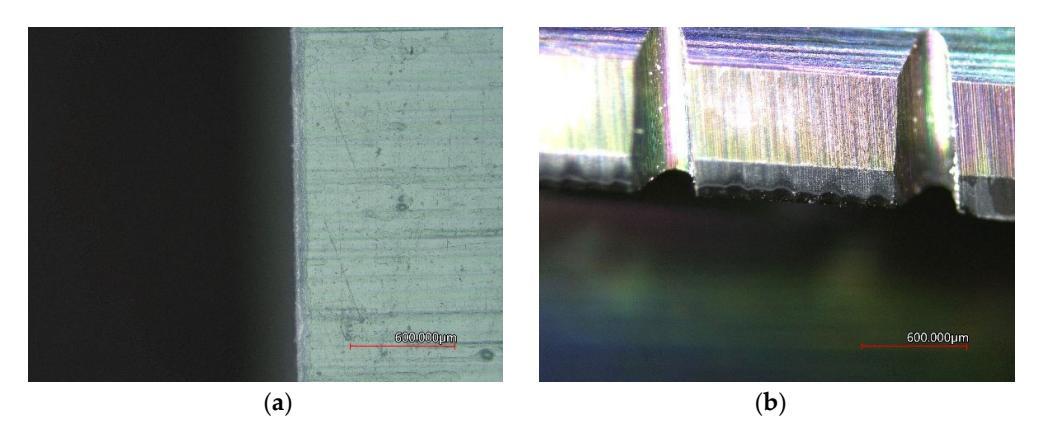
Figure 11. Capture after a tool path of 15×165 m. (a) Laminate thickness 3 mm; (b) ECSSF milling tool.

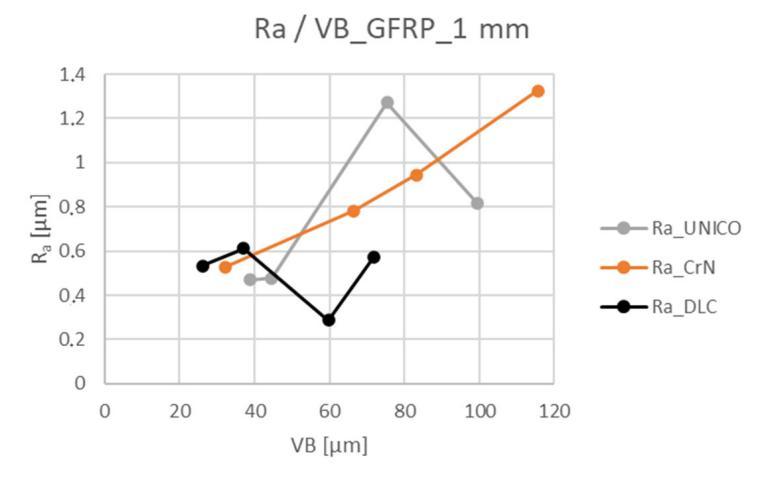
Figure 12. Dependence of the surface roughness parameter R_a on the tool wear, laminate thickness 1 mm.

Figure 12 for the roughness parameter R_a confirms the difficulty of choosing a suitable tool and cutting geometry in the 5 × 165 m section. The tool designed for machining CFRP and GFRP materials and equipped with a DLC coating shows the highest measured R_a values with the lowest amount of VB wear. In other control sections, the size of the surface roughness gradually increases with the increasing size of the VB wear.

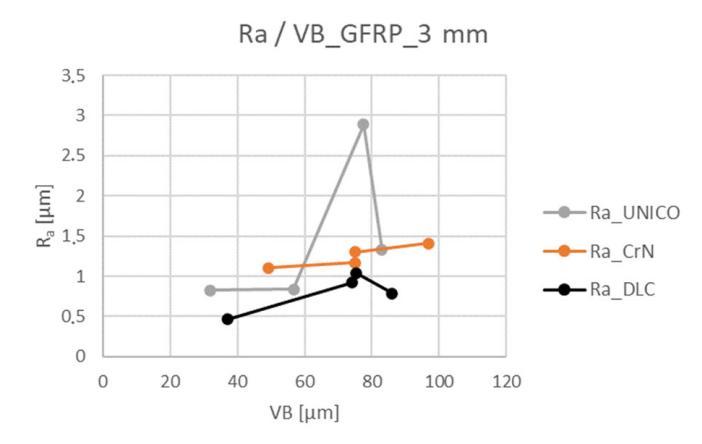
Figure 13. Dependence of the surface roughness parameter R_a on the tool wear, laminate thickness 3 mm.

Similar statements can also be applied to the results obtained when milling a sample thickness of 3 mm, as shown in Figure 13. An interesting point is the control point 15×165 m, where all 3 tools show a wear size of approximately 75 µm and the value of the R_a parameter varies between 1–3 µm. In the case of milling GFRP with a thickness of 3 mm, it is possible to observe the similarity of the magnitudes of the VB values for the A100 and ECSSF tools; the R_a values are in the range of 0.4–1.4 µm.

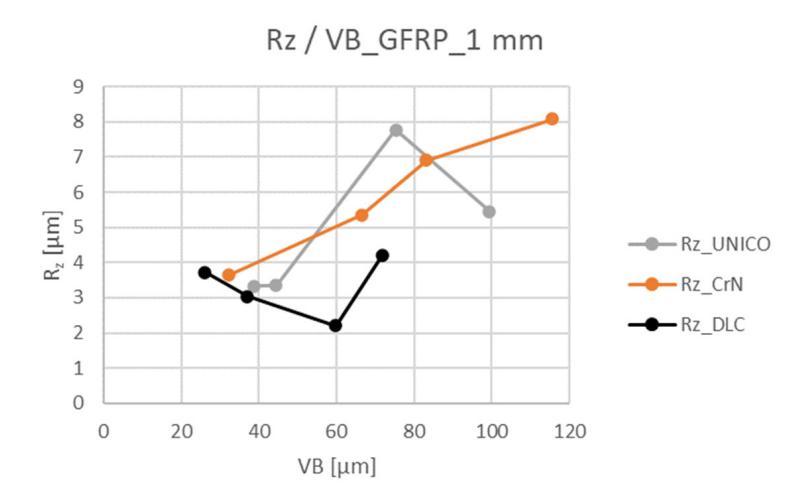
Figure 14. Dependence of the surface roughness parameter R_z on the tool wear, laminate thickness 1 mm.

As was already noted in the previous section, a similar course of the measured values of individual tools can be observed for the parameters R_a and R_z as the amount of tool wear increases, as shown in Figure 14. The course and distribution of the curves of the parameter R_z are very similar for the A100 and G550 tools, apart from the measured values

for the ECSSF tool. Here, from the beginning of the course, a downward tendency is visible again until section 15×165 m (see Figure 12).

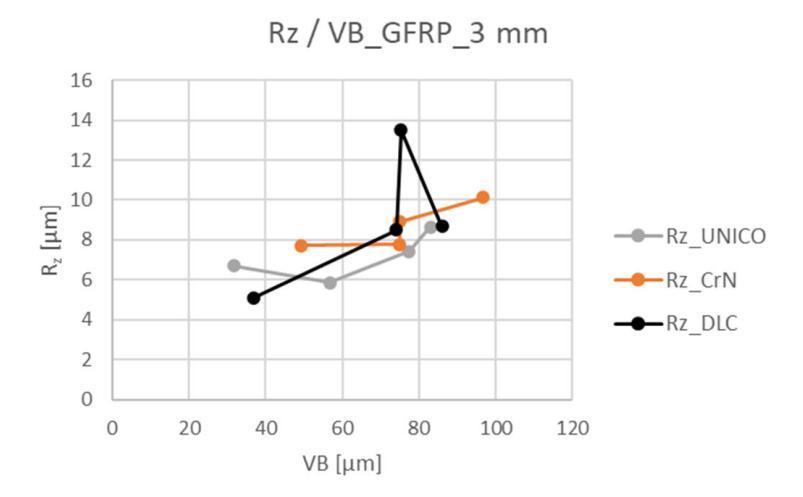
Figure 15. Dependence of the surface roughness parameter R_z on the tool wear, laminate thickness 3 mm.

When comparing the results obtained when machining a sample thickness of 1 mm and a thickness of 3 mm (see Figure 15), significant changes can be observed in the area of the size of the measured R_z values, the course of the individual curves, and the similarity of the results in the control area of 15×165 m, similar to Figure 13.

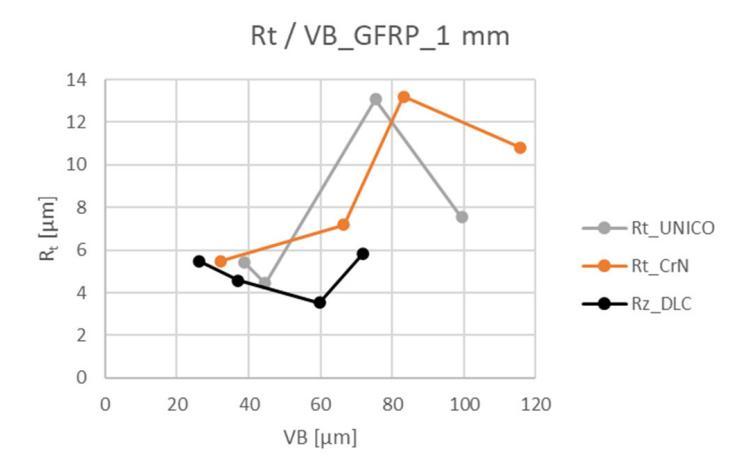
Figure 16. Dependence of the surface roughness parameter R_t on the tool wear, laminate thickness 1 mm.

From the results of the experiments, it can be observed that the surface roughness Rt was the highest at the end of the experiment when using the A100 cutter. The results showed that the quality of the milled surface improved significantly when using the G550 tool, UNICO coating. The best results were obtained using the ECSSF cutter, DLC coating; see Figures 16 and 17.

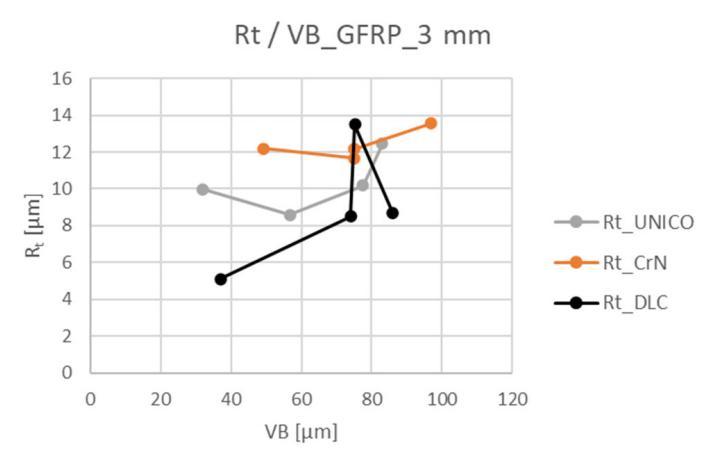
Figure 17. Dependence of the surface roughness parameter R_t on the tool wear, laminate thickness 3 mm.

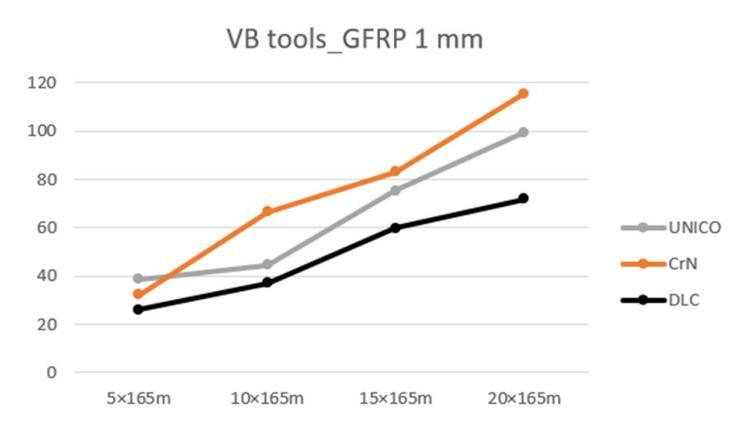
Figure 18. Tool wear, laminate thickness 1.

Across the experiments, after evaluating the VB tool wear parameter over a tool path of 5×165 m, 10×165 m, 15×165 m and 20×165 m, when machining 1 mm and 3 mm thick samples, the highest wear values were achieved with the A100, CrN coated tool in almost all controlled sections, see Figures 18 and 19.

From Figure 18, it is not possible to clearly determine the individual areas characterizing the course of the tool wear: the area of rapid initial wear, uniform wear rate, and accelerating wear rate.

The measured values of the amount of wear of individual tools plotted in Figure 18 clearly show the course and tendency of the growth in damage. It is clear from the graph that the highest wear values were achieved with tool A100, CrN coating. This tool showed up to 80% higher wear value, for the control section 10×165 m, compared to the ECSSF tool, DLC coating when milling 1 mm thick material. The tools used when milling a sample with a thickness of 1 mm show a relatively linear increase in wear values and the areas of rapid initial wear and uniform wear rate cannot be clearly determined. The measured wear values at the end of the experiment differ from the values for the ECSSF tool by 39% for the G550 tool and 61% for the A100 tool.

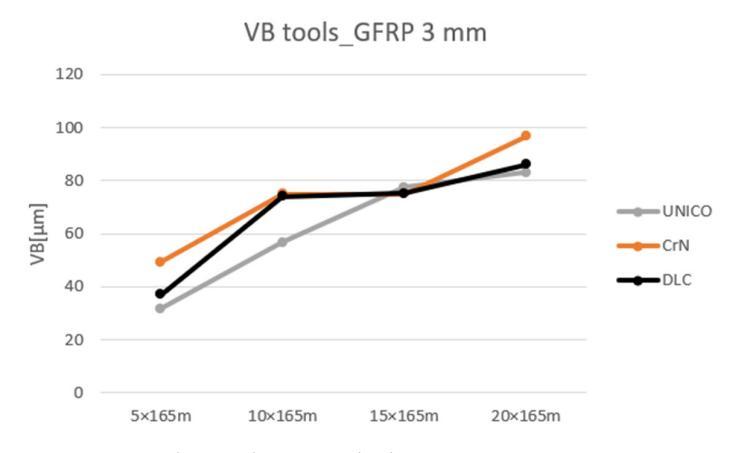
Figure 19. Tool wear, laminate thickness 3.

The curves of Figure 19 show a broken course. In section $5-10 \times 165$ m, the wear of the A100 and ECSSF tools increases linearly up to a value of approximately 75 µm. This is followed by an area with a minimal increase in the wear and from the 15×165 m section, a linear increase again follows. The wear curve of the G550 tool shows a linear increase from the beginning of the experiment up to the section 15×165 m, roughly VB = 75 µm, followed by a less steep growth of other values.

The difficulty of choosing a suitable cutting tool and cutting conditions for GFRP milling can be confirmed by the results shown in Figure 19. In most cases, the DLC-coated tool appeared to be the most suitable tool for the given application. From the graph, it is possible to observe a considerable similarity in the values achieved with both tools. In the first case, it is a similarity to the CrN coating measure tool, area $5 \times -10 \times 165$ m, and in the second case with the G550 tool UNICO coating, area $15 \times -20 \times 165$ m. A significant point is the wear value of about 75 µm, where all the curves intersect and the results obtained with the DLC tool change. The difference in the measured wear size values at the end of the experiment varies in the range of 13%.
