# Article Identifying Asphalt Pavement Distress Using UAV LiDAR Point Cloud Data and Random Forest Classification

# Zhiqiang Li<sup>1</sup>, Chengqi Cheng<sup>2,\*</sup>, Mei-Po Kwan<sup>3,4</sup>, Xiaochong Tong<sup>5</sup> and Shaohong Tian<sup>1</sup>

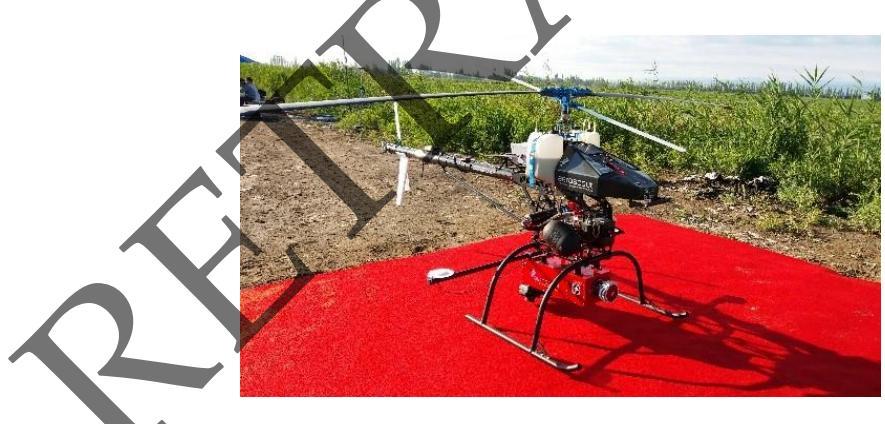
We conducted our research using a B1-100 UAV manufactured by Scout and a RIEGL VUX-1LR laser scanner (Figure 3). The UAV platform was equipped with an INS/GPS flight control system, with up to 31 kg of payload and two hours of flight endurance. The RIEGL VUX-1LR is a lightweight and compact airborne laser scanner with an accuracy of 15 mm (http://www.riegl. com/nc/products/airborne-scanning/produktdetail/product/scanner/49/). The sensor enables high-speed data acquisition through a near-infrared laser beam and fast line scanning, which results in high-quality measurements even under poor atmospheric conditions.

Figure 3. Light detection and ranging (LiDAR) data acquisition system.

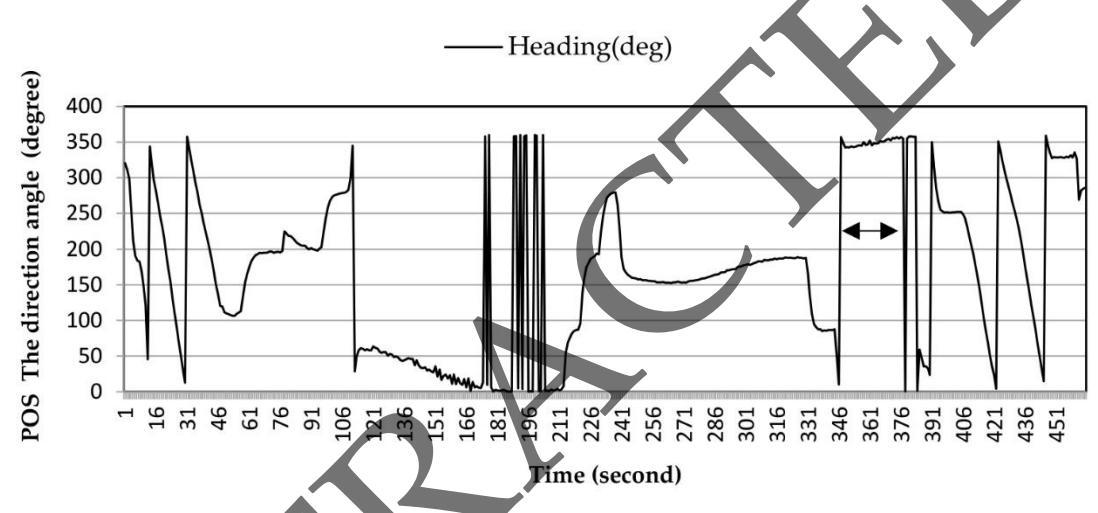
The point cloud data that were selected for the experiment were between 346 s and 376 s, with a total length of approximately 150 m. As shown in Figure 4, the UAV flight direction was relatively stable during this time period (indicated by the double arrow). As mentioned in Section 2.2, the UAV's flight altitude was set to 30 m during the flight. The format of the clipped point cloud data was set as LAS and the coordinate system was set as WGS84.

Figure 4. Direction angle variation in the POS system of an unmanned aerial vehicle (UAV) flight.

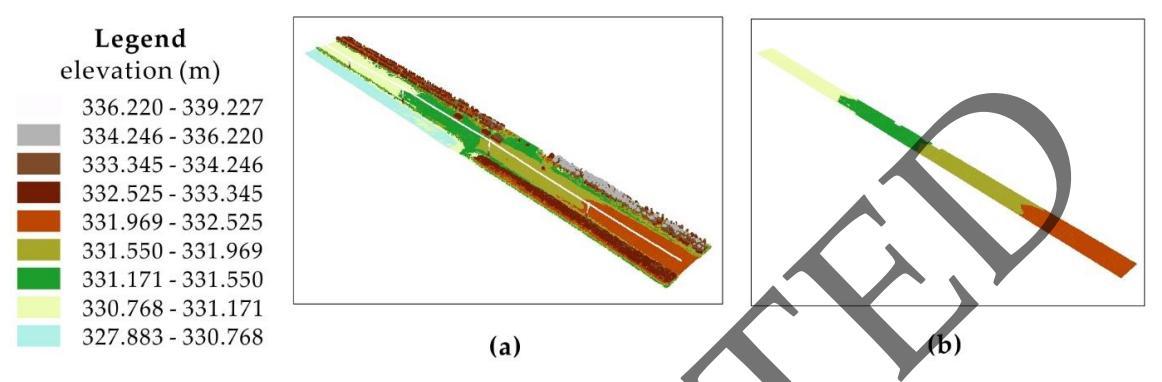
After the completion of point cloud filtering, the point cloud data could be used for feature extraction and classification (Figure 5).

Figure 5. Point cloud filtering. (a) The original point cloud, and, (b) the pavement point cloud.

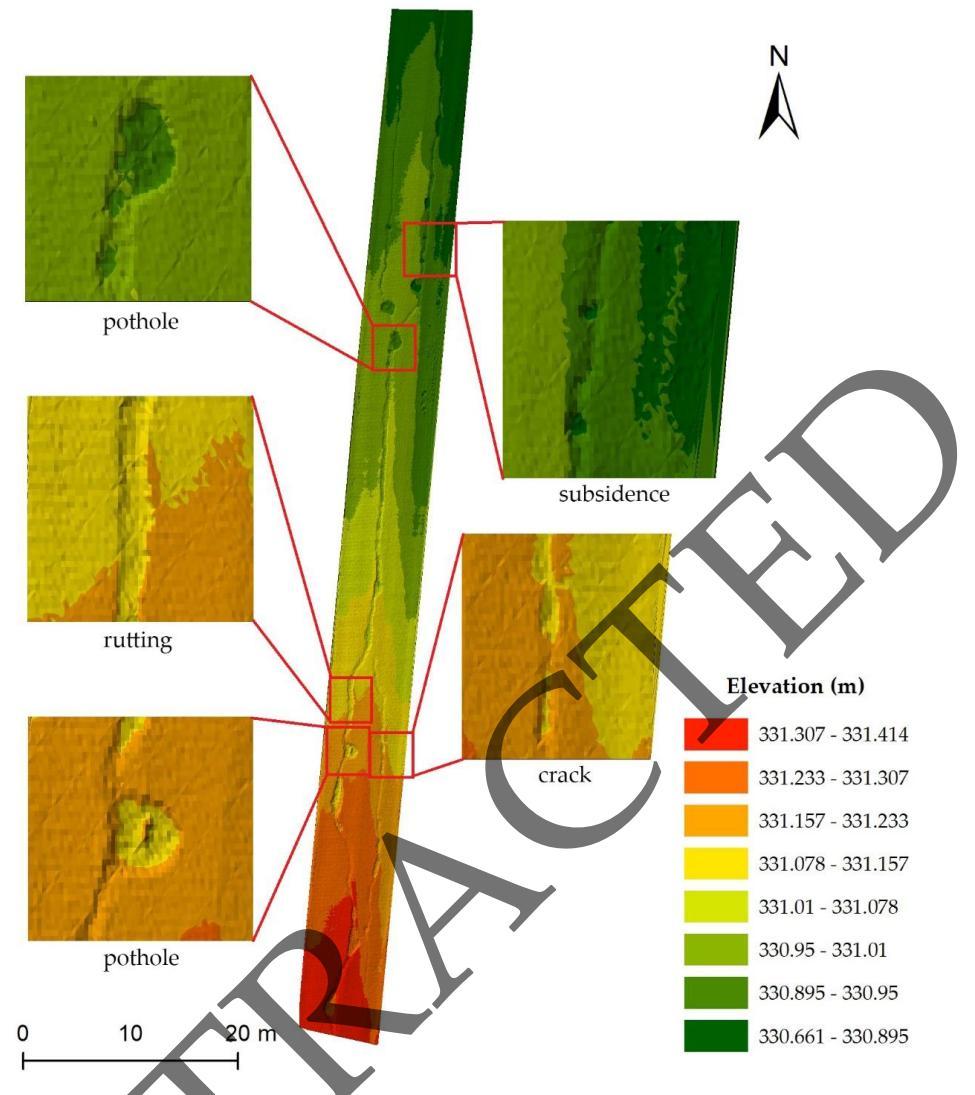
Figure 6. Triangulated irregular network (TIN) model of the road section in the study area.

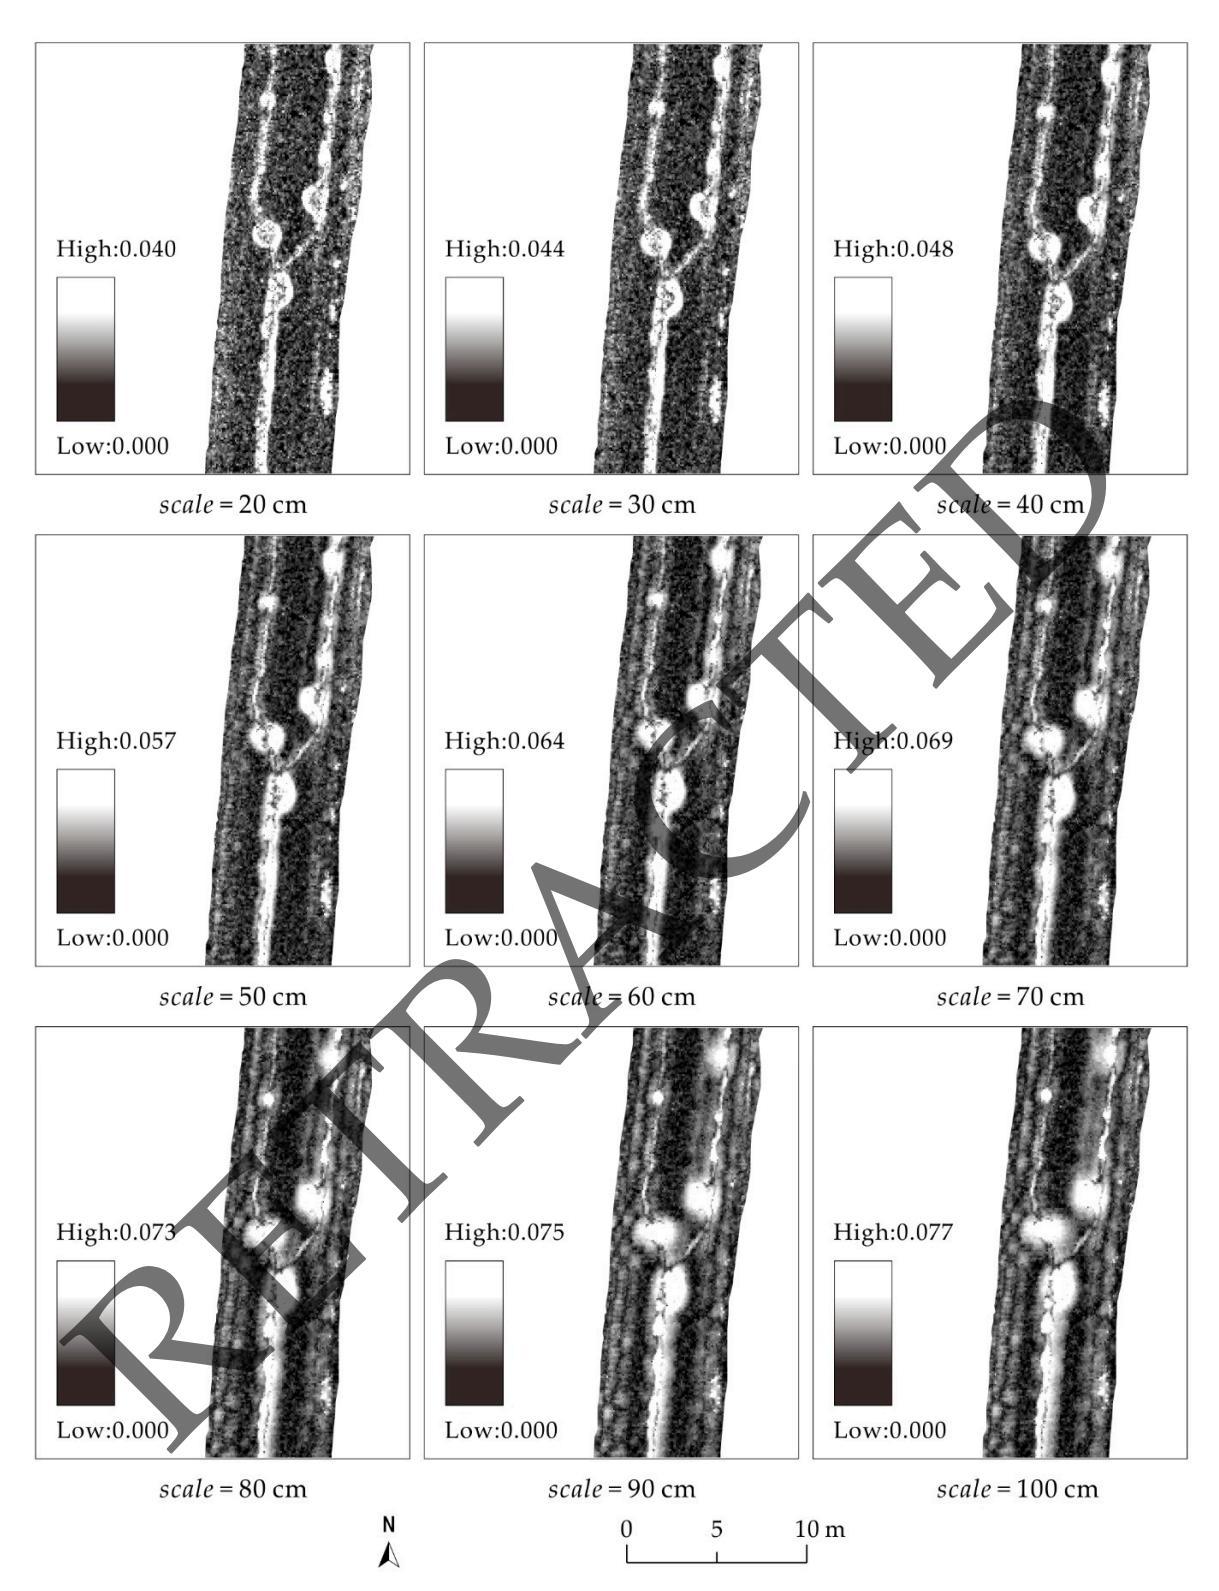
As shown in Figure 8, the microstructure of pavement distress is well expressed at the microscopic scales. As the elevation varies, the roughness index at the edge of a pavement distress is much greater than that in other regions. At a small measurement scale, the asphalt mixture in the middle of potholes is completely lost, and the roughness index is relatively low due to the absence of filler. At a large measurement scale, although the middle of potholes is relatively flat, the roughness index is still high, and the features of pavement distress are expressed. At several large measurement scales (Figure 9), some undamaged pavement areas also have higher roughness indexes because of their closeness to seriously damaged regions, which indicates the sensitivity of the roughness index to the neighborhood statistics and it is also an early warning for the risk of pavement distress. While considering that the optimal measurement scale that is required for feature extraction is different for various types of distress, the construction of multiscale roughness indexes is a promising approach to comprehensively and accurately represent the features of pavement distress.

Figure 8. Distribution of the roughness index on microscopic scales.

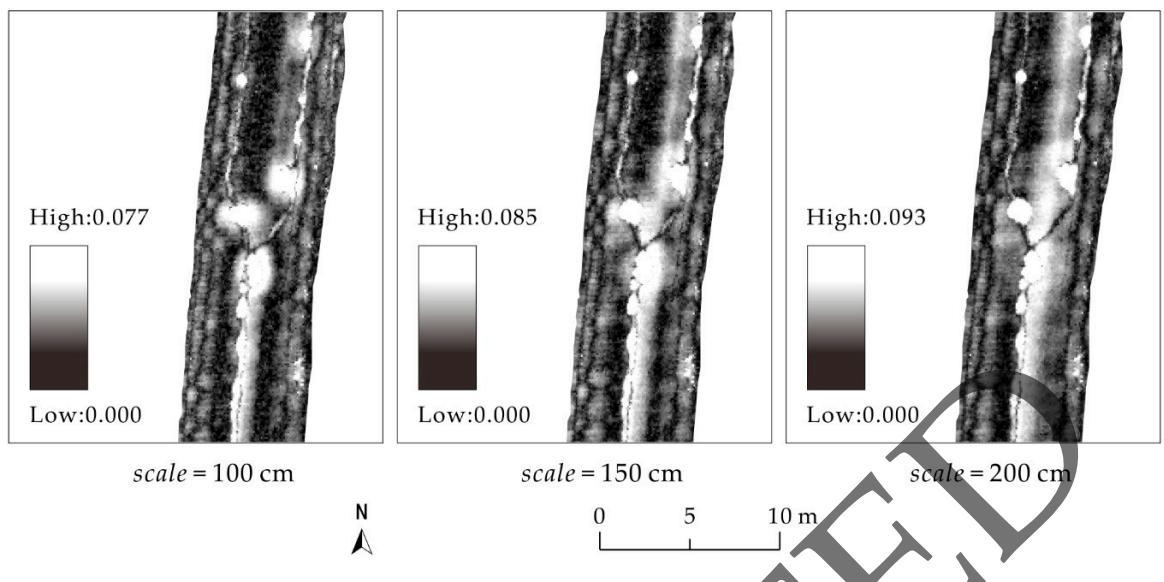
Figure 9. Distribution of the roughness index on macroscopic scales.

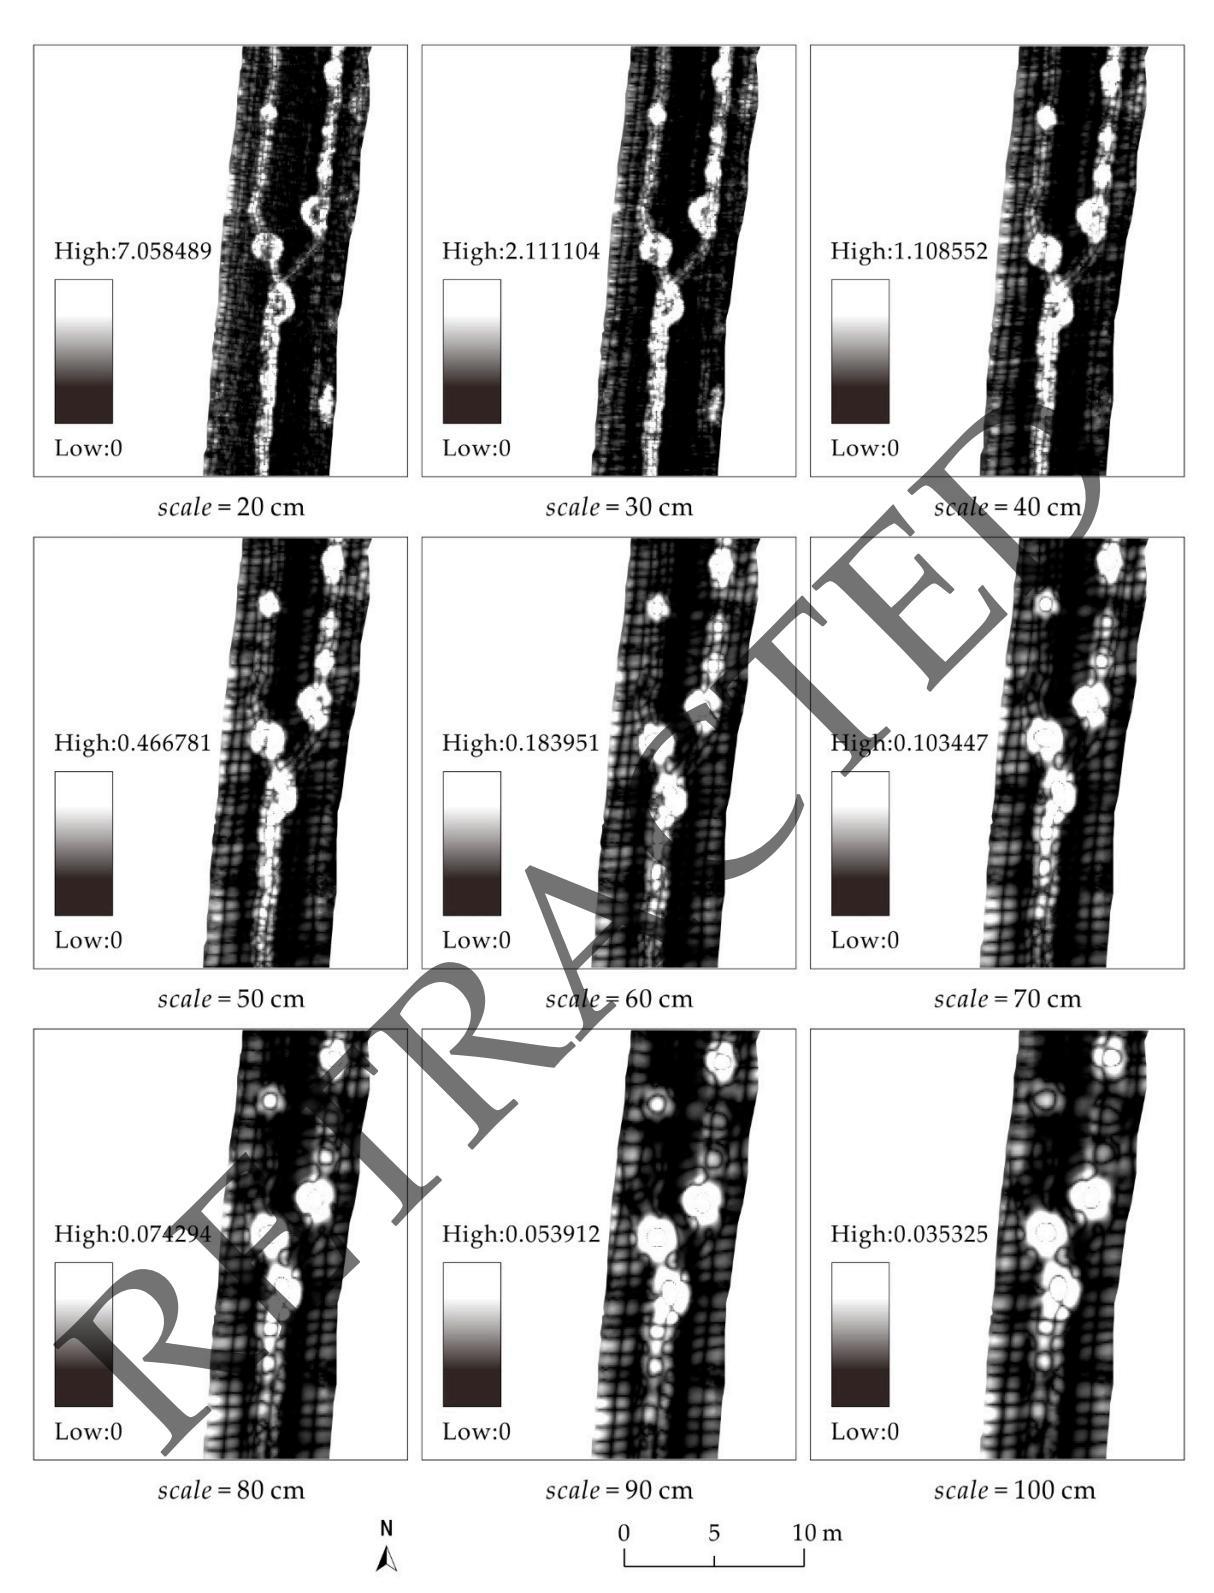
As shown in Figure 10, the asphalt mixture in the subsidence distress is not completely lost. The surface of these regions is very near a spherical or cylindrical surface, which has an effective expression on the distribution diagram of the Gaussian curvature at microscopic scales. The middle area of the potholes is relatively even and it shows the characteristics of a plane; thus, the Gaussian curvature is very small and it is similar to the roughness index. However, unlike the roughness index, which is easily influenced by neighborhood elevation at the macroscopic scale, the Gaussian curvature can be used to extract the distribution of pothole distress at a large measurement scale (Figure 11), even when the distress is serious or the area is large. At a large measurement scale, potholes with heavier damage can be effectively extracted. Meanwhile, adjacent undamaged pavement does not exhibit a large curvature. Therefore, by constructing and analyzing the multiscale Gaussian curvature of pavement in three-dimensional space, different types of distress can be effectively extracted.

Figure 10. Distribution of Gaussian curvature on microscopic scales.

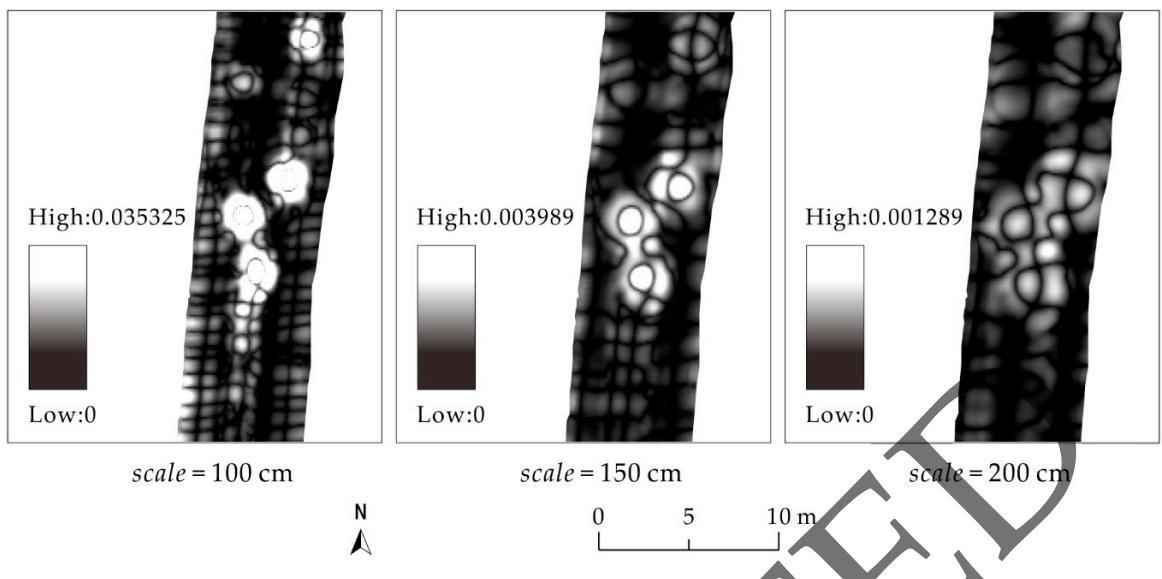
Figure 11. Distribution of Gaussian curvature on macroscopic scales.

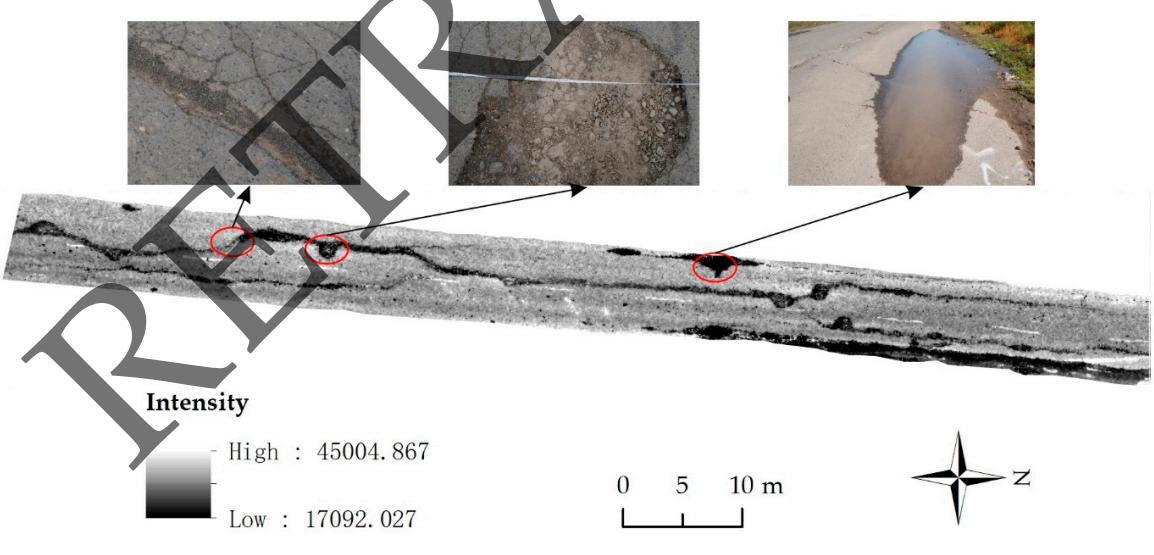
Figure 12. Reflection intensity interpolated image.

Figure 12 shows that pavement distresses in the selected road are very serious. There are many circular potholes and several longitudinal cracks along the road. There are some regions with low reflection intensity on both sides of the road, which result from the decrease in the reflection intensity in the near-infrared band due to the absorption of rainwater. Because of rainwater filling, the reflection intensity and elevation are affected by the absorption of laser energy and the refraction of water, which cause some errors in distress extraction.

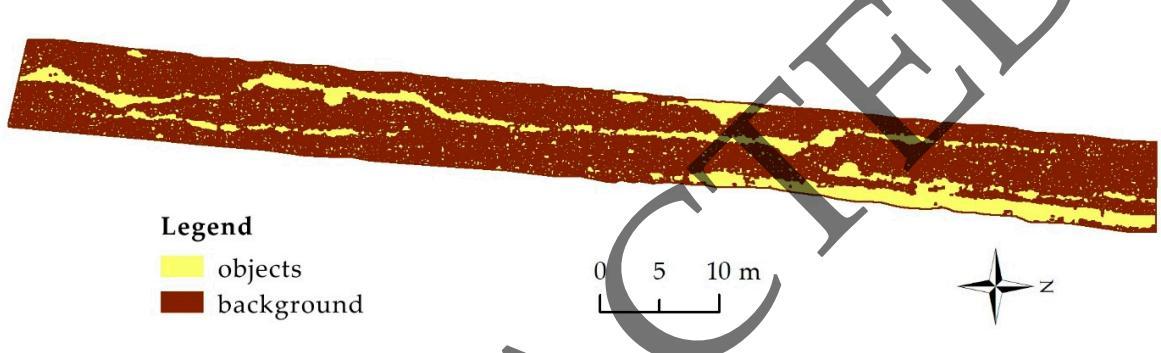
Figure 13. Object-oriented segmentation results.

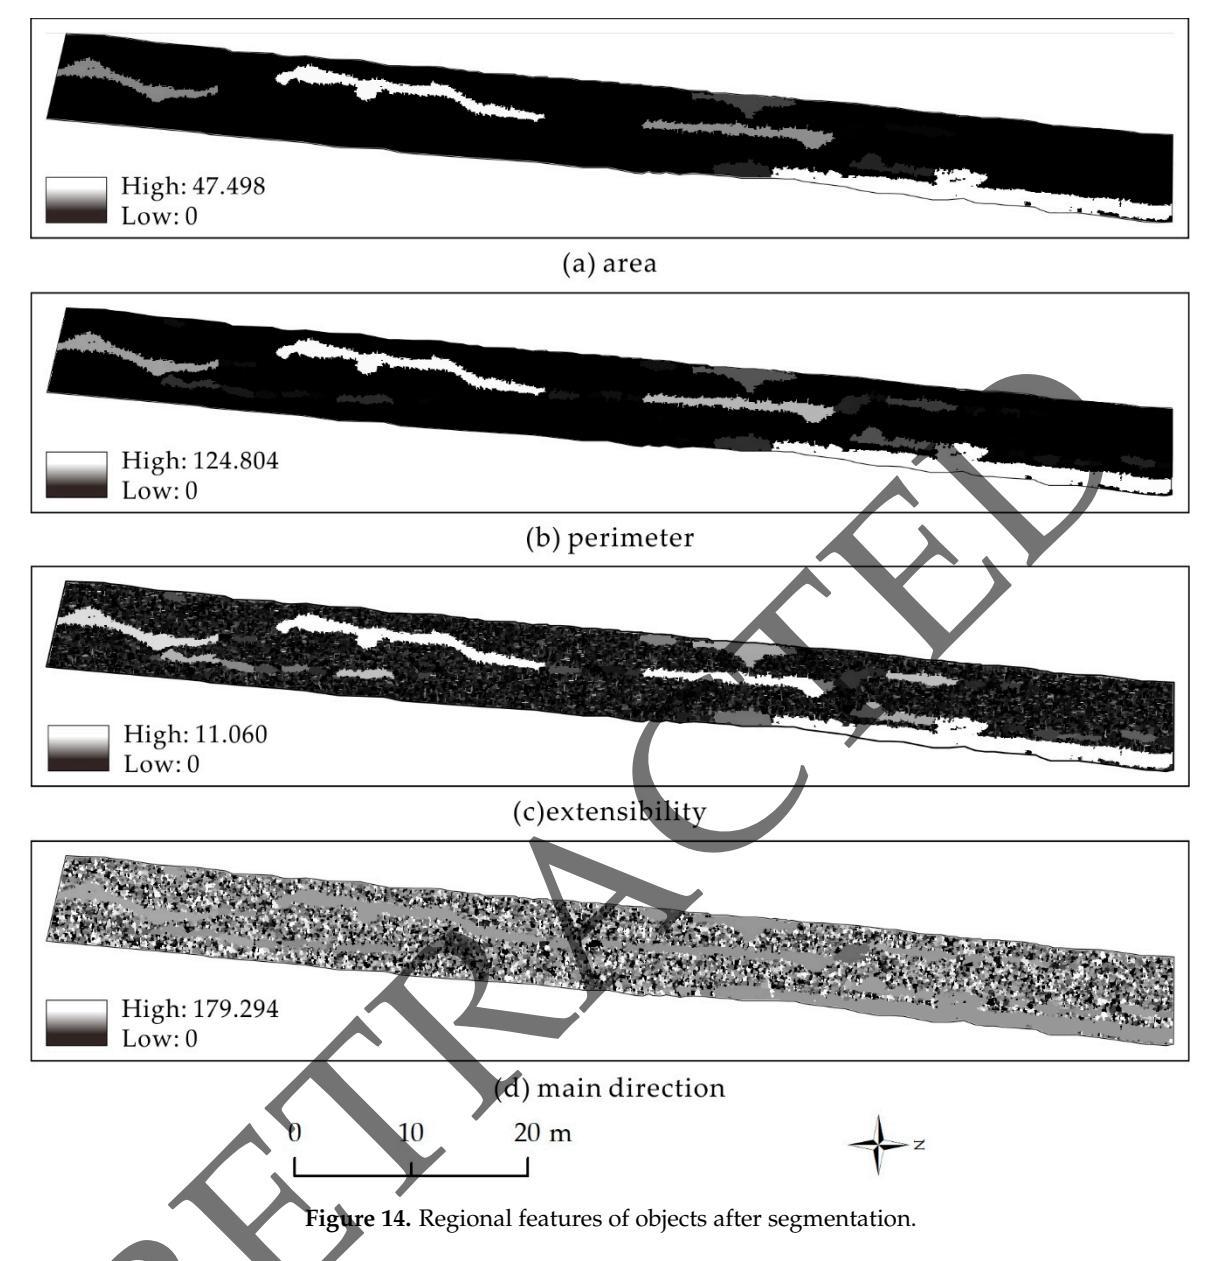
Figure 14 shows the distribution of four regional features. According to the segmentation result, the polygonal patches in the damaged areas are relatively large. Correspondingly, the area and perimeter features are also large. Most of the pavement distress is distributed along the north-south direction; thus, their extensibility is generally higher than that of undamaged pavement. The main direction reflects the principal direction of the deformed objects. In undamaged pavement, the main direction is randomly distributed because of the fragmentized segmentation result, while the main direction in the damaged regions is consistent.

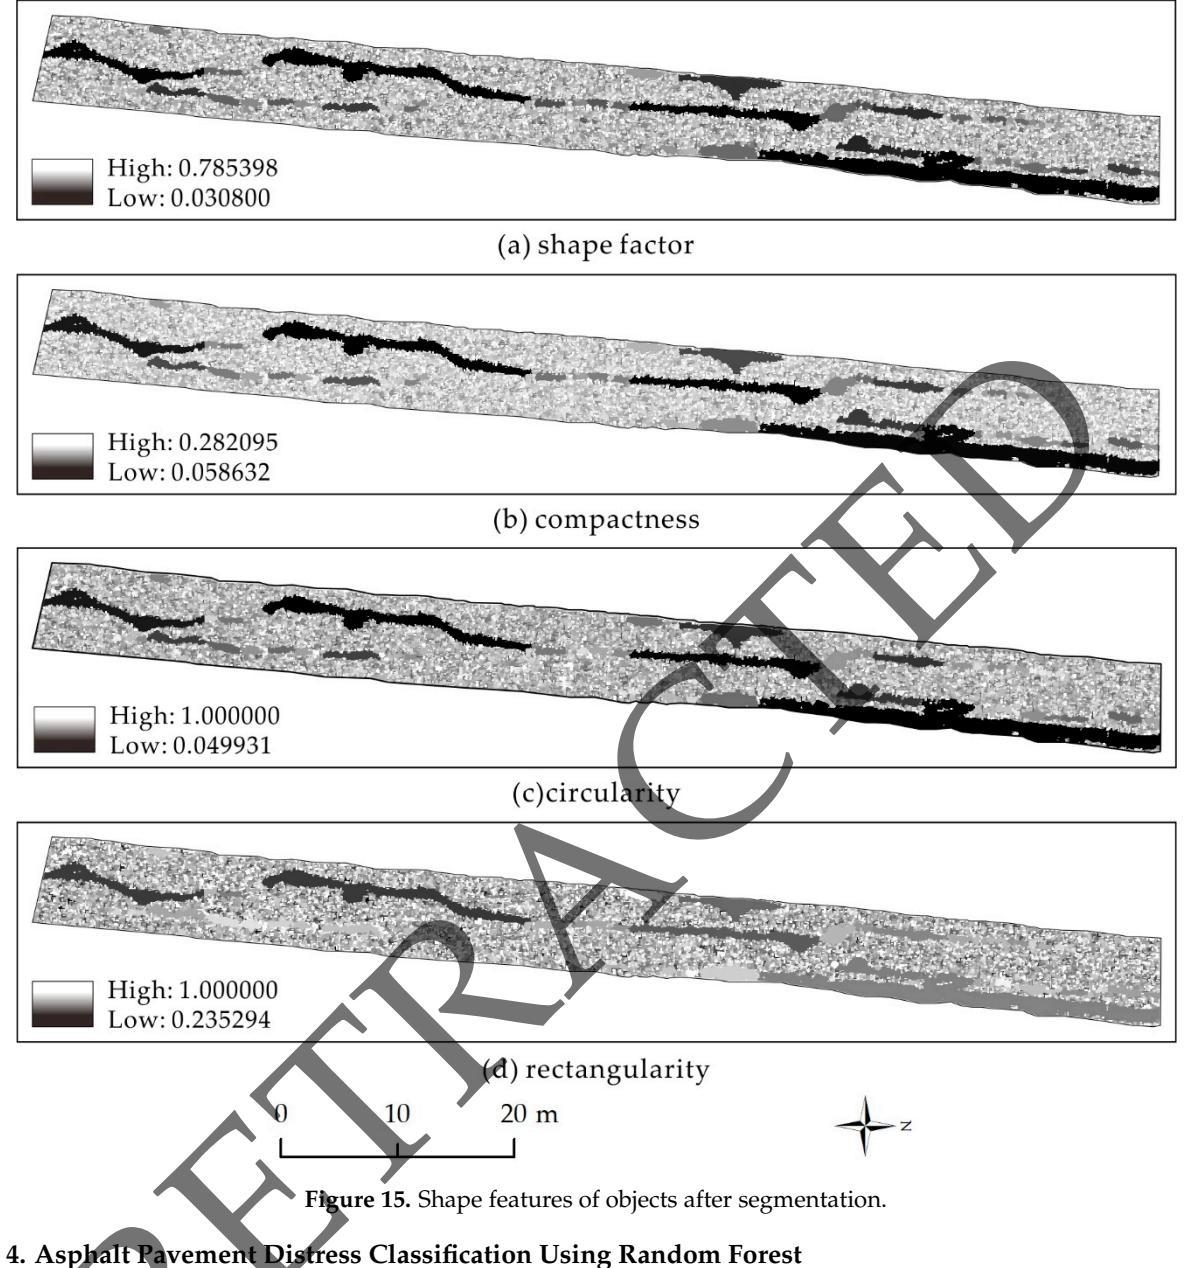
Shape factors are dimensionless quantities that are used in image analysis and numerically describe the shape of a polygon, independent of its size. The dimensionless quantities are utilized to represent the degree of deviation from a circle. Compactness is adopted to measure the degree of tightness for a polygonal boundary and the circle is the best compact shape. Circularity is used to measure the circular feature of a polygon, where the value of a standard circle is 1. Similarly, rectangularity is a measure of the rectangular feature, where the value of a rectangle is 1. These four features are calculated to measure the shape of the polygons (Figure 15). Some typical distresses, such as potholes, subsidence, and upheaval, have very recognizable geometrical shapes. The calculations of these shape features play an important role in pavement distress extraction and different types of distress distinctions.

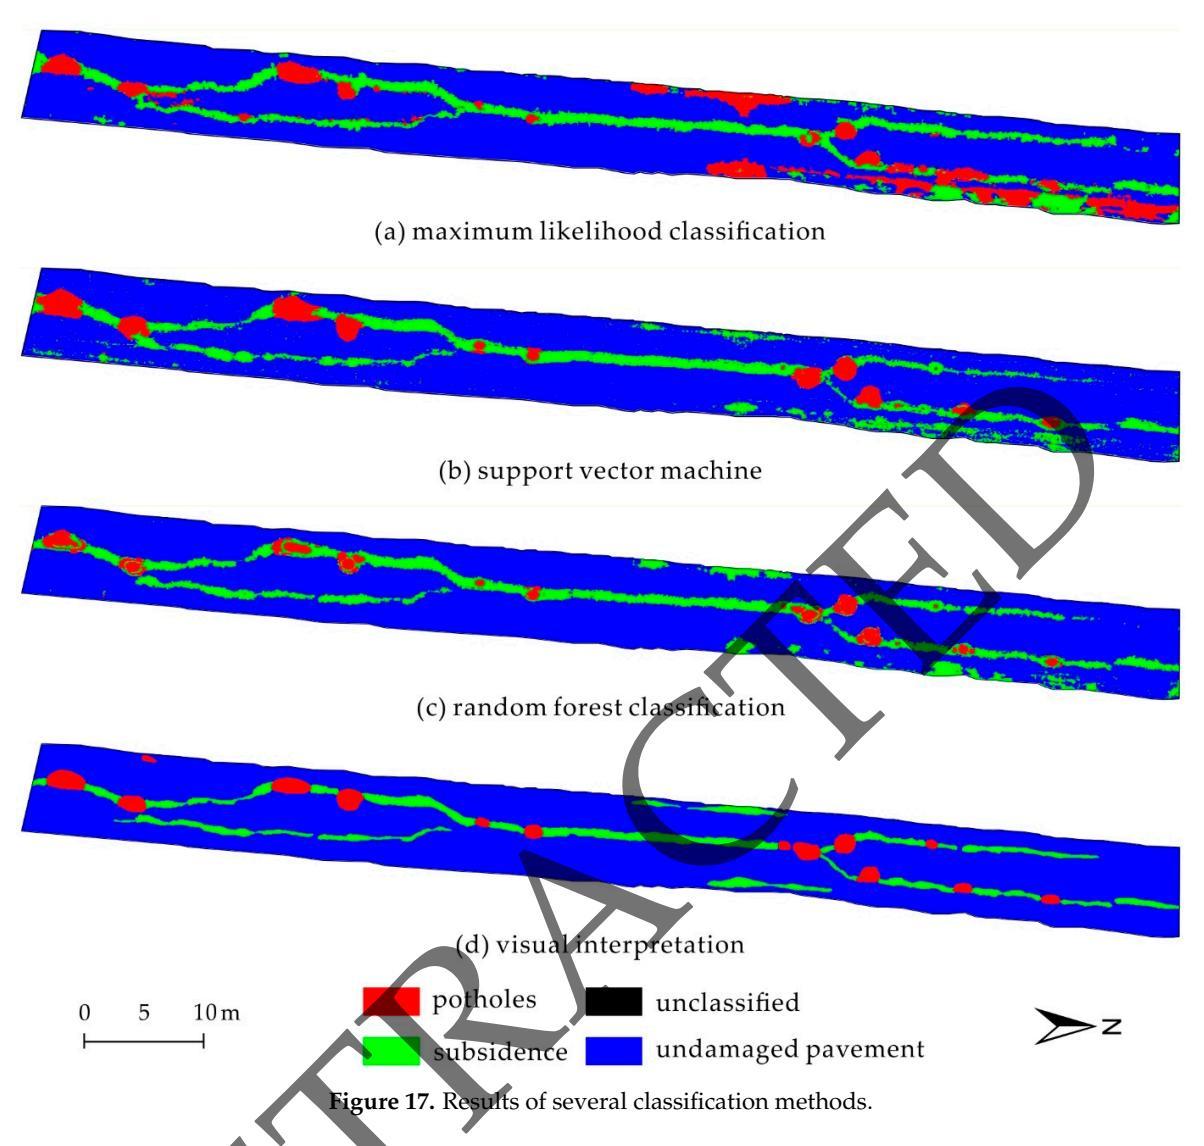
The classification results that were obtained with MLC and SVM were compared with the results of RFC (Figure 17). Simultaneously, the artificial visual interpretation results were used to verify the classification results. A comparison of the different methods is shown in Table 8.

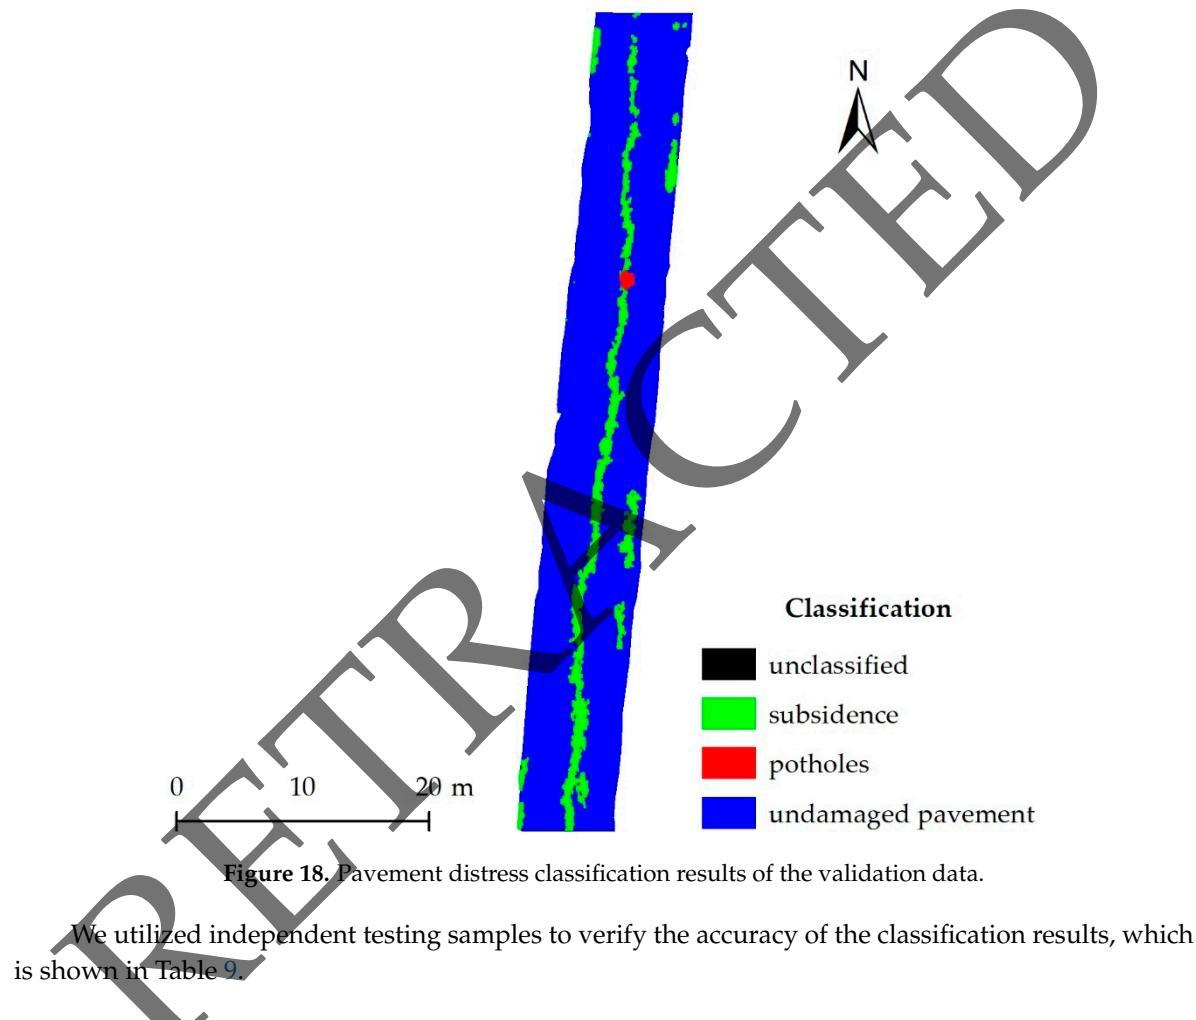
In this section, we applied the method proposed in this paper to the validation data to verify its stability. The acquisition and preprocessing of the validation data were the same as the experimental data. A multifeature dataset that included 48 features was extracted according to the elevation and reflection intensity of the original point cloud. The RFC method was adopted to conduct pavement distress classification. The classification results are shown in Figure 18.

accuracy was 95.86% and the Kappa coefficient was 0.9389. The classification accuracy of potholes was nearly 99%, while there was a certain degree of commission error in extracting subsidence distress. Combined with the reflection intensity image of the validation data, the damaged regions at the edge of subsidence areas were misclassified as subsidence distress. In these regions, the roughness index and Gaussian curvature were influenced by the surrounding pavement, and the eigenvalues were not obvious, which resulted in a certain degree of misclassification. However, the overall accuracy of the classification results was still high. Therefore, by using distress classification and the results analysis of the validation data, it is evident that our method was reliable and stable.
