# Corrosion Behavior and Mechanical Performance of Drill Pipe Steel in a CO<sub>2</sub>/H<sub>2</sub>S-Drilling-Fluid Environment

**Abstract:** Objectives: This article investigates the corrosion behavior and mechanical-property changes of S135, G105, and V150 drill pipe materials in a high-temperature-resistant, potassium amino poly-sulfonate drilling fluid, which has good lubrication performance and contains  $CO_2/H_2S$ , by applying an 80% yield-limit-load simulation. The results show that the  $CO_2$ -corrosion behavior of G105, S135, and V150 drill pipes are obvious under the simulated constant-load-stress-corrosion environments at the wellhead, well-middle, and bottomhole positions. Compared to uncorroded drill pipes, S135 and V150 drill pipes have increased strength and yield ratios, decreased fracture elongation, and increased sensitivity to hydrogen embrittlement under H<sub>2</sub>S action, and V150 has a greater risk of stress-hydrogen embrittlement. The strength and yield ratios of G105 -material drill pipes decrease, while the fracture elongation increases; the intensity-change amplitude levels are ranked V150 > G105 > S135, and the fracture-elongation-change amplitu

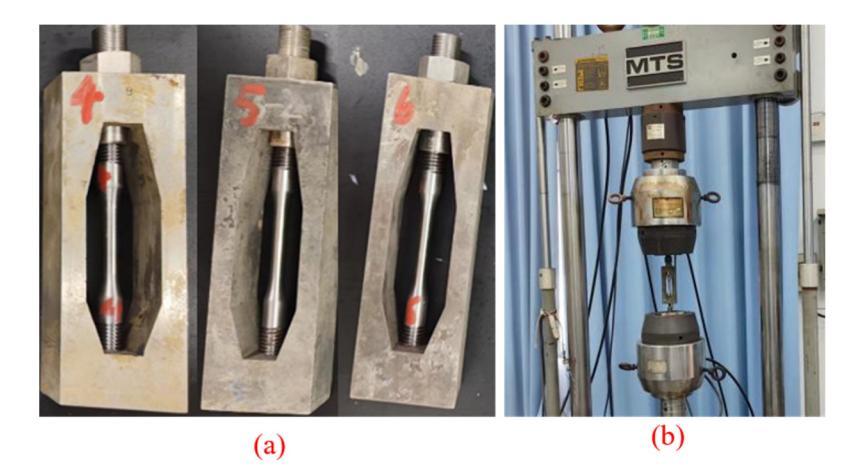
**Figure 1.** Test fixture device diagram. (**a**): Fixture assembly sample diagram; (**b**): MTS tensile testing machine loading.

We applied 80% constant-load-tensile stress to three materials based on the ultimate load that the drill pipe can withstand. We assembled the sample into the fixture, tightened the nut as shown in Figure 1a, and prepared the fixture for application of a constant load to the assembled sample; the upper and lower fixtures of the MTS tensile testing machine were respectively clamped at the upper and lower ends of the fixture, as shown in Figure 1b. An 80% constant load was applied, and the computer monitored in real-time the value of the tensile stress. When it reached 80% of the ultimate load, the loading stopped and the constant-load stress testing of the drill pipe was completed.

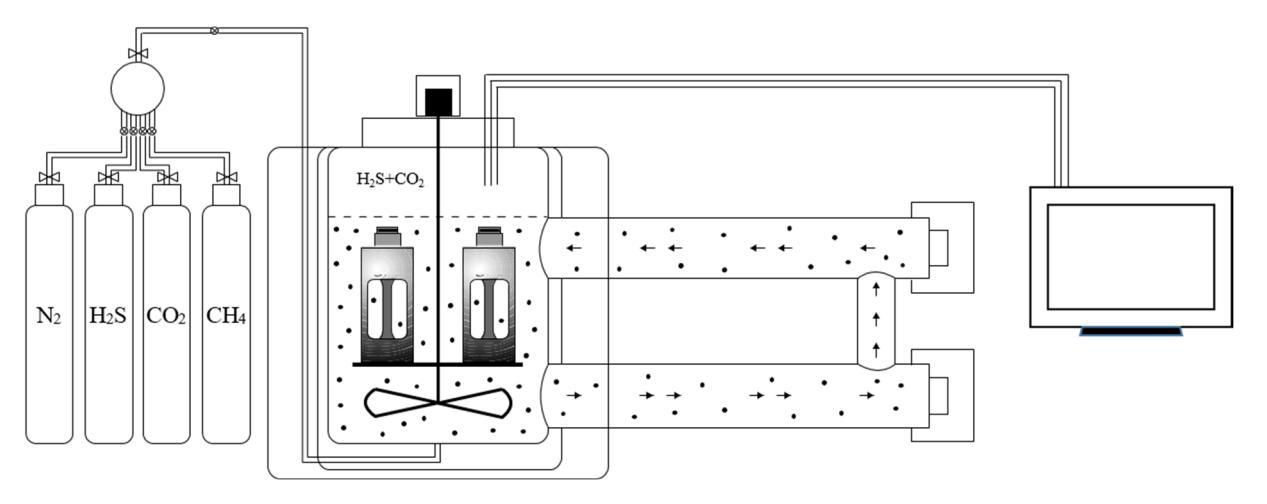
Figure 2. Schematic diagram of high-temperature and high-pressure kettle device.

The high-temperature and high-pressure vessel used in the experiment is a high-temperature and high-pressure flow cycle corrosion instrument, with a maximum temperature of 250 °C and a maximum pressure of 70 MPa. It can perform the constant-load-stress-corrosion experiments of  $CO_2^-$  and  $H_2S$ -flow-cycles under high-temperature and high-pressure environments. The schematic diagram of the vessel device is shown in Figure 2.

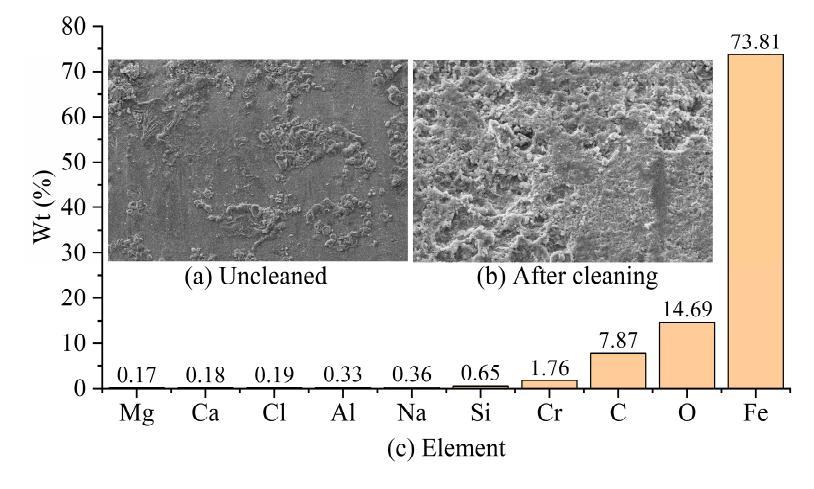
**Figure 3.** SEM image of corrosion morphology and EDS image of corrosion products of G105 material in a simulated wellhead-corrosion environment.

The corrosion-product morphology of the G105-material sample in the simulated wellhead location corrosion environment without cleaning is shown in Figure 3a. It can be seen that the corrosion product is dense and uneven in thickness, with the existence of micro-cracks in local areas. The corrosion morphology of the G105-material specimen after cleaning is shown in Figure 3b, and the sample shows serious uniform corrosion. In

addition to the chemical composition of the G105-material drill pipe shown in Table 2, the components of the uncleaned corrosion products are shown in Figure 3c. The main elements of the corrosion products of the G105 material after corrosion are C, O, Fe, and Cr, with a small amount of Si, Na, Al, Cl, Ca, and Mg elements. Fe, Cr, Si, and Al elements come from the metal matrix, while the other elements from the drilling fluid and  $CO_2$  gas, mainly resulting from  $CO_2$  corrosion. However, due to the lower temperature and pressure at the wellhead, the corrosion products are loose and do not easily form a film, leading to intensified corrosion.

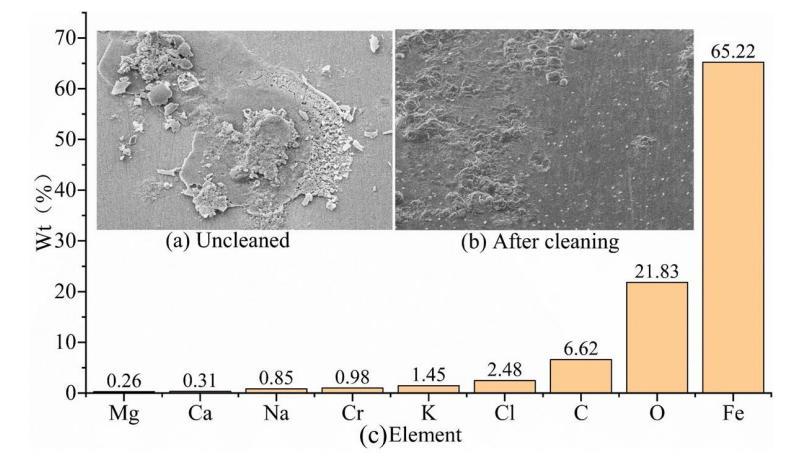
**Figure 4.** SEM image of corrosion morphology and EDS image of corrosion products of G105 material in a simulated well-middle-location corrosion environment.

The corrosion morphology of the uncleaned G105-material sample in the simulated well-middle corrosion environment is shown in Figure 4a, with loose and porous corrosion products and locally visible cracks visible. The corrosion morphology of the G105-material specimen after cleaning is shown in Figure 4b, with slight corrosion traces localized on the surface of the sample and with residual drilling fluid adhering. In addition to the chemical composition of the G105 drill pipe shown in Table 2, the components of the uncleaned corrosion products are shown in Figure 4c. The corrosion products of the G105 material mainly contain Fe, O, C, Cl, K, and Cr elements, in addition to a small amount of Cr, Na, Ca, and Mg elements. The Fe and Cr elements come from the metal matrix, and the remaining elements come from drilling fluid and CO<sub>2</sub> gas, mainly resulting from CO<sub>2</sub> corrosion. Compared with the simulated corrosion environment at the wellhead location, the increase in the mass fraction of Cl in the corrosion environment at the well-middle location promotes the initiation and development of local corrosion.

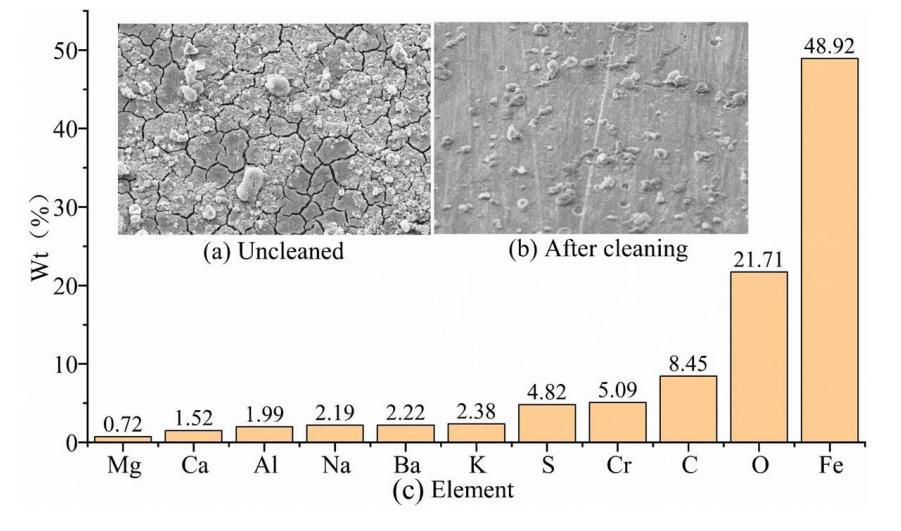
**Figure 5.** SEM image of corrosion morphology and EDS image of corrosion products of G105 material in a simulated bottomhole corrosion environment.

In the simulated corrosion environment at the bottomhole, the corrosion morphology of the uncleaned G105-material specimen, shown in Figure 5a, the corrosion products show typical turtle-shaped cracks. The reason for this is that after the sample is taken out of the high-temperature and high-pressure reactor,  $Cr(OH)_3$  in the corrosion products is easily dehydrated to form Cr<sub>2</sub>O<sub>3</sub> [23]. The corrosion morphology of the G105-material specimen after cleaning is shown in Figure 5b, and a small amount of corrosion products are still locally attached. In addition to the chemical composition of the G105 drill pipe shown in Table 2, the components of the uncleaned corrosion products are shown in Figure 5c. The corrosion products of the G105 material mainly contain Fe, O, C, Cr, S, K, Ba, Na, Al, and Ca elements, in addition to a small amount of Mg element. The Fe, Si, Cr, and Al elements come from the metal substrate, while the other elements come from drilling fluid and  $CO_2/H_2S$ gas, and they are mainly produced by CO<sub>2</sub> corrosion and H<sub>2</sub>S corrosion. Compared to the simulated environment at the wellhead and well-middle, a large number of cations were detected at the bottomhole, indicating an increase in the electrical conductivity of the simulated drilling fluid. The highly active Cr element will passivate to produce relatively dense  $Cr(OH)_3$  films in  $CO_2$ -corrosion environments [24]. The mass fraction of Cr at the bottom of the well is the highest, and the cracking phenomenon of the corrosion products also proves that it forms a relatively dense  $Cr(OH)_3$  film at the bottomhole, which can effectively block the ions from contacting the metal substrate.

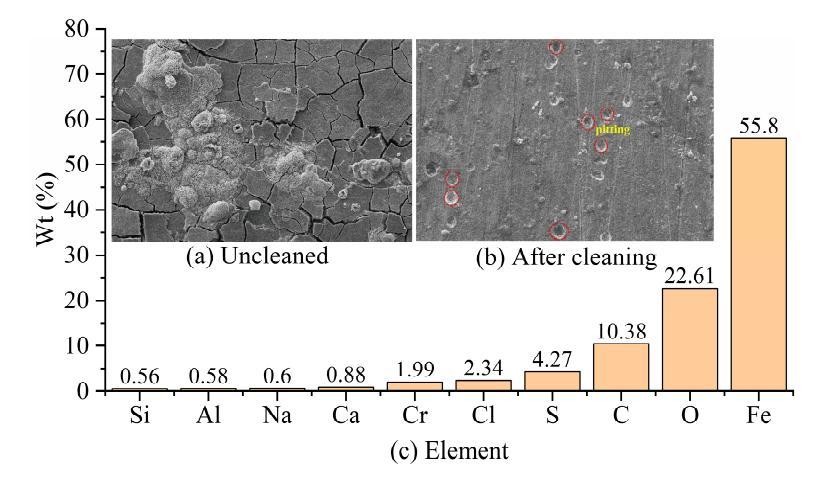
**Figure 6.** SEM image of corrosion morphology and EDS image of corrosion products of S135 material under simulated wellhead-corrosion environment.

The corrosion morphology of the S135 material in the simulated wellhead-corrosion environment without cleaning is shown in Figure 6a. It can be seen that the corrosion products present large-sized cracks, with local areas appearing in the shape of hairy balls. The corrosion morphology of the S135-material specimen after cleaning is shown in Figure 6b, with clearly visible but sparsely distributed pitting. In addition to the chemical composition of the S135-material drill pipe shown in Table 2, the components of the uncleaned corrosion products are shown in Figure 6c. The corrosion products mainly contain Fe, O, C, S, Cl, and Cr elements, in addition to a small amount of Ca, Na, Al, and Si elements. Fe, Cr, and Al elements come from the S135 material, while the other elements come from the drilling fluid and the  $CO_2/H_2S$  gas. The S135 material is mainly corroded by  $CO_2$  accompanied by  $H_2S$  at the wellhead, and the effect of  $Cl^-$  intensifies the occurrence of pitting corrosion.

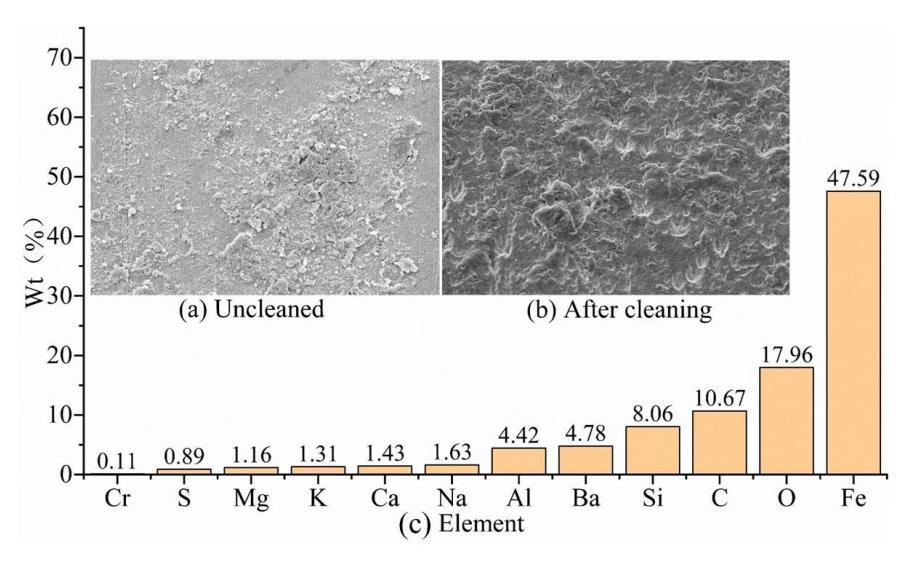
**Figure 7.** SEM image of corrosion morphology and EDS image of corrosion products of S135 material in a simulated well-middle corrosion environment.

The corrosion morphology of the S135 material from the simulated well-middle location corrosion environment and without cleaning is shown in Figure 7a, with loose corrosion products, local accumulation, and uneven thickness. The corrosion morphology of the S135-material specimens after cleaning is shown in Figure 7b, with corrosion pits of varying size scattered throughout the sample. In addition to the chemical composition of the S135-material drill pipe shown in Table 2, the components of the uncleaned corrosion products are shown in Figure 7c. The corrosion products of the S135 material mainly contain Fe, O, C, Si, Ba, Al, Na, Ca, K, and Mg elements, in addition to a small amount of S and Cr elements. The Fe, Si, Al, and Cr elements are from the S135 material, while the other elements are from the drilling fluid and the  $CO_2/H_2S$  gas. The S135 material in the well-middle is mainly corroded by CO<sub>2</sub> and slightly corroded by H<sub>2</sub>S. When the types and contents of elements are detected as increasing, the conductivity of the solution increases, exacerbating the corrosion of the S135 material's metal matrix. Compared with the wellhead, a large number of S135-material components and drilling fluid components were detected with corrosion products in the well-middle, with the lowest content of Cr proving that there is more serious corrosion under this working condition.

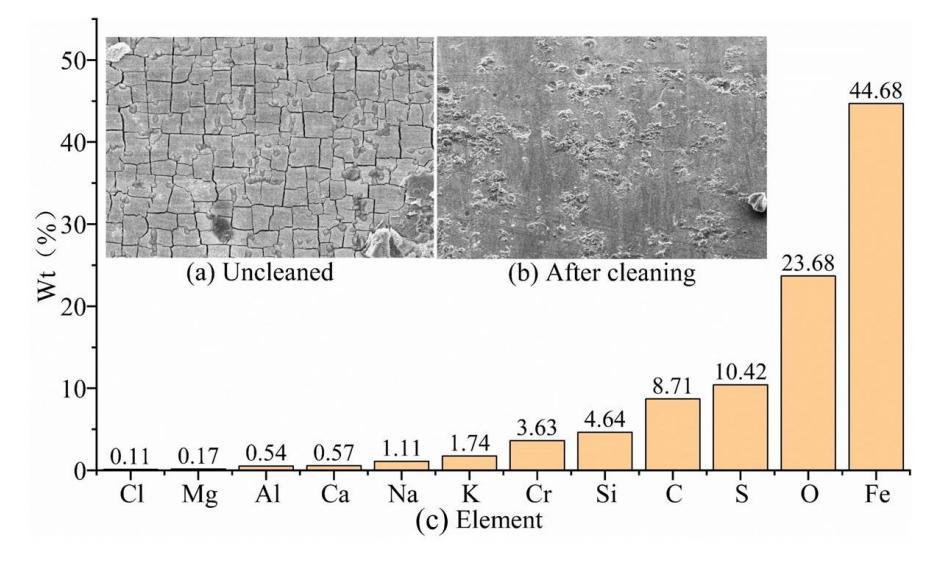
**Figure 8.** SEM image of corrosion morphology and EDS image of corrosion products of S135 material in a simulated bottomhole corrosion environment.

The corrosion morphology of the S135 material from the simulated bottomhole corrosive environment without cleaning is shown in Figure 8a. The corrosion products are densely cracked and there is also a small amount of residual drilling fluid attached to the surface. The corrosion morphology of the S135 material after cleaning is shown in Figure 8b, and there are still corrosion products attached to the surface of the sample, with an obvious pitting phenomenon visible locally. In addition to the chemical composition of the S135-material drill pipe shown in Table 2, the components of the uncleaned corrosion products are shown in Figure 8c. The corrosion products of the S135 material mainly contain Fe, O, S, C, Si, Cr, K, and Na elements, in addition to a small amount of Ca, Al, Mg, and Cl elements. The elements Fe, Si, Cr, and Al come from the metal substrate, while the other elements come from drilling fluid and  $CO_2/H_2S$  gas, mainly causing  $CO_2$  corrosion and  $H_2S$  corrosion. Compared with the wellhead and well-middle positions, the S135 material exhibits more serious  $H_2S$  corrosion at the bottomhole.

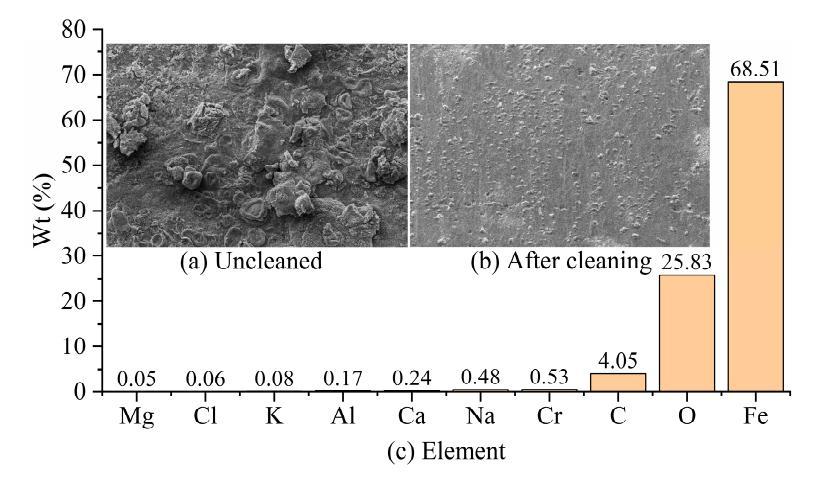
**Figure 9.** SEM image of corrosion morphology and EDS image of corrosion products of V150 material in a simulated wellhead-corrosion environment.

The corrosion morphology of the uncleaned V150-material specimen in a simulated wellhead-corrosion environment is shown in Figure 9a, with accumulation of the corrosion products and uneven thickness visible. The corrosion morphology of the V150-material specimen after cleaning is shown in Figure 9b, with a large number of corrosion products still adhering and slight pitting corrosion observed. In addition to the chemical composition of the V150 drill pipe shown in Table 2, the uncleaned corrosion products are shown in Figure 9c. The corrosion products of the V150 material mainly contain Fe, O, and C elements, with very little content from other elements. Fe and a small amount of Cr coming from the metal matrix, while the other elements are from drilling fluids and  $CO_2/H_2S$  gas, mainly resulting in CO<sub>2</sub> corrosion.

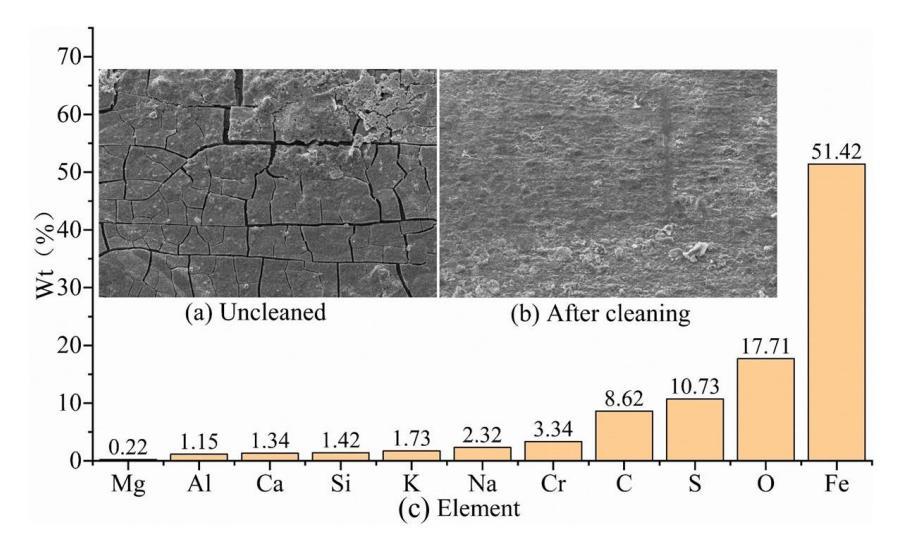
**Figure 10.** SEM image of corrosion morphology and EDS image of corrosion products of V150 material in the simulated well-middle corrosion environment.

The corrosion morphology of the V150 material in a simulated wellhead-corrosion environment is shown in Figure 10a, with locally visible large-sized cracks in the corrosion products. The corrosion morphology of the V150-material specimen after cleaning is shown in Figure 10b, and obvious homogeneous corrosion traces can be seen on the sample. In addition to the chemical composition of V150 drill pipe shown in Table 2, the components of the uncleaned corrosion products are shown in Figure 10c. In the simulated well-middle-

location corrosion environment, the corrosion products of the V150 material mainly contain Fe, O, S, C, Cr, Na, K, Si, Ca, and Al elements, in addition to a small amount of Mg elements. Fe, Cr, Si, and Al elements come from the metal matrix, while the other elements come from the drilling fluid and  $CO_2/H_2S$  gas.  $CO_2$  corrosion and  $H_2S$  corrosion co-exist. A large amount of Cr was detected and the corrosion products were in a cracked state, indicating that there is a dense  $Cr(OH)_3$  film that has formed on the surface of the metal matrix, which can slow down corrosion. Compared with the wellhead simulation, in the V150 material we detected a large number of S elements in the well-middle simulation, resulting in severe  $H_2S$  corrosion and an increase in Cr content.

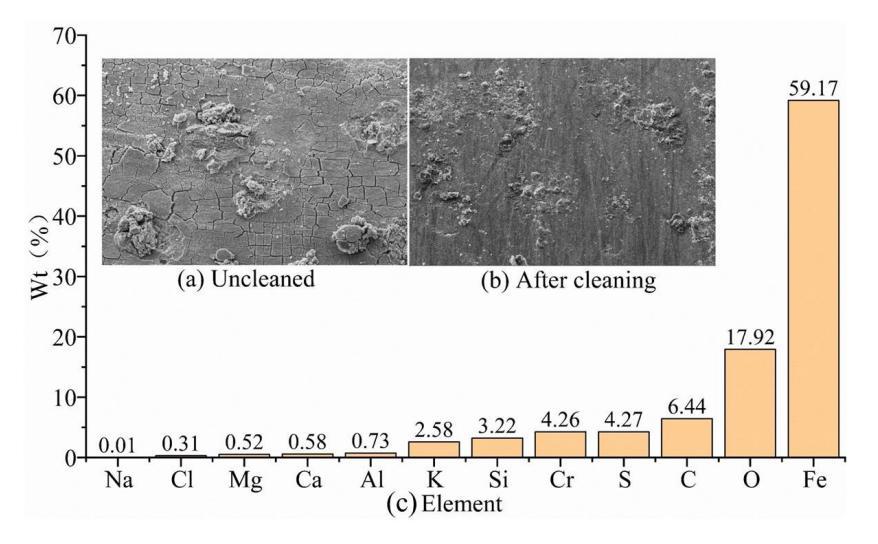
**Figure 11.** SEM image of corrosion morphology and EDS image of corrosion products of V150 material in the simulated bottomhole corrosion environment.

The corrosion morphology of the uncleaned V150 material in a simulated bottomhole corrosion environment is shown in Figure 11a. The corrosion products are ruptured and uneven in thickness, with local accumulation of products. The corrosion morphology of the V150 material specimen after cleaning is shown in Figure 11b, and there is no obvious corrosion phenomenon with local residual corrosion products. In addition to the chemical composition of the V150-material drill pipe shown in Table 2, the components of the uncleaned corrosion products are shown in Figure 11c. The corrosion products of the V150 material mainly contain Fe, O, C, S, Cr, Si, and K elements, in addition to a small amount of Al, Ca, Mg, Cl, and Na elements. Fe, Cr, Si, and a small amount of Al elements come from the metal matrix, while the other elements come from drilling fluid and  $CO_2/H_2S$  gas.

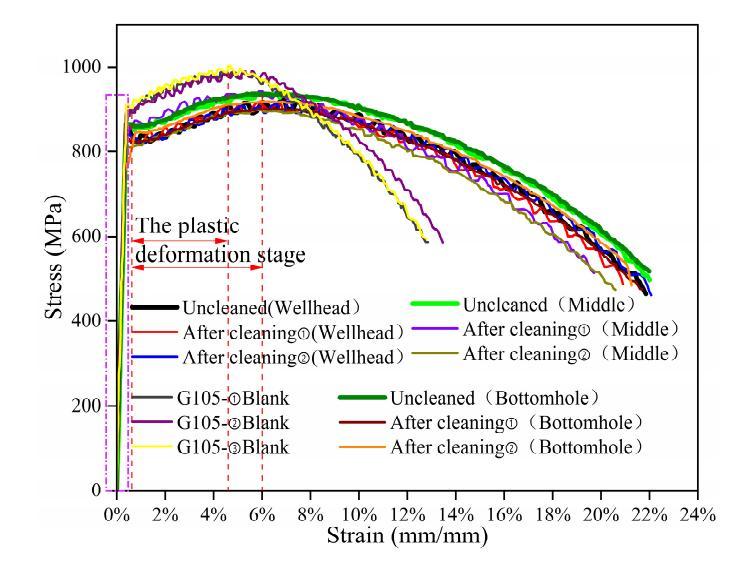
Figure 12. G105 material tensile stress-strain curve.

As shown in Figure 12, the tensile stress–strain curve of G105-material specimens was obtained under simulated corrosion environments at the wellhead, well-middle, and bottomhole positions, as well as without corrosion. The variation trend of the tensile stress–strain curves of the uncleaned specimen at the wellhead is consistent with that of the cleaned samples, while the tensile stress–strain curves of the uncleaned specimen in the well-middle and at the bottomhole are slightly higher than those of the cleaned samples. From this, it can be seen that when the temperature is low, the corrosion product becomes loose and easily falls off under the action of force; when the temperature is high, the corrosion products are dense, which can to some extent slow down the fracture of the specimen under constant load. After constant-load-stress-corrosion, the average strain values of G105-material fracture under simulated corrosion environments at the wellhead, well-middle, and bottomhole positions are 21.7%, 20.1% and 22.0%, respectively. The average strain value of the uncorroded specimen fracture is 13.0%. The average maximum stress value (average tensile strength value) of G105-material fracture in the simulated corrosion environments

at the wellhead, well-middle, and bottomhole positions are 907 MPa, 908 MPa, 901 MPa, respectively, and the average maximum stress value of the uncorroded specimen fracture is 986 MPa. During the elastic deformation stage (rectangular dashed line in Figure 12), the stress-increase trend of the corrosion-simulation environment of the three well-section locations and the uncorroded samples under the action of constant-load-tensile stress is consistent. It can be seen that the elastic deformation ability of the G105 material decreases after the constant-load-stress-corrosion experiments; in the plastic deformation stage (the area indicated by the red double arrows in Figure 12), the plastic deformation ability of the G105 material decreased compared to the uncorroded specimen after simulated corrosion experiments at the wellhead, well-middle, and bottomhole. After the stress value reaches the tensile strength (red dotted line), the decreasing trend of the stress–strain curve is slower compared with the uncorroded specimen under three simulated conditions.

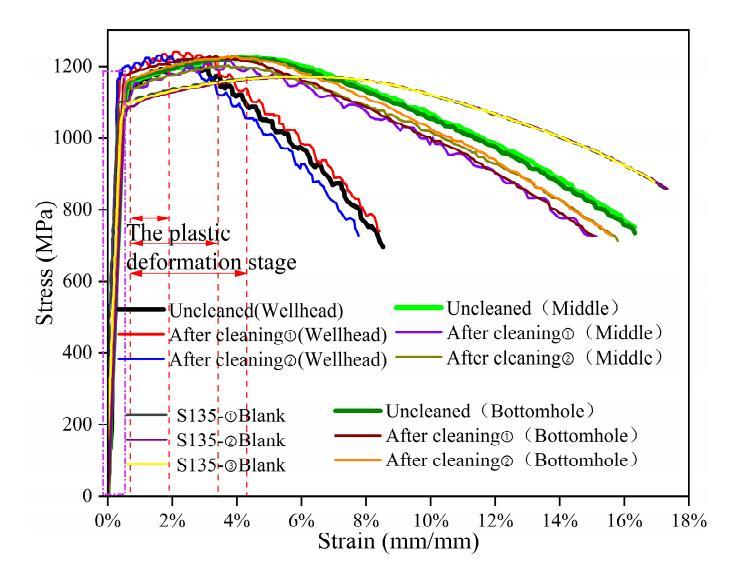
Figure 13. Tensile stress-strain curve of S135 material.

As shown in Figure 13, the tensile stress-strain curves of S135-material specimens were obtained in corrosion-simulation environments for the wellhead, the middle, and the bottomhole locations, as well as without corrosion. The variation trend of the tensile stress-strain curve of the uncleaned specimen at the wellhead is consistent with that of the cleaned specimen, while the tensile stress-strain curves of the uncleaned specimen at the well-middle and at the bottomhole are slightly higher than those of the cleaned specimen; it can be inferred that when the temperature and pressure at the wellhead are low, the corrosion products formed are loose and easily detached under the action of the force. The increasing temperature, pressure, and corrosive media in the well-middle and at the bottomhole can result in denser corrosion products, which can slow down the fracture of the sample to a certain extent under constant load. After constant-load-stress corrosion, the average strain value of S135-material fracture under simulated corrosion environments at the wellhead, well-middle, and bottomhole locations are 16.4%, 15.7%, and 15.8%, respectively. The average strain value of the uncorroded specimen's fracture is 17.1%; The average maximum stress values (the average tensile strength values) of the S135 material under corrosion-simulation environments at the wellhead, well-middle, and bottomhole locations are 1191 MPa, 1190 MPa, and 1203 Mpa, respectively. The average maximum stress value of the uncorroded specimen fracture is 1166 MPa. During the elastic deformation stage (dashed rectangle line in Figure 13), under constant-load tension, the stress-increase trend of the corrosion-simulation environment and the uncorroded specimen at the three well-section locations is consistent. It can be seen that the stress value of the S135 material increases after the constant-load-stress-corrosion experiment. In the plastic deformation stage (indicated by the red double arrows in Figure 13), the plastic deformation capacity of the S135 material increased compared to the uncorroded specimen

after the corrosion-simulation experiments at the wellhead, in the well-middle, and at the bottomhole, and the stress during the plastic deformation stage was the highest at the wellhead. After the stress value reaches the tensile strength (red dashed line), the decreasing trend of the stress–strain curve increases compared with the uncorroded specimens under the three simulated corrosion conditions, that is the susceptibility to SSCC increases, and the decreasing trend of the stress–strain curve is steepest at the wellhead. In the SEM of the cleaned specimen, it can be seen that the S135 material exhibits obvious pitting corrosion at the wellhead. In addition, and  $H_2S$  corrosion effect makes the S135 material the most SSCC-sensitive at the wellhead.

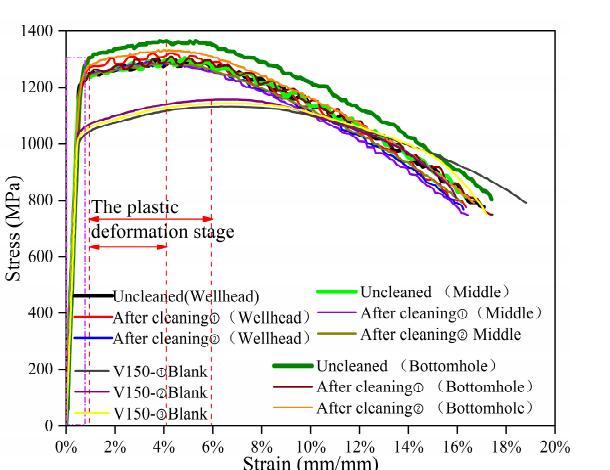
Figure 14. Stress-strain curve in tension for V150 material.

As shown in Figure 14, the tensile stress-strain curves of the V150 material were obtained under the corrosion-simulation environments at the wellhead, in the well-middle, and at the bottomhole, as was obtained for uncorroded V150 material. The variation trend of the tensile stress-strain curves of the specimens at the wellhead, well-middle, and bottomhole are consistent, but the tensile stress-strain curve of the uncleaned specimen at the bottomhole are highest; it can be seen that the dense corrosion products at the bottomhole have to some extent slowed down the fracture of the sample under constant load. After constant-load stress corrosion, the average strain values of V150-material fracture under the corrosion-simulation environment at the wellhead, well-middle, and bottomhole positions were 16.6%, 16.8% and 16.9%, respectively. The average strain value of the uncorroded specimen fracture was 17.4%. The average maximum stress values (average tensile strength values) of V150-material fracture under the corrosionsimulation environment at the wellhead, well-middle, and the bottomhole location are 1288 MPa, 1271 MPa, and 1304 MPa, respectively. The average maximum stress value of the uncorroded specimen fracture is 1148 MPa. During the elastic deformation stage (rectangular dashed line in Figure 14), under constant-load tension, the stress-increase trend of the corrosion-simulation environment and the uncorroded specimen at the three well sections is consistent. It can be seen that the elastic deformation capacity of the V150 material increases after the constant-load-stress-corrosion experiment; in the plastic deformation stage (indicated by the red double arrows in Figure 14), the plastic deformation capacity of the V150 material increases compared to uncorroded specimen after simulated corrosion experiments at the wellhead, in the well-middle, and at the bottomhole. After the stress value reaches the tensile strength (red dashed line), the decreasing trend of the stress-strain curve is steeper compared to the uncorroded specimen under the three simulated working conditions.

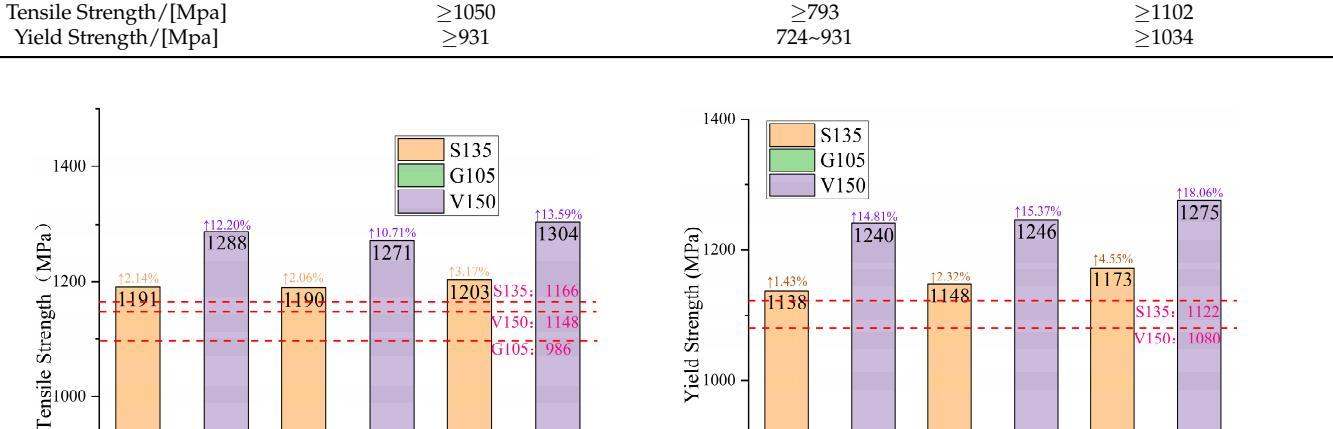
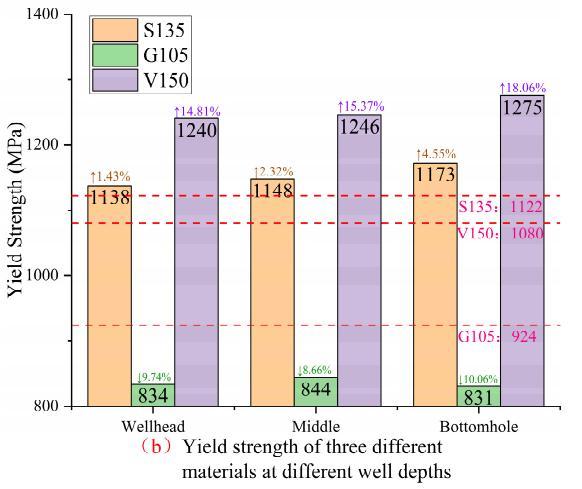
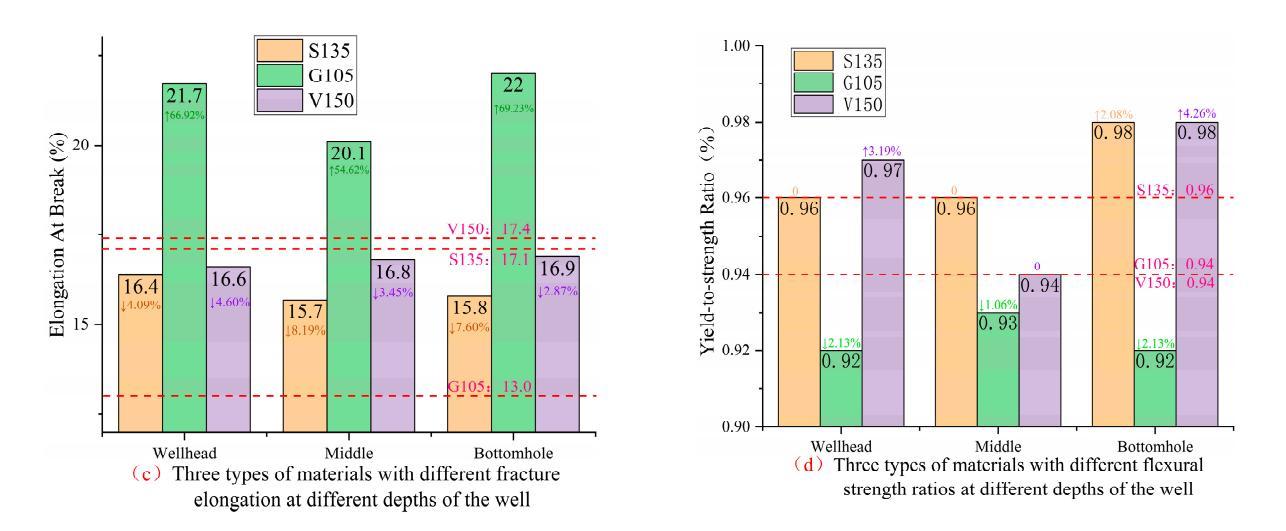
Figure 15. Schematic diagram of tensile performance of three materials under different working conditions.

As can be seen from Figure 15a, compared to the uncorroded specimens, the tensile strength of S135, G105, and V150 drill pipe materials increased by 2.06~3.17%, decreased by 7.91~8.62%, and increased by 10.71~13.59%, respectively. The S135 and V150 materials undergo strain hardening under the influence of H<sub>2</sub>S in the process of tensile stress. The increase in tensile strength implies a decrease in their plastic deformation ability and toughness, whereas the G105 drill pipe material is affected by CO<sub>2</sub> corrosion, resulting in a decrease in its fracture resistance. The change in tensile strength of three materials varies from largest to smallest as follows: V150 material > G105 material > S135 material.

According to Figure 15b, compared with the uncorroded specimens, the yield strength of the S135, G105, and V150 drill pipe materials increased by 1.43~4.55%, decreased by 8.66~10.06%, and increased by 14.81~18.06%, respectively. The increase in yield strength of S135 and the V150 material proves an increase in their susceptibility to stress corrosion cracking under H<sub>2</sub>S action, and the V150 material has a greater sensitivity to hydrogen embrittlement. Although the G105 material has no risk of hydrogen embrittlement-sensitive fracture, its yield strength is damaged after corrosion. The change in yield strength of three materials ranges from largest to smallest as follows: V150 material > G105 material > S135 material.

As can be seen from Figure 15c, compared with the uncorroded specimen, the fracture elongation of the S135, G105, and V150 drill pipe materials decreased by 4.09~8.19%, increased by 54.62~69.23%, and decreased by 2.87~4.60%, respectively. Fracture elongation is used to evaluate the plasticity of pipes. The decrease in elongation of S135 and V150 drill pipe materials indicates the existence of strain hardening, while the G105 material has good plastic deformation ability. The change in fracture elongation of the three materials ranges from largest to smallest as follows: G105 material > S135 material > V150 material.

According to Figure 15d, it can be seen that the flexural strength ratio of the S135 drill pipe material increases by 2.08% at the bottomhole, the yield ratio of the G105 drill pipe material decreases by 1.06~2.13%, and the yield ratio of the V150 drill pipe material increases by 3.19~4.26% at the wellhead and the bottomhole. The increases in flexural strength ratio of the S135 and V150 materials indicates an increased risk of brittle damage for both materials.
