Article Extreme Serum Titanium Concentration Induced by Acetabular Cup Failure: Unveiling a Unique Scenario of Titanium Alloy Debris Accumulation

Abstract: The majority of contemporary total hip arthroplasty (THA) implants are constructed from Ti alloys, which are generally believed to generate fewer adverse local tissue reactions (ALTRs) compared to CoCr alloys. This study presents a case of unusual primary THA failure where a substantial release of Ti alloy debris was observed. A 52-year-old active male underwent THA after post-traumatic aseptic necrosis of the femoral head in 2006. Seventeen years after the procedure, the patient presented with groin pain and a restricted range of motion. X-rays revealed the protrusion of the alumina ceramic head through the Ti₆Al₄V acetabular cup. Trace element analysis indicated significantly elevated levels of serum Ti, Al, and V. CT and MRI confirmed Ti alloy cup failure and a severe ALTR. During revision surgery, it was found that the worn-out ceramic head was in direct contact with the acetabular cup, having protruded through a central hole it had created over time. No acetabular liner was found. Histological analysis of his tissue sample

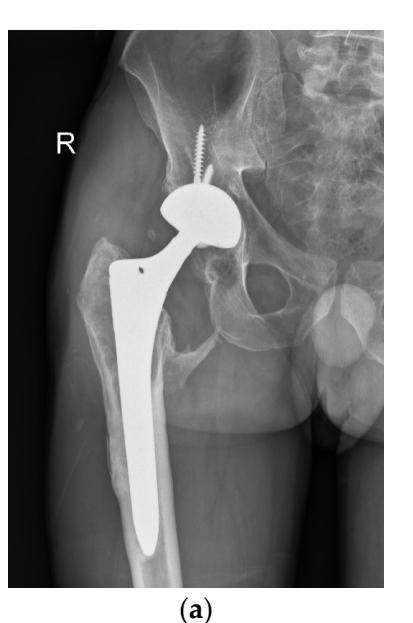
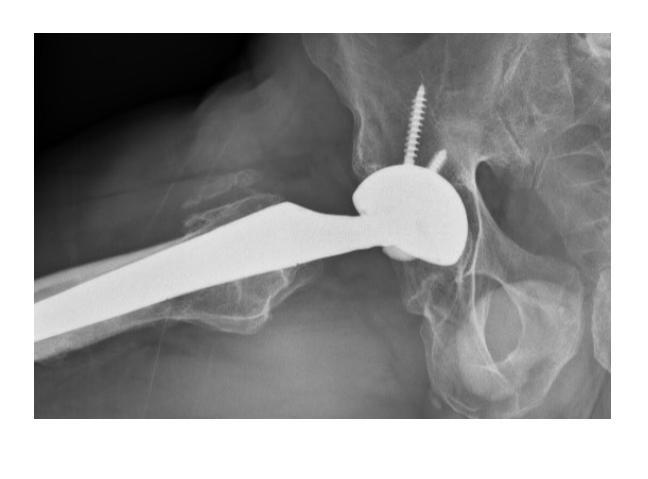
Figure 1. Radiographs of the patient's right hip 8 years after primary THA. (**a**) Antero-posterior view; (**b**) lateral view. Note that the head is penetrating a lot into the cup (**a**) and that there is an offset of the ceramic head within the cup (**b**). Some heterotopic ossification at the level of the lesser trochanter is likely related to the patient's previous osteosynthesis for a femoral neck fracture.

Despite the absence of pain, the patient reported unusual sounds in the hip during weight bearing, linked to the CoC bearing. Standard radiographs of the right hip were deemed normal, as depicted in the first available postoperative X-ray (Figure 1). Therefore, no further evaluation or specific treatment was advised for the patient.

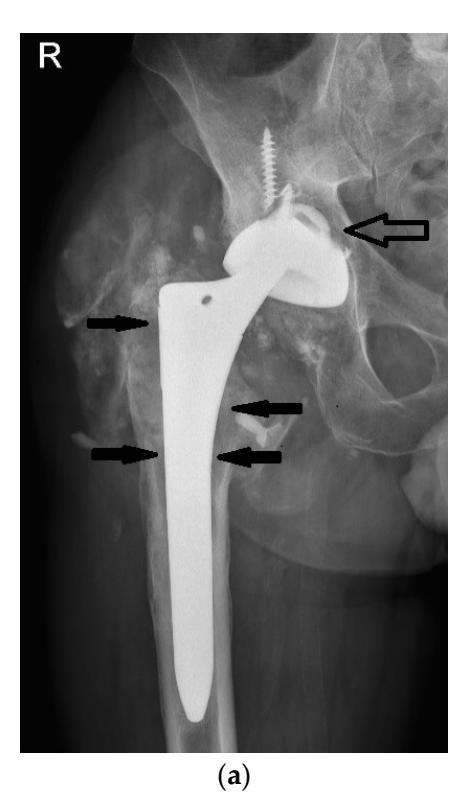
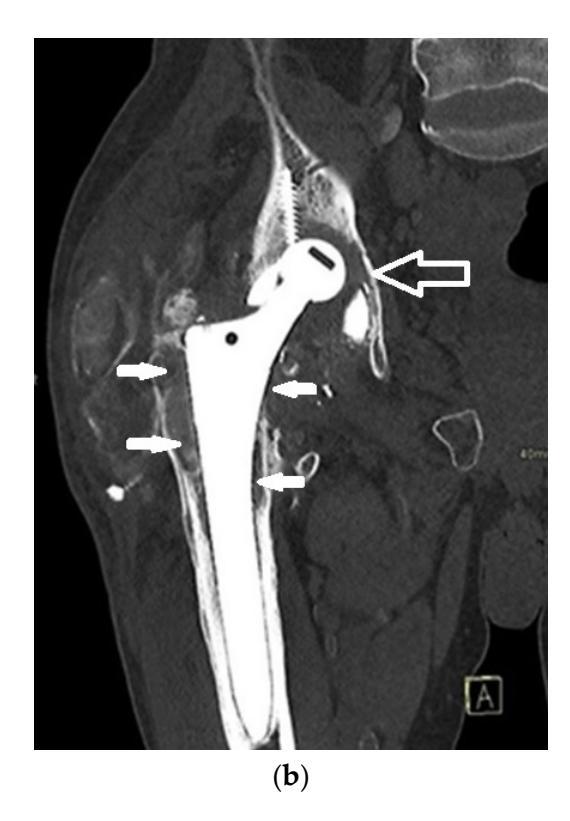
Figure 2. Radiographic imaging of the patient's right hip 17 years after primary THA. Note alumina ceramic femoral head protrusion through the acetabular cup (hollow arrows), extensive calcifications in the soft tissues, and osteolysis (solid arrows). (**a**) Antero-posterior X-ray; (**b**) computer tomography (CT) scan with coronal reconstruction.

Seventeen years post-THA, the now 52-year-old patient presented to our outpatient clinics with groin pain and a severely limited range of motion. The patient's Harris Hip Score (HHS) was 48 points. His laboratory parameters, including white cell count, hemoglobin level, liver and kidney function, erythrocyte sedimentation rate (ESR), and C-reactive protein (CRP) level, were within the normal limits (Table 1). Separate blood samples were taken and stored in special containers (BD Vacutainer[®] Trace Element, Becton Dickinson, Franklin Lakes, NJ, USA). His serum levels of titanium, aluminium, and vanadium were determined at the nationally accredited laboratory (Clinical Institute for Clinical Chemistry and Biochemistry, Ljubljana, Slovenia) for trace element analysis. Measurements of titanium in his blood samples were performed using inductively coupled plasma mass spectroscopy (ICP-MS) with the Octopole Reaction System (7700×, Agilent Technologies, Santa Clara, CA, USA). X-ray and computer tomography (CT) evaluation revealed the protrusion of the alumina ceramic head through the Ti6Al4V acetabular cup (Figure 2), necessitating immediate scheduling for THA revision due to the severe condition of the patient's hip and the significant risk of further complications.

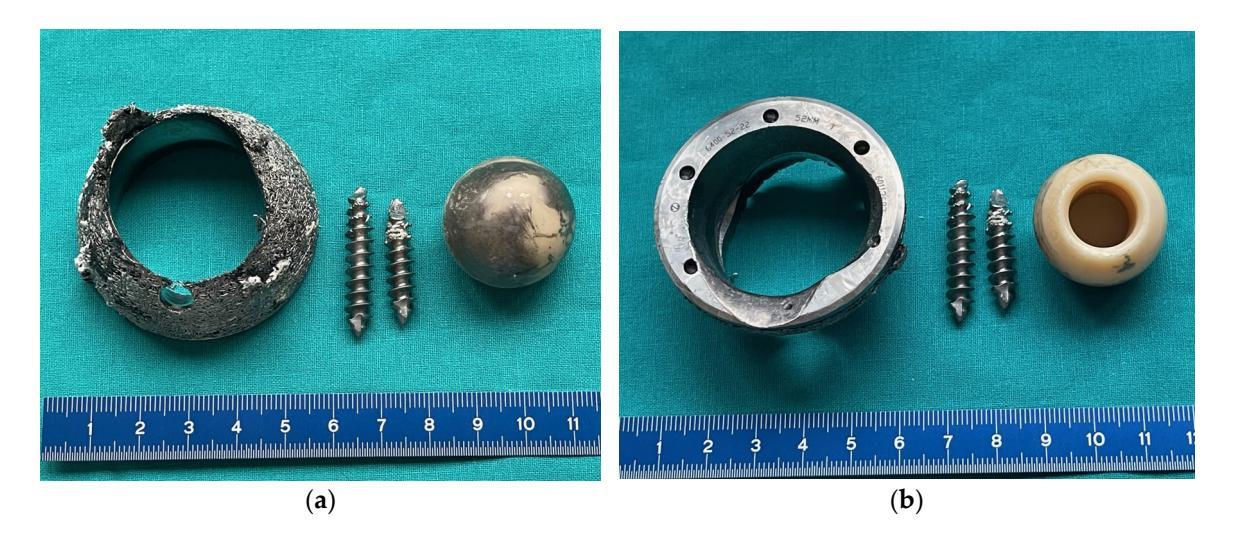
Figure 3. A photograph of the removed Ti6Al4V acetabular cup showing a central hole which was created by the alumina ceramic head. (**a**) Cranial view; (**b**) caudal view.

During the revision surgery, the absence of an acetabular liner was noted, and the wornout ceramic head had made direct contact with the acetabular cup, protruding through a central hole formed over time (Figure 3). Pseudo-tumors in the soft tissue and severe metallosis near the implant were excised, with tissue samples sent for histological analysis and cultures. Acetabular screws underwent sonication. The stable femoral stem with an intact Morse taper for femoral neck–head coupling necessitated only the exchange of the acetabular component and femoral head. A 58 mm Ti6Al4V press-fit acetabular cup (DELTA TT, LimaCorporate, Udine, Italy) with an aluminum oxide matrix composite ceramic liner (BIOLOX Delta, CeramTec) was inserted and secured with three screws. A 36 mm aluminum oxide matrix composite ceramic revision femoral head with a Ti6Al4V sleeve (BIOLOX Delta Option, CeramTec) was attached to the original femoral stem, followed by repositioning (Figure 4).

The etiology behind the catastrophic failure of the titanium alloy acetabular cup remains elusive. Although the original manufacturer's sticker, containing all pertinent data on the implant, was located in the patient's medical records, no evidence of the acetabular liner was discovered during revision surgery. Additionally, despite employing various radiographic procedures (X-rays, CT, and MRI), we were unable to identify fragments or remnants of the ceramic liner. It is plausible that the entire acetabular liner was ground into tiny and fine-grain debris; however, such debris was not identified in the histological samples obtained during revision surgery. Furthermore, the absence of larger pieces of alumina ceramic liner, which would likely have eluded the grinding process between the intact alumina ceramic femoral head and the dome of the acetabular cup, speaks against this hypothesis. Conversely, it would be highly unusual for an orthopedic surgeon not to insert the acetabular liner into the acetabular cup. In such a scenario, over the years, the harder ceramic femoral head would inevitably create a void in the softer titanium alloy acetabular cup, particularly in a young and physically active patient.

In the context of our patient, who engaged in demanding agricultural work, the higher mechanical loads expectedly expedited wear rates. This effect was exacerbated by the critical omission of a ceramic acetabular liner in the initial THA, a departure from best practices that significantly contributed to the accelerated wear of the titanium acetabular cup by the alumina ceramic head. Liners are essential for distributing load and minimizing friction between implant components; their absence in this case led to abnormal wear patterns and the observed failure. This study encompasses several limitations that merit attention. A primary limitation is the absence of a comprehensive analysis of the severe metallosis observed in the tissues surrounding the implant. Given that the sole metal component implanted in our patient was the titanium alloy (Ti6Al4V), it is reasonable to infer that the metal debris identified consisted of titanium, aluminum, and vanadium. This inference is further supported by blood trace element analysis, which revealed elevated levels of titanium, aluminum, and vanadium. Despite this logical deduction, the direct analysis of tissue debris to confirm its composition was not conducted, representing a significant gap in our investigation. It is worth noting that the presence of such metal debris and its composition have been demonstrated in several previous studies [37–40].

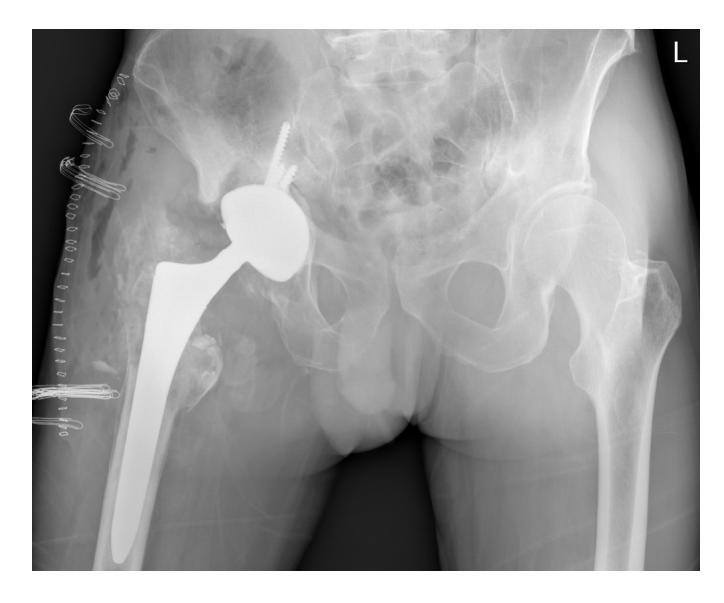
Figure 4. A radiograph of both hips depicting patient's right hip immediately after revision.

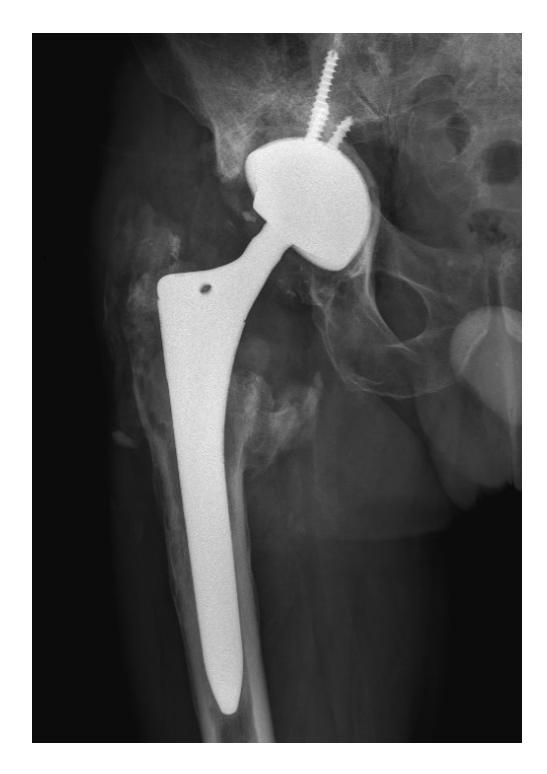
Figure 5. X-ray of the patient's right hip 6 months after THA revision.

Magnetic resonance imaging (MRI) of the patient's hip was performed using a 1.5 T MRI machine (MAGNETOM Sola, Siemens, Munich, Germany). The protocol parameters were as follows: STIR TSE sequence; slice thickness: 3 mm; body coil; flip angle: 150°; TR: 3790 ms; TE: 35 ms. The wound healed uneventfully, and the patient was discharged on the ninth postoperative day. After a 10-day incubation period, all samples were found to be sterile. At the six-month follow-up after the revision THA, the patient reported favorable outcomes. The patient's HHS was 97 points. His laboratory parameters, including white cell count, hemoglobin level, and liver and kidney function, as well as ESR and CRP level, were within the normal limits (Table 1). The radiograph of the patient's hip depicted a stable THA construct without additional osteolysis (Figure 5).

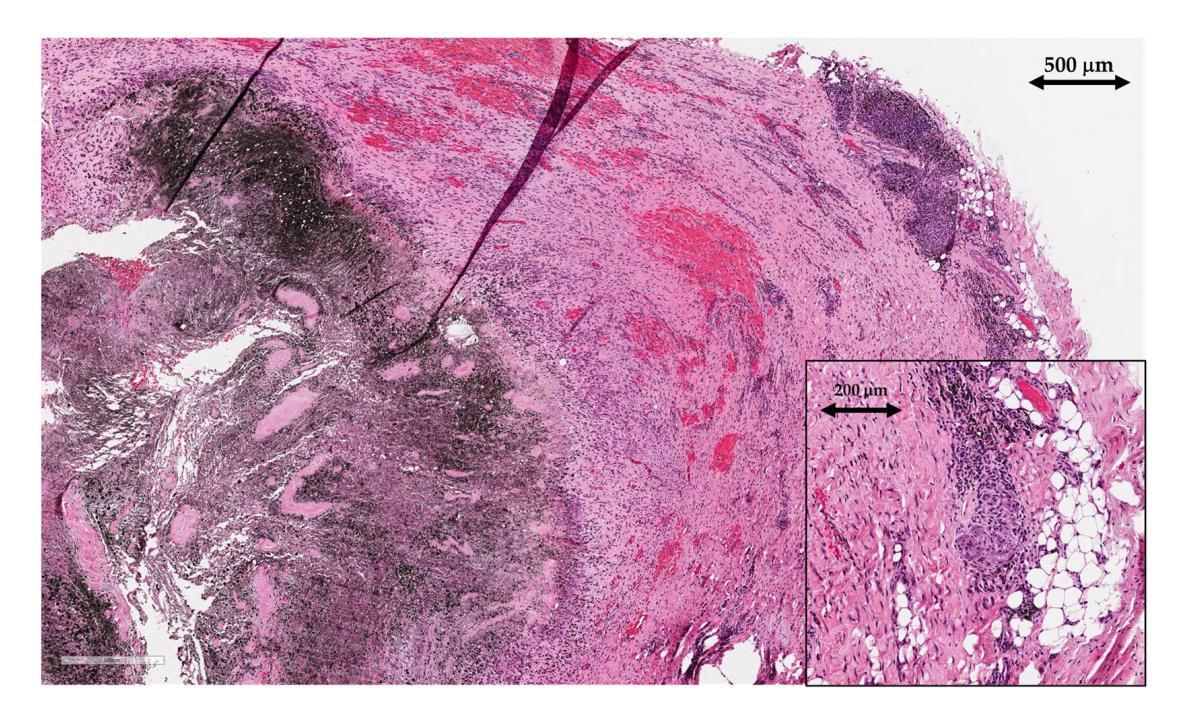
Figure 6. Histopathological findings of synovial-like interface membrane (SLIM), including areas of necrosis with abundant deposits of metallic microparticles and macroparticles (left), surrounded with layers of macrophages. Areas of hemorrhage (middle) and granulomatous inflammation with foreign body giant cells (upper-right corner, magnified in lower-right corner) are also present (scale is written on each part of the image).

Tissue samples of the periprosthetic soft tissue that gave a macroscopic impression of the pseudo-tumors were sent to the pathology lab for histological analysis. The tissue samples were of irregular shapes, soft, greyish–brown to black in color, and up to 4 cm in size. Microscopic examination showed areas of necrotic tissue and fibrin depositions admixed with abundant metallic microparticles (Figure 6). There was extensive infiltration predominantly with macrophages, containing metallic microparticles and macroparticles, as well as areas of granulomatous inflammatory reaction with foreign body giant cells. Lymphoplasmacytic infiltrate was present but there were no granulocytes, indicating the absence of acute inflammation and therefore excluding infection.

After joint replacement surgery, regenerated synovial tissue and the periprosthetic membrane are referred to using the term "synovial-like interface membrane" (SLIM). The histological findings of SLIM pathology are classified into groups that aid the recognition of underlying pathophysiological mechanisms leading to implant failure. Based on the International Expanded SLIM Consensus Classification, the patient had wear-induced synovitis/a wear-induced SLIM, leading to an adverse local tissue reaction to the implant wear particles (type VI) with a predominantly macrophagic pattern with an absent or minimal lymphocytic response [15]. The patient did not meet criteria for periprosthetic joint infection (no neutrophils present in the tissue).

Based on the histological particle algorithm proposed by Perino et al., the microparticles found in tissue samples are mostly likely conventional non-ferrous metallic particles due to implant wear [24]. The described microparticles and macroparticles were greyish to intensively black, which is consistent with metal. Ceramic particles could also be present with a blackish color if oxidized and could also be abundant but usually present only as microparticles except in cases of prosthesis fracture, where larger microparticles have been described as well. Other implant wear particles and endogenous particles (such as hemosiderin) differ from metal particles in shape, size, and color or are birefringent.

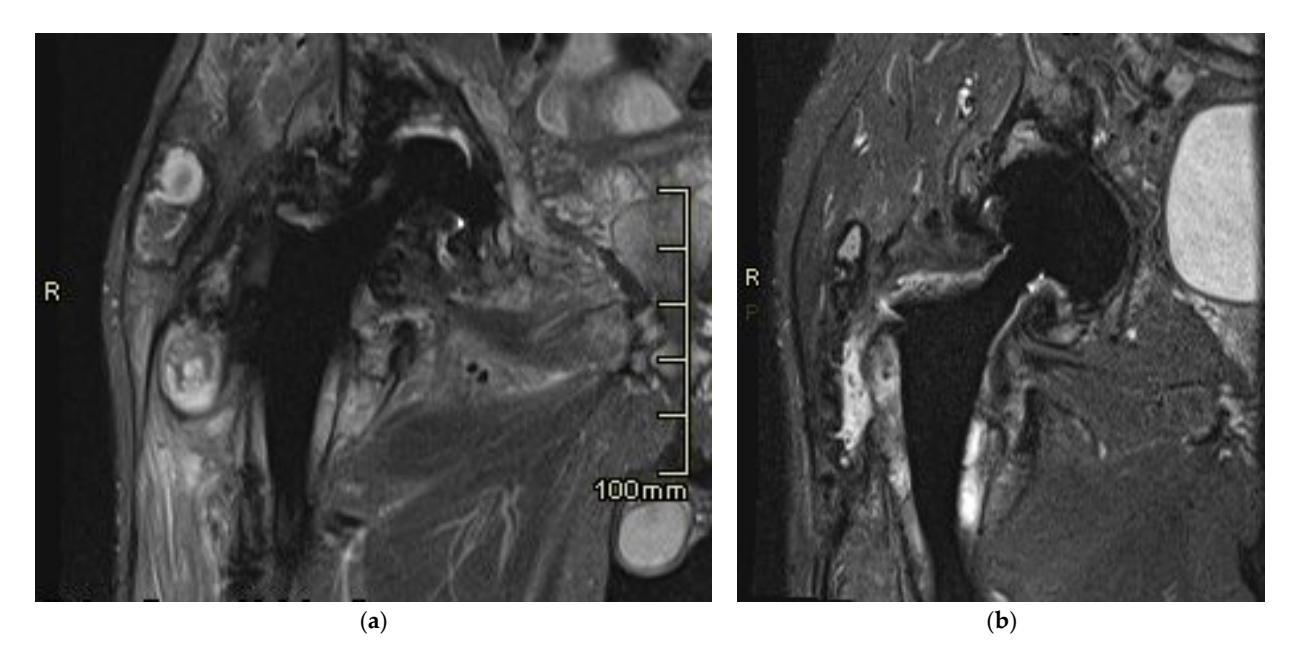
Figure 7. Magnetic resonance imaging (MRI) of the right hip in coronal plane. (**a**) Before revision; (**b**) six months after revision surgery.

Prior to the revision surgery, MRI revealed substantial soft tissue alterations around the endo-prosthesis, particularly in the muscles proximal to the greater trochanter of the femur. Primarily, these changes manifested as solid chronic granulation with a smaller cystic component that was partially calcified. In both the described soft tissue changes and the periprosthetic osteolytic regions, minute hypointense inclusions of metal microparticles were observed (Figure 7a). Six months post-revision surgery, the previously extensive granulation changes in the surrounding soft tissues were diminished. There was reduced soft tissue edema, and the indications of local irritation had also decreased. The presence of slightly increased fluid around the endoprosthesis indicated residual seroma following the surgery (Figure 7b).
