Article Influence of Boronizing on Steel Performance under Erosion-Abrasion-Corrosion Conditions Simulating Downhole Oil Production

Eugene Medvedovski *, Gerardo Leal Mendoza and Giovanny Vargas

Endurance Technologies Inc., 71-4511 Glenmore Trail SE, Calgary, AB T2C 2R9, Canada; gerardom@endurancetechnologies.com (G.L.M.); giovannyv@endurancetechnologies.com (G.V.) * Correspondence: emedvedovski@shaw.ca or eugenem@endurancetechnologies.com; Tel.: +1-403-724-6104

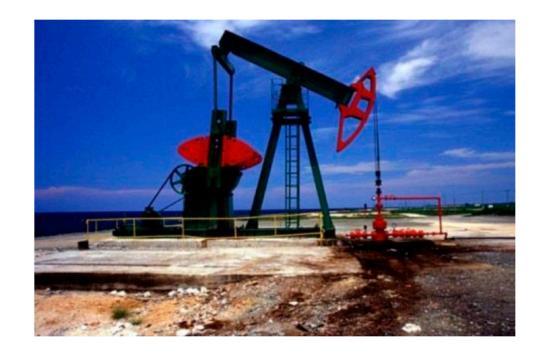
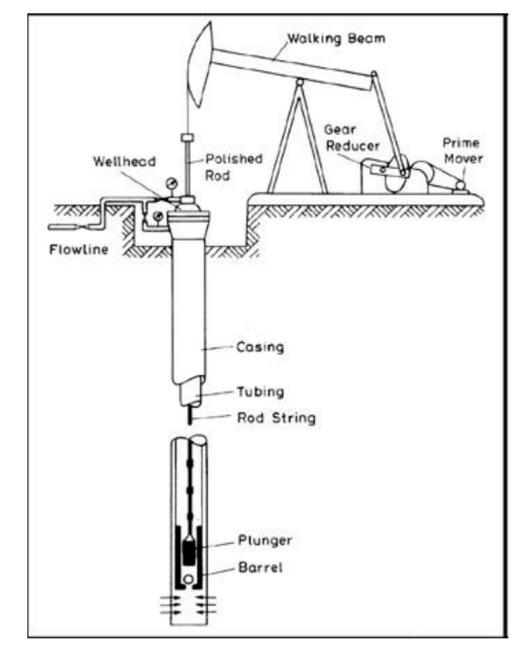
Figure 1. Oil production pumpjack (**top**) and schematic of production tubing with artificial lift system [4,5] (**bottom**) (Reprinted with permission from Ref. [4,5] Copyright 2015 Elsevier).

Wear and corrosion are serious problems in mineral and materials production and power generation. In particular, erosion-corrosion and abrasion issues widely occurring in downhole production and processing of heavy oil and oil sand result in sufficient losses in the industry. These problems lead to equipment failures and to related unpredictable shutdowns, necessary replacement of the damaged components, product contamination and possible environmental impact. Regarding the downhole oil production, the equipment components are subjected to high velocity flows of concentrated suspensions containing solid abrasive particles (e.g., silica sand, calcite, dolomite, clay-sand mud and others) with different sizes combining with mineral salts dissolved in corrosive media, often with a presence of corrosive gases. The depth of production wells of 2–3 km or more, which may be vertical or horizontal, is very common, and, in deep wells, oil and gas production requires elevated pressures and temperatures, which increase the above mentioned wear and corrosion problems. The problems associated with wear, especially erosion and abrasion, in the oil and gas industry have been reviewed and summarized in a few papers [1-3]. Thus, considering oil production problems, long production tubing strings and downhole tools are employed in every oil well utilizing the artificial lift systems, e.g., sucker rod pumps or progressing cavity pumps, with failures occurring because of wear and corrosion as the most-costly issues. In the artificial lift systems (see Figure 1) [4,5], wear occurs due to

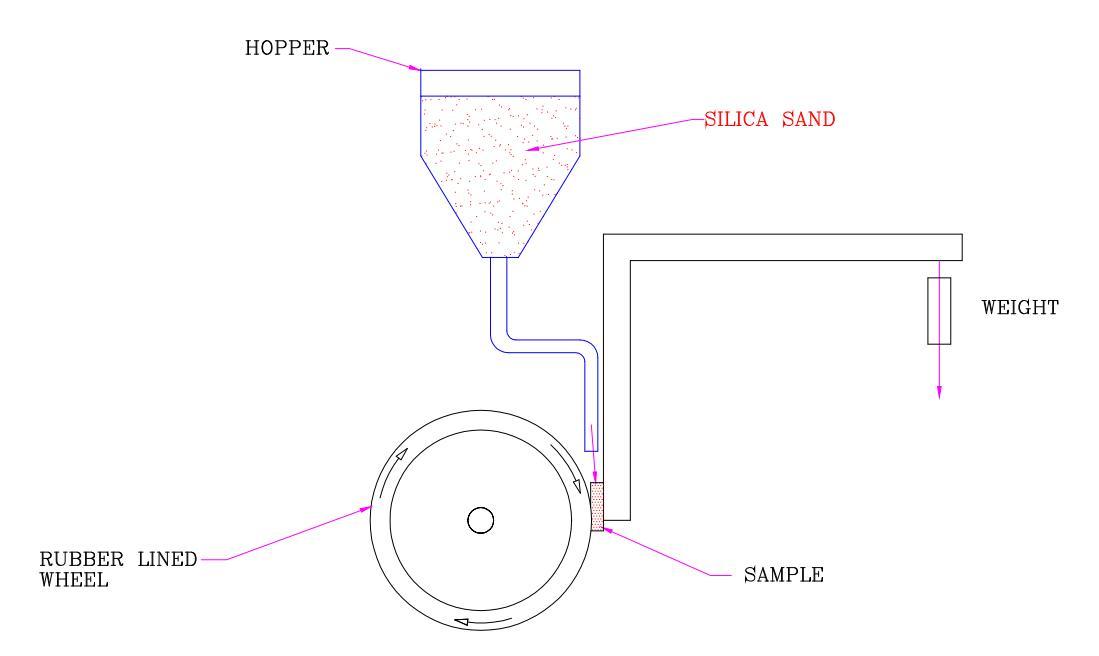
Figure 2. Schematic of the dry sand rubber wheel abrasion test (ASTM G65-16).

Abrasion testing was conducted according to ASTM G65-16 (Dry Sand Rubber Wheel Test) [73]. The apparatus consists of the rubber lined steel wheel rotating and touching the flat sample, which is tightly hold in the contact position with the weight. The abrasive medium (AFS 50–70 mesh sand) was continuously supplied between the fixed sample and the rotating wheel. According to the employed Procedure B designated for coatings' evaluation, the test duration was 2000 revolutions. The abrasion testing schematic is displayed in Figure 2. Upon the testing, the samples were weighed; the weight loss (in mg) and weight loss percentage were calculated, and, using the materials' density, the volume loss was also calculated.

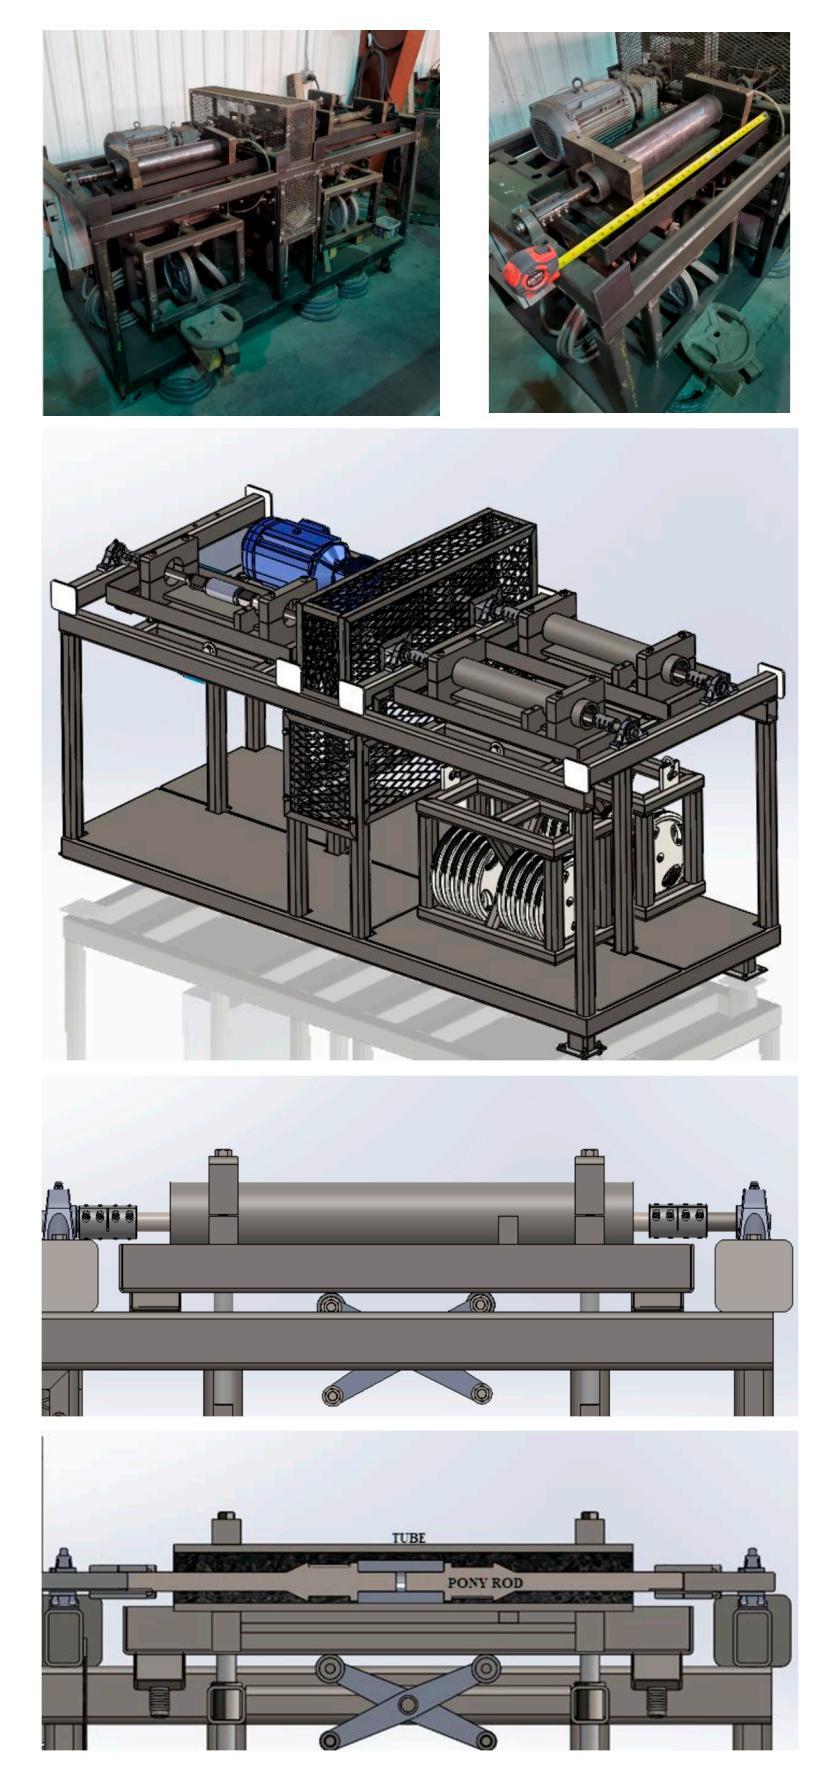
Figure 3. General view and schematic of the ETI device for the erosion-abrasion-corrosion testing of tubular sections. (**Top**)—general view (the mixing tank is not shown), (**Bottom**)—tube with pony rod.

The slurry erosion-abrasion-corrosion testing was conducted using the specially designed and fabricated ETI flow loop device (Figure 3) because, as noted above, there is no testing equipment that is capable to test the inner surface of the tubular pieces under the erosion-abrasion-corrosion conditions simulating processes in artificial lift systems and similar equipment. The total device dimensions are ~2.14 m (L) × 0.92 m (W) (~7 ft. × 3 ft.). This device provides the possibility to test, at the same time, up to three tubular sections mounted in the horizontal position at a small angle. The water-based slurry containing abrasive particles is circulated, using a diaphragm pump, through the test tubes; specifically, the slurry enters each tube simultaneously through the plastic hose system. Based on the device preliminary testing, it was found that the slurry line hoses need to be at least of 3/8'' (~9.5 mm) diameter because smaller hoses became clogged after short time and did not provide adequate slurry circulation. Simultaneously with the slurry flow, the installed steel pony rods create the rotating-oscillating motions inside the test tubes where the pony rod steel couplings (with 2" or ~50 mm diameter) constantly impact the inner surface of the test tubes. In this work, standard pony rods D78 SH T (~1.22 m or 4 ft. L) were used. In order to increase accuracy in wear of different tubes and couplings tested at the same time, the latter were additionally straightened and machined to exactly the same couplings' diameters minimizing their dimensional deviations. The selected load transfers the pressure to each pony rod, i.e., the contact of the pony rod's coupling with the tube inner surface can be managed. Before starting the erosion-abrasion-corrosion test, the sand containing slurry was prepared in the mixing tank using the three-blade impeller. Then the slurry was circulated through the whole system (from the tank through the tubing and returning back) for 30 min with no pony rods motion. When the slurry became homogenized, the test was started, turning on the pony rods motion. The fluid with abrasive particles penetrates between the tube inner surface and the pony rod coupling, and, as a result, the coupling's continual motion forced "embedding" the abrasive particles to the tube's inner surface. The following parameters can be set up, adjusted to the desired testing conditions and controlled during the test: the load applied onto the pony rods, pony rod rotation speed, slurry flow velocity and test duration. Additionally, the abrasive medium, e.g., type and particle size, solid concentration in the slurry, liquid phase composition can be varied creating more or less aggressive testing conditions. Thus, for the current testing, silica sand was selected as the abrasive medium, and water with machine oil addition was selected as a fluid. In order to increase a fluid's corrosivity, salts and/or some other additives (e.g., organic substances) can be added. As a result, the tubular samples become under continual action of rotating and impacting steel coupling combined with flow of the slurry with hard abrasive particles, i.e., under severe erosion-abrasion-corrosion conditions. The testing equipment units described in the literature generally consider only erosion flows of either dry powders or slurries containing hard particles, but with no involvement of mechanical actions of hard solid bodies, which creates a serious impact on the tubular materials' performance. The testing device design, testing method and selected conditions are based on the analysis of different artificial lift systems' designs and service conditions occurring in downhole oil production. In this testing, the slurry flow creates turbulence and low impingement angles, i.e., conditions occurring in production, which are the most critical for steel components [3,30–32,41].

The intensive rubbing of the rods against tubes' inner surface combined with continuous erosive flows and associated friction issues and wear during rather long testing cycles can lead to a temperature increase in the slurry and to associated water evaporation. These, in turn, can lead to reduced slurry homogeneity, gradual sand settling, motor overheating due to higher slurry viscosity, and, hence, to inconsistent results. Thus, initial testing of the wear device demonstrated a significant temperature increase in the slurry after a couple of hours of the device running (e.g., from ~20 °C to 50–55 °C). To minimize this issue, a chiller was submerged into the slurry tank, that prevented the slurry heating (the slurry temperature did not rise above 25 °C). The cooling fan focused on the motor was also installed to prevent the motor overheating.

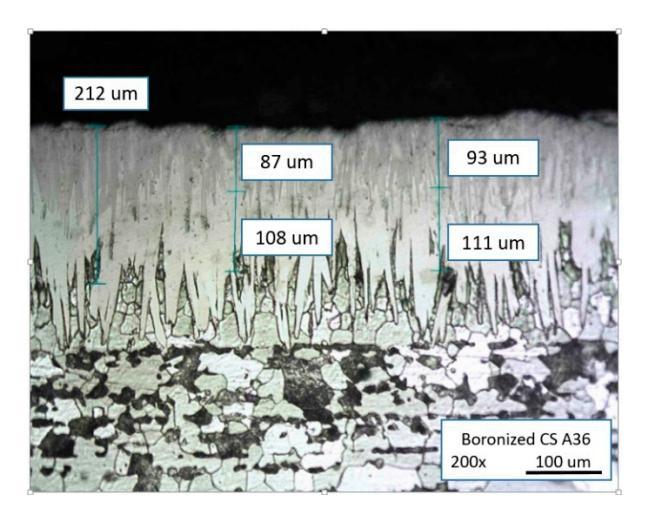
Figure 4. Microstructure of the boronized steel (typical), magnification 200×.

The boronized surface on carbon steel had the "saw-tooth" structure consisting of two layers (Figure 4). The inner "lighter" layer (the zone covering the substrate) mostly consists of the Fe₂B phase, and the outer "darker" layer mostly consists of the FeB phase. Both layers have similar "saw-tooth" morphology despite their different crystalline lattice parameters, i.e., the FeB phase grows on the Fe₂B repeating the morphology of the Fe₂B phase. The formation of the double-layer architecture occurs simultaneously through a single heat treatment boronizing step. It is related to B atoms' diffusion to steel, interaction of B with Fe with formation of iron borides and their further consolidation. Specifically, during the process, B reacts with Fe₂B forming FeB, and the FeB layer grows over the Fe₂B layer. The features of the iron boride layers formation were described earlier [24,25]. No mechanical interface between the boride coating and the substrate, no delamination and micro-cracks between the phases and no Kirkendall porosity are observed despite the difference in crystalline structures and values of coefficients of thermal expansion between the two iron boride phases, i.e., good bonding between the "Fe-B layers" is reached due to optimization of the pack composition and process parameters. The total case depths were $\sim 200 \ \mu m \ (\sim 0.008'')$ for the flat samples designated for dry sand abrasion test and in the range of ~275 μ m (~0.011")–325 μ m (~0.013") for tubular samples for slurry erosionabrasion. With regards to case depth determination, it was measured from the top of the coating surface to the middle of the "teeth". The columnar grain structure adherent to both layers reinforces the coating in general. The thermal diffusion process provides rather uniform coating for the entire treated surface with no delamination issues. It is related to the B-rich vapor formation (using CVD principles) uniformly within the "chamber" surrounding the steel body completely. The obtained structure fully correlates with earlier reported data [20-25,61,62].

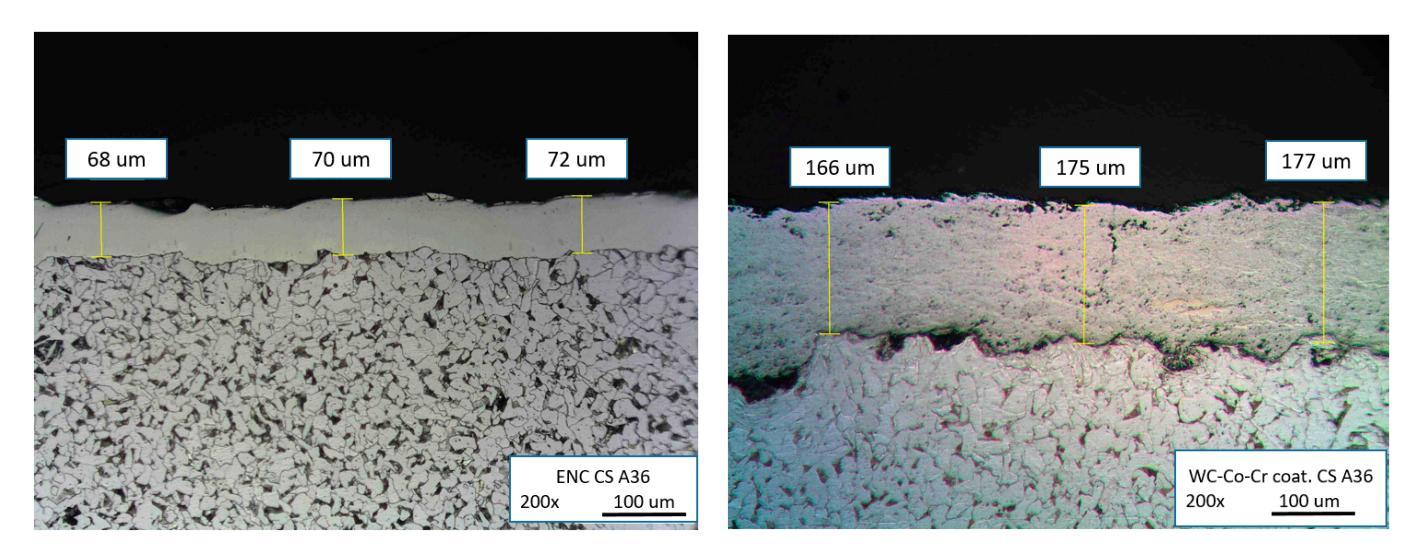
Figure 5. Microstructure of ENC (left) and WC-based coating (right) on carbon steel, magnification 200×.

The ENC samples had the coating thickness of ~65–75 μ m uniformly adhered to the carbon steel substrate (Figure 5). The coating's heat treatment provided precipitation and crystallization of nickel phosphide Ni₃P with expectable increased micro-hardness up to ~515 kgf/mm² (HK0.1). The thickness of the WC-Co-Cr composite coating was a ~175 μ m (Figure 5). Its micro-hardness HK0.1 was ~1800–1900 kgf/mm² that is comparable with the iron borides' micro-hardness; however, these data are related to the situations when the sharp diamond indenter was applied to the WC grains. When the indenter contacted the Co-based matrix, micro-hardness values were significantly lower. Because of a small amount of the metallic bonding phase in this coating, it was not possible to determine micro-hardness of the individual phases.

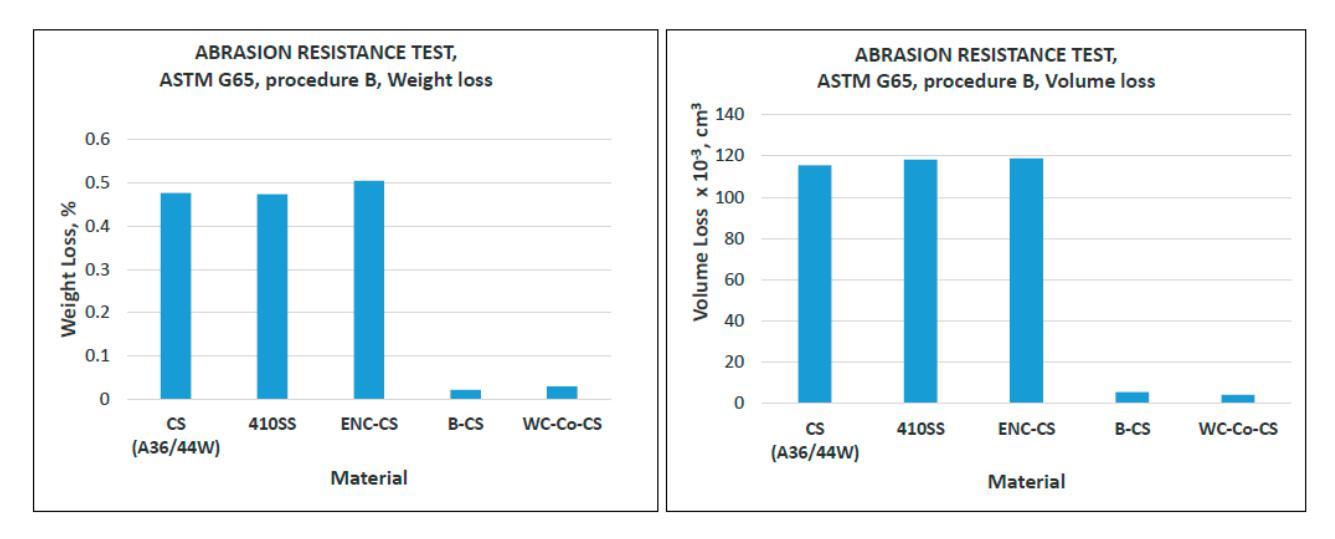
Figure 6. Abrasion testing results conducted according to ASTM G65-16 [73], Procedure B (2000 revolutions). (**Left**)—weight loss, (%); (**Right**)—volume loss (cm³).

The results of abrasion testing conducted according to ASTM G65-16 [73] are presented in Figures 6 and 7. This test was selected as a preliminary test to demonstrate the difference between the materials used for downhole oil production being in contact with abrasive particles and therefore to make a quick materials "screening" for the further slurry erosionabrasion testing. As can be seen from the weight and volume loss diagrams (Figure 6), carbon steel and stainless steel samples, as well as hardened ENC, demonstrated identical performance. Thus, weight and volume loss of these materials after 2000 revolutions became 0.47–0.5% and (115–120) \times 10⁻³ cm³, respectively, despite their different chemistry and hardness. These indicate that significantly more expensive stainless steel 410SS, which is identical to L80-13Cr steel designated for tubing in oil production for special needs when components should serve in contact with abrasive and corrosive environments, and ENC coating also with elevated hardness and corrosion resistance demonstrated the same performance as low-cost carbon steel. The occurred wear scars (grooves) with significant depths are well observed in these samples (Figures 7 and 8). The deep groove for the ENC sample indicates that this coating was completely removed from the surface. In fact, this test result demonstrates that the use of more expensive stainless steel and ENC is not reasonable for the abrasion related application conditions. In contrast, the samples of boronized carbon steel and steel with the thermal spray WC-Co composite protective

layer experienced significantly lower wear loss, which was only <0.05 wt % (weight loss) and ~5 × 10^{-3} cm³ (volume loss). The wear scars for these materials are not deep; they look like the surface polishing. Although both these materials demonstrated similar and low wear losses in dry erosion conditions, the thermal spray technology employed for the WC-Co-Cr coating is not applicable for protection of the inner surface of long tubing required for downhole oil production (there is no information, so far, about this possibility in industry), while boronizing technology (the EndurAlloy[®] process) is well suitable for long tubular products' protection.

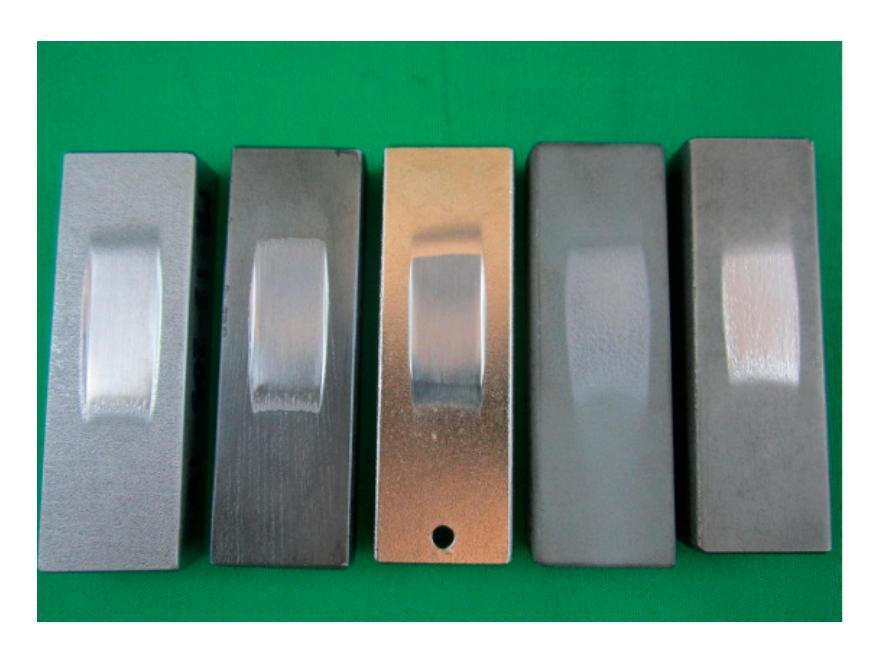
Figure 7. Appearance of the samples after the ASTM G65—16 abrasion test. From left to right: carbon steel (CS), 410 SS = L80-13Cr, ENC-CS, WC-Co-CS, B-CS (EndurAlloy[®]).

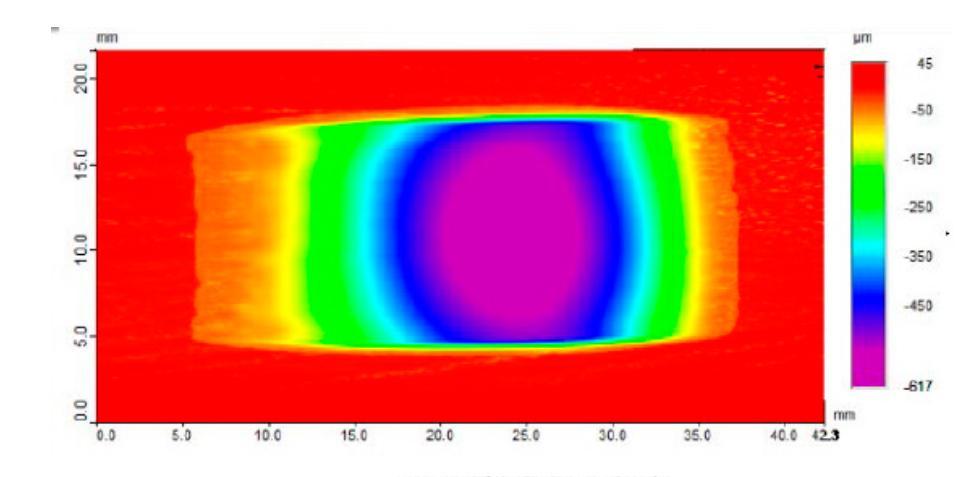
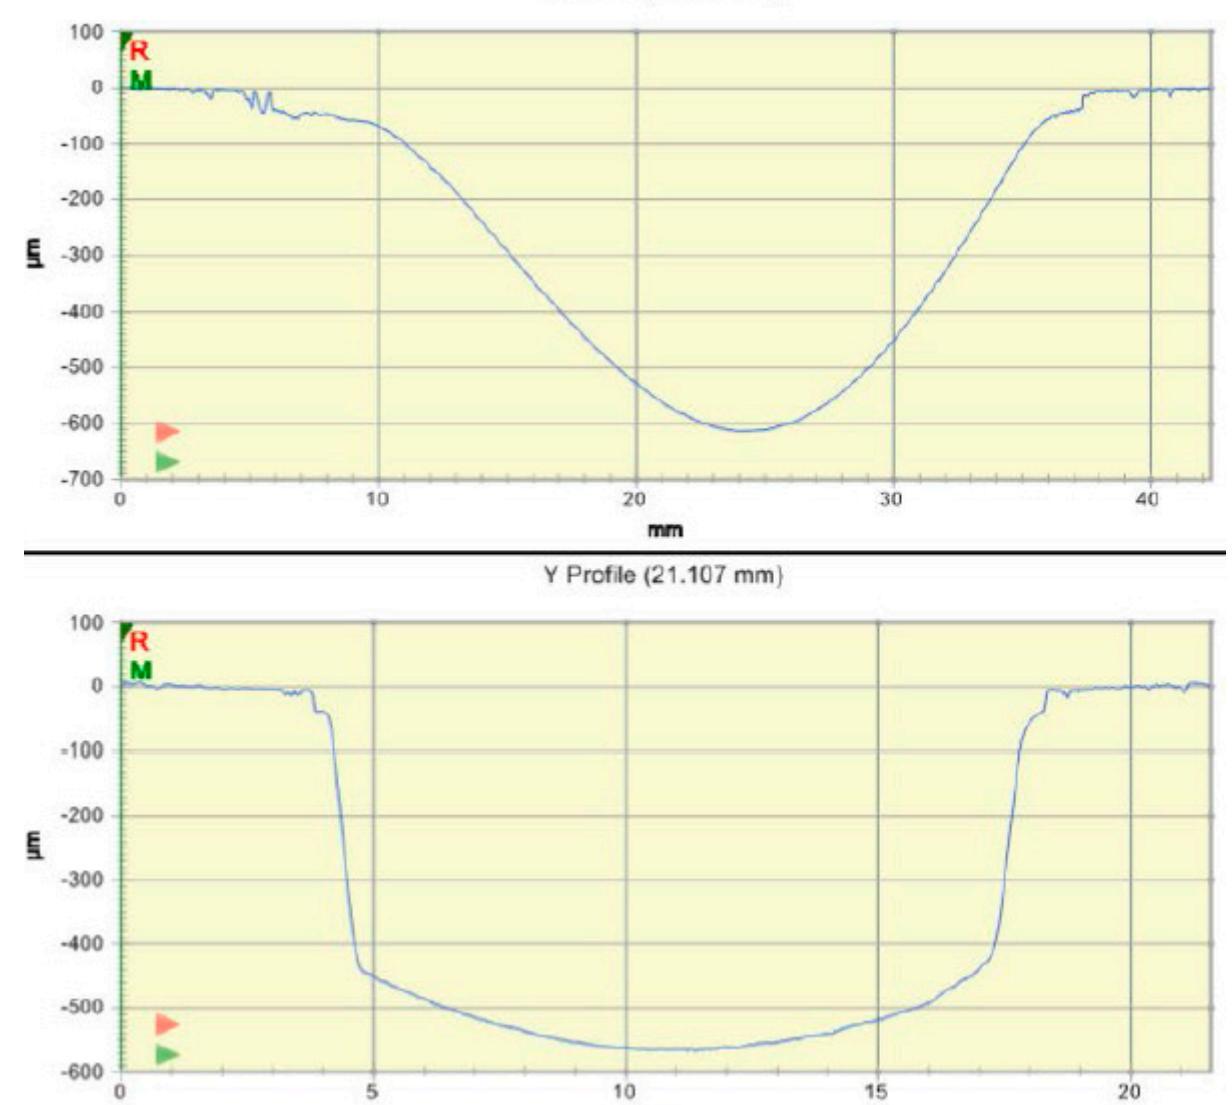
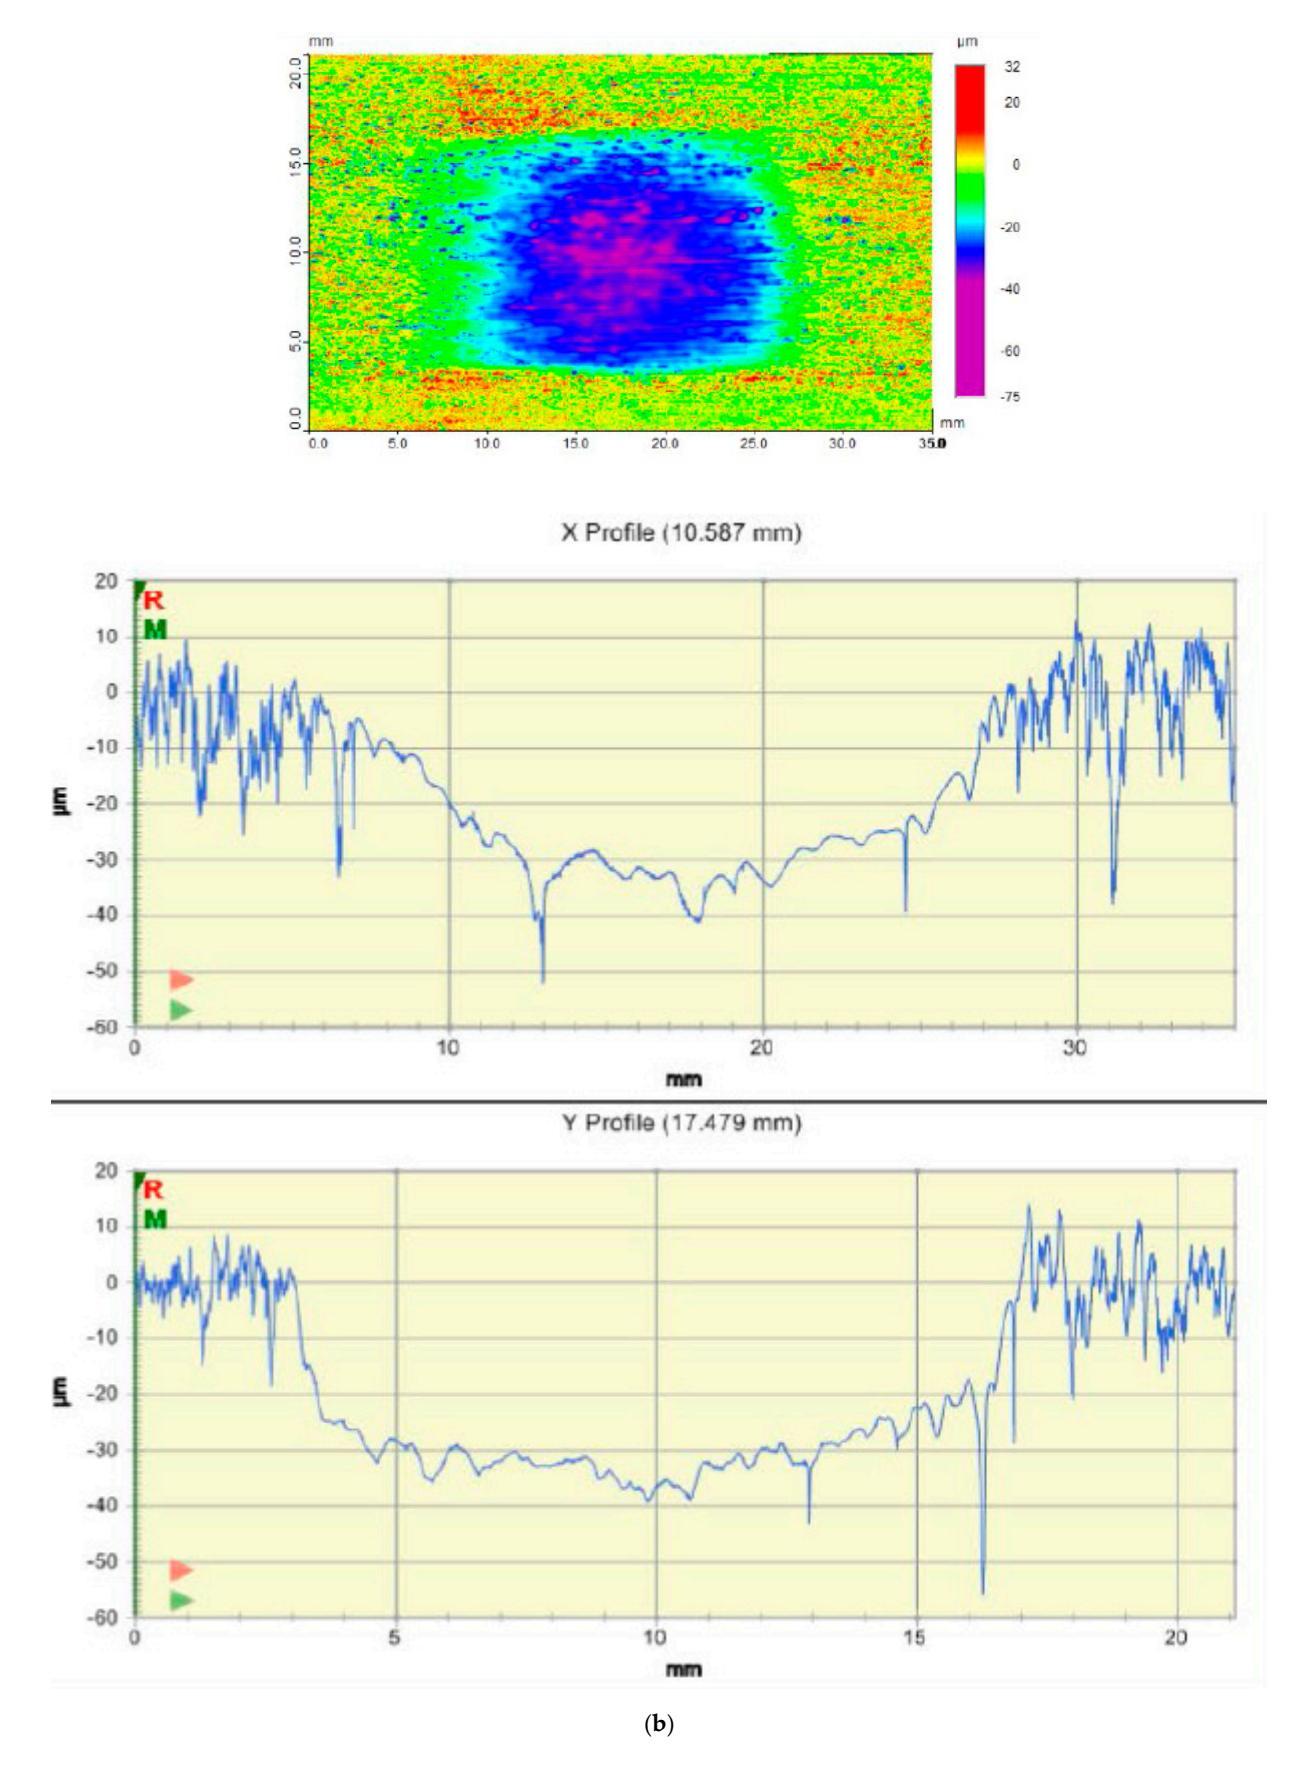
Figure 8. Comparison of the profilometer data for bare carbon steel (**top-a**) and boronized carbon steel (**bottom-b**) after abrasion ASTM G65 testing. The wear scar depth is ~600 μ m for bare carbon steel and ~30–35 μ m for boronized steel.

The comparison of the materials' wear scars examined by optical profilometry confirms that boronized steel significantly outperformed bare carbon steel (Figure 8). According to the calculation from the profilometry, the wear scar depth and volume loss for bare steel are ~600 μ m and ~130 mm³, respectively, while these data for boronized steel are ~30–35 μ m and ~8 mm³. It should be noted that the wear scar of the iron boride coating is not very smooth as the steels' wear scars. It is related to the micro-cracking wear mechanism for hard but brittle iron borides. Because the wear scar for boronized steel is significantly smaller than the original case depth (~200 μ m), it is easily concluded that the iron boride layer remained after the abrasion test, i.e., only a minor portion of the top FeB sub-layer was removed, and the Fe₂B layer was not affected.

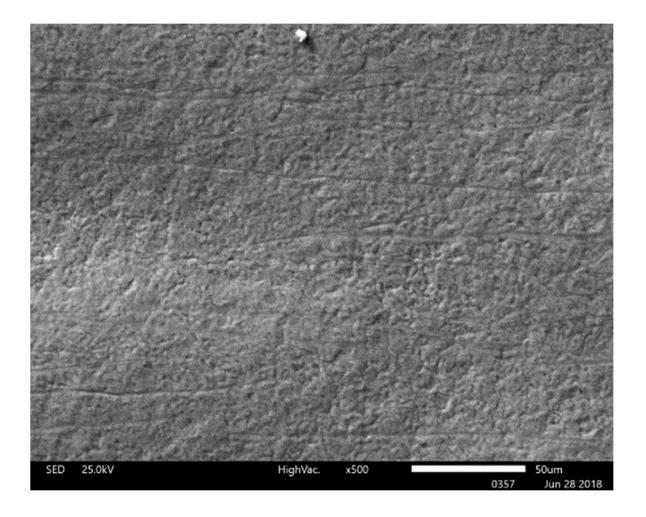
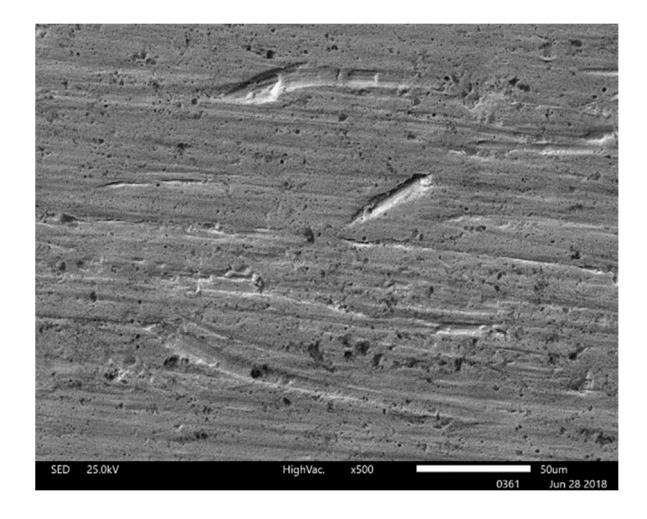
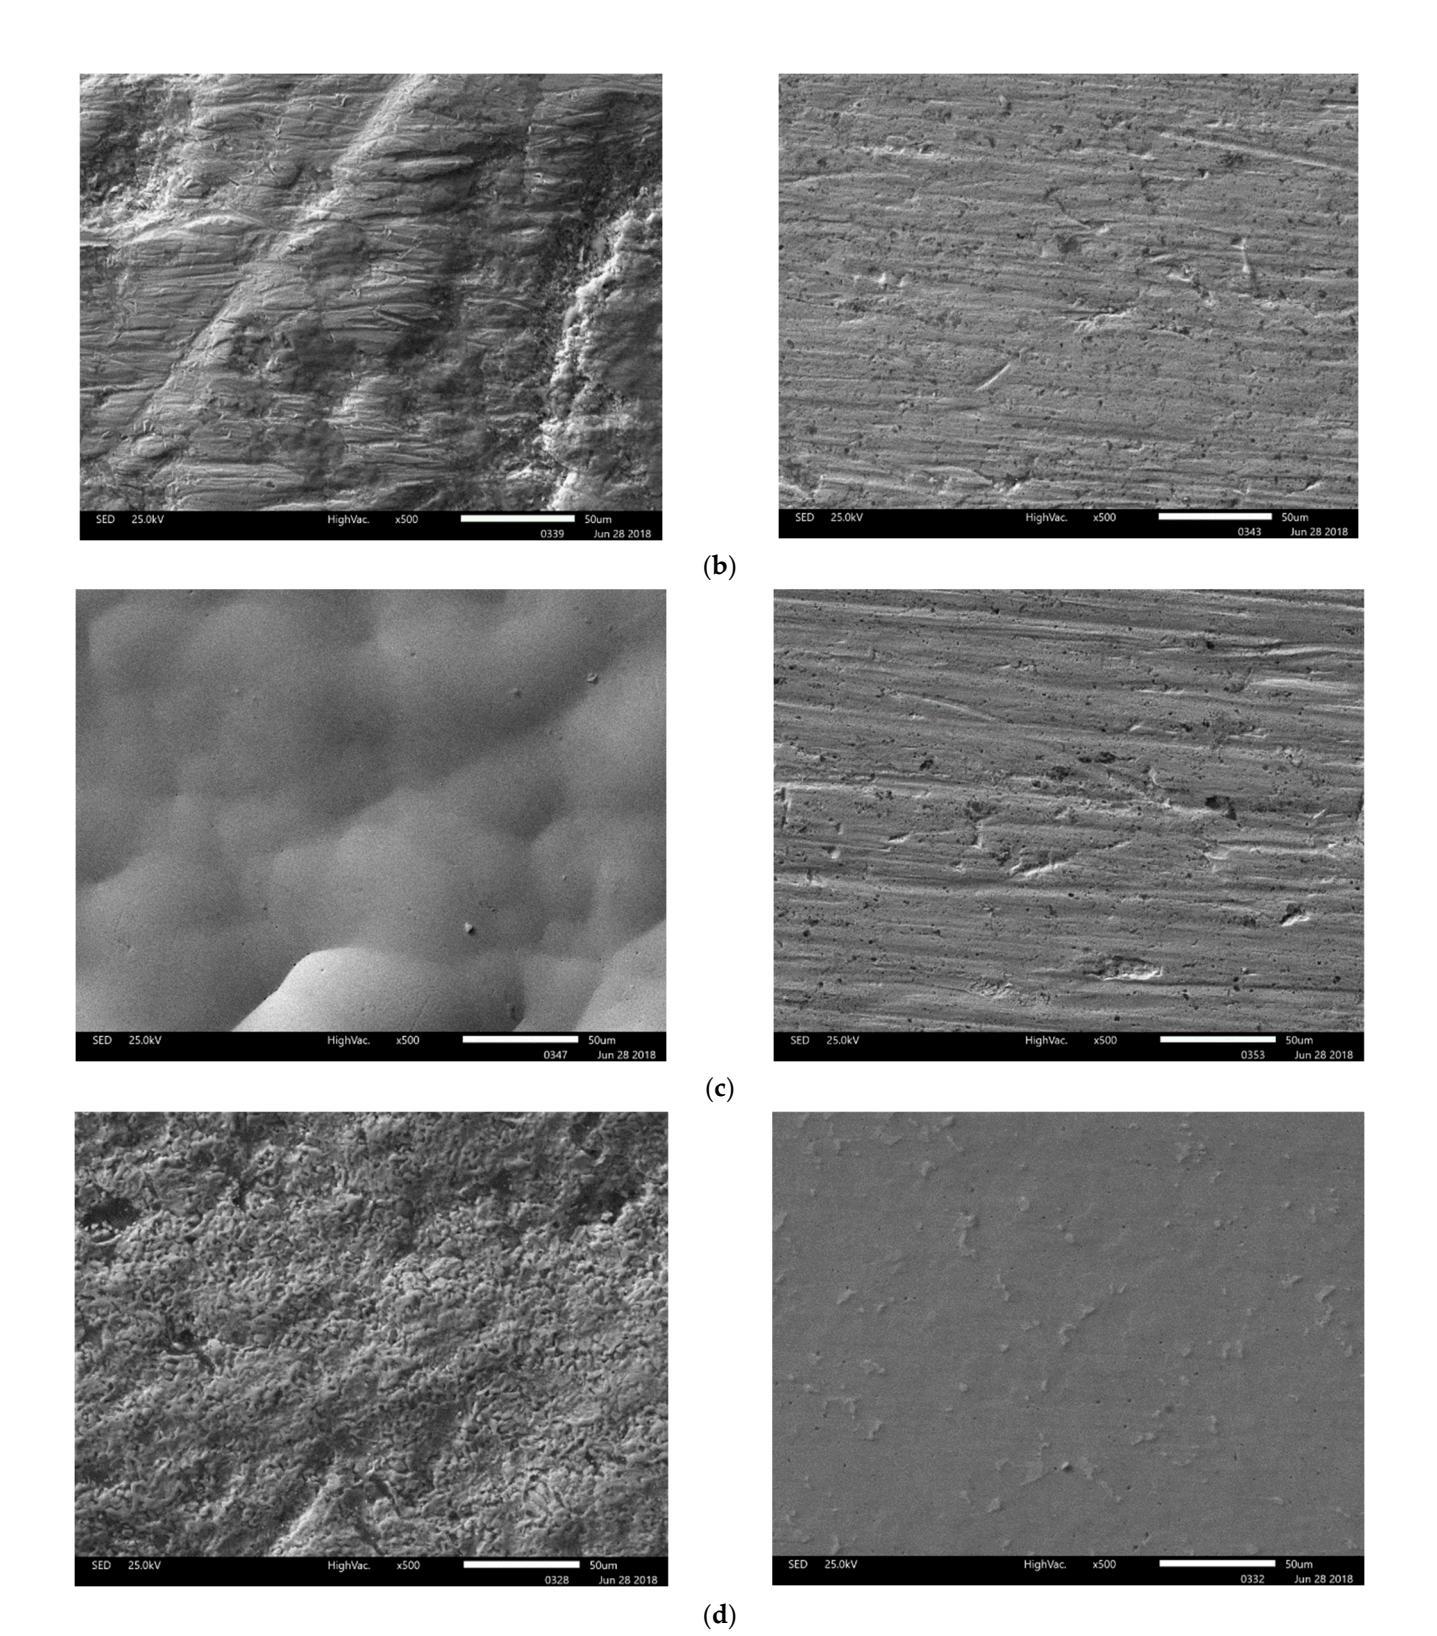
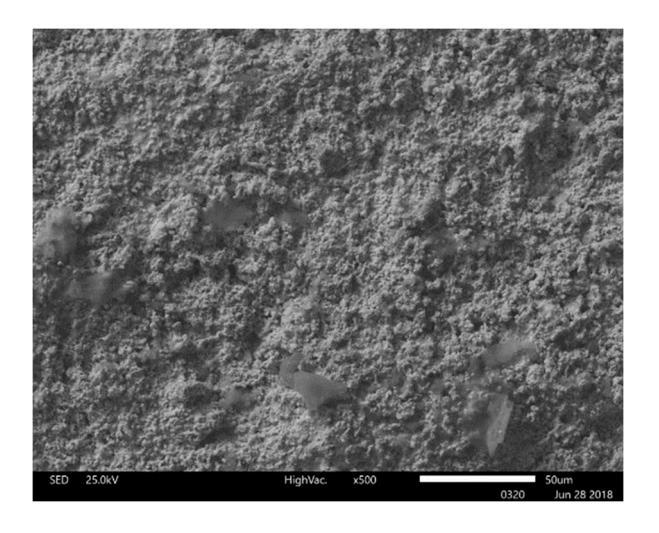
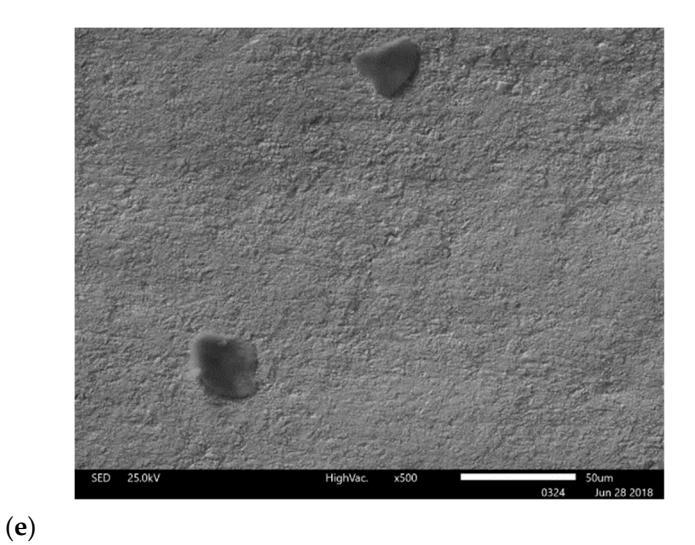
Figure 9. Surface morphology of the samples before (**left column**) and after (**right column**) abrasion testing (ASTM G65), $500 \times$ magnification. Samples from top to bottom: carbon steel (**a**), stainless steel 410SS (**b**), ENC on carbon steel (**c**), boronized carbon steel (**d**), WC-Co on carbon steel (**e**).

The materials surfaces, according to SEM examination (Figure 9), became significantly smoother after the testing that associates with their abrasion wear. However, the materials' wear occurred in different extents. Comparison with the ENC samples confirms complete removal of the ENC (the surface after testing became identical to the surface of the bare carbon steel sample). In the case of the composite WC-Co coating, it is assumed that the Co-rich rather soft matrix is worn out first by abrasion with hard silica particles. The presence of observed caverns on the surface of this sample, may be explained by the WC grains pull-out from softer Co-based matrix due to its wear and weakened bonding between the grains and the matrix. This is in a good correlation with other data [34,48,75]. For the boronized samples, mostly surface asperities were removed after 2000 revolutions; however, no cracks, large caverns and other defects were observed.

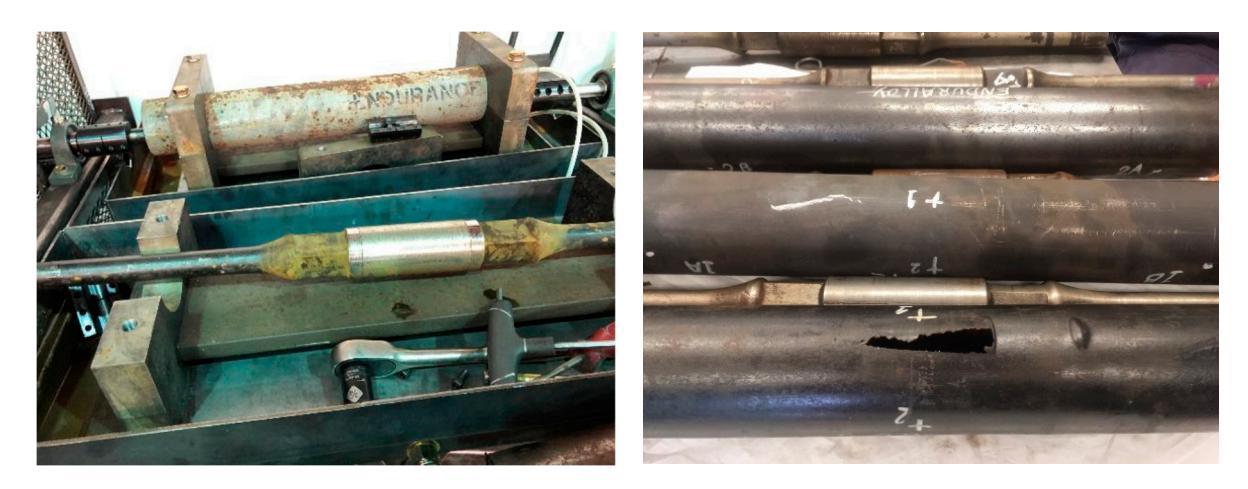
Figure 10. Appearance of the tubular sections after the wear test at the most severe conditions (see Table 2). (**Left**)—general view; (**Right**)—boronized and bare steel tubes (the bare steel tube has a perforation, while both boronized tubes did not).

The slurry erosion-abrasion tests were conducted, as mentioned above, varied the testing conditions, e.g., loads applied onto the pony rods, rotation frequency, slurry composition and test duration. It is obvious that, at more severe conditions, the tubes' wear occurred in greater extents regardless the material, e.g., bare steel and boronized steel. As expected, the wear occurred mostly in the areas where pony rod coupling (cylindrical area and "shoulders") was in contact with the tubing inner surface, particularly when silica sand containing in slurry penetrated between the tube and the pony rod (see Figures 3 and 10). The occurred wear scars had specific shapes of an uneven groove with sizes corresponding to the cylindrical part of a pony rod and two small grooves corresponding to the pony rod "shoulders". The wear scars for the bare tubes were significantly deeper or the remaining walls were significantly smaller than for boronized tubes after all tests (Table 2). Thus, for the most severe conditions significantly exceeded actual service conditions), the test was conducted for 93 h, i.e., until the perforation of the bare steel tubes (Figure 10). It was clearly observed that high loads and rotation speeds created intensive bouncing and vibration

resulted in continuous "micro-impacts" on the inner surfaces of tubes. The boronized tubular section tested at the same conditions and time lost only up to 15% in depth, i.e., the iron boride protective layer was completely lost under these conditions. However, the boronized protective layer significantly delayed erosion-related wear of the tube. Then it was decided to conduct testing in less severe conditions better simulating service conditions. In the softest test conditions, which had significantly better correspondence to the service conditions in the artificial lift systems, the wear losses for bare steel tubes reached ~18% (tube wall thickness loss) after 19 h, while the wall loss for the boronized tube was negligible (significantly less than 1%) after the same test duration and twice as long test duration. In this condition, the iron boride layer remained with only minor losses.

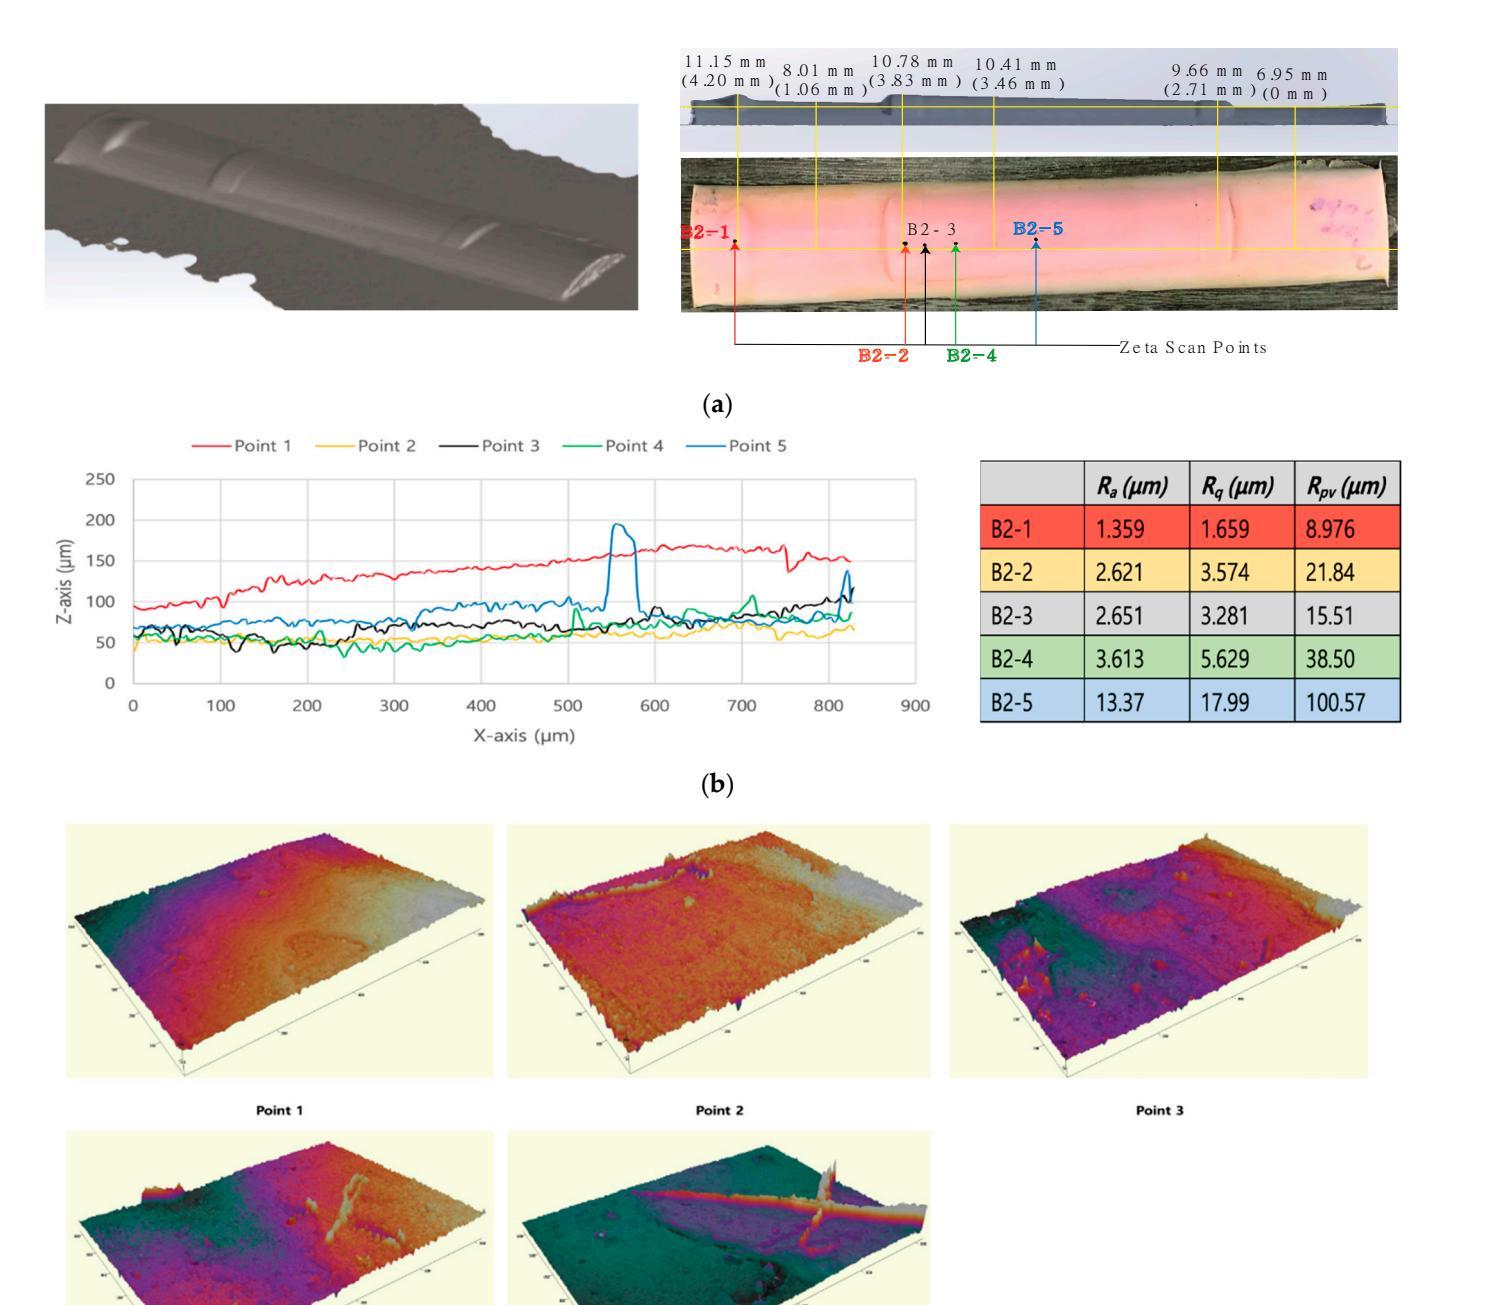
Figure 11. Creaform and Zeta 20 scans—bare carbon steel tube tested at condition 2 (see Table 2). (**a**) Replica; (**b**) Roughness data; (**c**) Surface scan data.

Some results obtained for the polymeric replicas made from boronized and bare carbon steel tubular samples using the Creaform Scanner and optical profilometer Zeta-20 are presented in Figures 11–14. The grooves' depths after wear testing are indicated in the brackets. The data for the wear scar depths obtained with the UT tester and Creaform Scan have some difference, which is related to the accuracy in these instruments and the testing and instruments' features. Additionally, the differences in data may be explained that these measurements were conducted not at the same points. However, these data clearly demonstrate that boronized steel samples had significantly shallow grooves (smaller wear scars' depths) and a smaller range of the roughness inside the wear scars indicating significantly higher performance of boronized steel over bare steels. The observed scars with high roughness' ranges within the same groove indicates a complexity of the materials' destruction process at the conducted testing and selected conditions.
