Article Influence of Boronizing on Steel Performance under Erosion-Abrasion-Corrosion Conditions Simulating Downhole Oil Production

Eugene Medvedovski *, Gerardo Leal Mendoza and Giovanny Vargas

Endurance Technologies Inc., 71-4511 Glenmore Trail SE, Calgary, AB T2C 2R9, Canada; gerardom@endurancetechnologies.com (G.L.M.); giovannyv@endurancetechnologies.com (G.V.) * Correspondence: emedvedovski@shaw.ca or eugenem@endurancetechnologies.com; Tel.: +1-403-724-6104

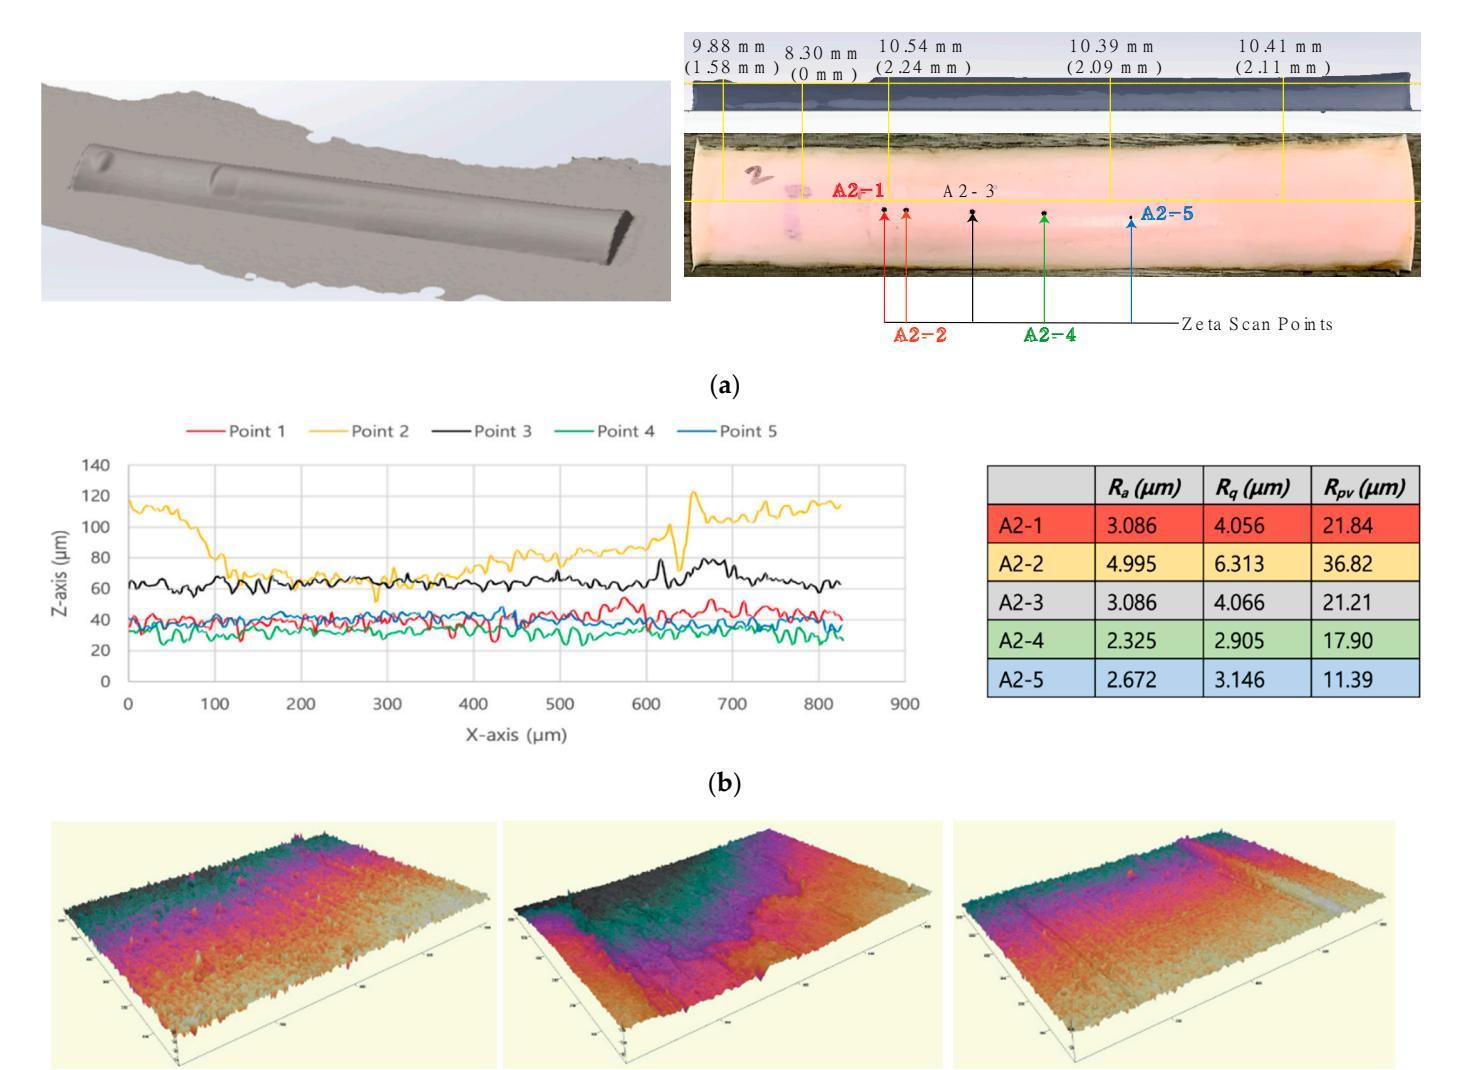
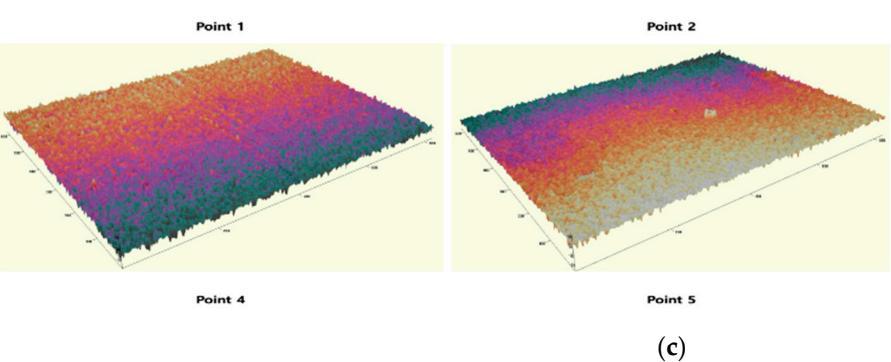
Figure 12. Creaform and Zeta 20 scans—boronized carbon steel tube tested at condition 1 (see Table 2). (a) Replica; (b) Roughness data; (c) Surface scan data.

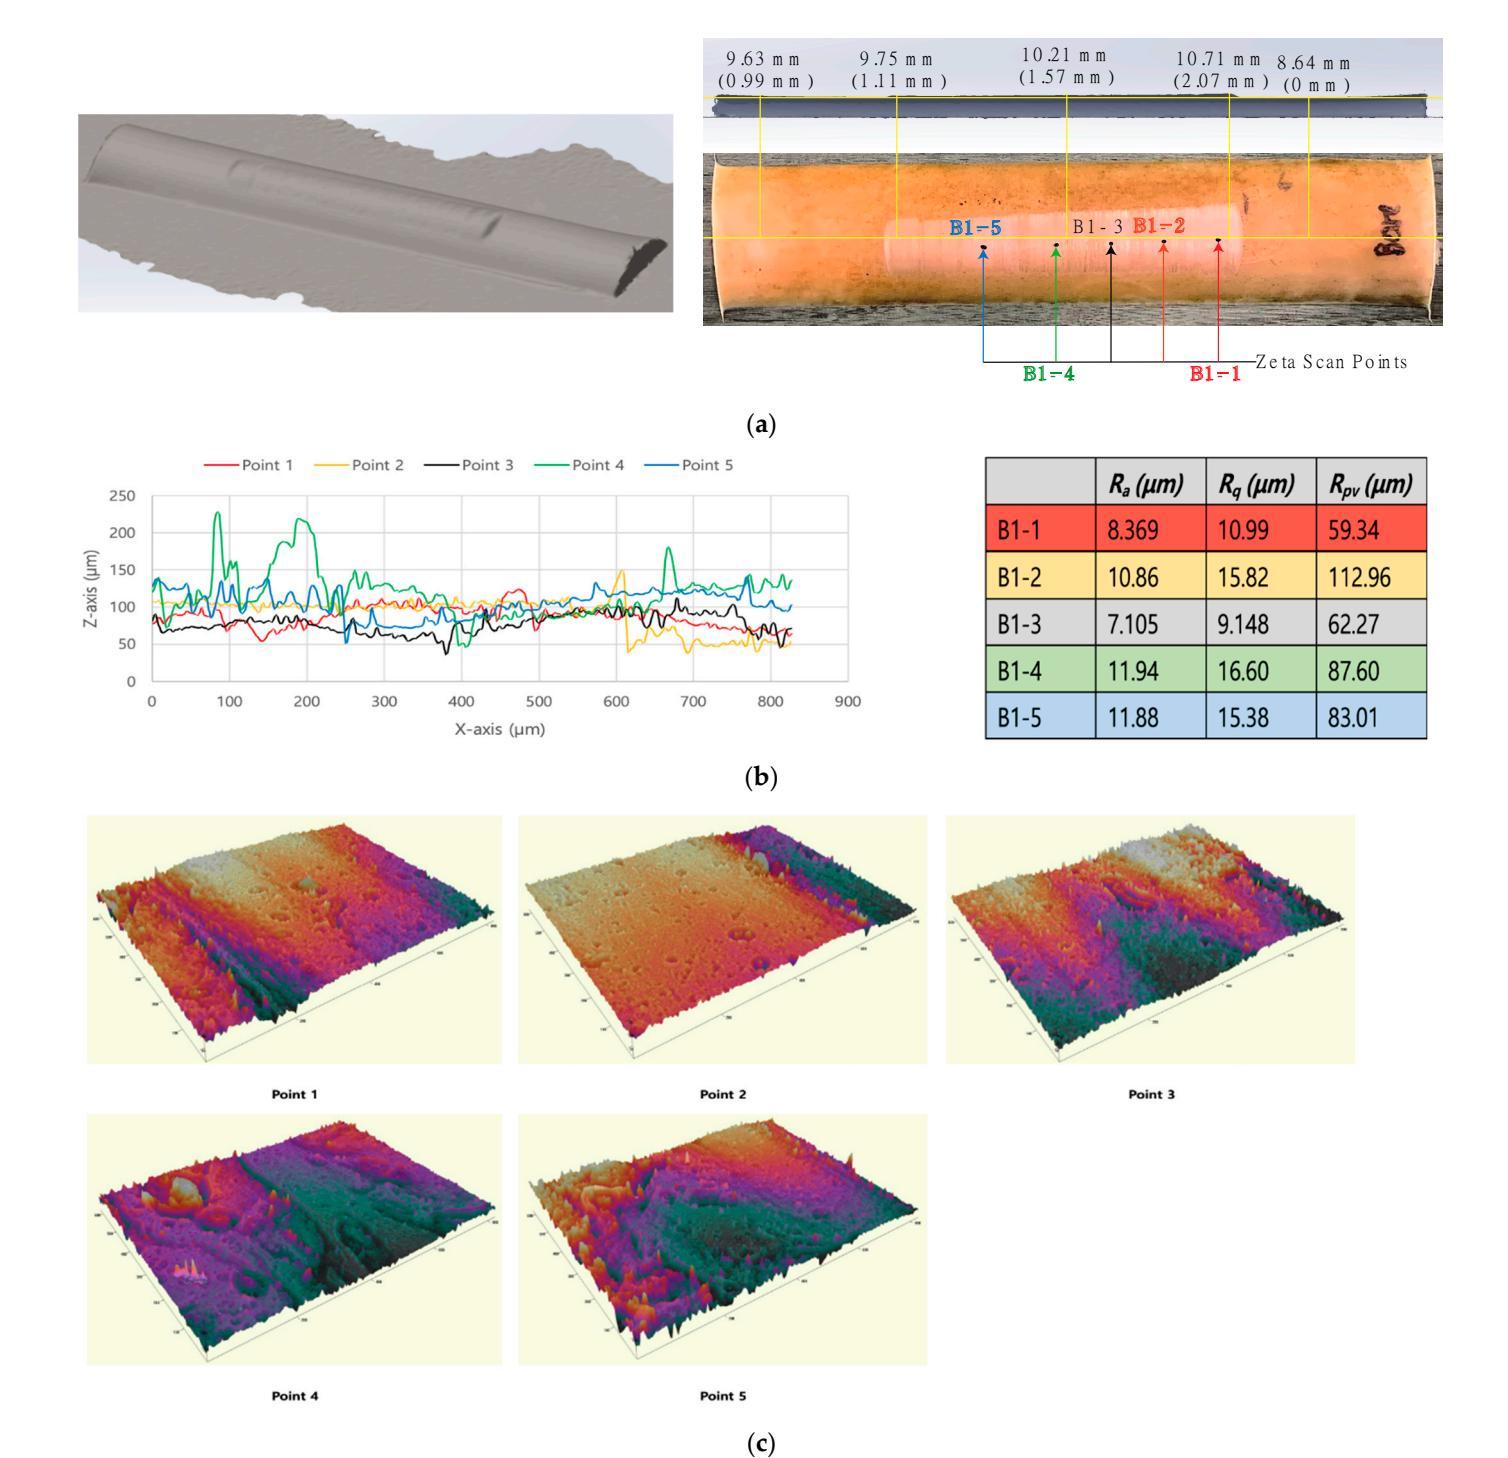
Figure 13. Creaform and Zeta 20 scans—bare carbon steel tube tested at condition 3 (see Table 2), 19 h. (a) Replica; (b) Roughness data; (c) Surface scan data.

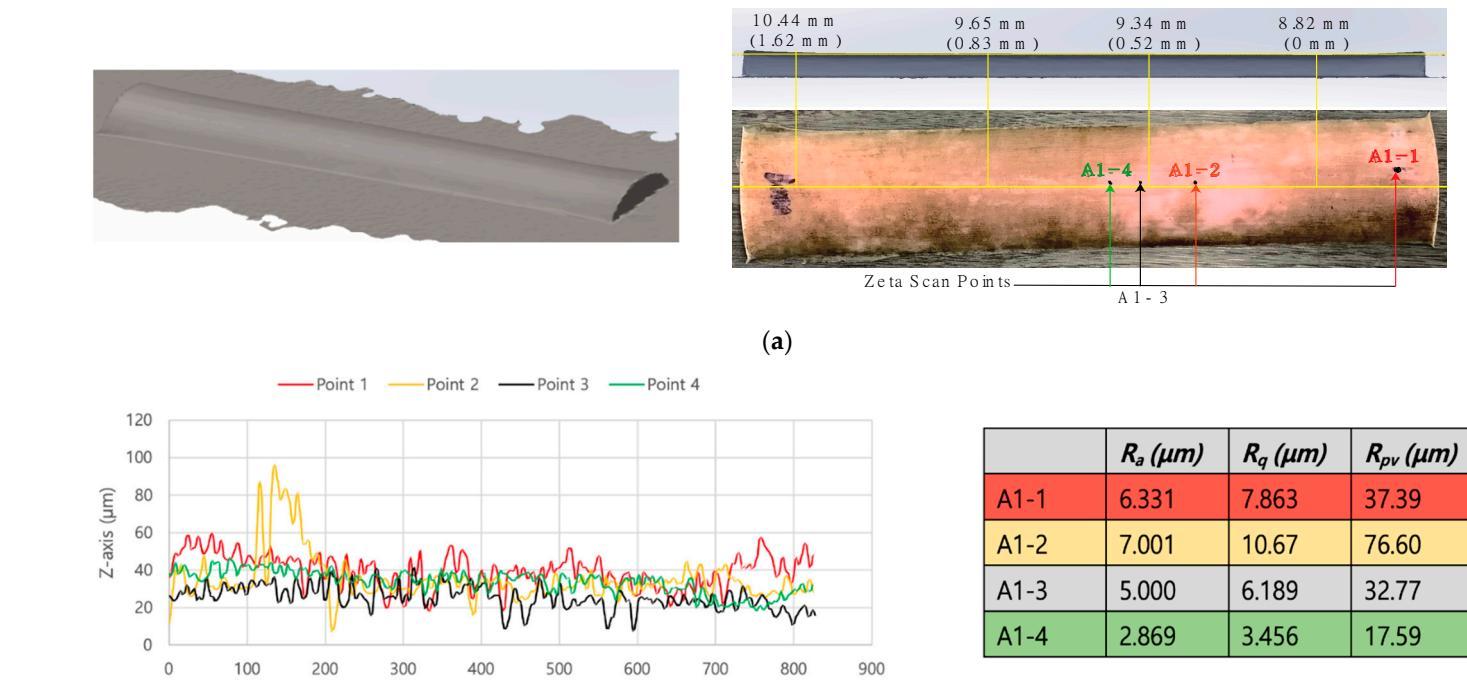
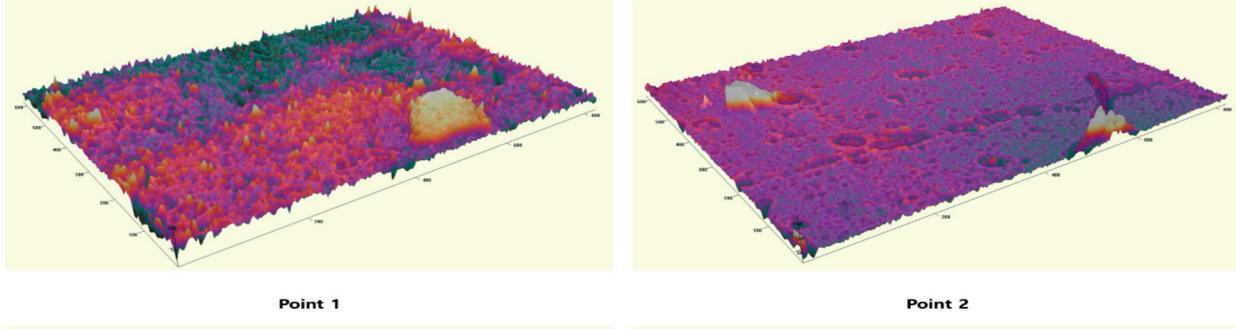
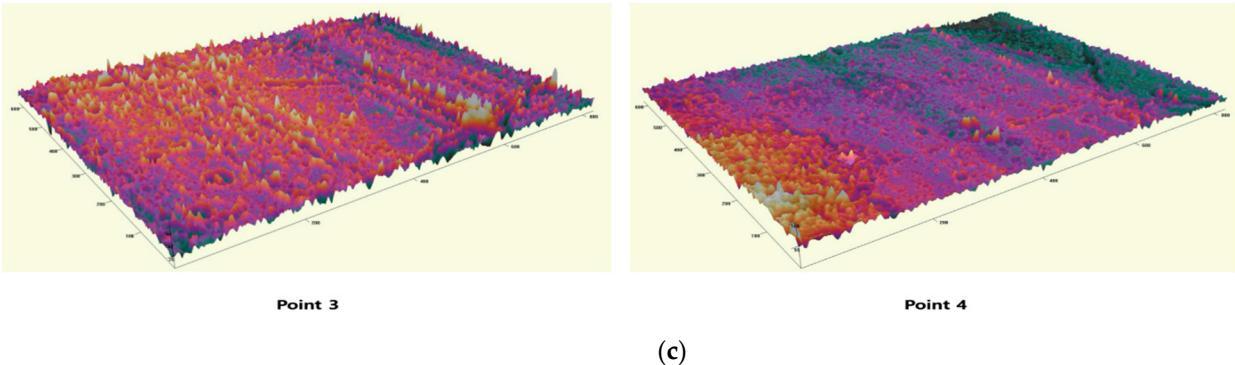
Figure 14. Creaform and Zeta 20 scans—boronized carbon steel tube tested at condition 2 (see Table 2). (a) Replica; (b) Roughness data; (c) Surface scan data.

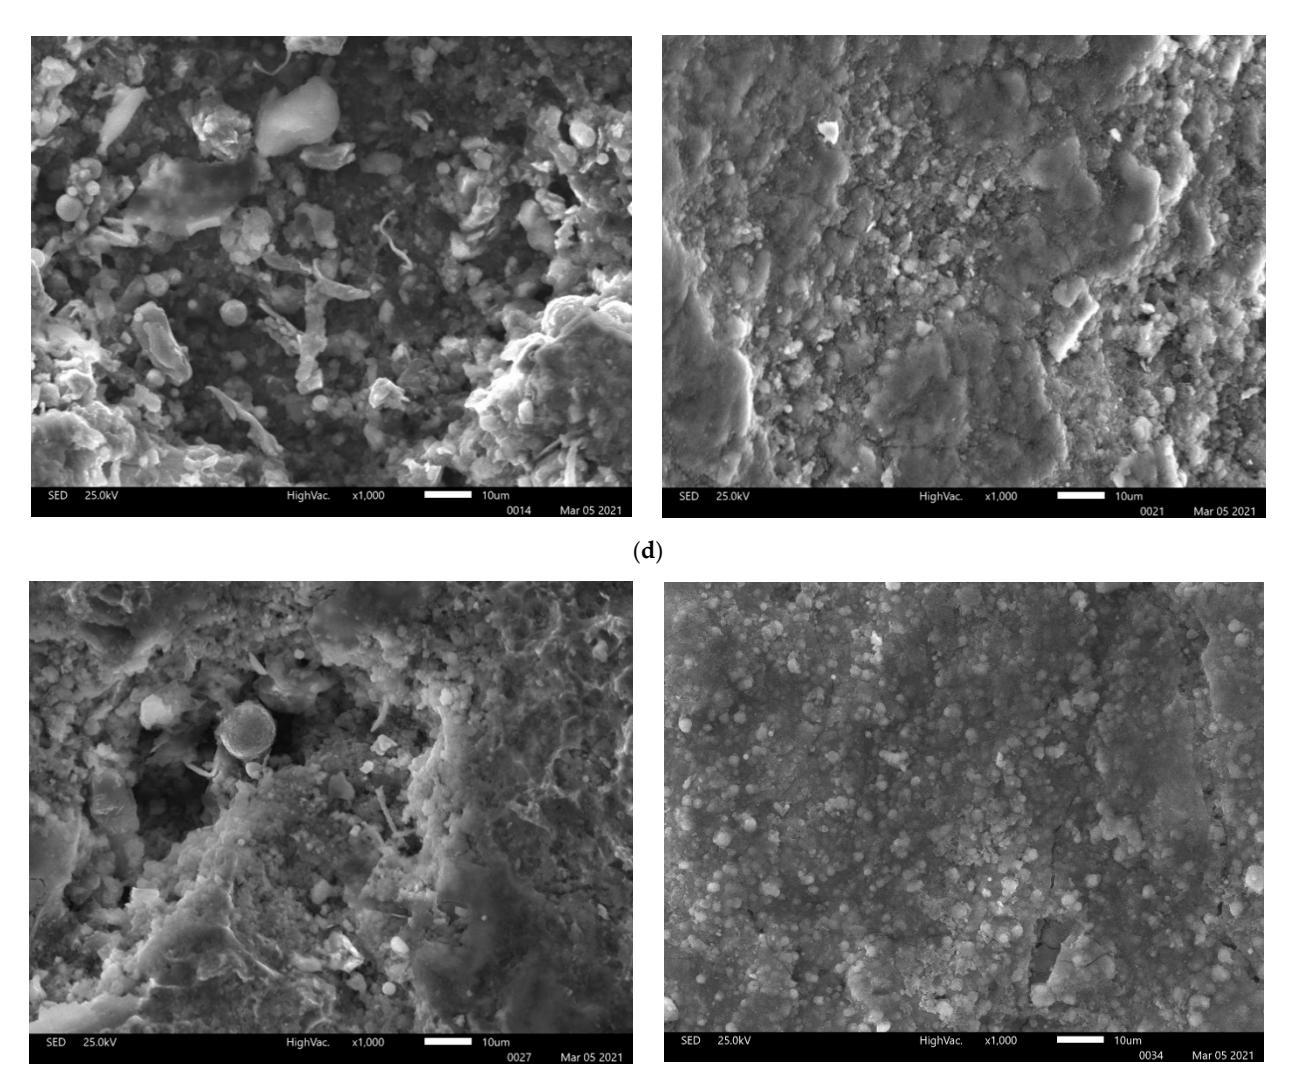
Figure 15. Surface morphology of steel J55 tube (**left column**) and boronized steel tube (**right column**) after slurry erosionabrasion-corrosion testing. (**a**,**b**)—wear scars (groove)—condition 3, after 19 h (SEM, magnifications $200 \times$ and $1000 \times$). Rows (**c**,**d**)—wear scars (groove)—condition 2 after 48 h. (J55) and condition 1 after 93 h. (boronized steel) (SEM, magnifications $200 \times$ and $1000 \times$). (**e**)—out of wear groove—condition 2 after 48 h (J55) and condition 1 after 93 h (boronized steel) (SEM, magnification $1000 \times$).

The SEM images of surface morphology for bare carbon steel and for boronized carbon steel tubing after slurry erosion-abrasion testing are demonstrated in Figure 15. The wear scars (grooves) of bare J55 steel tubes, which were in continual contacts with a steel pony rod coupling and a slurry-containing sand, had uneven surfaces where rather shallow smoother "valleys" and significantly deeper rougher "valleys" could be observed (the images are related to 19 h of testing in rather mild conditions). The significantly rougher and deeper scars (grooves) with numerous caverns and pits were observed after longer testing (48 h) in more severe conditions. In these testing conditions, the steel texture became less dense. The EDS analysis of this surface revealed, as expected, the presence of Fe and O that indicates oxidation and corrosion of steel. In some areas, notable amounts of Si were detected that is related to the embedding of silica sand grains or their fractures to the steel surface. The steel tube surface, which was subjected only by the slurry and was not in contact with a coupling, also had many caverns and pits occurred due to severe erosive flows with turbulence. When NaCl was added to the slurry, small amounts of Cl and Na were also detected on the steel surface by EDS analysis although the accuracy in Cl detection was not high. It may be speculated that some residues of salt remained in caverns on steel surface. In contrast, boronized steel tubing had significantly shallow wear scars with significantly smoother surface after the 19-hr. testing. Even after very severe testing conditions (93 h), which were significantly stronger than service conditions, the remained iron boride layer may be observed in some areas. The EDS elemental analysis of the boronized surface of the tube exposed for 93 h allowed detecting the presence of B, as well as Fe and O. The iron boride oxidation in the wear scar was expected, similarly to the earlier wear testing [52,61], i.e., an (Fe,B)_xO_y film was occurred. The B contents varied from ~8 wt % to ~2 wt % in different areas that indicates uneven wear of the iron boride layers. When the testing was conducted in the conditions 4 (with addition of NaCl), no presence of Cl was detected for the boronized steel by EDS. Moreover, the presence of O and Cl was not detected by EDS in the steel substrate under the boride layer that indicates a high level of protection through boronizing. These results correspond well to our previous study [52]. Because the sufficient wear was detected by the profilometry examination, it could be assumed that, after testing for 93 h under severe slurry erosion-abrasion-corrosion conditions (see Table 2), only oxidized F_2B layer remained in certain areas while it was completely gone in some zones. It is assumed that, at these severe conditions, the cracked and peeled-off iron boride layers' fragments were removed by high velocity slurry flows. The boronized surface that was not in contact in the steel coupling had small pits and even occasional surface micro-cracks occurred due to slurry erosive actions. The micro-

cracks were not detected in the groove areas; probably, the cumulative action of a rotating coupling and slurry flows worn the material surface where the micro-cracks became not well observed.

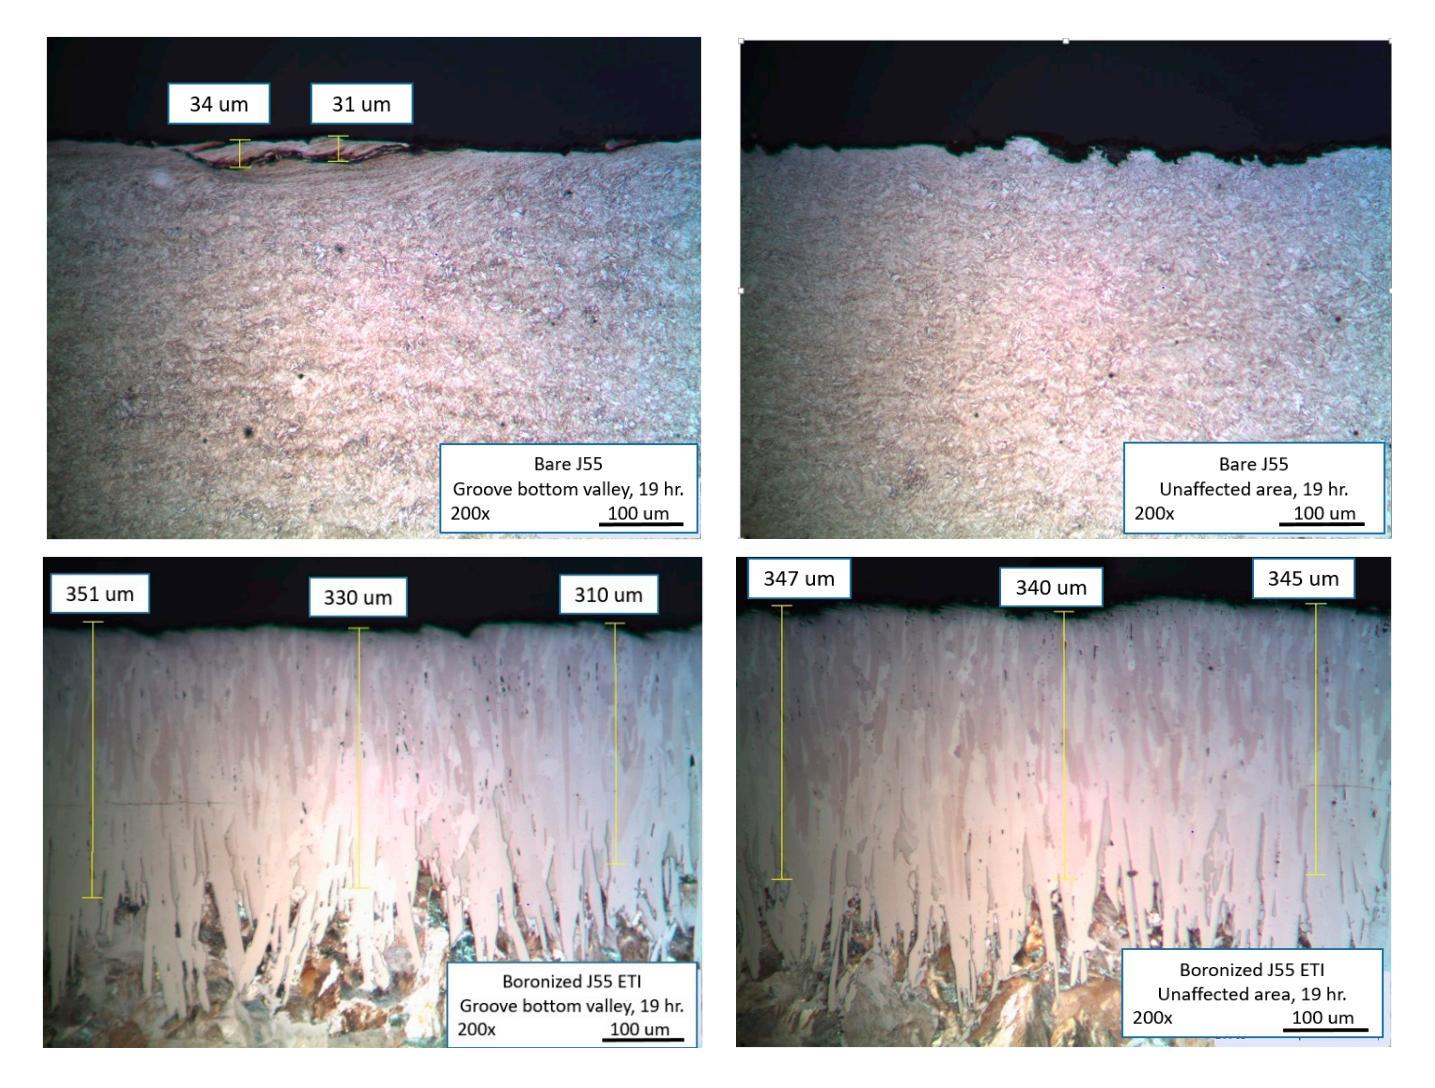
Figure 16. Surface structure for tubes J55 steel (**top row**) and boronized J55 steel (**bottom row**) after slurry (wirh NaCl) erosion-abrasion-corrosion testing for 19 h. (**Left column**)—area from the wear groove (affected by combined action of pony rod coupling and slurry containing silica sand). (**Right column**)—area out of the visible wear groove affected only by slurry containing silica sand.

> The images obtained under optical microscope from the cross-sections of materials after 19 h testing (conditions 3-4 Table 2) indicated insignificant wear of boronized steel and surface destruction of bare carbon steel (Figure 16). Thus, the boronized tube surface that was in contact with a pony rod coupling and a slurry contained silica sand lost only very insignificant portion of the iron boride layer; the remained case depth was ~300–340 μm. Some cracking within the iron boride protective layer parallel to the surface of the coating (or steel substrate) occurred, likely due to continual motion (particularly, impacts) of the pony rod coupling. The tube area, which was subjected only to the slurry with abrasive particles but not subjected to the pony rod coupling, had a case depth of 340–345 µm. The "wavier" surface could be observed; however, no significant crack propagation was detected. In contrast, the bare steel tube had a deep groove after 19 h of testing. Because of the size limitations of the optical microscope, the full groove could not be demonstrated. However, it can clearly be seen that the steel surface was destroyed under the slurry erosionabrasion where large steel flakes with thicknesses of more than 30 μ m were removed. The boronized tubes that were tested at significantly more severe conditions (~90 h duration) lost the protective iron boride layer in the area contacted with a pony rod coupling and

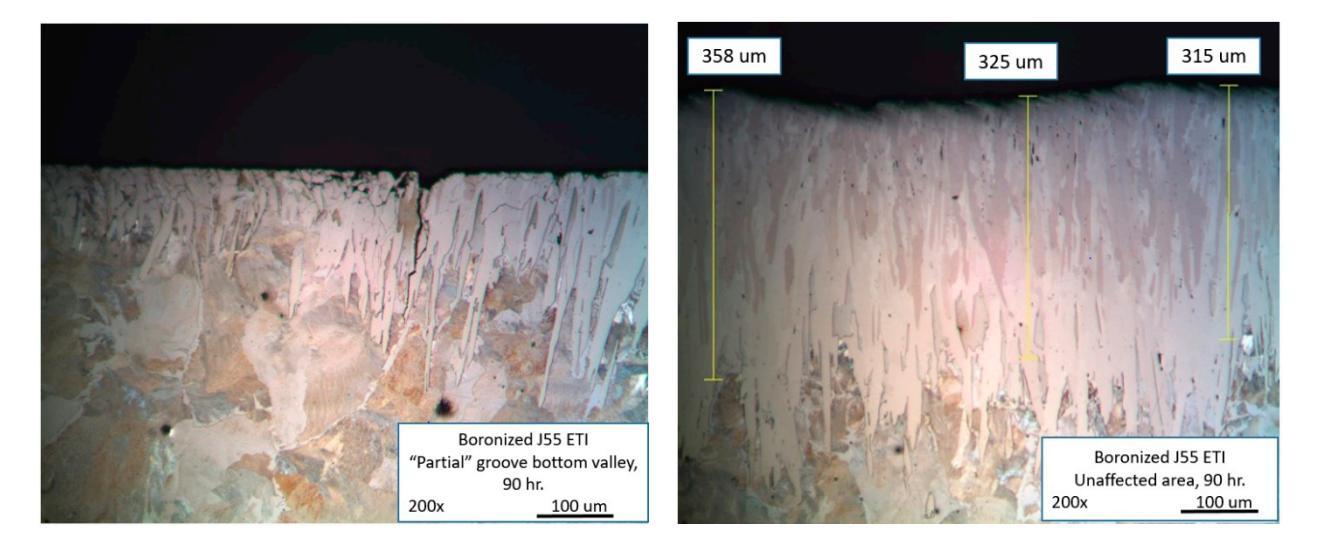
Figure 17. Surface structure for boronized J55 steel tube after slurry erosion-abrasion-corrosion testing for ~90 h. (**Left**)—area from the side of the wear groove "partially" affected by combined action of pony rod coupling and slurry containing silica sand. (**Right**)—area out of the visible wear groove affected only by slurry containing silica sand.

"shoulders", as was mentioned above; however, the iron boride layer still remained in the areas close to the deepest groove zone (Figure 17). This image shows the reduction of the case depth and the crack propagation through the boride layer. As opposed to this area, the boronized surface remained practically intact in the places where the pony rod coupling did not touch the tube surface; the thickness of the protective layer remained practically without changes (over $300 \ \mu\text{m}$), and no cracks were observed (Figure 17). The iron boride layer micro-hardness remained on the original level after testing; its HK0.1 was in the range of $1600-1800 \ \text{kgf/mm}^2$. Only the micro-hardness values had more discrepancies for certain indentations. This high level of micro-hardness indicates the high integrity of the iron boride coating structure, with only insignificant micro-cracks formation and propagation at selected testing conditions.
