# Article Time-Lapse Camera Monitoring and Study of Recurrent Breaching Flow Slides in Cap Ferret, France

Yves Nédélec \*<sup>D</sup>, Philippe Fouine, Cyrille Gayer and Florent Collin

Abstract: In this paper, we present a low-cost method designed to monitor recurrent breaching flow slides that impact the security of a beach. This beach, located in France at the inlet of Arcachon Bay, connects a sand spit to a tidal channel while ending at the toe of a coastal defense. Monitoring is based on capturing images and intends to add continuous information to intermittent direct observations so that triggering and influencing factors can be assessed more precisely. The method is based on time-lapse picture collection and processing. The field of view shows successive emerged manifestations of flow slide phenomena, as well as some possibly related environmental elements. On-site application for 576 days provides important indications and details on flow slide event progress and beach recovery. A simple but quantitative analysis of the influence of sand spit topographic changes is proposed as a preliminary approach of the method's suitability for studies of environmental processes in conj

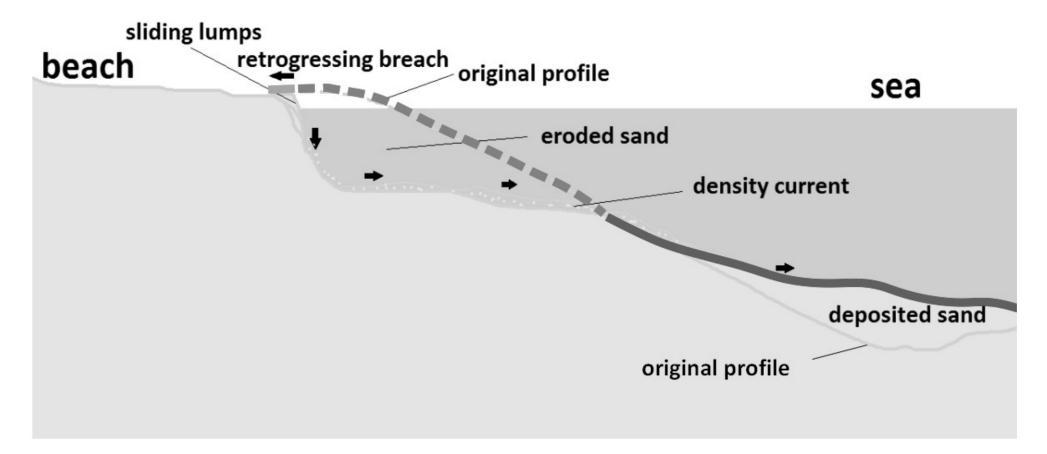
Figure 2. Schematic side view of flow slide process.

Coastal flow slides or retrogressive breach failures are uncommon forms of erosion events that impact compact underwater sandy or silty slopes. They mainly occur in tidal environments, but can be observed on riverbanks or lake shores as well. Their course is driven by gravity, but counter-intuitively, they progress upward. The complex process is triggered by processes at the toe, due to various identified factors (groundwater outflow, dredging, and bed incisions). The release of sediment particles from a vertical wall by sand dilatancy is activated. The wall retrogrades onshore at a slow and steady rate of approximately 0.8 m per minute, and can take the form of a circular excavation in the beach [2–4]. It grows in height and circumference as a plume of sand is drawn away by

density currents (Figure 2). The wall may fail with spectacular collapses and scars [5], which are potentially a deadly threat to beach walkers or fishers, such as in the case of North Wildwood, New Jersey [6]. The phenomenon may seriously endanger nearby constructions too, and further studies are needed in order to properly perform hazard assessments [7].

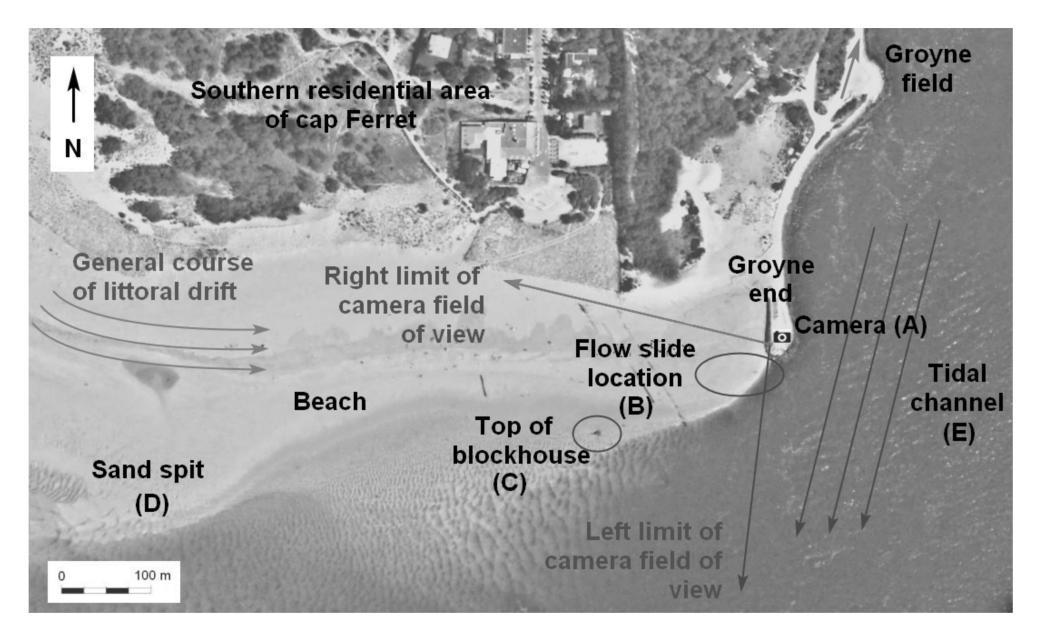
**Figure 3.** Map of the monitored beach centered towards the southwest, and environmental points of interest: (**A**) riprap in which the camera was inserted; (**B**) area exposed to flow slides; (**C**) top of a blockhouse from World War II; (**D**) western sand spit; and (**E**) outlet of tidal channel (background aerial view: Géolittoral Ortho-Littoral V2 © Cerema-IGN).

The experimental site was located on the southern beach of Cap Ferret, on the southwest Gironde coast in France (Figure 1). A camera was set up to capture views of flow slides always located near the toe of the southern end of a riprap groyne field bordering the tidal channel on the east. The monitored area of this beach extended from this groyne to a small sand spit facing the Atlantic Ocean further west, enabling environmental observations. Figure 3 shows a map of this monitored area, together with some topographic details.

Five sedimentary, hydrodynamic and environmental points of interest can be found at the study site:

- 1. Blocks forming the eastern groyne where site observation was performed and near to the area susceptible to flow slides;
- 2. The area susceptible to flow slides itself;
- 3. An immovable World War II blockhouse partially stuck in the sand since, showing a corner pointing upside, easy to spot, and providing a good sand level indicator;
- 4. The western end of the beach exposed to ocean waves, shaped like a moving sandy hook;
- 5. The outlet of the tidal channel, often marked by turbulence and strong flow patterns.

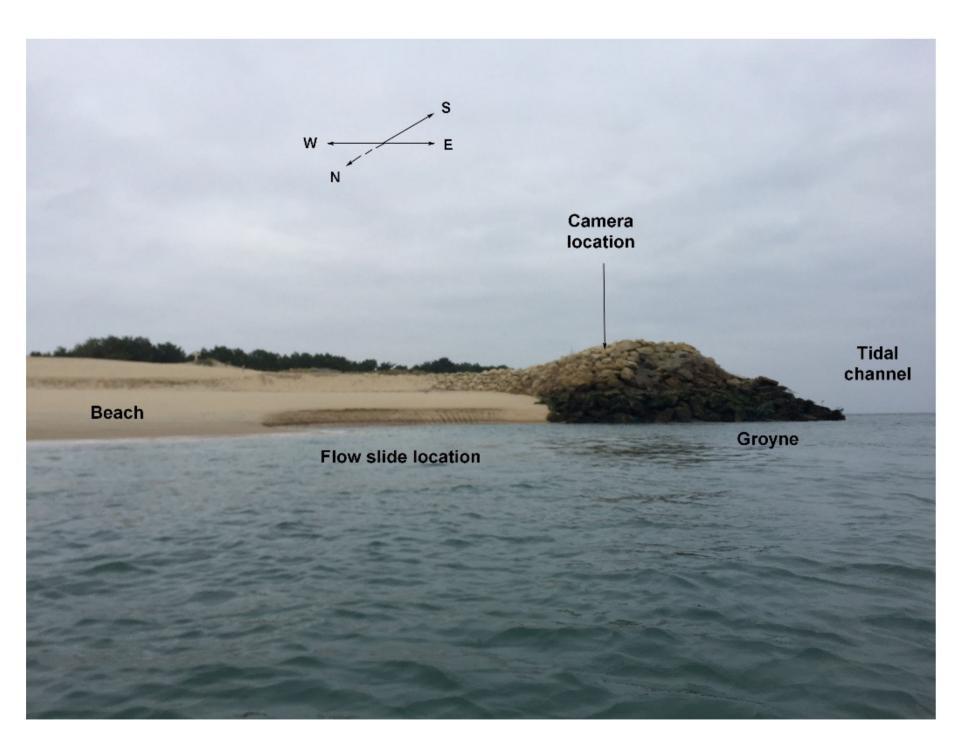
Figure 4. Sea view from the sea towards the part of the monitored beach where flow slides occur.

Figures 4 and 5 show the site from the water surface and from the top of the groyne, respectively.

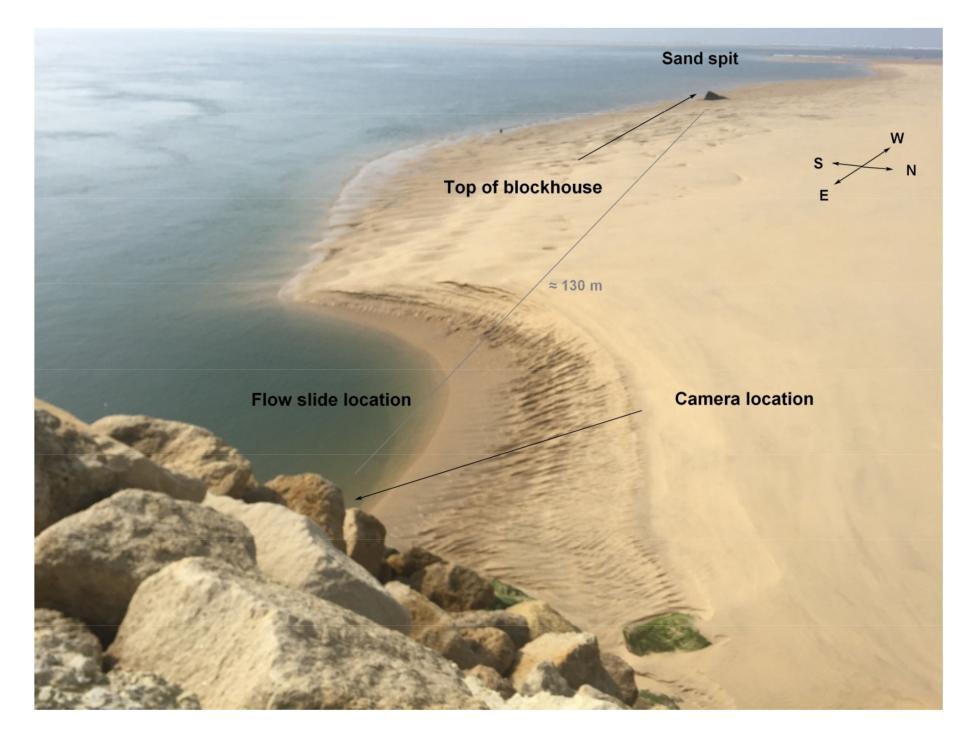
Figure 5. View from the top of the groyne towards the whole monitored beach.

Locations of the end of the western sand spit in daily pictures (see Figures 5 and 8) were recorded in order to study its influence. For example, in Figure 8, the relative coordinates of the spit end are (0.47, 0.59). All daily relative coordinates are plotted on the graph in Figure 20. Despite the loss of accuracy due to distance- and calibration-related uncertainties, changes in the x value were considered as good indicators of a southward extension of the spit. This was simultaneously observed through topographic surveys by Nahon [17].

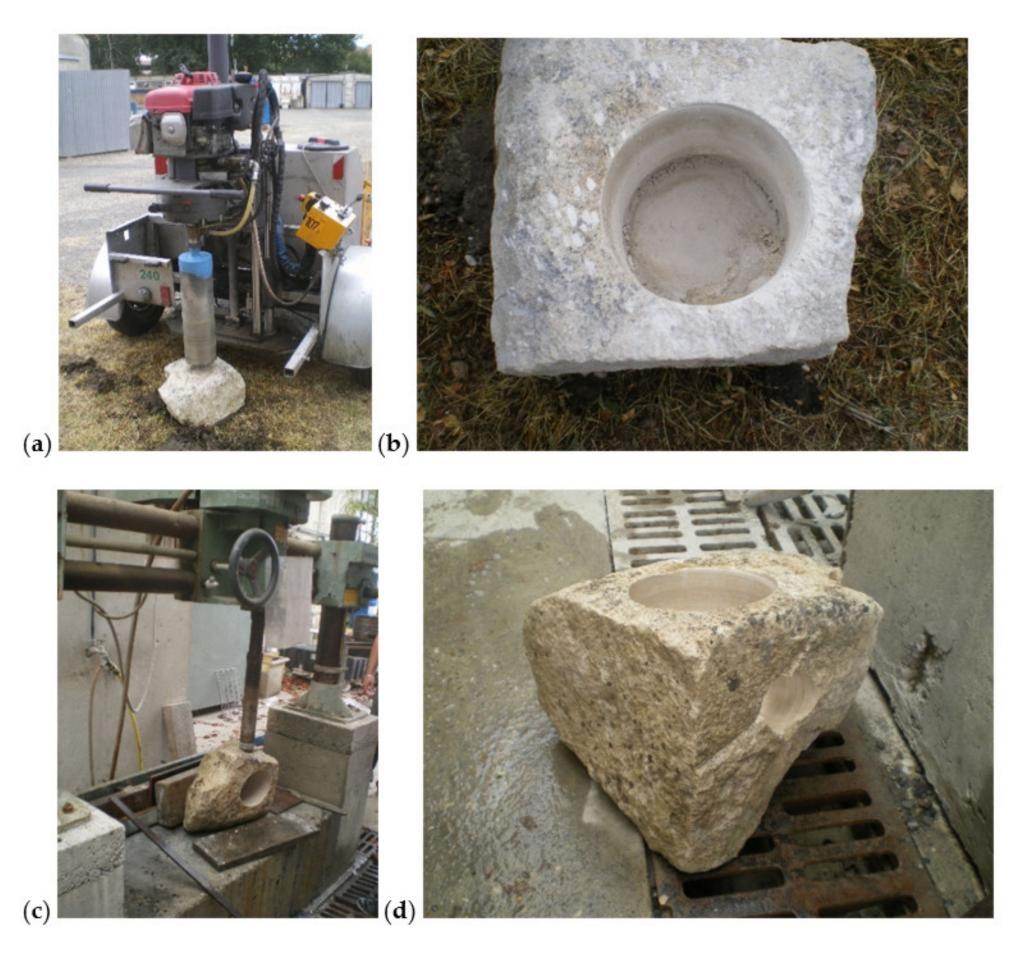
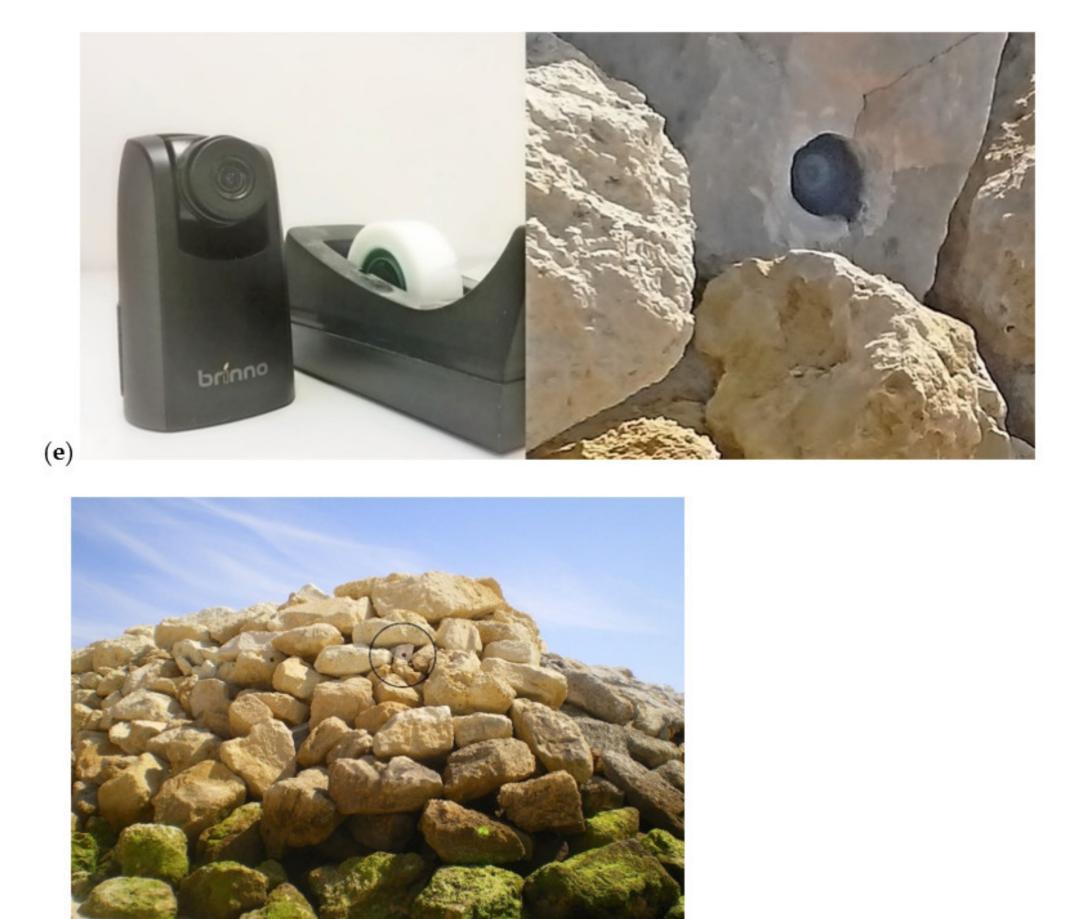
**Figure 6.** Special casing and placement of the camera: (**a**–**d**) drilling of the block, larger hole and locking plate were placed downside at the site; (**e**) Brinno 200TLC Pro camera, as seen out of package and as can be seen once in the block (large hole and steel plate are downside); (**f**) block inserted in the groyne.

An inexpensive time-lapse camera was chosen as a good compromise between robustness in a coastal environment facing oceanic waves, picture detail and accuracy, and stability of the targeted view. A Brinno 200TLC Pro and its protection case were used and fulfilled the first objective. Resistance to the environment was improved by inserting this into a rock drilled with two perpendicular holes. The first one, closed by a screwed steel plate, allowed the camera to be inserted and secured. The second and smaller hole was open in front of the objective. Image stability was improved too by the mass of the block.

A few steps of this procedure and a view of the camera in place are shown in Figure 6. Both the block and inserted camera were left in place between 30 July 2015 and 7 April 2017, with a capture interval of 10 min. This interval was a compromise between obtaining details about ongoing events (retrograding slowly) and maintaining long-term monitoring. Camera operation energy was provided by batteries that needed replacement approximately every month. Weather conditions could alter this periodicity, especially because of very high or very low temperatures, impacting data retrieval operations and battery replacement. This operation successively required extraction of the block from the groyne, and an extraction of the camera from the block. After on-site data collection by means of a USB cable, the material replaced.

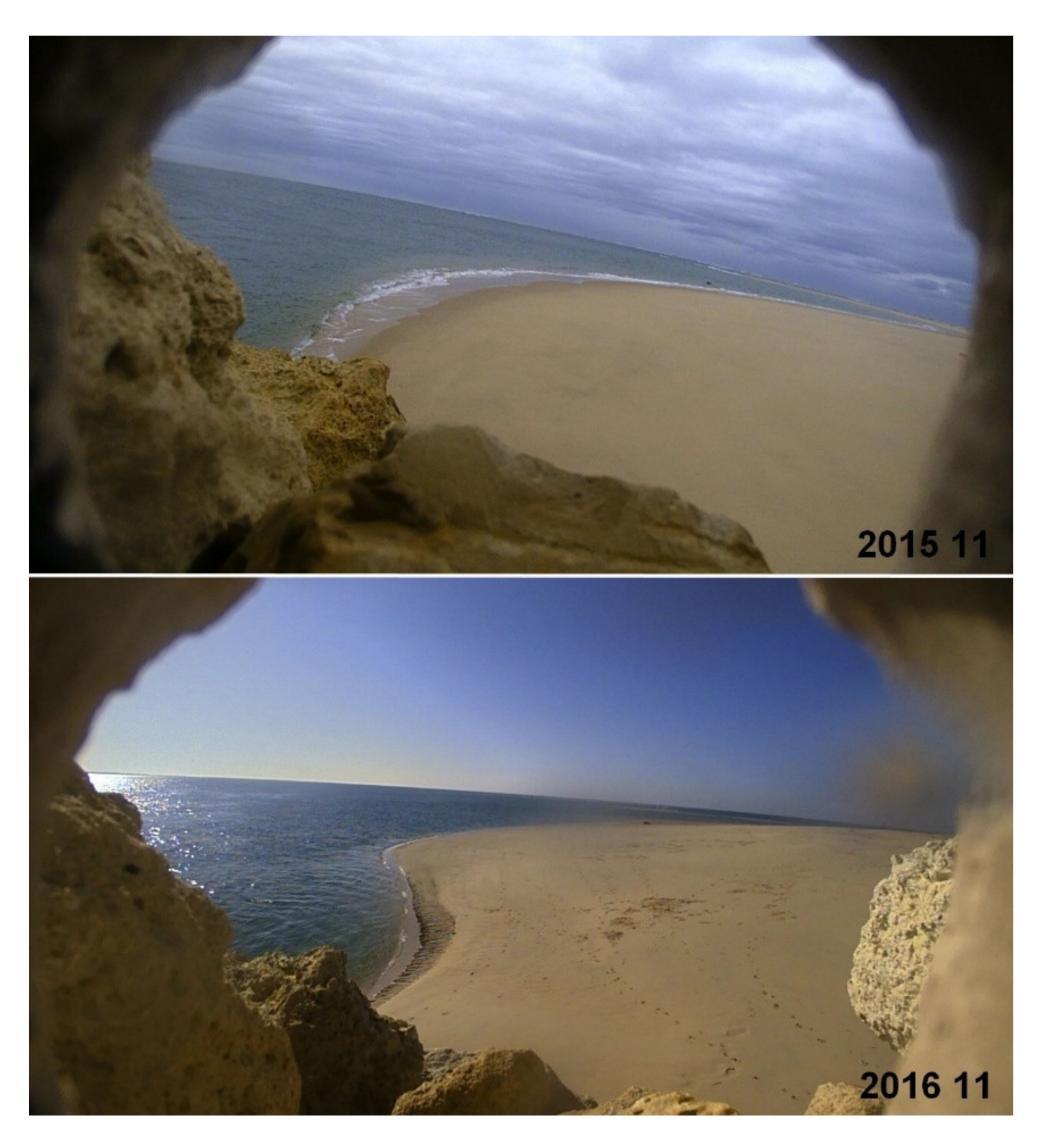
Figure 7. Raw views from picture collection periods with two different block positions.

As specified previously, data recovery entailed block removal from the coastal structure, followed by reinsertion. Due to changes in block position between these two procedures, image processing was necessary to correct them and obtain a fixed field of view (different fields of view in raw pictures are shown in Figure 7). This was performed with Hugin software.

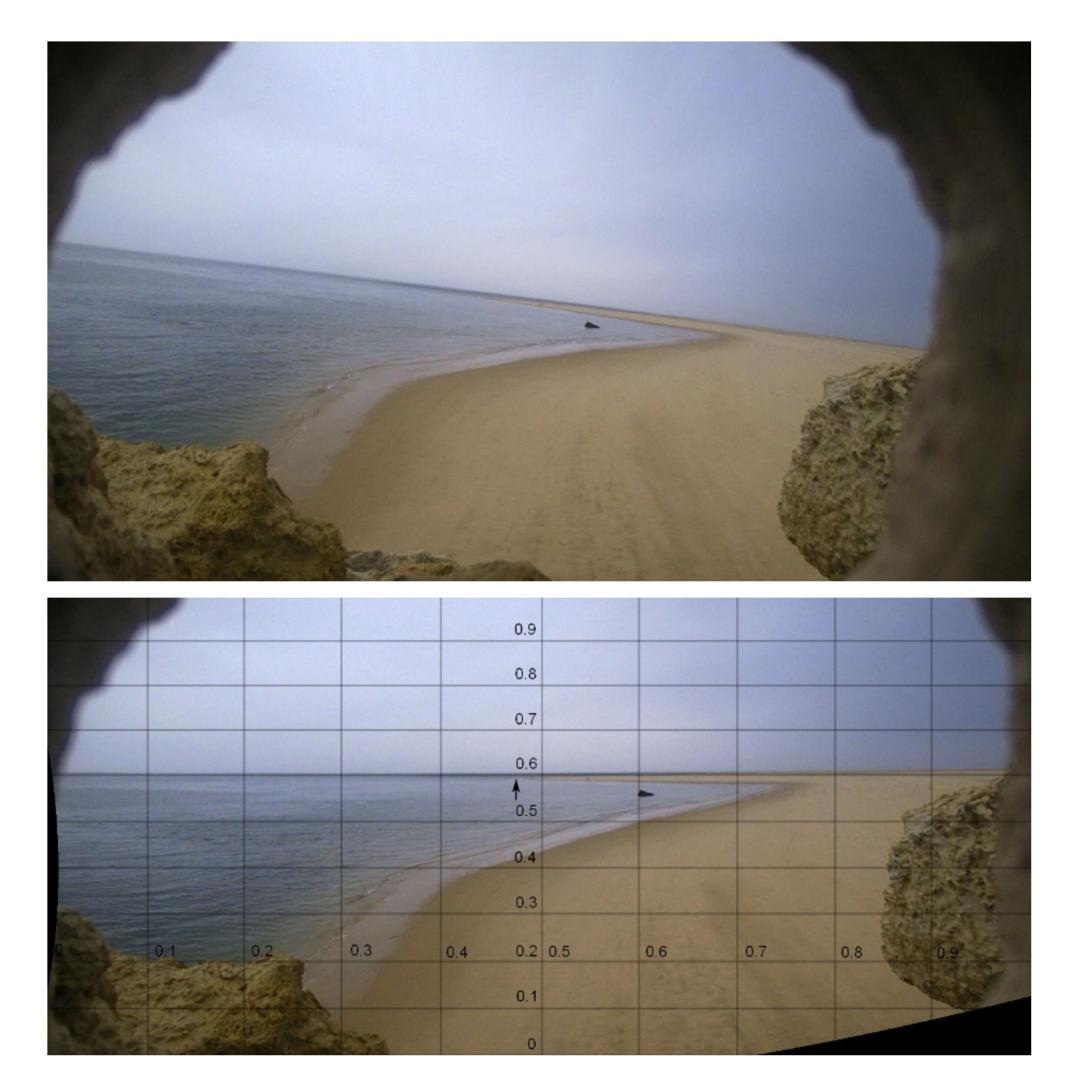
**Figure 8.** Example of a raw picture (**top**) and processed picture with grid and labels with relative coordinates (**bottom**). The black arrow indicates the sand spit end location in the picture (see Section 4.2.2).

The pictures were processed so that an almost invariant field of view can be seen; thus, differences between block positions were corrected. Hugin software, designed for perspective manipulation, was used to transform views according to a set of two geometric rules: (1) invariable relative coordinate x = 0.6 in the picture of the blockhouse top; and (2) invariant tilting and relative elevation of horizon y = 0.6 in the picture. Image processing by Hugin is carried out through three steps: (1) setting the camera lens parameters; (2) calibration of three Euler angles to satisfy geometric rules; and (3) numerical calculation. The completion of these geometric rules also yielded a quasi-straight horizon. Calibration was performed with two pictures, preceding and following the camera manipulation for data retrieval, respectively. Figure 8 shows the raw and processed pictures. A grid and labels for relative coordinates on the processed picture illustrate the geometric rules.

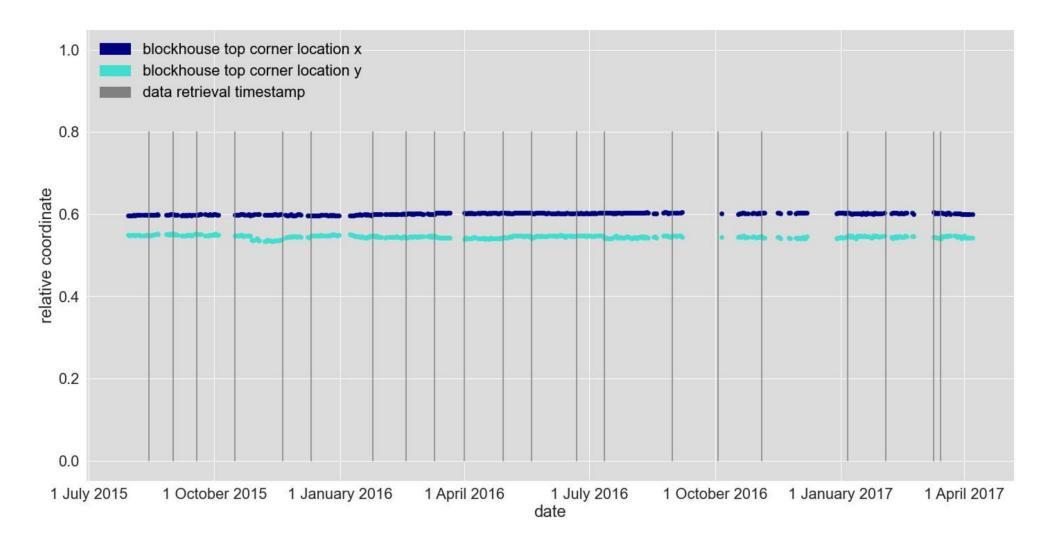
Figure 9. Blockhouse relative coordinates in the daily pictures after processing.

Vertical dark grey lines marking data retrieval timestamps have been added to both Figures 9 and 10.

Figure 9 reveals the movement of the block and camera during the experiment, due to wave impacts on the groyne. This occurred during the fifth monitoring period and produced a slight change in the blockhouse y coordinate.

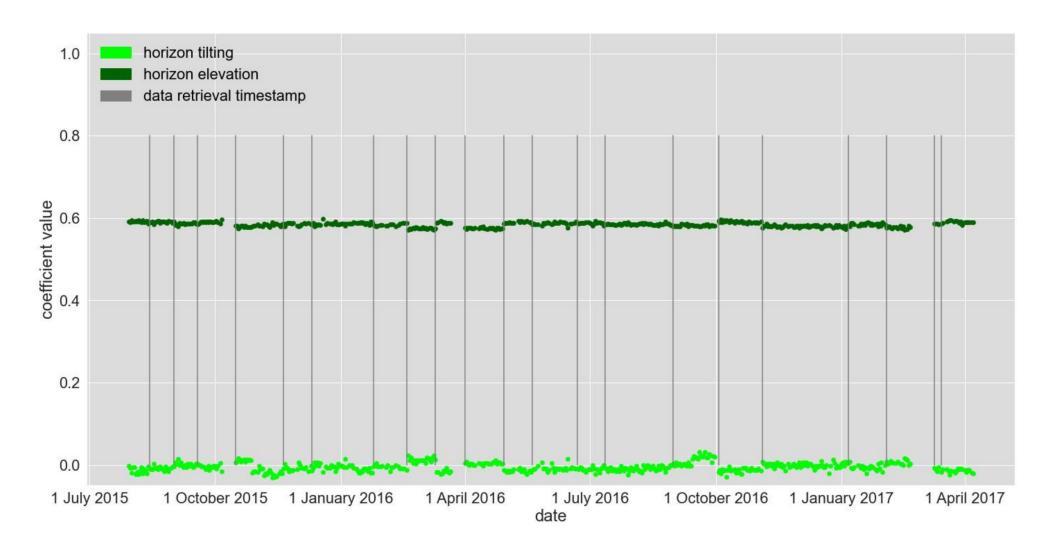
**Figure 10.** Horizon tilting (slope of the horizon line in picture) and relative elevation of the horizon in the daily pictures after processing.

Variability of the horizon data can be explained by the picture resolution being too low to ensure a clear view of the background, together with the sensitivity of near-edge pixels to Hugin Euler angles.

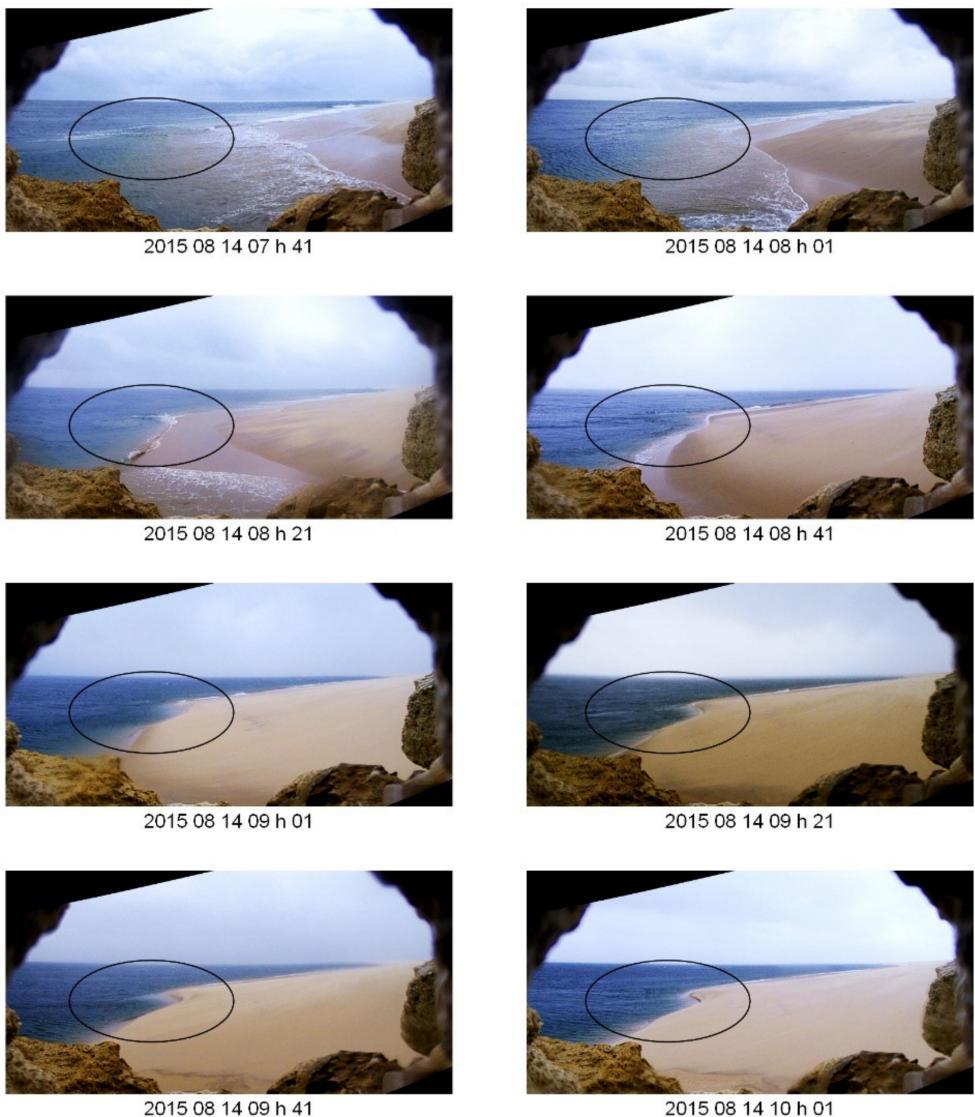
Figure 11. Successive raw images showing a mainly submerged event.

The first example (Figure 11) is that of a small event that takes place at some distance from the groyne (rare) and excavates the beach entirely underwater (barely observed during the day as well). A vortex with a sand load at 8 h 21 revealed underwater slide progress. Increased darkness of the water between 8 h 01 and 9 h 01 revealed the loss of sand below the surface.

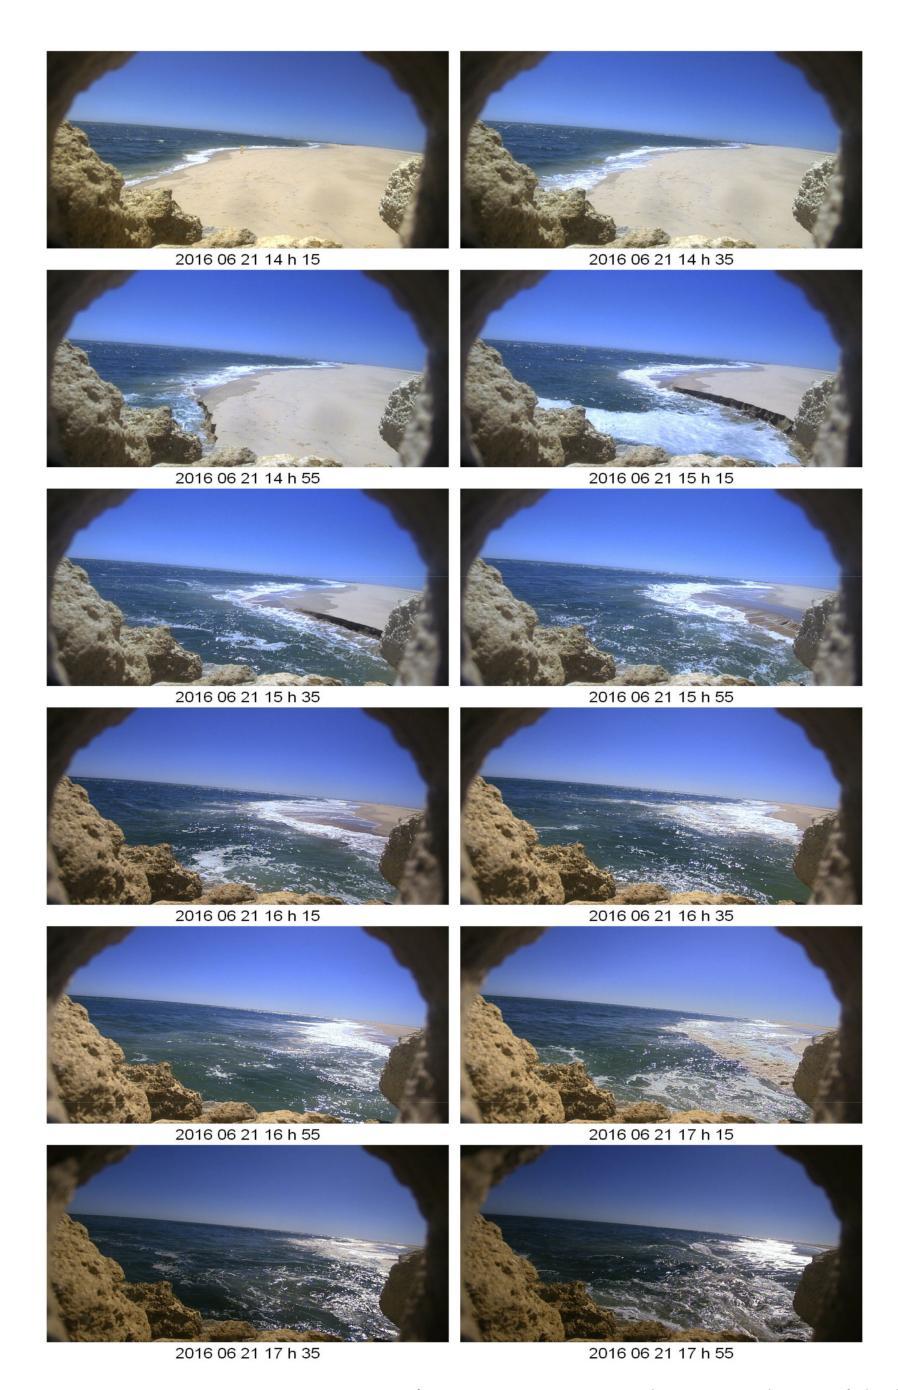
Figure 12. Successive raw images of an event excavating the emerged part of the beach.

The second example (Figure 12) is that of an event that started around noon and progressed into the beach, excavating its emerged part. Foam was present during most of its progression, and was remarkably abundant at 15 h 15 and 17 h 15. The origin of this foam cannot be determined from this set of pictures. Foam is considered by Beinssen [14] to be a characteristic of flow slides in sands which have not been disturbed for some time. The frequent repetition of events here indicates that there may be another cause, possibly with the same foam generation process. Unsaturated sand is suspected to produce foam; however, the smoothed excavation rim after 15 h 55 and an invisible part of the progressing event suggest alternative possible explanations. Large sand plumes emitted by the sliding phenomenon can be seen at 16 h 55. Pictures from 14 h 15 to 15 h 15 give a good idea of the rapidity of the progress.

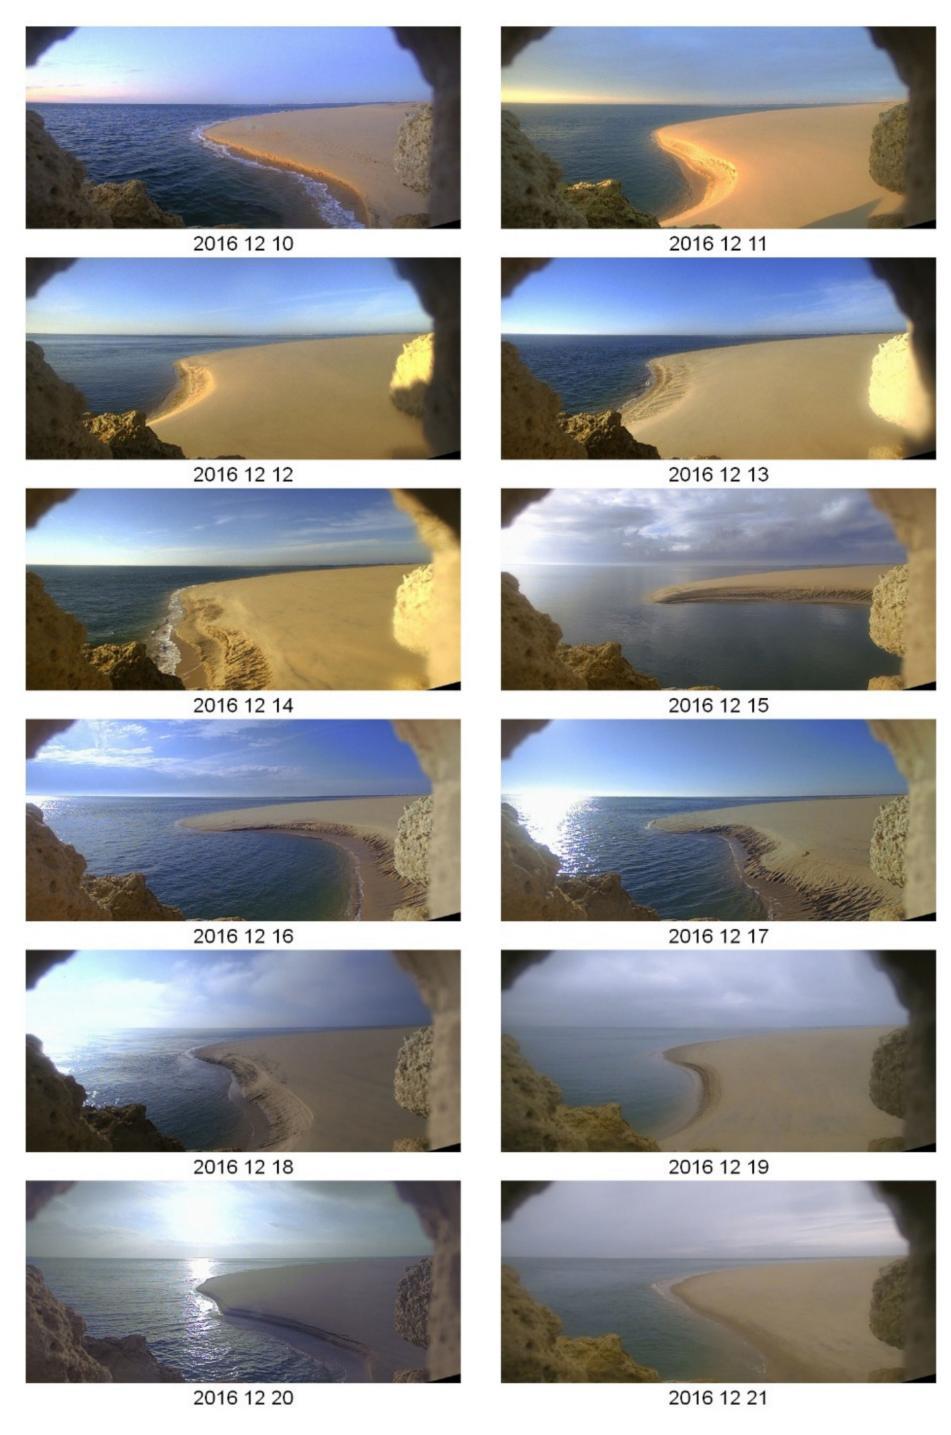
**Figure 13.** Daily processed images showing a succession of flow slide events and subsequent healing periods.

Daily pictures present interesting information about the beach healing process. This process depends on drift intensity; flow slides and coastal dynamics are closely related. Figure 13 shows an active succession of slides (Dates of these slides: December, 14, December, 15, December, 17, December, 20, 2016) and beach healing, which demonstrates the ability of the longshore drift to fill the void left by large flow slide events. During such periods of intense activity, the top corner of the blockhouse is covered by sand, as will be explained in Section 4.2.2.

This sequence of images also shows that flow slides may occur before total healing from the preceding event.

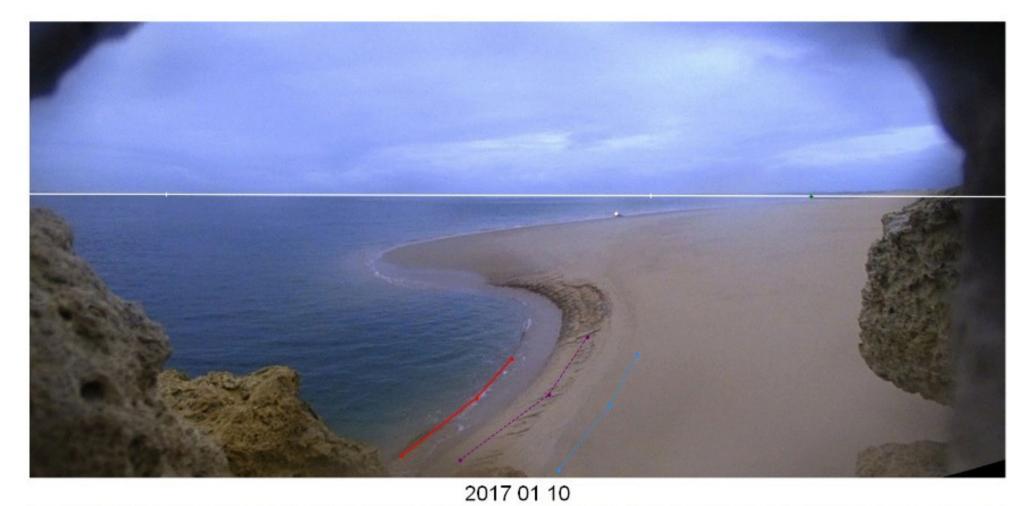
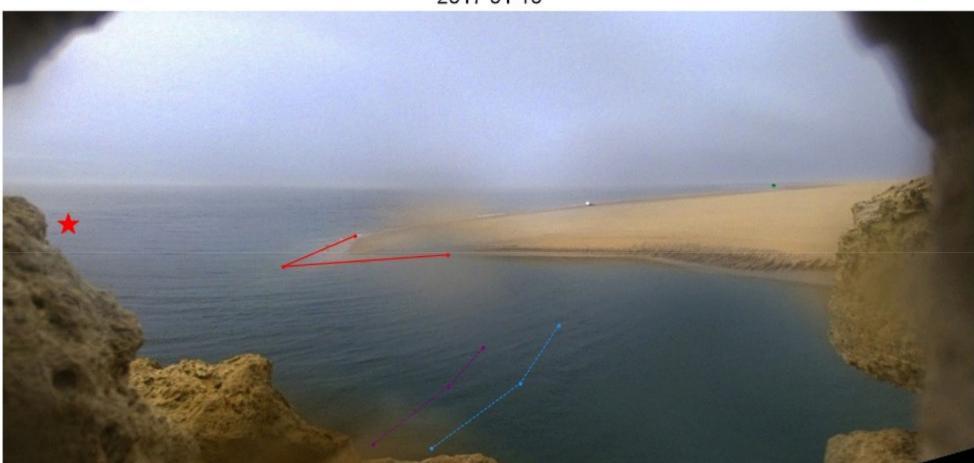
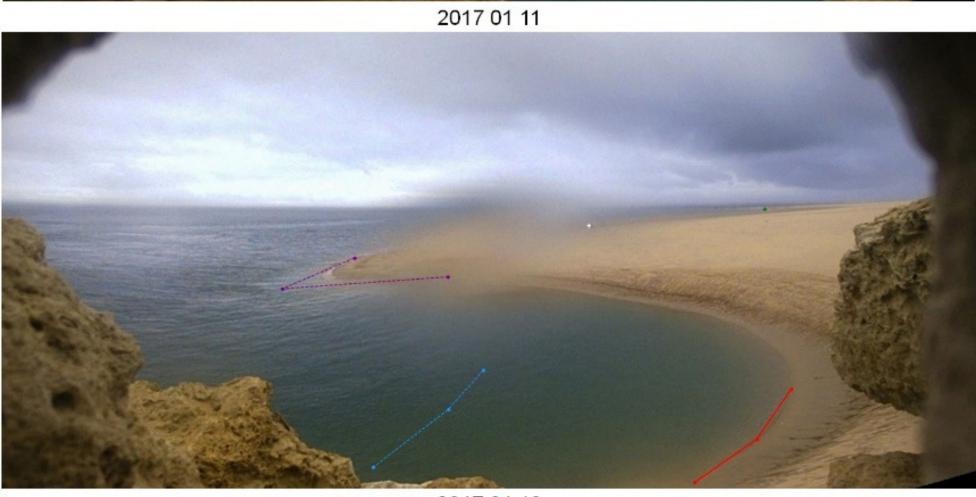
2017 01 12

**Figure 14.** Sequence of views captured on the screen during the digitizing process. Blue and purple lines are previous digitized shorelines, and the red line indicates the shoreline associated with the current view. Red stars mark events.

The sets of three points were digitized on images with a script developed in Python. Figure 14 shows a group of views captured from the digitizing process. Three sets of points (in blue, purple and red) visualized shoreline changes between former daily views.

A red star on the left indicates that the picture was taken the day following a flow slide event. In this case, one triplet was digitized on the distant corner side of excavation. Following triplets were digitized close to groyne again, even during the beach healing process. If a flow slide excavated an unhealed former event, one triplet was digitized on the new excavation corner.

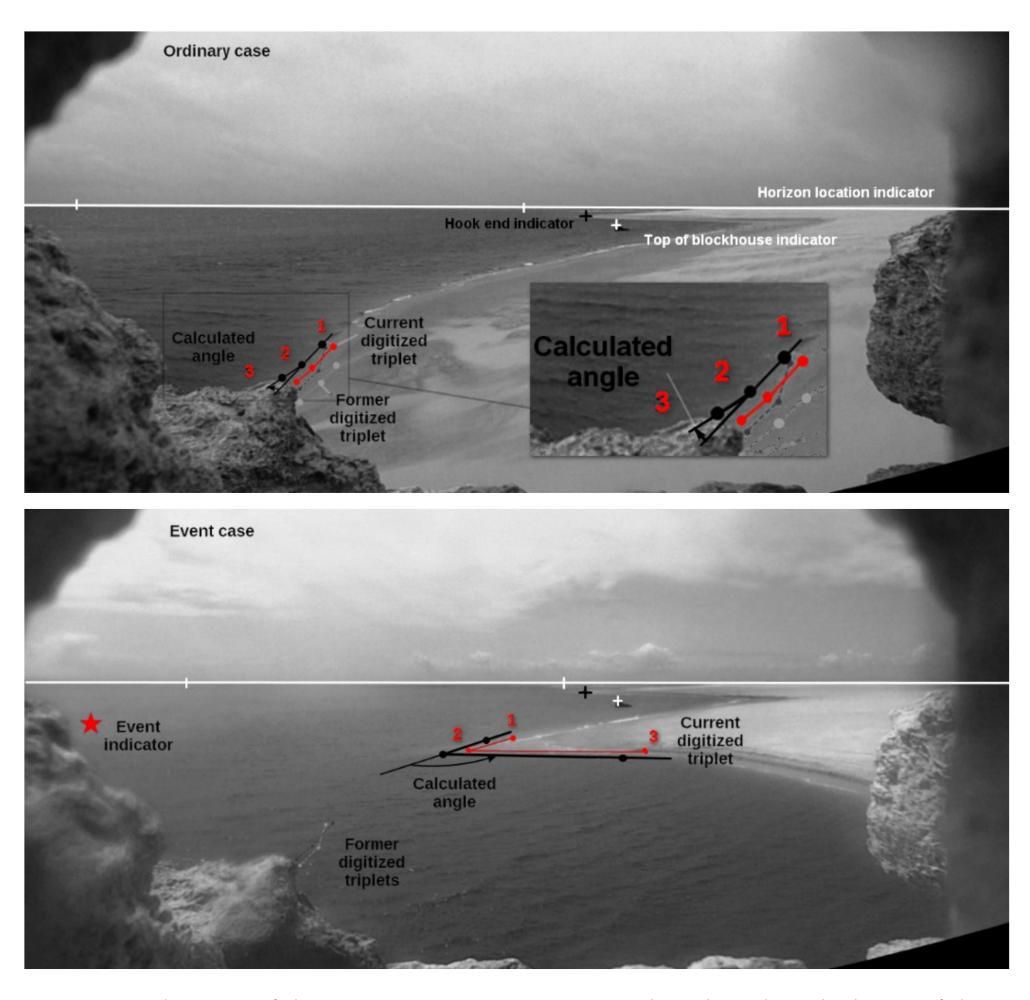
**Figure 15.** Schematic of the event intensity measurement based on the calculation of the nearby shoreline angle: ordinary case (**top**) and event case (**bottom**). Red dots and lines: current triplet used for angle calculation; black dots and lines: shifted copy of current triplet with graphical illustration of calculated angle; light grey and dark grey dots and lines: former locations of triplets.

Angles associated with triplets are meant to evaluate the shoreline deflection, substantially affected by excavations. The following schematic (Figure 15) illustrates the measurement principle. According to these principles, most angles should be close to 0, whereas angles related to flow slide events should have greater values, reaching more than 90 degrees.

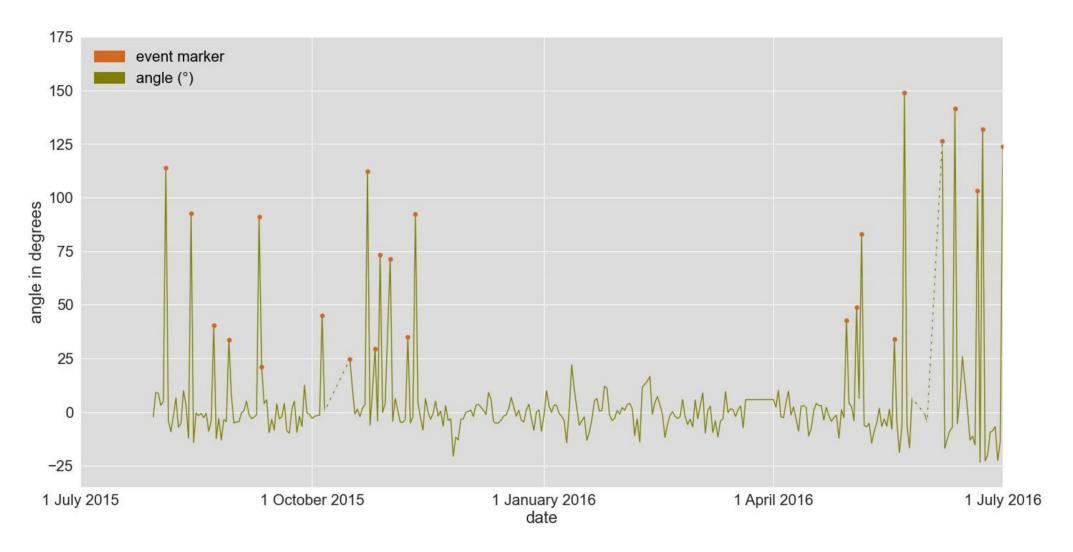
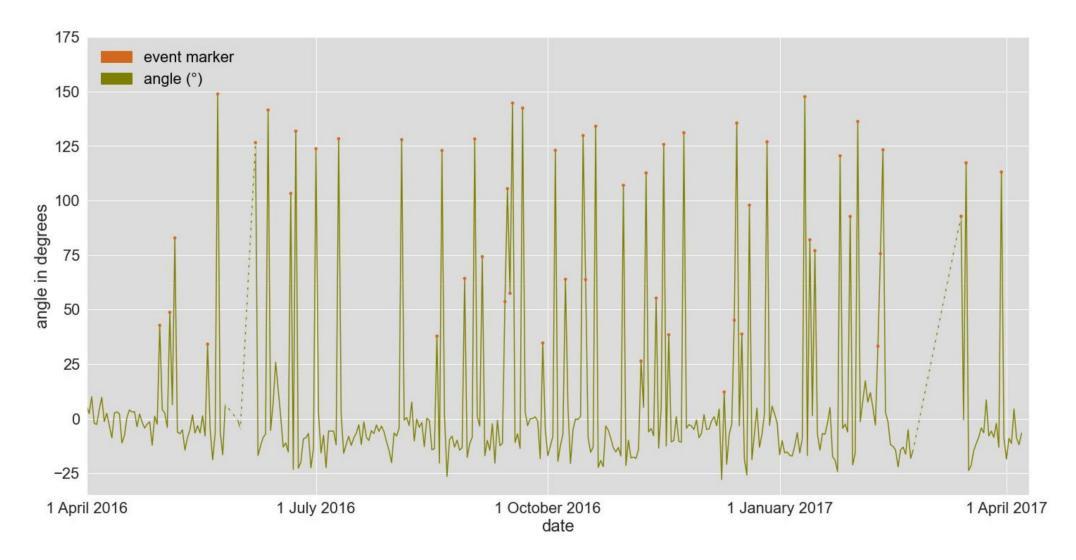
Figure 16. Timeline of shoreline angle and event markers.

Angles and events are presented on a timeline graph split into two periods (Figure 16). Missing dates are marked with a dotted line. Events are marked with red dots added to the curve. They mainly appear on peaks, but may be located on other parts of the curve when two events succeed one another before complete healing.

In the subsequent Discussion section, we develop an analysis, using the monitored data, of the relationship between the interruption of flow slide mechanisms, as seen in Figure 16, and movements of the sand spit, as seen in Figure 20.

This application shows true potential for studies of relationships between sedimentary processes and the occurrence of flow slides, as recorded in Figure 16 and classified in Figure 17.

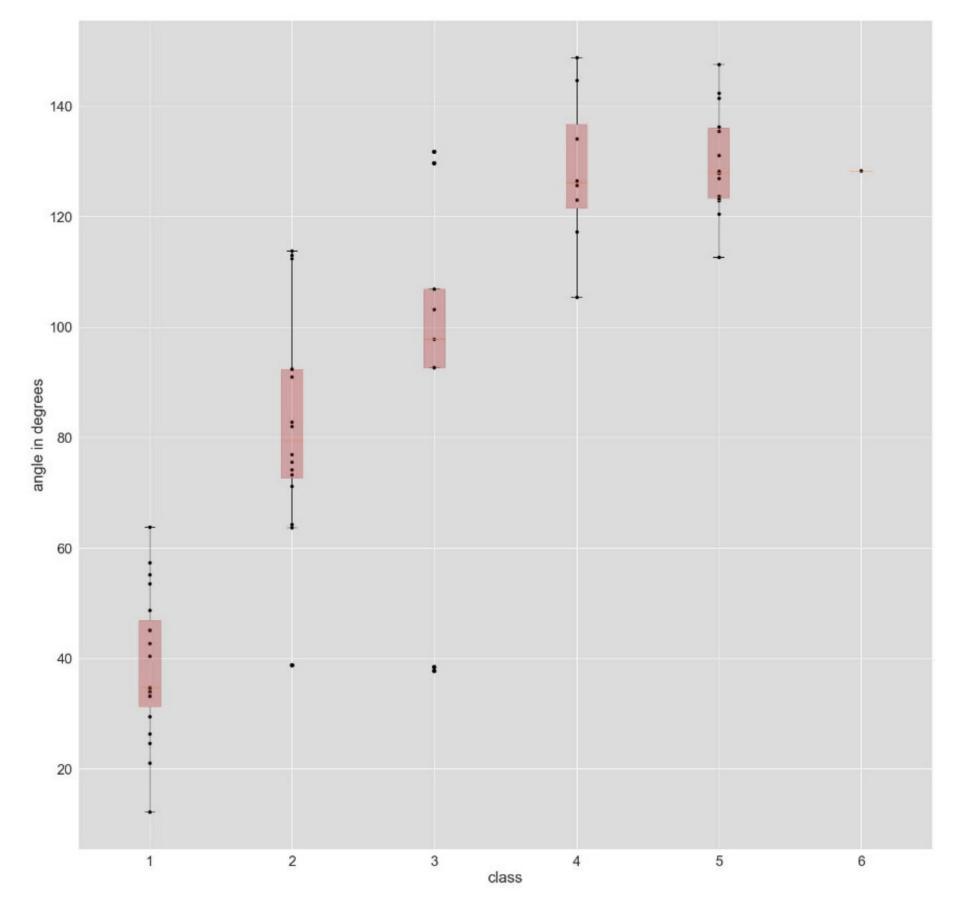
Figure 17. Comparison graph of event angle value versus visual class.

This quantitative method was compared with the simple visual classification of events into six classes. Figure 17 presents the angle versus the visual class. The only event in the sixth class was left separate because of its size being slightly greater in appearance than that of the largest class. This chart shows adequate overlapping between ranges of angles and visual classes for the first four classes. However, the operator's human eye could distinguish differences between events with angles greater than 120 degrees, which could not be distinguished by the angular method. This may be related to the loss of picture accuracy with distance and exact shoreline shape identification. In the Discussion, it is presented that this difference may not significantly affect season-scale interpretation.

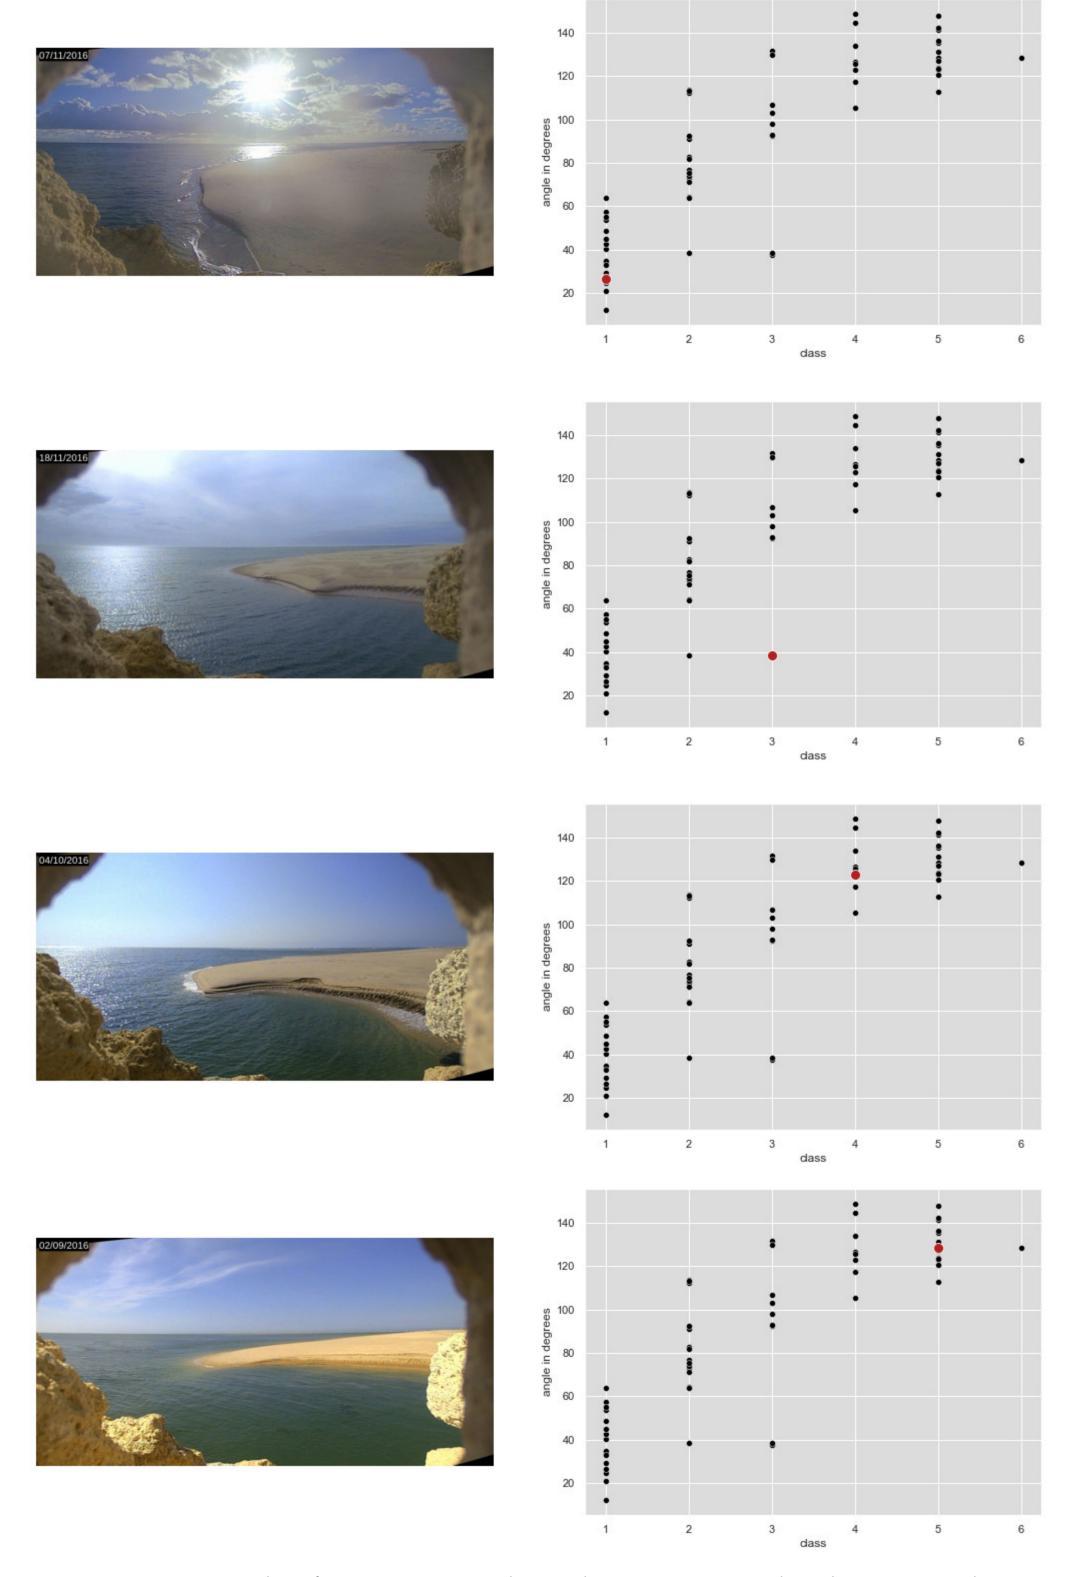
**Figure 18.** Four examples of event views together with comparison graphs. The corresponding point is red.

Differences between the visual class and angle value are illustrated by the four following representations of an image with their corresponding point in a comparison graph (marked by a red dot) (Figure 18). This shows the discordance between both methods due to double event occurrence, or a lack of accuracy with distance, in particular.
